## Laboratory Analyses of A Stone & Masonry Mortars From Robert C Weaver Federal Building in Washington, D.C.

Robert C Weaver Federal Building (HUD)  
451 7<sup>th</sup> Street SW  
Washington, D.C.

March 25, 2020  
CMC 0320114

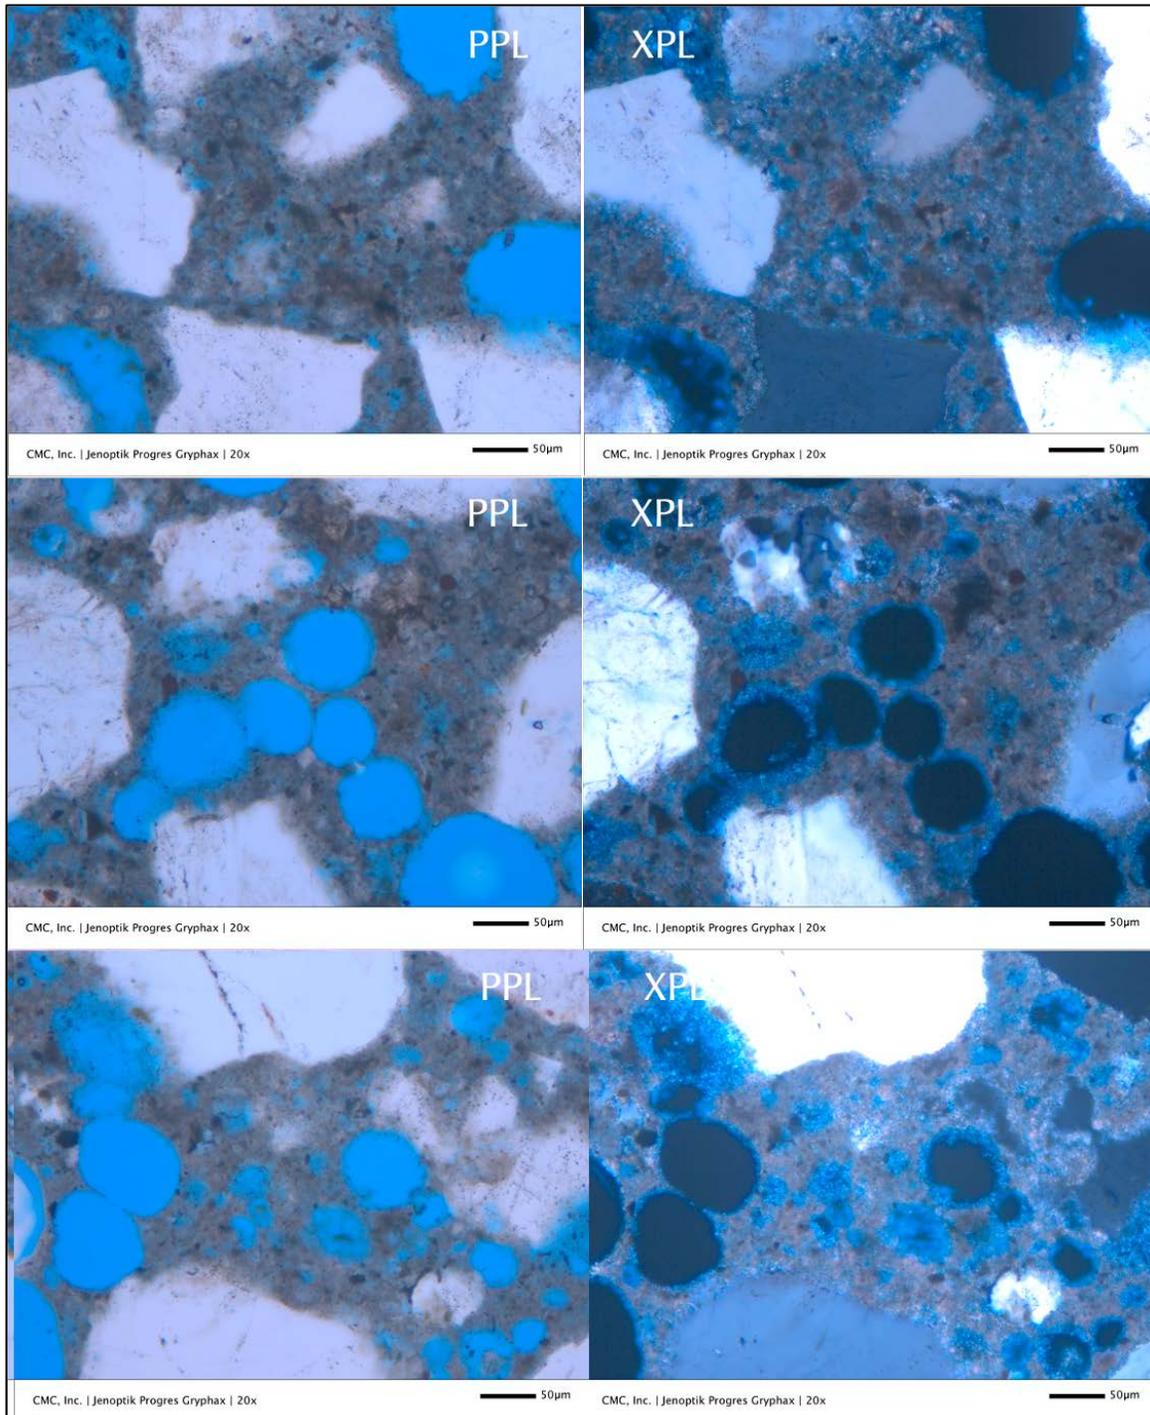
Figure 14: Optical micrographs of the original mortar (#3) from 1960s construction showing: (a) overall carbonated nature of the interstitial matrix between sand particles, which is a characteristic microstructure of many masonry cement mortars; (c) abundant fine discrete spherical and near-spherical entrained air voids (highlighted by blue epoxy), which is also common in many masonry cement mortars. This mortar also appeared to be a masonry cement mortar as the original one (#2) but has abundant air-entrainment and minor to trace amounts of limestone fines in the binder and major amount of hydrated lime contrary to lack of a good air entrainment, and abundant limestone fines found in the masonry mortar #2. Notice remains of Portland cement particles are very few to detect except for a few dark brown ferrite remains of cement, indicating use of more lime than cement in the original binder (proportions of binder components are similar to an ASTM C 270 Type N masonry cement mortar).

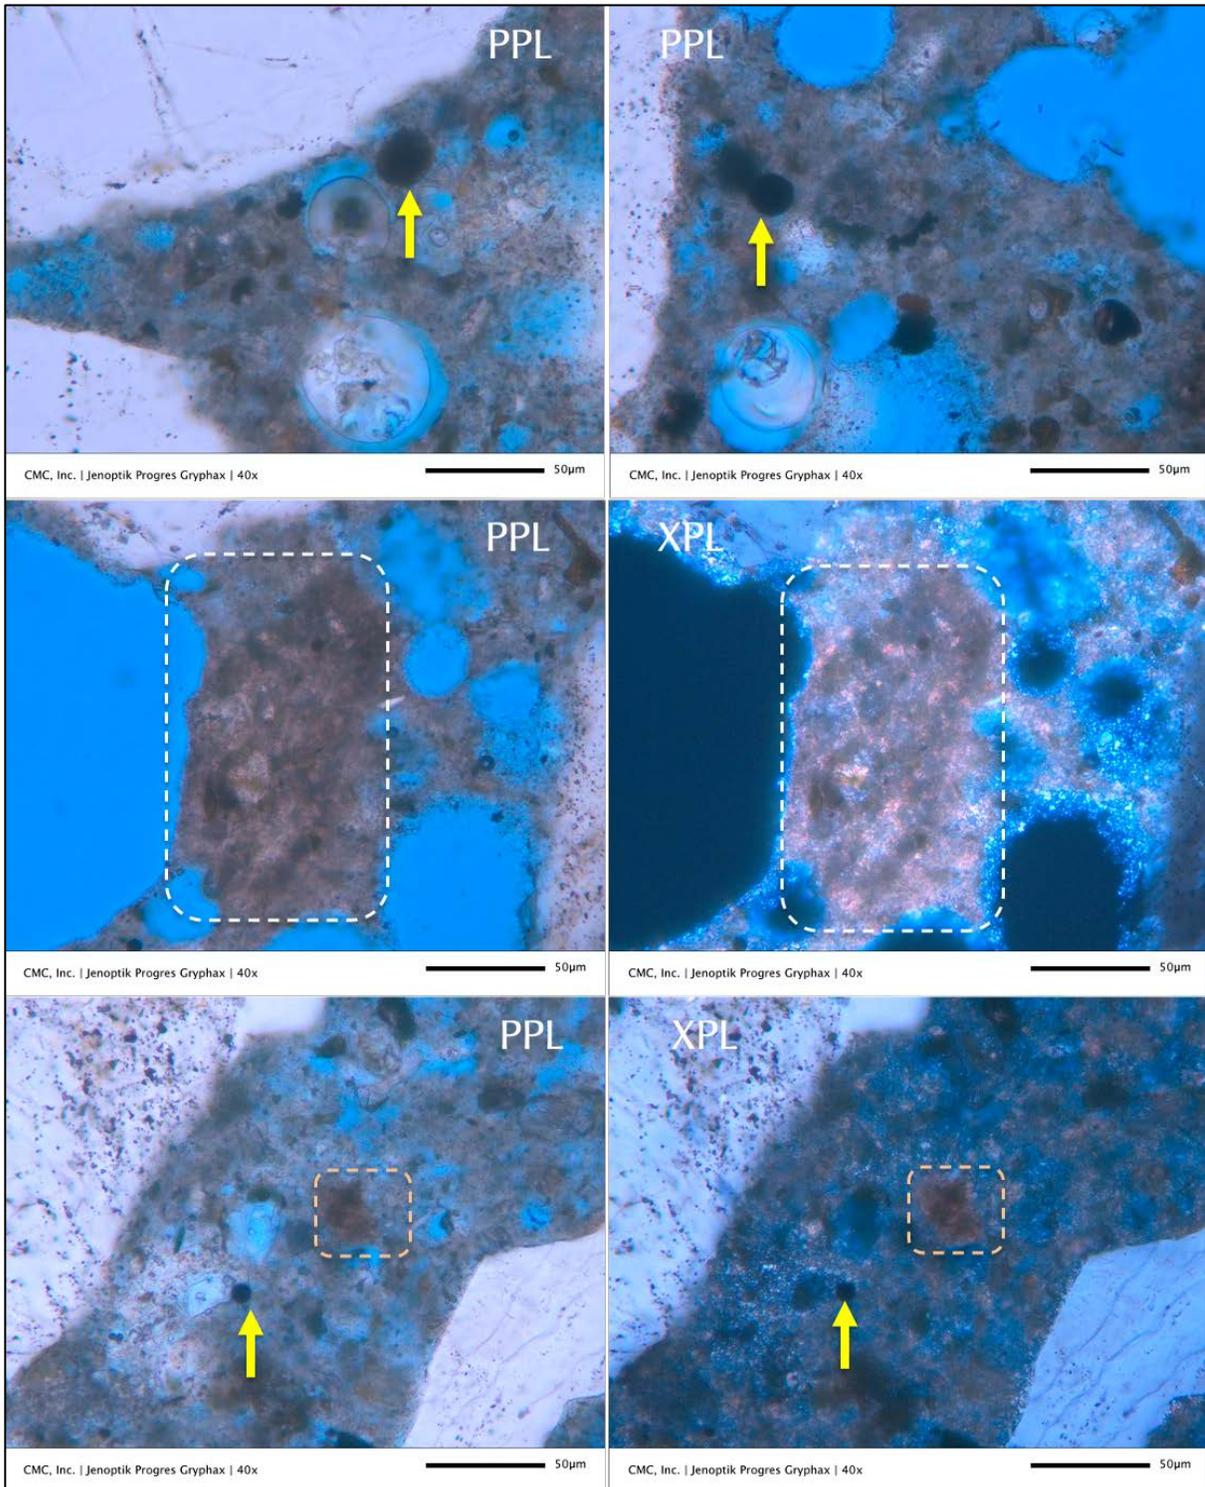
Figure 15: Optical micrographs of the original mortar (#3) from 1960s construction showing: trace amounts of dark brown to black spherical fly ash particles (marked with arrows) whose amount is lower than that anticipated from use of a blended cement and more representative of accidental contamination in the masonry cement. Boxed areas in the middle photo show a region that is denser than porous fine-grained carbonated lime based matrix, often occur as brown color tone that represents denser paste from cement hydration products. Small boxed areas in the bottom row show small patches of dolomitic hydrated lime that was added in the masonry cement binders.

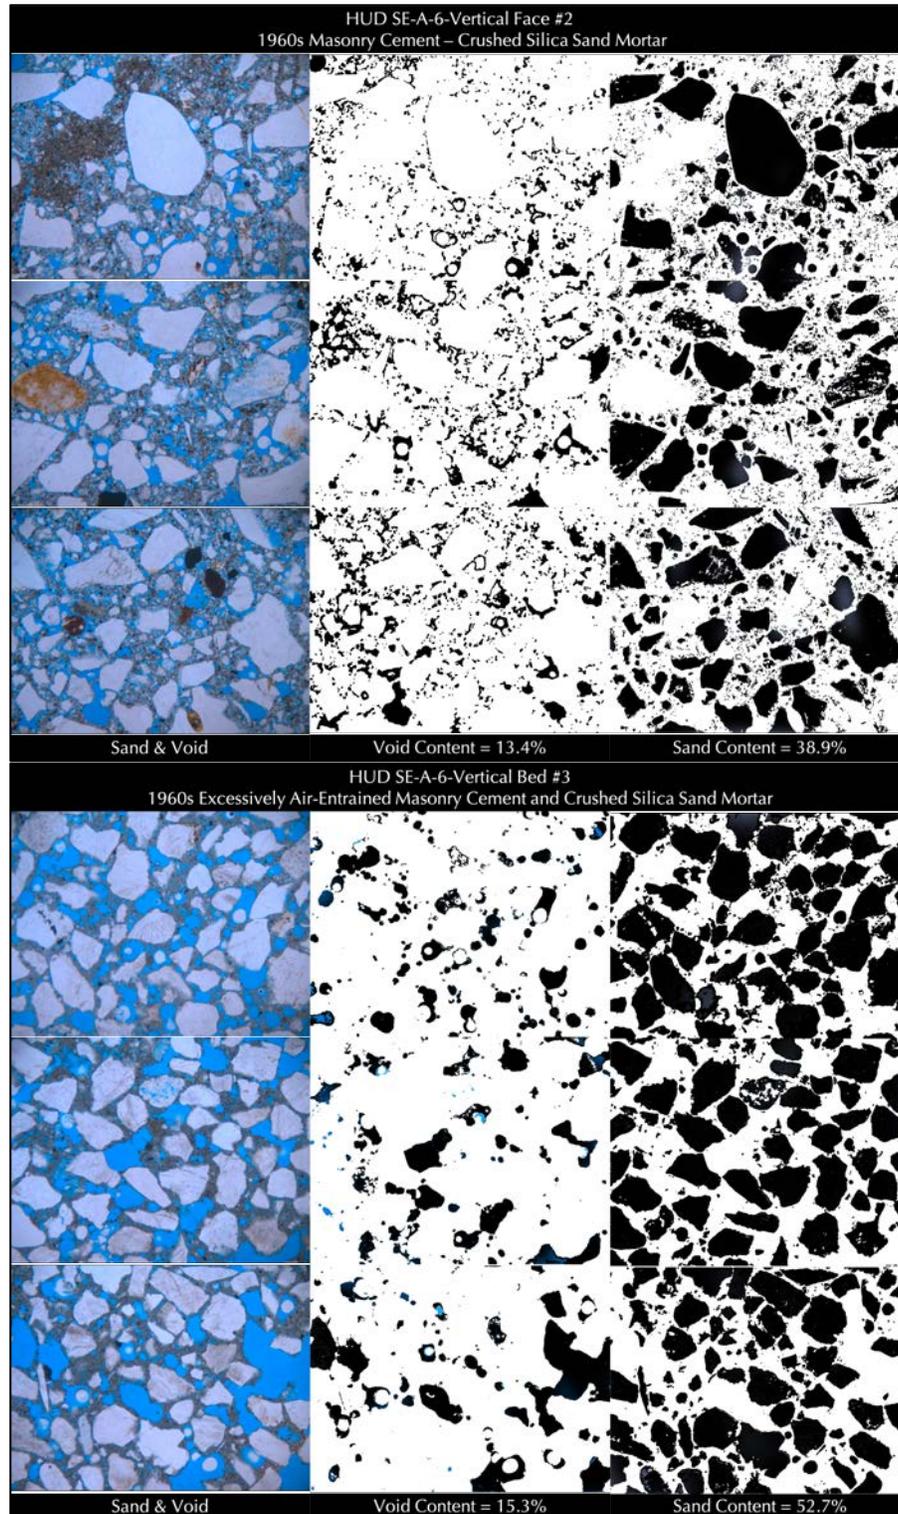
Figure 16: Image analyses (from Image J) to determine void and sand contents from optical micrographs of thin section of two original mortars. Left column shows plane polarized light photos of distribution of sands and voids from which black and white contrast enhancements were done to highlight voids in black in the middle column and sand in the right column. Void and sand contents were subsequently determined from Image J open source image analysis software (<https://imagej.nih.gov/ij>).

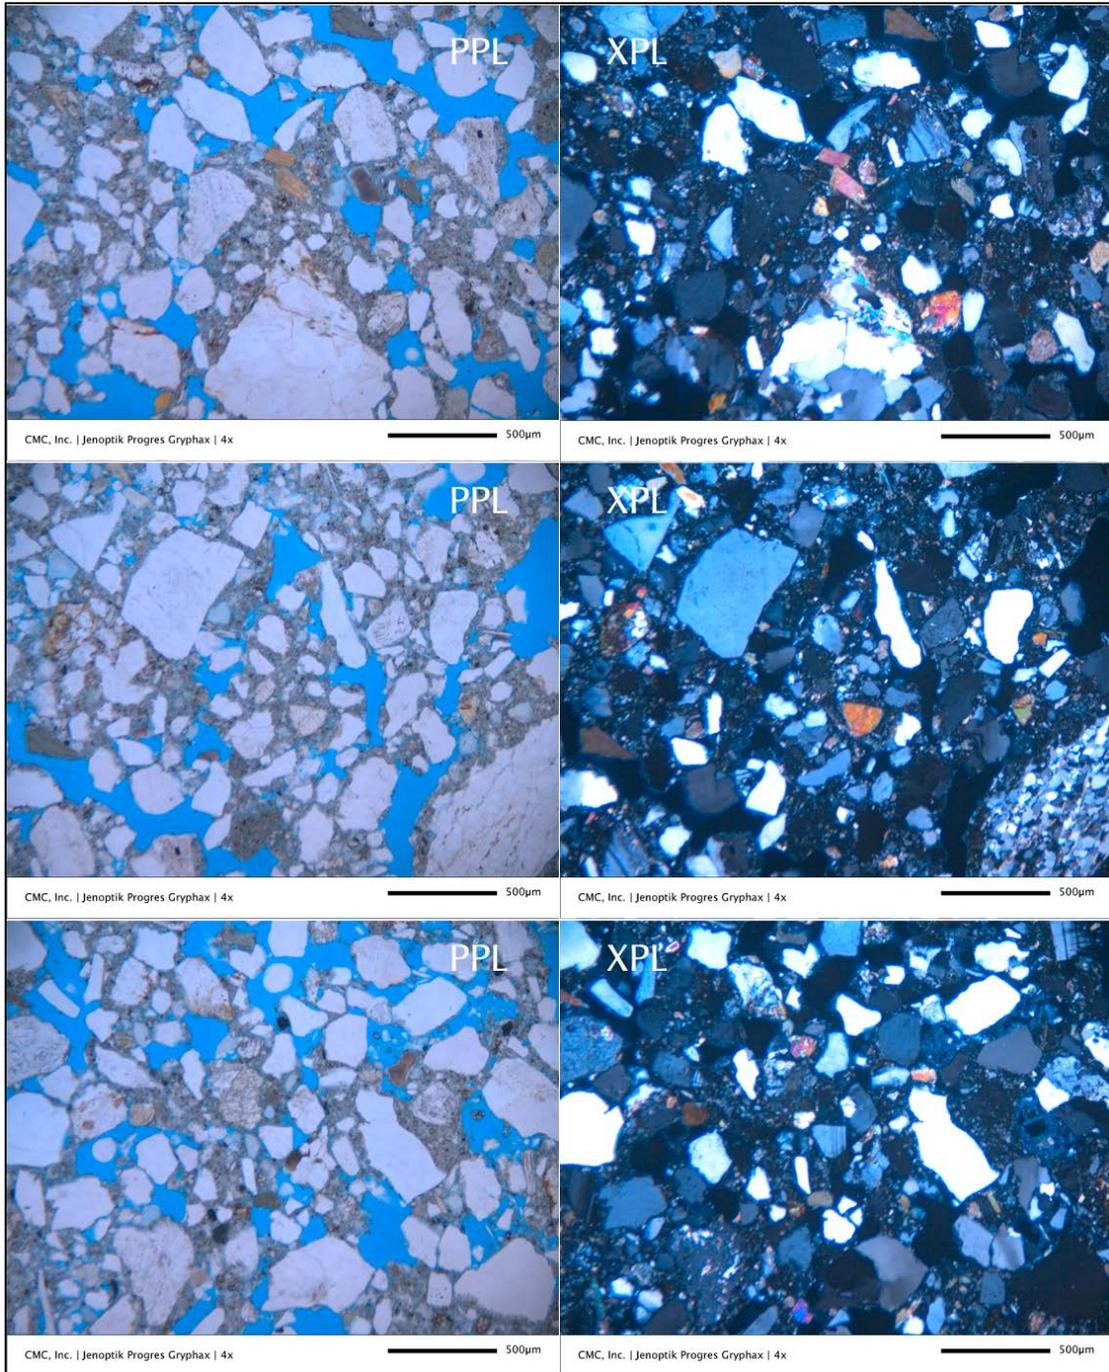
Figure 17: Optical micrographs of a recent mortar (#4) from 2019 construction showing: (a) crushed siliceous sand consisting of major amount of variably strained quartz, subordinate amount of quartzite, feldspar, schist, and other siliceous particles (no carbonate components were found in the sand, feldspar content of sand is higher than that found in the two original mortars); (b) overall non-carbonated nature of the interstitial matrix between sand particles, which is not a characteristic microstructure of masonry cement mortars found in the original mortars but more common of cement-lime mortars that have not been carbonated yet; (c) abundant irregularly-shaped air voids (highlighted by blue epoxy), giving an overall porous nature of the microstructure. The mortar appears to be a cement-lime mortar as opposed to two different types of masonry cement mortars (one with abundant lime and another with abundant limestone fines) found in the original 1960s construction.

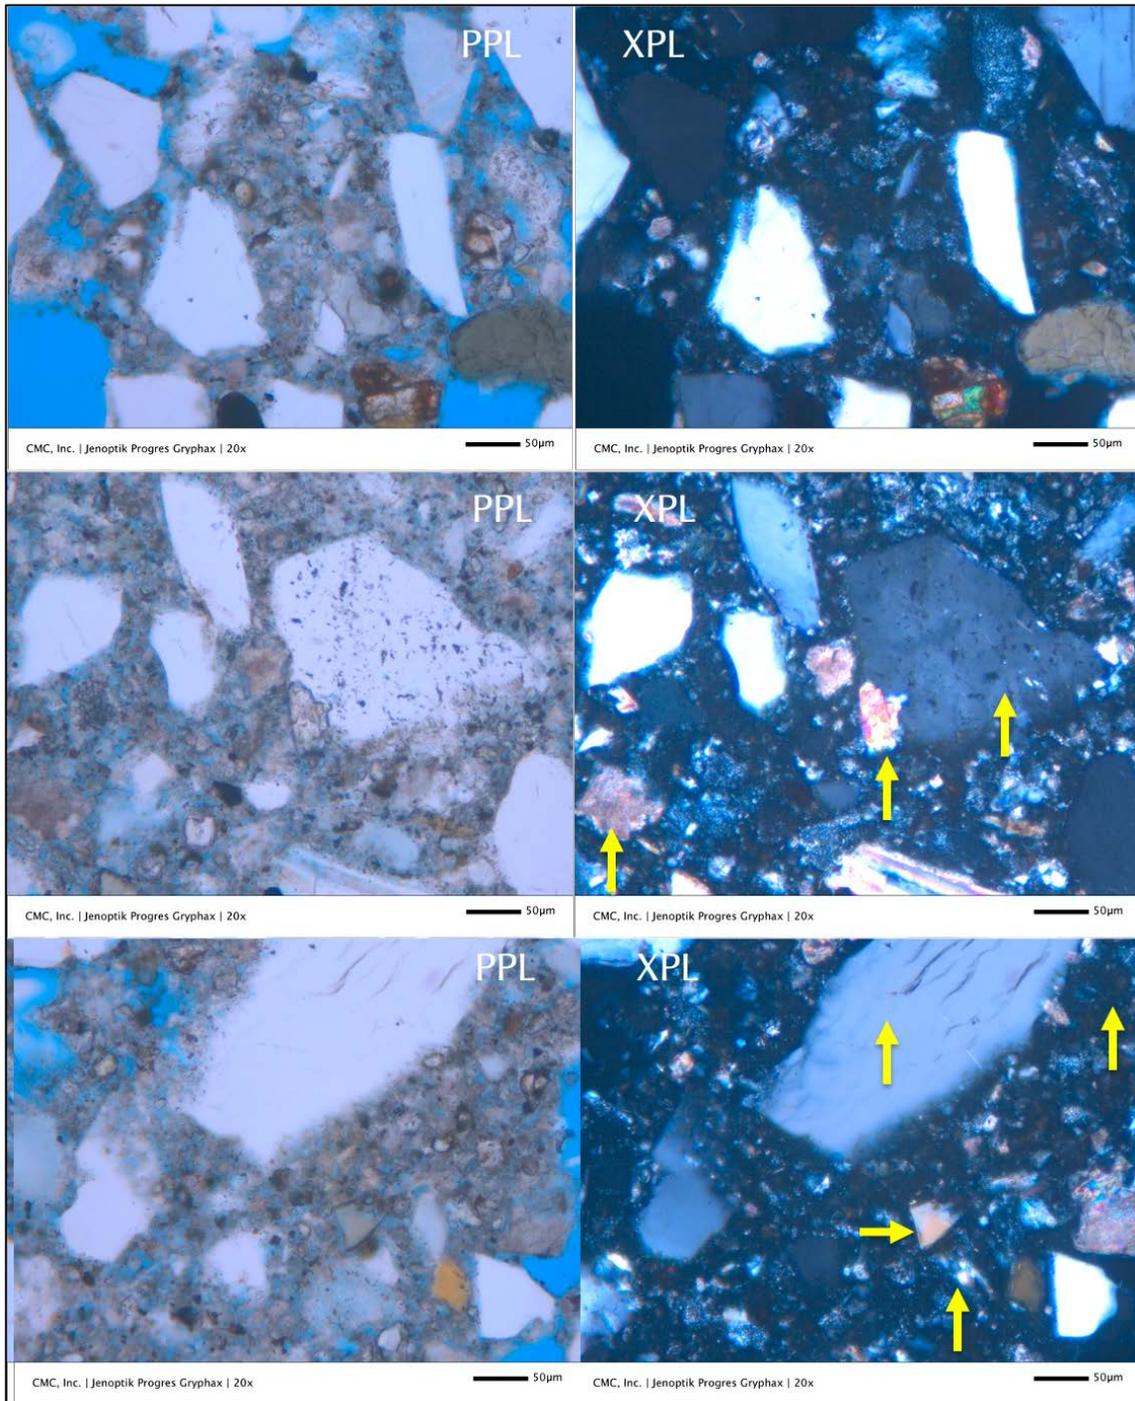
Figure 18: Optical micrographs of a recent mortar (#4) from 2019 construction showing: (a) crushed siliceous sand consisting of major amount of variably strained quartz, subordinate amounts of quartzite, feldspar, schist, and other siliceous particles (no carbonate components were found in the sand, feldspar content of sand is higher than that found in the two original mortars); (b) overall non-carbonated nature of the interstitial matrix between sand particles, which is not a characteristic microstructure of masonry cement mortars found in the original mortars but more common of cement-lime mortars that have not been carbonated yet; (c) hydration products of Portland cement and residual cement particles and a few clumps of hydrated lime and calcium hydroxide component of cement hydration (a few are marked with arrows) that are found in the denser paste fractions. The mortar appears to be a cement-lime mortar as opposed to two different types of masonry cement mortars (one with abundant lime and another with abundant limestone fines) found in the original 1960s construction.

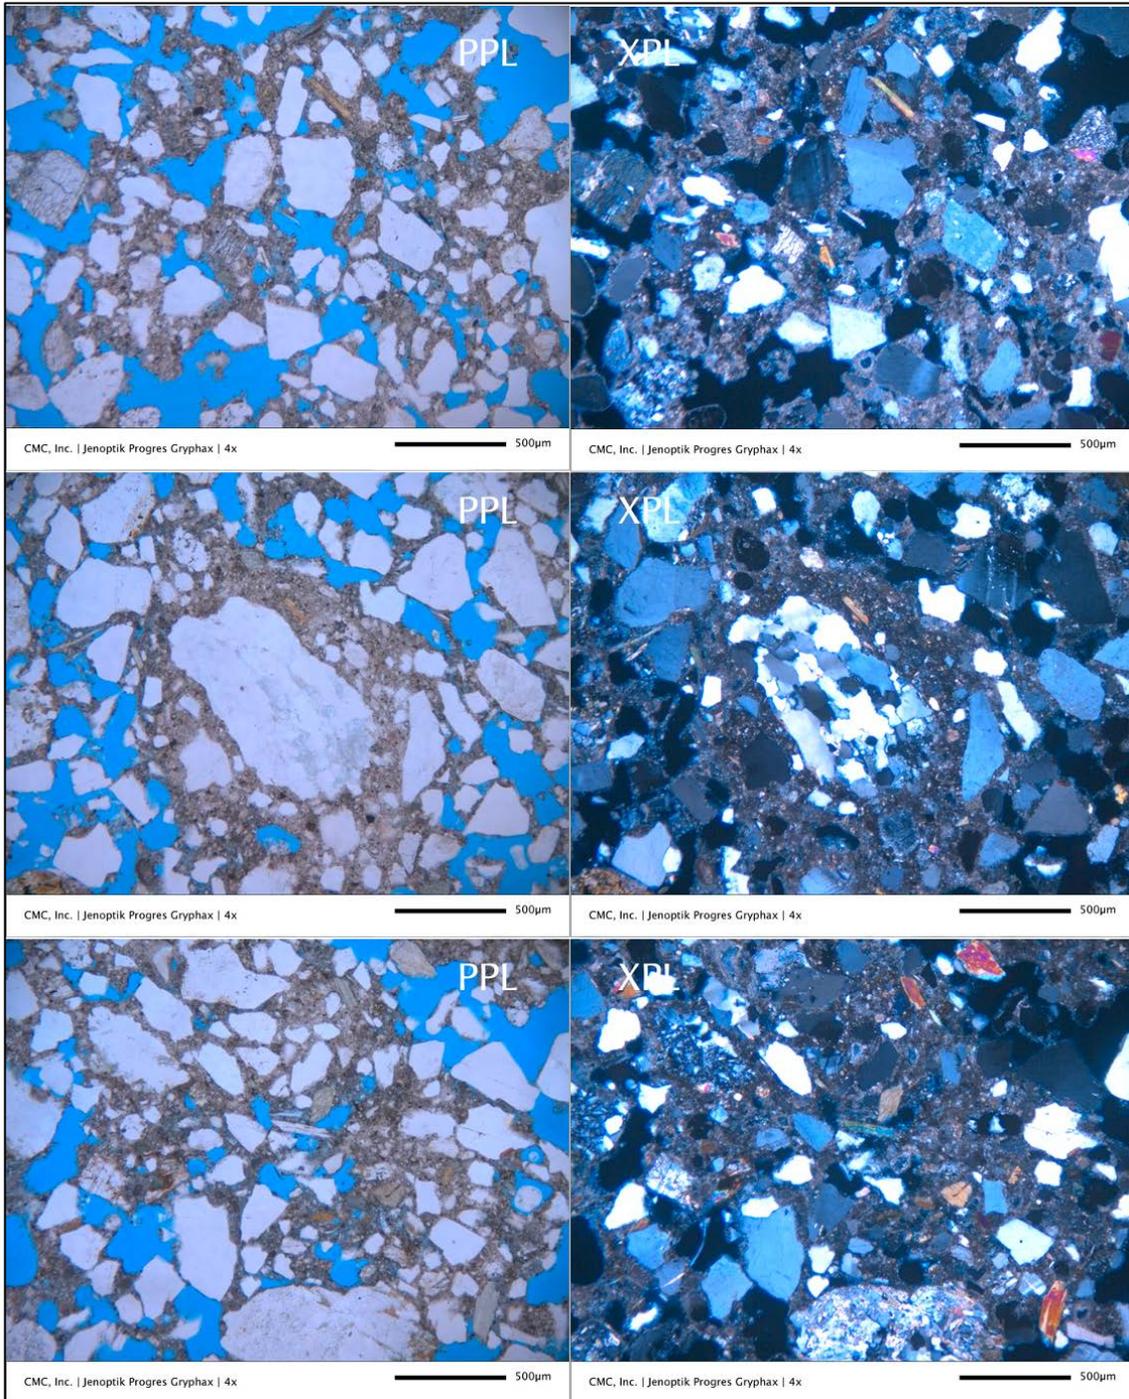
Figure 19: Optical micrographs of a recent mortar (#5) from 2019 construction showing: (a) crushed siliceous sand consisting of major amount of variably strained quartz, subordinate amount of quartzite, feldspar, schist, and other siliceous particles (no carbonate components were found in the sand, feldspar content of sand is higher than that found in the two original mortars); (b) overall carbonated nature of the interstitial matrix between sand particles, which is a characteristic microstructure of masonry cement mortars as found in the original mortars; (c) abundant irregularly-shaped air voids (highlighted by blue epoxy), giving an overall porous nature of the microstructure. The mortar appears to be a masonry cement mortar but not similar to the high-lime or high-limestone fine based masonry cement mortars found in the original 1960s construction since neither of those two binder components are found in levels higher than usually found in common ASTM C 270 Type M, S, or N masonry cement mortars.

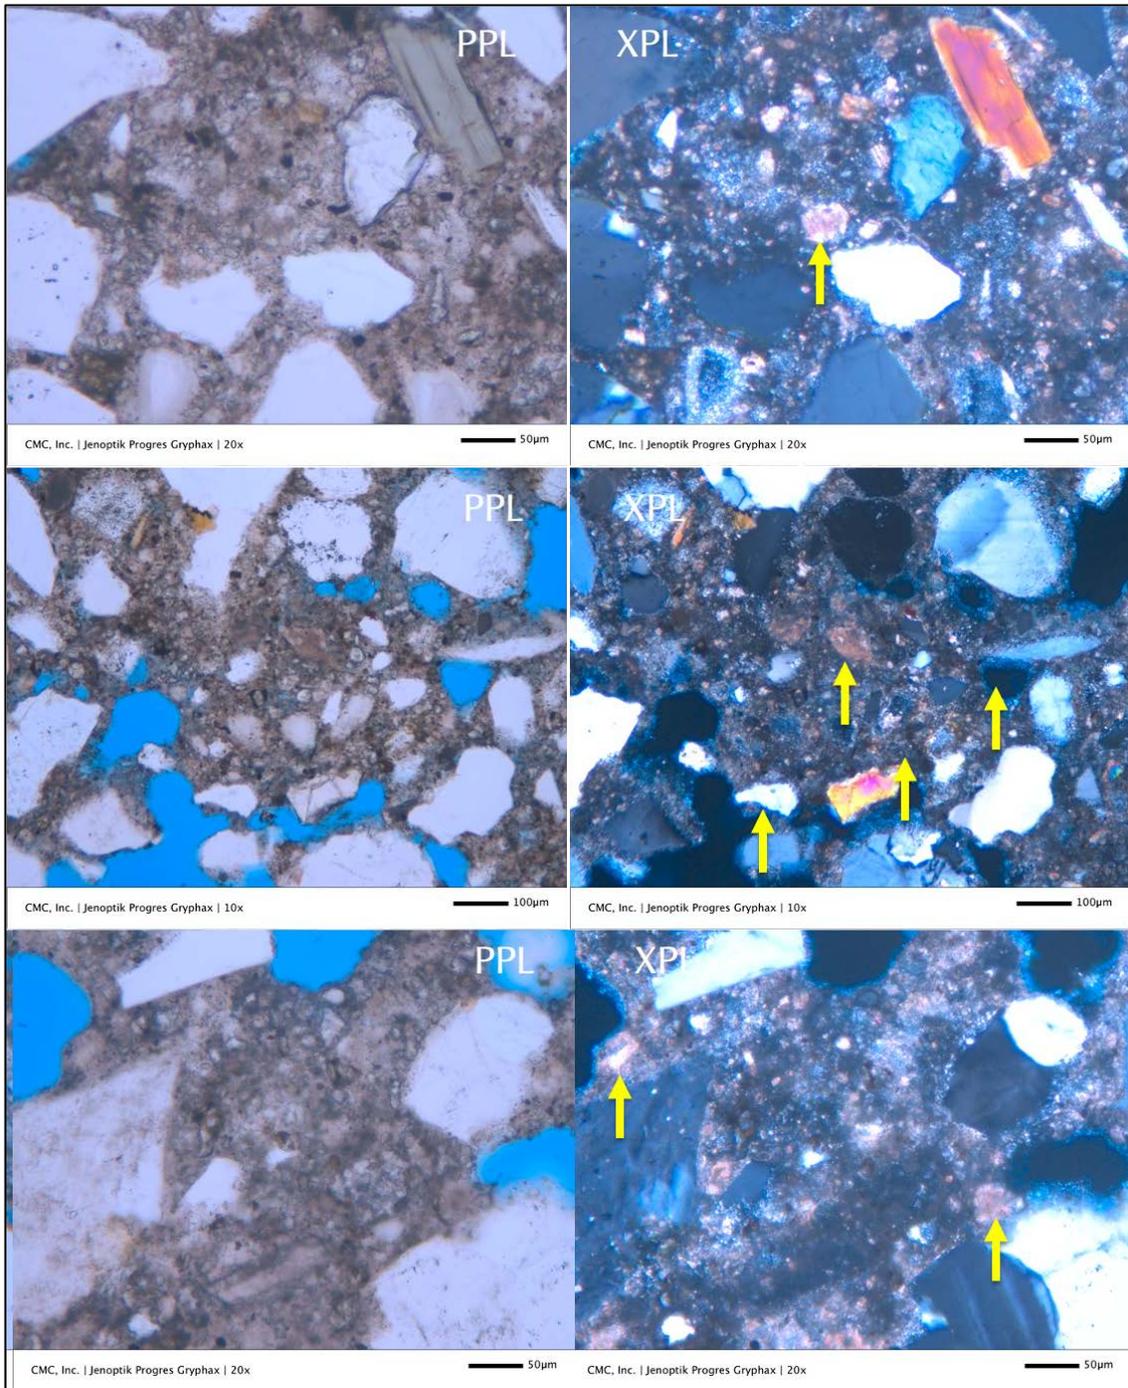
Figure 20: Optical micrographs of a recent mortar (#5) from 2019 construction showing: (a) crushed siliceous sand consisting of major amount of variably strained quartz, subordinate amount of quartzite, feldspar, schist, and other siliceous particles (no carbonate components were found in the sand, feldspar content of sand is higher than that found in the two original mortars); (b) overall carbonated nature of the interstitial matrix between sand particles, which is a characteristic microstructure of masonry cement mortars as found in the original mortars; (c) many patches of lime (some are marked with arrows) in the paste, which are mixed with limestone fines and abundant residual Portland cement particles. The mortar appears to be a masonry cement mortar but not similar to the high-lime or high-limestone fine based masonry cement mortars found in the original 1960s construction but in having more Portland cement than lime and limestone fine components (similar to an ASTM C 91 Type S masonry cement). The denser microstructure of paste is indicative of use of a polymer component in the mix.

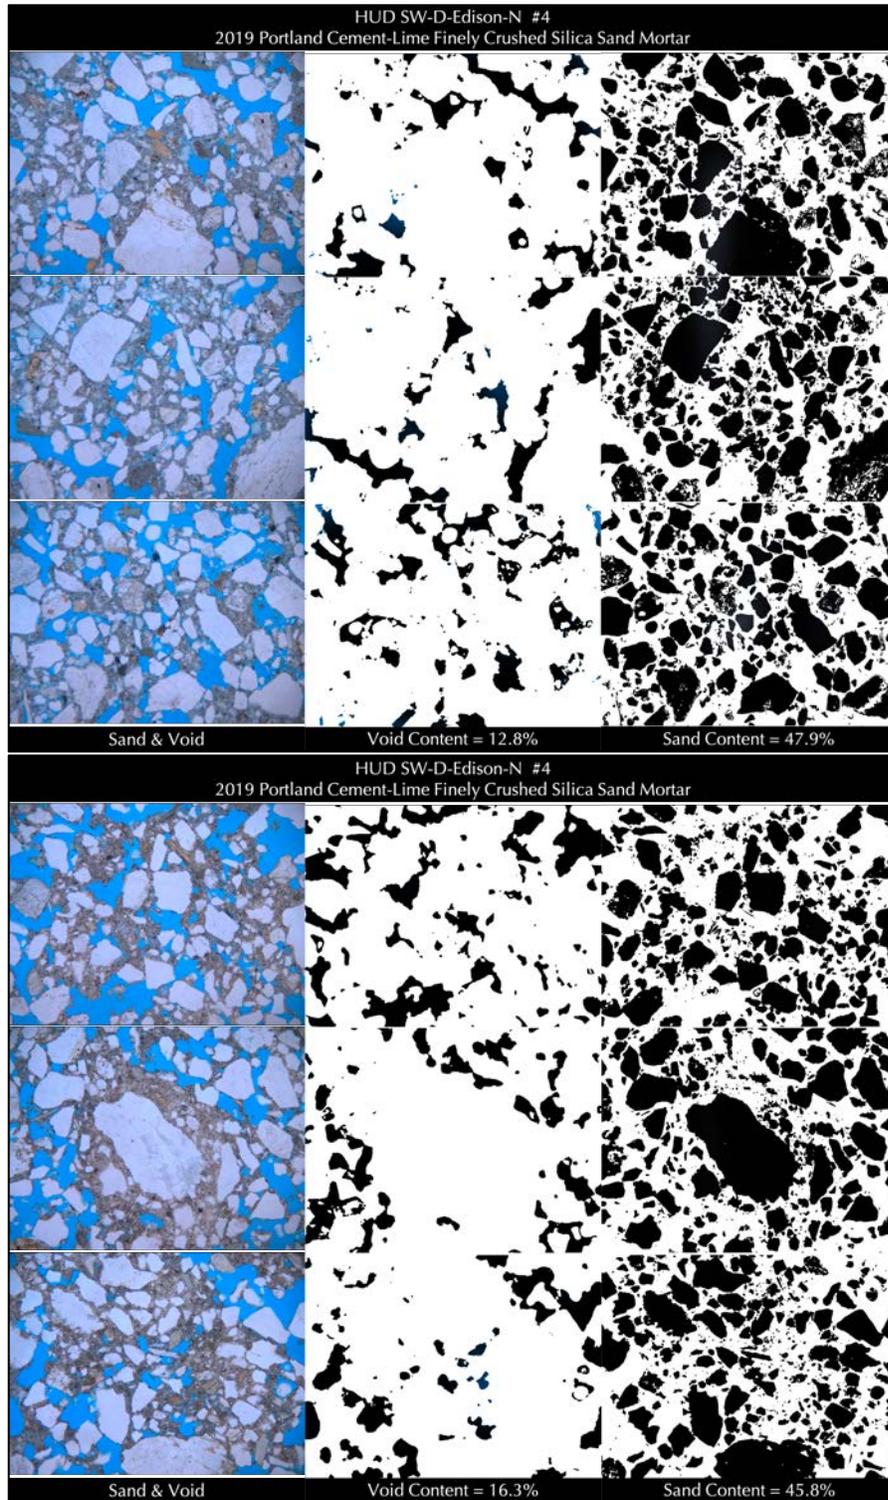
Figure 21: Image analyses (from Image J) to determine void and sand contents from optical micrographs of thin section of two recent mortars. Left column shows plane polarized light photos of distribution of sands and voids from which black and white contrast enhancements were done to highlight voids in black in the middle column and sand in the right column. Void and sand contents were subsequently determined from Image J open source image analysis software (<https://imagej.nih.gov/ij>).

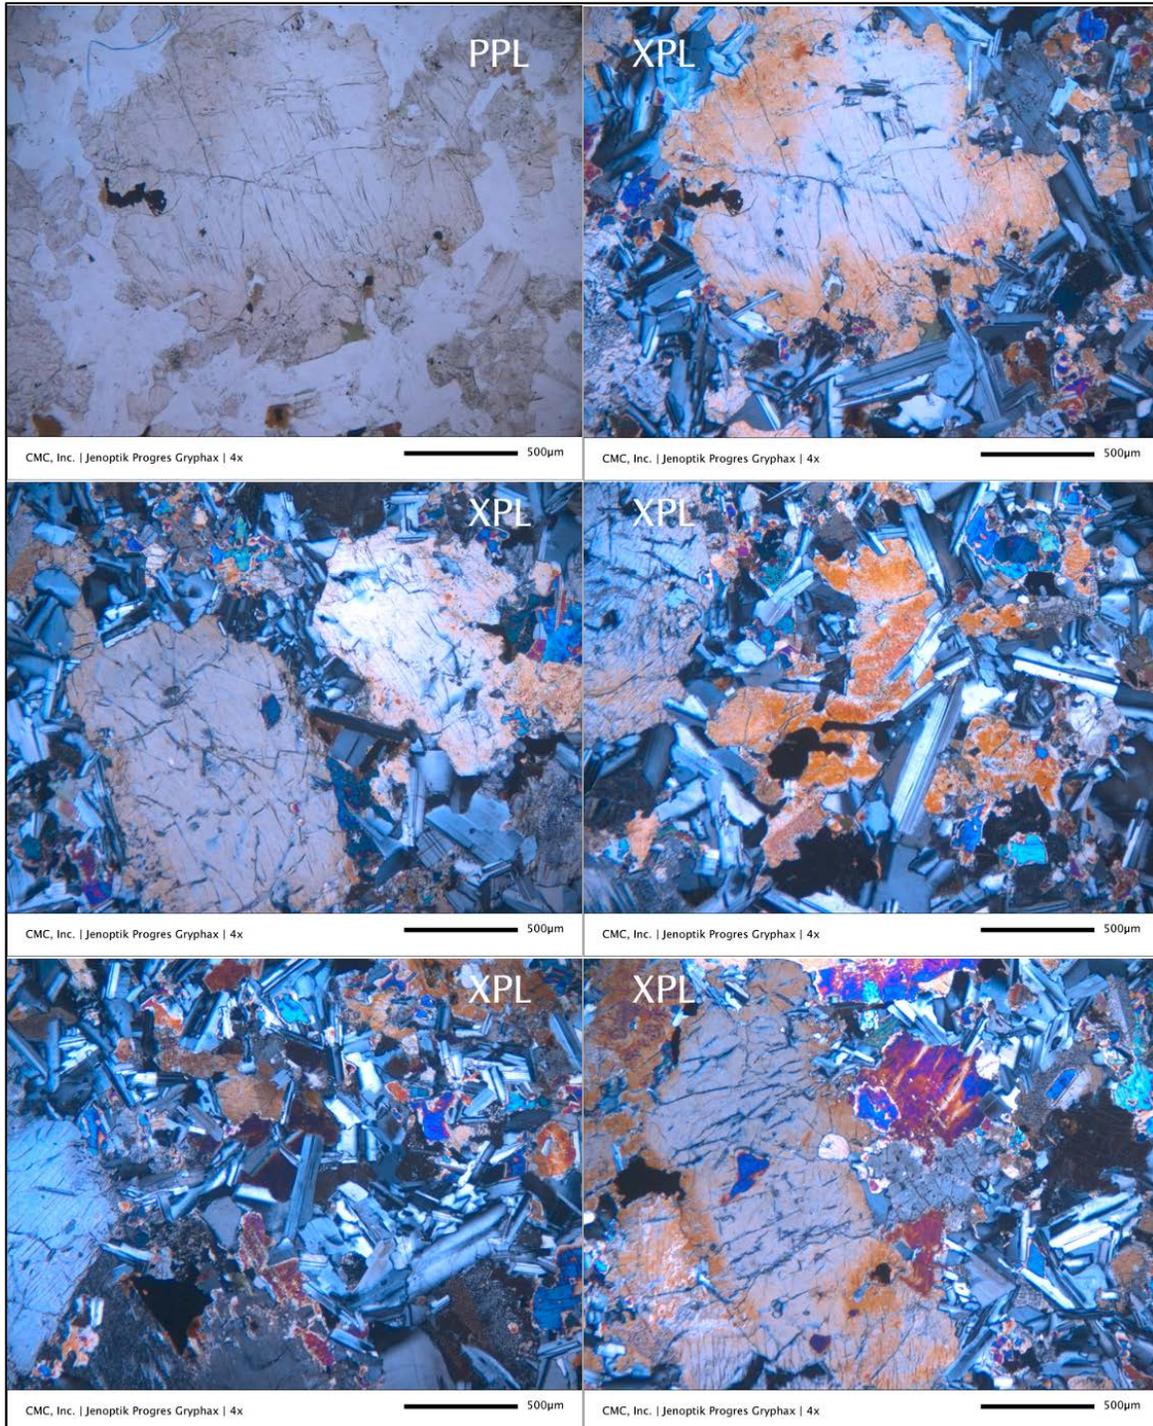
Figure 22: Optical micrographs of the stone sample showing medium-grained crystalline texture consisting of plagioclase feldspar laths and pyroxene crystals (ortho and clinopyroxenes) and a few dark mafic minerals in a subophitic textural arrangement due to partial enclosures of plagioclase laths by pyroxene crystals, which is typical mineralogy and texture of diabase, an intrusive basic igneous rock (also called dolerite in the European literatures), commonly found in many igneous sills (including the famous Palisades sill in New York).

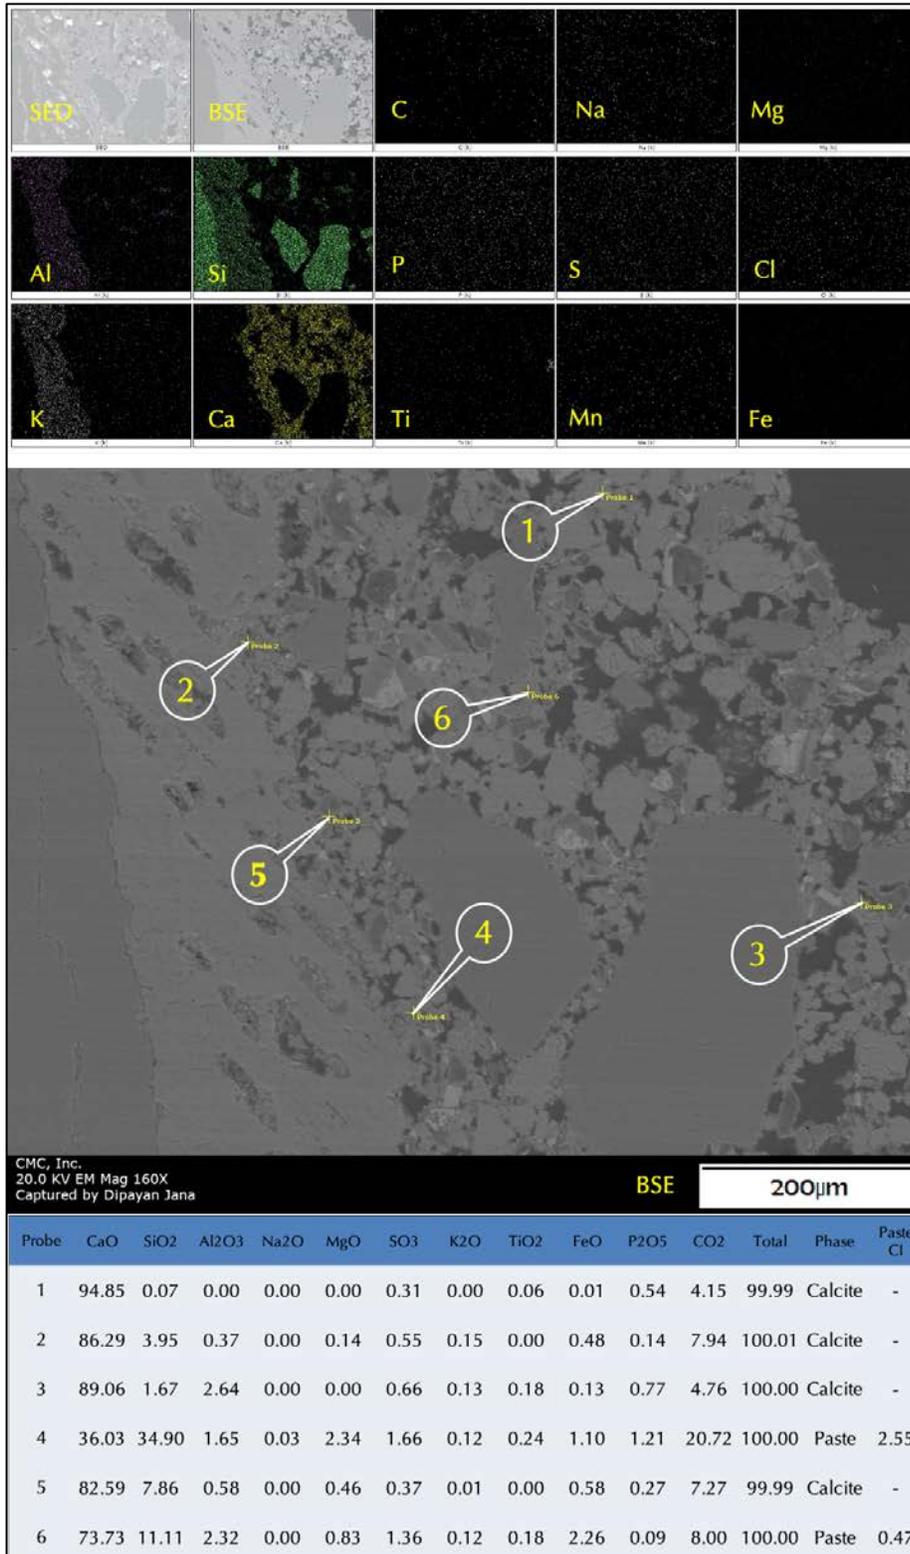
Figure 23: SEM-EDS studies of the original mortar #2 from 1960s construction.

The middle photo shows microstructure of mortar in an BSE image. Tips of callouts on this image are areas that were measured by energy-dispersive X-ray fluorescence spectrometer attached to SEM. Results are tabulated below for each Probe#.

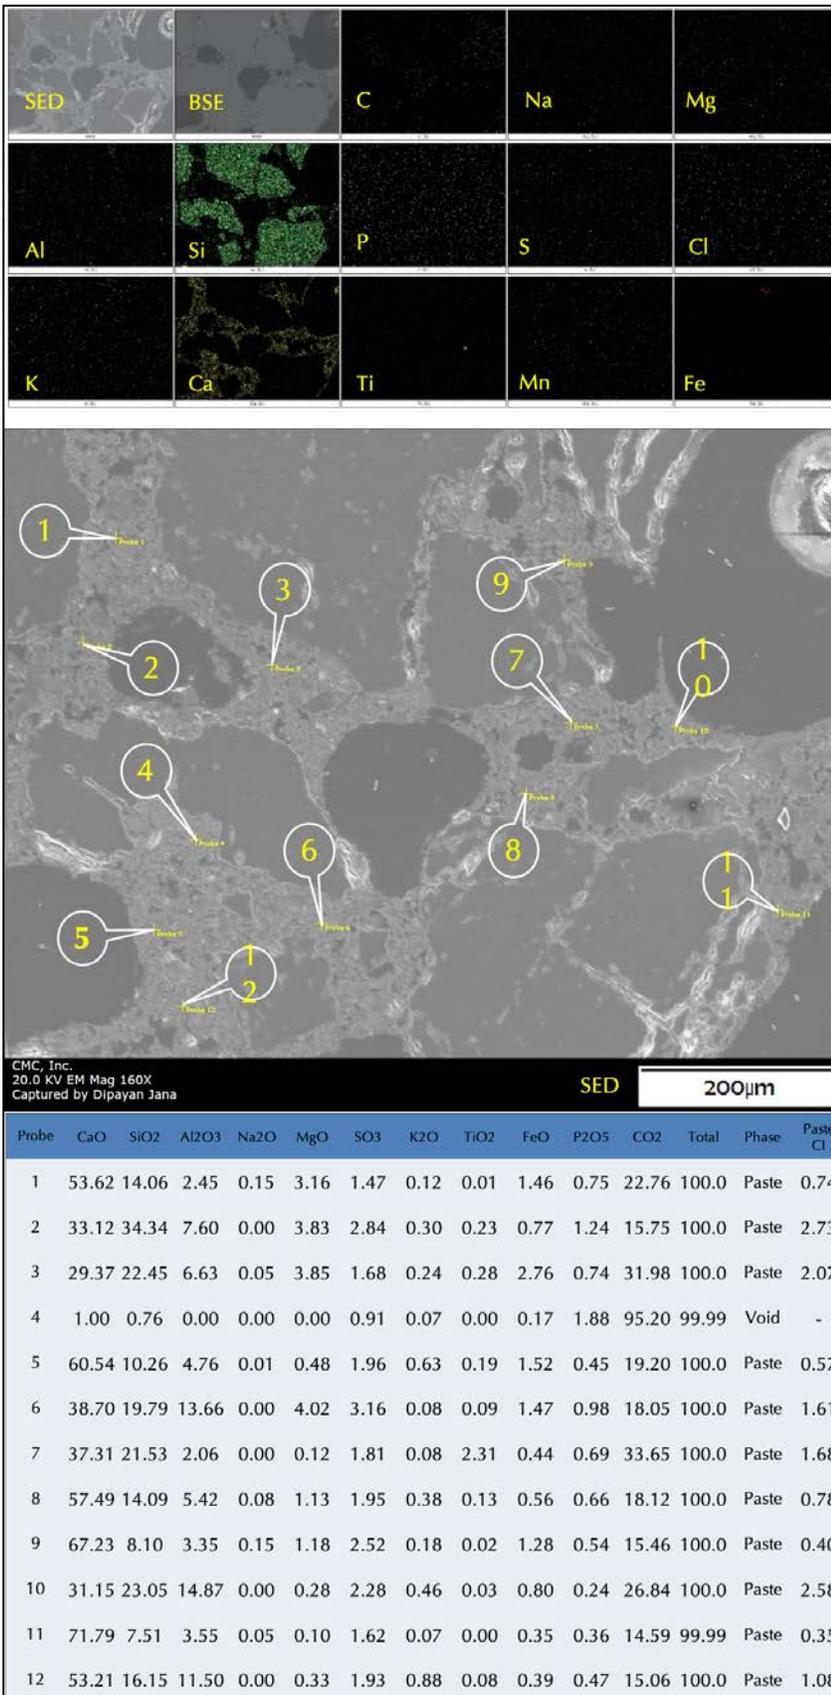
Figure 24: SEM-EDS studies of the original mortar #3 from 1960s construction.

The middle photo shows microstructure of mortar in an BSE image. Tips of callouts on this image are areas that were measured by energy-dispersive X-ray fluorescence spectrometer attached to SEM.

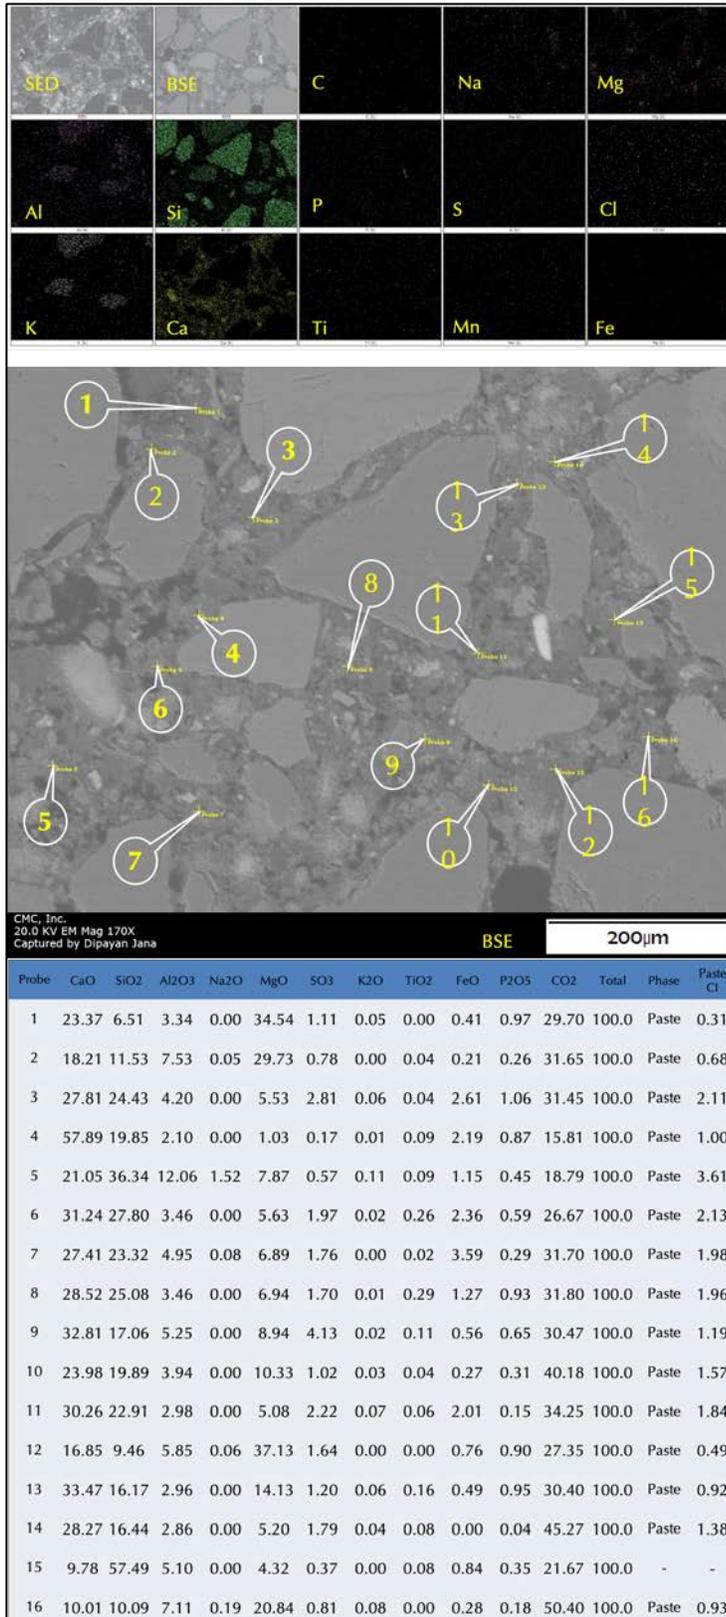
Figure 25: SEM-EDS studies of the recent mortar #4 from 2019 construction.

The middle photo shows microstructure of mortar in an BSE image. Tips of callouts on this image are areas that were measured by energy-dispersive X-ray fluorescence spectrometer attached to SEM.

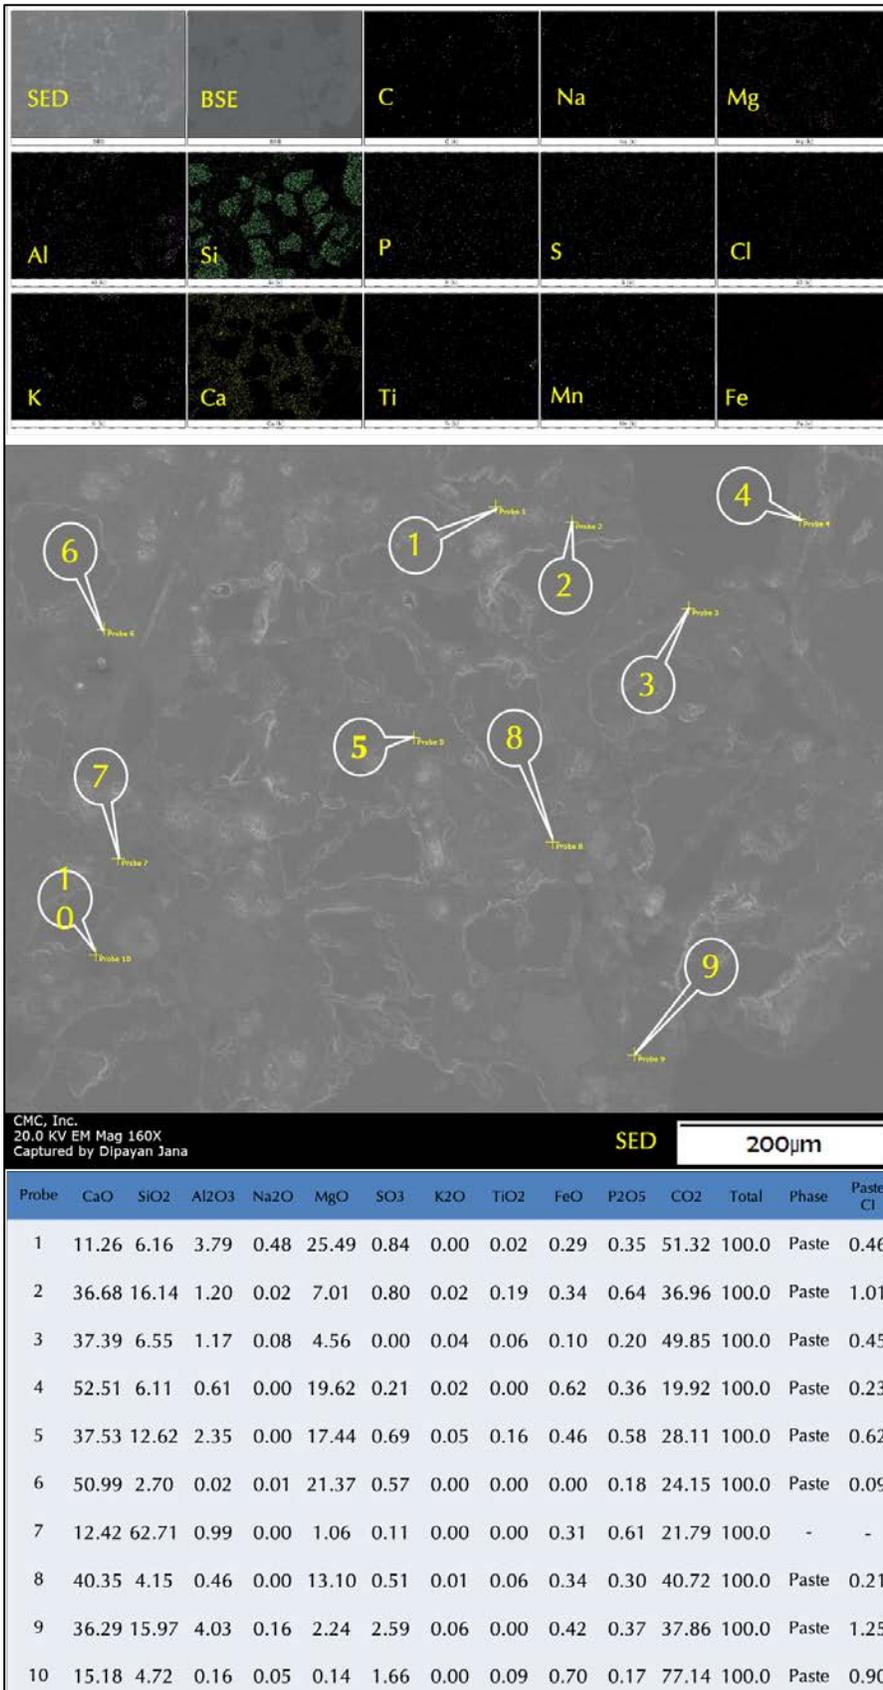
Figure 26: SEM-EDS studies of the recent mortar #5 from 2019 construction.

The middle photo shows microstructure of mortar in an SED image. Tips of callouts on this image are areas that were measured by energy-dispersive X-ray fluorescence spectrometer attached to SEM.

Notice the overall denser microstructure of paste compared to other mortars due to incorporation of a polymer component in the mix.
