## Laboratory Analyses of A Stone & Masonry Mortars From Robert C Weaver Federal Building in Washington, D.C.

Robert C Weaver Federal Building (HUD)  
451 7<sup>th</sup> Street SW  
Washington, D.C.

March 25, 2020  
CMC 0320114

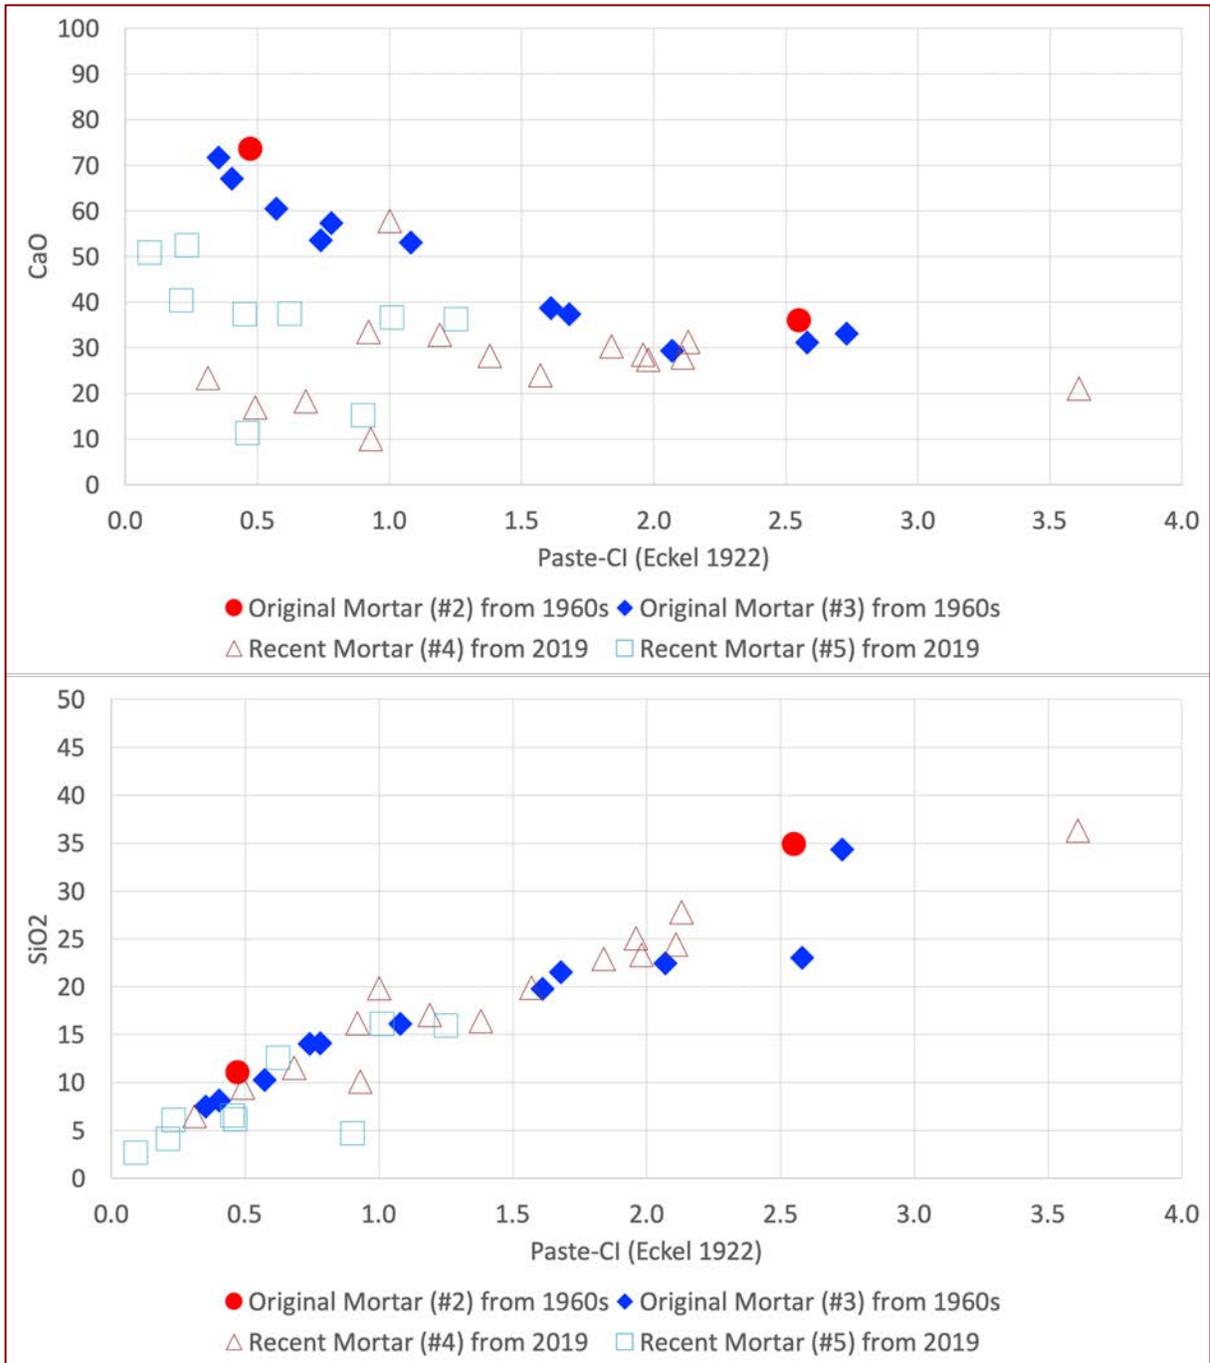
Figure 27: Variations in lime and silica contents of pastes plotted against paste-CIs from the original (1960s) mortars #2 (filled red circle) and #3 (filled blue diamond), and recent (2019) mortars #4 (open triangle) and #5 (open square). Results show a very typical characteristic trend of increasing silica content of paste with decreasing lime content resulting in increasing paste-CI. A modern cement-lime mortar shows similar trends of lime and silica contents against paste-CI due to variations in lime and cement contents. Trends as seen here are due to multiple factors from various binder types used in these mortars from Portland cement to lime to limestone fines along with various degrees of alterations during service that also alters the paste-CI, e.g., from lime leaching. Paste-CIs for most plots are results of such alterations, rather than pristine binder compositions (which are usually <1 for non-hydraulic lime binders, 1 to 1.5 for cement-lime binders, and 1.5 to 2 for cement-rich binders).

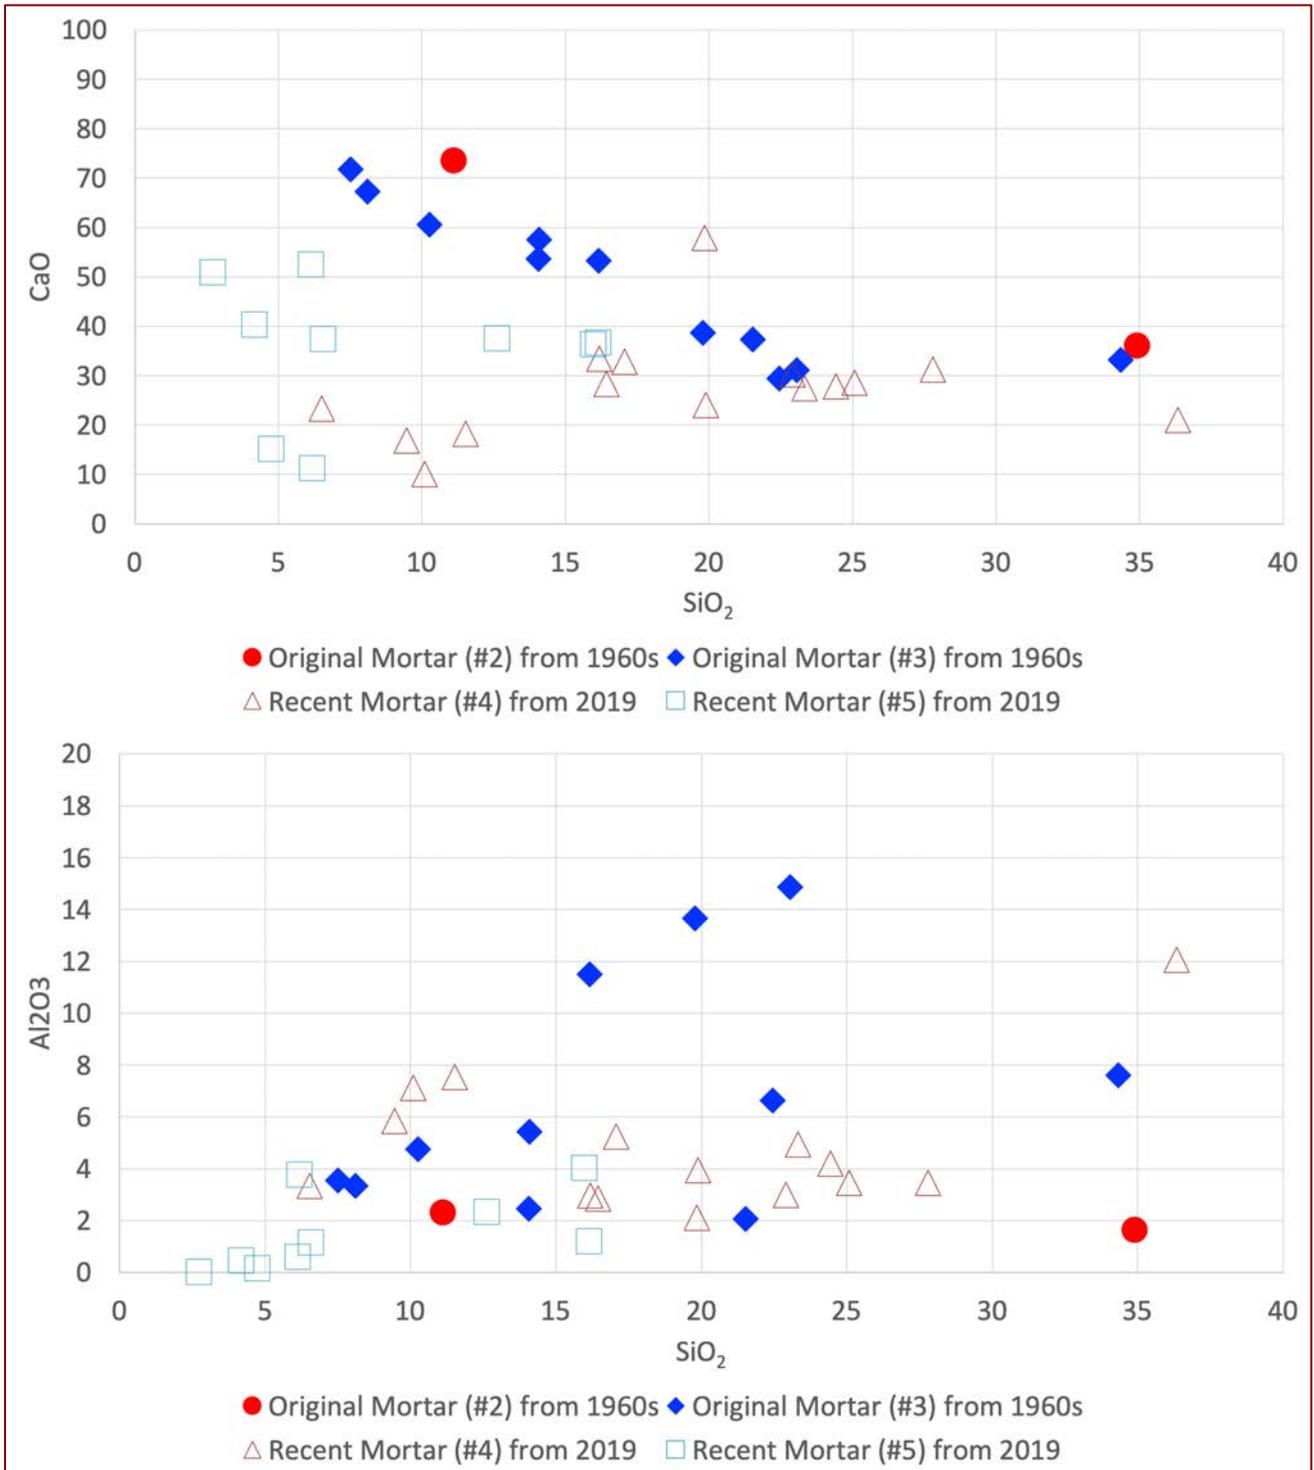
Figure 28: Variations in lime, silica, and alumina contents of pastes from the original (1960s) mortars #2 (filled red circle) and #3 (filled blue diamond), and recent (2019) mortars #4 (open triangle) and #5 (open square).

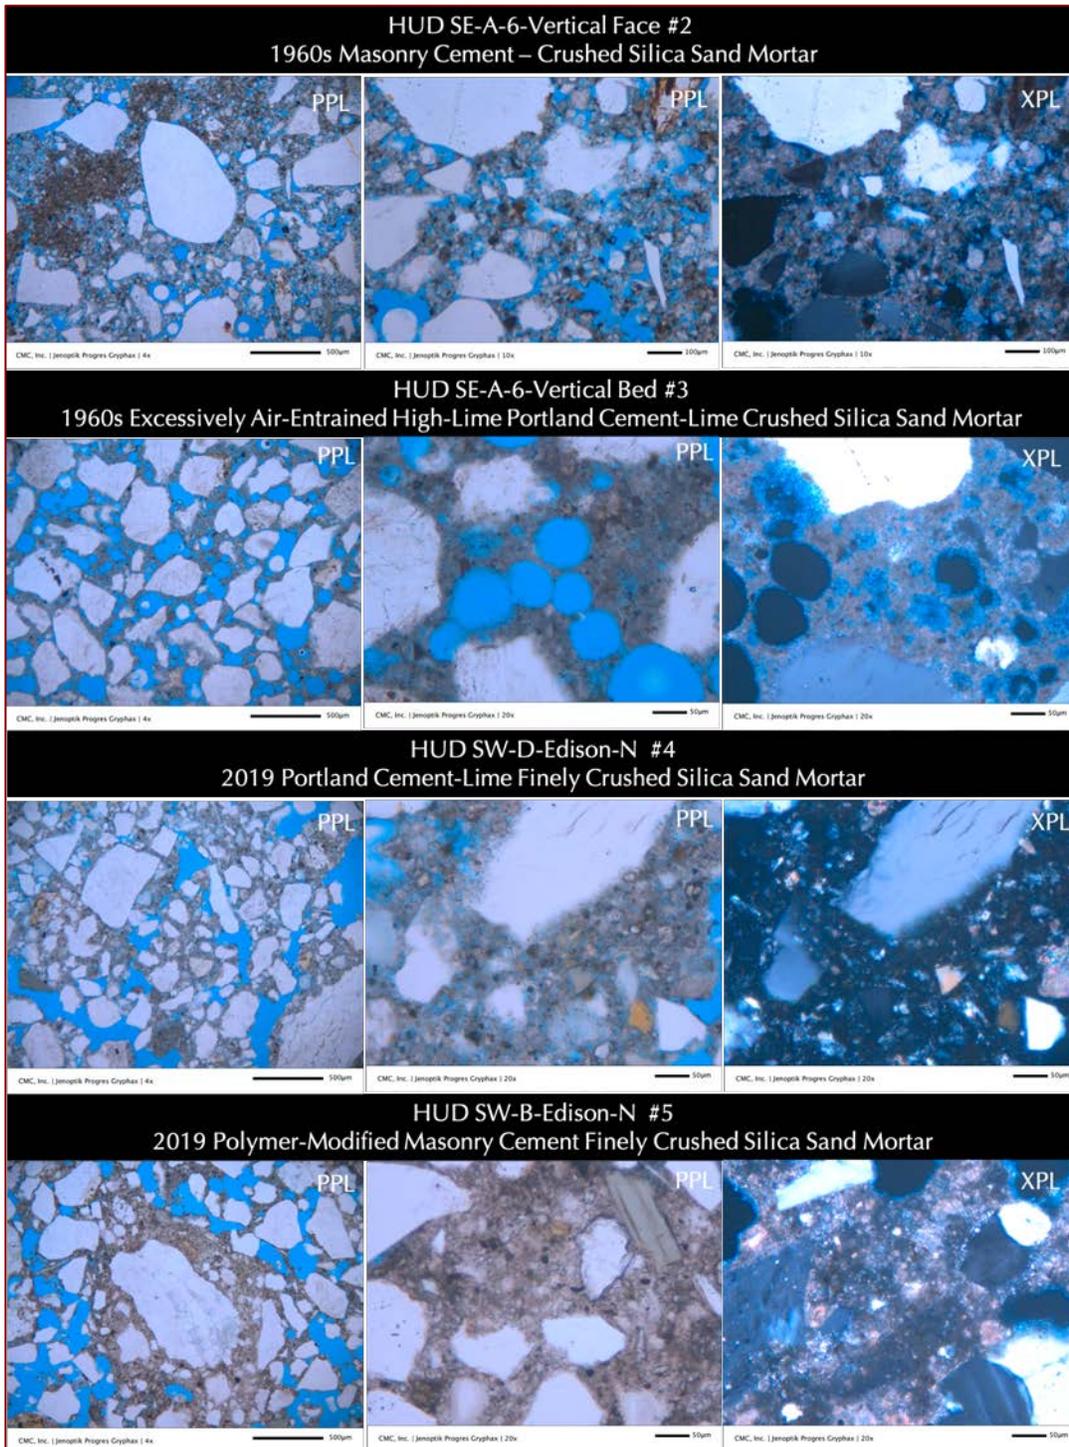
Figure 29: Summary of optical micrographs of four mortar types showing:

(d) Abundant limestone fine components in the masonry mortar from #2 compared to masonry mortars from # 3 (which has abundant dolomitic hydrated lime) or #5 which has reasonable cement and lime components as found in other masonry mortars).

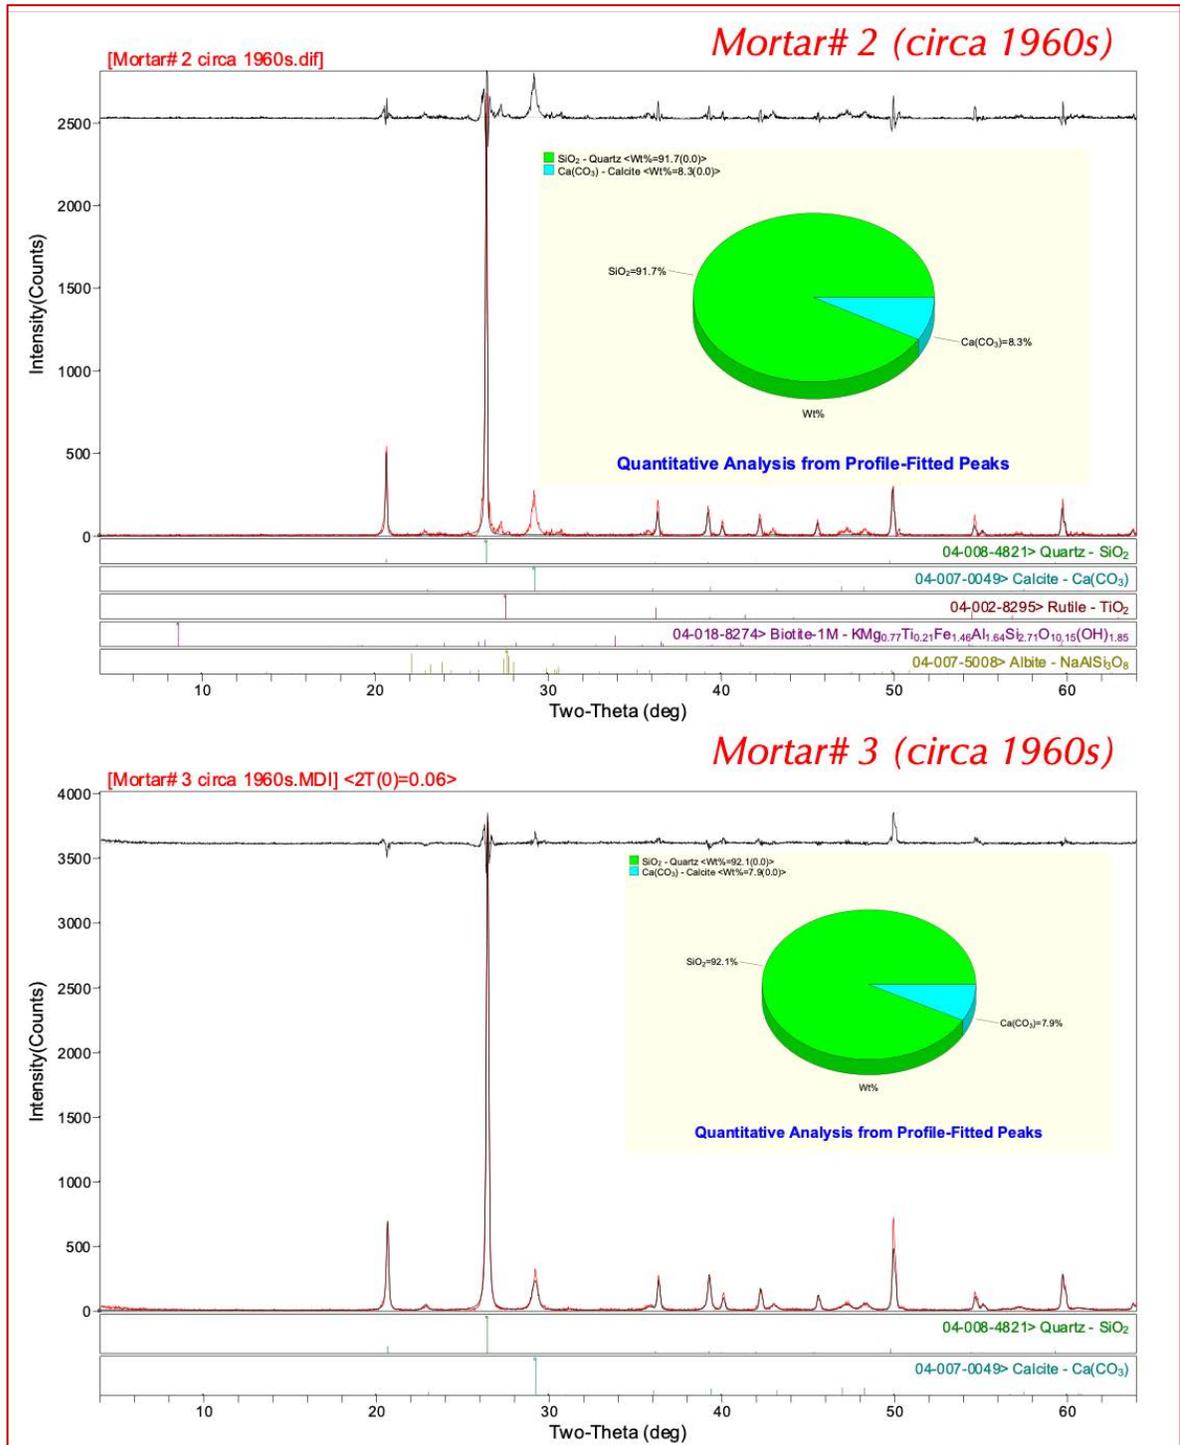
Figure 30: X-ray diffraction patterns of two original mortars from 1960s construction from #2 (top) and #3 (bottom) showing dominance of quartz in the silica sand, and subordinate calcite from finely crystalline fine-grained carbonated lime matrix in both mortars, and additionally calcite grains from the dominant limestone fine component of masonry cement in #2 mortar. Quartz contents from XRD, after corrections for acid-insoluble residue contents, show good matches to the quartz contents determined from DSC (thermal) studies.

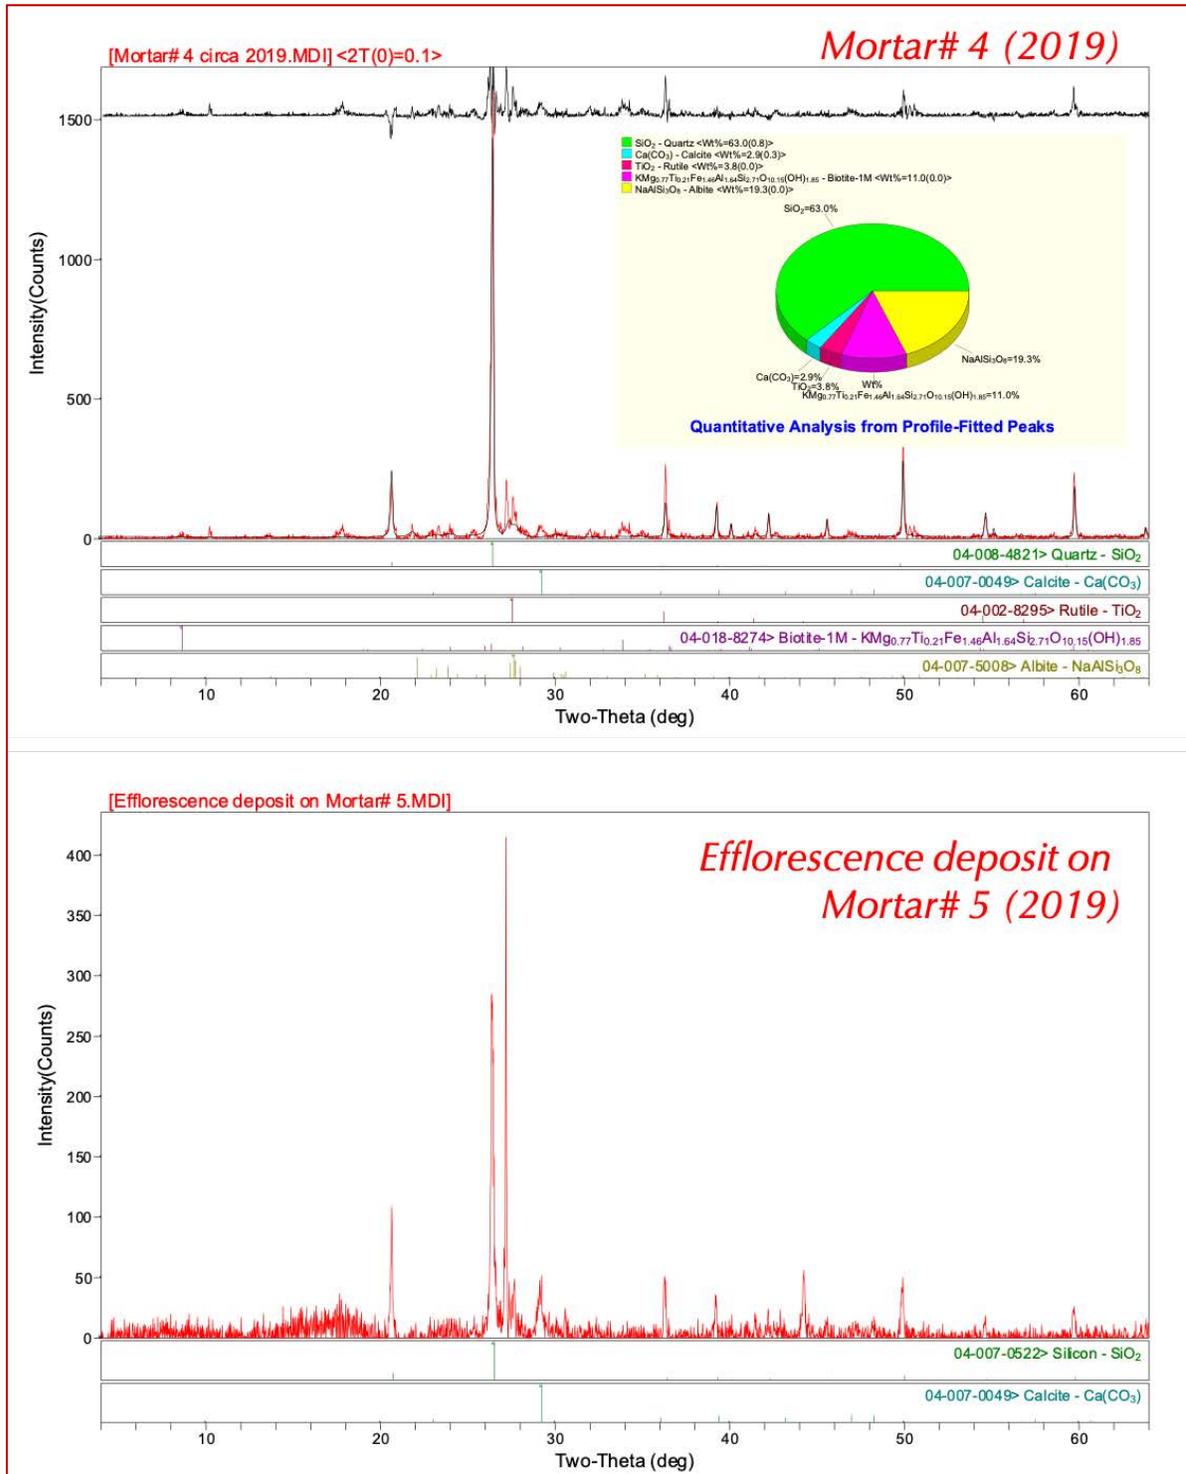
Figure 31: X-ray diffraction patterns of a recent mortar #4 from 2019 construction (top), and, white efflorescence deposits scrapped off from the surface of mortar #5 (bottom) showing dominance of quartz in the siliceous sand, followed by subordinate feldspar (albite) and mica in the sand in mortar #4. Efflorescence deposit on the surface of mortar #5 shows calcium carbonate (calcite) as the only salt (besides quartz from mortar’s sand). Quartz content in mortar #4 from XRD, after corrections for acid-insoluble residue contents, show good matches to the quartz content determined from DSC (thermal) studies.

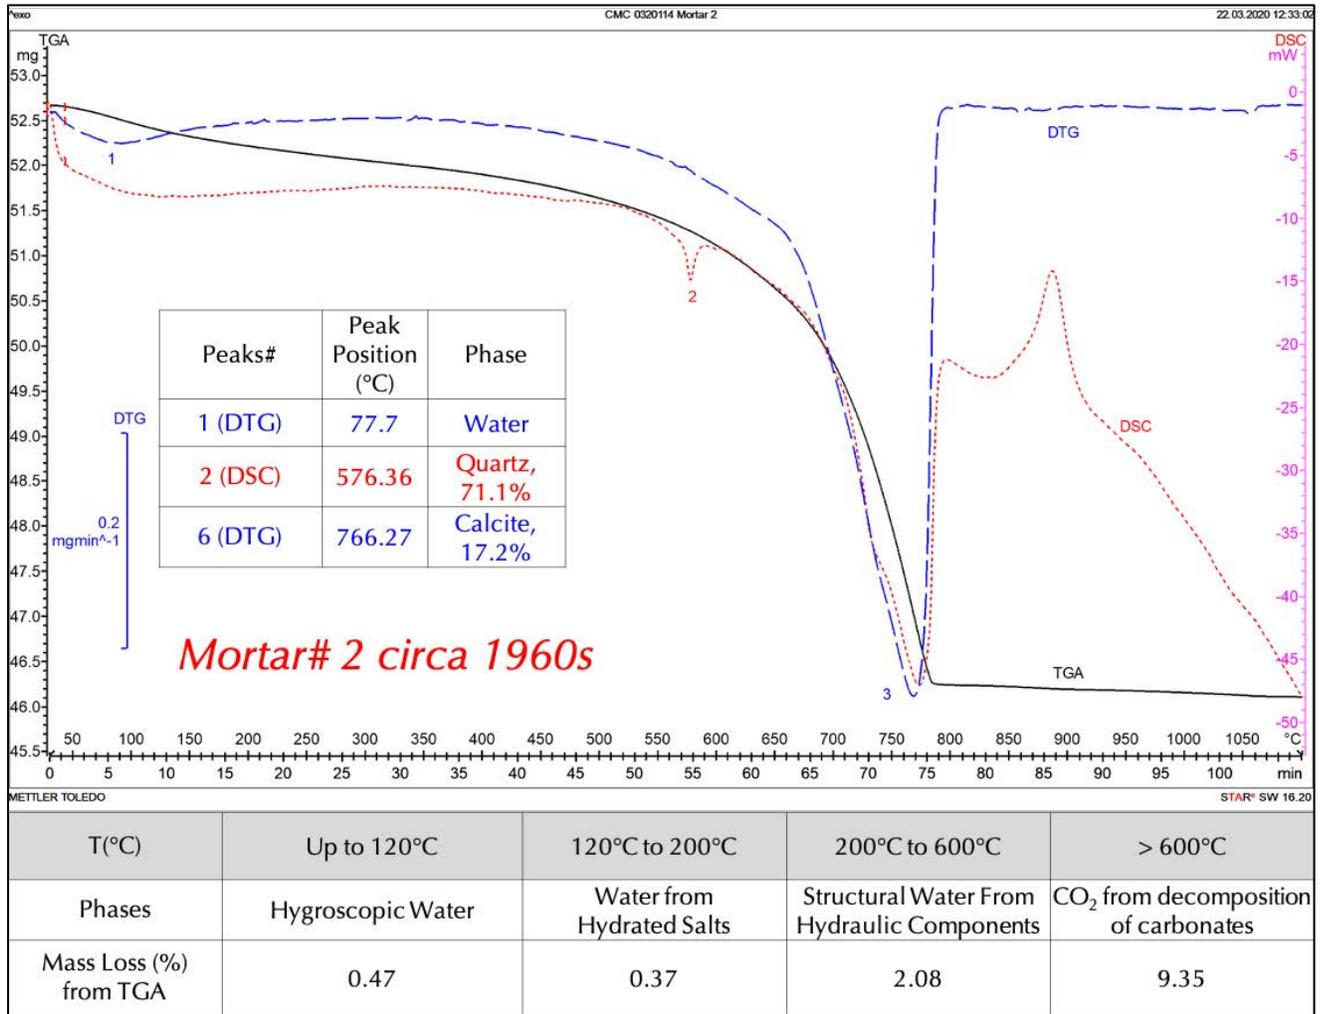
Figure 32: TGA (bold black), DSC (dotted red), and DTG (dashed blue) curves of mortar from 1960s construction showing losses in weight due to various decompositions (loss of water and carbon dioxide) during controlled heating in a Mettler-Toledo’s simultaneous TGA/DSC 1 unit from 30°C to 1000°C in a ceramic crucible (alumina 70µl, no lid) at a heating rate of 10°C/min in a nitrogen purge at a rate of 75 mL/min.

Original mortar #2 from 1960s construction showed a rather simple thermogram in Figure 32, which is unusual considering masonry cement composition of the binder. The main endotherm found is at 766.27°C from decarbonation of major amount of limestone fines and subordinate amount of hydrated lime components of the binder. Polymorphic transition of quartz sand at 576.36°C showed about 70 percent quartz, which shows a good resemblance to the quartz content determined (after correction for insoluble residue content) from XRD.

Figures 32 and 33 show very similar thermograms of two original mortars showing a minimal loss of free water (<0.5%) and water from hydrated salts (<0.5%) at up to 200°C followed by a measurable loss (2 to 2.2%) of hydrate water from 200°C to 600°C. Degrees of carbonation is higher in the #2 mortar (9.3% due to abundant limestone fine component along with hydrated lime) than 5.6% found in #3 mortar mostly from hydrated lime component on the latter. Quartz contents in both mortars are around 70 percent determined from polymorphic transition of quartz around 575°C.

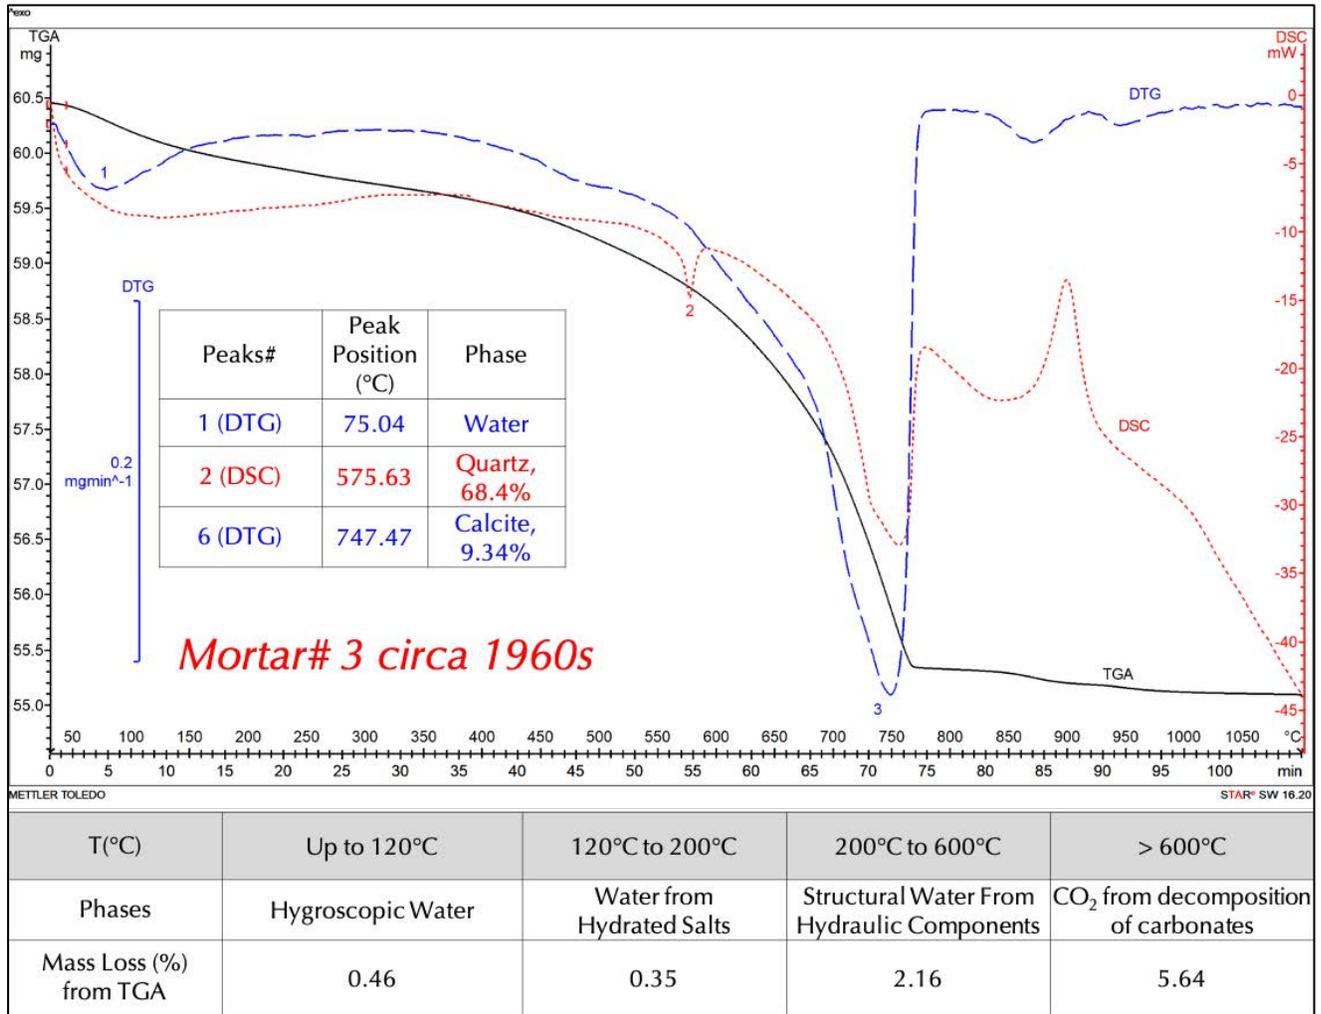
Figure 33: TGA (bold black), DSC (dotted red), and DTG (dashed blue) curves of mortar from 1960s construction showing losses in weight due to various decompositions (loss of water and carbon dioxide) during controlled heating in a Mettler-Toledo’s simultaneous TGA/DSC 1 unit from 30°C to 1000°C in a ceramic crucible (alumina 70µl, no lid) at a heating rate of 10°C/min in a nitrogen purge at a rate of 75 mL/min.

Original mortar #3 from 1960s construction showed a rather simple thermogram in Figure 33, which is not so unusual considering the dominant hydrated lime composition in the masonry cement binder of this mortar. The main endotherm found is at 747.47°C from decarbonation of major amount of limestone fines and subordinate amount of hydrated lime components of the binder. Polymorphic transition of quartz sand at 575.63°C showed about 68.4 percent quartz, which shows a good resemblance to the quartz content determined (after correction for insoluble residue content) from XRD.

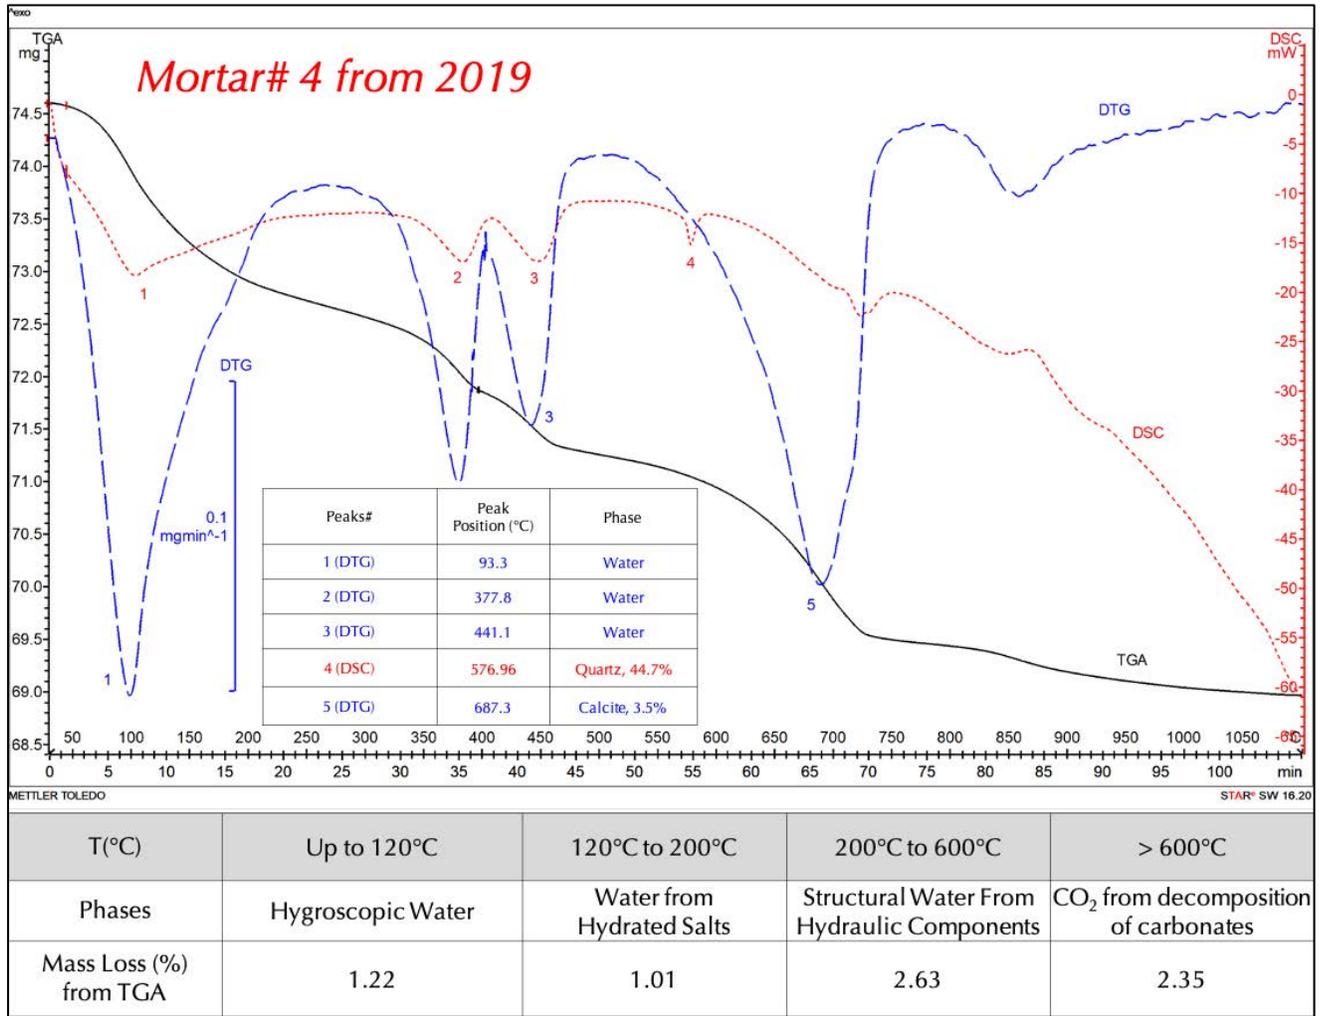
Figure 34: TGA (bold black), DSC (dotted red), and DTG (dashed blue) curves of mortar from 2019 construction showing losses in weight due to various decompositions (loss of water and carbon dioxide) during controlled heating in a Mettler-Toledo’s simultaneous TGA/DSC 1 unit from 30°C to 1000°C in a ceramic crucible (alumina 70µl, no lid) at a heating rate of 10°C/min in a nitrogen purge at a rate of 75 mL/min.

Recent mortar #4 from 2019 construction showed a rather complex thermogram in Figure 34, due to (i) the presence of noticeable free water and water from hydrated salts resulting in sharp endotherm by 200°C, (ii) noticeable peaks between 200°C and 600°C from dihydroxylation of structural water components in hydraulic phases, (ii) noticeably lower degree of carbonation than the original mortars, and (iv) lower quartz content (<50%) compared to much higher quartz contents (70%) found in the original mortars.

Loss of mass from heating (i) up to 120°C is 1.22%, which is a factor of 2.5 higher than that from the original mortars due to loss of free water, (ii) from 120°C to 200°C is 1%, which is also a factor 2.5 higher than 0.35-0.37% found in the original mortars from loss of water from hydrated salts, (iii) from 200°C to 600°C is 2.63%, which is higher than maximum 2.16% found in the original mortars from dihydroxylation of structural/hydrate water in various hydraulic components, and finally (iv) only 2.35% from 600°C to 950°C for decomposition of

carbonate phases from limestone fines and fine-grained calcite in carbonated pastes as opposed to 5.64-9.35% found in the original mortars.

Two recent mortars from 2019 construction, however, showed very different rather complex thermograms in Figures 34 through 36 due to (i) the presence of noticeable structural water components in the 200°C to 600°C range, along with (ii) noticeably larger losses of free water and from hydrated salts at <200°C, (iii) lower degree of carbonation than the original mortars, and (iv) lower quartz contents in the recent ones (<50%) compared to much higher quartz contents (70%) found in the original mortars.

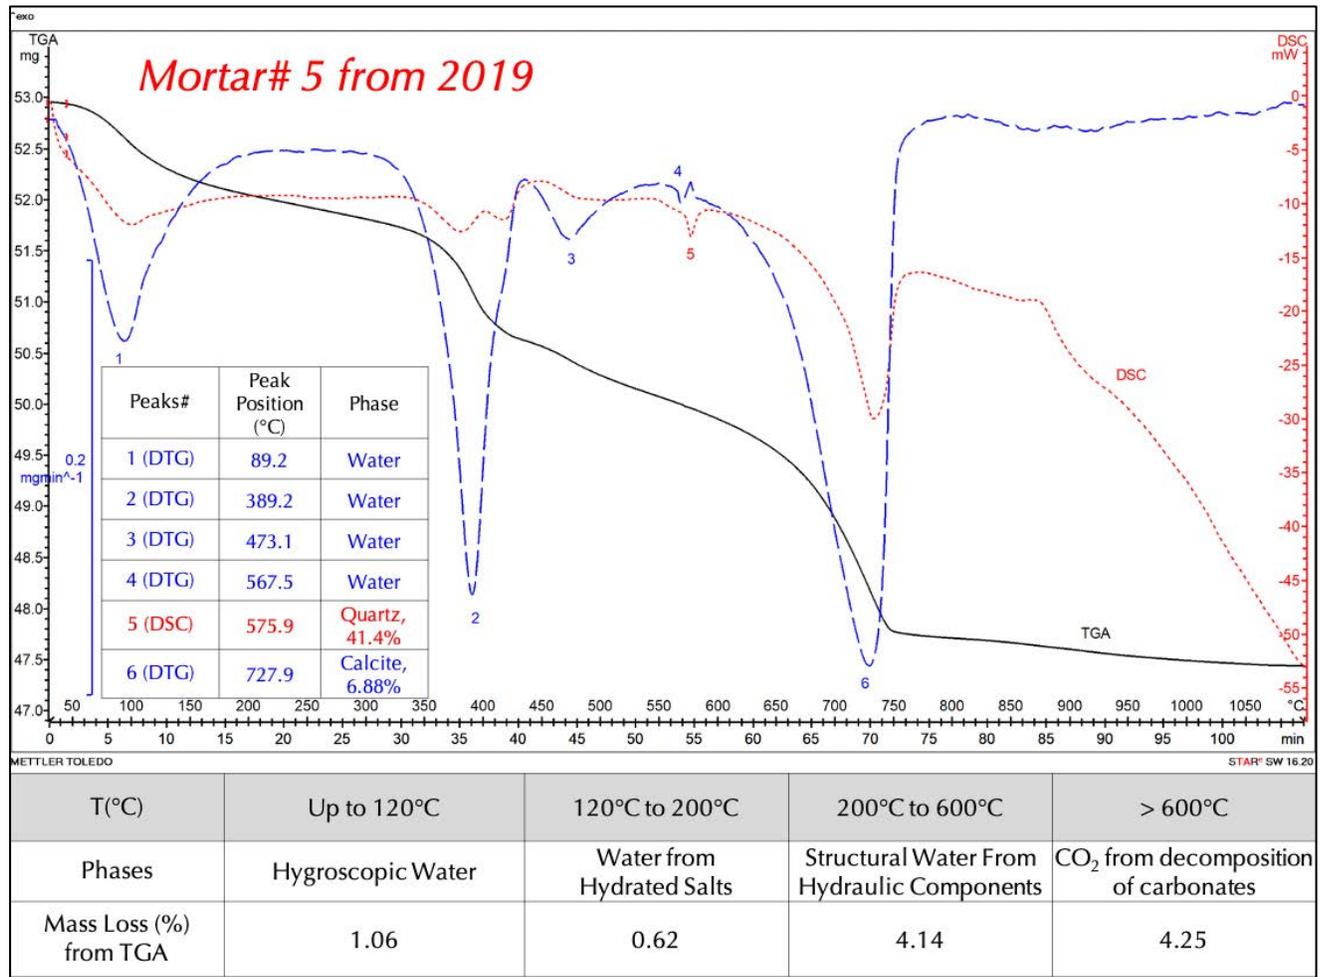
Figure 35: TGA (bold black), DSC (dotted red), and DTG (dashed blue) curves of mortar from 2019 construction showing losses in weight due to various decompositions (loss of water and carbon dioxide) during controlled heating in a Mettler-Toledo’s simultaneous TGA/DSC 1 unit from 30°C to 1000°C in a ceramic crucible (alumina 70µl, no lid) at a heating rate of 10°C/min in a nitrogen purge at a rate of 75 mL/min.

Recent mortar #5 from 2019 construction again showed another rather complex thermogram in Figure 35, more or less similar to the one found in #4 mortar due to (i) noticeable free water and water from hydrated salts resulting in sharp endotherm by 200°C, (ii) noticeable peaks between 200°C and 600°C from dihydroxylation of structural water components in hydraulic phases, (ii) noticeably lower degree of carbonation than the original mortars, and (iv) lower quartz content (<50%) compared to much higher quartz contents (70%) found in the original mortars.

Loss of mass from heating (i) up to 120°C is 1.06%, which is a factor of 2 to 2.5 higher than that from the original mortars due to loss of free water, (ii) from 120°C to 200°C is 0.62%, which is also a factor 1.5 higher than 0.35-0.37% found in the original mortars from loss of water from hydrated salts, (iii) from 200°C to 600°C is 4.14%, which is higher than maximum 2.16% found in the original mortars from dihydroxylation of structural/hydrate

water in various hydraulic components, and finally (iv) only 4.25% from 600°C to 950°C for decomposition of carbonate phases from limestone fines and fine-grained calcite in carbonated pastes as opposed to 5.64-9.35% found in the original mortars.

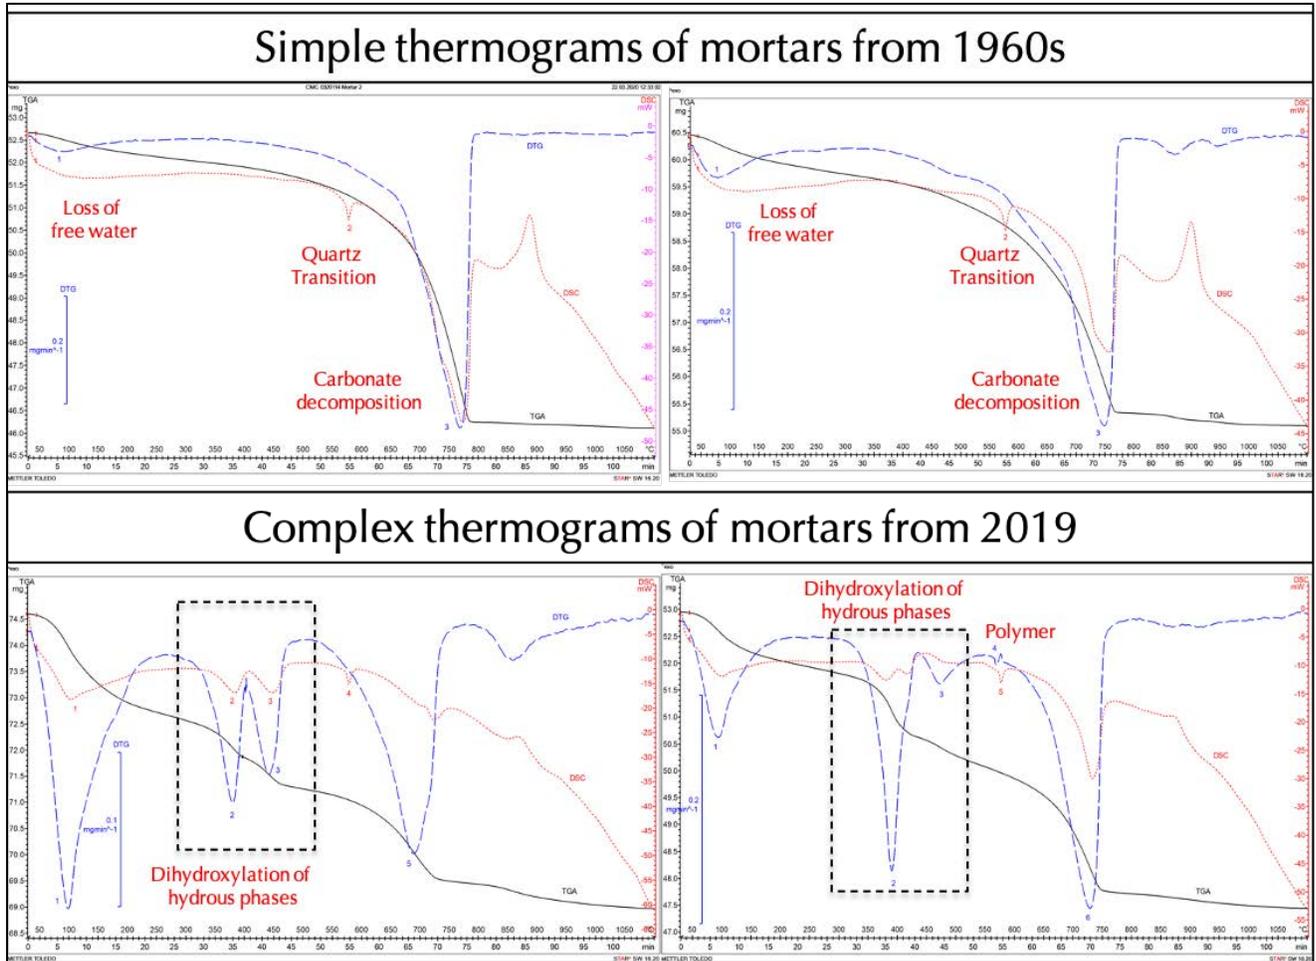
Figure 36: TGA (bold black), DSC (dotted red), and DTG (dashed blue) curves of mortars from 1960s (top) and 2019 (bottom) construction showing losses in weight due to various decompositions (loss of water and carbon dioxide) during controlled heating in a Mettler-Toledo’s simultaneous TGA/DSC 1 unit from 30°C to 1000°C in a ceramic crucible (alumina 70µl, no lid) at a heating rate of 10°C/min in a nitrogen purge at a rate of 75 mL/min.

Figure 36 shows comparison of thermograms between the original and recent mortars where recent mortars showed very different rather complex thermograms due to (i) the presence of noticeable structural water components in the 200°C to 600°C range resulting in large endotherms (shown within dashed boxes), along with (ii) noticeably larger losses of free water and from hydrated salts at <200°C, (iii) lower degree of carbonation than the original mortars, and (iv) lower quartz contents in the recent ones (<50%) compared to much high quartz contents (70%) found in the original mortars.

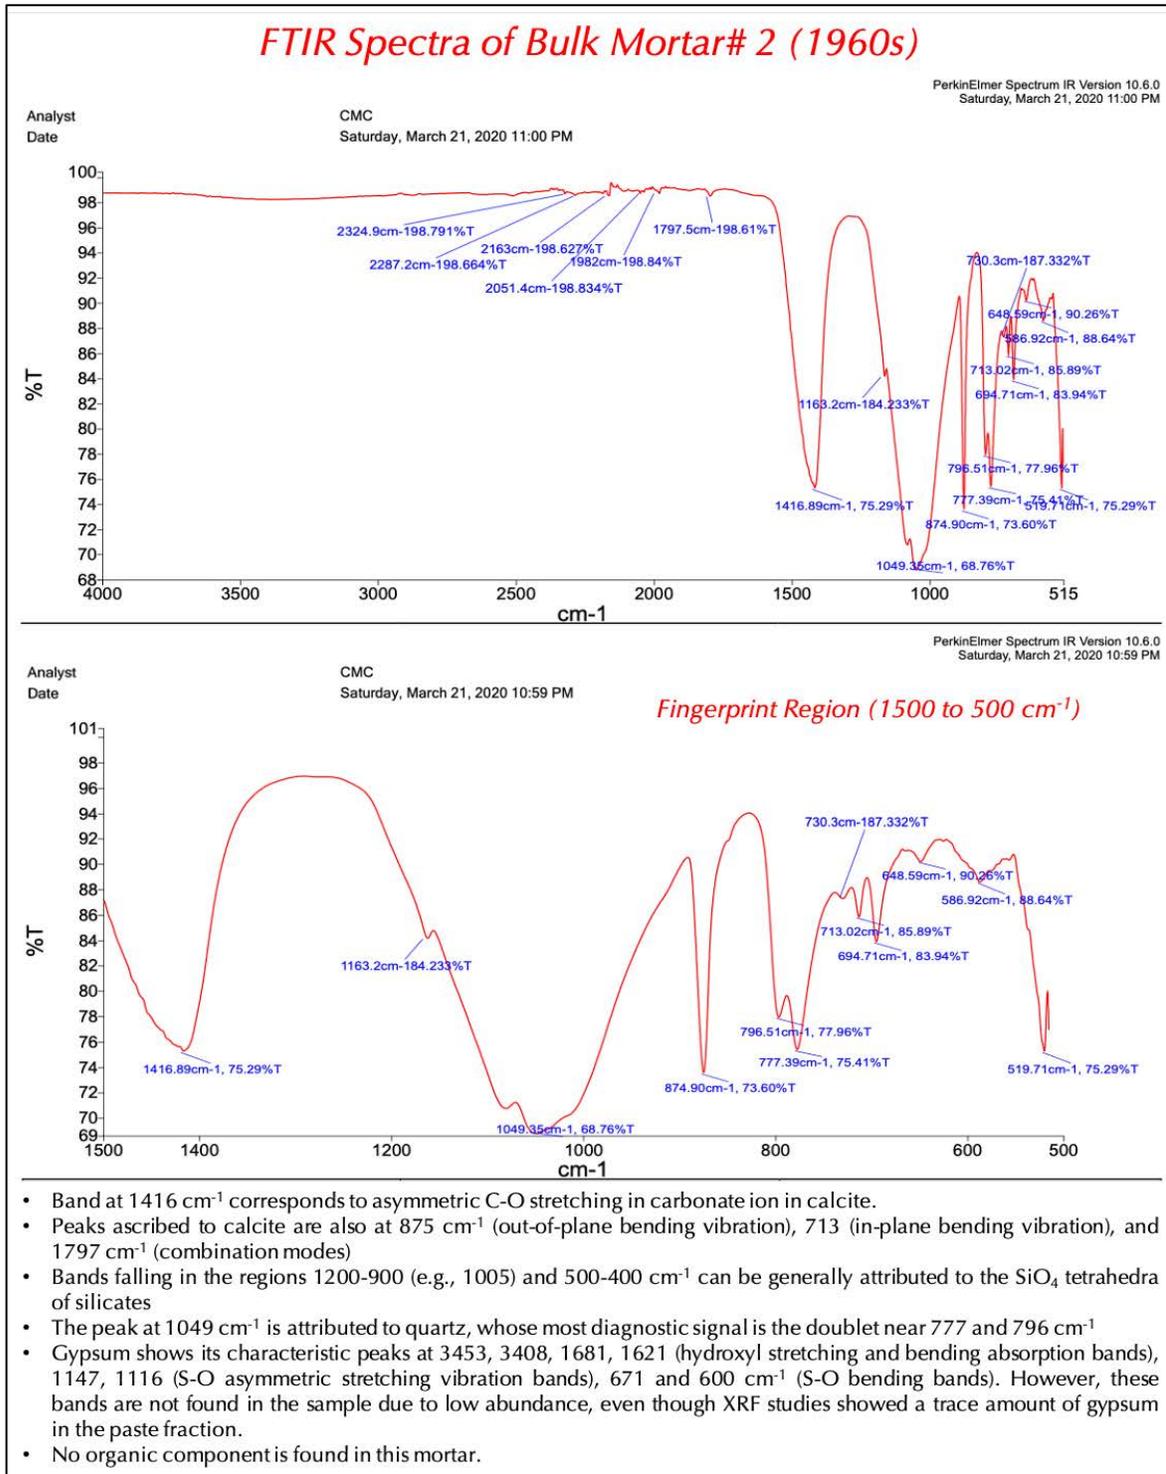
Figure 37: FTIR spectra of pulverized mortar #2 from original 1960s construction showing characteristic absorbance bands from calcite in the binder and quartz in the sand. No organic component is detected in this mortar from the lack of any characteristic functional group.

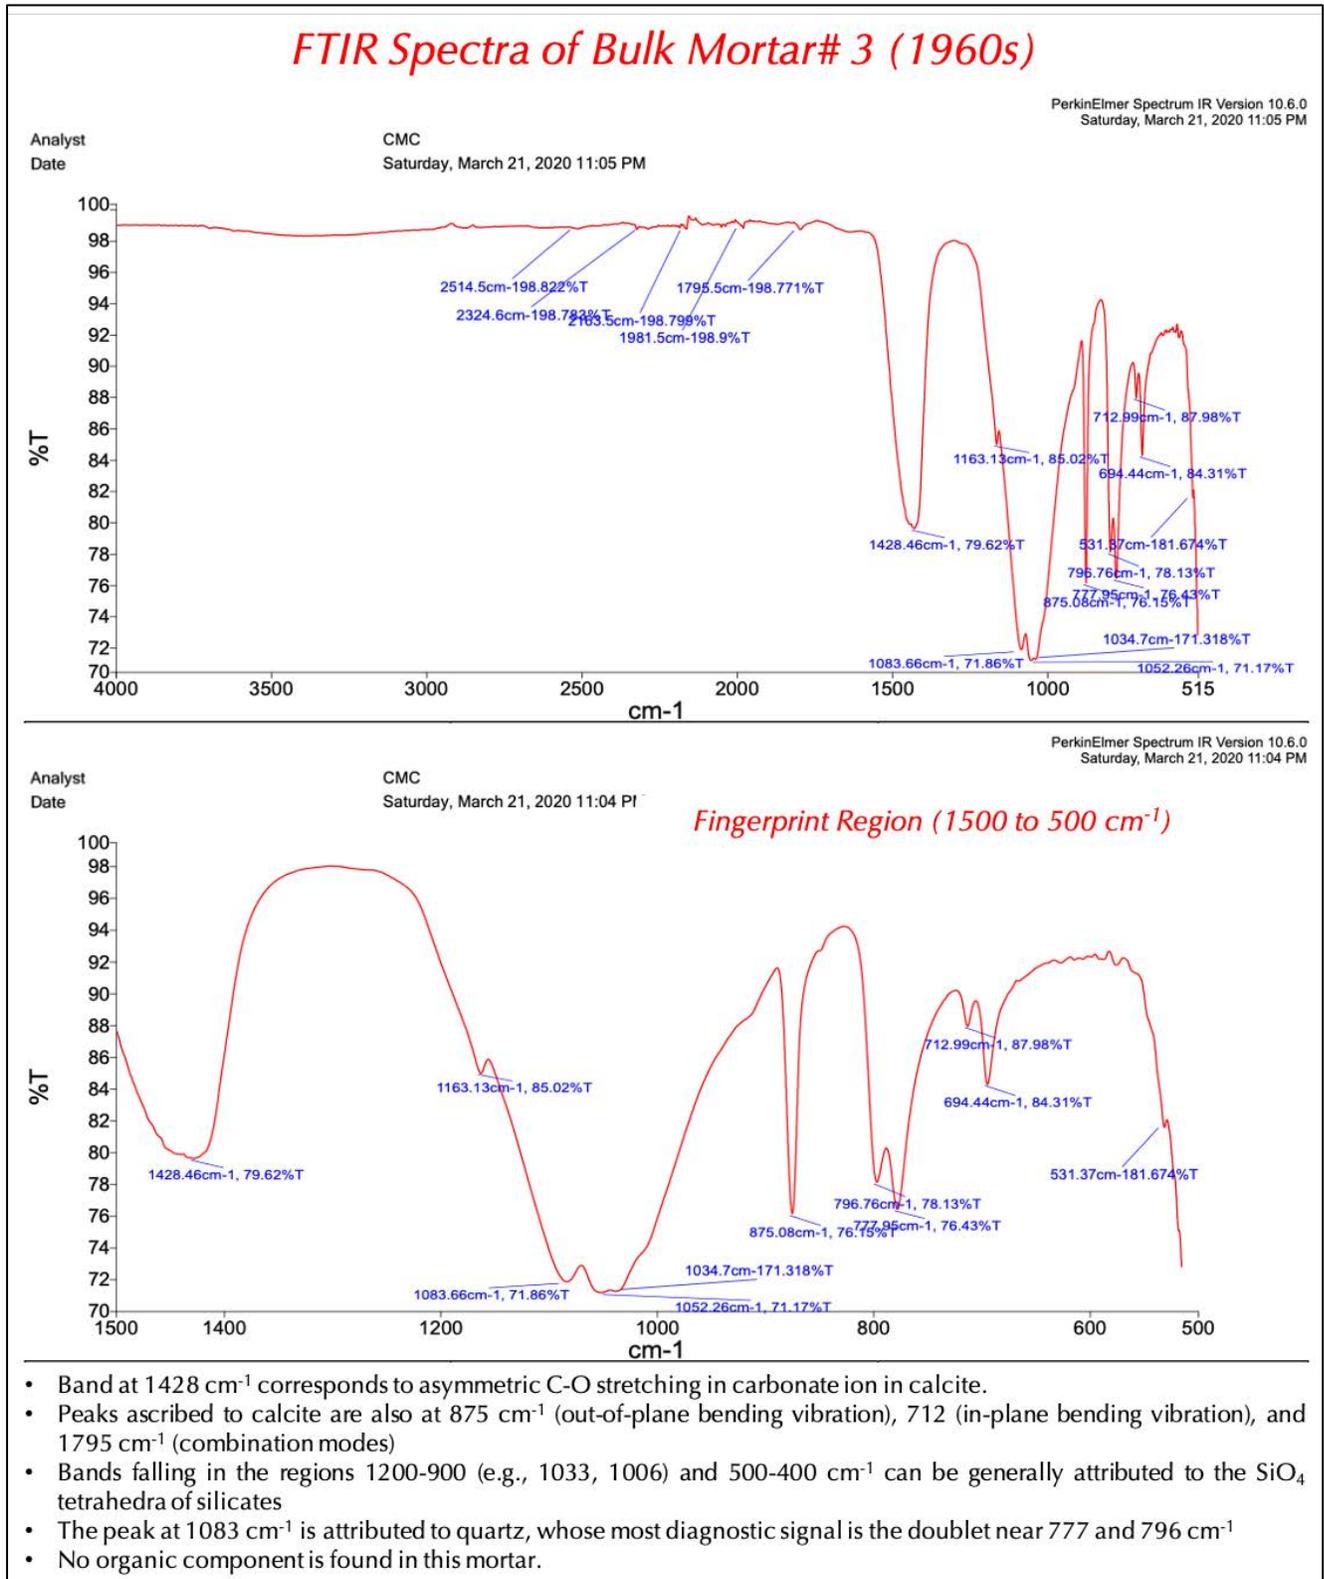
Figure 38: FTIR spectra of pulverized mortar #3 from original 1960s construction showing characteristic absorbance bands from calcite in the binder and quartz in the sand. No organic component is detected in this mortar from the lack of any characteristic functional group.
