## Laboratory Analyses of A Stone & Masonry Mortars From Robert C Weaver Federal Building in Washington, D.C.

Robert C Weaver Federal Building (HUD)  
451 7<sup>th</sup> Street SW  
Washington, D.C.

March 25, 2020  
CMC 0320114

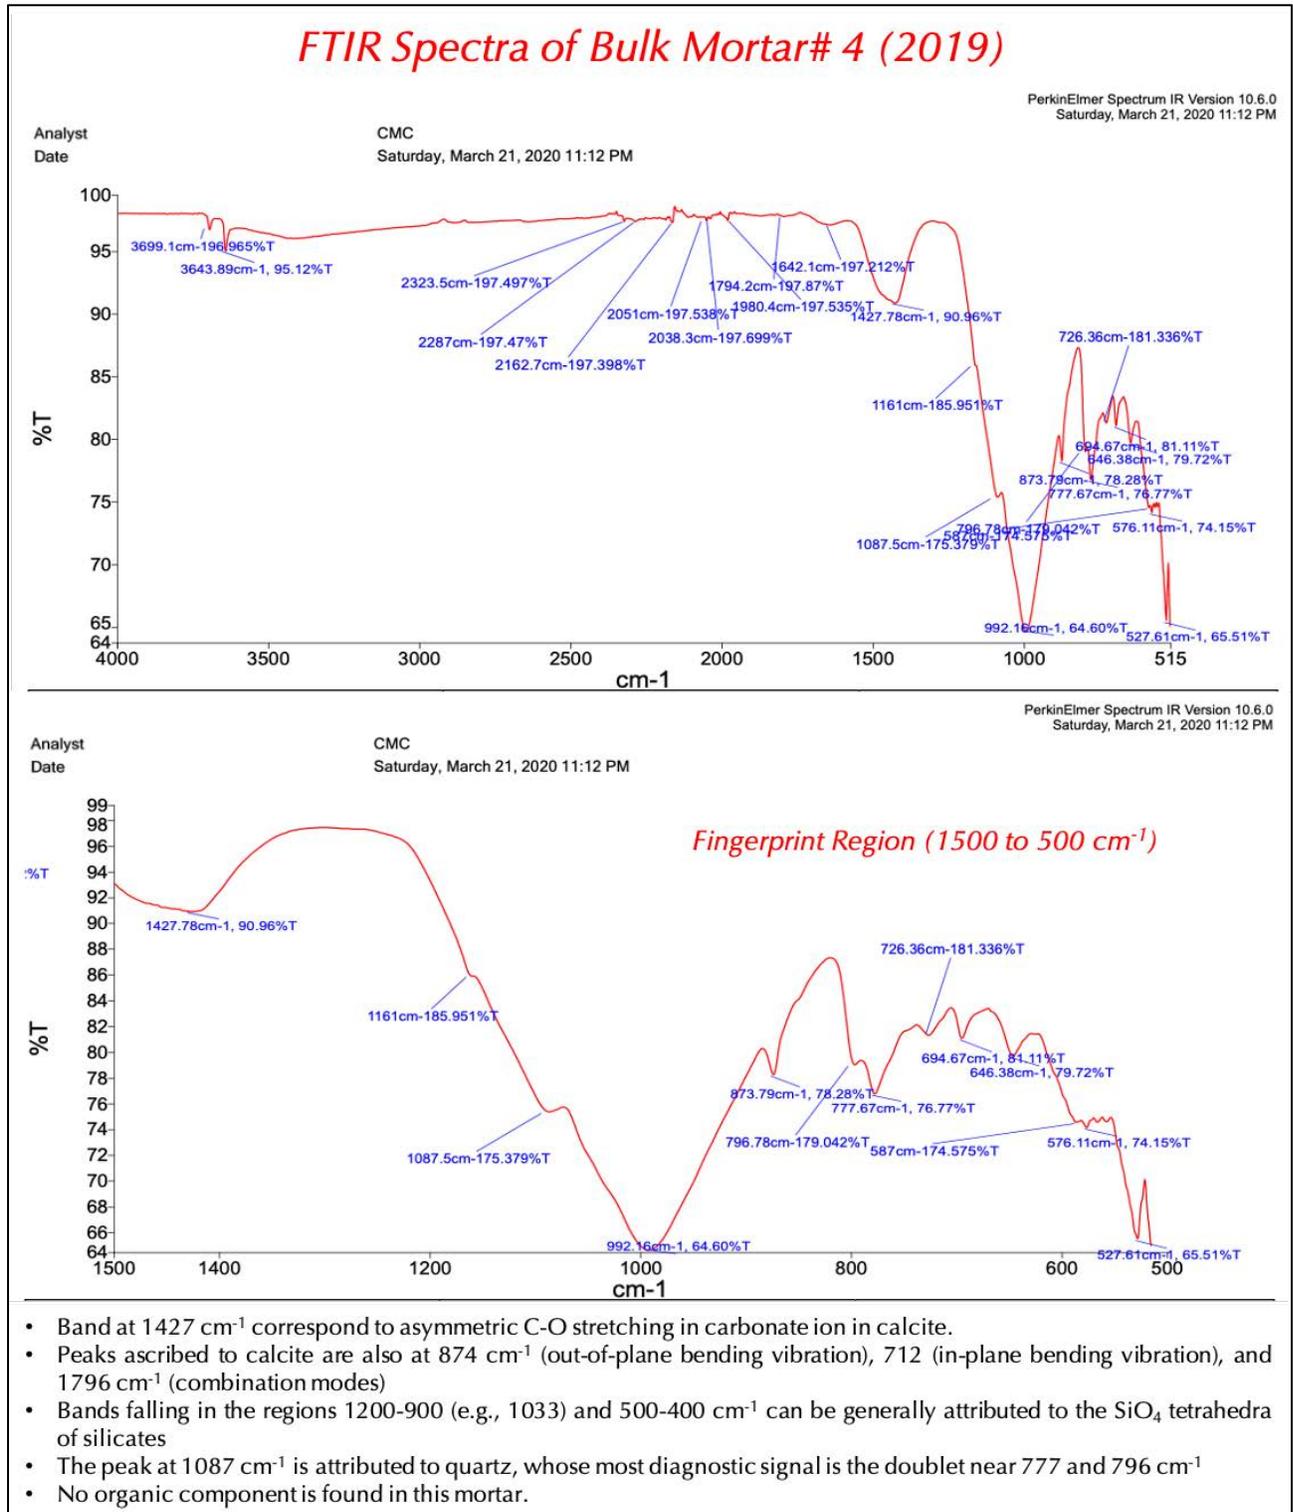
Figure 39: FTIR spectra of pulverized mortar #4 from 2019 construction showing characteristic absorbance bands from calcite in the binder and quartz in the sand. No organic component is detected in this mortar from the lack of any characteristic functional group.

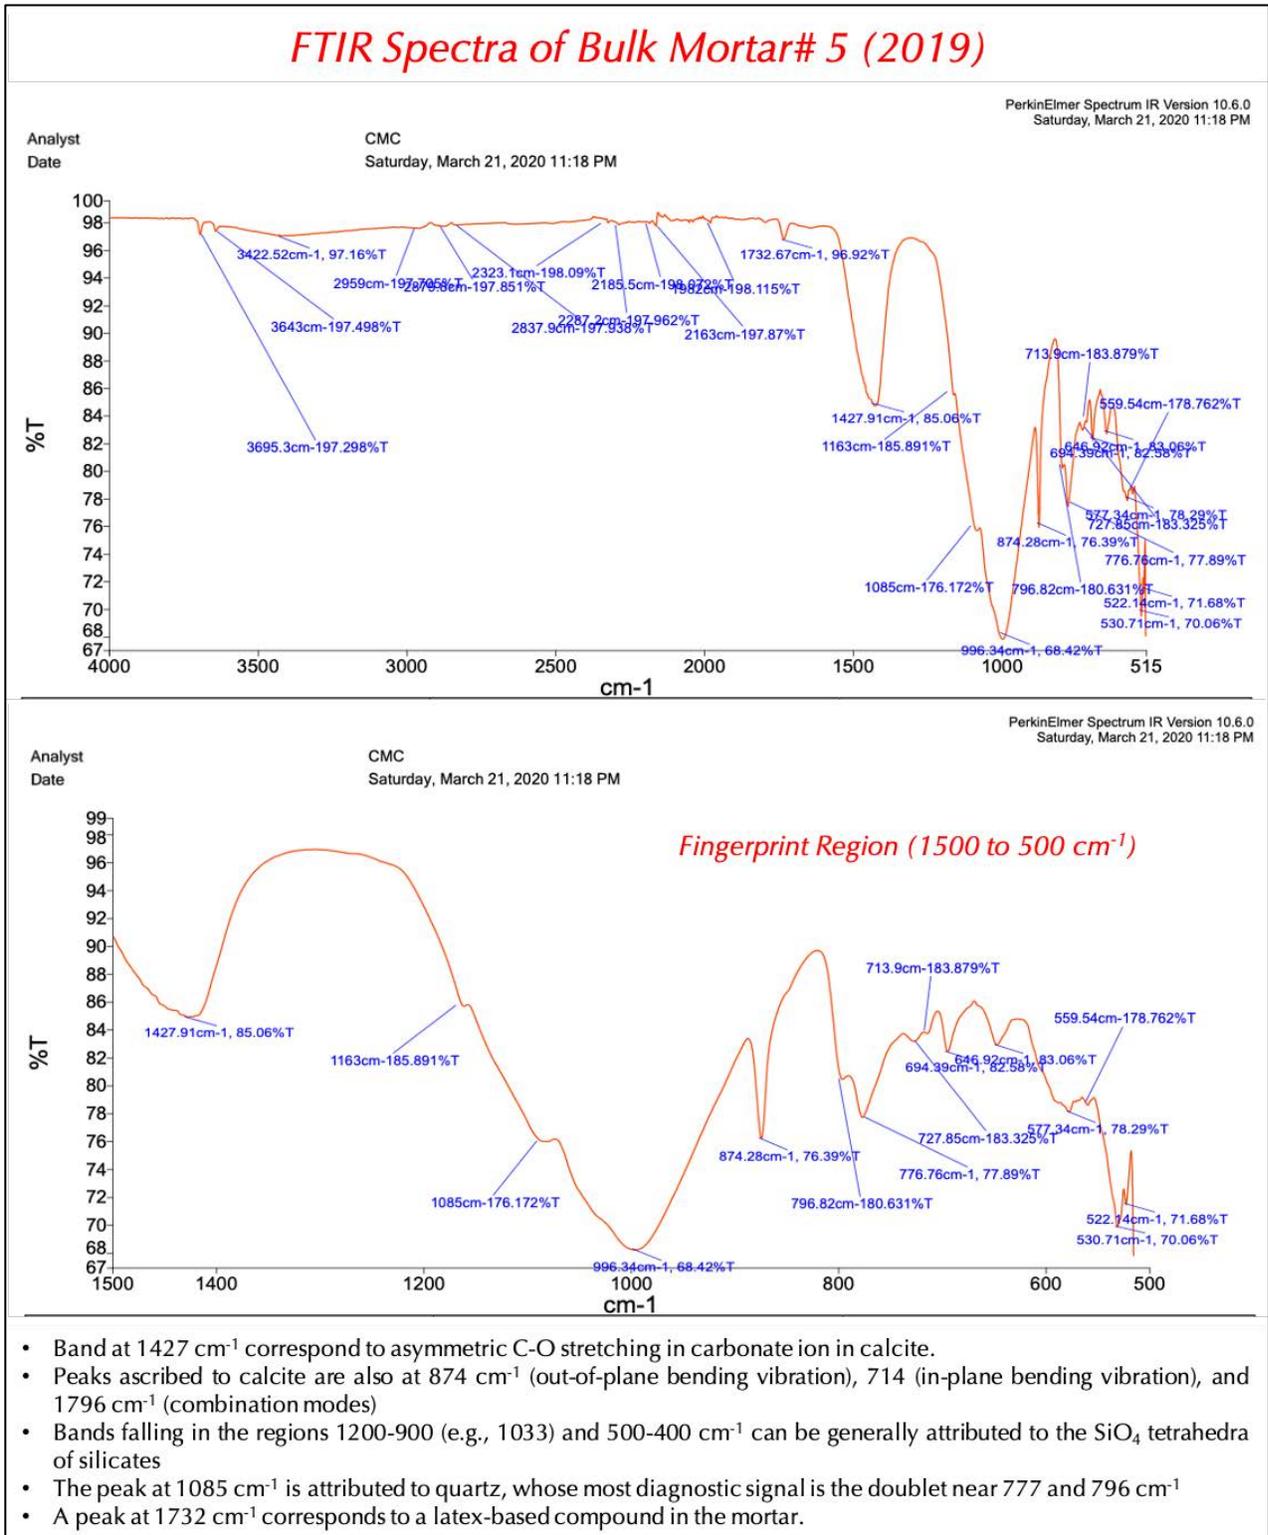
Figure 40: FTIR spectra of pulverized mortar #5 from 2019 construction showing characteristic absorbance bands from calcite in the binder and quartz in the sand. A latex-based polymer component is detected from the characteristic band at 1732 cm<sup>-1</sup> region.

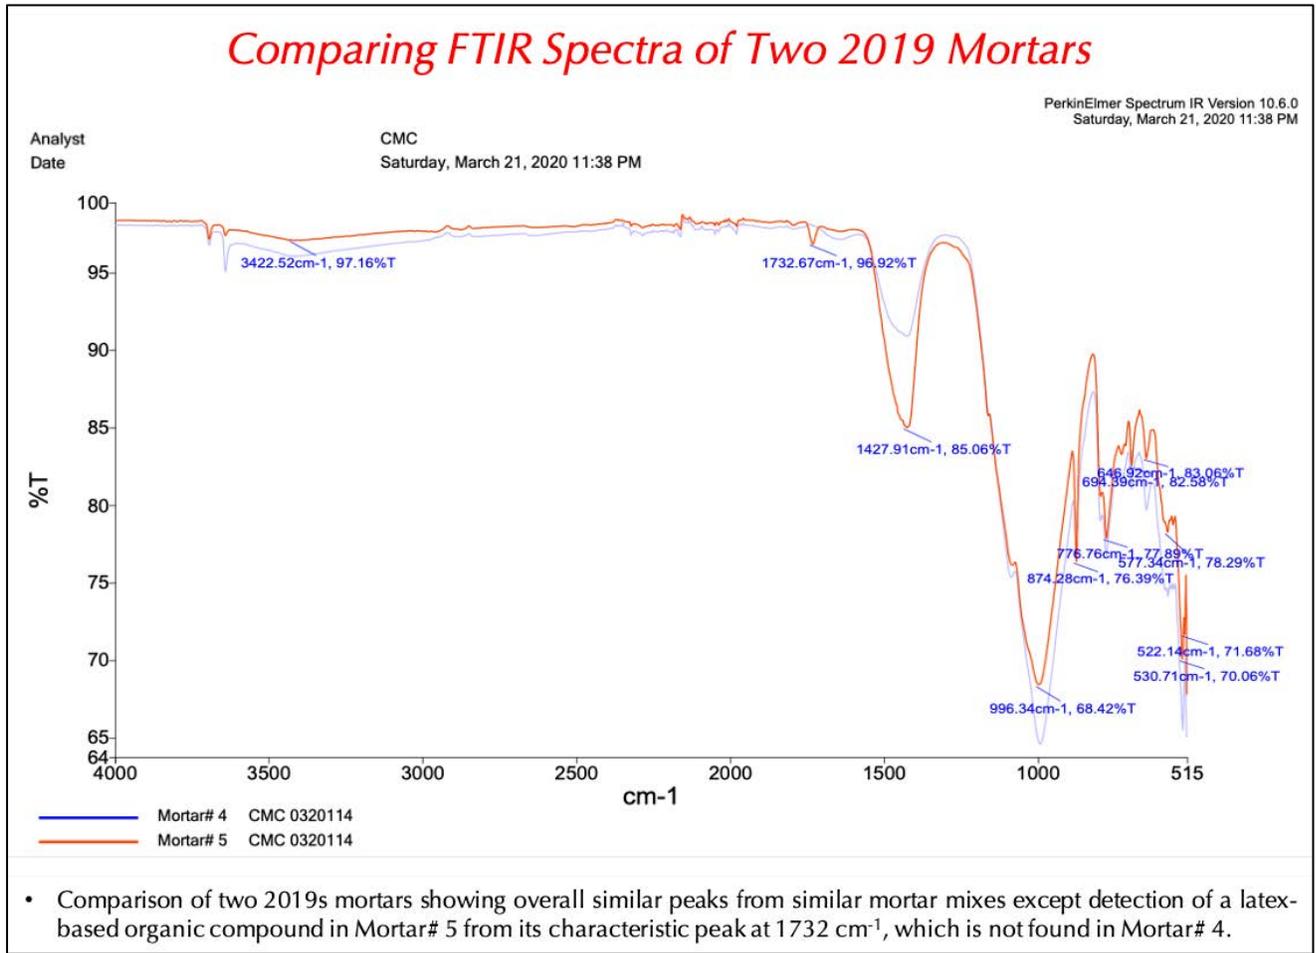
Figure 41: Comparison of FTIR spectra of two recent mortars showing overall similarities in both spectra except a peak at 1732 cm<sup>-1</sup> region in mortar #5 from the presence of a latex-based polymer in the mortar.

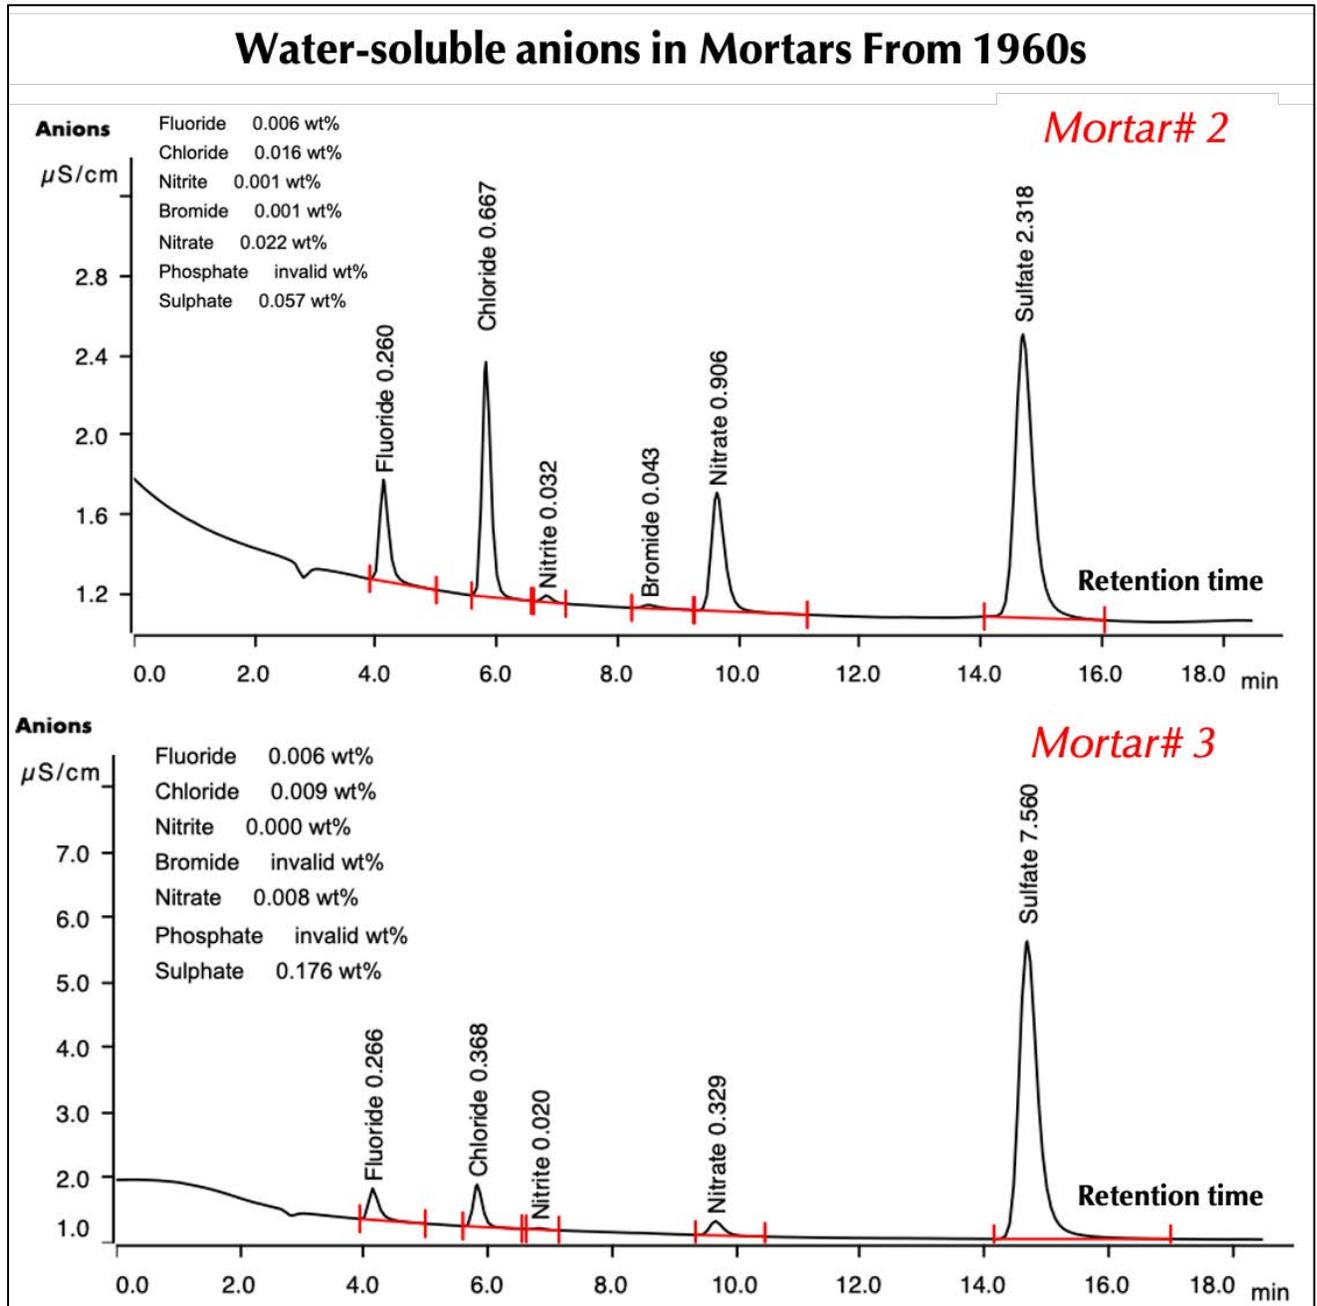
Figure 42: Ion chromatograms of water-soluble anions in two original mortars after digesting representative portions of pulverized mortars (about a gram) in deionized water for 30 minutes at a temperature below boiling, followed by continued digestion in water at the ambient laboratory condition for 24 hours. The digested solution was filtered under vacuum through 0.2-micron filter papers. The final filtrates diluted to 100 ml were analyzed by ion chromatography. Top left insets show results of concentrations of various water-soluble anions, notably water-soluble chloride and sulfate contents in the mortars. Chloride contents in the original mortars are negligible and do not indicate any chloride salts or related distress. However, sulfate contents are noticeable and large variations from 0.057% in #2 (limestone fine rich masonry cement) to 0.176% in #3 (hydrated lime rich masonry cement mortar).

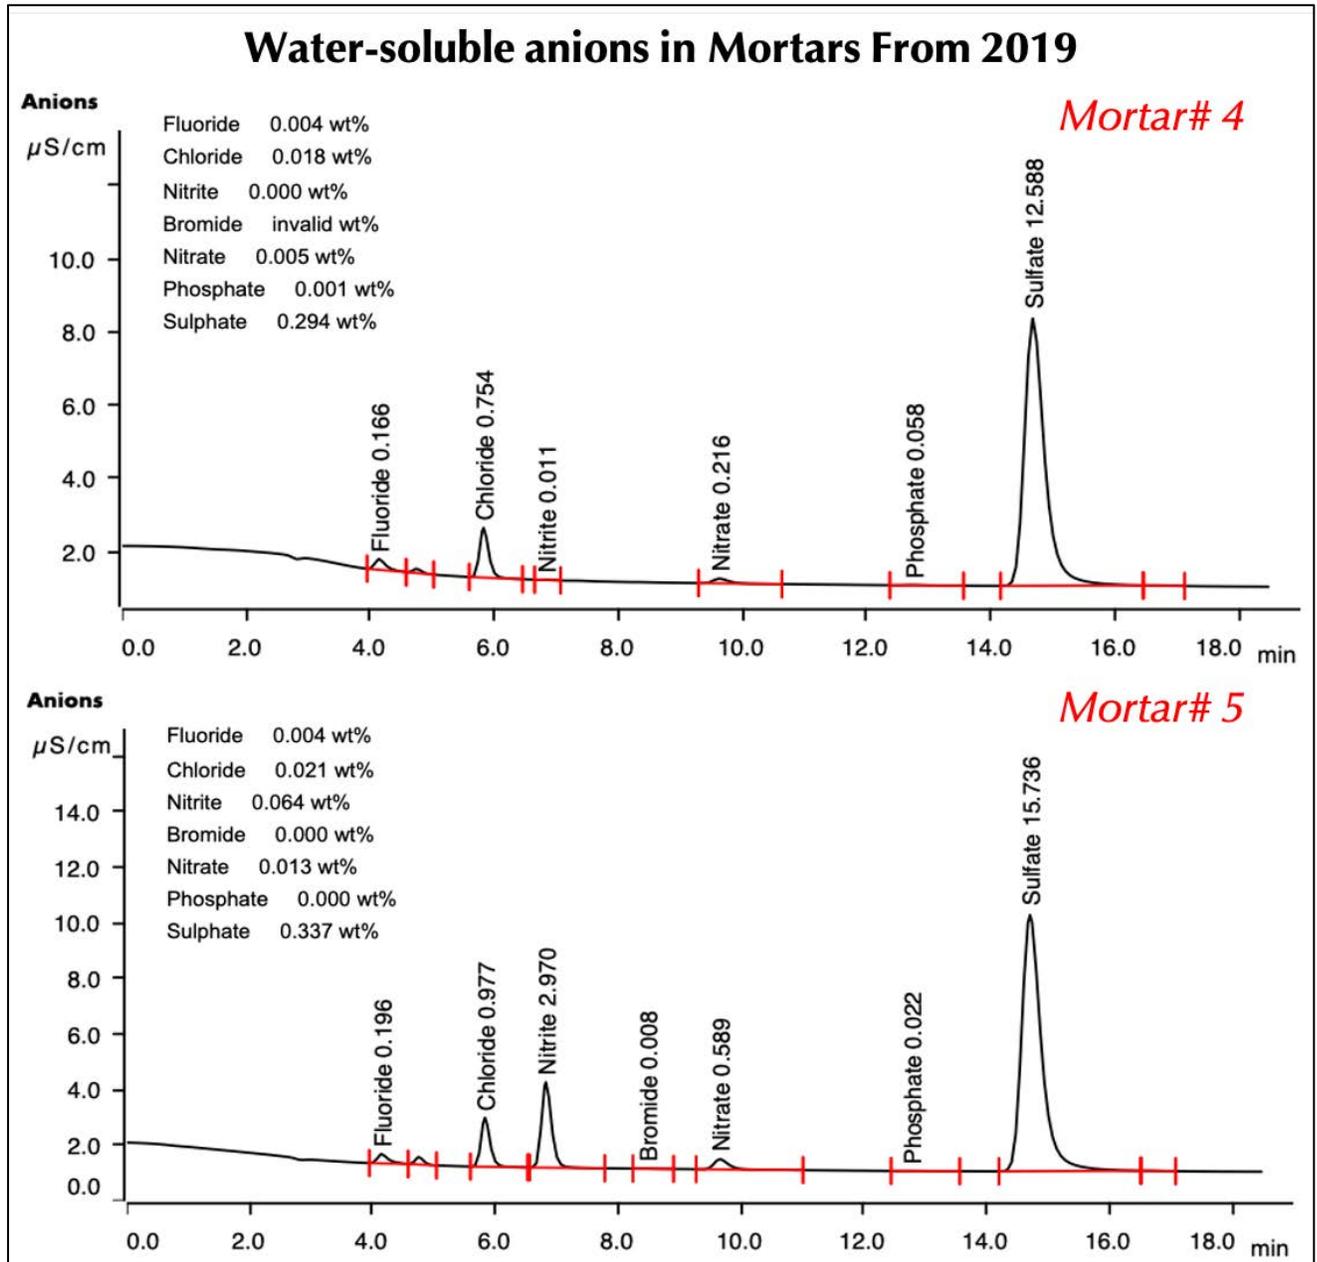
Figure 43: Ion chromatograms of water-soluble anions in two recent mortars after digesting representative portions of pulverized mortars (about a gram) in deionized water for 30 minutes at a temperature below boiling, followed by continued digestion in water at the ambient laboratory condition for 24 hours. The digested solution was filtered under vacuum through 0.2-micron filter papers. The final filtrates diluted to 100 ml were analyzed by ion chromatography. Top left insets show results of concentrations of various water-soluble anions, notably water-soluble chloride and sulfate contents in the mortars. Chloride contents in the recent mortars are negligible (as also found in the original mortars, all four mortars have <0.025% chloride) and do not indicate any chloride salts or related distress. However, sulfate contents are noticeable (from 0.294% to 0.337%) which are higher than the maximum 0.176% sulfate found in #3 original mortar. Presence of Portland cement at a higher amount in the binders of the recent mortars is responsible for the high water-soluble sulfate contents.

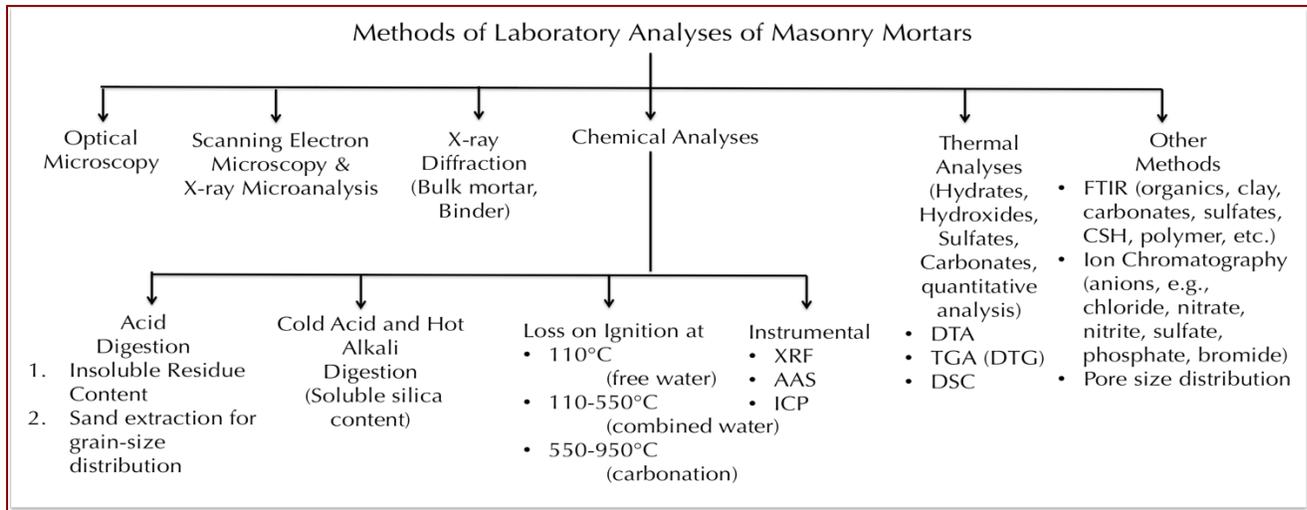
Figure A1: Various methods of laboratory analyses of masonry mortars. Optical microscopy is the first method that provides many useful information about the mortar and its ingredients, and dictates the subsequent methods to follow. Electron microscopy, X-ray diffraction, and various chemical analyses are commonly followed after optical microscopy to further determine the composition, microstructure, and mineralogy of sand and binder(s).

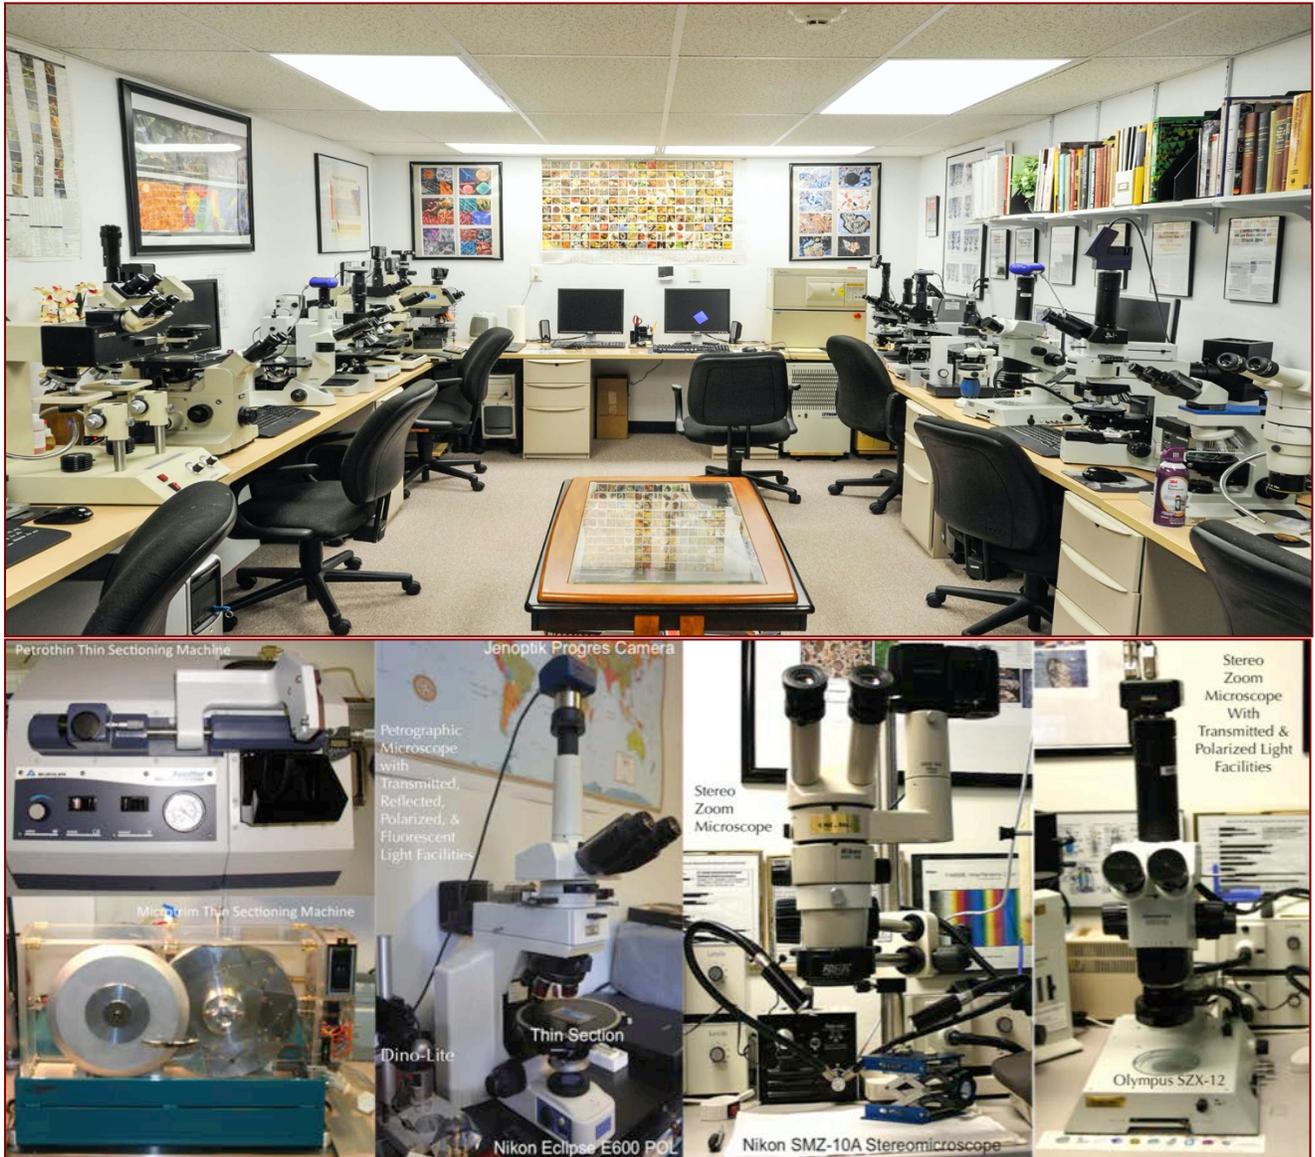
Figure A2: Top - Optical microscopy laboratory in CMC which houses a variety of optical microscopes including low-power stereomicroscopes, high-power transmitted, reflected, fluorescent, and polarized-light stereozoom microscope, metallurgical microscopes, petrographic microscopes with reflected, transmitted, fluorescent, and polarized light facilities, fluorescent microscopes, inverted microscopes, comparison microscopes, etc. Mortar examinations are done on stereomicroscopes, fluorescent light microscopes, and petrographic microscopes. Bottom – Thin sectioning equipments from Buehler and Microtec that prepare 25 to 30 micron thick thin-sections impregnated in clear, blue, or fluorescent dye-mixed epoxy for observations in petrographic and stereozoom microscopes (left), Nikon Eclipse E600 POL petrographic microscope (2<sup>nd</sup> from left), Nikon SMZ-10A stereomicroscope (3<sup>rd</sup> from left) and Olympus SZX-12 transmitted-light stereozoom camera microscope (rightmost) all having photomicrographic capabilities with advanced high-resolution microscope cameras (e.g., Jenoptik Progres Gryphax, Luminera Infinity series) for documenting compositional and microstructural features from optical microscopical examinations of masonry mortar.

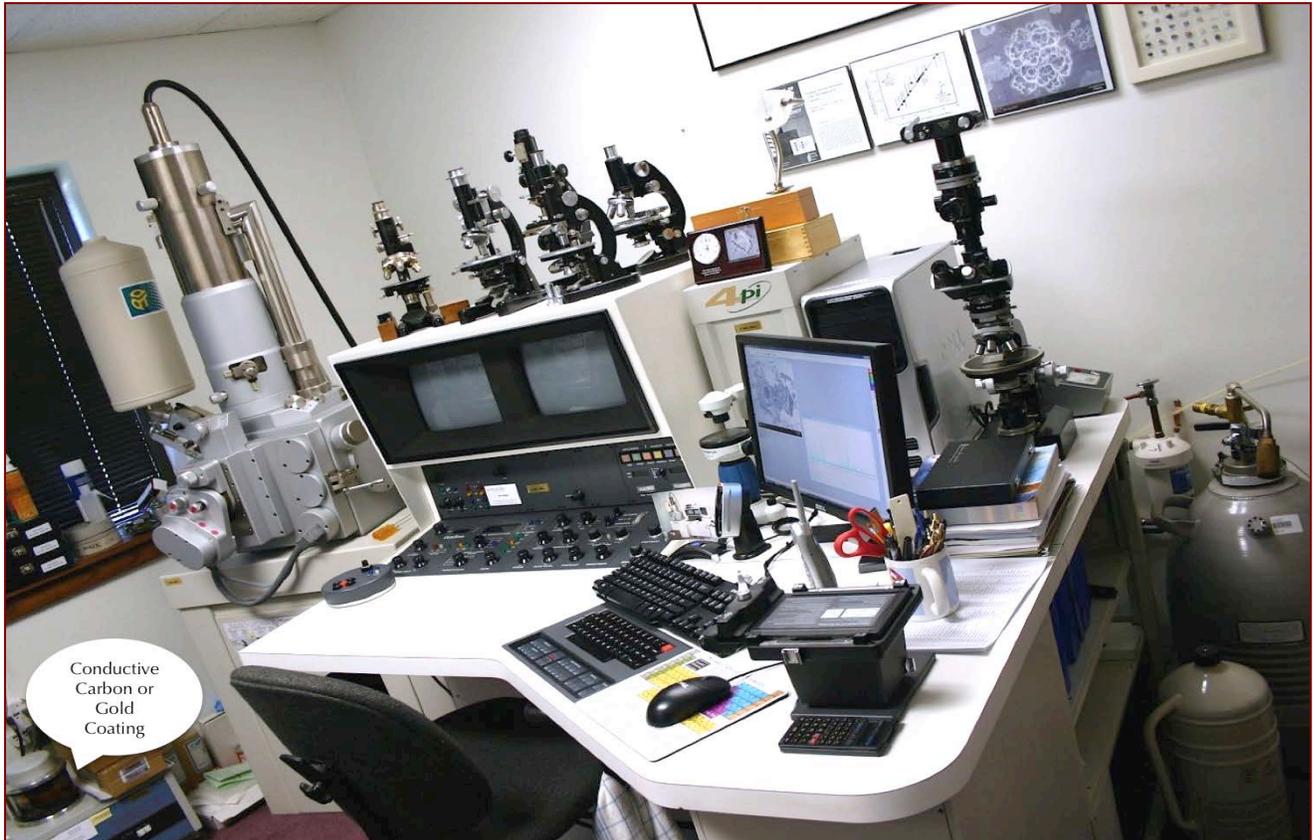
Figure A3: CamScan Series 2 scanning electron microscope in CMC that is attached to a backscatter detector, a secondary electron detector and an energy-dispersive X-ray detector.

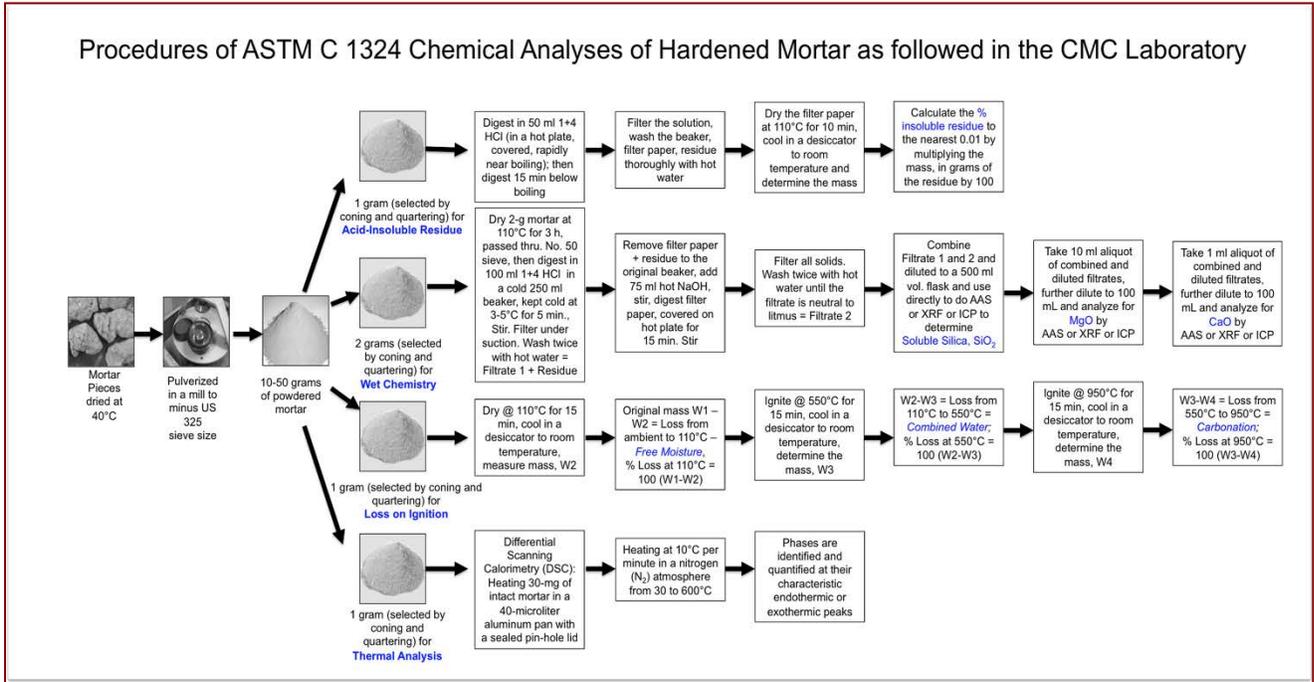
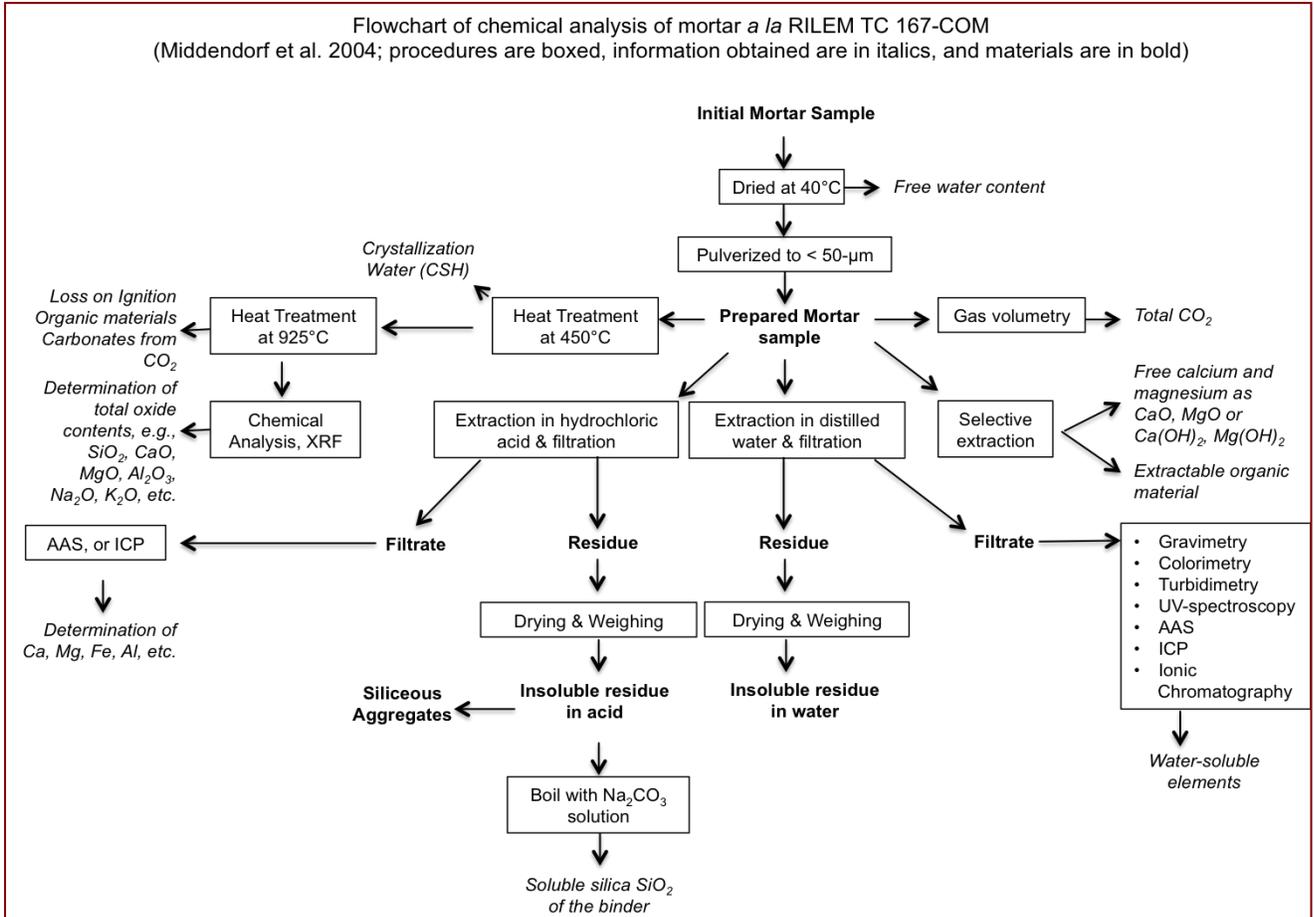
Figure A4: Flow charts for various chemical analyses of masonry mortar according to the US (top, ASTM C 1324) and European (bottom, RILEM) standards.

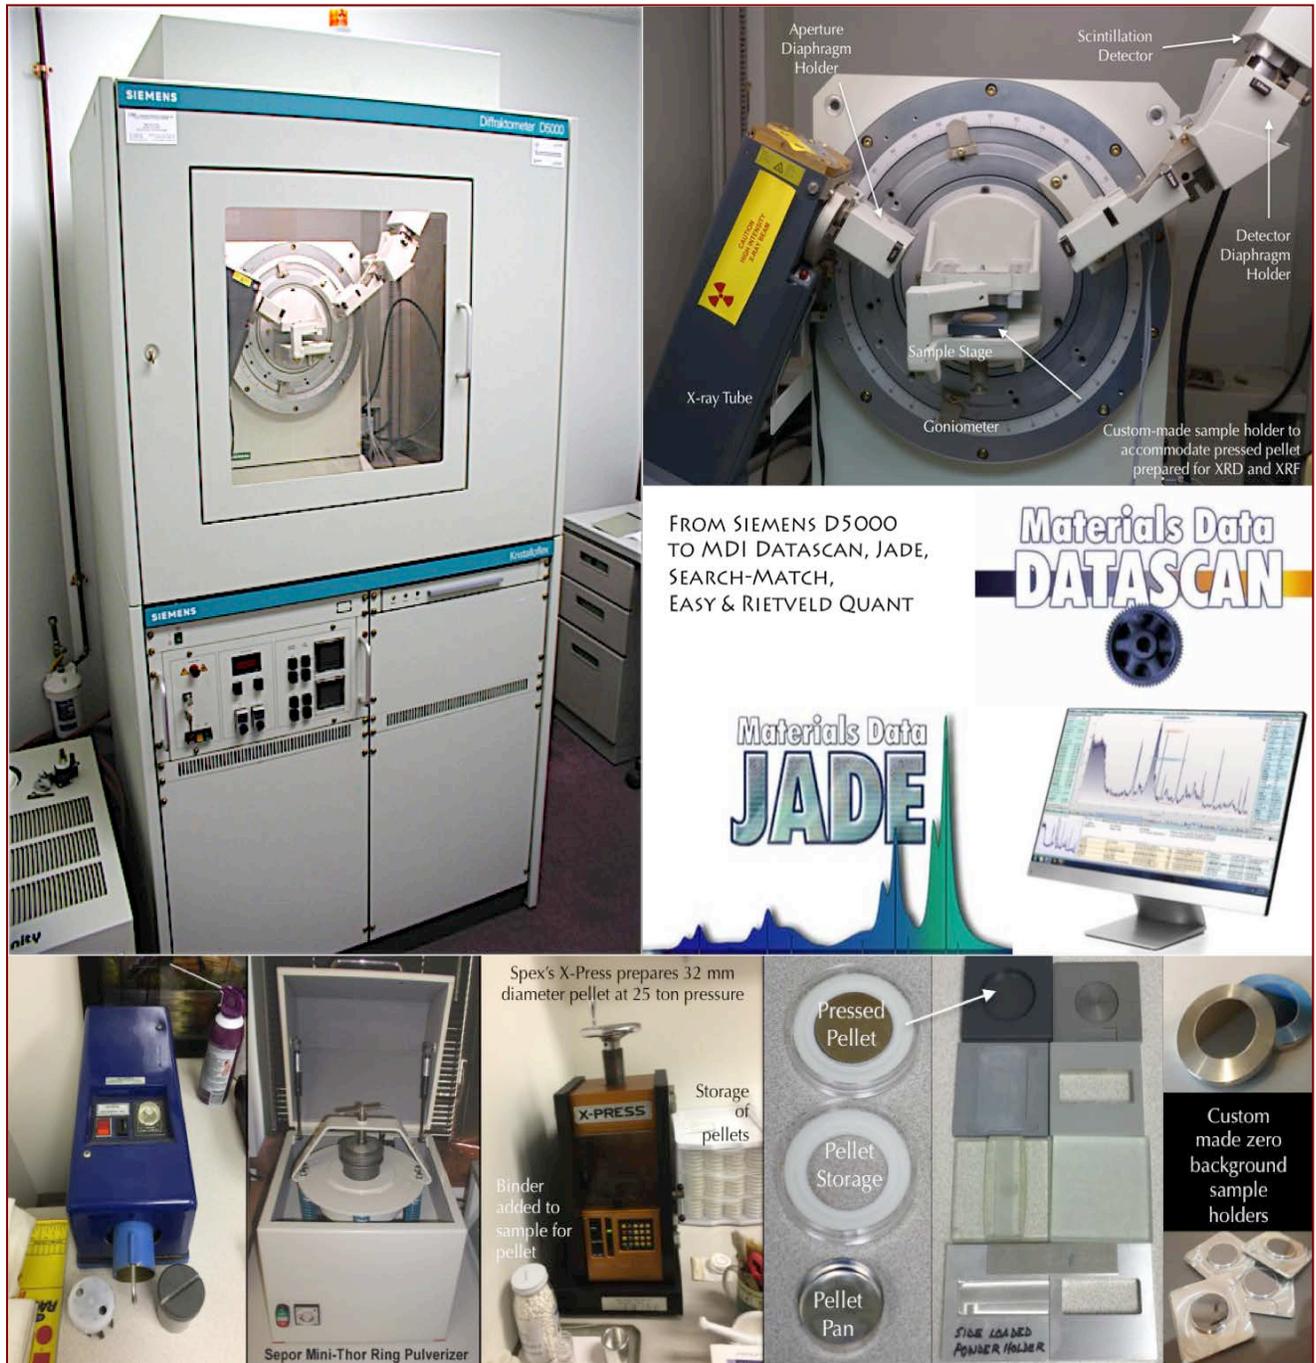
Figure A5: Siemens D5000 X-ray diffractometer in CMC that is connected to PC through MDI Datascan to collect diffraction data. XRD results are analyzed with MDI Jade software with search-match, easy quant, and Rietveld modules. The bottom row shows sample preparation for XRD where a Sepor Ring pulverizer (2<sup>nd</sup> from left) followed by McCrone micronizing mill (leftmost one) pulverized the sample to finer than 45-micron size. The pulverized sample is mixed with an appropriate binder and pressed in a 25-ton Spex press to form a 32-mm diameter pellet. Small amount of sample (i.e. not enough to prepare a pellet) is pulverized and spread over a quartz plate coated with a thin film of Vaseline.

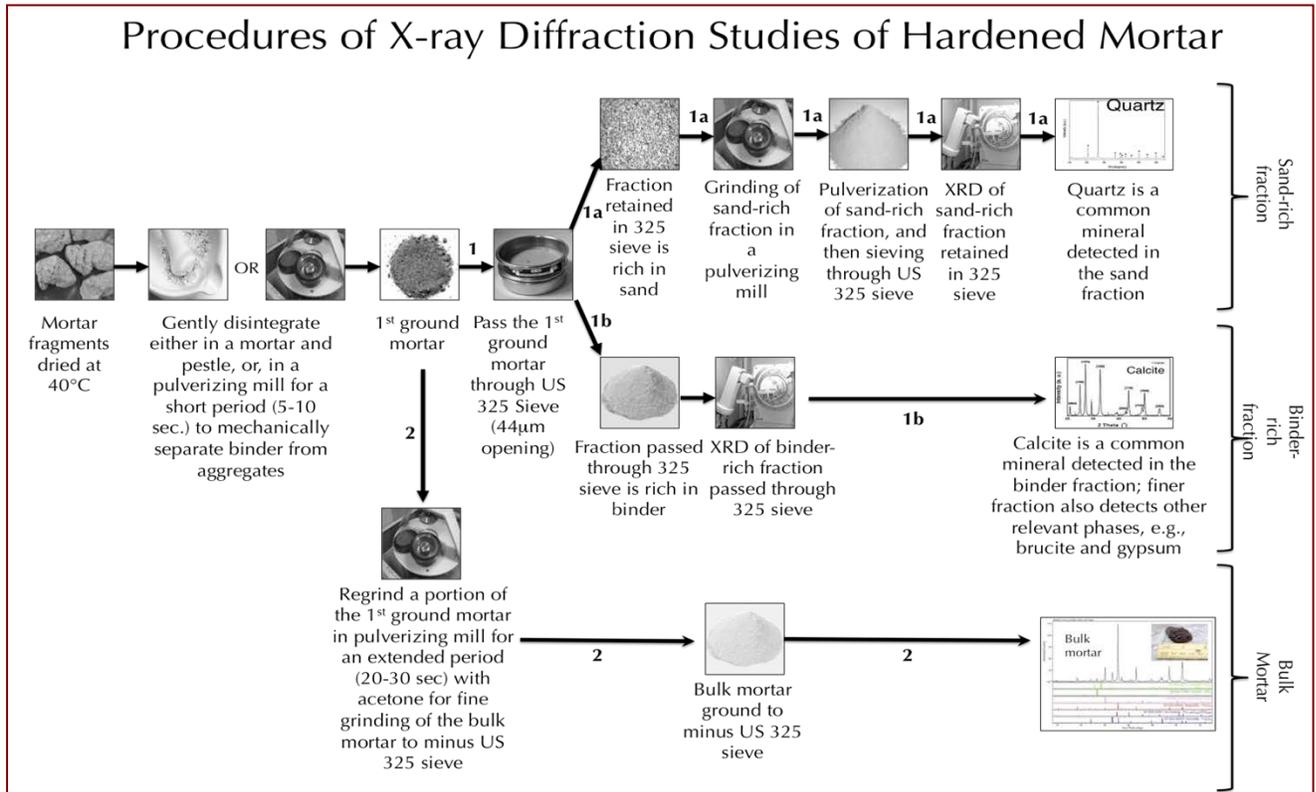
Figure A6: Various procedures for X-ray diffraction analysis of bulk mortar, and sand and/or binder fraction extracted from mortar.

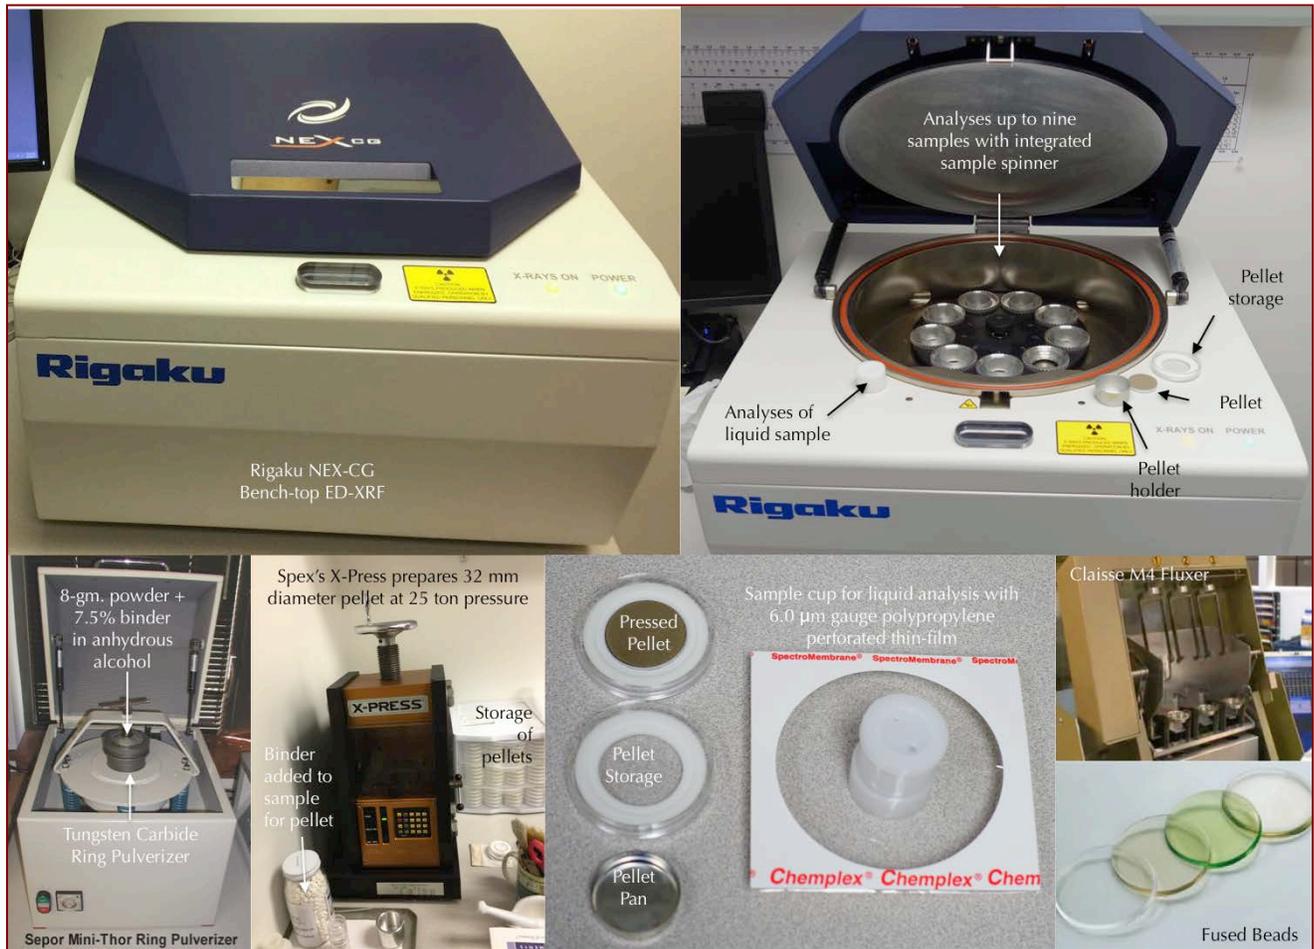
Figure A7: Rigaku NEX-CG in CMC, which can perform analyses of 9 pressed pellet or fused bead of mortar. Samples are prepared either as pressed pellet (usually the one already prepared for XRD) or can also accommodate fused bead with proper calibrate of standard beads.

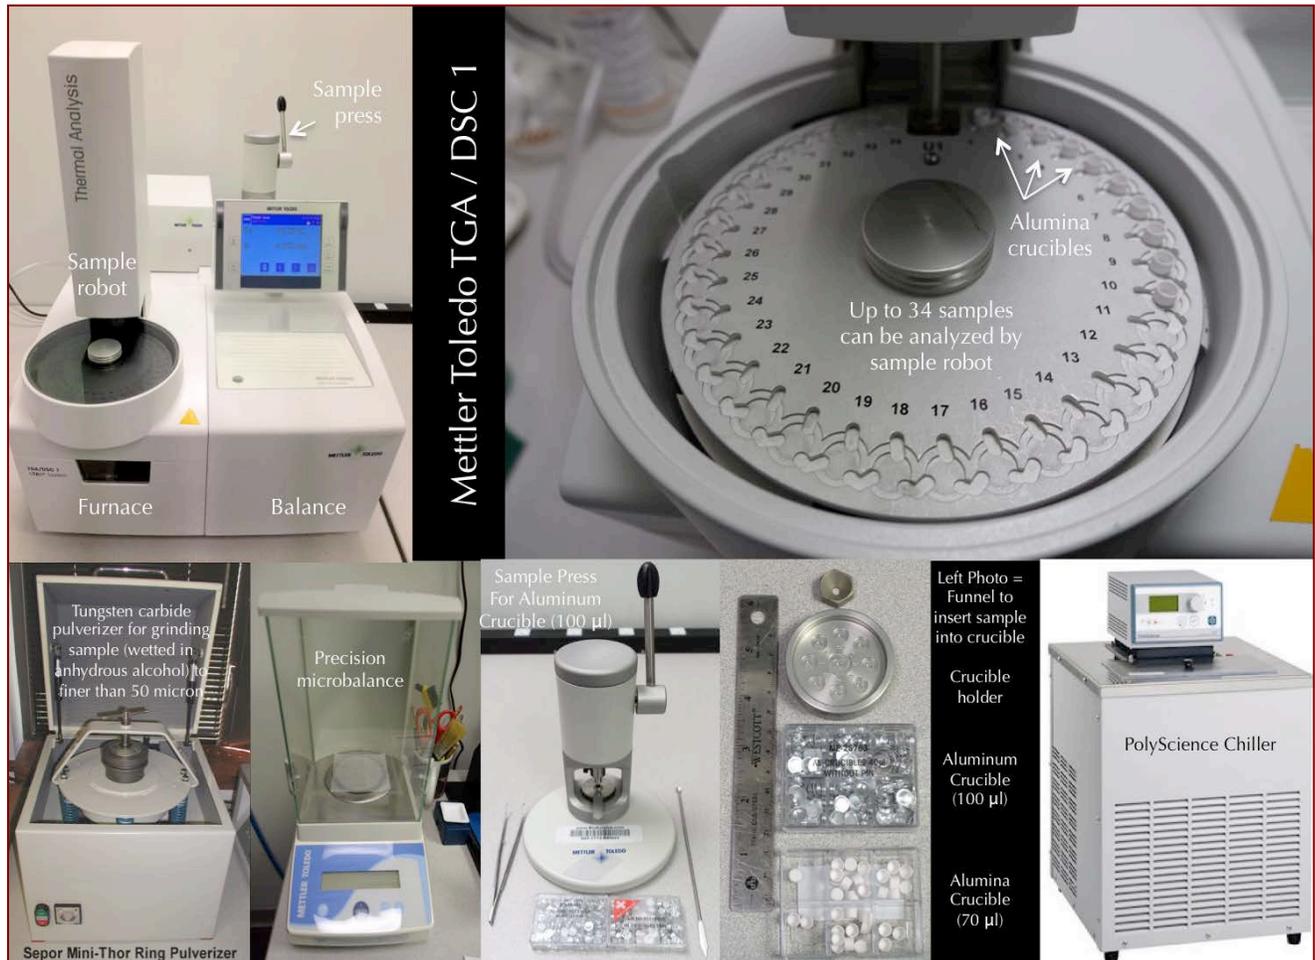
Figure A8: Mettler-Toledo simultaneous TGA/DSC1 unit in CMC that can accommodate 32 samples. The top left photo shows the TGA/DSC1 unit with sample robot for automation as well as the sample holder for pressing aluminum sample holders. Sample is pulverized in a ring pulverizer shown in the bottom left, then a small amount (usually 30-70 mg) is weighed in a precision balance (shown 2<sup>nd</sup> from left in bottom row) and taken in an alumina sample holder (without lid). For DSC measurements up to 600°C, sometimes sample is taken in an aluminum holder and pressed in sample press (3<sup>rd</sup> from left in bottom row) and pierced with a needle for release of volatiles from decomposition. A PolyScience chiller (rightmost one in the bottom row) is used to cool the furnace. An ultrapure nitrogen gas is purged through the system during analyses.

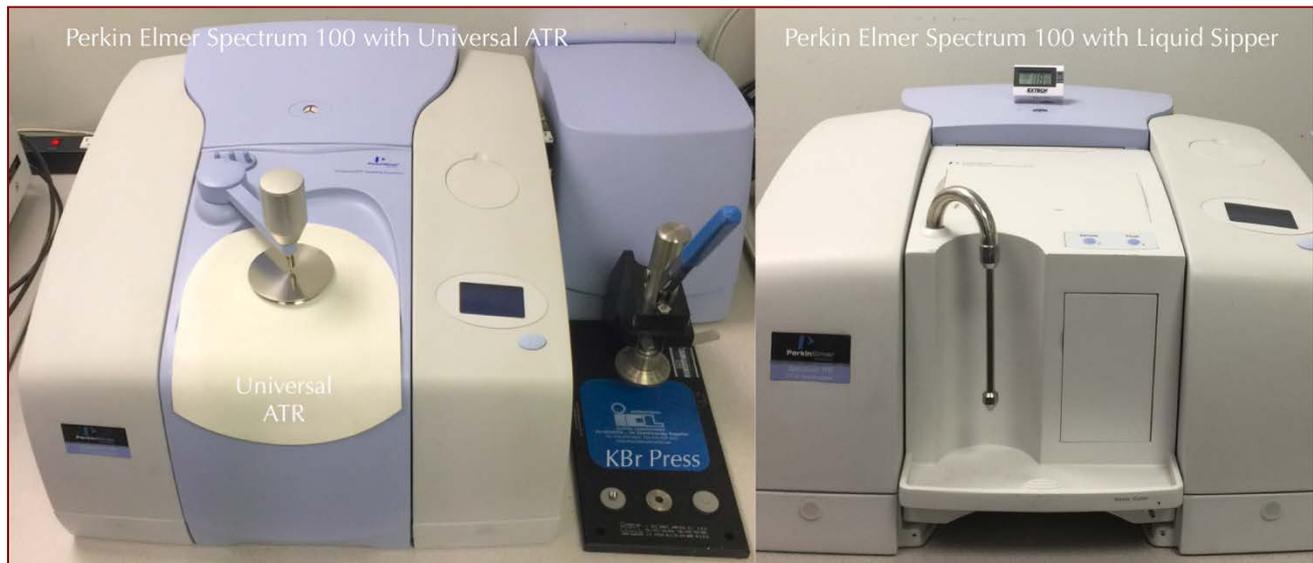
Figure A9: Perkin Elmer Spectrum 100 FT-IR unit in CMC with Universal ATR and Liquid Sipper attachments. The FT-IR unit can analyze a sample as-received in the Universal ATR (left), or as a pressed pellet after mixing with KBr powder in a KBr press (middle), or as a liquid either directly in Universal ATR or in Liquid Sipper unit (right).

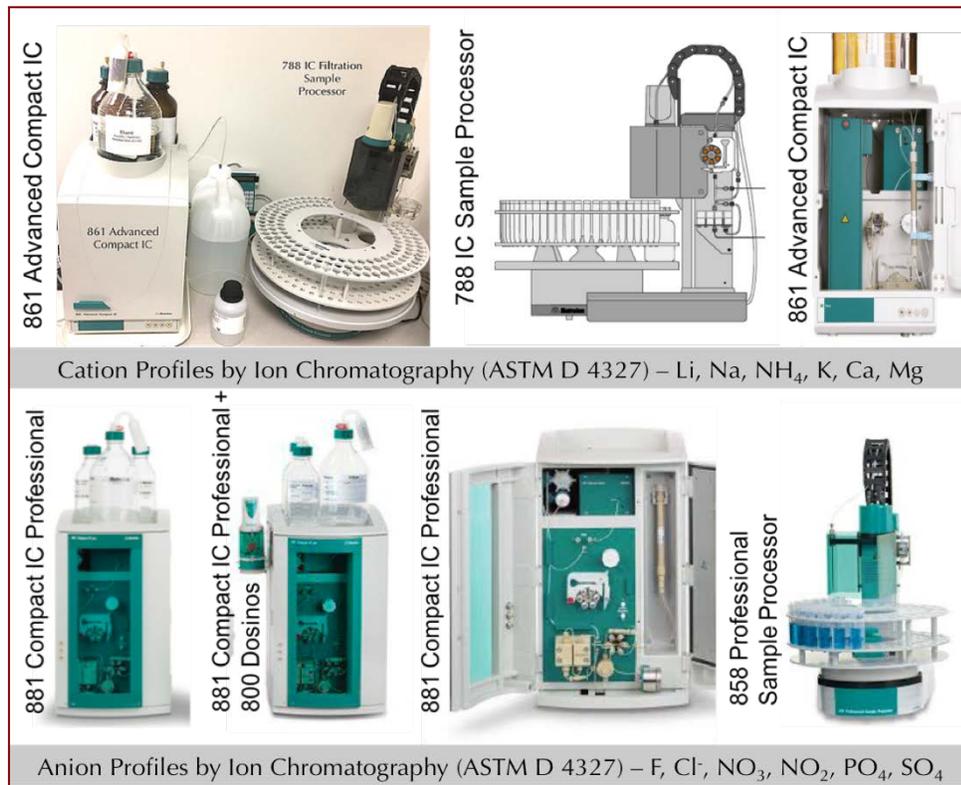
Figure A10: Various ion chromatography units used in CMC for determination of water-soluble ions after digestion of pulverized masonry mortar in deionized water to determine various anions (sulfate, chloride, nitrate, nitrite, phosphate, bromide) extracted from mortar.
