Improper Repointing of Masonry Mortars In A Historic Monument – A Case Study From Memorial Belltower At North Carolina State University, Raleigh, NC

North Carolina State University
2011 Hillsborough Street
Raleigh, NC 27607

October 25, 2019
CMC 0919153

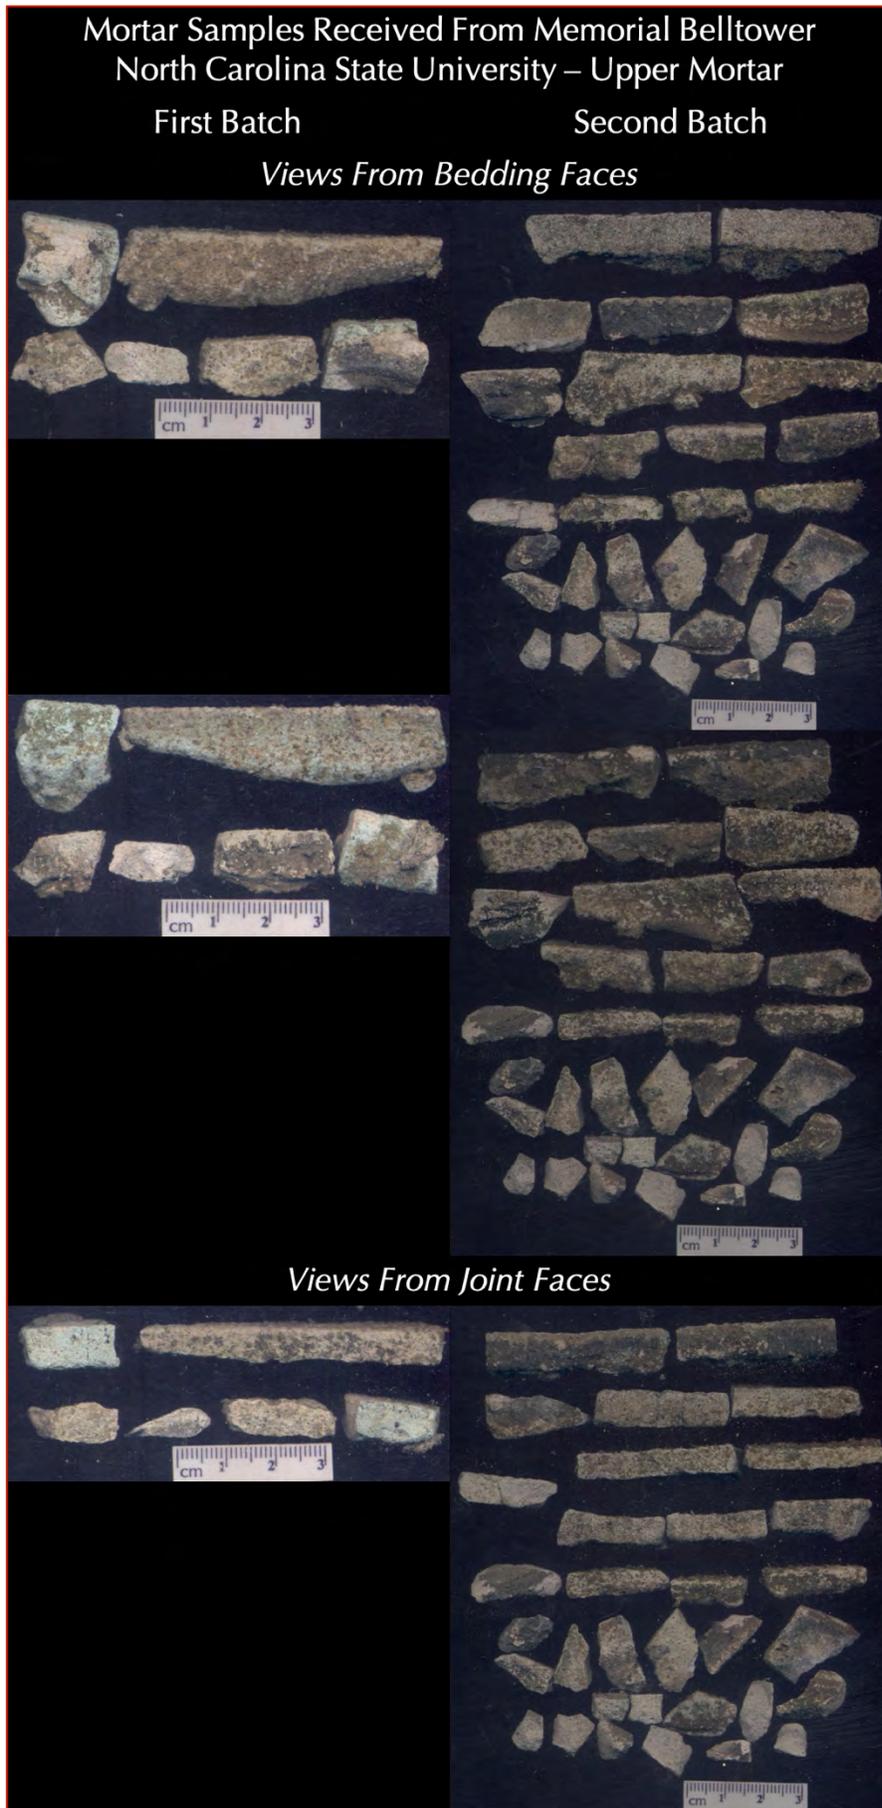
Figure 3: Mortar fragments collected from the upper level of the tower, which are marked as “upper,” reportedly constructed circa 1940s. The second batch of sample in the right column was provided as per request due to the lower amount of samples received in the first batch.

Most mortar pieces are dense, hard, weathered on the surfaces but when fractured or sectioned show darker gray interiors with a weathering rim. Relatively larger pieces of at least 25 mm length and of visually different appearances were selected for preparation of thin sections for optical and electron microscopical examinations and detection of various mortar types.

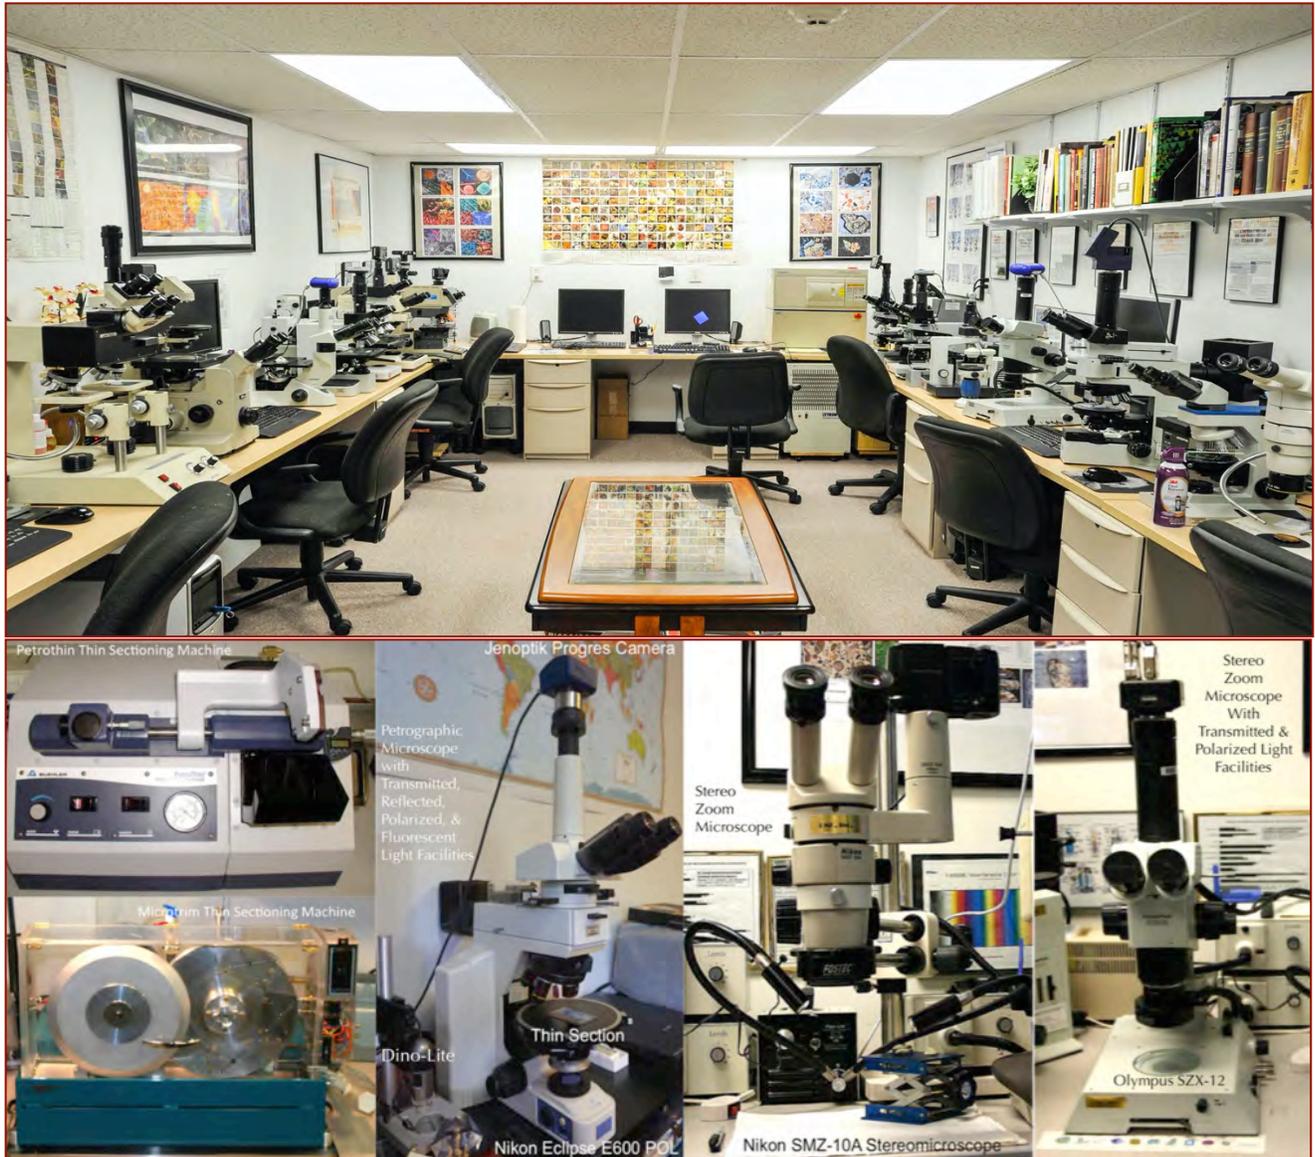
Figure A2: Top - Optical microscopy laboratory in CMC which houses a variety of optical microscopes including low-power stereomicroscopes, high-power transmitted, reflected, fluorescent, and polarized-light stereozoom microscope, metallurgical microscopes, petrographic microscopes with reflected, transmitted, fluorescent, and polarized light facilities, fluorescent microscopes, inverted microscopes, comparison microscopes, etc. Mortar examinations are done on stereomicroscopes, fluorescent light microscopes, and petrographic microscopes. Bottom – Thin sectioning equipments from Buehler and Microtec that prepare 25 to 30 micron thick thin-sections impregnated in clear, blue, or fluorescent dye-mixed epoxy for observations in petrographic and stereozoom microscopes (left), Nikon Eclipse E600 POL petrographic microscope (2nd from left), Nikon SMZ-10A stereomicroscope (3rd from left) and Olympus SZX-12 transmitted-light stereozoom microscope (rightmost) all having photomicrographic capabilities with advanced high-resolution microscope cameras (e.g., Jenoptik Progres Gryphax, Luminera Infinity series) for documenting compositional and microstructural features from optical microscopical examinations of masonry mortar.

CMC has a large assortment of optical microscopes from early 20th century to many latest advanced Nikon, Olympus, Leitz, Zeiss stereozoom and petrographic microscopes and several petrographic sample preparation and photomicrography facilities that can be found in our website at www.cmc-concrete.com.

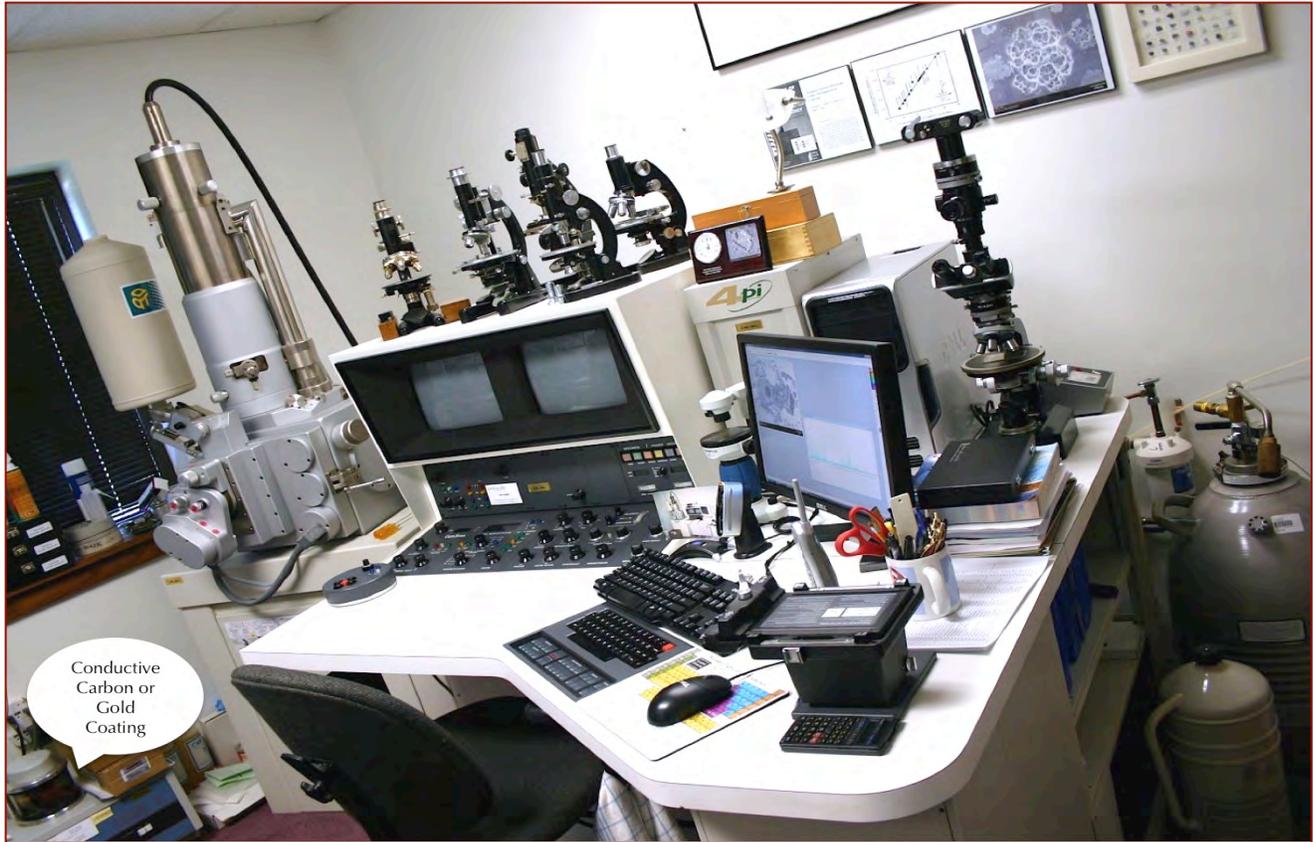
Figure A3: CamScan Series 2 scanning electron microscope in CMC that is attached to a backscatter detector, a secondary electron detector and an energy-dispersive X-ray detector.

Methods followed in scanning electron microscopy and energy-dispersive X-ray fluorescence spectroscopy (SEM-EDS) include: (a) secondary electron imaging (SEI) to determine the surface texture, microstructure and morphology of the examined surface, (b) backscatter electron (BSE) imaging to determine compositions of various phases from various shades of darkness/grayness from average atomic numbers of phases from the darkest pore spaces to brightest iron minerals (via minerals e.g., thaumasite, periclase, ettringite, quartz, dolomite, monosulfate, gypsum, calcite, C-S-H, aluminates, calcium hydroxide, belite, alite, free lime, and ferrite having progressively increasing average atomic numbers and brightness in BSE image), (c) X-ray elemental mapping (dot mapping) of an area of interest to differentiate various phases, (d) point-mode or area (raster)-mode analysis of specific area/phase of interest on a polished thin or solid section, and (e) average compositional analysis of a specific phase or an area on a polished thin or solid section or small subset of a sample.

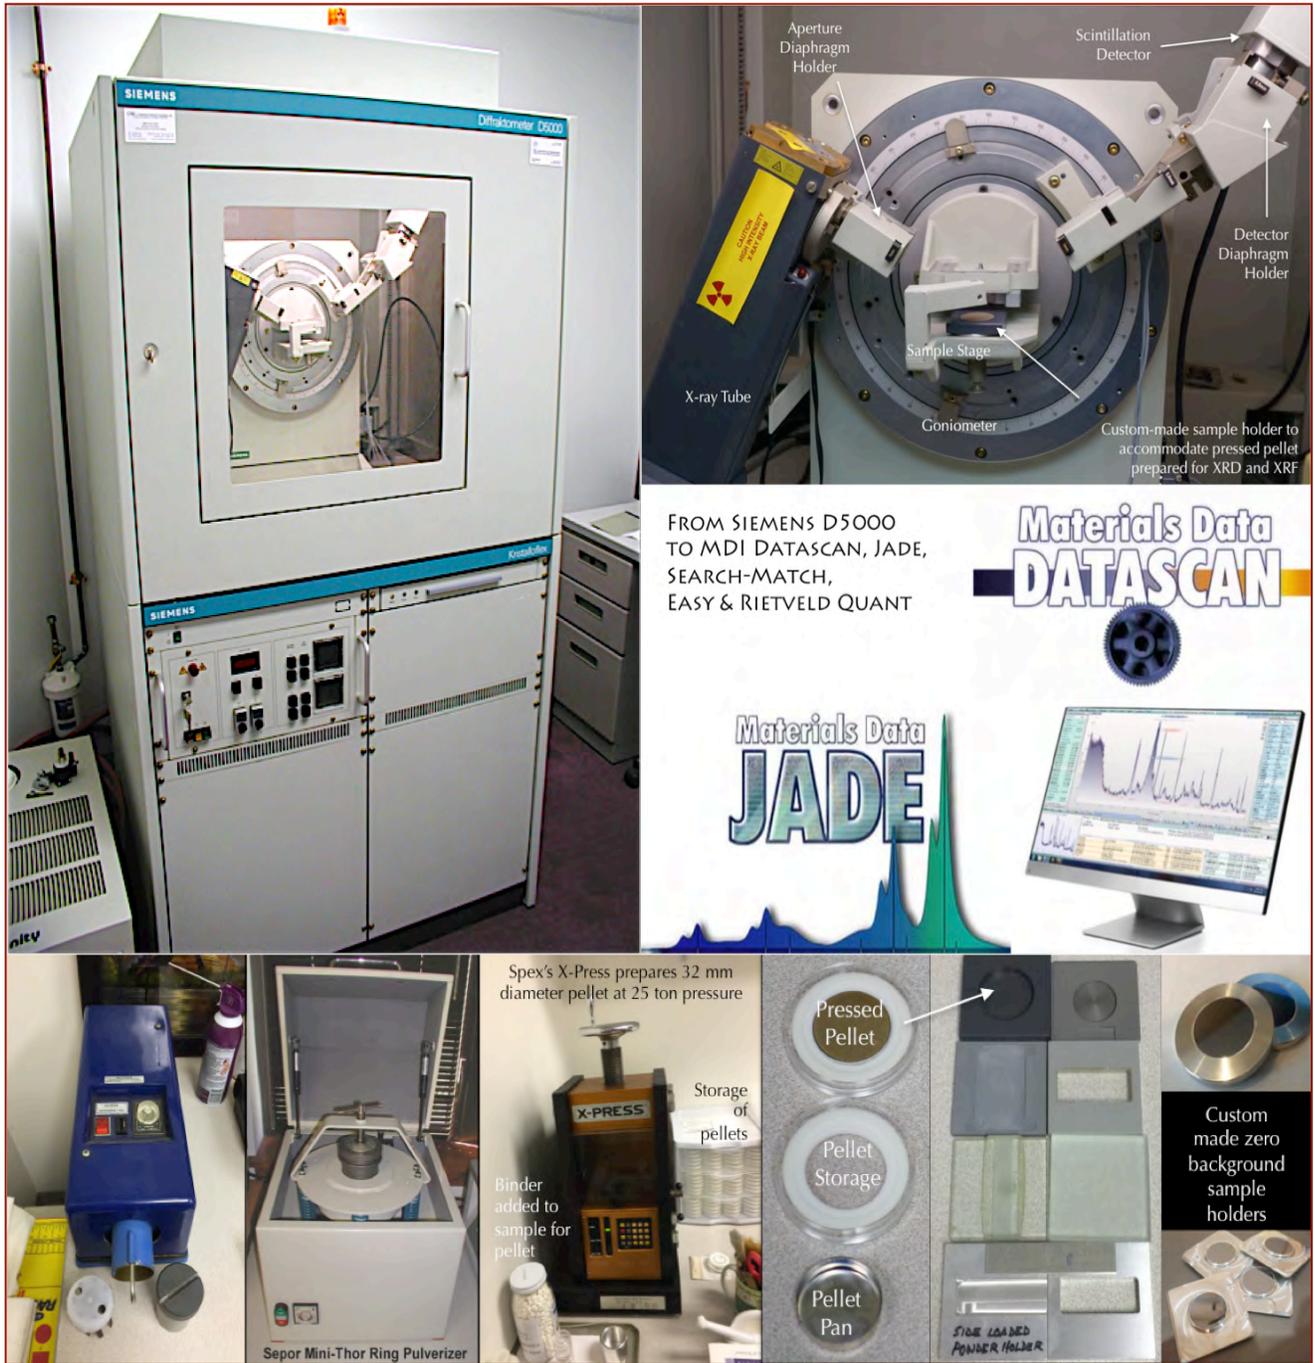
Figure A5: Siemens D5000 X-ray diffractometer in CMC that is connected to PC through MDI Datascan to collect diffraction data. XRD results are analyzed with MDI Jade software with search-match, easy quant, and Rietveld modules. The bottom row shows sample preparation for XRD where a Sepor Ring pulverizer (2nd from left) followed by McCrone micronizing mill (leftmost one) pulverized the sample to finer than 45-micron size. The pulverized sample is mixed with an appropriate binder and pressed in a 25-ton Spex press to form a 32-mm diameter pellet. Small amount of sample (i.e. not enough to prepare a pellet) is pulverized and spread over a quartz plate coated with a thin film of Vaseline.

XRD is carried out in a Siemens D5000 Powder diffractometer (θ - 2θ goniometer) employing a long line focus Cu X-ray tube, divergent and anti-scatter slits fixed at 1 mm, a receiving slit (0.6 mm), diffracted and incident beam Soller slits (0.04 rad), a curved graphite diffracted beam monochromator, and a sealed proportional counter. Siemens D5000 is equipped with (a) a horizontal stage (fixed), (b) an X-ray generator with $\text{CuK}\alpha$, fine focus sealed tube source, (c) large diameter goniometer (600 mm), low divergence collimator, and Soller slits, (d) fixed detector slits 0.05, 0.2, 0.6, 1.0, 2.0, and 6.0, and (e) Scintillation detector. Generator settings used are 40 kV and 30 mA. Tests are usually run at 2θ from 4° to 64° with a step scan of 0.02° and a dwell time of one second.

The resulting diffraction patterns are collected by DataScan 4 software of Materials Data, Inc. (MDI), analyzed by Jade software of MDI with ICDD PDF-4 (Minerals 2019) diffraction data. Phase identification, and quantitative analyses were carried out with MDI's Search/Match, Easy Quant, and Rietveld modules, respectively.

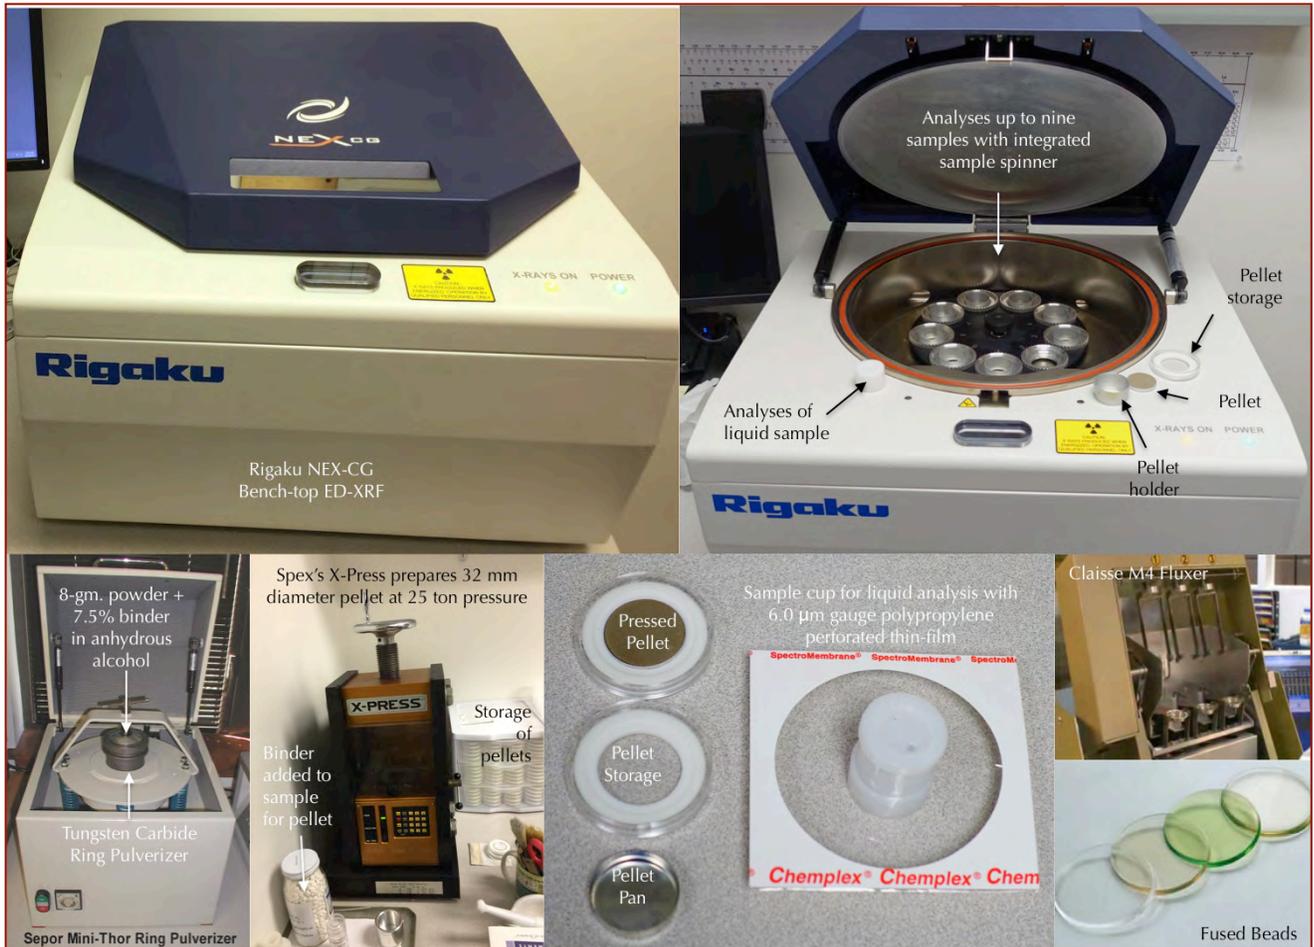
Figure A7: Rigaku NEX-CG in CMC, which can perform analyses of 9 pressed pellet or fused bead of mortar. Samples are prepared either as pressed pellet (usually the one already prepared for XRD) or can also accommodate fused bead with proper calibrate of standard beads.

An energy-dispersive bench-top X-ray fluorescence unit from Rigaku Americas Corporation (NEX-CG) is used (Figure A7). Rigaku NEX CG delivers rapid qualitative and quantitative determination of major and minor atomic elements in a wide variety of sample types with minimal standards. Unlike conventional EDXRF analyzers, the NEX CG was engineered with a unique close-coupled Cartesian Geometry (CG) optical kernel that dramatically increases signal-to-noise. By using monochromatic secondary target excitation, instead of conventional direct excitation, sensitivity is further improved. The resulting dramatic reduction in background noise, and simultaneous increase in element peaks, result in a spectrometer capable of routine trace element analysis even in difficult sample types. The instrument is calibrated by using various certified (CCRL, NIST, GSA, and Brammer) reference standards of cements and rocks. The same pellet used for XRD for mineralogical compositions is used for XRF to determine the chemical composition.
