## Laboratory Investigation of Anchoring Grout And Concrete Composite Cores From Balcony Slabs Of A Condominium

Building Façade and Waterproofing Repairs  
Bee Street Lofts  
150 Bee Street Condominiums  
Charleston, South Carolina

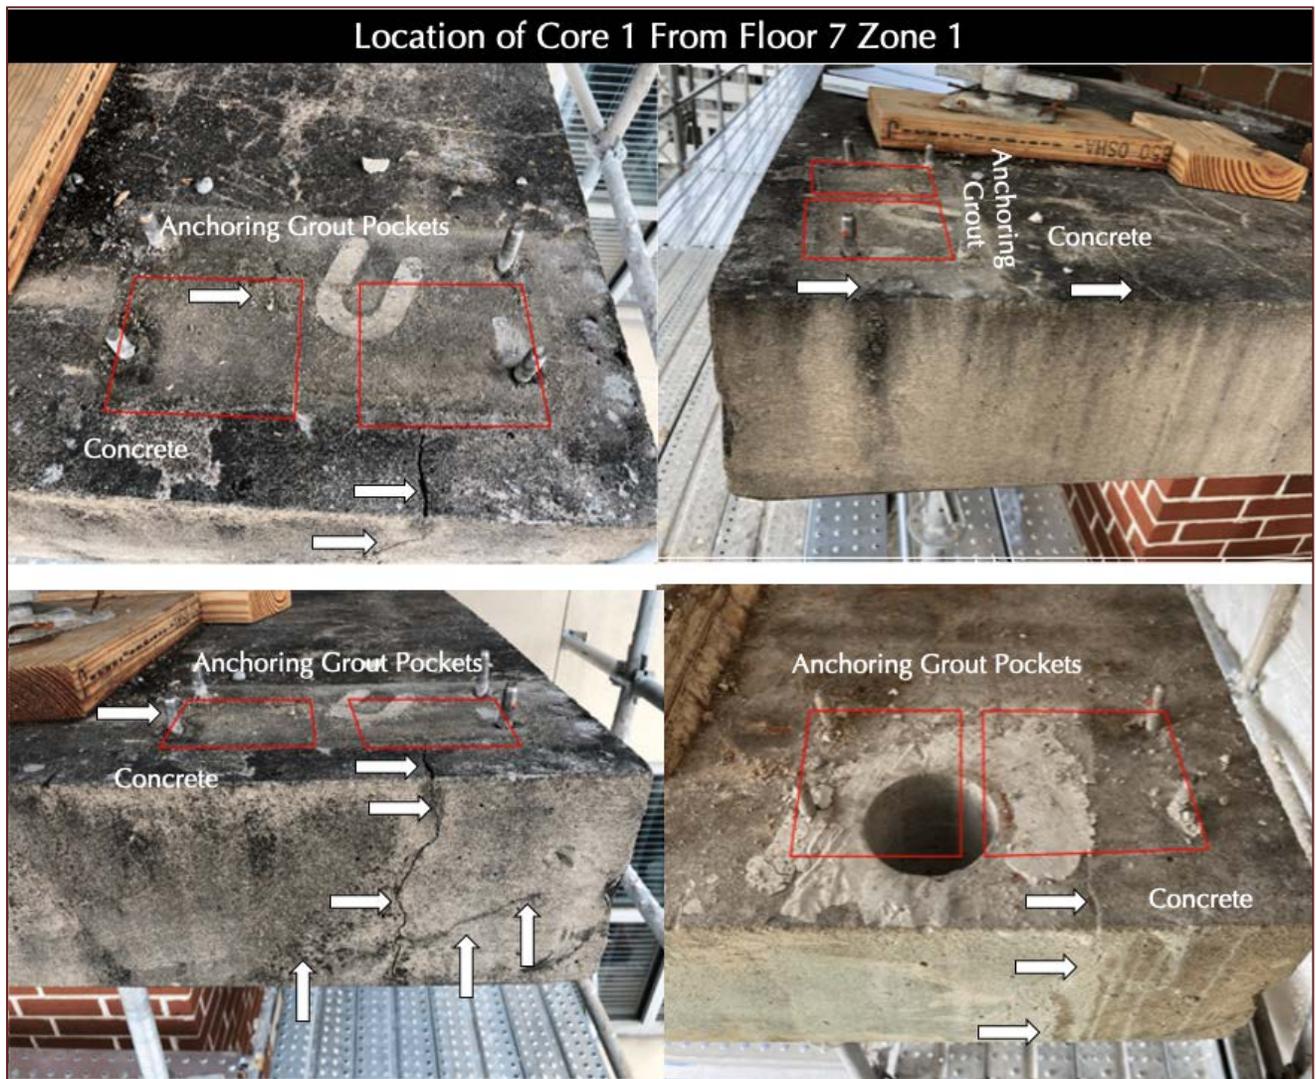
Figure 1: Field photographs showing cracking around the perimeter of the grout pocket indicated by arrows, which extend to the edges and face of the slab, and the location of Core 1 from Floor 7, Zone 1.

In summary, cracking of concrete around grout in the field photos are mostly formed due to one or a combination of the following factors: (a) continued expansion of grout after semi-plastic state to exert stresses to the neighboring concrete mass, which, however, seems unlikely due to reasonable 4 to 6 percent bulk sulfate content of grout to not leave any excess sulfate for continued sulfate-aluminate reactions at the semi-plastic or hardened states, and very dense and sound paste microstructure with no evidence of leaching softening or any moisture-induced alteration of paste during service; (b) restrain from expansion of grout at the plastic and semi-plastic state from concrete and metal plate installed above the grout; (c) freezing of non-air-entrained concrete at critically saturated conditions at the grout-concrete interface; and (d) some other factors not possible to evaluate from the present study. The present study found no deleterious reactions within the grout or concrete for cracking.

Field photographs in Figures 1 through 3 show cracking around the perimeter of the grout pockets, which extends to edges and face of the slab.

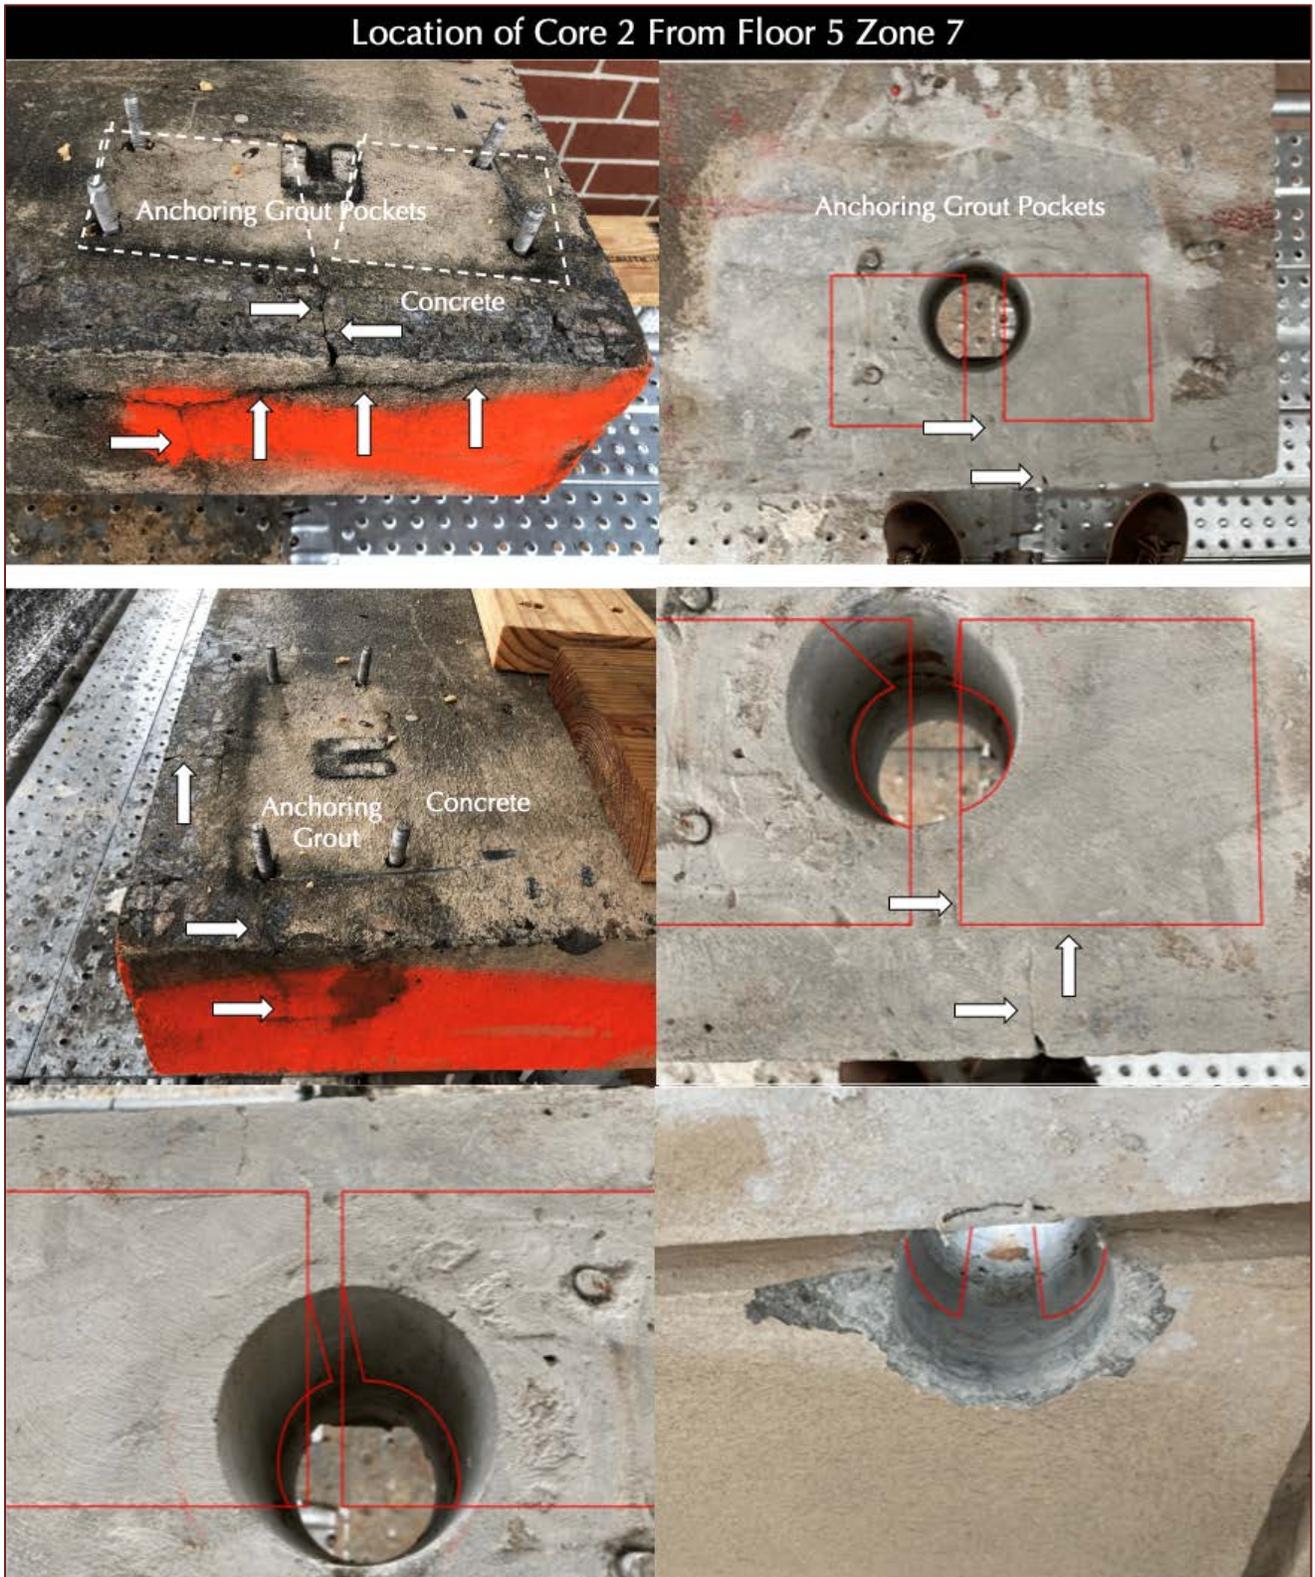
Figure 2: Field photographs showing cracking around the perimeter of the grout pocket indicated by arrows, which extend to the edges and face of the slab, and the location of Core 2 from Floor 5, Zone 7.

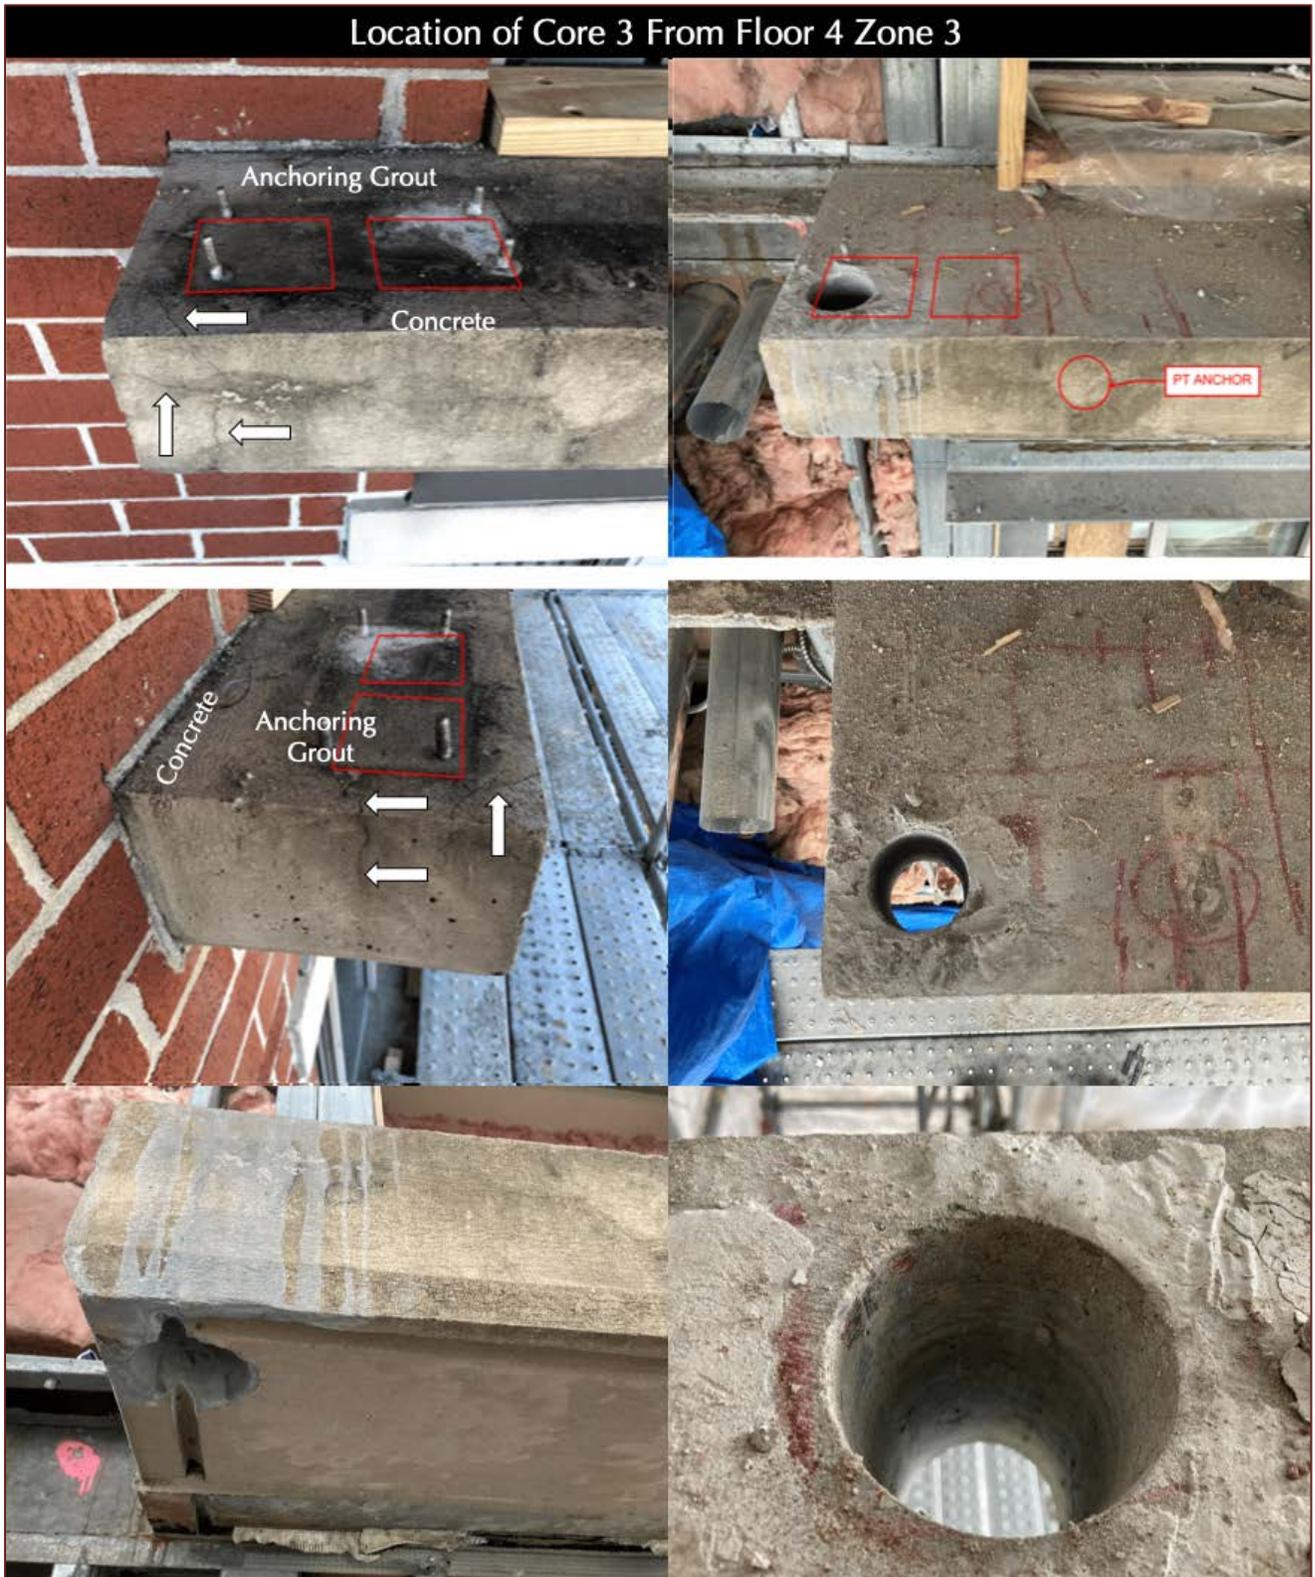
Figure 3: Field photographs showing cracking around the perimeter of the grout pocket indicated by arrows, which extend to the edges and face of the slab, and the location of Core 3 from Floor 4, Zone 3.

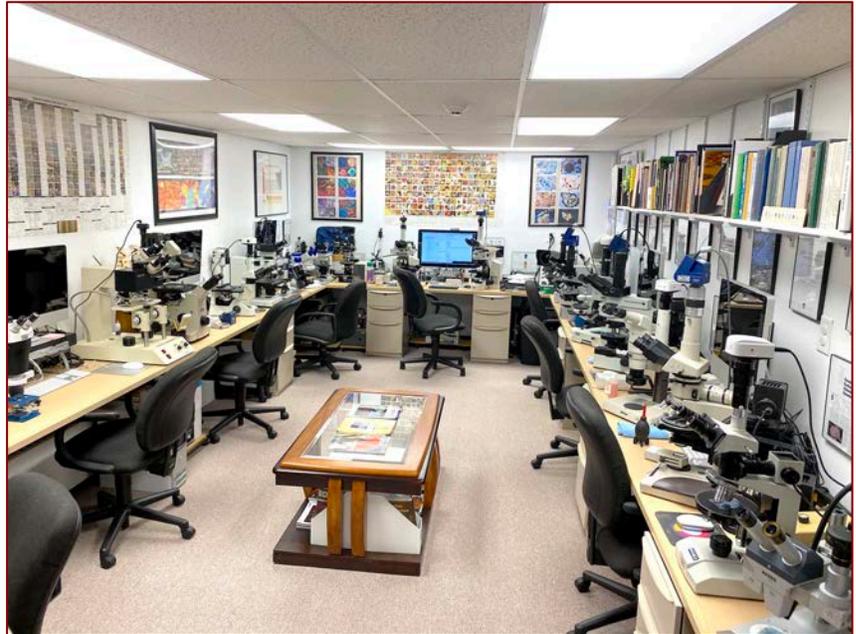
Figure 4: Optical microscopy laboratory in CMC that houses various stereo-microscopes, and petrographic microscopes used in this study.

The main purposes of optical microscopy are characterization of: (a) aggregates, e.g., type(s), chemical and mineralogical compositions, nominal maximum size, shape, angularity, grain-size distribution, soundness, alkali-aggregate reactivity, etc. (b) paste, e.g., compositions and microstructures to diagnose various type(s) of binder(s) used, (c) air, e.g., presence or absence of air entrainment, air content, etc., (d) alterations, e.g., lime leaching, carbonation, staining, etc. due to interactions with the environmental agents during service, and effects of such alterations on properties and performance; and (e) deteriorations, e.g., chemical and/or physical deteriorations during service, cracking from various mechanisms, salt attacks, possible reasons for the lack of bond if reported, etc. Portions selected from preliminary examinations for microscopy are sectioned, polished, and thin-sectioned (down to 25-30 micron thickness) preferably after encapsulating and impregnating with a dyed-epoxy to improve the overall integrity of the sample during precision sectioning and grinding, and to highlight porous areas, voids, and cracks. Prepared sections are then examined in a high-power (up to 100X) Stereozoom microscope having reflected and transmitted-light, and plane and crossed polarized-light facilities, and eventually in a high-power (up to 600X) petrographic microscope equipped with transmitted, reflected, polarized, and fluorescent-light facilities. Capturing high-resolution photomicrographs from these microscopes via digital microscope cameras with image analyses software are an integral part of documentations during petrographic examinations.

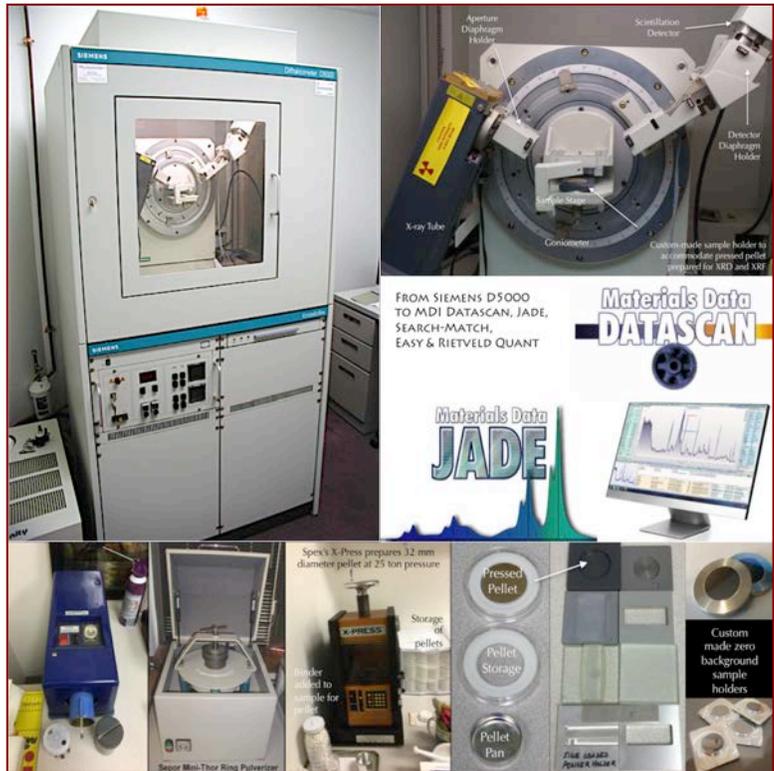
Figure 5: Siemens D5000 X-ray diffractometer in CMC that is connected to PC through MDI Datascan to collect diffraction data. XRD results are analyzed with MDI Jade software with search-match, easy quant, and Rietveld modules. The bottom row shows sample preparation for XRD where a Sepor Ring pulverizer (2<sup>nd</sup> from left) followed by McCrone micronizing mill (leftmost one) pulverized the sample to finer than 45-micron size. The pulverized sample is mixed with an appropriate binder and pressed in a 25-ton Spex press to form a 32-mm diameter pellet. Small amount of sample (i.e. not enough to prepare a pellet) is pulverized and spread over a quartz plate coated with a thin film of Vaseline.

XRD is carried out in a Siemens D5000 Powder diffractometer ( $\theta$ -2 $\theta$  goniometer) employing a long line focus Cu X-ray tube, divergent and anti-scatter slits fixed at 1 mm, a receiving slit (0.6 mm), diffracted and incident beam Soller slits (0.04 rad), a curved graphite diffracted beam monochromator, and a sealed proportional counter. Siemens D5000 is equipped with (a) a horizontal stage (fixed), (b) an X-ray generator with CuK $\alpha$ , fine focus sealed tube source, (c) large diameter goniometer (600 mm), low divergence collimator, and Soller slits, (d) fixed detector slits 0.05, 0.2, 0.6, 1.0, 2.0, and 6.0, and (e) Scintillation detector. Generator settings used are 40 kV and 30 mA. Tests are usually run at 2 $\theta$  from 4° to 64° with a step scan of 0.02° and a dwell time of one second. The resulting diffraction patterns are collected by DataScan 4 software of Materials Data, Inc. (MDI), analyzed by Jade software of MDI with ICDD PDF-4 (Minerals 2019) diffraction data. Phase identification, and quantitative analyses were carried out with MDI’s Search/Match, Easy Quant, and Rietveld modules, respectively.

For sample preparation, a Rocklab (Sepor Mini-Thor Ring) pulverizer is used to grind sample down to finer than 100 microns. Usually, a few drops of anhydrous alcohol are added to reduce decomposition of hydrous phases from the heat generated from grinding. Approximately 10 grams of sample is ground first in the pulverizer, from which about 8.0 grams of sample is selected, mixed with an appropriate binder (e.g., three Herzog grinding aid pellets from Oxford Instruments having a total binder weight of 0.6 gram for 8 grams of sample for a fixed binder proportion of 7.5 percent); the mixture is then further ground in Rocklab pulverizer and in a McCrone micronizing mill with anhydrous alcohol down to finer than 45-micron size. Approximately 7.0 grams of binder-mixed pulverized sample thus prepared is

weighed into an aluminum sample cup and inserted in a stainless steel die press to prepare the sample pellet. A 25-ton Spex X-press is used to prepare 32 mm diameter pellet from the pulverized sample. The pressed pellet is then placed in a custom-made circular sample holder for XRD and excited with the copper radiation of 1.54 angstroms. Sample holders made with quartz or silicon are best for working with very small quantities of sample because these holders create no diffraction peaks between 2° and 90° 2θ.

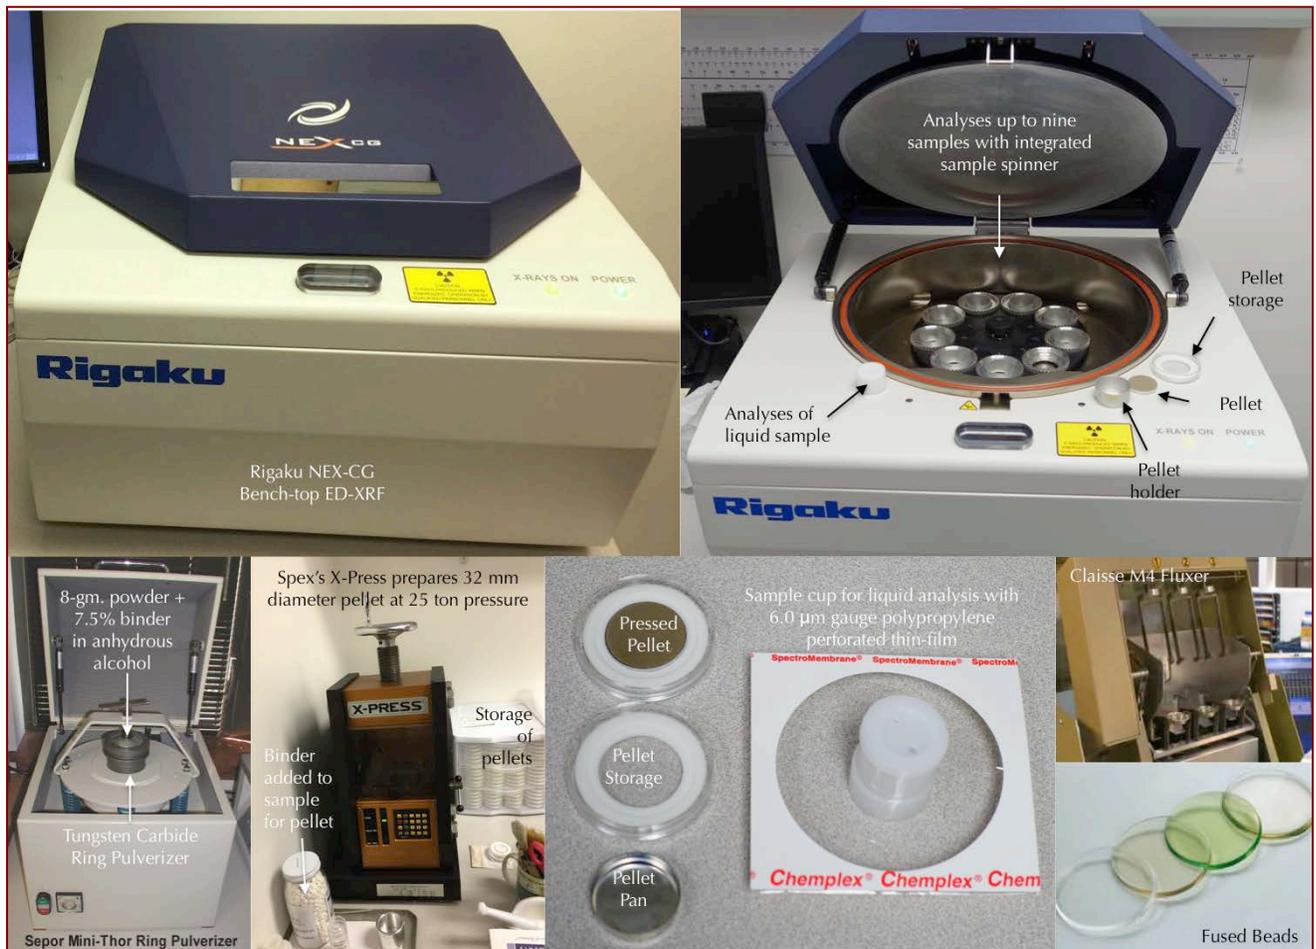
An energy-dispersive bench-top X-ray fluorescence unit from Rigaku Americas Corporation (NEX-CG) is used. Rigaku NEX CG delivers rapid qualitative and quantitative determination of major and minor atomic elements in a wide variety of sample types with minimal standards. Unlike conventional EDXRF analyzers, the NEX CG was engineered with a unique close-coupled Cartesian Geometry (CG) optical kernel that dramatically increases signal-to-noise. By using monochromatic secondary target excitation, instead of conventional direct excitation, sensitivity is further improved. The resulting dramatic reduction in background noise, and simultaneous increase in element peaks, result in a spectrometer capable of routine trace element analysis even in difficult sample types. The instrument is calibrated by using various certified (CCRL, NIST, GSA, and Brammer) reference standards of cements and rocks. The same pellet used for XRD for mineralogical compositions is used for XRF to determine the chemical composition.

Figure 6: Rigaku NEX-CG in CMC, which can perform analyses of up to 9 pressed pellets or fused beads of sample. Samples are prepared either as pressed pellet or can also accommodate fused bead with proper calibration of standard beads.

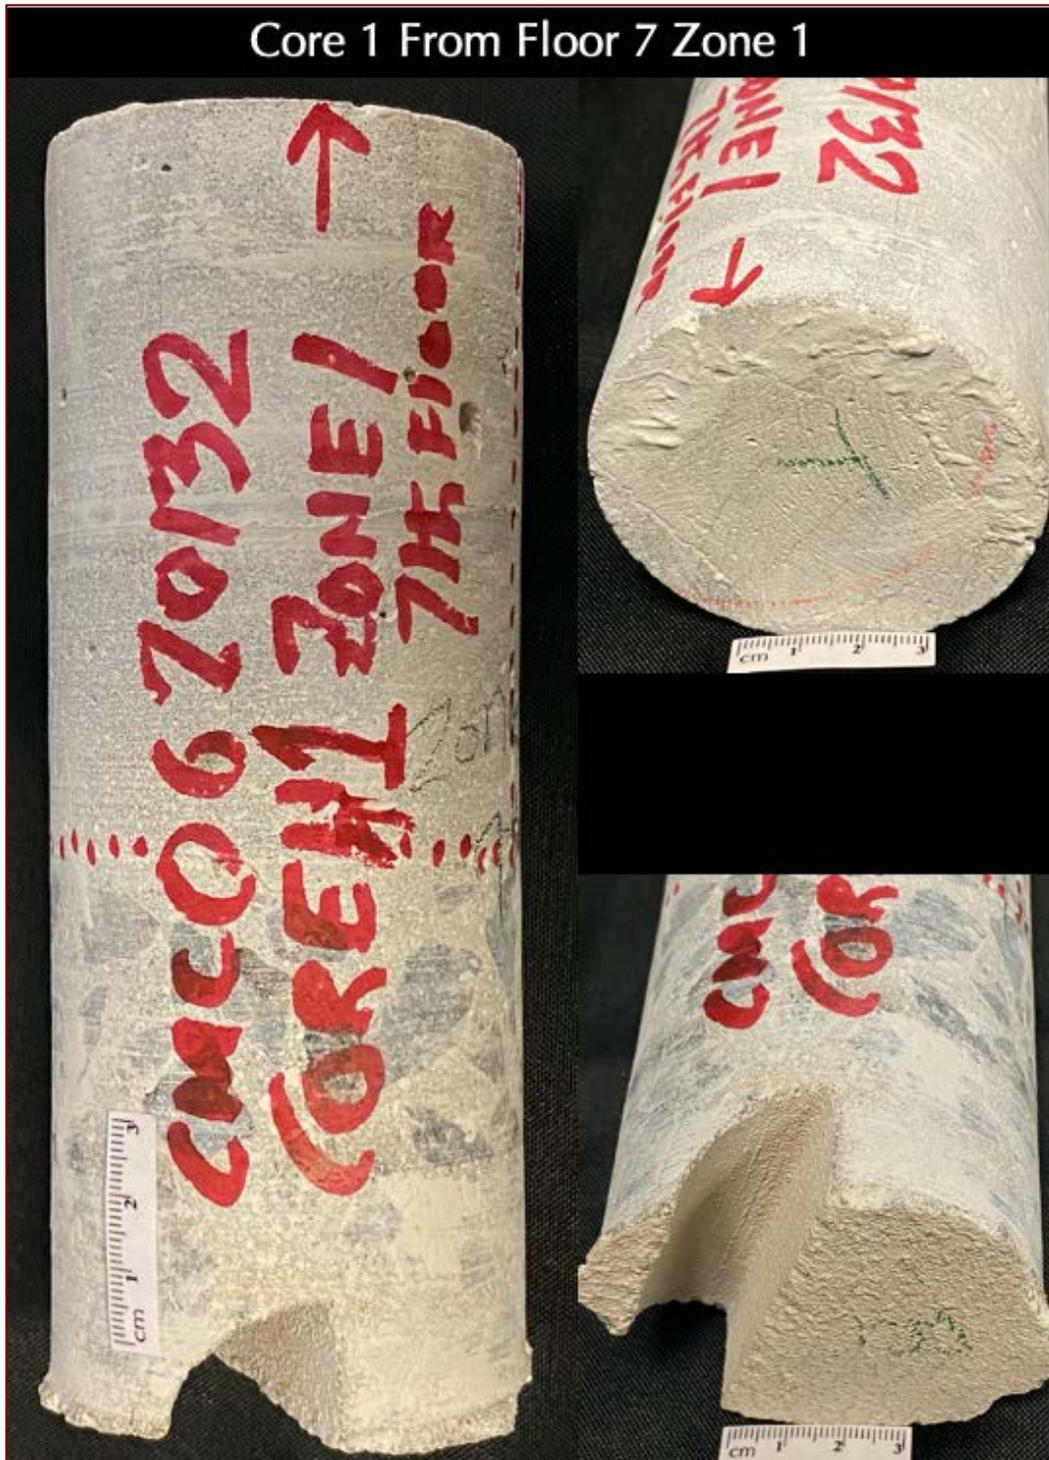
Figure 7: Core 1 from Zone 1 7<sup>th</sup> floor showing:

(a) A finished exposed surface of grout which is seen in sound condition;

(d) Overall intact condition of the grout-concrete composite core;

(f) Dense and well-consolidated natures of both grout and concrete components.

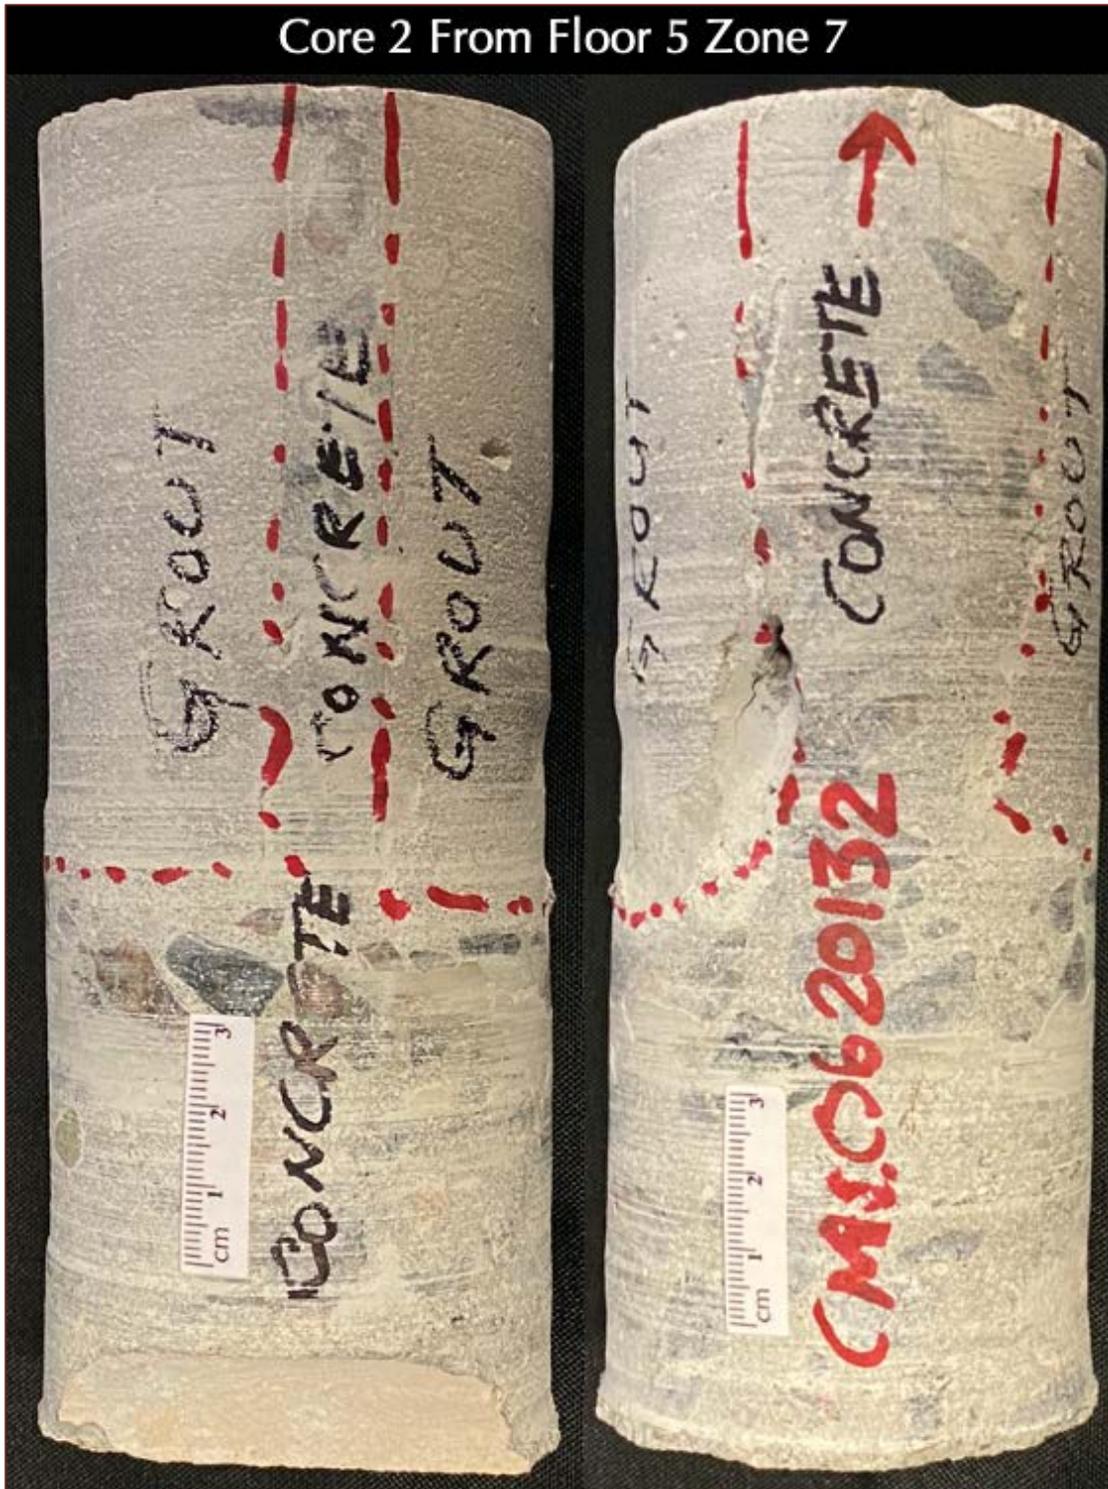
Figure 8: Core 2 showing:

(b) Overall intact condition of the grout-concrete composite core;

(d) Dense and well-consolidated natures of both grout and concrete components.

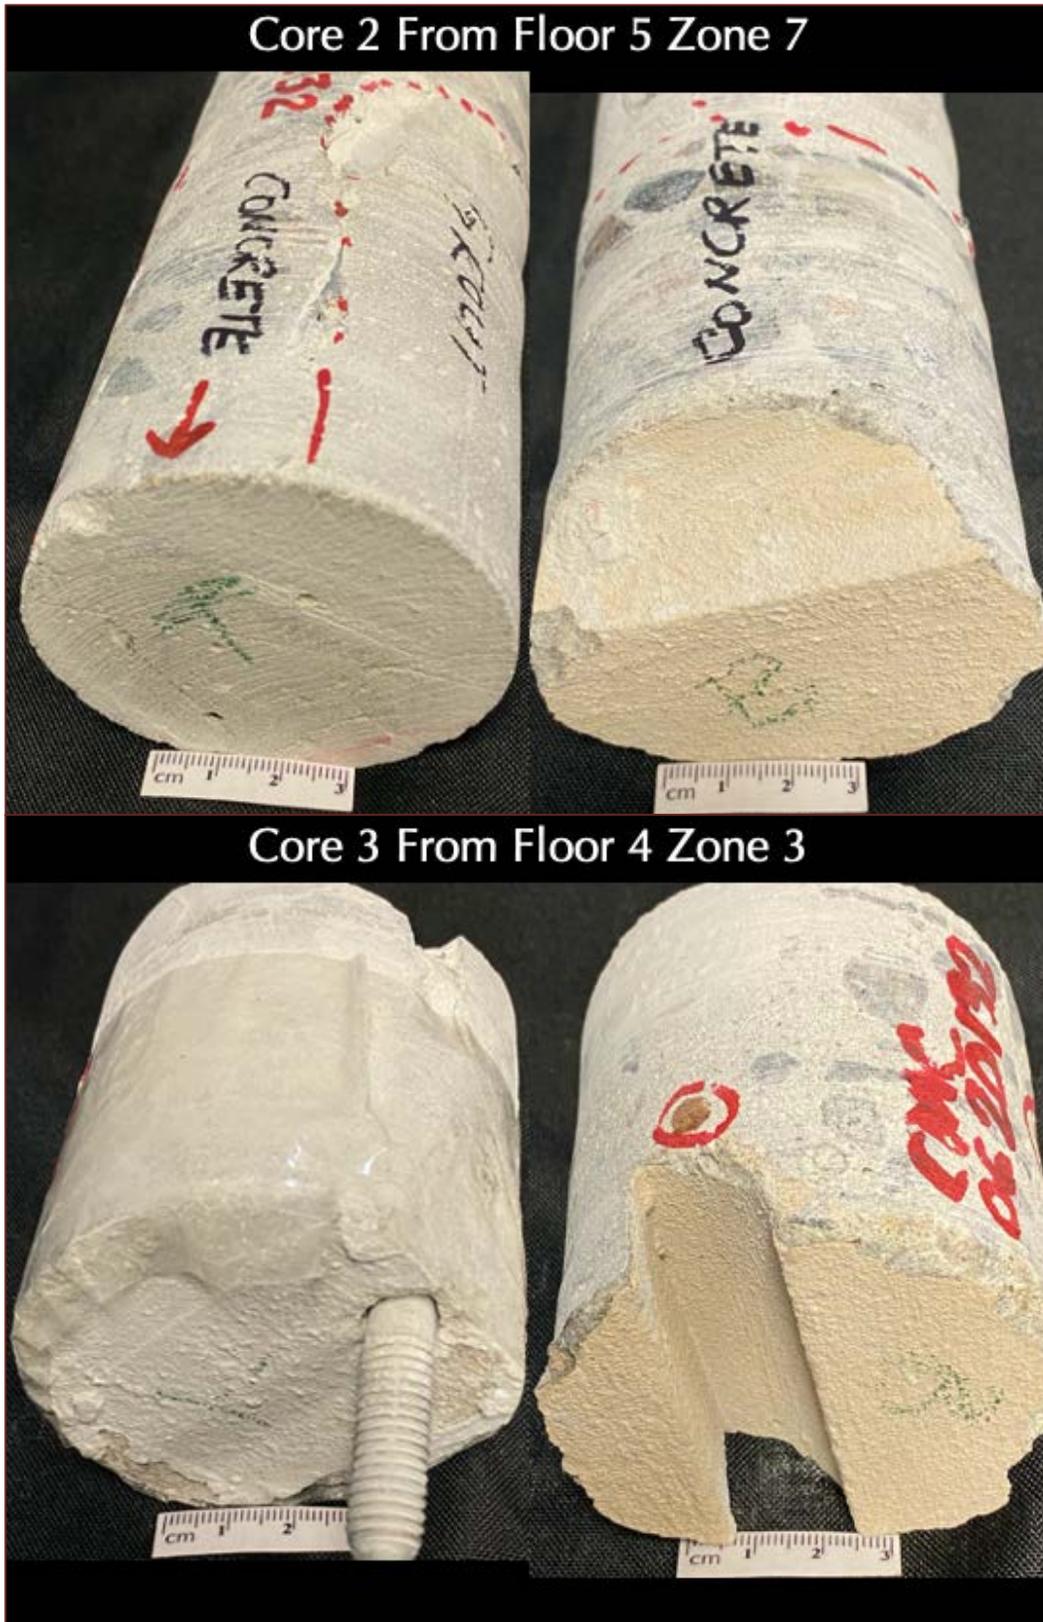
Figure 9: Exposed finished surfaces of grouts in Cores 2 and 3, and opposite formed surfaces of concretes in both cores showing placement of concrete slab on metal decking. Notice a cream-colored paint coat present on the concrete base in both cores (also seen in Core 1).

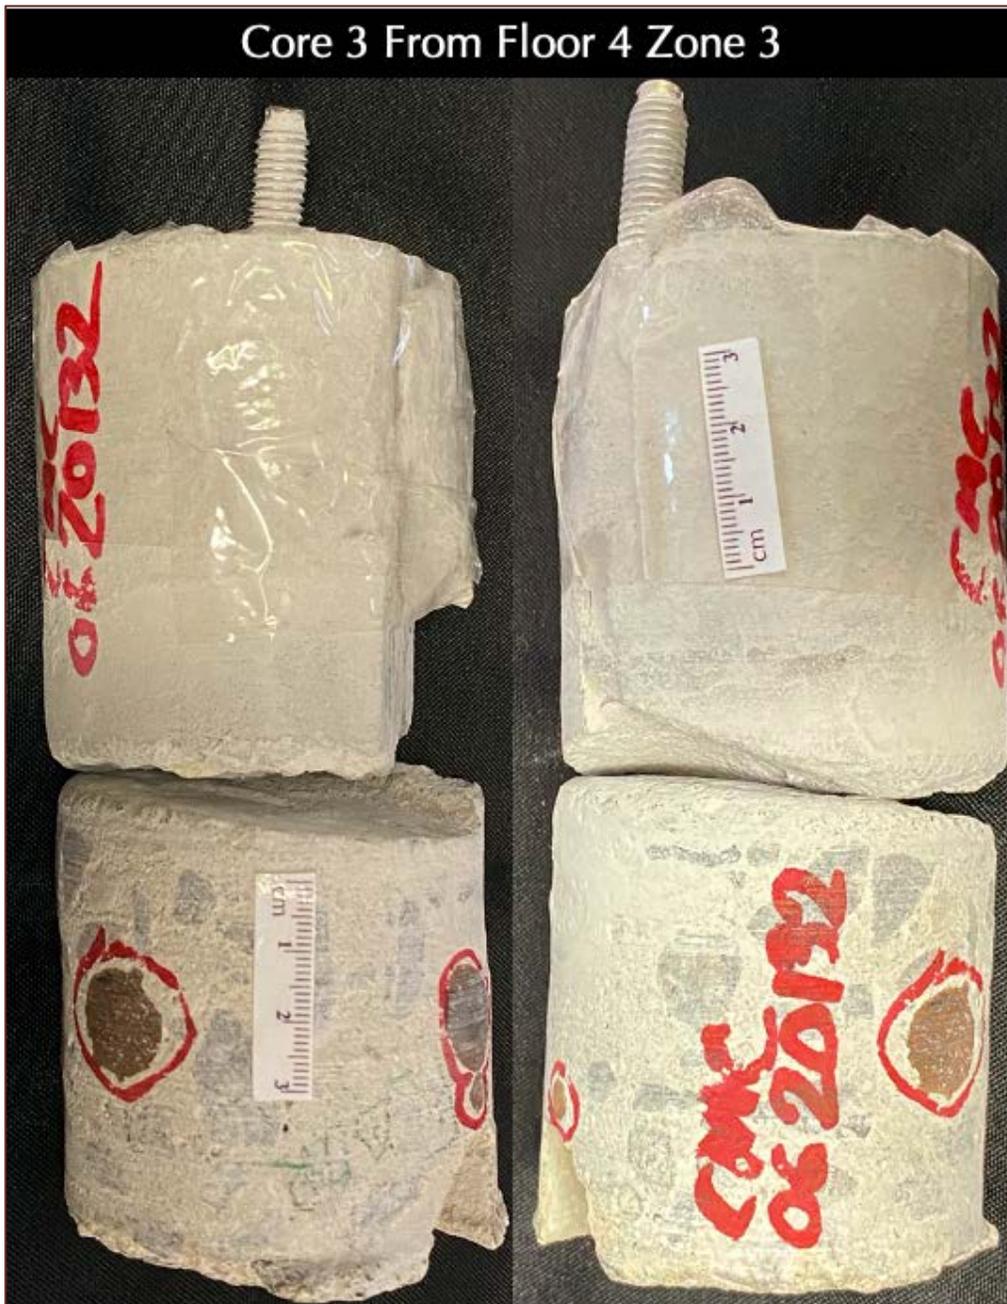
Figure 10: Core 3 showing:

- (a) Completely debonded nature of grout at the top from concrete at the bottom half of core;
- (b) A screw protruding from the grout;
- (c) A No. 4 reinforcing steel and a wire mesh in the concrete at the mid-depth location of the concrete component, about an inch above the formed base of concrete;
- (d) Overall intact condition of the grout and concrete components in the composite core despite complete debonding;
- (e) Crushed granite coarse aggregate particles in concrete; and,
- (f) Dense and well-consolidated natures of both grout and concrete components.

Core 3 was received broken into two portions due to debonding at the grout-concrete interface. There are no large voids or other visible distress in the three cores received.

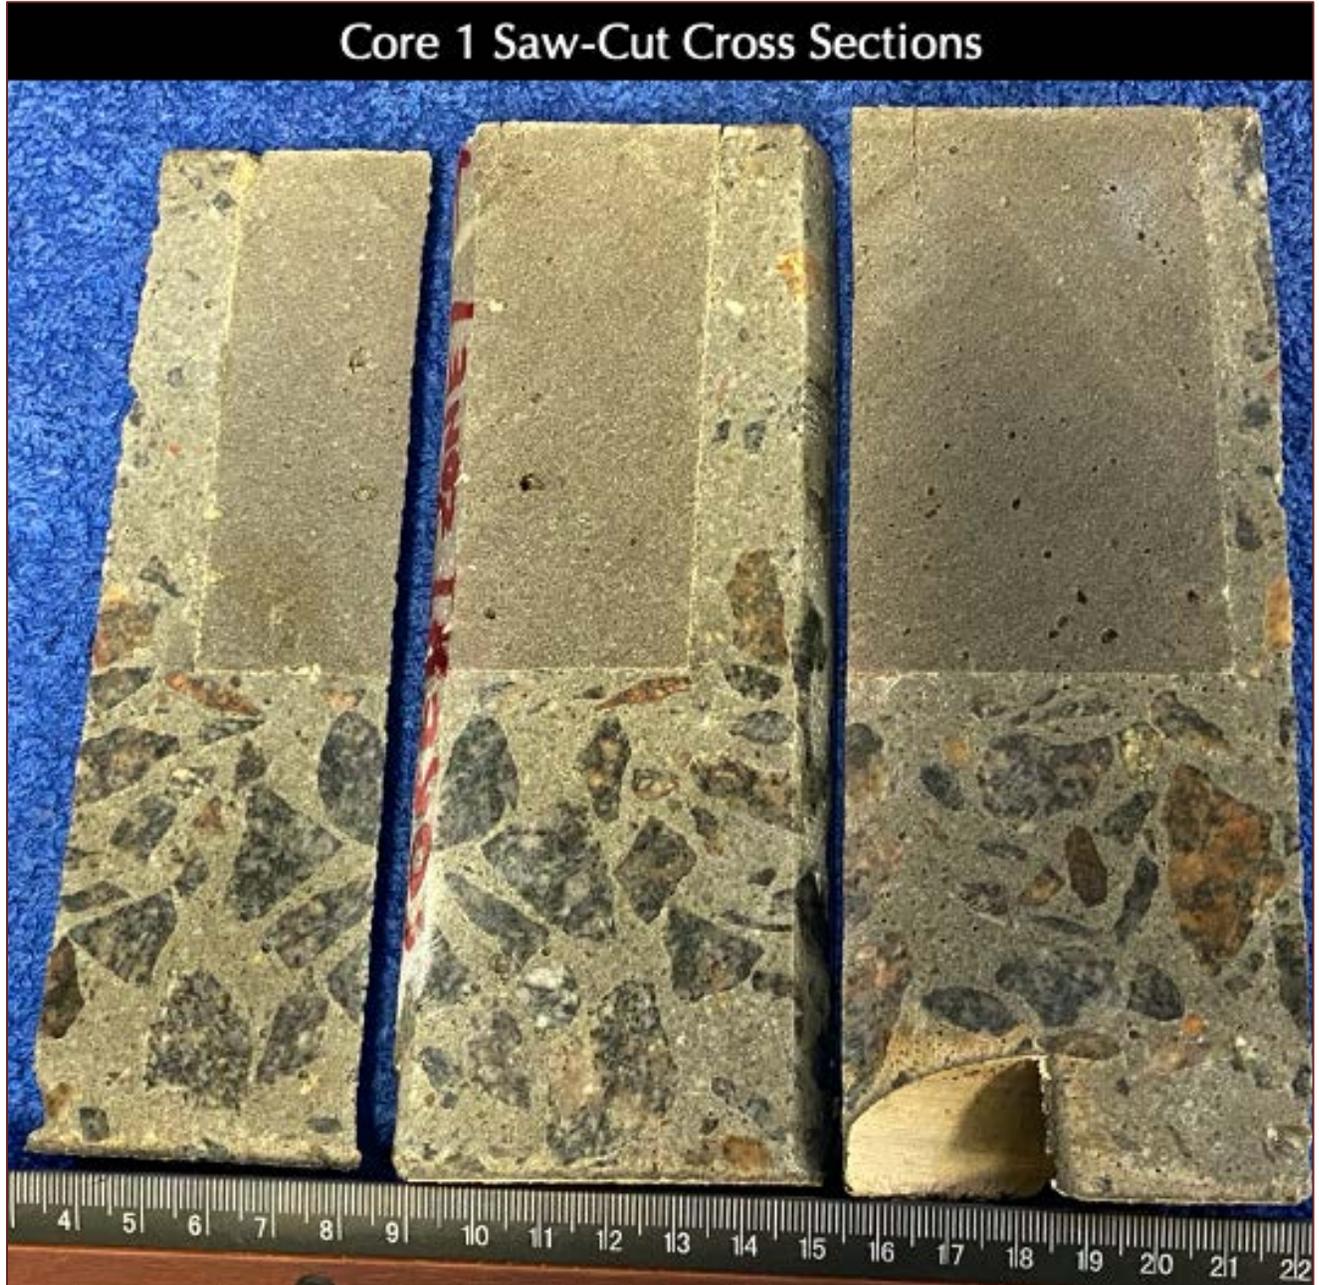
Figure 11: Saw-cut sections of Core 1 showing: (a) the dark gray grout and medium gray concrete components, (b) crushed granite coarse aggregate particles in concrete that are poorly graded due to the deficiency of some finer and intermediate-size particles, as well as poor distribution with some settlement of coarser fractions of coarse aggregate particles towards the bottom concrete portion of the core (concrete adjacent to the grout lacks coarser particles of crushed granite coarse aggregate), (c) good bond between the grout and concrete components, (d) a thin cream-colored paint coat at the formed bottom of concrete, (e) a thin light beige discolored carbonated concrete at the bottom end, indicating a period of atmospheric carbonation of concrete at its formed base prior to the installation of paint coat.

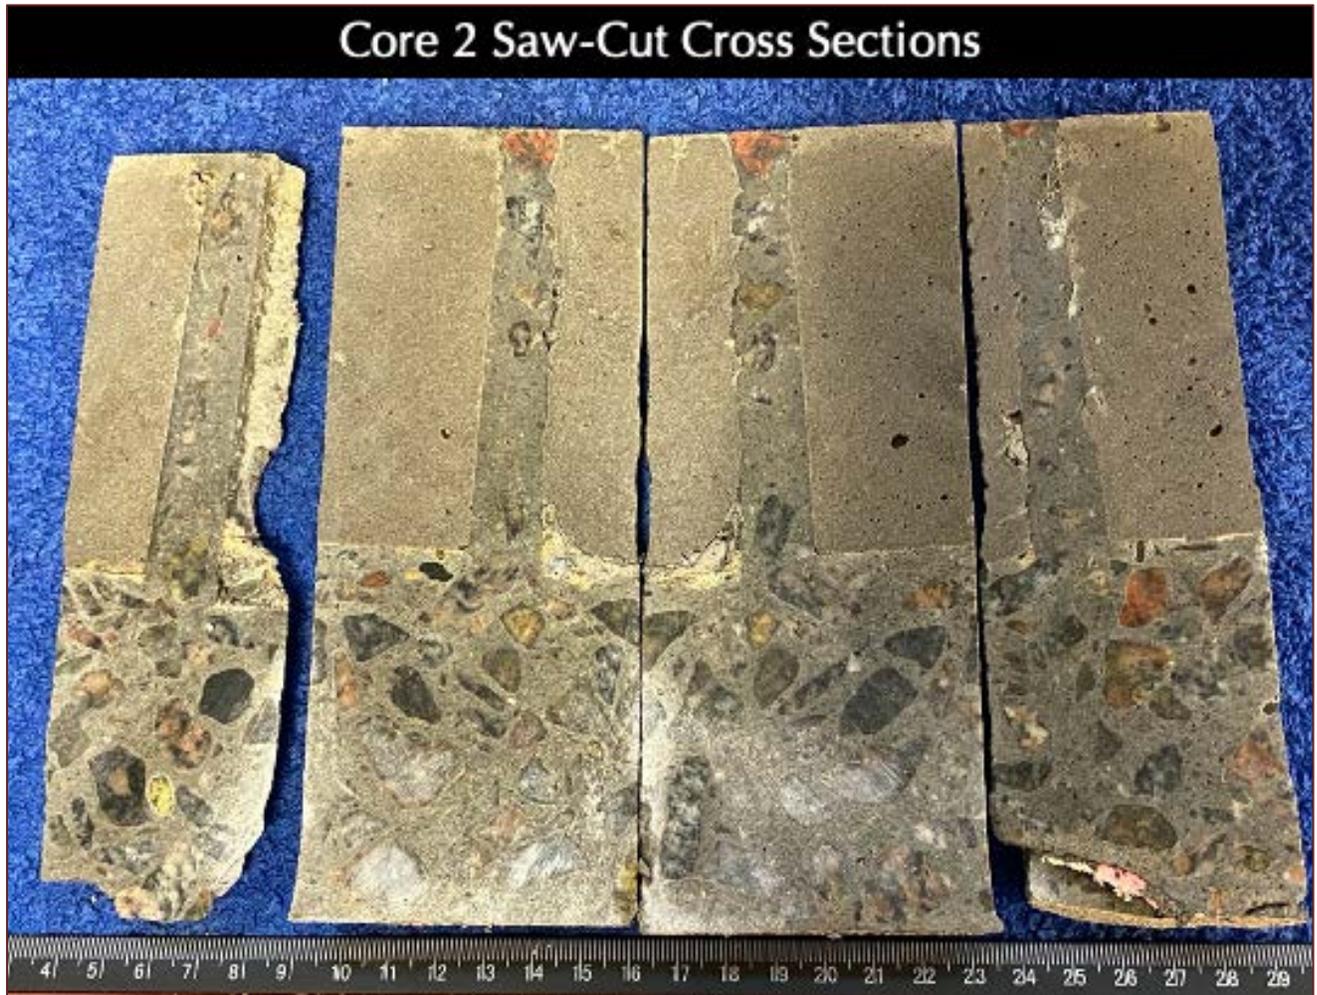
Figure 12: Saw-cut sections of Core 2 showing: (a) the dark gray grout and medium gray concrete components, (b) crushed granite coarse aggregate particles in concrete that are poorly graded due to the deficiency of some finer and intermediate-size particles, as well as poor distribution with some settlement of coarser fractions of coarse aggregate particles towards the bottom concrete portion of the core (concrete sandwiched between lacks coarser particles of crushed granite coarse aggregate), (c) good bond between the grout and concrete components, (d) a thin cream-colored paint coat at the formed bottom of concrete, (e) a thin light beige discolored carbonated concrete at the bottom end, indicating a period of atmospheric carbonation of concrete at its formed base prior to the installation of paint coat.

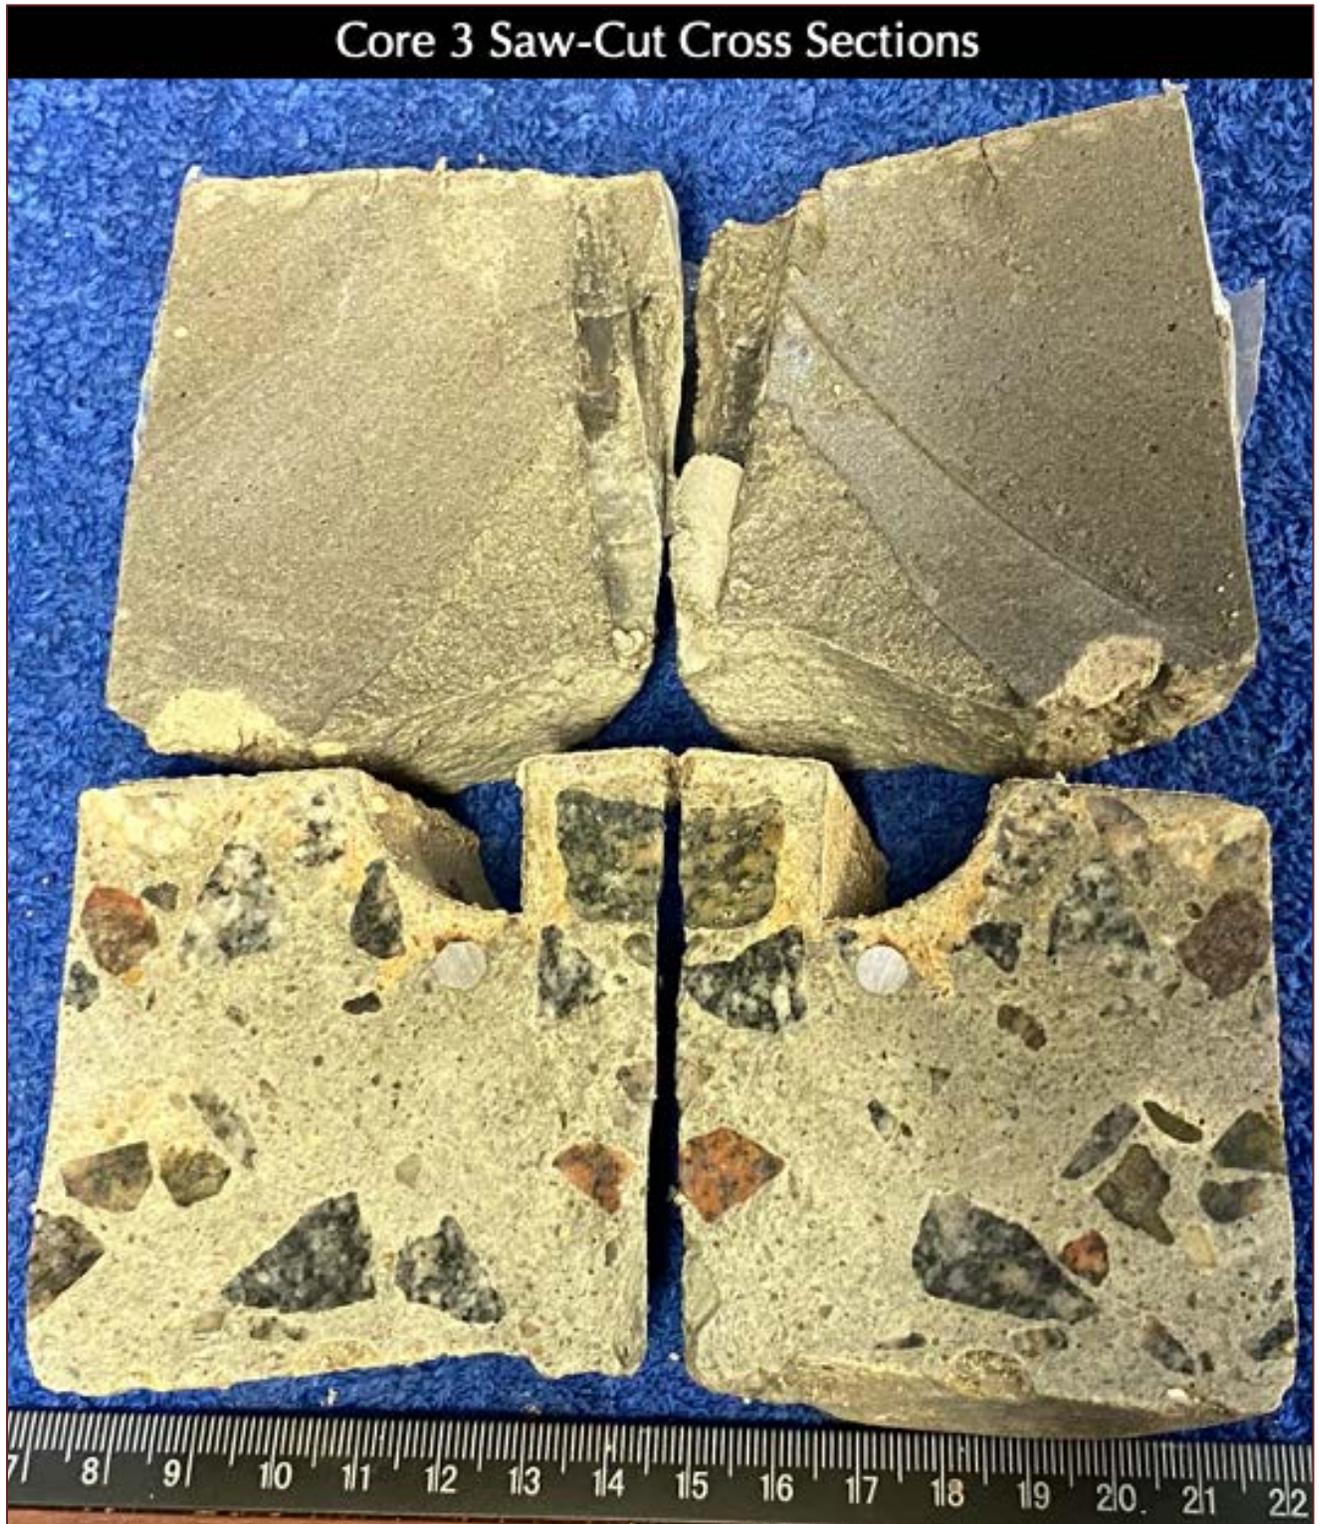
Figure 13: Saw-cut sections of Core 3 showing: (a) the dark gray grout and medium gray concrete components that are completely de-bonded, (b) crushed granite coarse aggregate particles in concrete that are poorly graded due to the deficiency of some finer and intermediate-size particles, and (c) a thin cream-colored paint coat at the formed bottom of concrete.
