## Laboratory Investigation of Anchoring Grout And Concrete Composite Cores From Balcony Slabs Of A Condominium

Building Façade and Waterproofing Repairs  
Bee Street Lofts  
150 Bee Street Condominiums  
Charleston, South Carolina

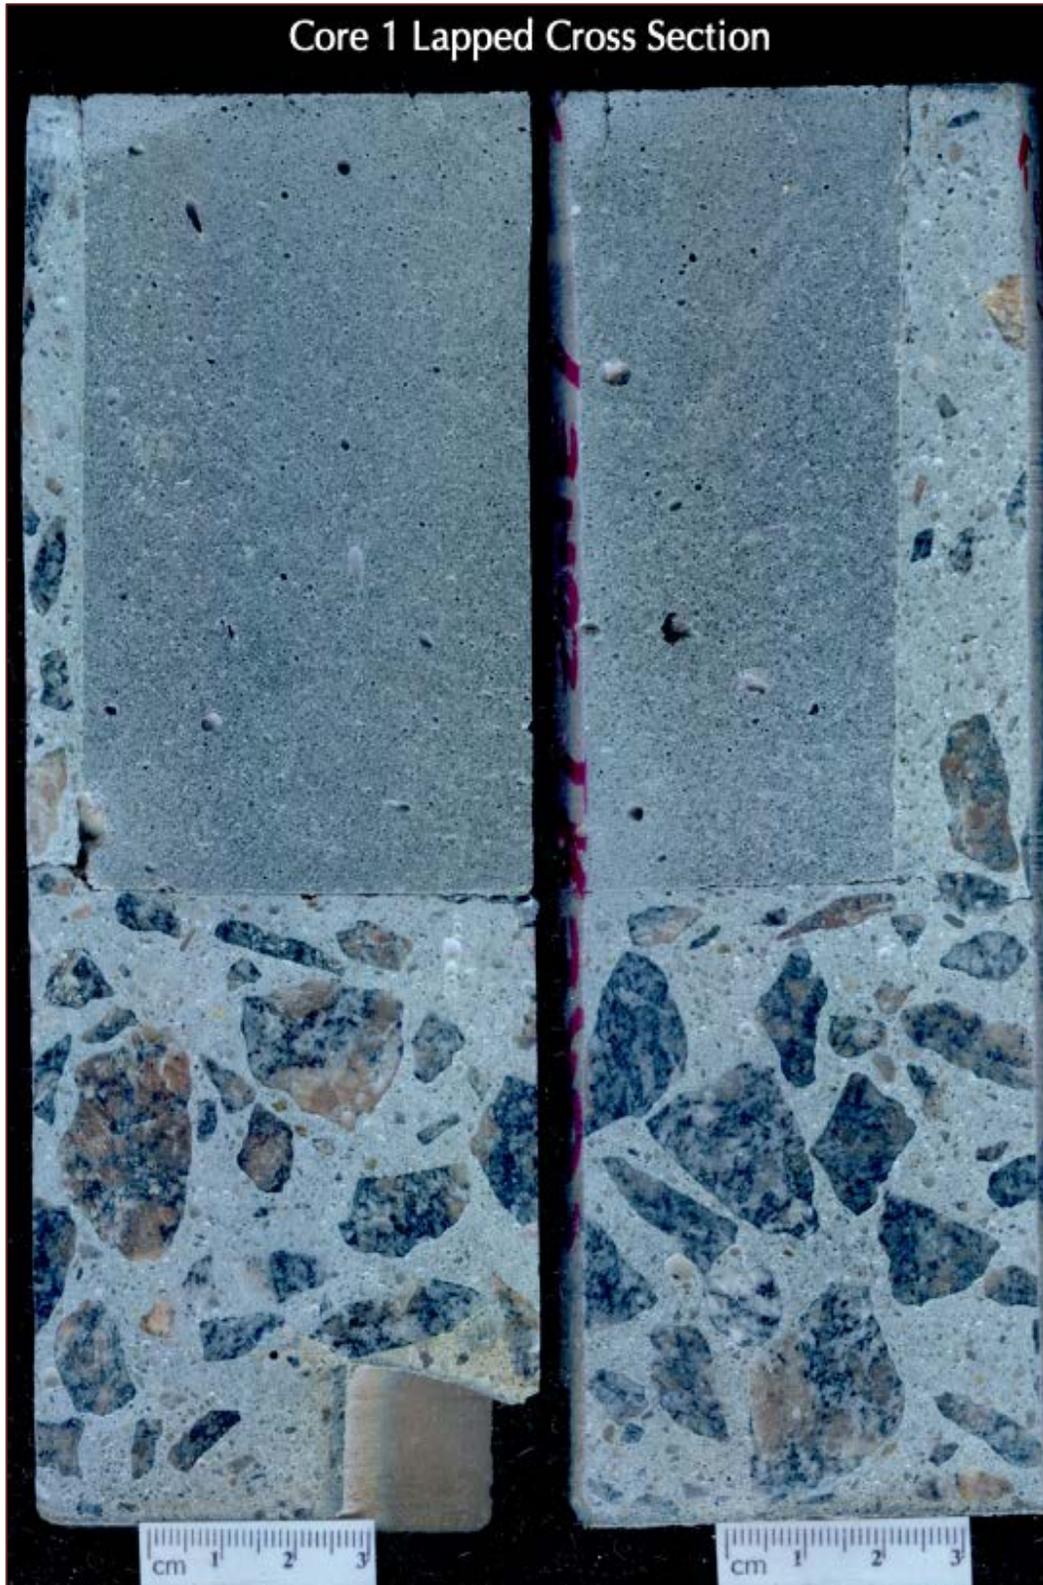
Figure 14: Lapped cross section of Core 1 showing:

(b) Crushed granite coarse aggregate particles in concrete that are poorly graded due to the deficiency of some finer and intermediate-sized particles as well as poor distribution with some settlement of coarser fractions of coarse aggregate particles towards the bottom concrete portion of the core (concrete adjacent to the grout lacks coarser particles of crushed granite coarse aggregate),

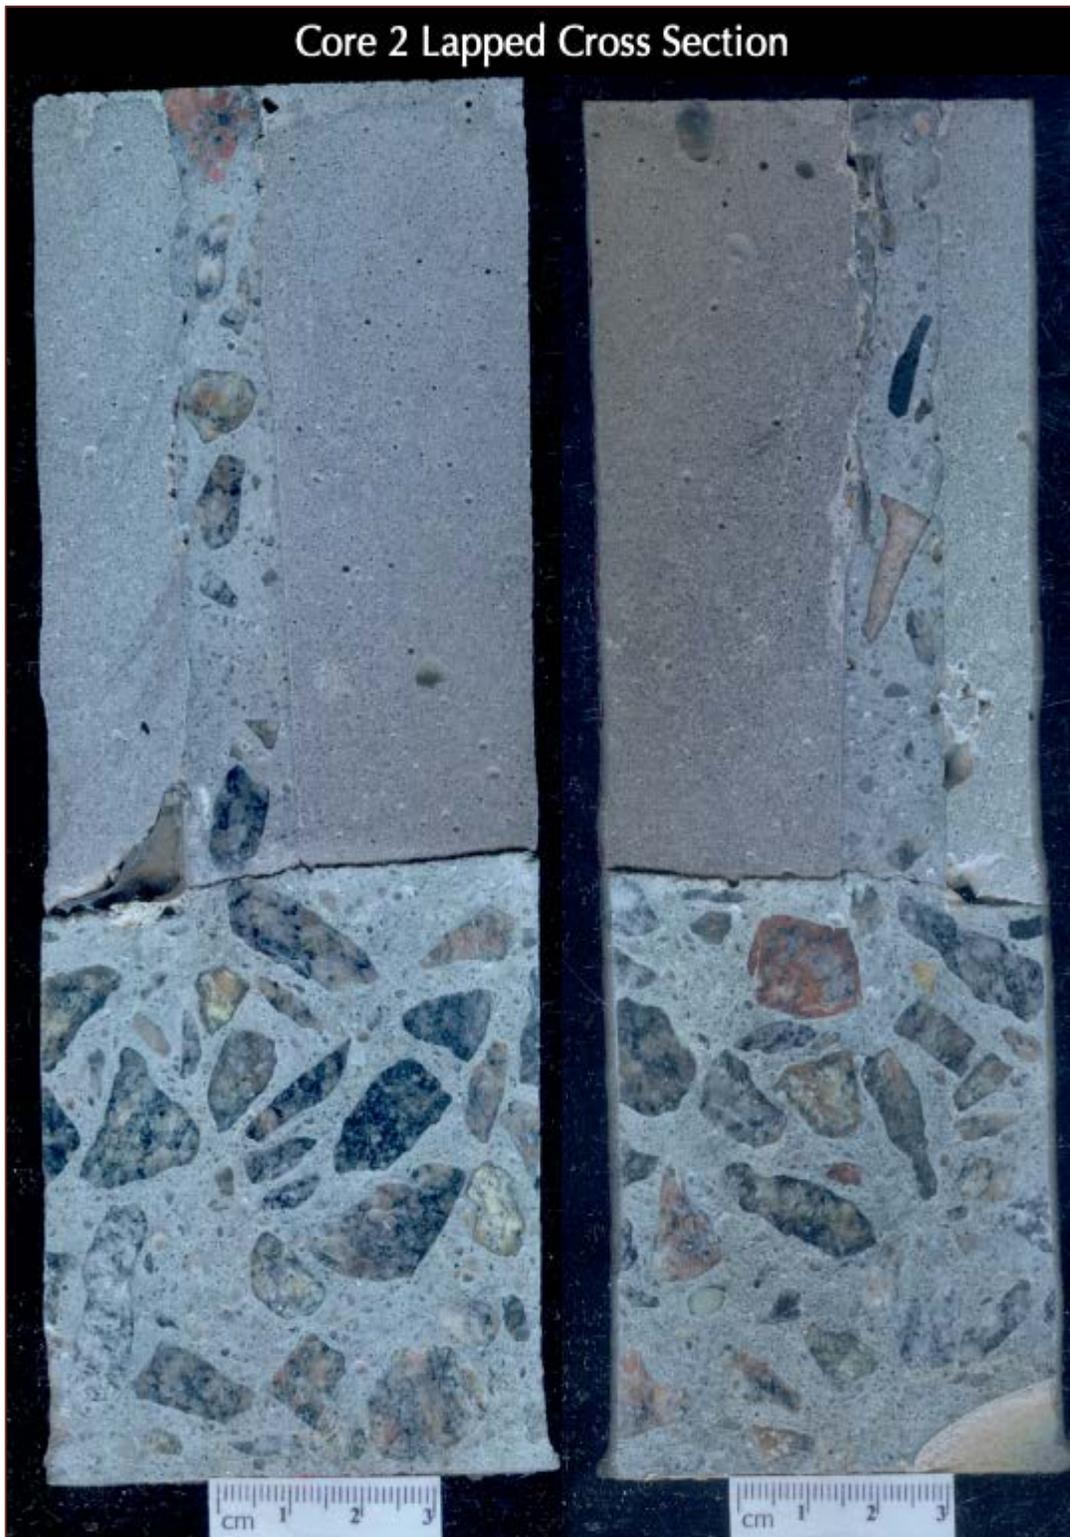
Figure 15: Lapped cross section of Core 2 showing:

(a) The dark gray grout and medium gray concrete components,

(d) A thin cream-colored paint coat at the formed bottom of concrete,

(e) A thin light beige discolored carbonated concrete at the bottom end, indicating a period of atmospheric carbonation of concrete at its formed base prior to the installation of paint coat.

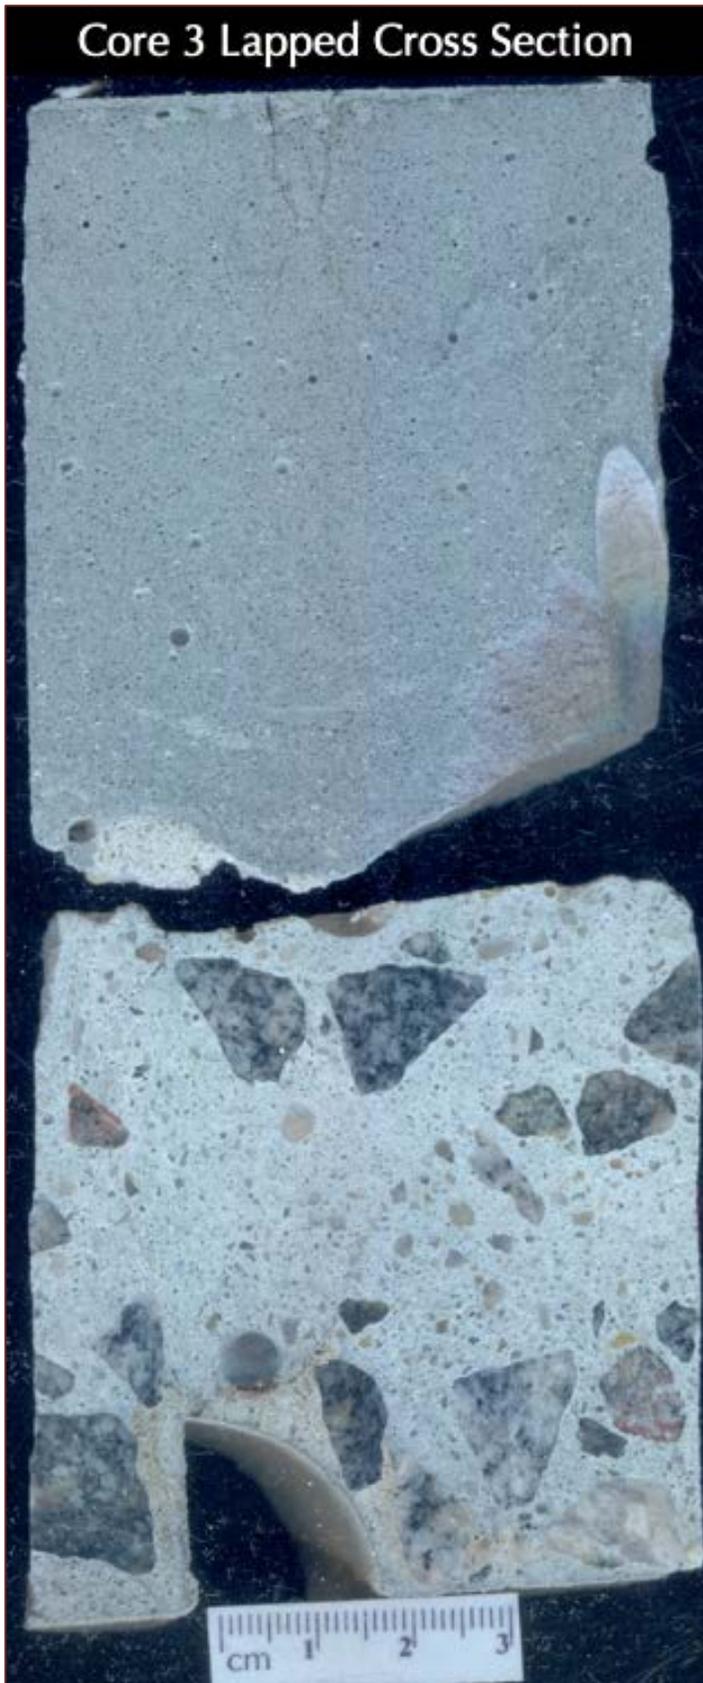
Figure 16: Lapped cross section of Core 3 showing:

- (a) The dark gray grout and medium gray concrete components that are completely debonded,
- (b) Crushed granite coarse aggregate particles in concrete that are poorly graded due to the deficiency of some finer and intermediate-size particles, and
- (c) A thin cream-colored paint coat at the formed bottom of concrete.

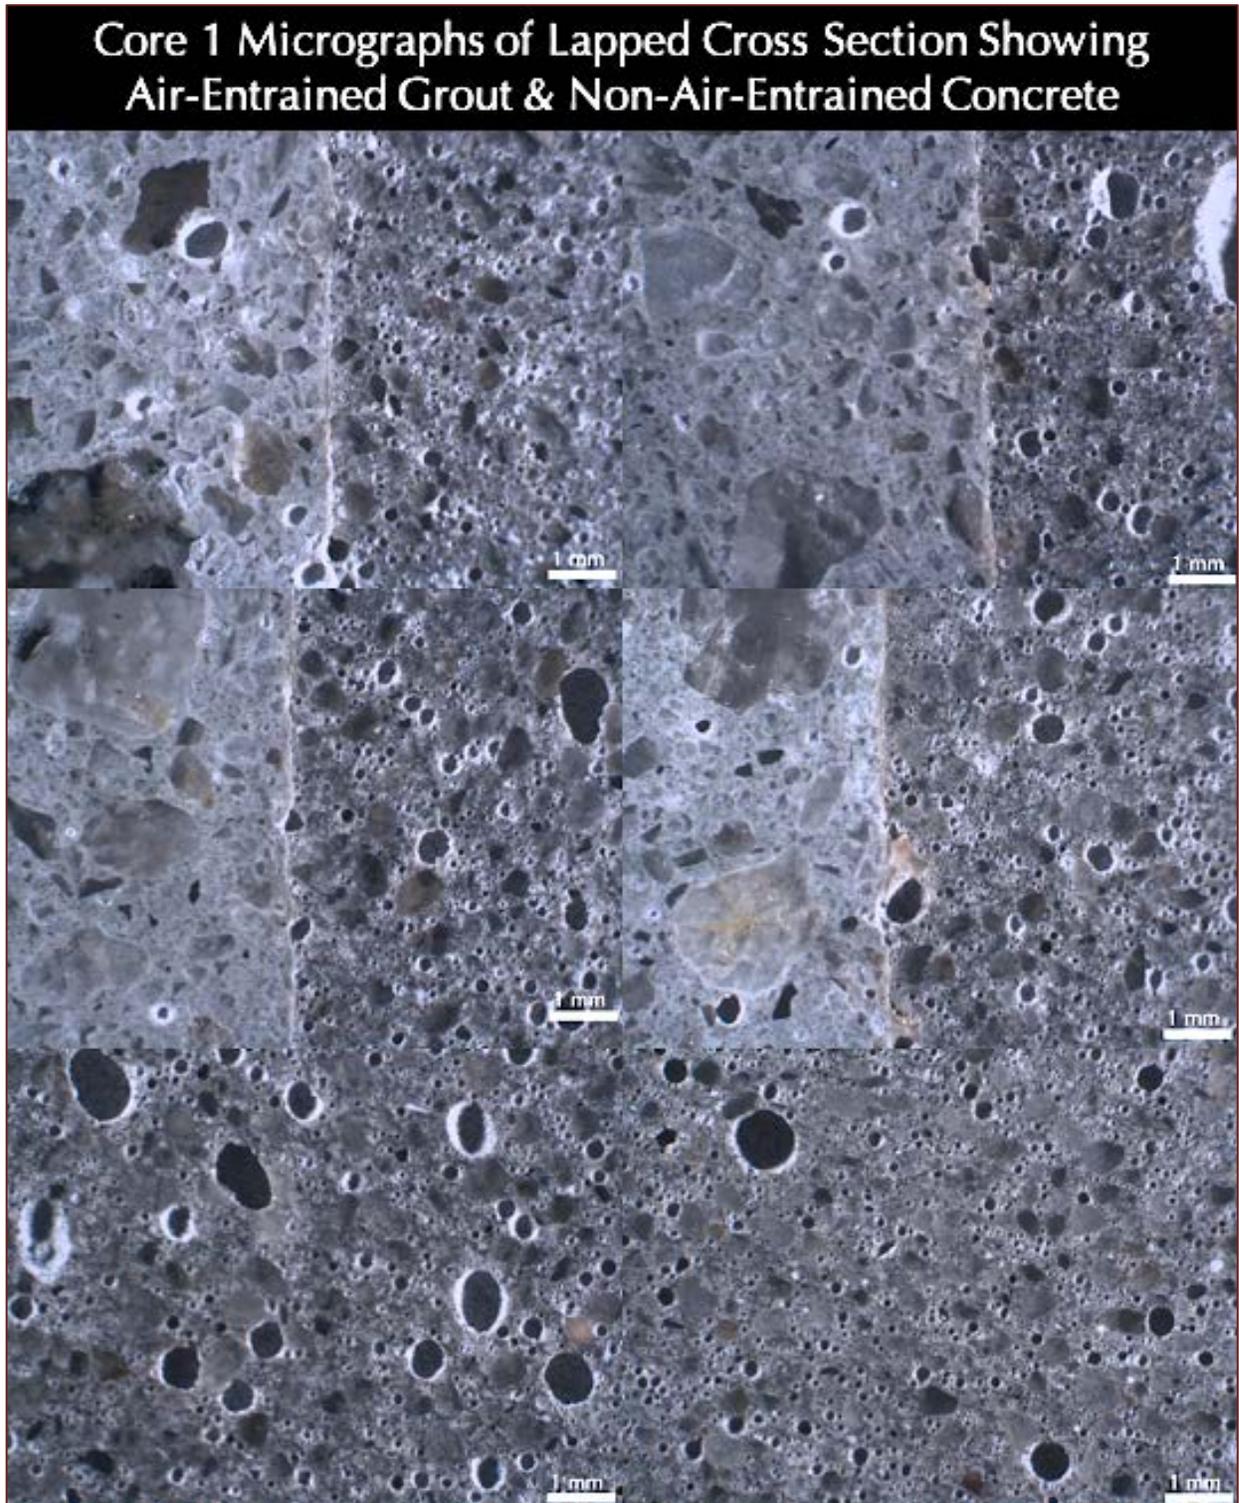
Figure 17: Micrographs of lapped cross section of Core 1 showing: (a) excessively air-entrained dark gray grout and non-air-entrained medium gray concrete; (b) good grading and well-distribution of crushed siliceous sand particles in dark gray grout; (c) poor grading of crushed granite coarse aggregate particles in concrete; and (d) good bond between the grout and concrete despite a marked difference in air content and air entrainment between the two components. Scale bars are 1 mm.

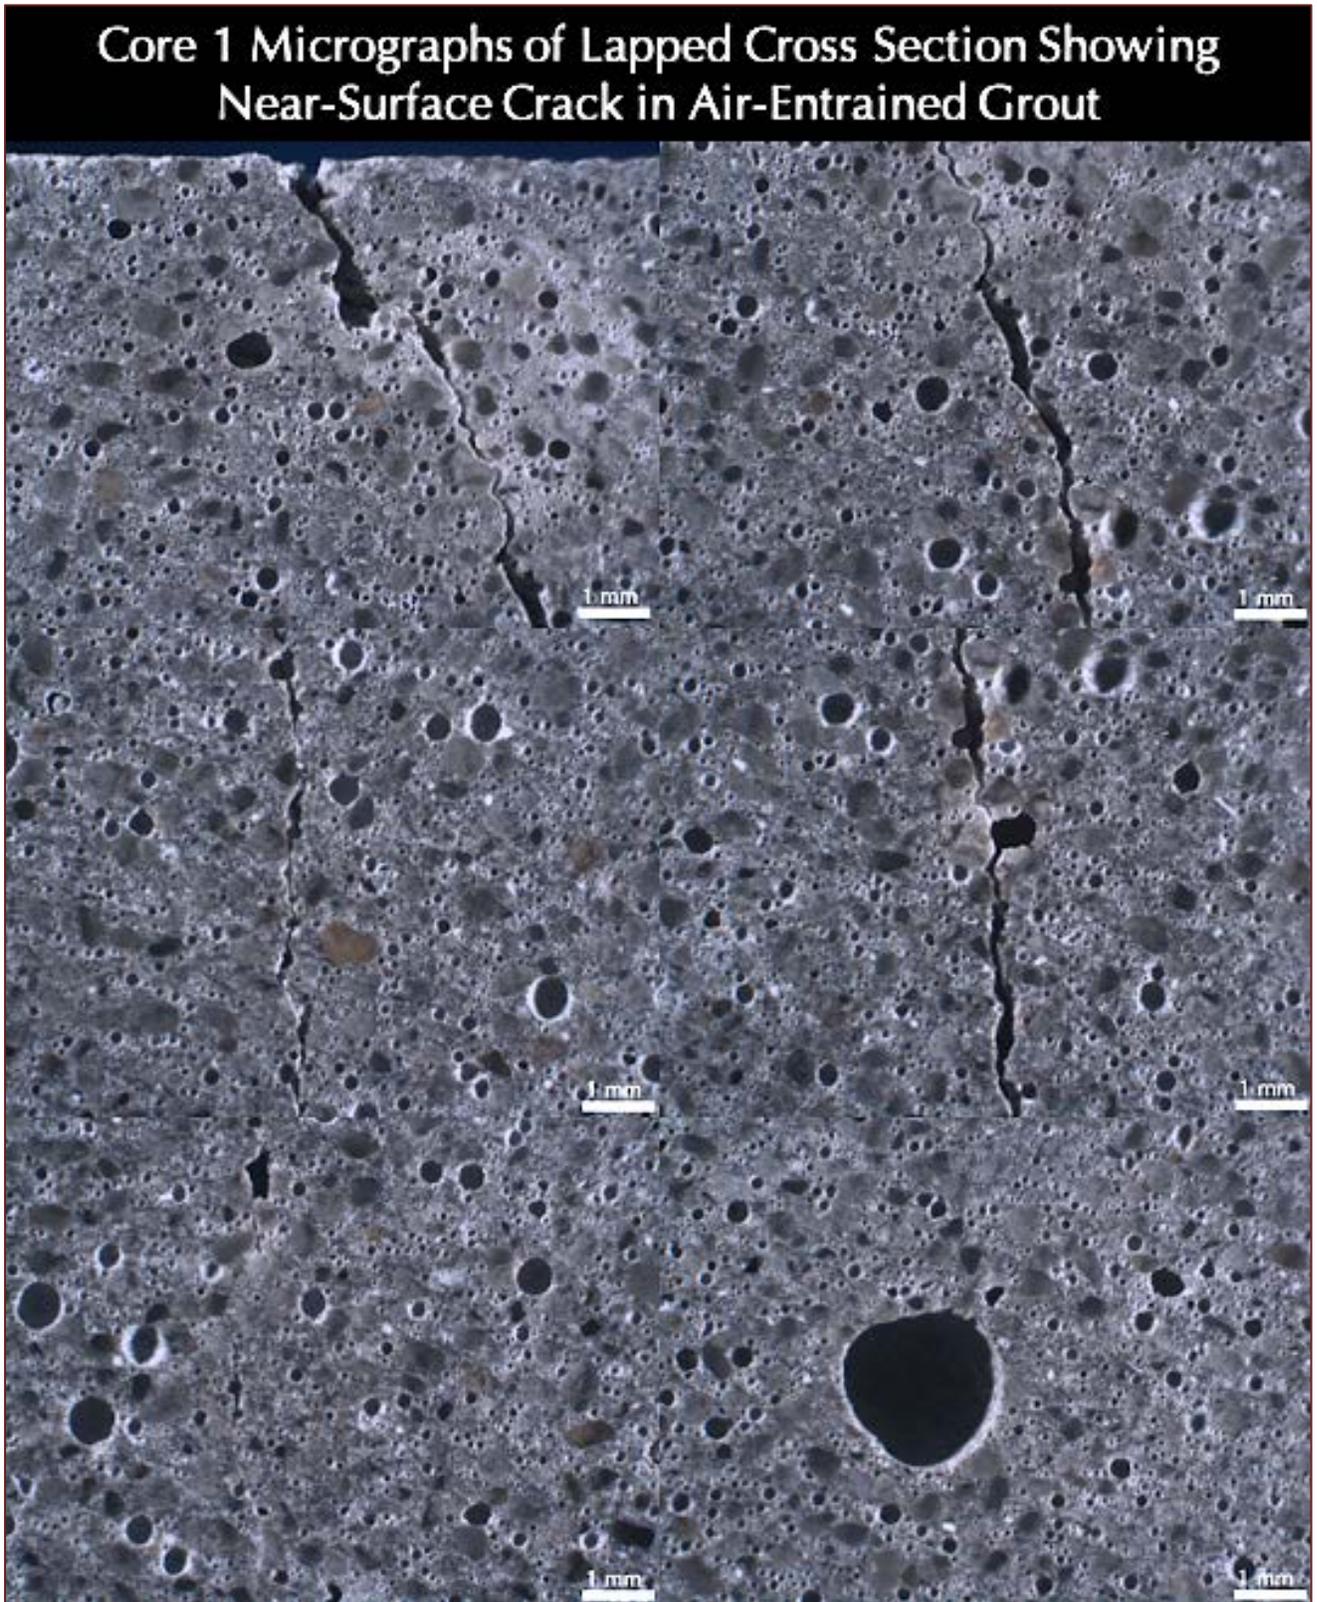
Figure 18: Micrographs of lapped cross section of Core 1 showing: (a) excessively air-entrained dark gray grout; and (b) a vertical shrinkage microcrack at the exposed surface of grout that has extended to a depth of 15 mm (micrographs have followed the crack path towards the interior until the crack disappeared). Scale bars are 1 mm.

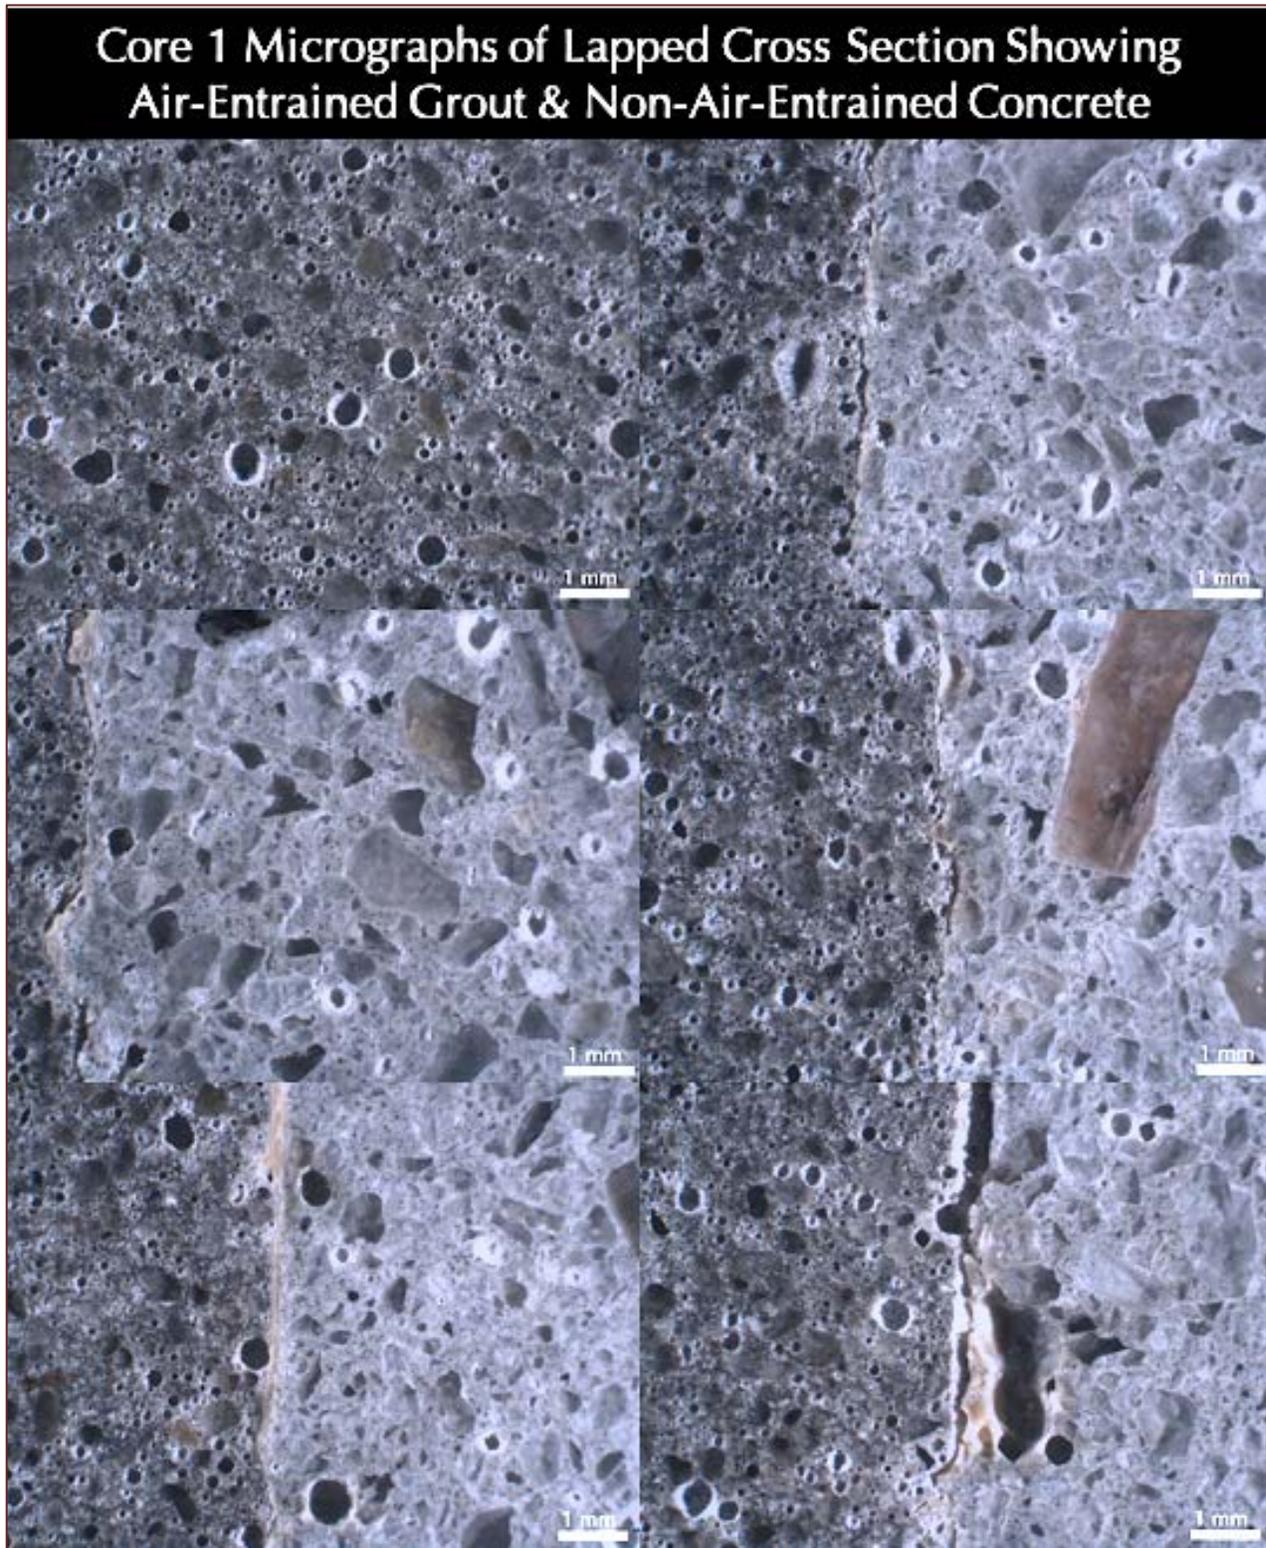
Figure 19: Micrographs of lapped cross section of Core 1 showing: (a) excessively air-entrained dark gray grout and non-air-entrained medium gray concrete; (b) good grading and well-distribution of crushed siliceous sand particles in dark gray grout; (c) poor grading of crushed granite coarse aggregate particles, but good grading and distribution of crushed silica sand fine aggregate in concrete; (d) good bond between the grout and concrete despite a marked difference in air content and air entrainment between the two components; and (e) secondary ettringite deposits lining the walls of some air voids in concrete. Scale bars are 1 mm.

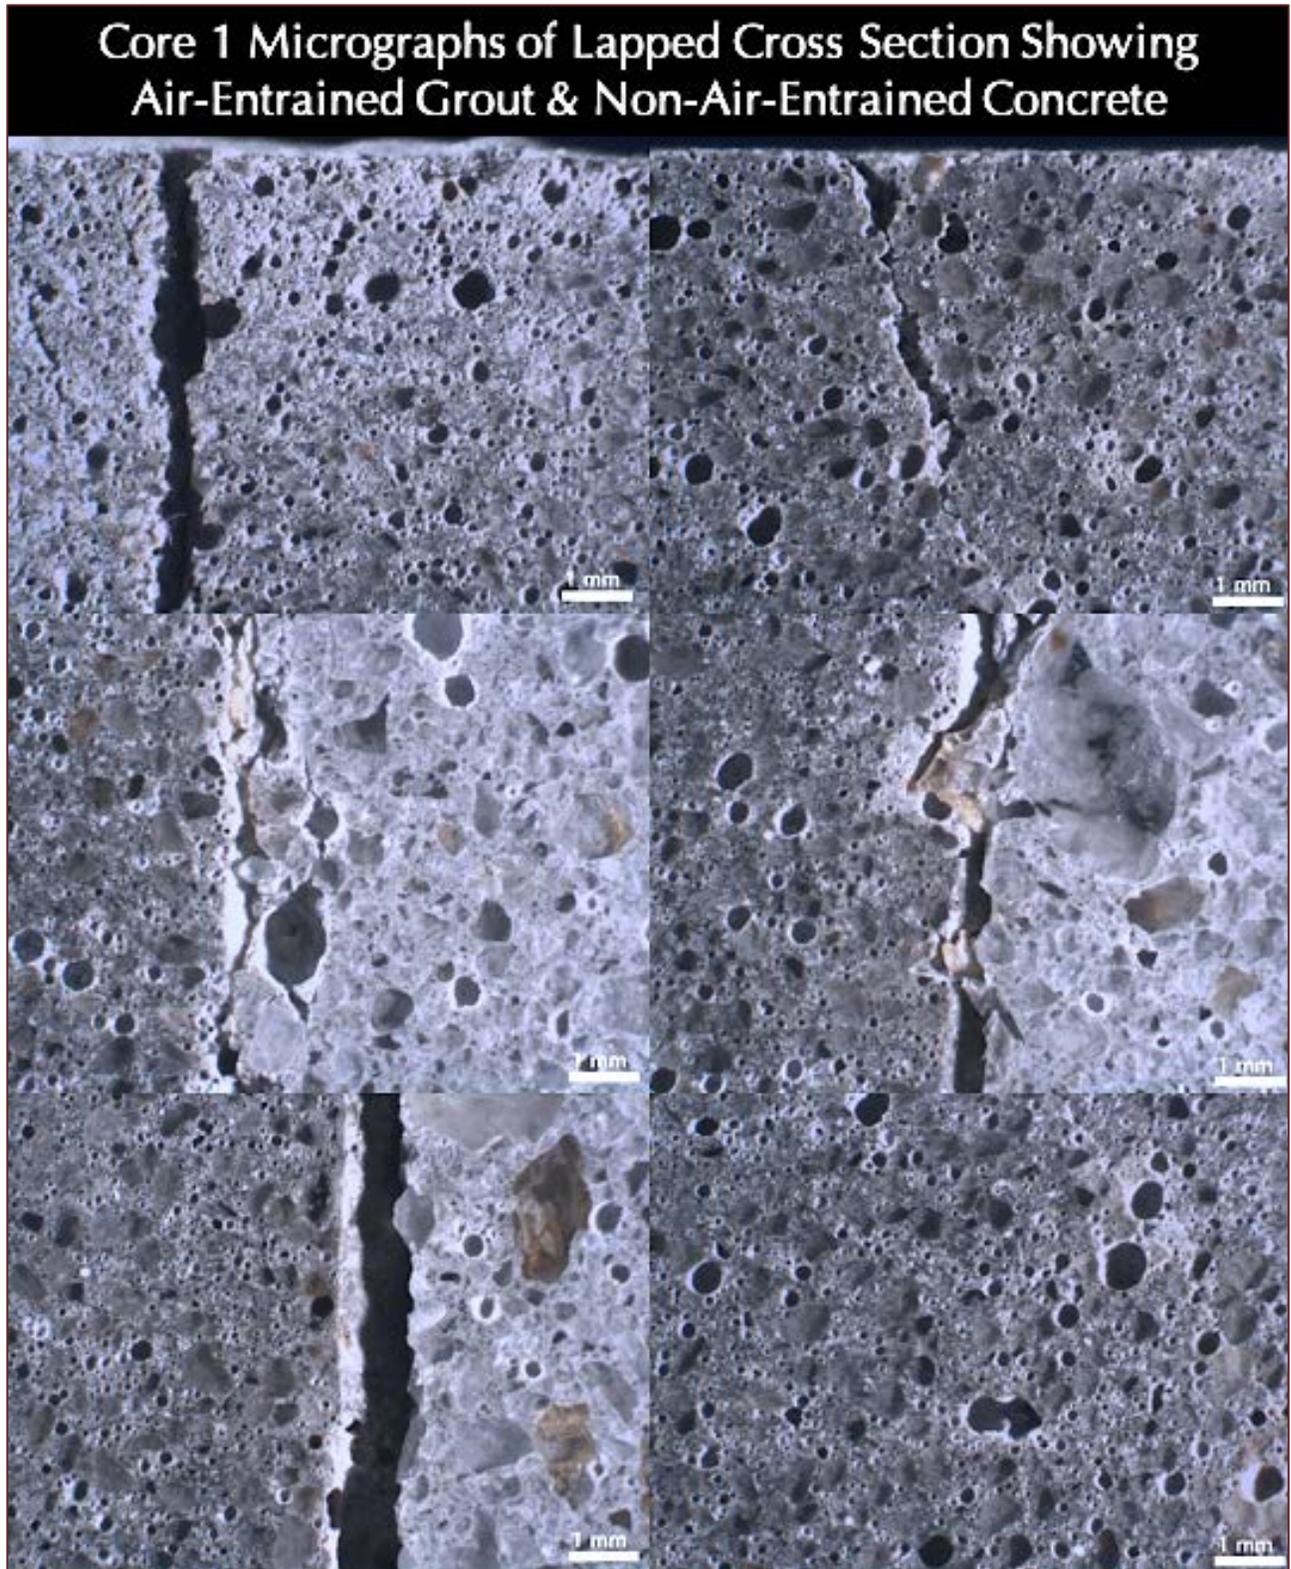
Figure 20: Micrographs of lapped cross section of Core 1 showing: (a) excessively air-entrained dark gray grout and non-air-entrained medium gray concrete; (b) good grading and well-distribution of crushed siliceous sand particles in dark gray grout; (c) poor grading of crushed granite coarse aggregate particles, but good grading and distribution of crushed silica sand fine aggregate in concrete; and (d) good bond between the grout and concrete despite a marked difference in air content and air entrainment between the two components. Scale bars are 1 mm.

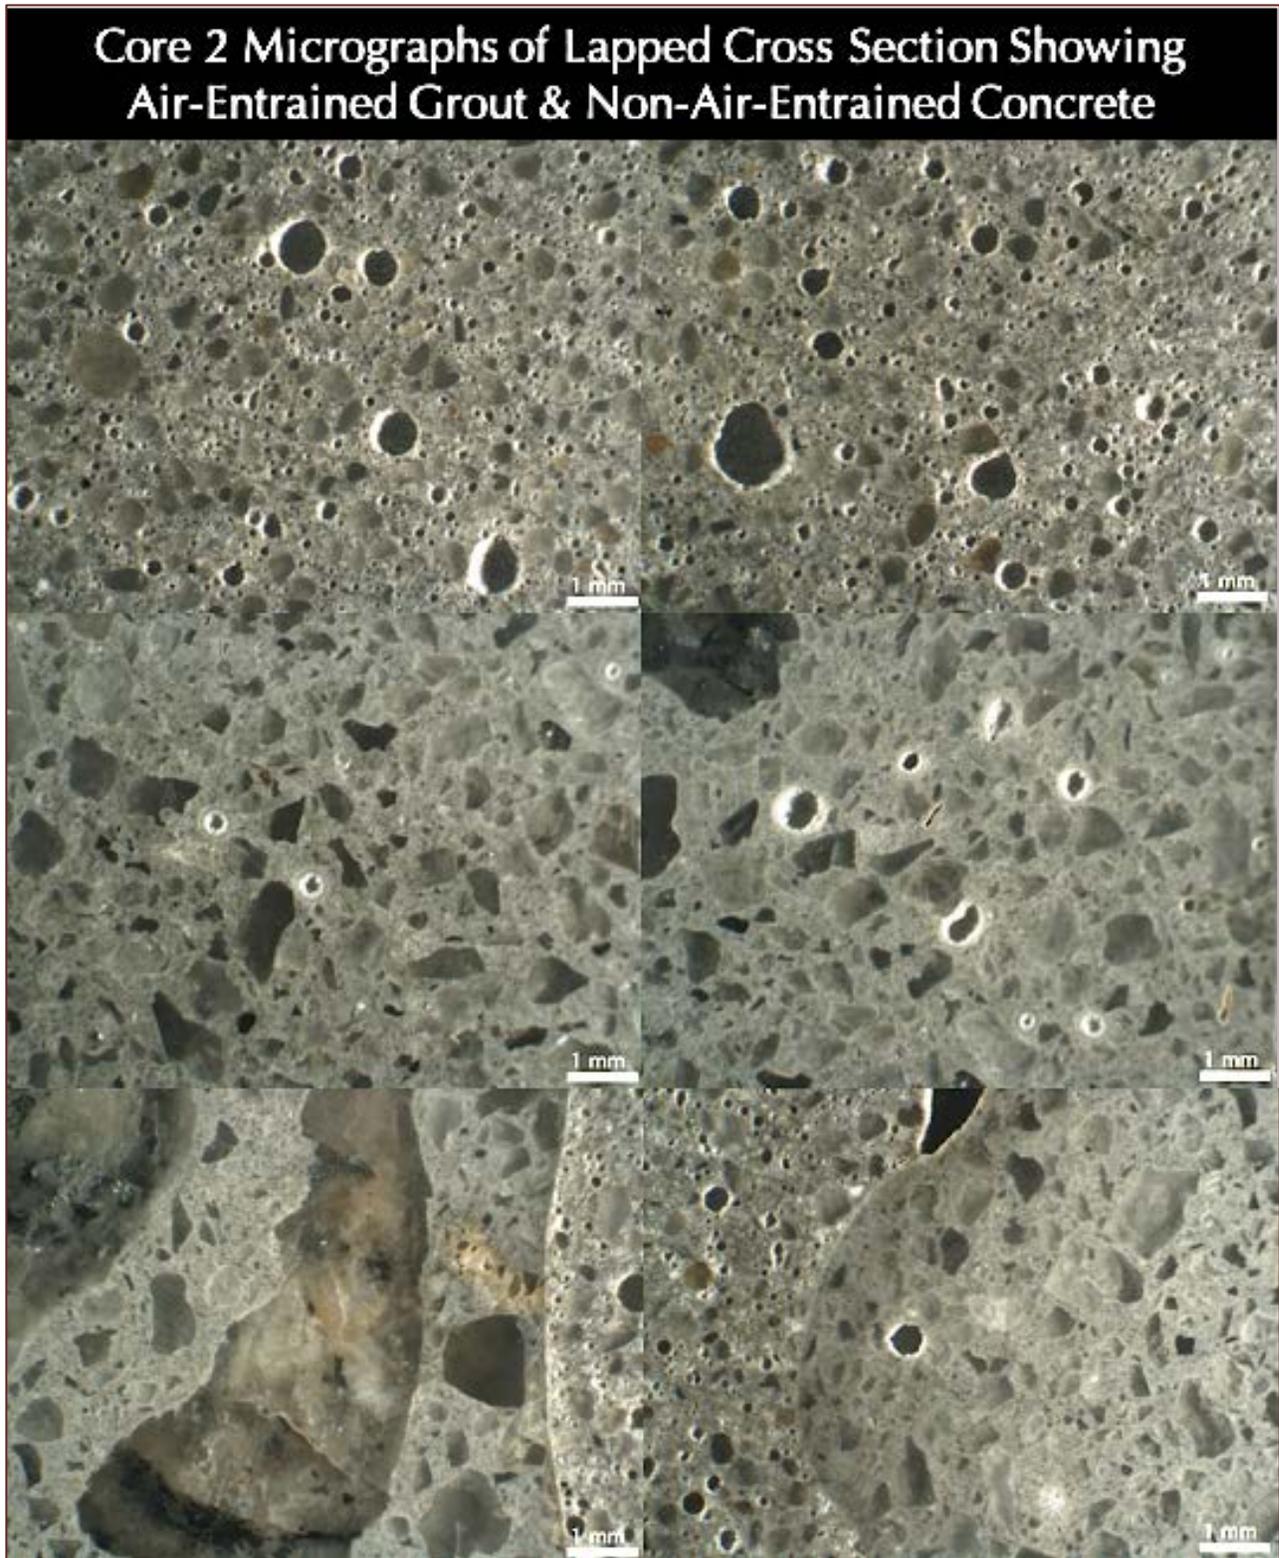
Figure 21: Micrographs of lapped cross section of Core 2 showing: (a) excessively air-entrained dark gray grout and non-air-entrained medium gray concrete; (b) good grading and well-distribution of crushed siliceous sand particles in dark gray grout; (c) poor grading of crushed granite coarse aggregate particles, but good grading and distribution of crushed silica sand fine aggregate in concrete; (d) good bond between the grout and concrete despite a marked difference in air content and air entrainment between the two components; and (e) secondary ettringite deposits lining the walls of some air voids in concrete. Scale bars are 1 mm.

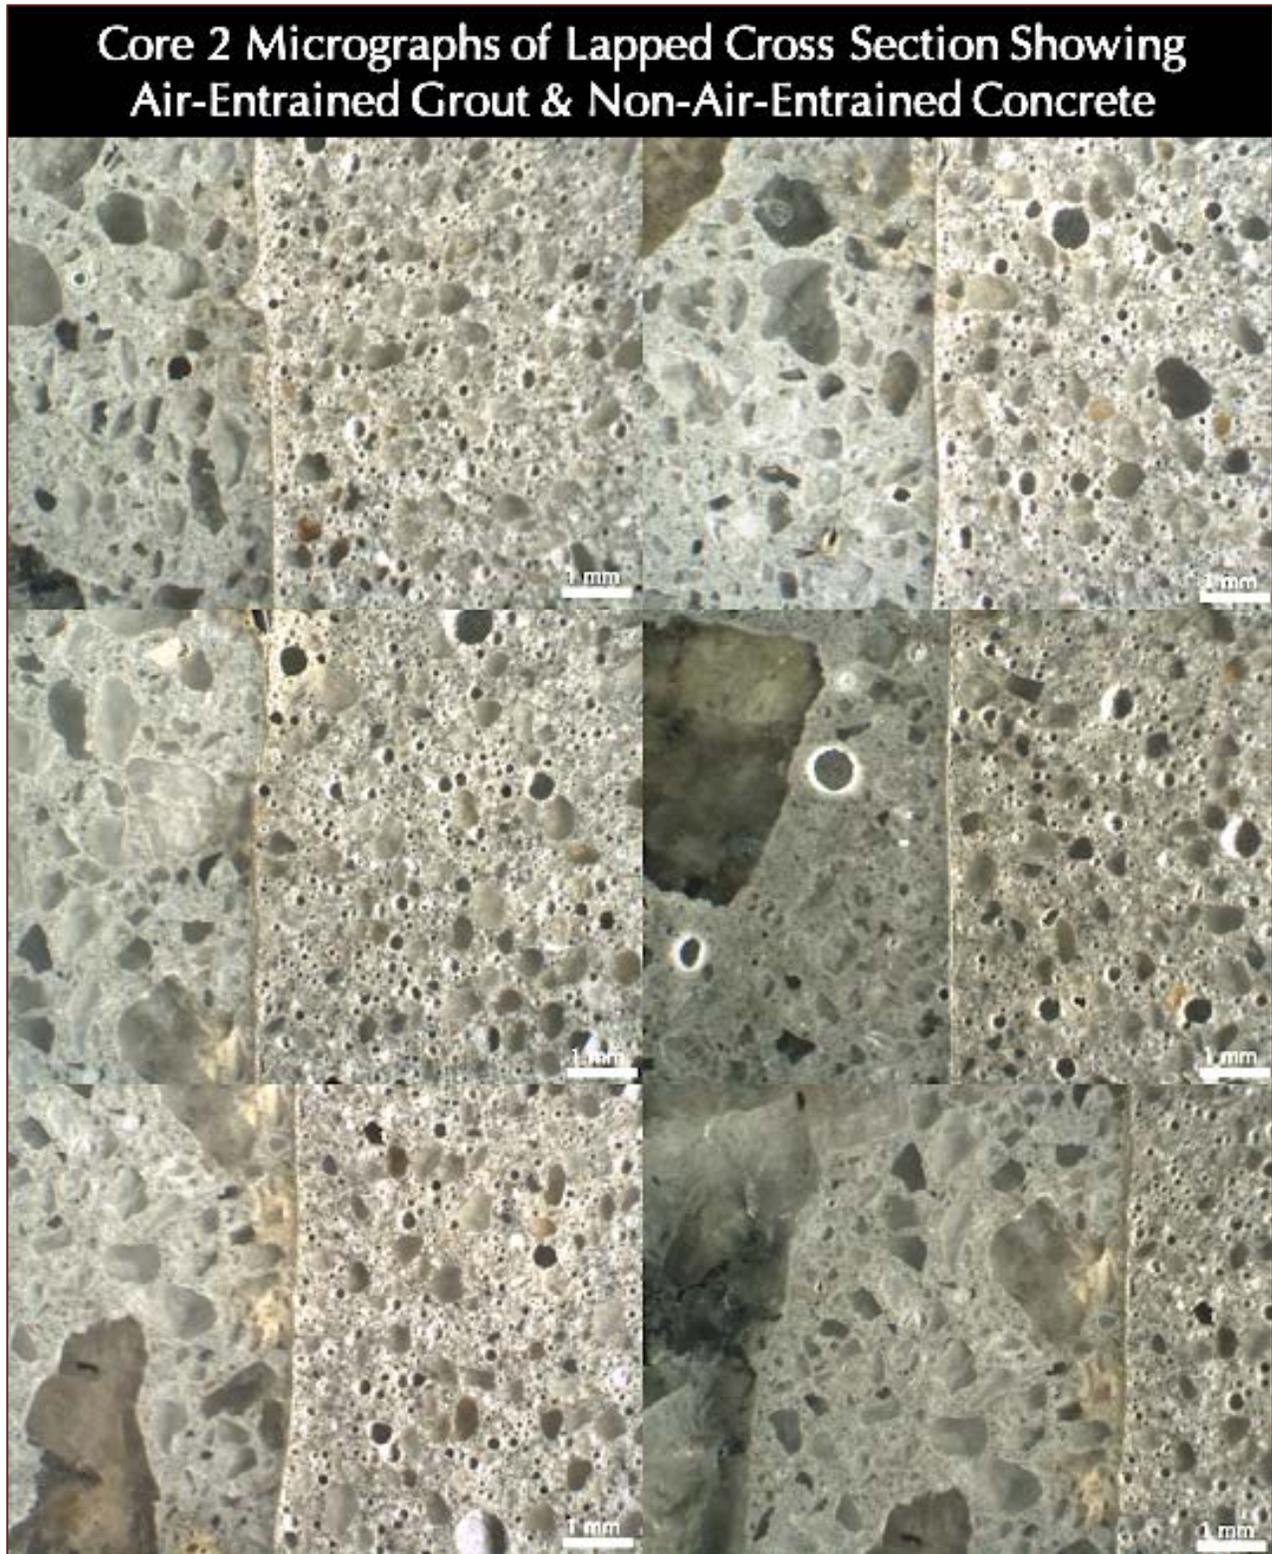
Figure 22: Micrographs of lapped cross section of Core 2 showing: (a) excessively air-entrained dark gray grout and non-air-entrained medium gray concrete; (b) good grading and well-distribution of crushed siliceous sand particles in dark gray grout; (c) poor grading of crushed granite coarse aggregate particles, but good grading and distribution of crushed silica sand fine aggregate in concrete; (d) good bond between the grout and concrete despite a marked difference in air content and air entrainment between the two components; and (e) secondary ettringite deposits lining the walls of some air voids in concrete. Scale bars are 1 mm.

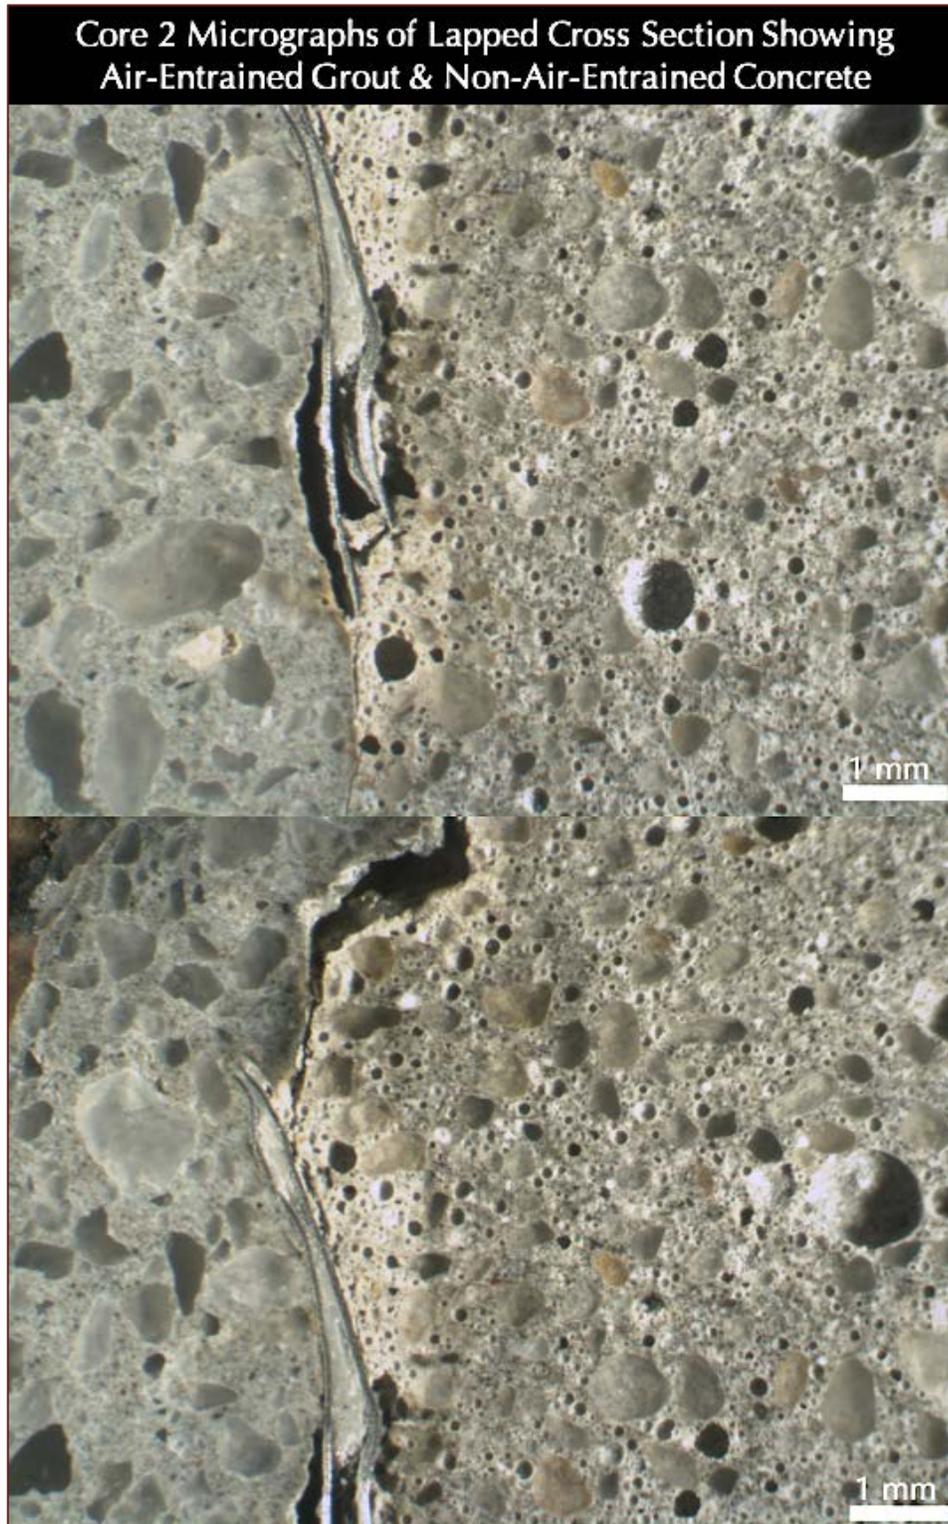
Figure 23: Micrographs of lapped cross section of Core 2 showing: (a) excessively air-entrained dark gray grout and non-air-entrained medium gray concrete; (b) good grading and well-distribution of crushed siliceous sand particles in dark gray grout; (c) poor grading of crushed granite coarse aggregate particles, but good grading and distribution of crushed silica sand fine aggregate in concrete; (d) good bond between the grout and concrete despite a marked difference in air content and air entrainment between the two components; (e) evidence of some beige discoloration in concrete adjacent to grout possibly due to some exposure to air before coming into contact with grout; and (f) presence of a sheet-like material at the grout-concrete interface. Scale bars are 1 mm.

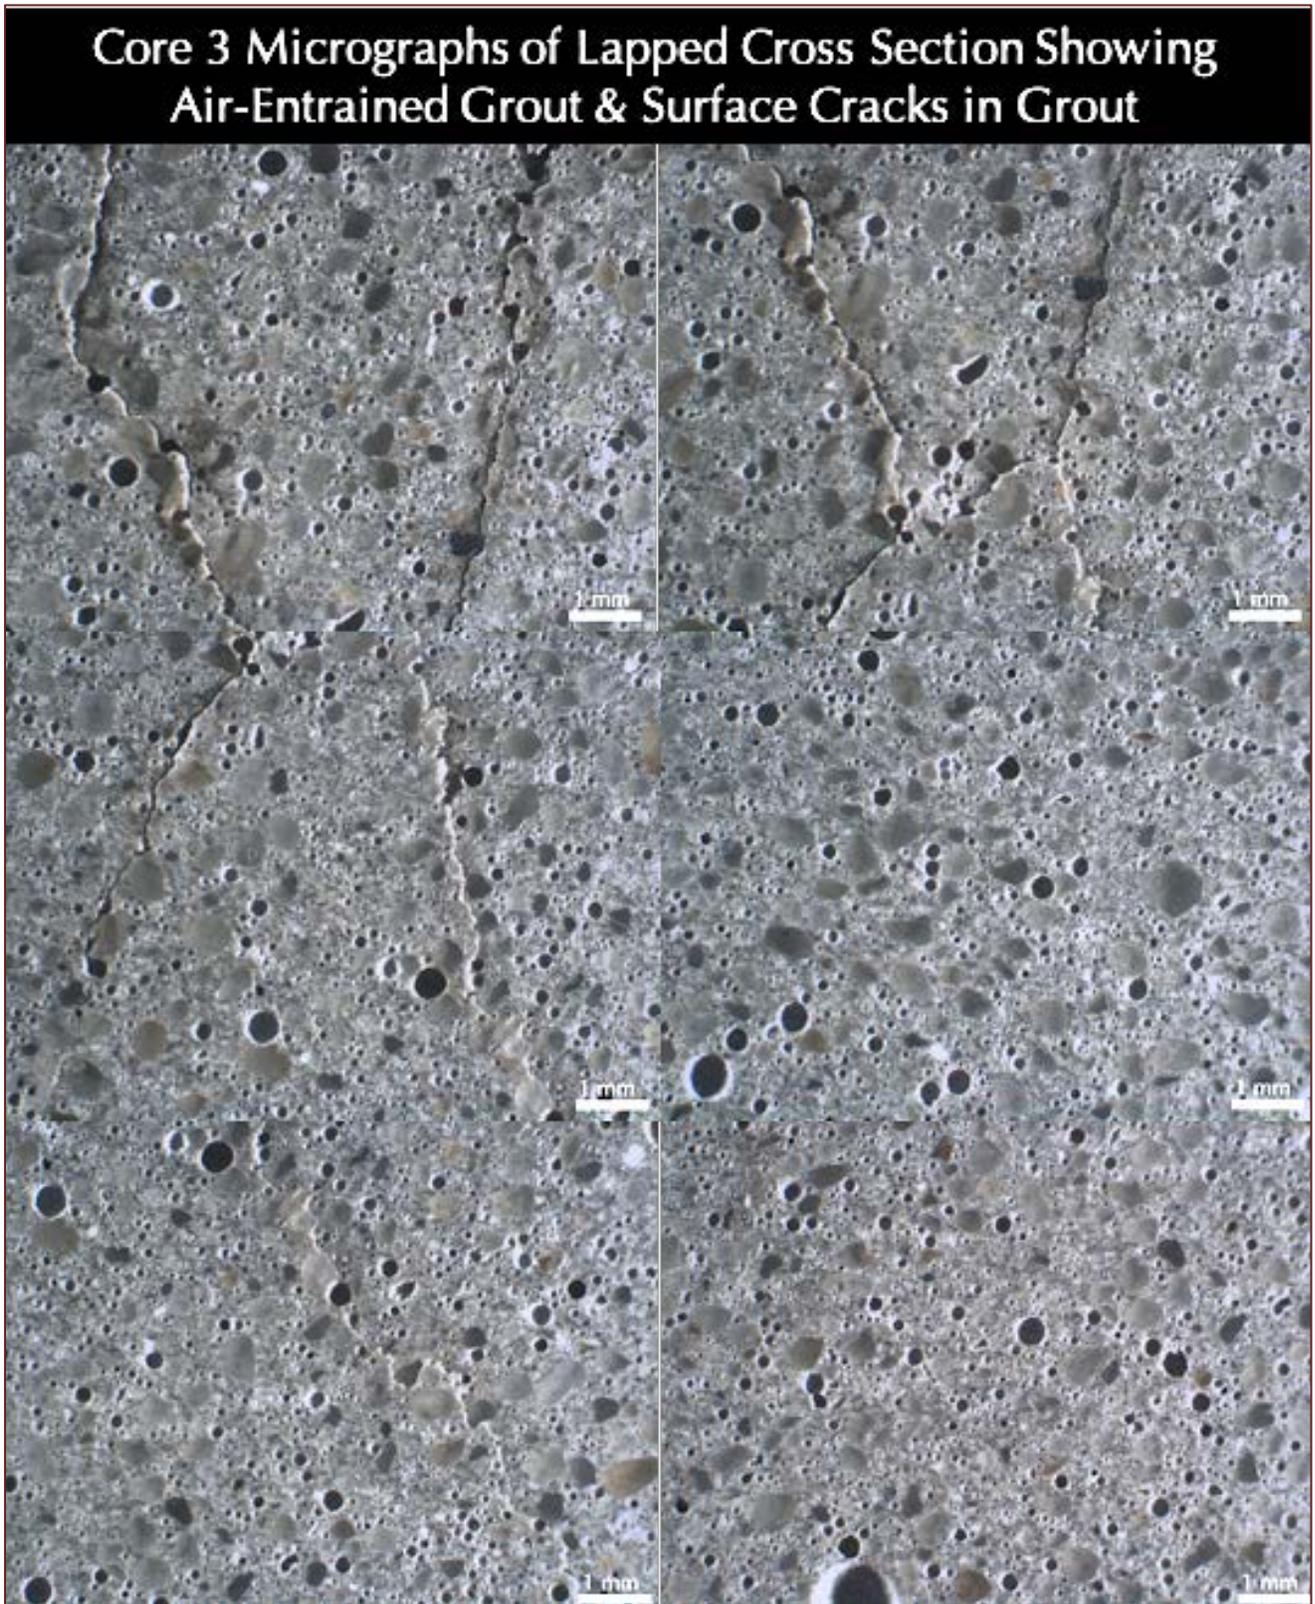
Figure 24: Micrographs of lapped cross section of Core 3 showing: (a) excessively air-entrained dark gray grout; and (b) two vertical shrinkage microcracks at the exposed surface of grout that extend to a depth of 20 mm (micrographs have followed the crack path towards the interior until the crack disappeared). Scale bars are 1 mm.
