## Laboratory Investigation of Anchoring Grout And Concrete Composite Cores From Balcony Slabs Of A Condominium

Building Façade and Waterproofing Repairs  
Bee Street Lofts  
150 Bee Street Condominiums  
Charleston, South Carolina

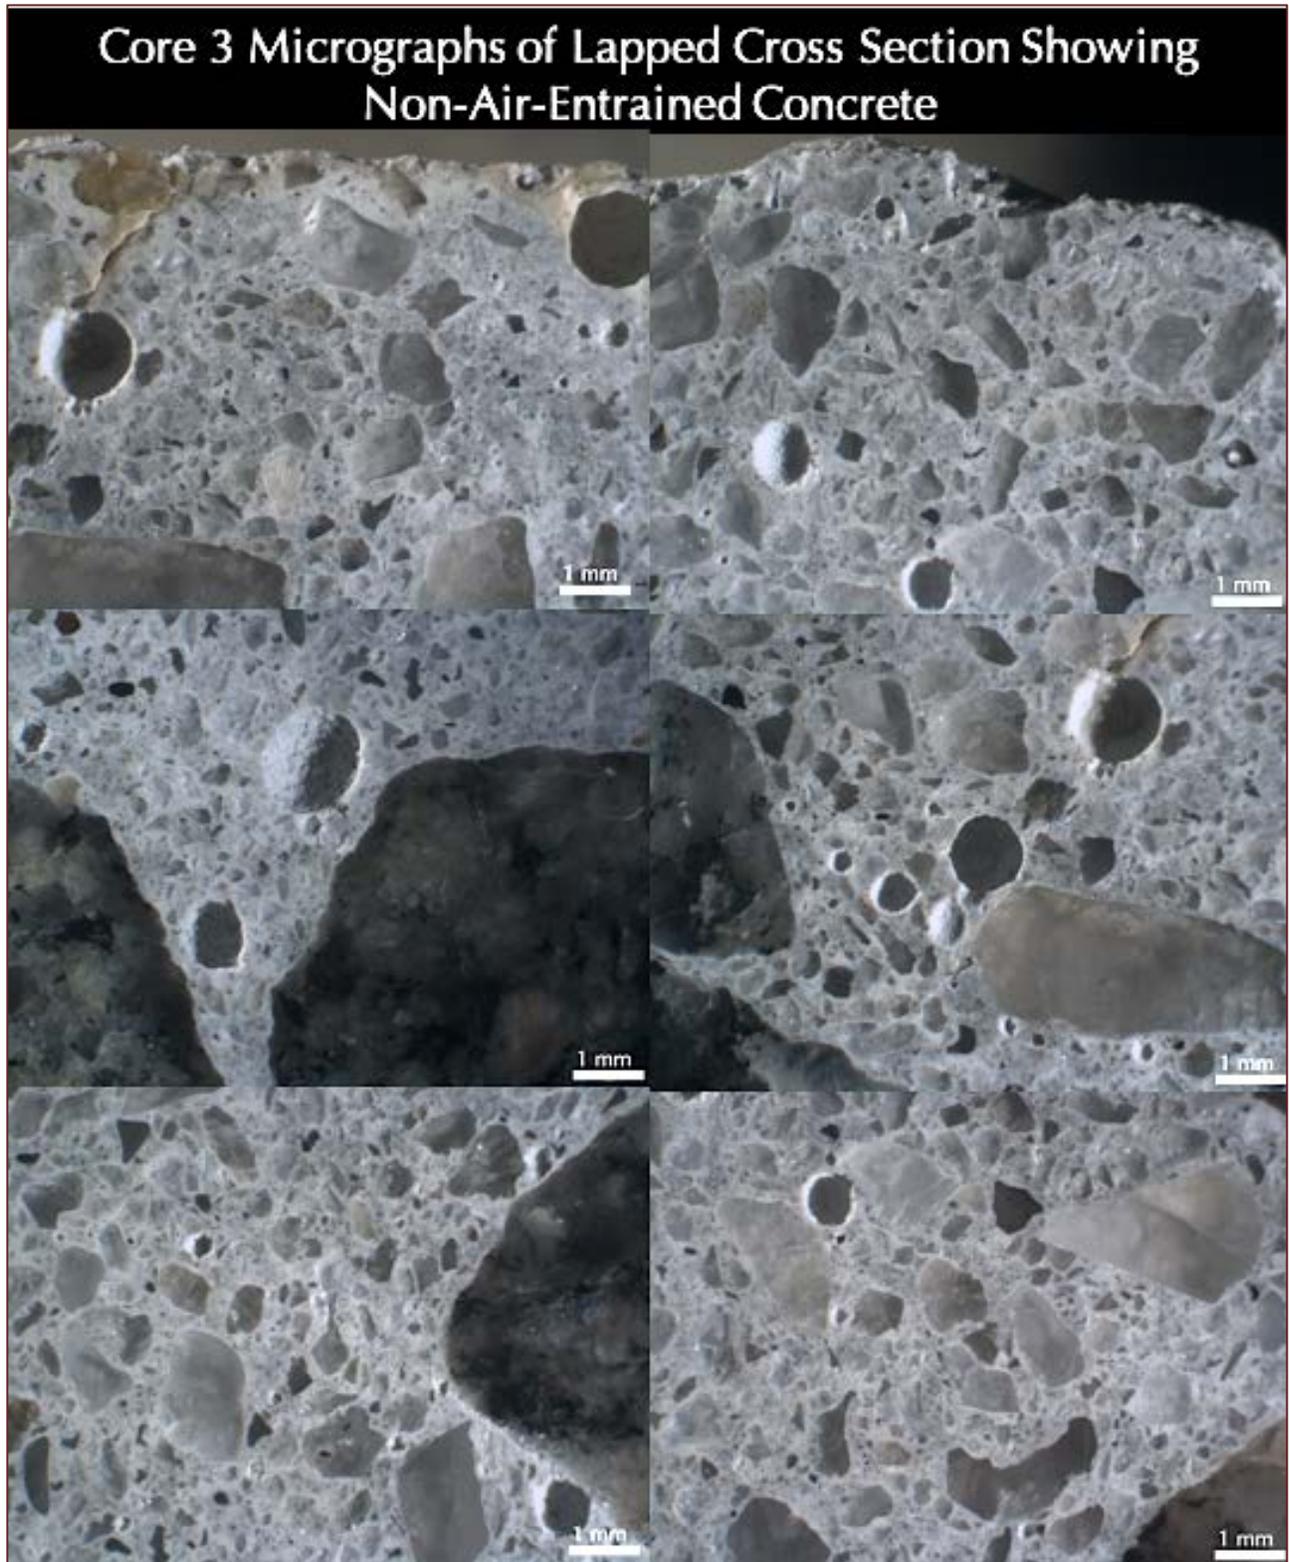
Figure 26: Micrographs of lapped cross section of Core 3 showing: (a) non-air-entrained medium gray concrete having a few coarse near-spherical and irregular-shaped entrapped air voids; (b) a fine shrinkage microcrack at the top end of concrete in the top left photo; (c) poor grading of crushed granite coarse aggregate particles, but good grading and well-distribution of siliceous sand fine aggregate particles in concrete; and (d) overall dense and well-consolidated nature of concrete. Scale bars are 1 mm.

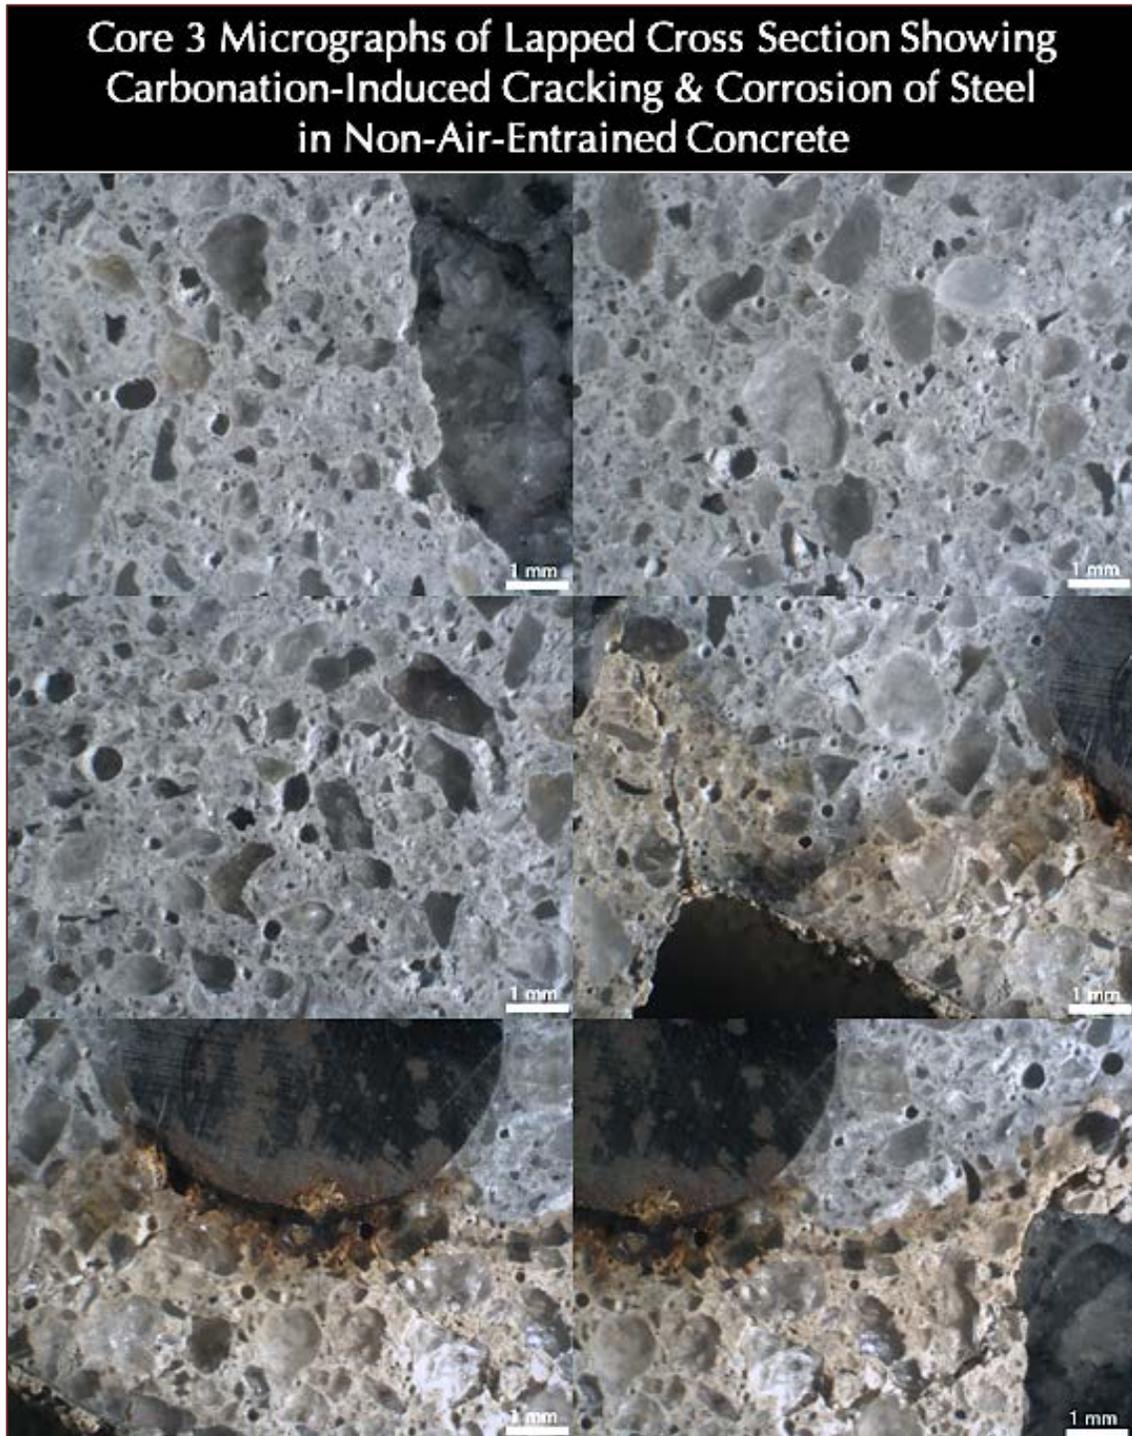
Figure 27: Micrographs of lapped cross section of Core 3 showing: (a) non-air-entrained medium gray concrete having a few coarse near-spherical and irregular-shaped entrapped air voids but overall dense and well-consolidated nature; and (b) carbonation-induced corrosion of a wire mesh situated at mid-depth location in concrete, about an inch above the formed concrete base. The mesh shows reddish-brown corrosion products and cracking associated with corrosion. The beige discoloration of concrete base from atmospheric carbonation has reached the level of wire mesh and hence caused carbonation-induced de-passivation of the protective oxide film around the mesh to initiate corrosion in the presence of moisture and oxygen. Cracks formed from corrosion of steel have opened up pathways for migration of carbon dioxide deep inside the concrete as seen by the V-shaped carbonation front along a radial crack from corroded steel in the middle right photo.

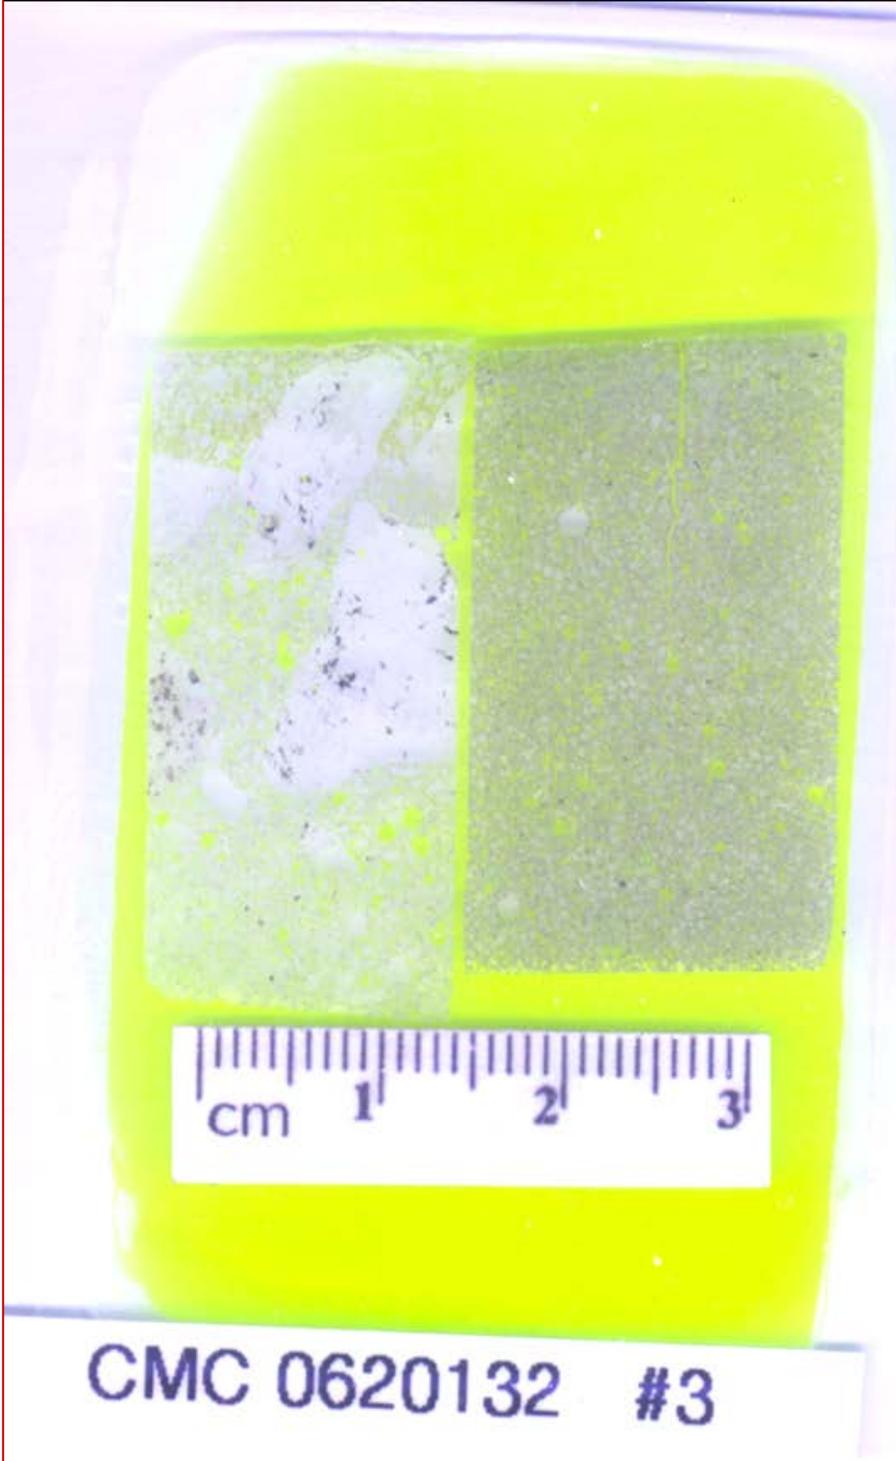
**Core 3 Fluorescent Dye-Mixed Epoxy-Impregnated Thin Section Showing Air-Entrained Grout & Non-Air-Entrained Concrete**

Thin section is approximately 30 microns (0.03 mm) in thickness and transparent to polarized-light.

Figure 30: Fluorescent dye-mixed epoxy-impregnated thin section of grout and concrete in Core 3 showing:

(a) Overall denser nature of grout relative to concrete;

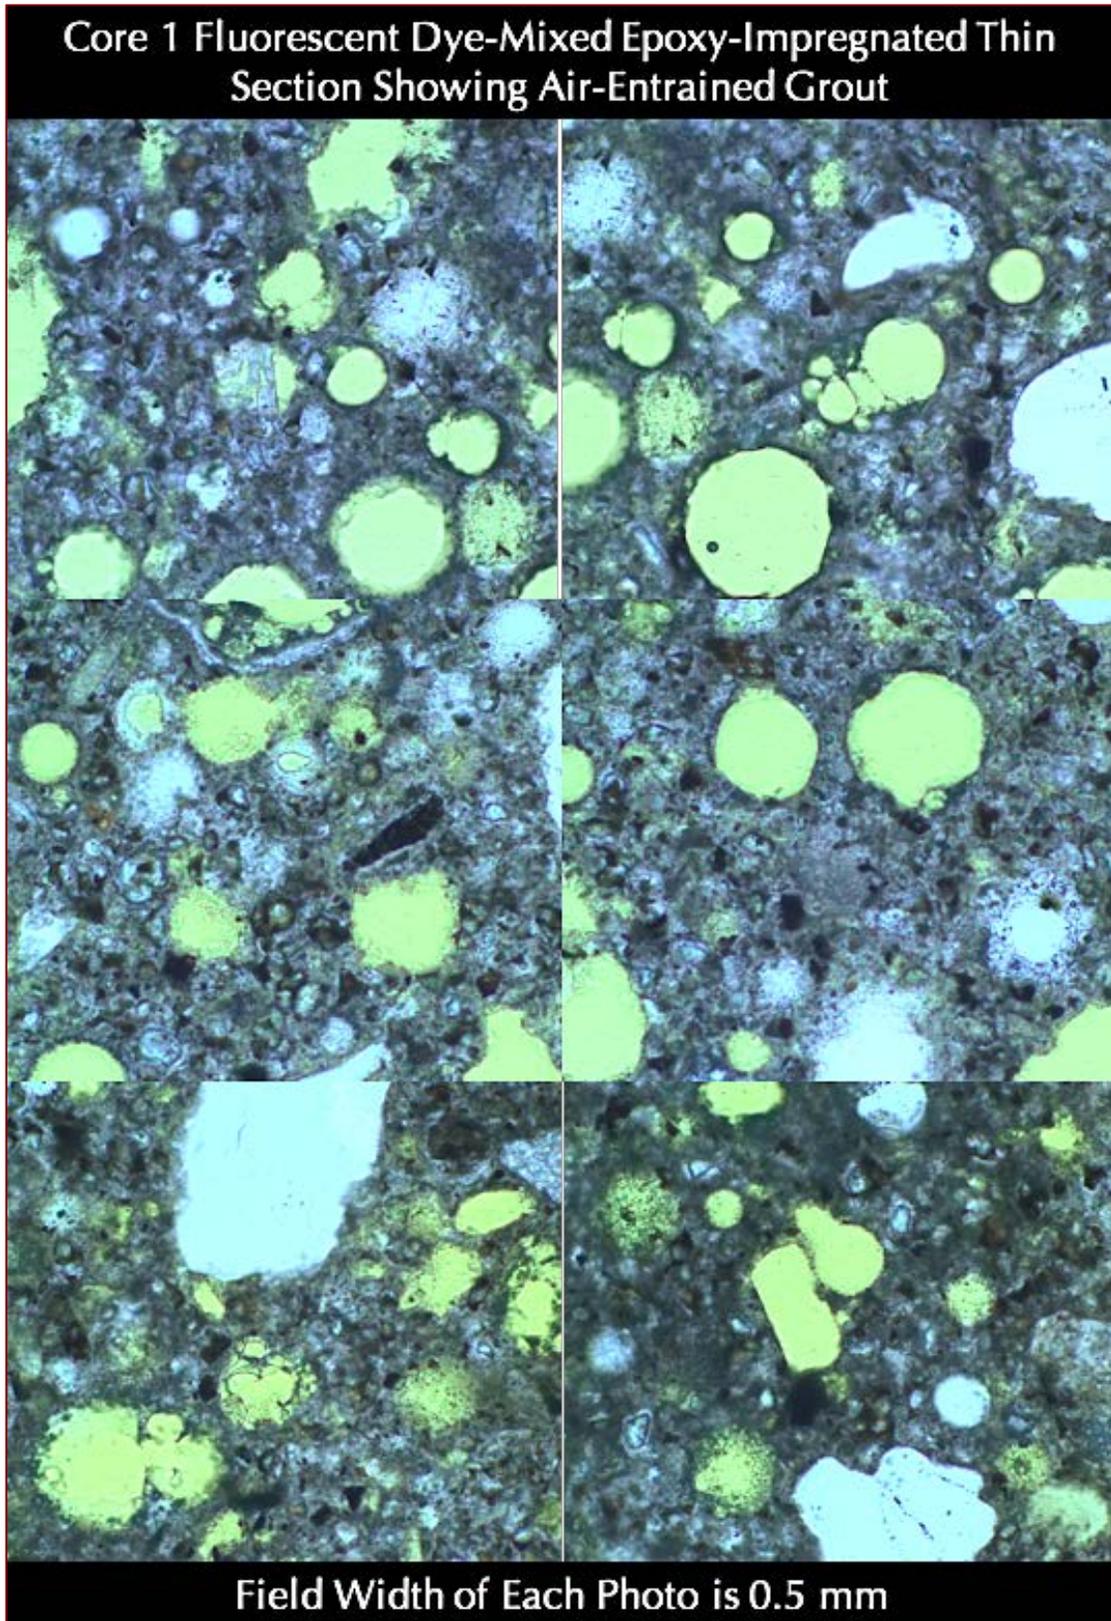
Figure 36: A mosaic of six micrographs of thin section of Core 1 taken in plane-polarized light mode with a Nikon Eclipse E600 fluorescent-light microscope with attachments for polarized light showing a dense paste of grout having abundant residual Portland cement particles, cement hydration products, and potential addition of other pozzolanic and/or cementitious materials to create a dense paste microstructure.

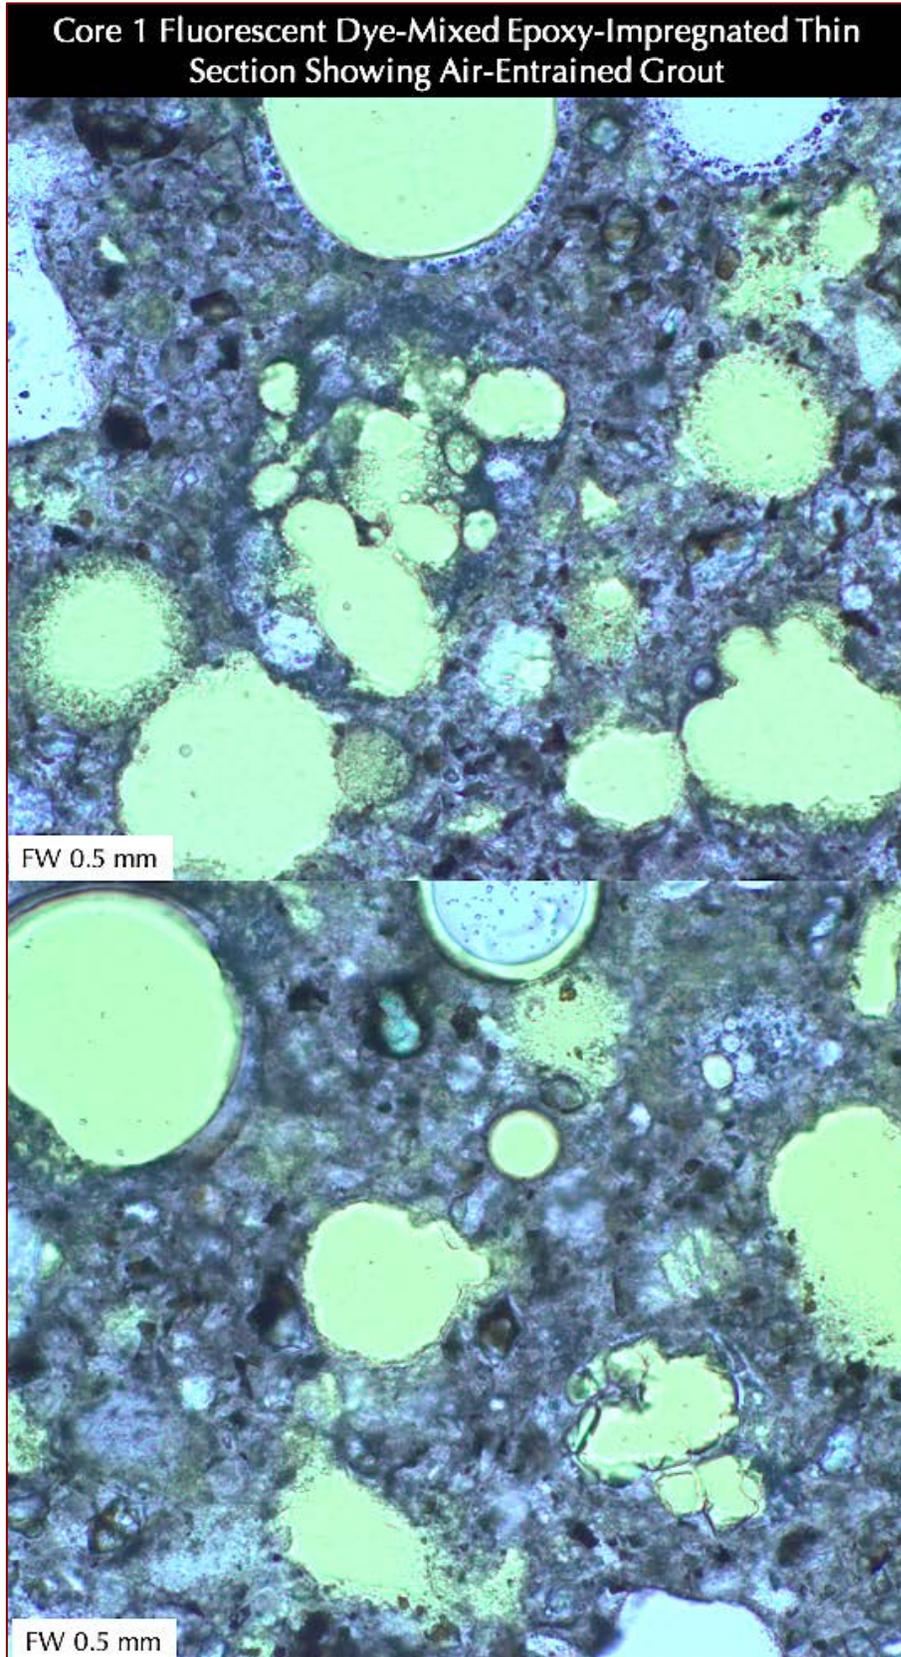
Figure 37: Two micrographs of thin section of Core 1 taken in plane-polarized light mode with a Nikon Eclipse E600 fluorescent-light microscope with attachments for polarized light showing a dense paste of grout having abundant residual Portland cement particles, cement hydration products, and potential addition of other pozzolanic and/or cementitious materials to create a dense paste microstructure.

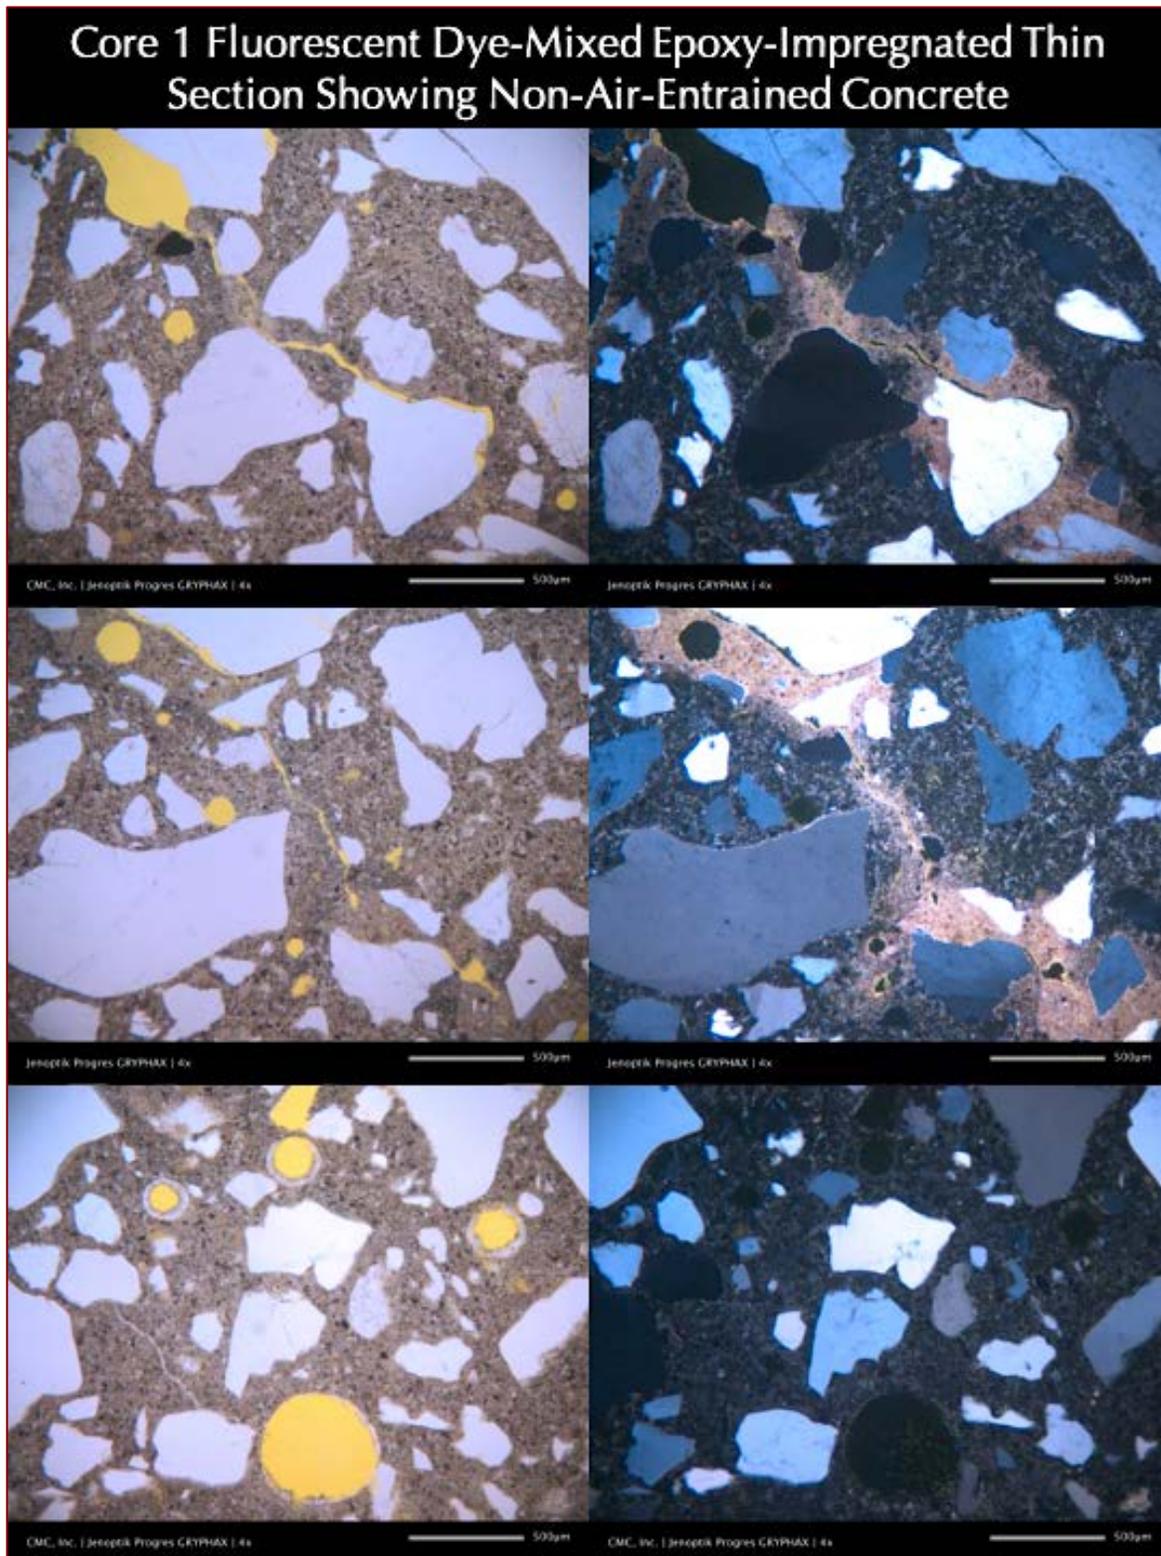
Figure 47: Micrographs of thin section of concrete portion of Core 1 taken with a Nikon Eclipse E600 POL petrographic microscope in plane (left column) and crossed (right column) polarized light modes showing: (a) crushed silica sand fine aggregate particles, (b) a dense Portland cement paste having a few residual Portland cement particles in cement hydration products, (c) a few entrapped air voids highlighted by fluorescent epoxy; (d) fine acicular secondary ettringite deposits lining walls of some air voids; and (d) shrinkage microcrack in paste and carbonation of paste along the walls of microcrack (top and bottom right photos).

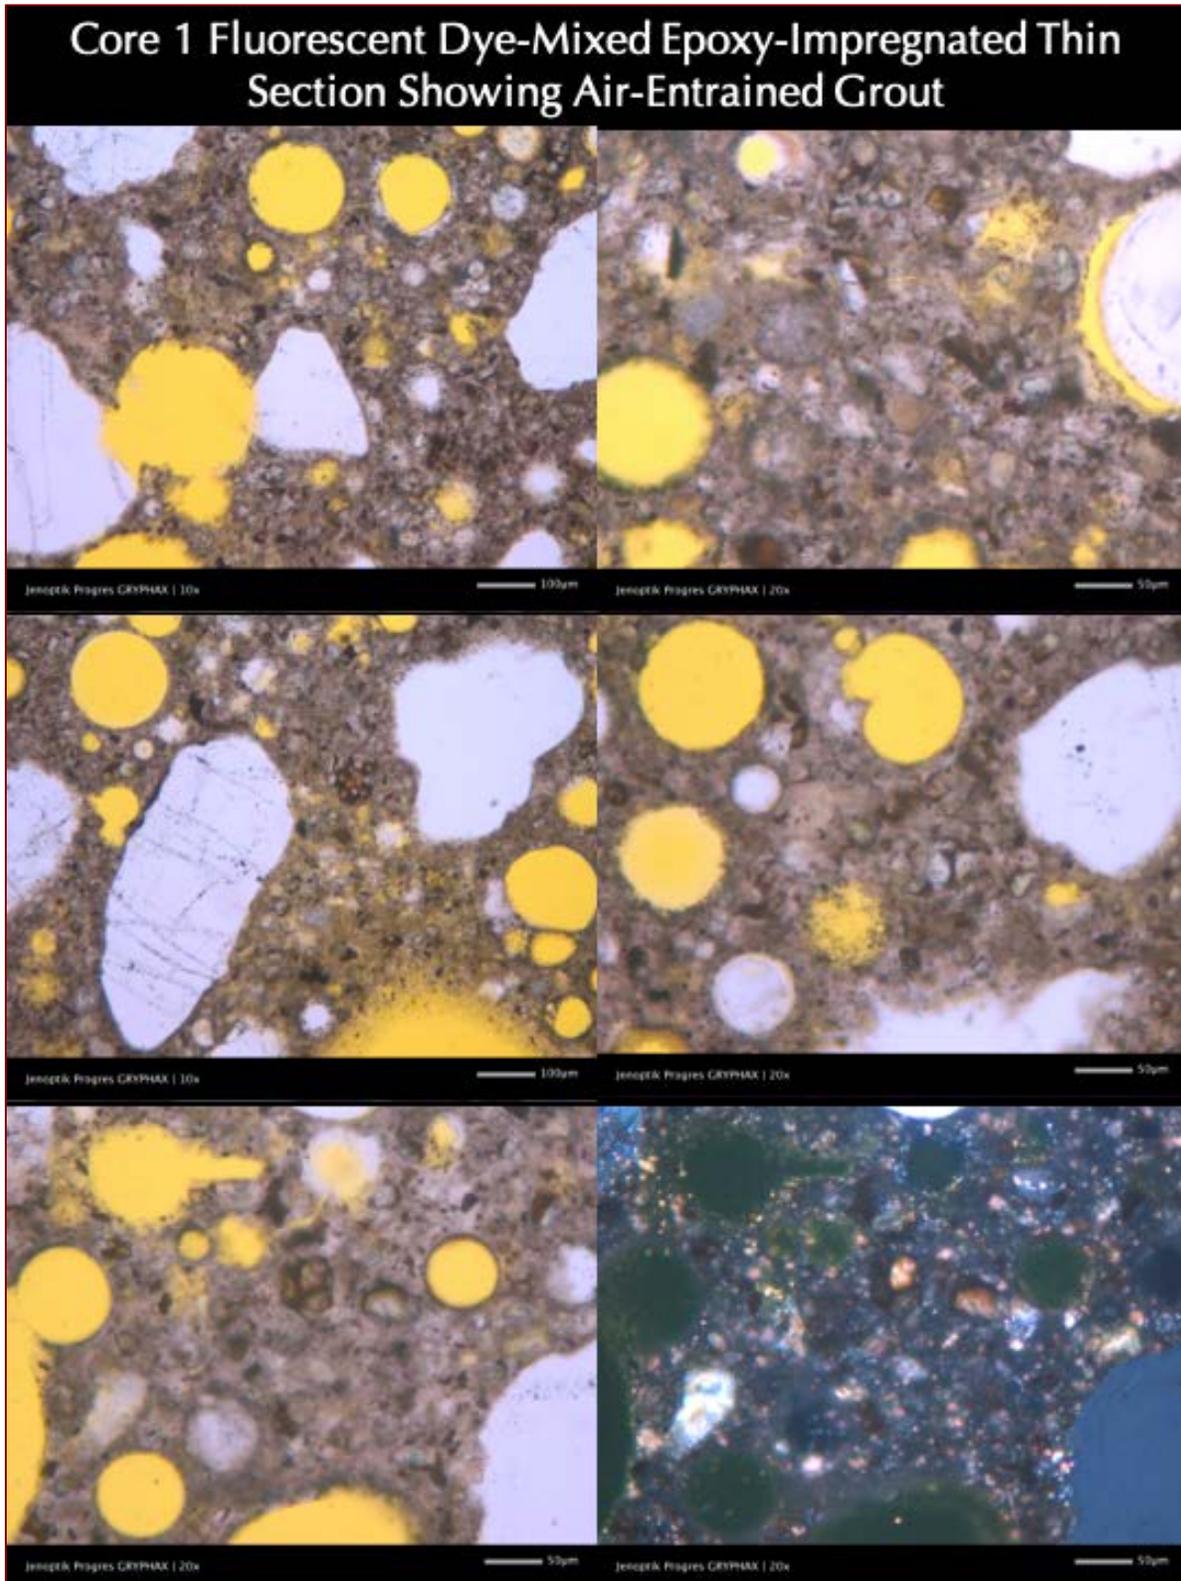
Figure 48: Micrographs of thin section of grout portion of Core 1 taken with a Nikon Eclipse E600 POL petrographic microscope in plane and crossed (bottom right photo) polarized light modes showing: (a) lightly crushed silica sand fine aggregate particles, (b) a dense paste having abundant residual Portland cement particles and evidence of addition of some other pozzolanic and cementitious materials distributed in cement hydration products, and (c) spherical entrained air voids highlighted by fluorescent epoxy.

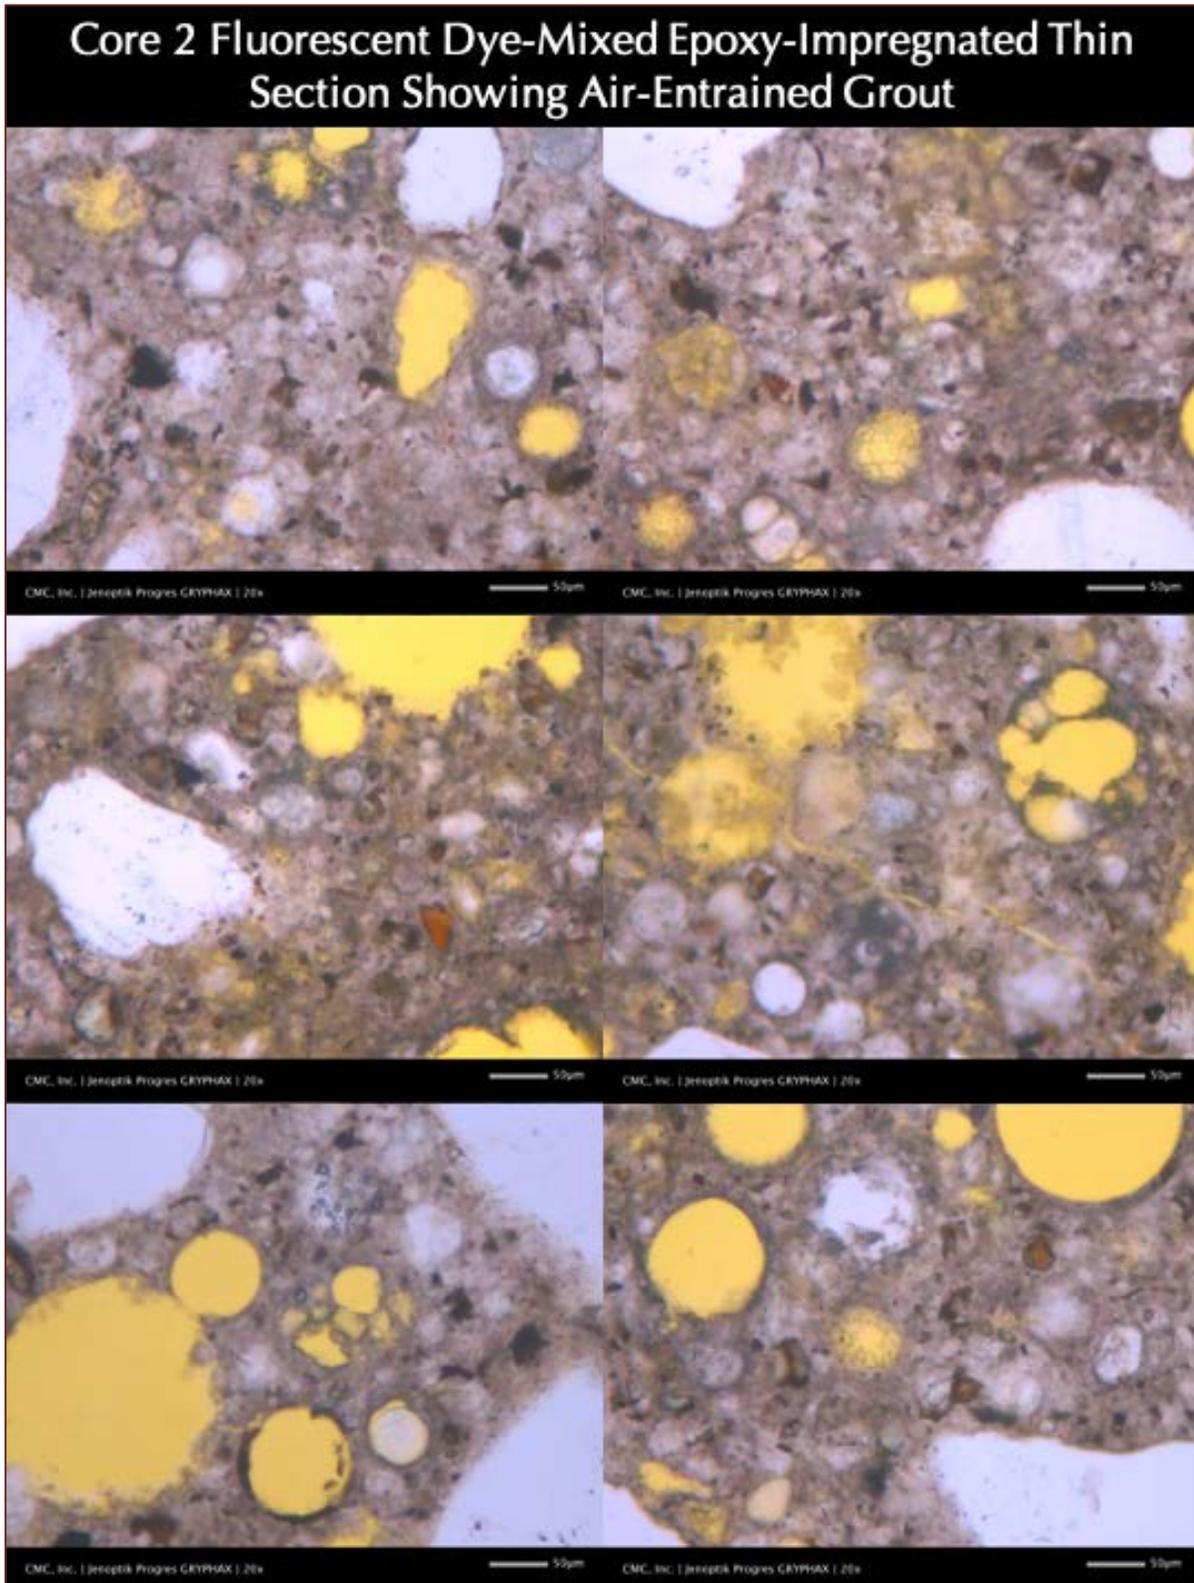
Figure 49: Micrographs of thin section of grout portion of Core 2 taken with a Nikon Eclipse E600 POL petrographic microscope in plane polarized light mode showing: (a) lightly crushed silica sand fine aggregate particles, (b) a dense paste having abundant residual Portland cement particles and evidence of addition of some other pozzolanic and cementitious materials distributed in cement hydration products, and (c) spherical entrained air voids highlighted by fluorescent epoxy.

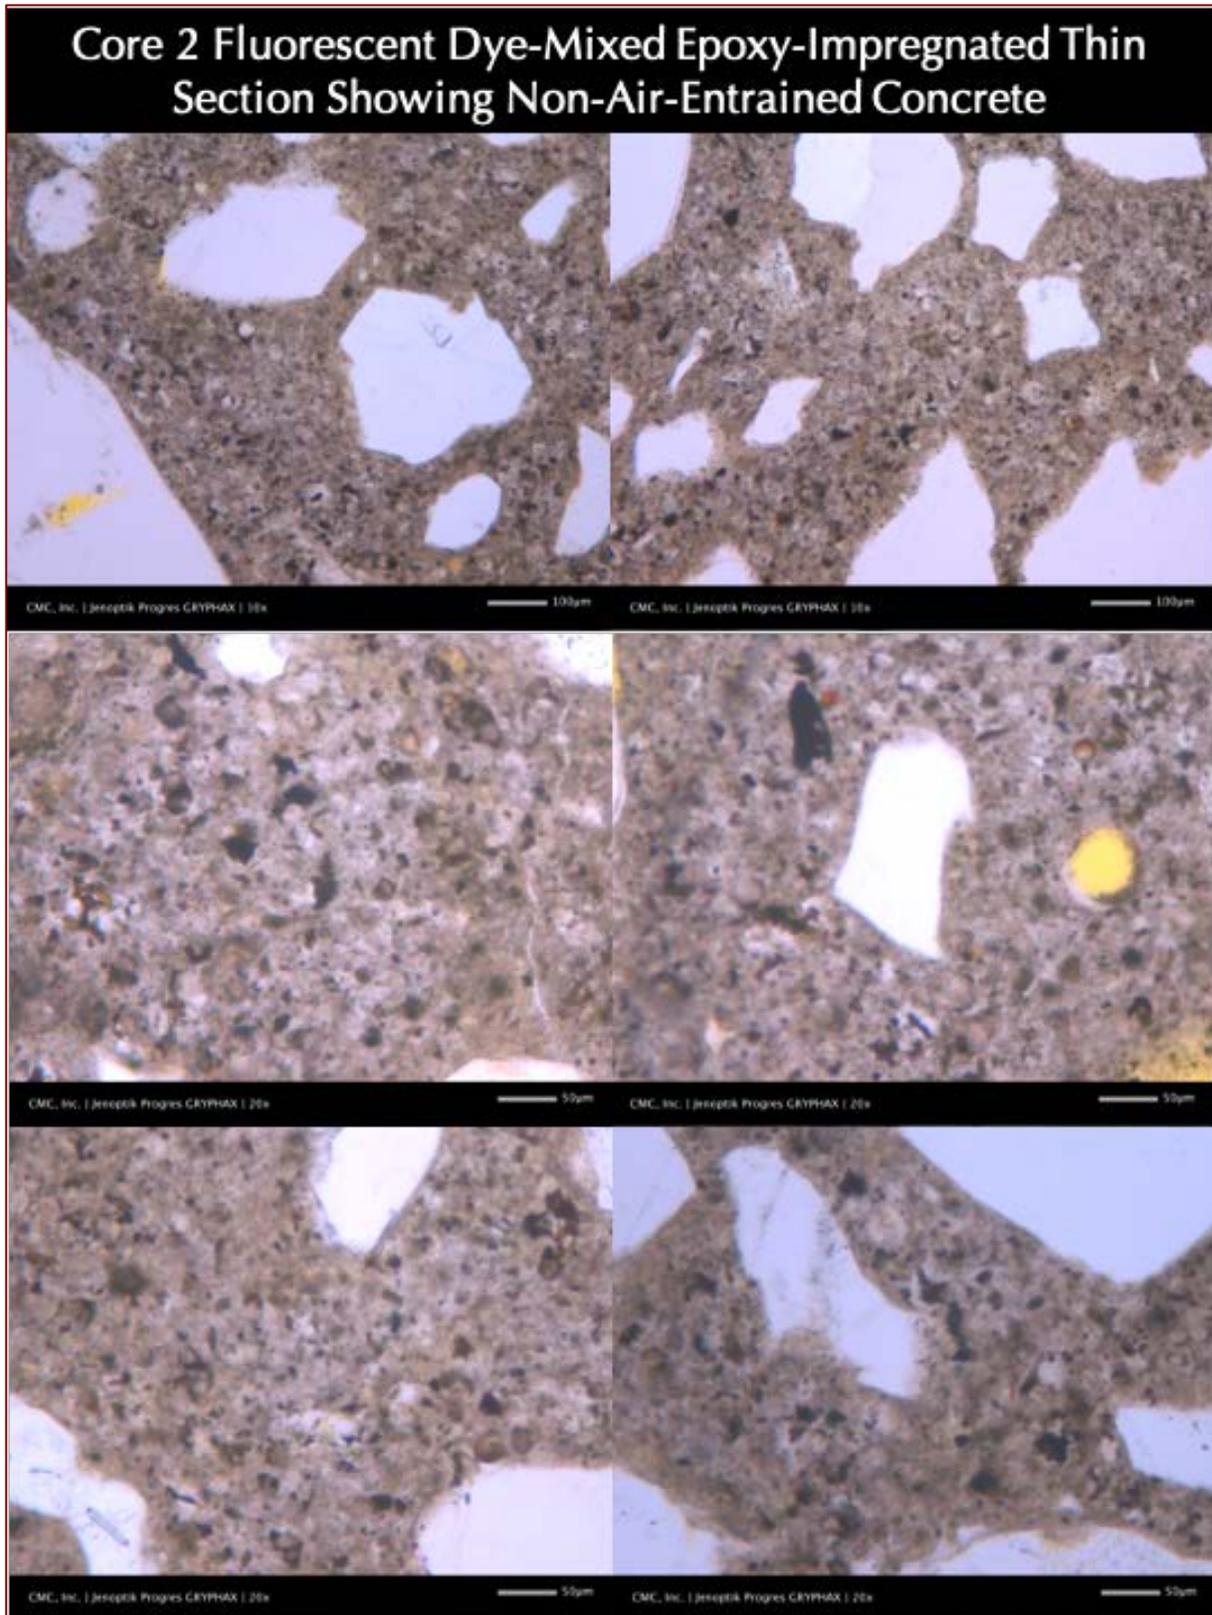
Figure 50: Micrographs of thin section of concrete portion of Core 2 taken with a Nikon Eclipse E600 POL petrographic microscope in plane polarized light mode showing: (a) crushed silica sand fine aggregate particles, (b) a dense Portland cement paste having a few residual Portland cement particles in cement hydration products, and (c) a few entrapped air voids highlighted by fluorescent epoxy.

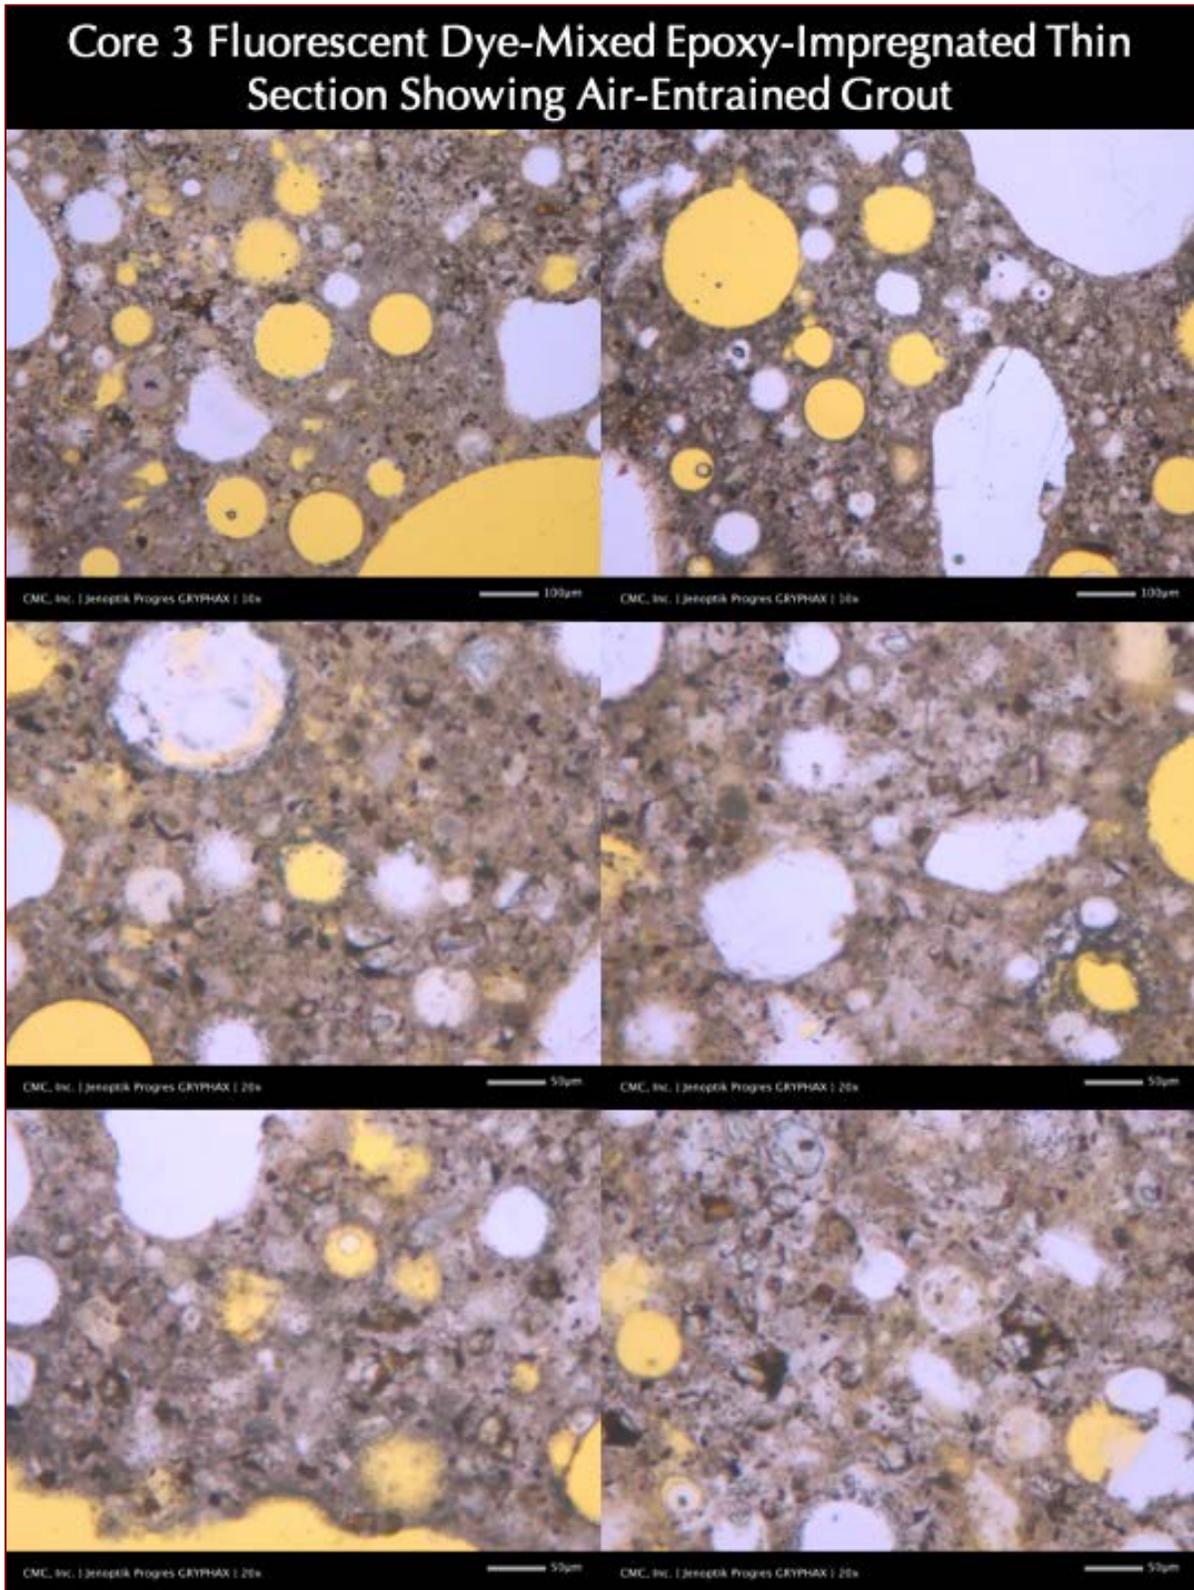
Figure 51: Micrographs of thin section of grout portion of Core 3 taken with a Nikon Eclipse E600 POL petrographic microscope in plane polarized light mode showing: (a) lightly crushed silica sand fine aggregate particles, (b) a dense paste having abundant residual Portland cement particles and evidence of addition of some other pozzolanic and cementitious materials distributed in cement hydration products, and (c) spherical entrained air voids highlighted by fluorescent epoxy.

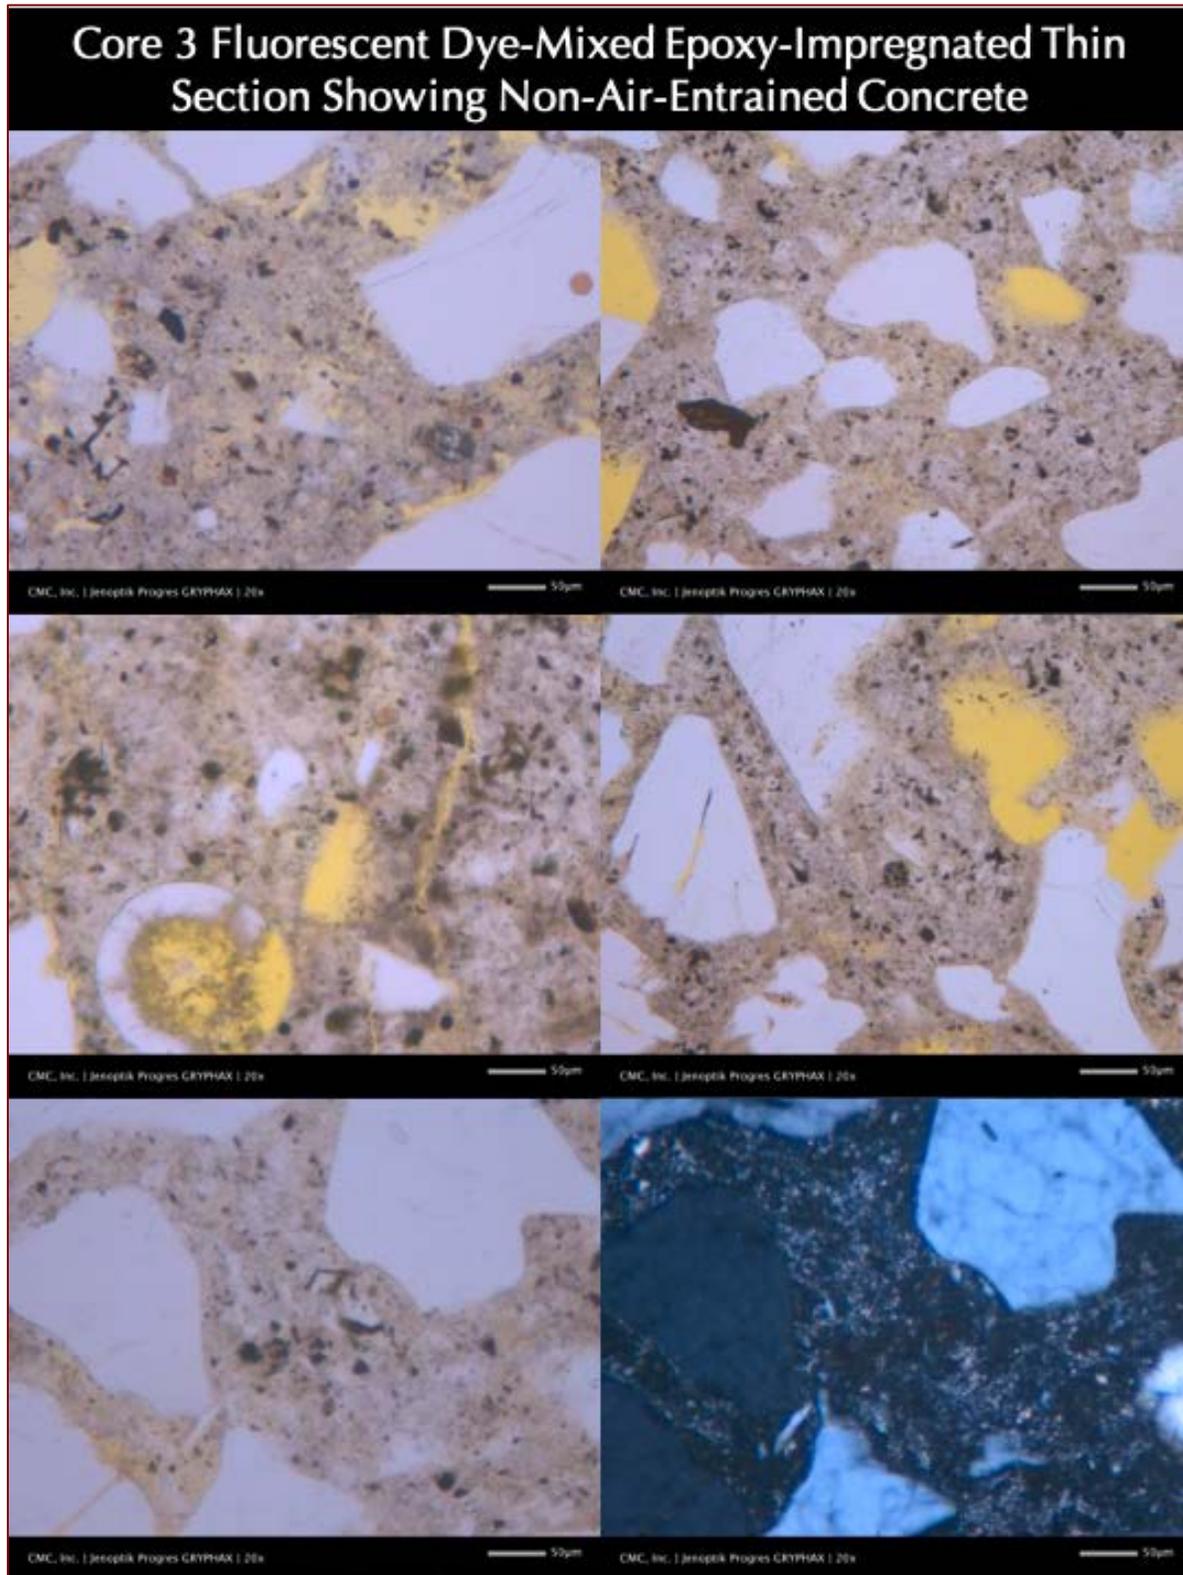
Figure 52: Micrographs of thin section of concrete portion of Core 3 taken with a Nikon Eclipse E600 POL petrographic microscope in plane and crossed (bottom right photo) polarized light modes showing: (a) crushed silica sand fine aggregate particles, (b) a dense Portland cement paste having a few residual Portland cement particles in cement hydration products, (c) a few entrapped air voids highlighted by fluorescent epoxy, and (d) fine acicular secondary ettringite deposits lining walls of some air voids.

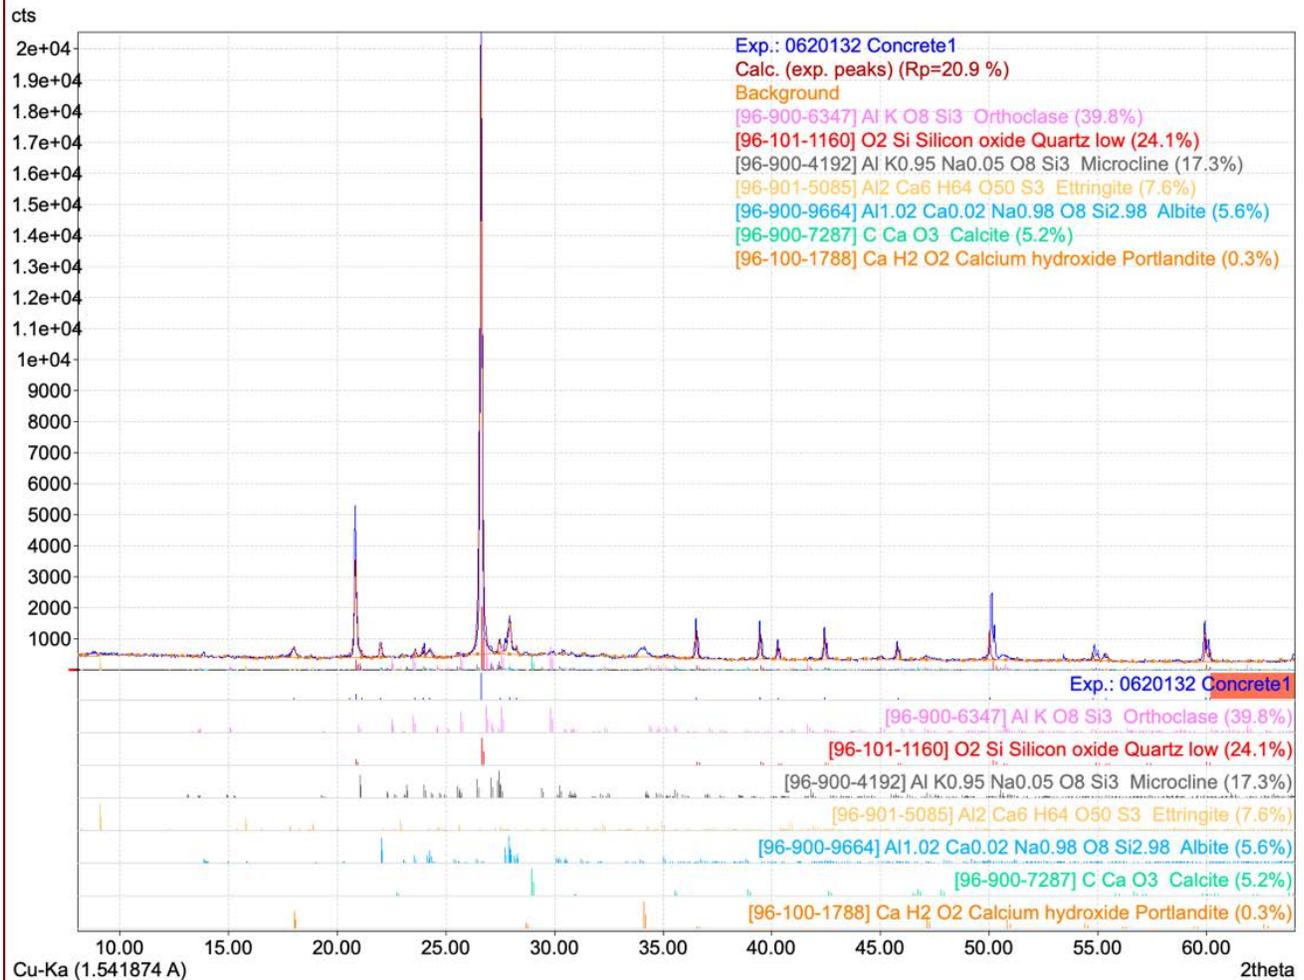
X-ray Diffraction Studies Found Dominant Quartz And Feldspar (Albite-Orthoclase-Microcline) From Crushed Granite Coarse Aggregate and Quartz Sand Fine Aggregate, and, Portlandite-Calcite-Ettringite From Paste As Detectable Crystalline Phases

XRD studies showed quartz and feldspar (microcline, orthoclase, and albite) as the dominant minerals from crushed granite coarse aggregate particles and minor portlandite, calcite, and occasional secondary ettringite from paste where secondary ettringite found in the XRD are innocuous, and similar to the ones found in optical microscopy lining the walls of air voids that are indicative of the presence of moisture during service.
