## Laboratory Investigation of Anchoring Grout And Concrete Composite Cores From Balcony Slabs Of A Condominium

Building Façade and Waterproofing Repairs  
Bee Street Lofts  
150 Bee Street Condominiums  
Charleston, South Carolina

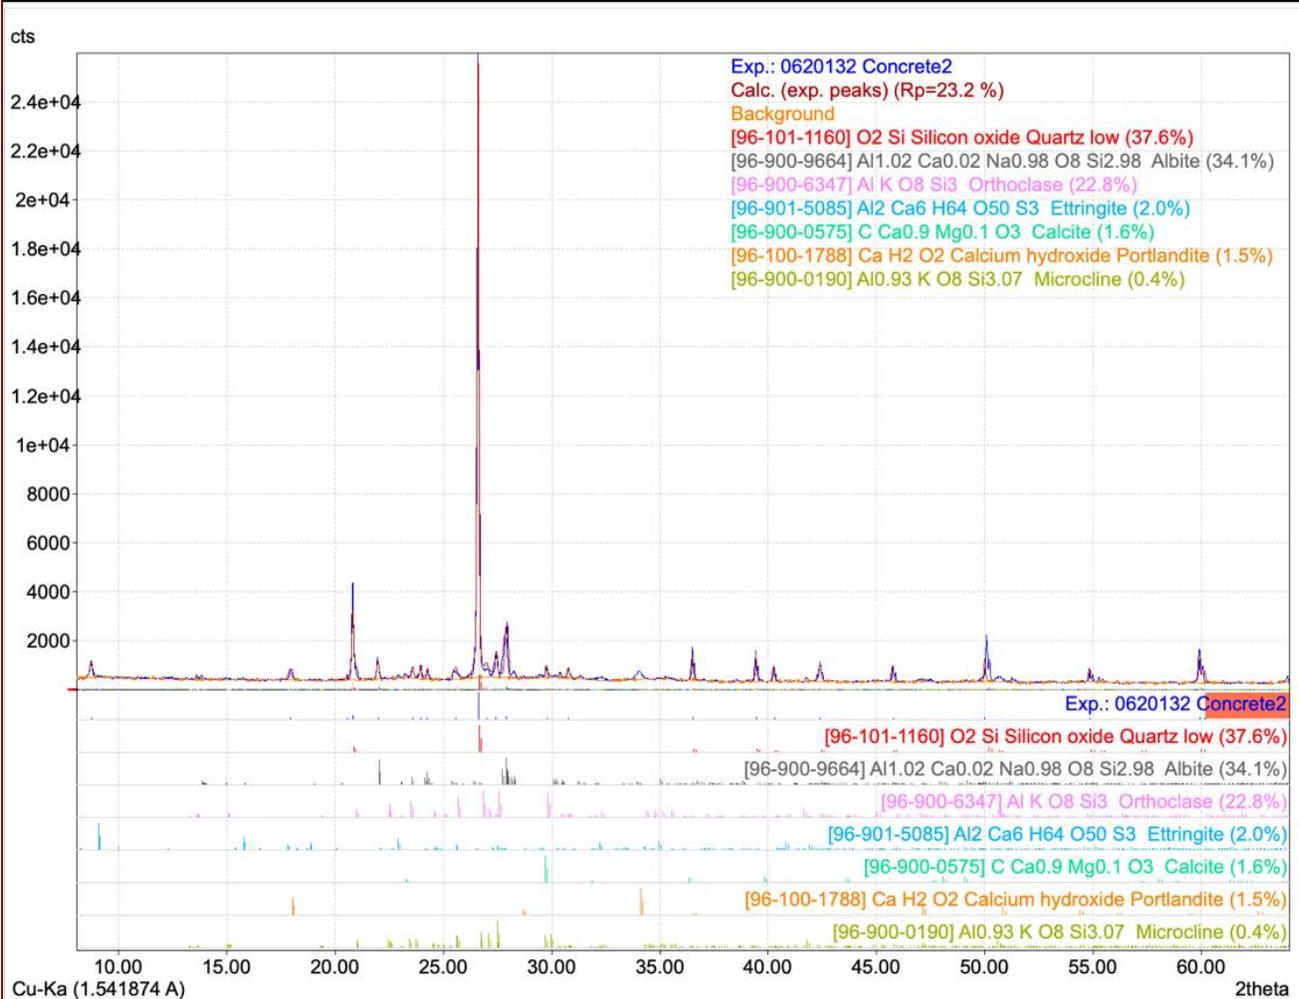
X-ray Diffraction Studies Found Dominant Quartz  
 And Feldspar (Albite-Orthoclase-Microcline) From  
 Crushed Granite Coarse Aggregate and Quartz  
 Sand Fine Aggregate, and,  
 Portlandite-Calcite-Ettringite From Paste  
 As Detectable Crystalline Phases

XRD studies showed quartz and feldspar (microcline, orthoclase, and albite) as the dominant minerals from crushed granite coarse aggregate particles and minor portlandite, calcite, and occasional secondary ettringite from paste where secondary ettringite found in the XRD are innocuous, and similar to the ones found in optical microscopy lining the walls of air voids that are indicative of the presence of moisture during service.

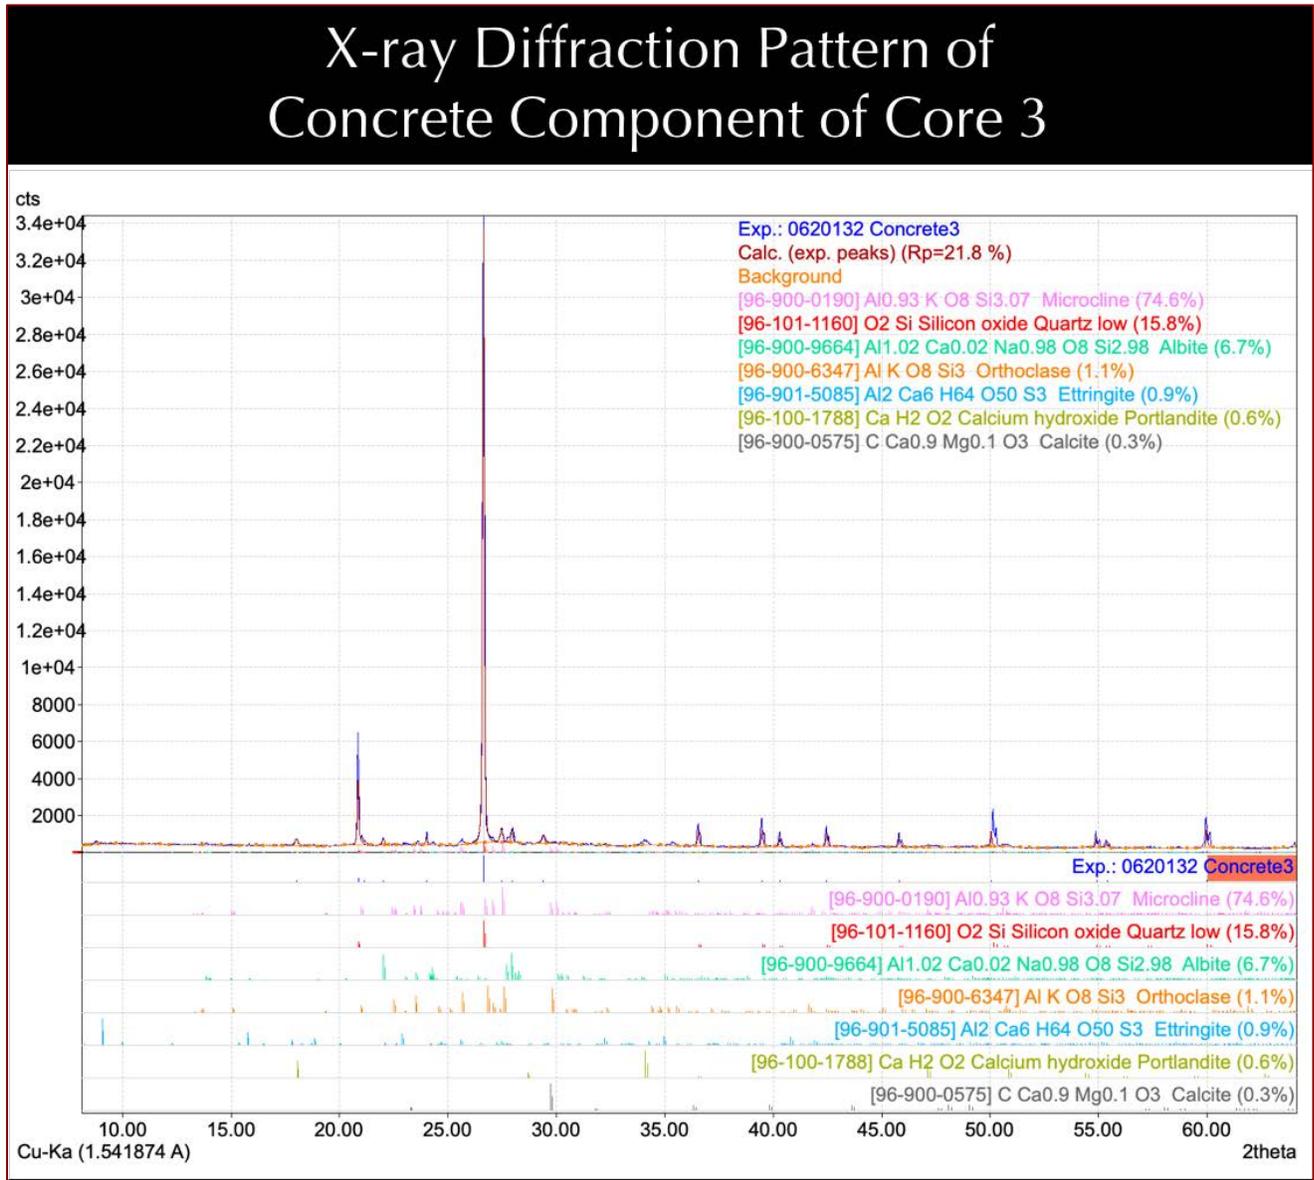
X-ray Diffraction Studies Found Dominant Quartz And Feldspar (Albite-Orthoclase-Microcline) From Crushed Granite Coarse Aggregate and Quartz Sand Fine Aggregate, and, Portlandite-Calcite-Ettringite From Paste As Detectable Crystalline Phases
