# Type IL Cement and Concrete Scaling

by Dipayan Jana

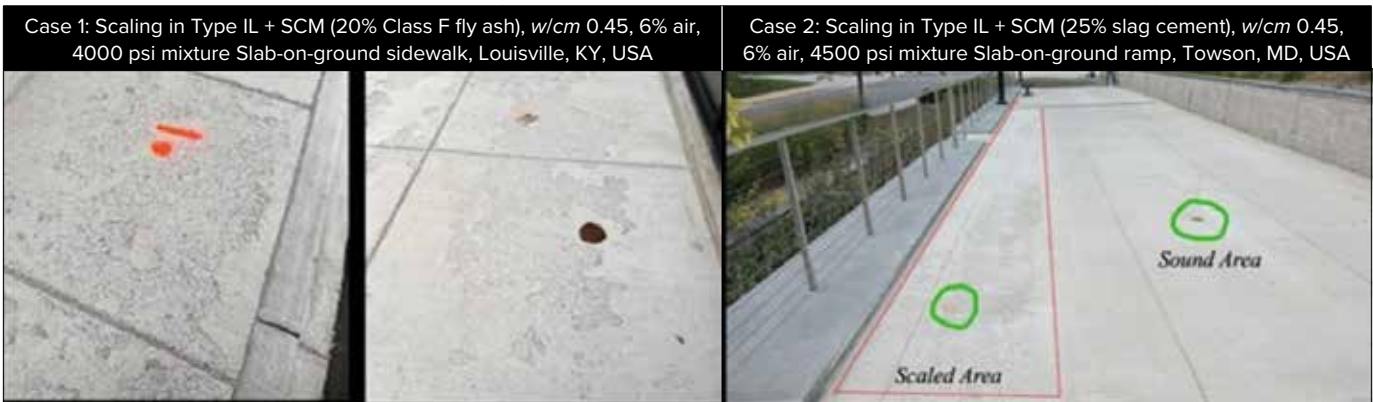
Fig. 1(a): Summary of parameters investigated in Cases 1 and 2

Case 1: Scaling in Type IL + SCM (20% Class F fly ash), w/cm 0.45, 6% air, 4000 psi mixture Slab-on-ground sidewalk, Louisville, KY, USA		Case 2: Scaling in Type IL + SCM (25% slag cement), w/cm 0.45, 6% air, 4500 psi mixture Slab-on-ground ramp, Towson, MD, USA	
<b>Materials, ASTM specifications, and 1 yd<sup>3</sup> weight</b>			
Type IL cement, ASTM C595/C595M	451	Type IL cement, ASTM C595/C595M	476
Class F fly ash, ASTM C618	113	Slag cement, ASTM C989/C989M	159
Natural sand, ASTM C33/C33M	1205	Natural sand, ASTM C33/C33M	1090
Mixed No. 8 and No. 11 crushed limestone, ASTM C33/C33M	1785	No. 57 crushed limestone, ASTM C33/C33M	1900
Water, ASTM C1602/C1602M	257.3	Water, ASTM C1602/C1602M	280
Air-entraining agent, ASTM C260/C260M	1.1 oz/cwt	Air-entraining agent, ASTM C260/C260M	0.25 to 4 oz/cwt
Water reducer, ASTM C494/C494M	5 oz/cwt	Water reducer, ASTM C494/C494M	3 to 7 oz/cwt
<b>Background information</b>

Concrete placement	April to May 2023, maturity was attained	July to August 2021, maturity was attained	
Distress reported	Winter 2024		Spring 2022
Exposure	Severe weather, exposed to salts		Severe weather, exposed to acetate/chloride salts
<b>Plastic concrete properties</b>			
Slump (in.), design air content (%), unit weight (lb/ft <sup>3</sup> ), design w/cm	4 in., 6 (±1.5)%, 140, 0.45		2 to 5 in., 6.5 (±1.5)%, 146, 0.42
<b>Compressive strengths of lab-cured cylinders</b>			
Design strength and lab-cured cylinder strengths (psi) at 7 and 28 days	4000, 2950, 4780		4500, 4240, 5850
<b>Hardened air (ASTM C457/C457M) of cores from sound and scaled areas; all cores are air-entrained</b>			
<b>Total air (%), void frequency (%), specific surface (in.<sup>2</sup>/in.<sup>3</sup>), void-spacing factor (in.)</b>			
Air-void parameters of sound core	—		6.8%, 14.4%, 850 in. <sup>2</sup> /in. <sup>3</sup> , 0.0062 in.

Air-void parameters of scaled core	6.08%, 5.38%, 354 in. <sup>2</sup> /in. <sup>3</sup> , 0.0137 in.		7.9%, 13.7%, 690 in. <sup>2</sup> /in. <sup>3</sup> , 0.0066 in.
Finishing-induced air loss at the surface	Yes		Slight air loss at the top 5 mm with coarse, irregular voids from finishing a high-air mixture
<b>Water-soluble chloride (ASTM C1218/C1218M) from exposed surface—to middepth—to bottom end of cores, in ppm</b>			
Sound core	—		671-70-135 (chloride salt exposure)
Scaled core	3153-89-116 (severe chloride salt exposure)		565-125-146 (chloride salt exposure)

Petrographic observations (ASTM C856/C856M)		
Type of surface distress in the cores	Severe scaling, incipient scales from near-surface microcracks at top 3 to 4 mm	Severe scaling in scaled core
Coarse aggregate, WG is well graded, WD is well distributed, UA is unaltered, UC = uncracked, S is sound aggregate	9.5 mm maximum size crushed limestone dolomite, WG, WD, UA, UC, S	19 mm maximum size crushed limestone (limestone, many with argillaceous bands), limestone with detrital quartz inclusions, sparite WG, WD, UA, UC, S
Fine aggregate	6.5 mm maximum size natural siliceous-argillaceous-calcareous sand, WG, WD, UA, UC, S	9.5 mm maximum size size natural siliceous sand, WG, WD, UA, UC, S
Finishing-induced high $w/cm$ soft, porous paste at the surface, mm	None, $w/cm$ is slightly lower at the surface than the interior	None in the sound core but very thin high $w/cm$ paste at the top of the scaled core

Finishing-induced densified low $w/cm$ zone at the surface with lower air, mm	0.40 to 0.45 at top 3 to 4 mm, air loss at 3 to 4 mm	Dense carbonated zone beneath the porous carbonated top in the scaled core, but dense carbonated zone above relatively less dense non-carbonated paste in the body of the sound core
$w/cm$ , estimated in the body	0.45 to 0.50	0.40 to 0.45
Excessive bleeding, laitance, bleed water accumulation beneath the finished surface, finishing with bleed water on the surface	Despite sheet like scaling from freezing-related near-surface cracking, no evidence of premature finishing or bleed water trapping beneath finished surface	None
Tempered water addition	None	Evidence of tempered water addition during placement
Depth of carbonation, mm	Shallow (<5 mm) in both sound and scaled cores	Shallow (<5 mm) in both sound and scaled cores
Depth of distressed zone, maximum, mm	10	<5 mm
Microcracking at the surface region, mm	Near-surface, surface-parallel extensive microcracks, a few vertical microcracks, all within <10 mm	None

Inadequate curing/restricted hydration and hence soft, porous, crumbled paste?	Not in any cores	None found in the cores
Interior concrete	Dense, well-consolidated, sound, but with questionable durability for poor air-void system	Dense, well-consolidated, sound, durable, and serviceable
Conformance to materials and mixture proportions	Yes	Yes
Interpretation of surface distress		
Concrete materials and mixture proportions	Sound materials, proportions as per design mixture, but lack of adequate entrained air from low dosage of AEA resulting in a poor air-void system	Sound materials, proportions as per design mixture
Workmanship	Finishing-induced loss of air at the top 10 mm	Finishing-induced air loss at the top 10 mm, higher $w/cm$ at the top <5 mm of scaled surface due to finishing a "sticky" high-air (8%) concrete
Future durability and serviceability	Questionable durability and serviceability for low air	Once distressed surface is repaired with a well-bonded, durable coating, interior concrete is serviceable

Figure 1(a) and (b) summarize the process followed for these scaling investigations. In all cases, relevant factors included: 1) materials and mixture proportions; 2) background information (timing of placement and distress, extent, and severity of scaling); 3) fresh concrete properties, design  $w/cm$ , and design strength; 4) compressive strength of laboratory-cured cylinders; 5) results of hardened air analysis by modified point-count method of ASTM C457/C457M; 6) results of water-soluble chloride analyses (ASTM C1218/C1218M) at the surface region, middepth, and bottom ends of the cores from the scaled and sound areas; 7) information obtained from petrography (ASTM C856/C856M), including the depth of distressed surface to replace, condition and future serviceability of the interior concrete, and conformance to materials and mixture design; and 8) the author's interpretations of factors responsible for surface distress.

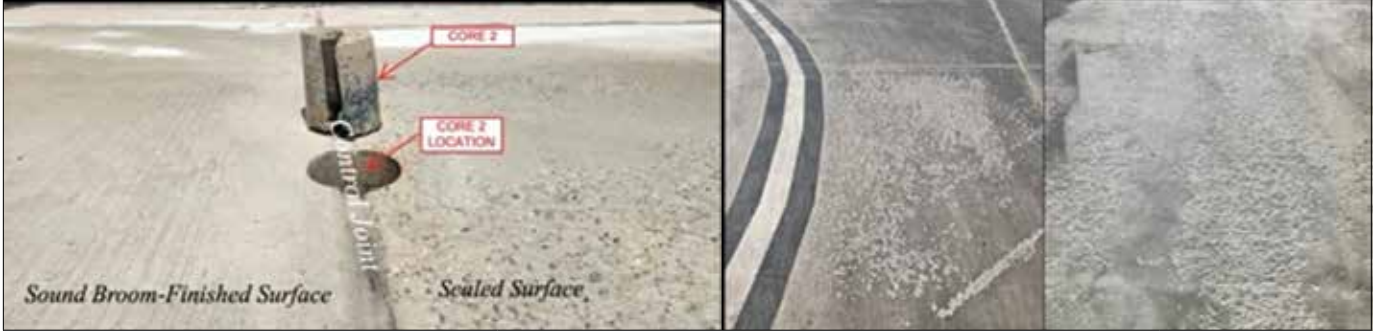
**Fig. 1(b): Summary of parameters investigated in Cases 3 and 4**

Case 3: Scaling in Type IL + SCM (35% slag), w/cm 0.45, 7% air, 3500 psi mixture Slab-on-ground, Michigan, USA

Case 4: Scaling in Type IL + SCM (40% slag), w/cm 0.42, 6% air, 4500 psi mixture Airport apron pavement slab, Washington, DC, USA

Type IL cement, ASTM C595/C595M	367	Type IL cement, ASTM C595/C595M	382
Slag cement, ASTM C989/C989M	197	Slag cement, ASTM C989/C989M	254
Sand, ASTM C33/C33M	1323	Sand, manufactured, ASTM C33/C33M	334
No. 57 crushed limestone, ASTM C33/C33M	1635	Sand, natural, ASTM C33/C33M	930
Water, ASTM C1602/C1602M	254	No. 57 crushed limestone, ASTM C33/C33M	1800
Air-entraining agent, ASTM C260/C260M	8.5 oz	Water, ASTM C1602/C1602M	267
Water reducer, ASTM C494/C494M	50.8 oz	Air-entraining agent, ASTM C260/C260M	0.1 to 6 oz
—		Water reducer, ASTM C494/C494M	2 to 8 oz

Concrete placement	April to May 2023, maturity was attained	May to November 2024, summer placements were matured
Distress reported	Winter 2024	January 2025
Exposure	Severe weather, exposed to salts	Severe weather, exposed to acetate/chloride salts

Slump (in.), design air content (%), unit weight (lb/ft <sup>3</sup> ), design w/cm	6 in., 7 (±1.5)%, 140, 0.45	3 in., 6%, 147, 0.42
---	-----------------------------	----------------------

Design strength and lab-cured cylinder strengths (psi) at 7 and 28 days	3500, 2250, 4150	4500, 4250, 5850
---	------------------	------------------

Air-void parameters of sound core	6.5%, 13.5%, 833 in. <sup>2</sup> /in. <sup>3</sup> , 0.0057 in.	5.1%, 12.5%, 991 in. <sup>2</sup> /in. <sup>3</sup> , 0.0052 in.
Air-void parameters of scaled core	7.2%, 14.2%, 791 in. <sup>2</sup> /in. <sup>3</sup> , 0.0059 in.	8.5%, 15.0%, 707 in. <sup>2</sup> /in. <sup>3</sup> , 0.0057 in.
Finishing-induced air loss at the surface	Yes, at the top 2 mm in all cores	No

Sound core	203-71-83 (chloride salt exposure)	284-63-55 (chloride salt exposure)
Scaled core	271-73-37 (chloride salt exposure)	237-65-59 (chloride salt exposure)

Petrographic observations (ASTM C856/C856M)		
Type of surface distress in the cores	Severe scaling, incipient scales from near-surface microcracks at top 3 to 4 mm, mortar liftoffs	Severe scaling
Coarse aggregate, WG is well graded, WD is well distributed, UA is unaltered, UC is uncracked, S is sound aggregate	19 mm maximum size crushed limestone (biosparite, biomicrite) WG, WD, UA, UC, S	19 mm maximum size crushed limestone (limestone, dolomitic, dolomitic, marble) WG, WD, UA, UC, S
Fine aggregate	9.5 mm maximum size natural siliceous-calcareous sand, WG, WD, UA, UC, S	9.5 mm maximum size natural siliceous sand WG, WD, UA, UC, S
Finishing-induced high $w/cm$ soft, porous paste at the surface, mm	None	Slightly higher (0.45 to 0.50) in lighter gray paste at the top 3 to 4 mm
Finishing-induced densified low $w/cm$ zone at the surface with lower air, mm	0.40 to 0.45 at top 3 to 4 mm, <b>air loss at 3 to 4 mm</b>	None

$w/cm$ , estimated in the body	0.45 to 0.50	0.40 to 0.45
Excessive bleeding, laitance, bleed water accumulation beneath the finished surface, finishing with bleed water on the surface	None	None
Tempered water addition	None	Evidence of tempered water addition during placement
Depth of carbonation, mm	7 mm in both sound and scaled cores	<5 mm in both sound and scaled cores
Depth of distressed zone, maximum, mm	<5 mm	<5 mm
Microcracking at the surface region, mm	Vertical shrinkage microcracks at the top 5 mm of all cores	—
Inadequate curing/restricted hydration and hence soft, porous, crumbled paste?	Not in any cores	Not in any cores
Interior concrete	Dense, well-consolidated, sound, durable, and serviceable	Dense, well-consolidated, sound, durable, and serviceable
Conformance to materials and mixture proportions	Yes	Yes
Interpretation of surface distress		
Concrete materials and mixture proportions	Sound materials, proportions as per design mixture	Sound materials, proportions as per design mixture

Workmanship	<b>Finishing-induced air loss, prolonged finishing of densified surface to cause mortar liftoff and freezing-related near-surface cracking</b>	<b>Potential water addition during finishing a high-air “sticky” concrete creating a higher <math>w/cm</math> zone at surface, inadequate mixing of tempered water</b>
Future durability and serviceability	Once distressed surface is repaired with a well-bonded, durable coating, interior concrete is serviceable	Once distressed surface is repaired with a well-bonded, durable coating, interior concrete is serviceable
