Pyrrhotite Epidemic in Eastern Connecticut – A Case Study From Ellington, CT

Cracking & Crumbling of A Residential Concrete Foundation In
Ellington, Connecticut

January 2018
CMC Interim Report

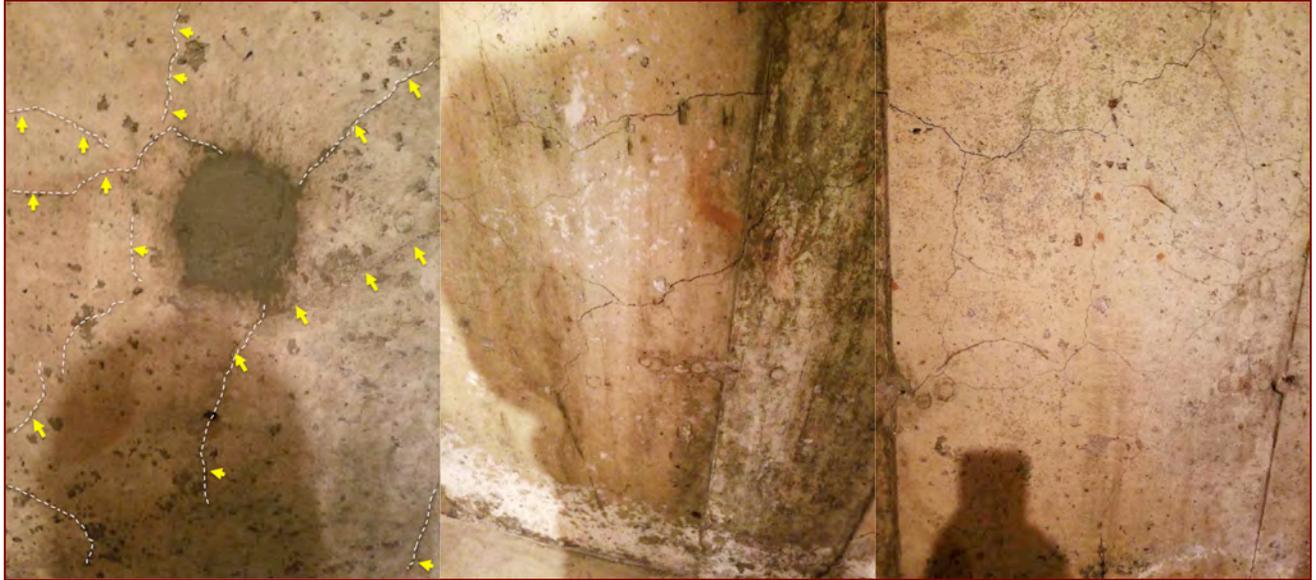
Figure 2: Field photographs showing cracking of the foundation wall, and the location on the wall from where the core for the present study was reportedly retrieved.

Figure 2 shows field photographs of the foundation wall that has exhibited random and closed polygonal-shaped map cracking. Figure 2 also shows location of the concrete core provided for this study from over a visible crack on the wall. From the total full-length retrieved thickness of the core, which is 10 in., as well as evidence of through depth cracking in the core, the foundation wall is determined to be 10 in. thick that has shown severe internal cracking. The observed cracking in the core is in conformance to the cracking of the foundation wall, which could also lead to the reported crumbling of concrete.

11. In light of the observed severe cracking of the foundation wall all throughout the thickness, and its anticipated progress with potential worsening of condition with time, replacement of the wall is the only viable option with particular emphasis to avoid use of any aggregate from the subject quarry or elsewhere that contains pyrrhotite, at least anywhere near the amounts that have caused the cracking.

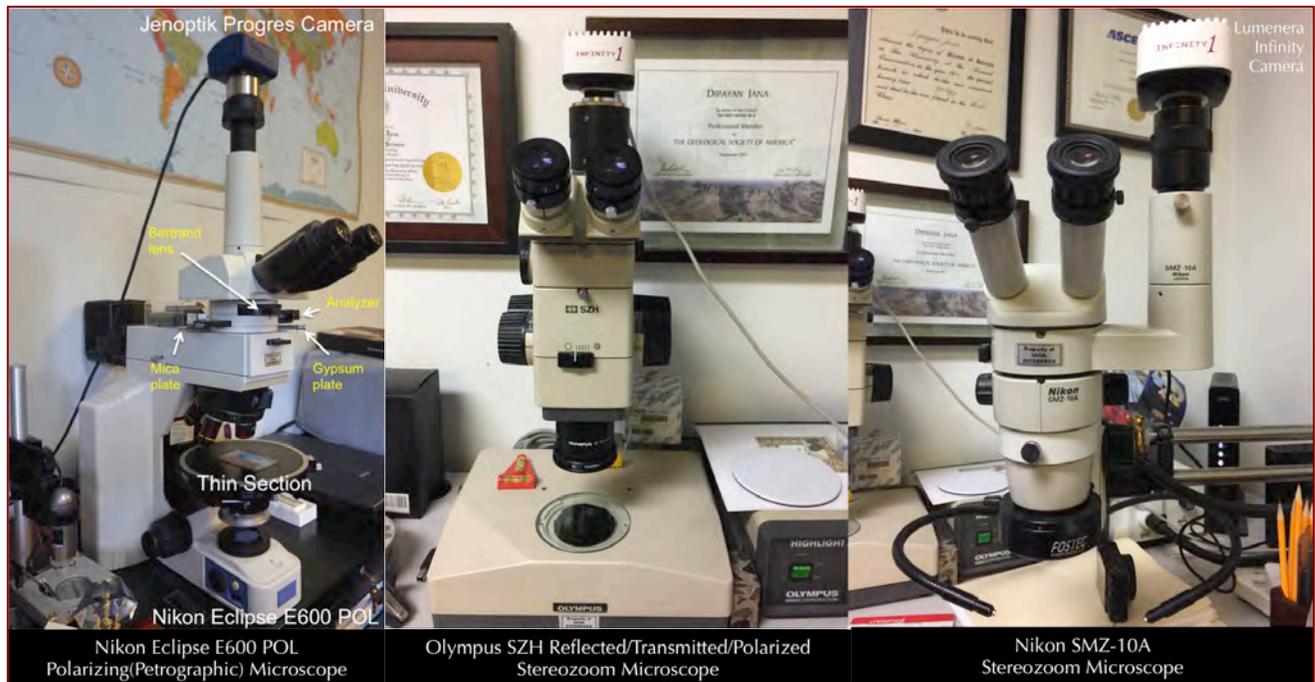
Figure 3: Optical Microscopy: Left - A Nikon Eclipse E600 POL polarizing (petrographic) microscope at left with reflected, transmitted, polarized-light, and fluorescent-light capabilities; Middle – An Olympus SZH reflected/transmitted/polarized-light Stereozoom microscope; and Right – A Nikon SMZ-10A Stereozoom microscope. All microscopes are equipped with Jenoptik Gryphax and Lumenera Infinity digital cameras.

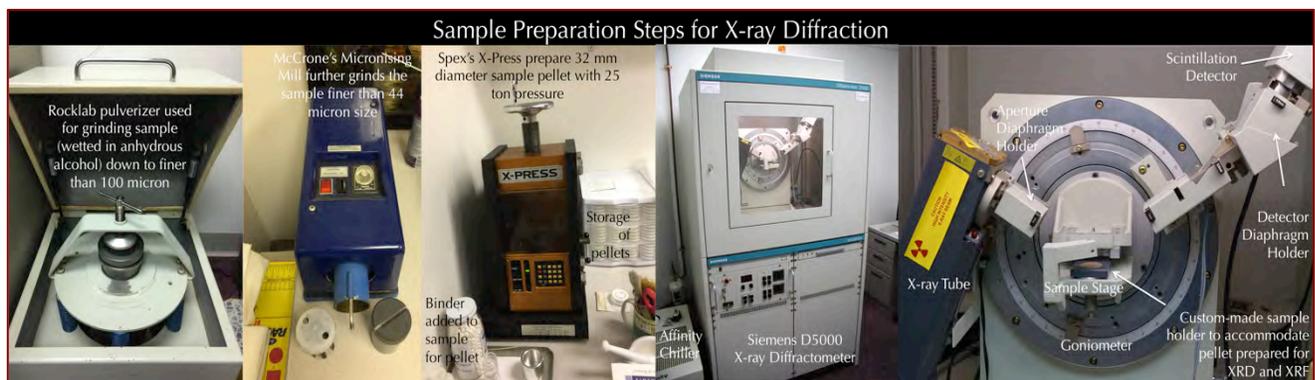
Figure 4: XRD: Siemens D5000 X-ray diffractometer and MDI Jade search/match software used for determination of mineralogical compositions of extracted concrete aggregates. Left to right: Rocklab pulverizer for initial grinding of aggregate with anhydrous alcohol; McCrone micronizing mill for final grinding; Spex 25-ton press for pellet preparation; Siemens D5000 X-ray diffractometer; and custom-made sample holder to place a 32-mm diameter pellet on sample stage.

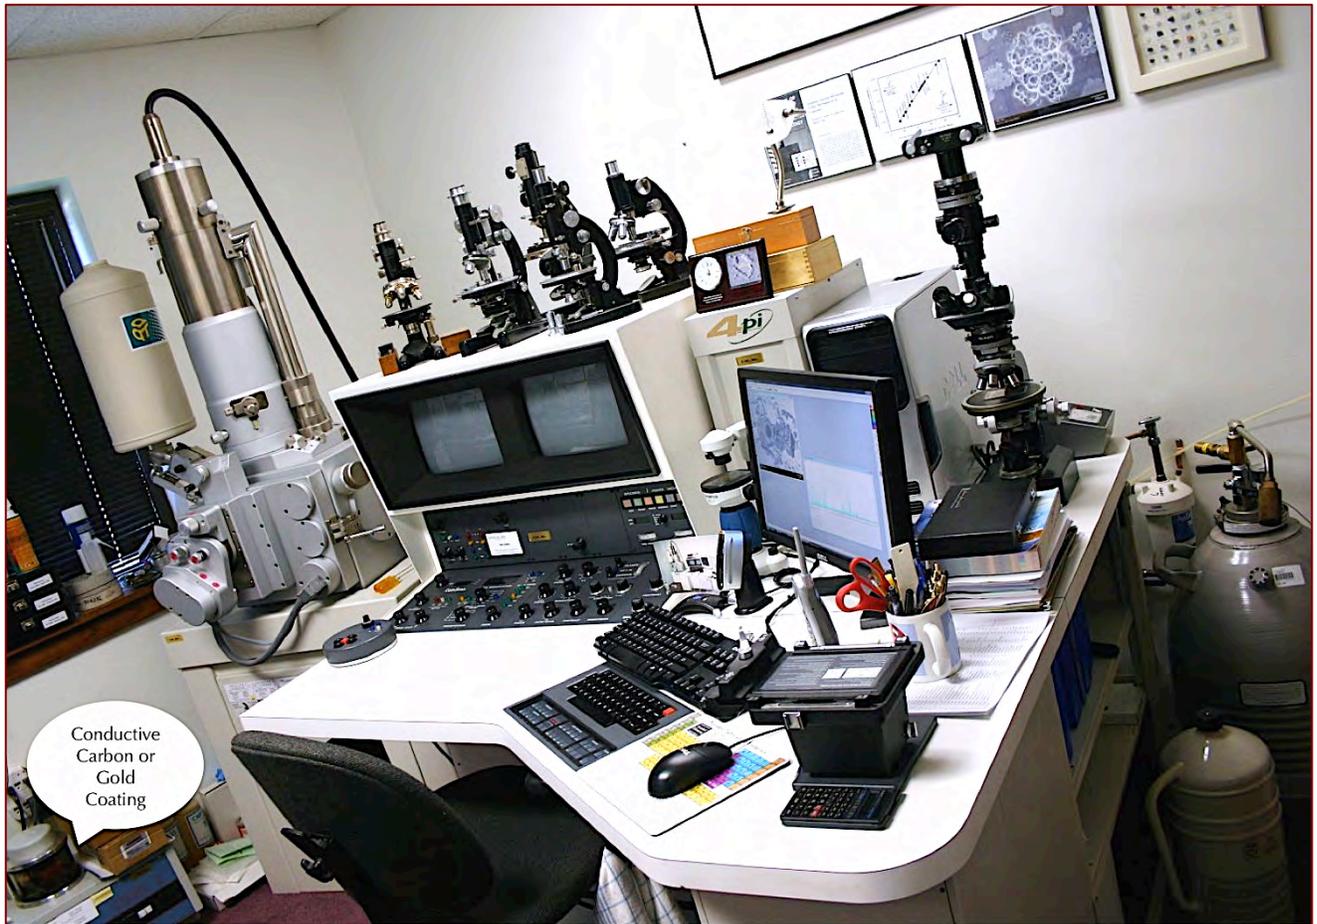
Figure 5: SEM-EDS: Cambridge CamScan Series II Scanning Electron Microscope and 4Pi Revolution software, backscatter detector, secondary electron detector, and energy-dispersive X-ray fluorescence spectrometer used for microstructural and microchemical analyses of concrete and aggregate.

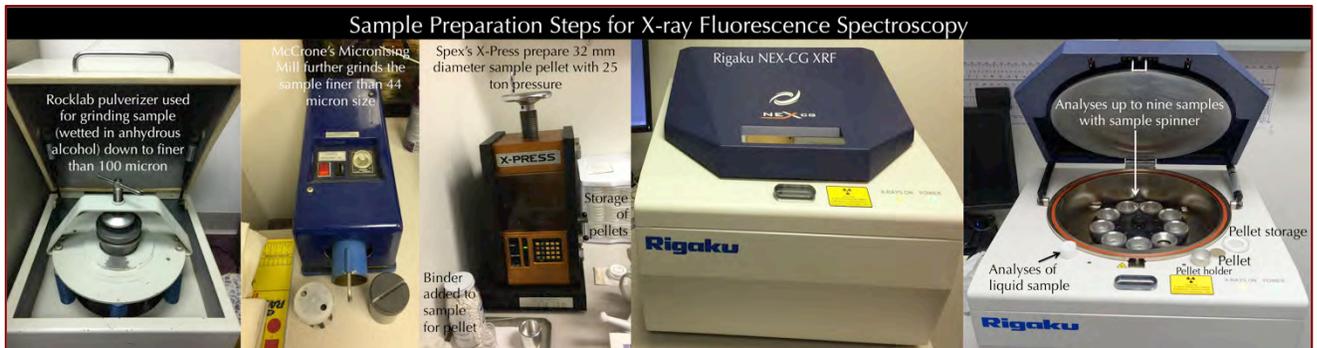
Figure 6: XRF: Rigaku NEX-CG bench-top ED-XRF unit used for bulk chemical compositions of aggregates.

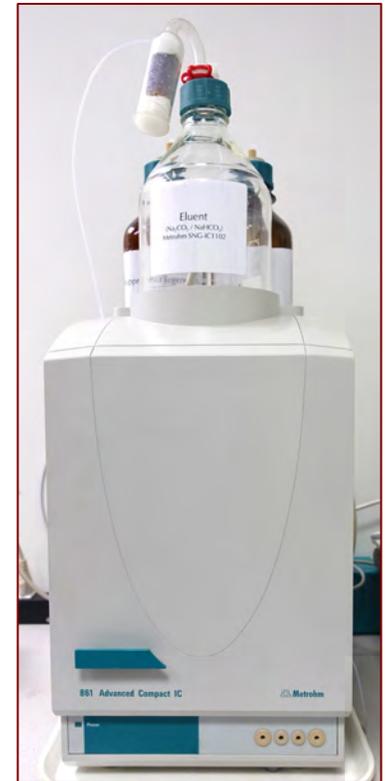
Figure 7: IC: Metrohm 861 Advanced IC used for analysis of sulfate released from aggregate.

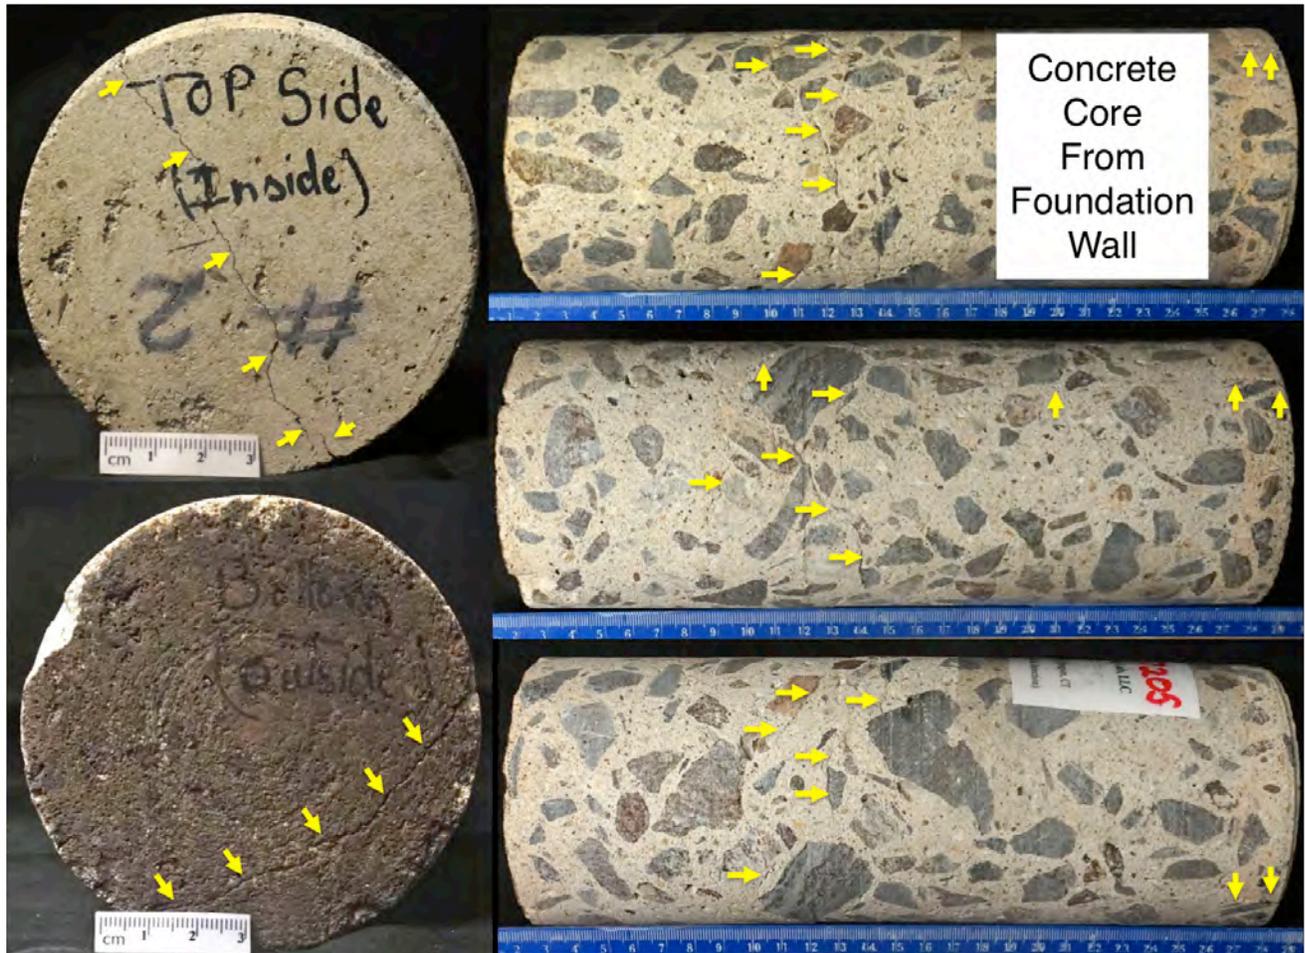
Figure 8: Shown are the formed end surfaces (left), and three cylindrical side views of the core (right), as received. Arrows in the right column indicate major cracks visible on the cylindrical side surfaces of the core, both parallel and perpendicular to the end surfaces. The core was rolled over a flatbed scanner to get three photos of the cylindrical surface.

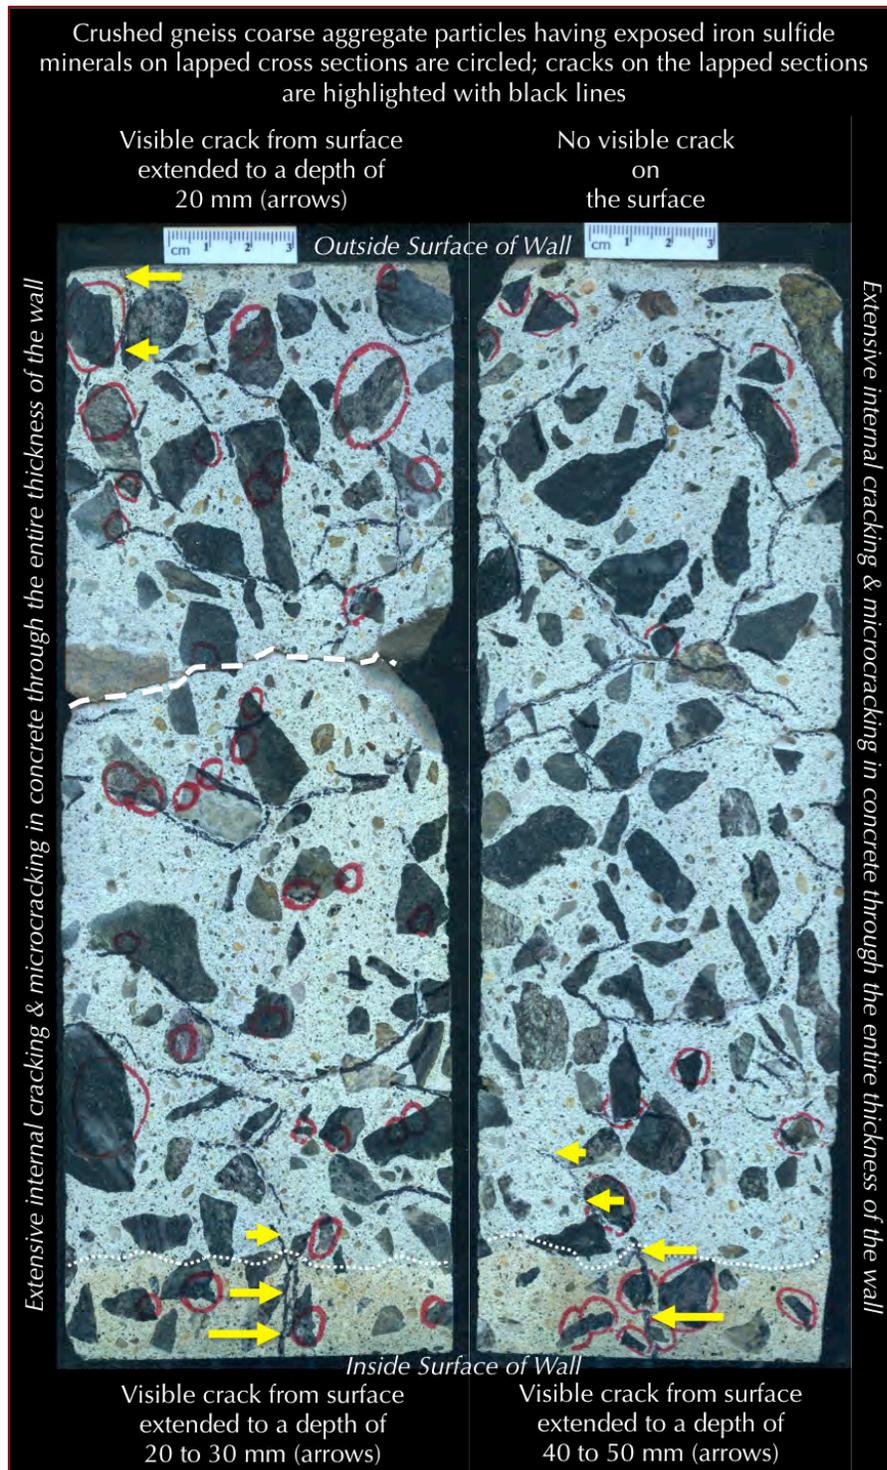
Figure 9: Lapped cross sections of the core showing: (a) extensive cracking all throughout the depth of the core (i.e. thickness of the wall) many of which are highlighted by black lines (see also Figure 10), (b) iron sulfide minerals in crushed stone coarse aggregate particles that show characteristic metallic luster, many of which are circled in red, (c) beige discoloration of concrete at the exposed surface ends due to atmospheric carbonation (white dotted line shows depth of advancement of carbonation into concrete), (d) visible surface cracking from both ends of the core (wall) that have extended to depths of 20 to 40 mm (marked by arrows at the ends), (e) a major crack at the middle probably formed from a pre-existing crack during coring and sectioning, and (f) the good grading and well-distribution of the crushed stone coarse aggregate particles.

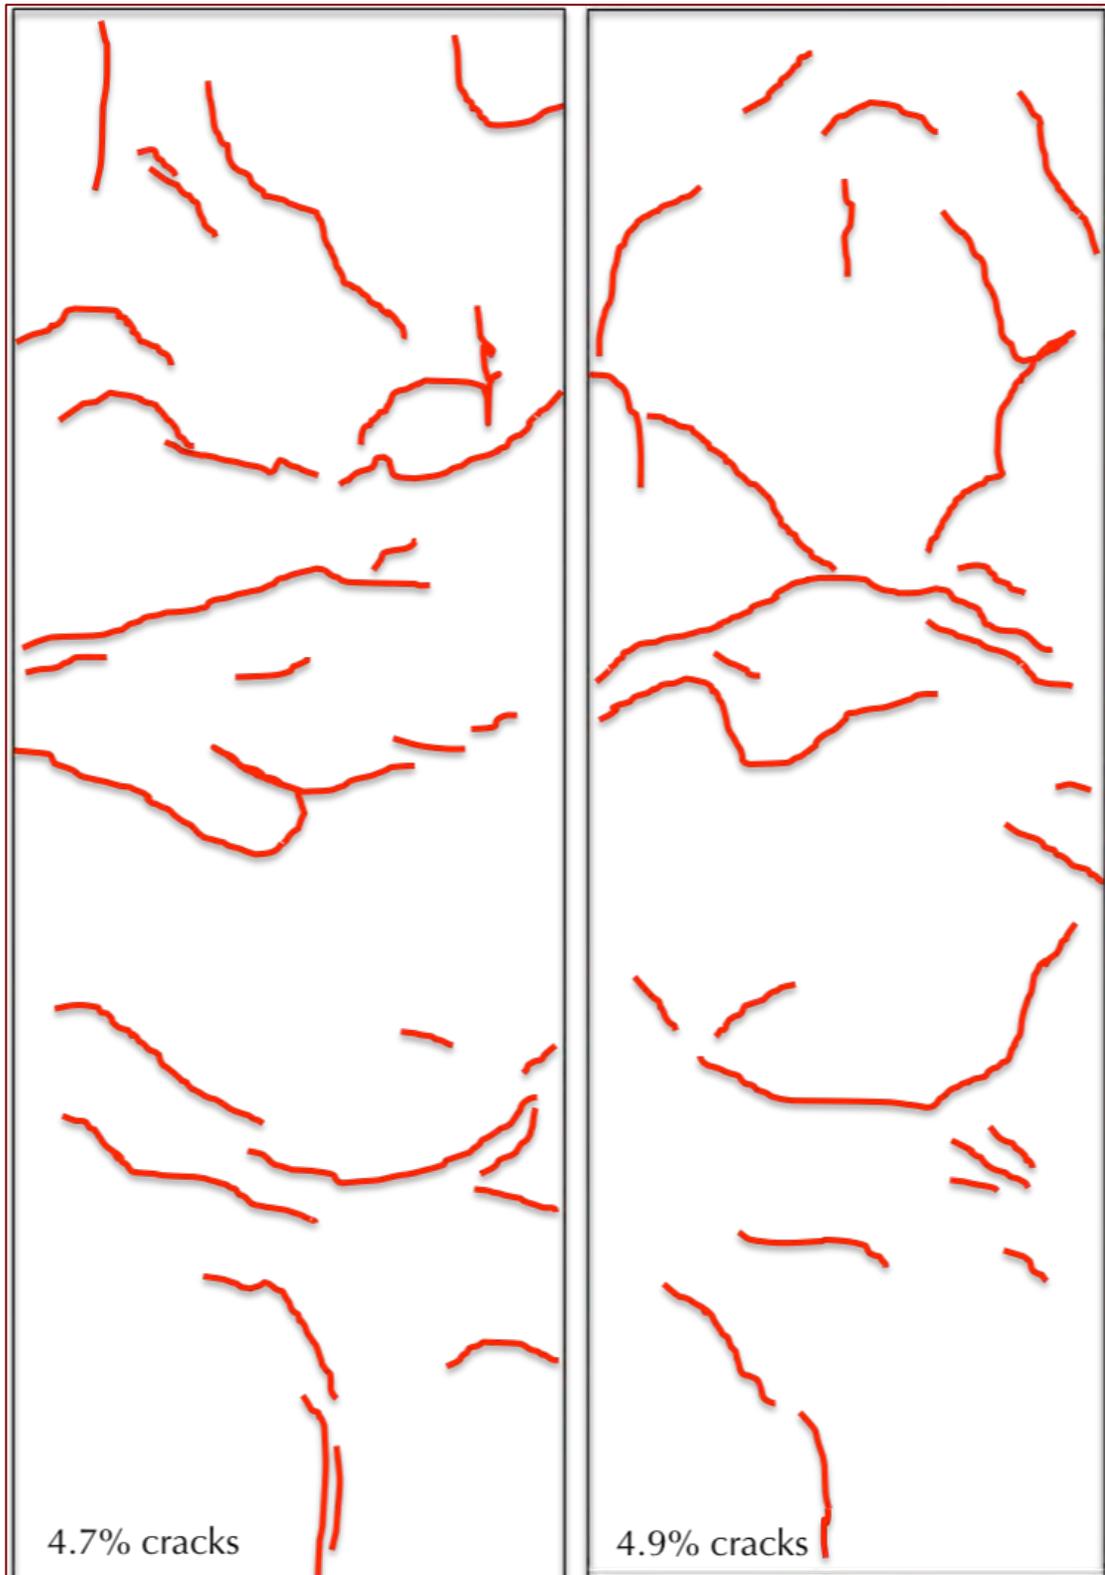
Figure 10: Crack traces and approximate crack volumes (calculated from ImageJ) on lapped cross sections of core from Figure 9 where cracks traced in black ink on the lapped sections are highlighted in this Figure in red. Individual cracks were first identified with the help of a Stereozoom microscope and traced on the lapped surface in black ink pen while examining under the microscope, thereafter cracks were re-marked in red for this Figure.

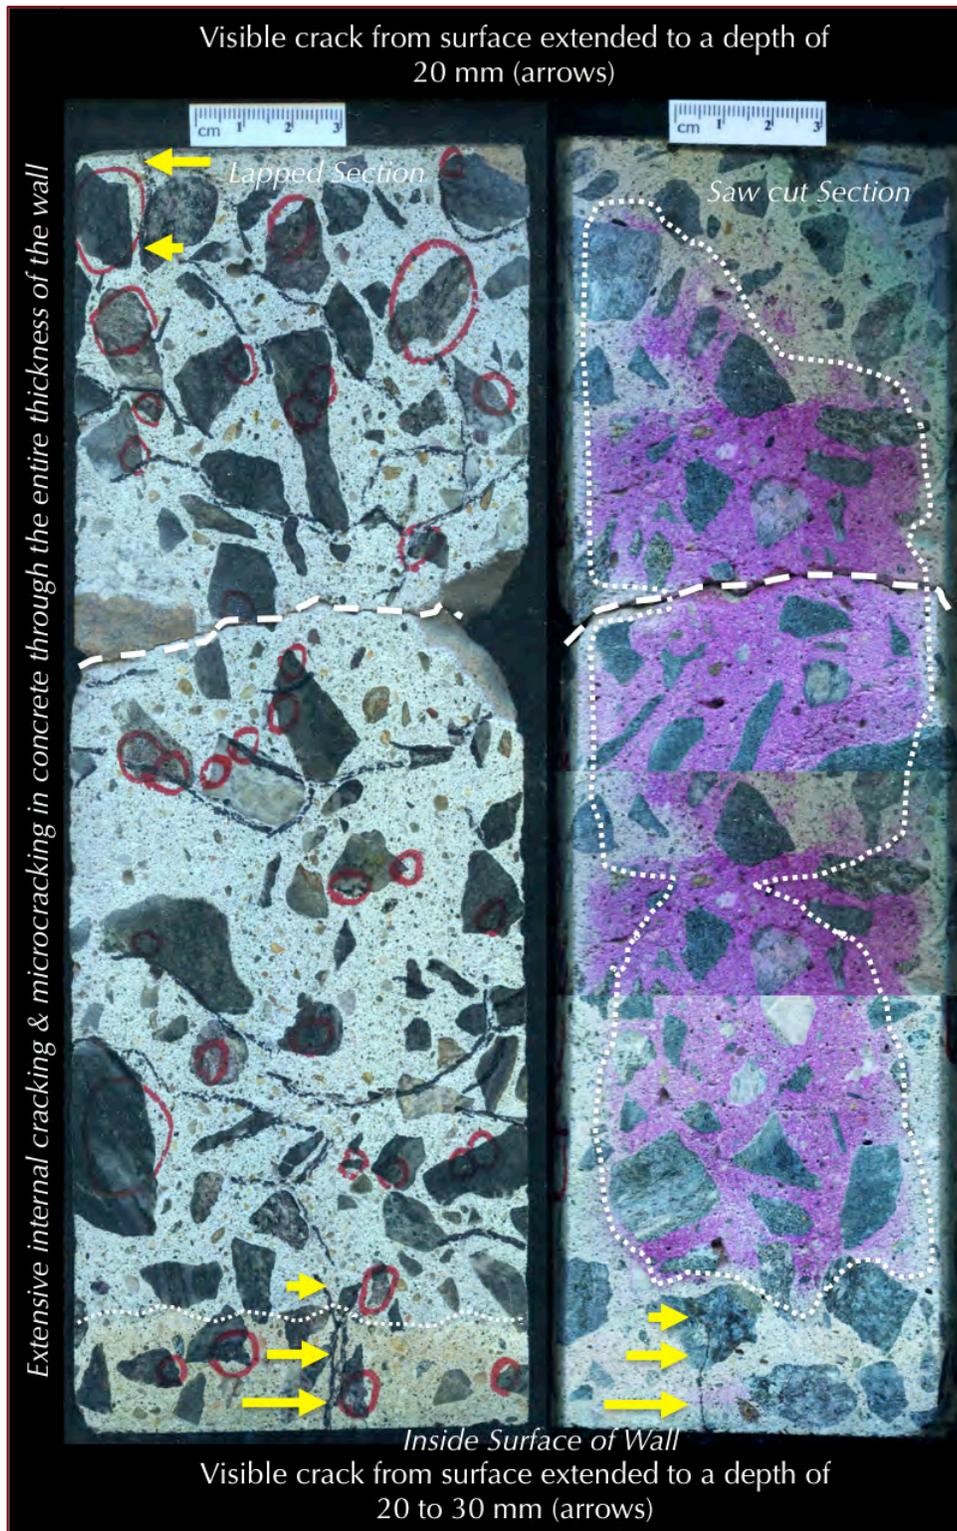
Figure 11: Lapped cross sections of the core showing the same features found in the previous Figure (in the left column), and corresponding extent of carbonation on the opposite saw-cut section after treatment with phenolphthalein alcoholic solution where carbonated portion remains colorless whereas non-carbonated interior turned pink (mostly within the dotted lines). Enclosed within red circles in the left column are iron sulfide minerals detected in crushed stone coarse aggregate particles; many visible cracks are traced in black ink.

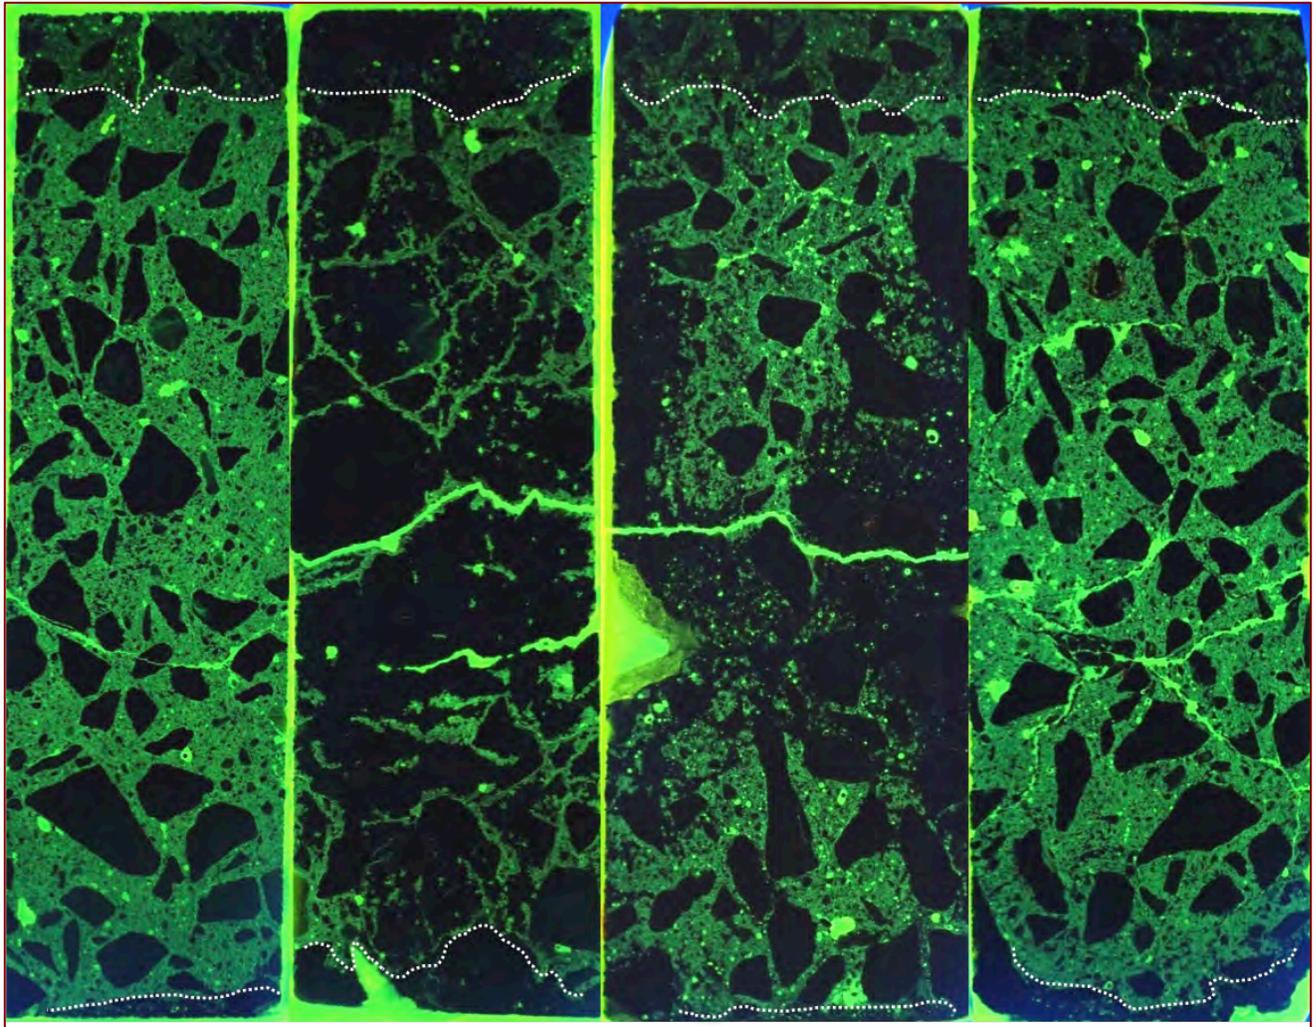
Figure 12: Lapped cross sections of core after treatment with a fluorescent dye-mixed epoxy and viewed in a short wavelength ultraviolet light in a dark room where cracks, air-voids, and open spaces and porous areas of concrete are highlighted in green to greenish-yellow (latter mostly in cracks and voids) as opposed to darker toned denser areas.

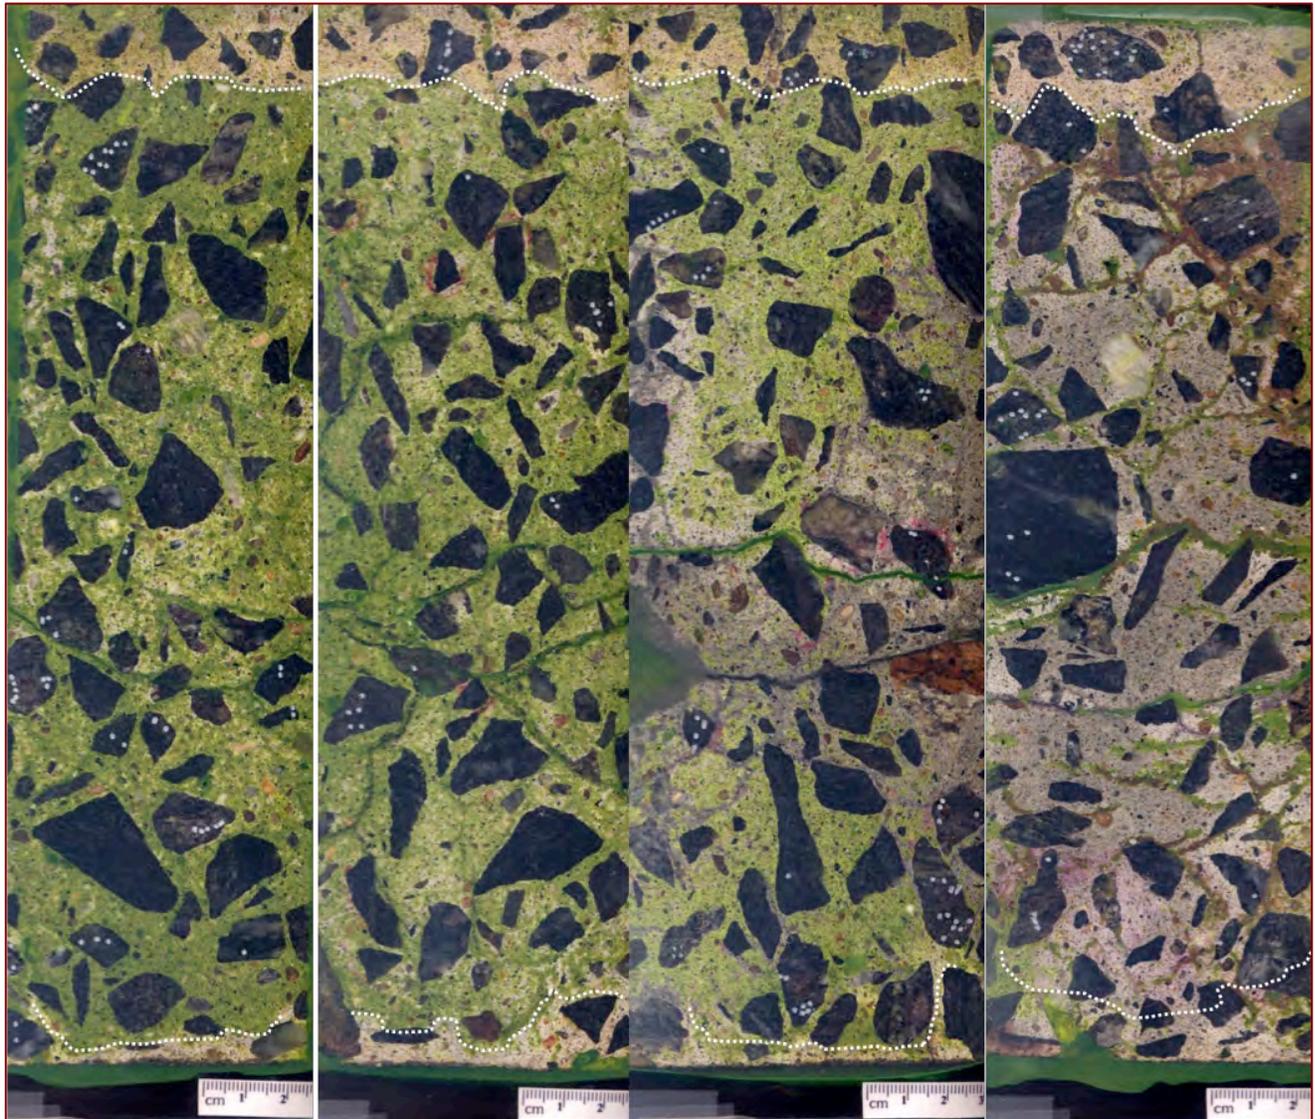
Figure 13: Lapped cross sections of core after treatment with a fluorescent dye-mixed epoxy and scanned on a flatbed scanner. Shown in this Figure are the amount and distribution of iron sulfide (pyrrhotite) inclusions in crushed stone coarse aggregate where individual pyrrhotite grains are highlighted with a small silver 'dot.' Pyrrhotite-bearing aggregate particles are highlighted in red circles in Figure 9, but in this Figure they are first detected with the help of a stereo-microscope and then highlighted with a silver marker pen.

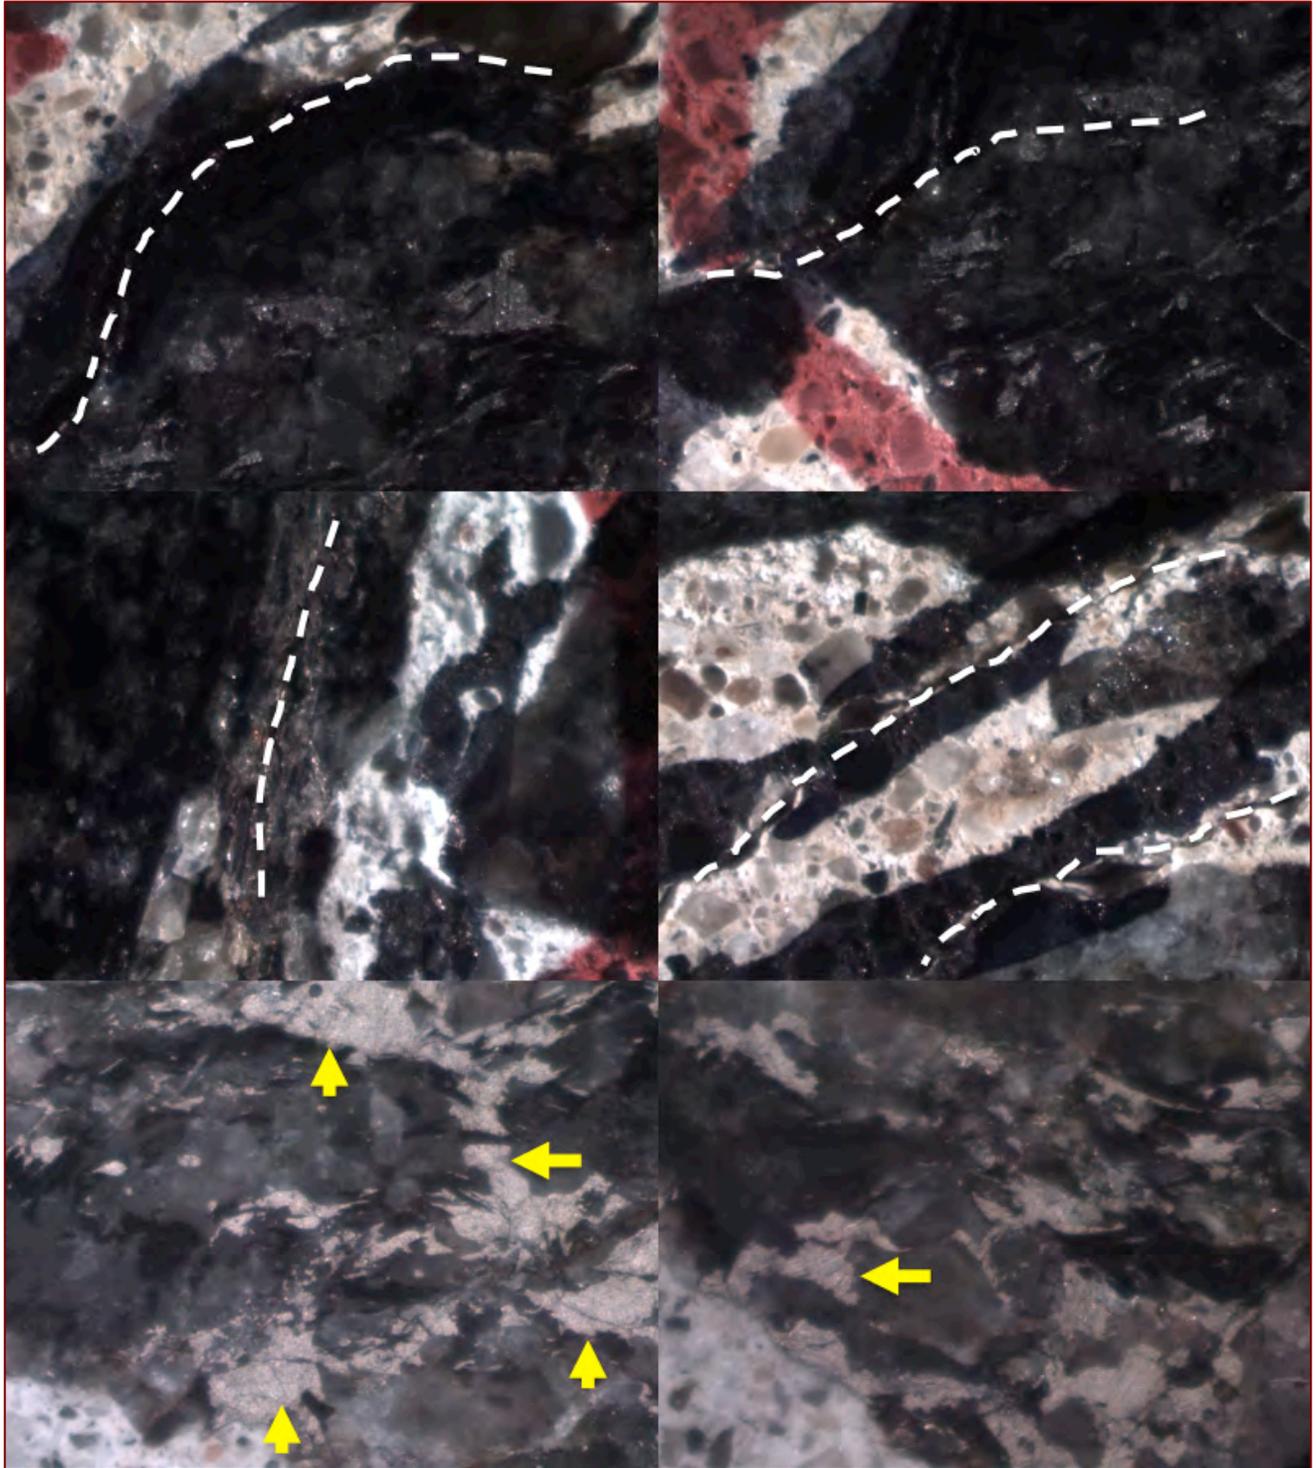
Figure 14: Photomicrographs of lapped cross section of core showing some iron sulfide minerals within crushed gneiss coarse aggregate particles that are identified by characteristic golden yellow metallic luster (some are marked with arrows), and some visible cracking in coarse aggregates (white dashed lines). Field width of each photo is 9 mm.

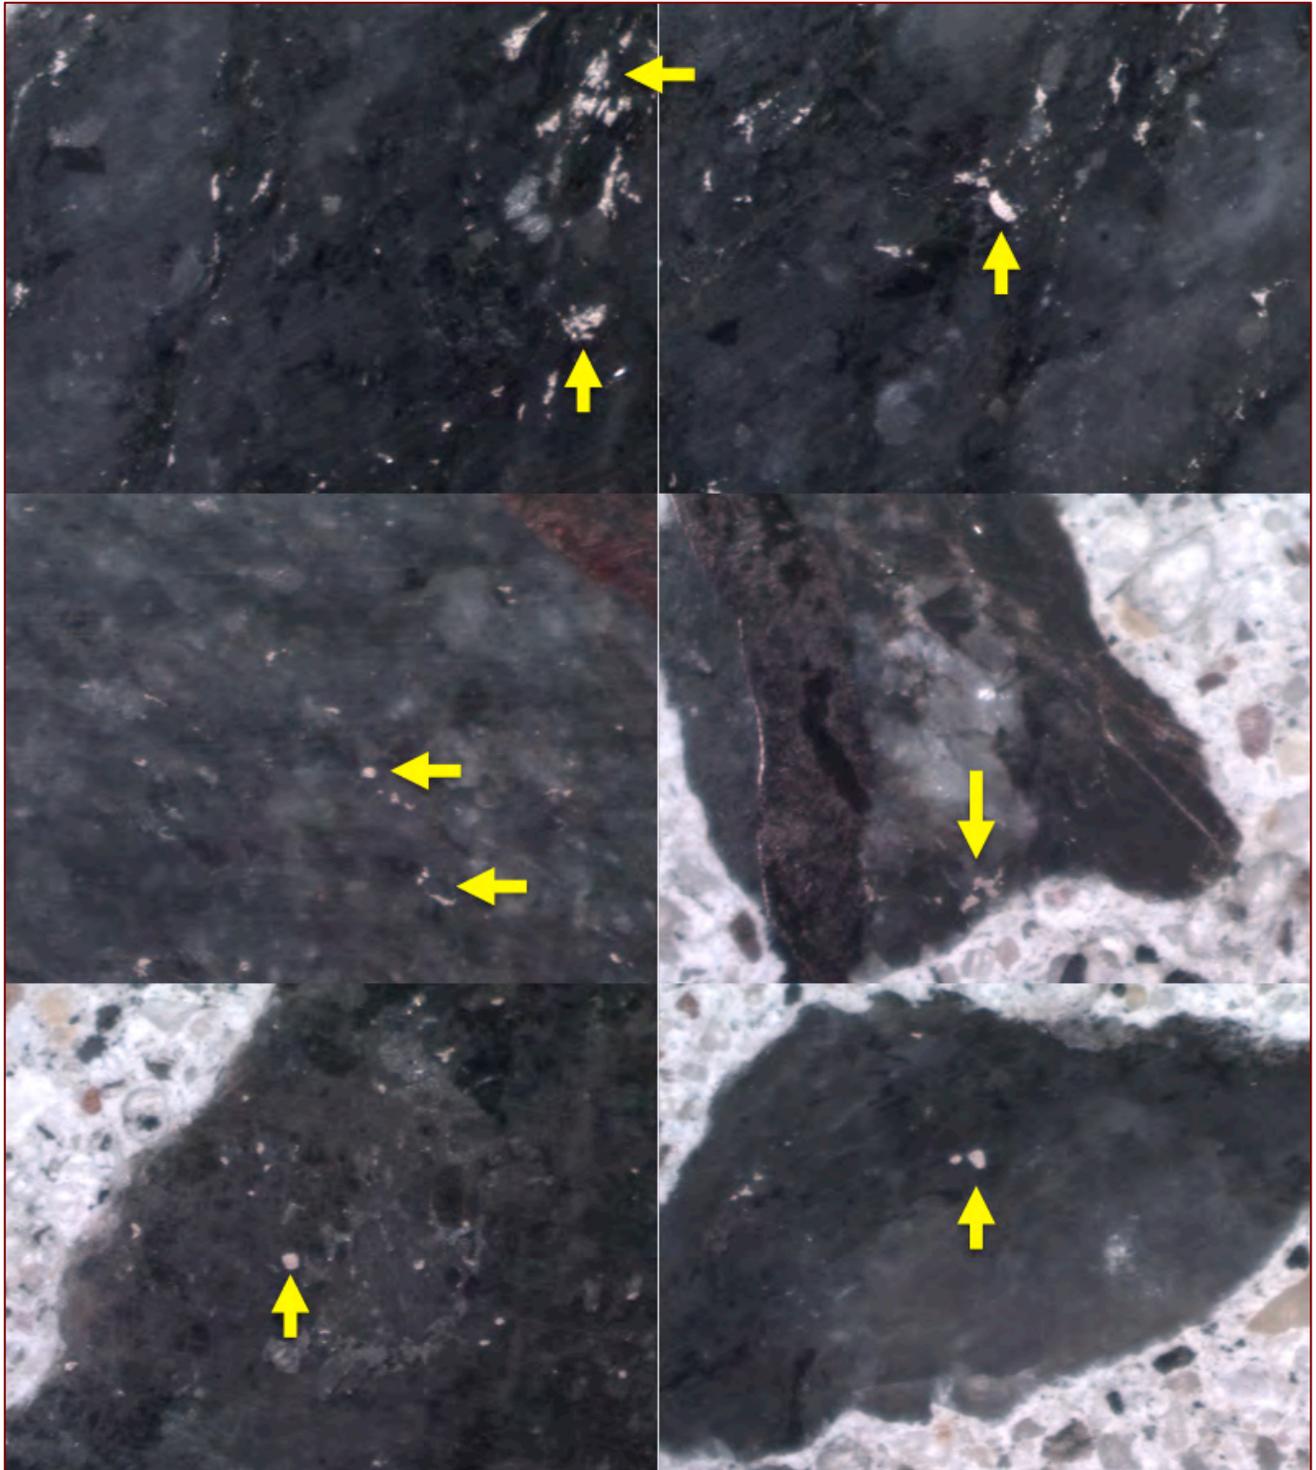
Figure 15: Photomicrographs of lapped cross section of core showing some iron sulfide minerals within crushed gneiss coarse aggregate particles that are identified by characteristic golden yellow metallic luster (some are marked with arrows). Field width of each photo is 9 mm. Amount of pyrrhotite is estimated to be 0.4 to 2.4 percent by volume of individual aggregate particles on lapped cross section (calculated by Image J).

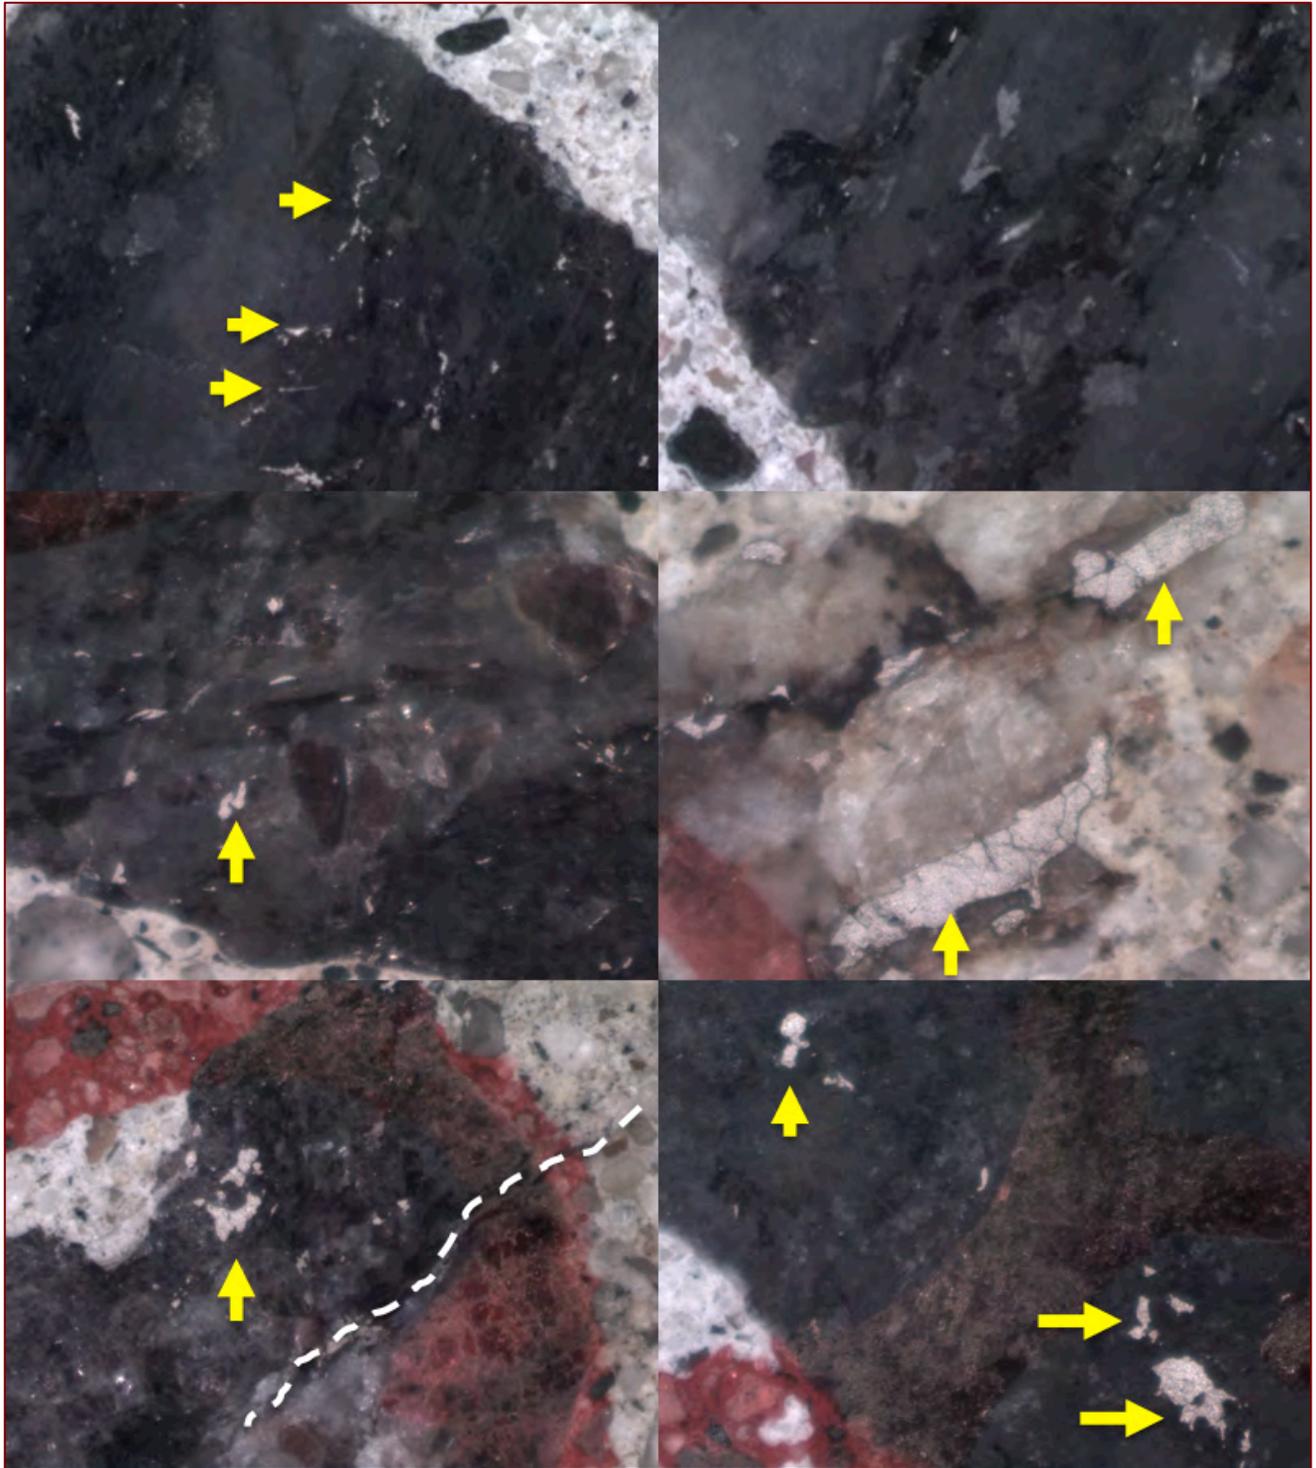
Figure 16: Photomicrographs of lapped cross section of core showing some iron sulfide minerals within crushed gneiss coarse aggregate particles that are identified by characteristic golden yellow metallic luster (some are marked with arrows), and some visible cracking in coarse aggregates (white dashed lines). Field width of each photo is 9 mm.

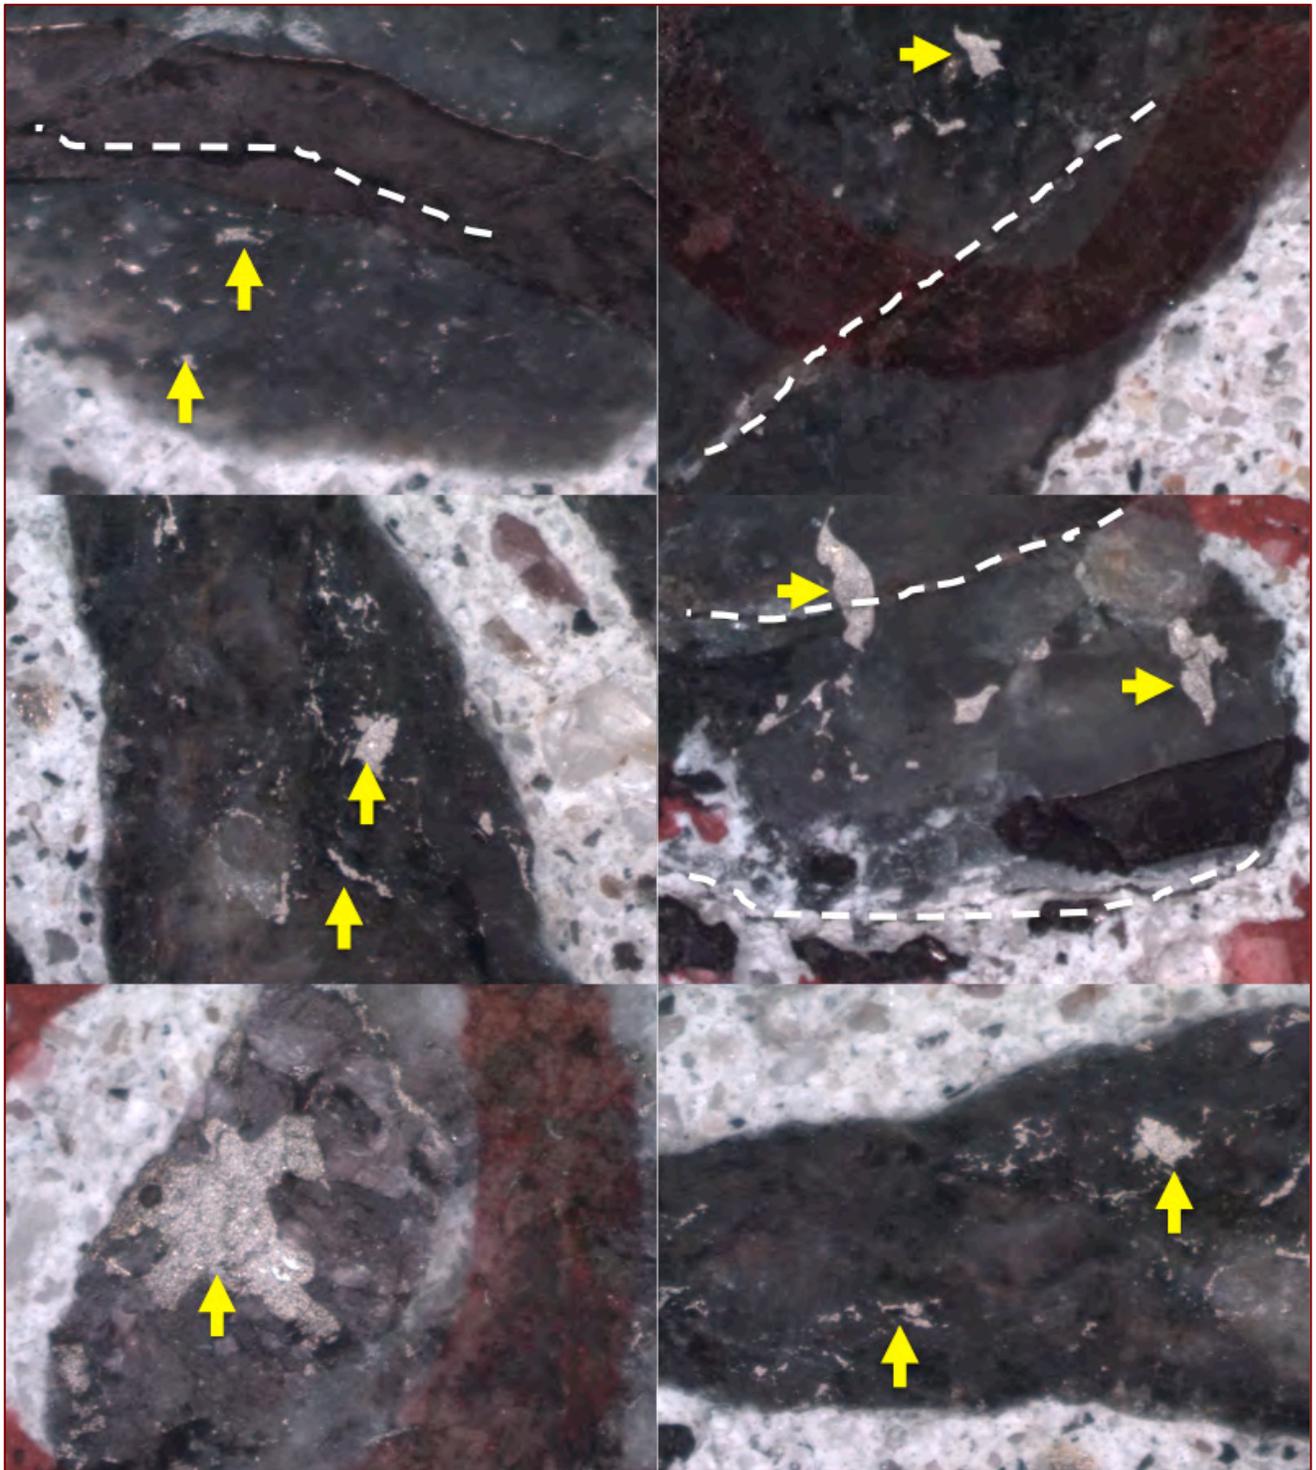
Figure 17: Photomicrographs of lapped cross section of core showing some iron sulfide minerals within crushed gneiss coarse aggregate particles that are identified by characteristic golden yellow metallic luster (some are marked with arrows), and some visible cracking in coarse aggregates (white dashed lines). Field width of each photo is 9 mm. Amount of pyrrhotite is estimated to be 0.4 to 2.4 percent by volume of individual aggregate.
