Pyrrhotite Epidemic in Eastern Connecticut – A Case Study From Ellington, CT

Cracking & Crumbling of A Residential Concrete Foundation In
Ellington, Connecticut

January 2018
CMC Interim Report

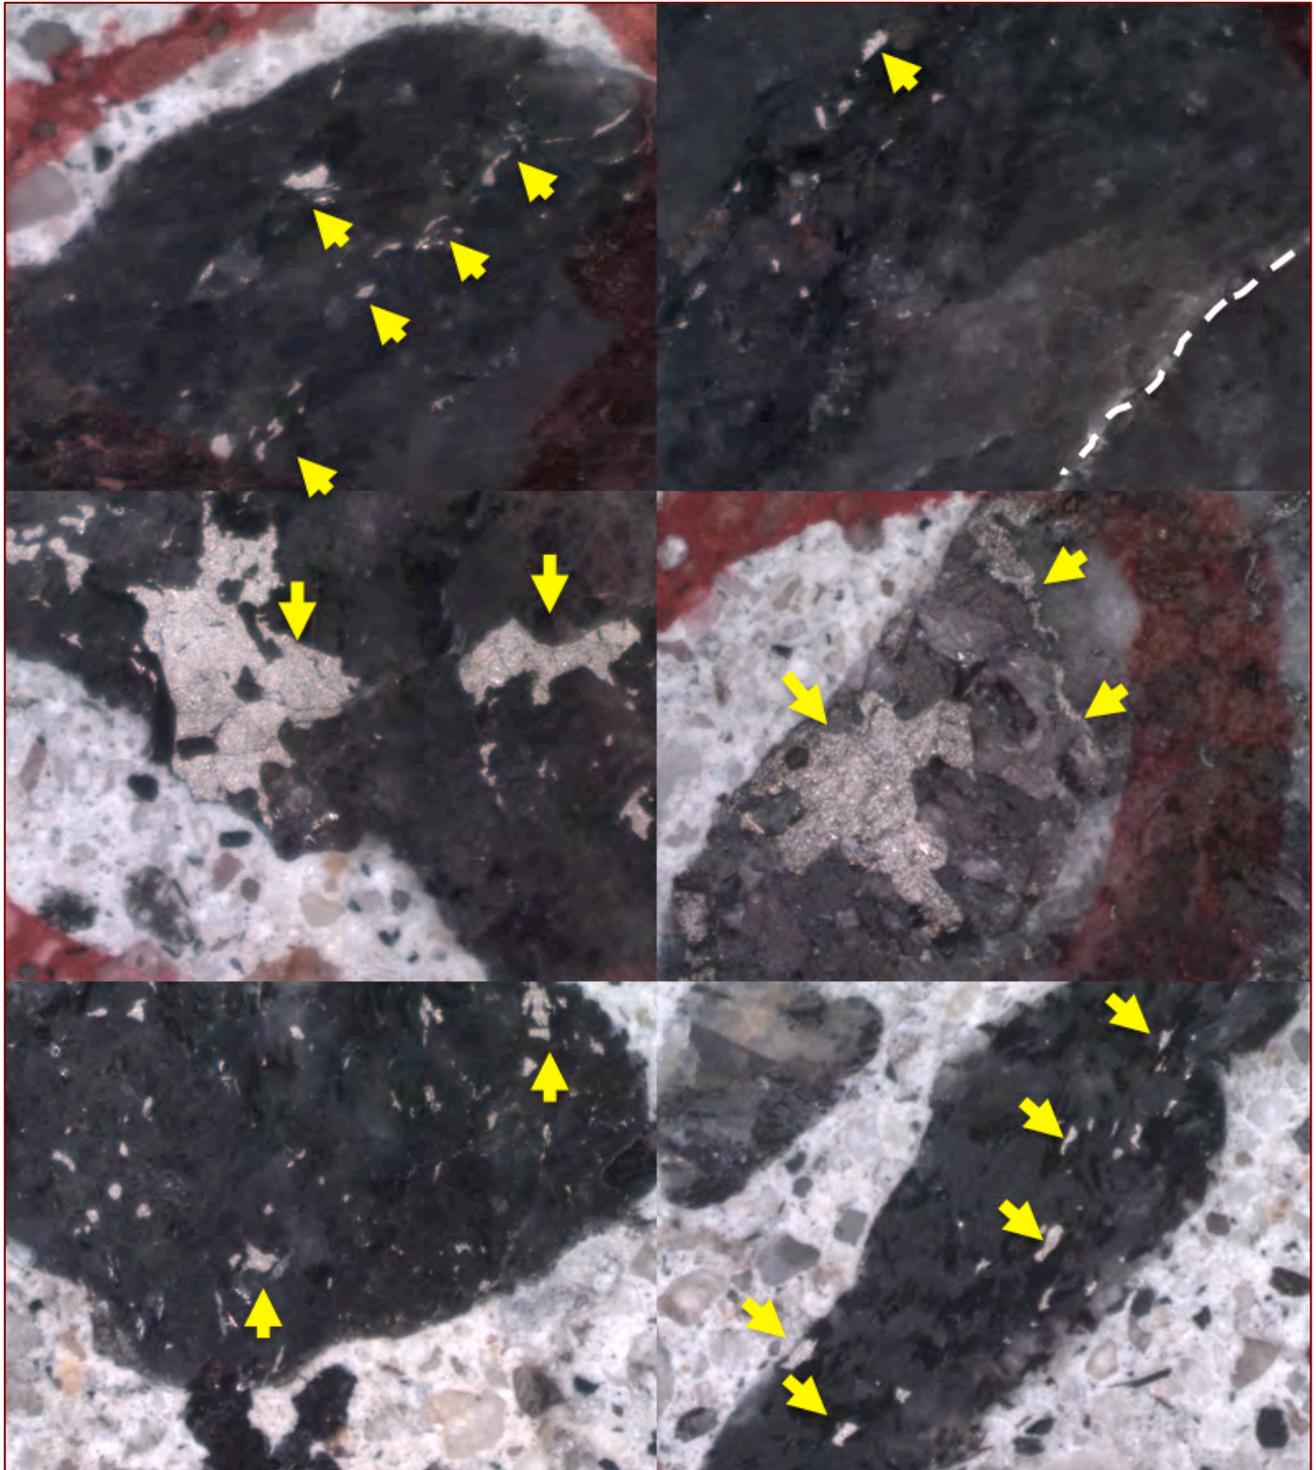
Figure 18: Photomicrographs of lapped cross section of core showing some iron sulfide minerals within crushed gneiss coarse aggregate particles that are identified by characteristic golden yellow metallic luster (some are marked with arrows), and some visible cracking in coarse aggregates (white dashed lines). Field width of each photo is 9 mm. Amount of pyrrhotite is estimated to be 0.4 to 2.4 percent by volume of individual aggregate.

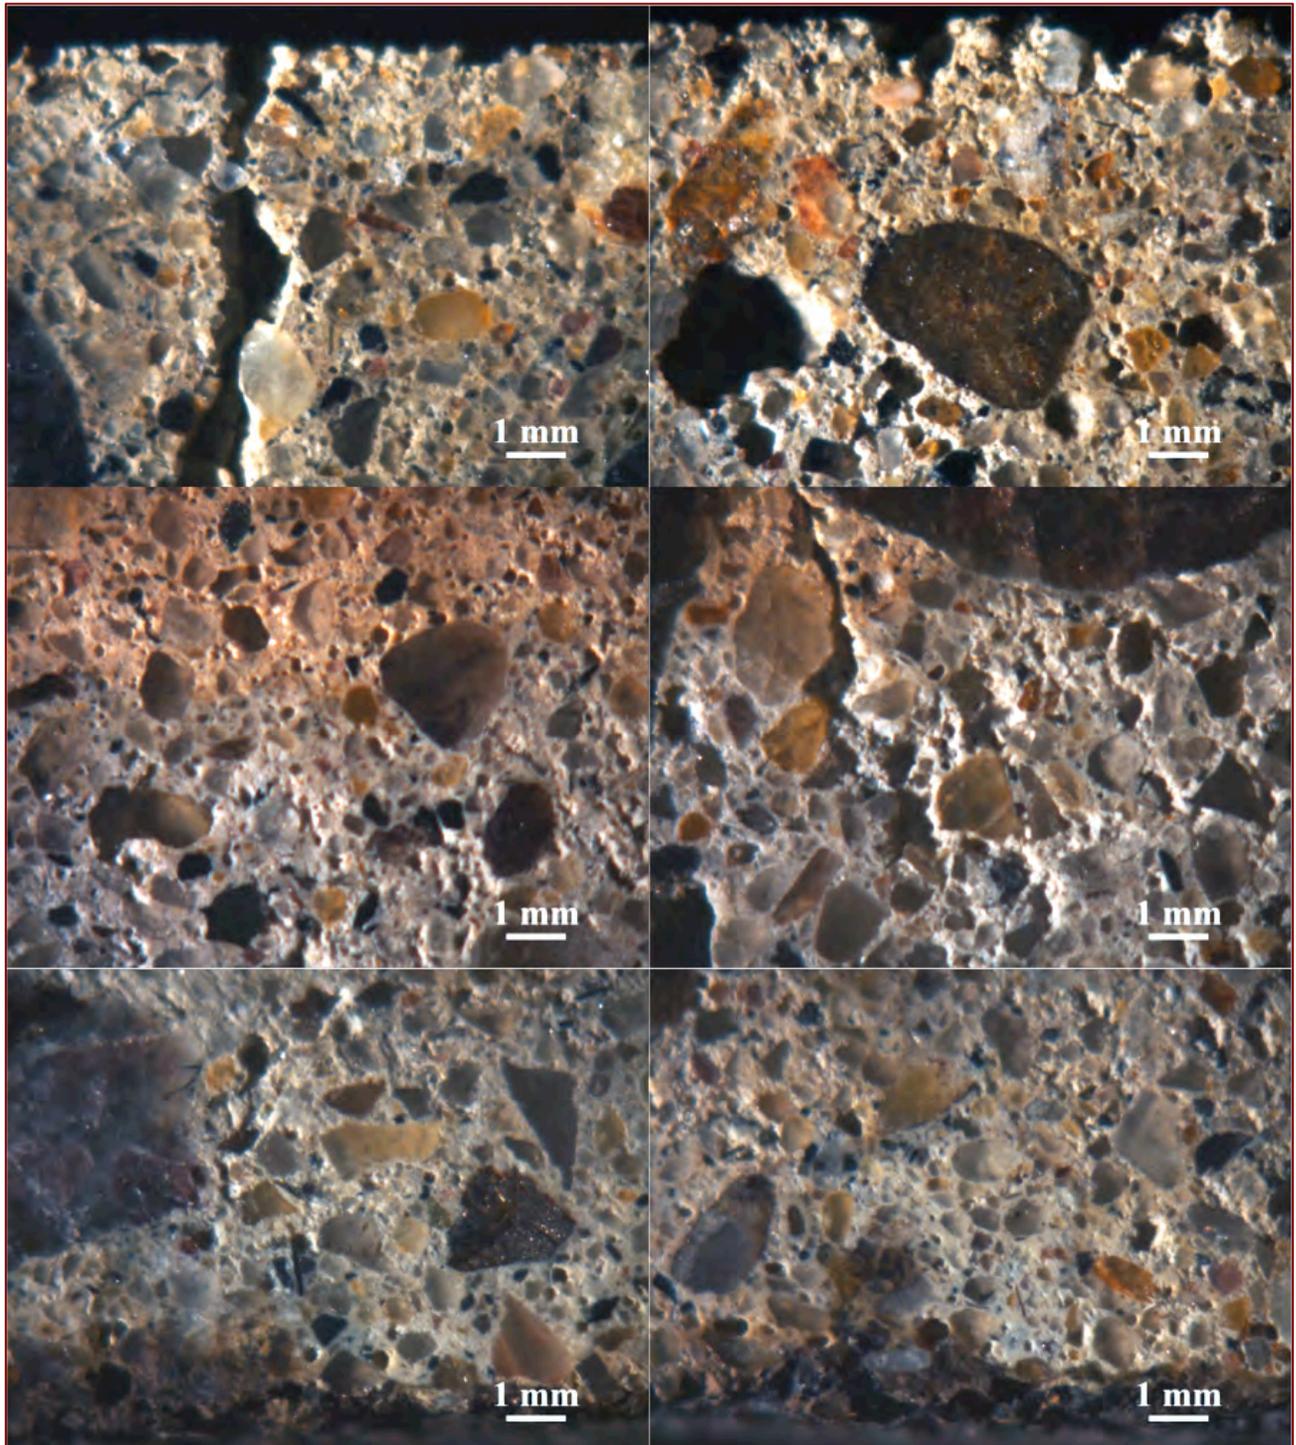
Figure 19: Photomicrographs of lapped cross section showing the air-entrained nature of concrete and many fine to coarse spherical and irregularly-shaped air-voids. Beige-toned paste areas are carbonated.

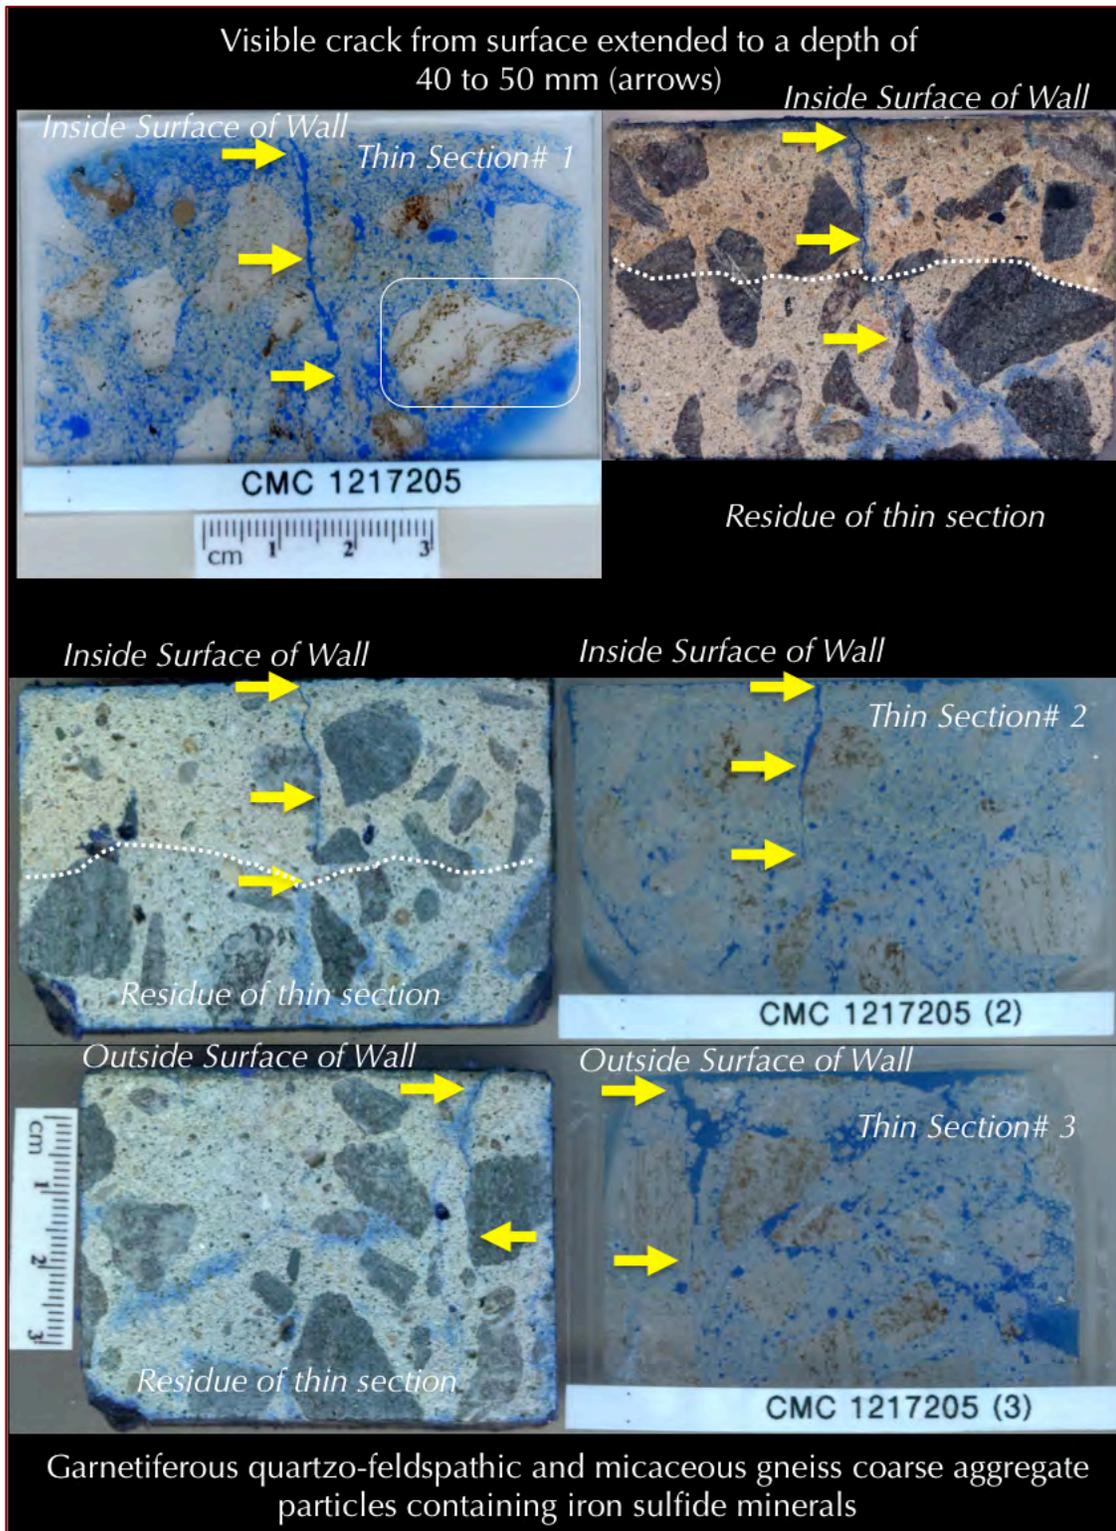
Figure 20: Blue dye-mixed epoxy-impregnated thin sections (30 micron thickness) of the core taken from inside and outside surfaces of the wall showing extension of visible map cracking from the opposite surfaces of the wall to the interior concrete (arrows) as well as depths of carbonation (marked as white dotted lines) and other cracks in concrete that are highlighted by the blue epoxy. The boxed coarse aggregate particle in the top thin section clearly shows alternate banding of light-colored quartzo-feldspathic and dark brown colored biotite bands defining the gneissose texture common in these crushed gneiss coarse aggregate particles.

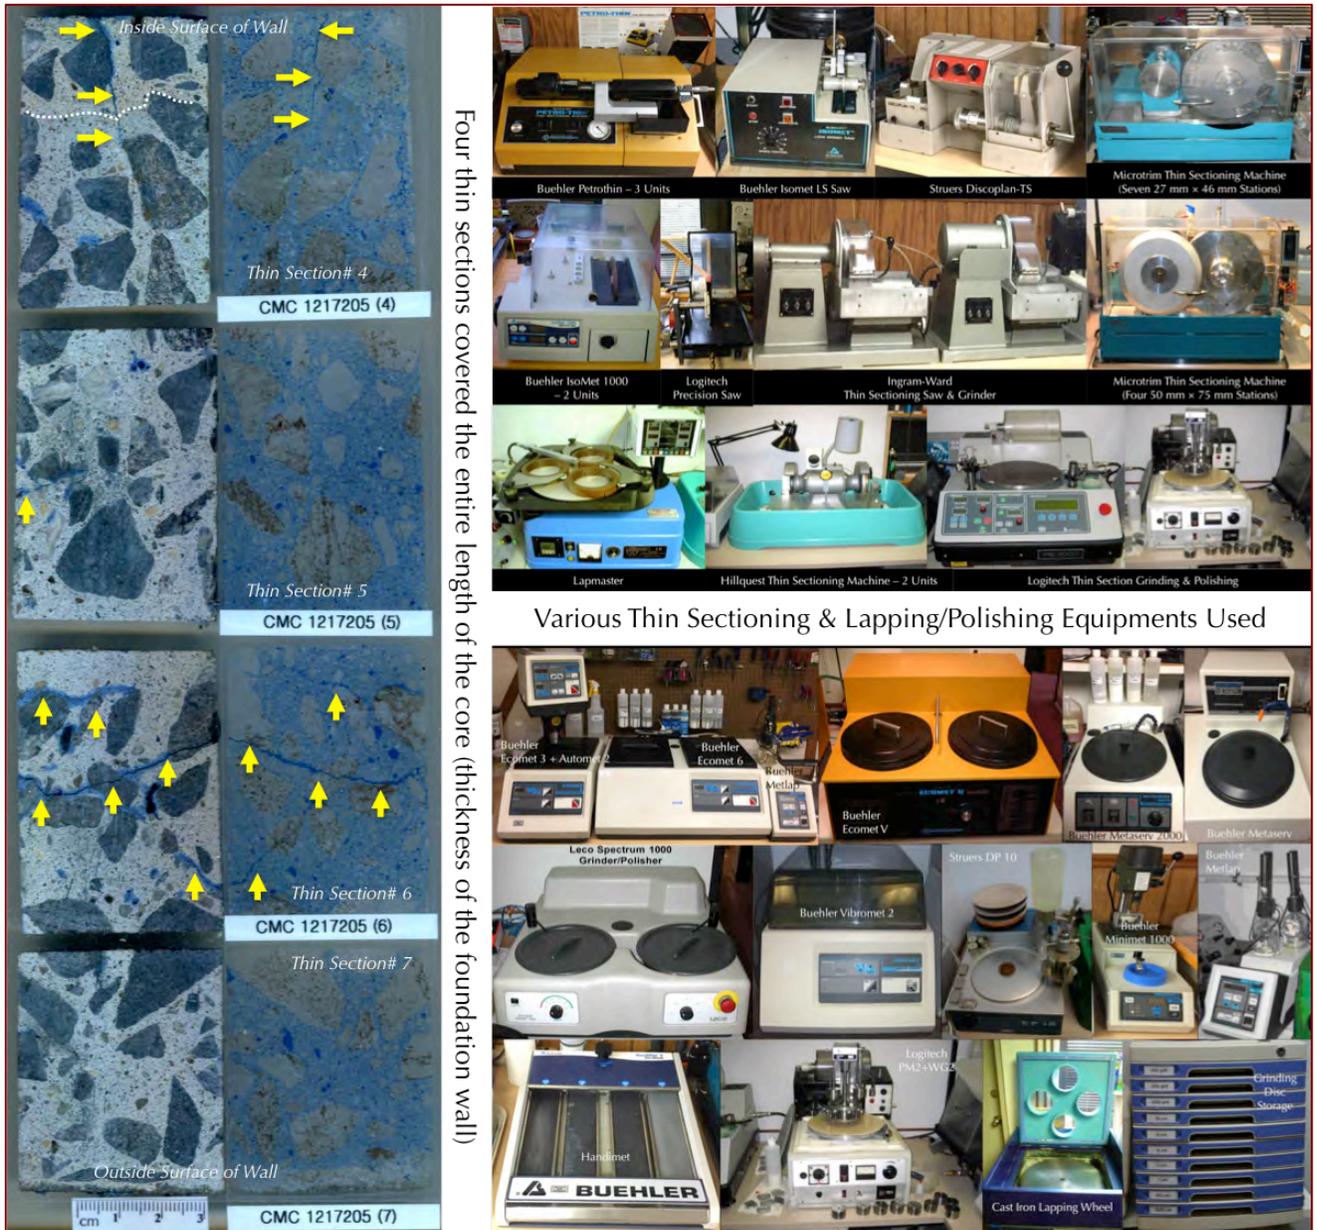
Figure 21: Four additional blue dye-mixed epoxy-impregnated thin sections (right column, 30 micron thickness) and corresponding residues left from thin sections (left column) from a full-depth cross section of the core taken from the inside through depth to the outside surface of the core/wall showing extension of visible map cracking from the opposite surfaces of the wall to the interior concrete (arrows) as well as depths of carbonation (marked as white dotted lines) and other cracks in concrete that are highlighted by the blue epoxy.

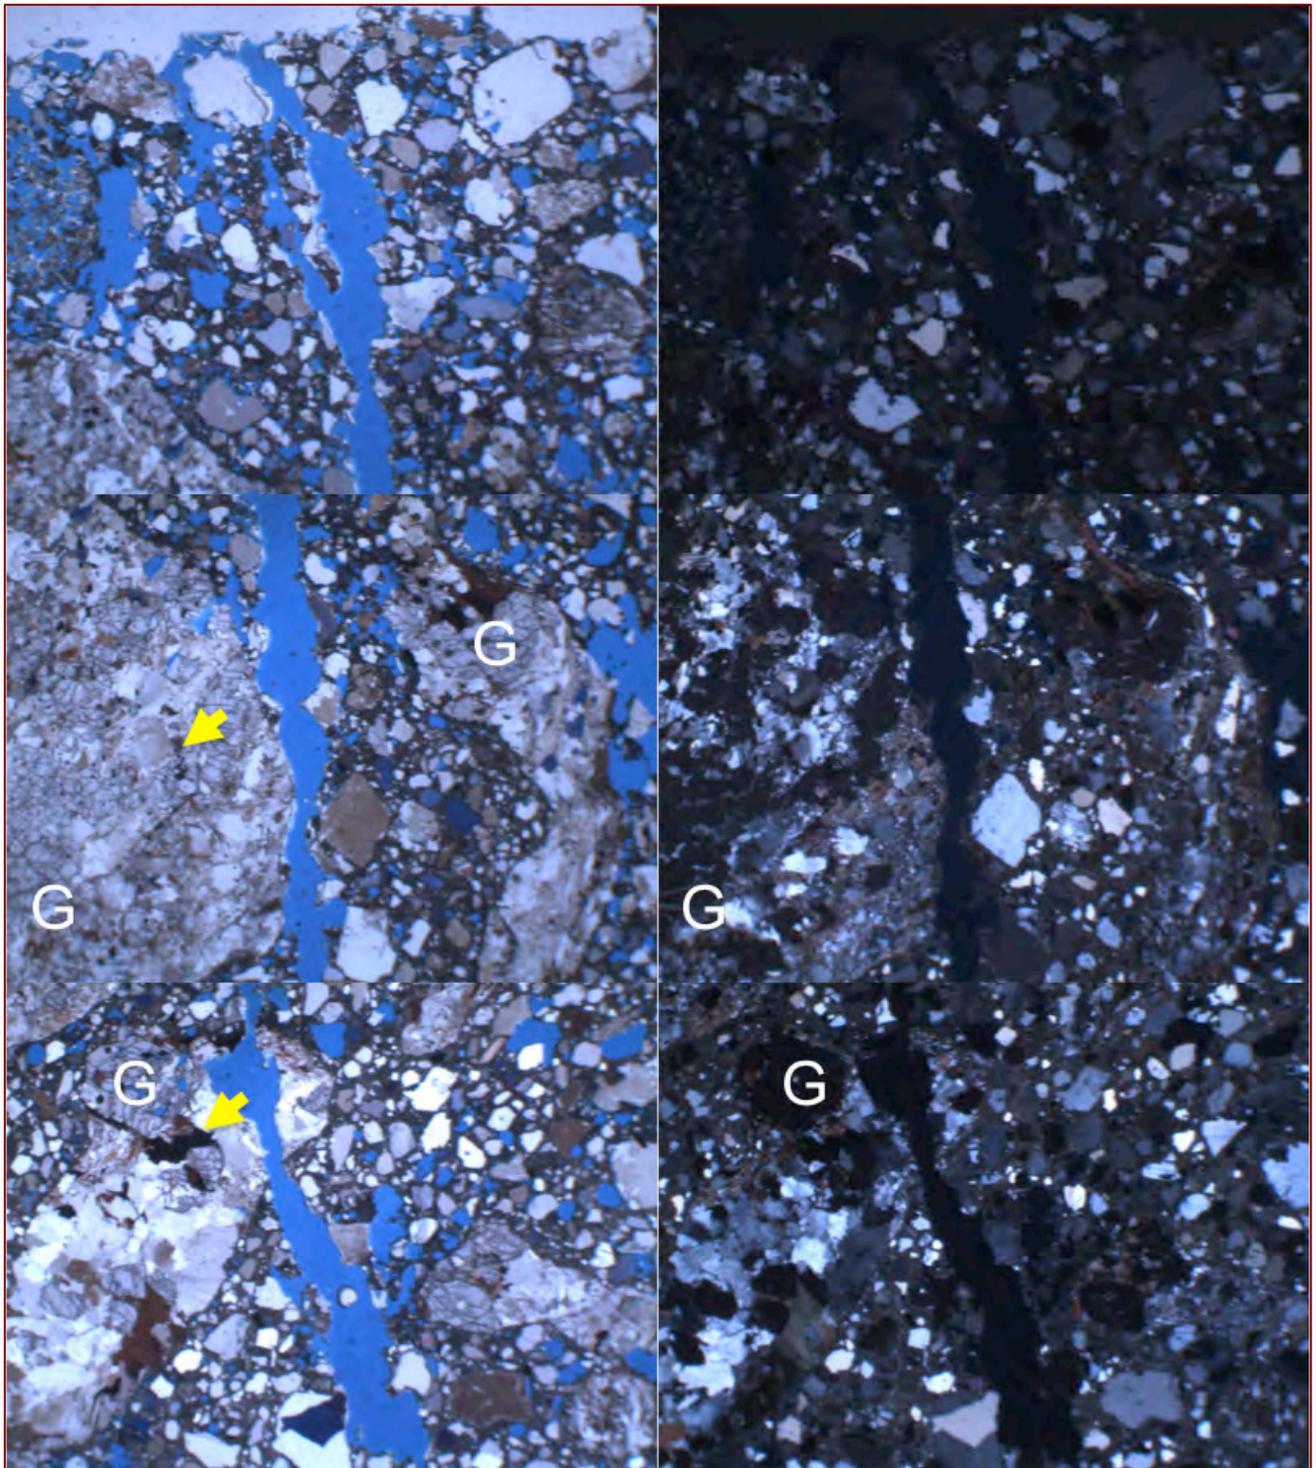
Figure 22: Photomicrographs of blue dye-mixed epoxy-impregnated Thin section (#1) of concrete showing: (a) visible cracking highlighted by blue epoxy, (b) garnetiferous gneiss crushed stone coarse aggregate having alternating bands of quartzo-feldspathic and micaceous minerals (some garnet grains are marked in 'G' that are optically isotropic), and siliceous sand fine aggregate. Left column photos were taken in PPL and right column ones in corresponding XPL modes in a transmitted-light stereo-zoom microscope. A few dark opaque iron sulfide and oxide are marked with yellow arrows. Field width of each photo is 12 mm.

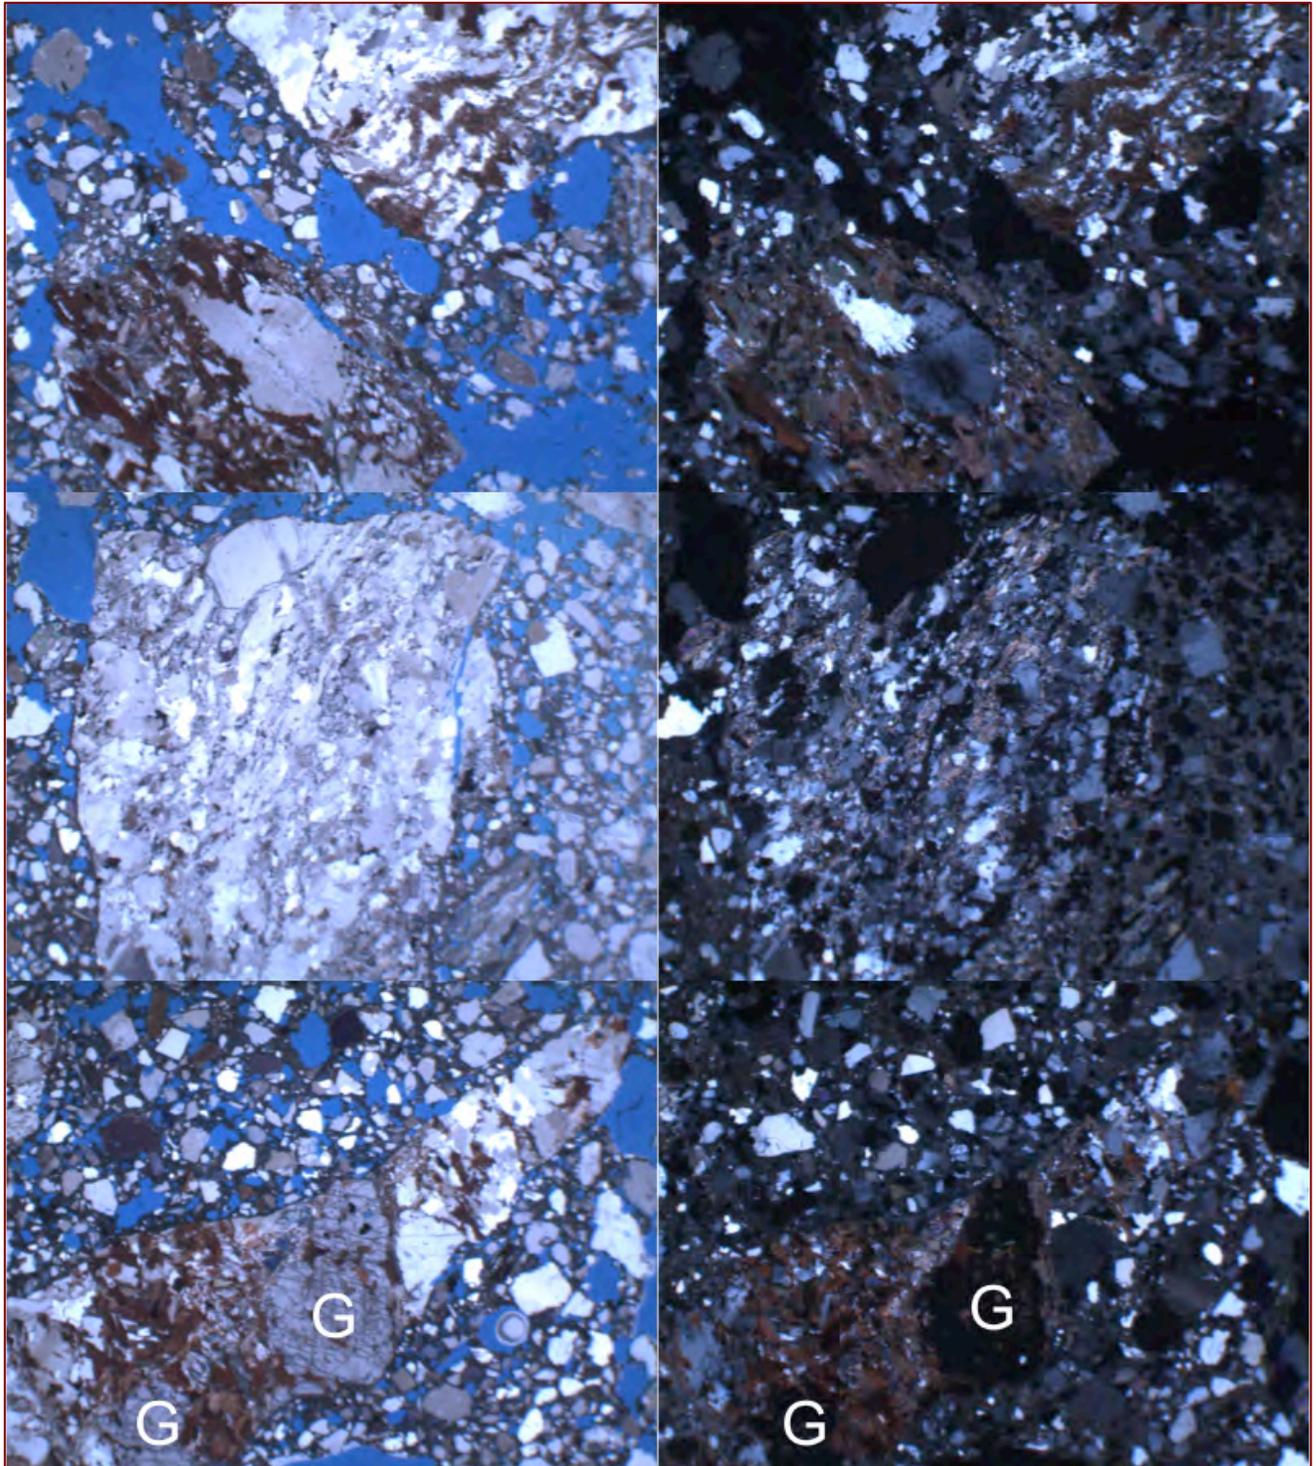
Figure 23: Photomicrographs of blue dye-mixed epoxy-impregnated Thin section (#2) of concrete showing: (a) visible cracking highlighted by blue epoxy, (b) garnetiferous gneiss crushed stone coarse aggregate having alternating bands of quartzo-feldspathic and micaceous minerals (some garnet grains are marked in 'G' that are optically isotropic), and siliceous sand fine aggregate. Left column photos were taken in PPL and right column ones in corresponding XPL modes in a transmitted-light stereo-zoom microscope. Field width of each photo is 12 mm.

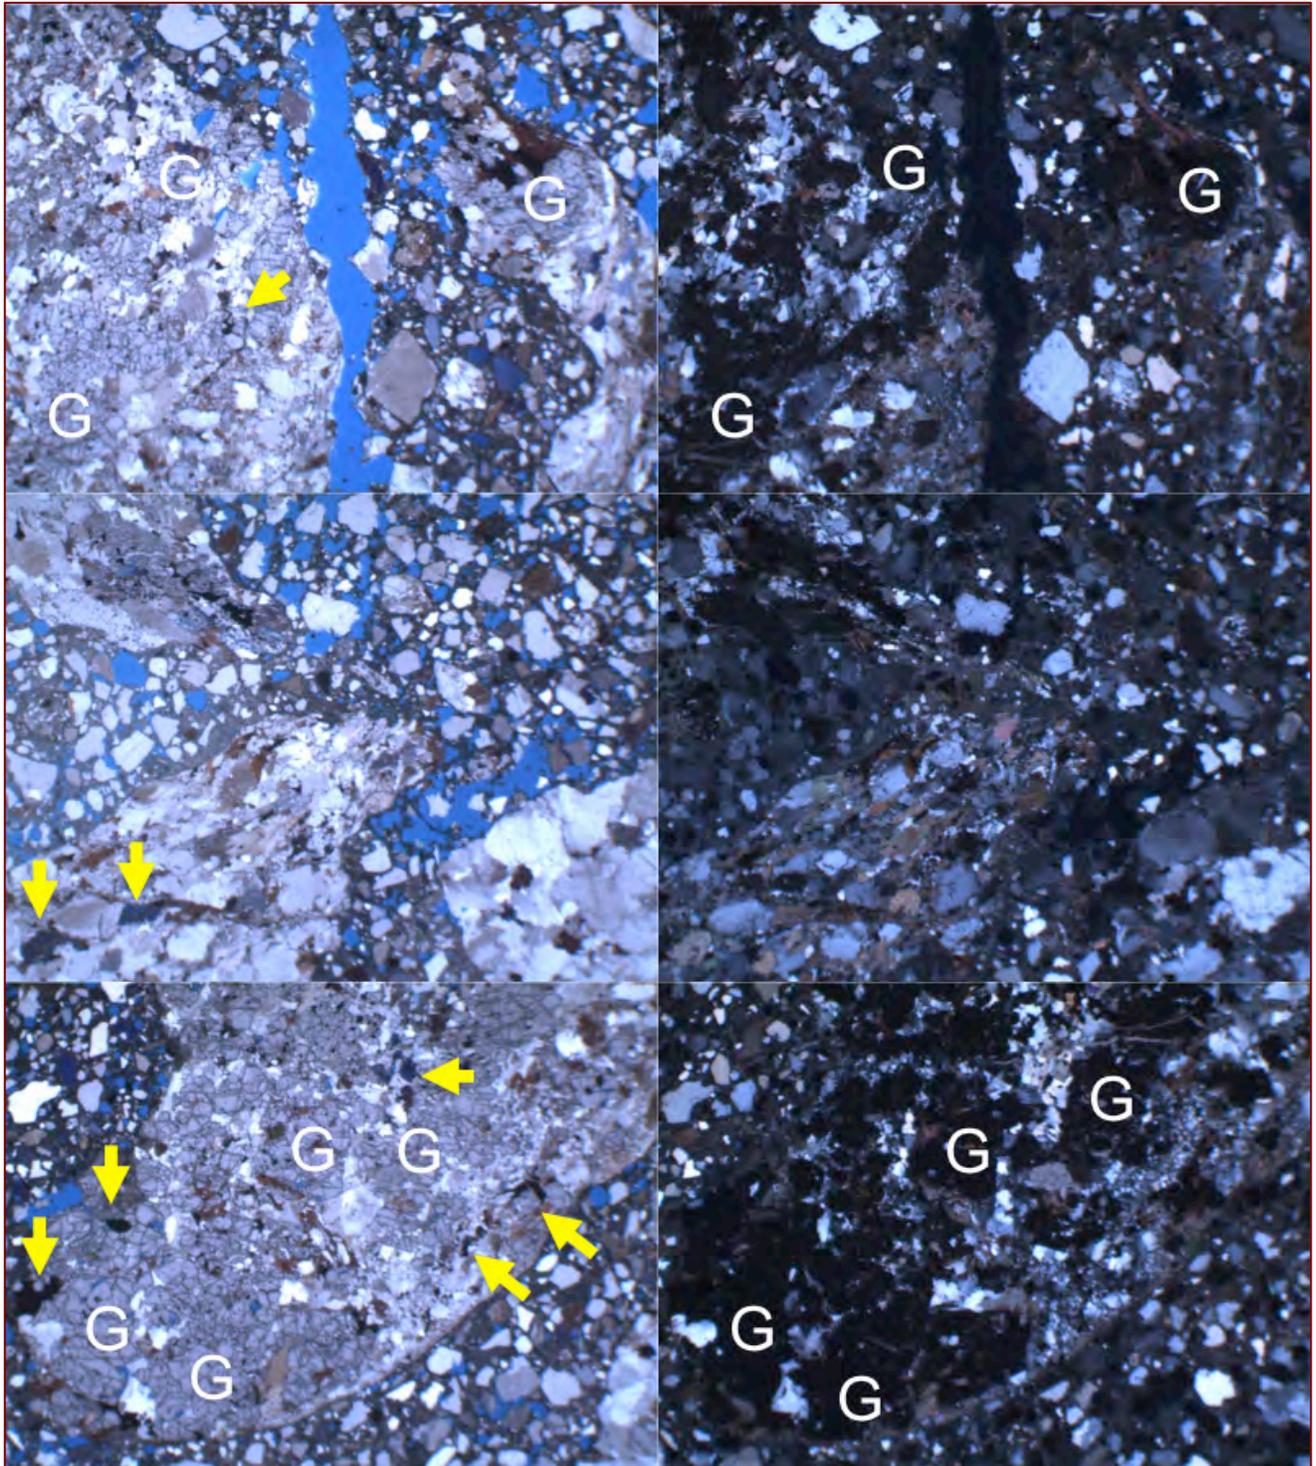
Figure 24: Photomicrographs of blue dye-mixed epoxy-impregnated Thin section (#3) of concrete showing: (a) visible cracking highlighted by blue epoxy, (b) garnetiferous gneiss crushed stone coarse aggregate having alternating bands of quartzo-feldspathic and micaceous minerals (some garnet grains are marked in 'G' that are optically isotropic), and siliceous sand fine aggregate. Left column photos were taken in PPL and right column ones in corresponding XPL modes in a transmitted-light stereo-zoom microscope. A few dark opaque iron sulfide and oxide are marked with yellow arrows. Field width of each photo is 12 mm.

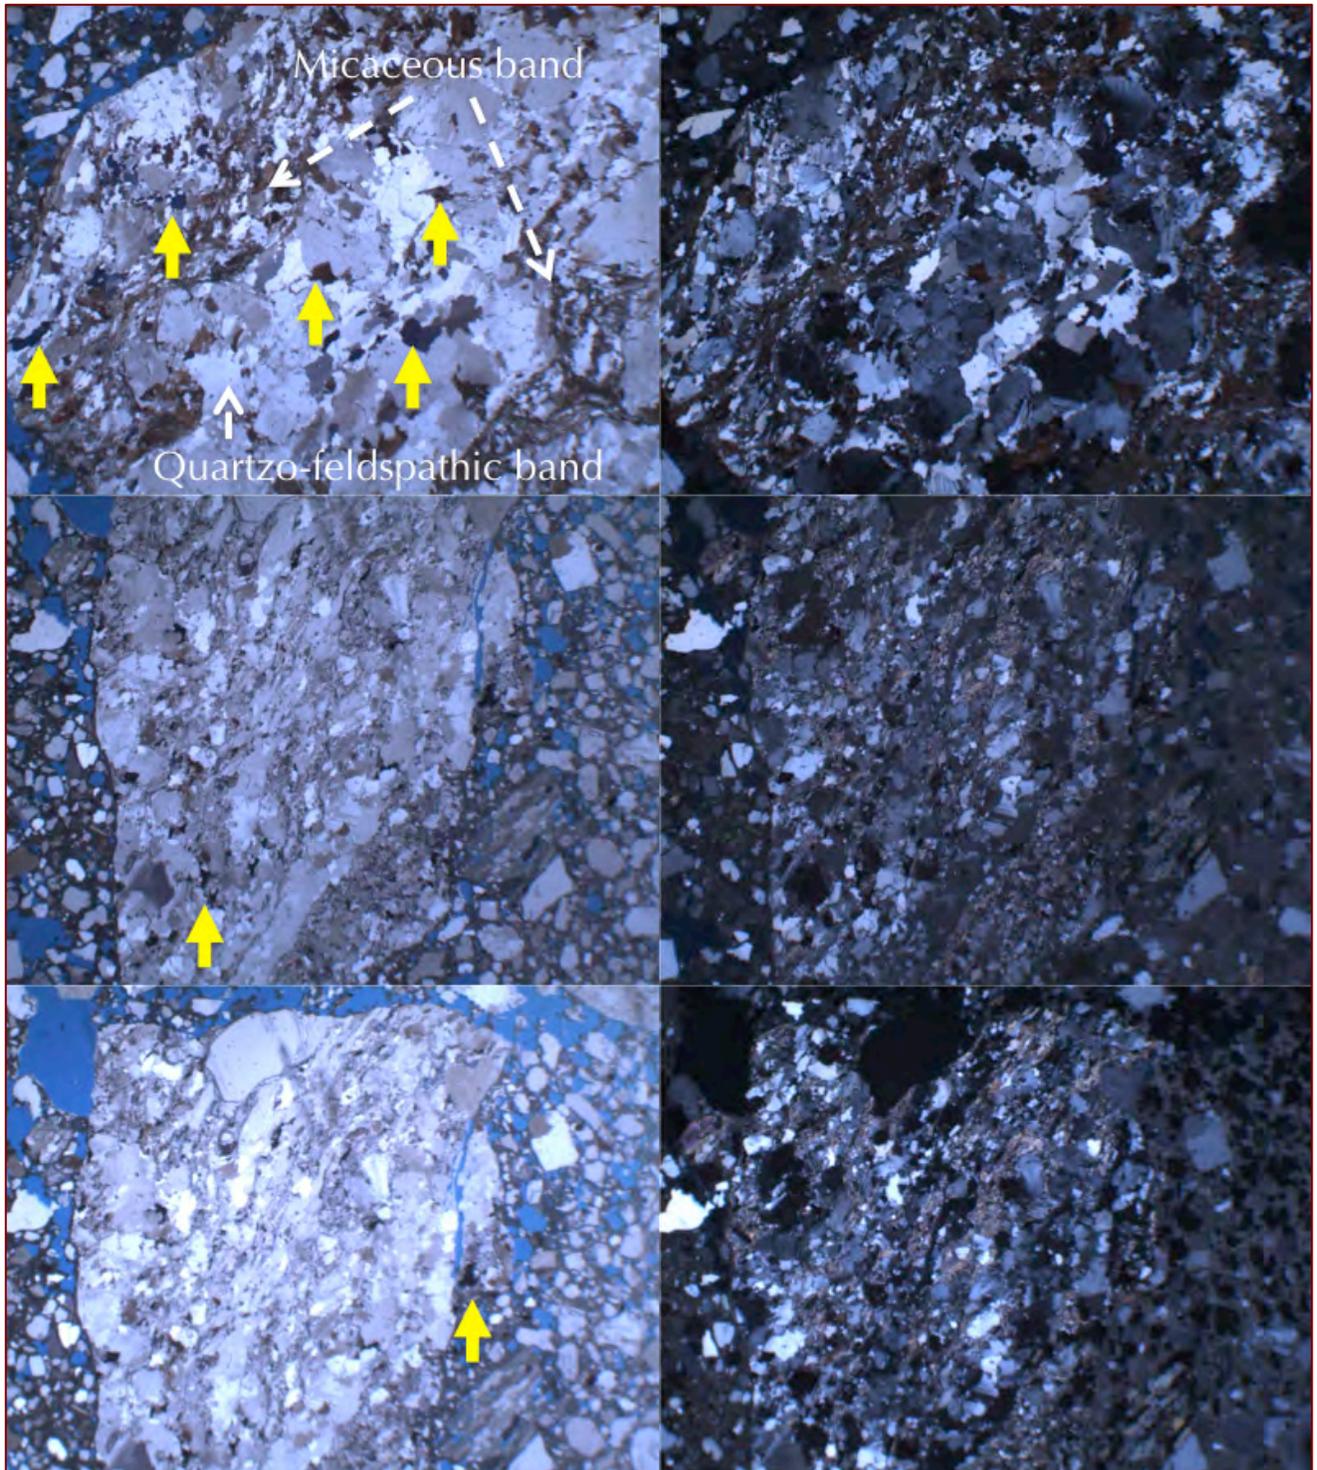
Figure 25: Photomicrographs of blue dye-mixed epoxy-impregnated Thin section (#4) of concrete showing: (a) visible cracking highlighted by blue epoxy, (b) garnetiferous gneiss crushed stone coarse aggregate having alternating bands of quartzo-feldspathic and micaceous minerals (some garnet grains are marked in 'G' that are optically isotropic), and siliceous sand fine aggregate. Left column photos were taken in PPL and right column ones in corresponding XPL modes in a transmitted-light stereo-zoom microscope. A few dark opaque iron sulfide and oxide are marked with yellow arrows. Field width of each photo is 12 mm.

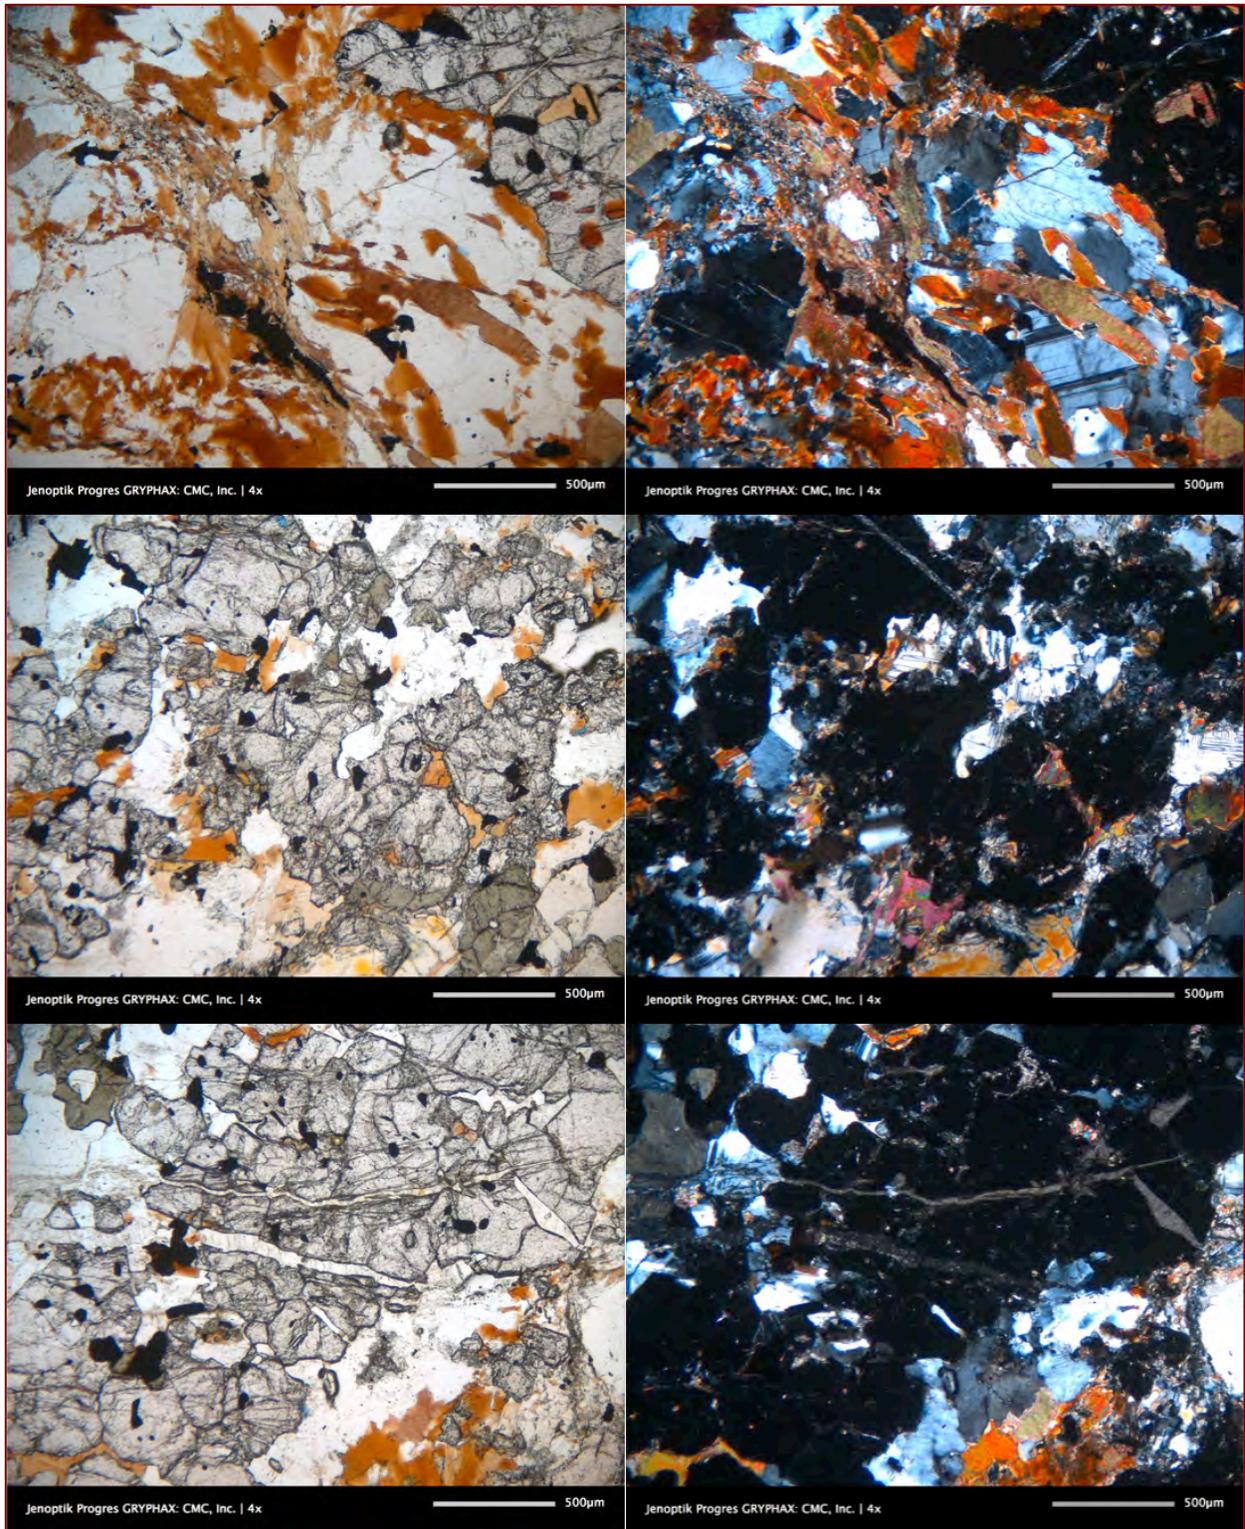
Figure 26: Thin Section# 1: Pyrrhotite-bearing quartz-feldspar-biotite-garnet gneiss coarse aggregate having gneissose texture characterized by alternate bands of quartzo-feldspathic and micaceous minerals, and optically isotropic garnet porphyroblasts caught in the middle of bands (often containing surrounding minerals). Pyrrhotite grains and oxidation products of pyrrhotite occur as small equant opaque phases scattered as inclusions in garnet or along biotite flakes, or as isolated accessory phase.

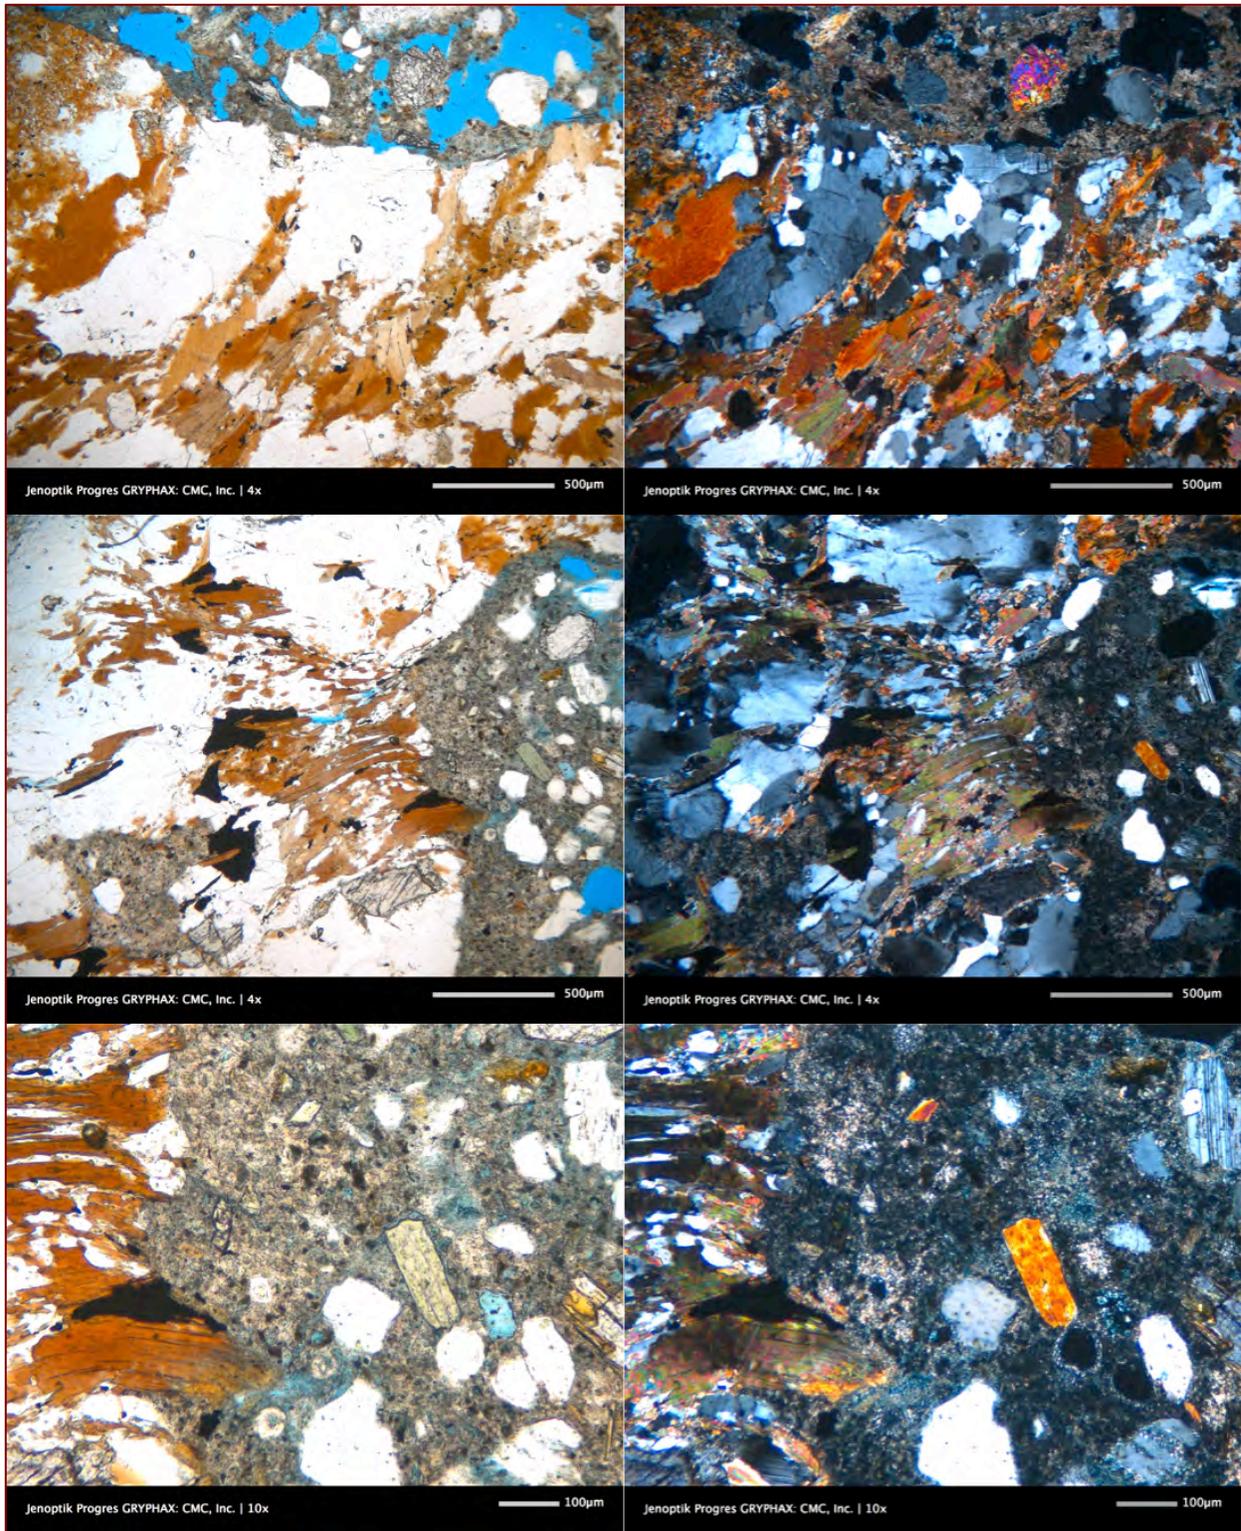
Figure 27: Thin Section# 1: Pyrrhotite-bearing quartz-feldspar-biotite-garnet gneiss coarse aggregate having gneissose texture characterized by alternate bands of quartzo-feldspathic and micaceous minerals. Pyrrhotite grains and oxidation products of pyrrhotite occur as small equant opaque phases scattered as inclusions in garnet or along biotite flakes, or as isolated accessory phase.

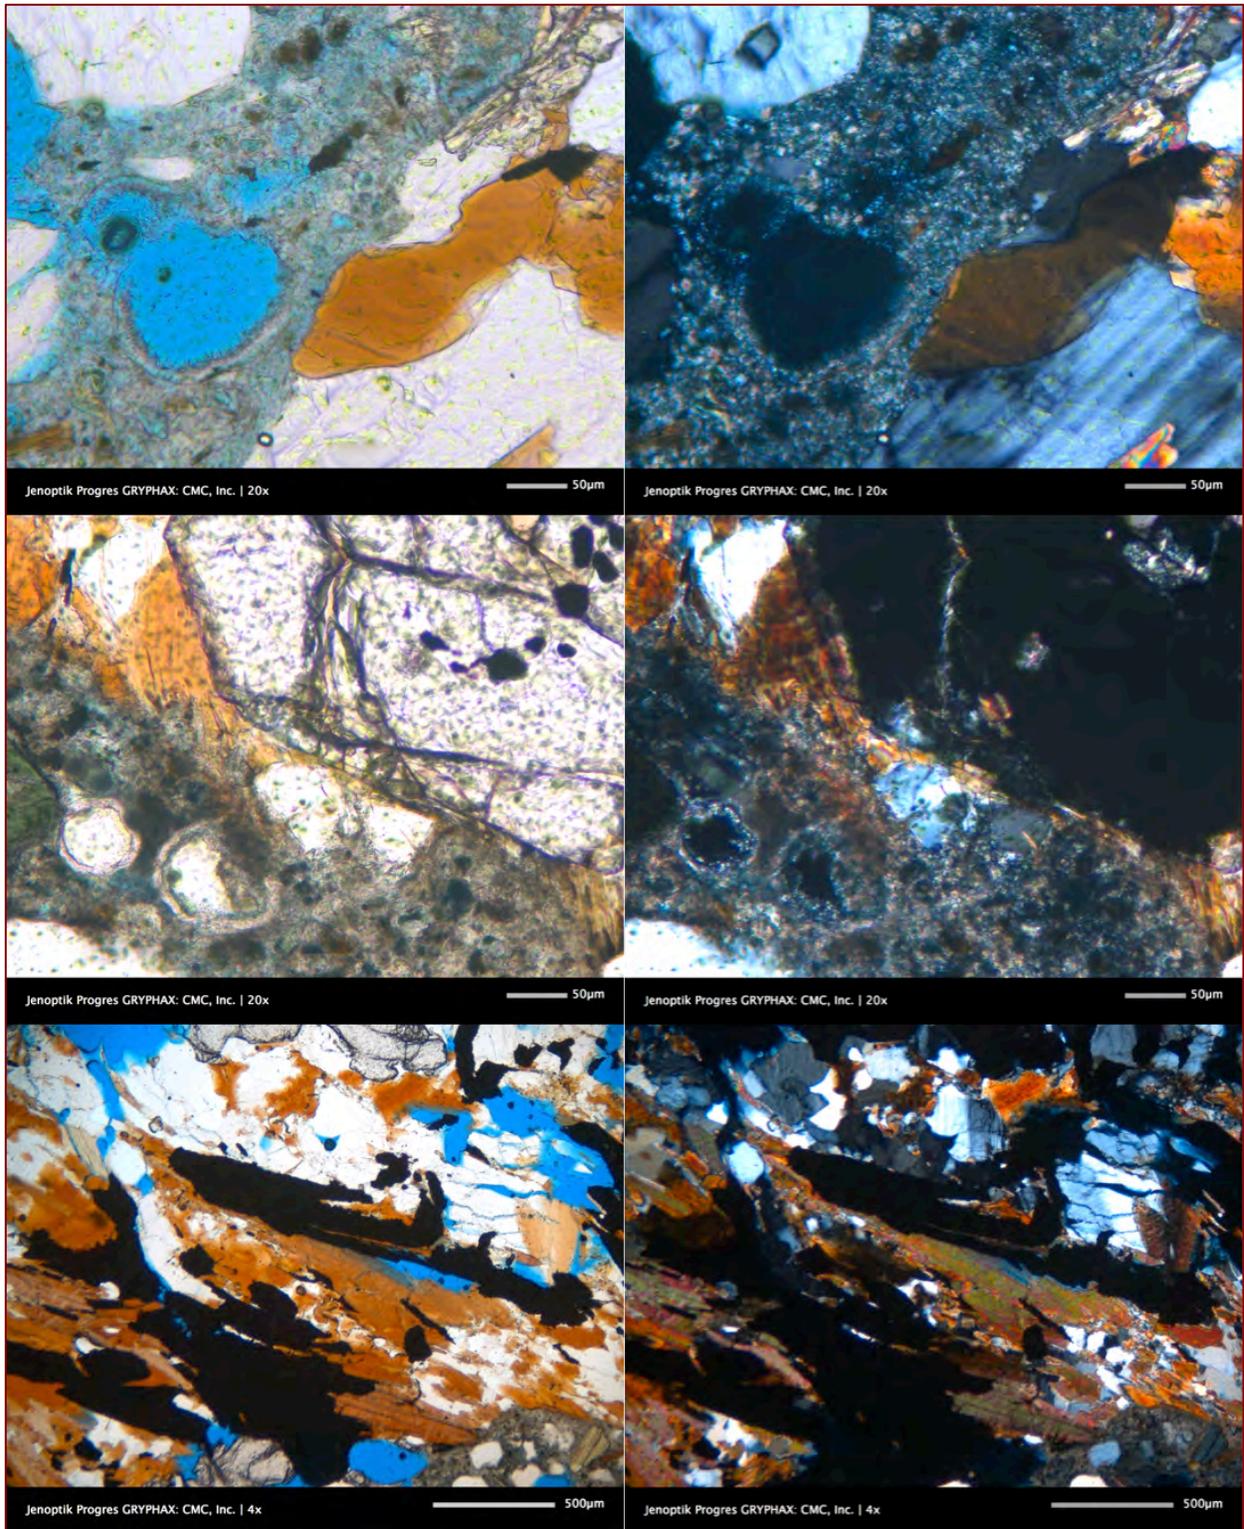
Figure 28: Thin Section# 1: Pyrrhotite-bearing quartz-feldspar-biotite-garnet gneiss coarse aggregate having gneissose texture characterized by alternate bands of quartzo-feldspathic and micaceous minerals, and optically isotropic garnet porphyroblasts caught in the middle of bands (often containing surrounding minerals). Pyrrhotite grains and oxidation products of pyrrhotite occur as small equant opaque phases scattered as inclusions in garnet or along biotite flakes, or as isolated accessory phase.
