Pyrrhotite Epidemic in Eastern Connecticut – A Case Study From Ellington, CT

Cracking & Crumbling of A Residential Concrete Foundation In
Ellington, Connecticut

January 2018
CMC Interim Report

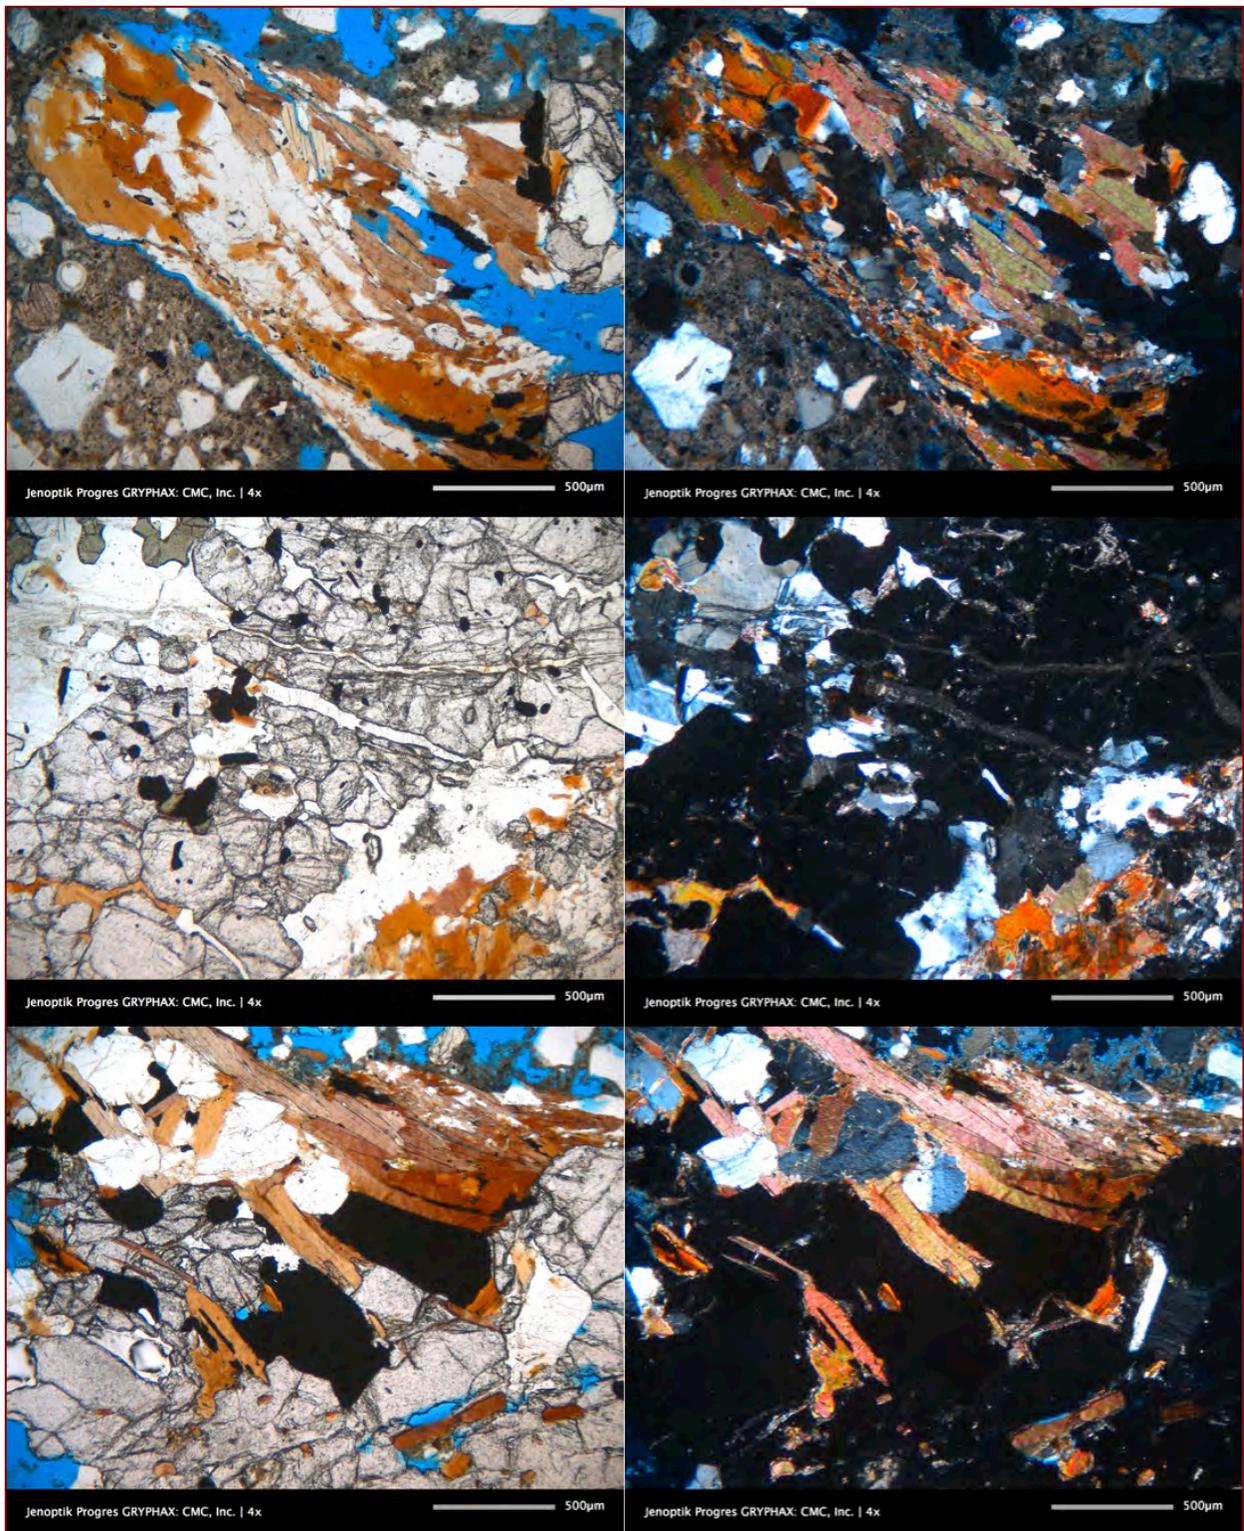
Figure 29: Thin Section# 1: Pyrrhotite-bearing quartz-feldspar-biotite-garnet gneiss coarse aggregate having gneissose texture characterized by alternate bands of quartzo-feldspathic and micaceous minerals, and optically isotropic garnet porphyroblasts caught in the middle of bands (often containing surrounding minerals). Pyrrhotite grains and oxidation products of pyrrhotite occur as small equant opaque phases scattered as inclusions in garnet or along biotite flakes, or as isolated accessory phase.

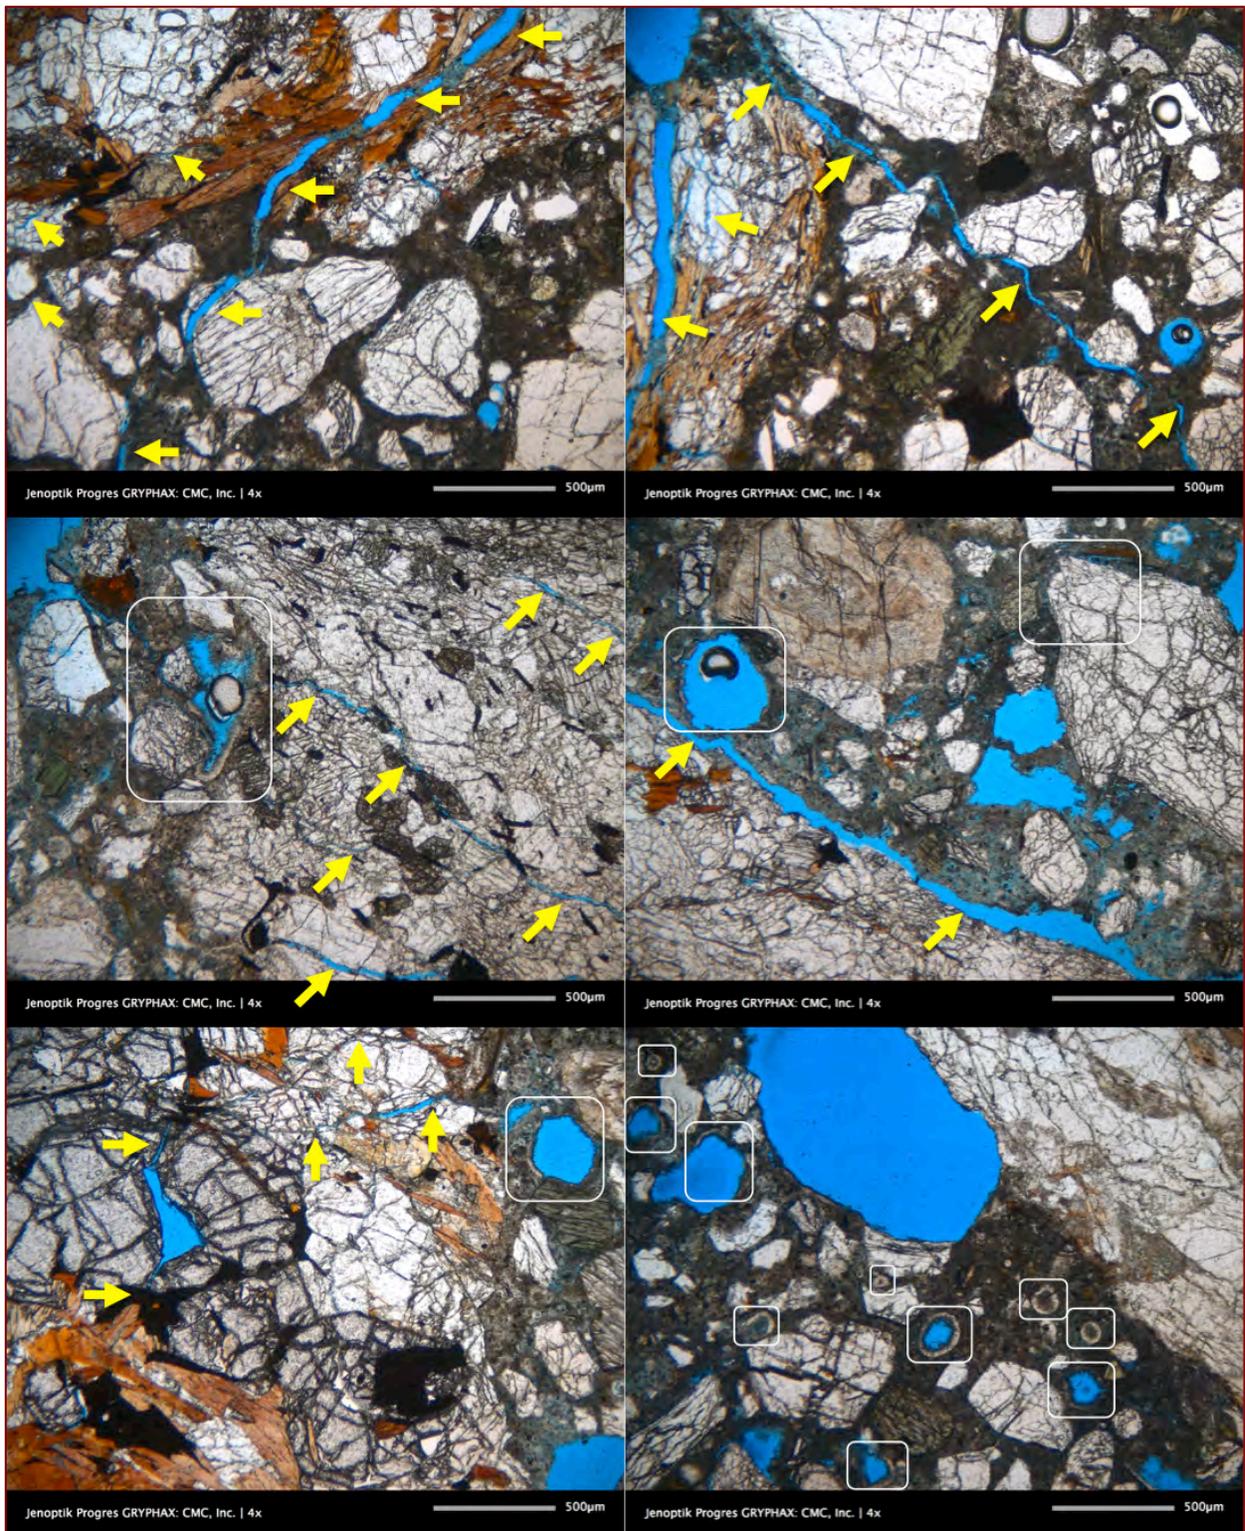
Figure 30: Thin Section# 2: Microcracking in and around concrete aggregate particles shown by arrows and secondary ettringite crystallization lining the air-voids shown by boxed areas.

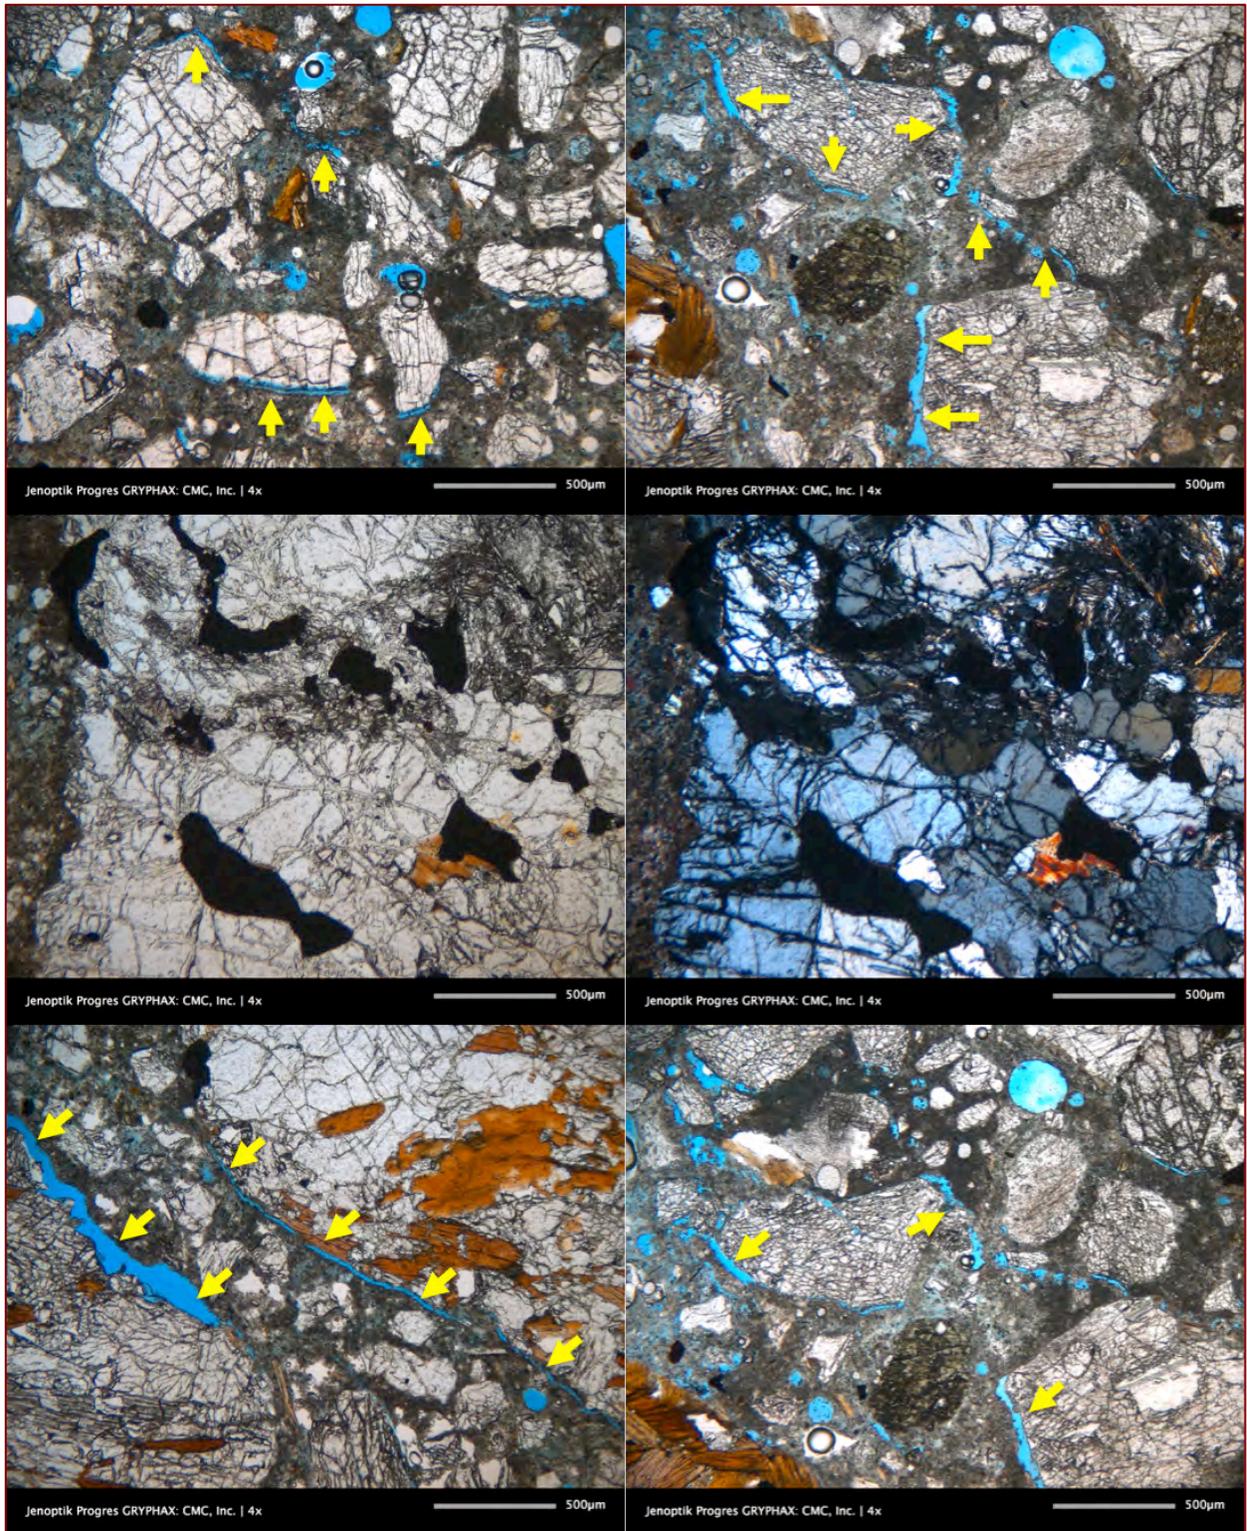
Figure 31: Thin Section# 3: Microcracking in and around concrete aggregate particles shown by arrows.

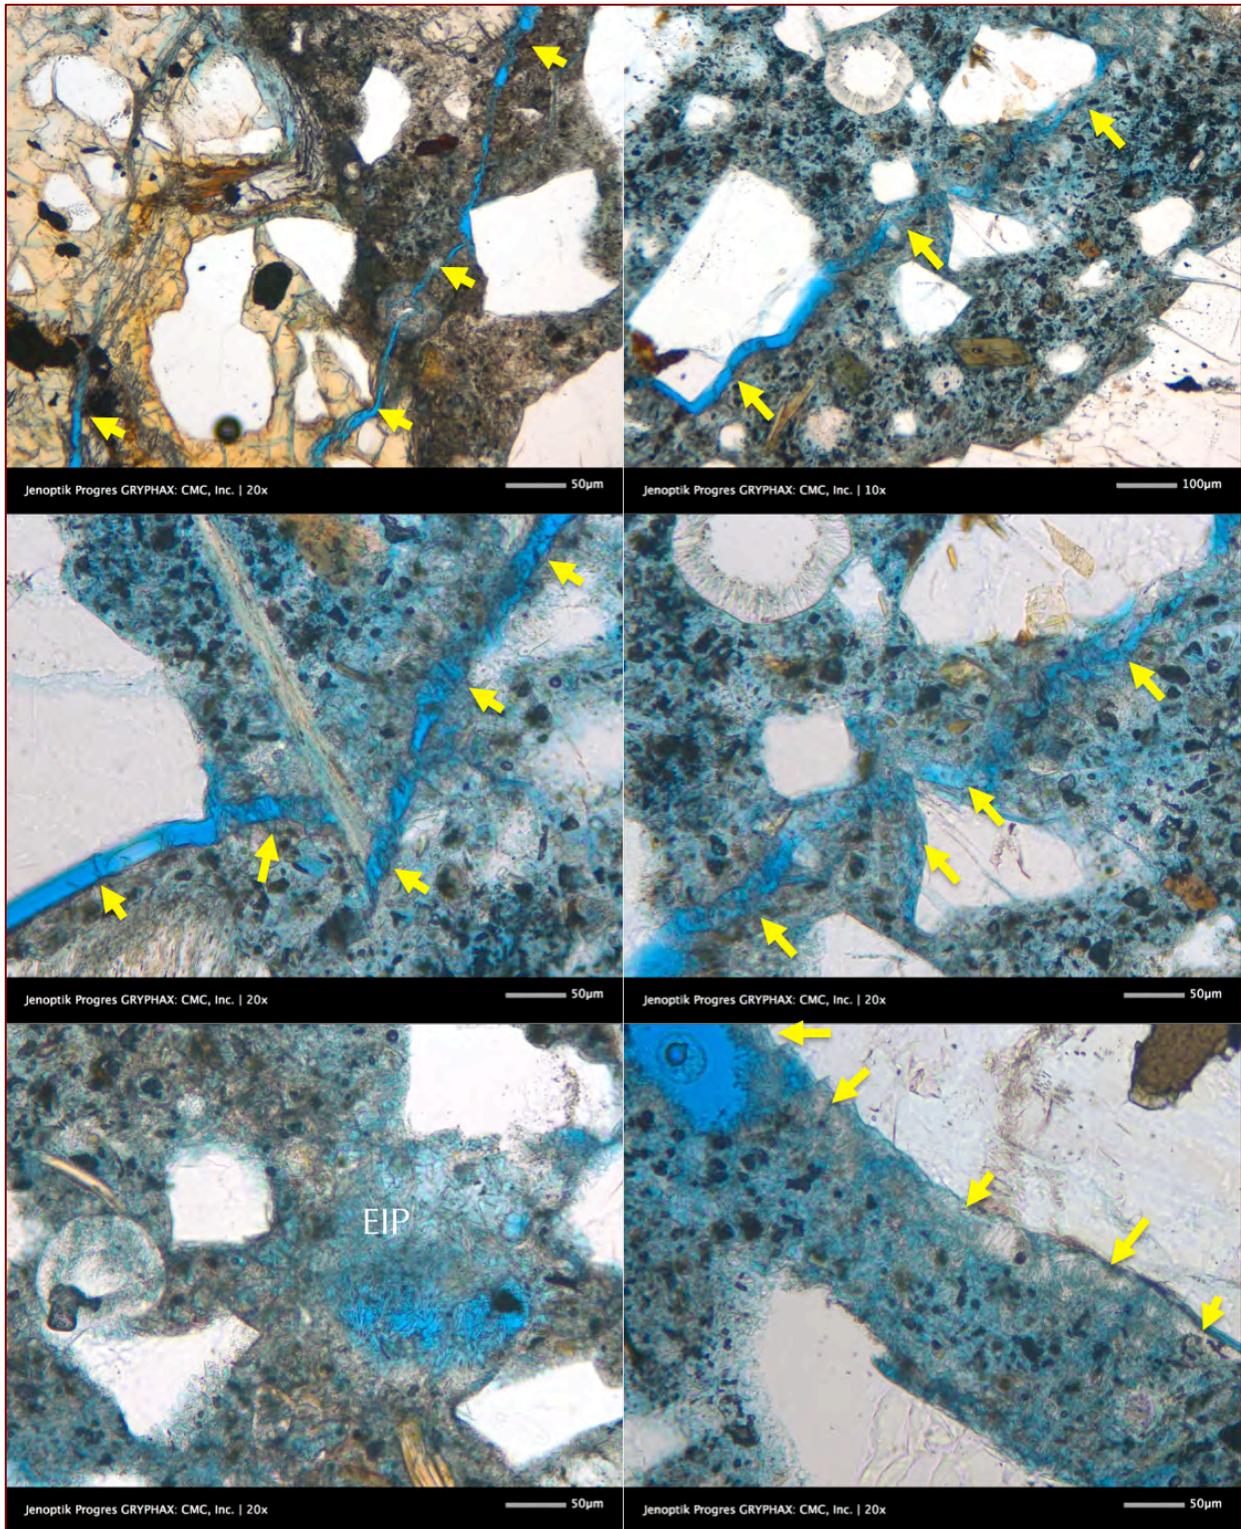
Figure 32: Thin Section# 4: Microcracking in and around concrete aggregate particles shown by arrows. Notice secondary ettringite crystallization in cracks as well as poorly crystalline secondary ettringite formation in paste, called ettringite infested paste (EIP) that are the breeding grounds for internal sulfate attack due to deleterious poorly crystalline ettringite formation in confined spaces in paste to cause expansion.

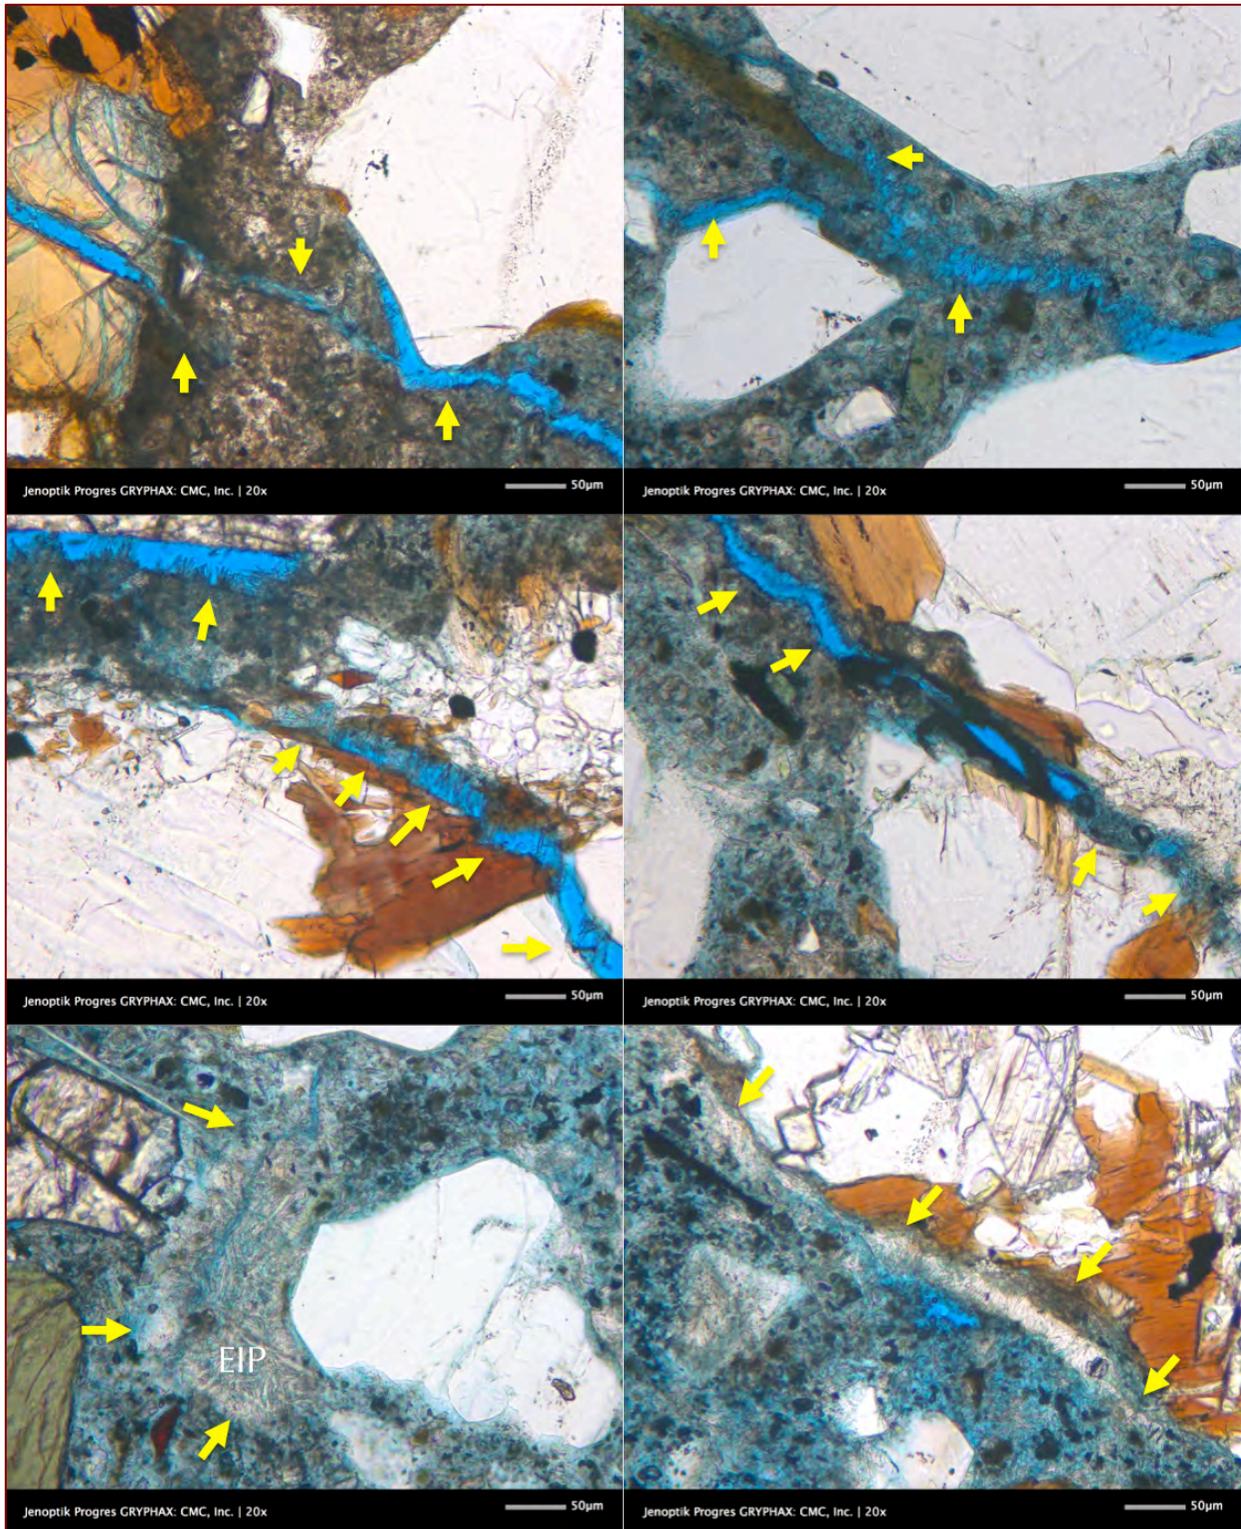
Figure 33: Thin Section# 4: Microcracking in and around concrete aggregate particles shown by arrows. Notice secondary ettringite crystallization in cracks as well as poorly crystalline secondary ettringite formation in paste, called ettringite infested paste (EIP) that are the breeding grounds for internal sulfate attack due to deleterious poorly crystalline ettringite formation in confined spaces in paste to cause expansion.

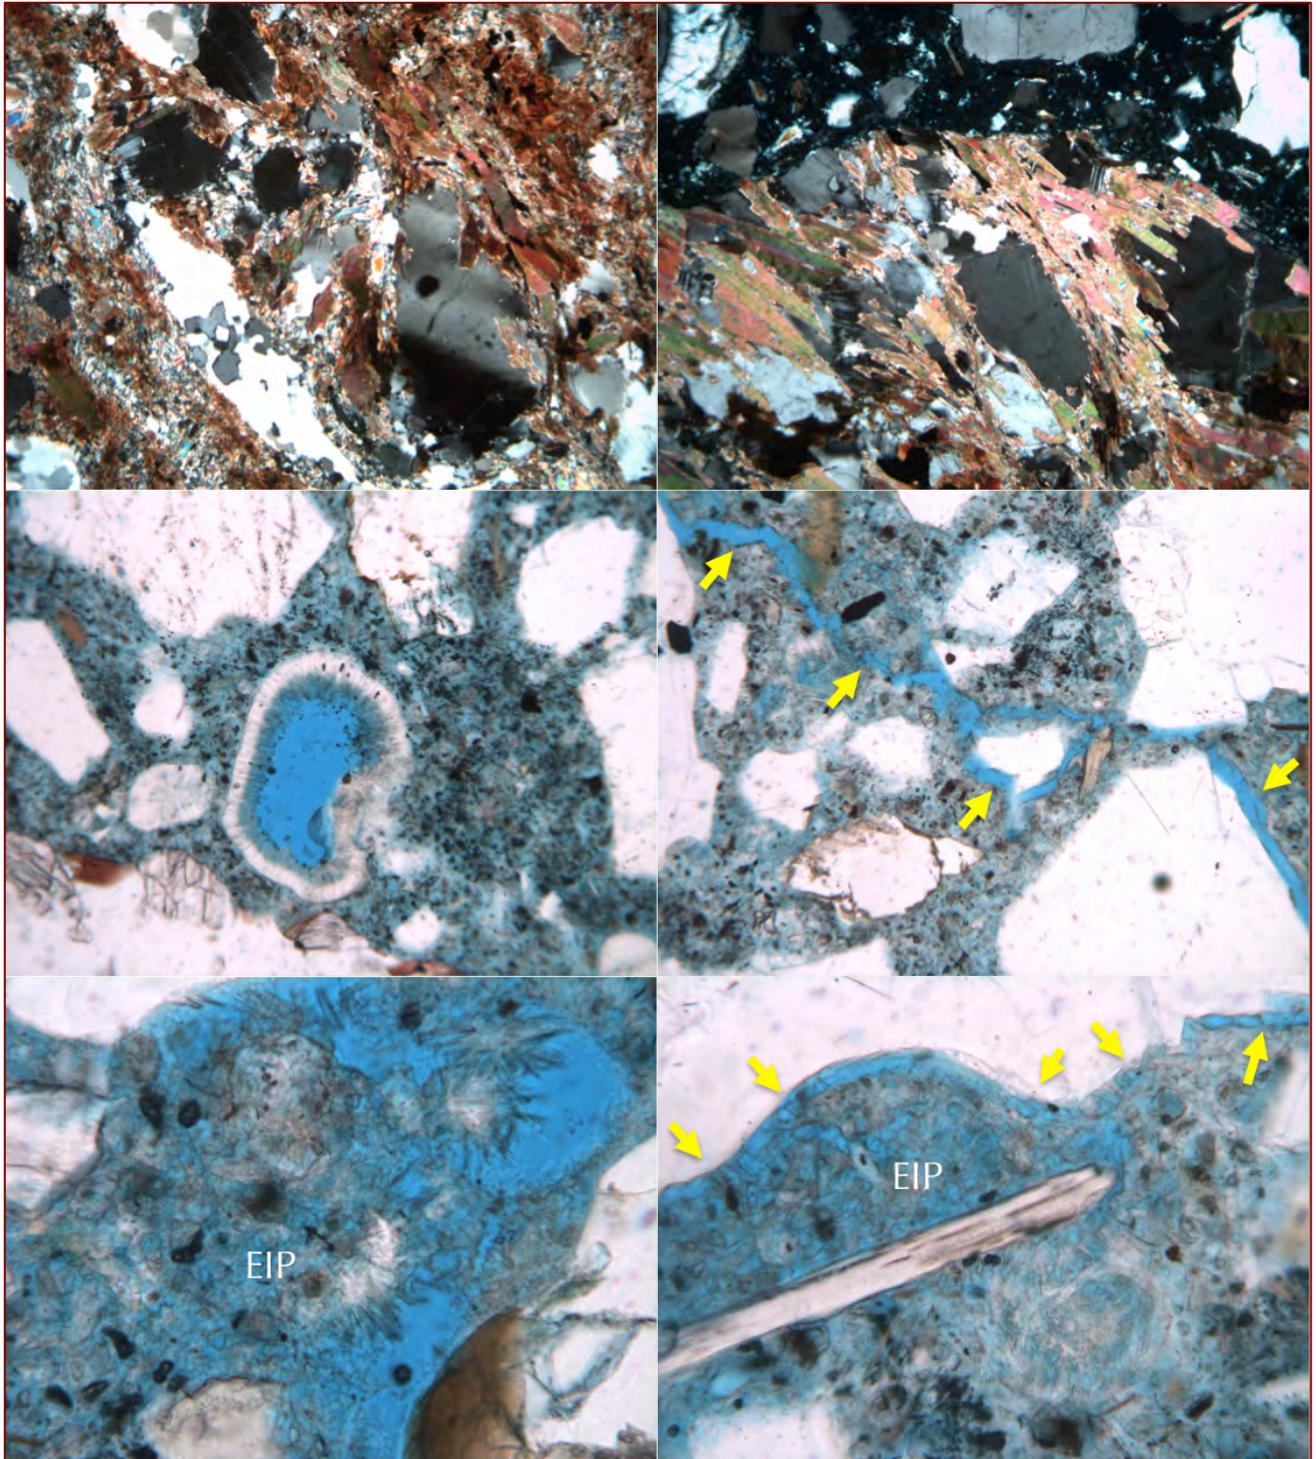
Figure 34: Thin Section# 5: Top row shows gneiss coarse aggregate. Middle row shows an ettringite-lined void and a microcrack (arrows). Bottom row shows EIP or ettringite infested paste, which is the breeding ground for internal sulfate attack. Field width of each photo is 0.25 mm for the top and middle row, and 0.04 mm for the bottom row.

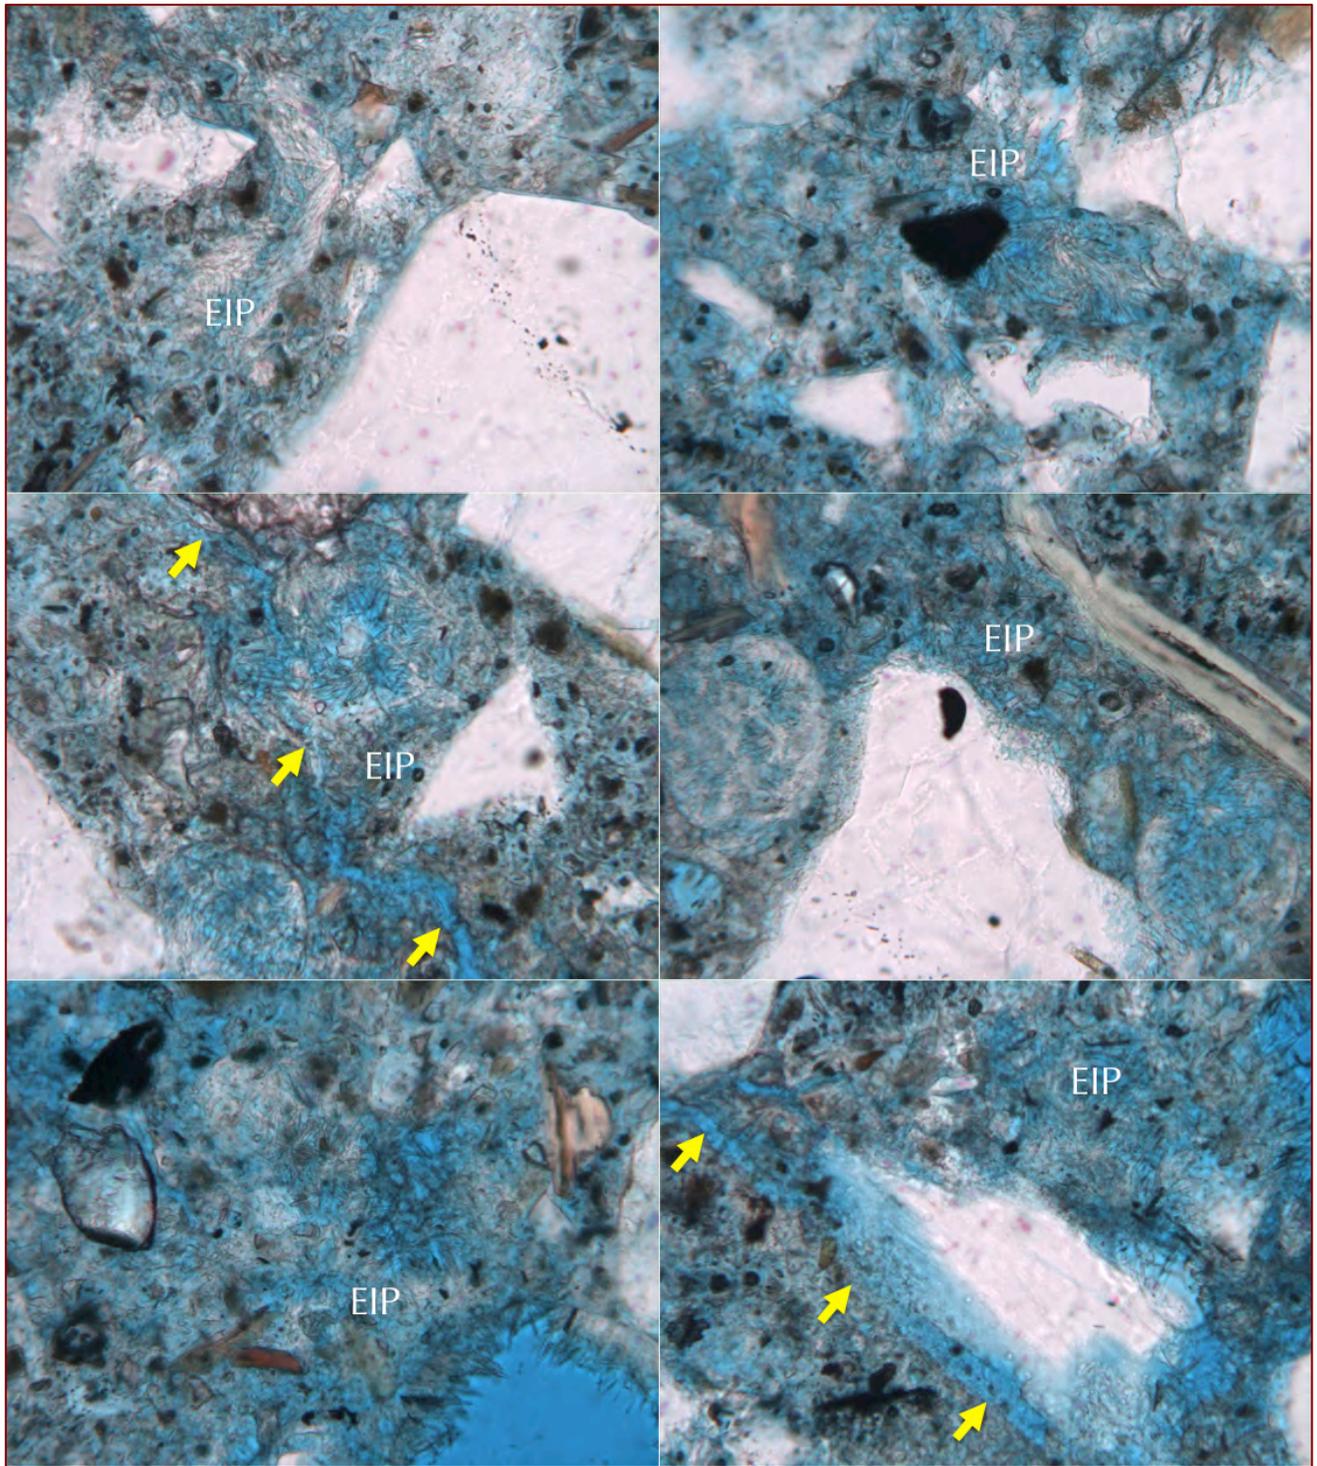
Figure 35: Thin Section# 5: EIP or ettringite infested paste is the breeding ground for internal sulfate attack that forms poorly crystalline ettringite in the confined spaces in paste, and becomes well crystalline when formed in an open void or a crack. Arrows show incipient crack development through EIP. Field width of each photo is 0.04 mm.

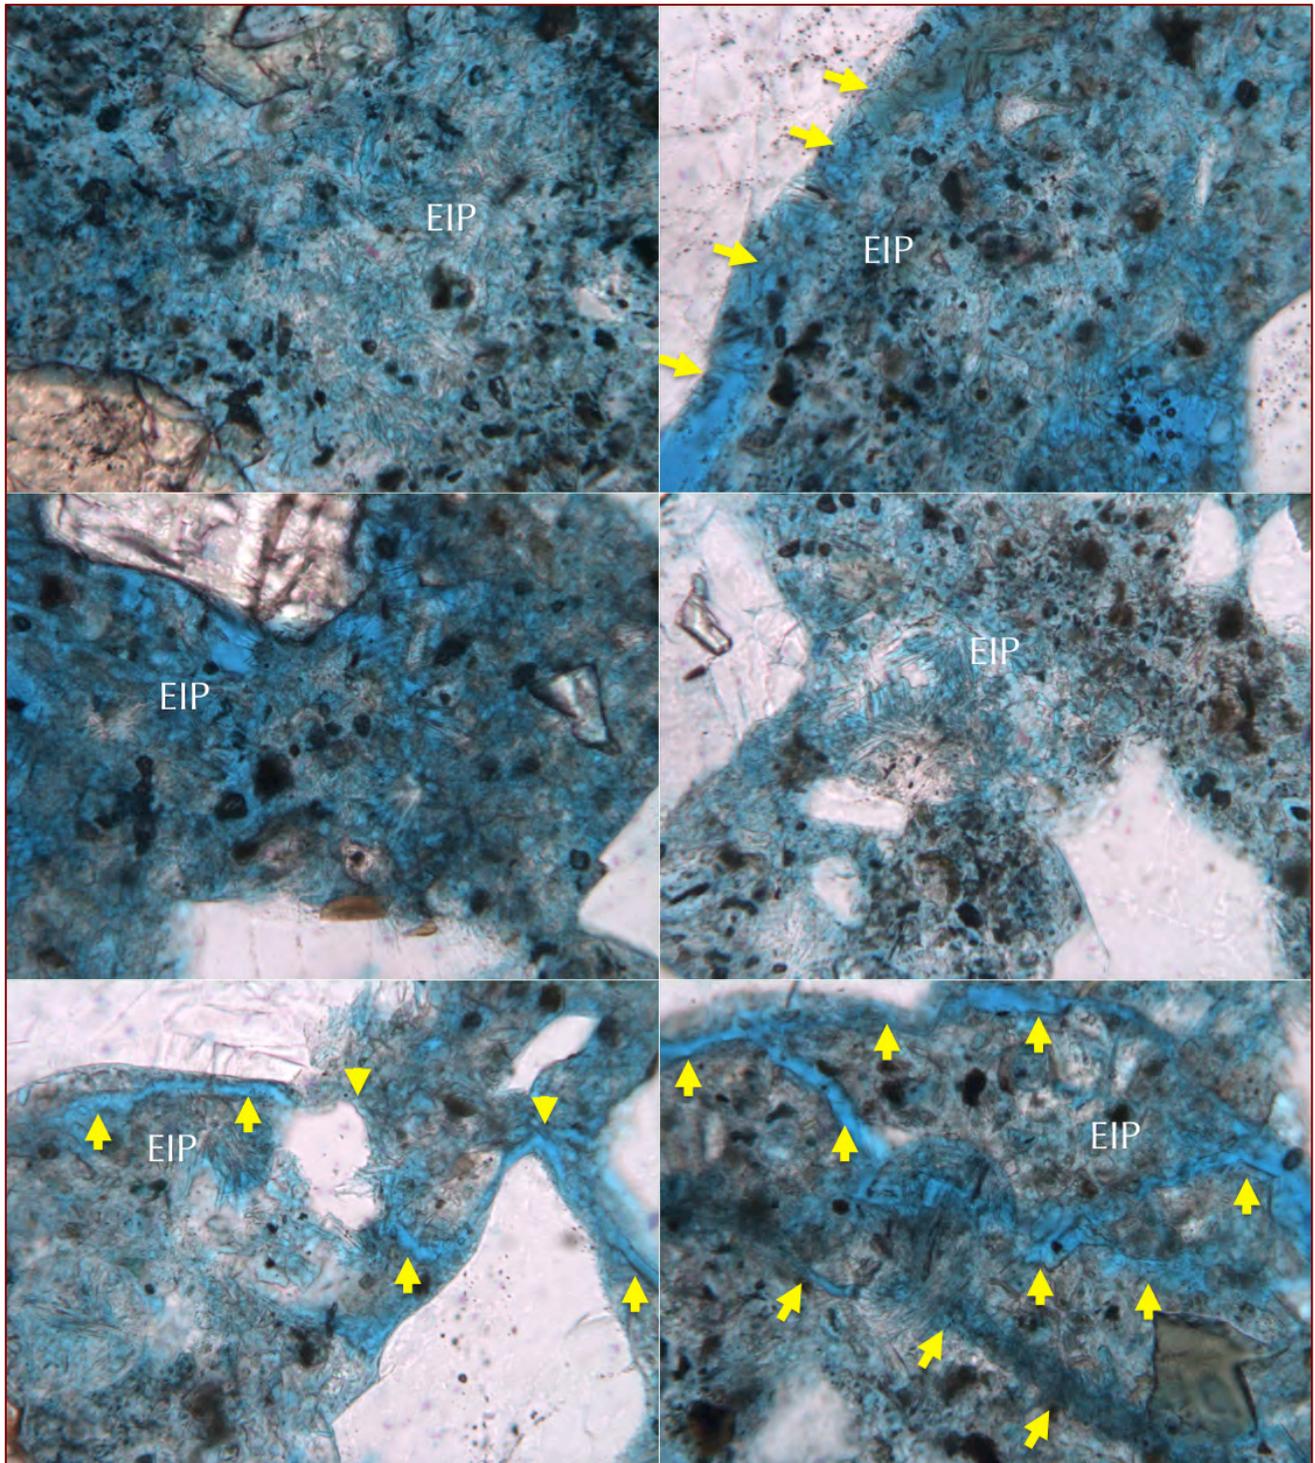
Figure 36: Thin Section# 5: EIP or ettringite infested paste is the breeding ground for internal sulfate attack that forms poorly crystalline ettringite in the confined spaces in paste, and becomes well crystalline when formed in an open void or a crack. Arrows in the top right photo show ettringite formation along an aggregate-paste interface. Arrows in the bottom row show incipient crack development through EIP. Field width of each photo is 0.04 mm.

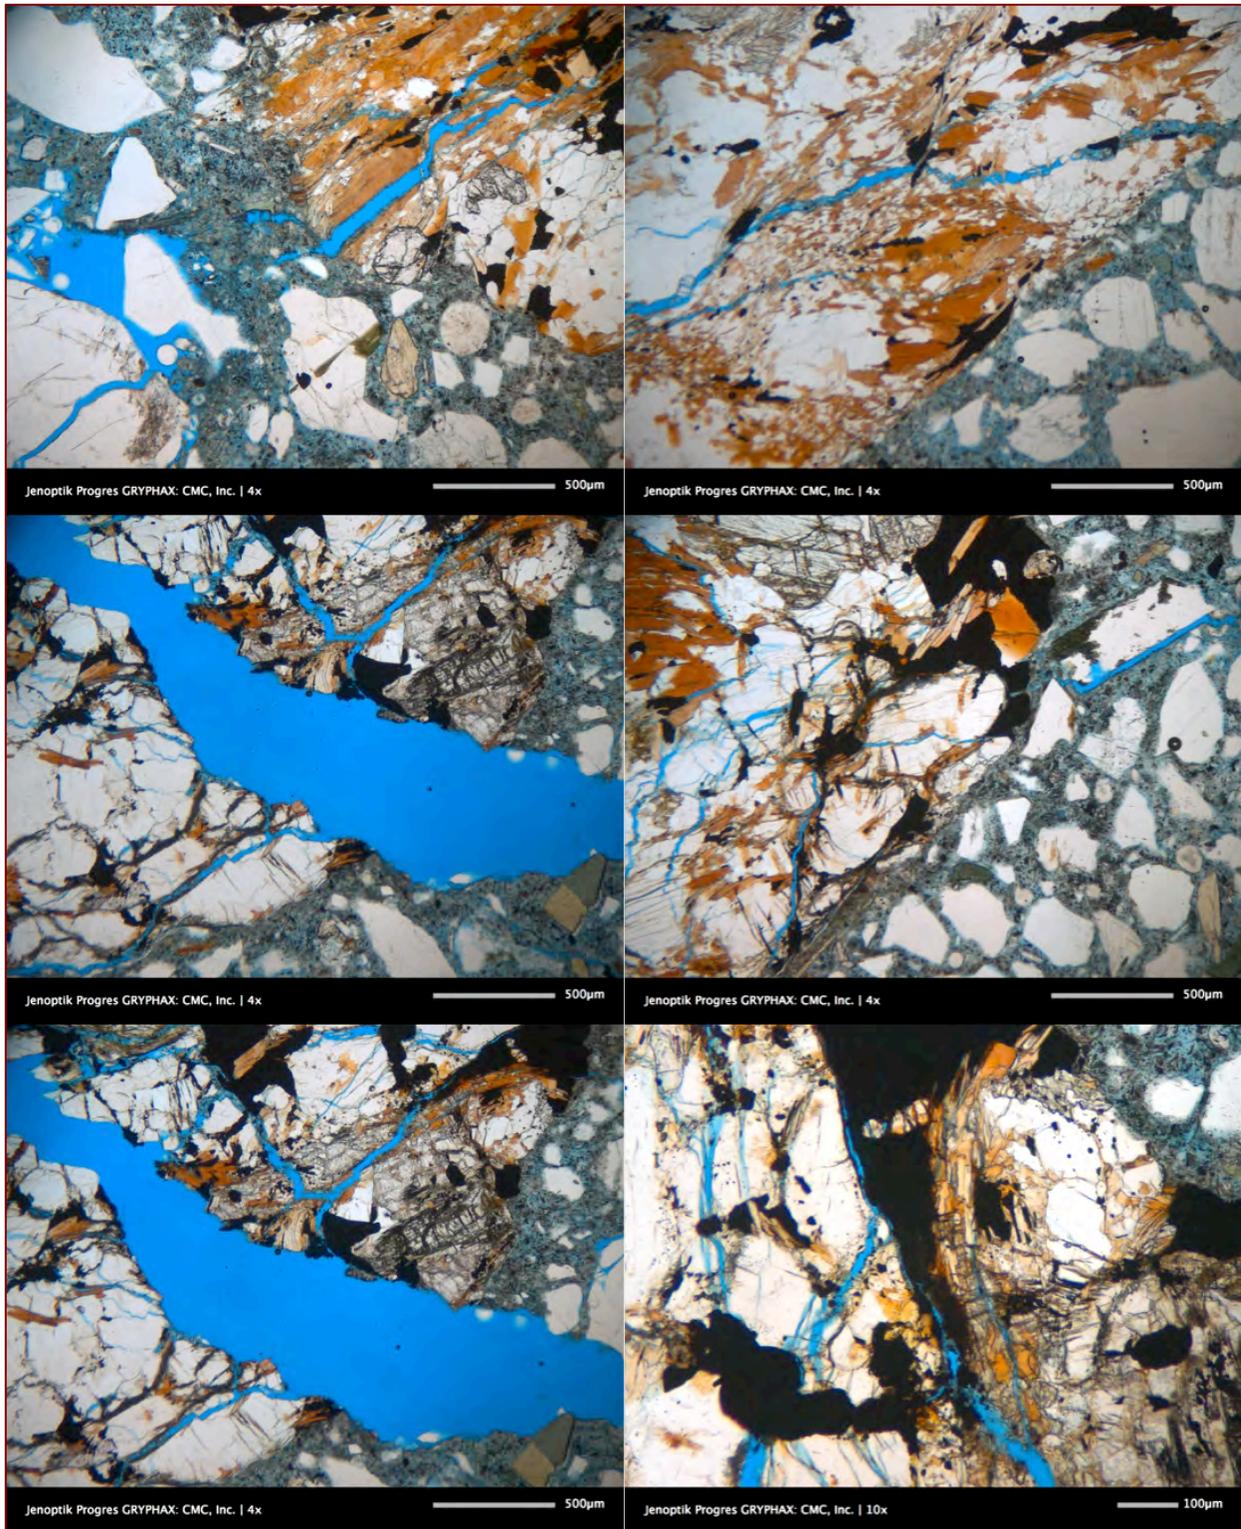
Figure 37: Thin Section# 6: Microcracking in and around concrete aggregate particles shown by arrows. Such extensive cracking of aggregates are testaments of expansion due to pyrrhotite oxidation.

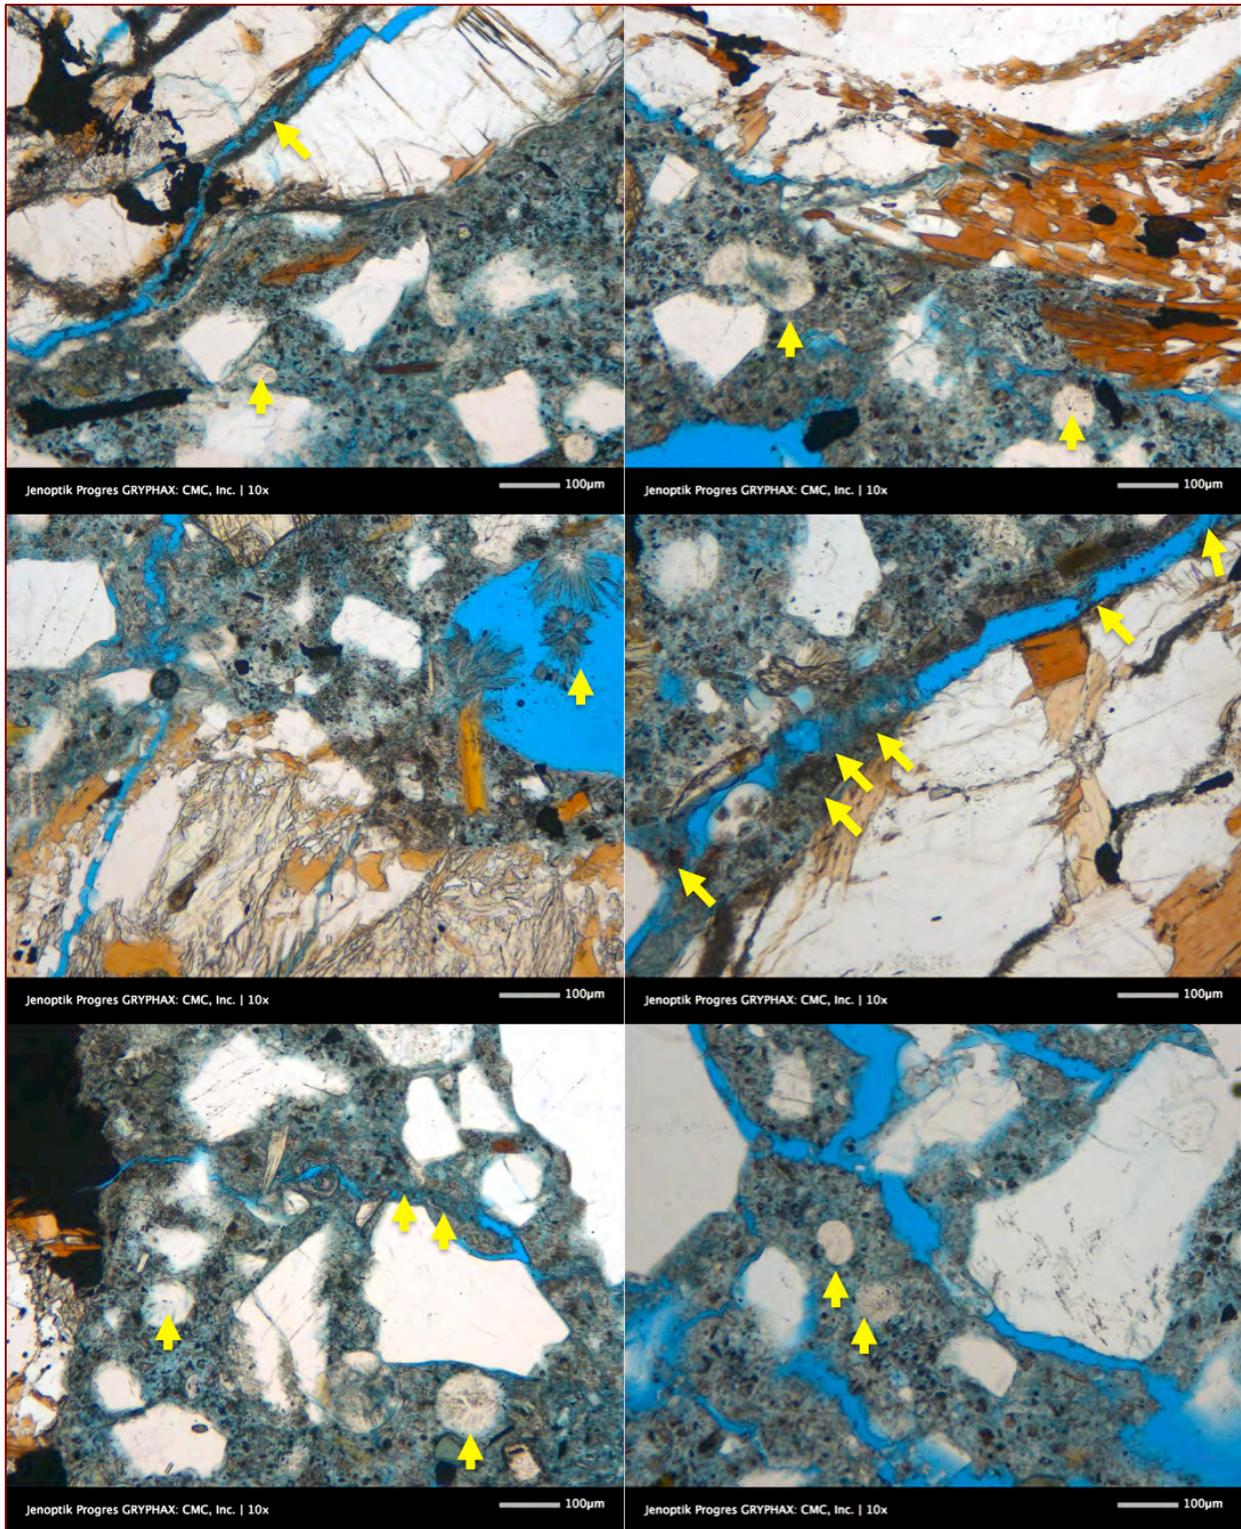
Figure 38: Thin Section# 6: Microcracking in and around concrete aggregate particles and in surrounding paste, and, secondary ettringite deposits in voids and cracks (shown by arrows). Middle row right photo shows 'bridges' of fine fibrous ettringite across the crack walls along aggregate-paste interface.

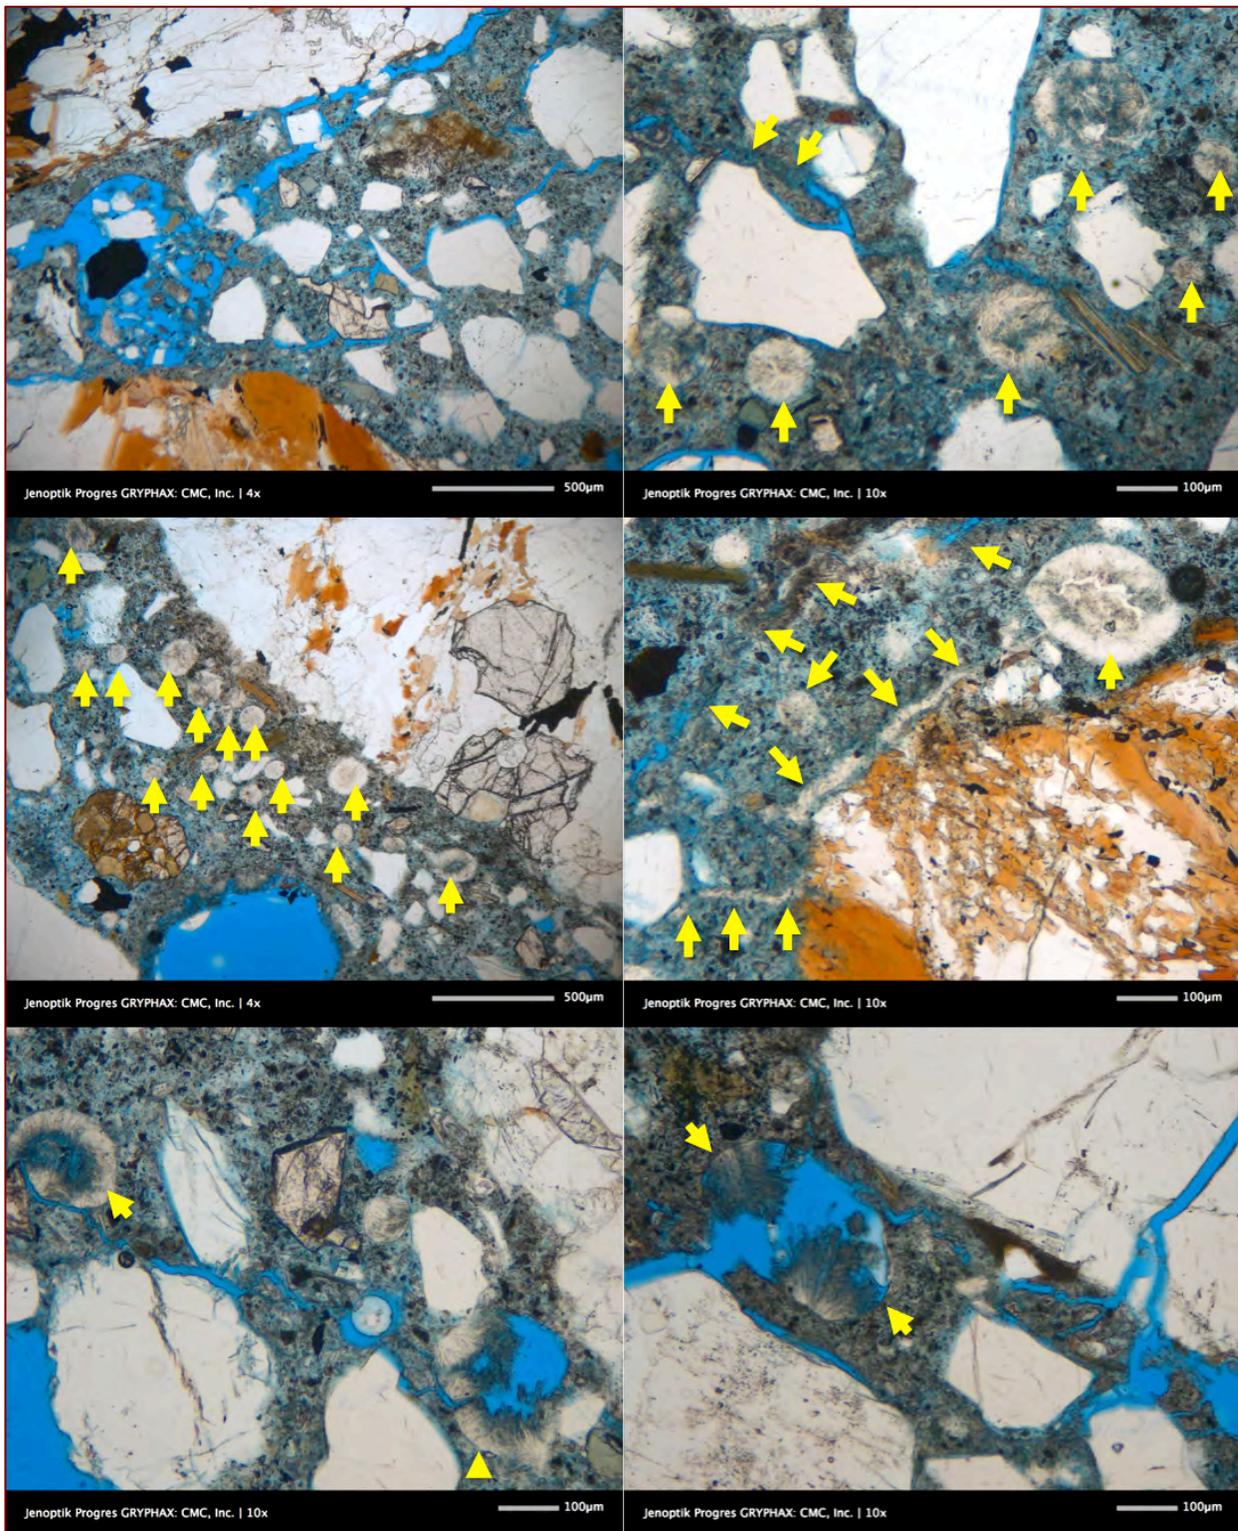
Figure 39: Thin Section# 6: Microcracking in and around concrete aggregate particles and in surrounding paste, and, secondary ettringite deposits in voids and cracks (shown by arrows). The second row of this figure shows most spectacular ettringite-filled air-voids (left) and cracks (right) in Thin Section# 6 taken from interior of the core.
