Pyrrhotite Epidemic in Eastern Connecticut – A Case Study From Ellington, CT

Cracking & Crumbling of A Residential Concrete Foundation In
Ellington, Connecticut

January 2018
CMC Interim Report

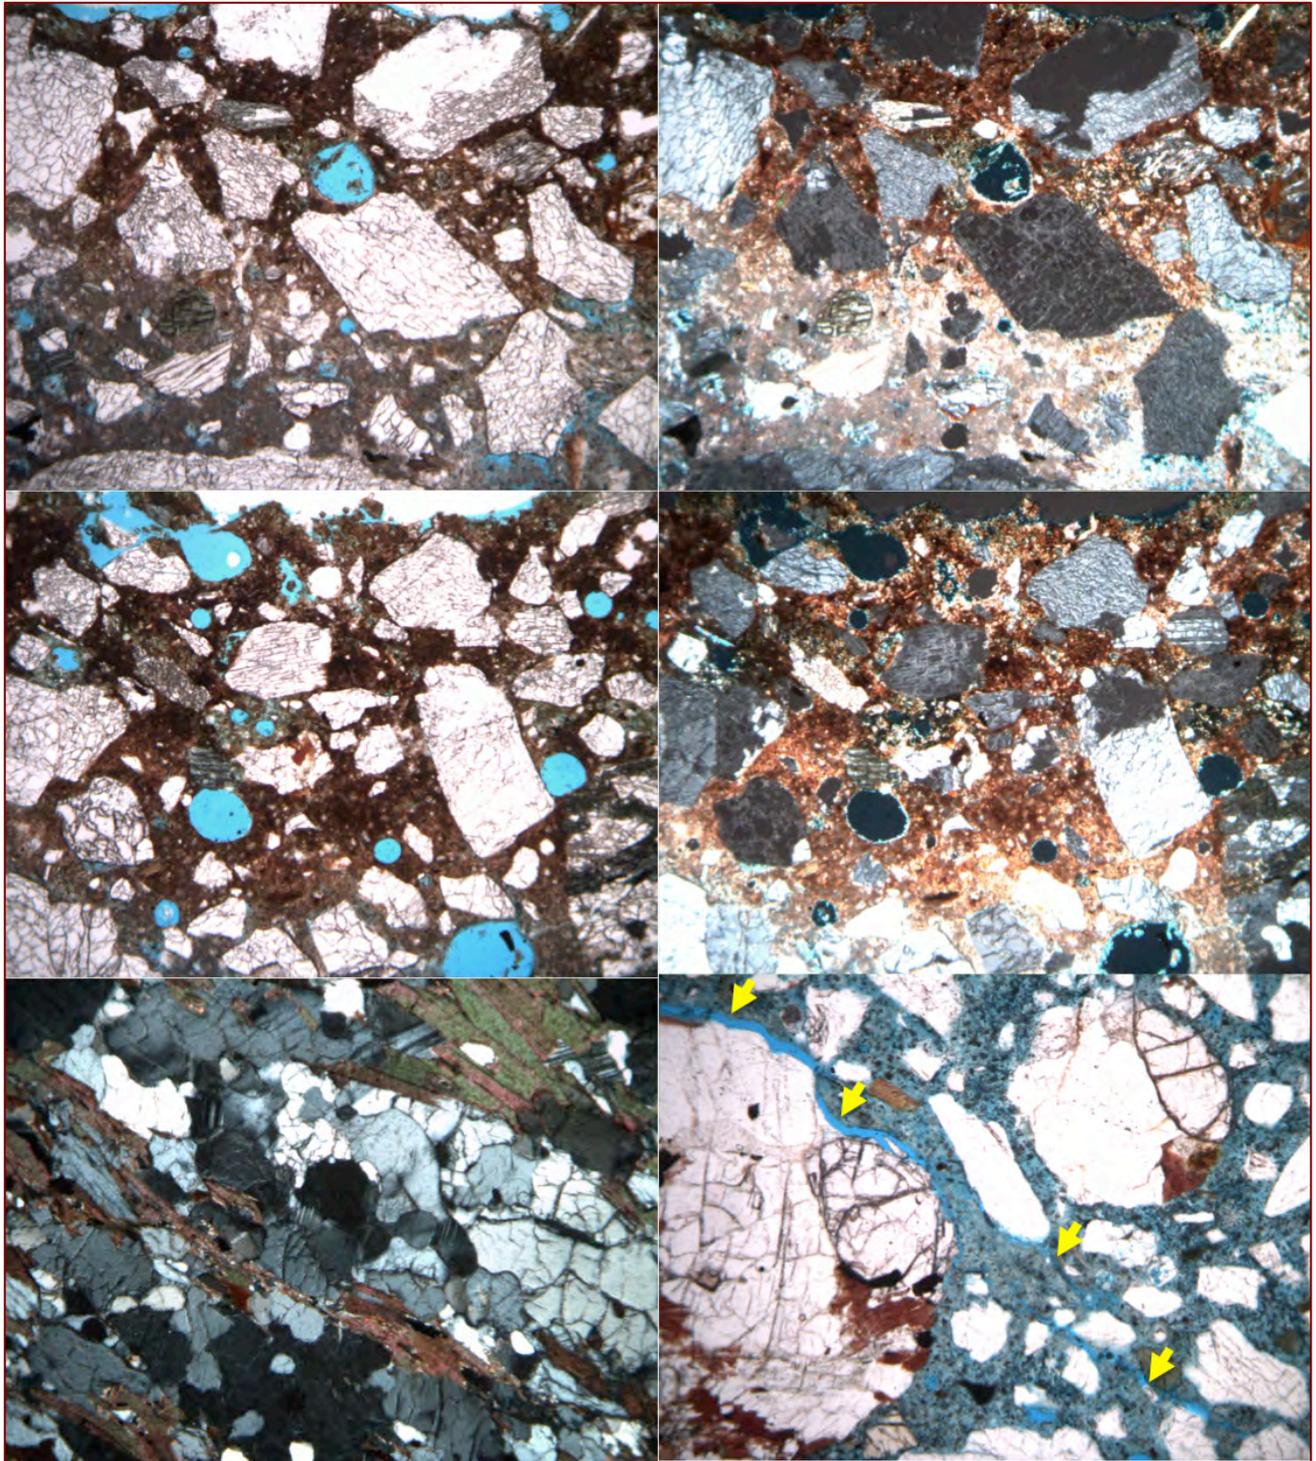
Figure 40: Thin Section# 7: Top and bottom row shows reddish brown weathered dark gray exterior surface end of the core (wall) that has carbonated paste. Bottom left photo shows a gneiss coarse aggregate having alternating bands of biotite and quartzo-feldspathic minerals. Bottom right photo shows cracking in the mortar fraction. Field width of each photo is 0.25 mm.

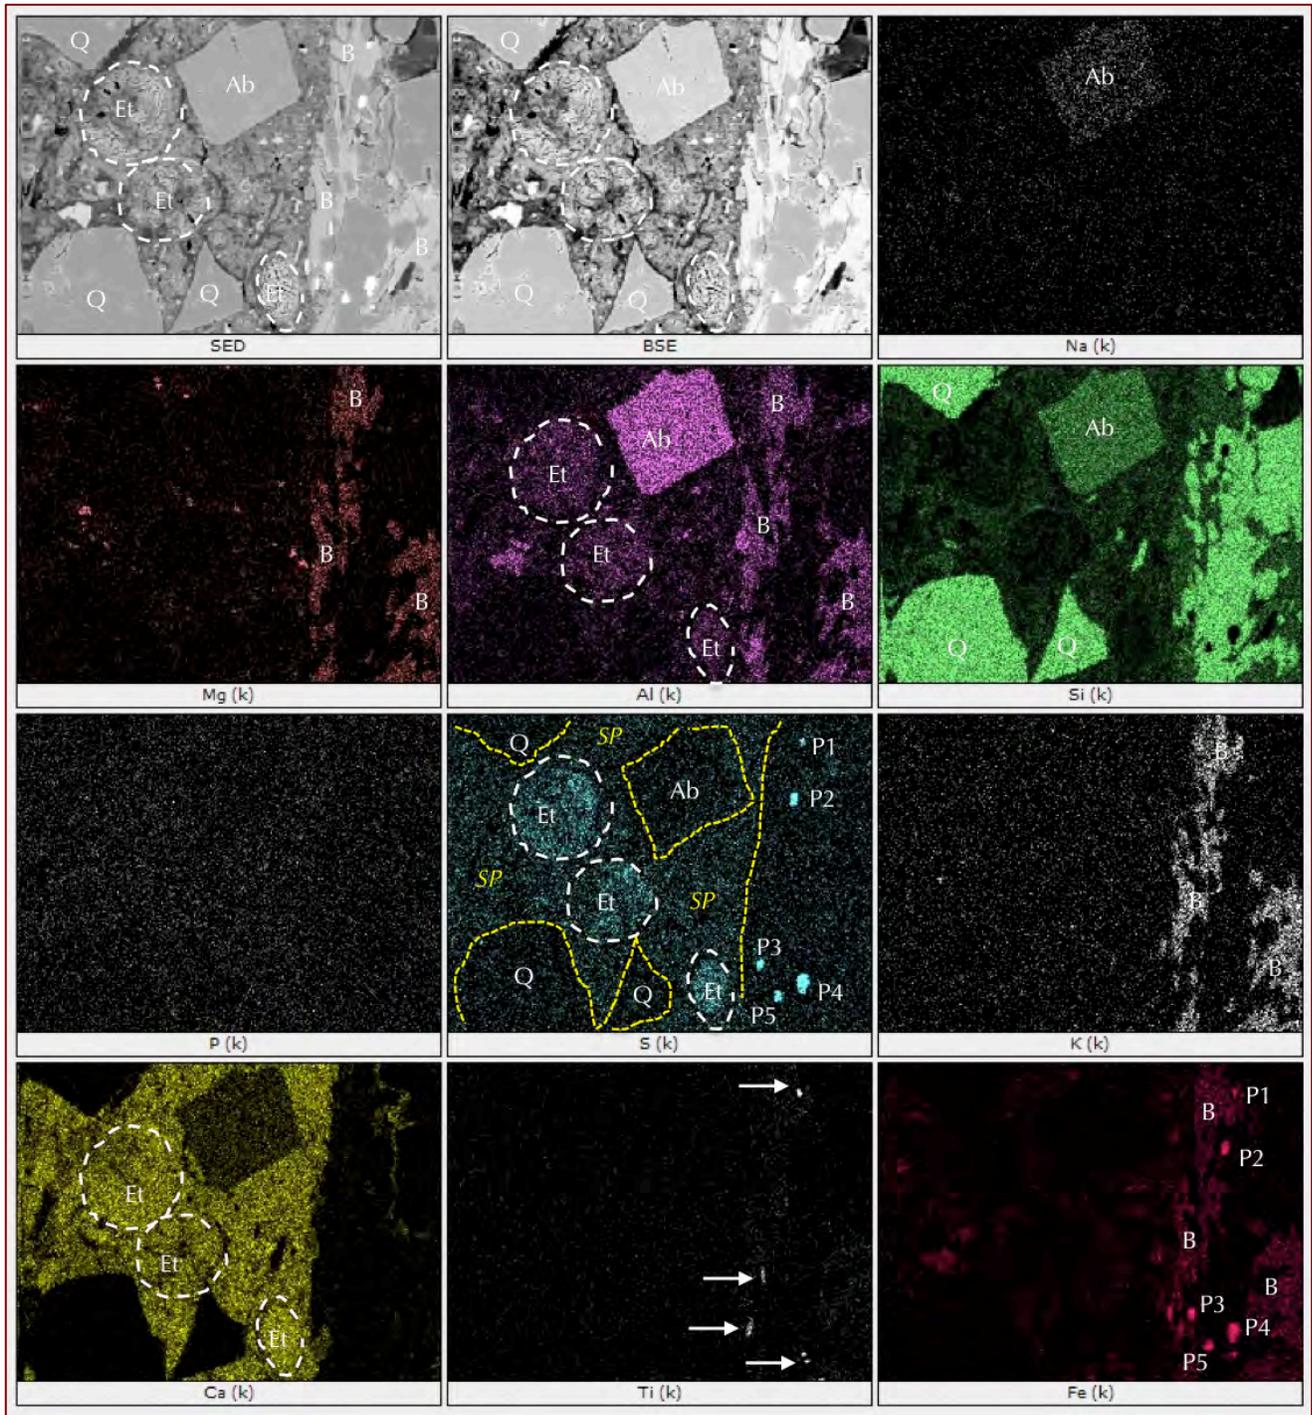
Figure 41: X-ray elemental maps of various elements (K-lines) showing: (a) three ettringite (Et) filled air-voids that are highlighted in respective maps of Ca, Al, and S the three main elements in ettringite, (b) albitic feldspar (Ab) in gneiss from Na-Al-Si maps, (c) quartz (Q) sand particles from characteristic Si-maps, (d) biotite (B) flakes in gneiss from characteristic Fe-Mg-K-Si-Al maps, (e) sulfate-contaminated paste (SP) in S-map having higher S-concentrations than aggregates (but lower sulfur than ettringite-filled voids), (f) five pyrrhotite (P1 to P5) grains in aggregate highlighted in Fe and S maps, and (g) a few tiny iron-titanium (ilmenite) grains marked by arrows in Ti-map.

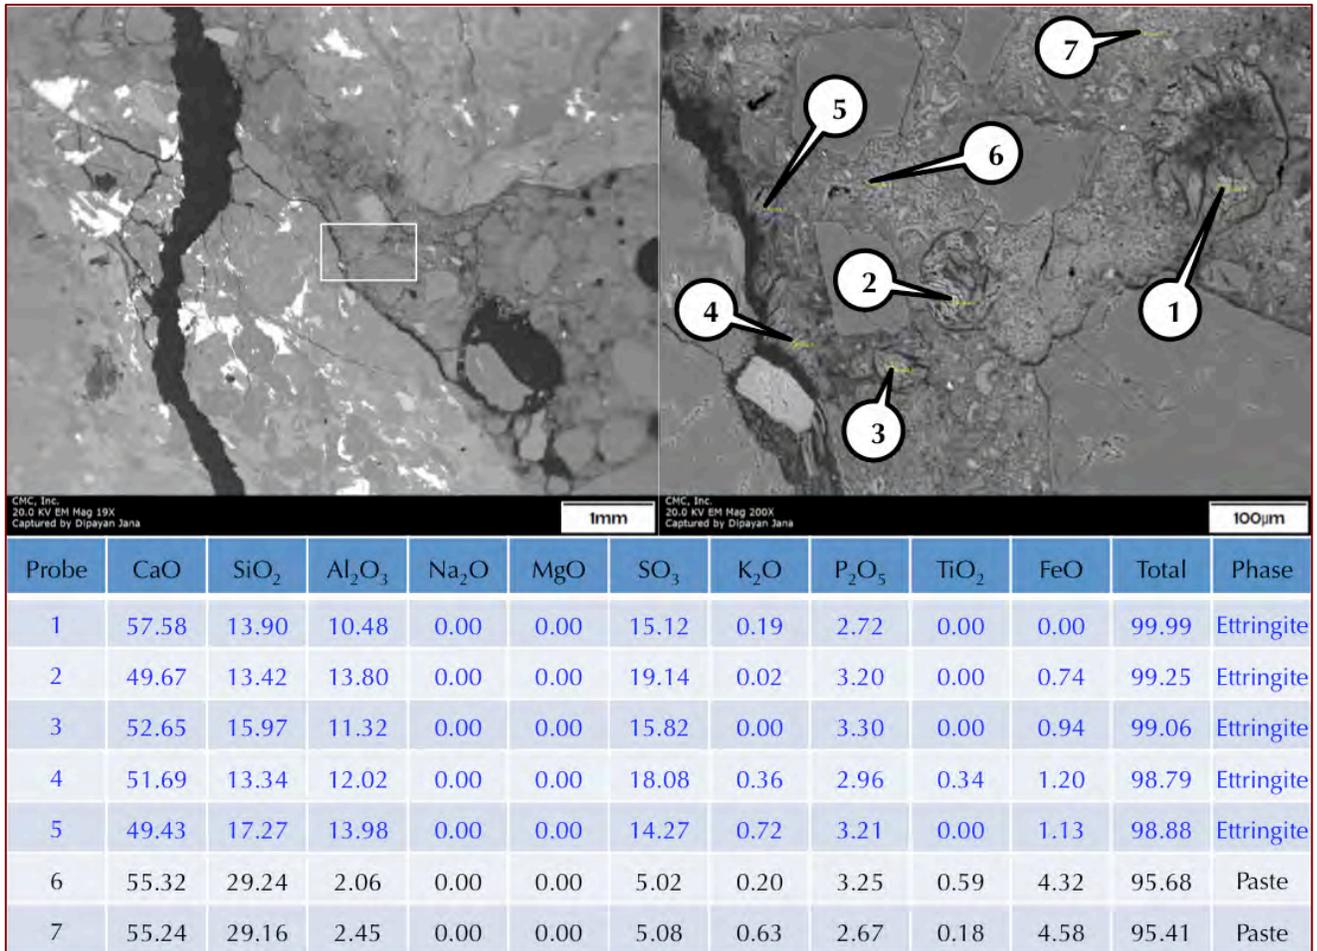
Figure 42: Secondary electron image (top left), enlarged view of the boxed area in the top left shown in the top right, and X-ray elemental analyses of various phases (bottom Table) showing compositions of secondary ettringite crystallization in three air-voids (Probe Nos. 1 through 3), in aggregate-paste interface (Probe Nos. 4 and 5) and compositions of paste (Probe Nos. 6 and 7). In all Probes, analyses were done at the tips of the callouts. The top left photo shows a pyrrhotite-bearing crushed gneiss coarse aggregate particle with extensive macro and microcracking (highlighted in dark), and, pyrrhotite and other iron inclusions (highlighted in bright areas in aggregates). Paste in Probe Nos. 6 and 7 show sulfate contents (as SO₃) of 5 percent, which are significantly higher than normal less than 1% sulfate (as SO₃) in a paste commonly found in Portland cement concretes containing no iron sulfide contaminants. Clearly, release of sulfate from pyrrhotite has contaminated the paste to promote internal sulfate attack with manifestation of additional cracking in the paste and along aggregate-paste interfaces, above and beyond cracking in the unsound aggregates from pyrrhotite oxidation.

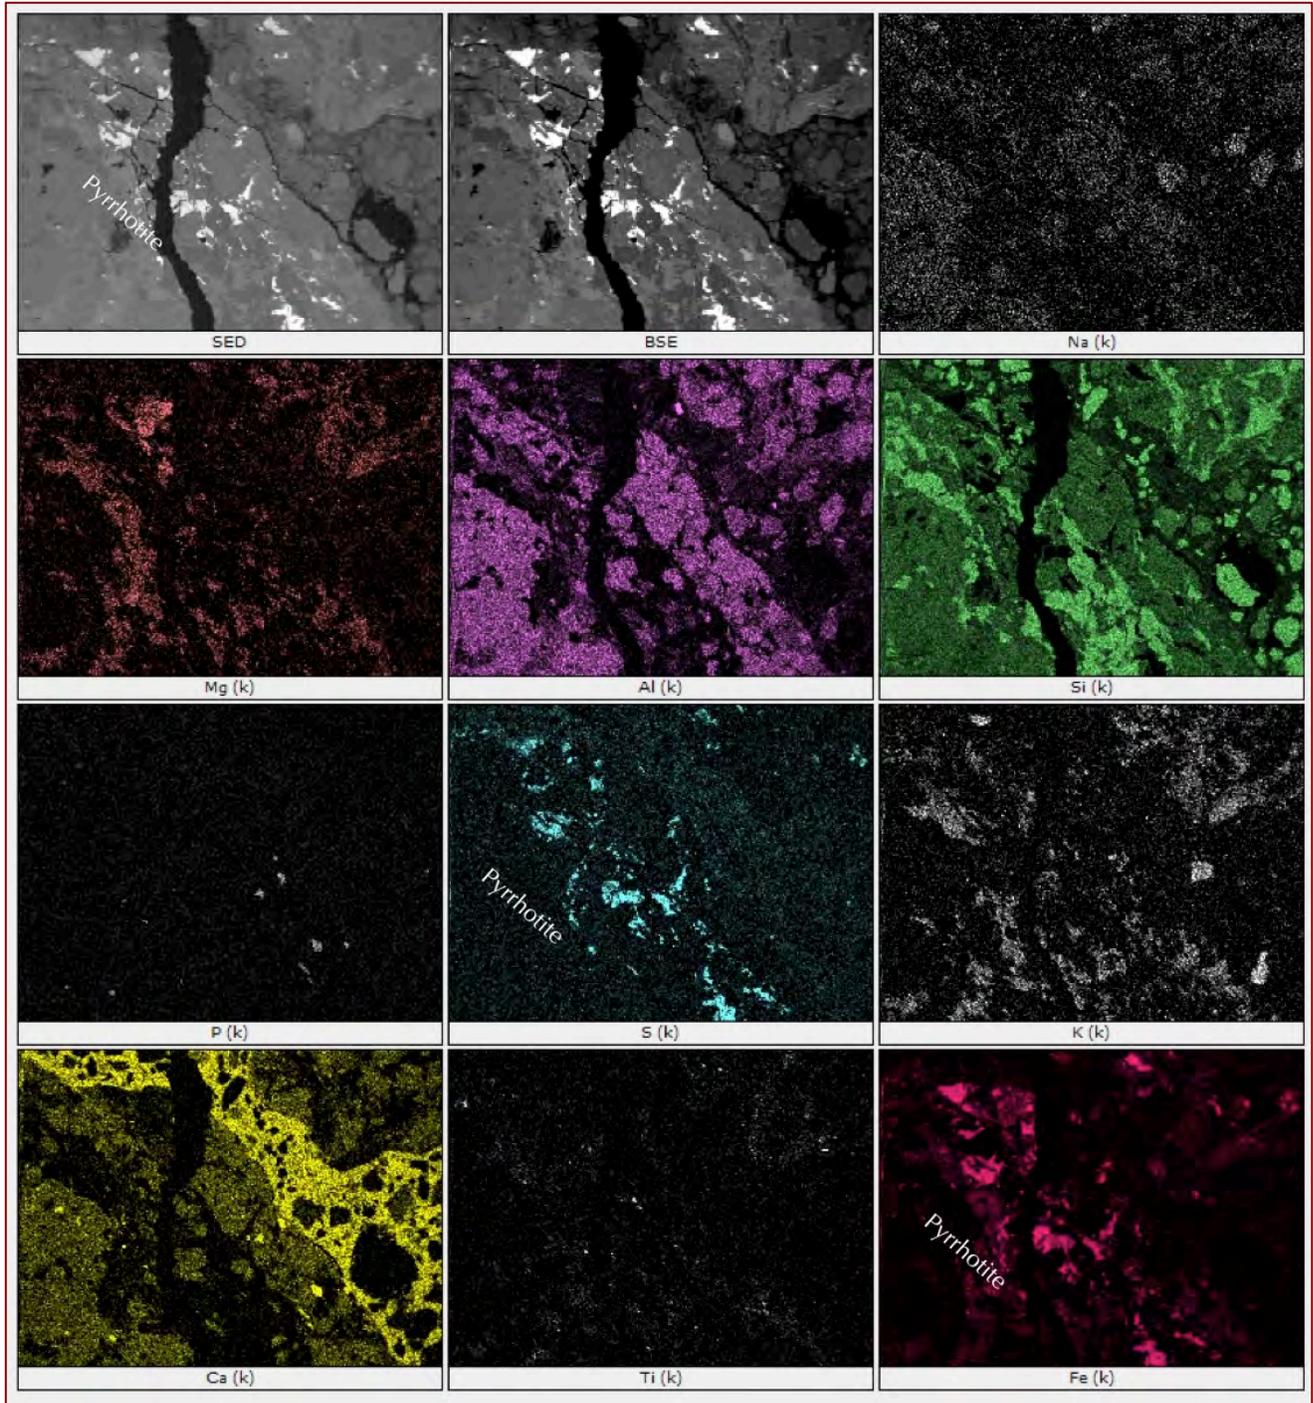
Figure 43: X-ray elemental maps of various elements (K-lines) showing pyrrhotite inclusions in a crushed gneiss coarse aggregate particle (shown in Figure 34) that is characterized by high sulfur and iron in respective elemental maps. Paste between two gneiss aggregate particles show characteristic high calcium and silica in respective maps. The bright spots in the Mg, Al, Na, K, and Si maps show biotite mica in gneiss; very bright areas in the Si map in paste are from quartz sand particles in paste.

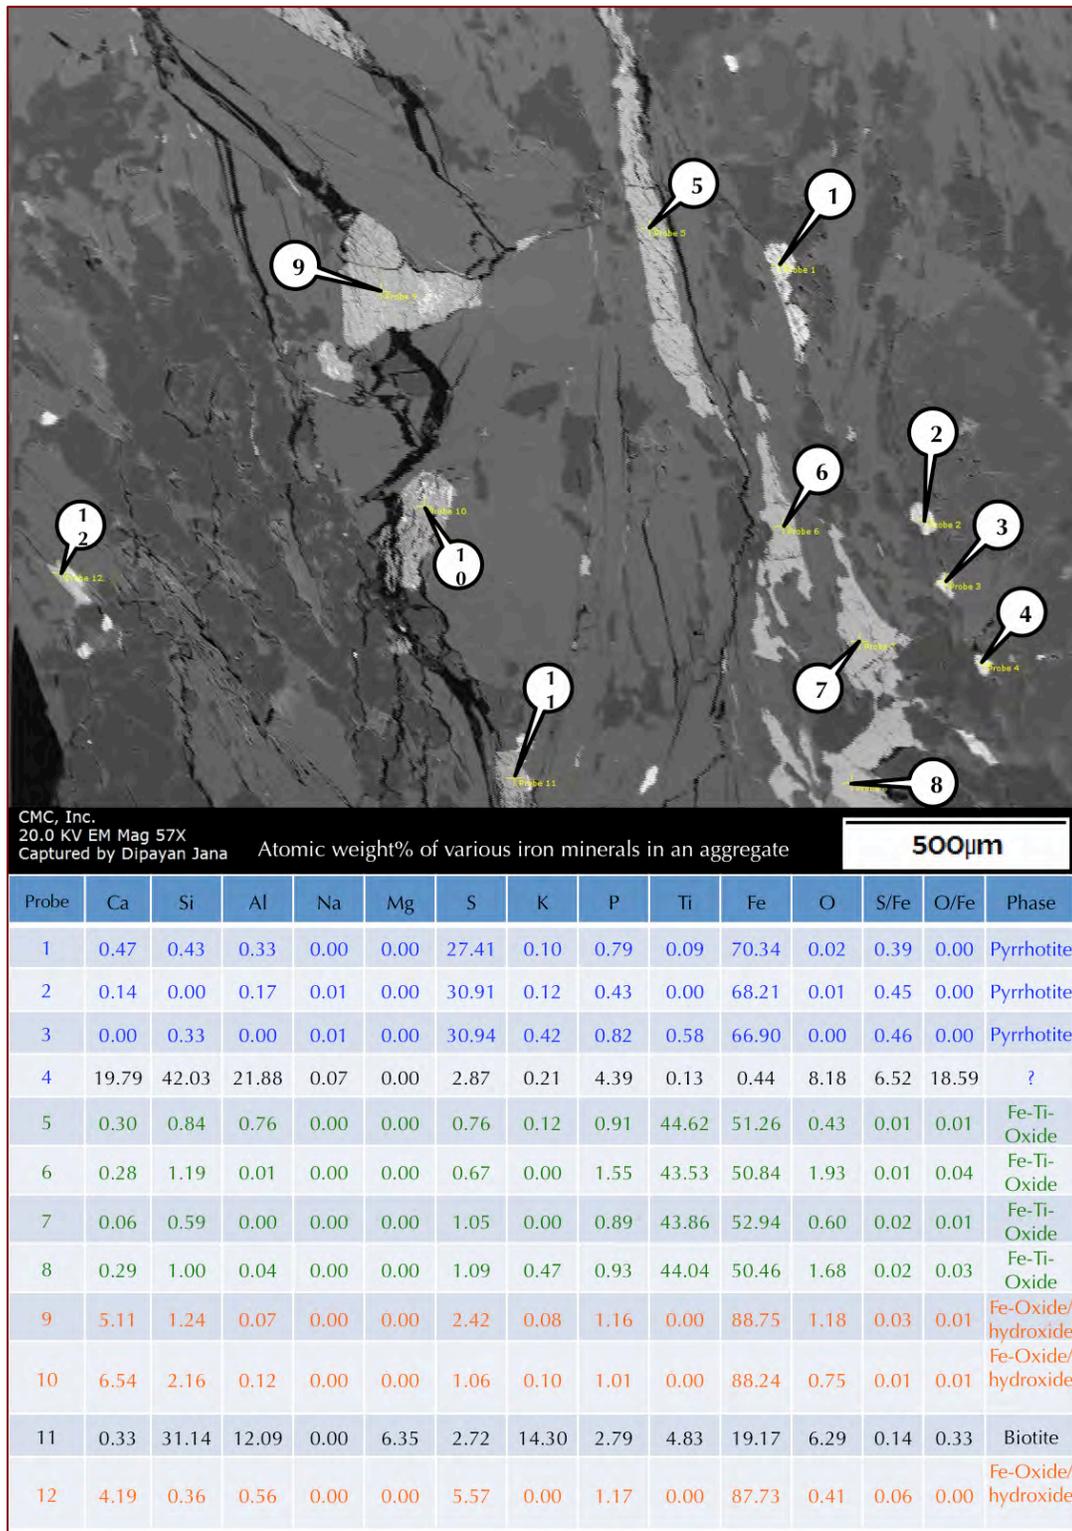
Figure 44: Secondary electron image (top) and X-ray elemental analyses (bottom) of various iron minerals in a crushed gneiss coarse aggregate particle showing three different types of opaque iron minerals: (a) iron sulfide (pyrrhotite) having high Fe and S (S/Fe ratio <0.5 indicating oxidation) in the blue rows in the Table, (b) iron-titanium oxides (rutile, ilmenite) having high Fe and Ti in the green rows, and Fe-oxide or hydroxide having very high Fe in orange rows. All three opaque iron minerals show similar bright areas in the secondary and backscatter electron images.

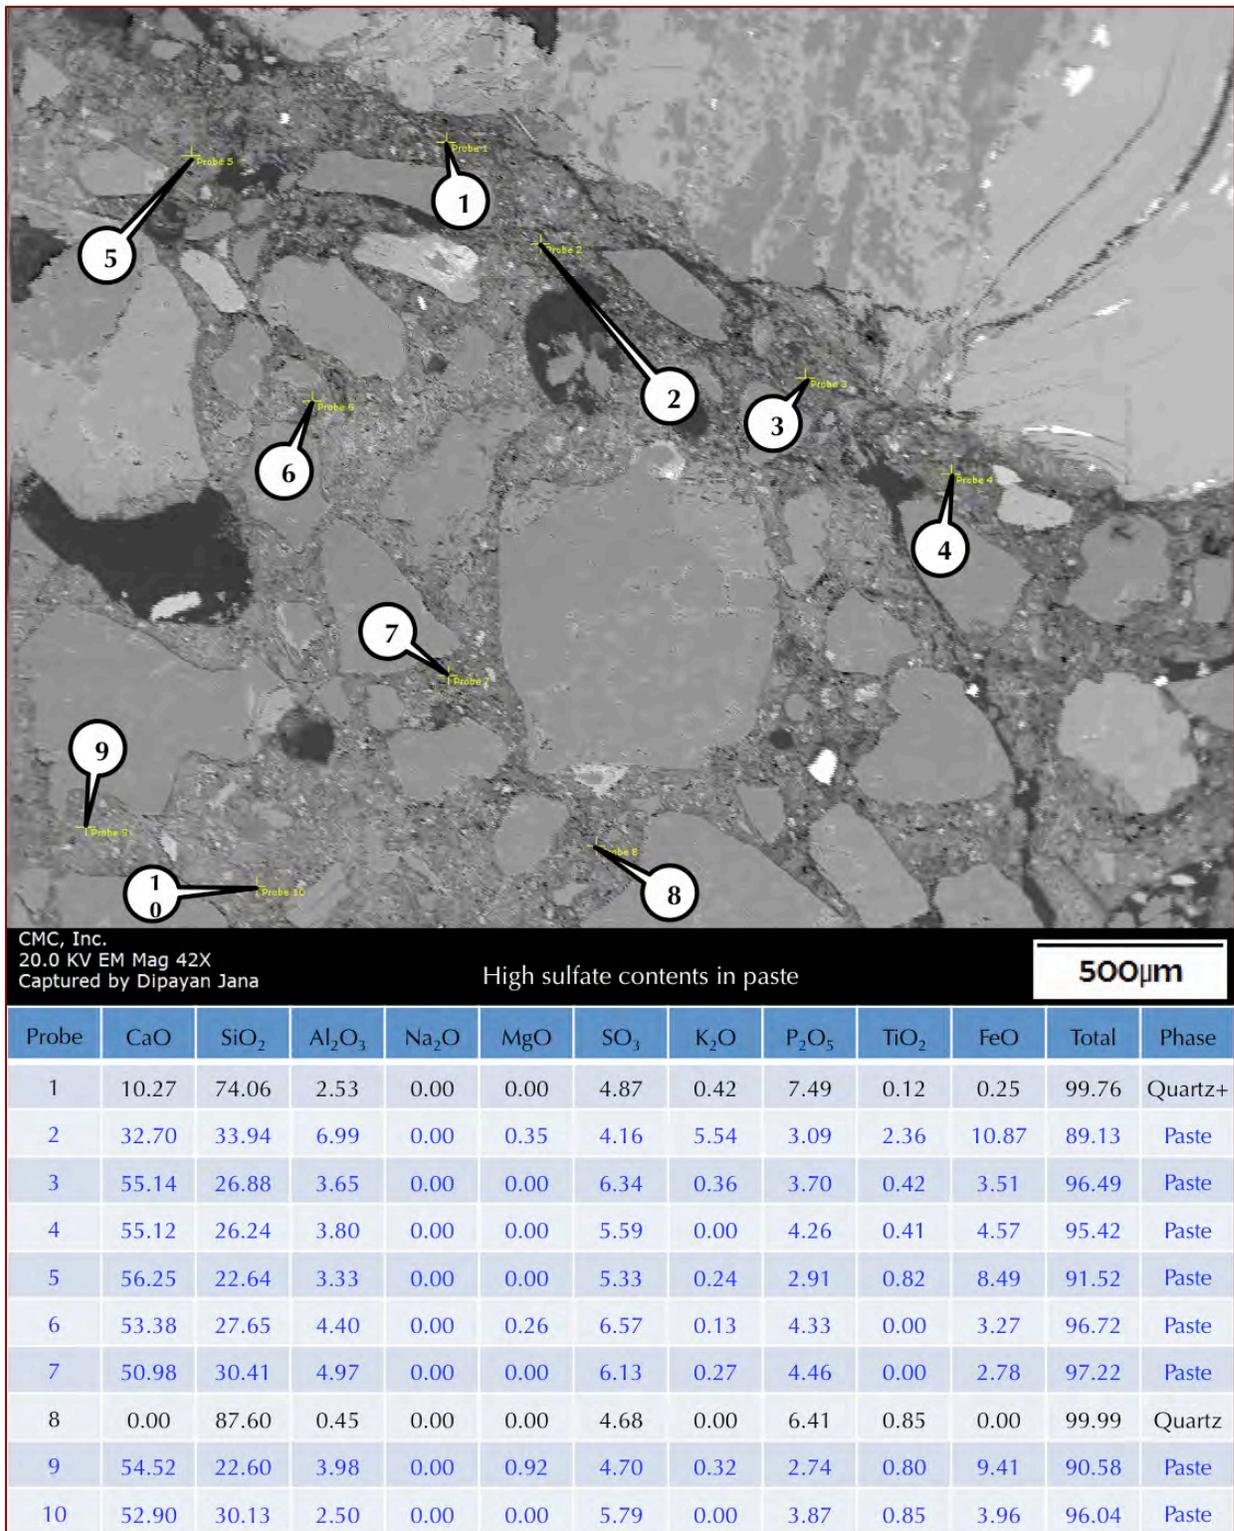
Figure 45: : Secondary electron image (top) and X-ray elemental analyses (bottom) of various areas of paste showing sulfate contents (as SO₃) of 4.1 to 6.5 percent, which are significantly higher than normal less than 1% sulfate (as SO₃) in a paste commonly found in Portland cement concretes containing no iron sulfide contaminants. Clearly, release of sulfate from pyrrhotite has contaminated the paste to promote internal sulfate attack with manifestation of additional cracking in the paste and along aggregate-paste interfaces, above and beyond cracking in the unsound aggregates from pyrrhotite oxidation.

6. Pyrrhotite oxidation has readily released sulfates and contaminated the Portland cement paste as detected from high (4 to 6.5%) sulfate contents in the SEM-EDS analyses of paste as opposed to normal less than 1% sulfate found in the paste of a Portland cement concrete containing no iron sulfide contaminants. Ready release of sulfate has promoted internal sulfate attack and subsequent secondary expansion of paste with additional cracking.

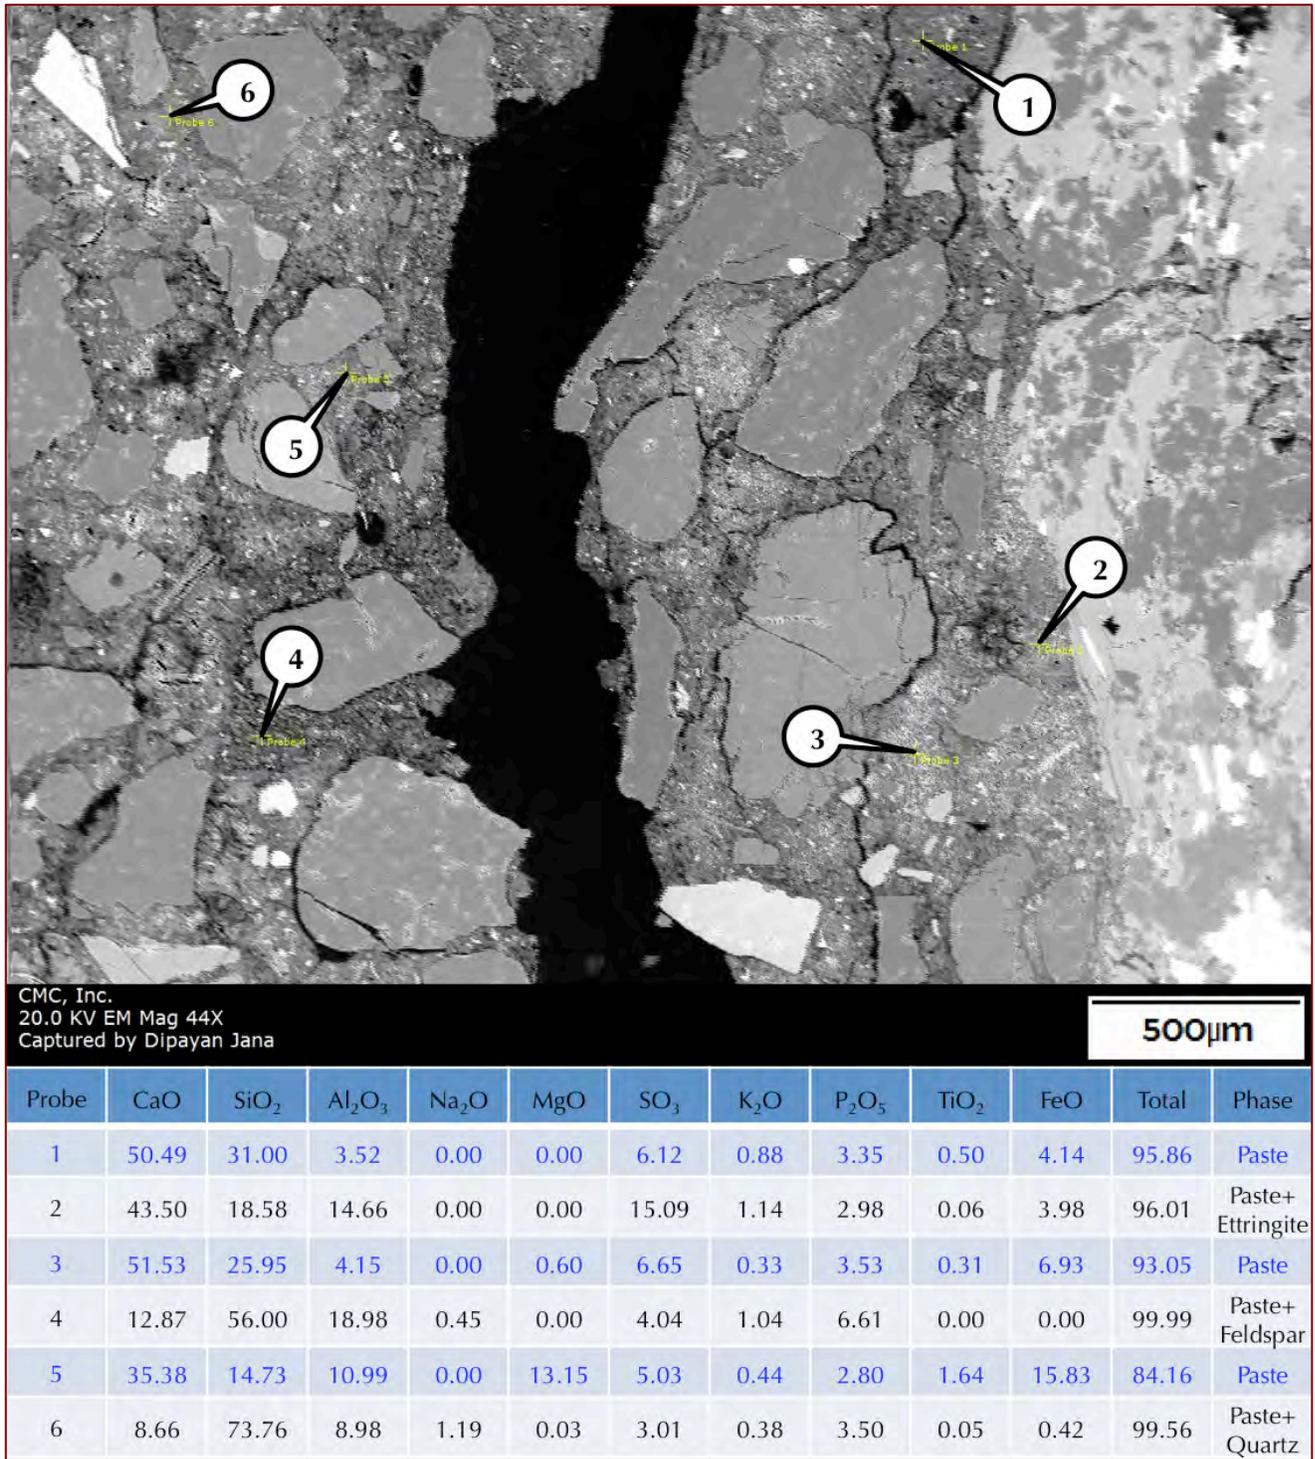
Figure 46: Backscatter electron image (top) and X-ray elemental analyses (bottom) of various areas of paste showing gaps around fine aggregates that are common in many DEF-affected concretes due to expansion of paste due to internal sulfate attacks. Compositional analyses of paste *per se* in Probe Nos. 1, 3, and 5 show sulfate contents (as SO₃) from 5 to 6.6 percent, which are significantly higher than normal less than 1% sulfate (as SO₃) in a paste commonly found in Portland cement concretes containing no iron sulfide contaminants. Clearly, release of sulfate from pyrrhotite has contaminated the paste to promote internal sulfate attack with manifestation of additional cracking in the paste and along aggregate-paste interfaces, above and beyond cracking in the unsound aggregates from pyrrhotite oxidation.

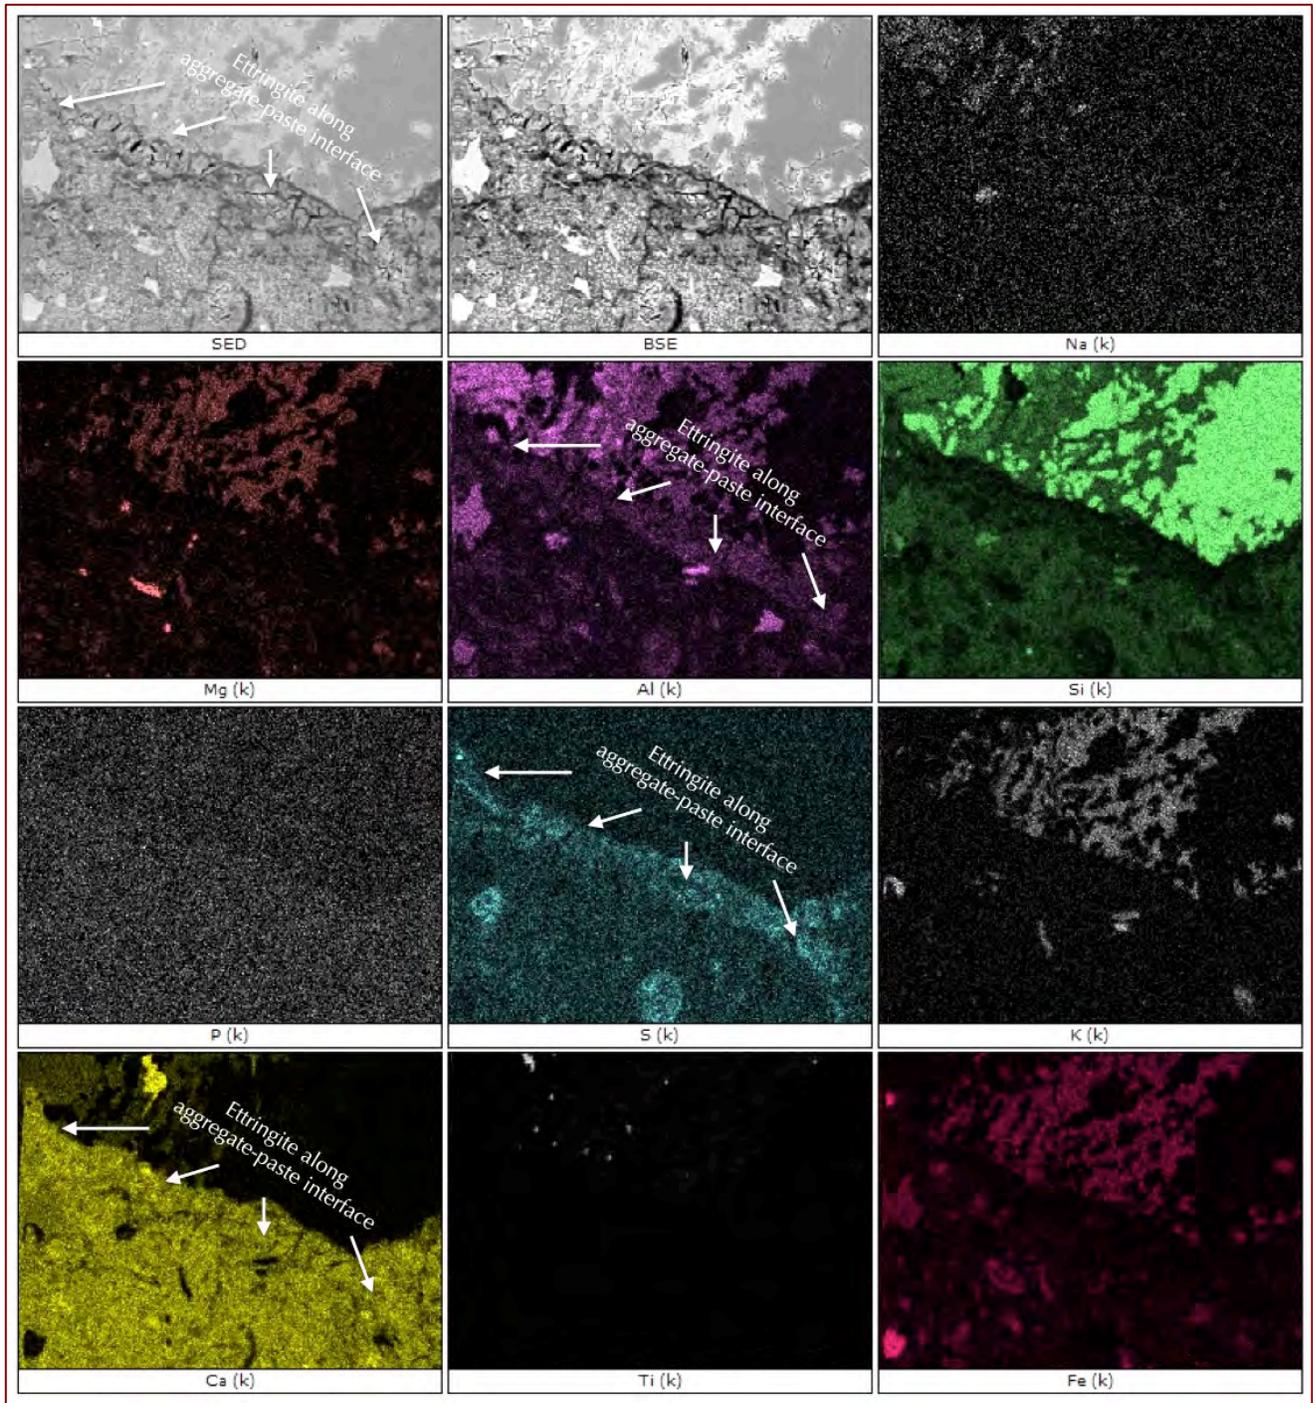
Figure 47: X-ray elemental maps of various elements (K-lines) showing secondary ettringite crystallization along aggregate-paste interface that is characterized by high sulfur, aluminum, and calcium in respective elemental maps.

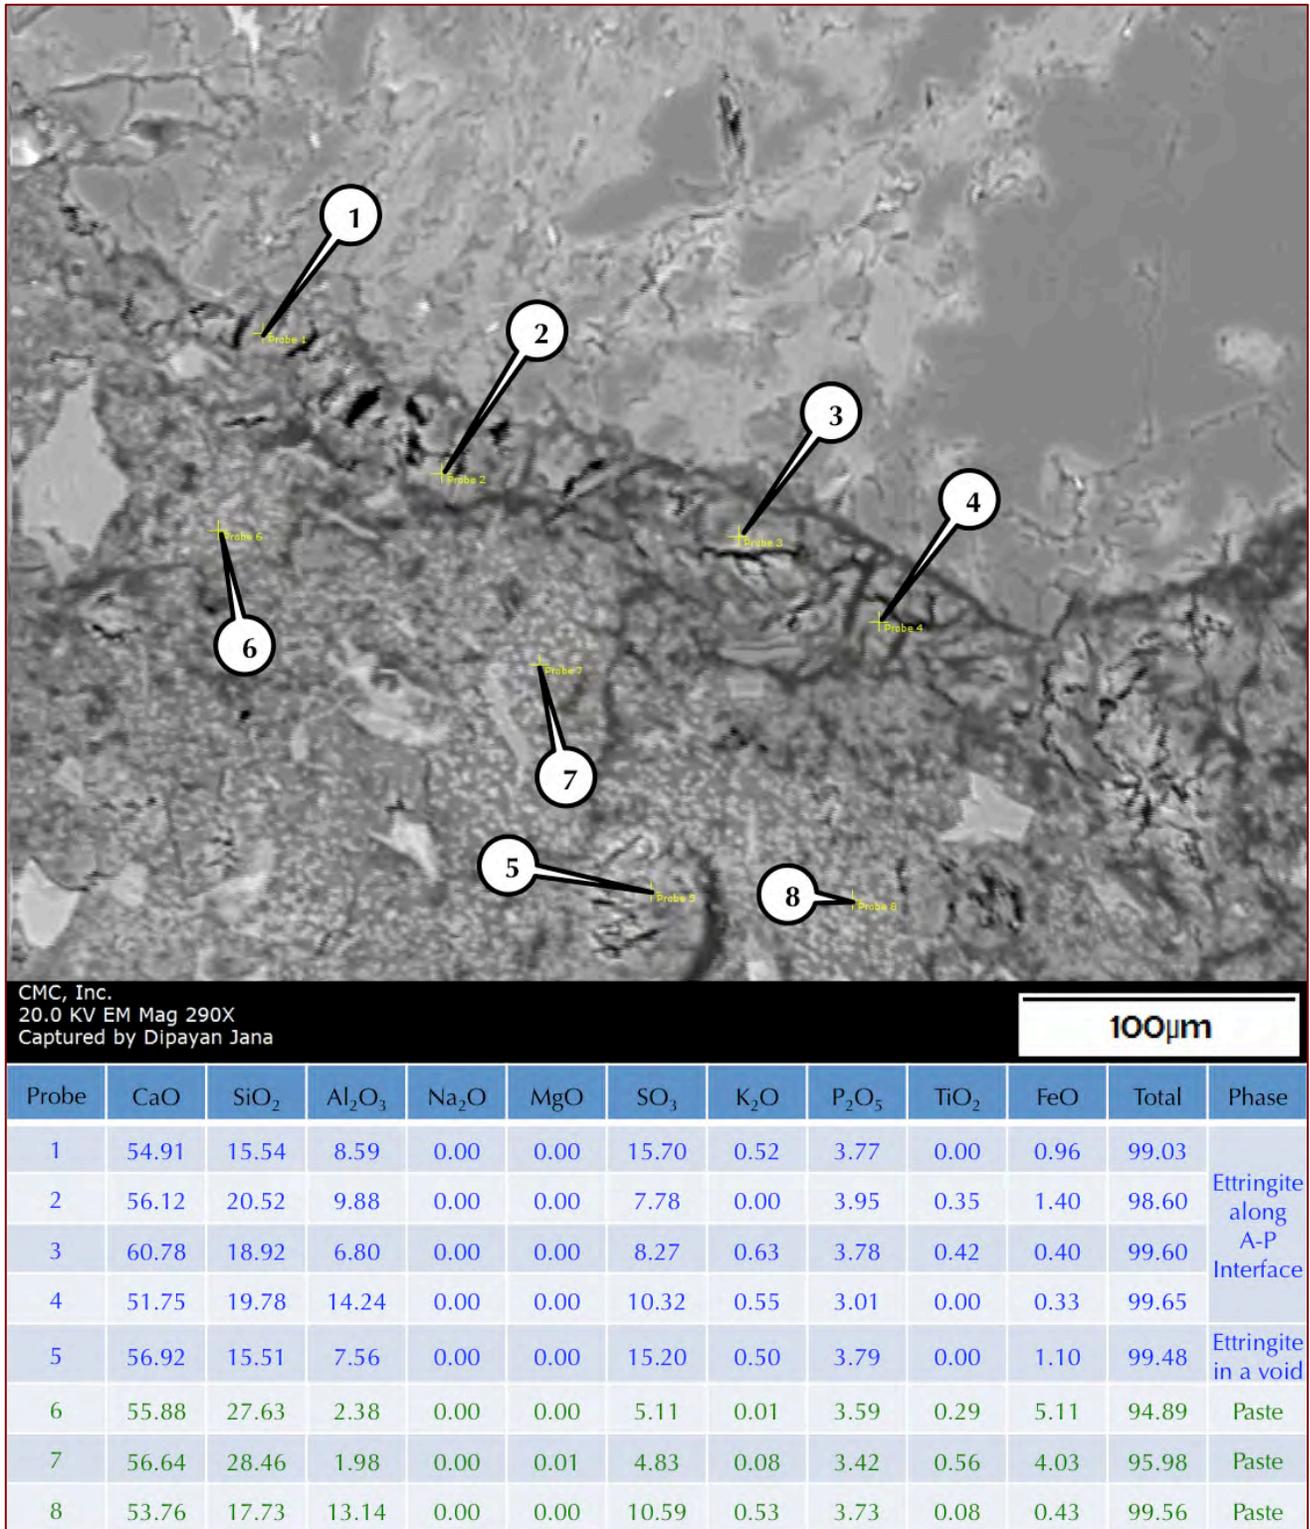
Figure 48: Backscatter electron image (top) and X-ray elemental analyses (bottom) of secondary ettringite crystallization along aggregate-paste interface showing characteristic Ca-Al-S compositions of ettringite and sulfate-contaminated calcium aluminum silicate hydrate paste.

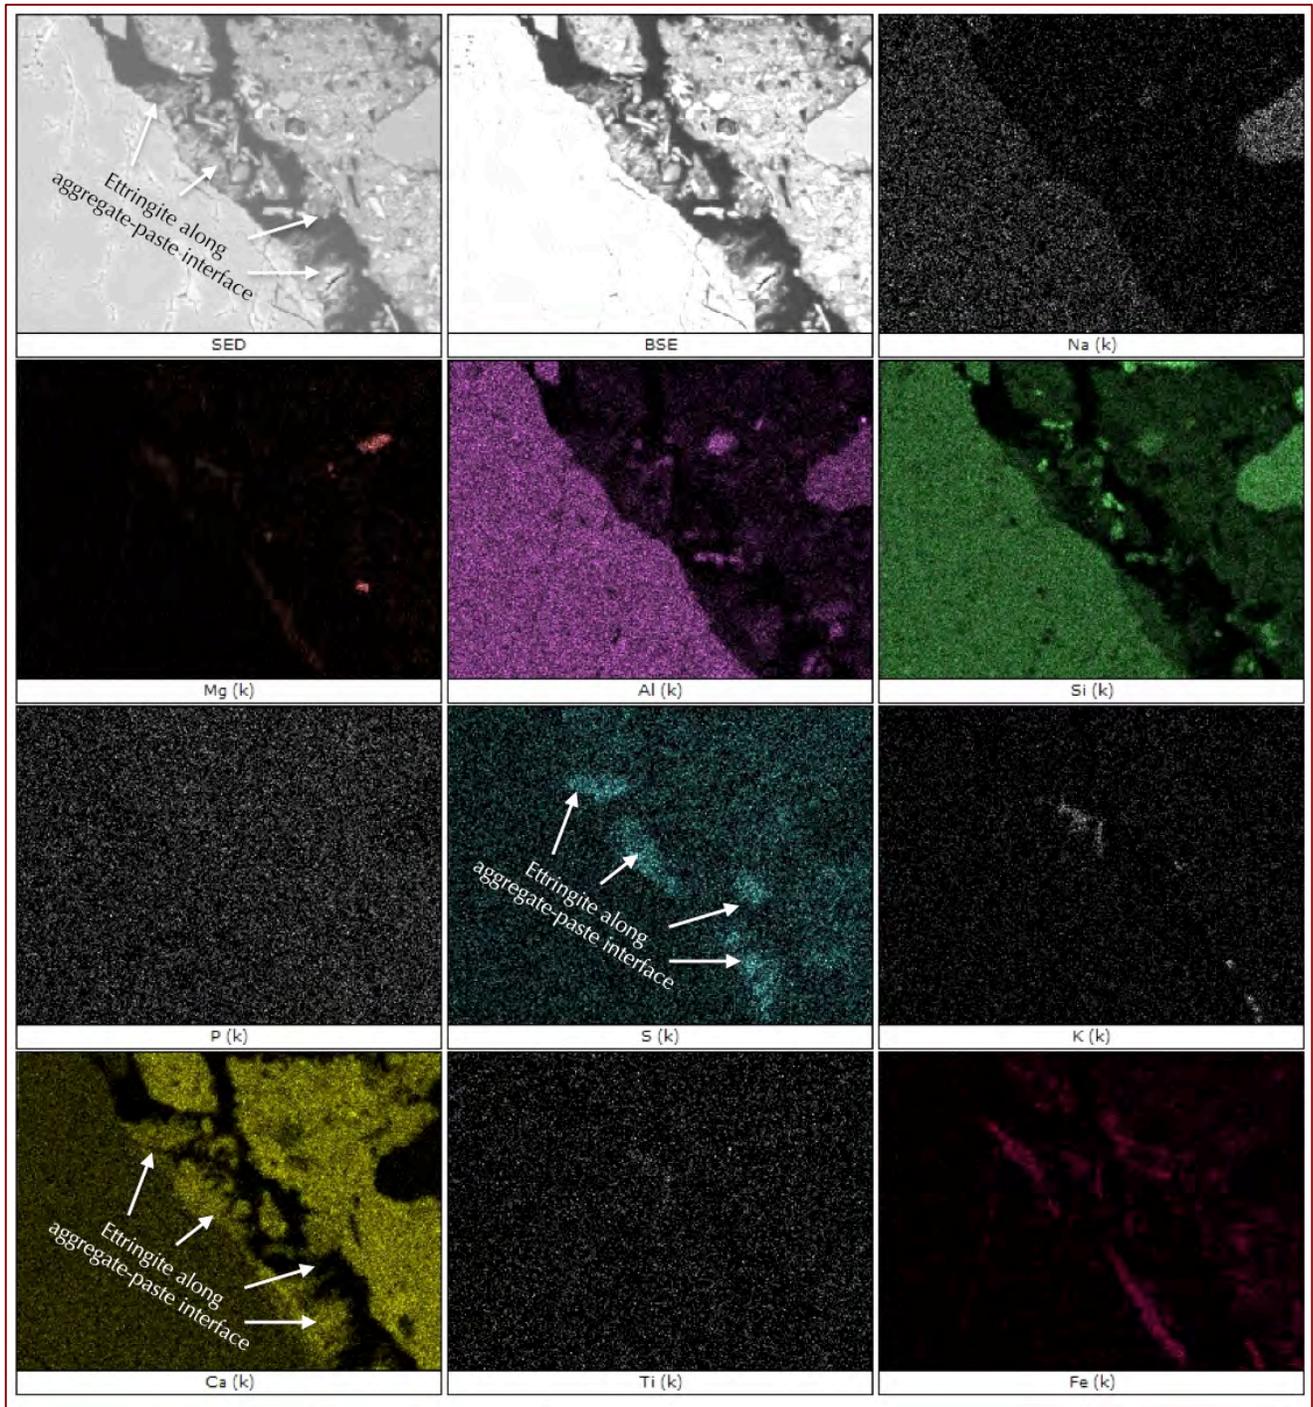
Figure 49: X-ray elemental maps of various elements (K-lines) showing secondary ettringite crystallization along aggregate-paste interface that is characterized by high sulfur, aluminum, and calcium in respective elemental maps.

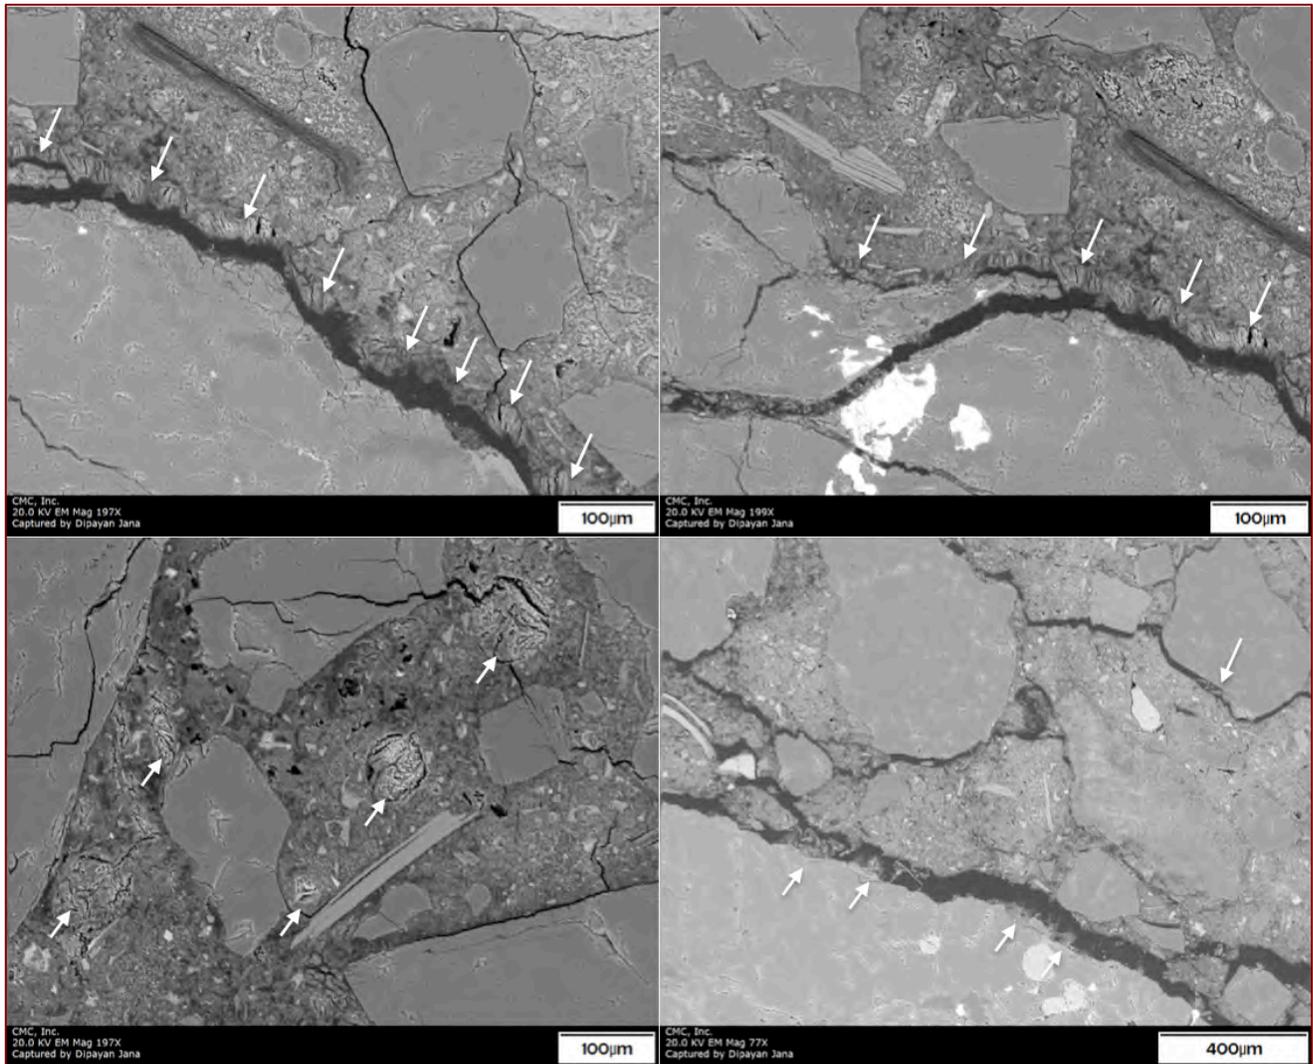
Figure 50: Secondary electron images showing secondary ettringite crystallization in microcracks along aggregate-paste interfaces, and in air-voids (bottom left photo). All these features are testaments of having moisture in a sulfate-contaminated paste.

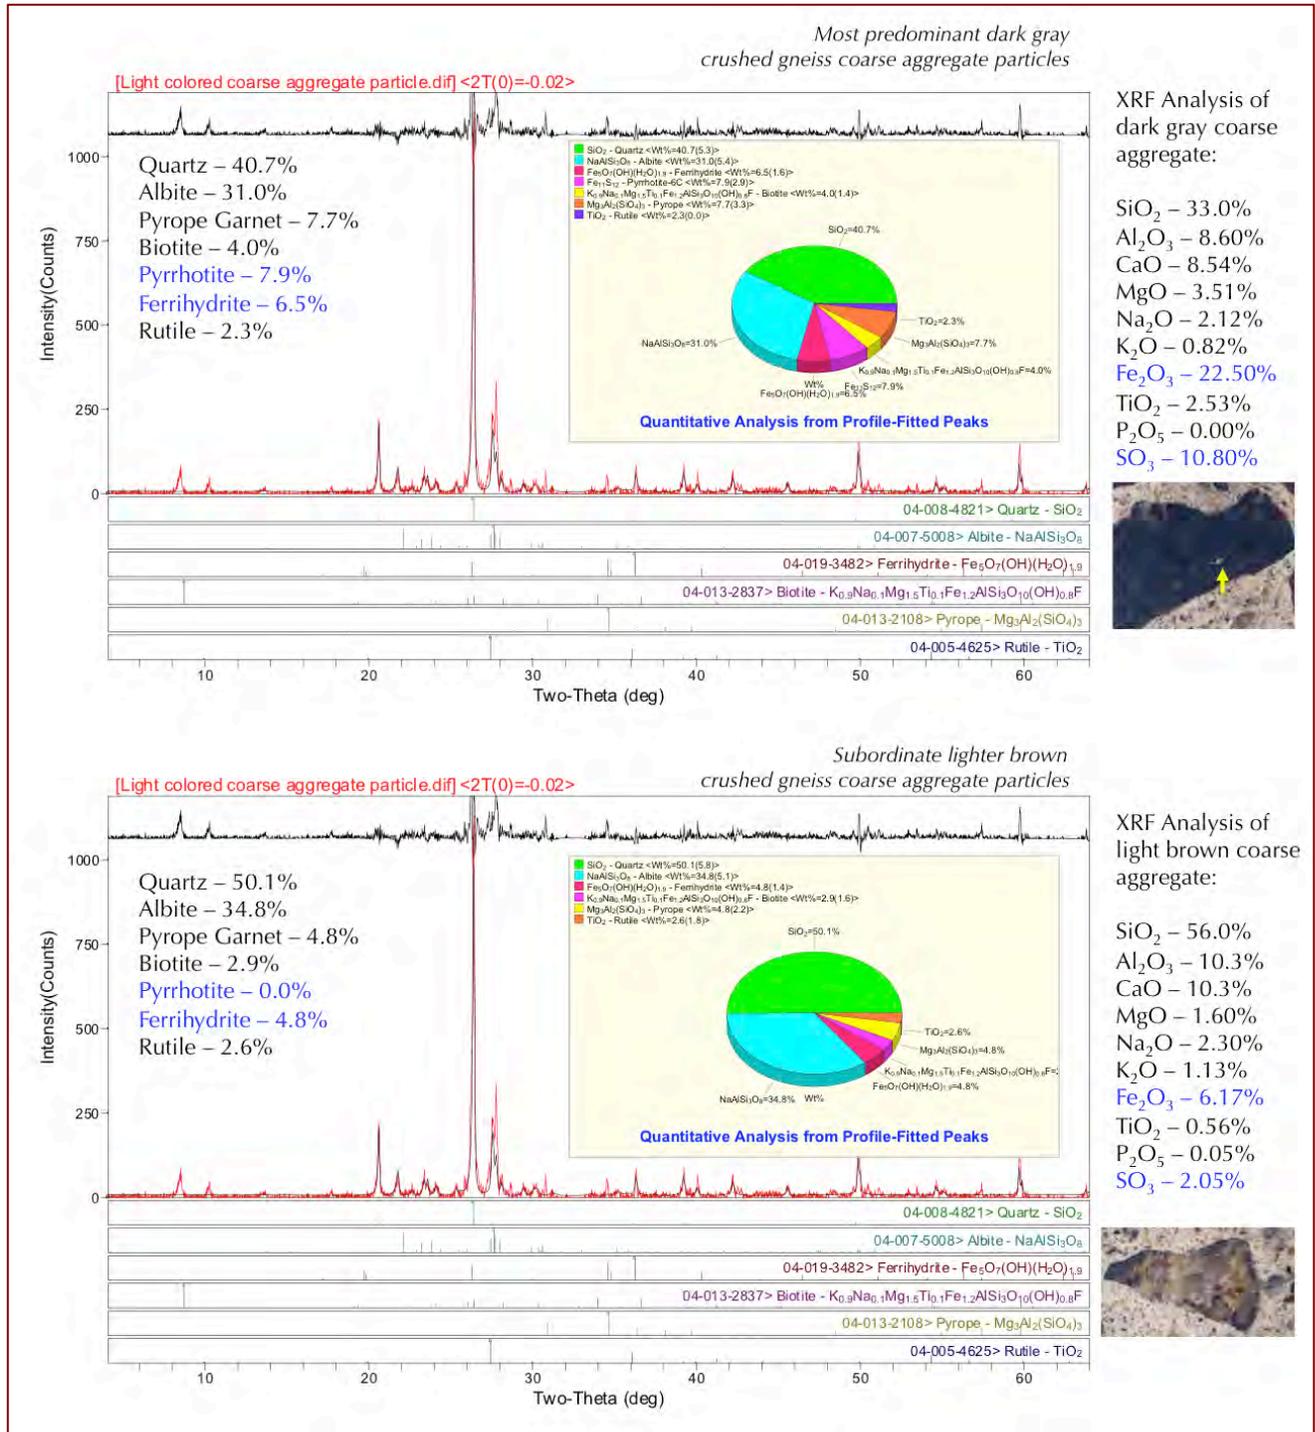
Figure 51: X-ray diffraction patterns, quantitative proportions of minerals, and X-ray fluorescence analyses of a representative dark gray crushed gneiss coarse aggregate (top) and a light brown crushed gneiss coarse aggregate (bottom) showing the presence of pyrrhotite only in the dark gray particle (inset at the top right shows one such particle with a pyrrhotite grain shown by an arrow) and its oxidation product ferrihydrite in both particles, and the presence of pyrope garnet.
