Pyrrhotite Epidemic in Eastern Connecticut – A Case Study From Ellington, CT

Cracking & Crumbling of A Residential Concrete Foundation In
Ellington, Connecticut

January 2018
CMC Interim Report

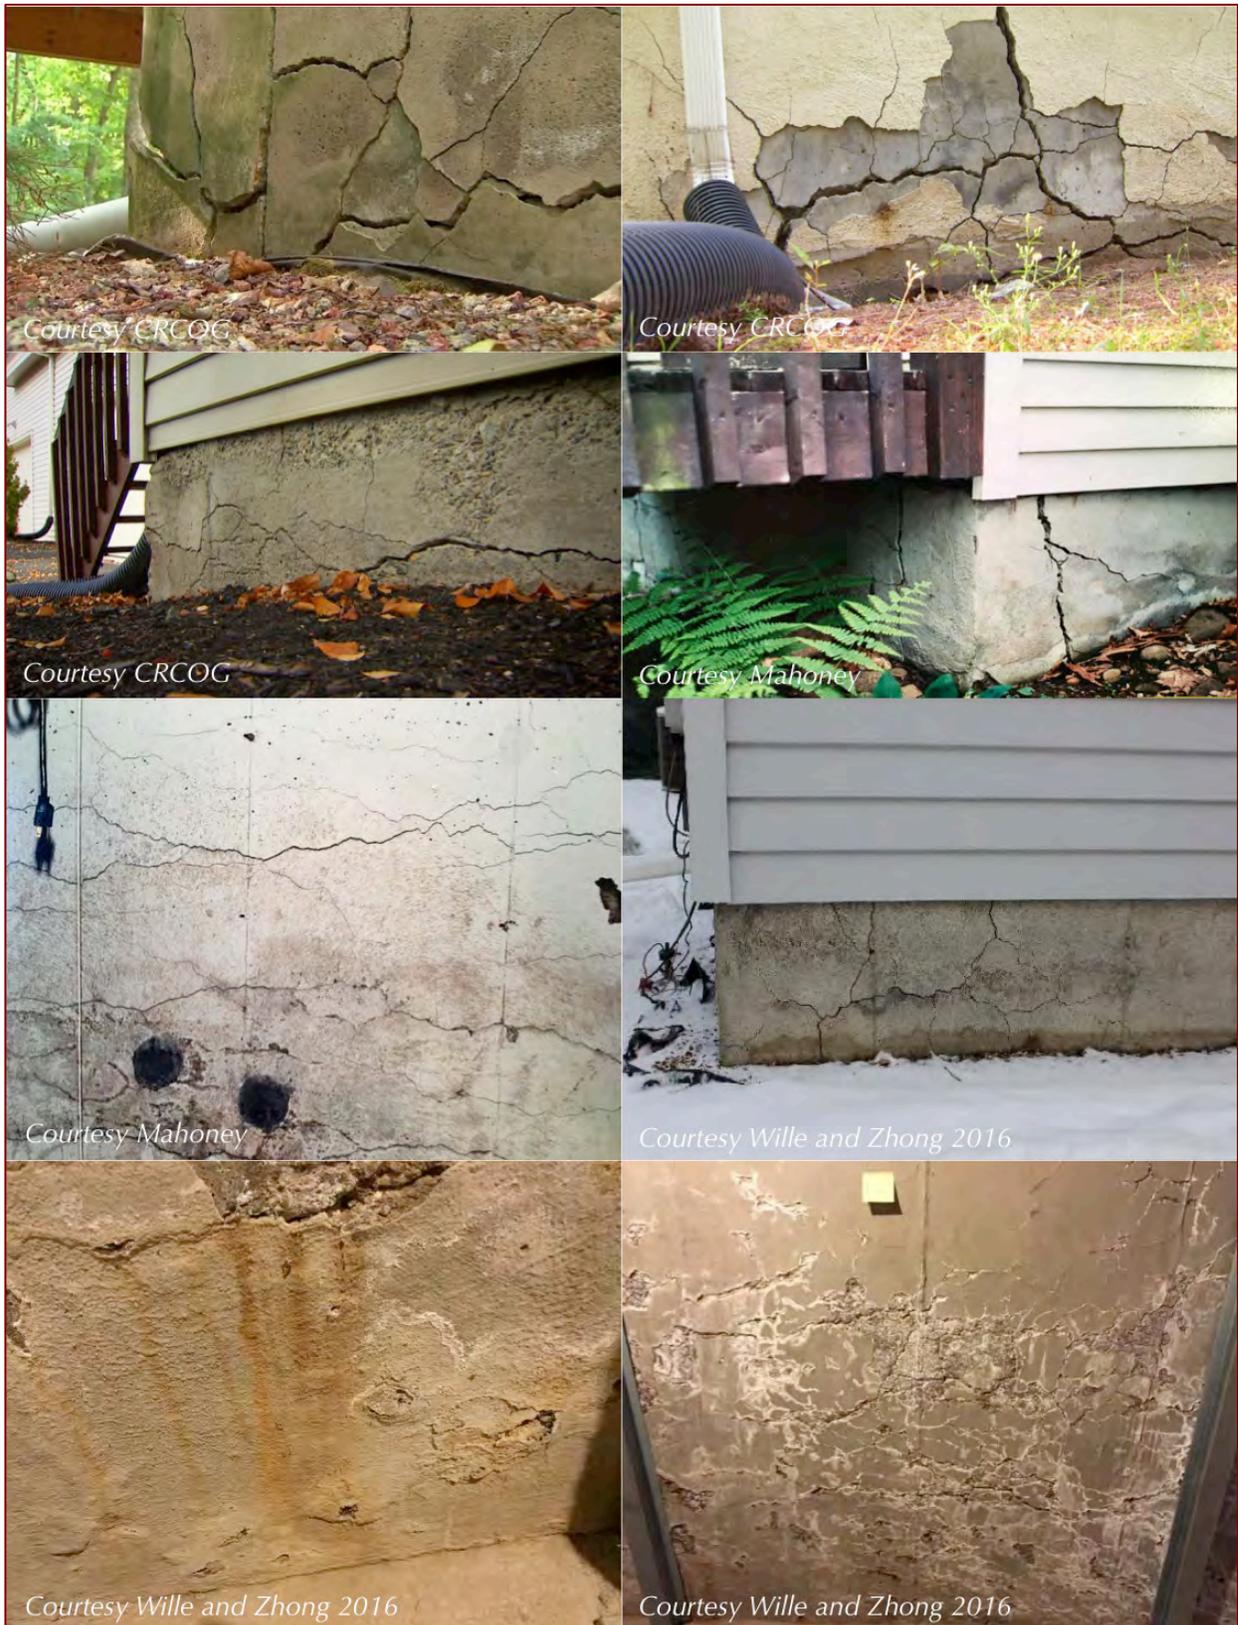
Figure 55: Cracking of concrete foundations in Connecticut due to oxidation of pyrrhotite bearing aggregates in concrete. Notice wide cracks in the top row as well as a network of numerous fine cracks in the wall in the bottom right row all from pyrrhotite oxidation and associated expansion of concrete.

Figure 54 shows regional spread of the latest reported incident of widespread outbreak of deterioration of concrete due to pyrrhotite oxidation in the aggregate along northeastern Connecticut with many hundreds of homes being affected. Figures 55 through 58 show various manifestations of distress in the affected homes from various sources. Typical visual deterioration was in the form of map cracking, some causing deformation of the wall, extensive longitudinal to random cracking of the wall, reddish-brown discoloration, and whitish formation in the vicinity of surface cracking most of which are shown in Figures 55 to 58. Currently, much of the information available on this problem is limited to newspaper articles but the cause of deterioration has been confirmed by an investigation conducted at the University of Connecticut (Wille and Zhong, 2016) as oxidation of pyrrhotite present in the aggregate. In contrast to the problems encountered in Quebec, manifestation of the damage in Connecticut has taken as much as 10 to 20 years.

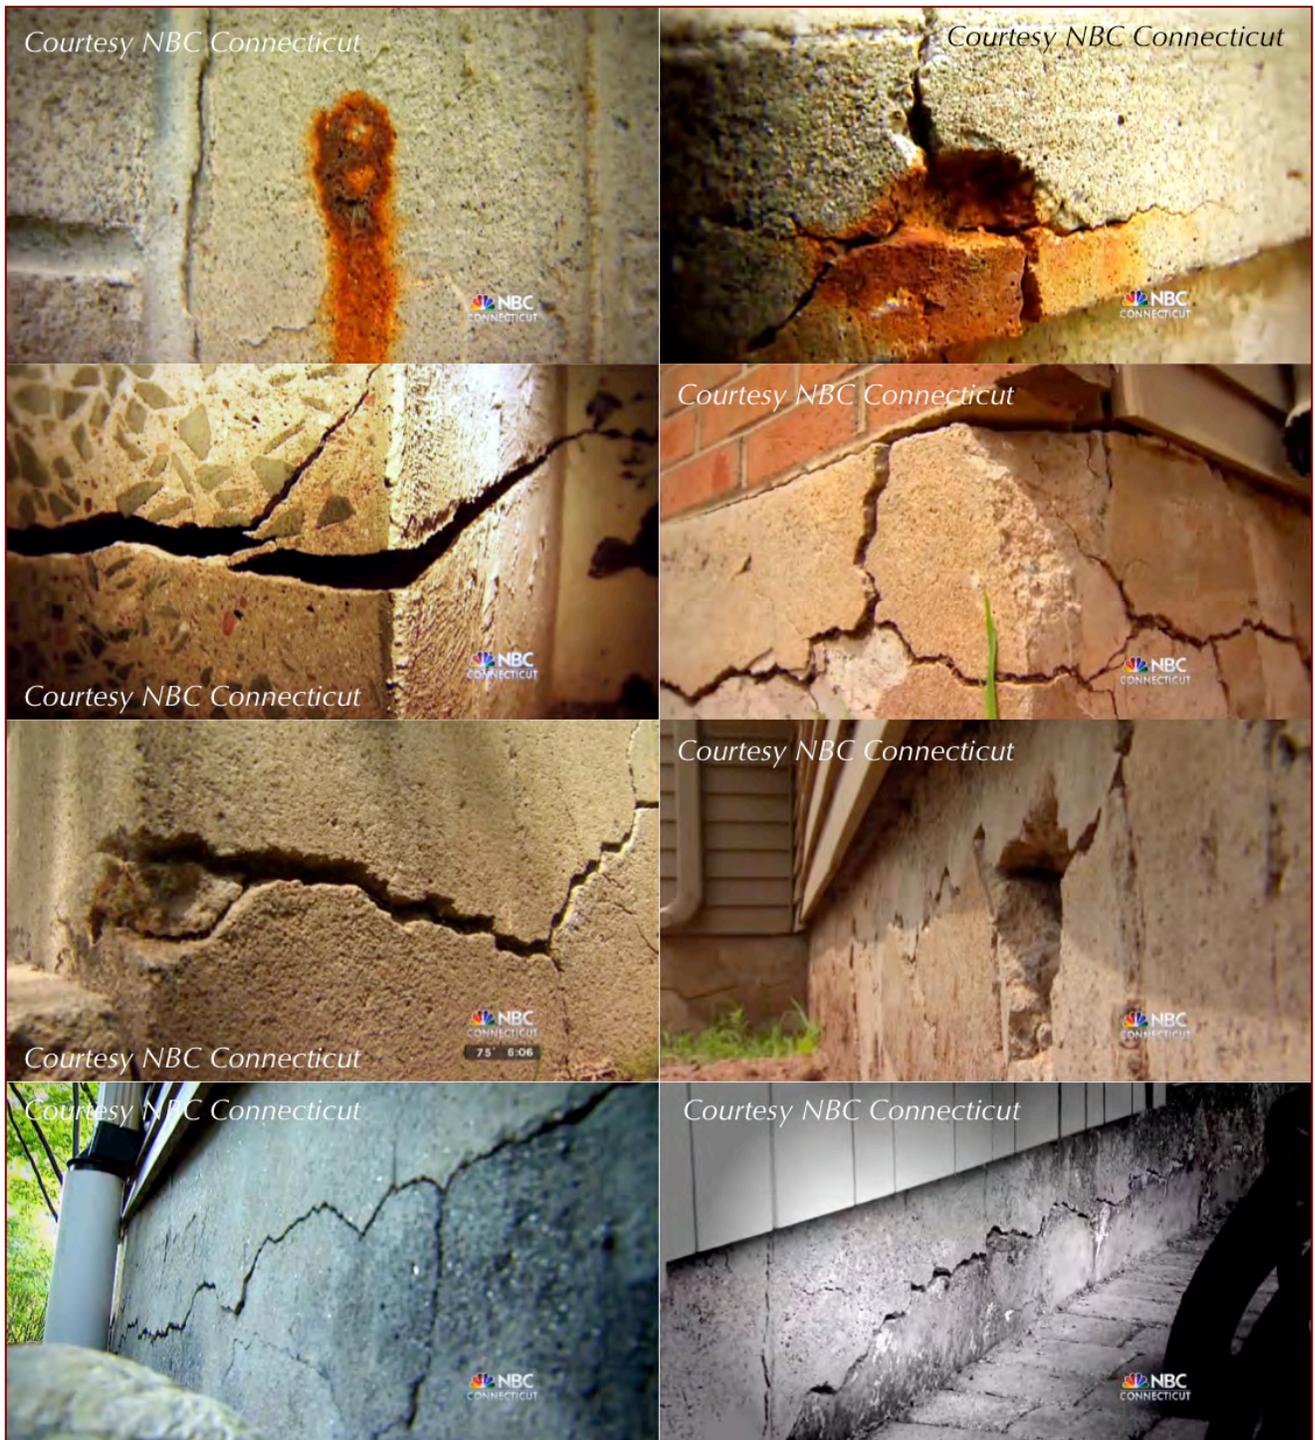
Figure 56: Cracking of concrete foundations in Connecticut due to oxidation of pyrrhotite bearing aggregates in concrete. Notice dark reddish brown rust staining on the wall and associated cracking in the top row from pyrrhotite oxidation and formation of ferric oxy-hydroxide oxidation products (goethite, limonite, ferrihydrite rust minerals). Notice wide cracks in the 2nd through 4th rows from pyrrhotite oxidation and associated expansion of concrete.

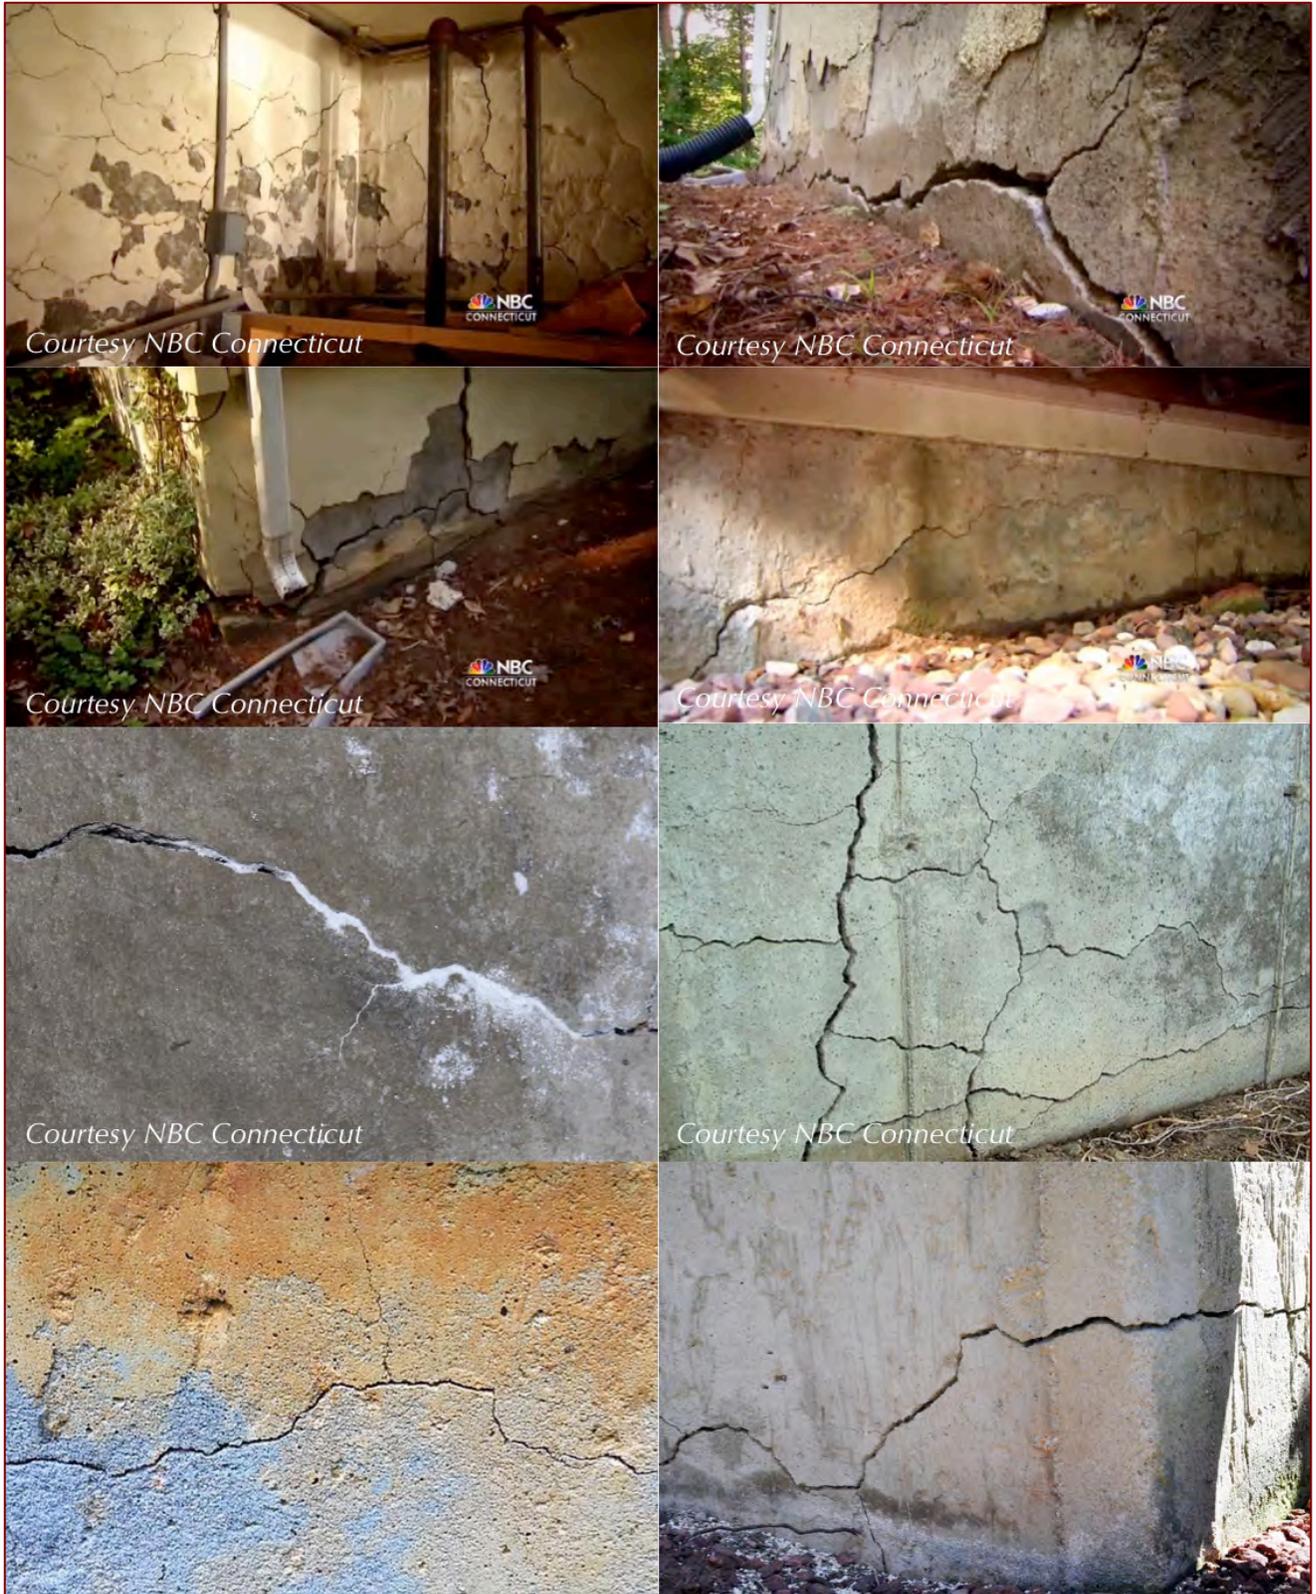
Figure 57: Cracking of concrete foundation in Connecticut due to oxidation of pyrrhotite bearing aggregates in concrete. Notice wide cracks in the foundation walls, extensive cracking of walls in the top left photo all reportedly from pyrrhotite oxidation and associated expansion of concrete.

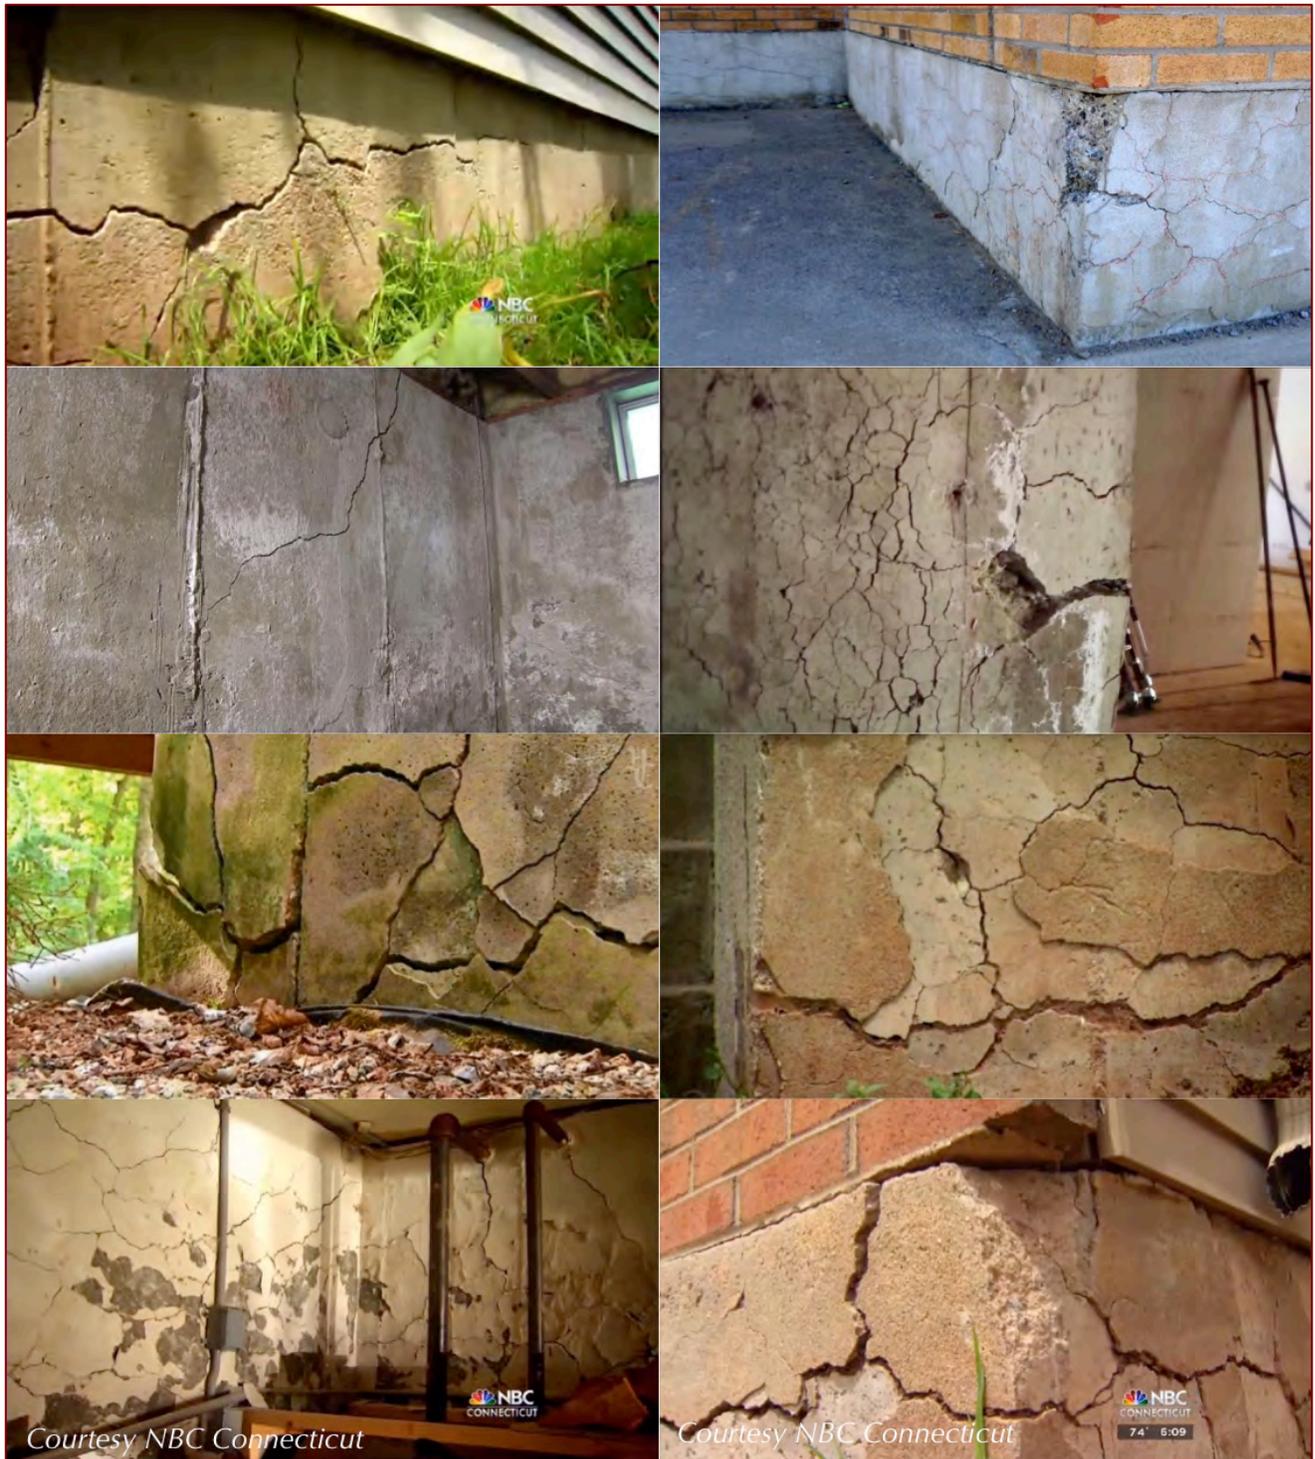
Figure 58: Cracking of concrete foundation in Connecticut due to oxidation of pyrrhotite bearing aggregates in concrete. Notice extensive cracking of foundation in all photos reportedly from pyrrhotite oxidation and associated expansion of concrete.
