## Investigation of Concrete Surface Distress by Petrographic Examinations of Two Concrete Cores

National Cemetery of the Alleghenies Design Build Expansion  
1158 Morgan Road  
Bridgeville, PA 15017

March 14, 2019  
CMC 0219106

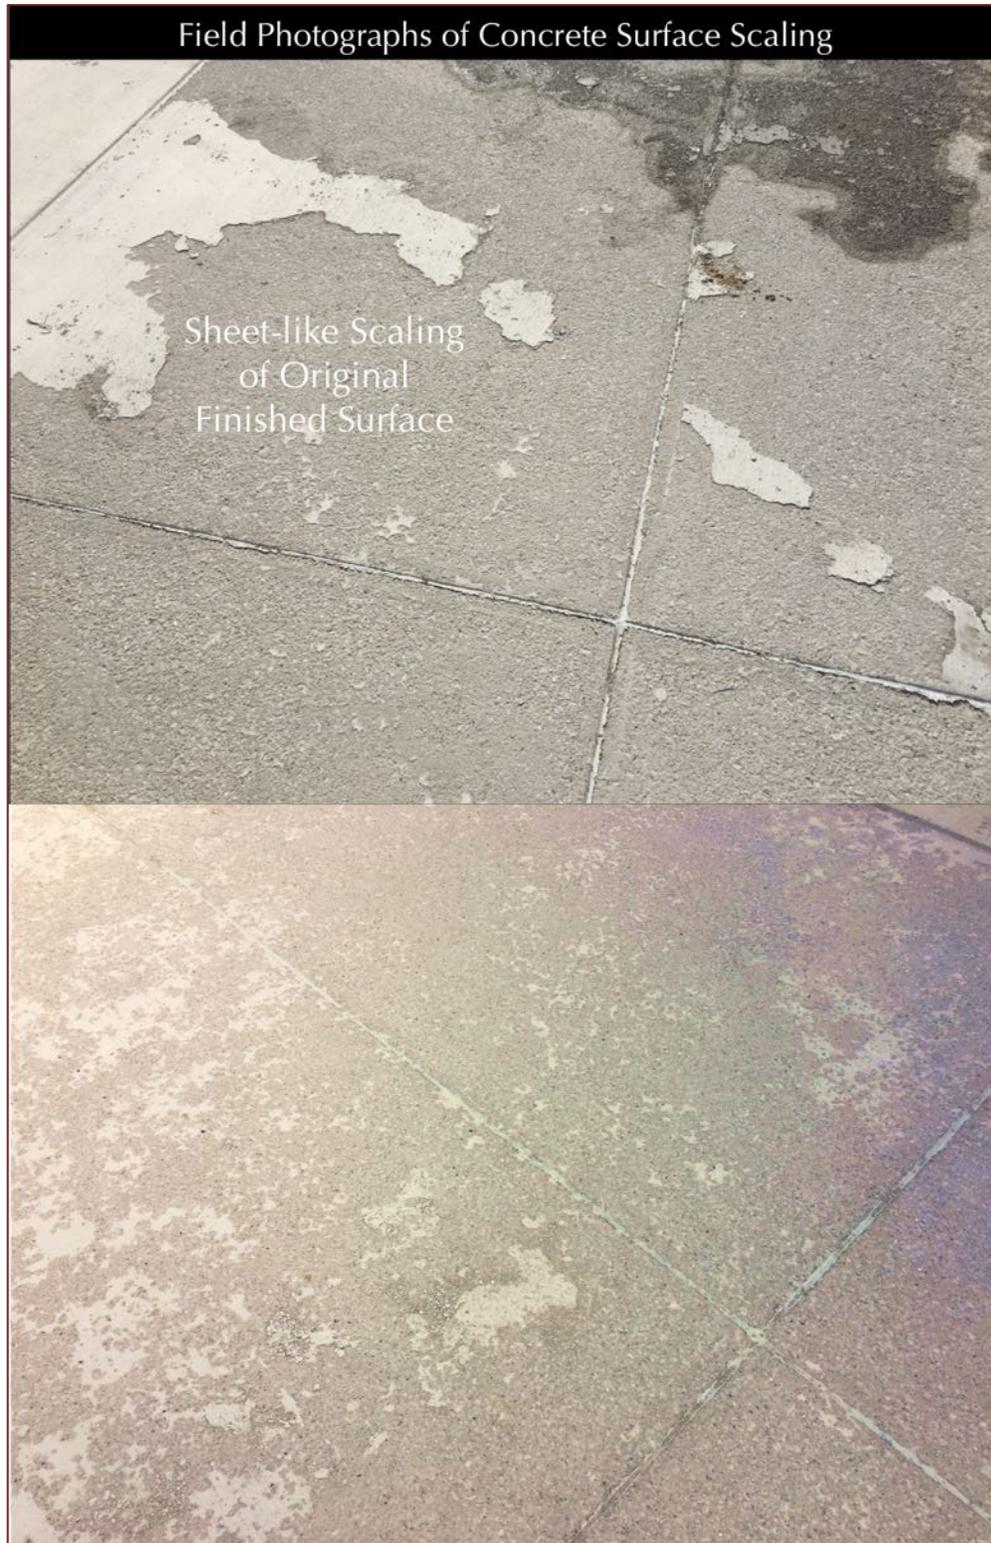
Figure 2: Field photographs of concrete slab showing surface scaling problem as loss of the original finished surface.

Figure 2 shows overall conditions of concrete slab. A close examination of distress in these field photos shows ***thin sheet-like separation of the finished surface from the body in the top photo*** as opposed to ***loss of the original finished concrete as eroding or washing away at isolated locations in the slab*** which is common in the bottom photo. The latter type of scaling in the bottom photo is common when the finished surface is soft, porous, and earthy-textured preferentially at the locations where water was accumulated at the finished surface during finishing (e.g., from the bleed water on the surface) and/or from excess water present during finishing (either water added during finishing and/or mixing of bleed water at the surface during finishing). The former type of scaling (i.e. *sheet scaling*) in the top photo is common where bleed water accumulates beneath the finished surface usually from premature finishing operations prior to the cessation of bleeding thus creates a plane of weakness immediately beneath the finished surface causing eventual loss of bond of the top finished surface from the body and subsequent separation of the top finished surface as thin sheets.

Although both types of scaling, as described above are the consequences of **improper finishing operations**, either of these two types, however can also occur from **cyclic freezing and thawing of a poor quality concrete at critically saturated conditions**, e.g., a concrete having improper air-void system and/or inadequate amount of entrained air that is needed for protection of concrete in a moist outdoor environment exposed to freezing.

The latter type of scaling in the bottom photo can also occur from **premature application of salt on a concrete surface that has: (a) not been matured, or (b) a concrete that has inadequate air and/or improper air-void system at the surface or (c) has a soft, porous surface that is not resistant to the potentially deleterious actions of salts**. A chemically corrosive salt (magnesium sulfate, ammonia based salt) can also cause chemical erosion of paste from the surface apparently creating a distress similar to local loss of the original finished surface as seen in the field photos.

As opposed to **scaling** (i.e. loss of original finished surface), two other types of distresses usually found in scaled surfaces but not found in Figure 2 are: (a) **popout**, which usually occur from moisture saturation of porous, unsound aggregates situated immediately beneath the surface and thus expansion of those near-surface particles often aggravated by freezing at saturated conditions, or as (b) **mortar lift-off** over flat top sides of near-surface aggregate particles where exposed aggregate itself is sound but finished surface did not bond adequately to the aggregate, eventually lifted off thus exposing the flat topsides of near-surface aggregate that resembles popout. Both types of distress could have also appeared but cannot be evaluated from the field photos provided.

Field photographs of concrete scaling showed sheet-type scaling where original finished surface is loosely bonded at some locations to the body, which is due to premature finishing operations prior to the cessation of bleeding. A non-air-entrained concrete bleeds more and longer than an air-entrained concrete and thus increases the potential for bleed water accumulation beneath the finished surface if finishing operation starts prior to the cessation of bleeding. Such bleed water accumulation can cause sheet-like scaling of the finished surface due to the weak bond between the finished surface and the body.

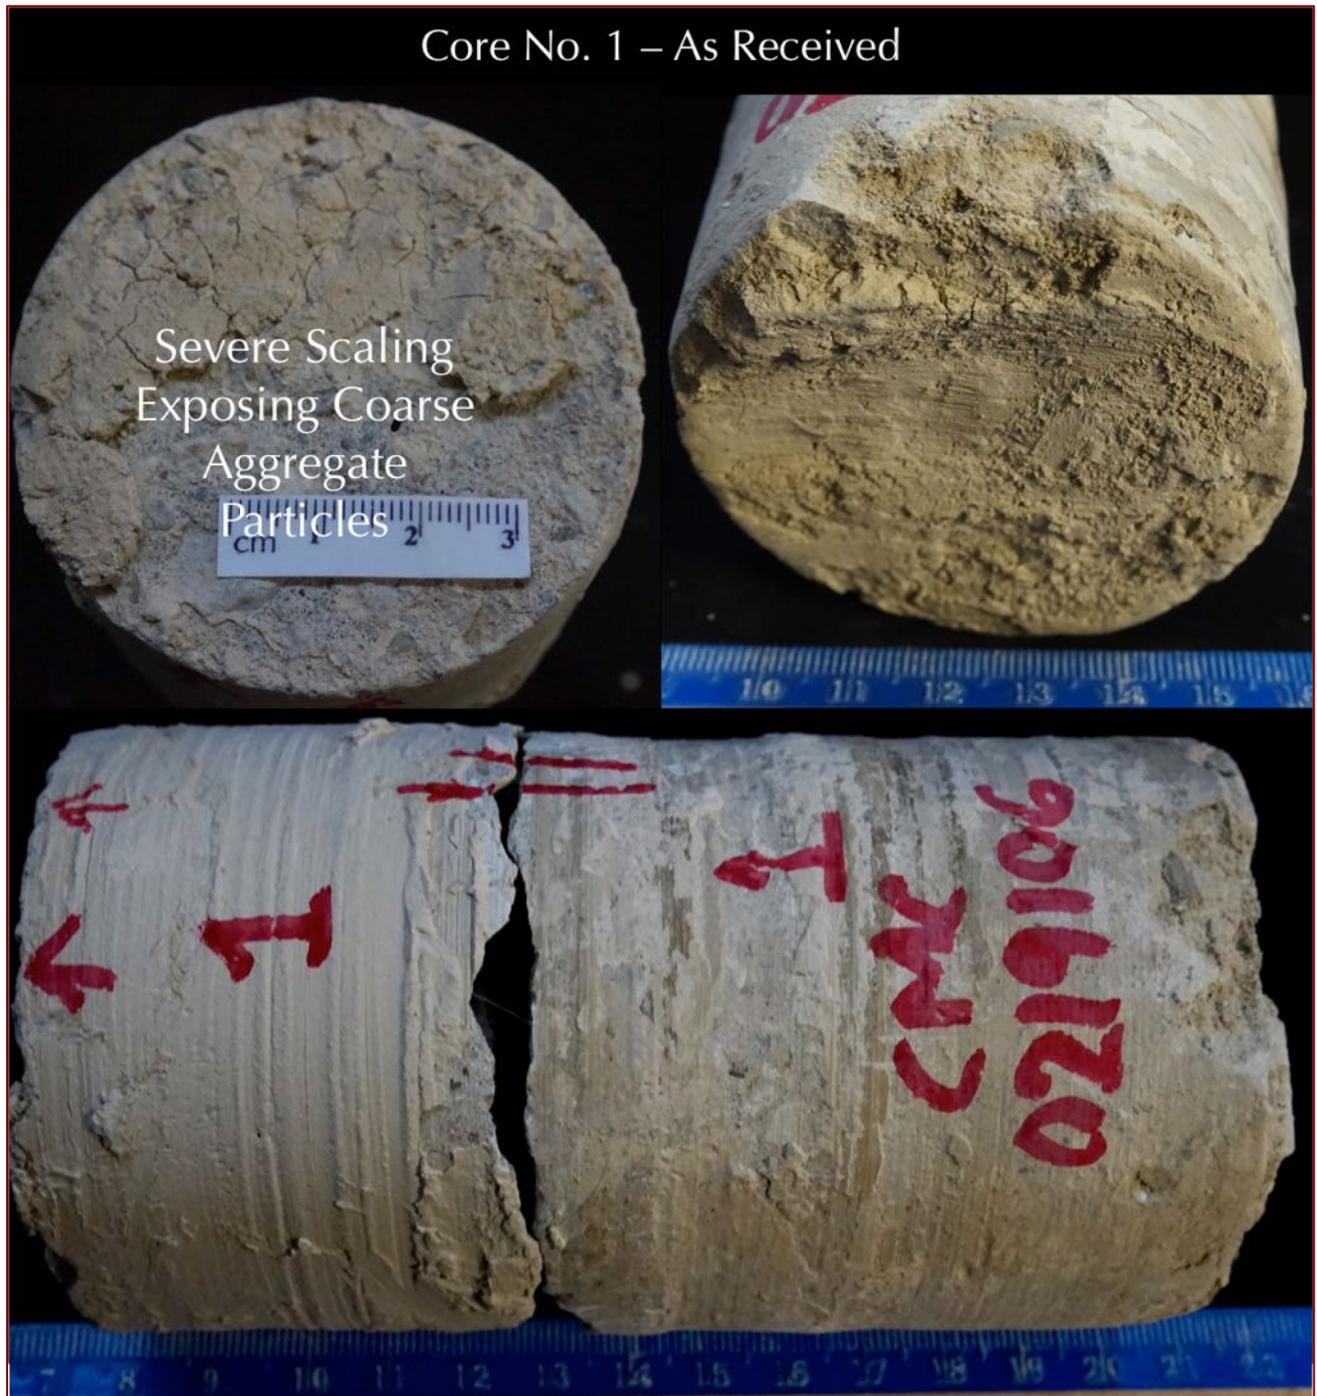
Both cores show severely scaled surfaces at the top and formed, wavy bottom surfaces (Figures 3 and 4).

The top end of core 1 has a thin layer of soft, hardened mud-like layer of paste with closed polygonal-shaped mud cracks covering almost 50 percent of the top scaled surface, which is judged to have formed from drilling operation, where drilling mud that came out of the core has dried on the scaled top when received in the lab with mud cracks.

Figure 3: Photographs of Core 1 as received – Top left – Exposed surface with severe scaling and complete loss of the finished surface with exposed coarse and fine aggregate particles and a thin coating of drilling mud with fine hair-like mud cracks covering almost 50 percent of the scaled top; Top right – smooth formed wavy bottom surface with a thin layer of fine subbase, and bottom row - cylindrical side view of the core with identification showing a crack at the mid-depth location probably formed during the coring operation.
