Proceedings of the Sixth Euroseminar on Microscopy Applied to Building Materials

DETERIORATION OF CONCRETE DIAGNOSED BY OPTICAL MICROSCOPY

Niels Thaulow and Ulla Hjorth Jakobsen
G.M. Idorn Consult, RAMBØLL, Bredevej 2, DK-2830 Virum

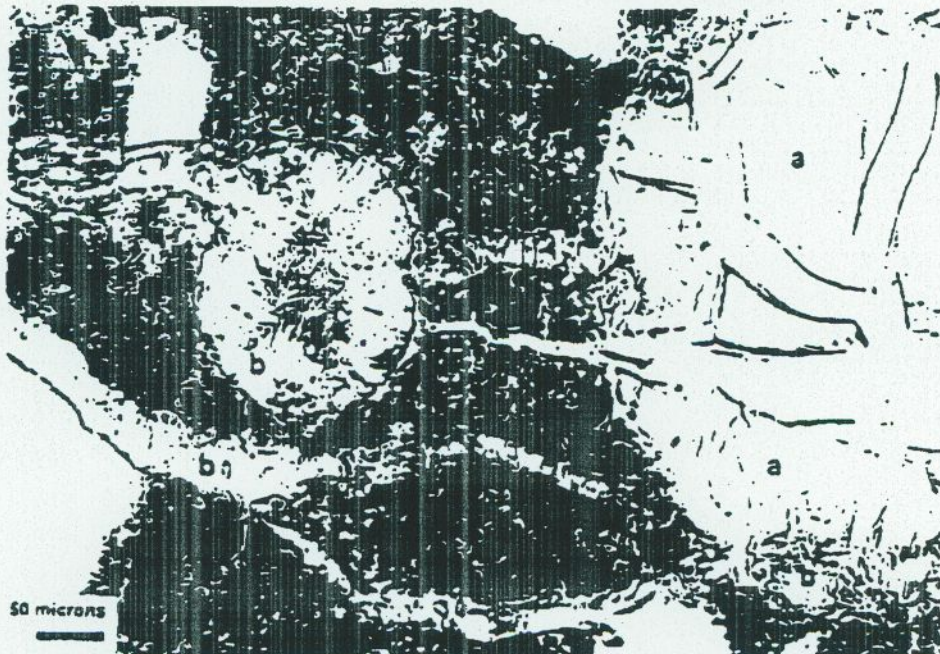
Figure 3 Difference between alkali silica gel (a) and ettringite (b) in voids. The image is taken in ordinary light. Scale bar measures 50 microns.

Another diagnostic feature of alkali silica reaction is the presence of *alkali silica gel*. Alkali silica gel is a clear, colourless isotropic material with low refractive index (1.46 - 1.53) and a typical shrinkage crack pattern (Figure 3a) (ASTM C356, 1993). Alkali silica gel may, however, be partly crystalline, showing an orange interference colour in crossed polarised light. This feature is generally only observed in gel that is situated in cracks inside aggregates or in cracks of rather old concrete (Thaulow et al., 1989). Gel may be observed replacing the outer part of e.g. a porous flint particle (Figure 2a), be situated in cracks and/or in air voids. Etringite in pores and cracks is commonly found in ASR-affected concrete. The trained petrographer can, however, distinguish alkali silica gel from massive ettringite formation (Figure 3b) by the slight birefringence of ettringite. Furthermore, ettringite exhibits a different crack pattern consisting of almost parallel microcracks. The use of a yellow fluorescent epoxy for preparing the thin sections facilitates the distinction between alkali silica gel and ettringite (Thaulow et al., 1996).

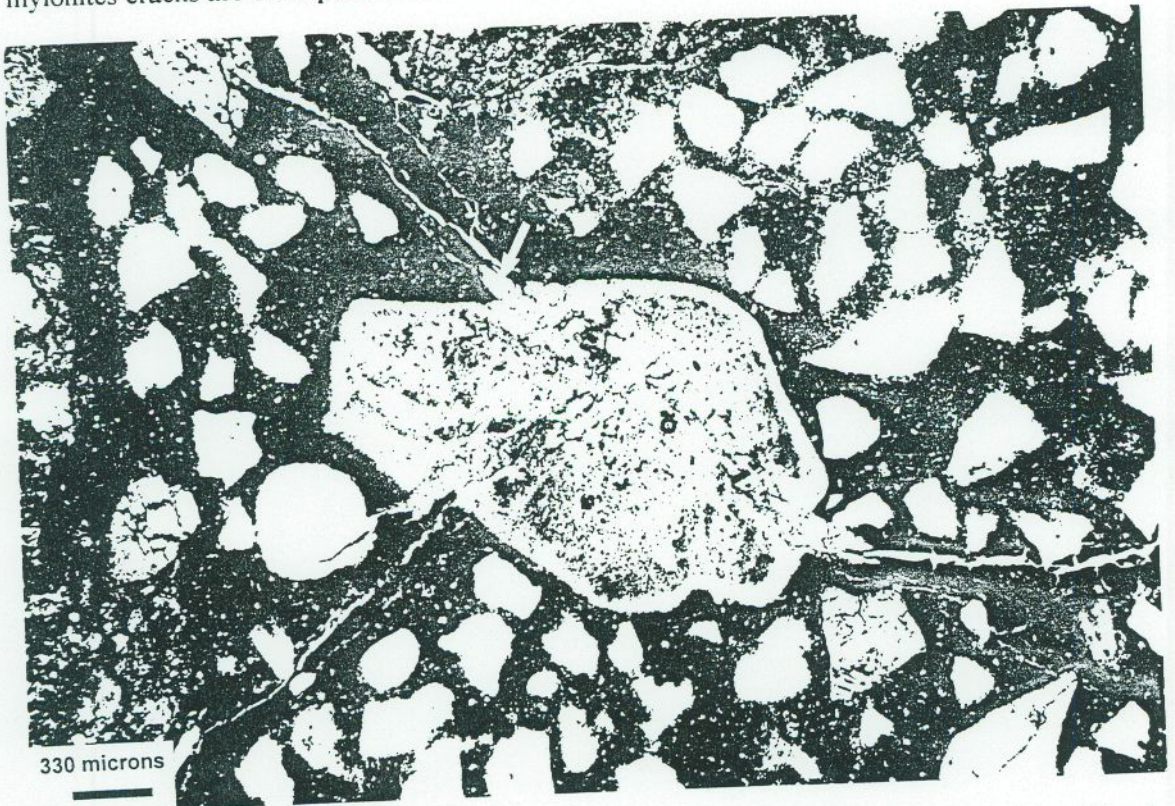
Figure 2 Alkali silica reactive aggregates in concrete. (A) cracked porous flint particle with gel in the cracks (arrow). The image is taken in ordinary light. Scale bar measures 330 microns.

The *crack pattern* observed depends on the type of reactive aggregate (Figure 2). Aggregates without preferred orientation of the mineral grains such as porous flint create three-legged cracks with angles of 120° between cracks. In aggregates with oriented minerals such as mylonites cracks are often parallel to the mineral orientation.

In aggregates such as sandstones the cracks may run along grain boundaries. Typically for all types of aggregates the cracks are wide in the centre and narrow toward the rim of the aggregates. Locally the cracks tend to be perpendicular to the surface of the reactive particle (radial cracks).

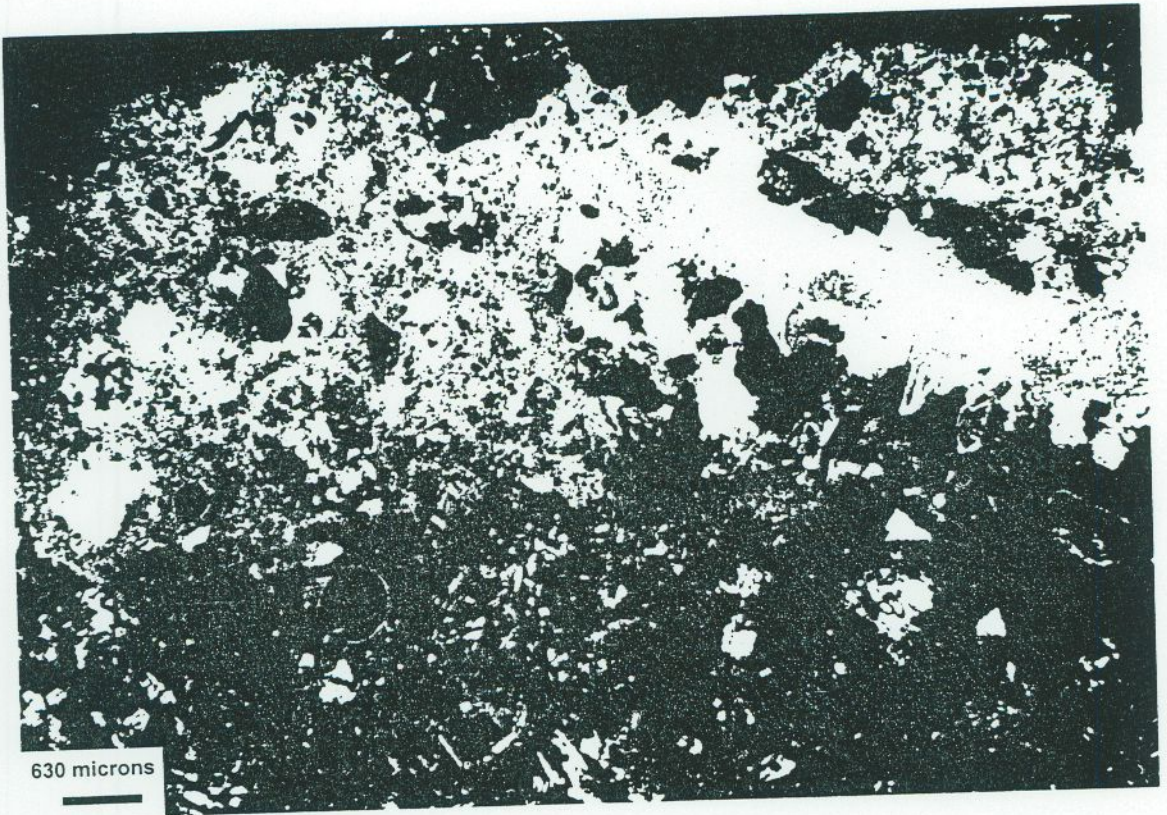
Figure 7 Carbonated concrete. Calcite crystals of high birefringence appear in the surface zone. The image is taken in crossed polarized light. Scale bar measures 630 microns.

The porosity of the paste is often unchanged or lower in the carbonated zone that is found at the surface of the concrete and along cracks perpendicular to the surface. By comparing the depth of carbonation at the surface with the depth of carbonation at the crack it is often possible to estimate the age of the cracks.

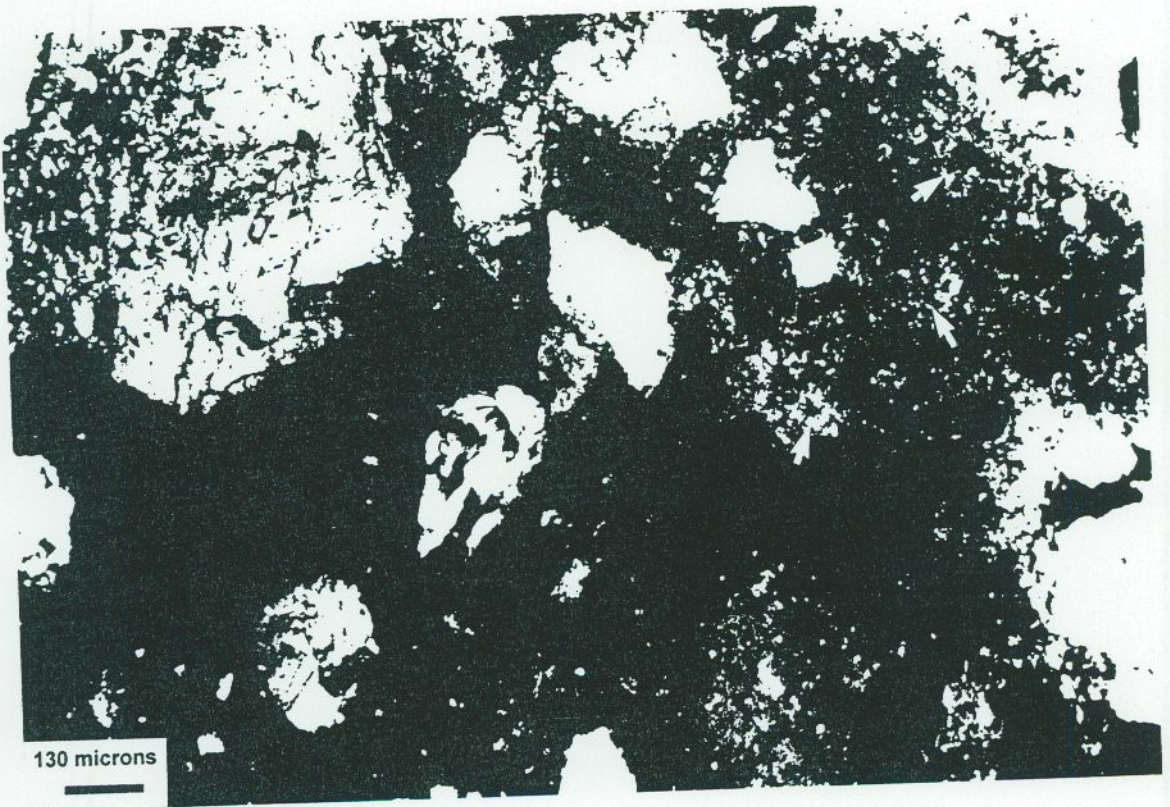
Figure 8 "Bi-carbonation". Large "pop-corn" crystals of calcite (arrows) are found in an isotropic matrix. The image is taken in crossed polarized light. Scale bar measures 130 microns.
