CONSTRUCTION MATERIALS CONSULTANTS, INC.

## Investigation of Failure of Anchoring Grout & Associated Distress in Concrete

ABC Condominiums  
ABC Road, Wilmington, DE 19810

Prepared for:  
ABC, Inc.  
ABC Condominium Association, Inc.

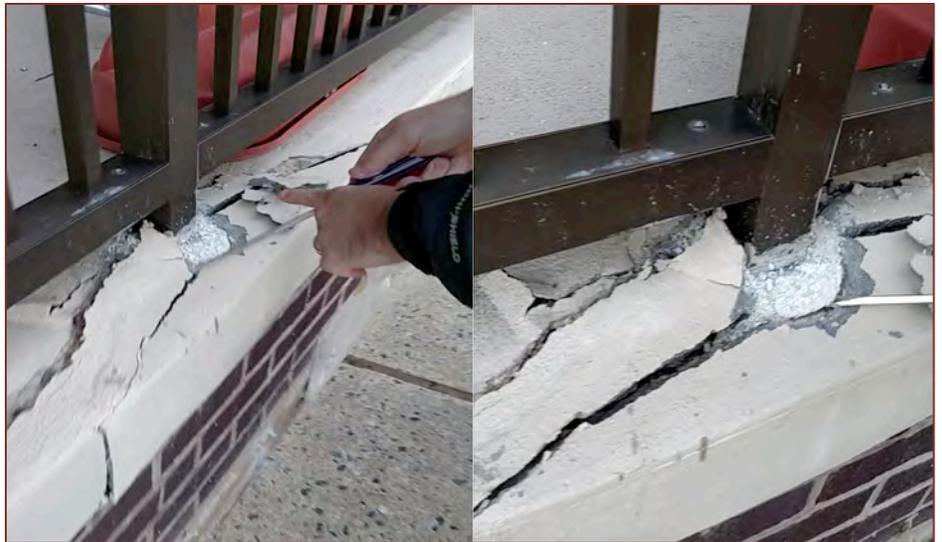
Field photographs retrieved from the video of sample collection process show severe cracking and spalling of concrete at the base of the railing posts as well as severe disintegration of the anchoring grout as seen in the following photos (as well as in Figure A1 in the Appendix).

Figure 1: Photographs showing severe cracking and spalling of concrete and disintegration of anchoring grout.

Unfortunately, the best method to mitigate the existing problem is to remove the distressed material and reinstall the anchoring grout with a more durable and acceptable (preferably a non-gypsum-based) material with a proven service-record in the moist outdoor environment, and installed by strictly following the manufacturer's application guidelines. Access of moisture to the grout during service must also be restricted.

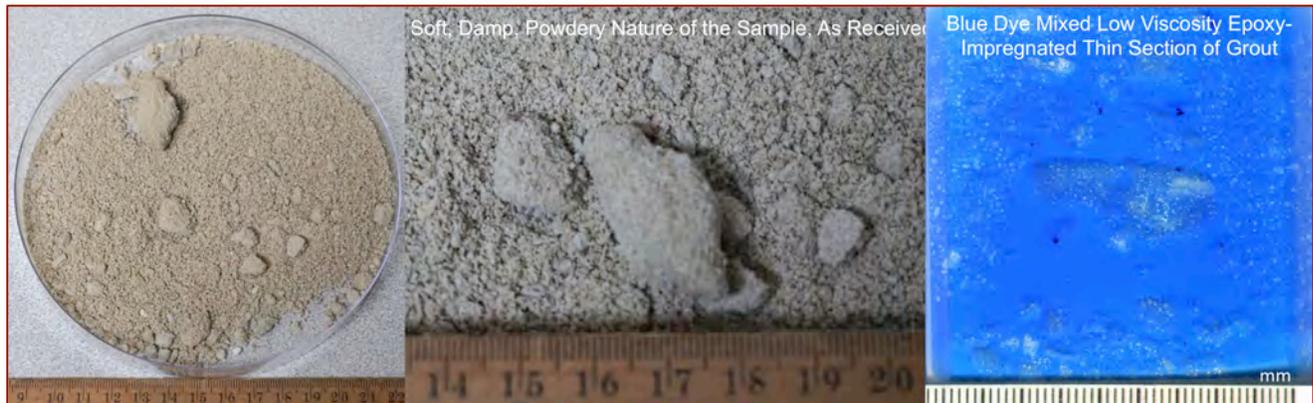
Figure 2 (and Figure A2 in the Appendix) show the soft, light gray, powdery nature of sample from severe disintegration of grout. The sample, as received was damp, indicating the presence of moisture during service.

Figure 2: The powdery nature from severe disintegration of the grout, as received. The left photo shows the sample after placing in a petri dish, the right photo shows blue dye-mixed low-viscosity epoxy-impregnated thin section of grout prepared for petrographic examinations, and the middle image shows the sample at a higher magnification in a low-power stereomicroscope.

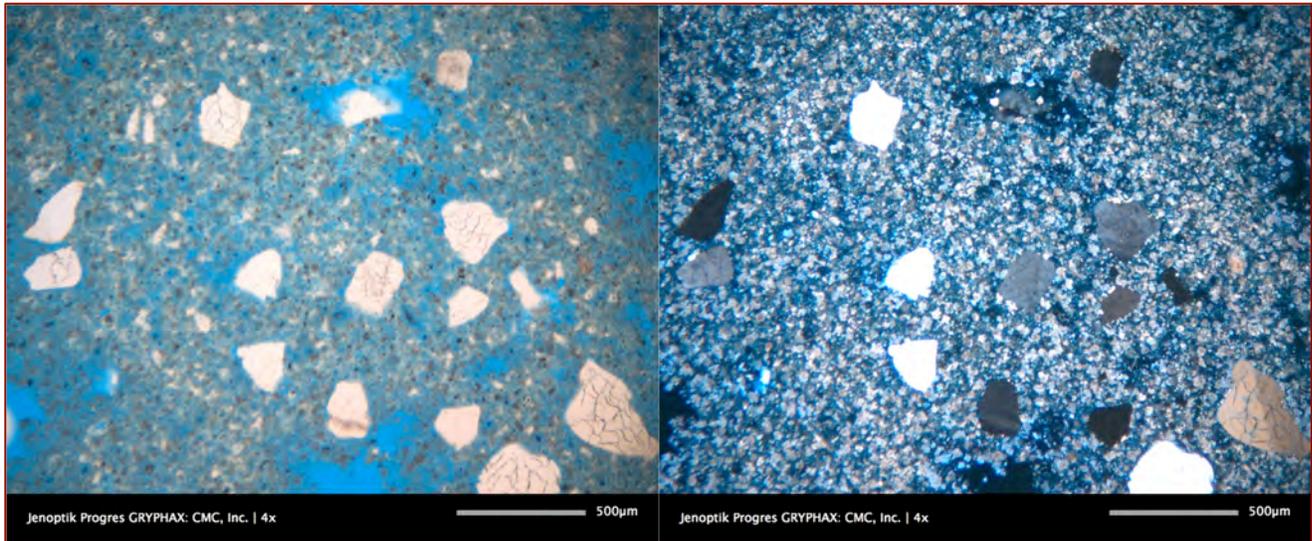
The observed quartz sand is consistent with the reported use of quartz in the safety data sheet of ‘Anchor All.’

Figure 3: Photomicrographs of blue dye-mixed epoxy-impregnated thin section of the grout showing quartz sand fine aggregate particles.

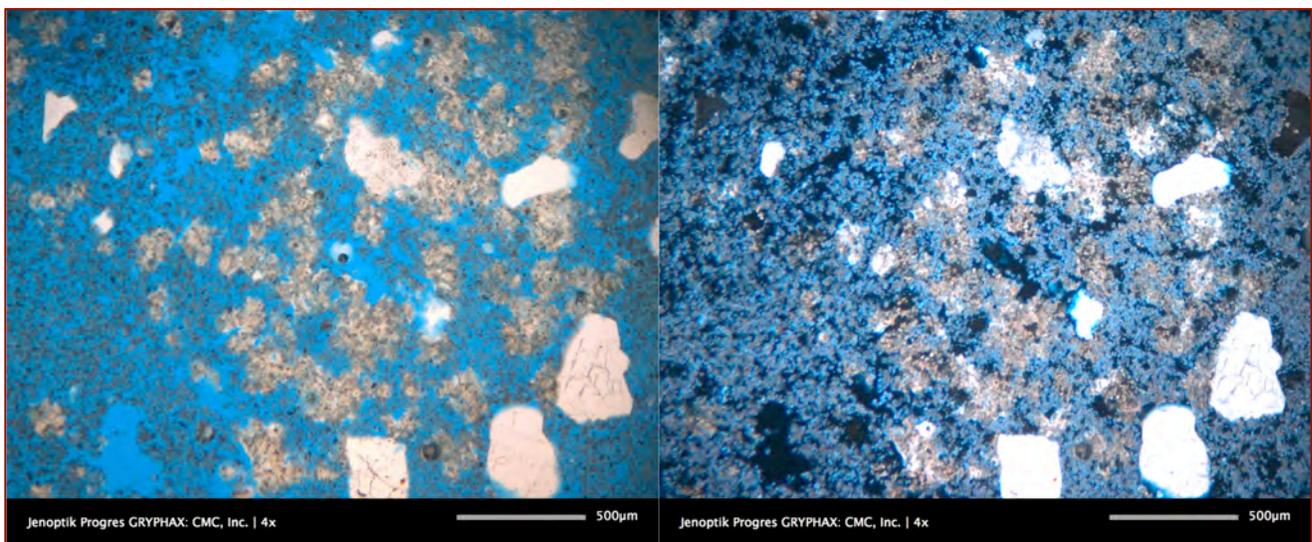
Paste is soft, gray, powdery, and shows abundant very fine-grained gypsum intermixed with calcium carbonate, in the overwhelming matrix within which are patchy areas representing hydration products of a hydraulic cement component from the binder. Figure 4 shows such a patchy appearance from a mixed gypsum plus hydraulic cement binder (where the former occupies a much larger volume than the latter).

Figure 4: Photomicrographs of blue dye-mixed epoxy-impregnated thin section of the grout showing patchy nature of the paste consisting of dominant porous areas of paste that are represented by blue tones from absorption of dye and smaller portions of patches where dye did not absorb due to denser areas.

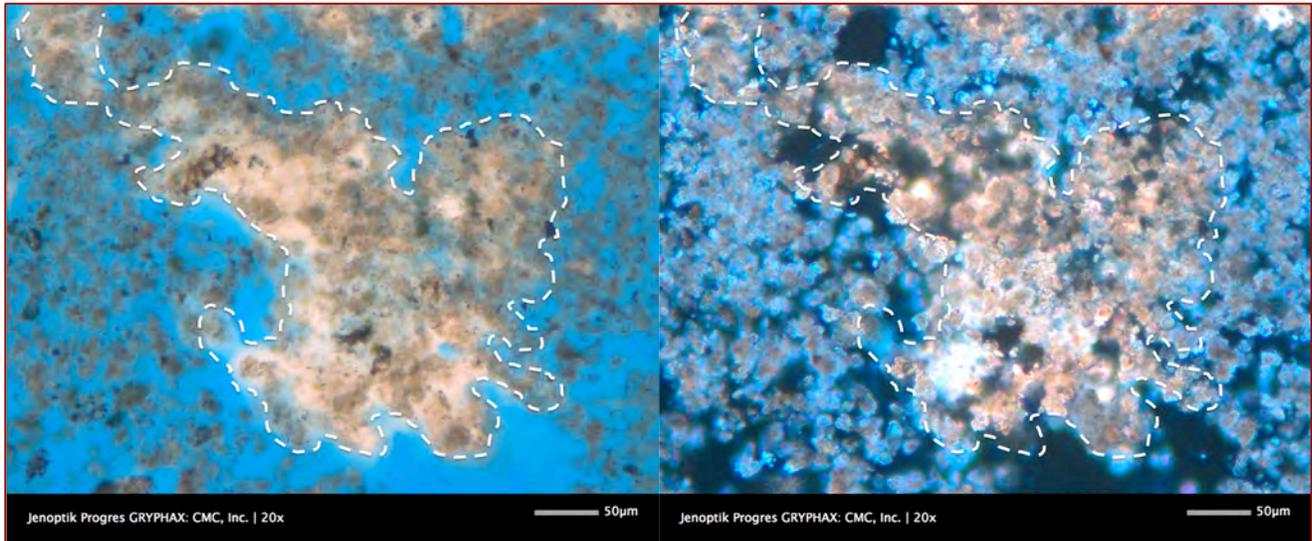
Figure 5: Photomicrographs of blue dye-mixed epoxy-impregnated thin section of the grout showing patchy nature of the paste consisting of dominant porous areas of paste that are represented by blue tones from greater absorptions of dye, and, smaller portions or patches where dye was not absorbed due to denser areas.

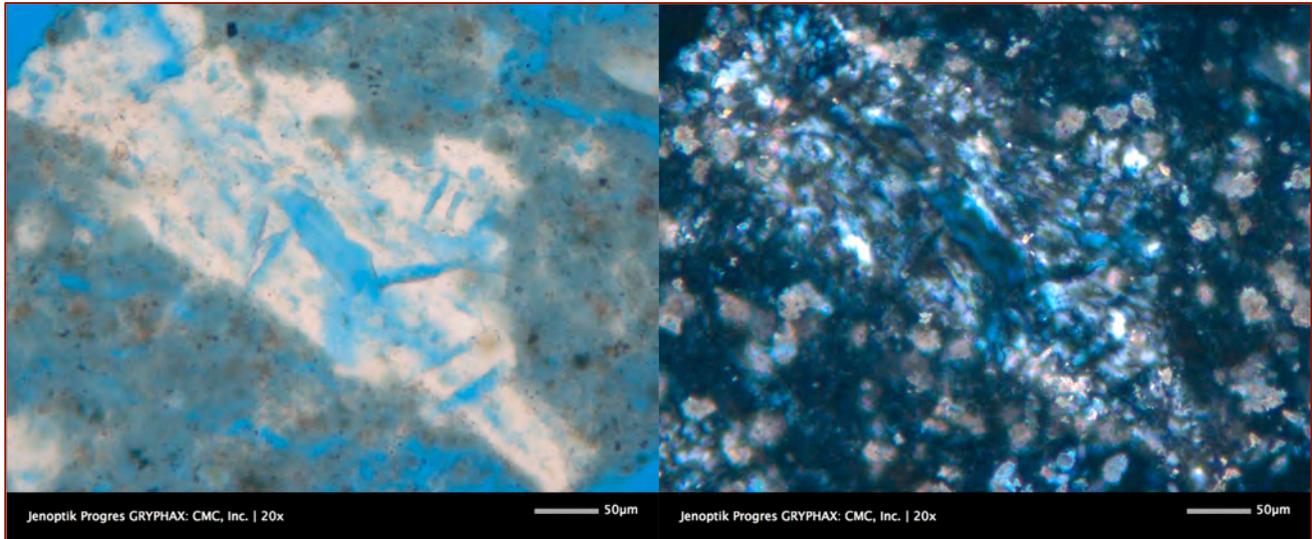
Occasional coarse subhedral crystals of gypsum in paste indicates secondary crystallization or re-crystallization of gypsum during drying after a wetting event in the hardened state, as shown below:

Figure 6: Photomicrographs of blue dye-mixed epoxy-impregnated thin section of the grout showing coarse subhedral secondary gypsum recrystallization from drying of grout after a period of wetting.

- Coarse, subhedral secondary (recrystallized) gypsum crystals from wetting and drying of grout (Figure 6);
- Shrinkage microcracks in paste from excessive moisture, which are not anticipated in a nonshrink grout (Figure 7);

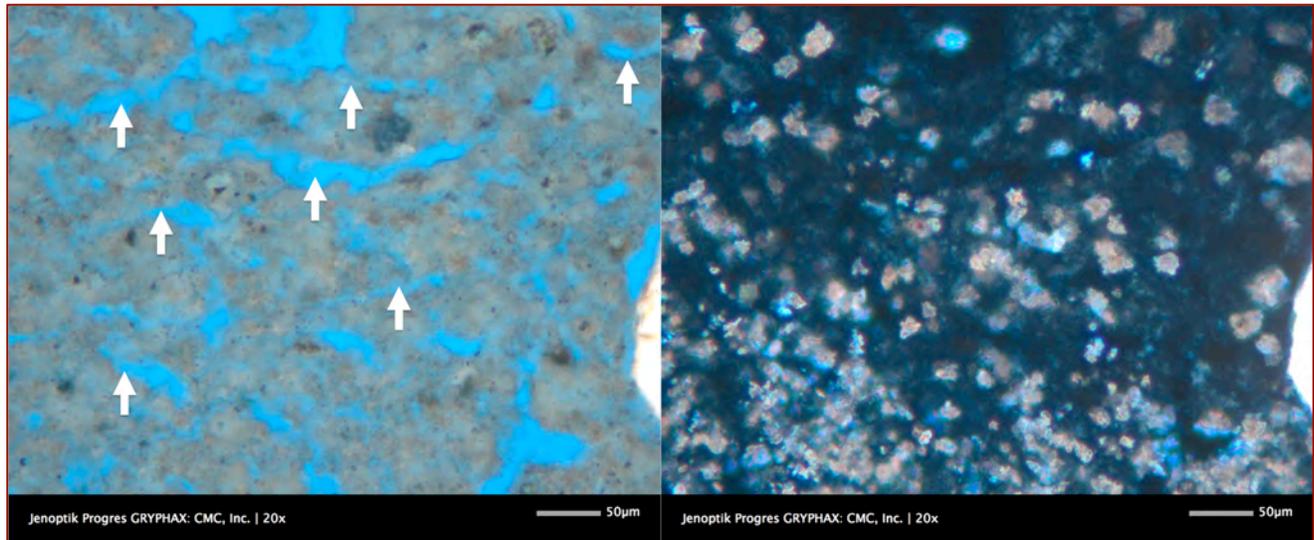
Excessive water in the mix has produced shrinkage microcracking, which is not anticipated in a nonshrink grout:

Figure 7: Photomicrographs of blue dye-mixed epoxy-impregnated thin section of the grout showing parallel shrinkage microcracks in the paste, many of which are marked with arrows.

- Abundant secondary calcite precipitates indicating atmospheric carbonation of the main gypsum skeleton of the basic microstructure of gypsum-based grout, where calcite was not formed by solid-state or topochemical reaction but by dissolution of gypsum in the presence of moisture, and precipitation of calcite due to atmospheric carbonation of gypsum (Figures 7 and 8);

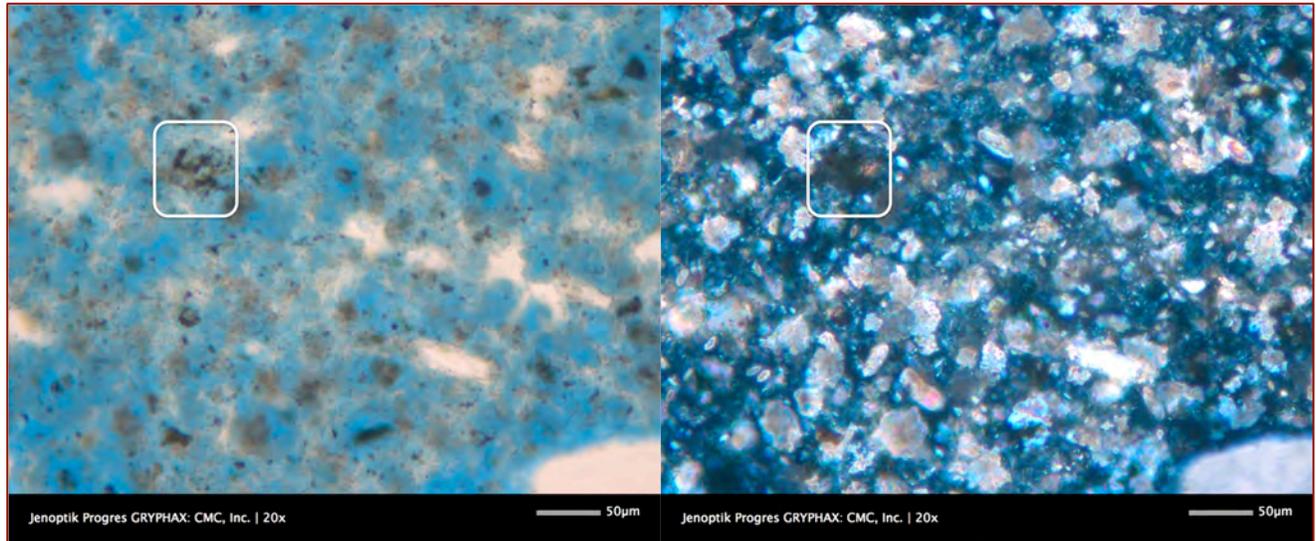
General microstructure of paste shows an overwhelming matrix of intermixed calcium carbonate occurring as small blots of high birefringence masses intermixed with not so discernable masses of gypsum and ettringite, as shown in Figures 7, 8, and 9. Such an abundance of calcium carbonate indicates atmospheric carbonation of the original gypsum hydration products in the presence of moisture and atmospheric carbon dioxide, since such a high abundance of calcium carbonate cannot be formed from carbonation of hydrated products of a small amount of Portland cement added to the gypsum-based grout. The anhedral shapes of secondary calcium carbonate masses in Figures 8 and 9 as opposed to clear euhedral shapes of calcite fines indicate their secondary formation after dissolution of gypsum, carbonation, and precipitation as secondary calcite precipitates, by e.g., the following reactions:

Figure 8: Photomicrographs of blue dye-mixed epoxy-impregnated thin section of the grout showing an overwhelming matrix of high birefringent masses of secondary calcium carbonate and low birefringent masses of gypsum (plus some ettringite), and a few residual (or relict) hydraulic cement particles that appeared to be of Portland cement mineralogy and microstructure showing residual belite and interstitial dark ferrite (boxed).

- An overwhelming matrix of high birefringent masses of anhedral calcium carbonate precipitates and low birefringent crystals of gypsum, and a few residual (or relict) hydraulic cement particles that appeared to be of Portland cement mineralogy and microstructure showing residual belite and interstitial dark ferrite (Figure 8);

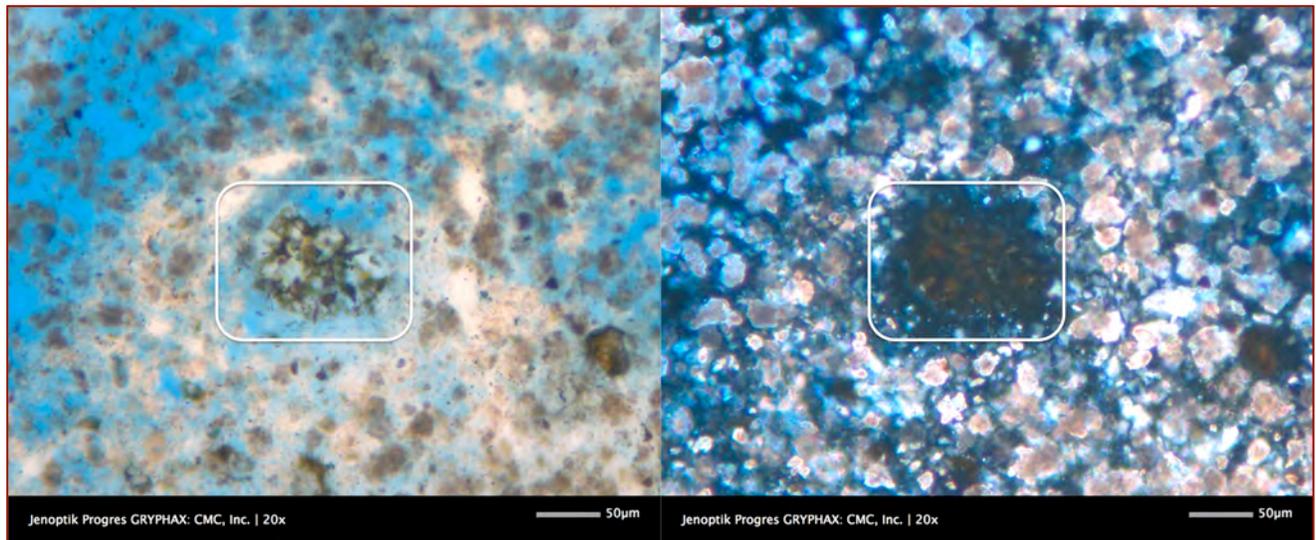
Another set of photomicrographs show the residual Portland cement particle in a better detail:

Figure 9: Photomicrographs of blue dye-mixed epoxy-impregnated thin section of the grout showing an overwhelming matrix of high birefringent masses of secondary calcium carbonate precipitates and low birefringent masses of gypsum (plus some ettringite), and a few residual (or relict) hydraulic cement particles that appeared to be of Portland cement mineralogy and microstructure showing residual belite and interstitial dark ferrite (boxed).

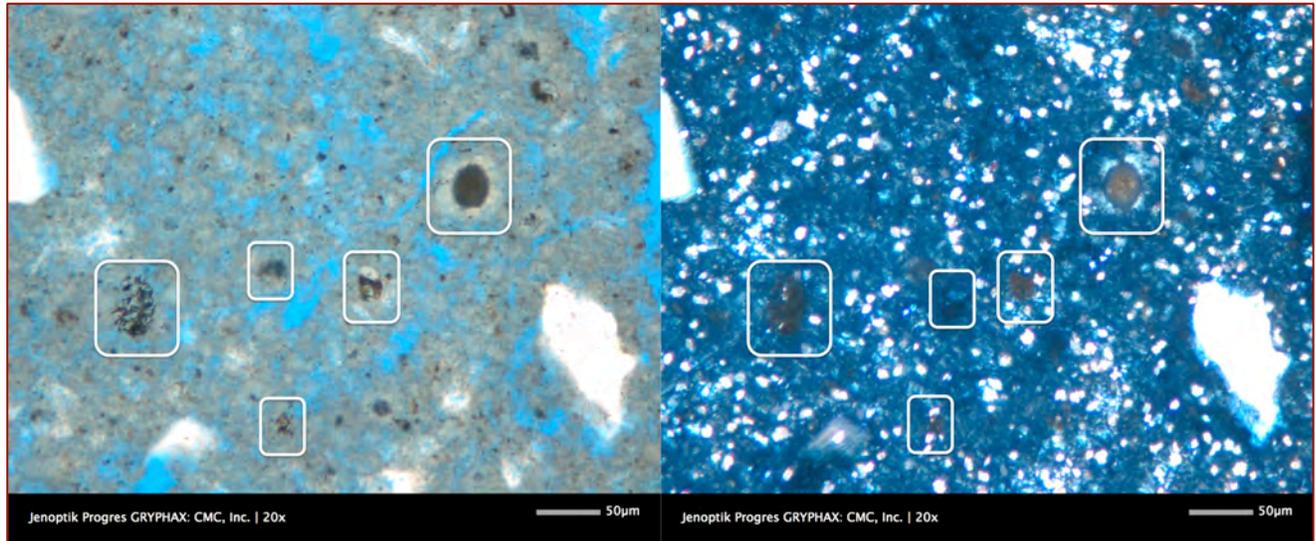
Residual cement particles are scattered throughout the matrix, as shown in another set below. Their low abundance is due to excessive water in the system as well as of using a gypsum-based grout containing a minor amount of Portland cement.

Figure 10: Photomicrographs of blue dye-mixed epoxy-impregnated thin section of the grout showing a few residual cement particles (marked with boxes).

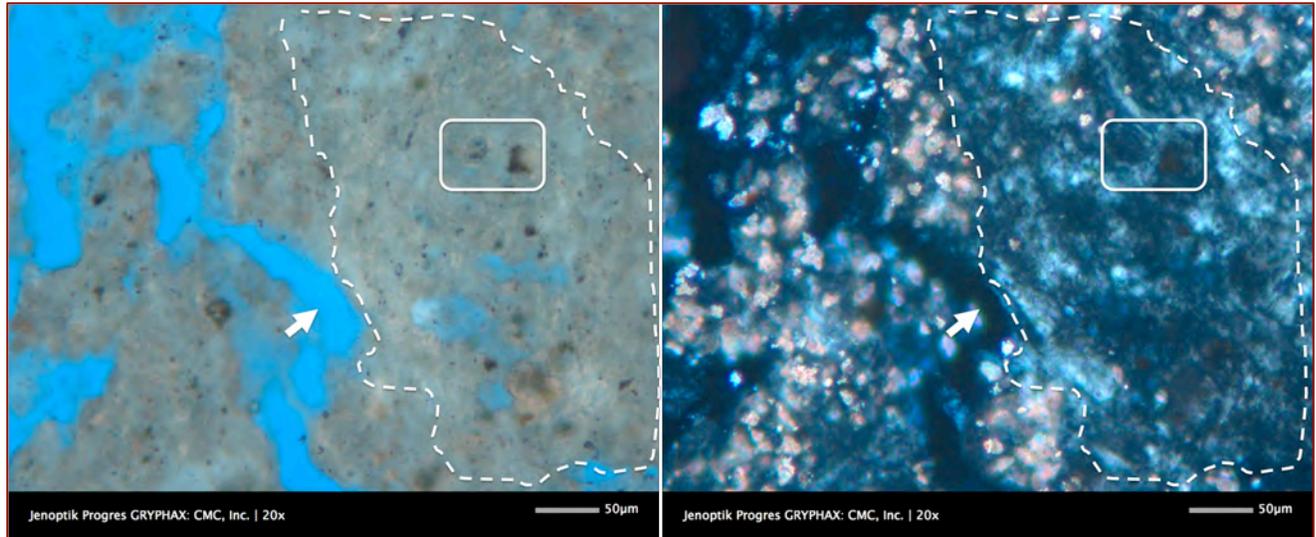
The gypsum binder in the paste is noticed in portions that are not invaded by the high birefringent calcium carbonate masses, such as the one shown below, where gypsum occurs as low birefringent (first order gray to white) fibrous masses.

Figure 11: Photomicrographs of blue dye-mixed epoxy-impregnated thin section of the grout showing an area enriched in gypsum and lack of calcium carbonate masses (within the dashed line). Within the boxed area in the gypsum-rich area are a few residual cement particles. The area on right outside the gypsum-rich mass is the typical matrix consisting of both secondary calcium carbonate, and hydrates of sulfate, sulfoaluminate, etc.

- Gypsum-rich areas of paste that are not invaded by calcium carbonate masses (Figure 11);
- Leaching of water-soluble components from matrix by moisture and microcracks (Figure 12); and,

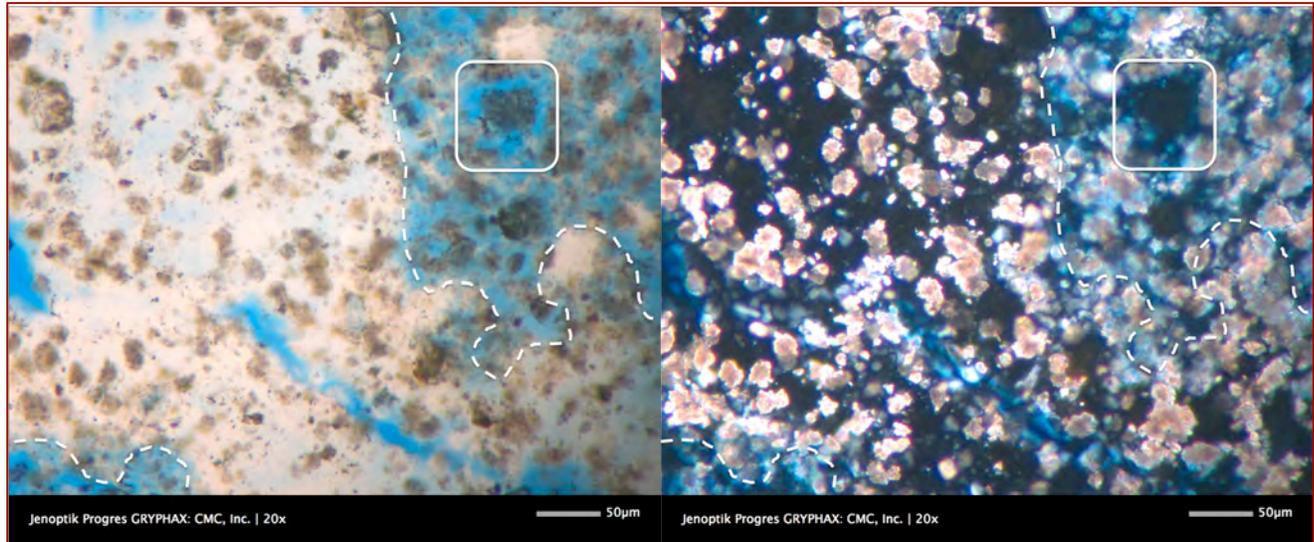
Leaching of water-soluble components due to the presence of excess moisture in the system is anticipated, which is evidenced by isotropic nature of leached areas in crossed-polarized light despite an apparent appearance of dense areas due to the lack of absorption of blue dye. The following set of photomicrographs show a leached area marked with dashed line that shows the presence of a microcrack that has acted as a channel for leaching out of

masses. Notice the calcium carbonate masses are still present in the leached area, as well as some gypsum crystals with weak birefringence.

Figure 12: Photomicrographs of blue dye-mixed epoxy-impregnated thin section of the grout showing an area having an isotropic nature in XPL (within the dashed lines), which contains birefringent calcium carbonate masses, and a microcrack (highlighted by dye) that has acted as a channel to remove some water-soluble gypsum.

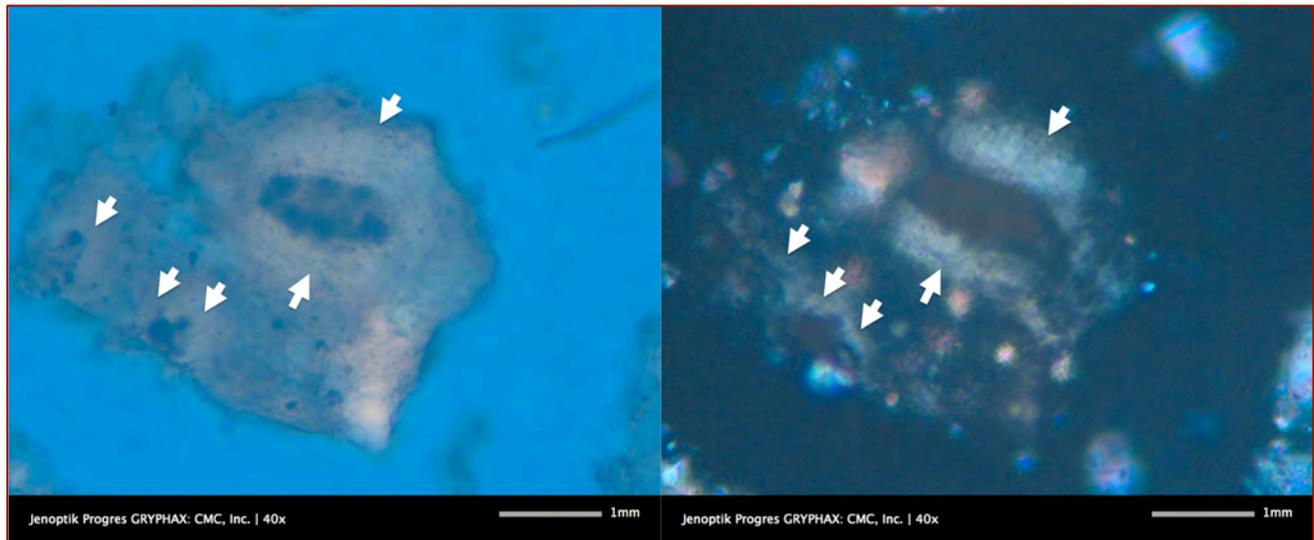
At high magnifications, some fibrous ettringite deposits are found formed topochemically on the surfaces of residual aluminate phases in residual cement particles.

Figure 13: Photomicrographs of blue dye-mixed epoxy-impregnated thin section of the grout showing topochemical formation of fibrous ettringite deposits (arrows) on the surfaces of residual aluminate phases in the cement particles.

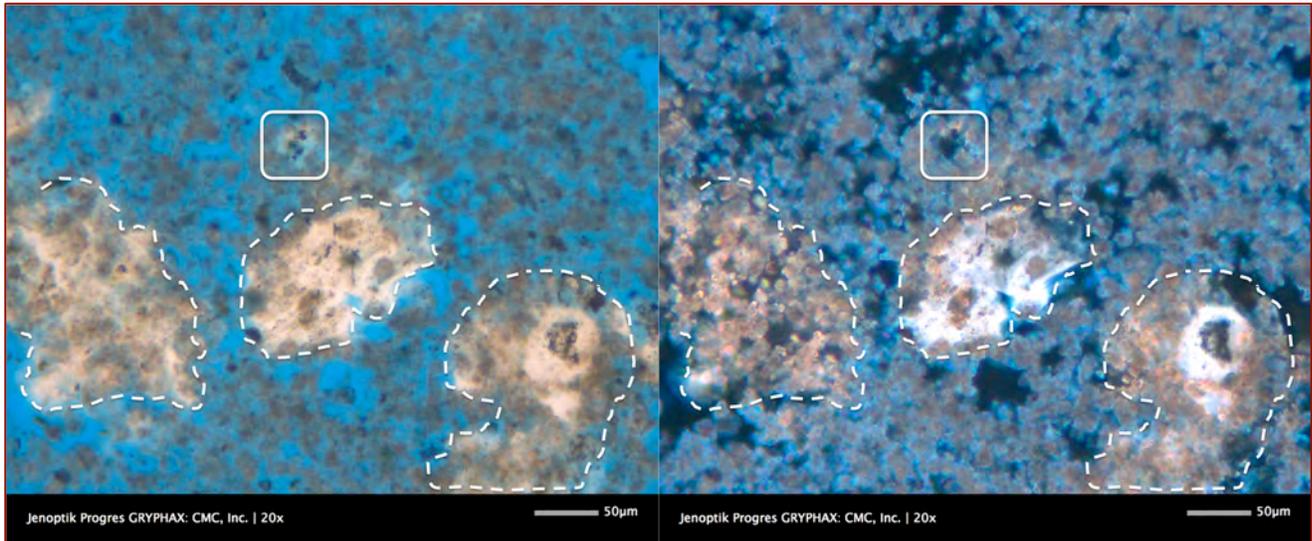
The following set of photomicrographs also shows such topochemical formation of ettringite having first order white to grey birefringence on the surfaces of residual cement particles.

Figure 14: Photomicrographs of blue dye-mixed epoxy-impregnated thin section of the grout showing topochemical formation of fibrous ettringite deposits (mostly in the right two areas within dashed lines) on the surfaces of residual aluminate phases in the cement particles.

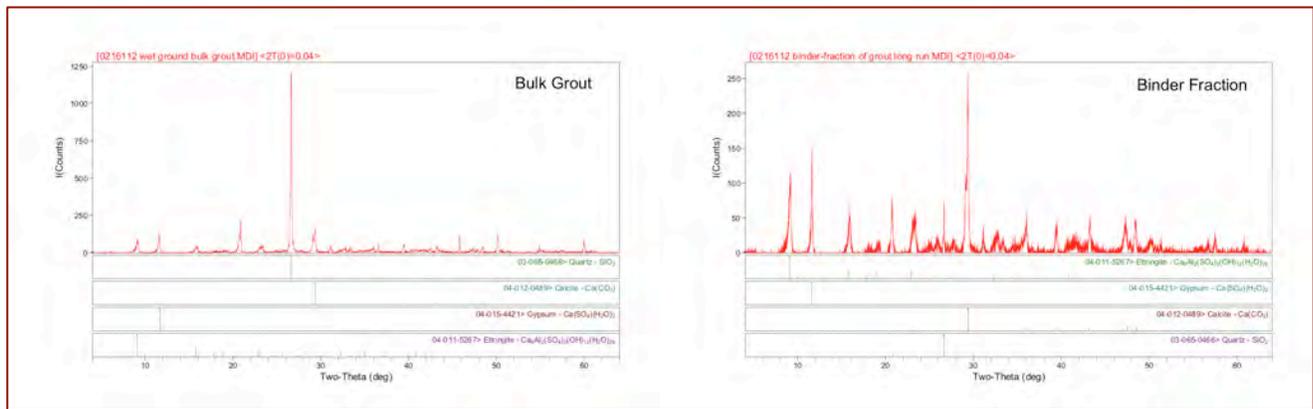
XRD of the binder-fraction passing the US 200 sieve (i.e. finer than  $74\text{-}\mu\text{m}$ , Figure A16 in the Appendix) showed lesser quartz than that detected in the bulk sample for mechanical separation, but clear discernable peaks of three main minerals present in the paste - calcite, gypsum, and ettringite.

Figure 15: XRD patterns showing various phases in the bulk grout sample at left and in the binder-fraction at right [after separating sand from the binder by passing gently disintegrated grout through US No. 200 sieve ( $74\text{-}\mu\text{m}$ ) and analyzing the fraction that has passed the sieve (finer than  $74\text{-}\mu\text{m}$ )].

Bulk mineralogy of grout shows 75-25 by weight of quartz sand to binder minerals, which is also found to be 50-50 in a separate batch of sample in a second XRD run. Clearly, sand distribution in the grout is not uniform, which could be due to some segregation of sand from an over-watered mixture. Etringite formation in the hardened state due to sulfate-aluminate reactions in the presence of moisture during service causes expansion and cracking of grout and the surrounding medium. Detection of both gypsum and calcite in the XRD indicates adequate presence of both sulfate and carbonate, respectively, which is consistent with optical microscopy and SEM-EDS studies.

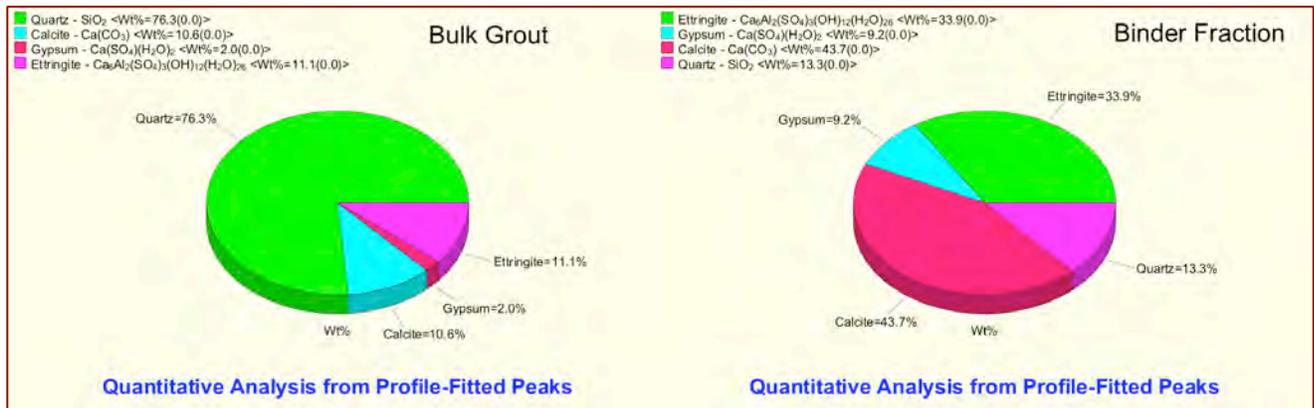
Figure 16: Pie-graphs showing semi-quantitative proportions of various phases in the bulk grout sample at left and in the binder-fraction at right [after separating sand from the binder by passing gently disintegrated grout through US No. 200 sieve (74-µm) and analyzing the fraction that has passed the sieve (finer than 74-µm)].

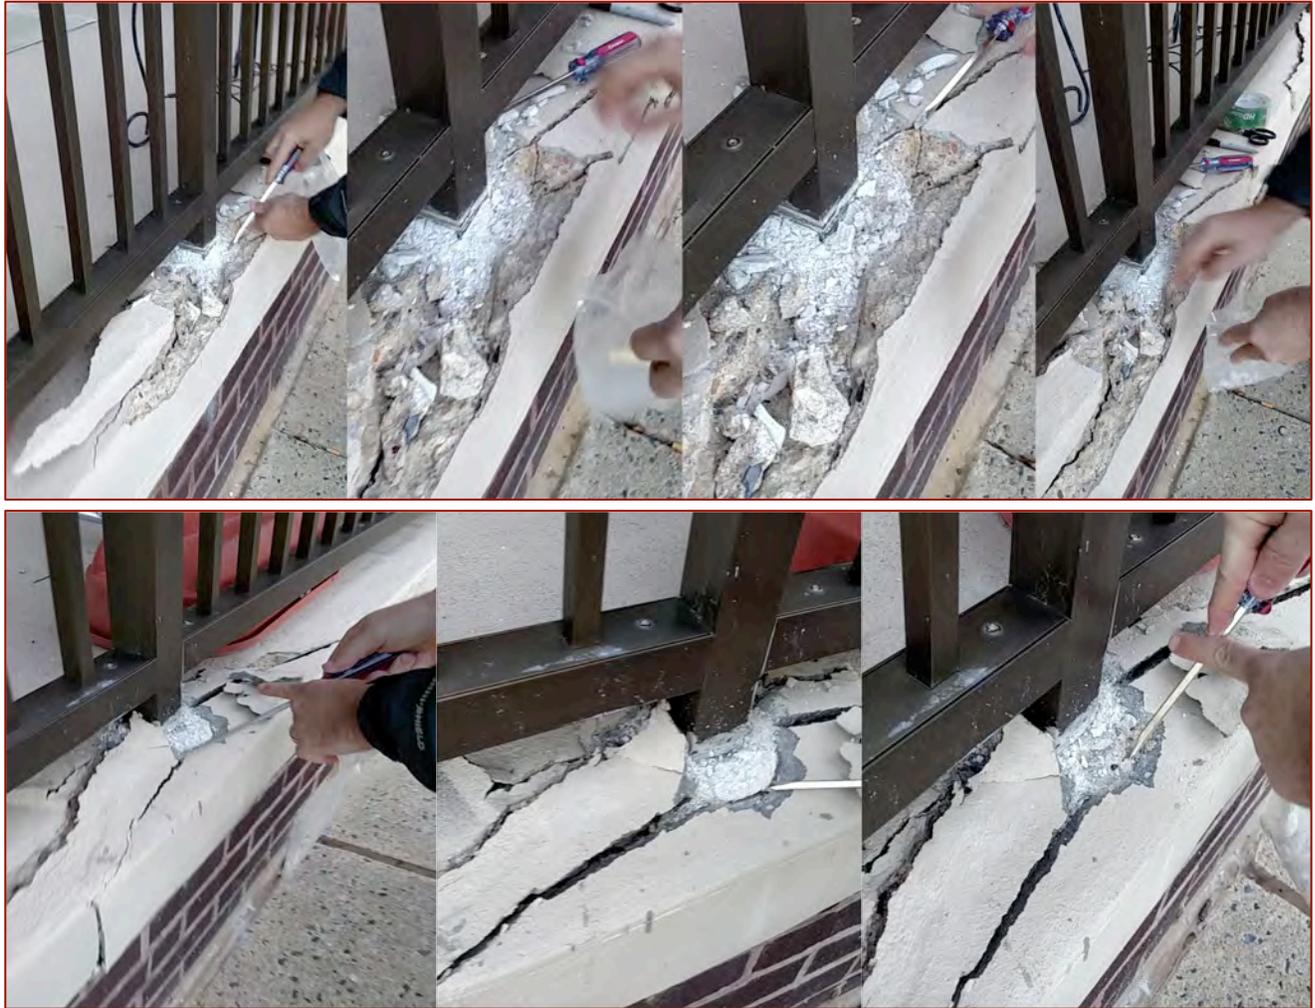
**Figure A1:** Cracking, spalling, and disintegration of concrete at the base of two railings, as well as severe disintegration of anchoring grout that has been exposed from severe cracking and spalling. Notice cracks are long, continuous and extended from one railing base to the neighboring ones. Cracks are wide and indicative of an expansion of the underlying grout material, including expansion and disintegration of the anchoring grout itself. Notice how readily the anchoring grout is disintegrated during sample collection with a screwdriver. The top row shows collection of anchoring grout sample from one railing and the bottom row shows sample collection from the adjacent railing. Grout samples from both railings were collected in a plastic bag (shown in Figure A2) that was received in our laboratory.

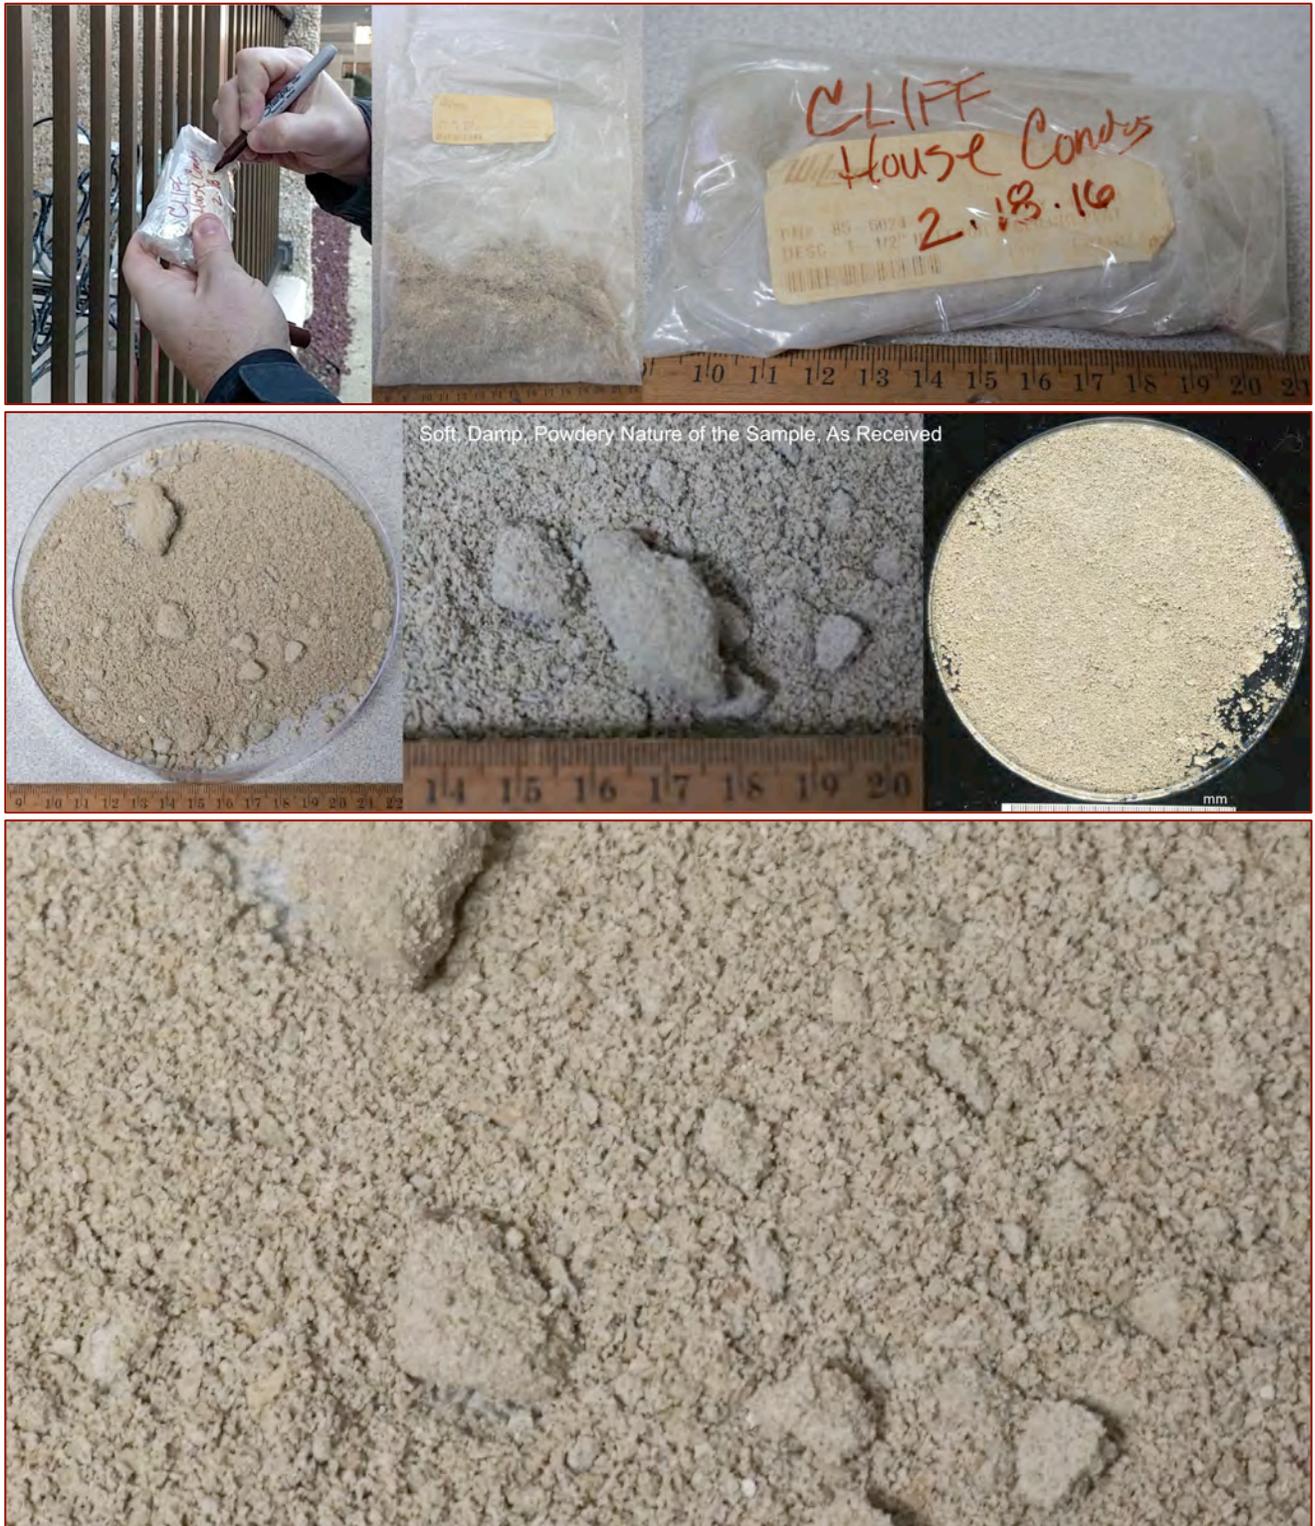
**Figure A2:** Shown is the anchoring grout sample collected from the field and received in our laboratory in a double plastic bag. Notice the severe fragmentation and powdery nature of the material. Sample was damp when received.

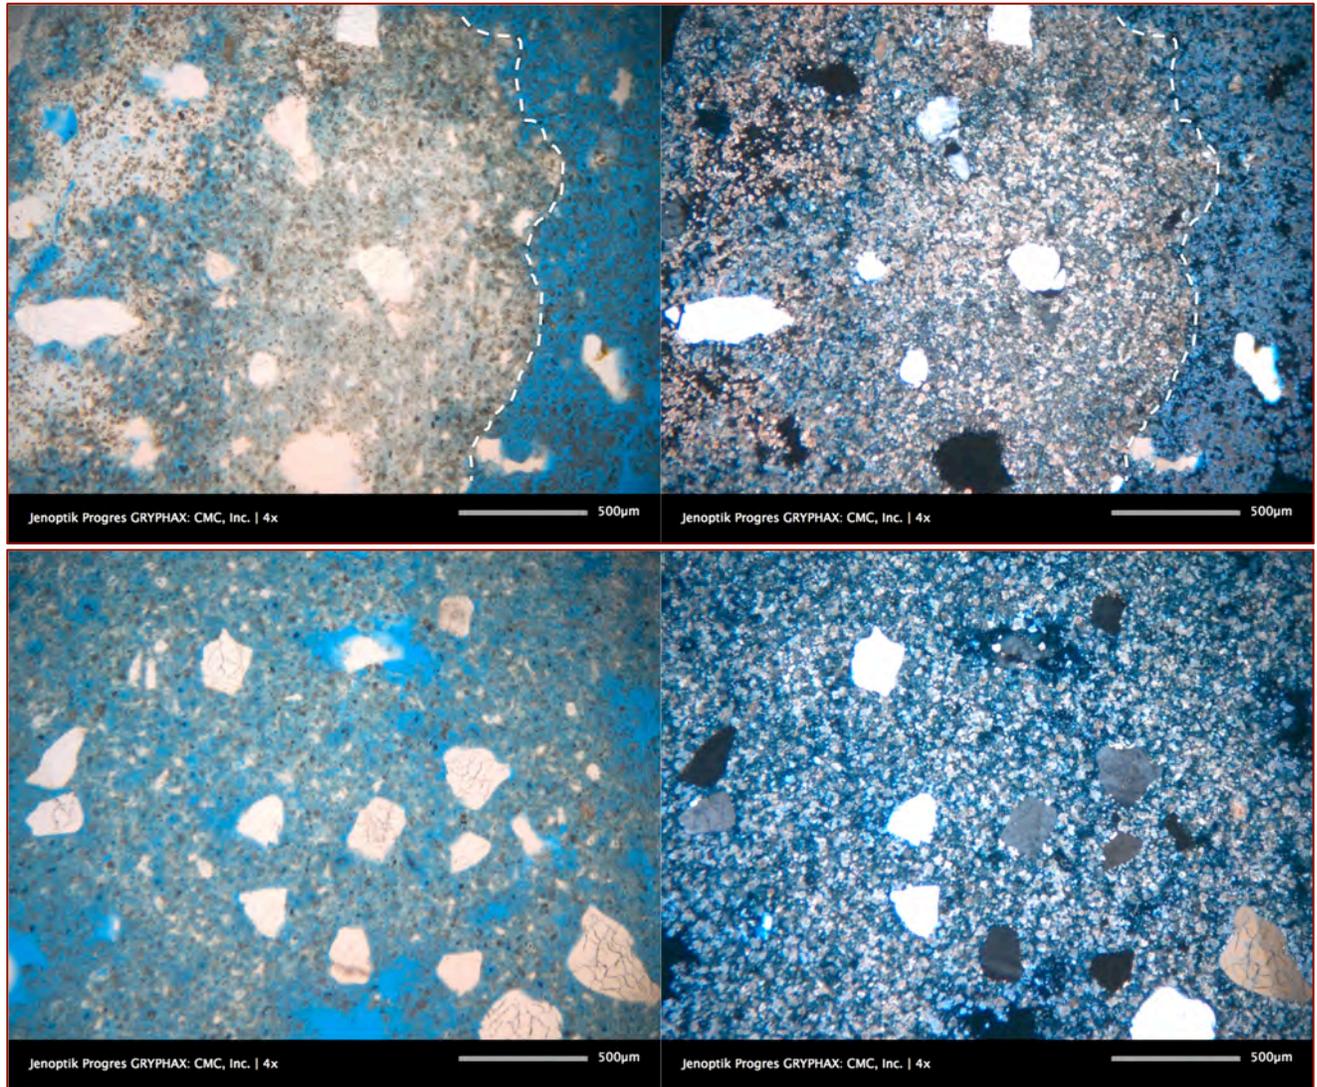
**Figure A4:** Photomicrographs of thin section of grout showing quartz sand scattered in an overwhelming porous matrix of calcium carbonate and gypsum.

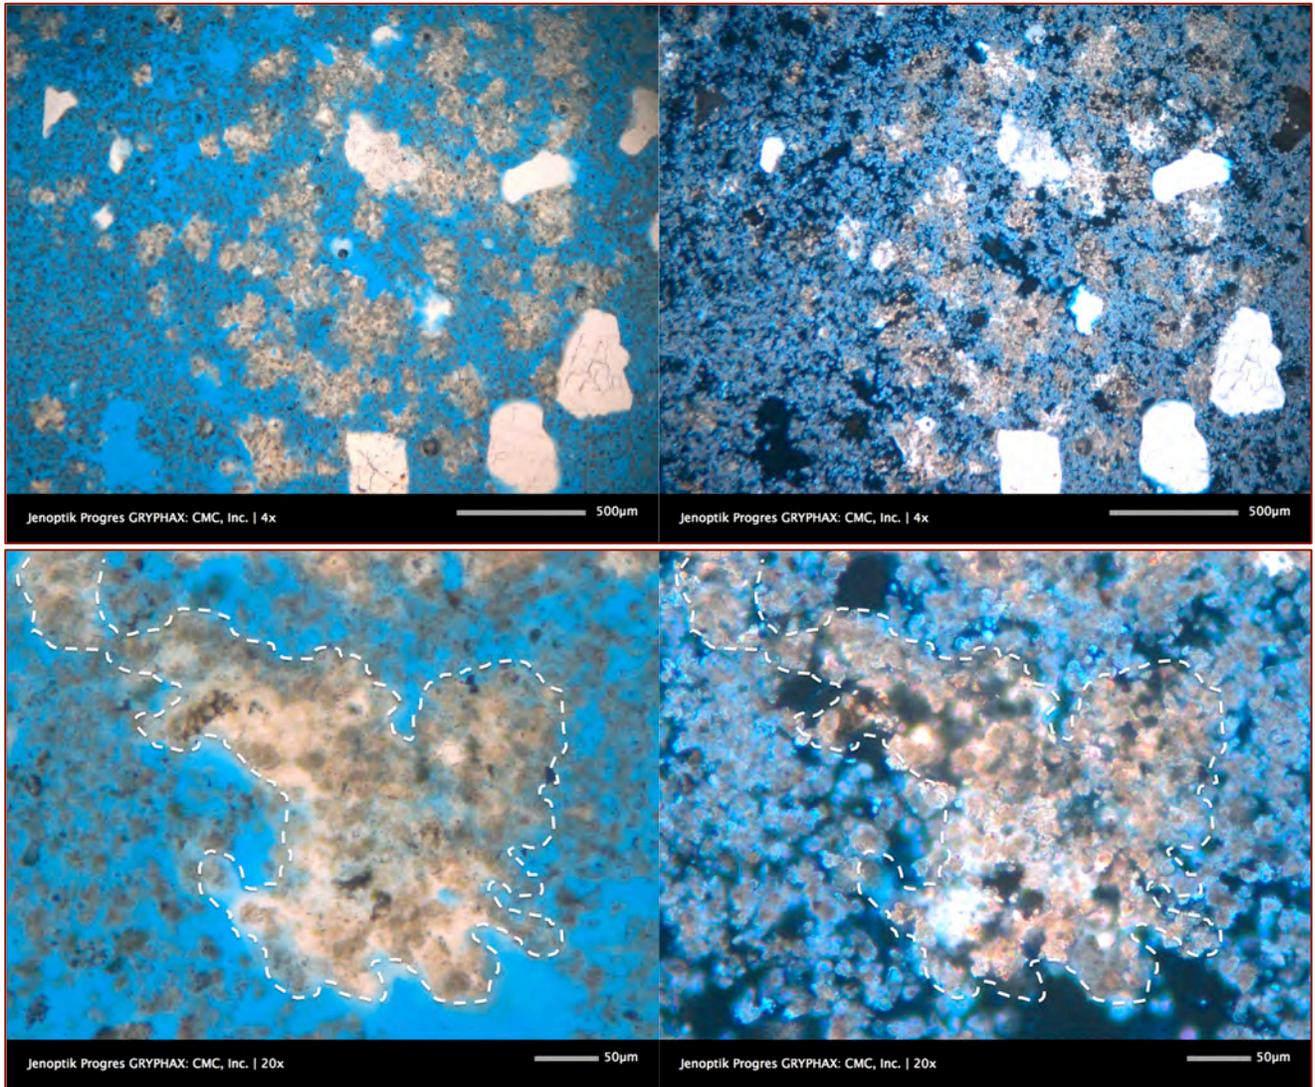
**Figure A5:** Photomicrographs of thin section of grout showing patchy areas of relatively denser paste that are scattered in an overwhelming porous matrix of calcium carbonate and gypsum.

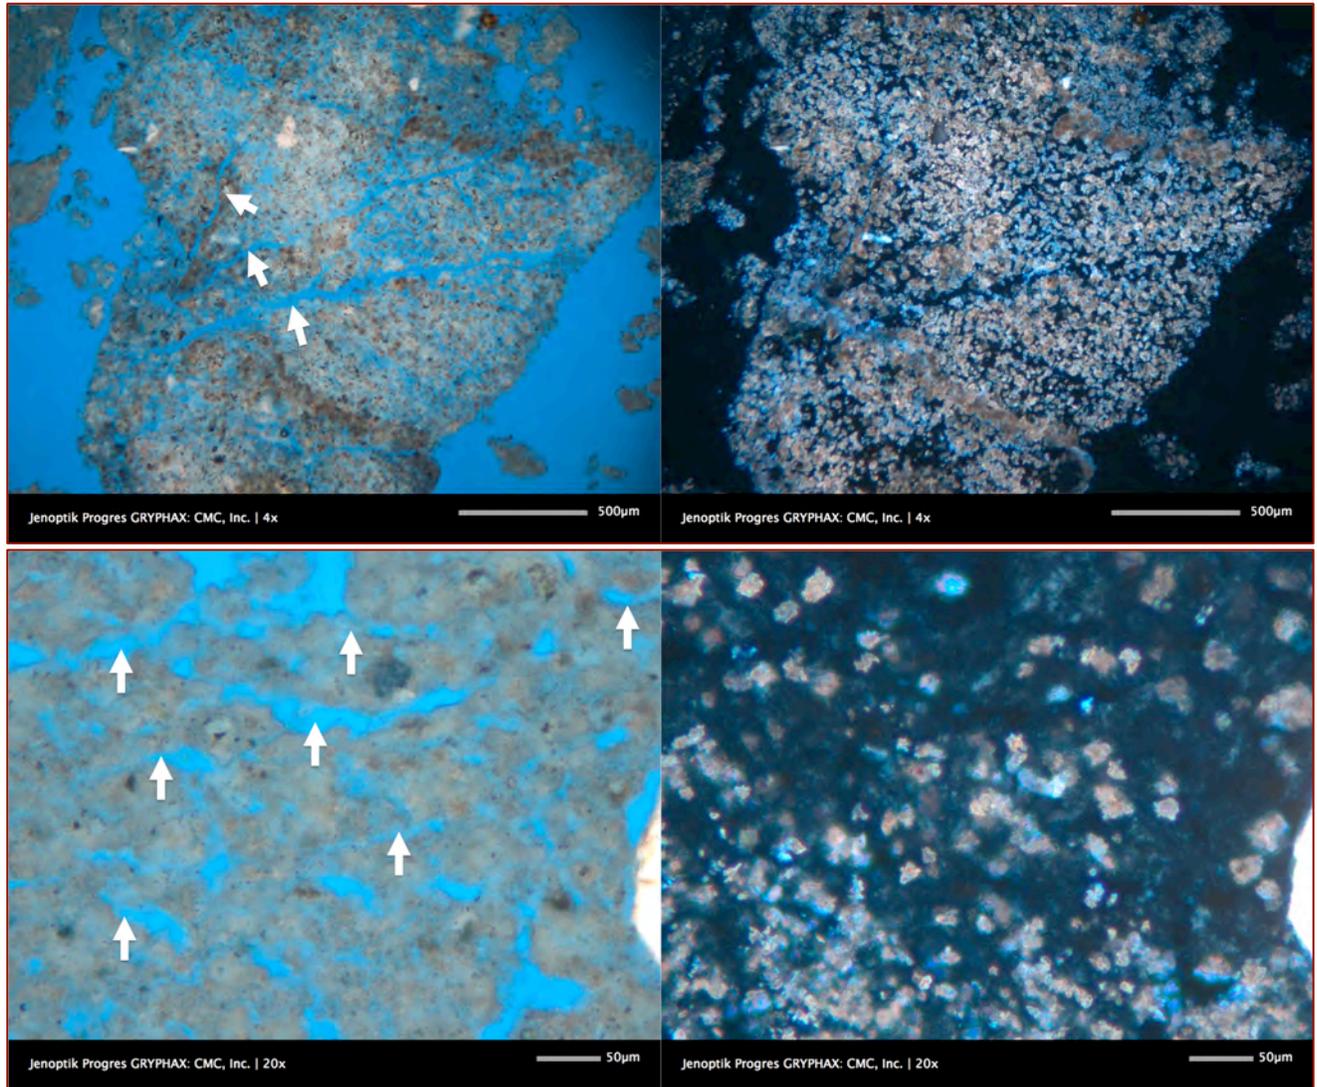
**Figure A6:** Photomicrographs of thin section of grout showing shrinkage microcracks from excessive moisture in the paste that are not anticipated in a nonshrink grout.
