CONSTRUCTION MATERIALS CONSULTANTS, INC.

## Investigation of Failure of Anchoring Grout & Associated Distress in Concrete

ABC Condominiums  
ABC Road, Wilmington, DE 19810

Prepared for:  
ABC, Inc.  
ABC Condominium Association, Inc.

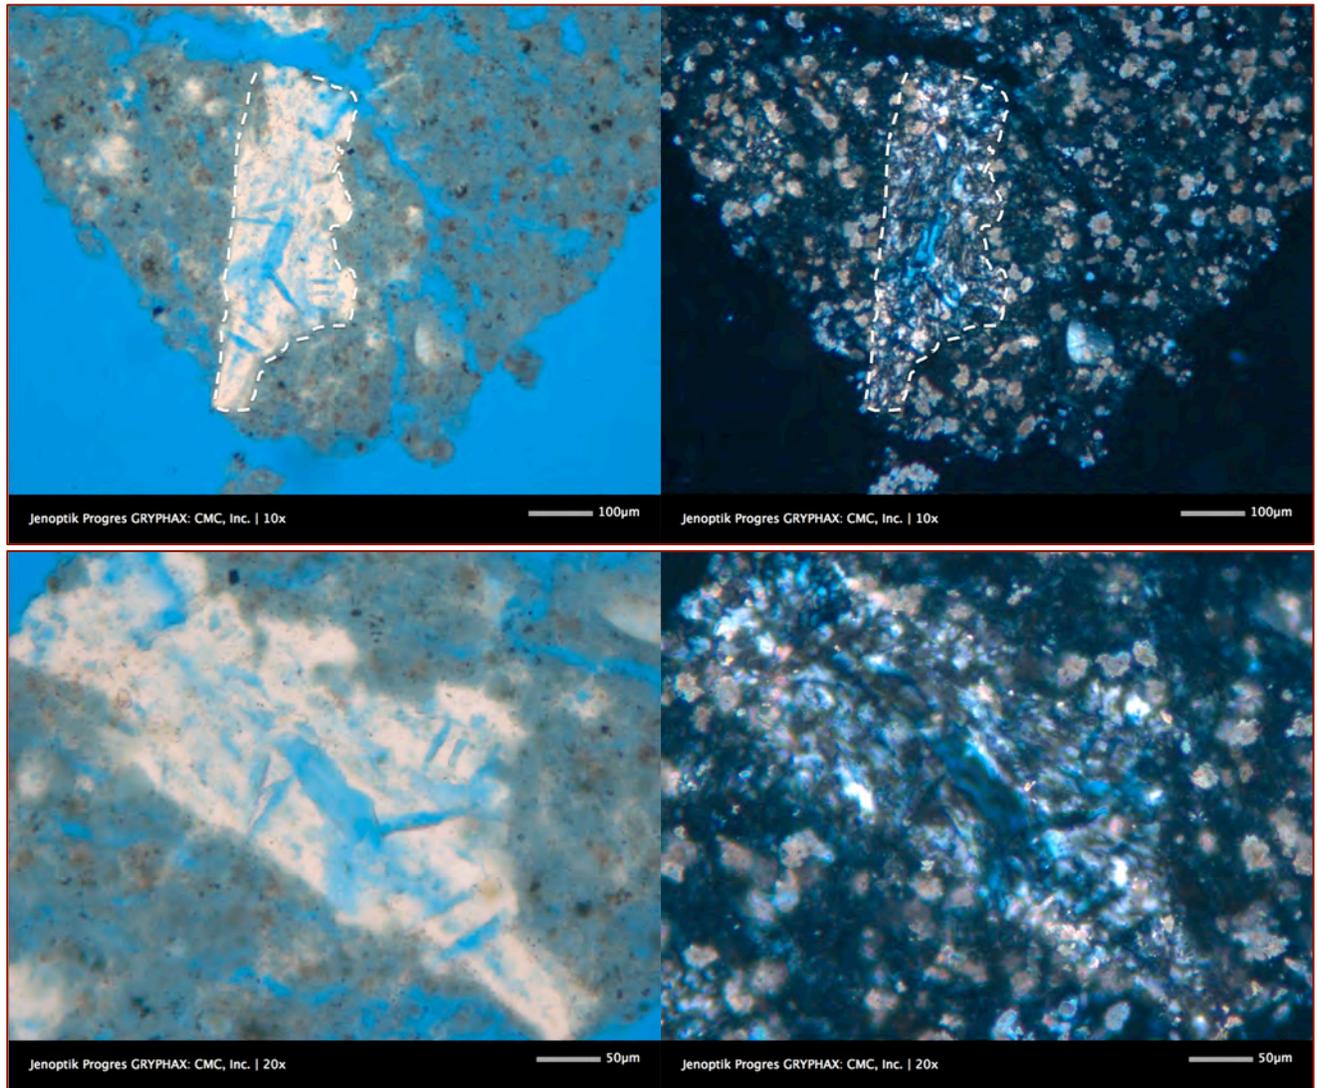
**Figure A7:** Photomicrographs of thin section of grout showing large subhedral secondary (recrystallized) gypsum that were formed from wetting and drying of grout.

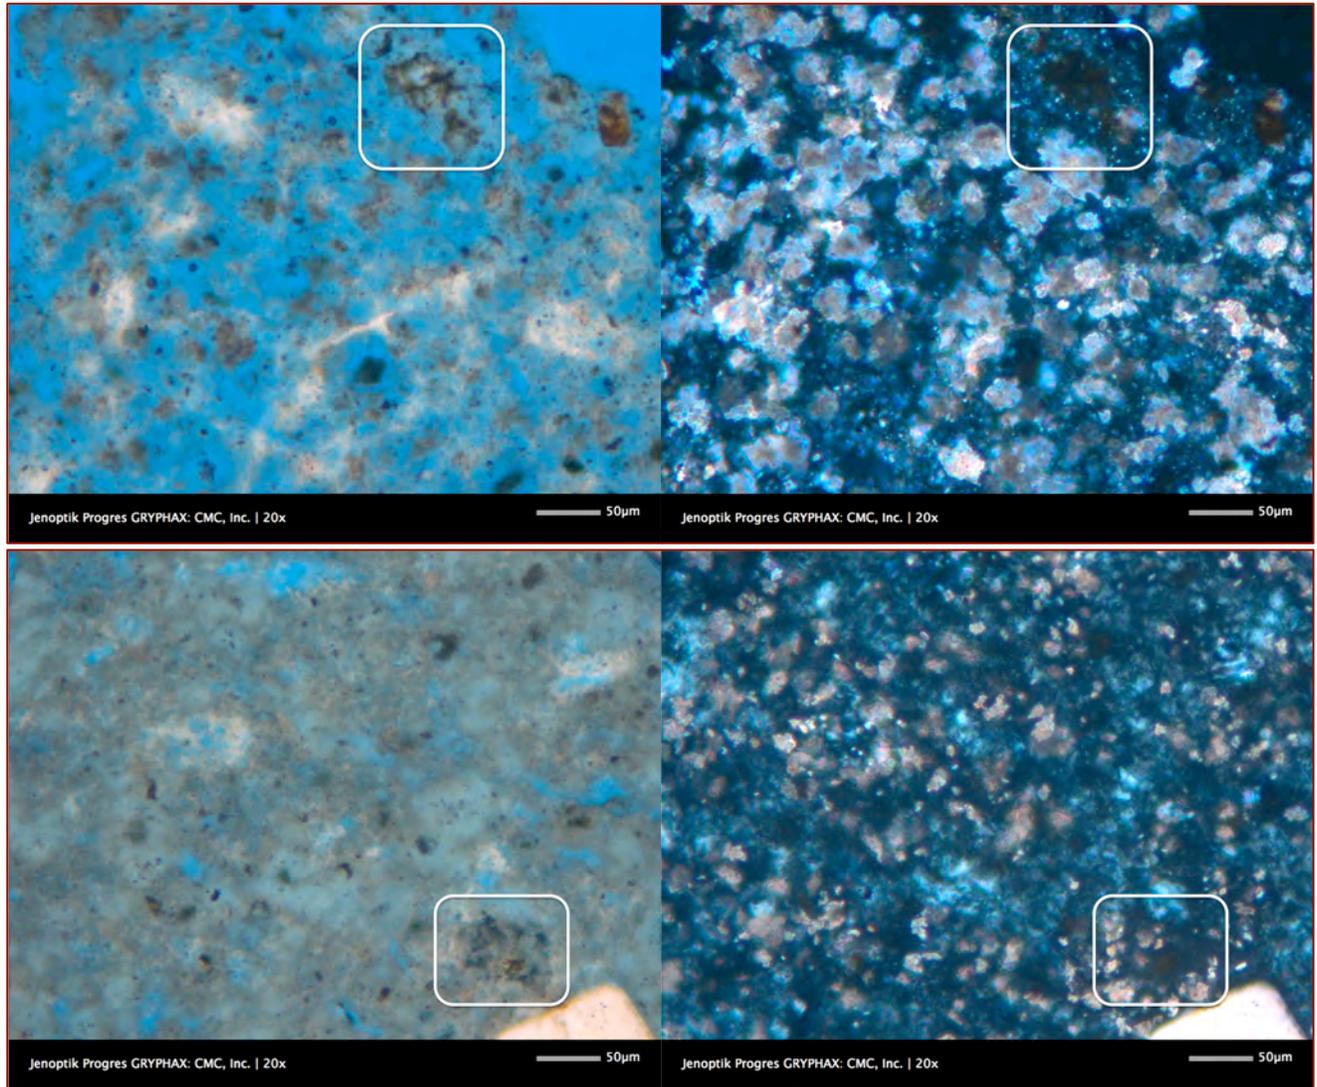
**Figure A8:** Photomicrographs of thin section of grout showing the dominant matrix consisting of overwhelming mixtures of calcium carbonate and gypsum and a few scattered residual and relict cement particles (boxed).

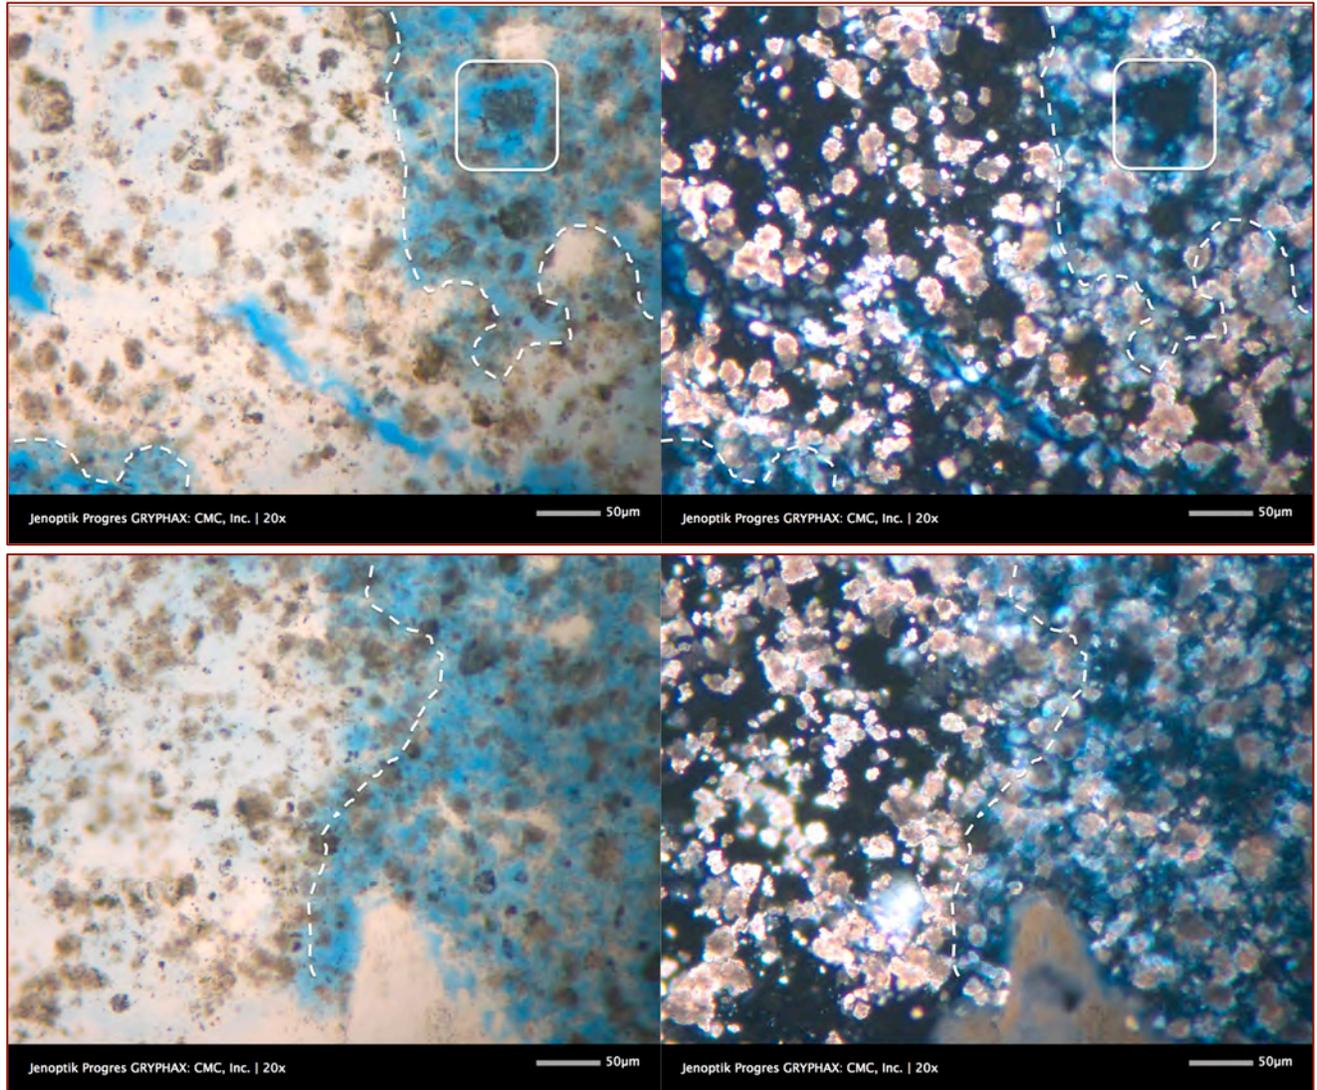
**Figure A9:** Photomicrographs of thin section of grout showing leaching of water-soluble masses creating an isotropic appearance of areas in XPL (separated by dashed lines from the non-leached porous areas).

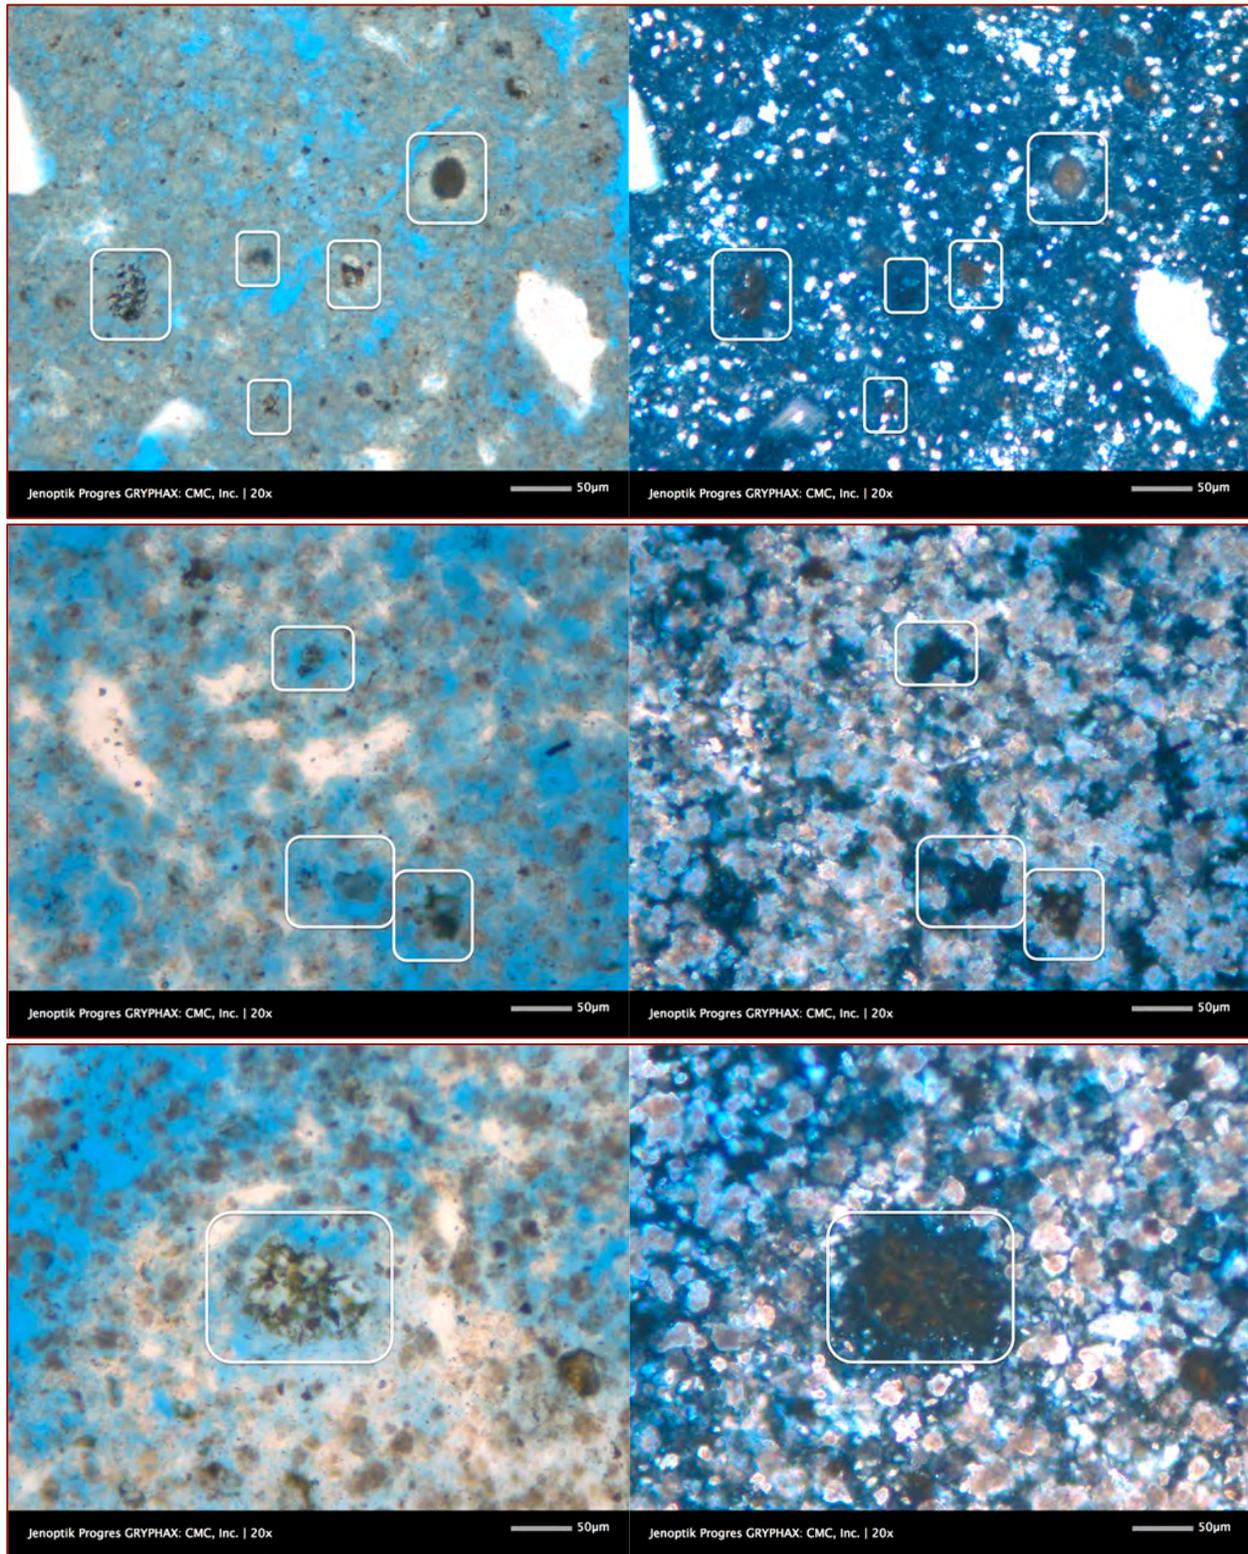
**Figure A10:** Photomicrographs of thin section of grout showing a few scattered residual and relict cement particles (boxed) that are indicative of the presence of a minor cement component in the gypsum-based grout.

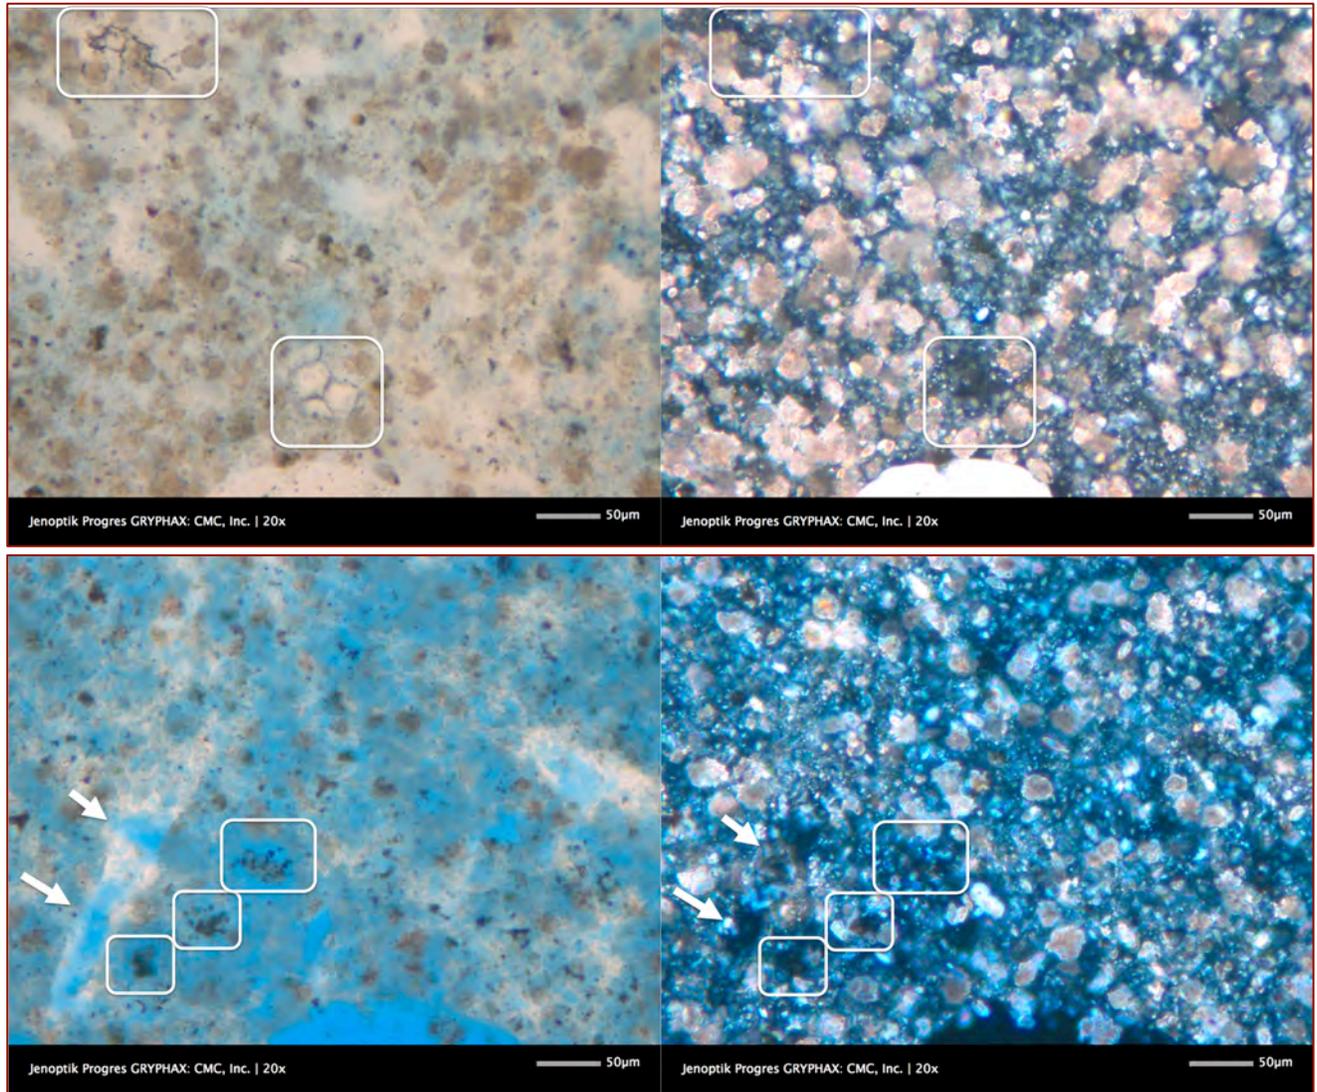
**Figure A11:** Photomicrographs of thin section of grout showing a few scattered residual and relict cement particles (boxed) that are indicative of the presence of a minor cement component in the gypsum-based grout.

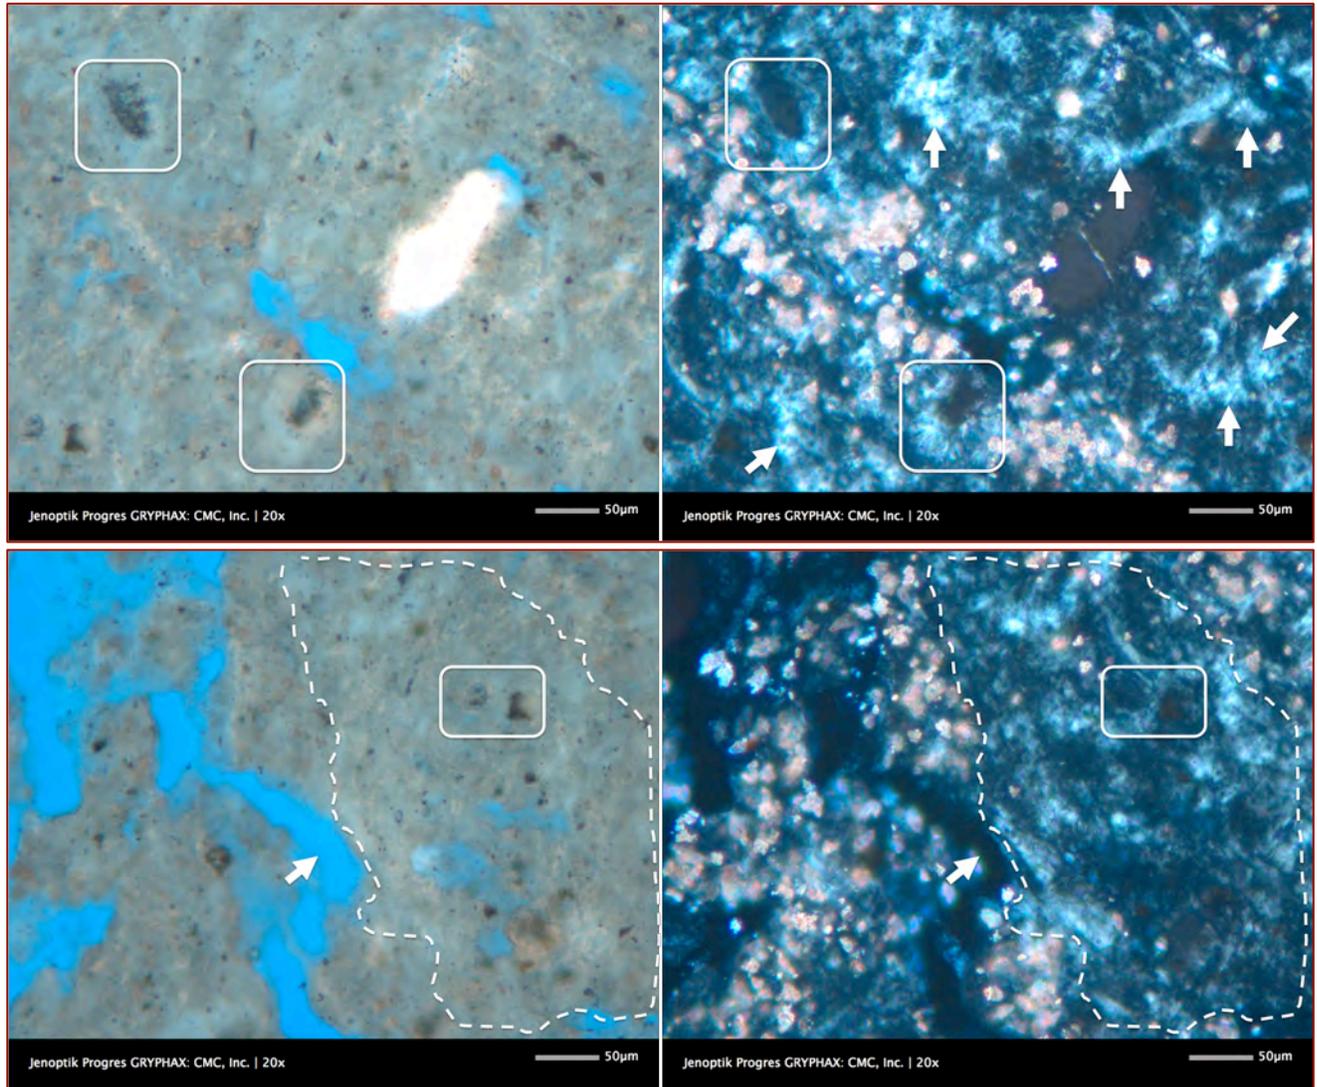
**Figure A12:** Photomicrographs of thin section of grout showing gypsum-rich areas in paste that are not mixed with calcium carbonate masses.

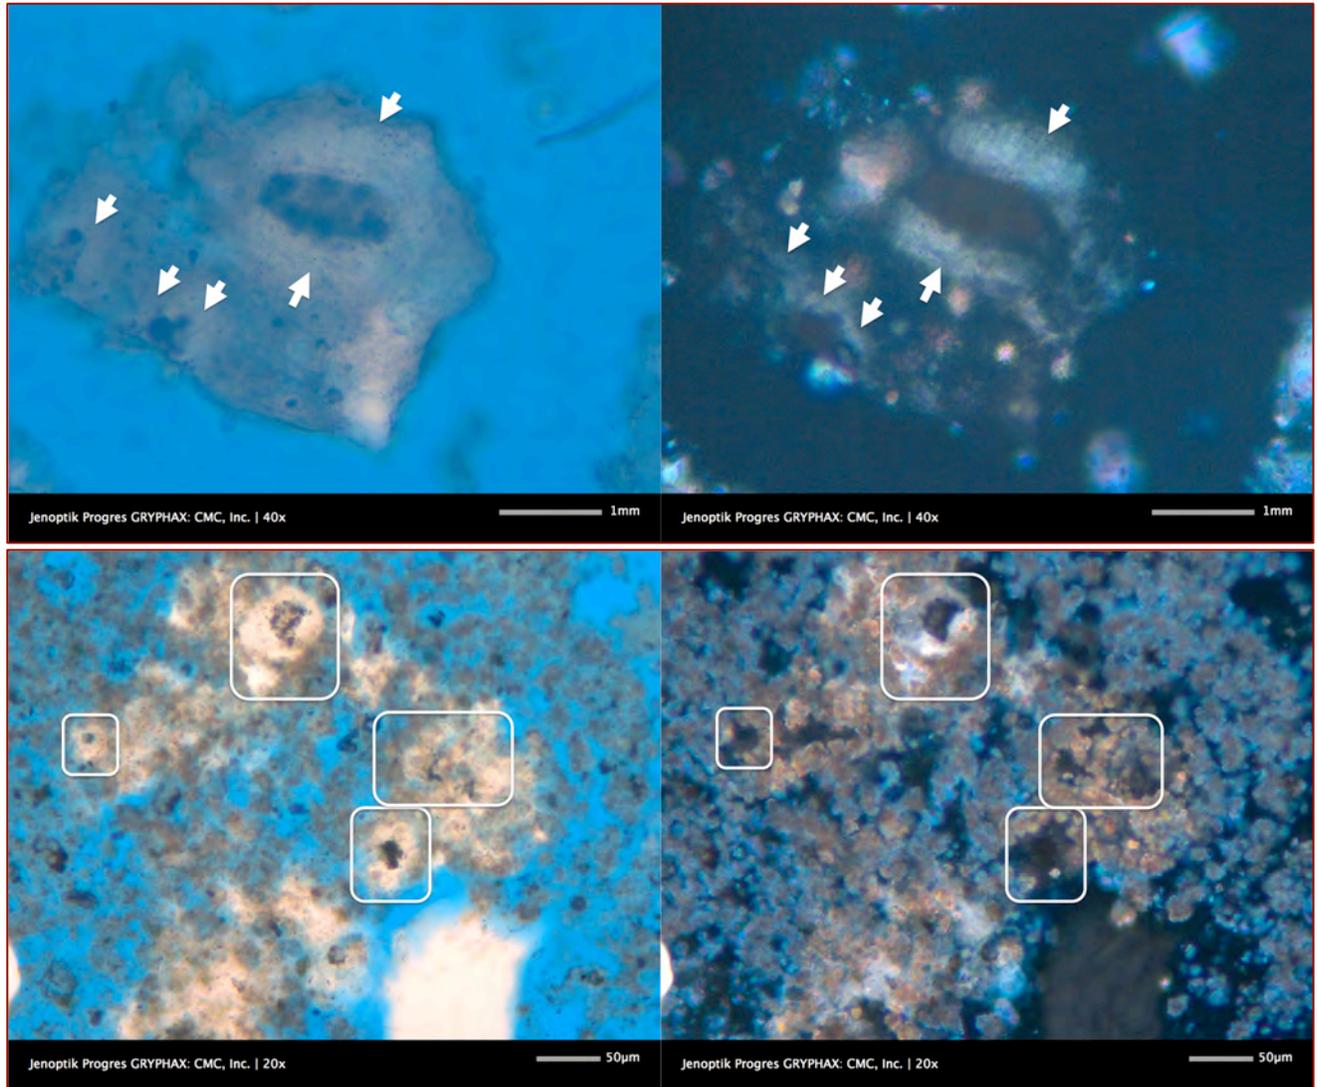
**Figure A13:** Photomicrographs of thin section of grout showing topochemical formation of fibrous ettringite on the surfaces of residual aluminate phases within the residual cement particles.

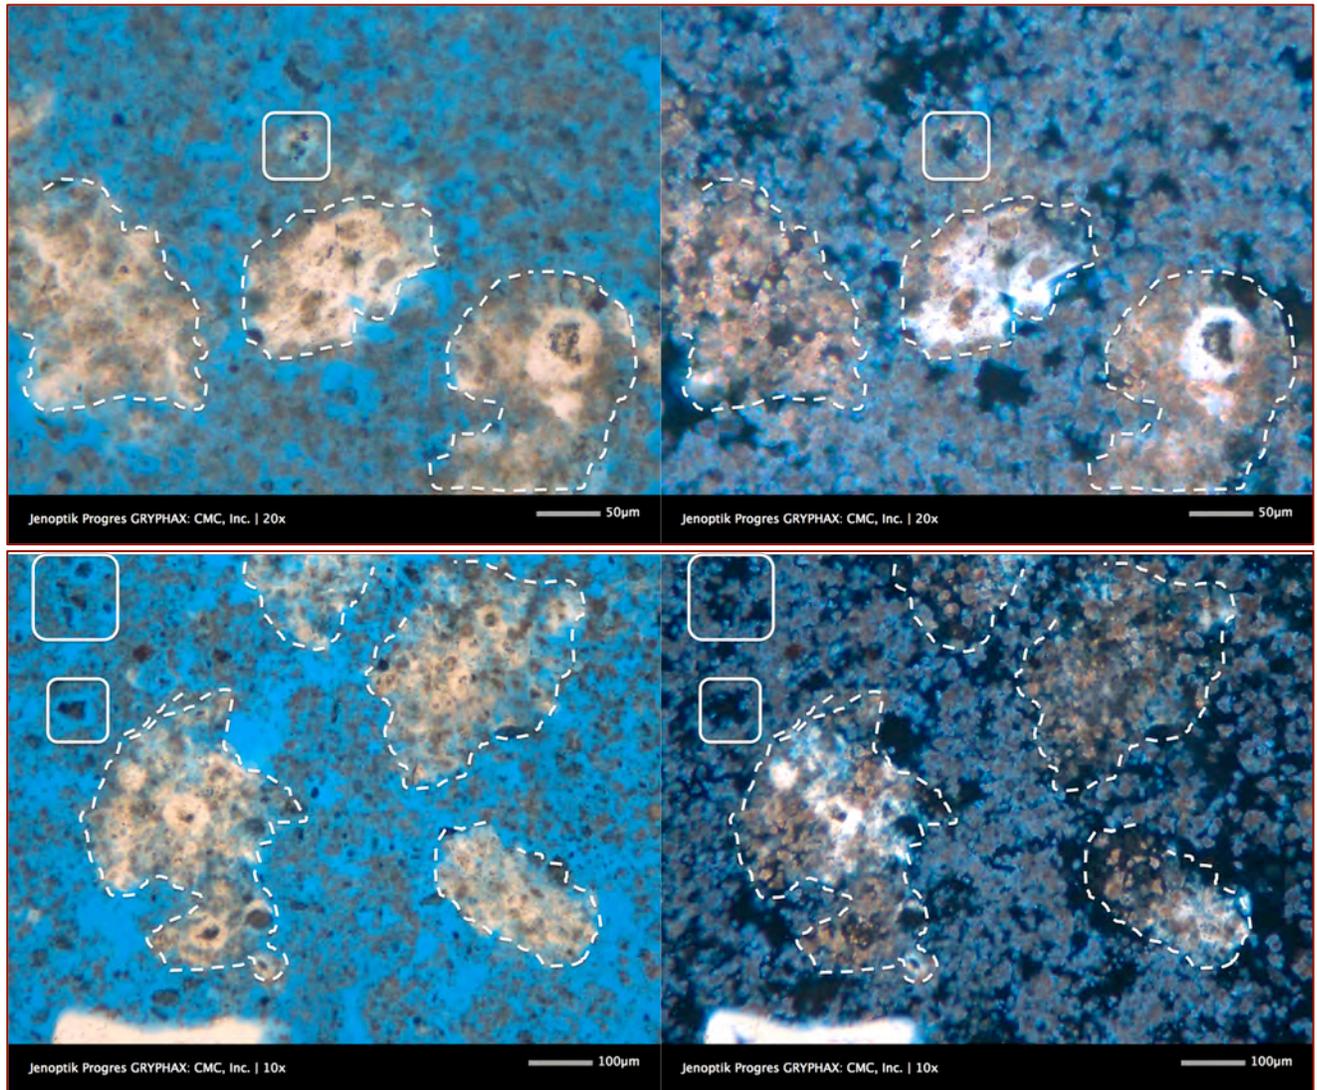
**Figure A14:** Photomicrographs of thin section of grout showing topochemical formation of fibrous ettringite on the surfaces of residual aluminate phases within the residual cement particles.

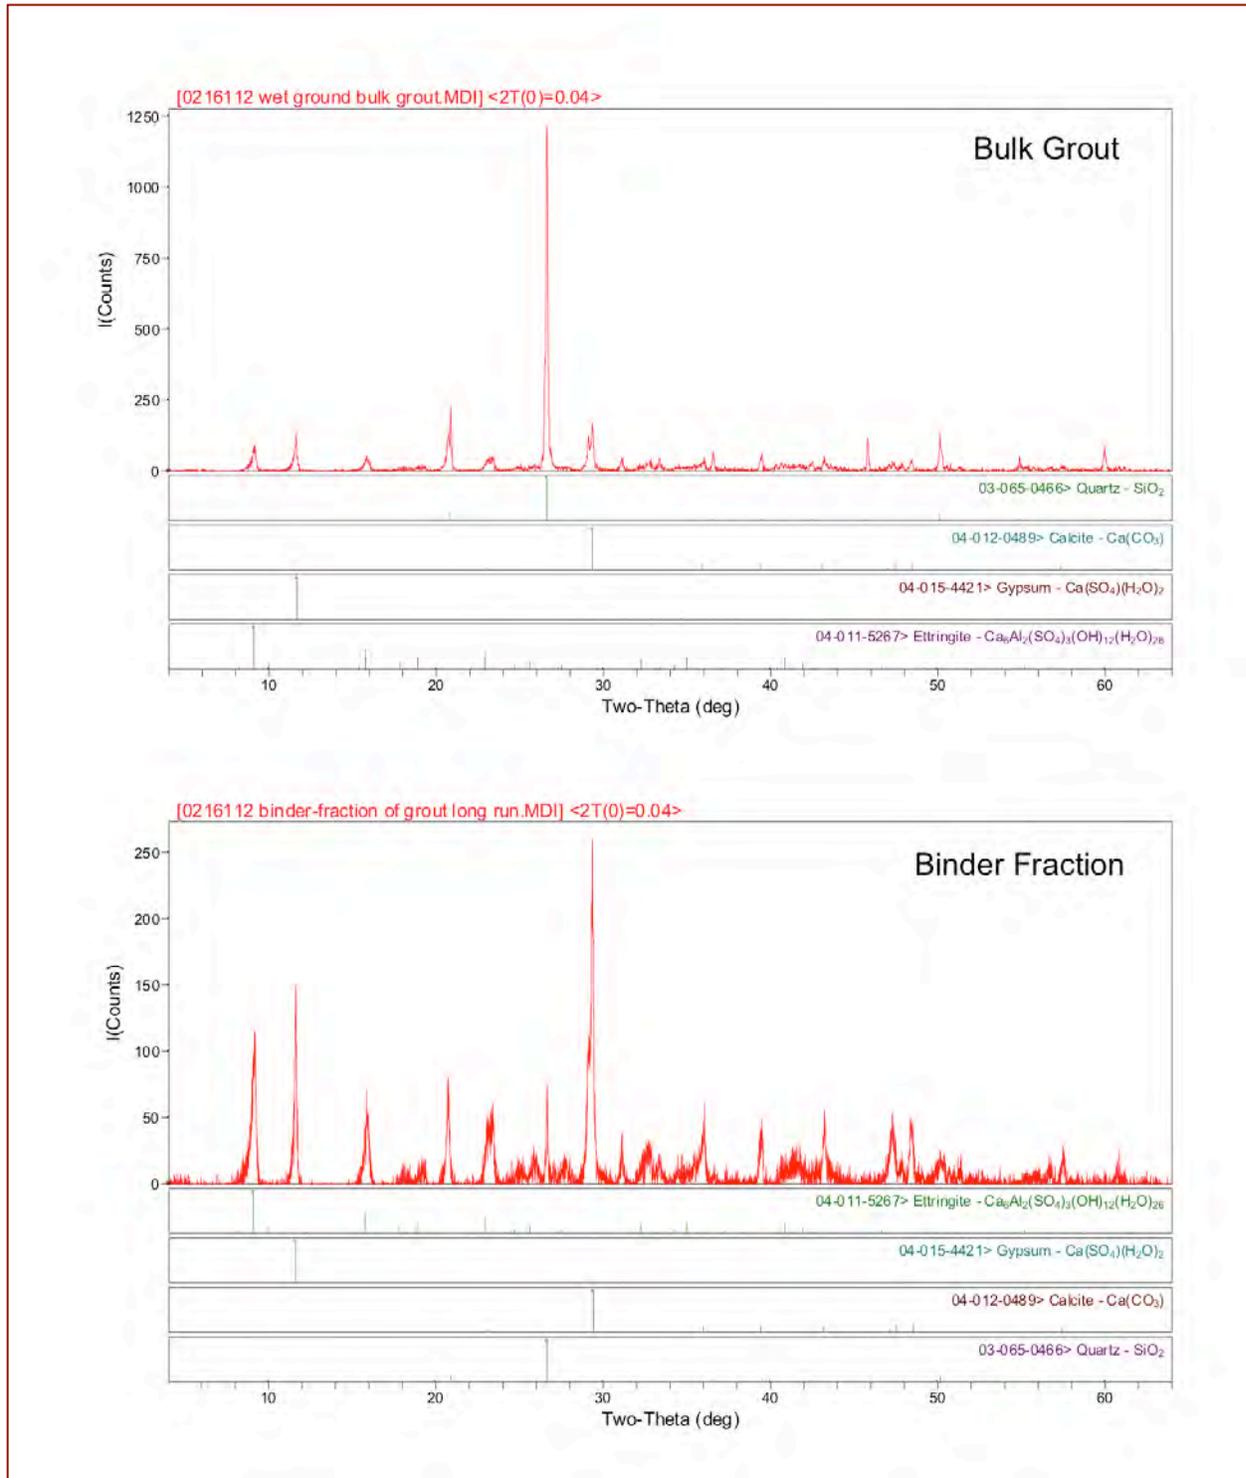
**Figure A15:** X-ray diffraction patterns of bulk grout (top) and binder fraction after screening out quartz sand (bottom) showing gypsum, ettringite, and calcite as the three predominant minerals in the paste. Notice the noticeable drop in count rates in the binder fraction, despite doubling the scan-time, due to the absence of the major mineral, quartz, which was responsible for the high-count rate in the bulk grout.

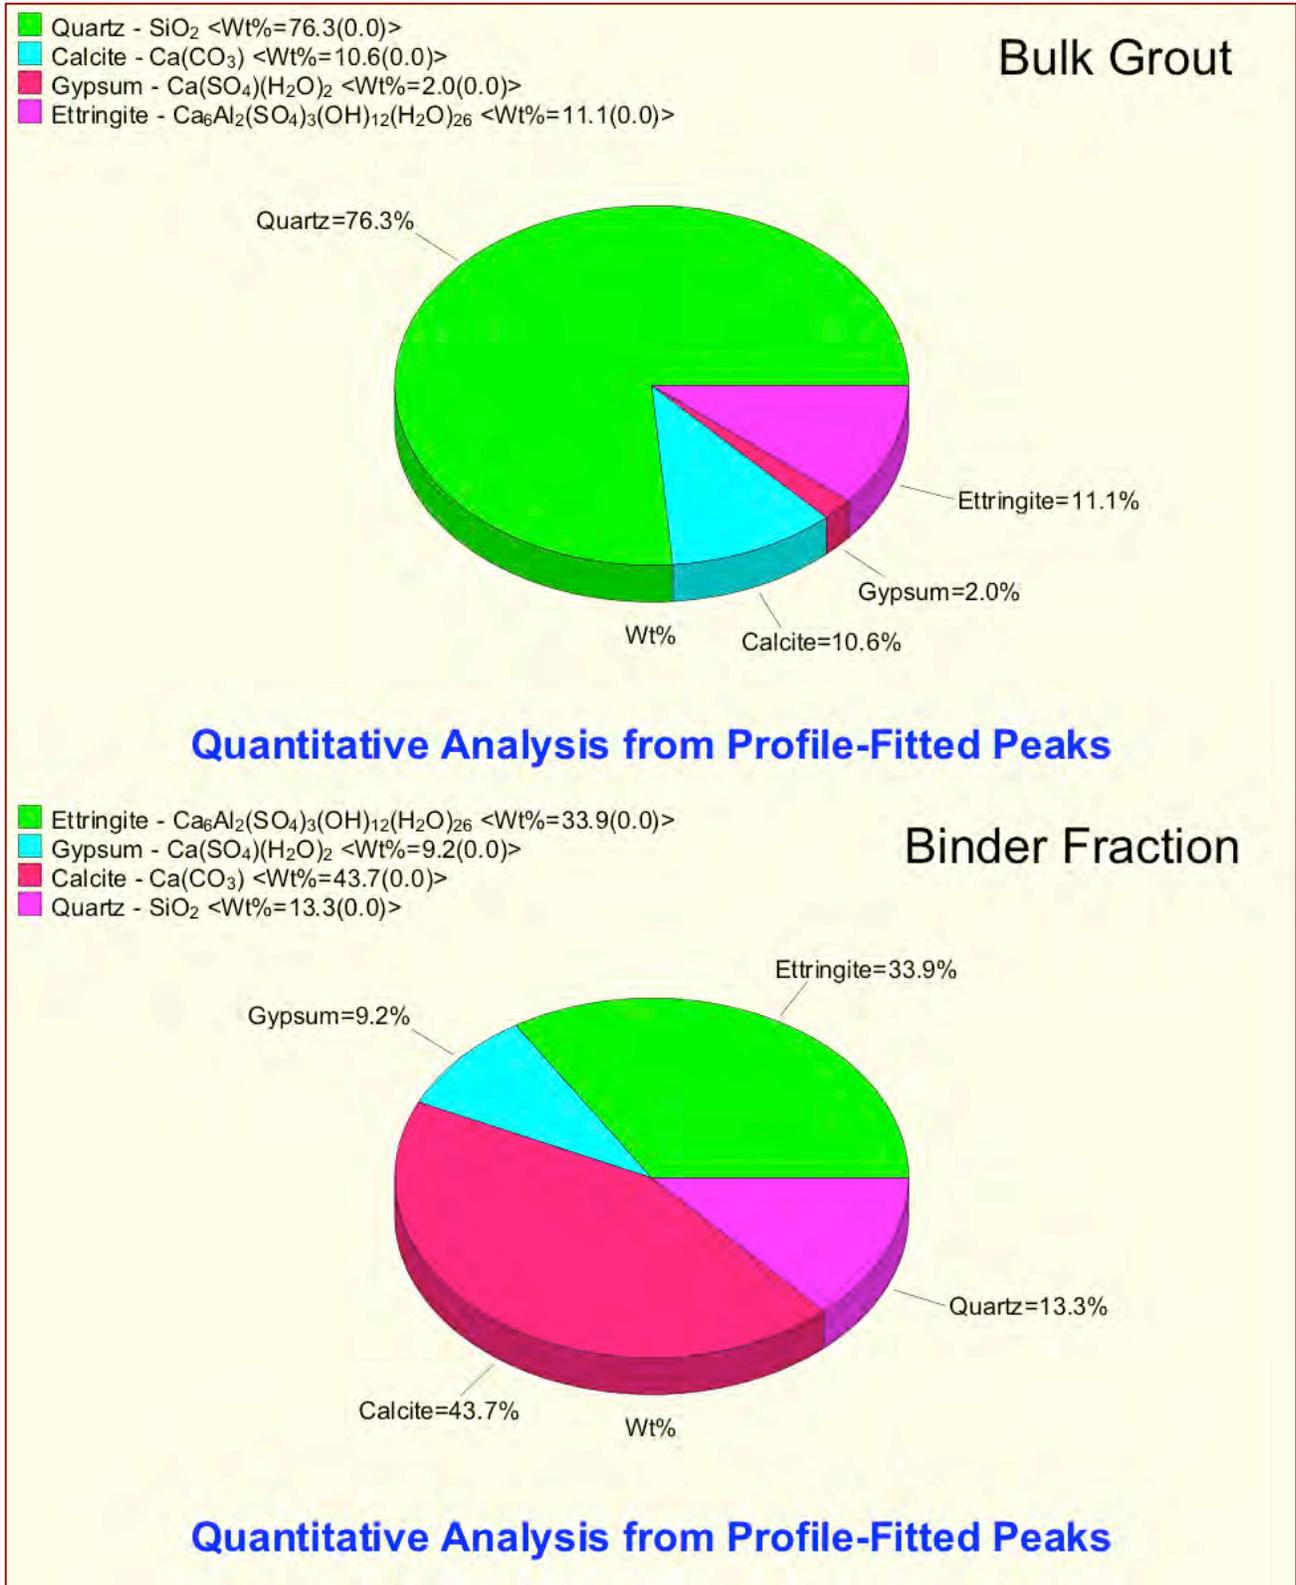
**Figure A16:** Semi-quantitative proportions of various minerals in the bulk grout (top) and binder fraction after screening out quartz sand (bottom) showing gypsum, ettringite, and calcite as the three predominant minerals in the paste.

XRD of the binder-fraction passing the US 200 sieve (i.e. finer than  $74\text{-}\mu\text{m}$ , Figure A16 in the Appendix) showed lesser quartz than that detected in the bulk sample for mechanical separation, but clear discernable peaks of three main minerals present in the paste - calcite, gypsum, and ettringite.

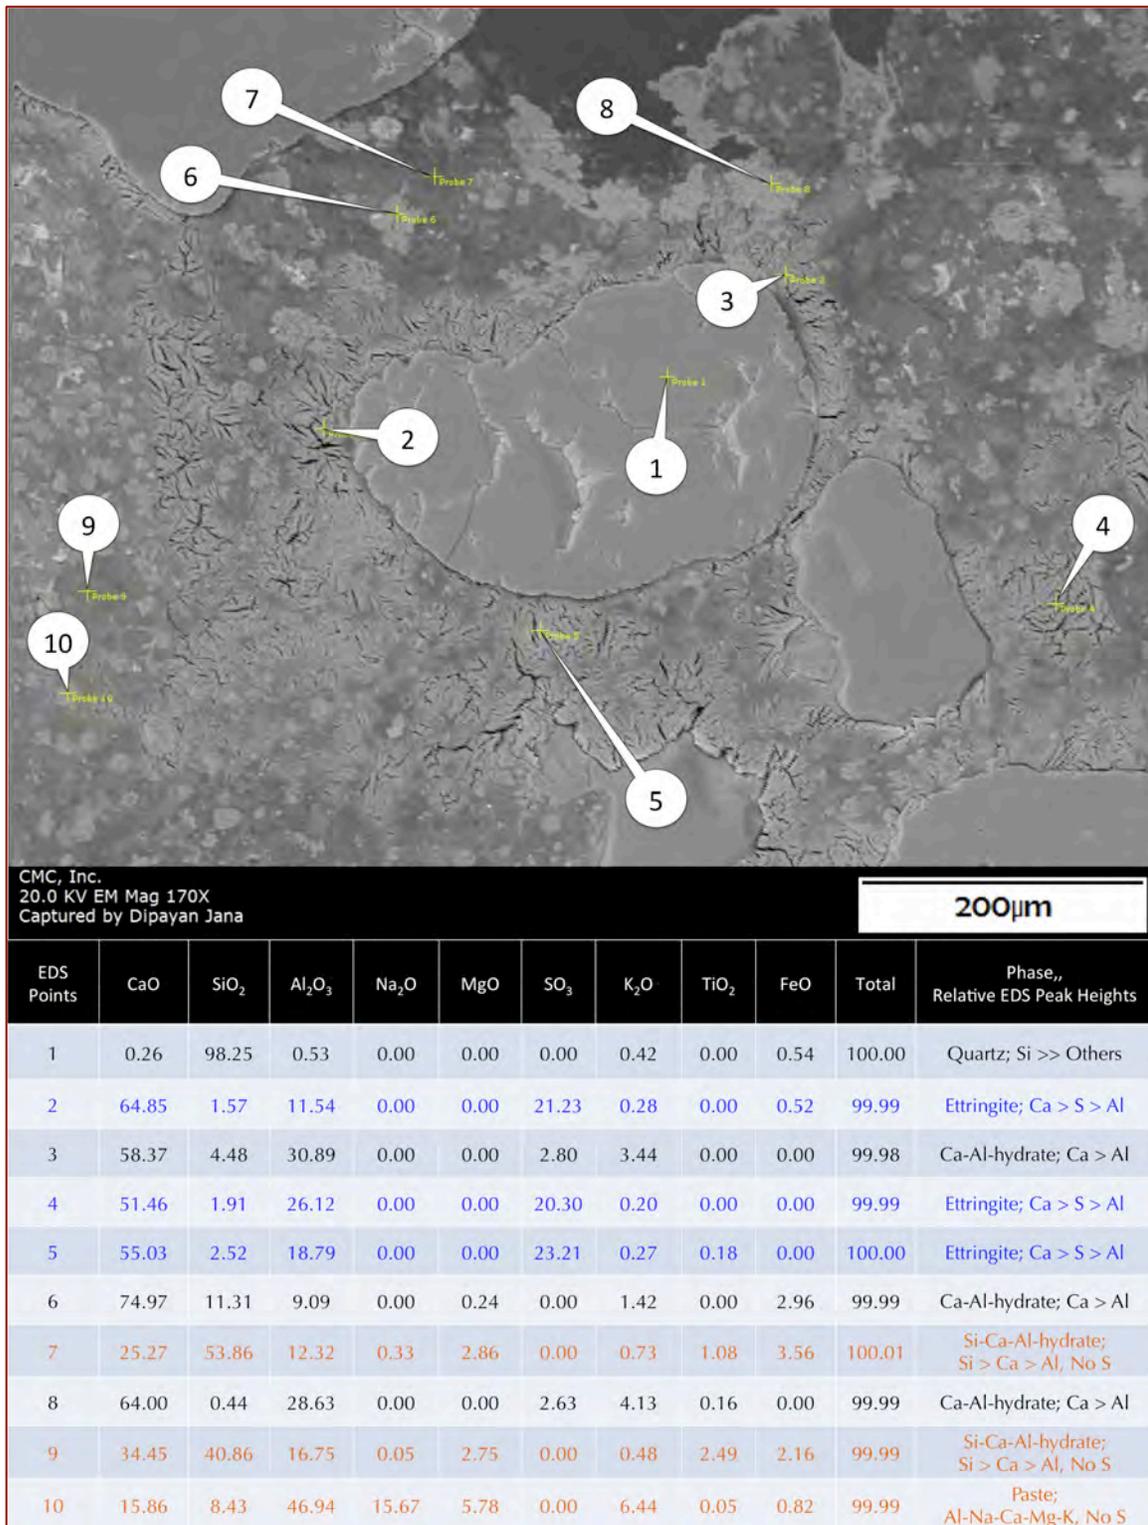
**Figure A17:** Secondary electron image and x-ray elemental analyses of various marked areas around paste showing the presence of: (a) quartz sand; (b) ettringite deposits, having its characteristic fibrous habit and shrinkage microstructure, in blue, measured in Probe Nos. 2, 4, and 5; (c) Paste areas having no sulfate, in orange, measured in Probe Nos. 7, 9, and 10; and (d) calcium aluminate hydrates, in black, in Probe Nos. 3, 6, and 8.

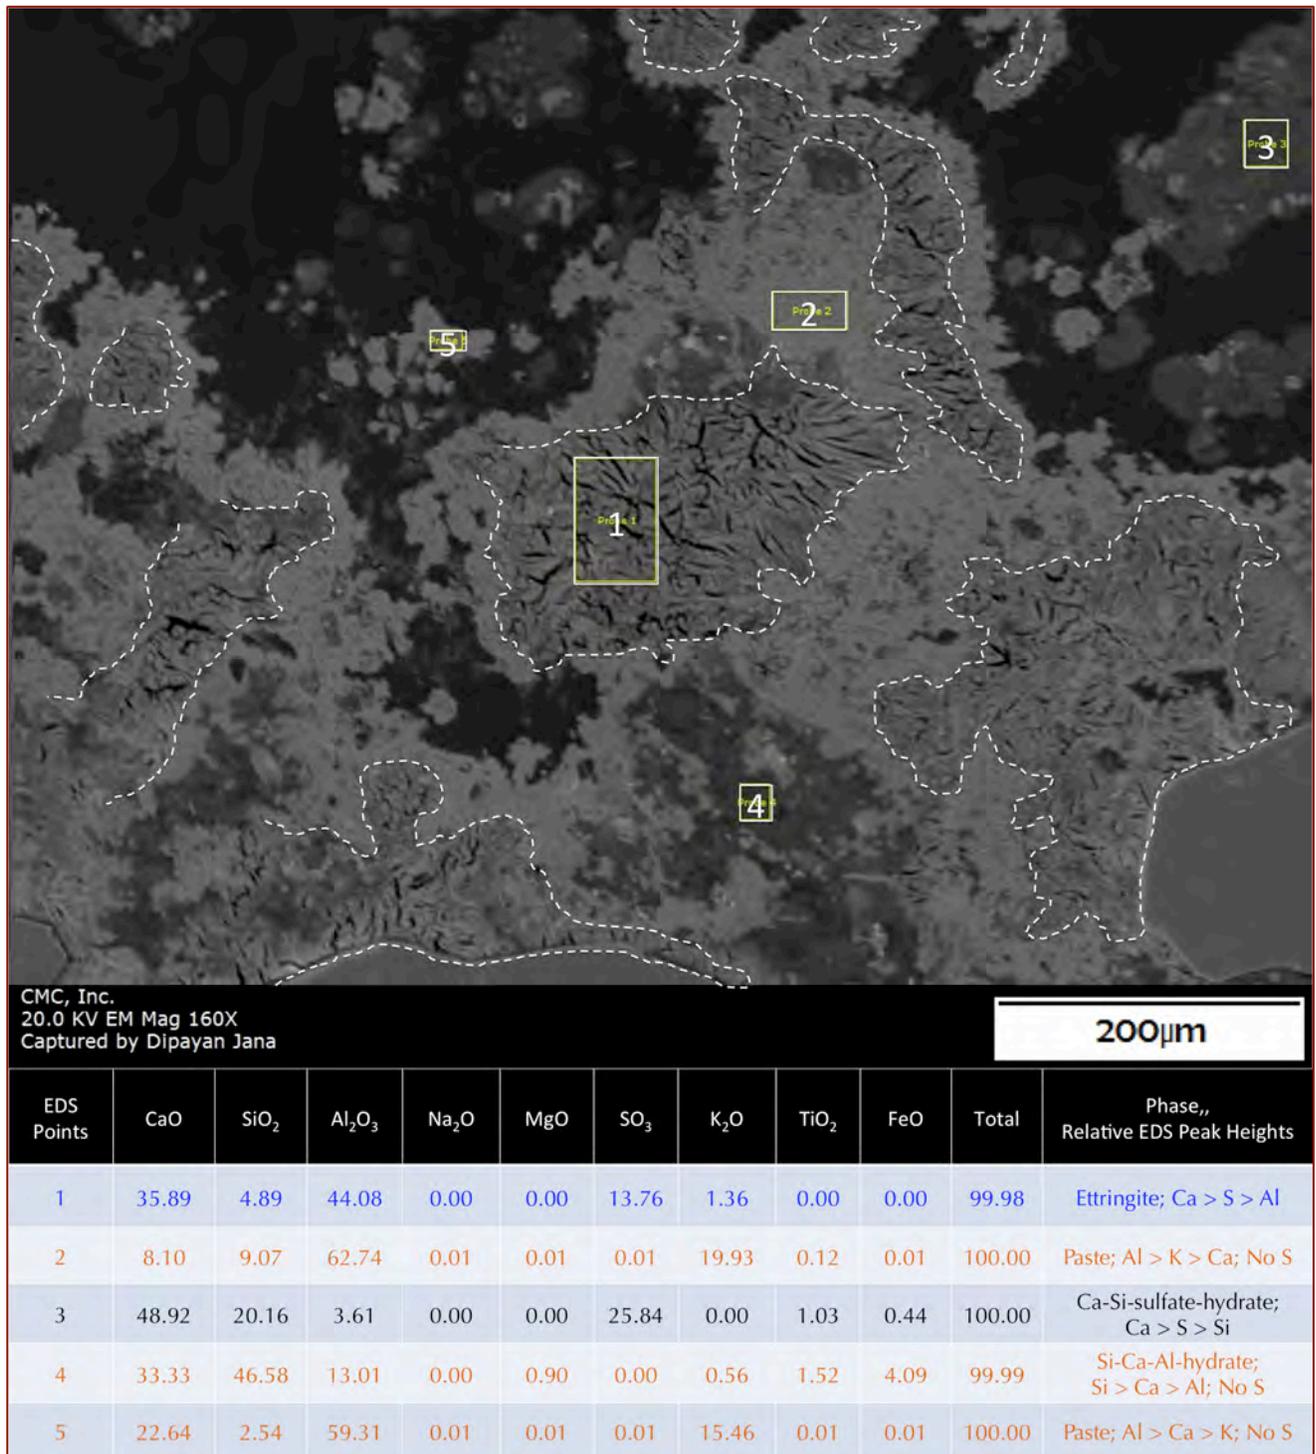
**Figure A18:** Secondary electron image and x-ray elemental analyses of various marked areas around paste showing the presence of: (a) profuse ettringite deposits, having its characteristic fibrous habit and shrinkage microstructure, marked within dashed lines, and measured in Probe No. 1; (b) Paste areas having no sulfate, in orange, measured in Probe Nos. 2, 4, and 5; and (c) calcium silica-sulfate-hydrates, in black, in Probe No. 3.

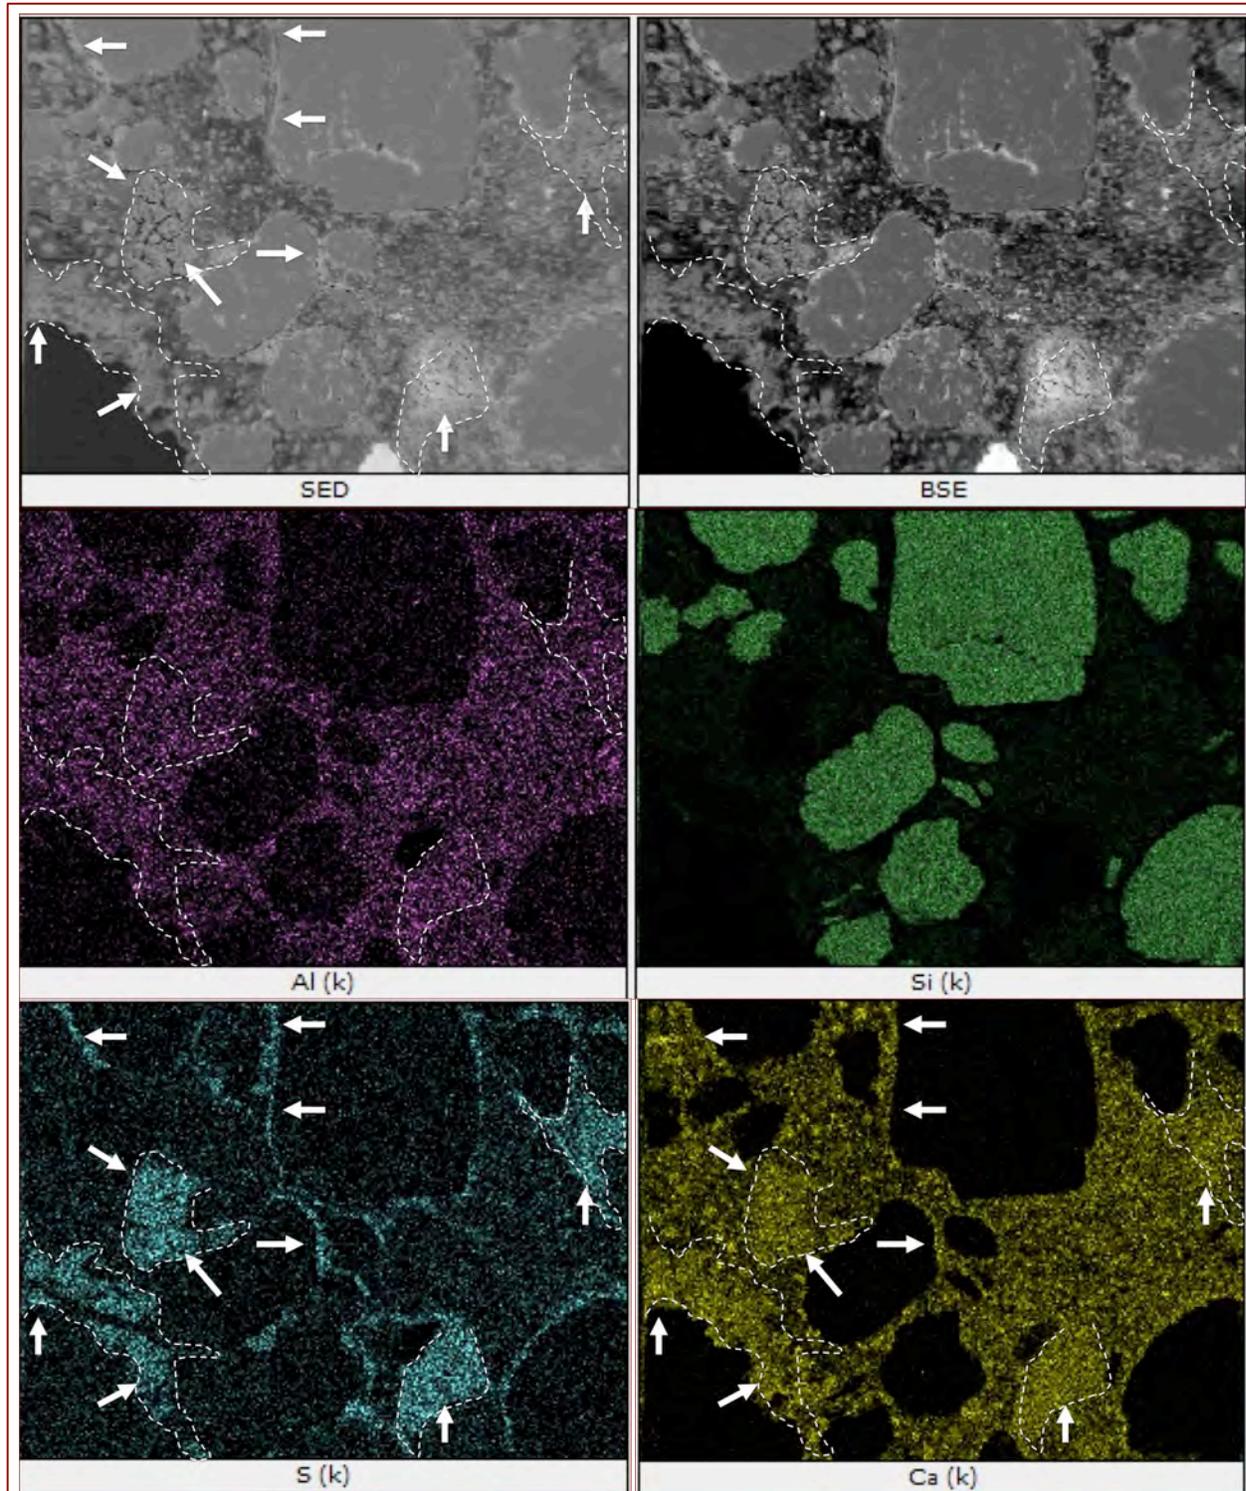
**Figure A19:** Secondary (SED) and backscatter electron image (BSE) at the top row and corresponding X-ray elemental map of four major elements - aluminum (Al), silicon (Si), sulfur (S), and calcium (Ca) showing high sulfate areas within dashed lines as well as with arrows that are also rich in calcium, and aluminum (indicating the presence of gypsum and/or ettringite). Quartz sand particles are highlighted in silicon map. Paste is overwhelmingly rich in calcium and aluminum, besides sulfate-rich areas.
