CONSTRUCTION MATERIALS CONSULTANTS, INC.

## Investigation of Failure of Anchoring Grout & Associated Distress in Concrete

ABC Condominiums  
ABC Road, Wilmington, DE 19810

Prepared for:  
ABC, Inc.  
ABC Condominium Association, Inc.

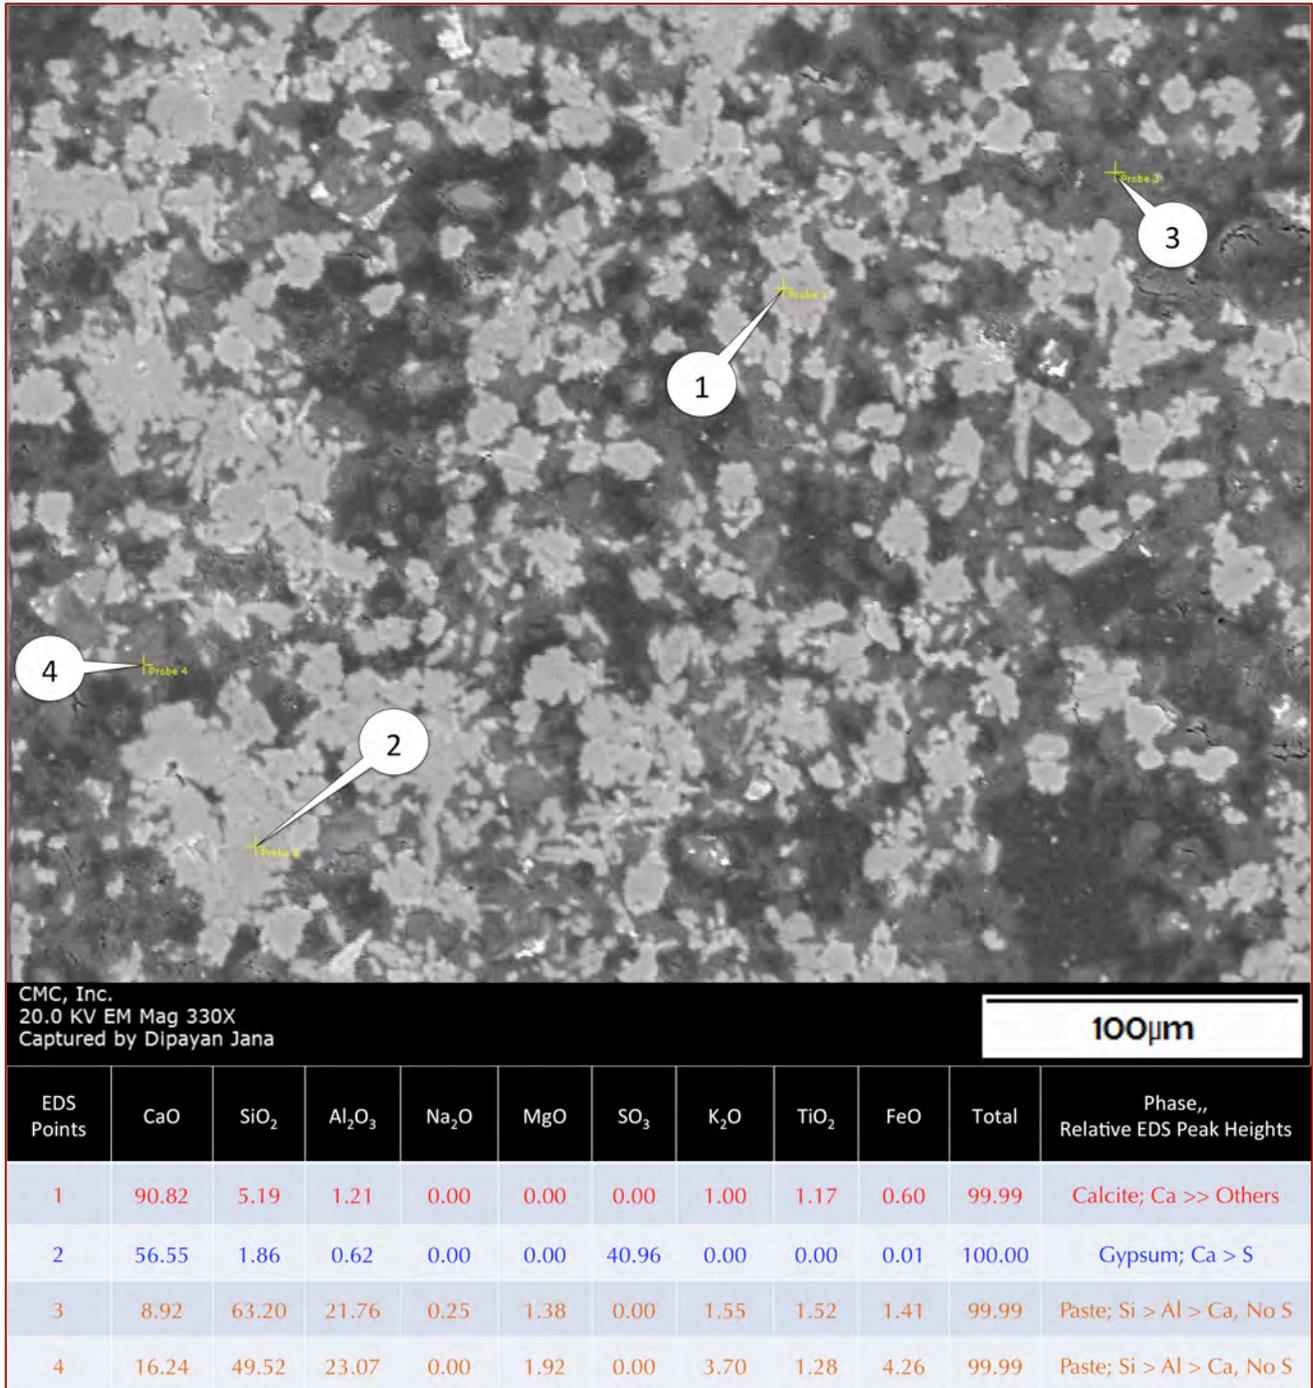
**Figure A20:** Secondary electron image and x-ray elemental analyses of various marked areas around paste showing the presence of: (a) calcite, measured in Probe No. 1; (b) gypsum, in blue, measured in Probe No. 2; and (c) Paste areas having no sulfate, in orange, measured in Probe Nos. 3 and 4.

- Distribution of calcite grains in various areas of paste having characteristically very high calcium compared to all other elements, which are shown in Figures A20, A22, and A24 in secondary electron images with x-ray elemental analyses. Consistent with observations from optical microscopy, SEM-EDS studies also show secondary precipitation of calcium carbonate crystals by atmospheric carbonation of gypsum in the presence of moisture and atmospheric carbon dioxide.

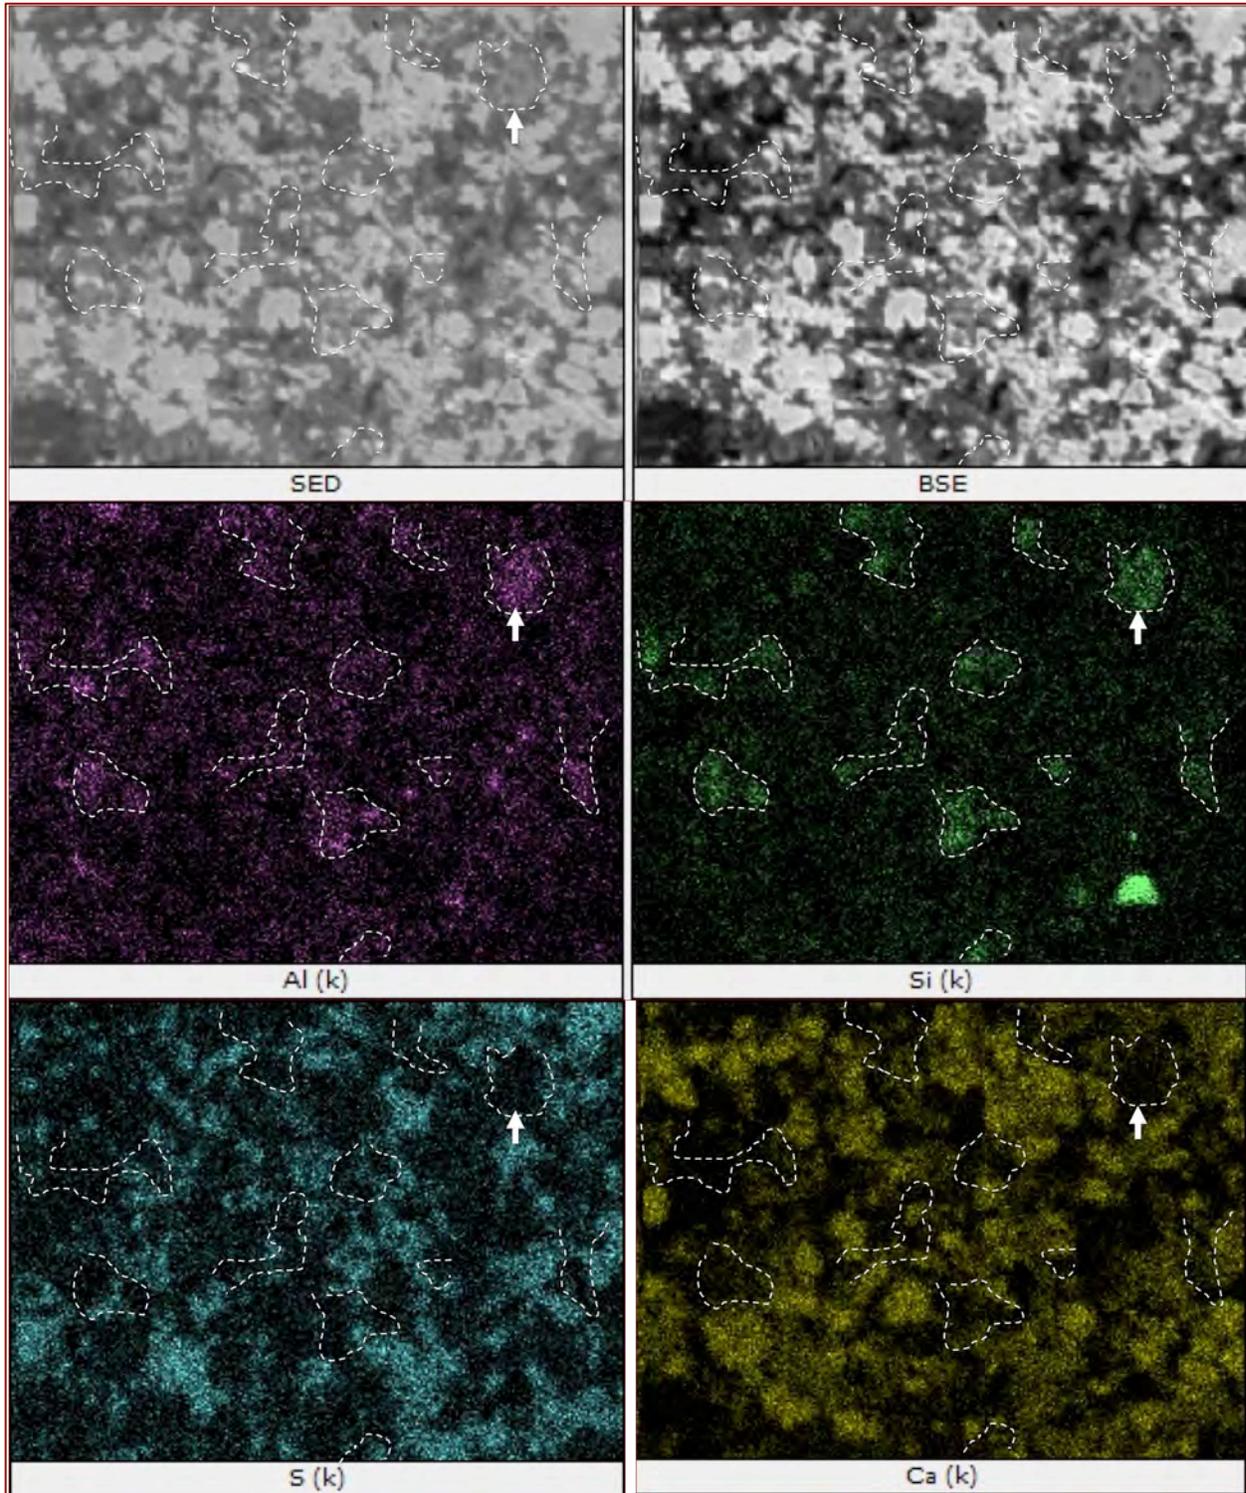
**Figure A21:** Secondary (SED) and backscatter electron image (BSE) at the top row and corresponding X-ray elemental map of four major elements - aluminum (Al), silicon (Si), sulfur (S), and calcium (Ca) showing patches of high silica (beside very bright quartz grain at the bottom right in silicon map) areas in paste within the dashed lines that are also rich in aluminum but depleted in sulfur and calcium.

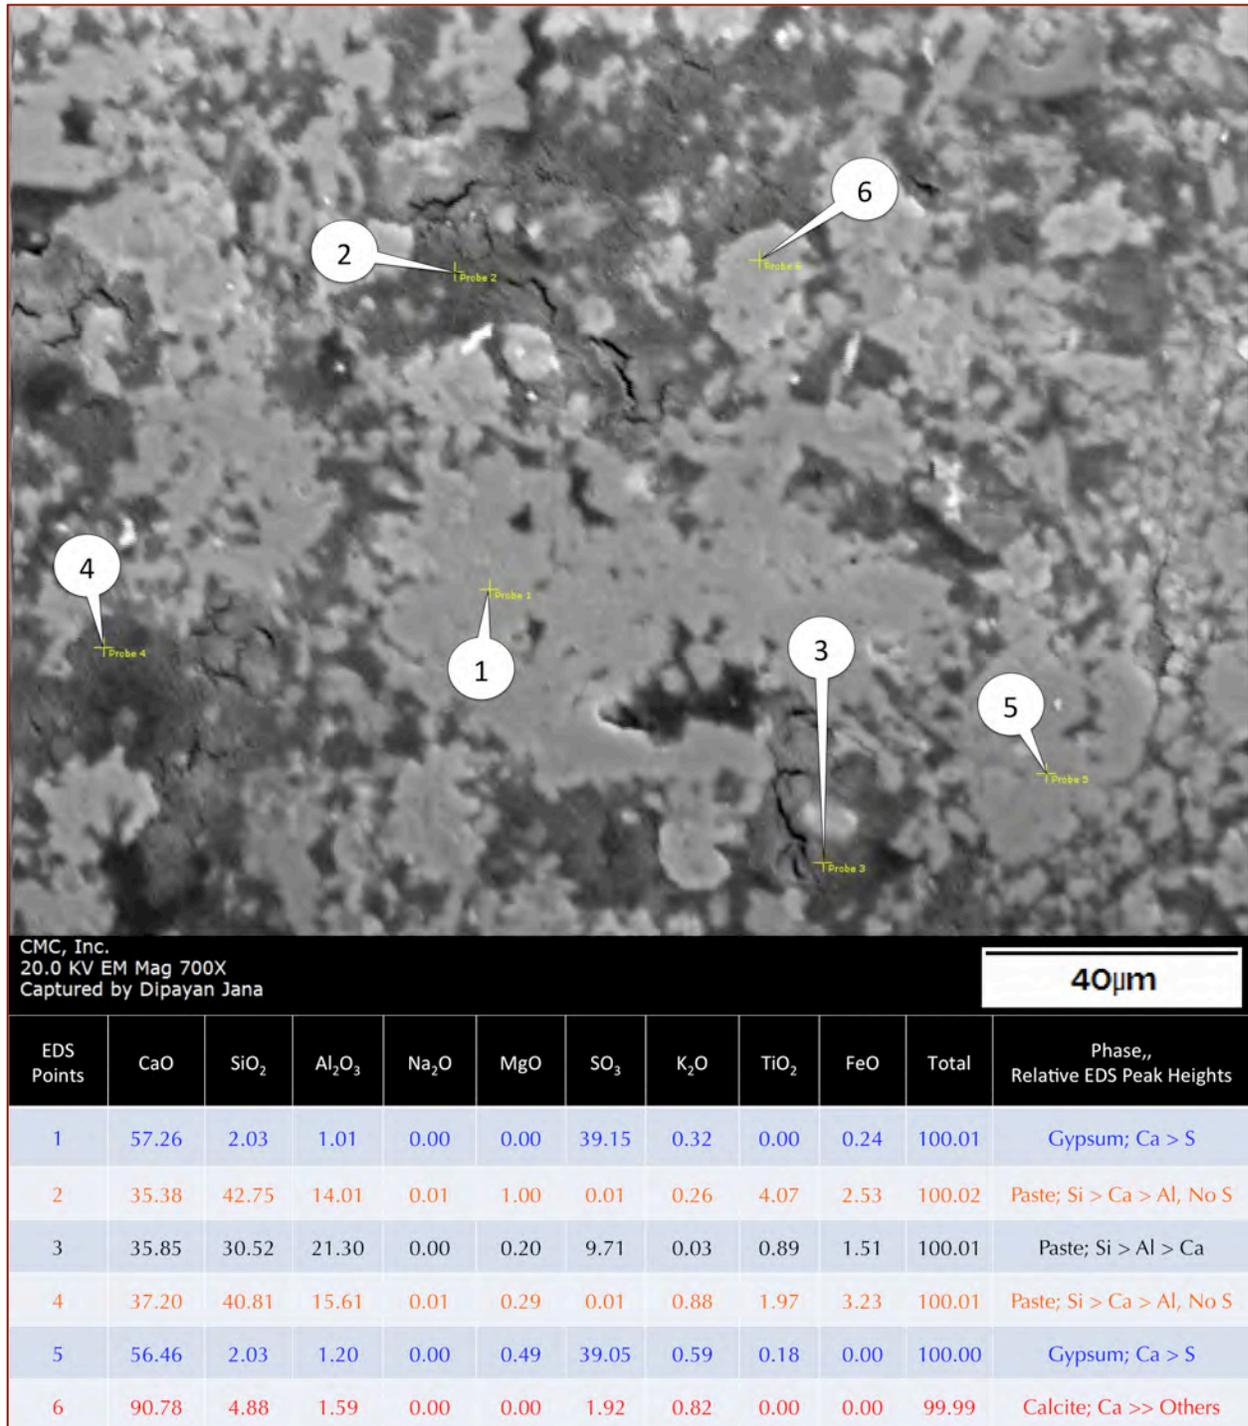
**Figure A22:** Secondary electron image and x-ray elemental analyses of various marked areas around paste showing the presence of: (a) gypsum, in blue, measured in Probe Nos. 1 and 5; (b) calcite, in red, measured in Probe No. 6; and (c) Paste areas having no sulfate, in orange, measured in Probe Nos. 2 and 4. Probe No. 3 shows an area in paste having silica, alumina, and calcium in decreasing orders of abundances.

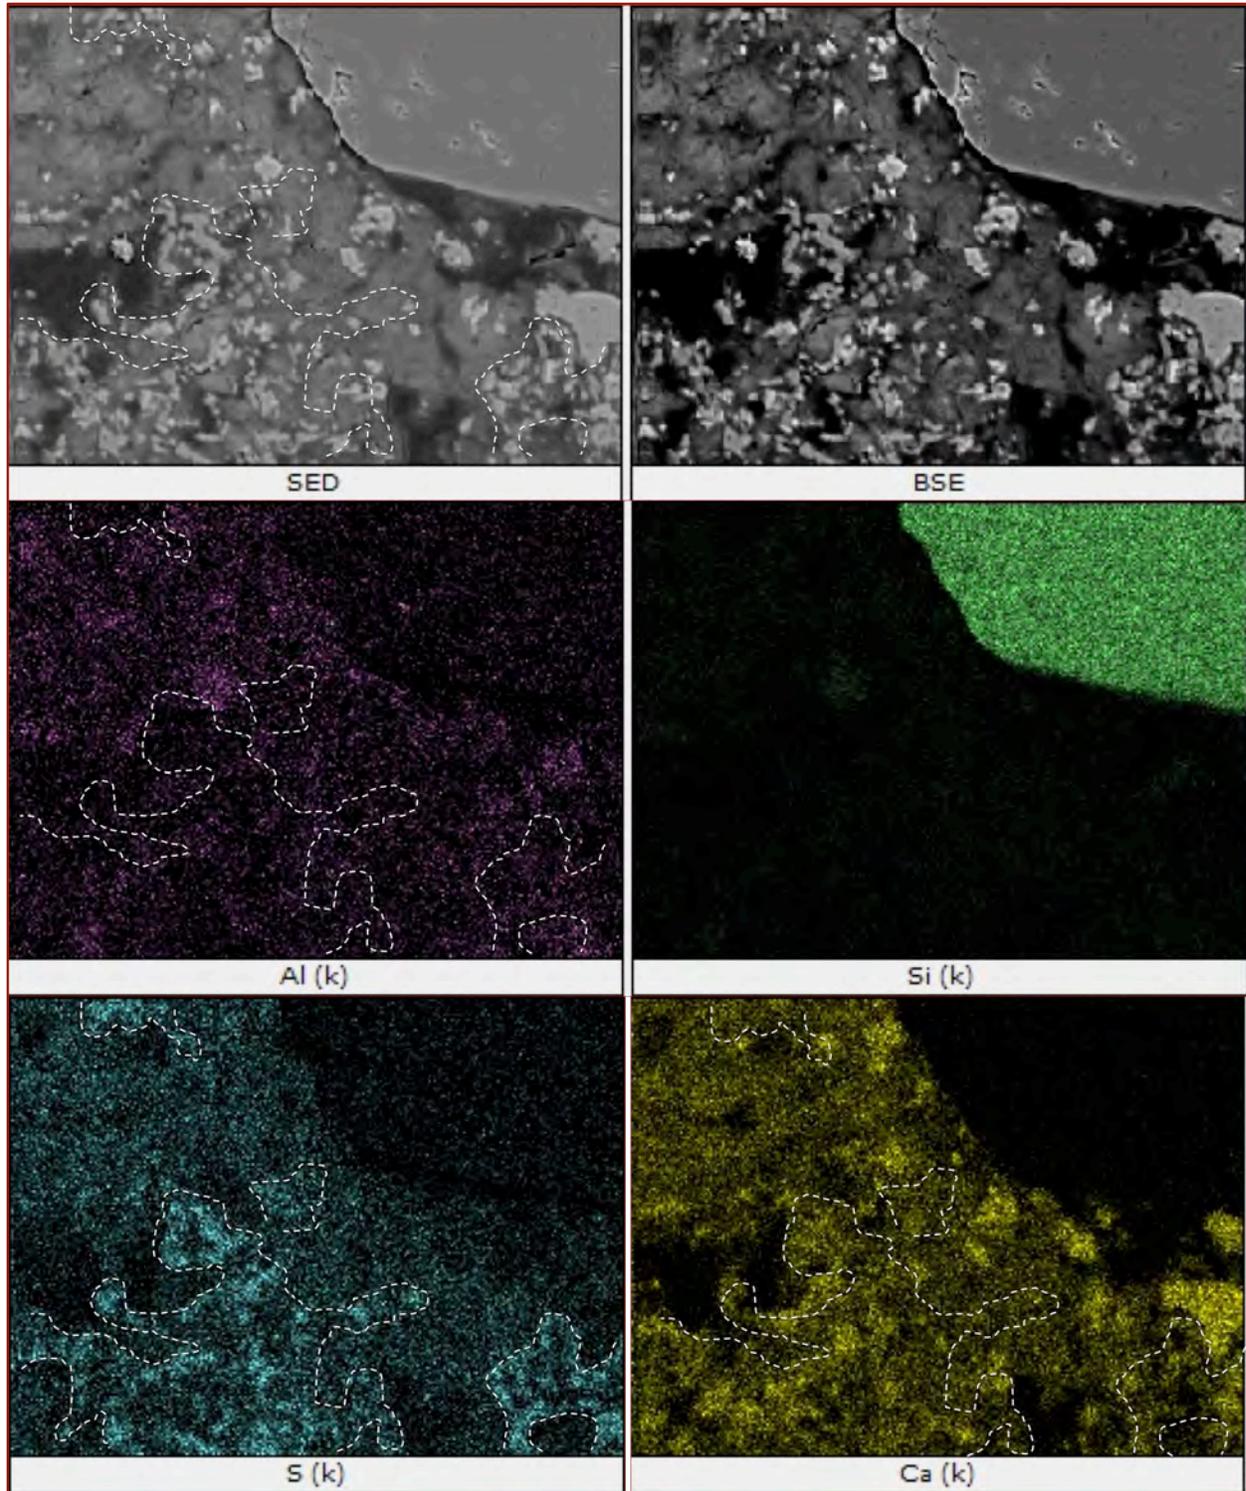
**Figure A23:** Secondary (SED) and backscatter electron image (BSE) at the top row and corresponding X-ray elemental map of four major elements - aluminum (Al), silicon (Si), sulfur (S), and calcium (Ca) showing high sulfate areas within dashed lines that are also rich in calcium, but depleted in aluminum (indicating the presence of gypsum but not intermixed with ettringite for lack of aluminum). A quartz sand particle is highlighted at the top right corner in the silicon map. Paste is overwhelmingly rich in calcium, aluminum, and sulfur i.e. outside the dashed sulfate-rich (gypsum-based) areas.

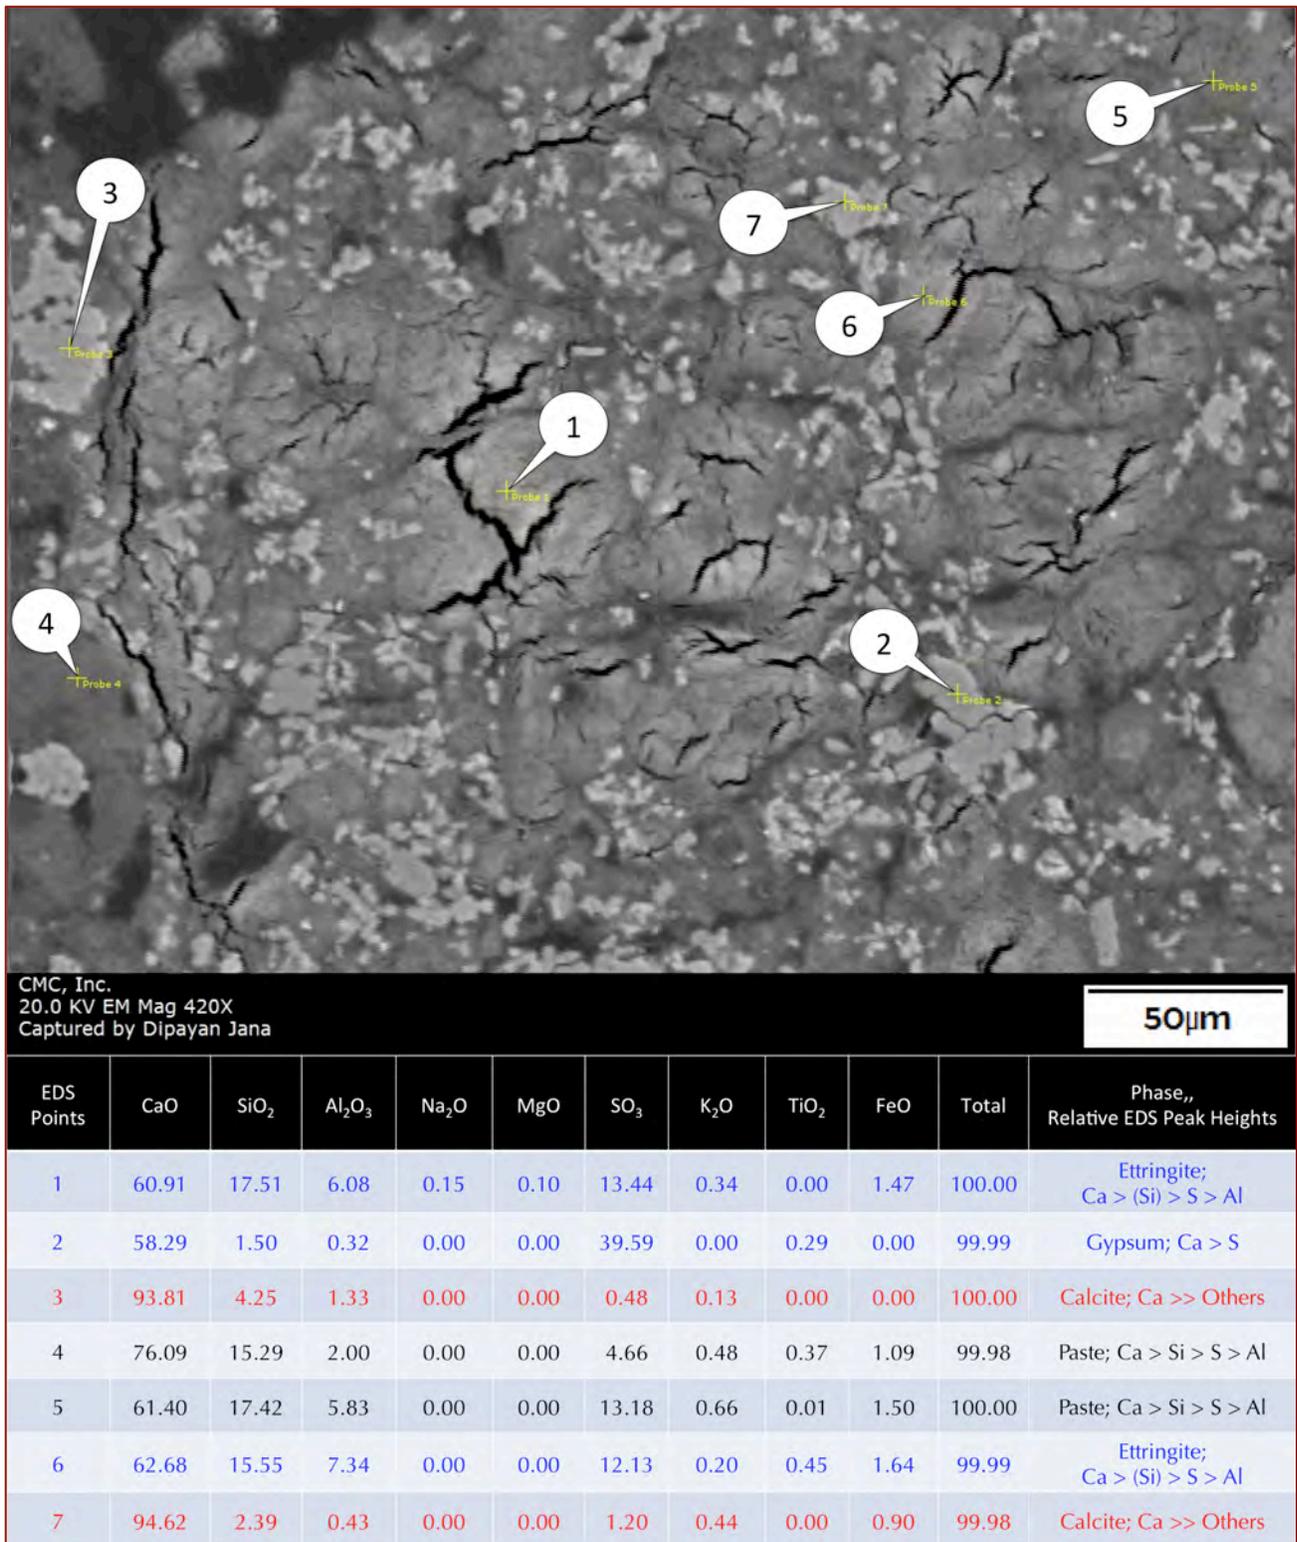
**Figure A24:** Secondary electron image and x-ray elemental analyses of various marked areas around paste showing the presence of: (a) gypsum and ettringite, in blue, measured in Probe Nos. 1, 2, and 6; (b) calcite, in red, measured in Probe Nos. 3 and 6; Probe Nos. 4 and 5 show paste areas having calcium, silica, sulfur, and alumina in decreasing orders of abundances.

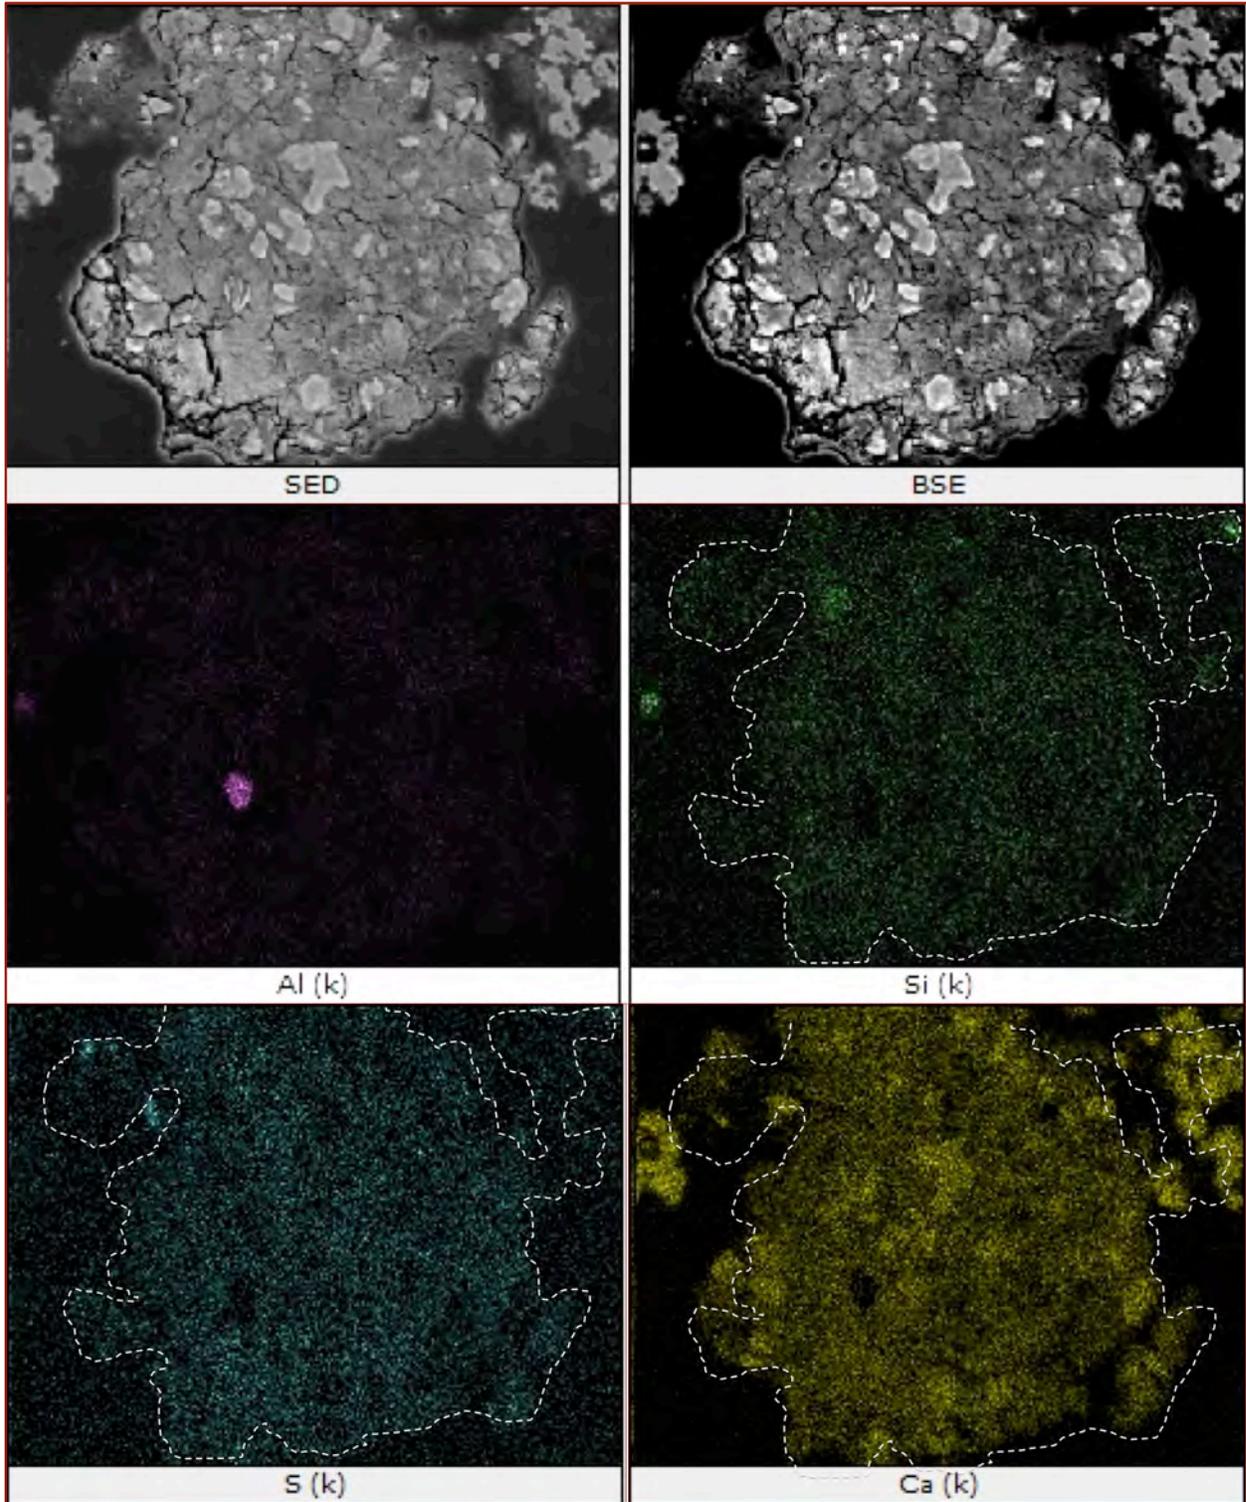
**Figure A25:** Secondary (SED) and backscatter electron image (BSE) at the top row and corresponding X-ray elemental map of four major elements - aluminum (Al), silicon (Si), sulfur (S), and calcium (Ca) showing an overall paste area within the dashed line that is rich in calcium, silica, and sulfur, and a few grains of calcite.
