Petrographic Examinations of A Concrete Core To Investigate Quality & Condition of A Concrete Parking Garage Deck

Henderson Parking Garage
Indiana University
Bloomington, Indiana 47401

Reported herein are the results of detailed petrographic examinations of a hardened concrete core received from the exposed deck of Henderson Parking Garage at Indiana University in Bloomington, Indiana. The purpose of the examinations is to determine the composition, quality, and condition of concrete in the deck. A field photograph of the core retrieval process showed sound, fine broom-finished surface of the deck without any visible cracking, scaling, spalling, or any other surface distress. The core was examined by detailed petrographic examinations *a la* ASTM C 856.

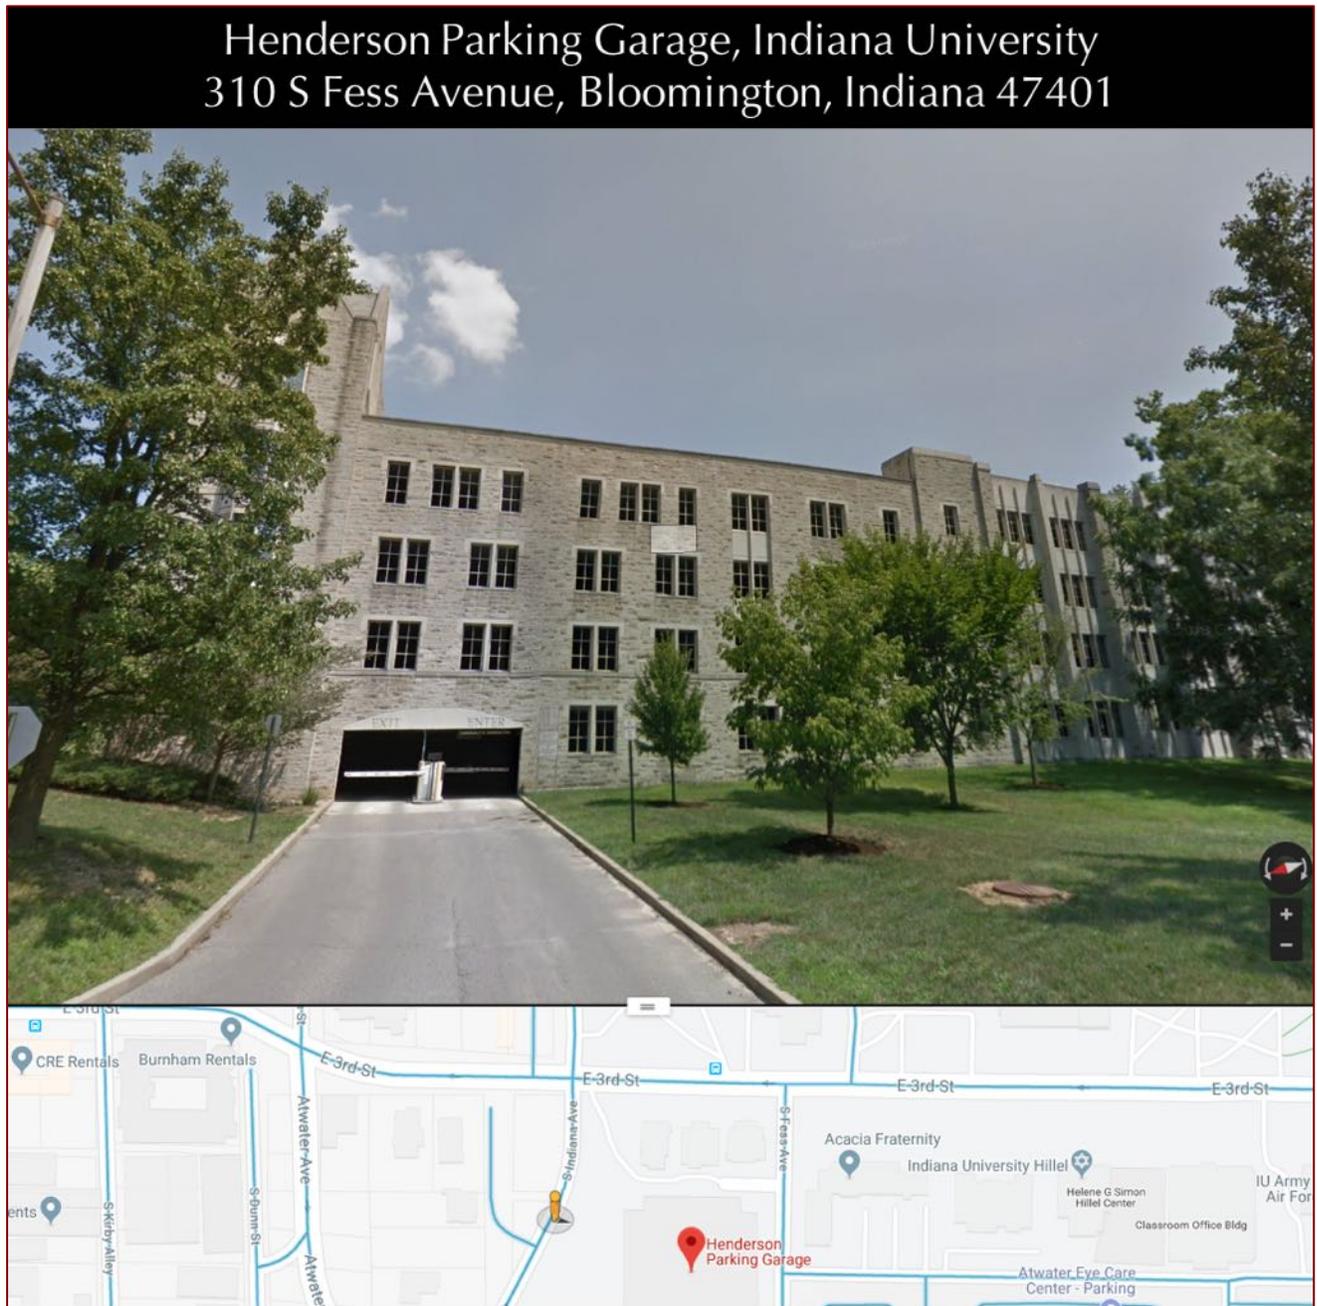
Figure 1: Henderson Parking Garage at Indiana University in Bloomington, Indiana.

The parking garage is located at 319 S Fess Avenue in Bloomington, Indiana shown in Figure 1. The proposed testing is part of renovation of the preexisting parking garage to check quality of concrete in the deck. No background information regarding placement, weather condition, or mix design of the concrete are available.

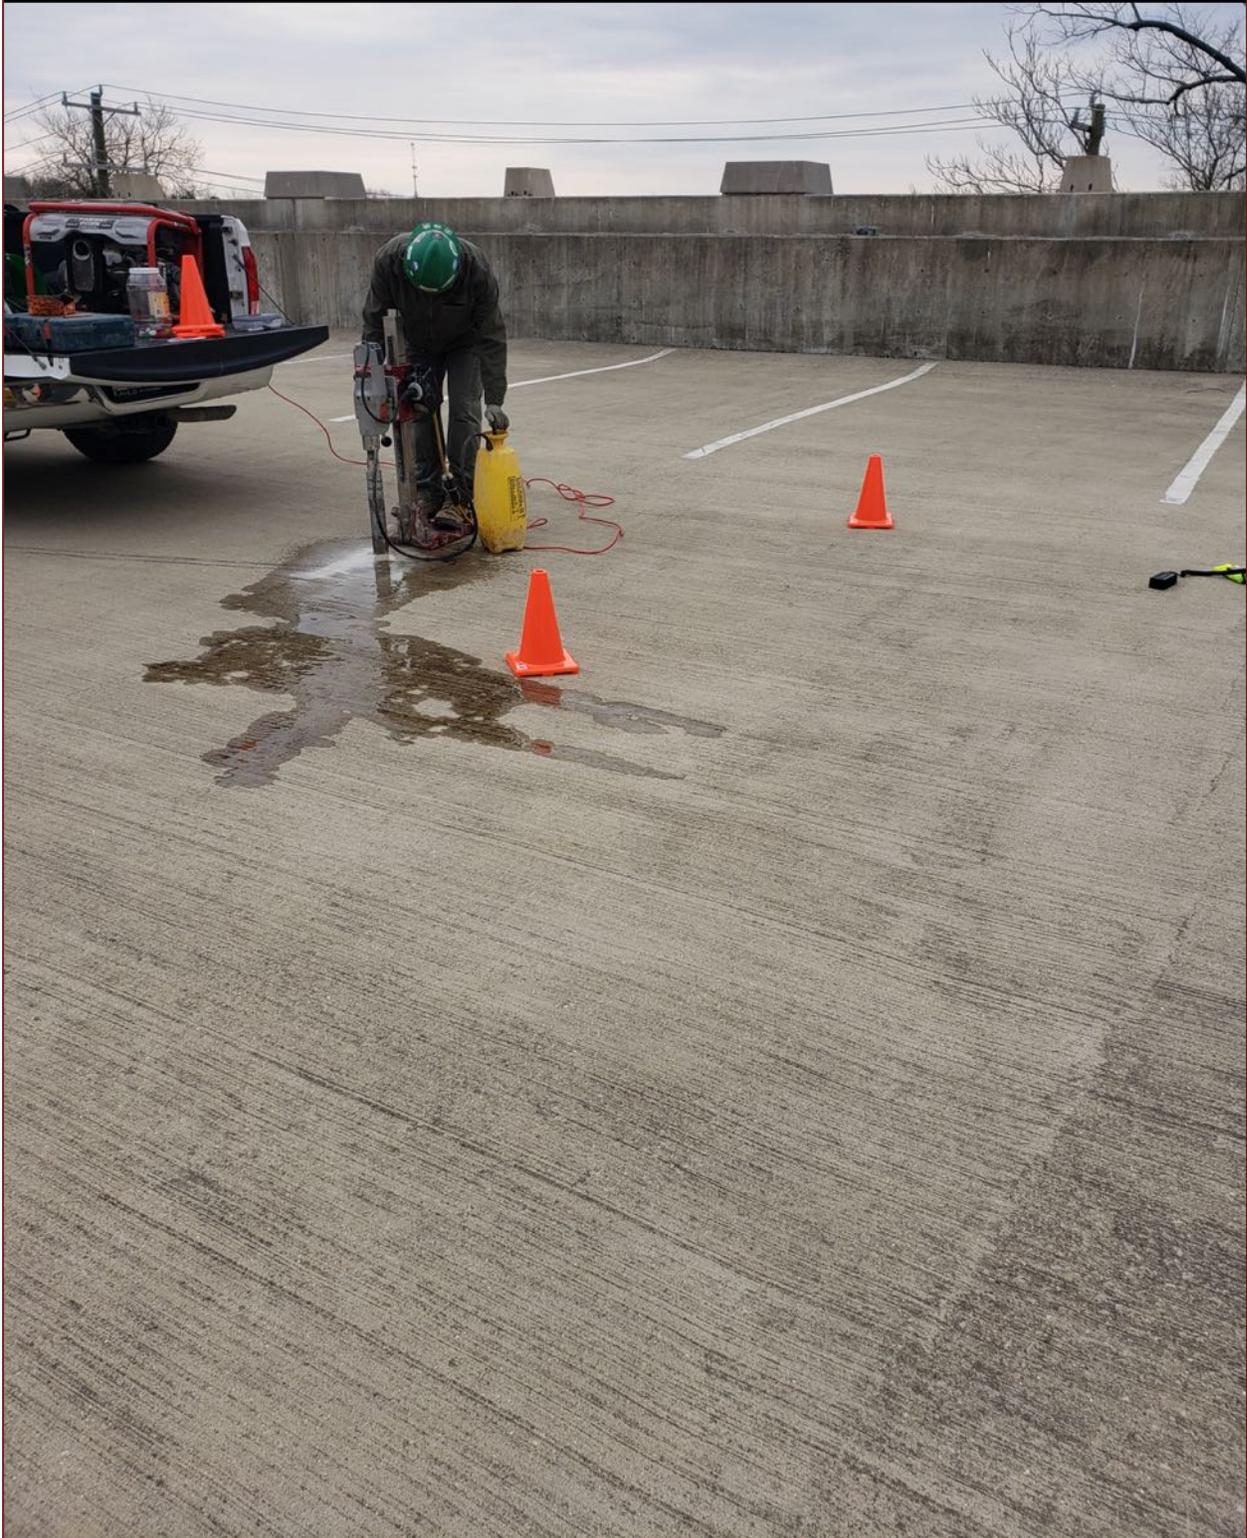
Field Photograph Showing Core Retrieval From A Broom-Finished Parking Deck

Figure 2 shows core retrieval process from sound broom-finished surface of existing parking garage deck. No cracking, scaling, spalling or any other surface distress is found in the field photo.

Figure 2: Field photograph showing sound, broom-finished concrete surface and core retrieval from the parking deck.

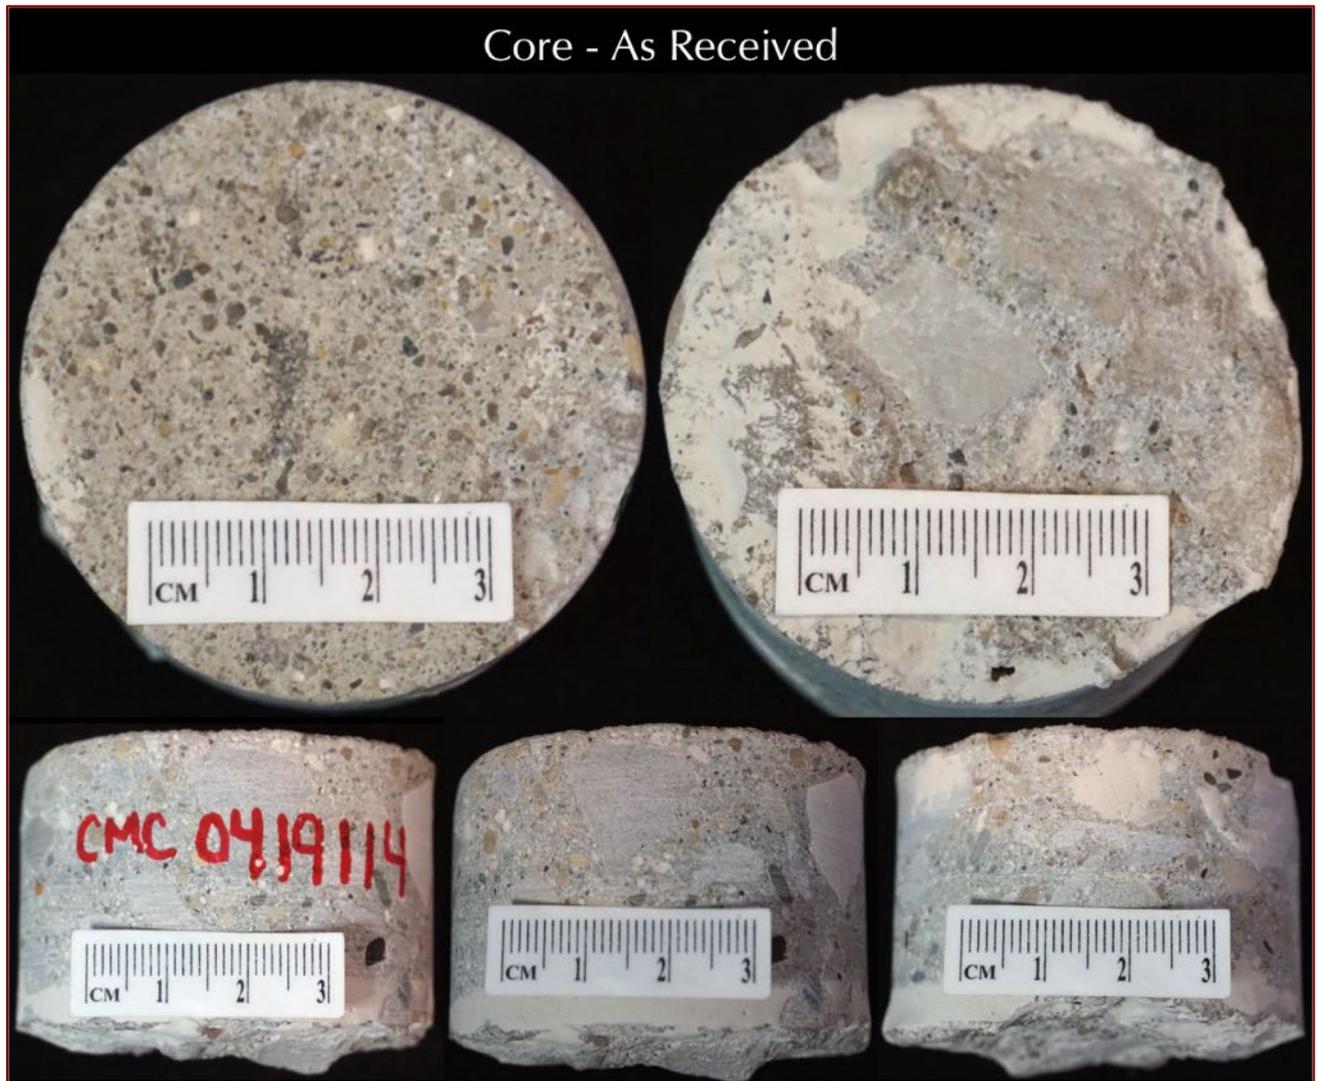
Figure 3 shows the core, as received, which is 2¹/₄ in. (55 mm) in diameter and 1¹/₂ in. in. (40 mm) in nominal length. The core has a finished surface with exposures of fine aggregate particles at the top and freshly fractured bottom end. No visible cracking or other distress are found. No reinforcing steel, wire mesh, fibers, or other embedded items are present in the core. The core has a ringing resonance when hammered. The core was received in intact, surface dry condition.

Figure 3: Photographs of core as received – Top left – Exposed surface with exposed fine aggregate particles; Top right – partially fresh fractured bottom end of core; and bottom row – three cylindrical side views of the core showing overall sound, crack-free nature of concrete in the core.

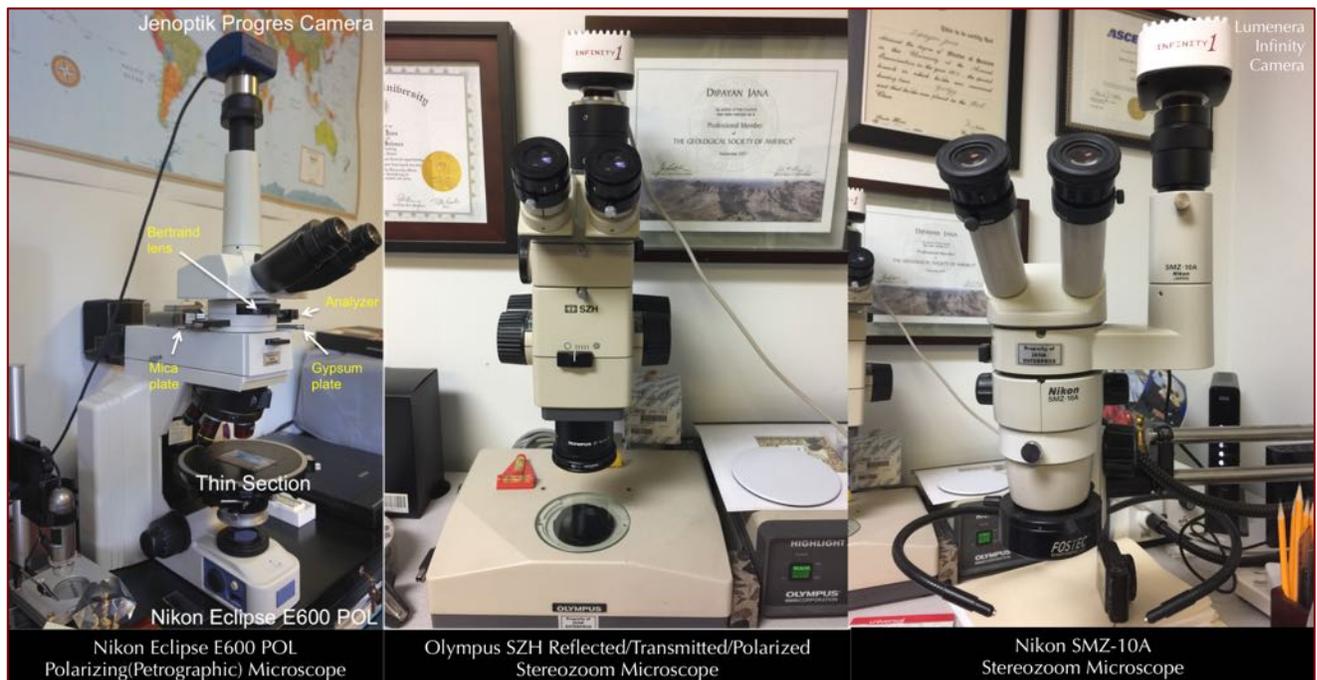
Figure 4: Nikon Eclipse E600POL Petrographic Microscope with Jenoptik Gryphax Camera (left), Olympus SZH (middle), and Nikon SMZ-10A Stereozoom Microscope (right) used for petrographic examinations.

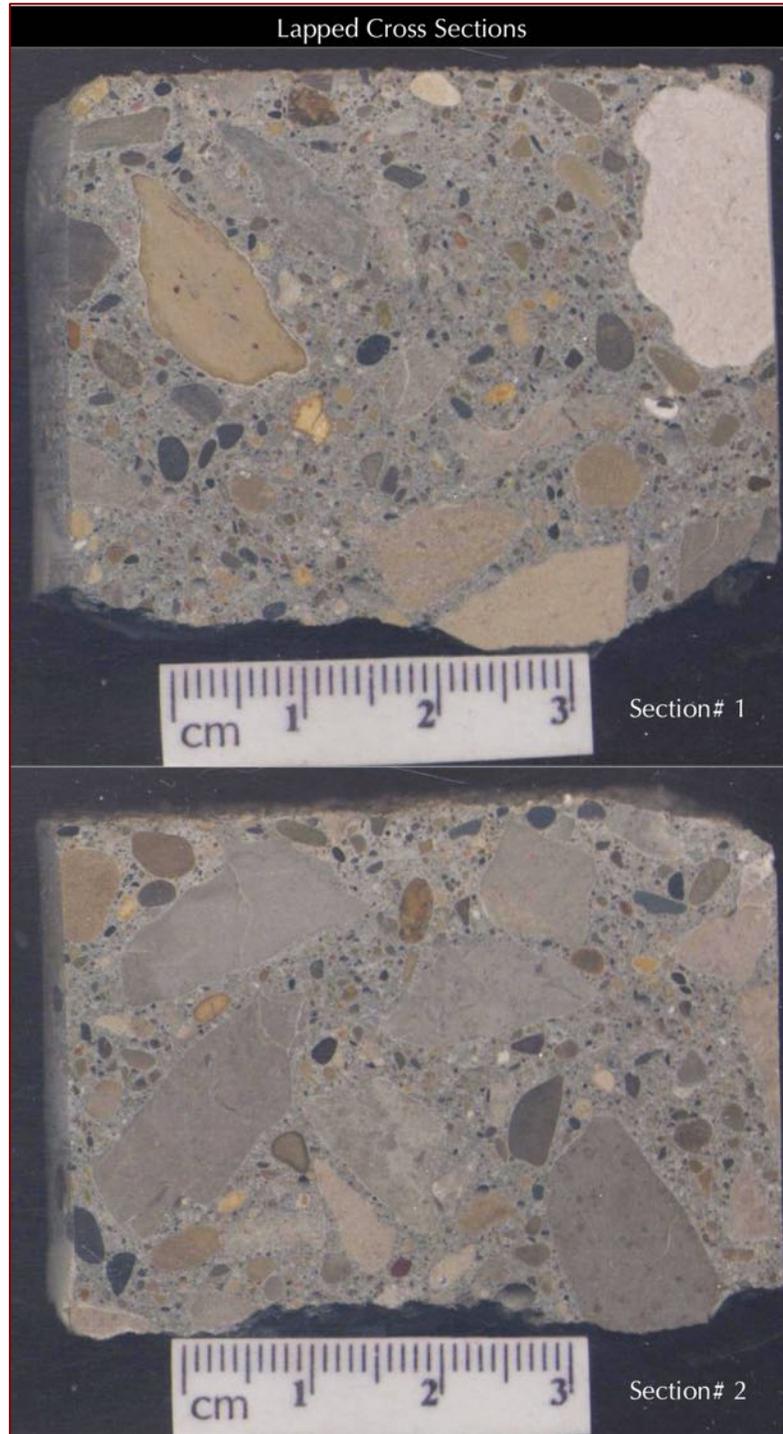
Figure 5: Two lapped cross sections of core showing crushed stone coarse aggregate, natural siliceous-calcareous sand fine aggregate, dense and well-consolidated nature of concrete, good grading and distribution of aggregates and absence of any visible cracking in the concrete.
