CONSTRUCTION MATERIALS CONSULTANTS, INC.

## Assessment of Concrete Inside A Train Shed From The Grand Central Terminal In The City Of New York

Rehabilitation of the Grand Central Terminal Train Shed  
– Sector 2 (53/55 St)  
Park Avenue between 53<sup>rd</sup> and 55<sup>th</sup> St.  
New York, New York

September 9, 2021  
CMC 0821148

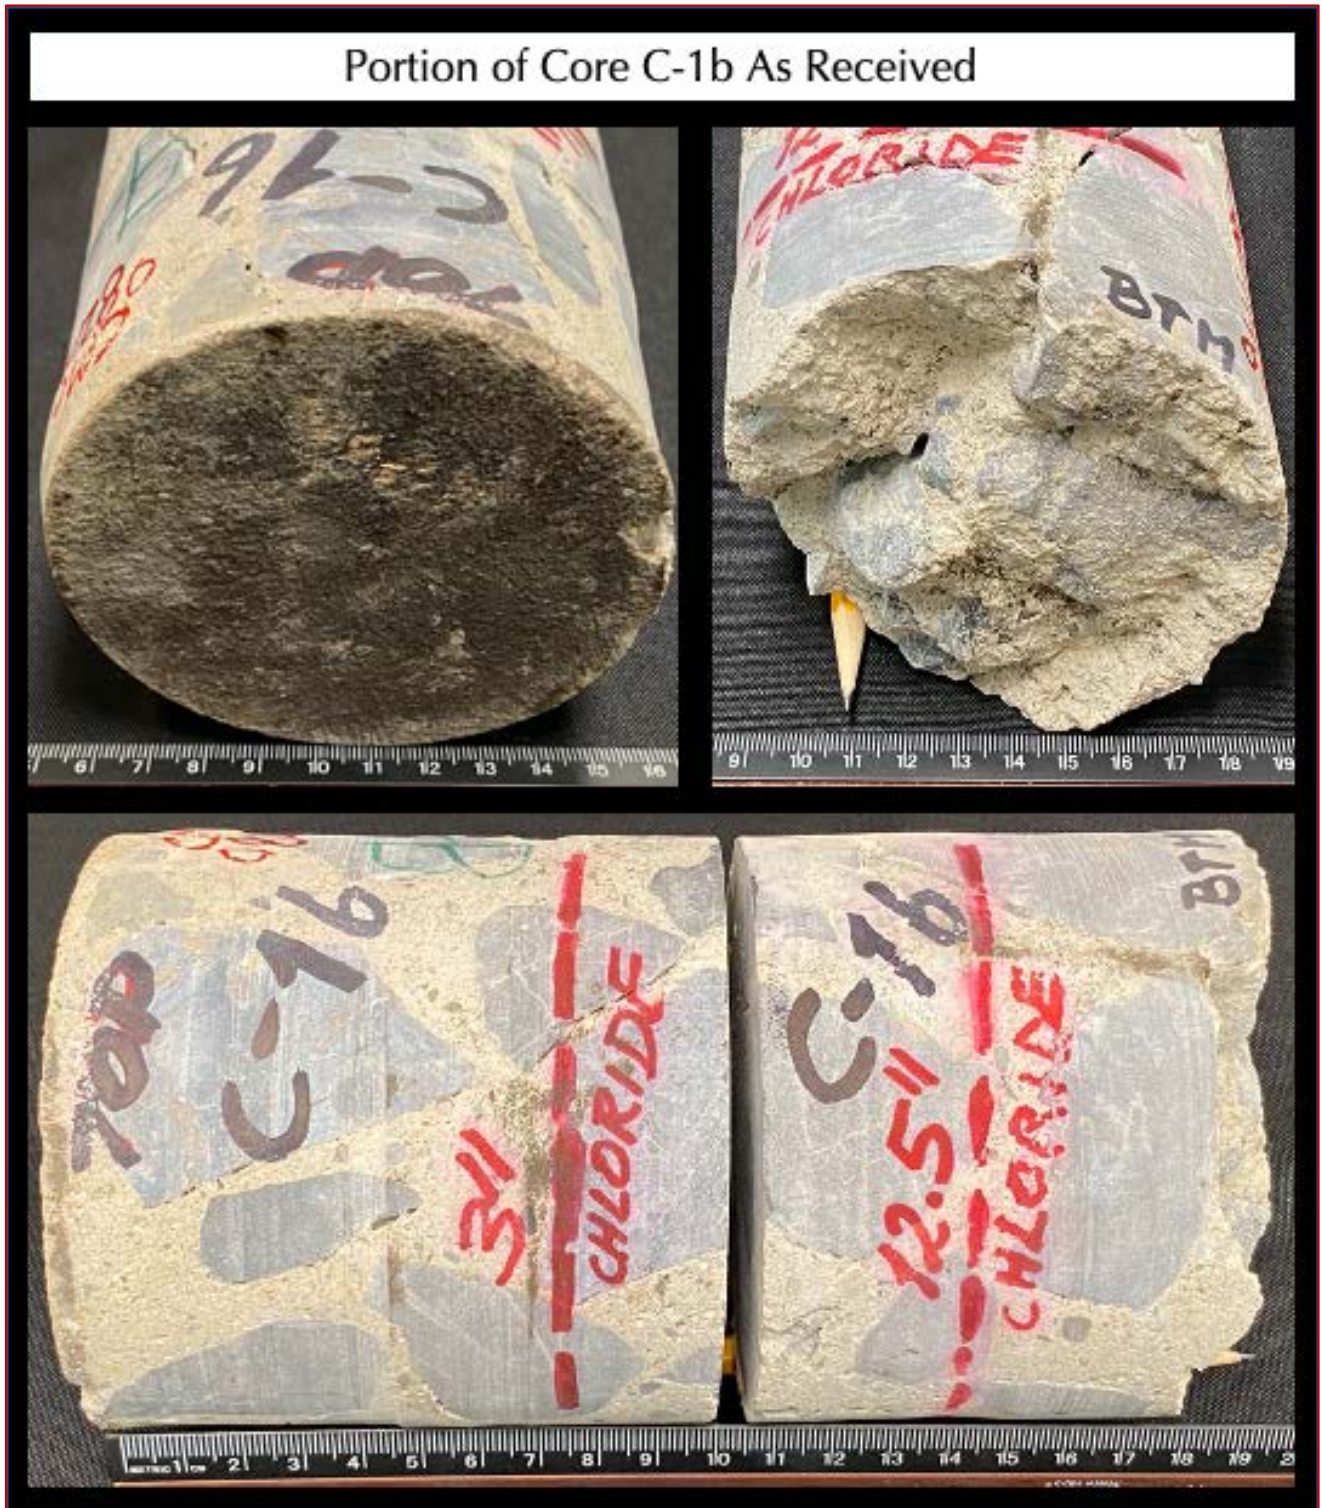
Figure 2: Portions of core as received from C-1b and the requested testing.

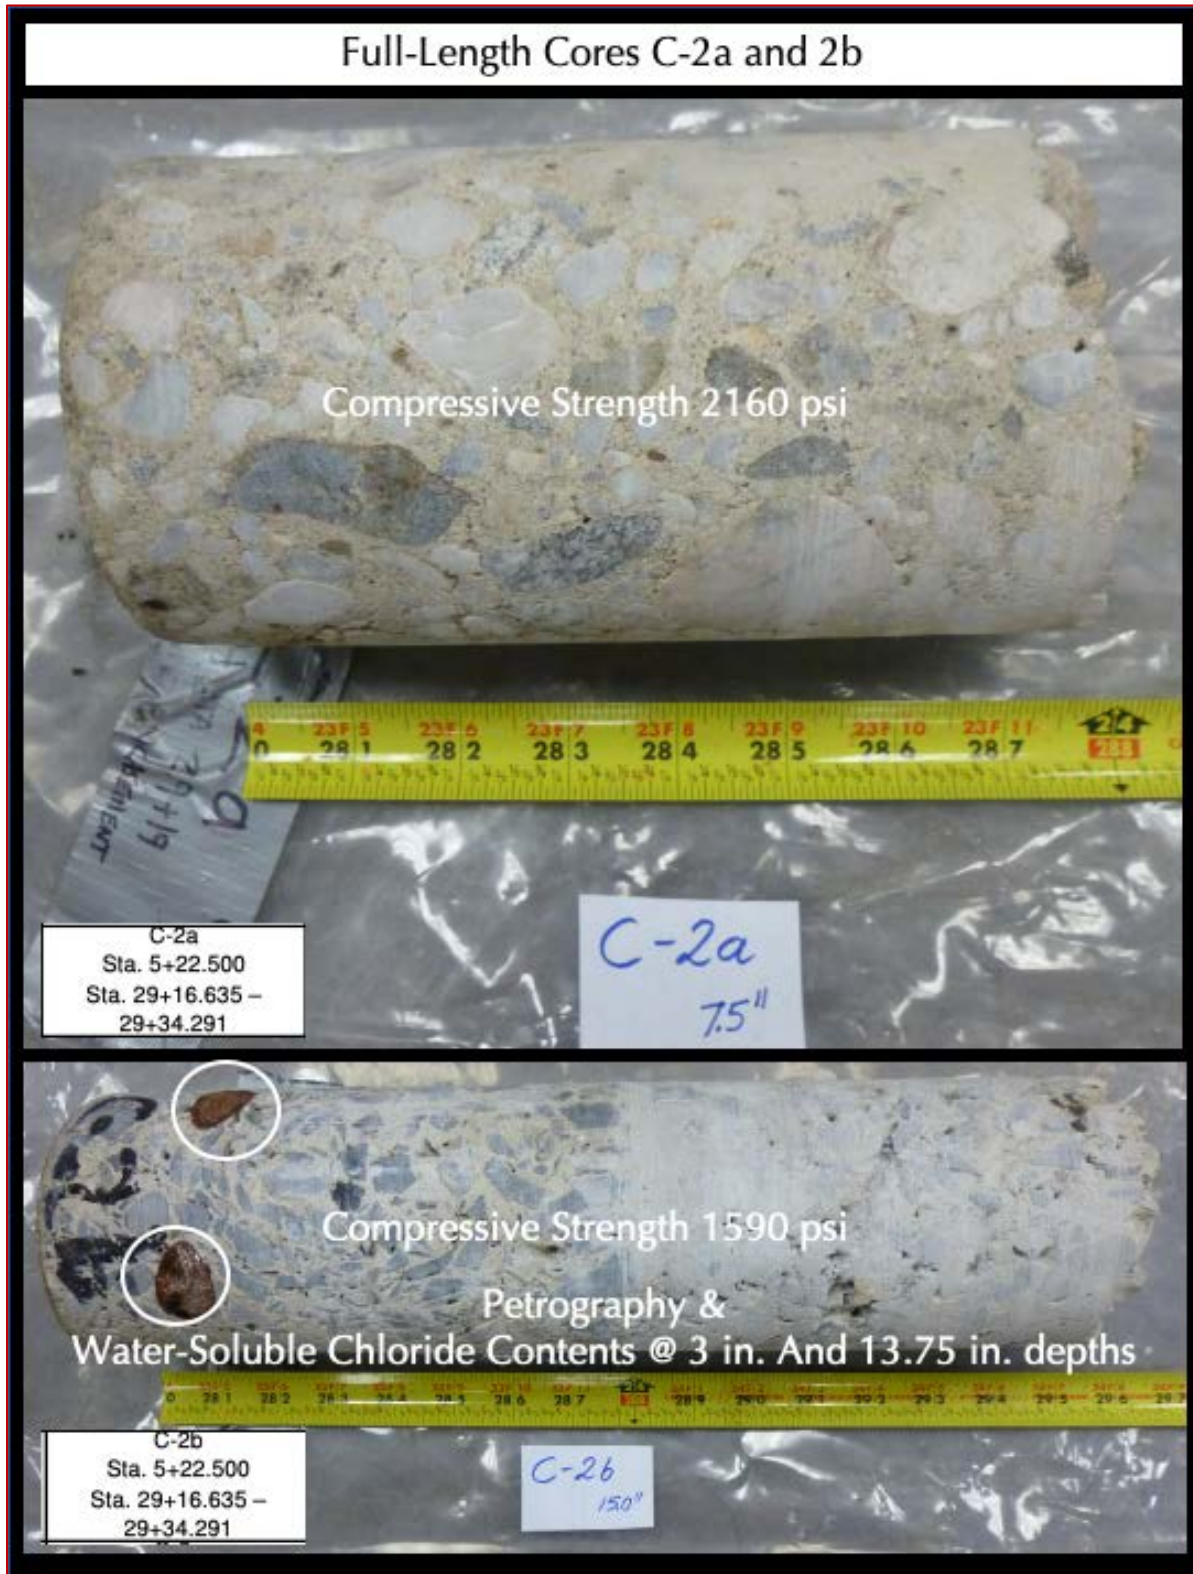
Figure 3: Full lengths of Cores C-2a and 2b, type of testing done, and compressive strength results.

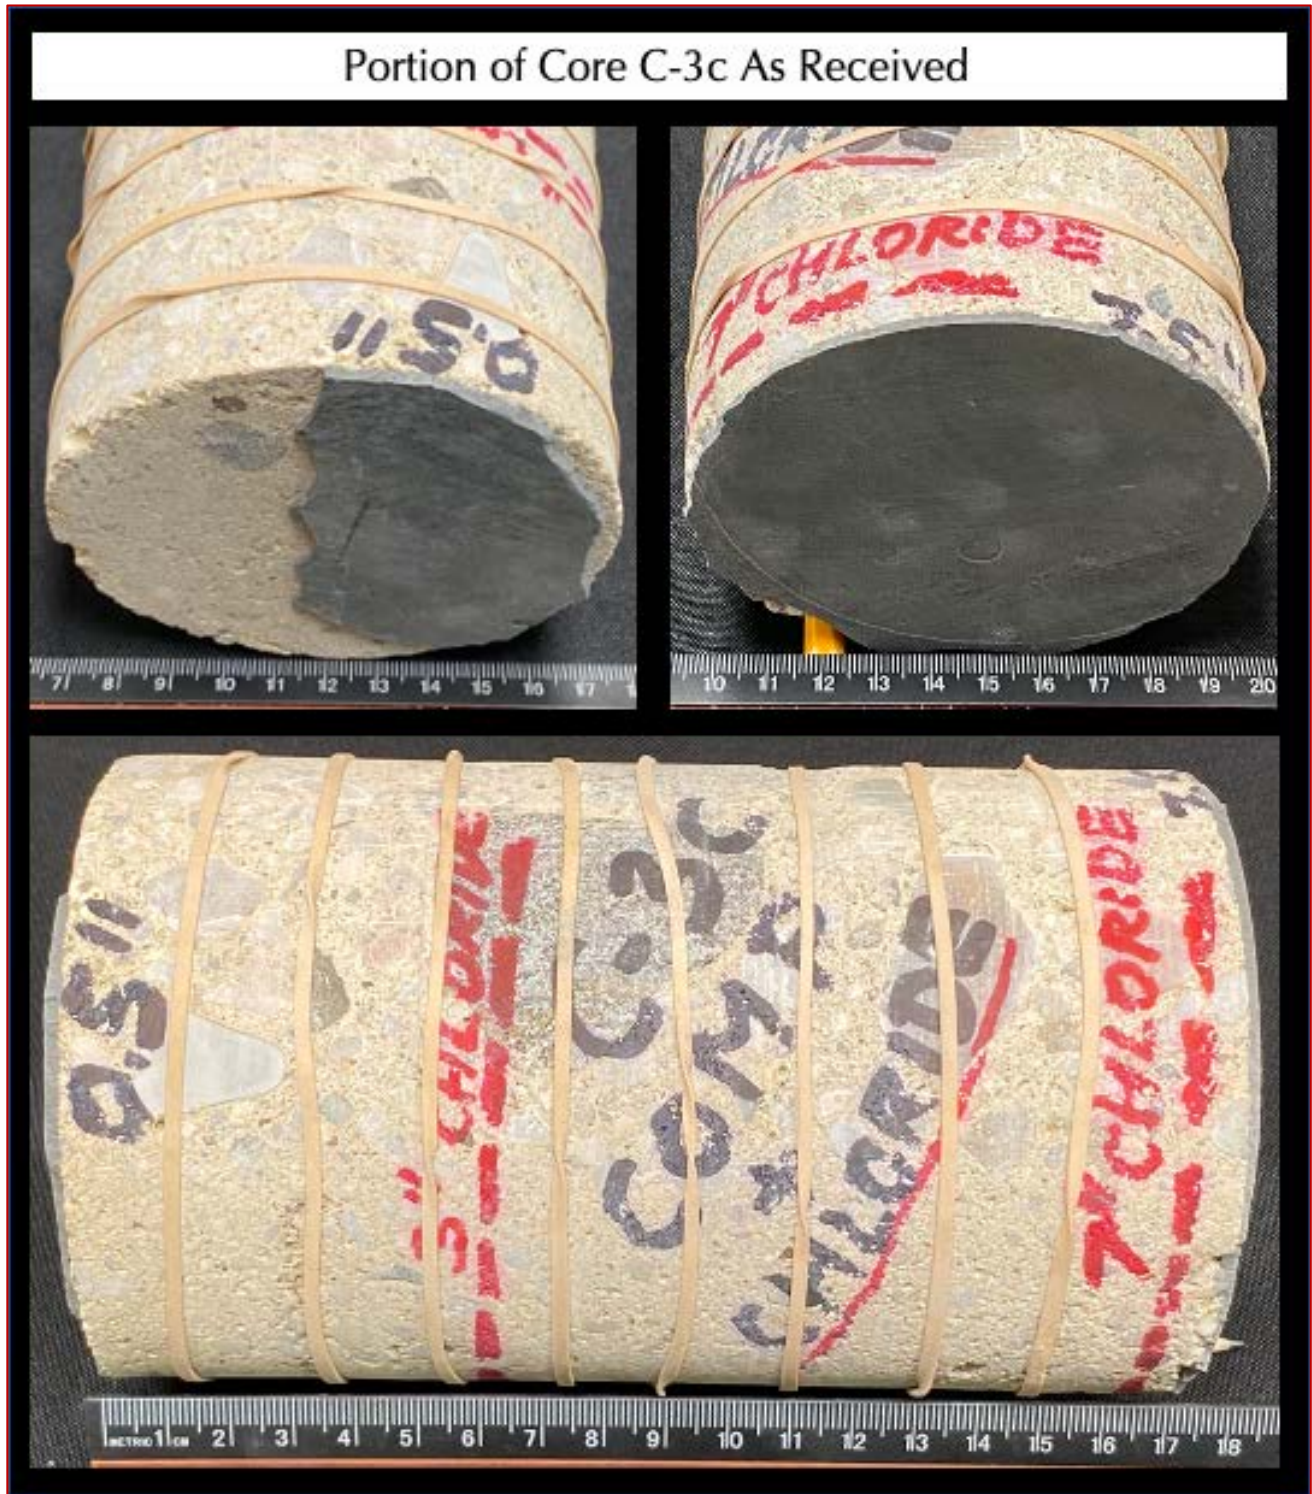
Figure 9: Portion of core as received from C-3c and the requested testing.

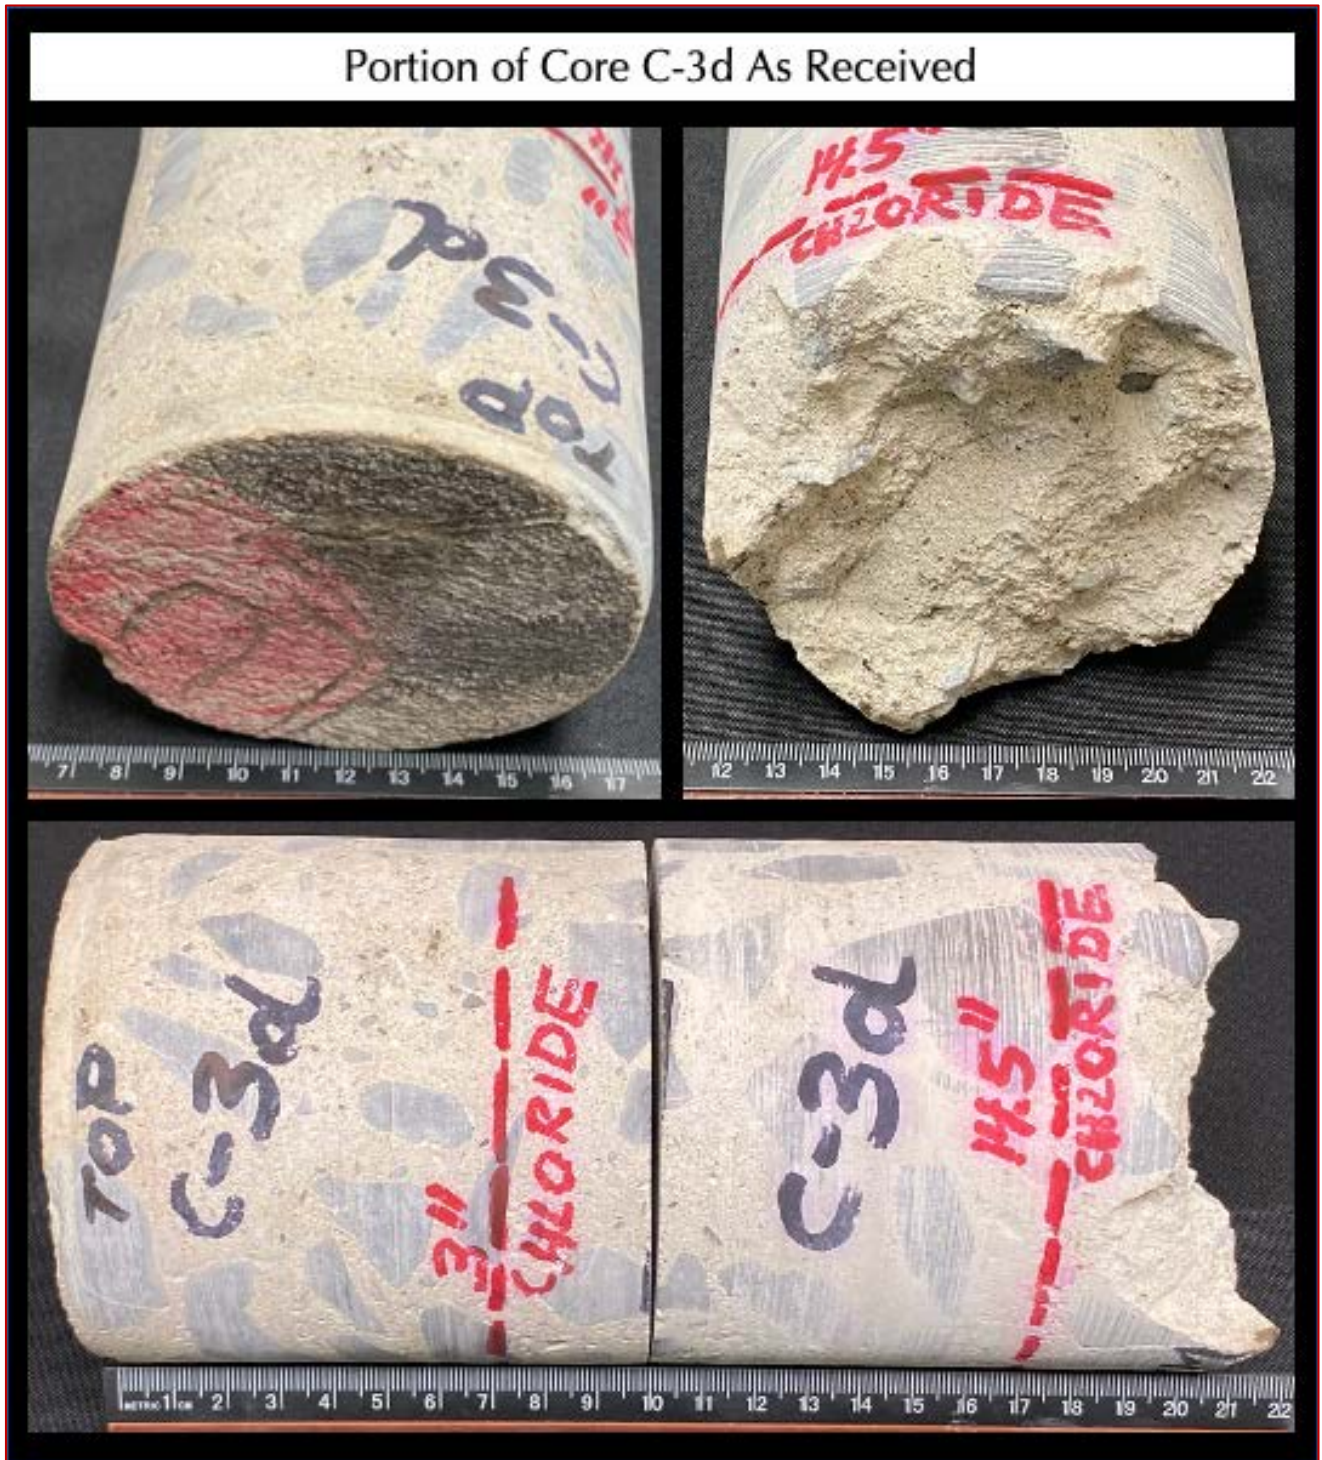
Figure 10: Portions of core as received from C-3d and the requested testing.

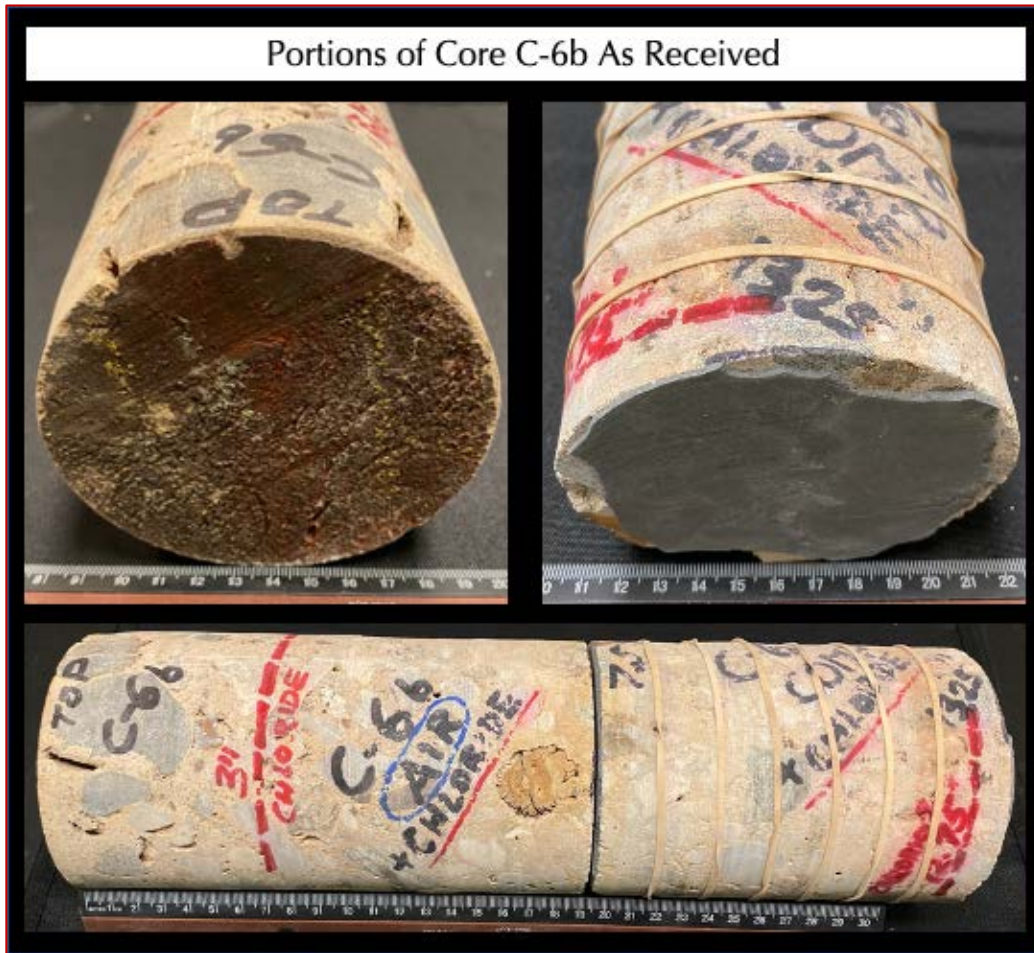
Figure 15: Portions of core as received from C-6b and the requested testing.

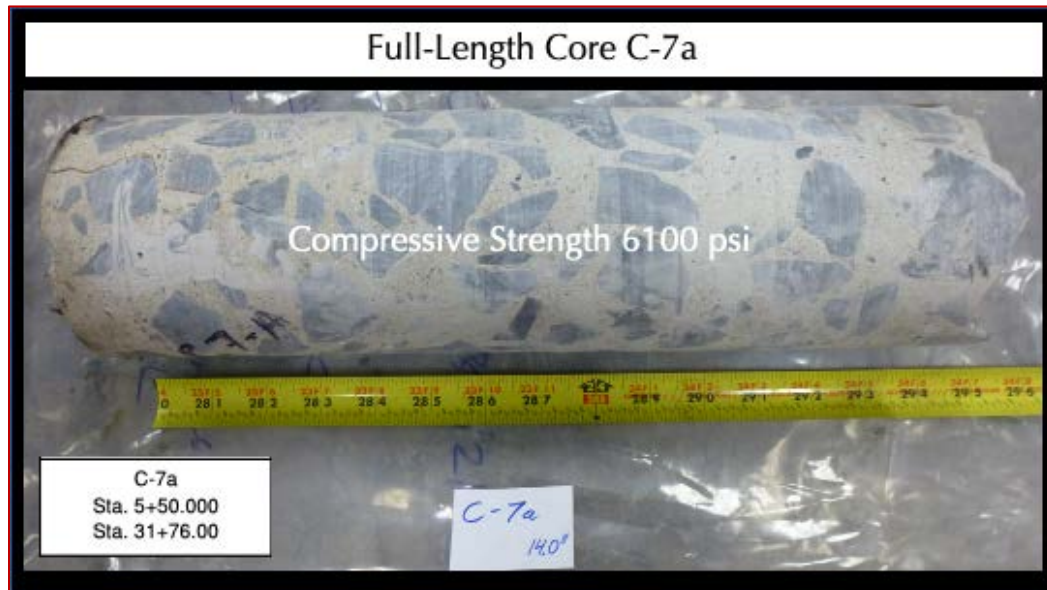
Figure 16: Full lengths of Core C-7a, and compressive strength result.

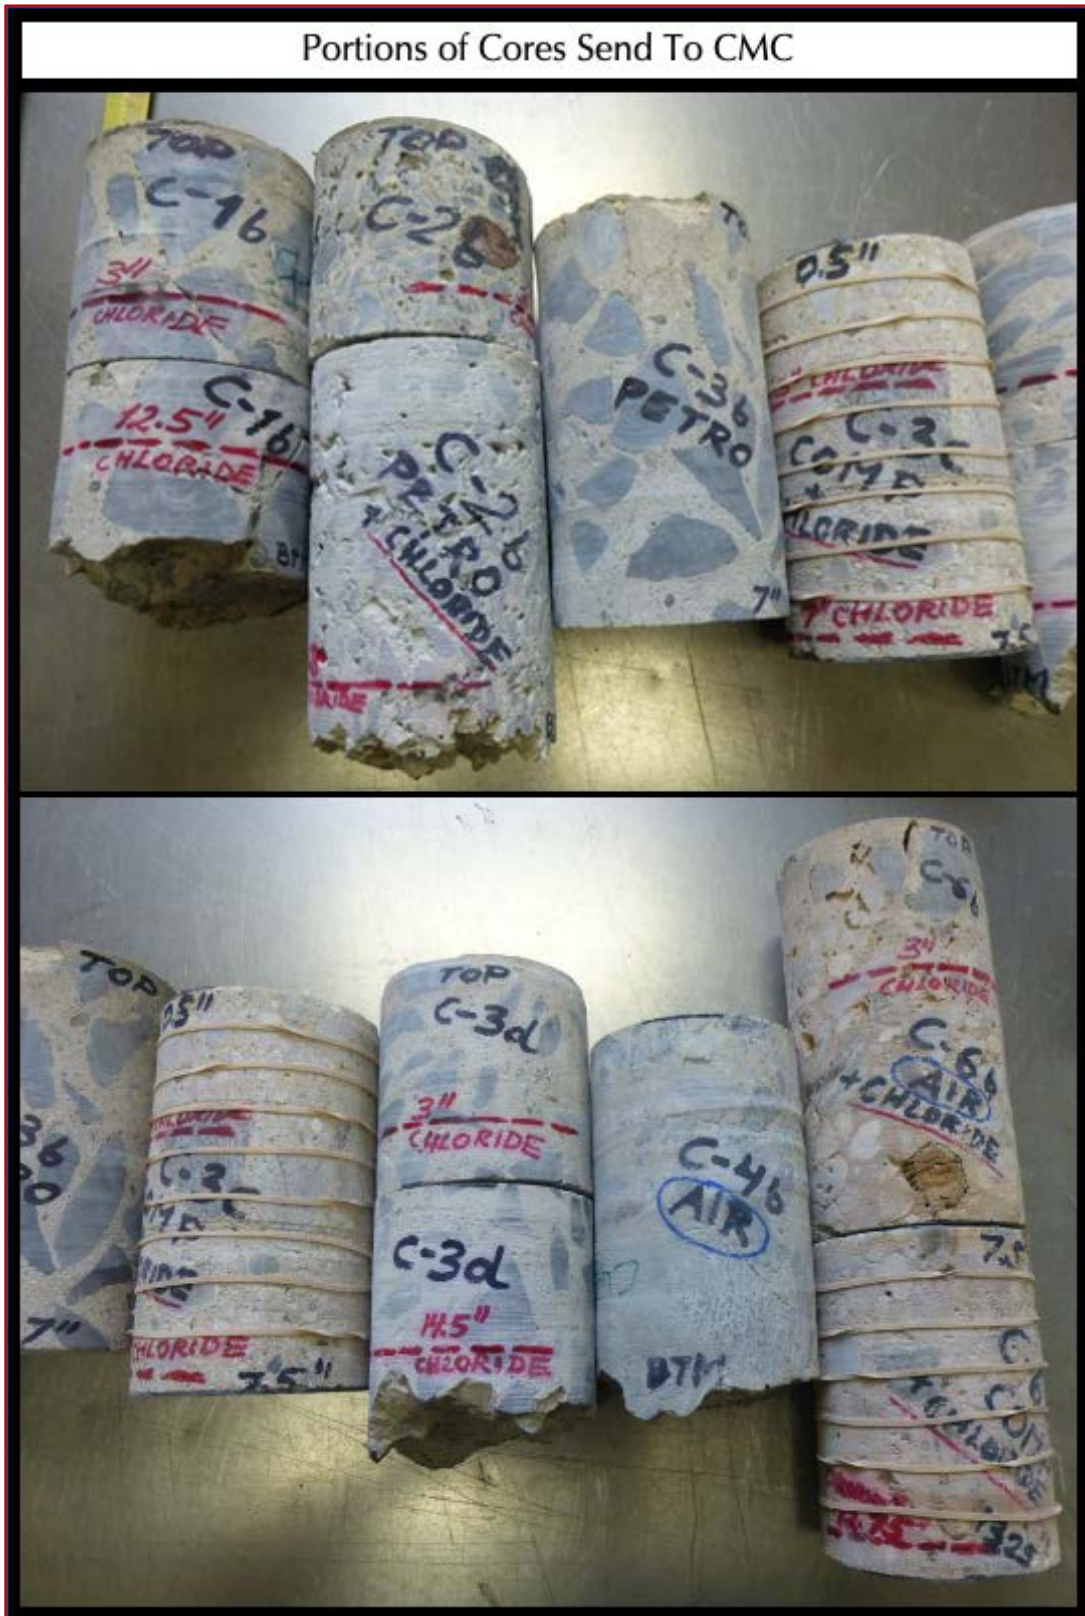
Figure 17: Portions of cores received for petrographic examinations (Cores C-2b and 3b), air-void analysis (Cores C-4b and 6b), and depth markings for water-soluble chloride contents at two depths (Cores C-1b, 2b, 3c, 3d, and 6b).

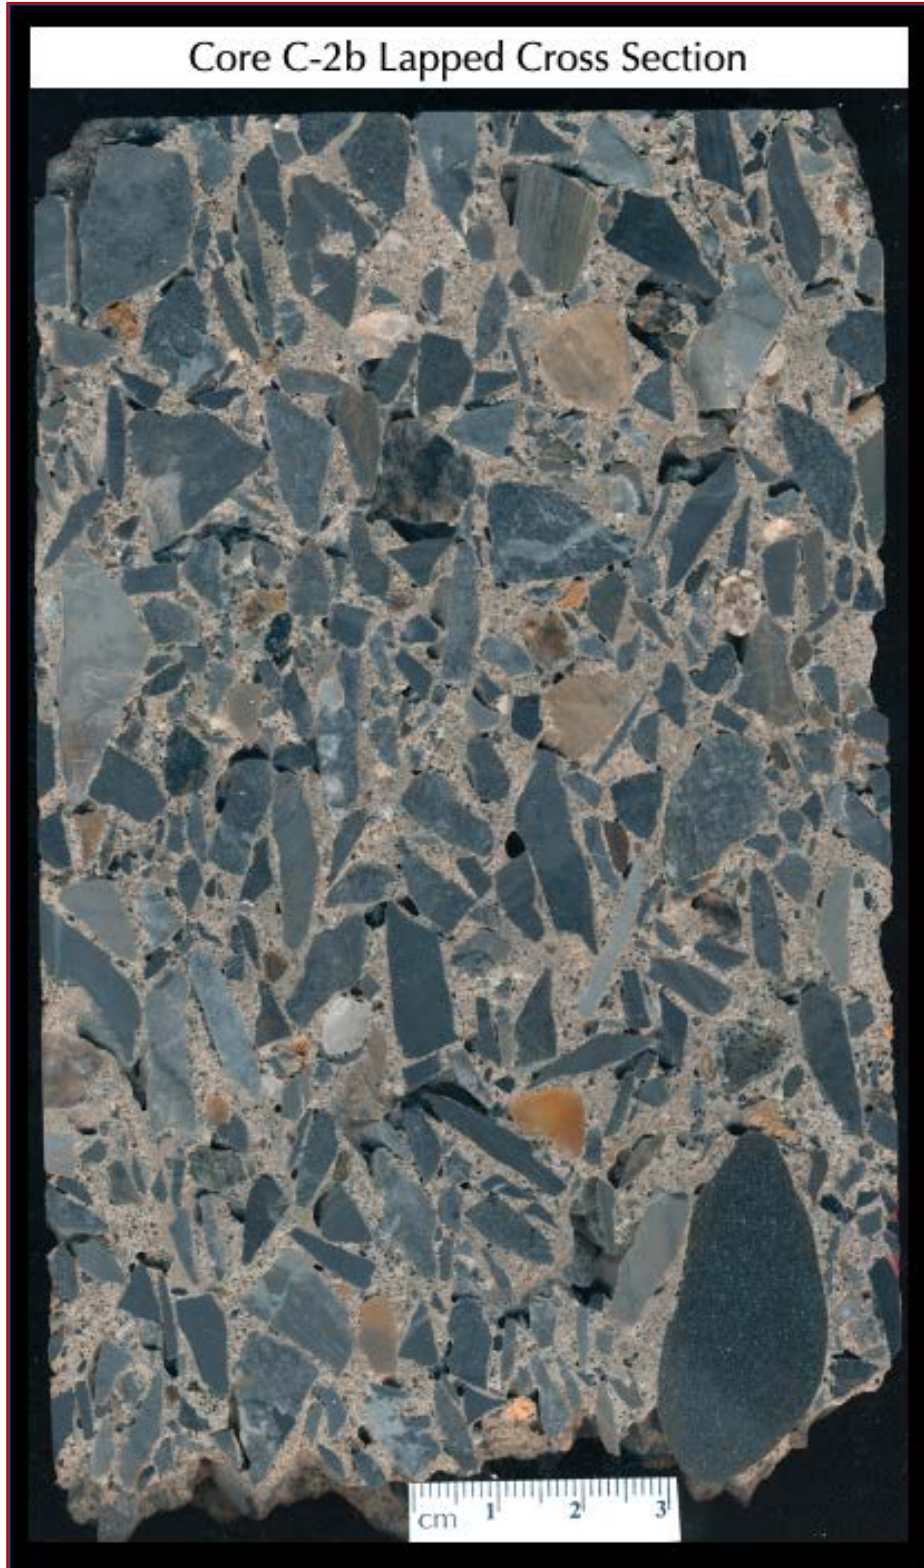
Figure 21: Lapped cross section of a middle portion of Core C-2b having a saw-cut end at one side and fractured end at the opposite side, showing:

- (a) Crushed limestone-dolomite coarse aggregate where most particles are elongated, which usually increases water requirement of concrete, angular, well-graded, and well-distributed;
- (b) Interstitial mortar fraction of siliceous-calcareous-argillaceous sand and Portland cement paste having a soft, porous, high water-cement ratio paste;
- (c) Notice abundant coarse, irregularly-shaped entrapped voids left from inadequate filling of interstitial spaces between crushed stone coarse aggregate, that have provided a dry-pack appearance of concrete with the resultant very low (in fact the lowest) reported compressive strength of 1590 psi.

For concrete in Core C-2b, crushed limestone/dolomite particles are mostly elongated, well-graded, and well-distributed where abundance of elongated particles has not only increased the water requirements of concrete but also created difficulty in effective filling of all interstitial spaces with the mortar fraction thereby leaving many coarse irregular-shaped entrapped voids between the particles and weak aggregate-mortar bonds due to inadequate consolidation and filling of particles with mortar fraction to the extent of creating a dry pack appearance of concrete. This has direct influence on the compressive strength, which showed only 1590 psi strength.

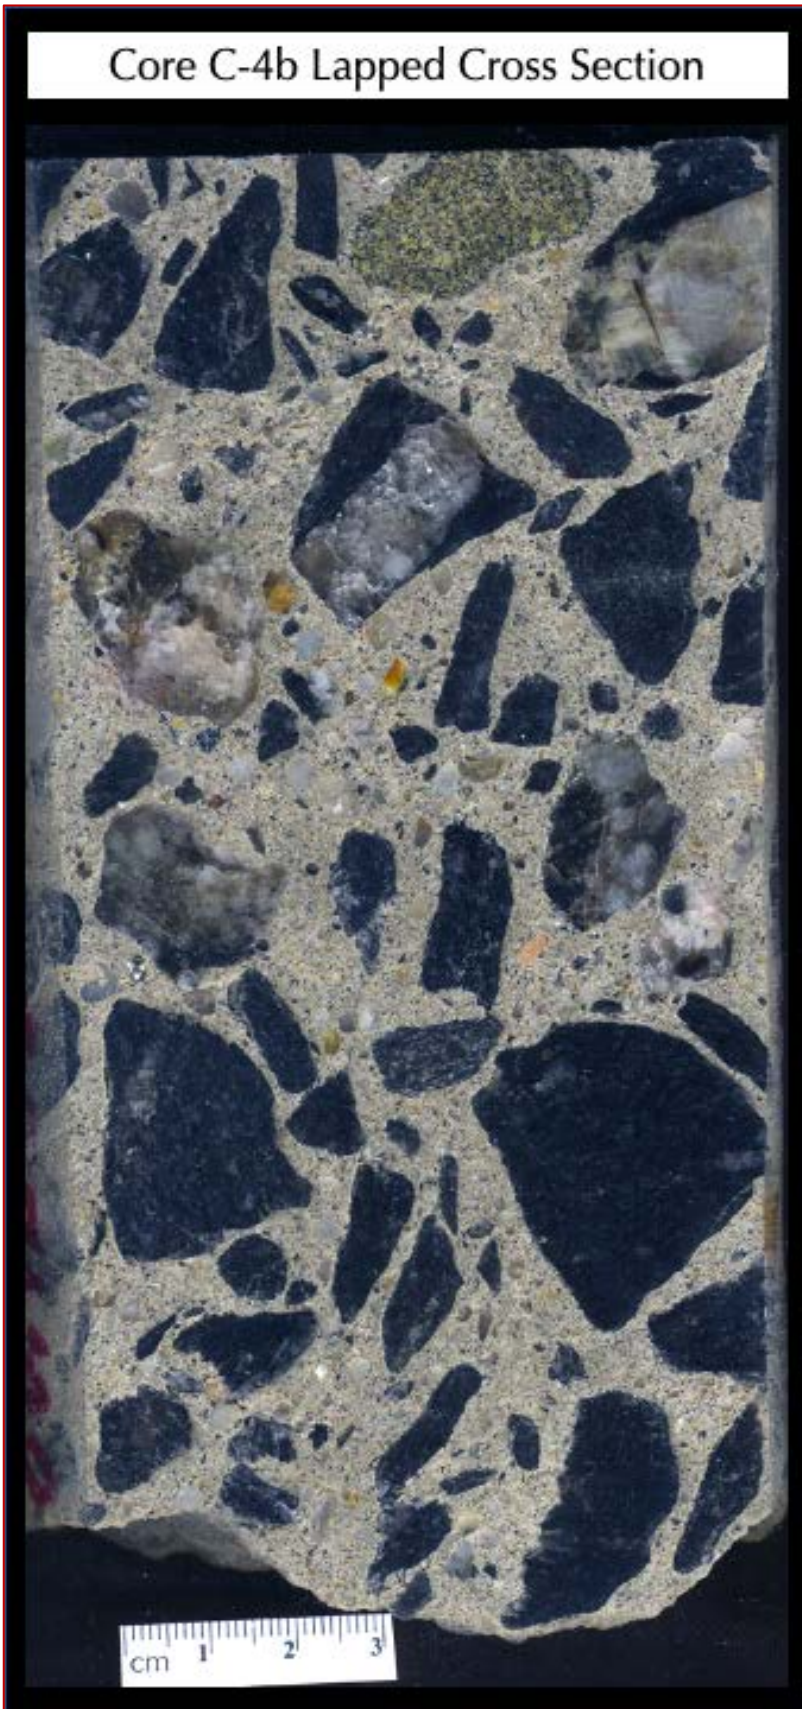
Figure 23: Lapped cross section of middle portion of Core C-4b having a saw-cut end at one side and a fresh fractured end at the opposite side, showing:

- (a) Crushed stone coarse aggregate where most particles are equant to a few elongated, dense, well-graded and well-distributed;
- (b) Interstitial mortar fraction of siliceous sand and Portland cement paste having a soft, porous, high water-cement ratio paste;
- (c) Reported compressive strength of concrete is 2420 psi, which is attributed mainly to the soft, porous, high water-cement ratio nature of the interstitial paste.

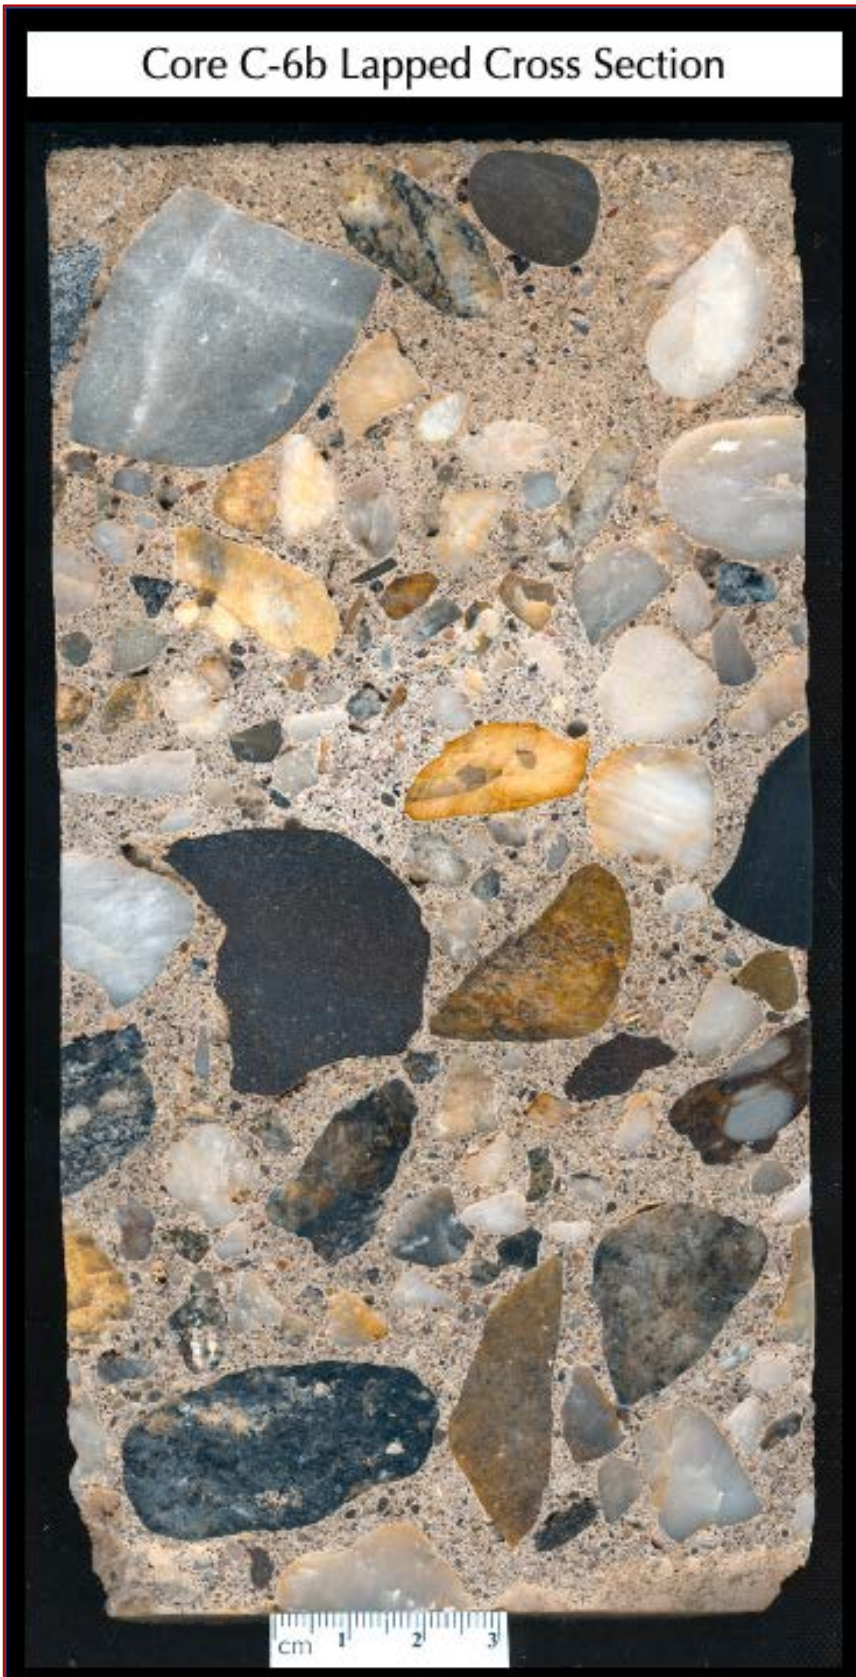
Figure 24: Lapped cross section of top portion of Core C-6b having a weathered exposed end at one side and a saw-cut end at the opposite side, showing:

- (a) Lightly crushed gravel coarse aggregate where most particles are well-rounded to subrounded depending on crushing, mostly equant to a few elongated, dense, well-graded and well-distributed;
- (b) Interstitial mortar fraction of siliceous sand and Portland cement paste having a soft, porous, high water-cement ratio paste; and,
- (c) Reported compressive strength of concrete is 1640 psi, which is attributed mainly to the soft, porous, high water-cement ratio nature of the interstitial paste.

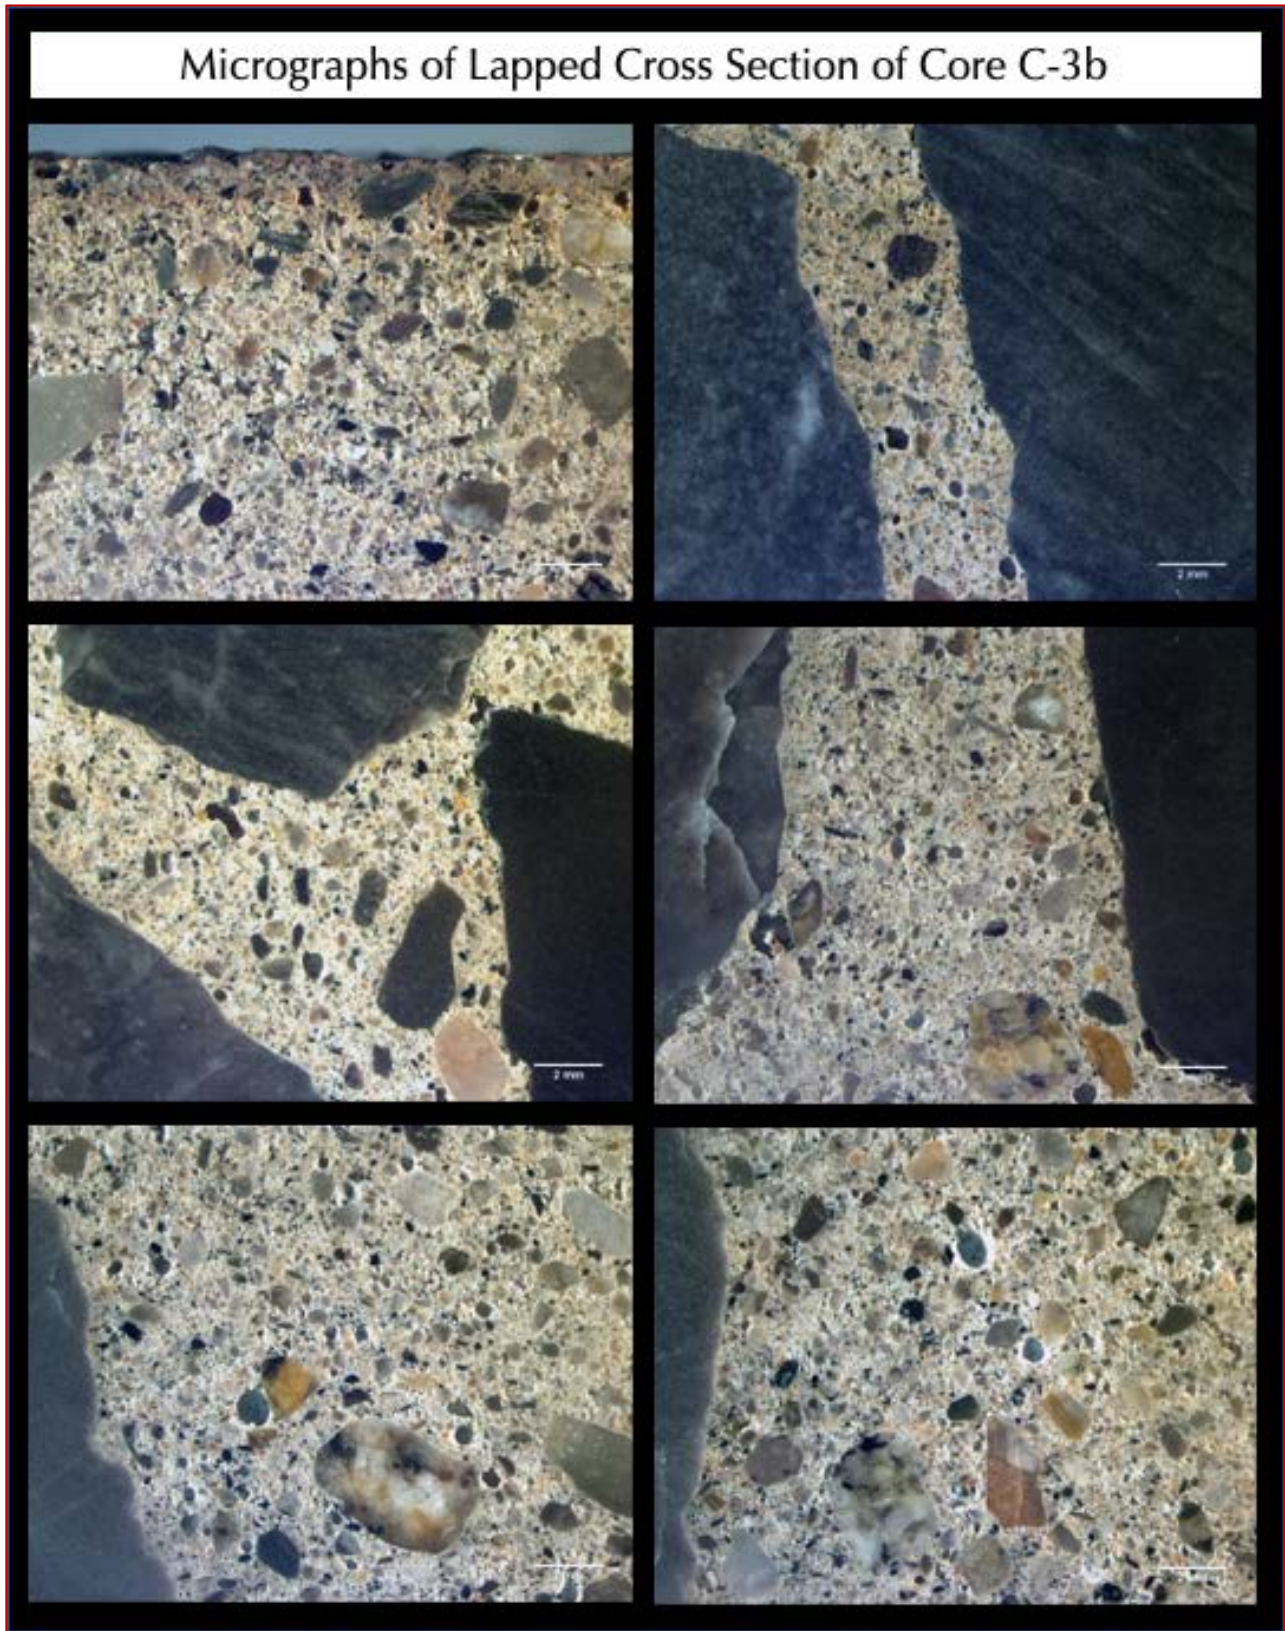
Figure 26: Micrographs of lapped cross section of Core C-3b showing: (a) the overall non-air-entrained nature of concrete having a few discrete, spherical and near-spherical entrapped air bubbles, and (b) overall porous but well-consolidated nature of concrete.

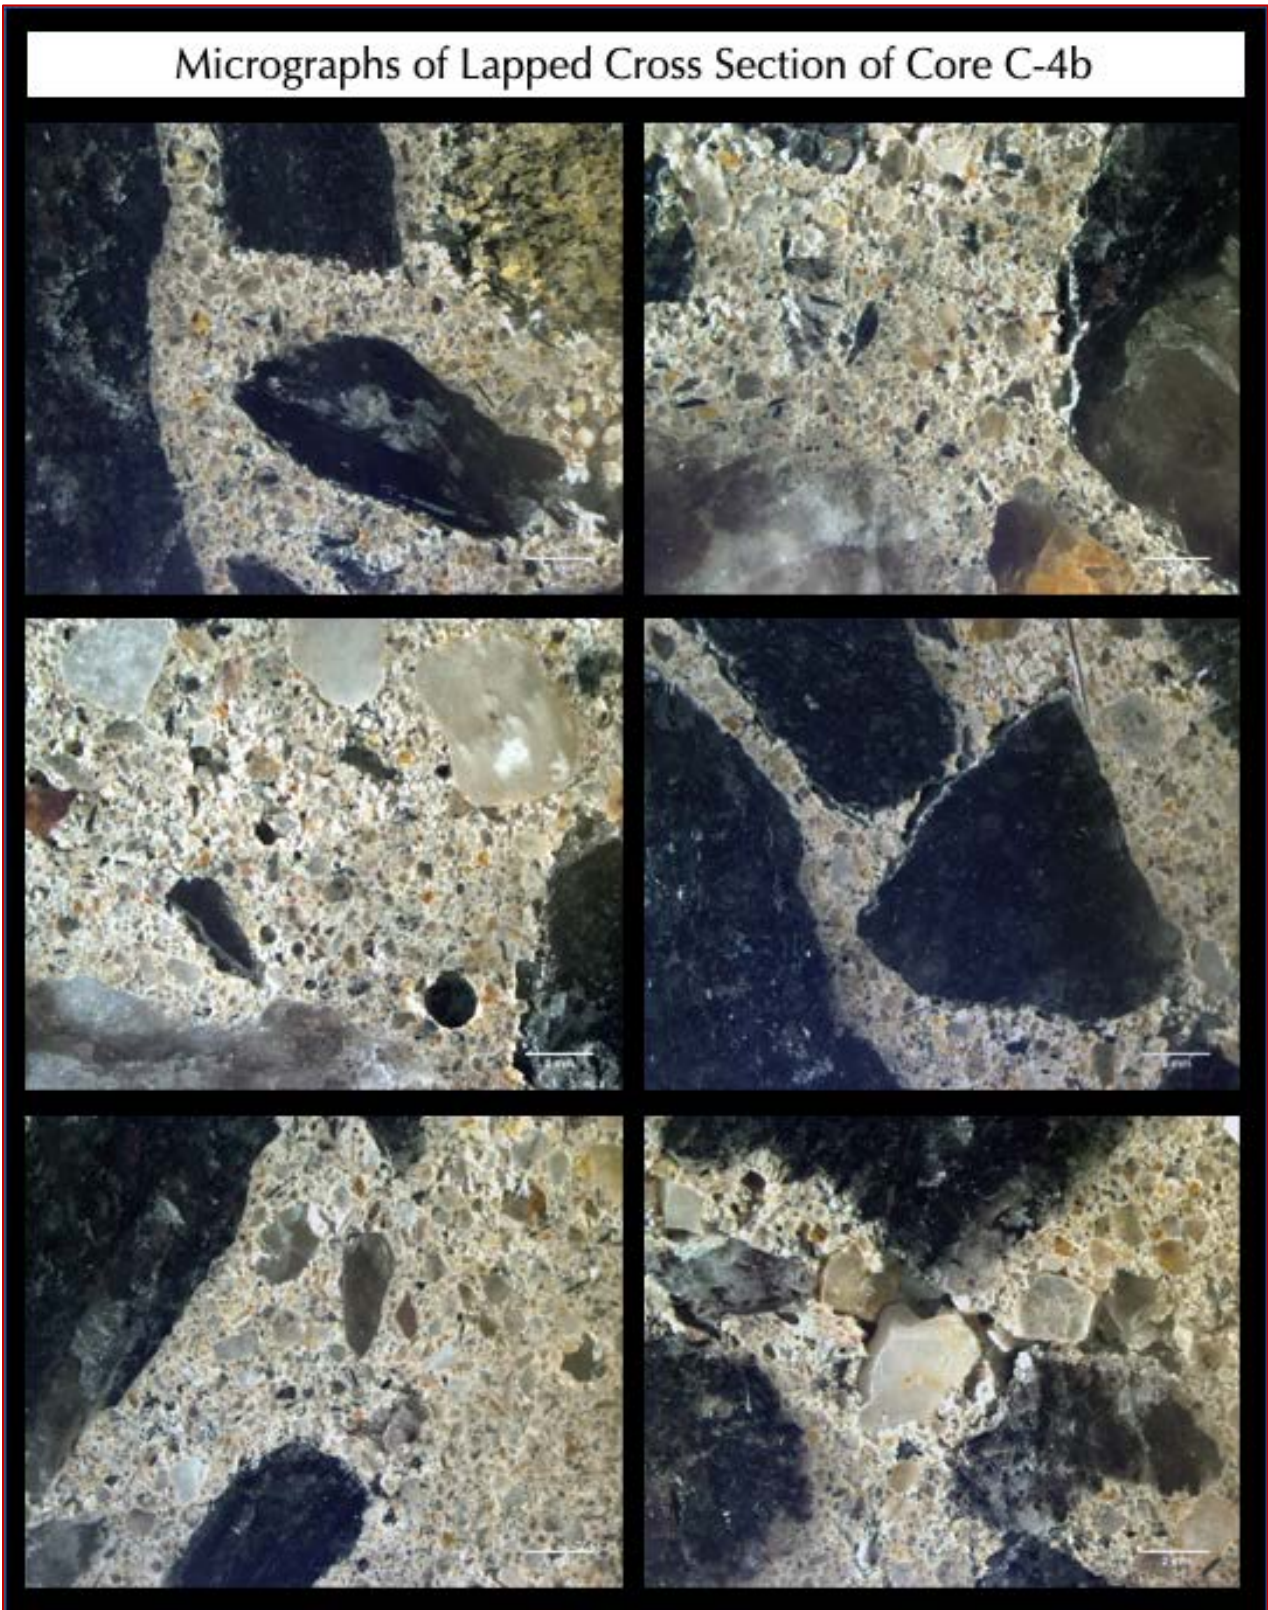
Figure 27: Micrographs of lapped cross section of Core C-4b showing: (a) the overall non-air-entrained nature of concrete having a few discrete, spherical and near-spherical entrapped air bubbles, and (b) overall porous but well-consolidated nature of concrete.

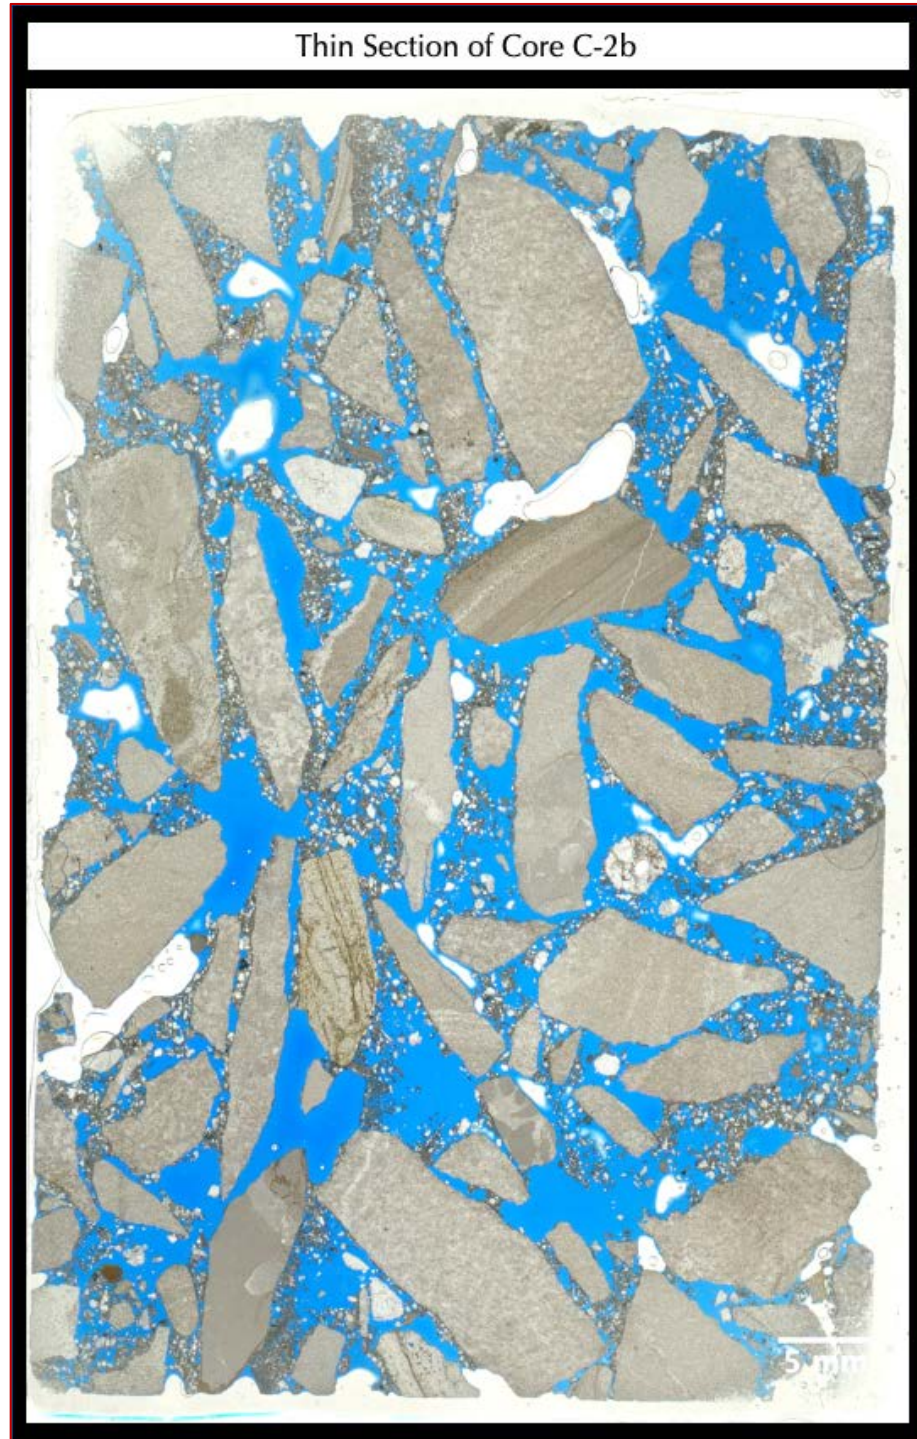
Figure 29: Enlarged view of a 50 mm × 75 mm size blue dye-mixed epoxy-impregnated thin section of Core C-2b, shown in plane polarized light mode by scanning the thin section on a flatbed scanner with a polarizing filter. The image highlights abundant coarse entrapped air voids in the concrete due to inadequate filling of interstitial spaces between elongated crushed limestone-dolomite coarse aggregate leaving only minor mortar fraction of natural siliceous-argillaceous sand fine aggregate and Portland cement paste.
