CONSTRUCTION MATERIALS CONSULTANTS, INC.

## Assessment of Concrete Inside A Train Shed From The Grand Central Terminal In The City Of New York

Rehabilitation of the Grand Central Terminal Train Shed  
– Sector 2 (53/55 St)  
Park Avenue between 53<sup>rd</sup> and 55<sup>th</sup> St.  
New York, New York

September 9, 2021  
CMC 0821148

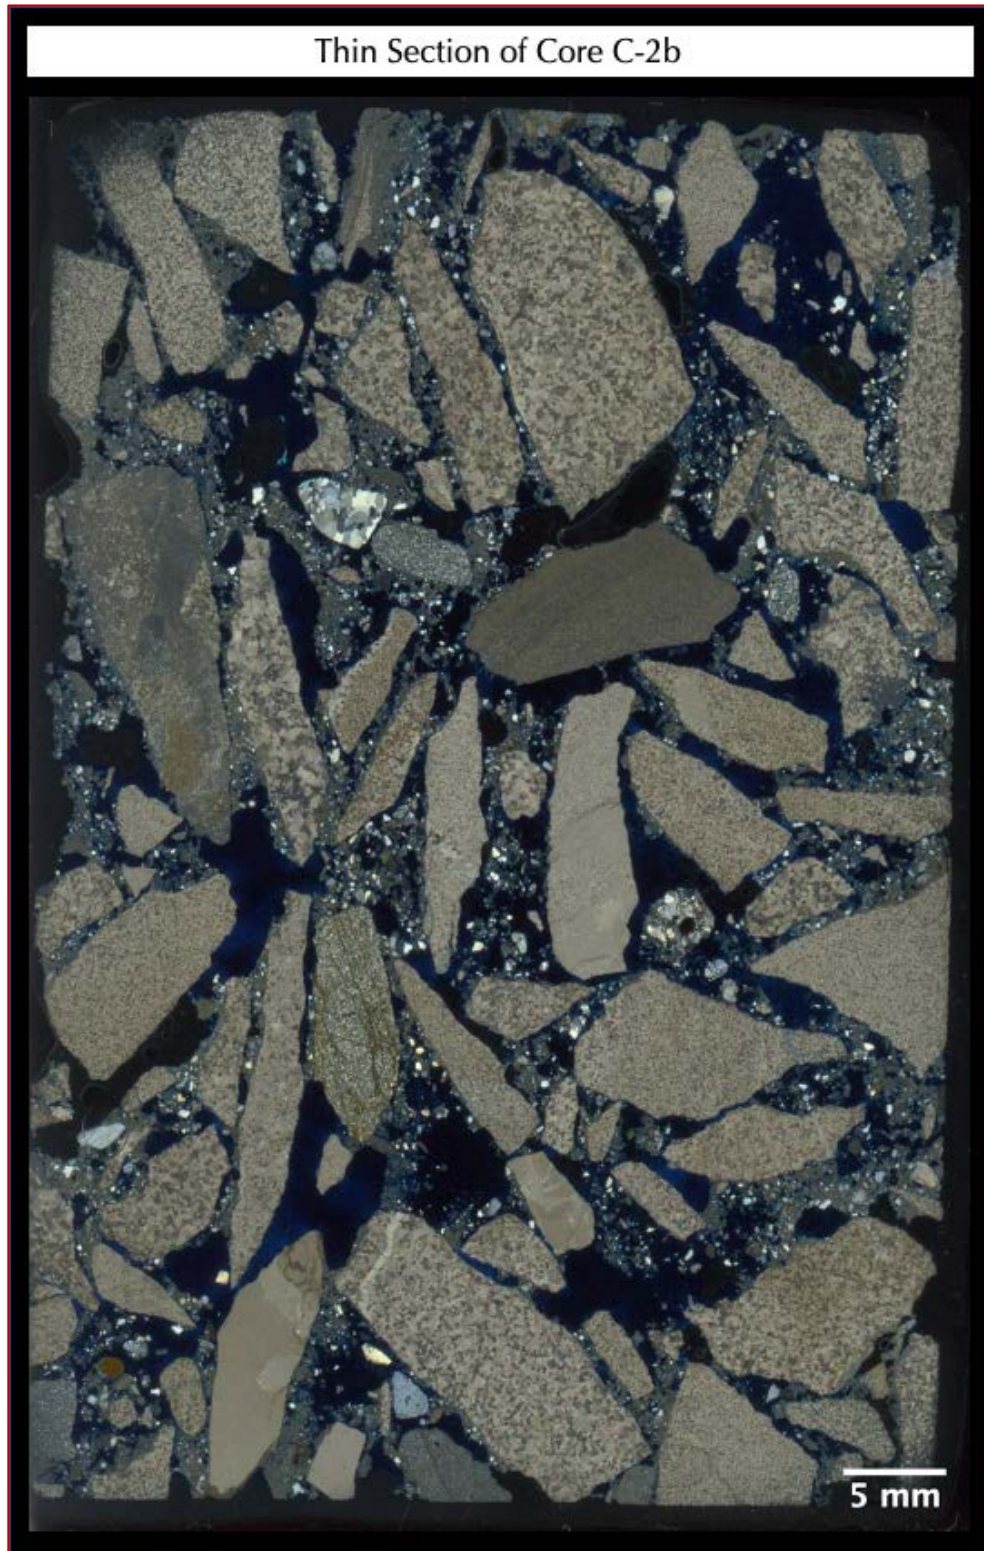
Figure 30: Enlarged view of a 50 mm × 75 mm size blue dye-mixed epoxy-impregnated thin section of Core C-2b, shown in crossed polarized light mode by scanning the thin section on a flatbed scanner with two perpendicular polarizing filters between the thin section. The image highlights crushed limestone-dolomite coarse aggregate leaving only minor mortar fraction of natural siliceous-argillaceous sand fine aggregate and Portland cement paste.

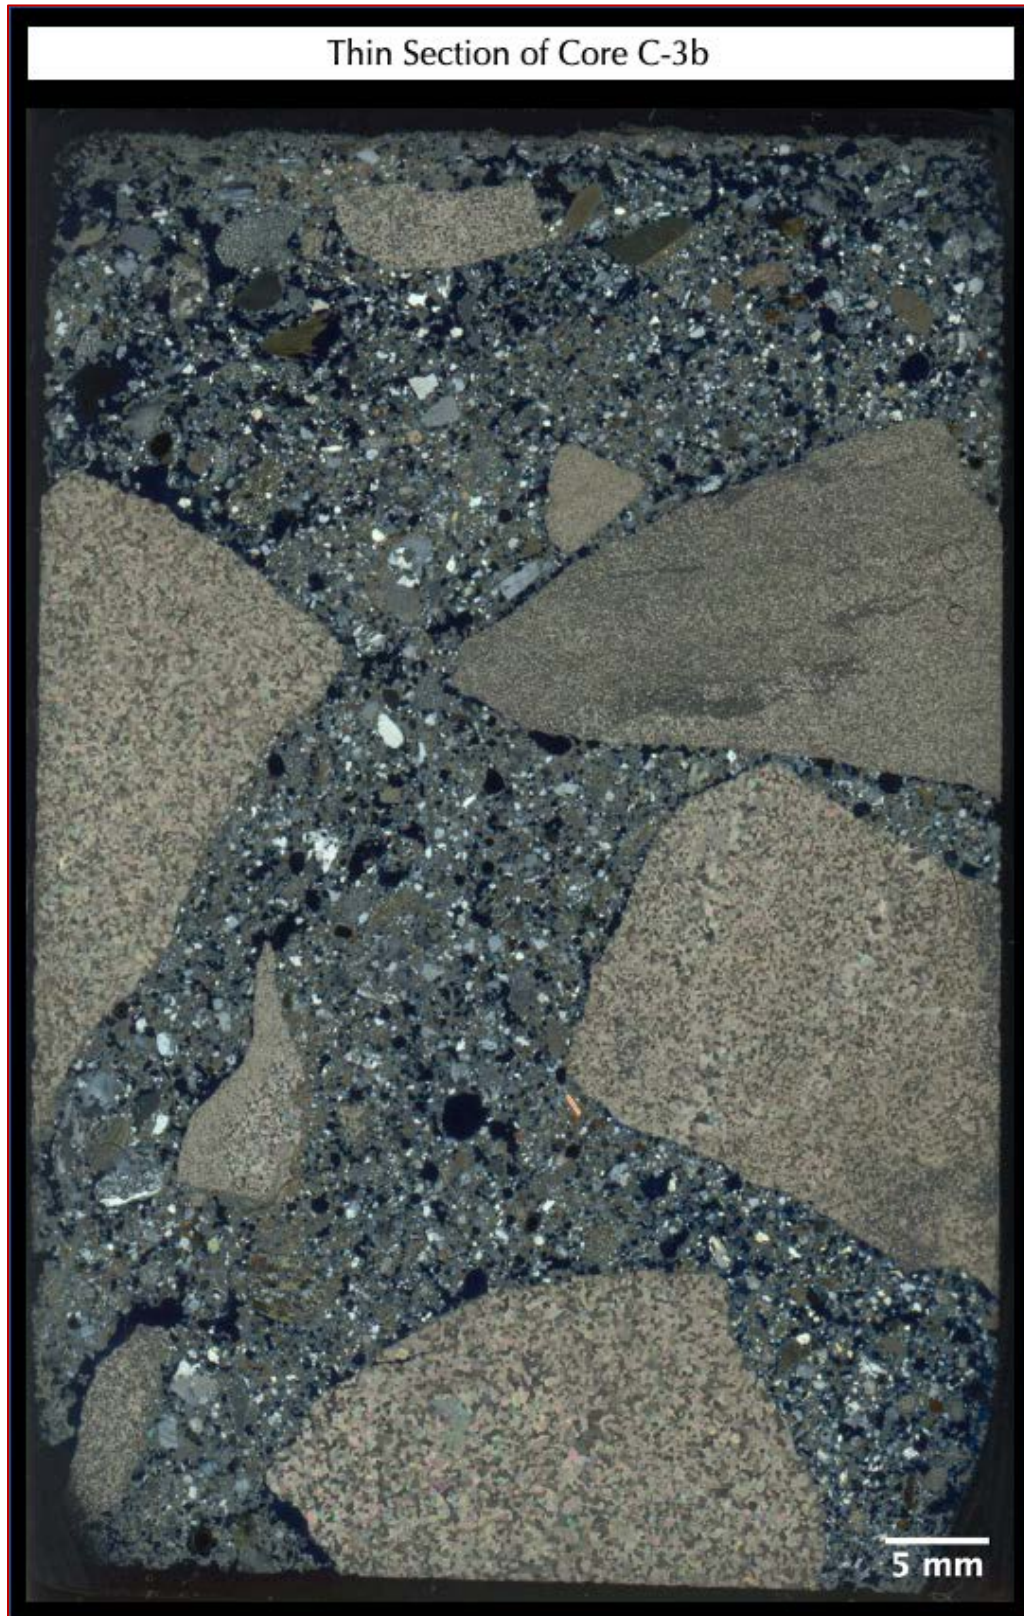
Figure 32: Enlarged view of a 50 mm × 75 mm size blue dye-mixed epoxy-impregnated thin section of Core C-3b, shown in cross polarized light mode by scanning the thin section on a flatbed scanner with two perpendicular polarizing filters between the thin section. The image highlights crushed limestone-dolomite coarse aggregate and an interstitial mortar fraction of natural siliceous-argillaceous sand fine aggregate and Portland cement paste.

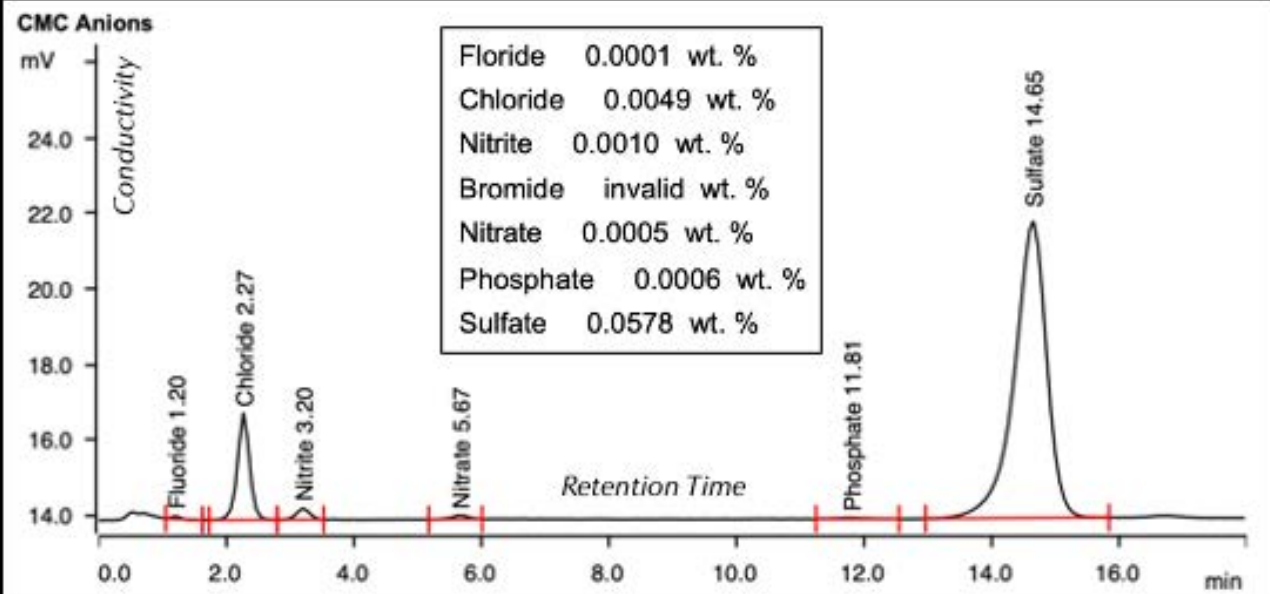
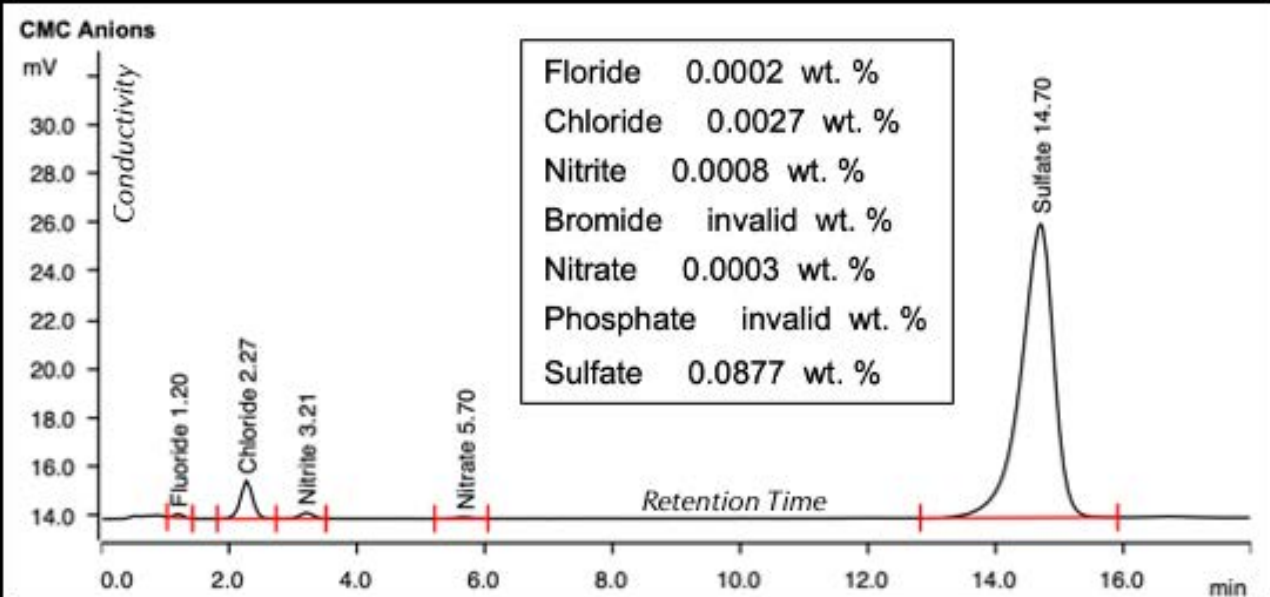
### Water-Soluble Anions In Core C-2b At 3 in. (Top) and 13.25 in. (Bottom) Depths From Ion Chromatography

Figure 38: Ion chromatograms of water-soluble anions of filtrates from the 3 in. and 13.25 in. depths of Core C-2b showing negligible chloride and sulfate ions at the exposed and interior concrete with slightly lesser values from the interior. Results are indicative of the lack of any external exposures to chloride or sulfate salts during service, which is consistent with its reported mild exposure of interior train shed location of core.

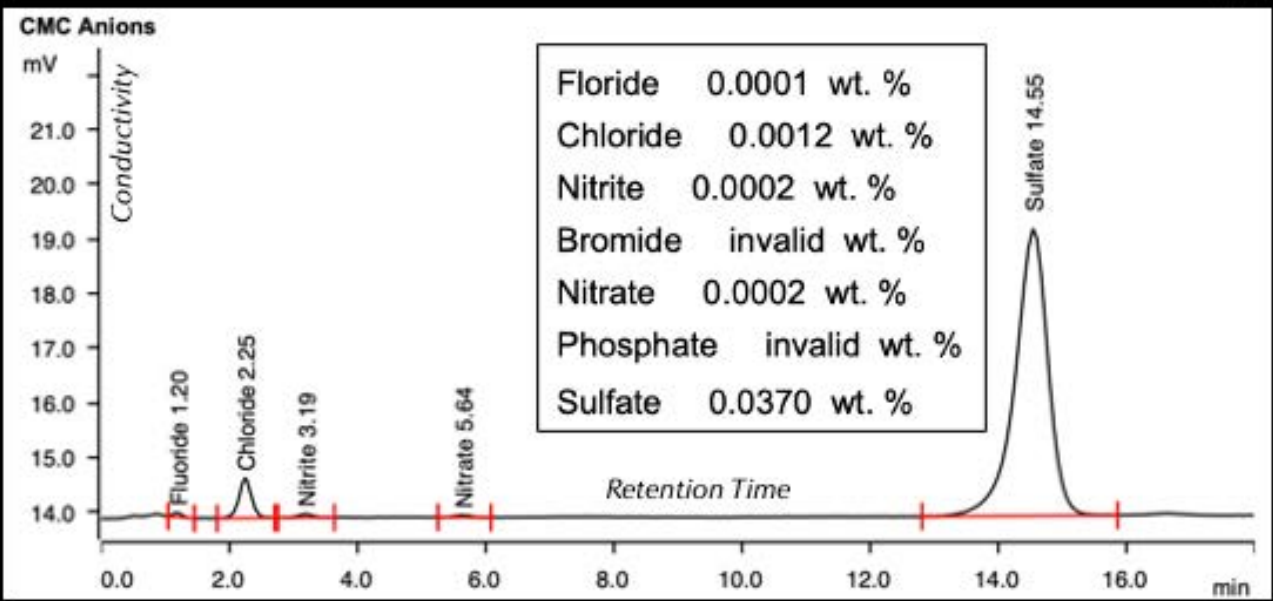
### Water-Soluble Anions In Core C-6b At 3 in. (Top) and 12.75 in. (Bottom) Depths From Ion Chromatography

Figure 41: Ion chromatograms of water-soluble anions of filtrates from the 3 in. and 12.75 in. depths of Core C-6b showing negligible chloride and sulfate ions at the exposed and interior concrete with slightly lesser values from the interior. Results are indicative of the lack of any external exposures to chloride or sulfate salts during service, which is consistent with its reported mild exposure of interior train shed location of core.
