## Laboratory Analyses of A Stain From A Concrete Slab Surface

SMC Distribution Center-Noblesville, IN  
10650 SMC Boulevard  
Noblesville, IN 46060

February 22, 2019  
CMC 0219104

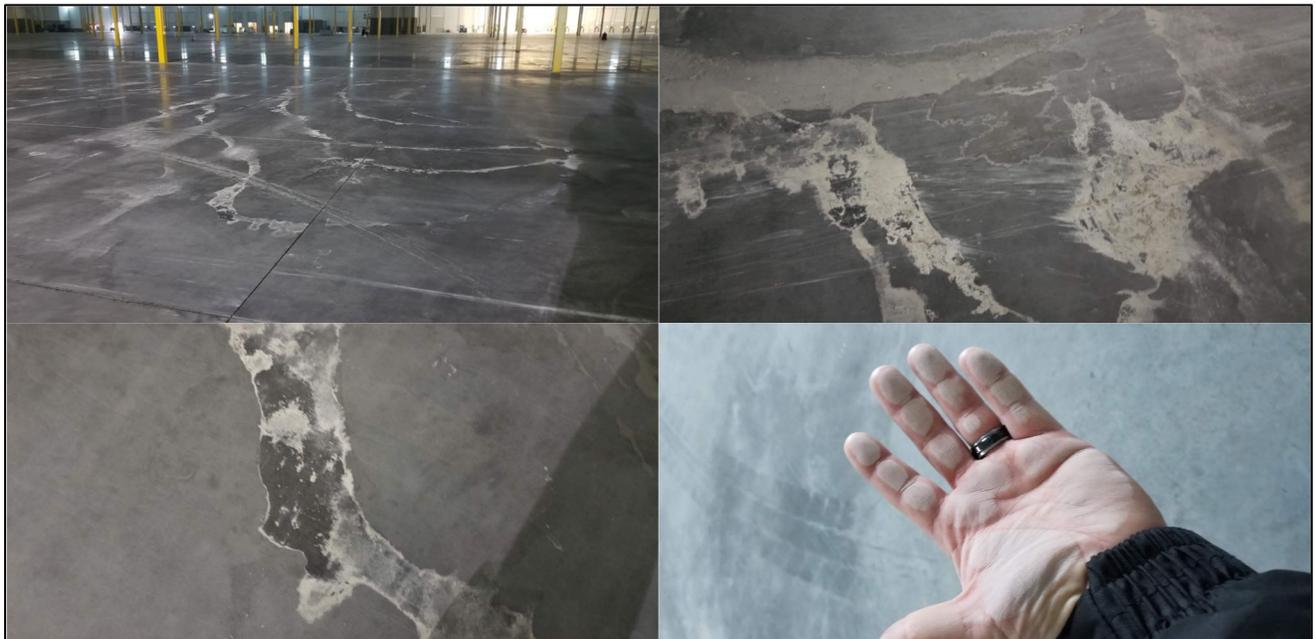
Figure 1: White stain on a trowel-finished concrete surface at SMC Distribution Center in Noblesville, Indiana.

A powder of off-white to light gray stain on the trowel-finished surface of a concrete slab located at SMC Distribution Center at 10650 SMC Boulevard, Noblesville, Indiana was provided for examination. The floor surface was reportedly treated with (a) Speedhide interior Dry-Fog vinyl acrylic latex mixture containing kaolin ( $\cong 20$  to  $\cong 50\%$ ), limestone ( $\cong 1.0$  to  $\cong 5.0\%$ ), diatomaceous earth ( $\cong 1.0$  to  $\cong 5.0\%$ ), and titanium dioxide ( $\cong 1.0$  to  $\cong 5.0\%$ ), and, (b) SpecChem E-Cure water-based concrete curing agent of sodium silicate composition (Sodium Silicate N <50%). Field photographs (Figure 1) showed white stains, reportedly appeared within 2 weeks of hard trowel finish, either as long trails or as isolated patches that is soft, dusty and easily rubbed into fingers. The purpose of laboratory testing is to identify the stain and its composition.

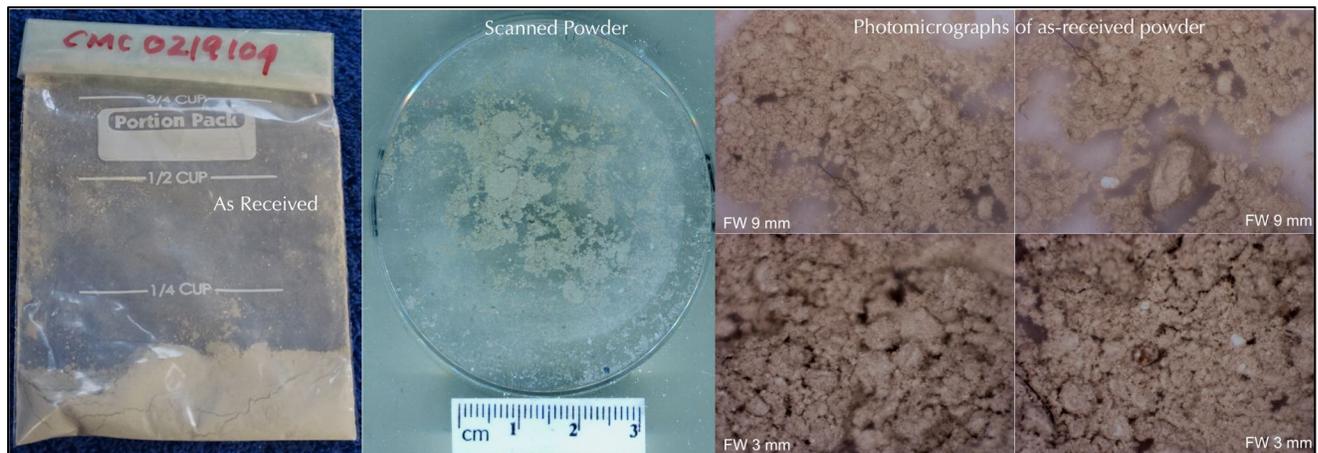
Figure 2 shows the off-white to light gray powder, as received in a plastic ziploc bag, as well as after removing a portion of it on a petri dish, and its appearance while viewed through a low-power stereomicroscope.

Figure 2: Off-white to light gray stain sample as received, and viewed through a low-power stereomicroscope.

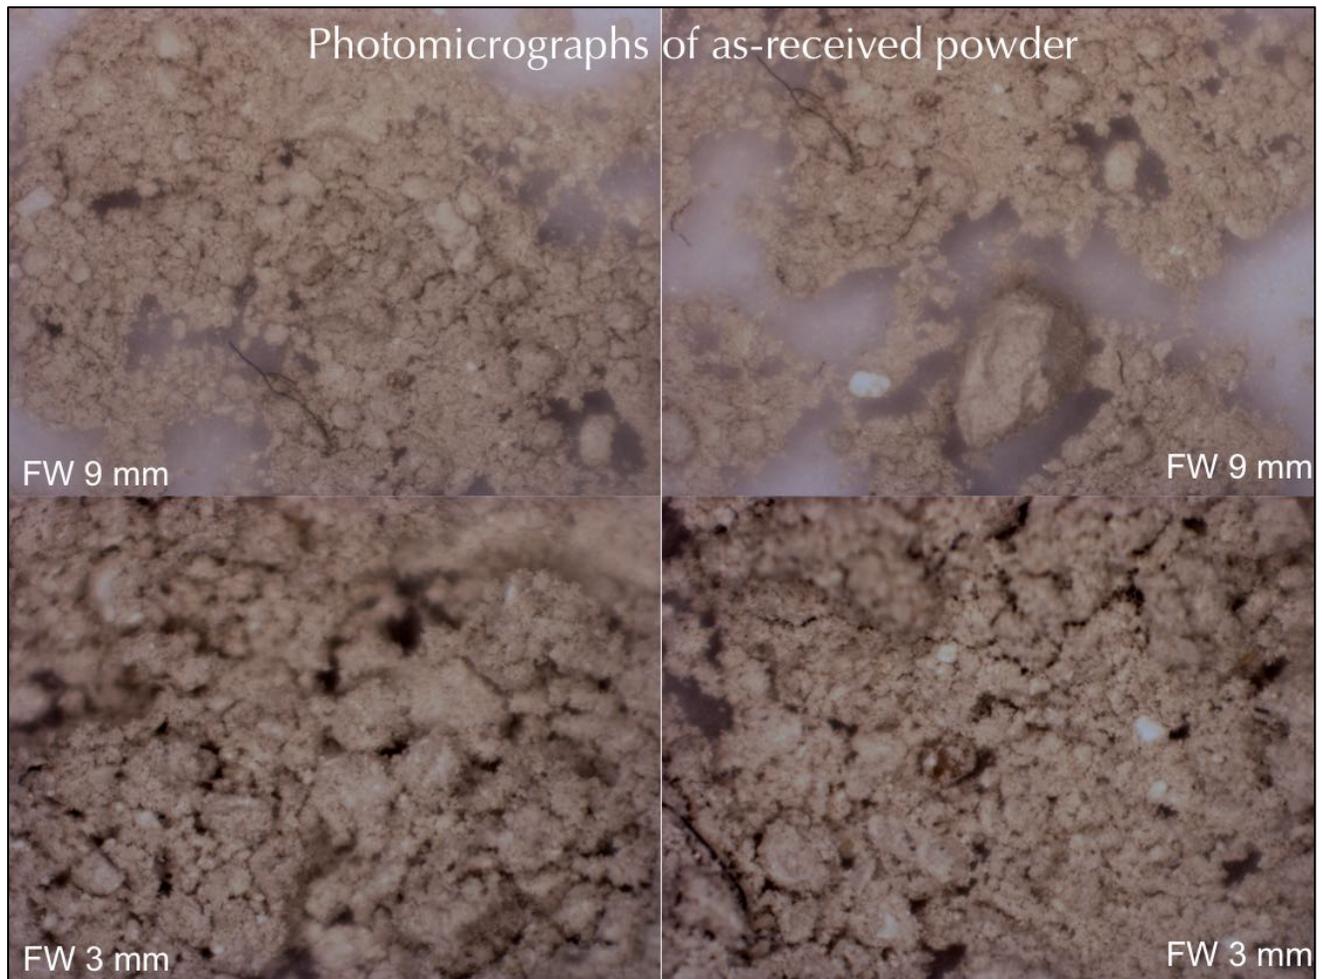
Low-power stereomicroscopical examinations of as-received powder shows its soft, dusty, particulate nature with occasional very fine (less than 0.5 mm) sand grains, probably from concrete sand mixed in other off-white to light gray components. No fibers, metals, bituminous materials, grease or other contaminants are found.

Figure 3: Photomicrographs of as-received powder.

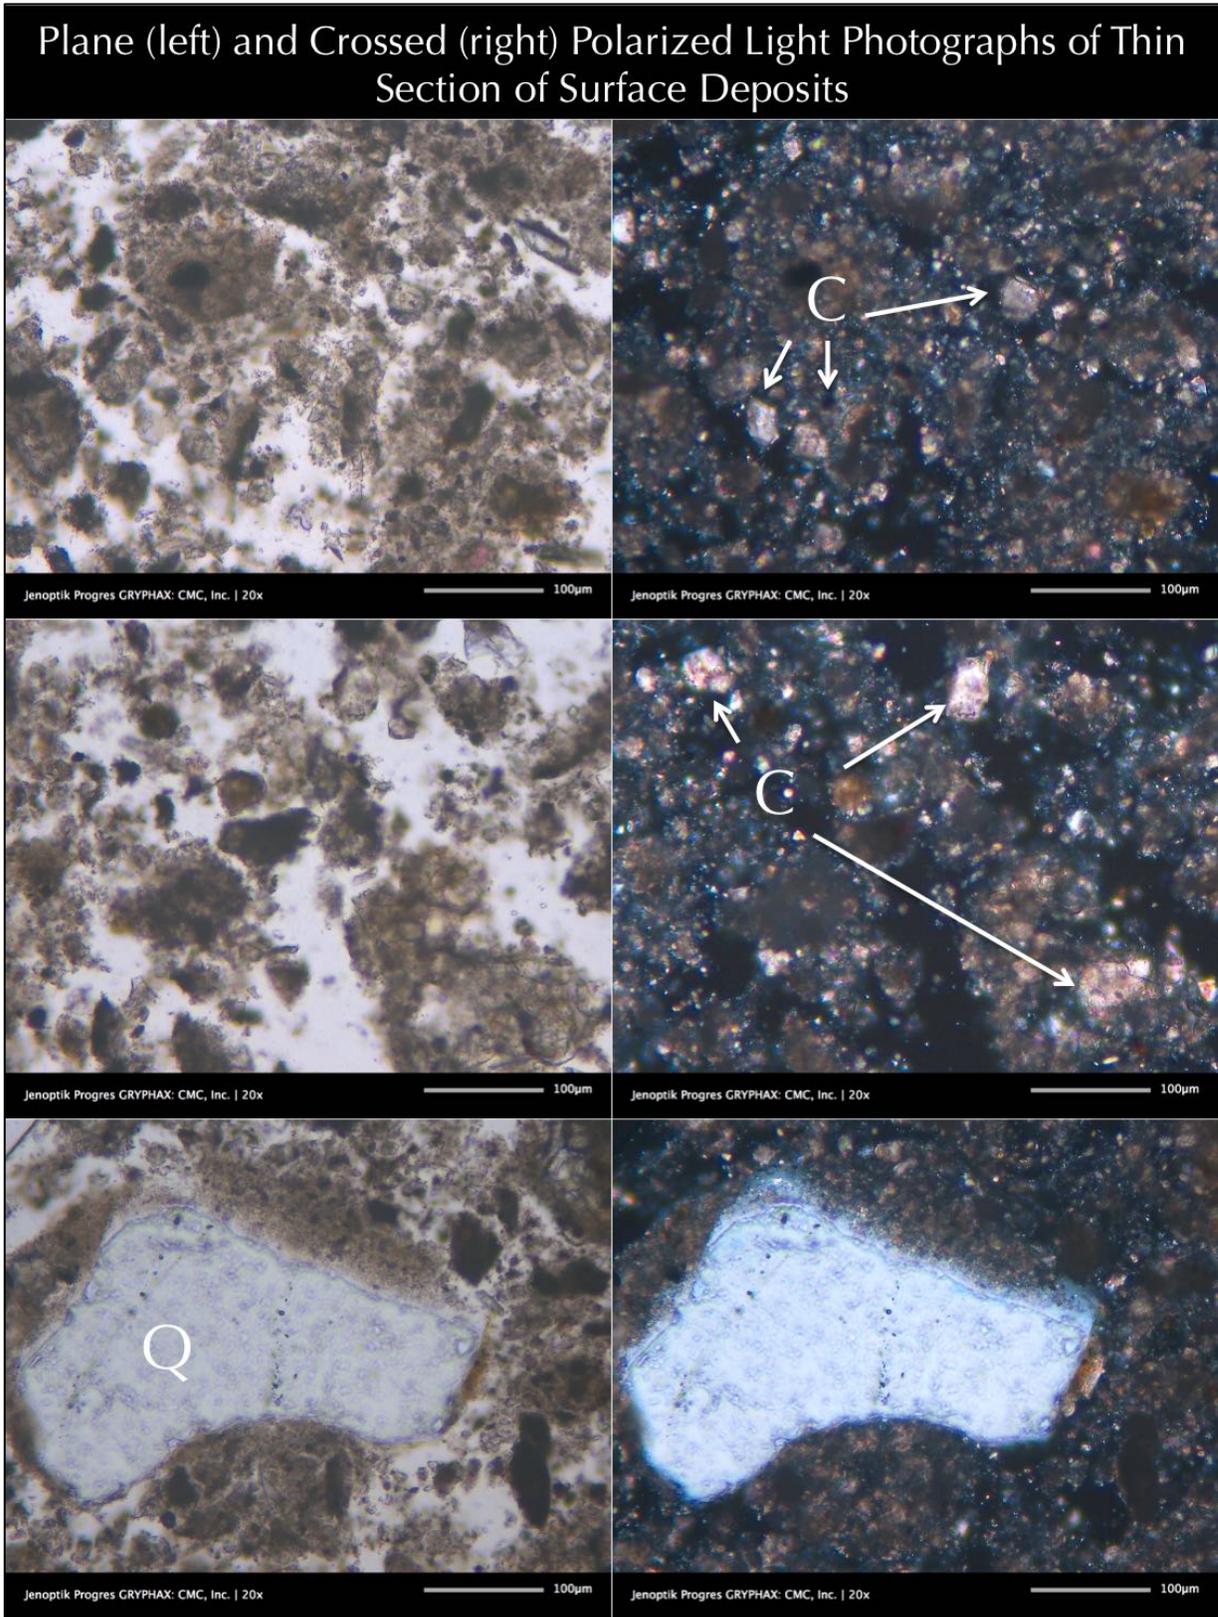
Subsequent examinations of thin section of powder in a petrographic microscope determined the presence of very fine particles of: (a) **calcite and dolomite** (some coarser ones are marked as 'C' in Figures 4 and 5), (b) **quartz** (some are marked as 'Q' in Figures 4 and 5), and (c) occasional trace **feldspar** (marked as 'F' in Figure 5) – all in a cloudy mass of **intermixed clay and cement hydration products**. The stain, therefore is similar in appearance to a dried out cream of dissolved matter from the concrete surface that contains some common usual components of concrete surface, e.g., calcite, quartz, and cement paste. Organic matter, if present, e.g., the reported vinyl acrylic-based and sodium silicate-based surface treatments and curing agents cannot be determined from optical microscopy. No contaminant or potentially deleterious salts were found, nor was the typical calcium carbonate composition of surface deposit that is a common efflorescence deposit on concrete surface formed by atmospheric carbonation of precipitate brought to the surface by moisture from within the concrete.

Figure 4: Photomicrographs of thin section of surface deposit showing abundant particulate matters consisting of carbonates (calcite and dolomite grains, some are marked as 'C'), quartz (largest particle is marked as 'Q'), and cloudy mixture of Portland cement paste and ultrafine particles of clay.

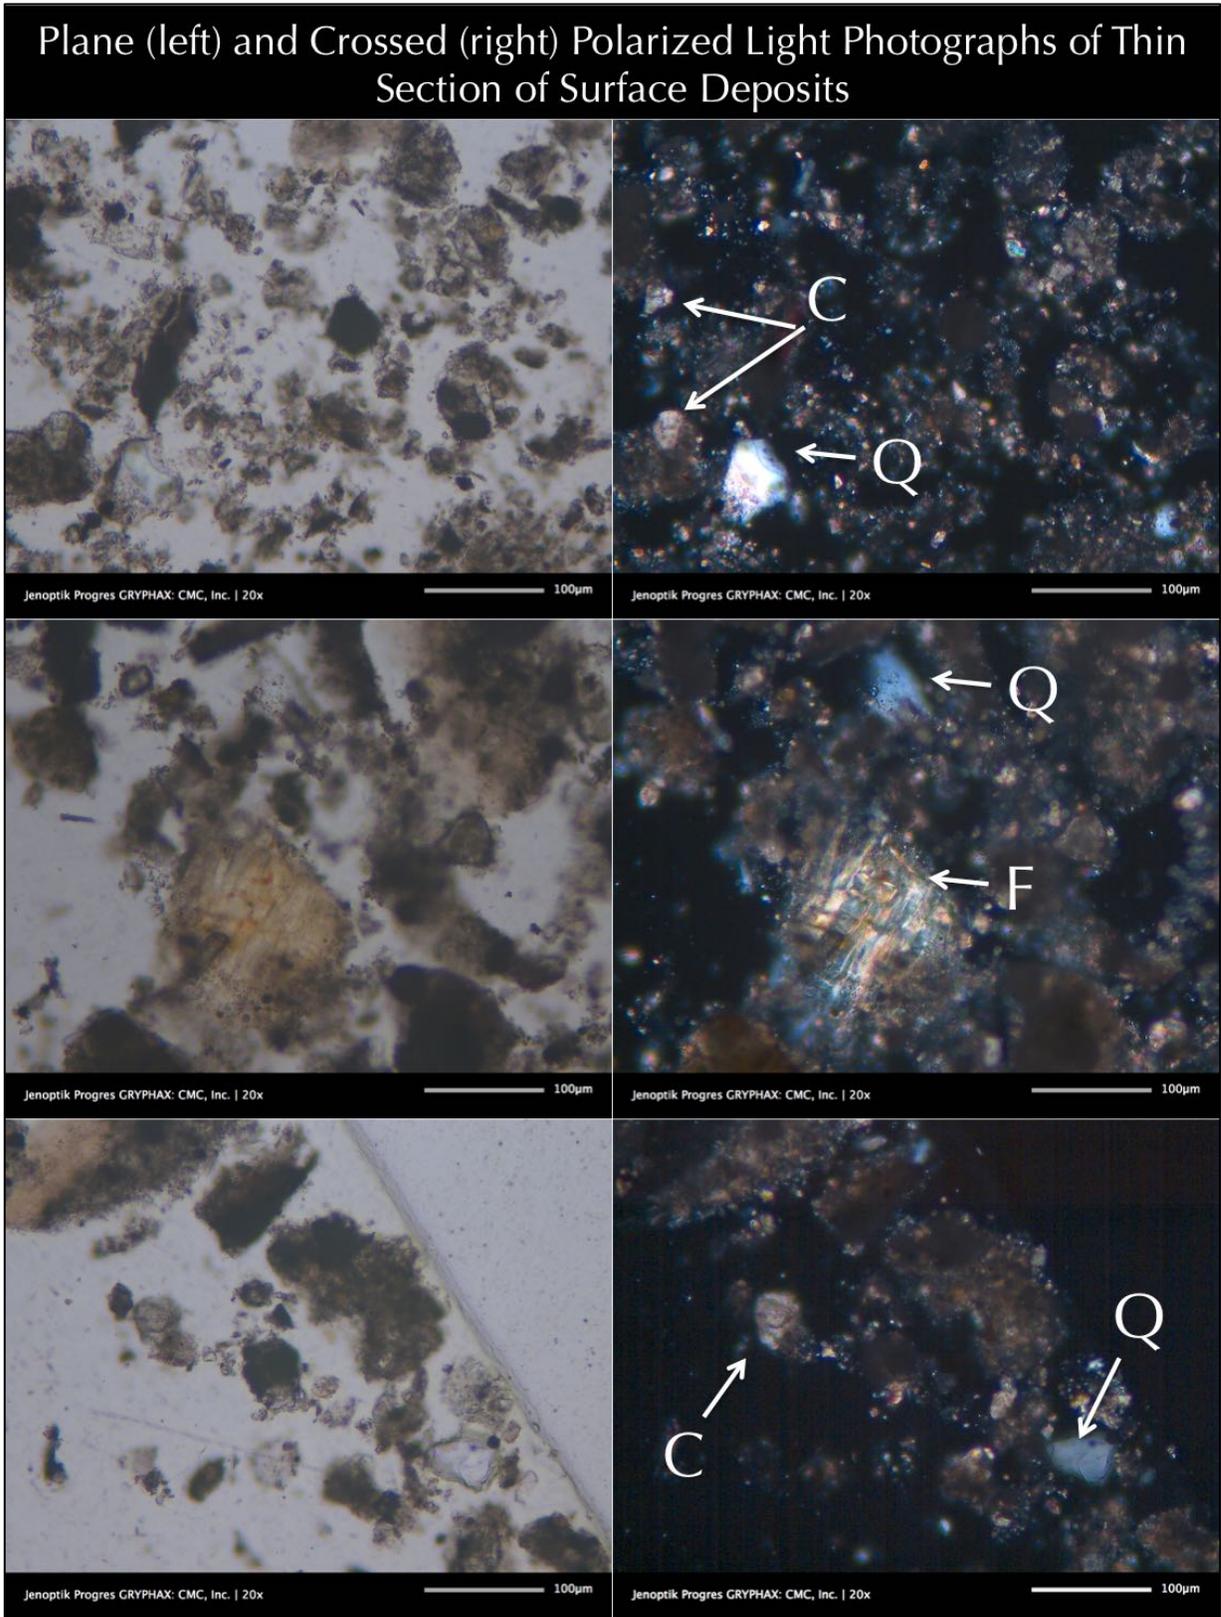
Figure 5: Photomicrographs of thin section of surface deposit showing abundant particulate matters consisting of carbonates (calcite and dolomite grains, some are marked as 'C'), quartz (largest particle is marked as 'Q'), feldspar (marked as 'F'), and cloudy mixture of Portland cement paste and ultrafine particles of clay.

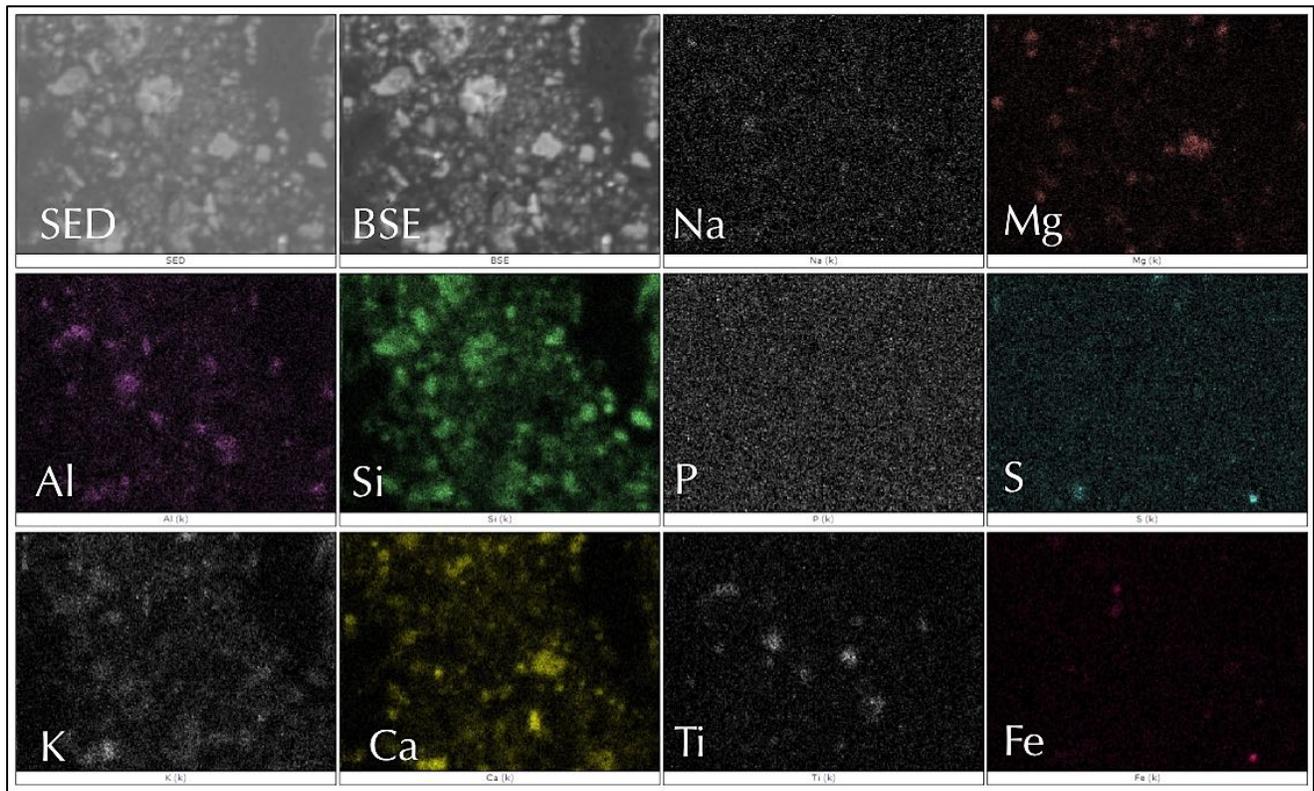
Figure 6 shows secondary electron image (SED), backscatter electron image (BSE) and X-ray elemental maps of thin section of surface deposit showing

- (a) Overall silica-rich particulate matters highlighted in silicon (Si) map, which is consistent with optical microscopical determination of fine quartz and ultrafine clay,
- (b) Isolated particulate matters rich in aluminum (Al) from clay and feldspar,
- (c) Isolated particules rich in calcium as seen in Ca-map from calcite and dolomite,
- (d) Fine particles of dolomite rich in magnesium as seen in Mg-map,
- (e) Isolated spots rich in titanium in Ti-map, which is consistent with reported presence of titanium dioxide in the Speedhide interior Dry-Fog vinyl acrylic latex mixture.
- (f) Alkalies are from concrete along with reported sodium silicate surface treatment.

Figure 6: Secondary electron image (SED), backscatter electron image (BSE) and X-ray elemental maps of thin section of surface deposit.

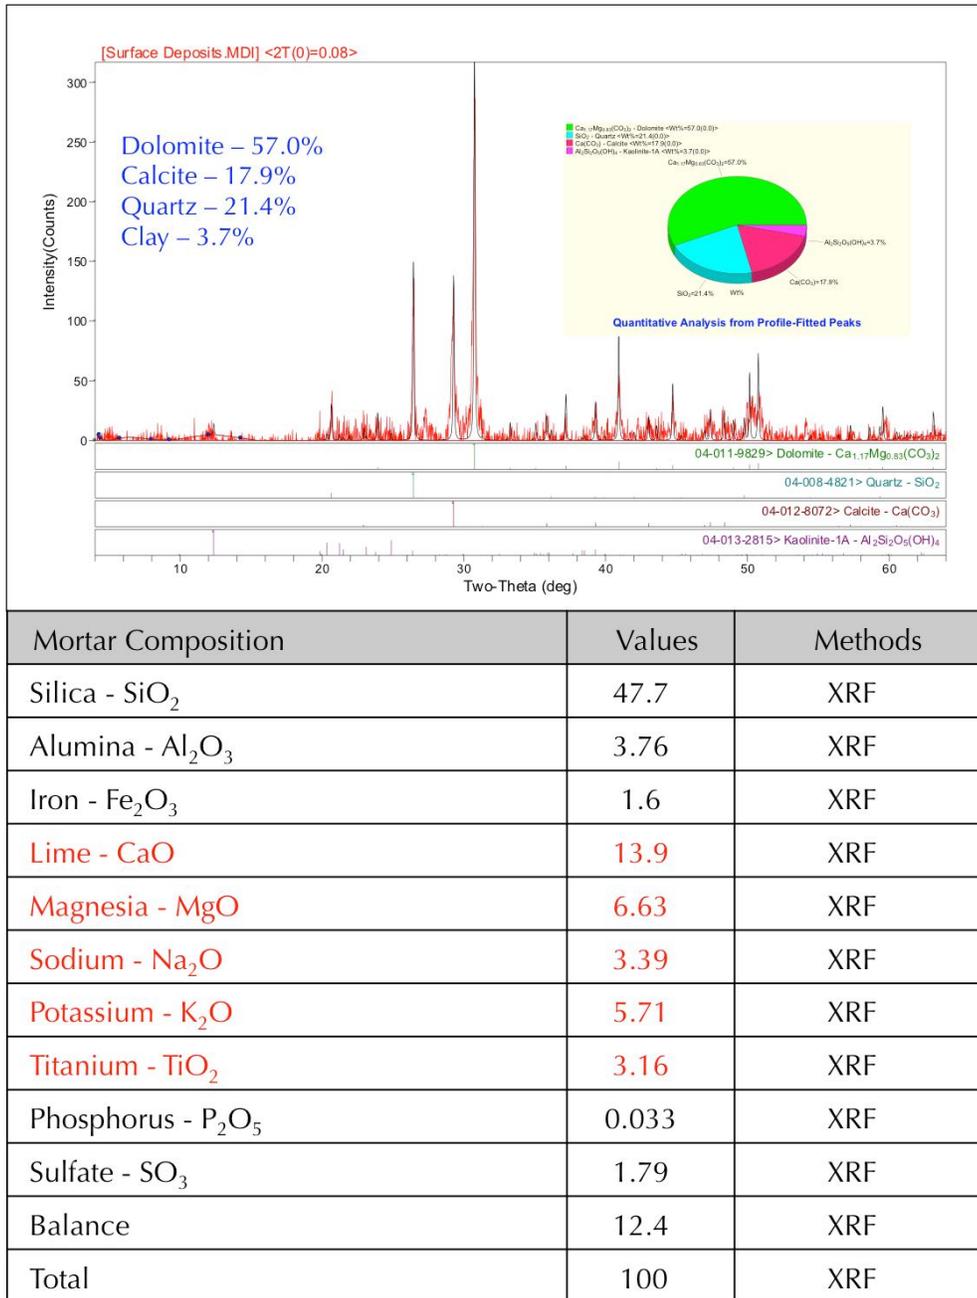
Figure 7 shows mineralogical and chemical compositions of surface deposits as determined from X-ray diffraction (XRD), and X-ray fluorescence spectroscopy (XRF), respectively. XRD pattern of surface deposit, and quantitative analysis (Rietveld) of major mineralogical compositions show dominant 57% dolomite, 17.9% calcite, 21.4% quartz and 3.7% kaolinite clay as the recognizable crystalline materials. XRF showed high lime and magnesium from dolomite and calcite found in XRD, silica is from quartz, clay, and reported sodium silicate surface treatments, and alumina is from clay. High titanium is from titanium dioxide present in Speedhide interior Dry-Fog vinyl acrylic latex mixture. Of particular interest are high alkalis, especially sodium from reported sodium silicate surface treatment along with alkalis from concrete.

Figure 7: XRD (top) and XRF (bottom) analyses of surface deposits showing mineralogical and chemical compositions, respectively.

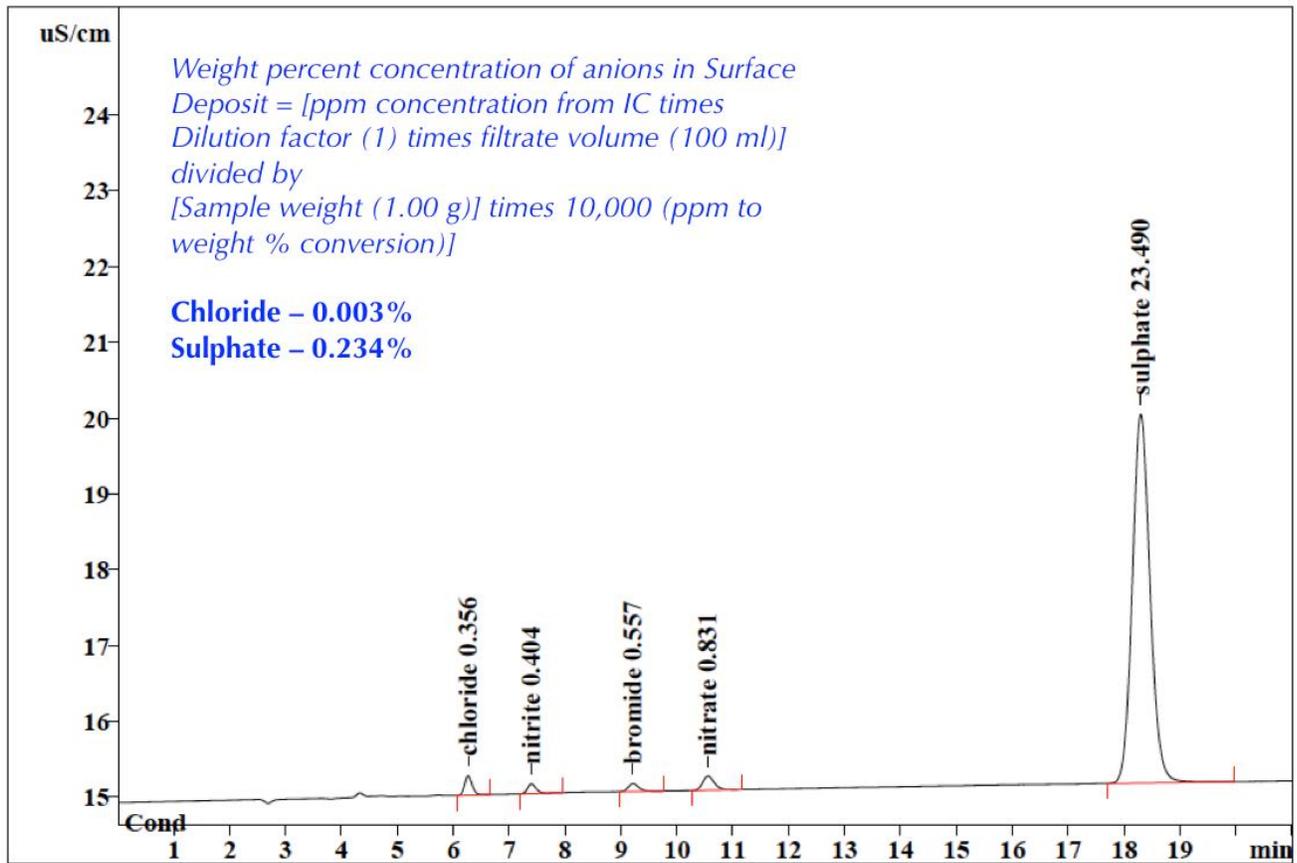
Figure 8 shows chromatogram of water-soluble salts in surface deposit after digesting a gram of pulverized deposit in distilled water for 30 minutes at a temperature below boiling, followed by continued digestion in water at the ambient laboratory condition for 24 hours. The filtrate was analyze by ion chromatography. Results showed 0.003% chloride and 0.234% sulphate with no major concentration of any potentially deleterious salts. Chloride result is typical of an indoor concrete containing negligible chloride, not exposed to chloride from the environment, and has no chloride-containing set accelerating admixture. Sulfate result is typical of surface deposit on a Portland cement concrete slab where sulfate was derived from cement sulfate after hydration and moisture migration through the slab.

Figure 8: Ion chromatogram of water-soluble filtrate of surface deposit showing chloride and sulfate typical of an indoor Portland cement concrete slab with no indication of any deleterious salts or contaminant.

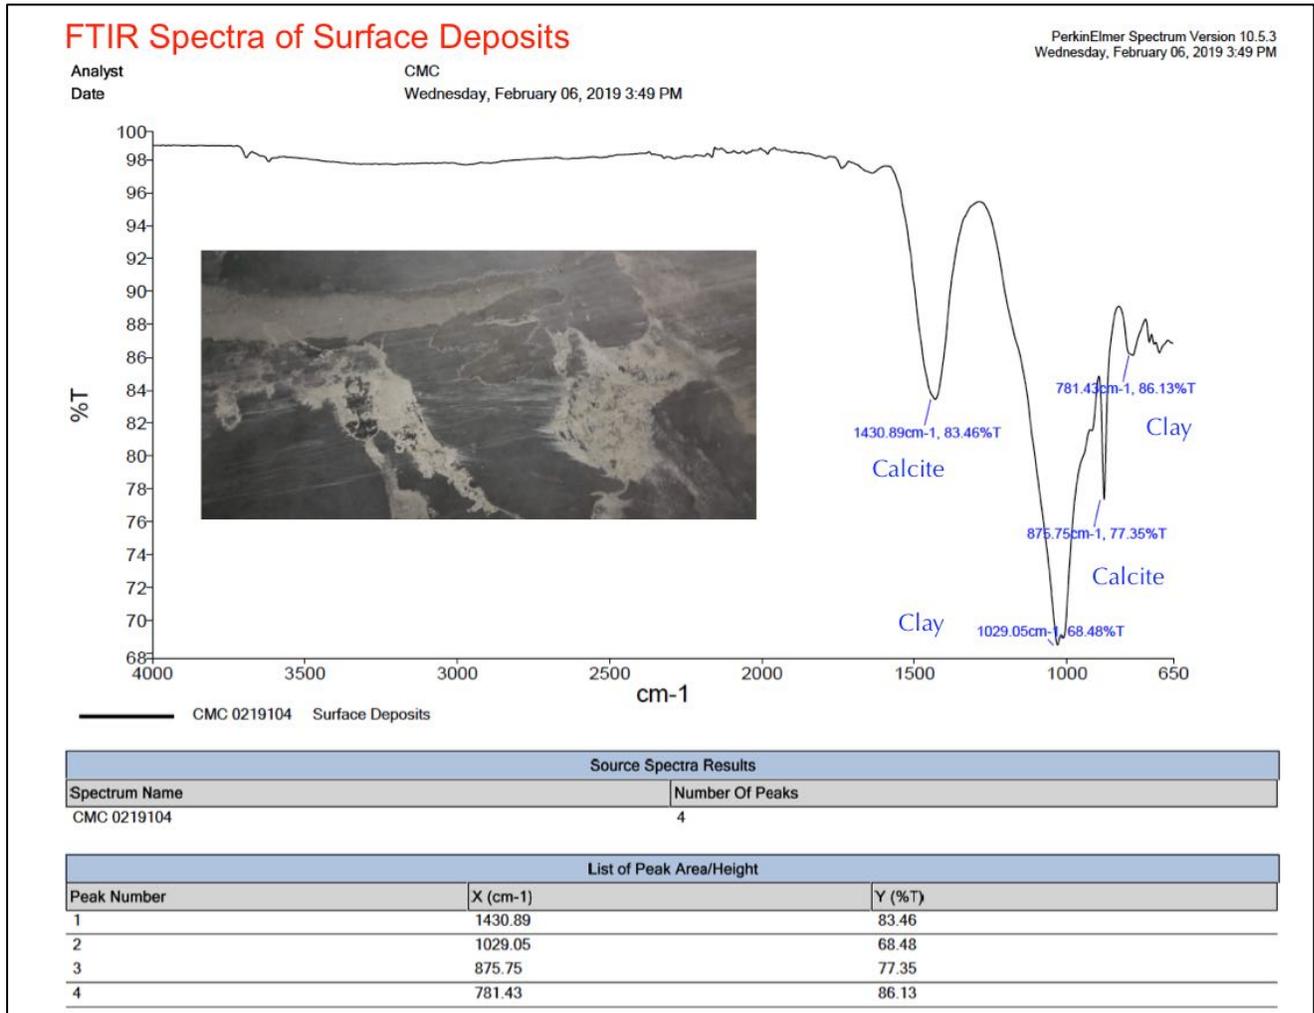
Figure 9 shows FTIR spectrum of surface deposit obtained from a Perkin Elmer FTIR spectrometer with an Universal ATR module where the powder as received was directly analyzed in the ATR module. Spectrum showed no detectable epoxy or acrylic as reported in surface treatments except calcite and clay from particulate (crystalline) matters on the surface, which were already diagnosed in XRD. Absence of organics indicate possible washing away of organics by sweeping action on the surface.

Figure 9: FTIR Spetrum of surface deposits showing calcite and clay but no detectable organics.

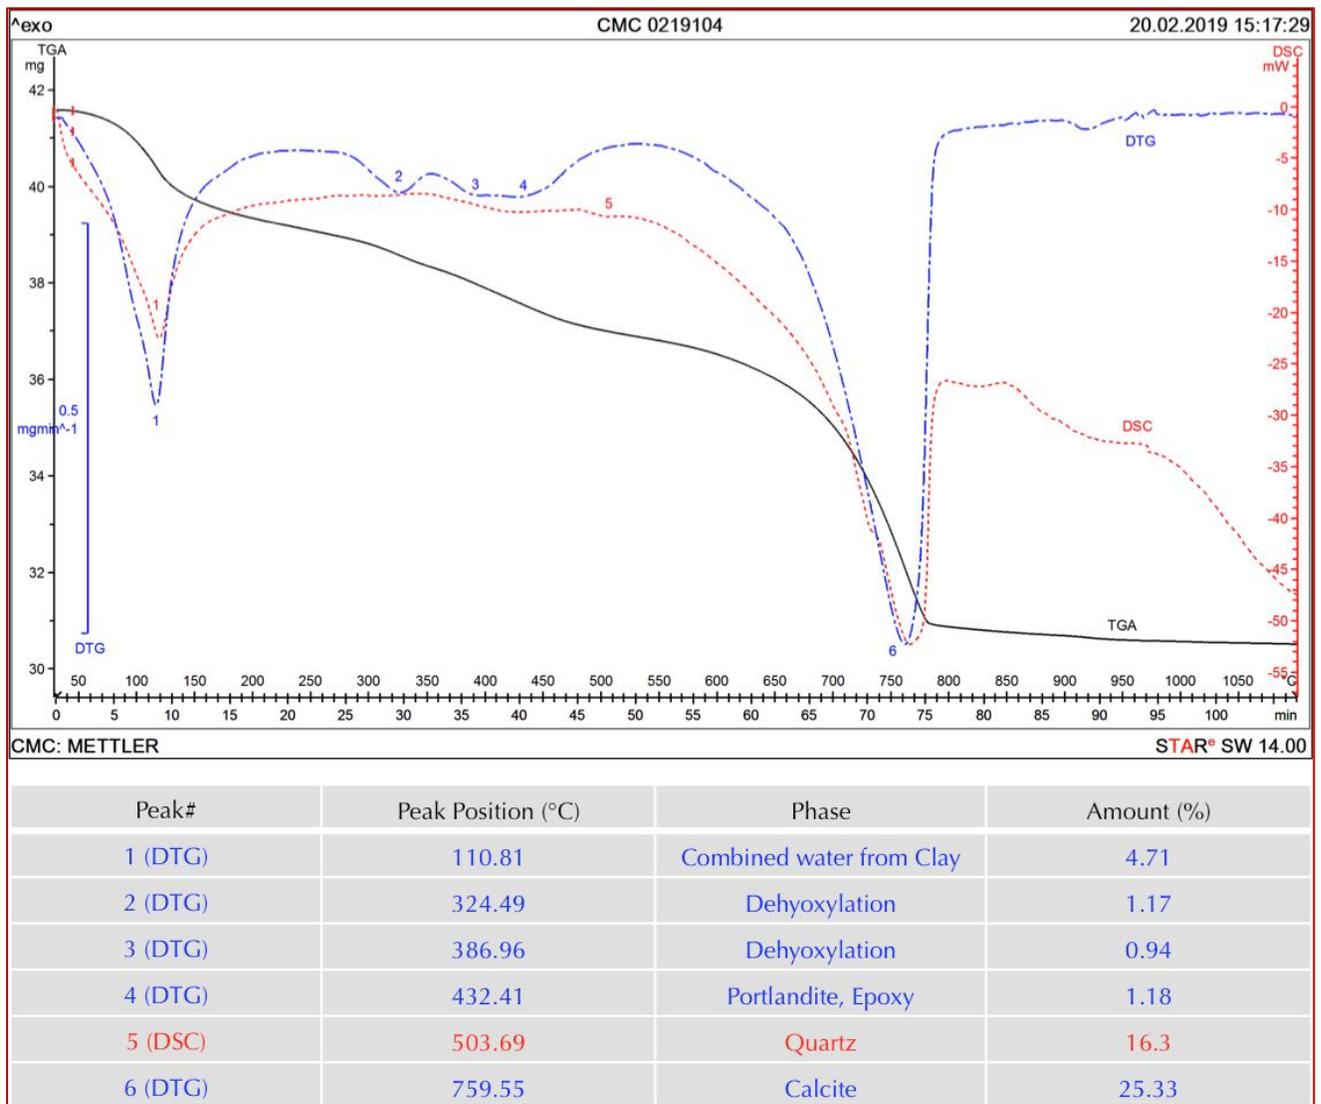
Figure 10 shows TGA (in bold black), DSC (in dotted red), and DTG (in dashed blue) curves of surface deposits showing losses in weight due to decompositions (loss of water and carbon dioxide) of various phases during controlled heating in a Mettler-Toledo's simultaneous TGA/DSC 1 unit from 30°C to 1000°C in a ceramic crucible (alumina 70µl, no lid) at a heating rate of 10°C/min in a nitrogen purge at a rate of 75 mL/min. Dehydration and decarbonation reactions are marked as endothermic peaks in the DTG curve, whereas alpha to beta-form polymorphic transition of quartz is marked at the characteristic temperature of 573°C in the DSC curve.

In the DTG curve, successive losses in weights are detected at Peaks 1, 2, 3, 4, and 6, of which the most pronounced peak is from dehydroxylation of clays at 110°C and decarbonation of carbonates at 759.5°C. DSC curve shows polymorphic transition from alpha to beta form of quartz at 503.7°C from silica (quartz) sand (Peak# 5). Quantitative estimates of quartz and calcite are determined to be 16.3 and 25.33 percent, respectively.

Figure 10: Thermal analysis of surface deposits.
