Petrographic Examinations and Chloride Analyses Of Concrete Cores For PRASA (Puerto Rico Aqueduct and Sewer Authority)

Puerto Rico Aqueduct and Sewer Authority (PRASA)
Guayama, PR 00784

EXECUTIVE SUMMARY

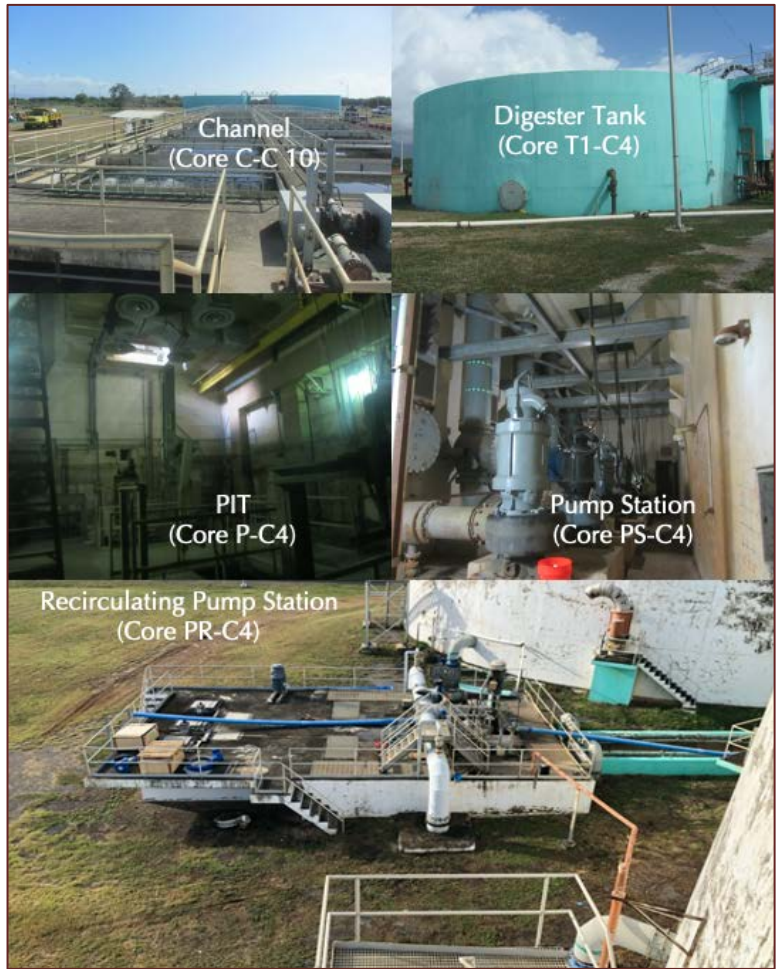
The subject wastewater treatment plant (WWTP) was reportedly built in early 80's. The channel structure has spalling due to rebar corrosion and concrete deterioration. A total of five cores were extracted, one per each structure. A total of six (6) structures/rooms are located near to the beach. The purpose of this investigation is to assess the status of the concrete in the structural elements to evaluate the concrete durability including the potential carbonation and/or chloride-induced corrosion of reinforcing steel in concrete. As part of complete remodeling of the WWTP the present investigation is done to determine which of the structures under investigation require repair, which are beyond repair, and which are sound. Spalling of concrete is reported in the channel beams. No spalling is observed at the walls where the cores were taken, but need to investigate the status of the concrete. WWTP is directly exposed to chemicals and corrosive environment due to wastewater processes and its proximity to the ocean.

Figure 1: Field photos of five structural elements of wastewater treatment plant from where five concrete cores for this study were reportedly retrieved. The core ID received for each structure is marked.

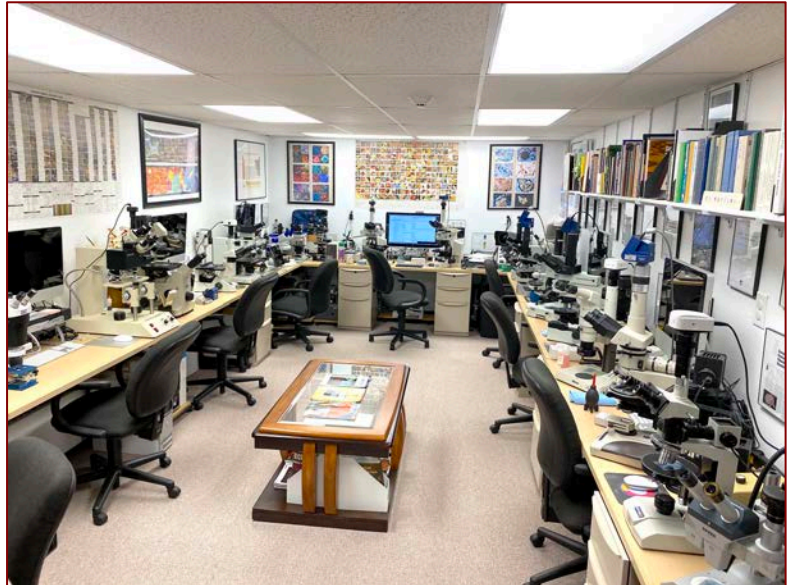
- viii. A Jenoptik Progres GRYPHAX camera attached to a Nikon Eclipse 600 POL petrographic microscope (equipped with reflected, transmitted, polarized and fluorescent-light facilities), a Jenoptik Progres C14 camera attached to an Olympus SZH reflected and transmitted-light stereomicroscope, and an OMAX digital camera attached to a Nikon SMZ-10A low-power stereomicroscope were used together for detailed optical microscopical examinations and associated digital photomicrography (Figure 2).

Figure 2: CMC's optical microscopy lab that houses microscopes used in this study.

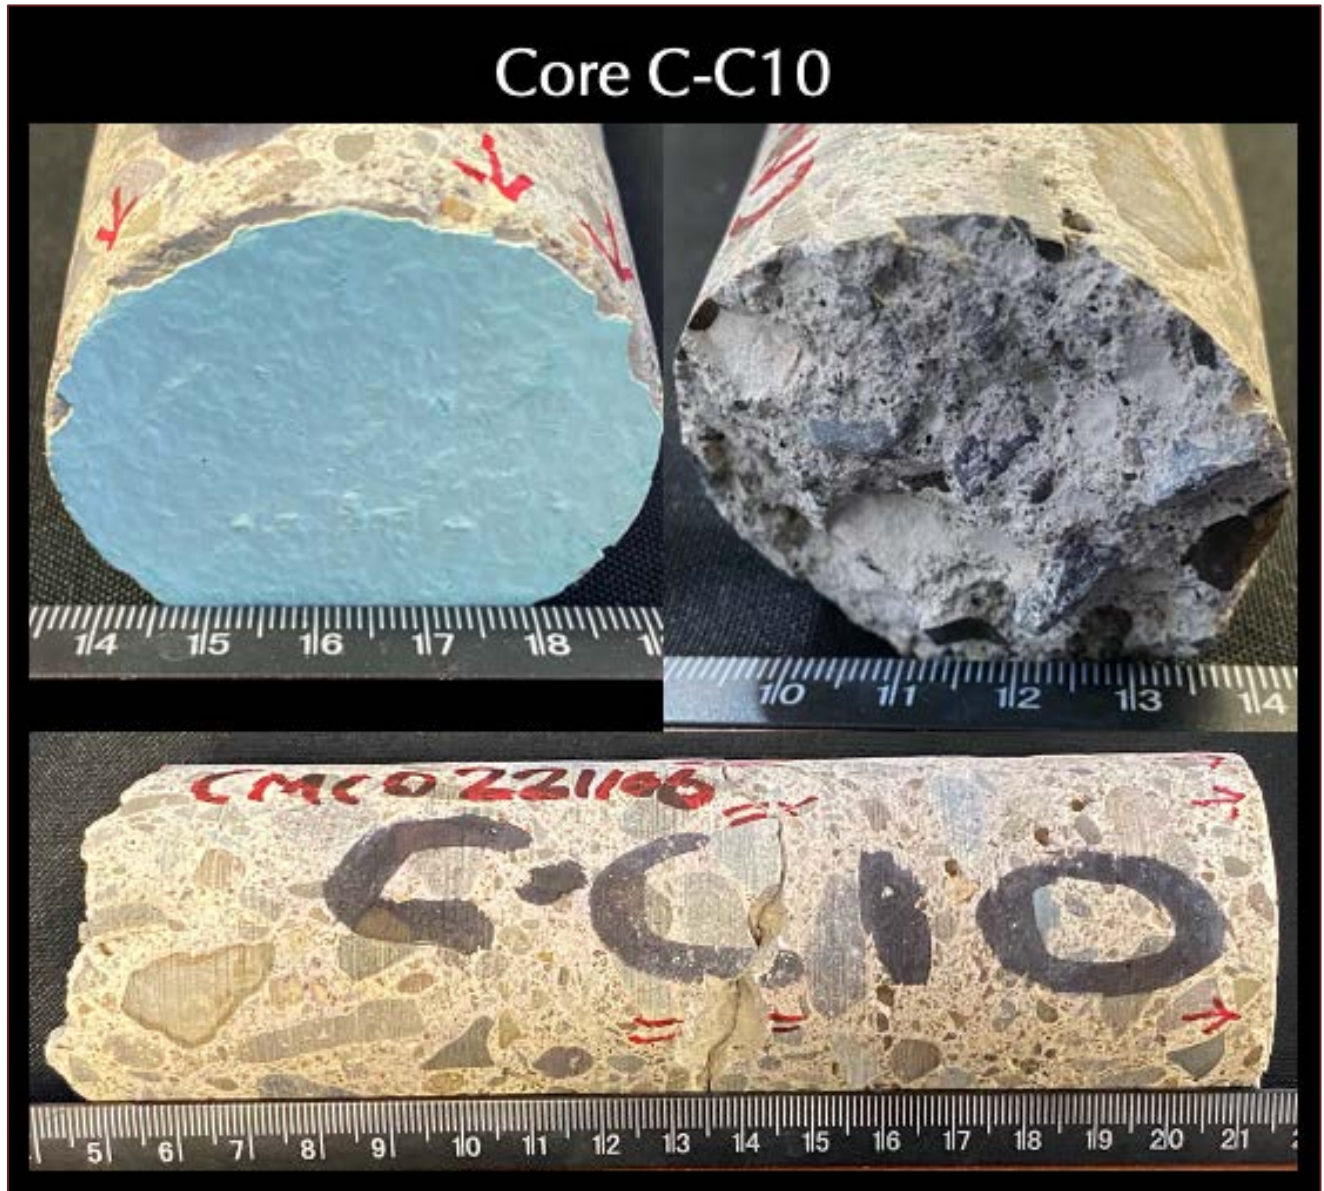
Core C-C10 was broken in the middle into two halves which probably occurred during the coring operations. Other four cores were received in intact crack-free conditions.

Figure 4: Shown are the exterior painted surface (top left), interior fractured end (top right) and side cylindrical surfaces of the Core C-C10 from Channel.

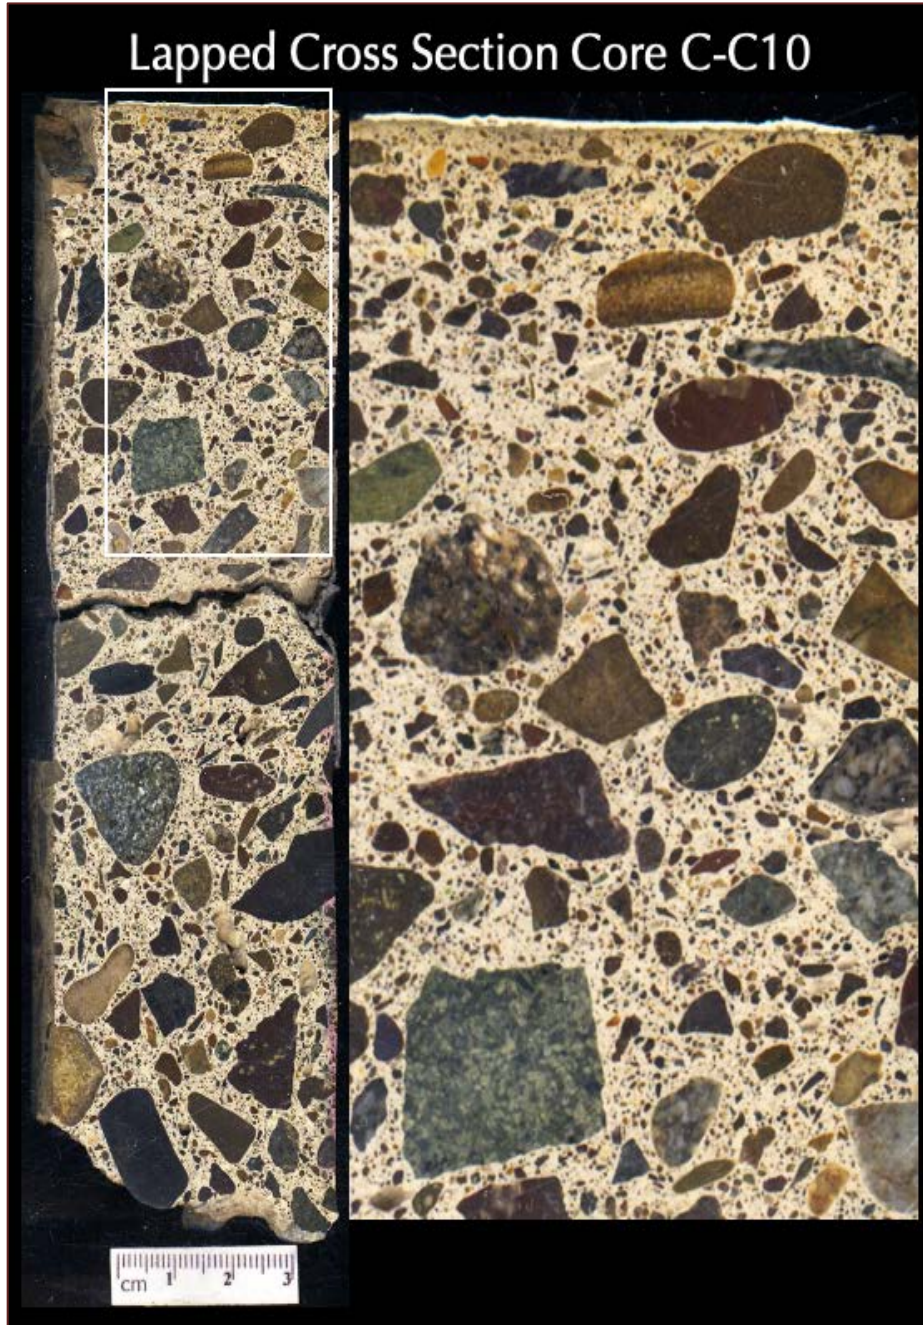
Figure 9: Lapped cross section of Core C-C10 showing:

- (a) A thin **paint coat** at the top well-bonded to the underlying concrete having a nominal thickness of < 1 mm;
- (b) The **main concrete body** containing crushed volcanic and volcaniclastic gravel coarse aggregate where aggregate particles are subrounded to subangular, dense, variably colored, well-graded, and well-distributed, natural siliceous sand and finer fractions of volcanic rocks and minerals in fine aggregate, all dispersed in a Portland cement paste; and,
- (c) The overall sound (visually crack-free), dense, well-consolidated nature of the concrete in the body.

The beige discoloration of paste at the top 15 mm beneath the protective coating is due to atmospheric carbonation of paste prior to the application of protective coating.

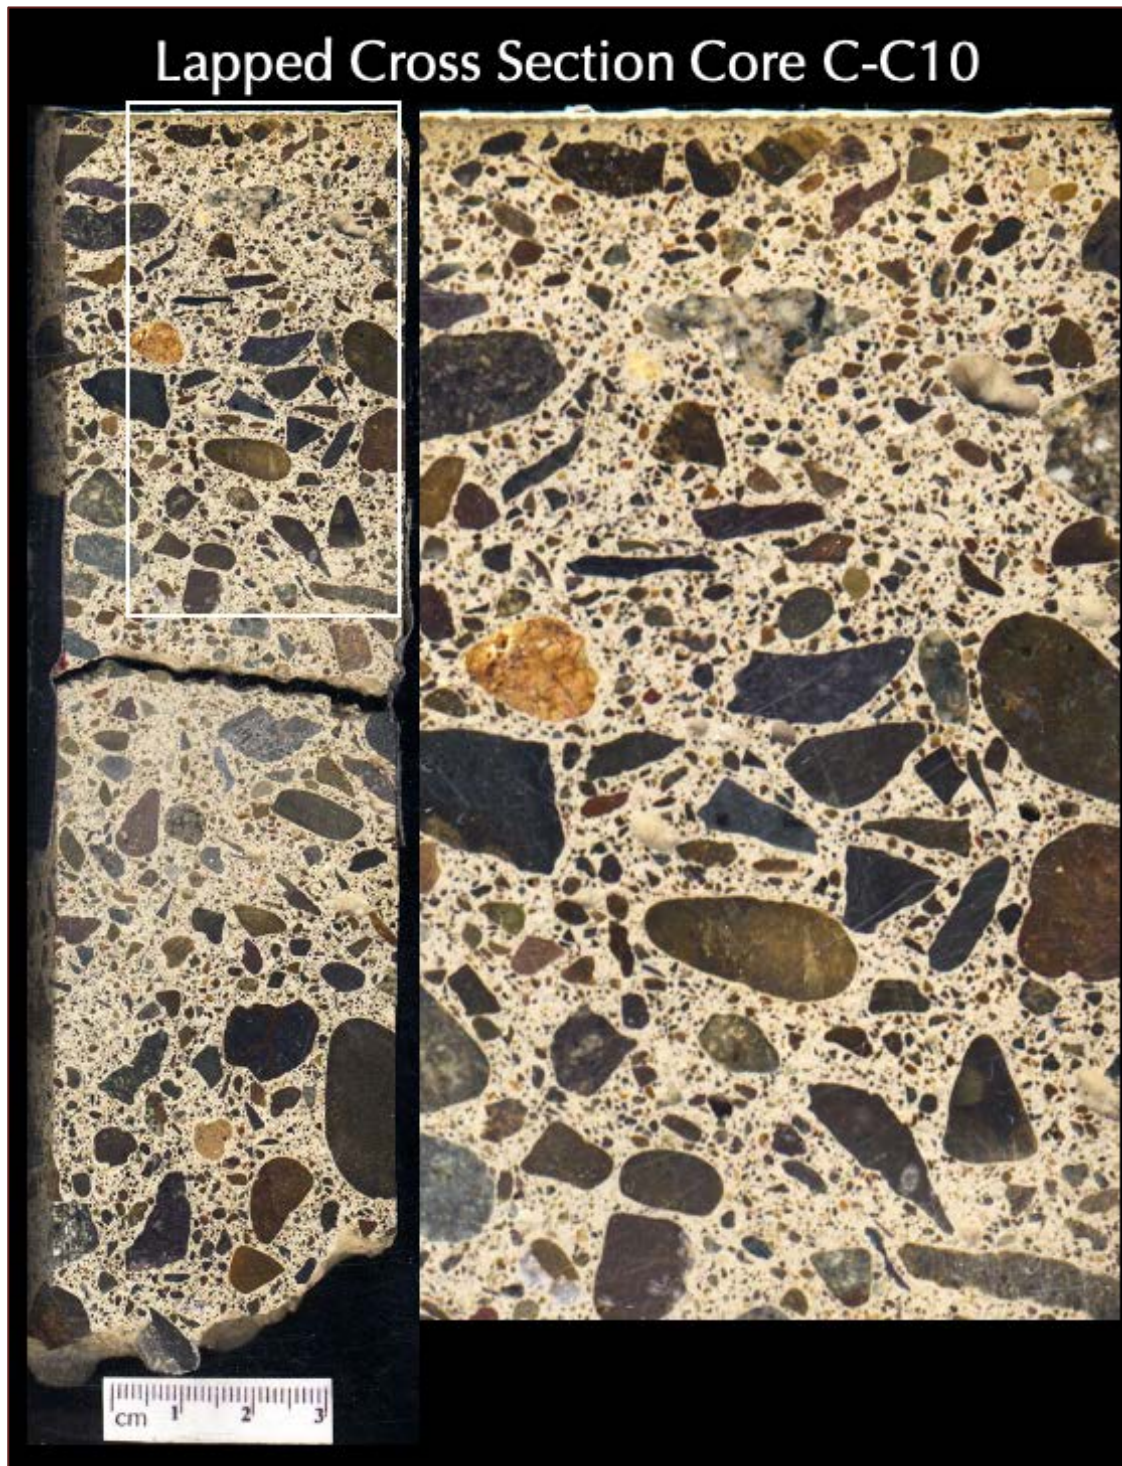
Figure 10: A second lapped cross section of Core C-C10 showing: (a) a thin paint coat at the top well-bonded to the underlying concrete having a nominal thickness of < 1 mm; (b) the main concrete body containing crushed volcanic and volcaniclastic gravel coarse aggregate where aggregate particles are subrounded to subangular, dense, variably colored, well-graded, and well-distributed, natural siliceous sand and finer fractions of volcanic rocks and minerals in fine aggregate, all dispersed in a Portland cement paste; and, (c) the overall sound (visually crack-free), dense, well-consolidated nature of the concrete in the body. The boxed area at left is enlarged at right. The beige discoloration of paste at the top 10 mm beneath the protective coating is due to atmospheric carbonation of paste prior to the application of protective coating.

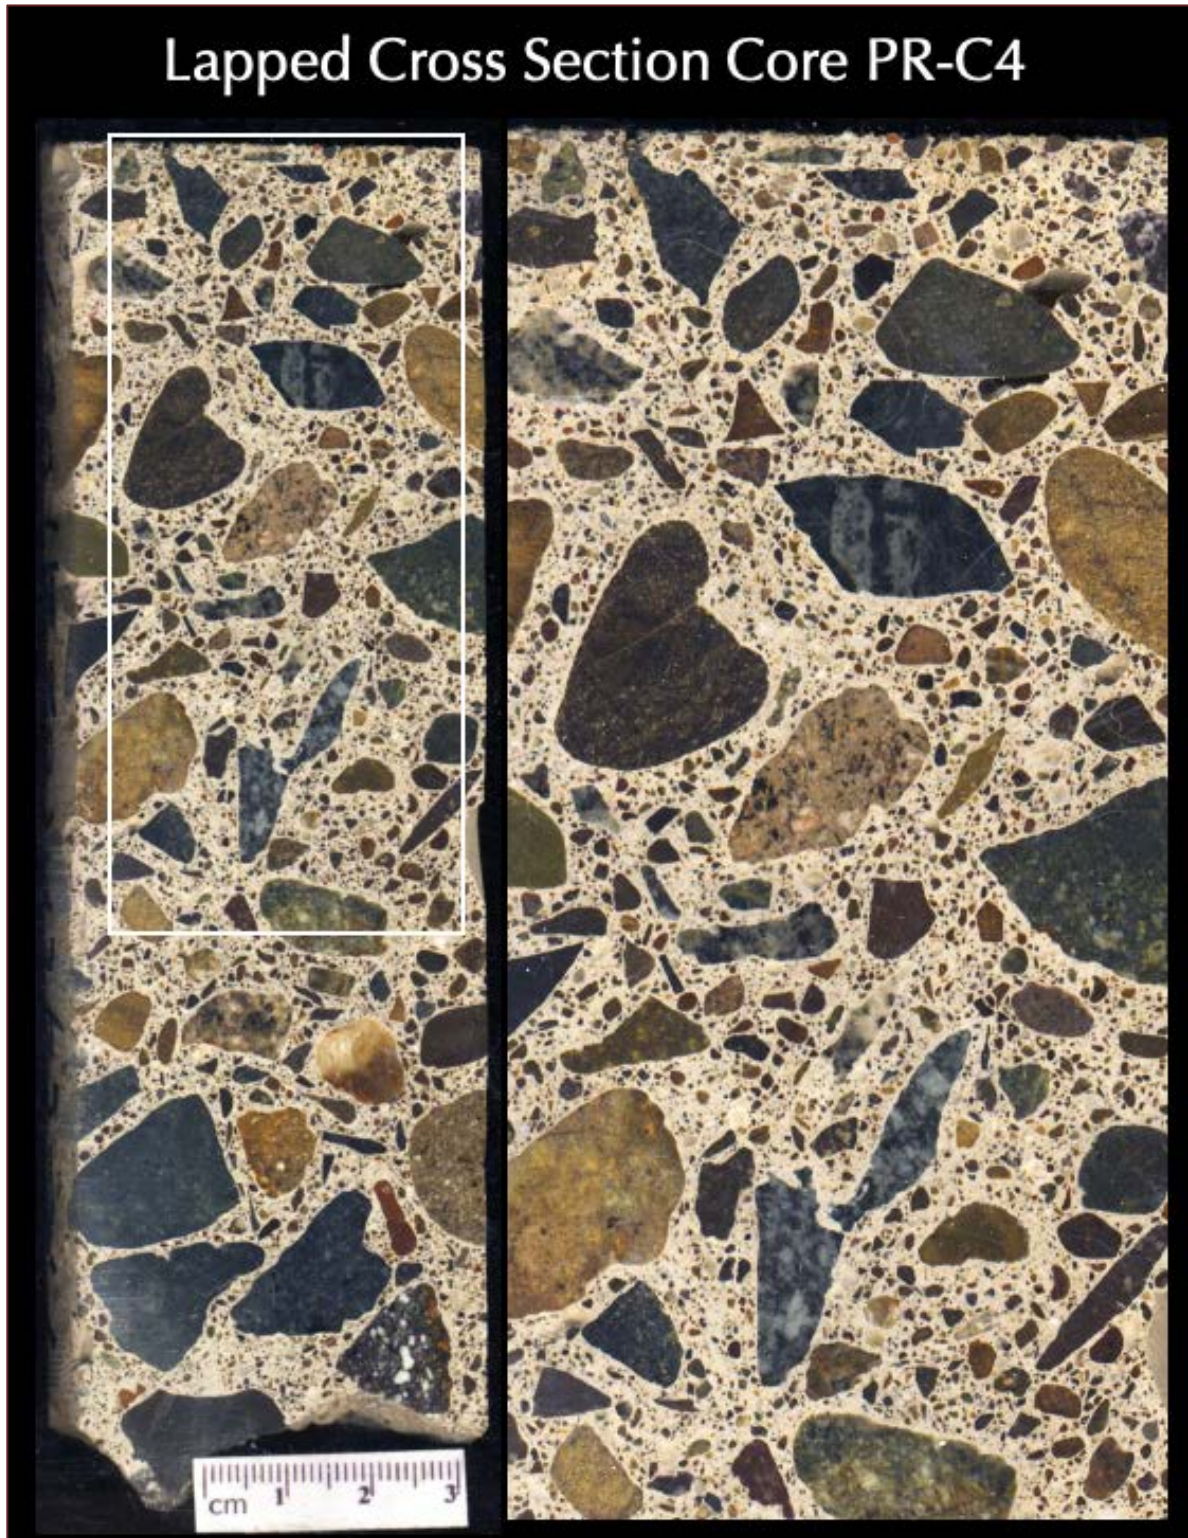
Figure 13: Lapped cross section of Core PR-C4 showing: (a) a thin paint coat at the top well-bonded to the underlying concrete having a nominal thickness of < 1 mm; (b) the main concrete body containing crushed volcanic and volcanoclastic gravel coarse aggregate where aggregate particles are subrounded to subangular, dense, variably colored, well-graded, and well-distributed, natural siliceous sand and finer fractions of volcanic rocks and minerals in fine aggregate, all dispersed in a Portland cement paste; and, (c) the overall sound (visually crack-free), dense, well-consolidated nature of the concrete in the body. The boxed area at left is enlarged at right.

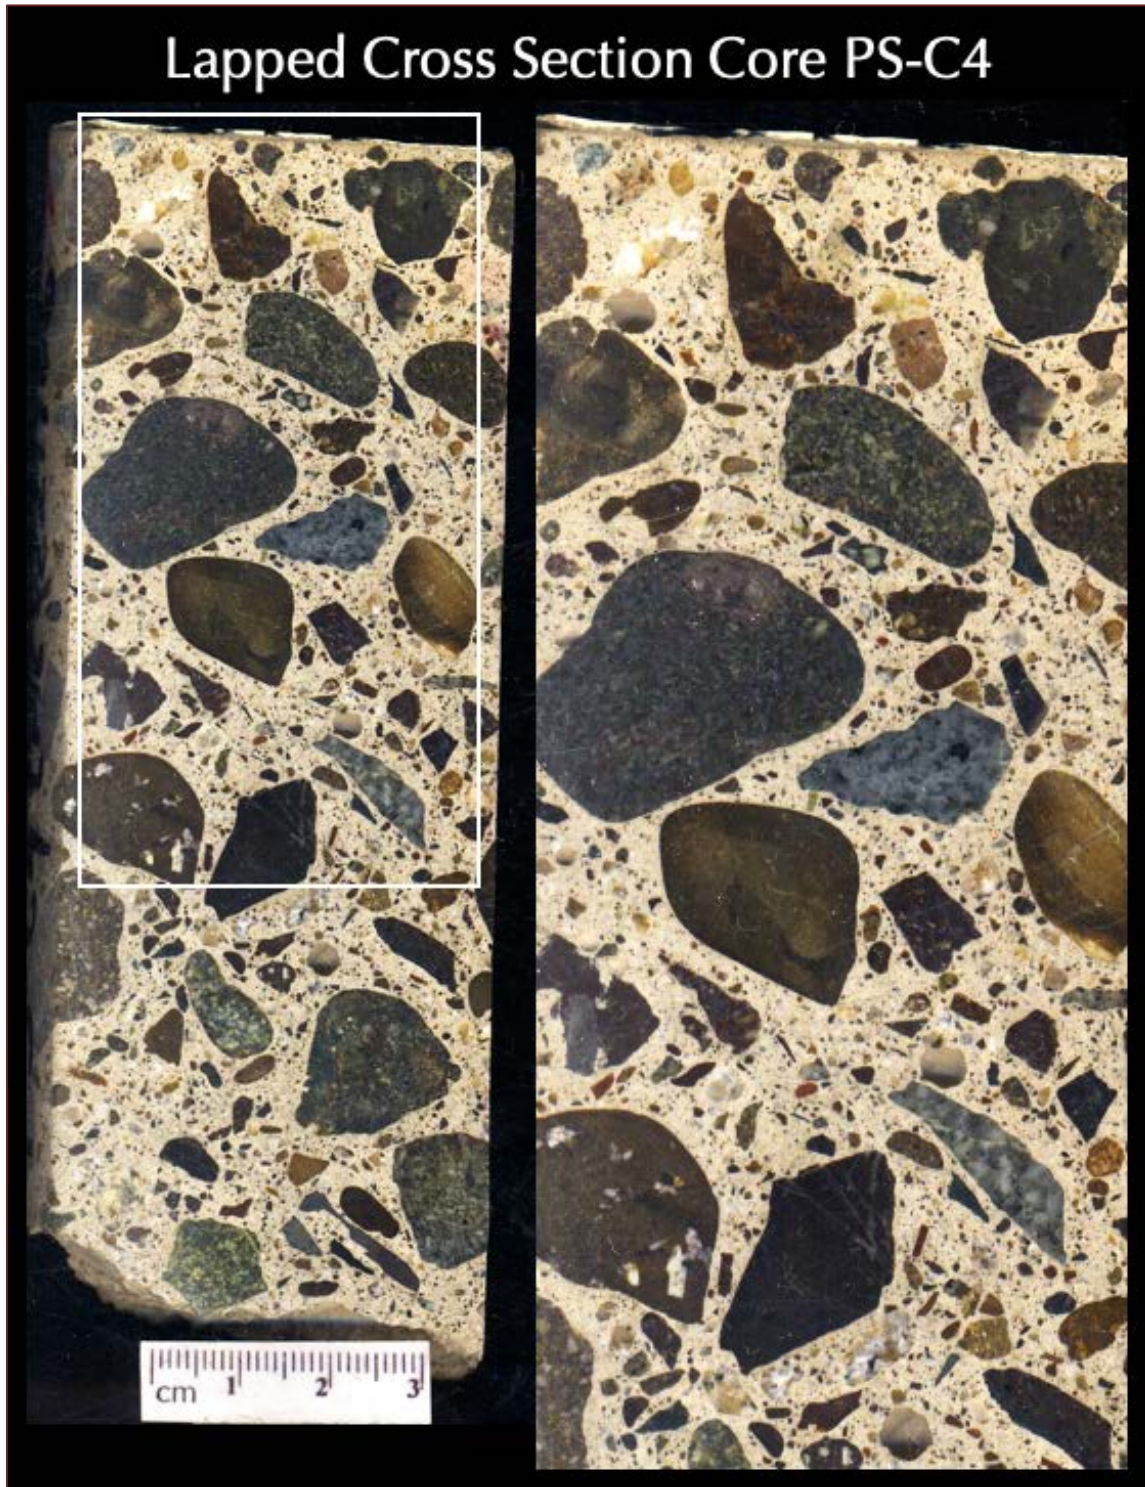
Figure 15: Lapped cross section of Core PS-C4 showing: (a) a thin paint coat at the top well-bonded to the underlying concrete having a nominal thickness of < 1 mm; (b) the main concrete body containing crushed volcanic and volcanoclastic gravel coarse aggregate where aggregate particles are subrounded to subangular, dense, variably colored, well-graded, and well-distributed, natural siliceous sand and finer fractions of volcanic rocks and minerals in fine aggregate, all dispersed in a Portland cement paste; and, (c) the overall sound (visually crack-free), dense, well-consolidated nature of the concrete in the body. The boxed area at left is enlarged at right.

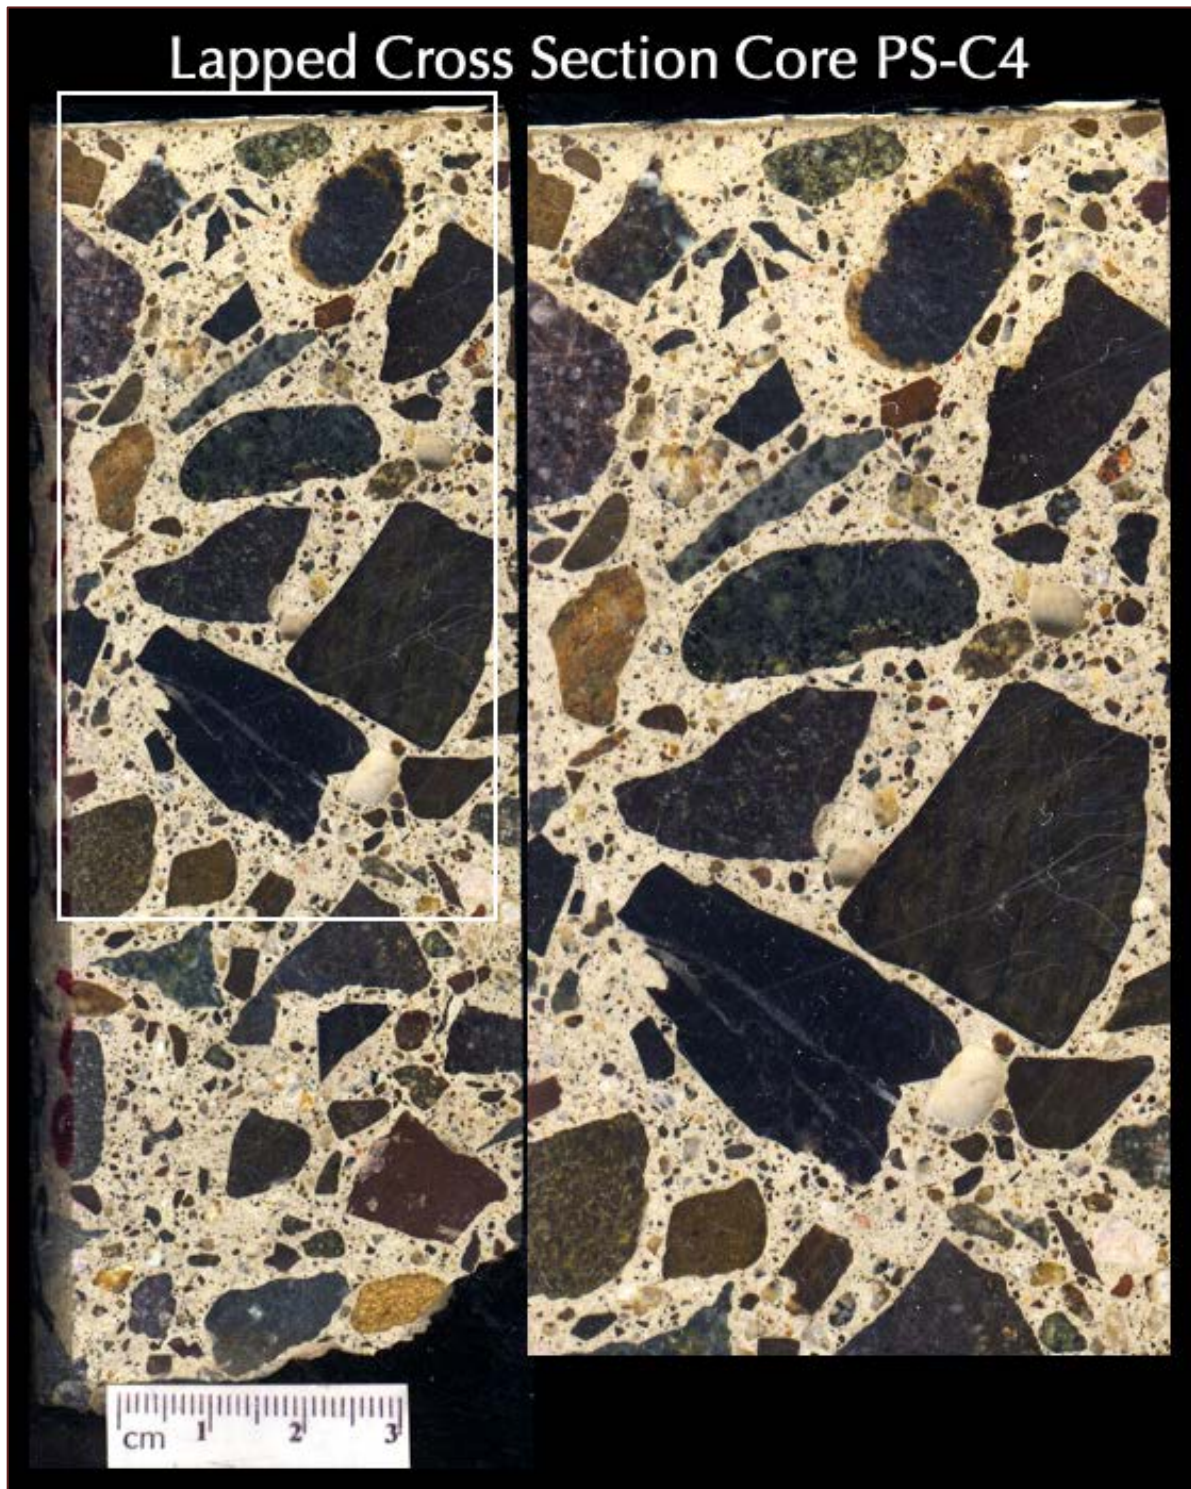
Figure 16: A second lapped cross section of Core PS-C4 showing: (a) a thin paint coat at the top well-bonded to the underlying concrete having a nominal thickness of < 1 mm; (b) the main concrete body containing crushed volcanic and volcaniclastic gravel coarse aggregate where aggregate particles are subrounded to subangular, dense, variably colored, well-graded, and well-distributed, natural siliceous sand and finer fractions of volcanic rocks and minerals in fine aggregate, all dispersed in a Portland cement paste; and, (c) the overall sound (visually crack-free), dense, well-consolidated nature of the concrete in the body. The boxed area at left is enlarged at right.

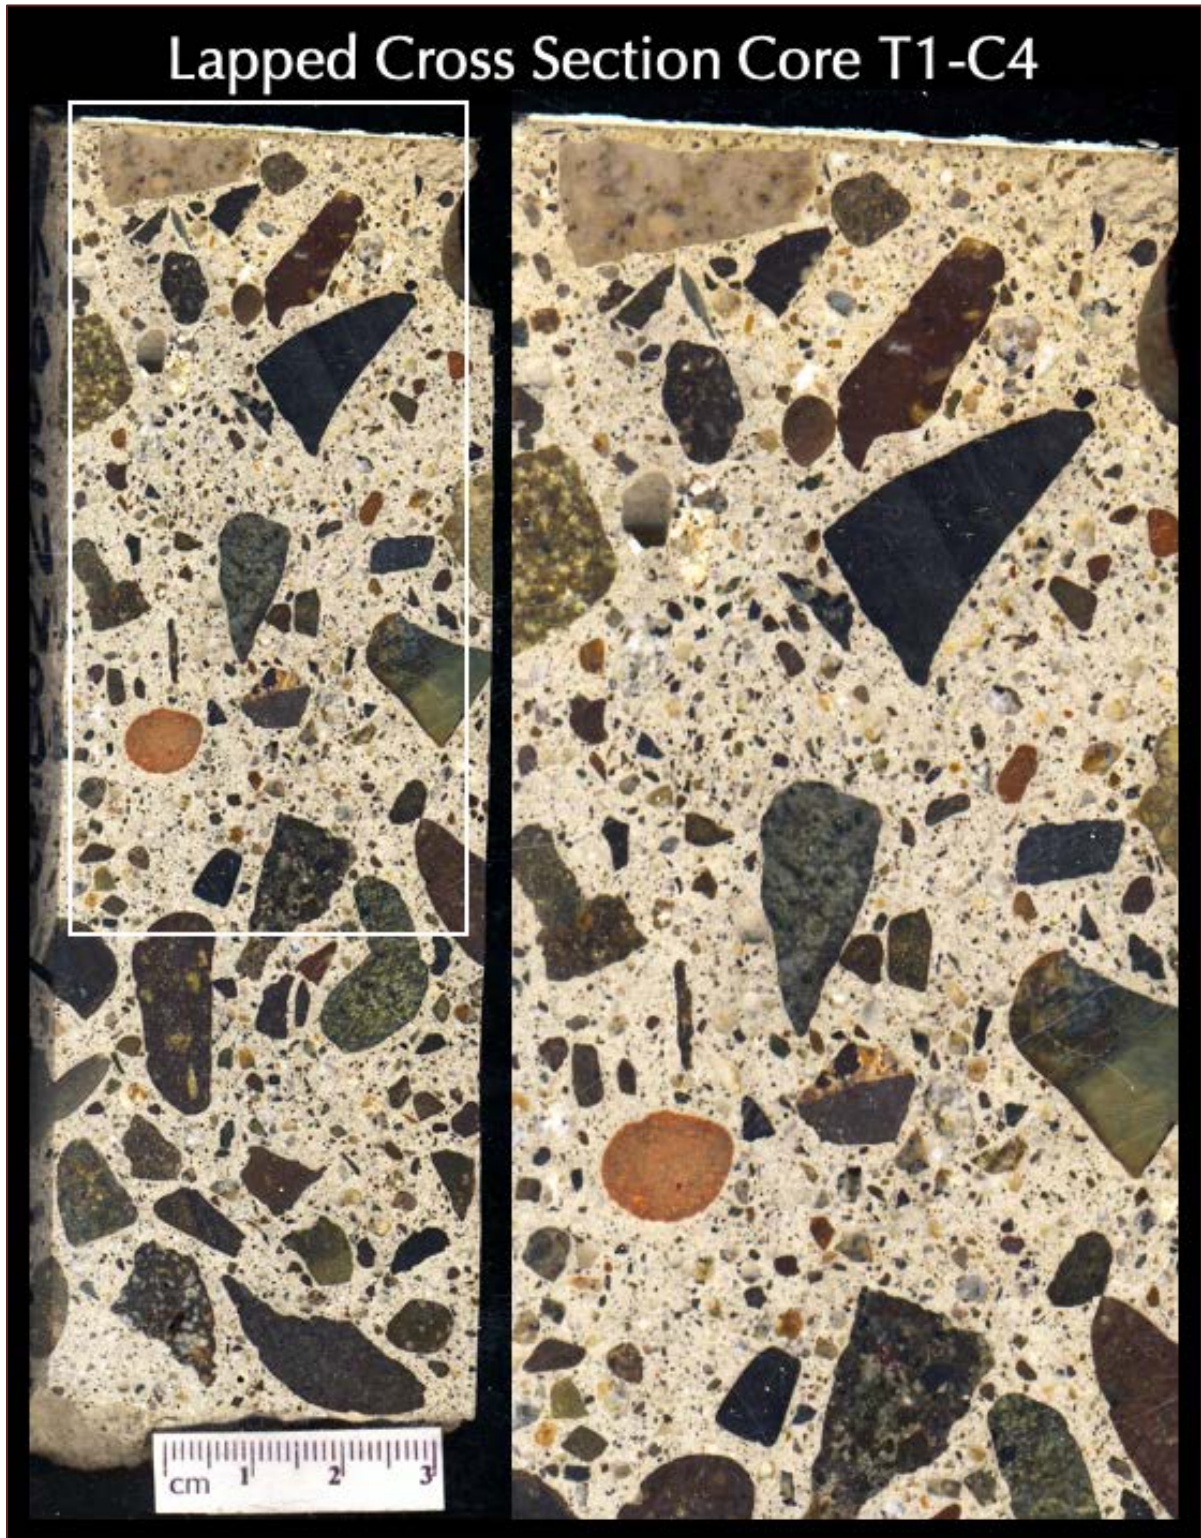
Figure 17: Lapped cross section of Core T1-C4 showing: (a) a thin paint coat at the top well-bonded to the underlying concrete having a nominal thickness of < 1 mm; (b) the main concrete body containing crushed volcanic and volcaniclastic gravel coarse aggregate where aggregate particles are subrounded to subangular, dense, variably colored, well-graded, and well-distributed, natural siliceous sand and finer fractions of volcanic rocks and minerals in fine aggregate, all dispersed in a Portland cement paste; and, (c) the overall sound (visually crack-free), dense, well-consolidated nature of the concrete in the body. The boxed area at left is enlarged at right.

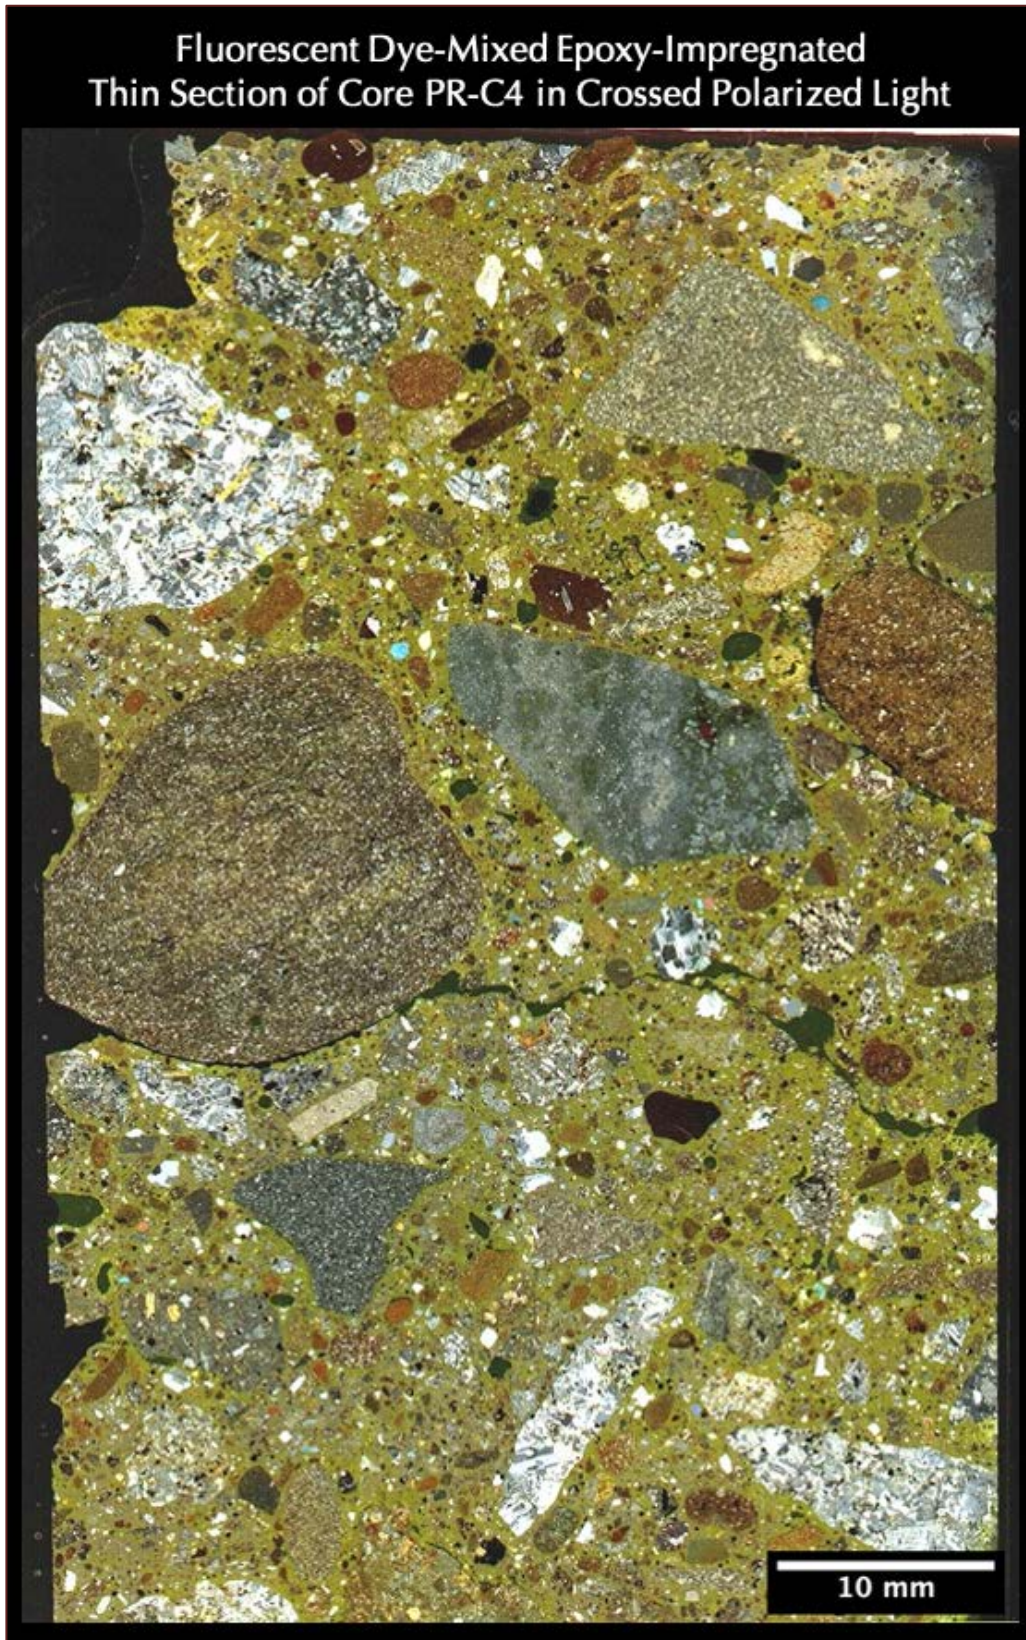
Figure 34: Fluorescent dye-mixed epoxy-impregnated thin section of Core PR-C4 seen in the crossed polarized light (XPL) mode by scanning the section in a film scanner sandwiched between two polarizing filters at perpendicular positions showing:

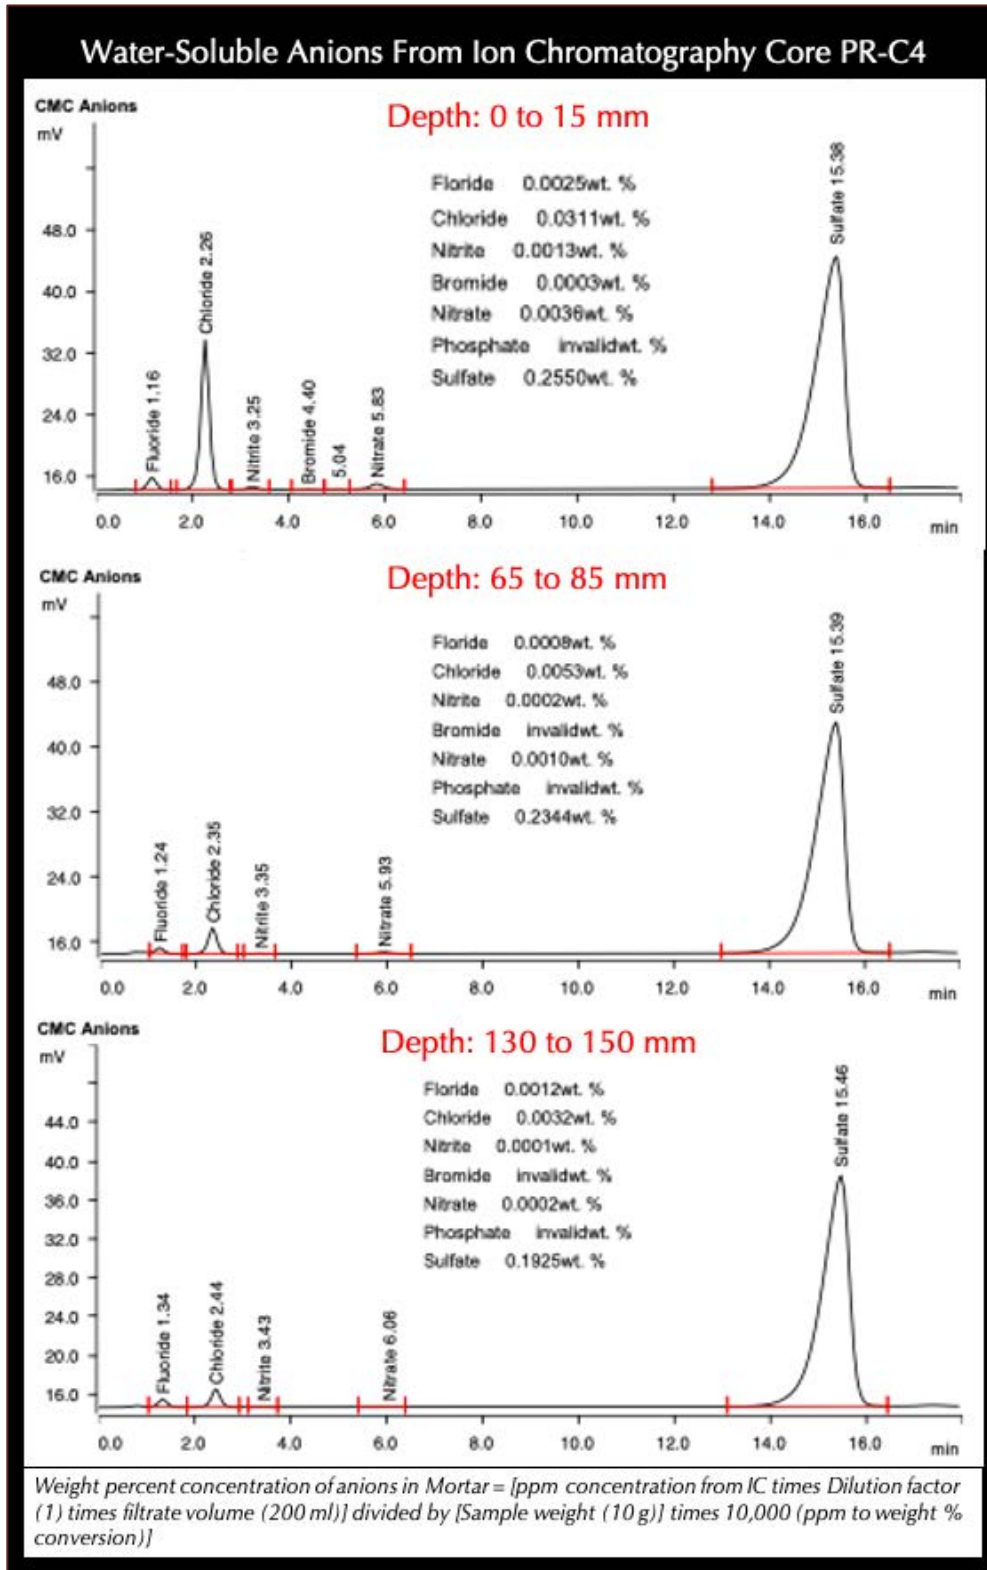
Figure 62: Ion chromatographs of water-soluble anions from the top, mid-depth, and bottom ends of Core PR-C4.

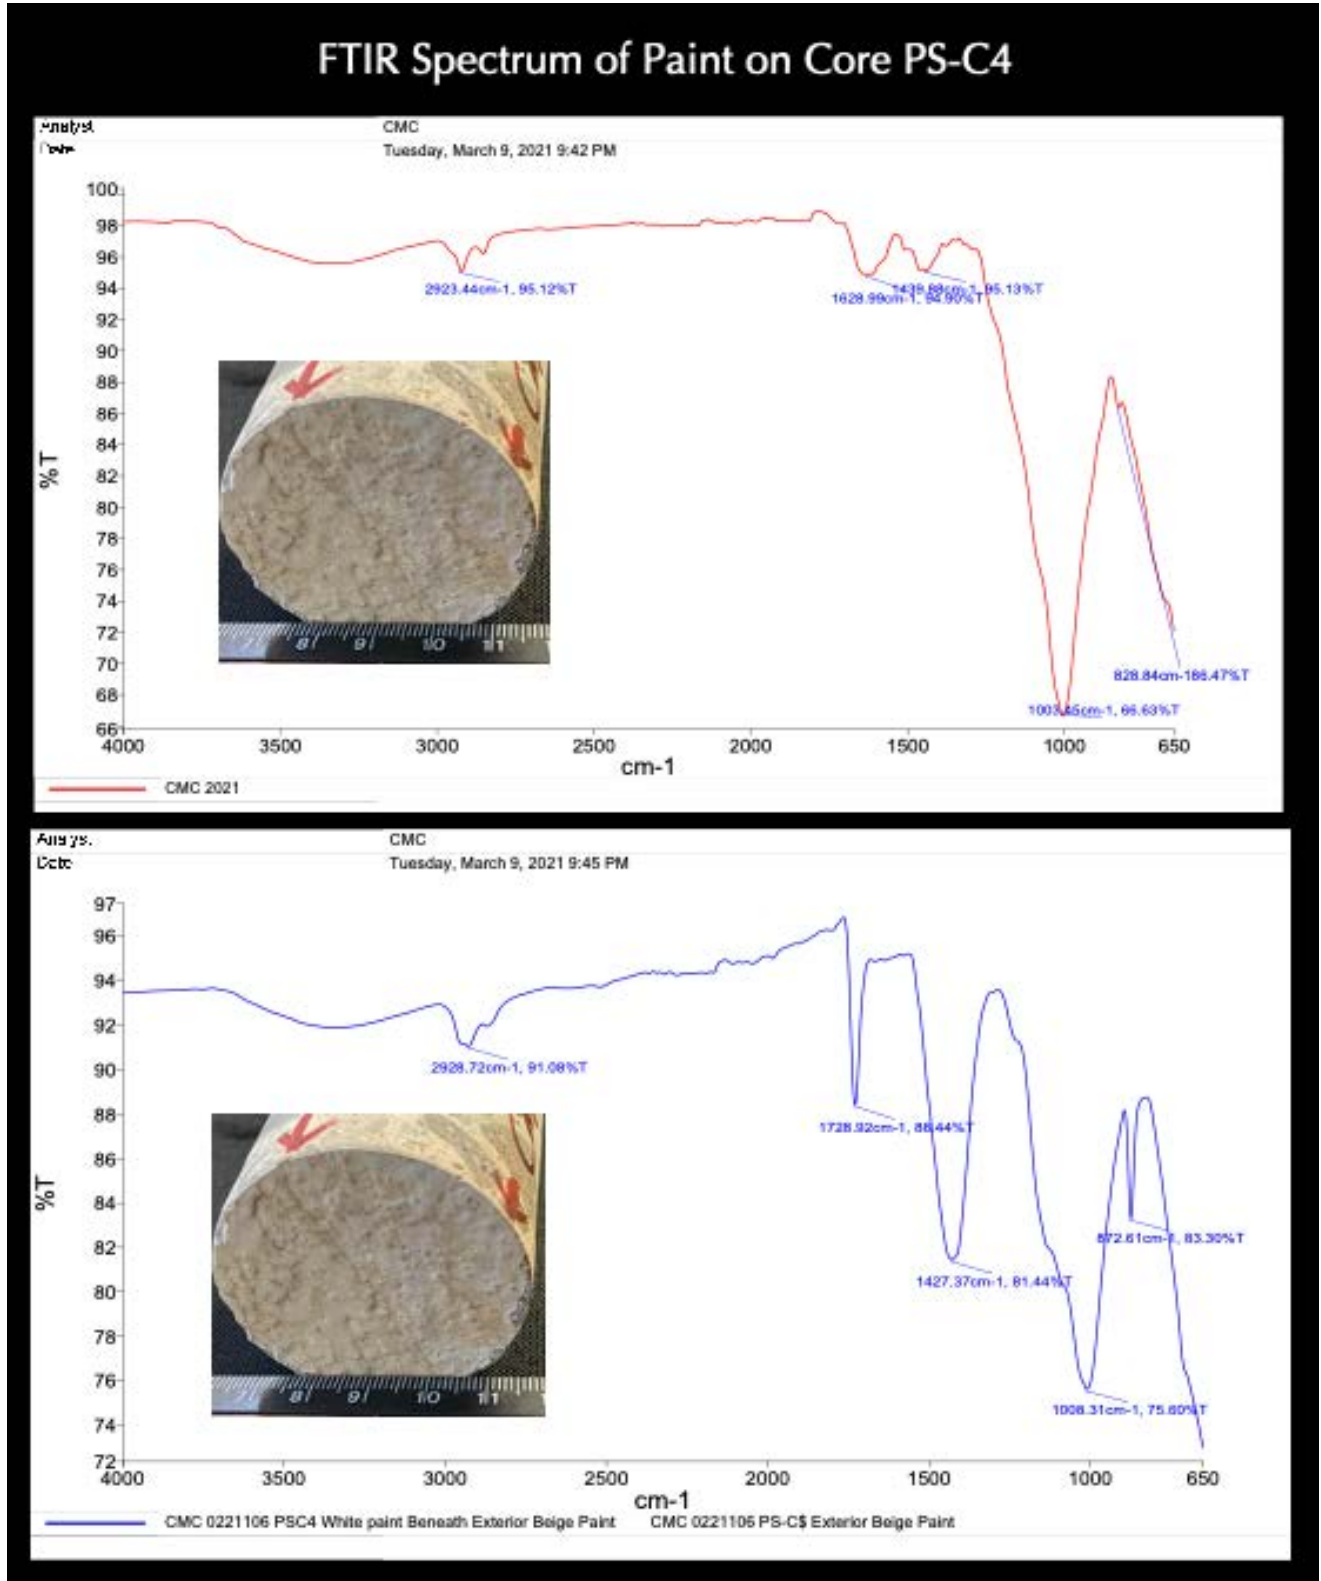
Figure 66: FTIR spectra of paint coats on Core PS-C4.
