Investigation of Pyrrhotite-Related Deterioration In Residential Concrete Foundations In Mansfield, Connecticut

Villages At Freedom Green Condominium Association, Inc.
1 Liberty Drive and 2 Fort Griswold
Mansfield, Connecticut

May 31, 2019
CMC 0419120

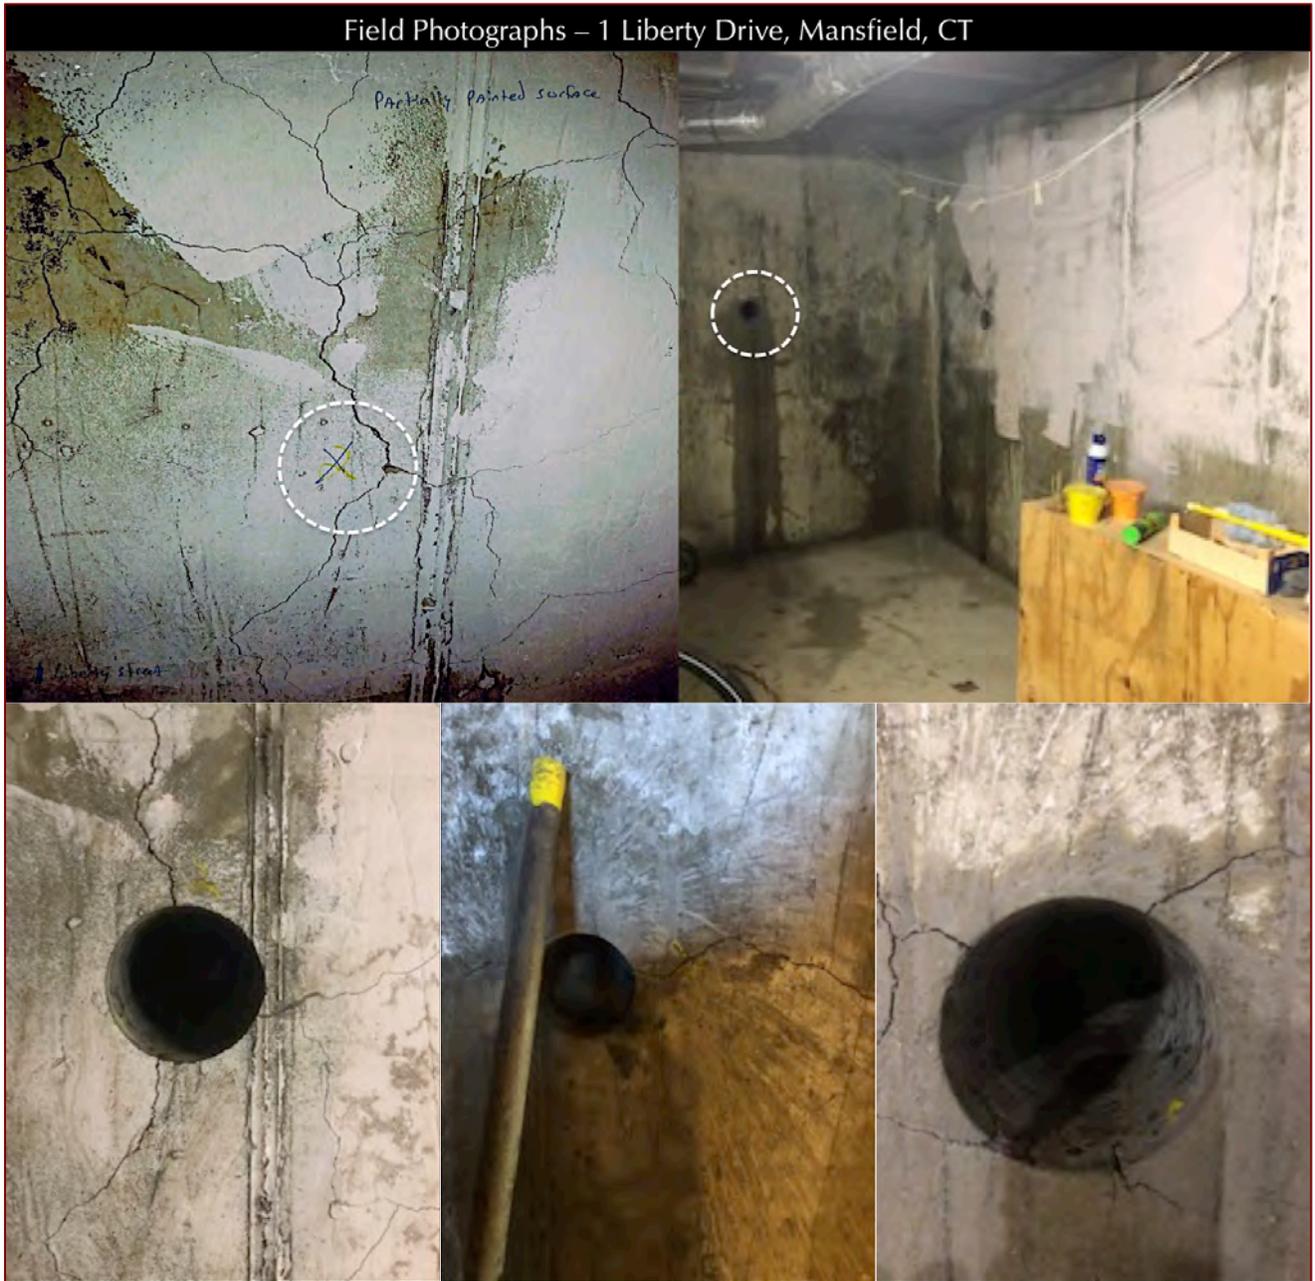
Figure 1 shows the visibly cracked foundation wall at 1 Liberty Drive where a network of closed polygonal-shaped cracks are seen. Also shown in Figure 1 is the location at the intersection of radial cracks from where the core for the present study was retrieved. The core was taken from a center position of the wall about halfway above the floor.

Figure 1: Field photographs of concrete foundation at 1 Liberty Drive showing extensive cracking of the foundation wall, overall closed polygonal-shaped pattern of many visible cracks, and location of the core for the present study retrieved from over visible radial cracks. Notice extension of the crack across the wall thickness at the core hole in the bottom photos, which is more clearly shown in the photos of the core when received in the laboratory.

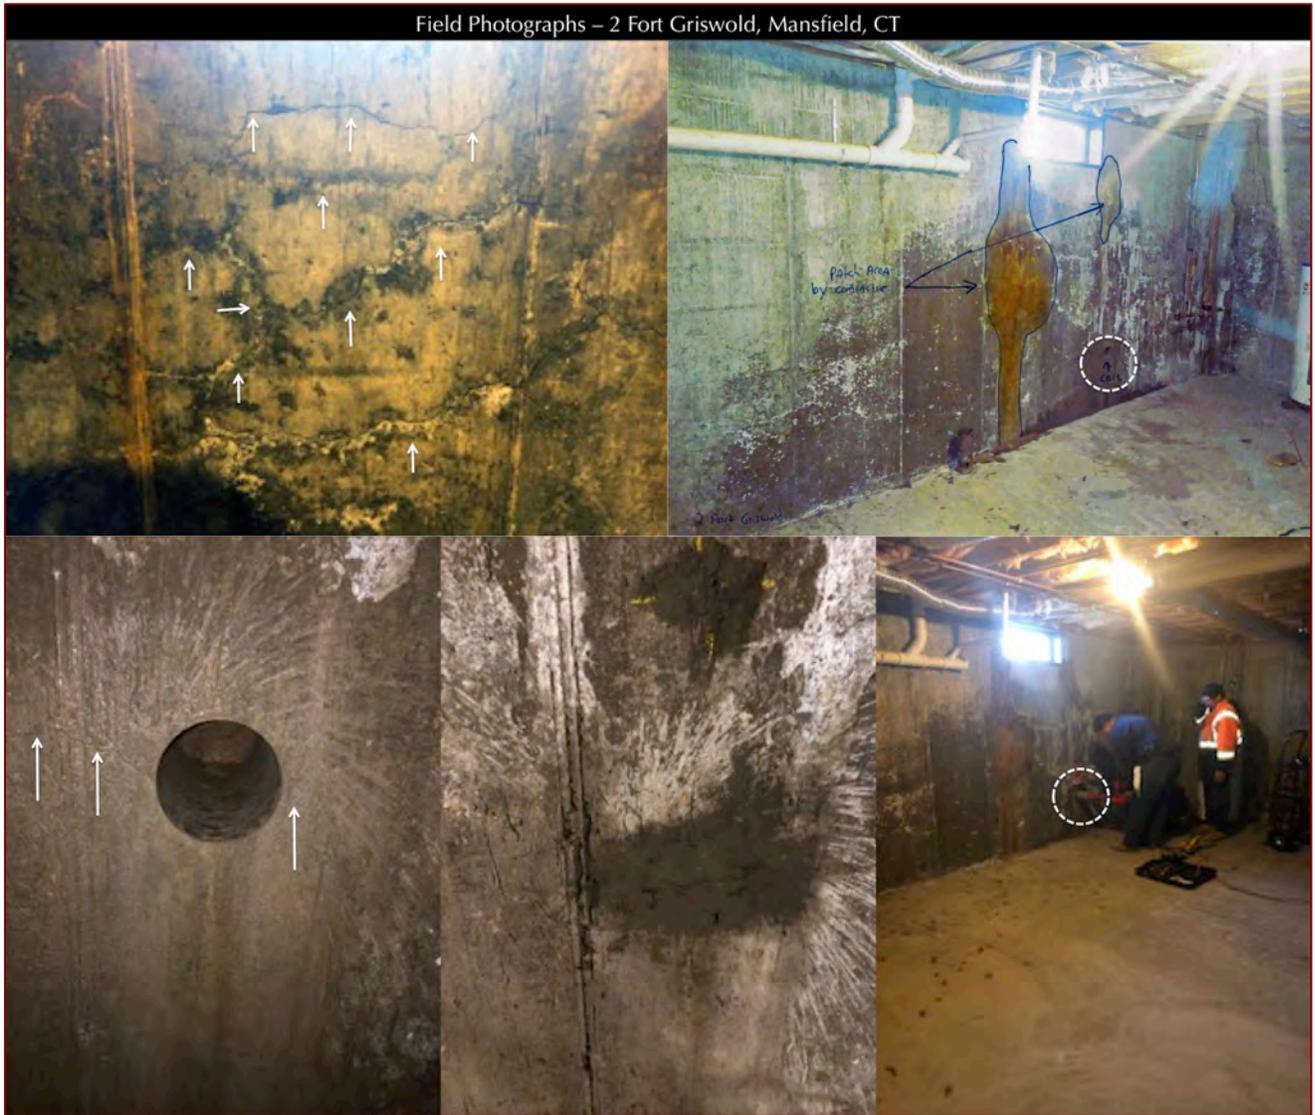
Figure 2 shows the visibly cracked foundation wall at 2 Fort Griswold where many parallel and intersecting cracks are seen as opposed to closed polygonal-shaped cracks found in the foundation wall at 1 Liberty Drive. Extent of cracking is reported to be more at the 1 Liberty Drive foundation than the 2 Fort Griswold foundation. Field photos in Figure 2 shows an area on the wall that has received repair patch. The core was taken from near the floor over a visible crack on the wall.

Figure 2: Field photographs of concrete foundation at 2 Fort Griswold showing extensive cracking of the foundation wall and location of the core for the present study retrieved from over a visible crack.

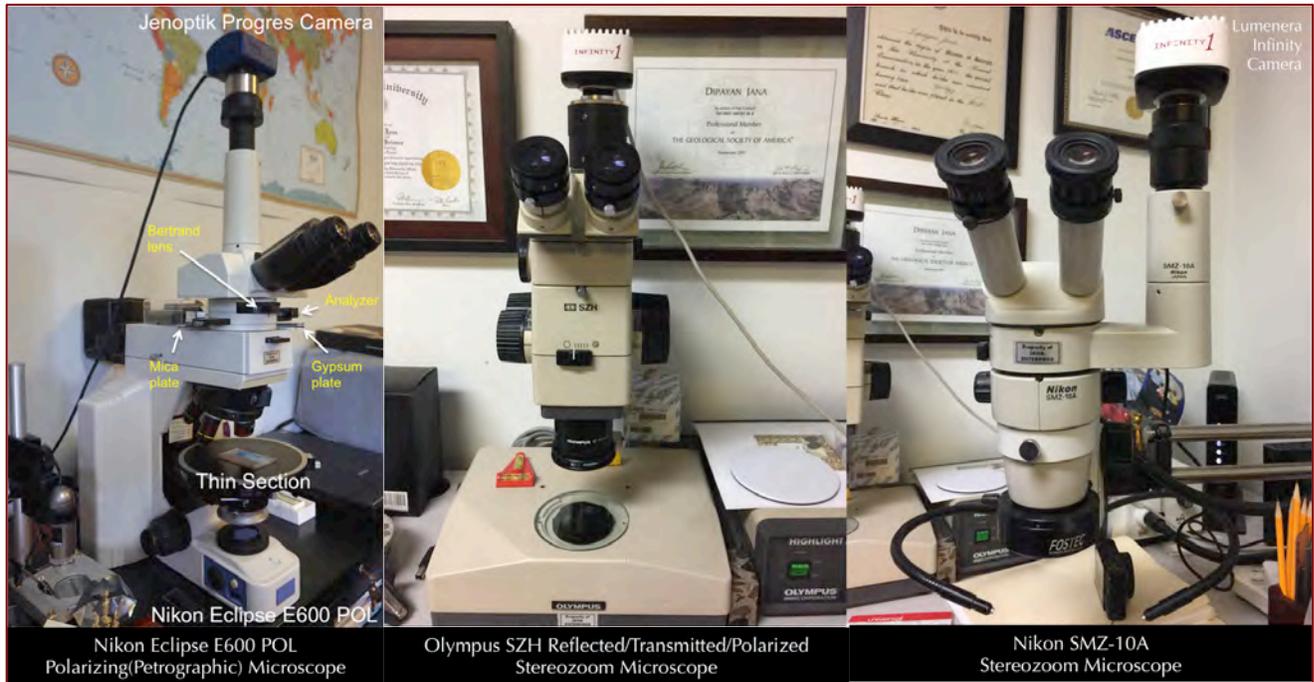
- xi. A Nikon Eclipse 600 POL petrographic microscope attached to a Jenoptik Progres GRYPHAX high-resolution digital camera were used for petrographic examinations and collecting photomicrographs of thin sections of concretes (Figure 3). A Nikon SMZ-10A stereomicroscope (Figure 3) and an Olympus SZH stereo zoom microscope (equipped with transmitted polarizing light facilities) were used for examinations of fresh fractured and lapped sections and transmitted-light examinations of thin sections, respectively.

Figure 3: Optical Microscopy: Left - A Nikon Eclipse E600 POL polarizing (petrographic) microscope at left with reflected, transmitted, polarized-light, and fluorescent-light capabilities; Middle – An Olympus SZH reflected/transmitted/polarized-light Stereozoom microscope; and Right – A Nikon SMZ-10A Stereozoom microscope. All microscopes are equipped with Jenoptik Gryphax and Lumenera Infinity digital cameras.

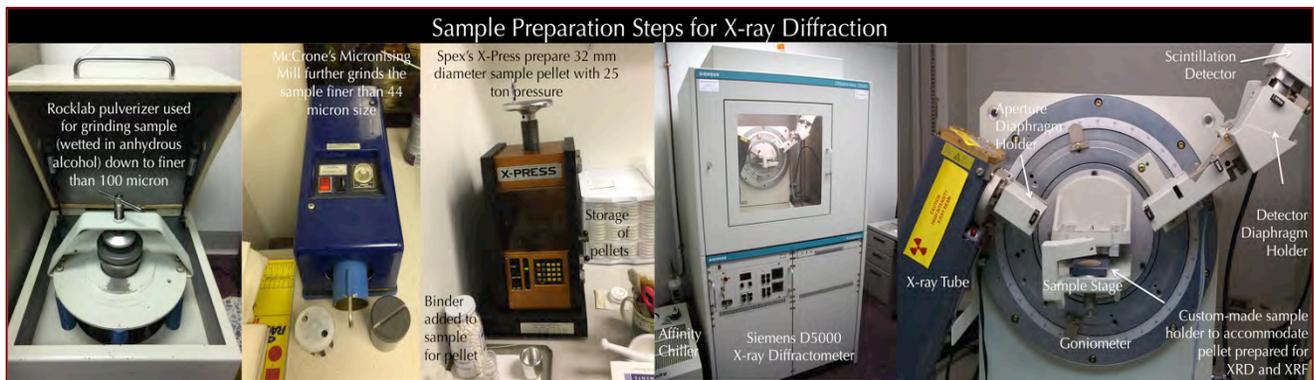
Figure 4: XRD: Siemens D5000 X-ray diffractometer and MDI Jade search/match software used for determination of mineralogical compositions of extracted concrete aggregates. Left to right: Rocklab pulverizer for initial grinding of aggregate with anhydrous alcohol; McCrone micronizing mill for final grinding; Spex 25-ton press for pellet preparation; Siemens D5000 X-ray diffractometer; and custom-made sample holder to place a 32-mm diameter pellet on sample stage.

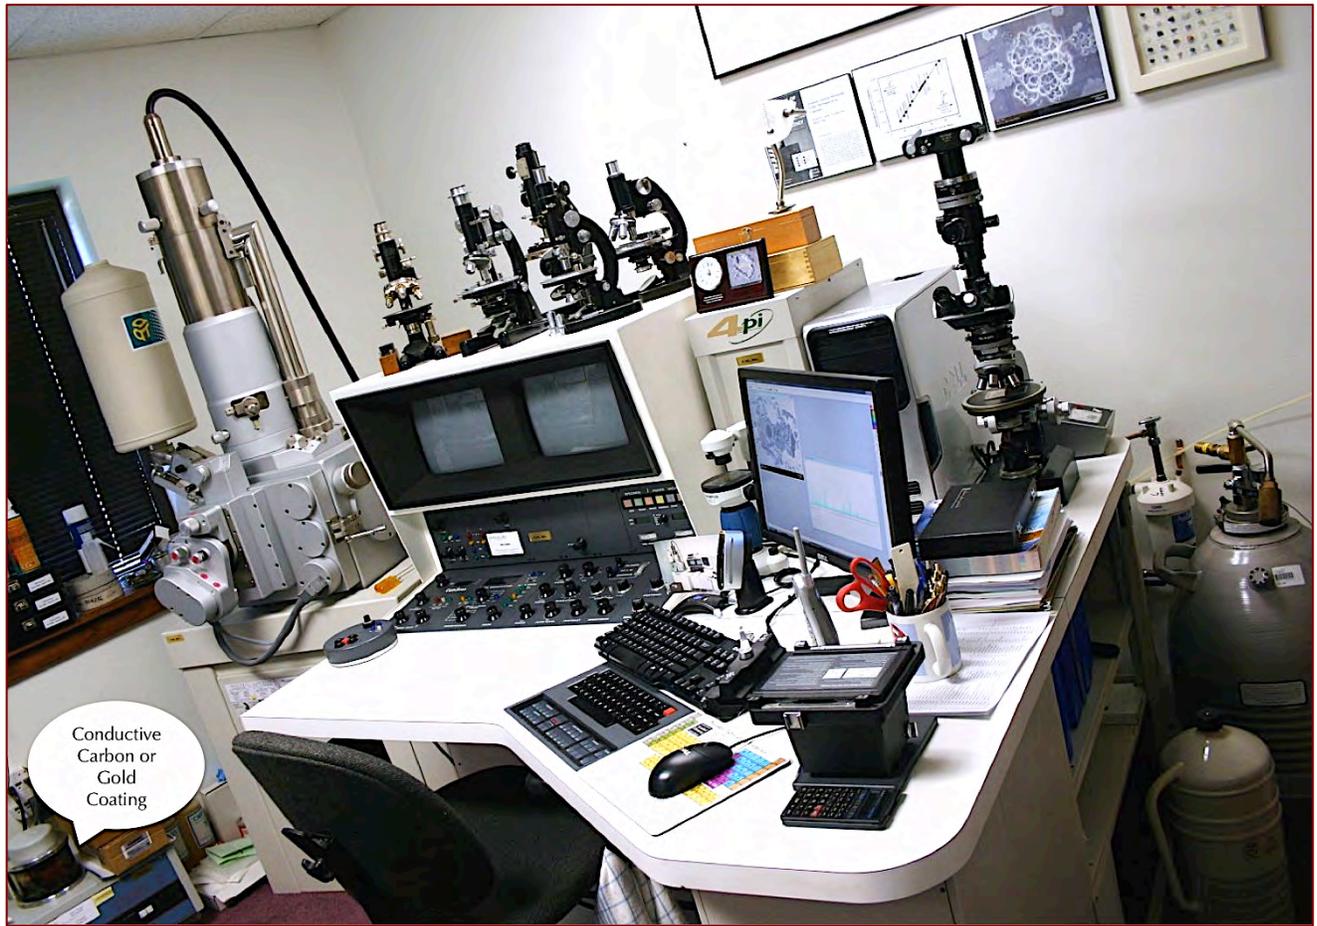
Figure 5: SEM-EDS: Cambridge CamScan Series II Scanning Electron Microscope and 4Pi Revolution software, backscatter detector, secondary electron detector, and energy-dispersive X-ray fluorescence spectrometer used for microstructural and microchemical analyses of concretes and aggregates.

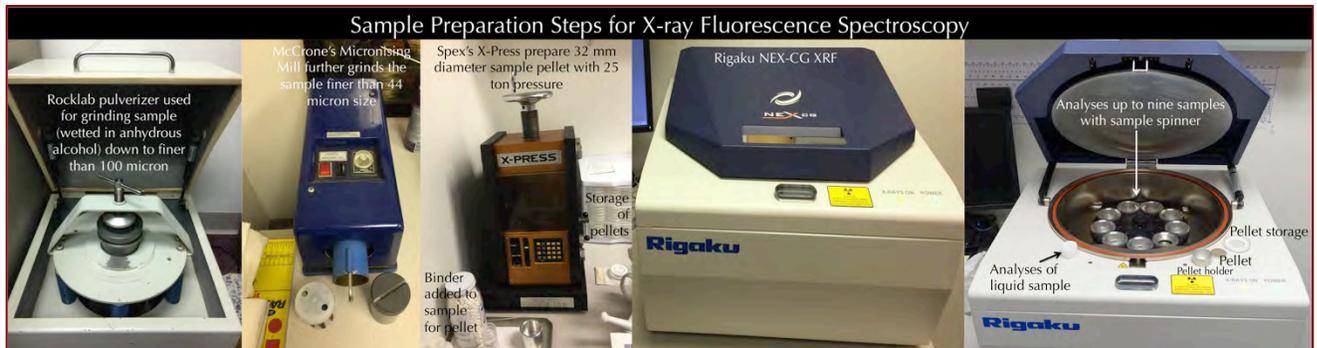
Figure 6: XRF: Rigaku NEX-CG bench-top ED-XRF unit used for bulk chemical compositions of aggregates.

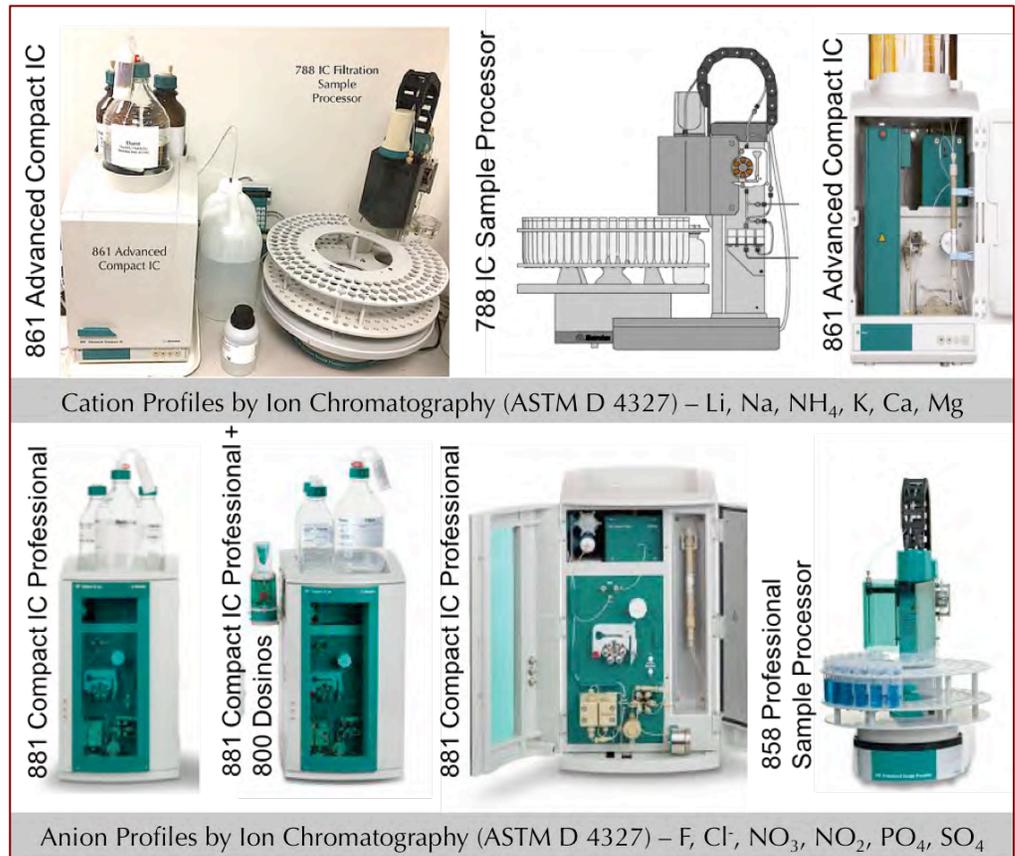
In order to investigate sulfate-leaching capacity of pyrrhotite in coarse aggregates to cause internal sulfate attack in paste, aliquots of pulverized pyrrhotite-bearing coarse aggregate particles extracted from the cores and studied for XRD and XRF were digested in a hydrogen peroxide (35%) solution for ten days for accelerated oxidation, then filtered through 2.5-micron and 0.2-micron micro-filter papers under vacuum. The filtrates were then diluted to 100 mL with distilled water to be analyzed by Metrohm’s 861 Advanced Ion Chromatograph (Figure 7) for determination of released sulfates from oxidation of sulfides.

Figure 7: Set ups of Metrohm ion chromatography units for analysis of water-soluble anions in concretes and concrete aggregates. Cations were not measured.

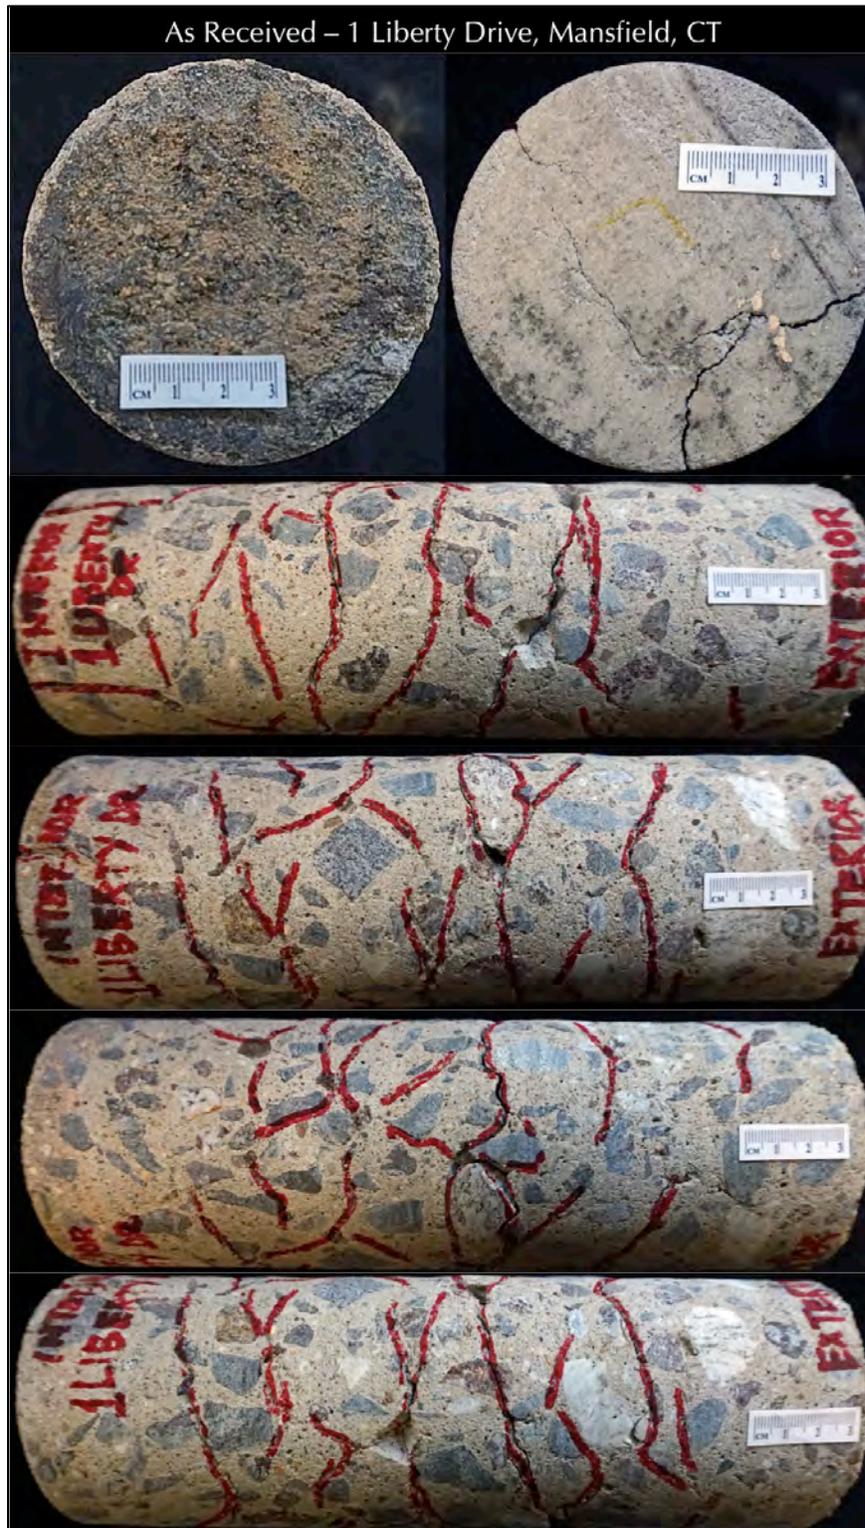
Figures 8 and 9 show the cores from the foundation walls of 1 Liberty Drive and 2 Fort Griswold, respectively, as received. Since the cores were retrieved from over visible cracks in the walls, the cracks show full-depth extensions in the cores from the interior to the opposite exterior ends mostly concentrated within the bodies of the cores than at the ends. The cores are 10¹/₄ in. (260 mm) and 10 in. (250 mm) in total lengths representing thicknesses of foundation walls at 1 Liberty Drive and 2 Fort Griswold, respectively, and 3¹/₂ in. (95 mm) in nominal diameters.

Figure 8: Shown are: (a) the black formed exterior surface of the foundation wall on the core end in the top left photo, (b) smooth, flat, gray formed interior surface of the foundation wall with visible cracks on the core end in the top right photo, and cylindrical side views of the core from 1 Liberty Drive (rest photos), as received, showing full-depth extension of numerous visible cracks due to retrieval of the core from over visible cracks on the wall. Visible cracks on cylindrical surface of core are highlighted, which are mostly concentrated in the interior of the core (wall) than the interior or exterior ends.

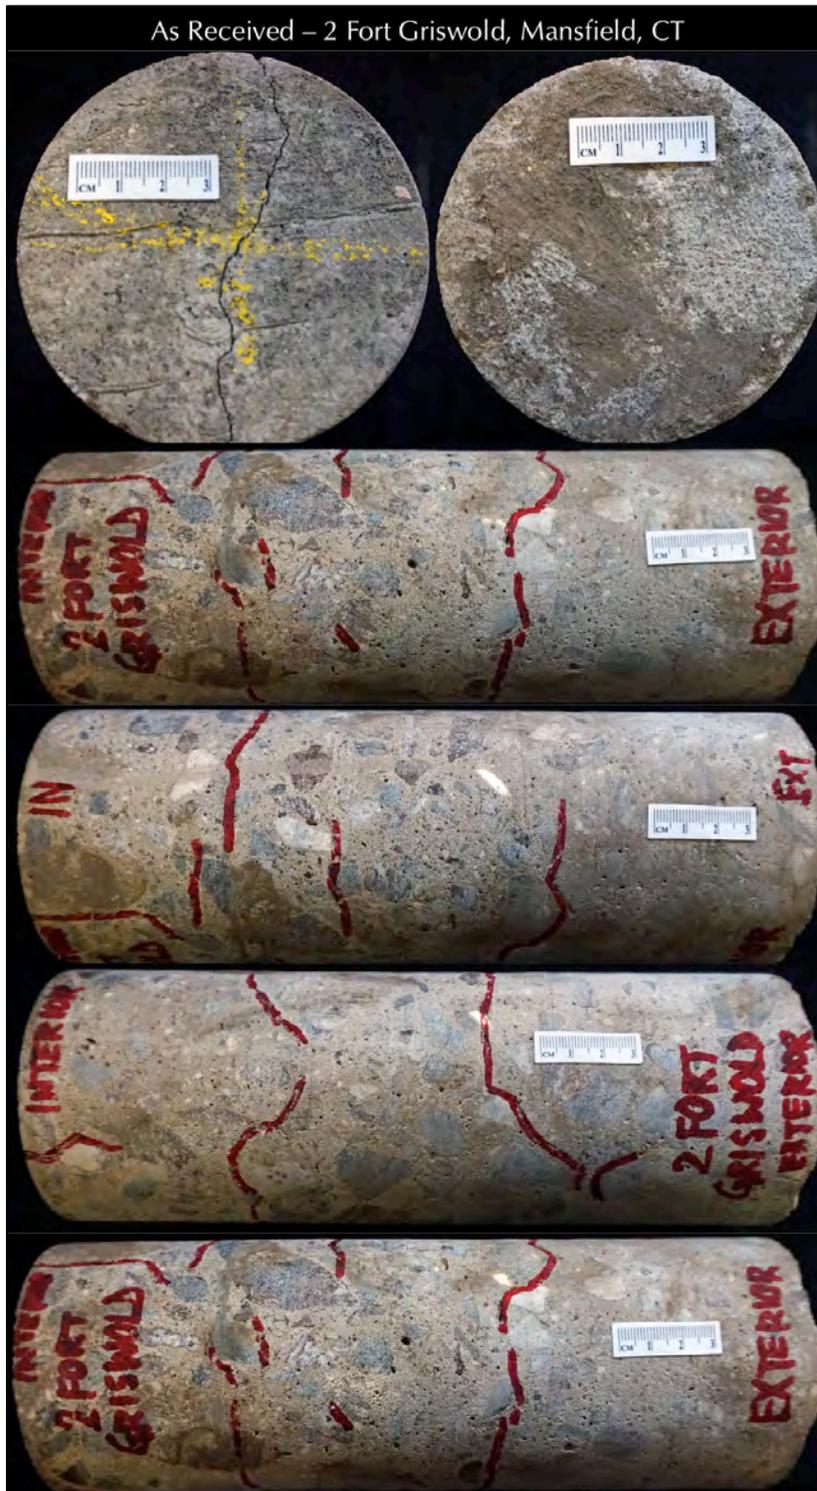
Figure 9: Shown are: (a) the formed exterior surface of the foundation wall on the core end in the top right photo, (b) smooth, flat, gray formed interior surface of the foundation wall with visible cracks on the core end in the top left photo, and cylindrical side views of the core from 2 Fort Griswold (rest photos), as received, showing full-depth extension of numerous visible cracks due to retrieval of the core from over visible cracks on the wall. Visible cracks on cylindrical surface of core are highlighted, which are mostly concentrated in the interior of the core (wall) than the interior or exterior ends. Interior wall has a vertical crack extended to a distance of 1.5 in. inside the core. Notice this core from 2 Fort Griswold residence has less visible cracks in the interior than that from 1 Liberty Drive.

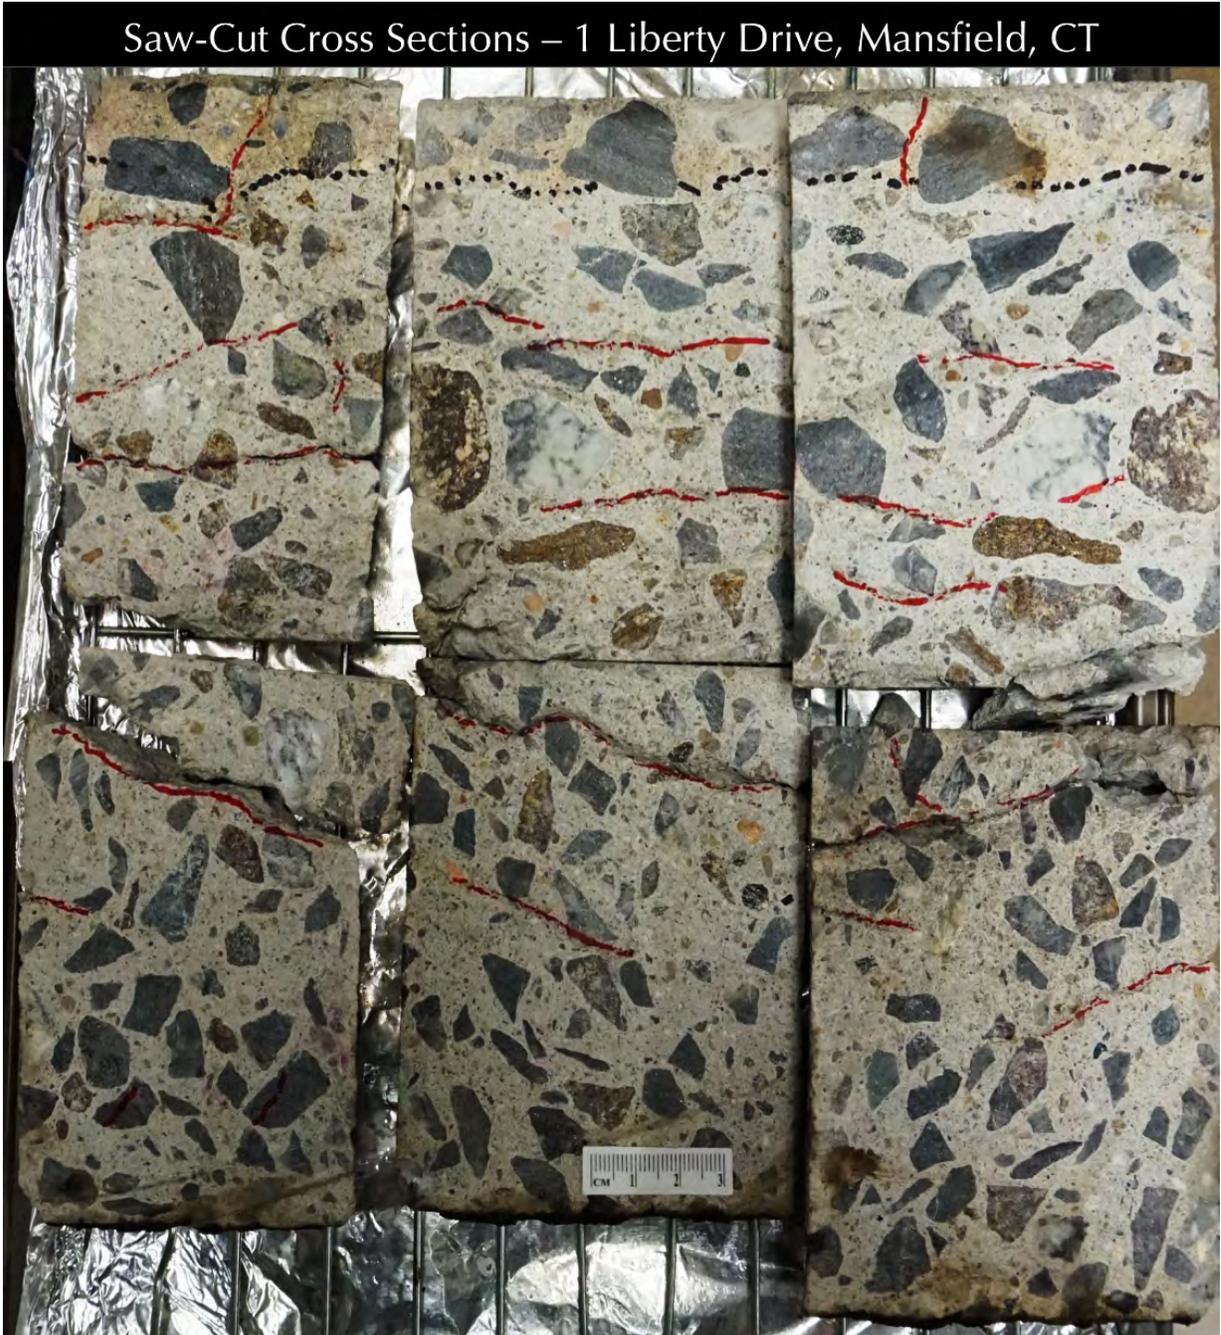
Figure 10: Multiple saw-cut cross sections of the core from 1 Liberty Drive showing: (a) full-depth extension of visible cracks that are highlighted in red (mostly concentrated in the inside of the core); (b) beige discoloration of paste at the interior end of the wall (at the top) and also at the exterior end (bottom) that are marked with black dashed lines at the top, where beige discoloration is due to atmospheric carbonation of concrete during service, mostly occurred along the interior wall surface (to a distance of 20 to 25 mm) than from the exterior end (only 5 mm). Notice a vertical crack from the interior end (at the top) extended to a distance of 1.5 in.

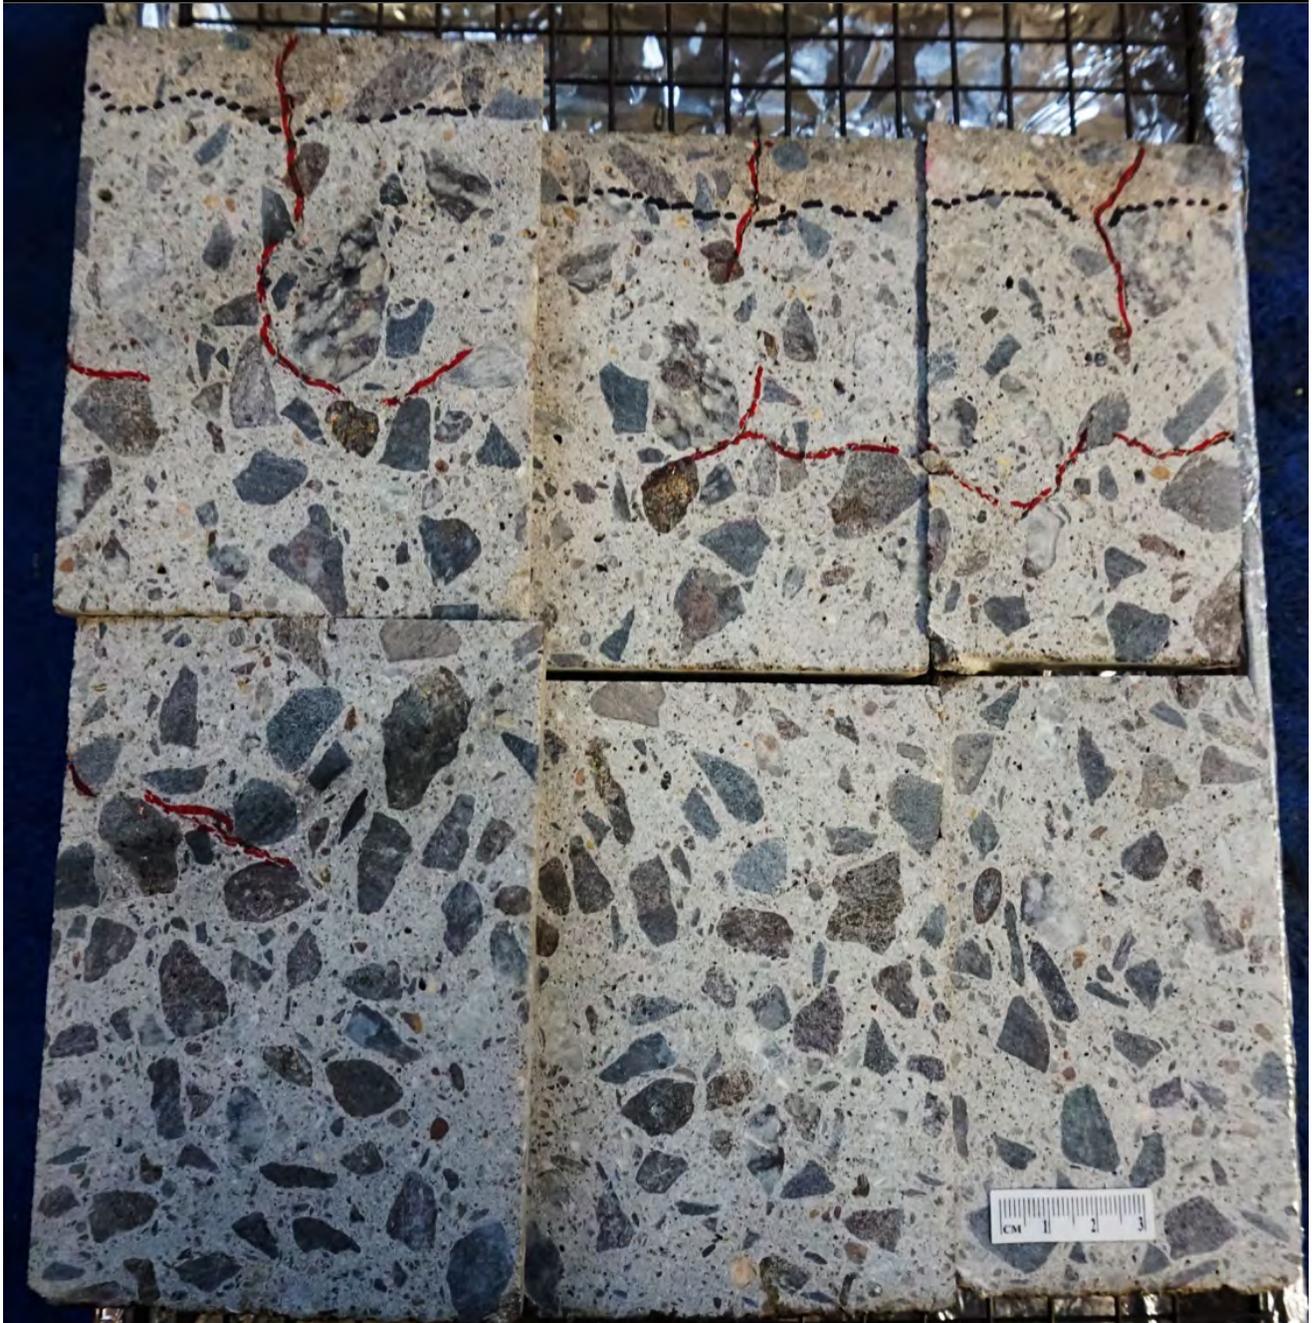
Figure 11: Multiple saw-cut cross sections of the core from 2 Fort Griswold showing: (a) full-depth extension of visible cracks that are highlighted in red (mostly concentrated in the inside of the core); (b) beige discoloration of paste at the interior end of the wall (at the top) and also at the exterior end (bottom) that are marked with black dashed lines at the top, where beige discoloration is due to atmospheric carbonation of concrete during service, mostly occurred along the interior wall surface (to a distance of 20 to 25 mm) than from the exterior end (only 5 mm). Notice a vertical crack from the interior end (at the top) extended to a distance of 1.5 in. Notice this core from 2 Fort Griswold residence has less visible cracks in the interior than that from 1 Liberty Drive.

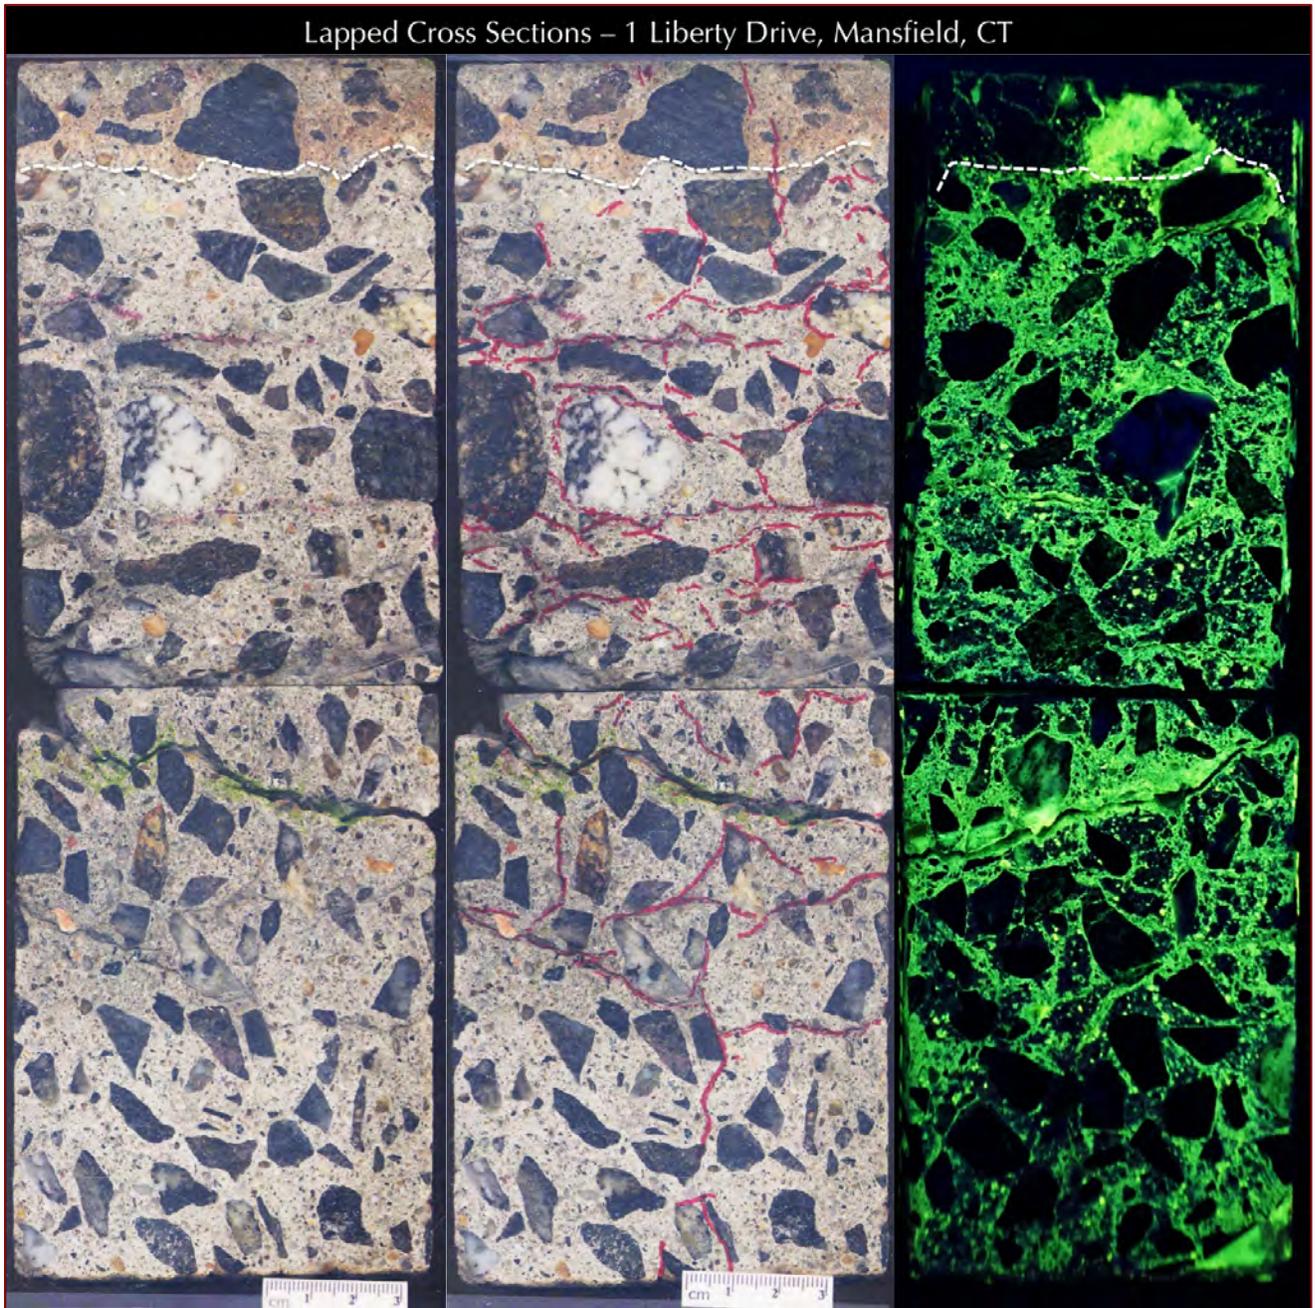
Figure 12: Multiple lapped cross sections of the core from 1 Liberty Drive showing: (a) full-depth extension of visible cracks that are highlighted in red in the middle column (mostly concentrated in the inside of the core); (b) beige discoloration of paste at the interior end of the wall (at the top) and also at the exterior end (bottom) that are marked with white dashed lines at the top, where beige discoloration is due to atmospheric carbonation of concrete during service, mostly occurred along the interior wall surface (to a distance of 20 to 25 mm) than from the exterior end (only 5 mm). Notice a vertical crack from the interior end (at the top) extended to a distance of 1.5 in. Right column shows fluorescent dye-mixed epoxy-impregnated lapped cross section viewed in an ultraviolet light where all visible and invisible cracks as well as porous areas of paste and voids are highlighted whereas dense aggregates appeared dark. Carbonated concrete at the interior end (at the top above white dashed line) remained dark in fluorescent light due to densification of paste by carbonation.

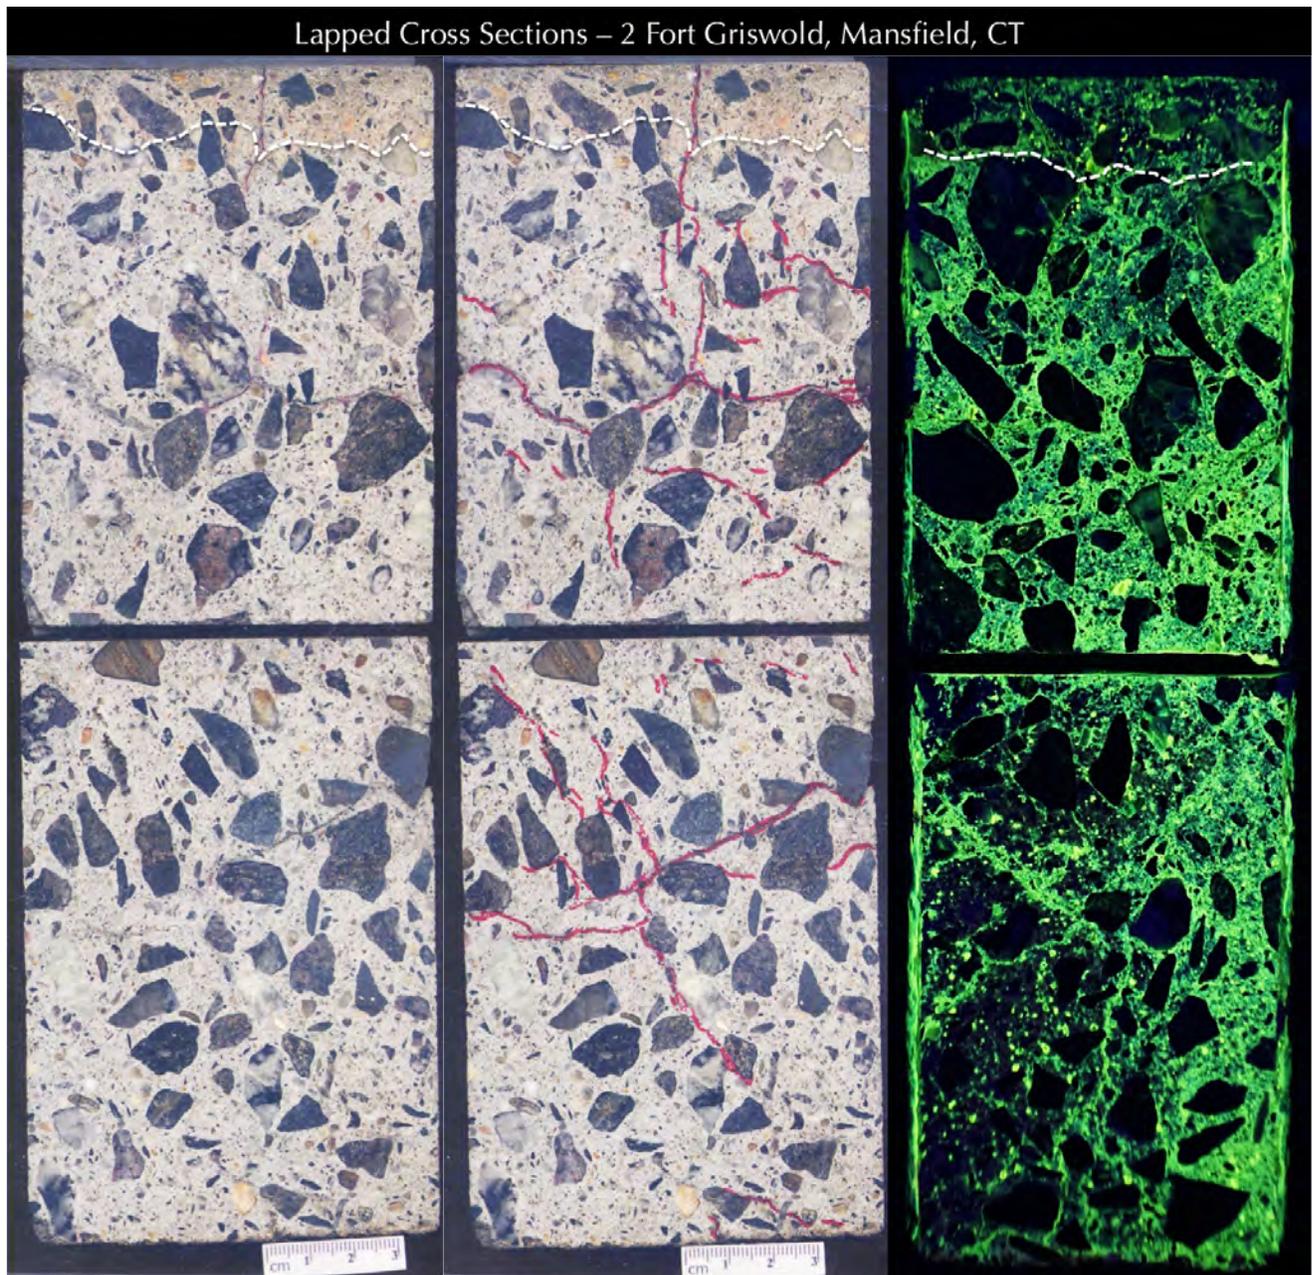
Figure 13: Multiple lapped cross sections of the core from 2 Fort Griswold showing: (a) full-depth extension of visible cracks that are highlighted in red in the middle column (mostly concentrated in the inside of the core); (b) beige discoloration of paste at the interior end of the wall (at the top) and also at the exterior end (bottom) that are marked with white dashed lines at the top, where beige discoloration is due to atmospheric carbonation of concrete during service, mostly occurred along the interior wall surface (to a distance of 20 to 25 mm) than from the exterior end (only 5 mm). Notice a vertical crack from the interior end (at the top) extended to a distance of 1.5 in. Right column shows fluorescent dye-mixed epoxy-impregnated lapped cross section viewed in an ultraviolet light where all visible and invisible cracks as well as porous areas of paste and voids are highlighted whereas dense aggregates appeared dark. Carbonated concrete at the interior end (at the top above white dashed line) remained dark in fluorescent light due to densification of paste by carbonation.

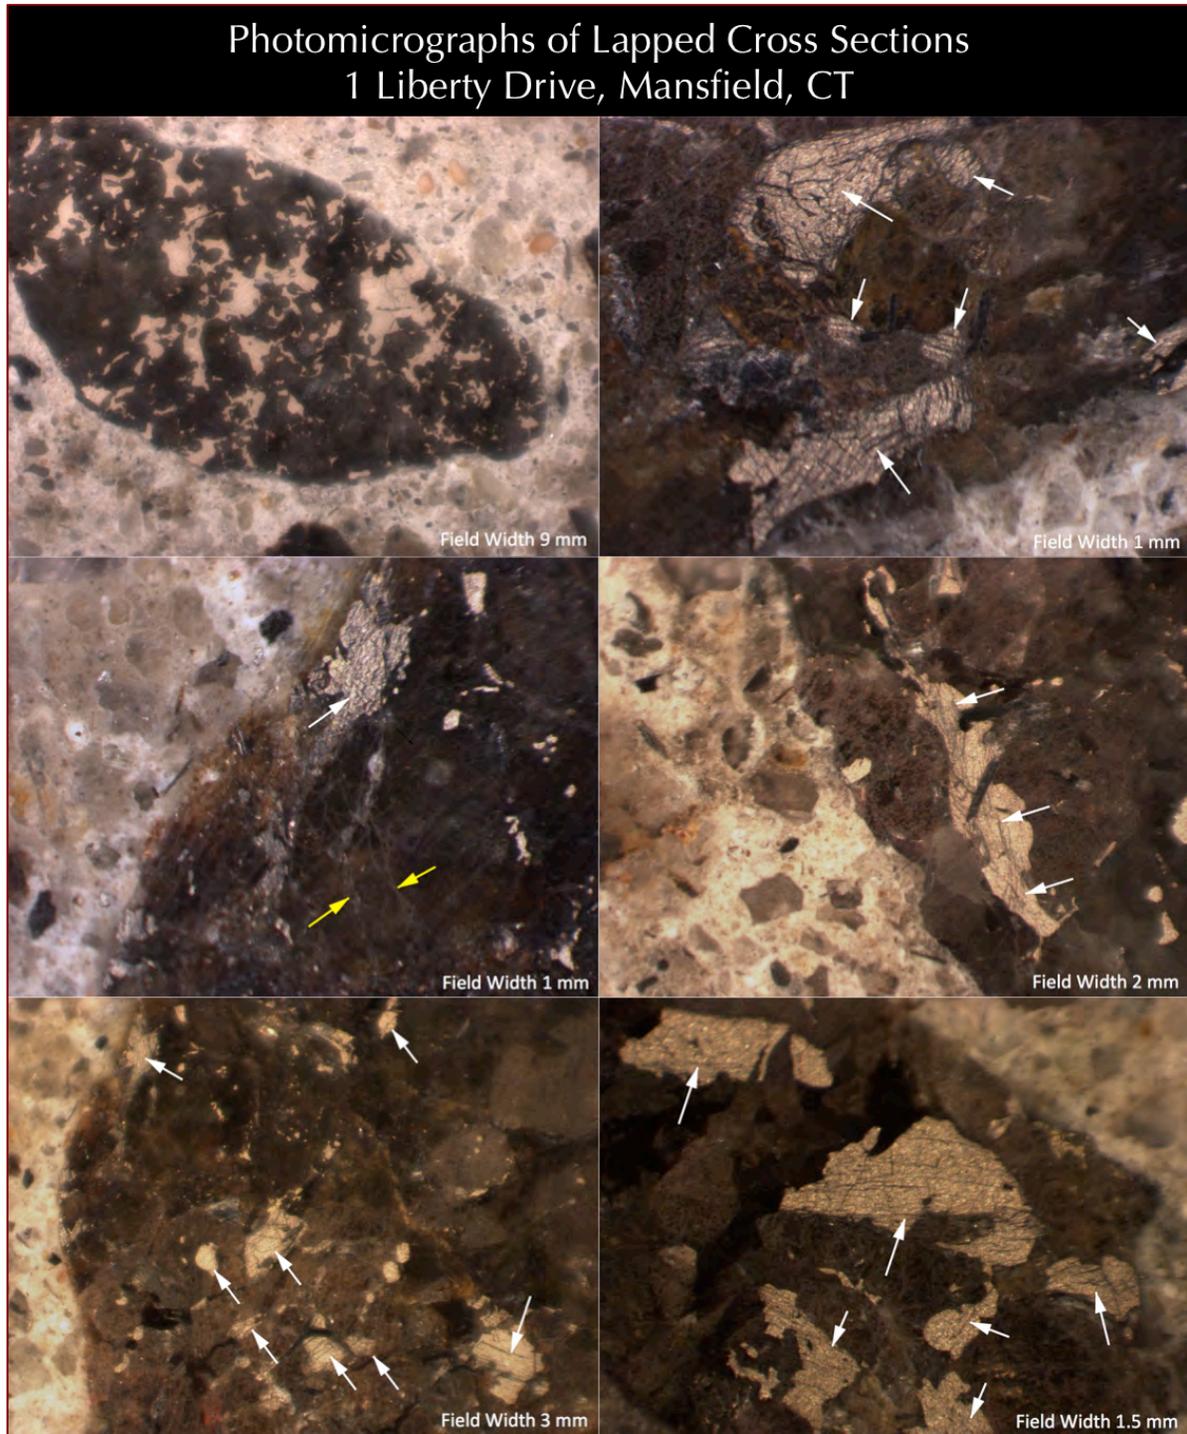
Figure 14: Photomicrographs of lapped cross sections of core from 1 Liberty Drive showing disseminated iron sulfide (pyrrhotite) and oxidized iron sulfide grains scattered throughout the crushed gneiss coarse aggregate particles many of which are marked with arrows. Oxidation causes development of fine parallel striations within pyrrhotite as seen in the top and bottom right photos, which are later in subsequent SEM-EDS studies found to be oxidized iron veins within pyrrhotite. Expansions due to oxidation causes formation of fine hairline cracks within pyrrhotite.
