Investigation of Pyrrhotite-Related Deterioration In Residential Concrete Foundations In Mansfield, Connecticut

Villages At Freedom Green Condominium Association, Inc.
1 Liberty Drive and 2 Fort Griswold
Mansfield, Connecticut

May 31, 2019
CMC 0419120

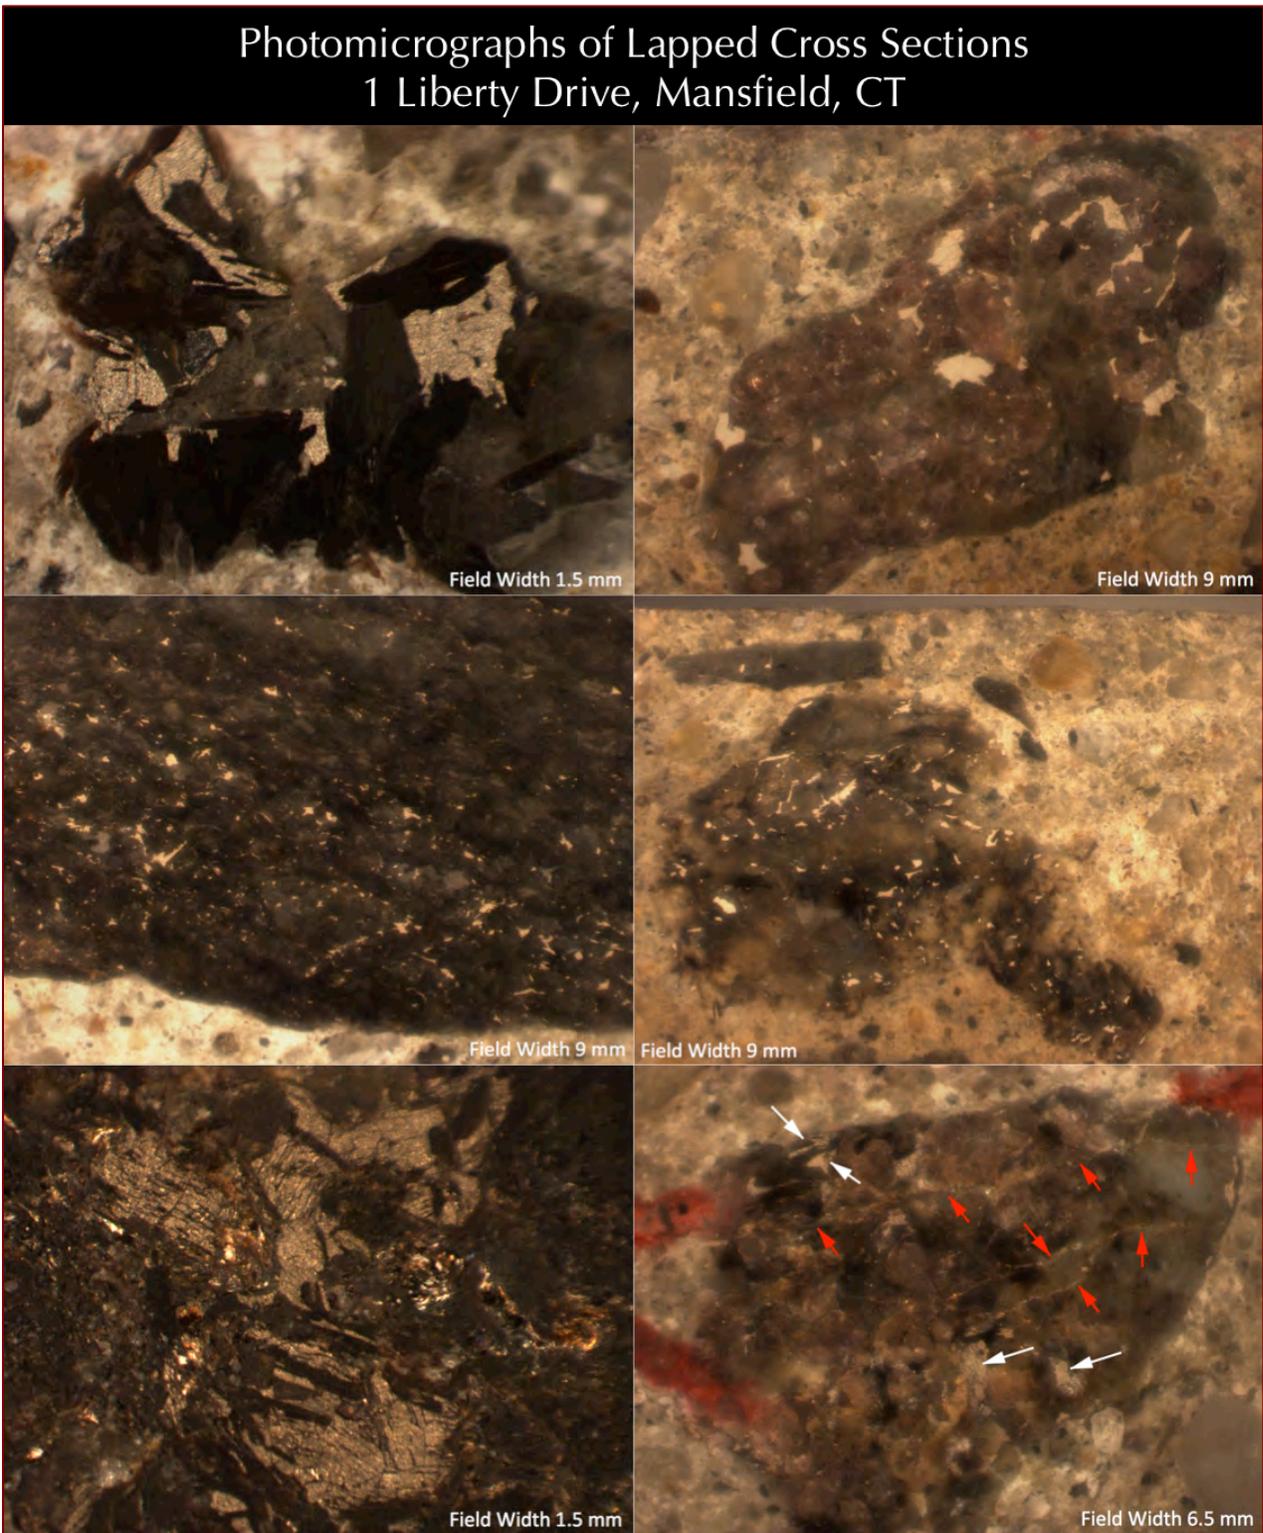
Figure 15: Photomicrographs of lapped cross sections of core from 1 Liberty Drive showing disseminated iron sulfide (pyrrhotite) and oxidized iron sulfide grains scattered throughout the crushed gneiss coarse aggregate particles many of which are marked with arrows. Oxidation causes development of fine parallel striations within pyrrhotite as seen in the top and bottom left photos, which are later in subsequent SEM-EDS studies found to be oxidized iron veins within pyrrhotite. Expansions due to oxidation causes formation of fine hairline cracks within pyrrhotite some of which are marked in red arrows in the bottom right photo.

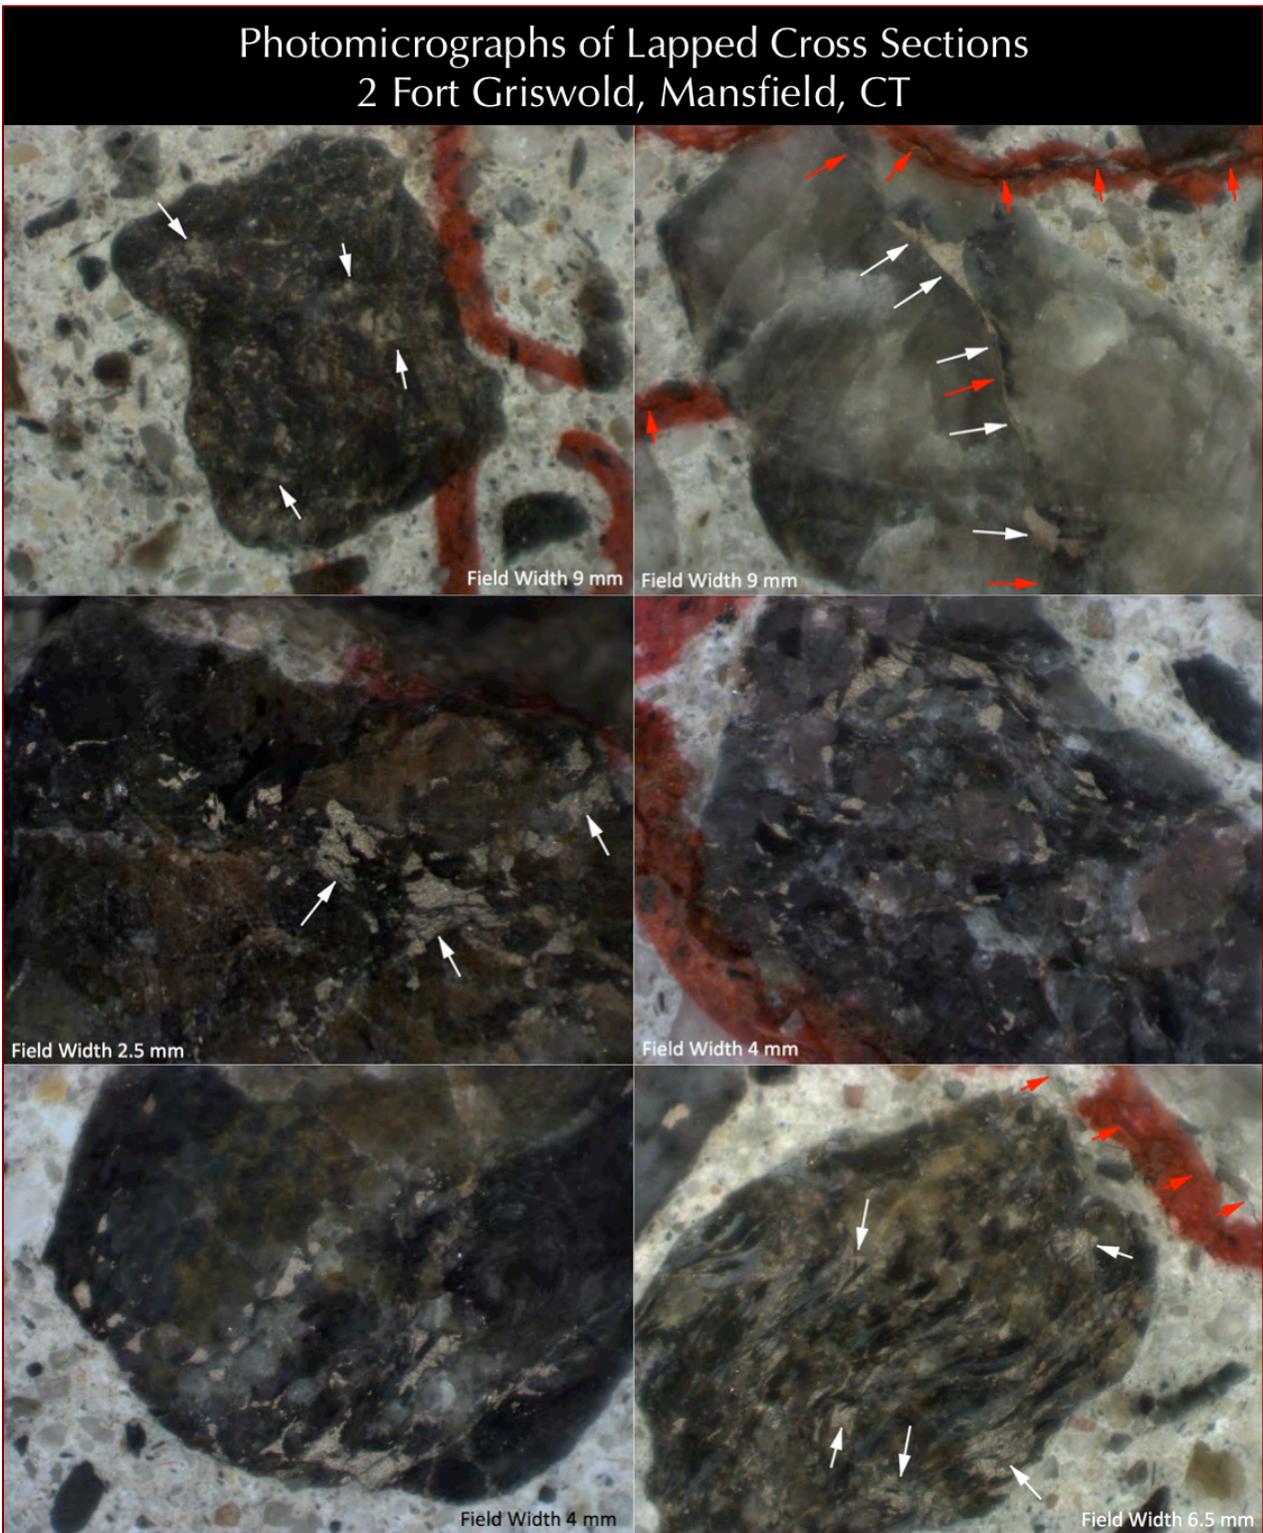
Figure 16: Photomicrographs of lapped cross sections of core from 2 Fort Griswold showing disseminated iron sulfide (pyrrhotite) and oxidized iron sulfide grains scattered throughout the crushed gneiss coarse aggregate particles many of which are marked with arrows. Oxidation causes development of fine parallel striations within pyrrhotite as seen in the middle left and bottom right photos, which are later in subsequent SEM-EDS studies found to be oxidized iron veins within pyrrhotite. Expansions due to oxidation causes formation of fine hairline cracks within pyrrhotite.

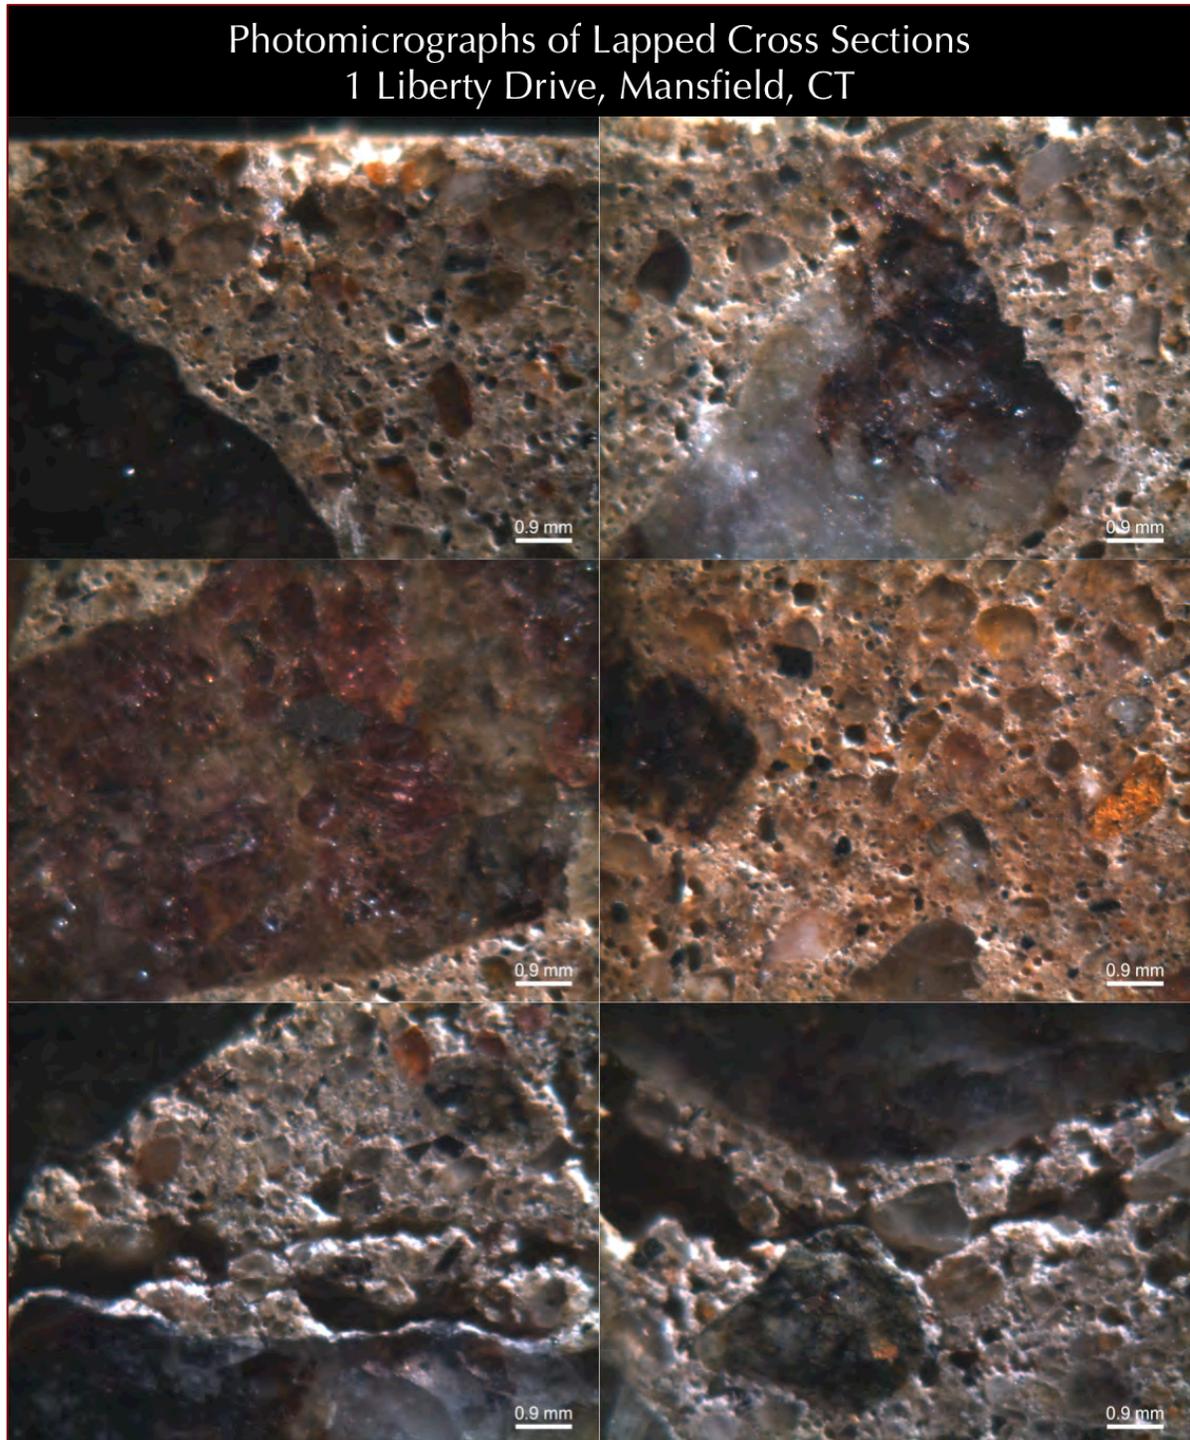
Figure 17: Photomicrographs of lapped cross section of core from 1 Liberty Drive showing crushed gneiss coarse aggregate particles, e.g., white granite gneiss with black specs of mica in parallel (gneissose) arrangements, light to medium brown granite gneiss, and dark gray to black gneiss. Notice air-entrained nature of concrete having many fine, discrete spherical and near-spherical entrained air voids of sizes 1 mm or less. Carbonation of paste has caused beige discoloration from the normal gray color tone of non-carbonated paste. Notice cracking in interior concrete in the bottom row.

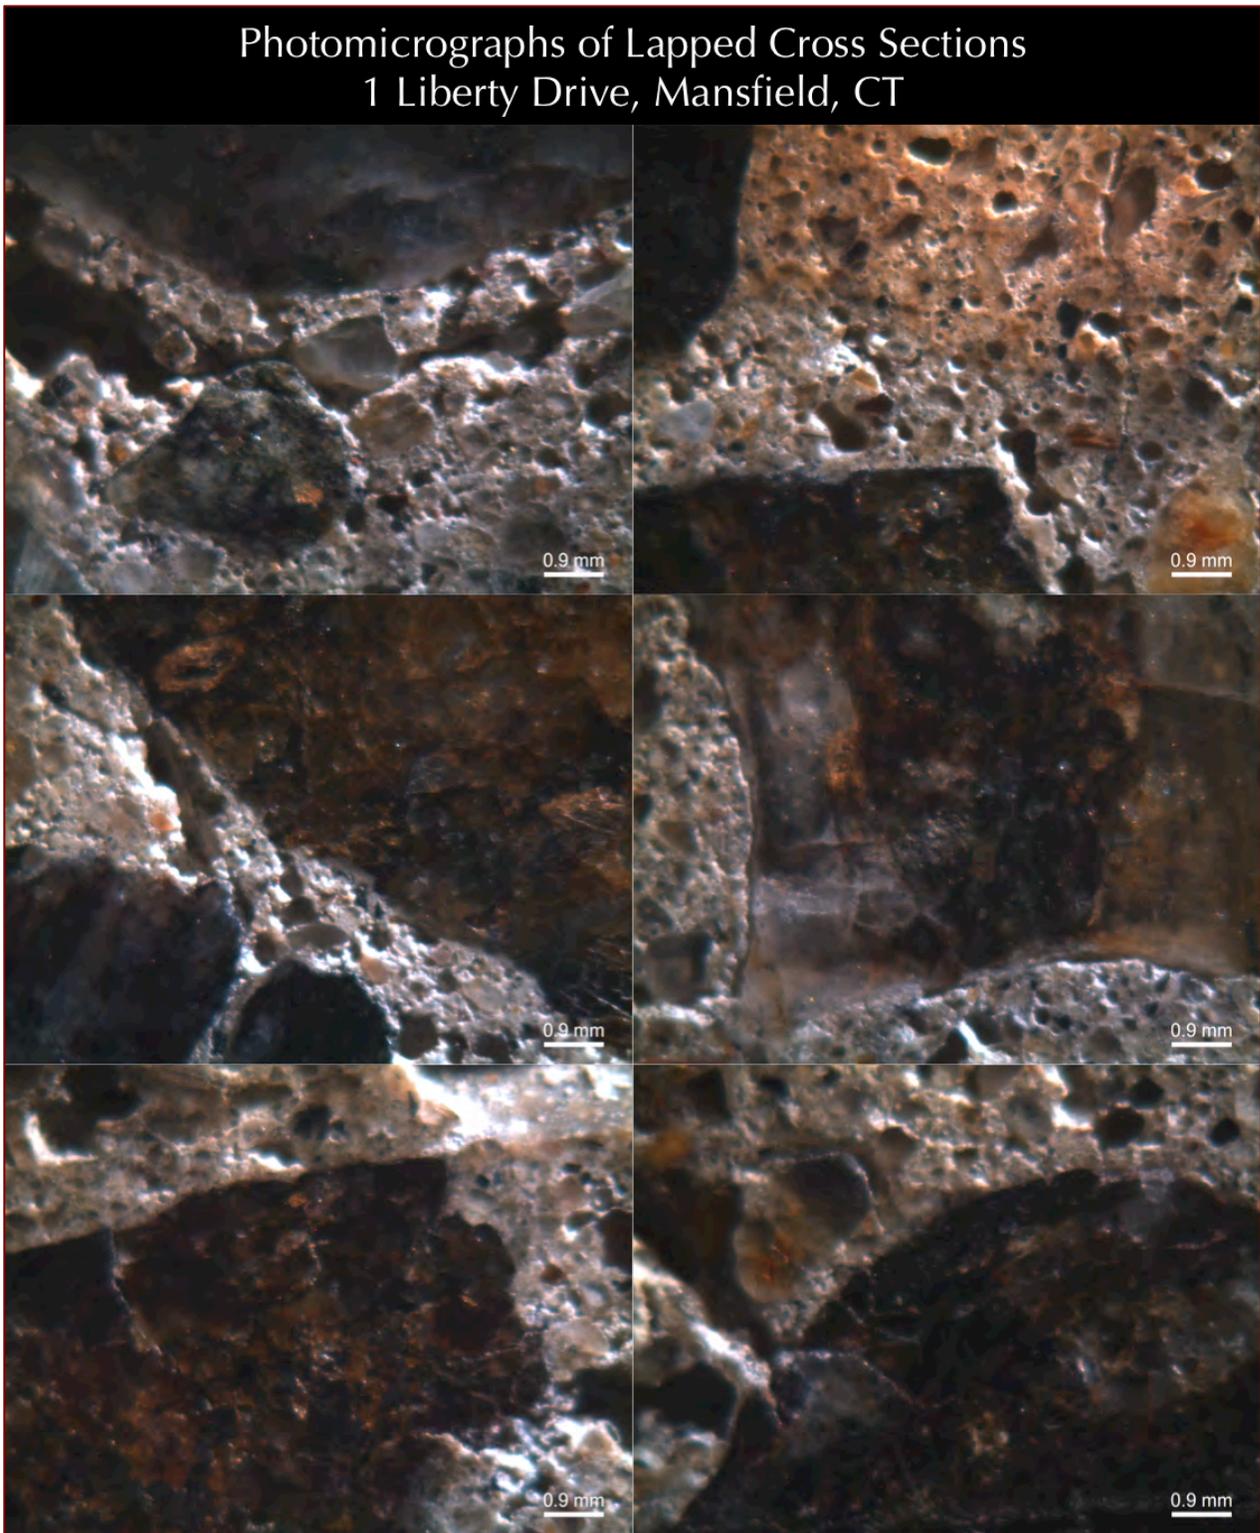
Figure 18: Photomicrographs of lapped cross section of core from 1 Liberty Drive showing crushed gneiss coarse aggregate particles, e.g., white granite gneiss with black specs of mica in parallel (gneissose) arrangements, light to medium brown granite gneiss, and dark gray to black gneiss. Notice air-entrained nature of concrete having many fine, discrete spherical and near-spherical entrained air voids of sizes 1 mm or less. Carbonation of paste has caused beige discoloration from the normal gray color tone of non-carbonated paste. Notice cracking in interior concrete.

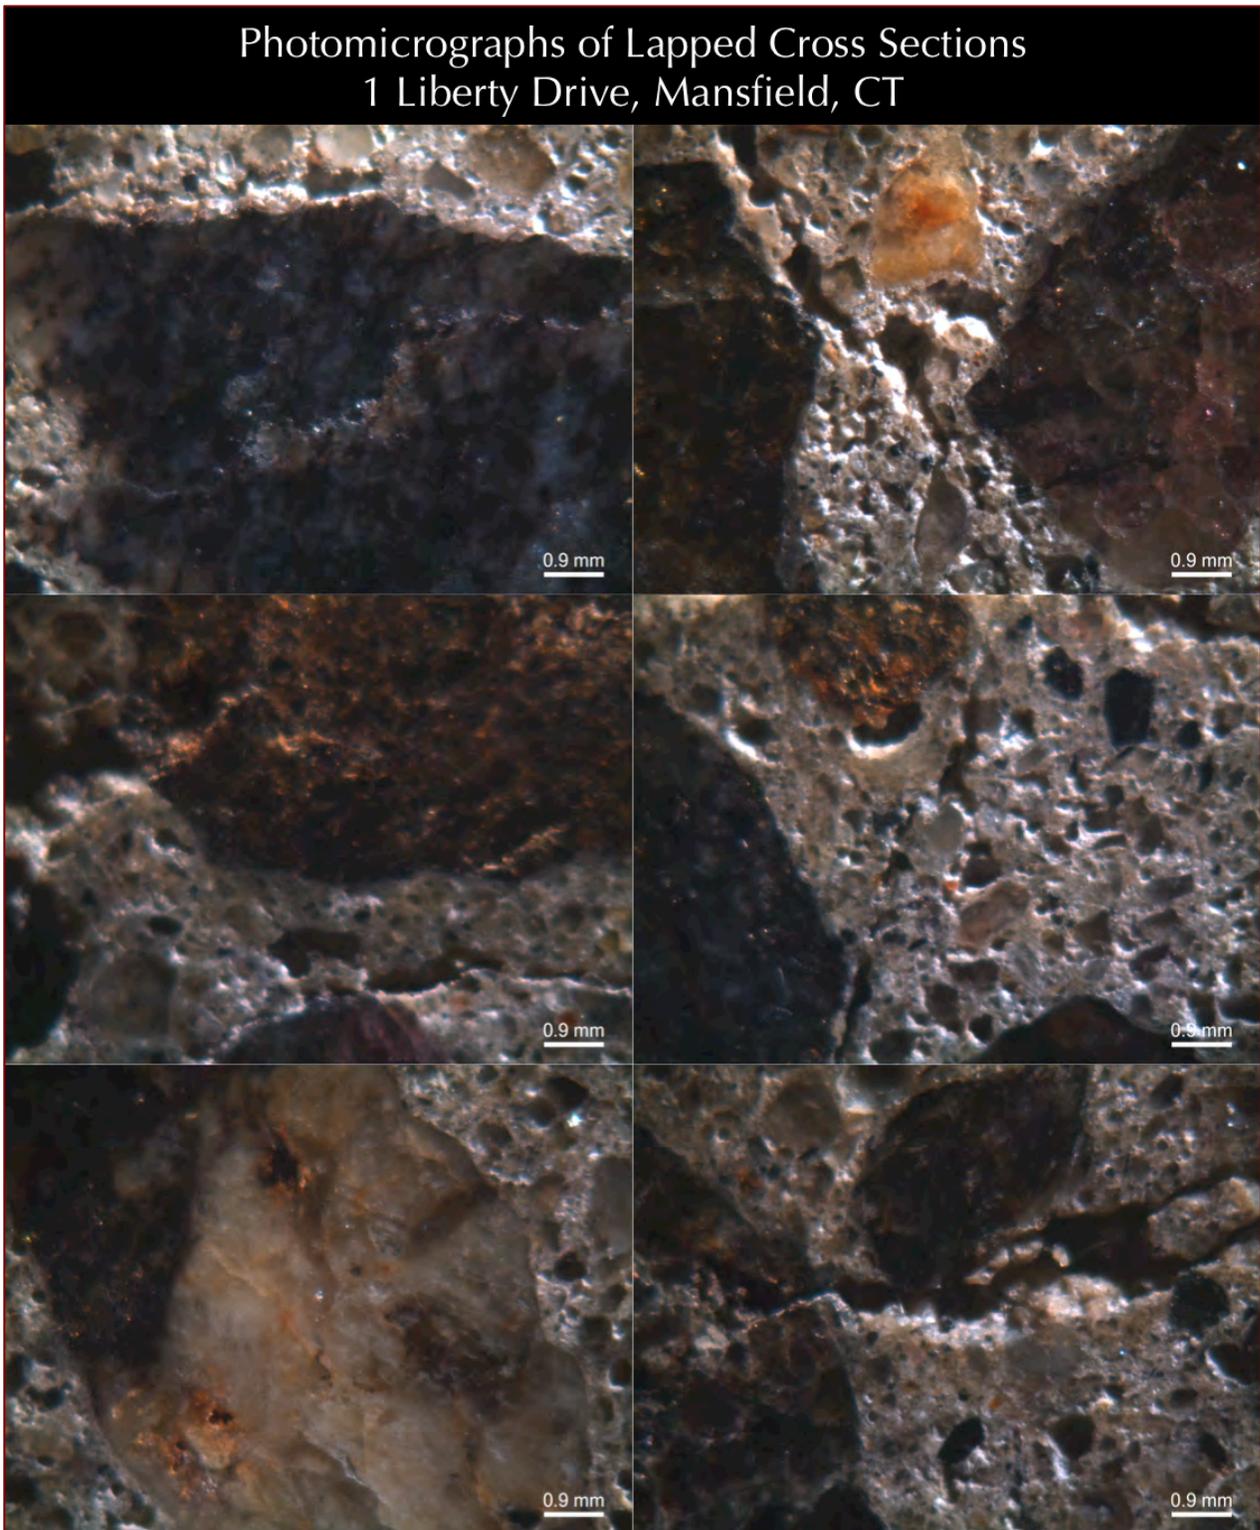
Figure 19: Photomicrographs of lapped cross section of core from 1 Liberty Drive showing crushed gneiss coarse aggregate particles, e.g., white granite gneiss with black specs of mica in parallel (gneissose) arrangements, light to medium brown granite gneiss, and dark gray to black gneiss. Notice air-entrained nature of concrete having many fine, discrete spherical and near-spherical entrained air voids of sizes 1 mm or less. Notice cracking in interior concrete.

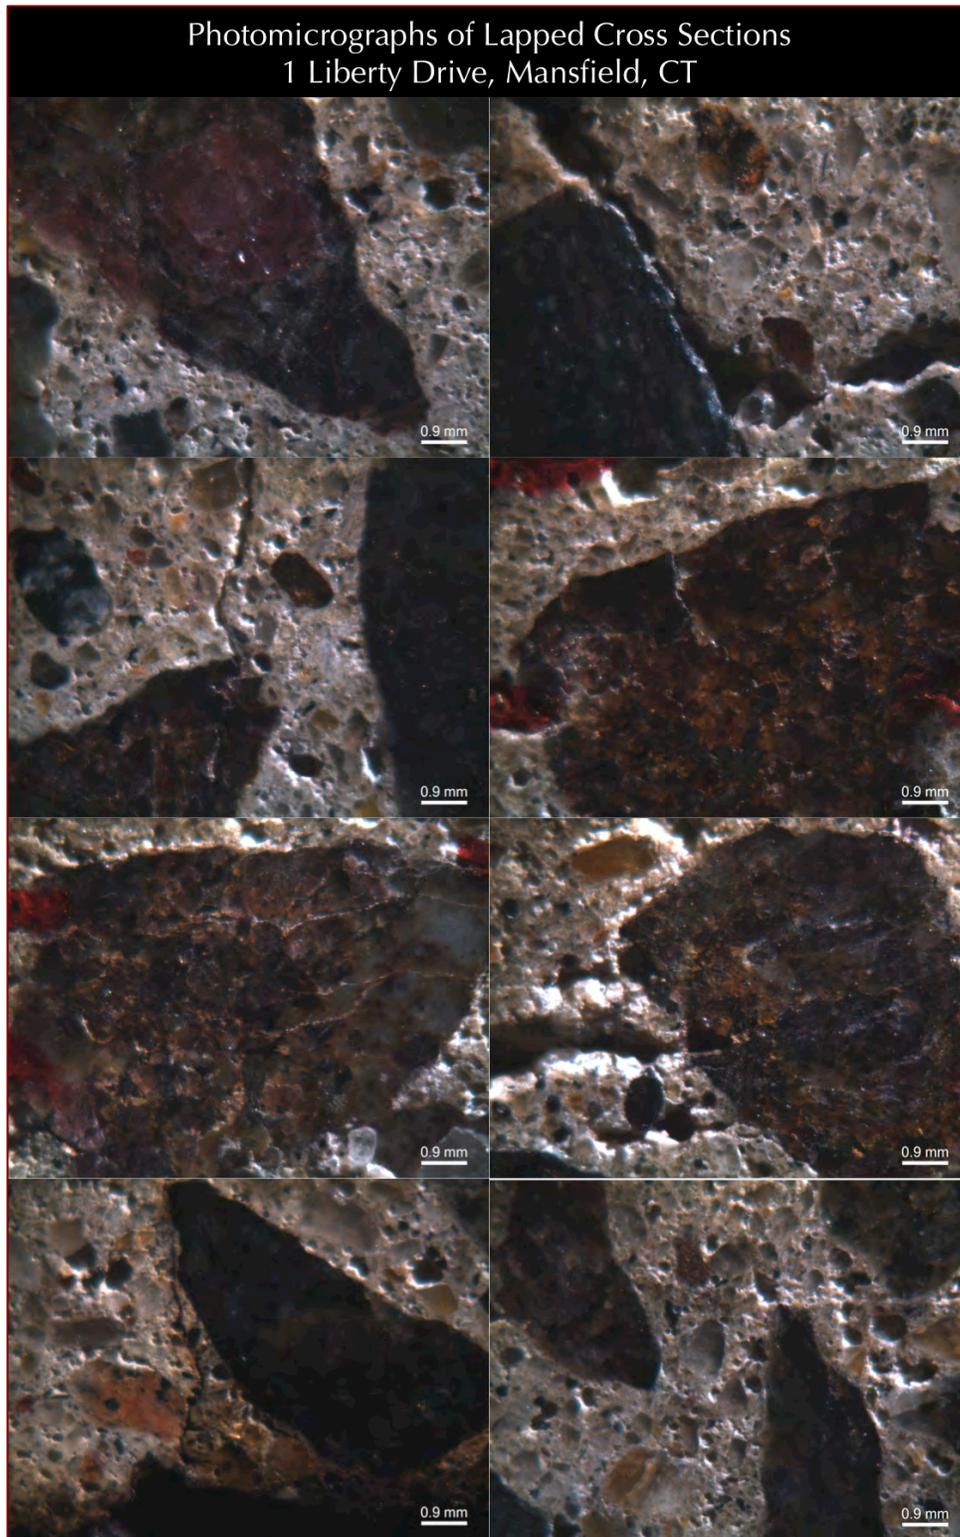
Figure 20: Photomicrographs of lapped cross section of core from 1 Liberty Drive showing crushed gneiss coarse aggregate particles, e.g., white granite gneiss with black specs of mica in parallel (gneissose) arrangements, light to medium brown granite gneiss, and dark gray to black gneiss. Notice air-entrained nature of concrete having many fine, discrete spherical and near-spherical entrained air voids of sizes 1 mm or less. Notice cracking in interior concrete.

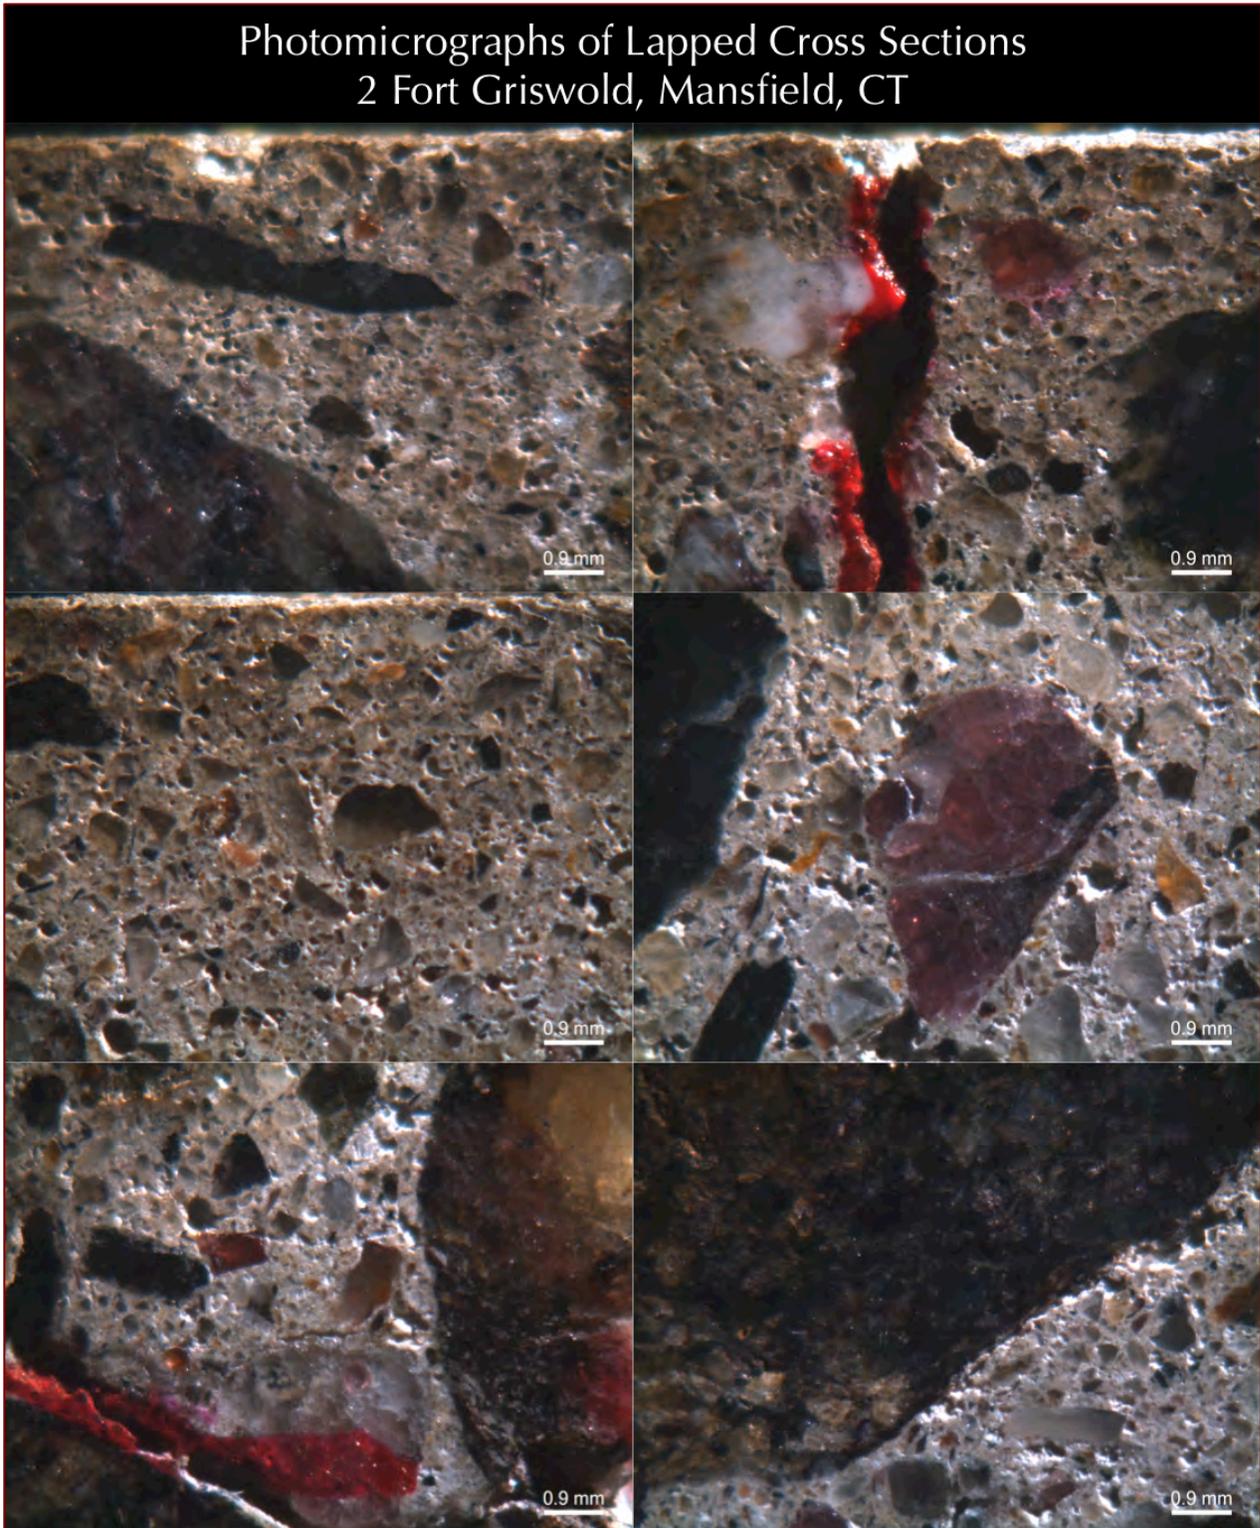
Figure 21: Photomicrographs of lapped cross section of core from 2 Fort Griswold showing crushed gneiss coarse aggregate particles, e.g., white granite gneiss with black specs of mica in parallel (gneissose) arrangements, light to medium brown granite gneiss, and dark gray to black gneiss. Notice air-entrained nature of concrete having many fine, discrete spherical and near-spherical entrained air voids of sizes 1 mm or less. Notice cracking in interior concrete.

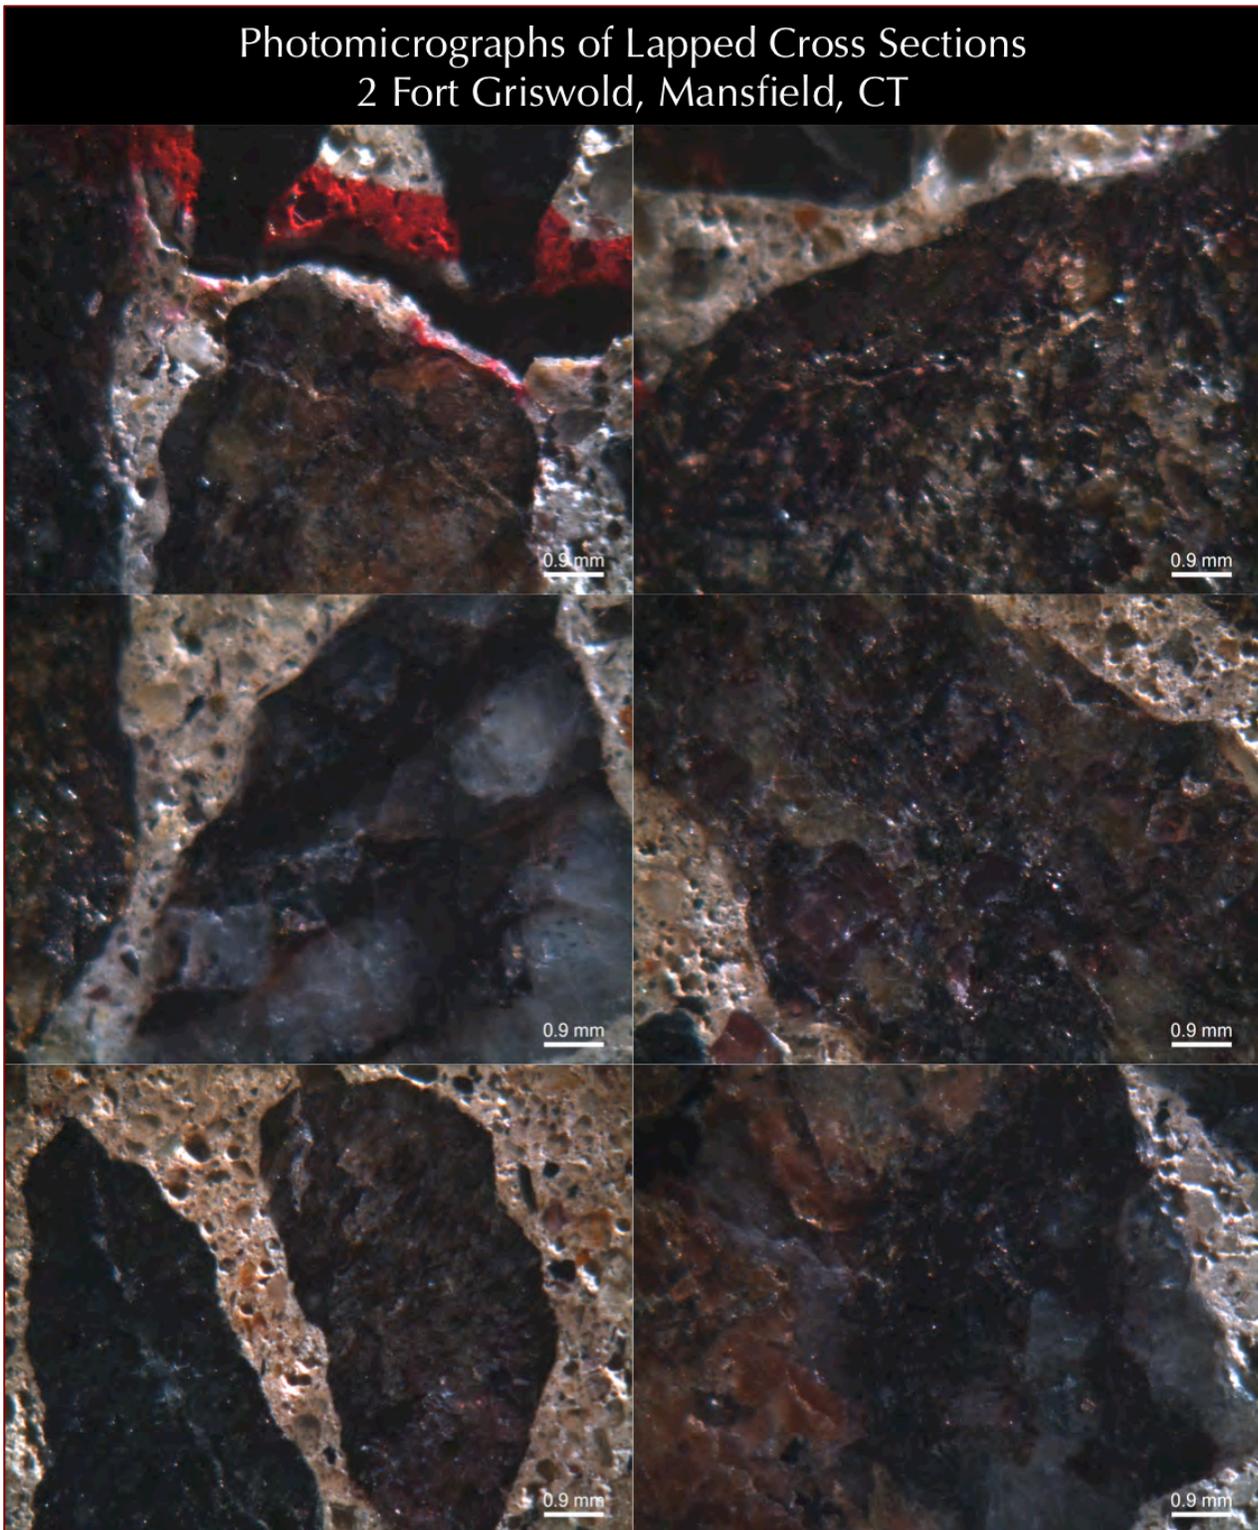
Figure 22: Photomicrographs of lapped cross section of core from 2 Fort Griswold showing crushed gneiss coarse aggregate particles, e.g., white granite gneiss with black specs of mica in parallel (gneissose) arrangements, light to medium brown granite gneiss, and dark gray to black gneiss. Notice air-entrained nature of concrete having many fine, discrete spherical and near-spherical entrained air voids of sizes 1 mm or less. Notice cracking in interior concrete. Carbonation of paste has caused beige discoloration from the normal gray color tone of non-carbonated paste.

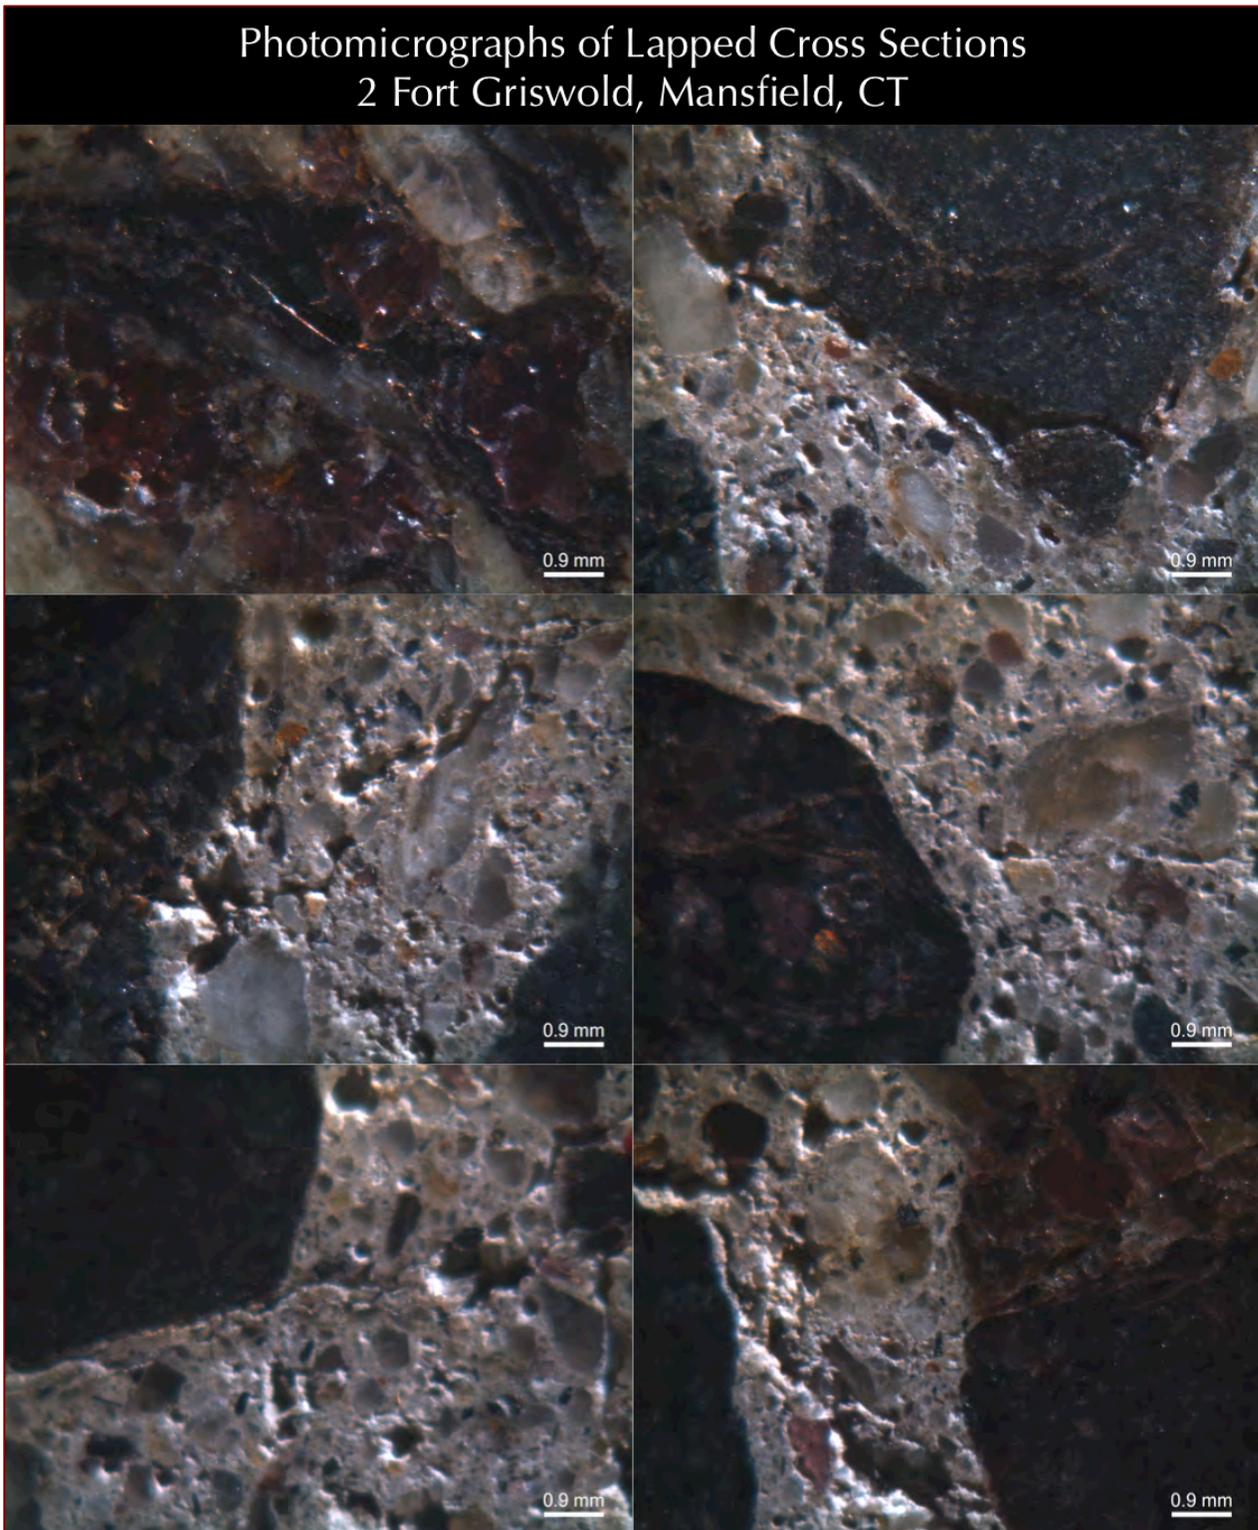
Figure 23: Photomicrographs of lapped cross section of core from 2 Fort Griswold showing crushed gneiss coarse aggregate particles, e.g., white granite gneiss with black specks of mica in parallel (gneissose) arrangements, light to medium brown granite gneiss, and dark gray to black gneiss. Notice air-entrained nature of concrete having many fine, discrete spherical and near-spherical entrained air voids of sizes 1 mm or less. Notice cracking in interior concrete.

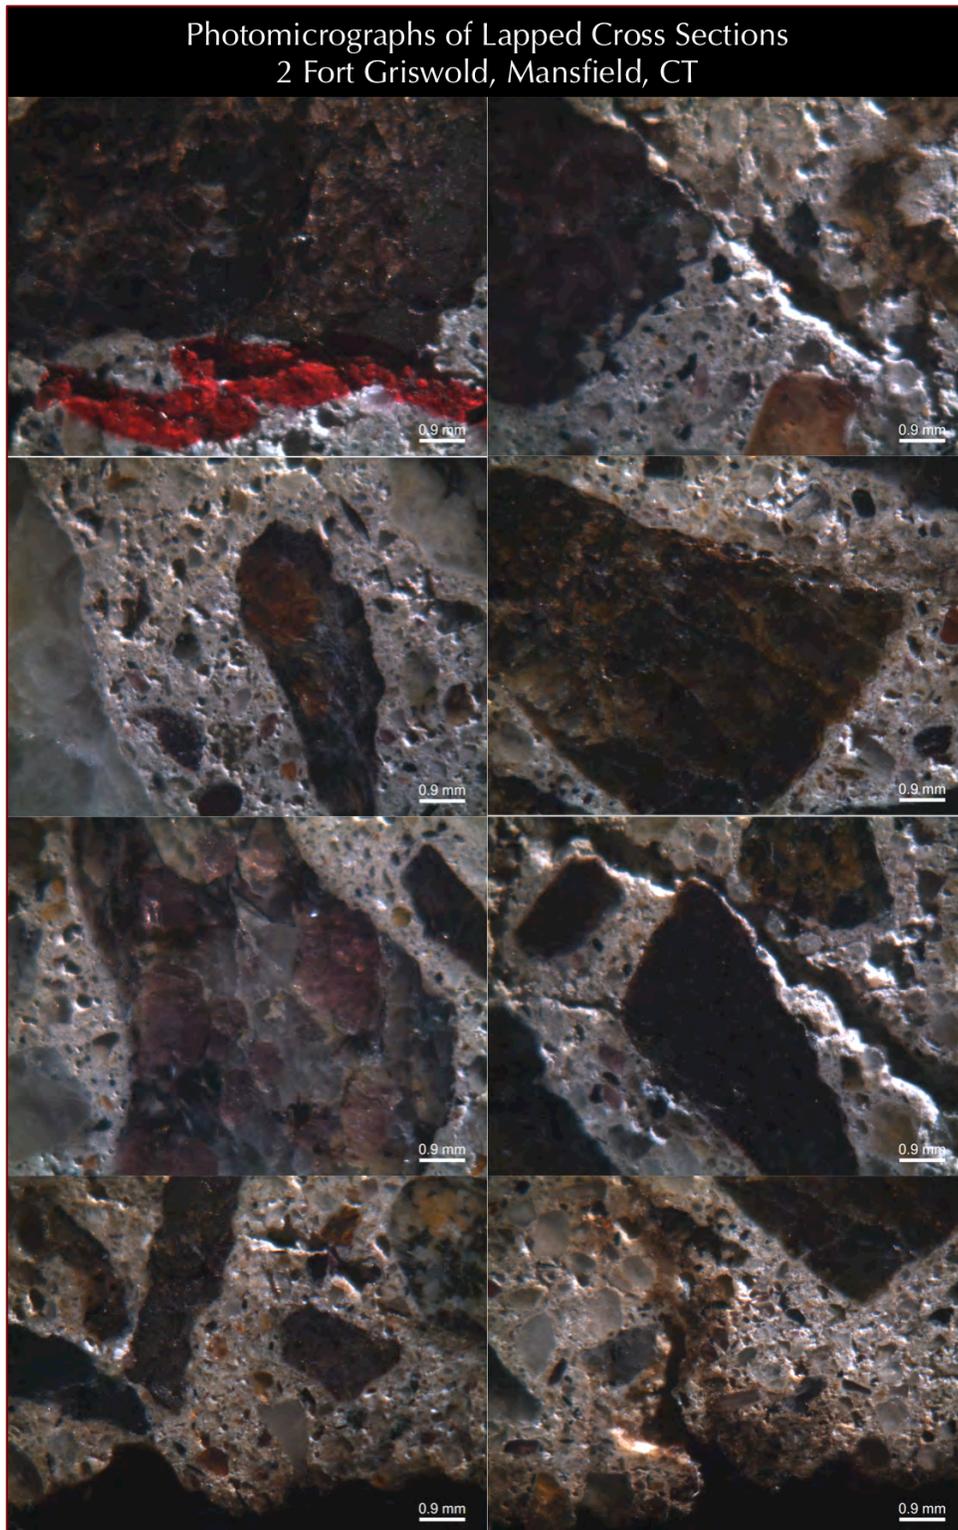
Figure 24: Photomicrographs of lapped cross section of core from 2 Fort Griswold showing crushed gneiss coarse aggregate particles, e.g., white granite gneiss with black specs of mica in parallel (gneissose) arrangements, light to medium brown granite gneiss, and dark gray to black gneiss. Notice air-entrained nature of concrete having many fine, discrete spherical and near-spherical entrained air voids of sizes 1 mm or less. Notice cracking in interior concrete.

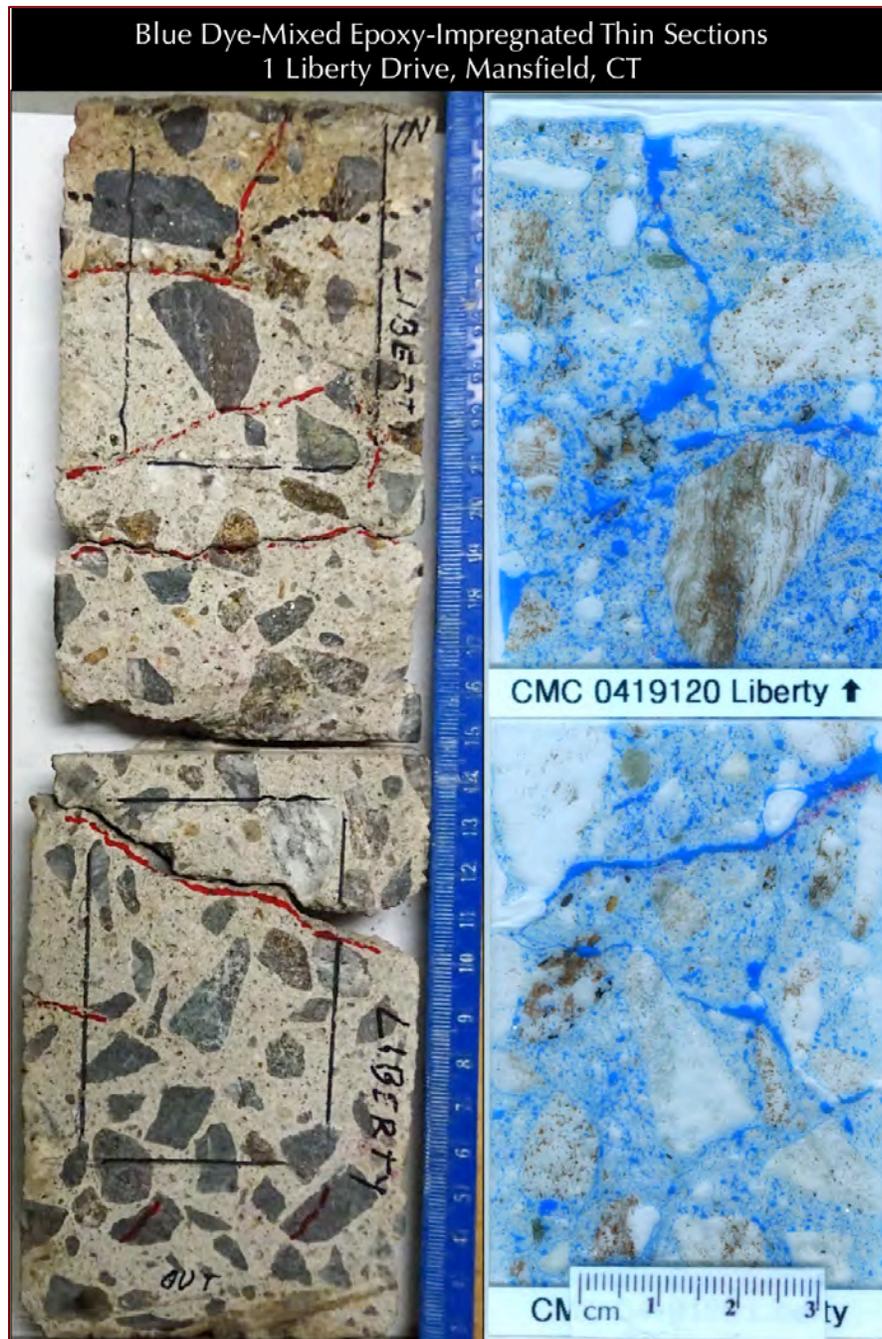
Figure 25: Blue dye-mixed epoxy-impregnated thin sections (30 micron thickness, right) and corresponding saw-cut sections (left) having rectangular marked portions selected for trimming and thin section preparation for the core from 1 Liberty Drive. Thin sections were examined: (a) in a stereozoom microscope, in transmitted and reflected-light modes to highlight pores, air voids, and cracks, (b) in a petrographic microscope to examine various microstructural features at higher magnifications than that from stereomicroscope, and (c) finally in a scanning electron microscope with attached energy-dispersive X-ray spectrometer to examine specific areas of interests for microstructural and microchemical analyses selected from optical microscopy (after coating the sections with a thin conductive gold film). Visible and invisible cracks, porous areas of paste, and air voids are highlighted by blue dyed epoxy. Coarse aggregate particles are dense gneiss, hence did not absorb blue epoxy.

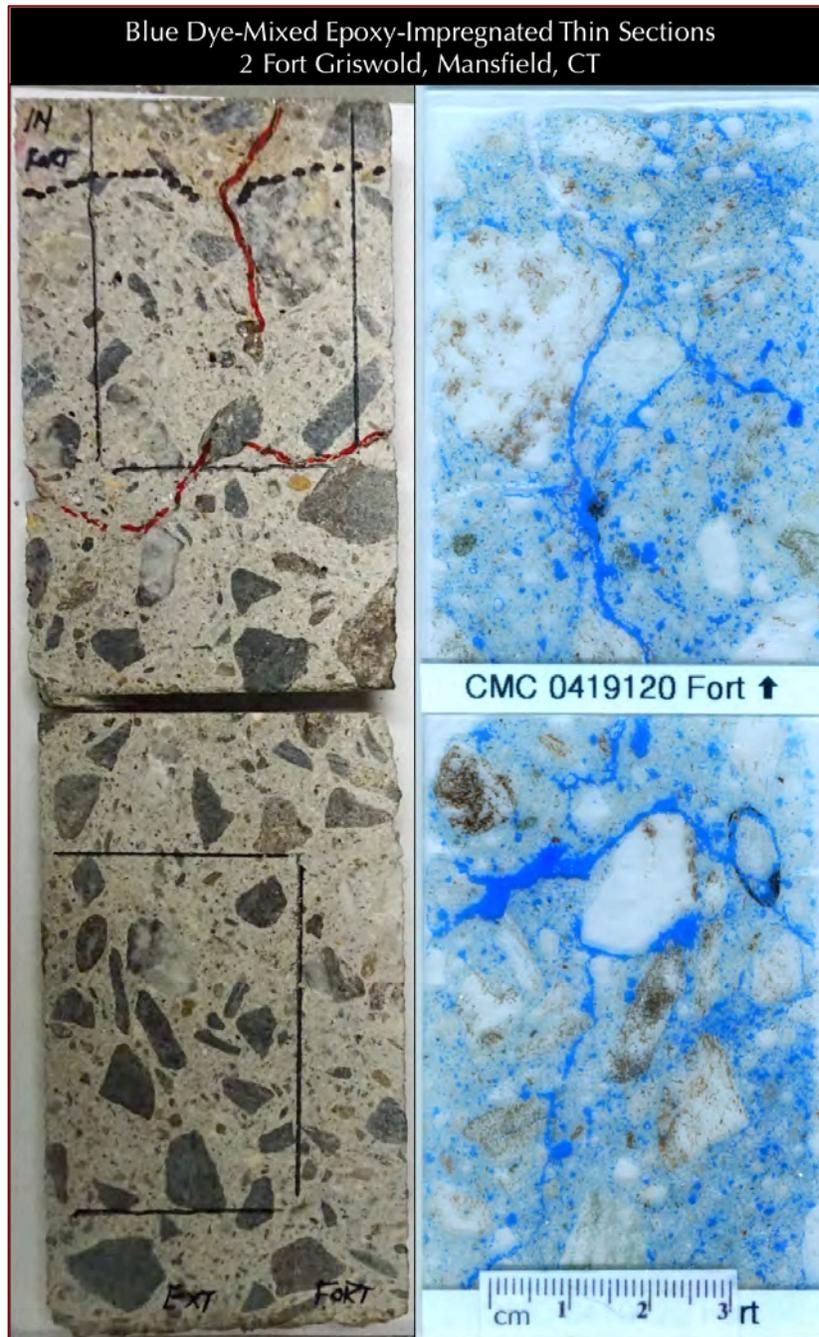
Figure 26: Blue dye-mixed epoxy-impregnated thin sections (30 micron thickness, right) and corresponding saw-cut sections (left) having rectangular marked portions selected for trimming and thin section preparation for the core from 2 Fort Griswold. Thin sections were examined: (a) in a stereozoom microscope, in transmitted and reflected-light modes to highlight pores, air voids, and cracks, (b) in a petrographic microscope to examine various microstructural features at higher magnifications than that from stereomicroscope, and (c) finally in a scanning electron microscope with attached energy-dispersive X-ray spectrometer to examine specific areas of interest for microstructural and microchemical analyses selected from optical microscopy (after coating the sections with a thin conductive gold film). Visible and invisible cracks, porous areas of paste, and air voids are highlighted by blue dyed epoxy. Coarse aggregate particles are dense gneiss, hence did not absorb blue epoxy.
