Investigation of Pyrrhotite-Related Deterioration In Residential Concrete Foundations In Mansfield, Connecticut

Villages At Freedom Green Condominium Association, Inc.
1 Liberty Drive and 2 Fort Griswold
Mansfield, Connecticut

May 31, 2019
CMC 0419120

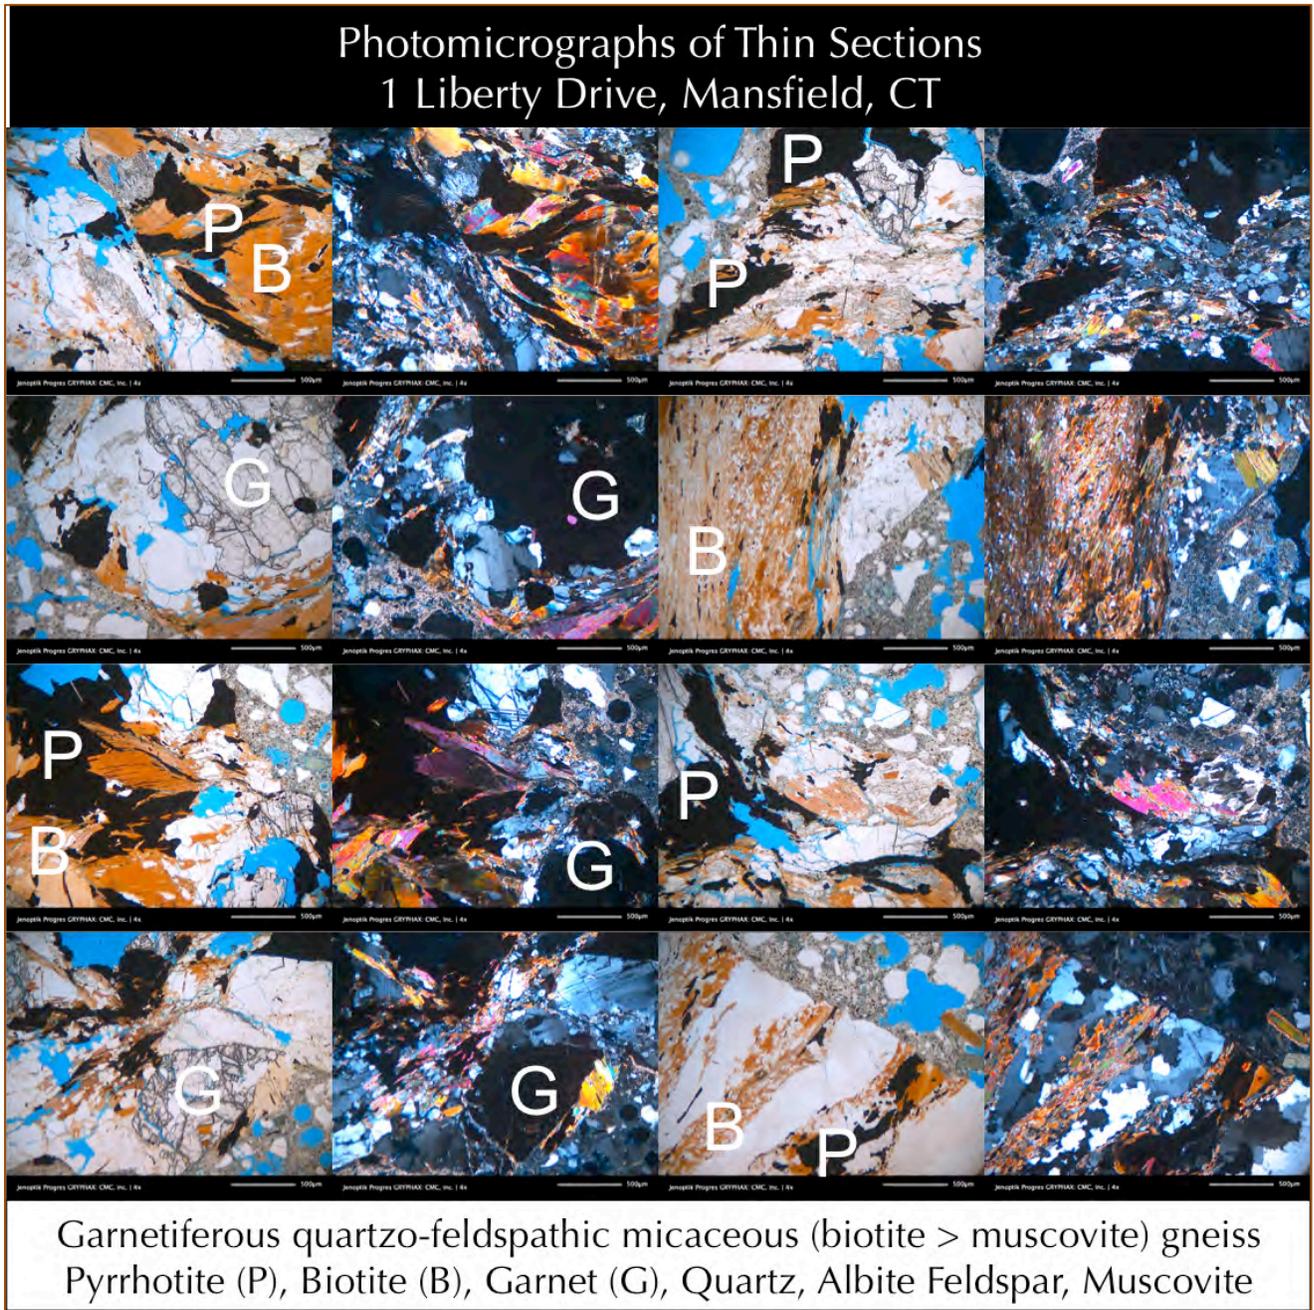
Figure 27: Photomicrographs of blue dye-mixed epoxy-impregnated thin section (30 micron thickness) of core from 1 Liberty Drive showing: (a) crushed gneiss coarse aggregate particles having anhedral to subhedral porphyroblasts of garnet (marked as 'G') and alternating bands of light-colored quartzo-feldspathic and dark brown colored pleochroic biotite (marked as 'B') and light-colored muscovite/chlorite micaceous minerals defining the gneissose texture common in these crushed gneiss coarse aggregate particles, and (b) dark opaque iron sulfide and iron oxide minerals (marked as 'P') scattered throughout the grains in fine disseminated forms. Right column photomicrographs in the 2nd and 4th columns were taken in crossed-polarized light modes and left columns in corresponding 1st and 3rd columns were taken in plane polarized modes with a petrographic microscope.

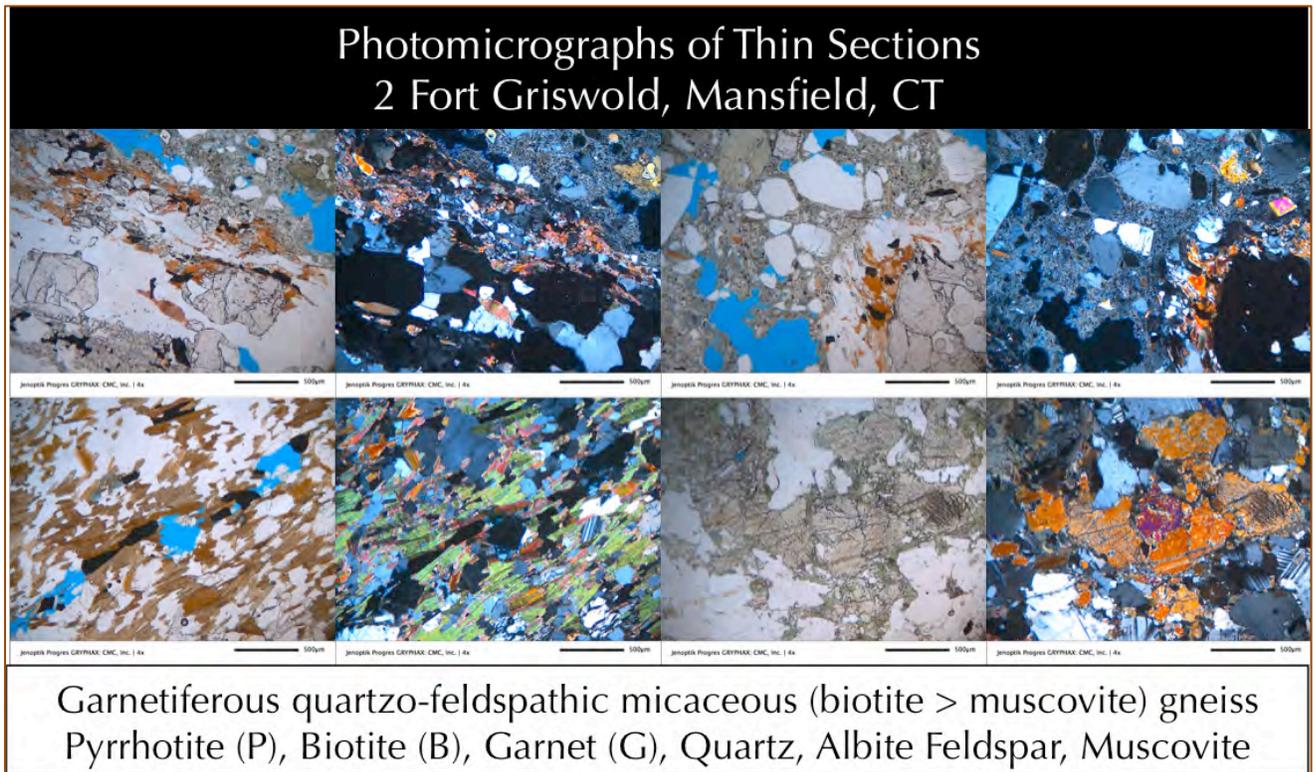
Figure 28: Photomicrographs of blue dye-mixed epoxy-impregnated thin section (30 micron thickness) of core from 2 Fort Griswold showing: (a) crushed gneiss coarse aggregate particles having anhedral to subhedral porphyroblasts of garnet and alternating bands of light-colored quartzo-feldspathic and dark brown colored pleochroic biotite and light-colored muscovite/chlorite micaceous minerals defining the gneissose texture common in these crushed gneiss coarse aggregate particles, and (b) dark opaque iron sulfide and iron oxide minerals scattered throughout the grains in fine disseminated forms. Right column photomicrographs in the 2nd and 4th columns were taken in crossed-polarized light modes and left columns in corresponding 1st and 3rd columns were taken in plane polarized modes with a petrographic microscope. Notice some clinopyroxene grains in coarse aggregate in the bottom photos in 3rd and 4th columns. Notice parallel alignment of fine lath-shaped biotite mica in the bottom 1st and 2nd column photos, which define the gneissose texture of crushed gneiss coarse aggregate. The top photos in the 1st and 2nd columns show plane and crossed polarized light photos of garnet porphyroblasts in parallel alignment to micaceous layers of gneiss.

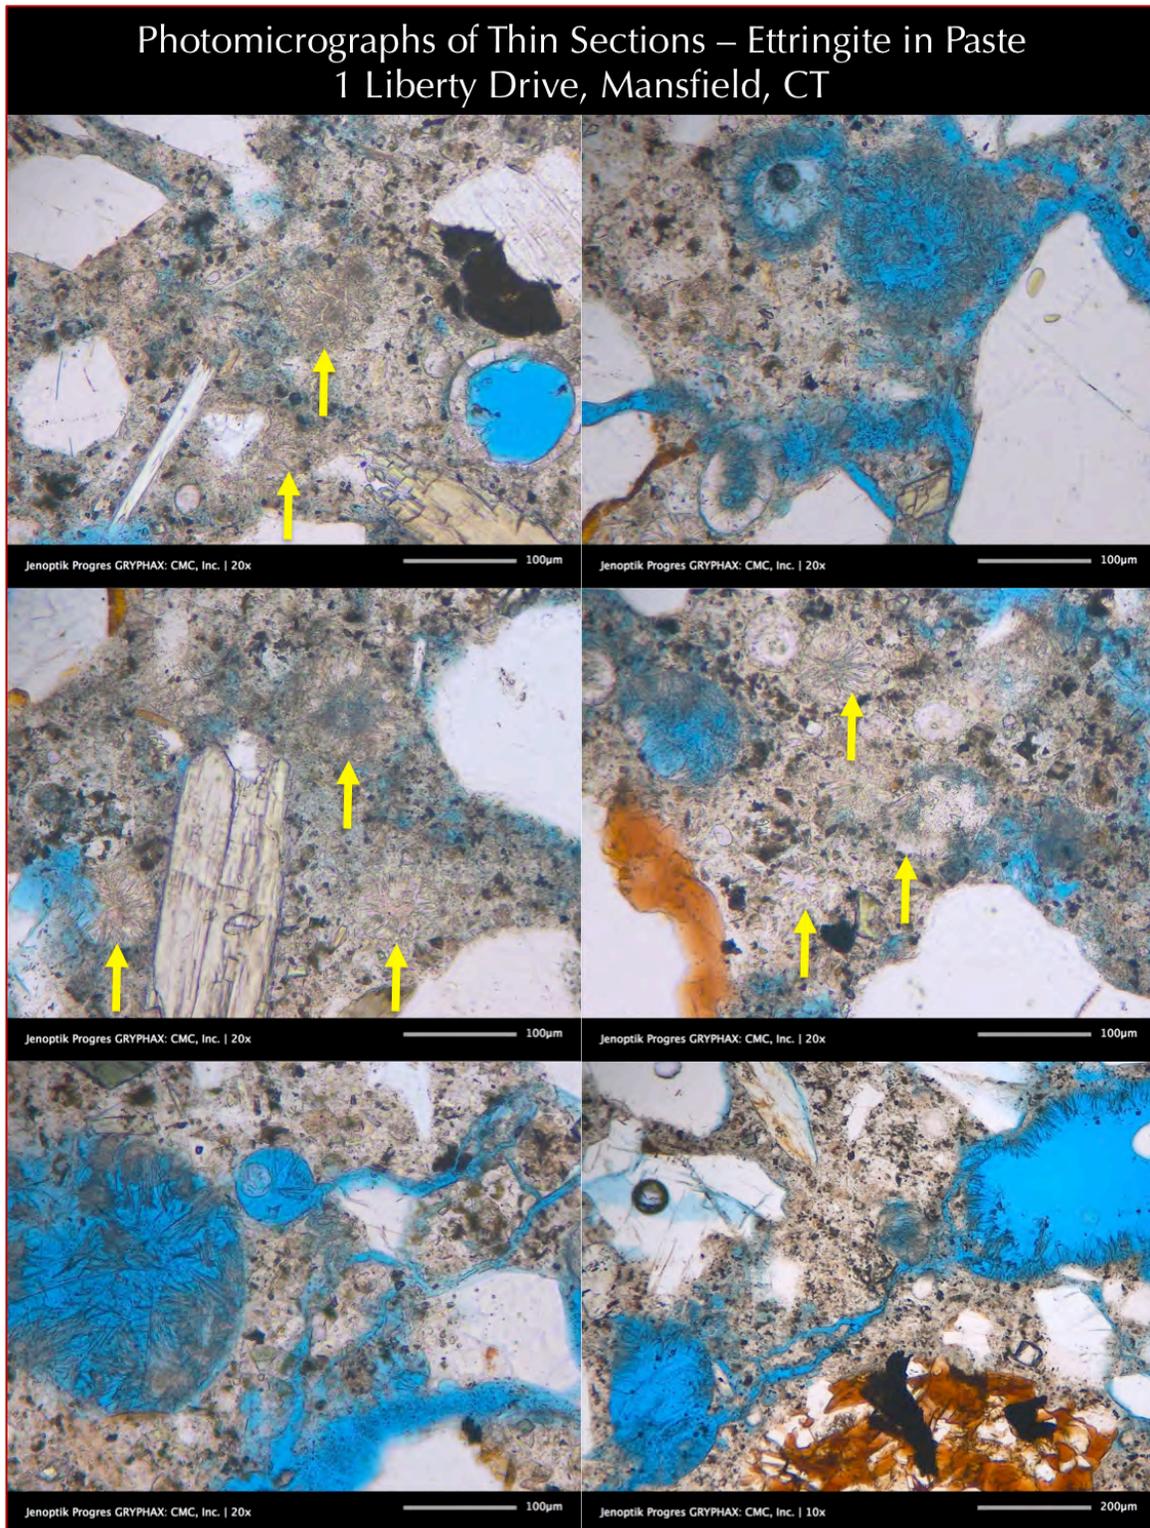
Figure 29: Photomicrographs of blue dye-mixed epoxy-impregnated thin section (30 micron thickness) of core from 1 Liberty Drive showing the mortar fraction of concrete away from crushed gneiss coarse aggregate particles. Notice many fine, fibrous and acicular secondary ettringite deposits lining the walls of coarse voids as well as filling the smaller voids, secondary ettringite in cracks, and also in confined areas in paste (many are marked with arrows).

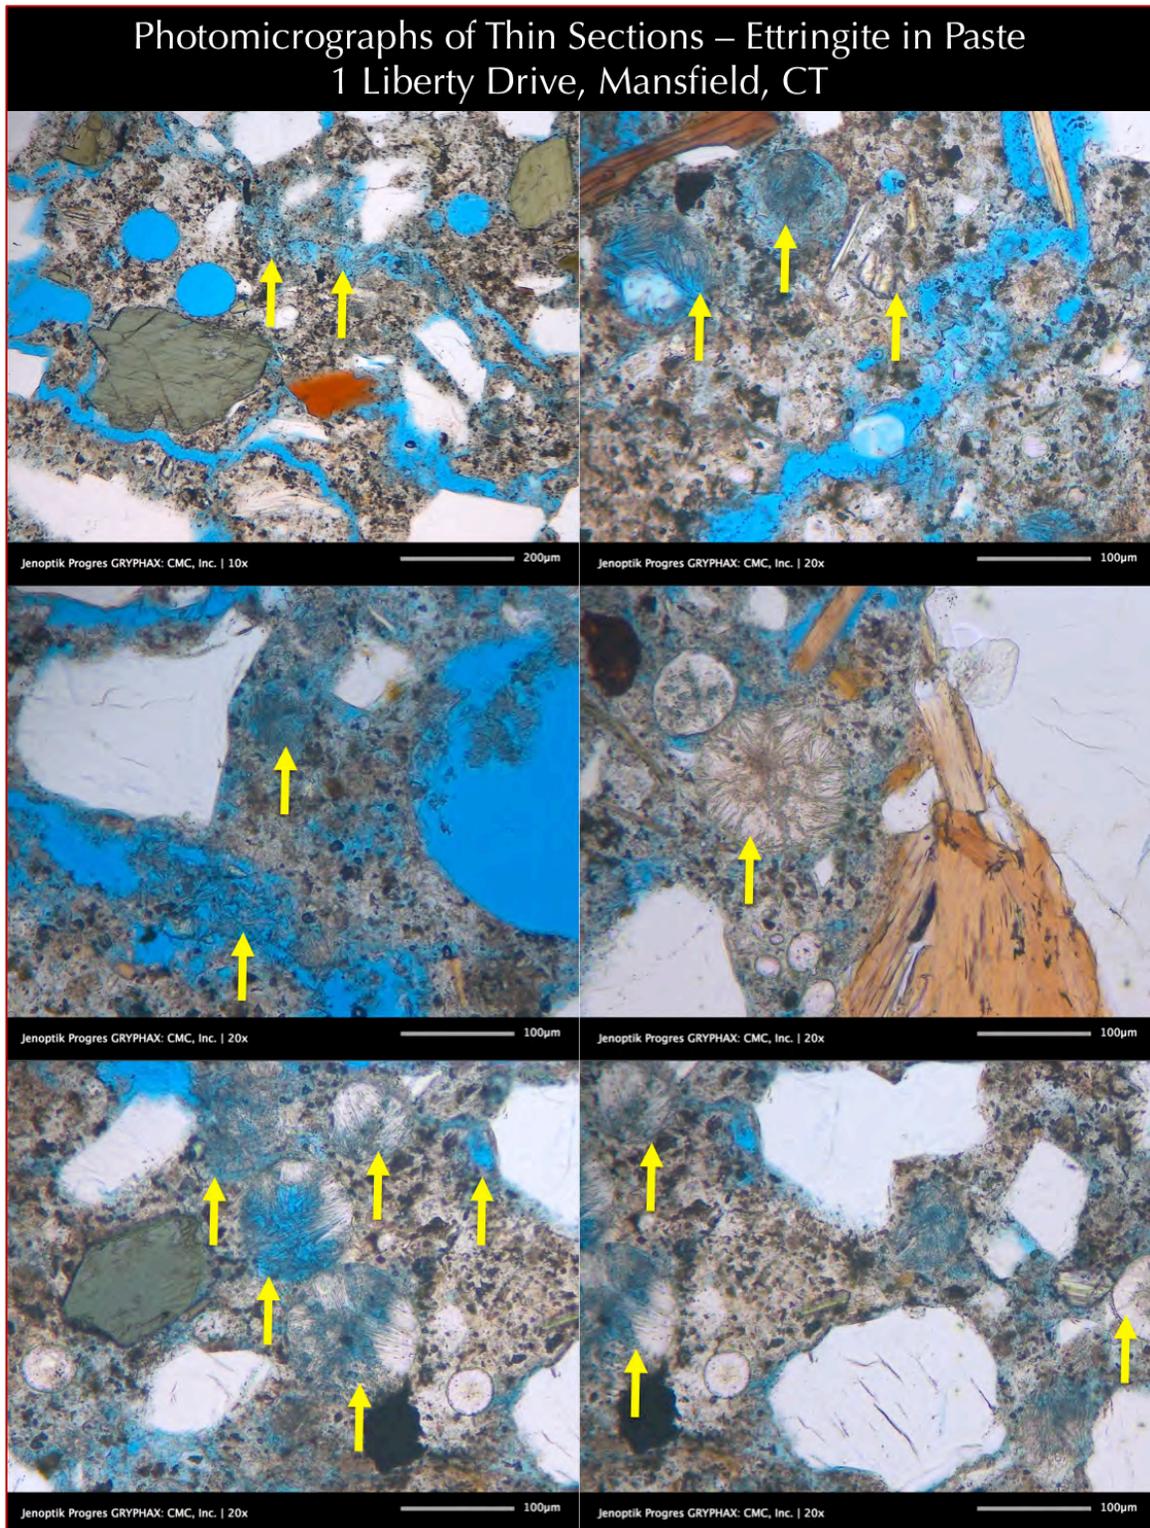
Figure 30: Photomicrographs of blue dye-mixed epoxy-impregnated thin section (30 micron thickness) of core from 1 Liberty Drive showing the mortar fraction of concrete away from crushed gneiss coarse aggregate particles. Notice many fine, fibrous and acicular secondary ettringite deposits lining the walls of coarse voids as well as filling the smaller voids, and secondary ettringite in cracks (many are marked with arrows).

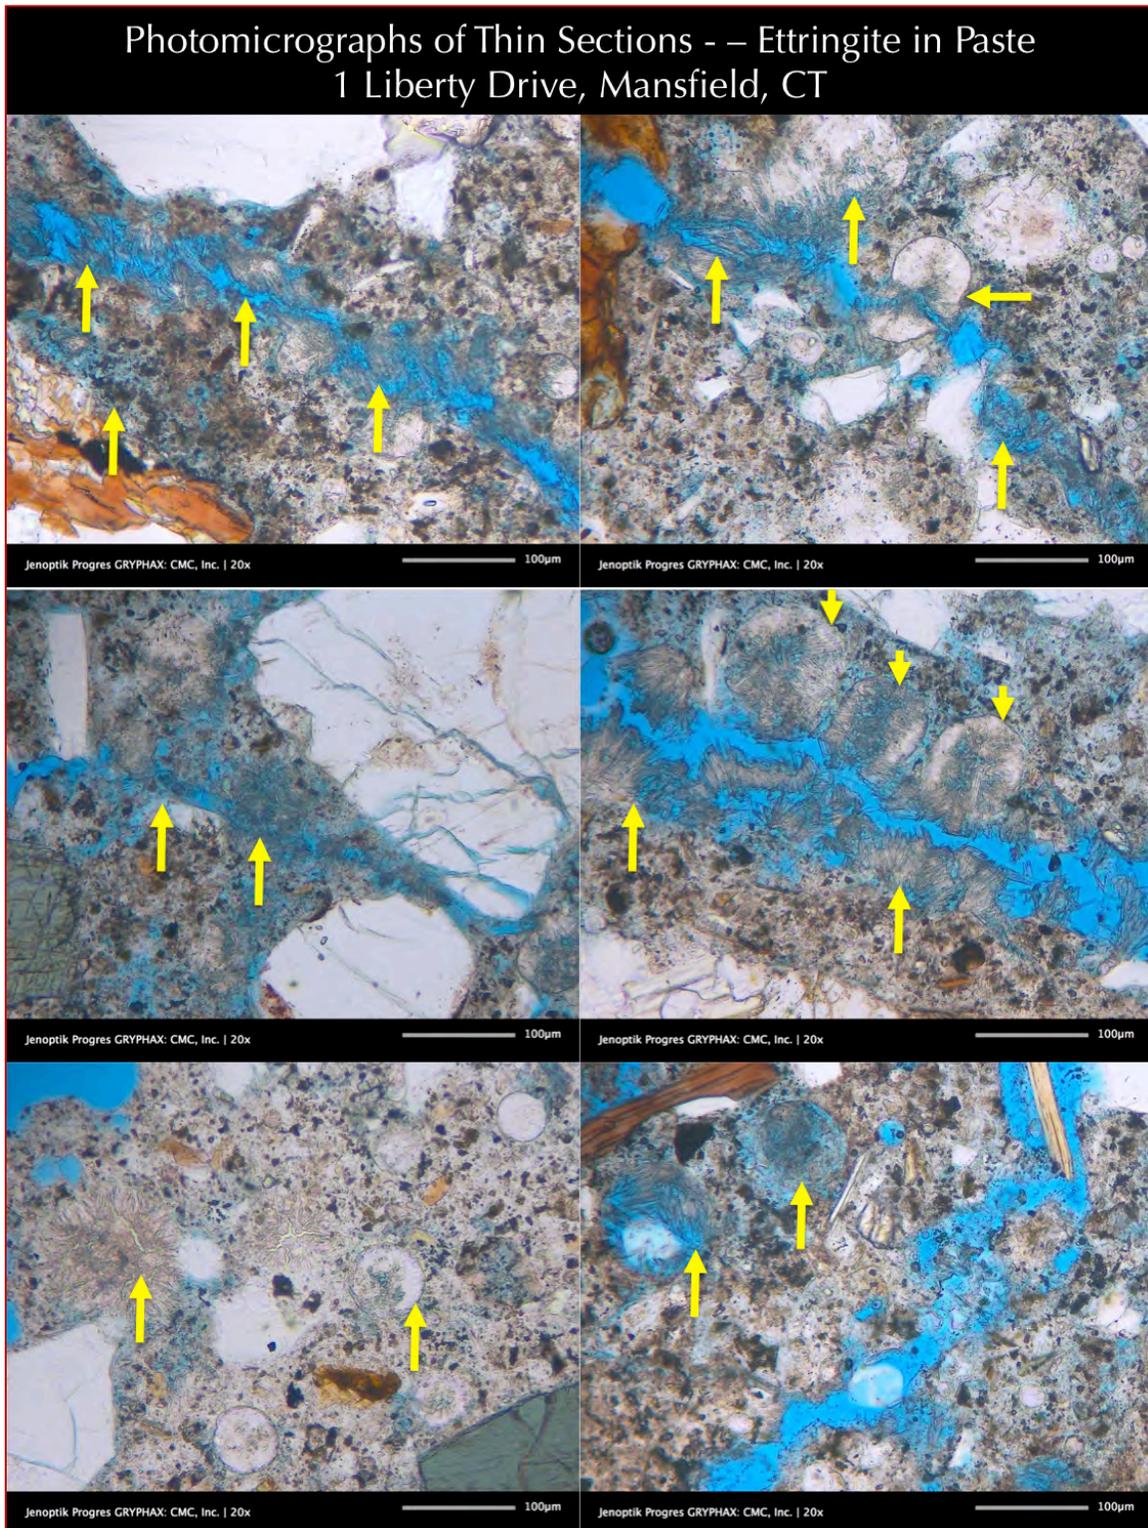
Figure 31: Photomicrographs of blue dye-mixed epoxy-impregnated thin section (30 micron thickness) of core from 1 Liberty Drive showing the mortar fraction of concrete away from crushed gneiss coarse aggregate particles. Notice many fine, fibrous and acicular secondary ettringite deposits lining the walls of coarse voids as well as filling the smaller voids, and secondary ettringite in cracks (many are marked with arrows).

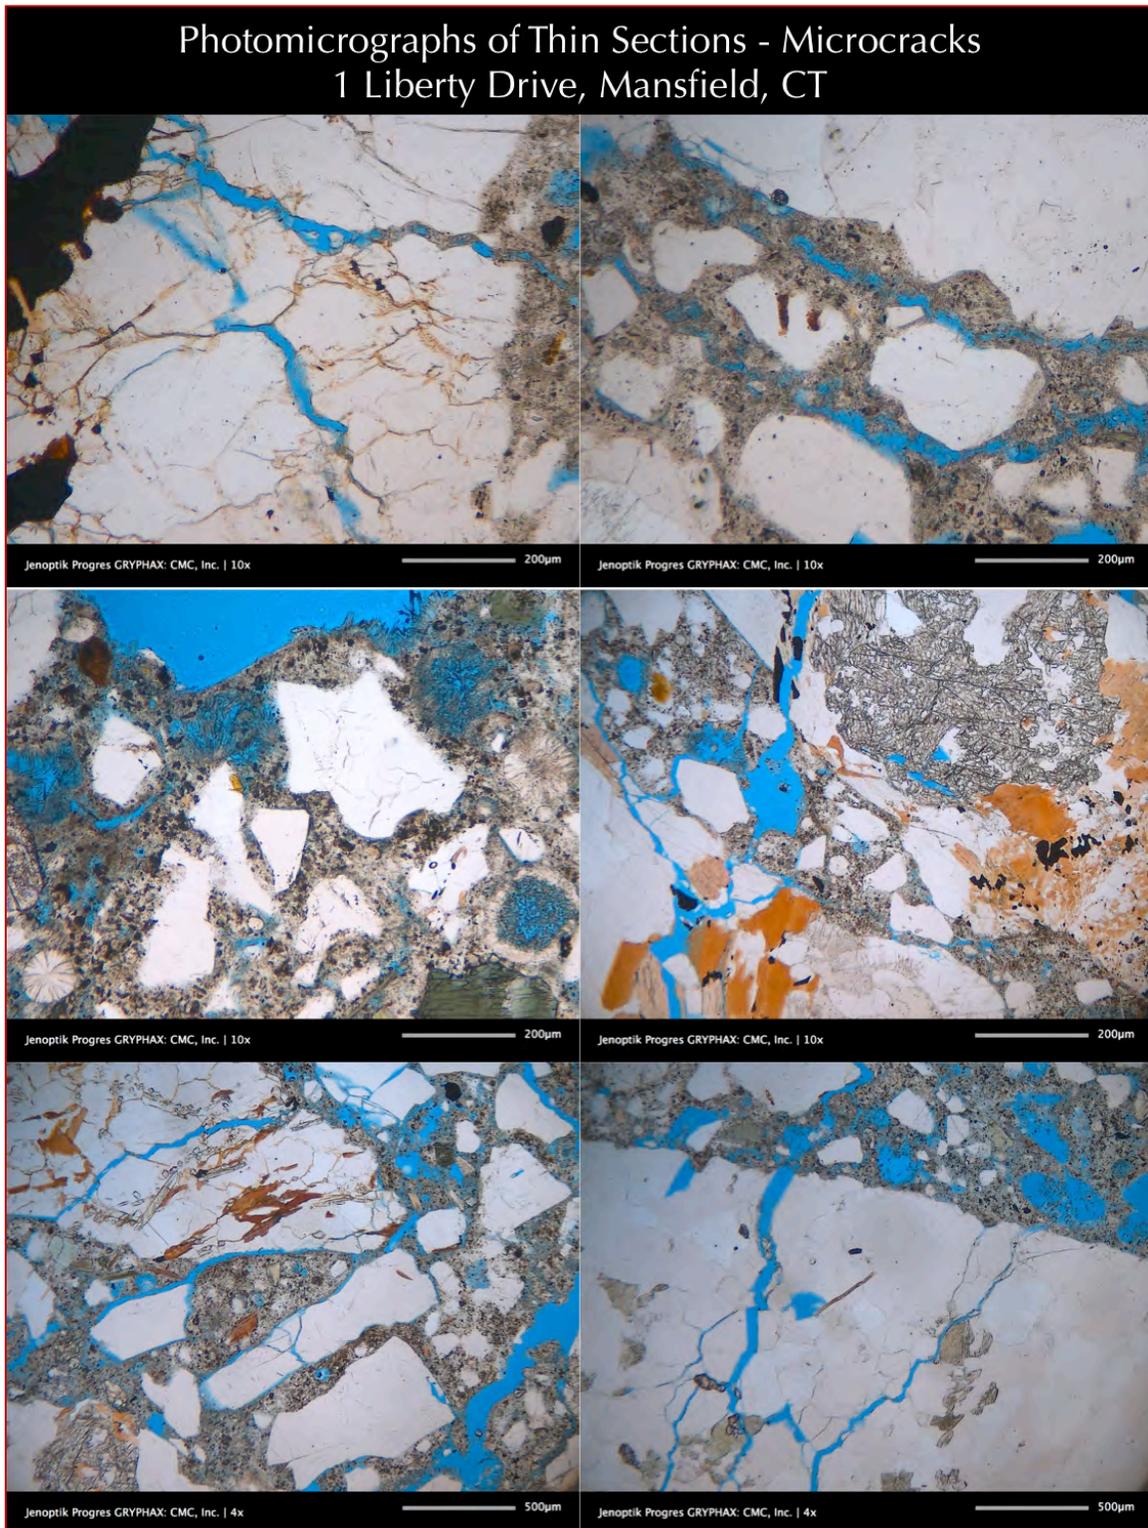
Figure 32 Photomicrographs of blue dye-mixed epoxy-impregnated thin section (30 micron thickness) of core from 1 Liberty Drive showing the mortar fraction of concrete away from crushed gneiss coarse aggregate particles. Notice many fine, fibrous and acicular secondary ettringite deposits lining the walls of coarse voids as well as filling the smaller voids, secondary ettringite in cracks, and also in confined areas in paste. Notice extensive cracking in concrete through aggregates and paste.

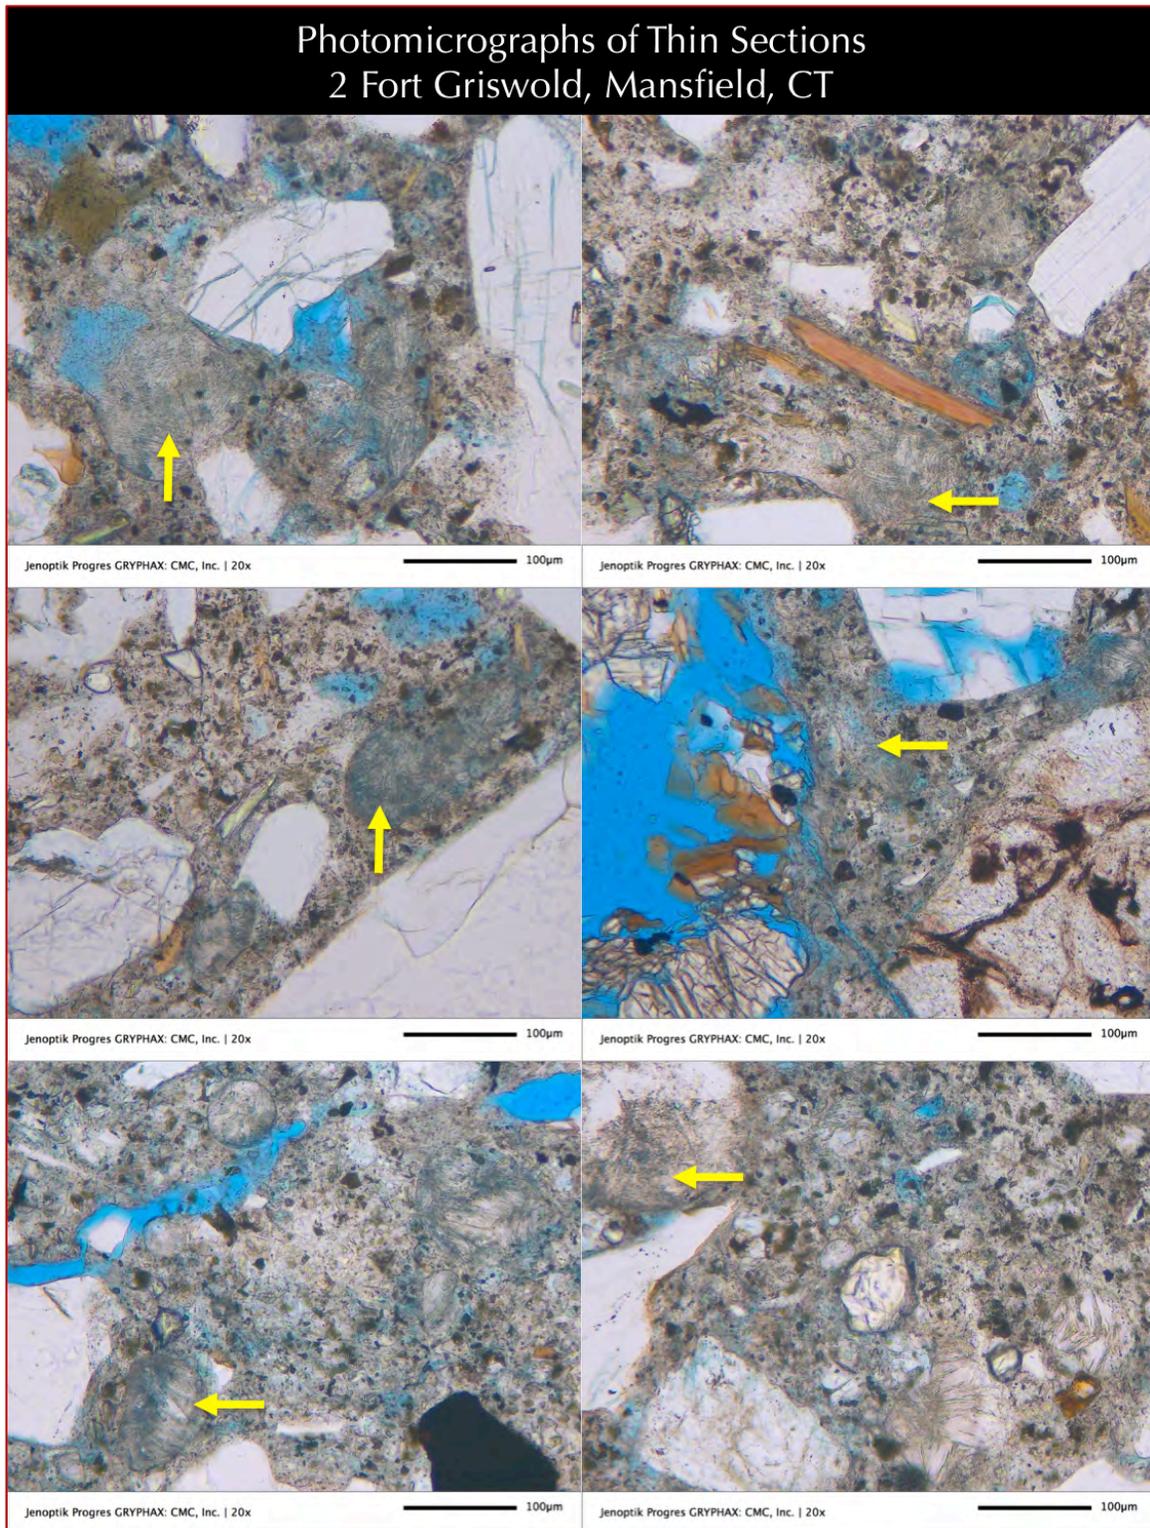
Figure 33: Photomicrographs of blue dye-mixed epoxy-impregnated thin section (30 micron thickness) of core from 2 Fort Griswold showing the mortar fraction of concrete away from crushed gneiss coarse aggregate particles. Notice many fine, fibrous and acicular secondary ettringite deposits lining the walls of coarse voids as well as filling the smaller voids, secondary ettringite in cracks, and also in confined areas in paste (many are marked with arrows).

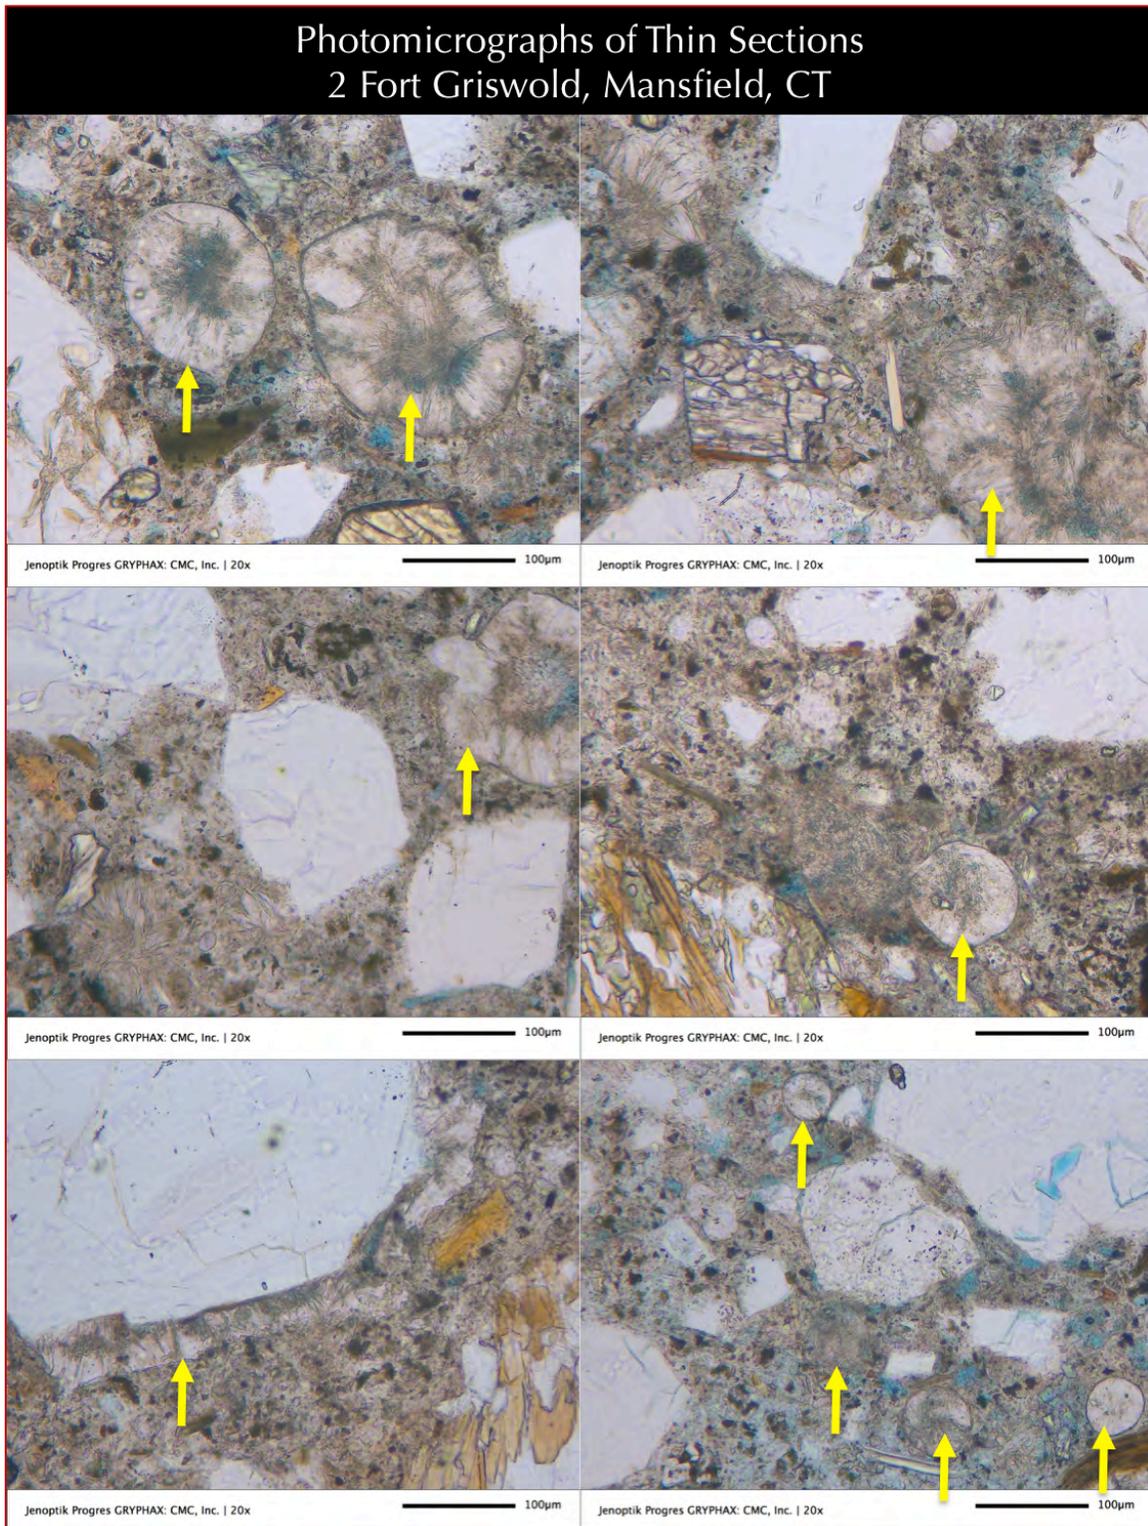
Figure 34: Photomicrographs of blue dye-mixed epoxy-impregnated thin section (30 micron thickness) of core from 2 Fort Griswold showing the mortar fraction of concrete away from crushed gneiss coarse aggregate particles. Notice many fine, fibrous and acicular secondary ettringite deposits lining the walls of coarse voids as well as filling the smaller voids, secondary ettringite in cracks, and also in confined areas in paste (many are marked with arrows).

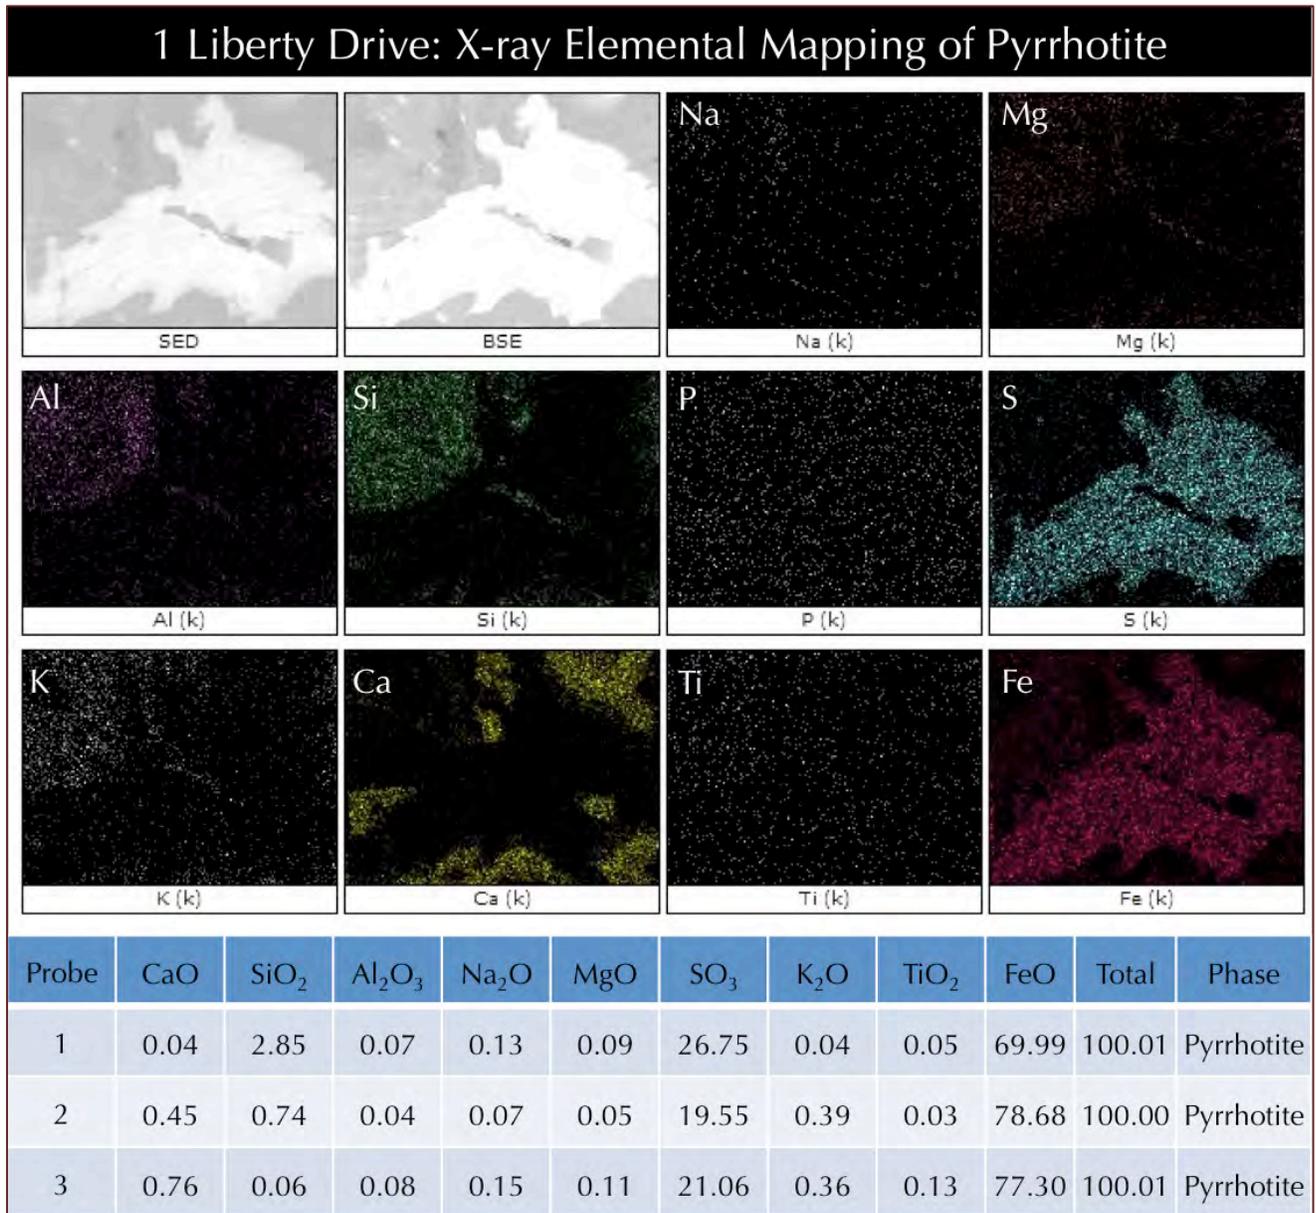
Figure 35: Secondary electron image (top left), corresponding backscatter electron image (2nd from top left) and corresponding X-ray elemental maps (rest) of Core from 1 Liberty Drive showing pyrrhotite grains highlighted in iron (Fe) and sulfur (S) maps, calcium silicate hydrate paste highlighted in calcium (Ca) and silicon (Si) maps, and feldspar grains in aggregate highlighted in aluminum (Al), silicon (Si), and potassium (K) maps. The bottom Table shows compositional analysis of pyrrhotite grains showing 70 to 78% FeO and 20 to 26% SO₃.

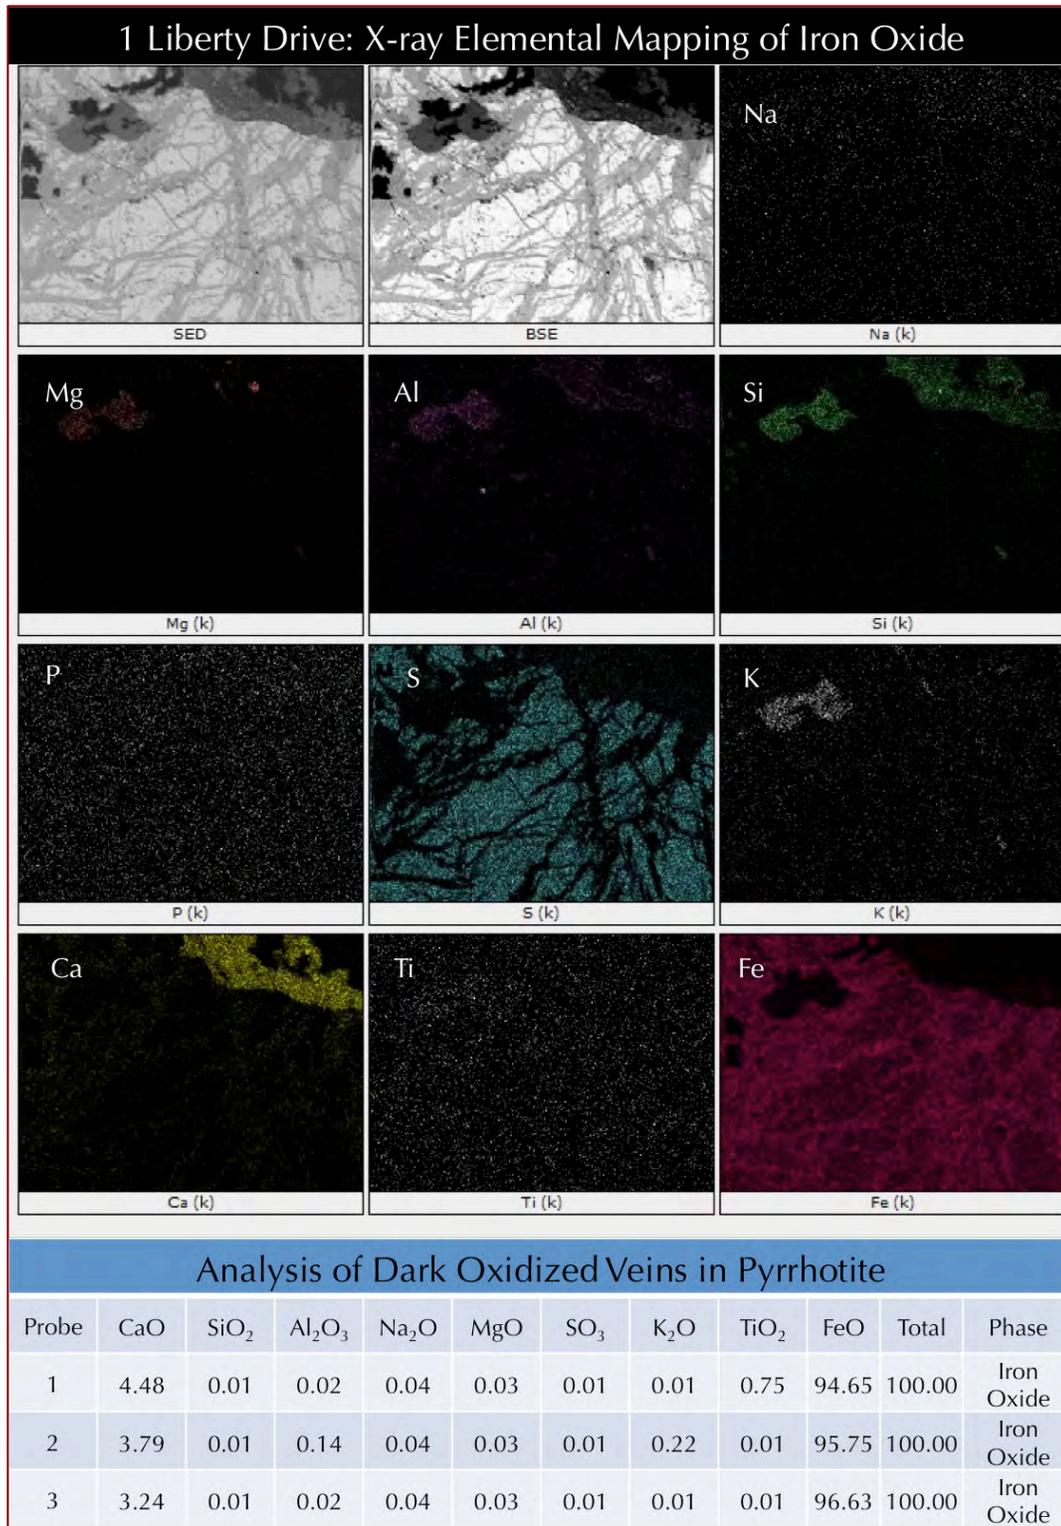
Figure 36: Secondary electron image (top left), corresponding backscatter electron image (2nd from top left) and corresponding X-ray elemental maps (rest) of Core from 1 Liberty Drive showing pyrrhotite grains highlighted in iron (Fe) and sulfur (S) maps, oxidized iron within pyrrhotite that appear as dark veins in S map, calcium silicate hydrate paste highlighted in calcium (Ca) and silicon (Si) maps, and feldspar grains in aggregate highlighted in aluminum (Al), silicon (Si), and potassium (K) maps. Some biotite grains are highlighted in Mg map. The bottom Table shows compositional analysis of oxidized iron veins in pyrrhotite showing 95 to 96% FeO.

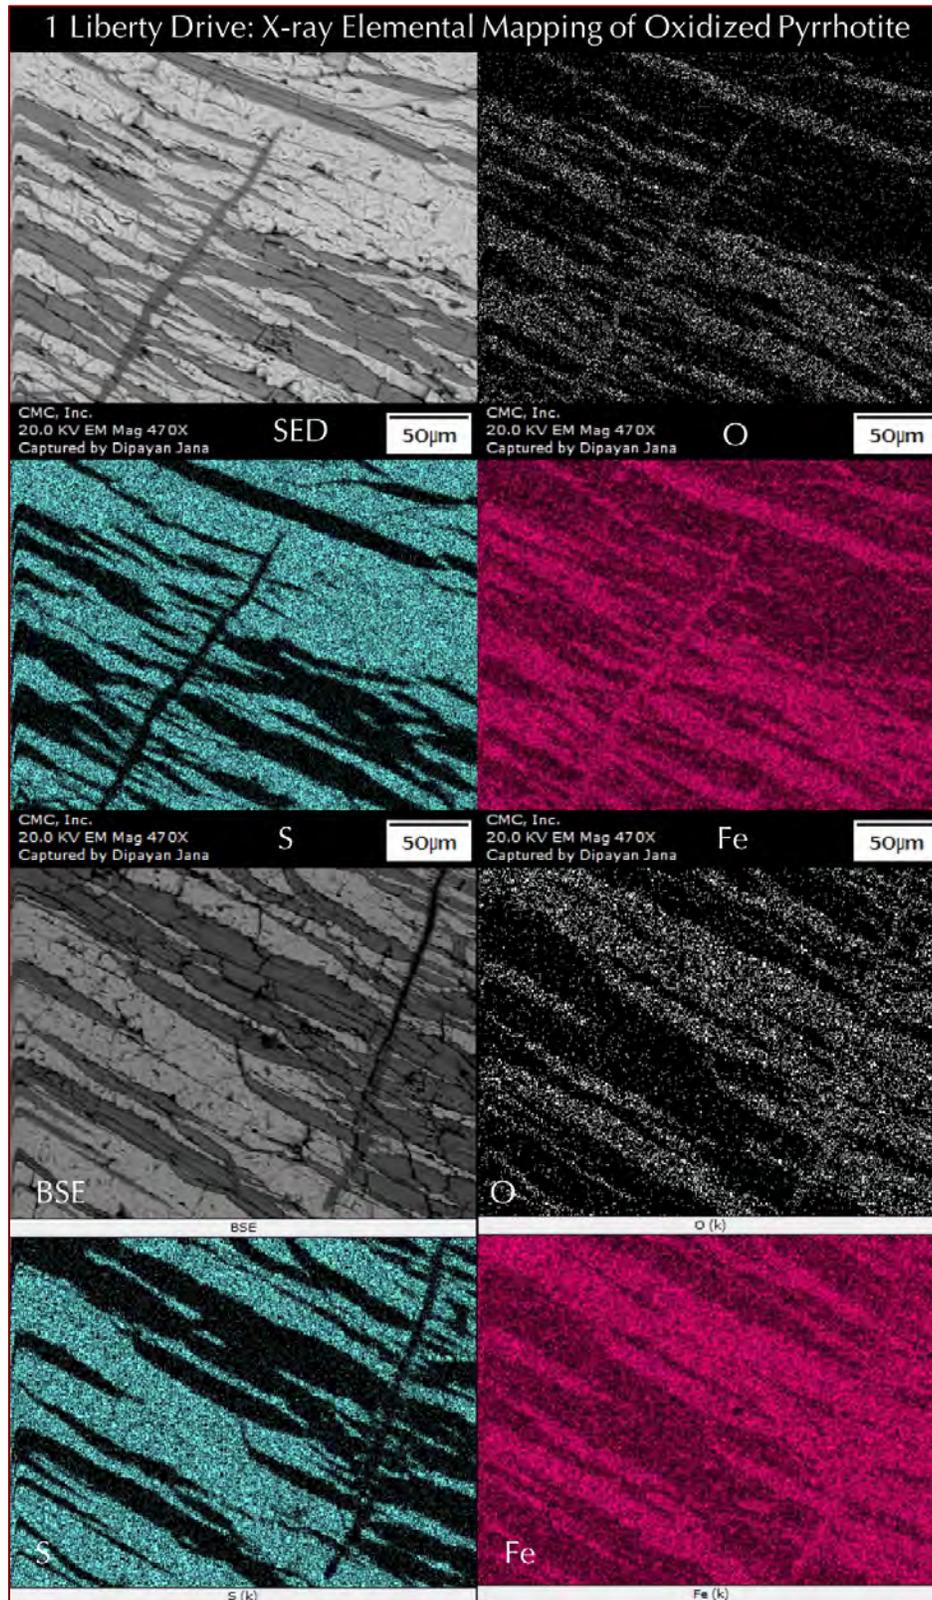
Figure 37: Secondary electron image (top left) and corresponding X-ray elemental maps of an oxidized pyrrhotite grain showing veins of oxidized iron within the pyrrhotite as highlighted by iron (Fe) and oxygen (O) maps for oxidized iron veins, which appear as dark veins in S-map within the pyrrhotite as highlighted in Fe and S maps. Similar compositional features are seen in another oxidized pyrrhotite grain in the bottom two rows.

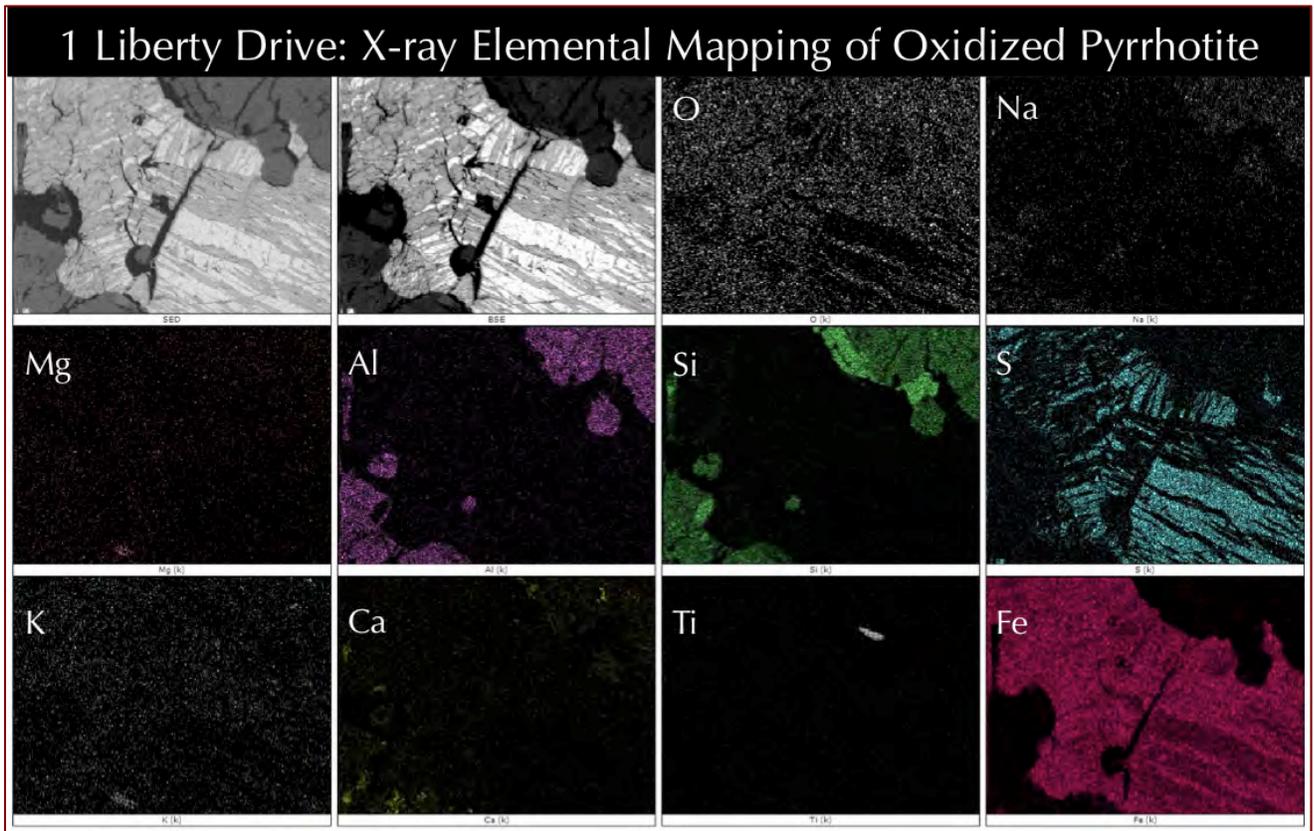
Figure 38: Secondary electron image (top left), corresponding backscatter electron image (2nd from top left) and corresponding X-ray elemental maps (rest) of Core from 1 Liberty Drive showing a veined oxidized pyrrhotite grain highlighted in iron (Fe) and sulfur (S) maps, that has veins of oxidized iron as highlighted in Fe and O maps (which appear as dark veins in S map).

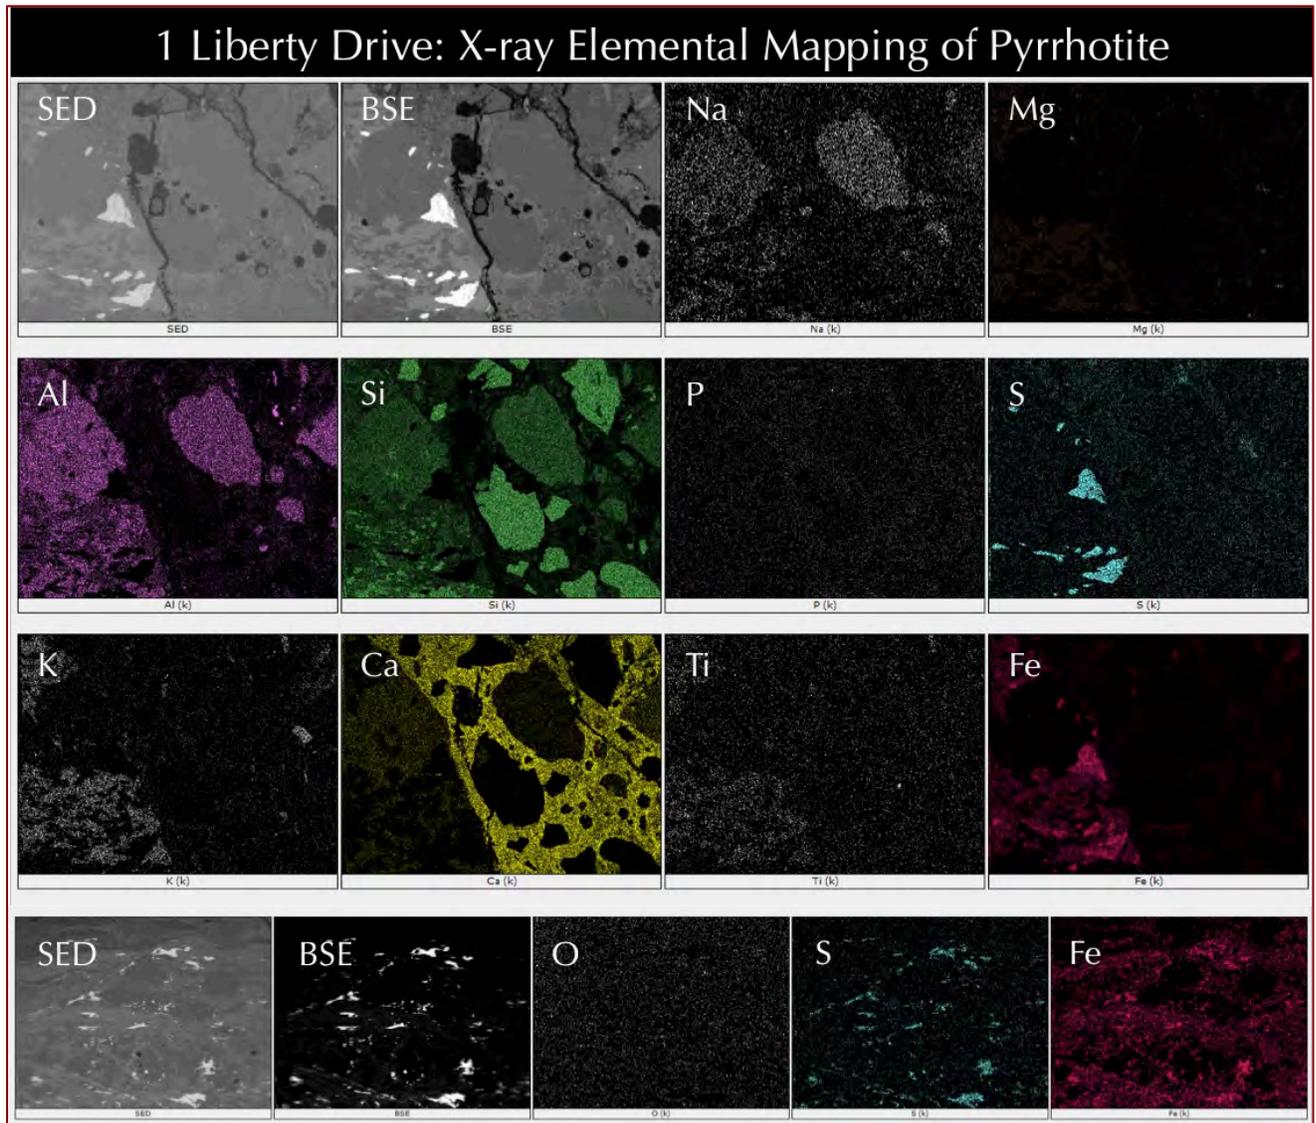
Figure 39: Secondary electron image (top left), corresponding backscatter electron image (2nd from top left) and corresponding X-ray elemental maps (rest) of Core from 1 Liberty Drive showing disseminated pyrrhotite grains highlighted in iron (Fe) and sulfur (S) maps, calcium silicate hydrate paste highlighted in calcium (Ca) and silicon (Si) maps, and feldspar grains in aggregate highlighted in aluminum (Al), silicon (Si), and potassium (K) maps. The bottom row shows another area of paste where fine disseminated pyrrhotite grains are seen in Fe and S maps.
