Investigation of Pyrrhotite-Related Deterioration In Residential Concrete Foundations In Mansfield, Connecticut

Villages At Freedom Green Condominium Association, Inc.
1 Liberty Drive and 2 Fort Griswold
Mansfield, Connecticut

May 31, 2019
CMC 0419120

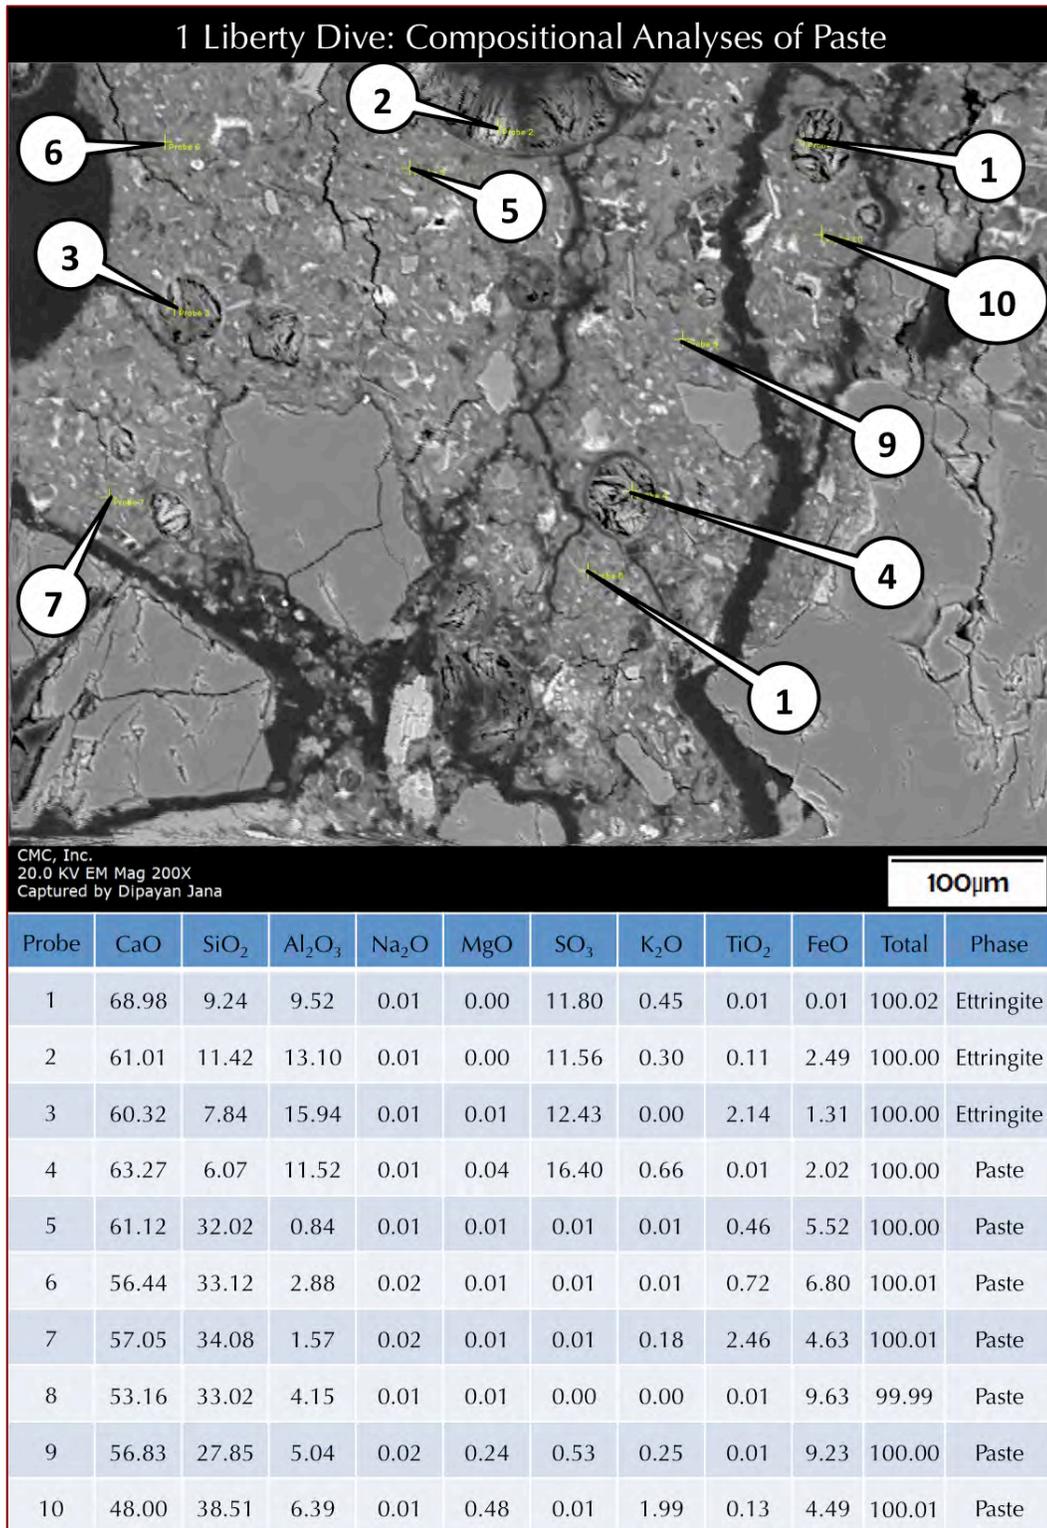
Figure 40: Backscatter electron image (top) and X-ray compositional analyses of concrete in the Core from 1 Liberty Drive showing compositions of secondary ettringite deposits in voids and various areas of paste at the tips of callouts that are provided in the Table below the image. Secondary ettringite shows high Ca, Al, and S whereas paste shows typical calcium silicate hydrate composition with negligible or no evidence of contamination by sulfates released from pyrrhotite oxidation, which is typically found in many other pyrrhotite-related distress in the area.

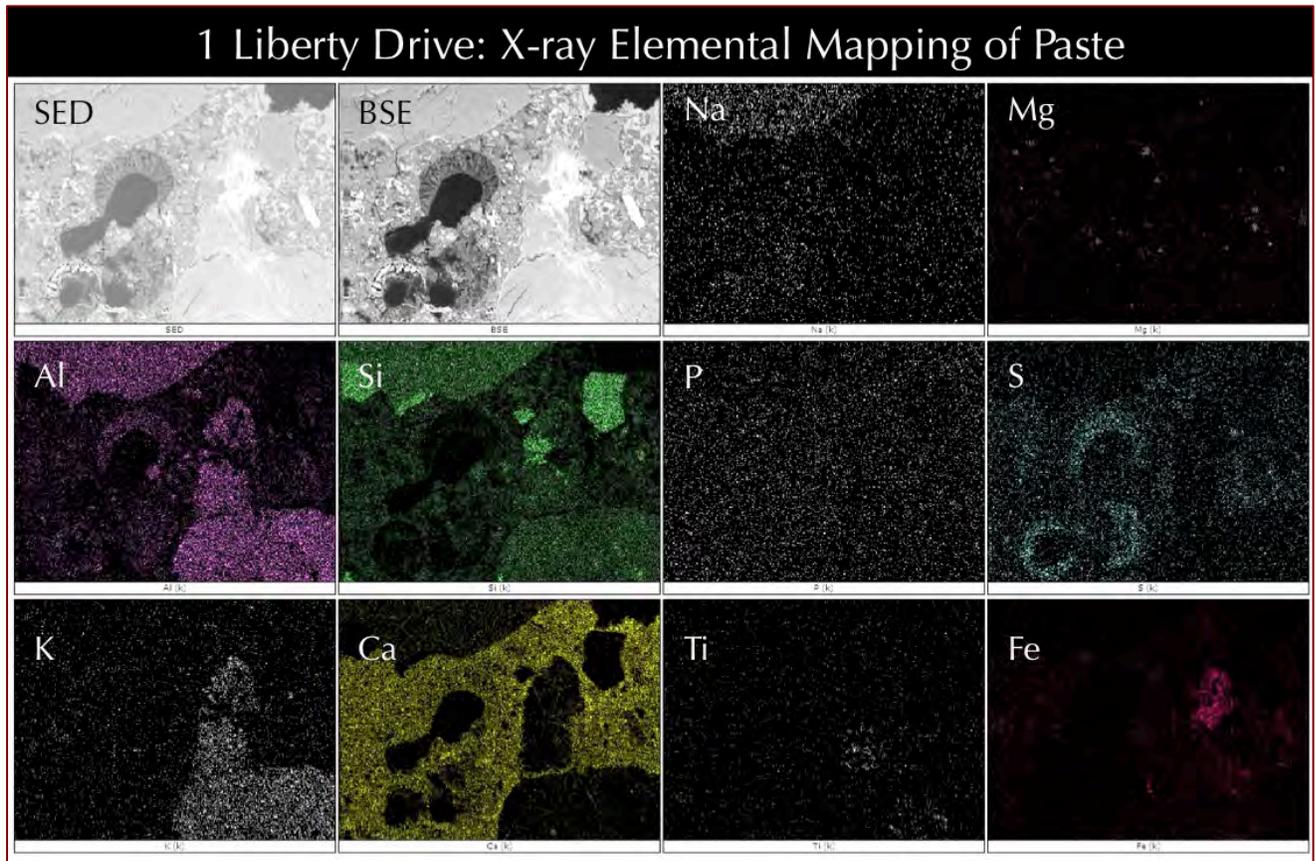
Figure 41: Secondary electron image (top left), corresponding backscatter electron image (2nd from top left) and corresponding X-ray elemental maps (rest) of Core from 1 Liberty Drive showing calcium silicate hydrate paste highlighted in calcium (Ca) and silicon (Si) maps, feldspar grains in aggregate highlighted in aluminum (Al), silicon (Si), and sodium and potassium (Na and K) maps, and secondary ettringite deposits in air voids highlighted in Ca, Al, and S maps.

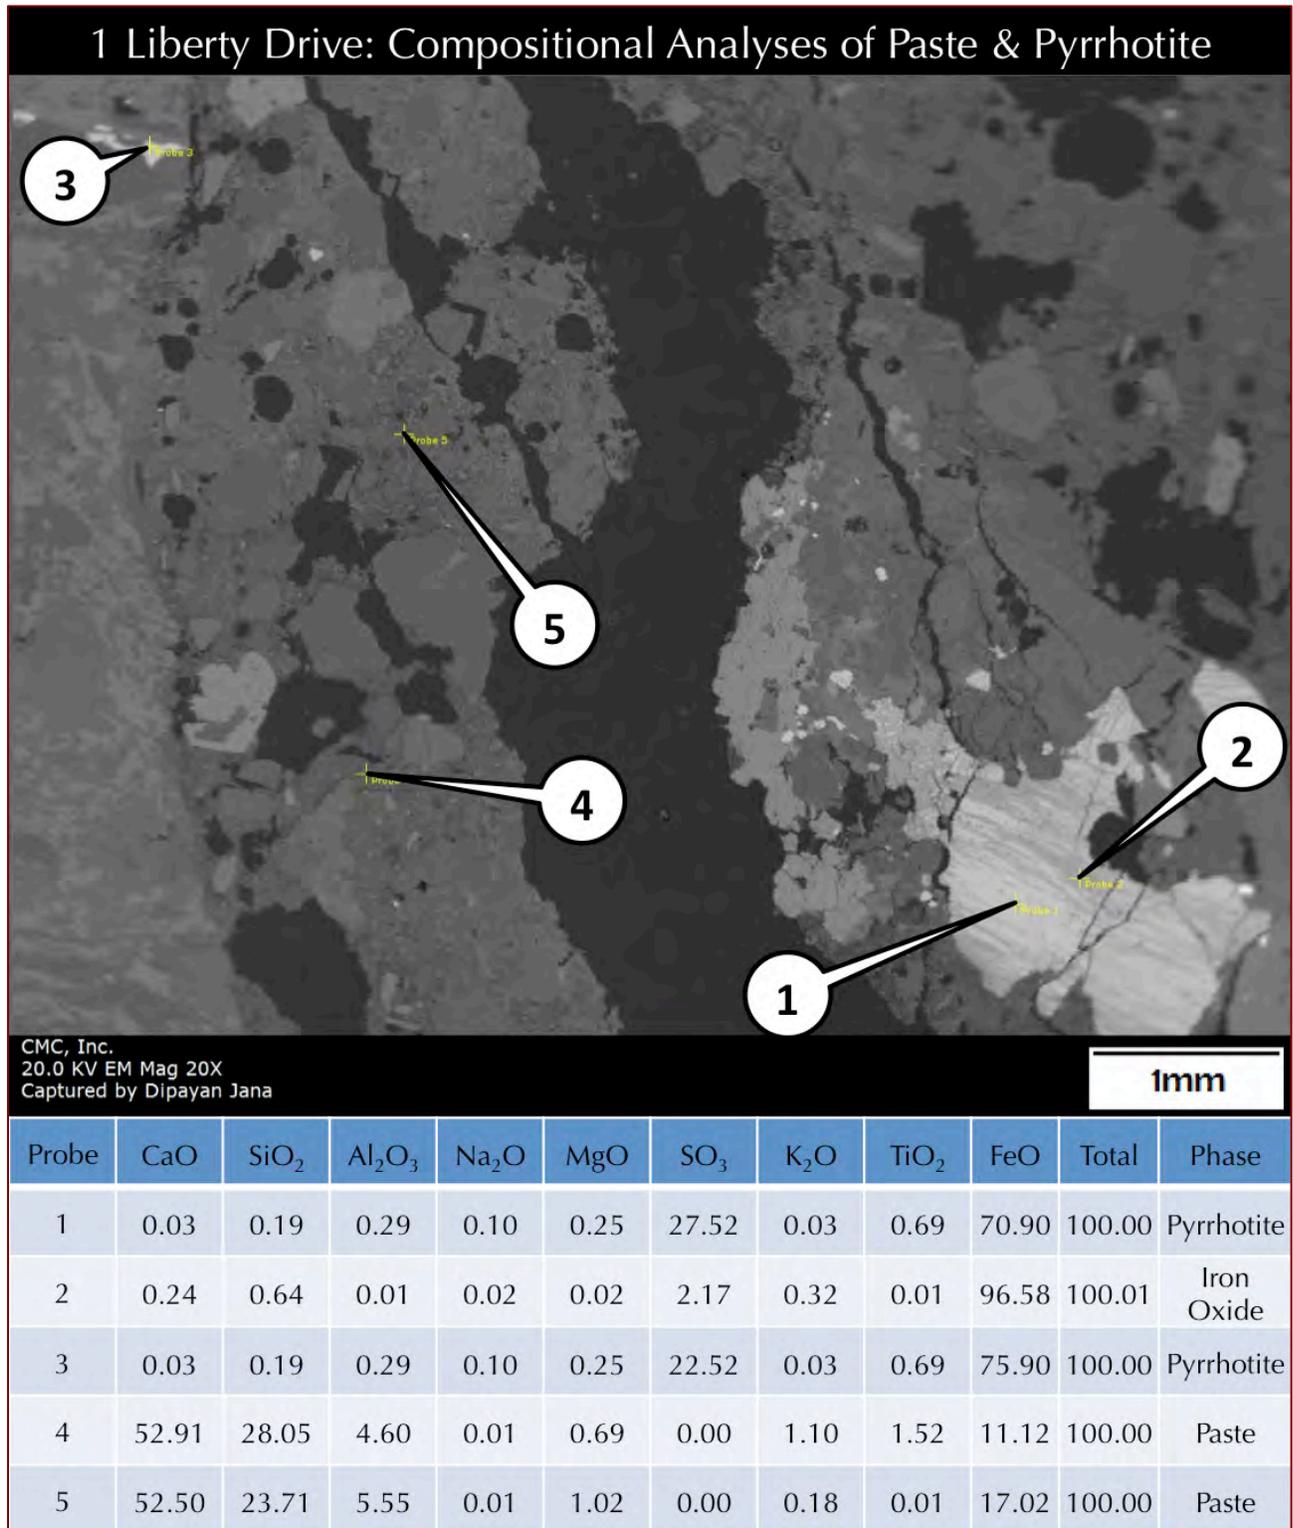
Figure 42: Backscatter electron image (top) and X-ray compositional analyses of concrete in the Core from 1 Liberty Drive showing compositions of pyrrhotite, oxidized iron, and various areas of paste at the tips of callouts that are provided in the Table below the image. Two pyrrhotite grains show typical high FeO and SO₃, oxidized iron veins within pyrrhotite show mostly FeO, whereas paste shows typical calcium silicate hydrate composition with no evidence of contamination by sulfates released from pyrrhotite oxidation, which is typically found in many other pyrrhotite-related distress in the area.

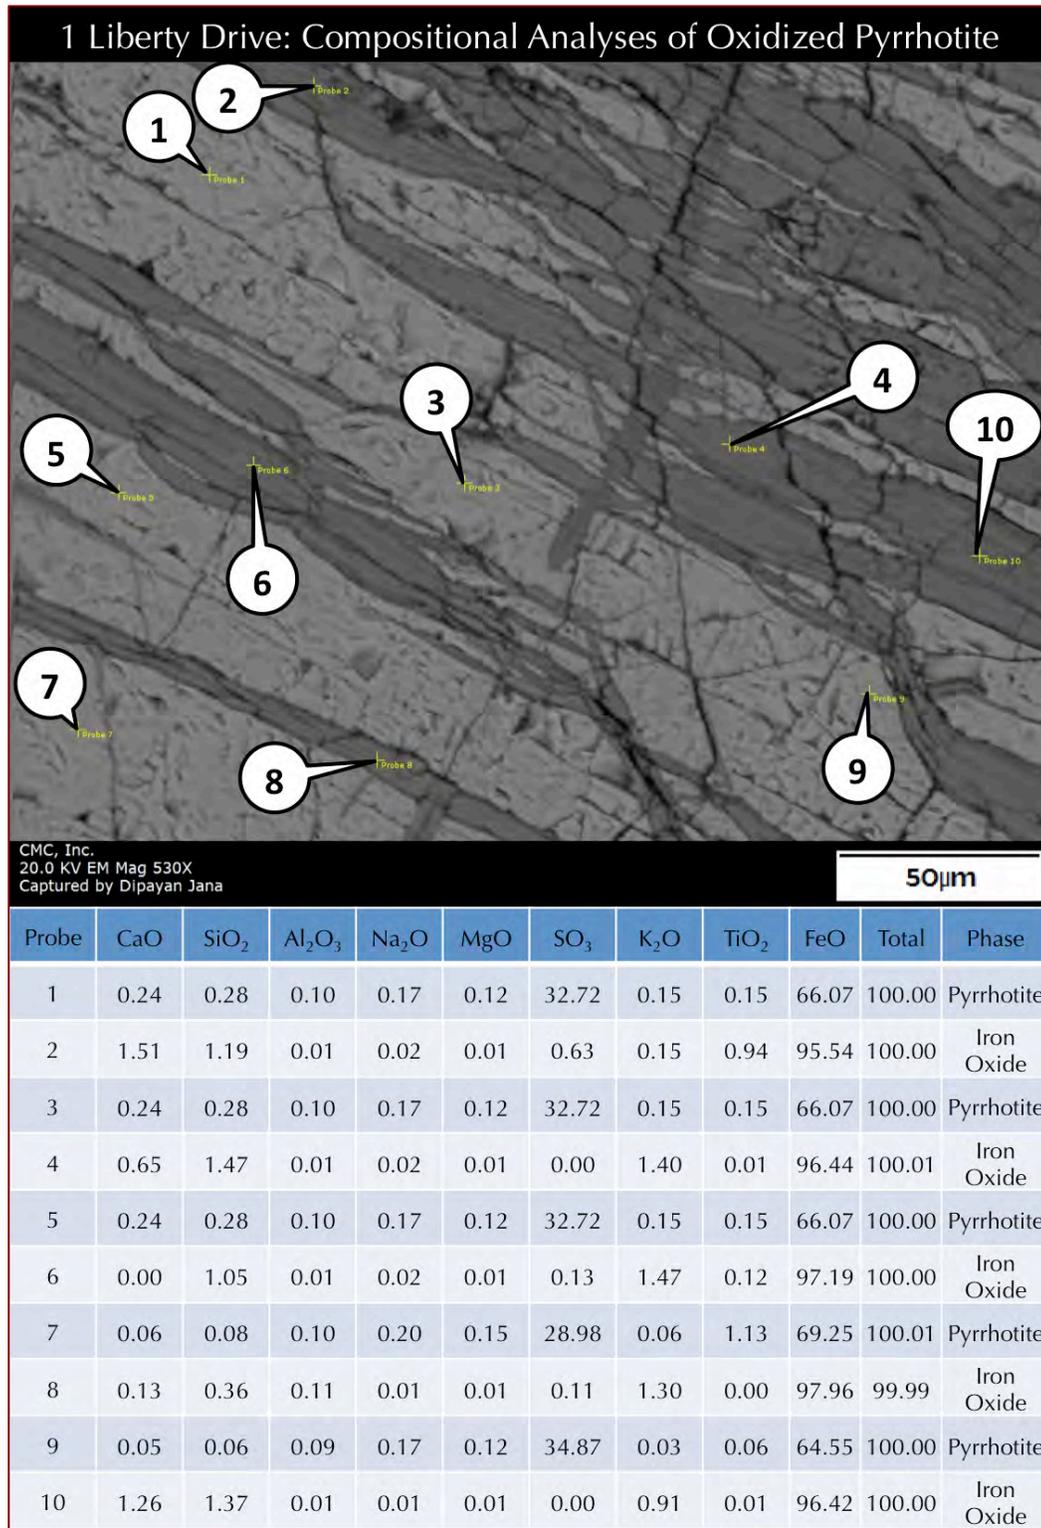
Figure 43: Backscatter electron image (top) and X-ray compositional analyses of concrete in the Core from 1 Liberty Drive showing compositions of oxidized iron veins within a pyrrhotite measured at the tips of callouts that are provided in the Table below the image. Pyrrhotite shows typical high FeO and SO₃ whereas oxidized iron veins within pyrrhotite show mostly FeO.

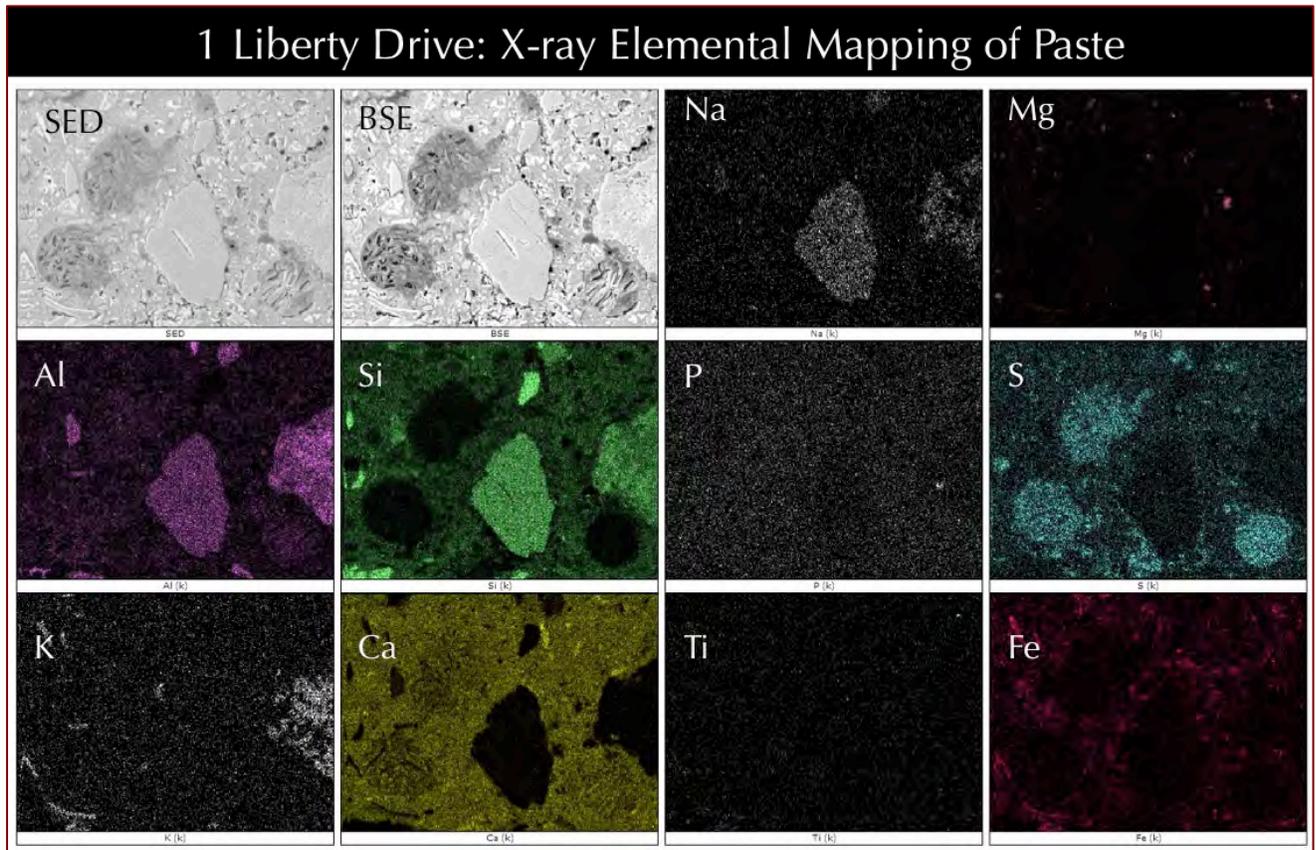
Figure 44: Secondary electron image (top left), corresponding backscatter electron image (2nd from top left) and corresponding X-ray elemental maps (rest) of Core from 1 Liberty Drive showing calcium silicate hydrate paste highlighted in calcium (Ca) and silicon (Si) maps, feldspar grains in aggregate highlighted in aluminum (Al), silicon (Si), and sodium and potassium (Na and K) maps, and secondary ettringite deposits in air voids highlighted in Ca, Al, and S maps.

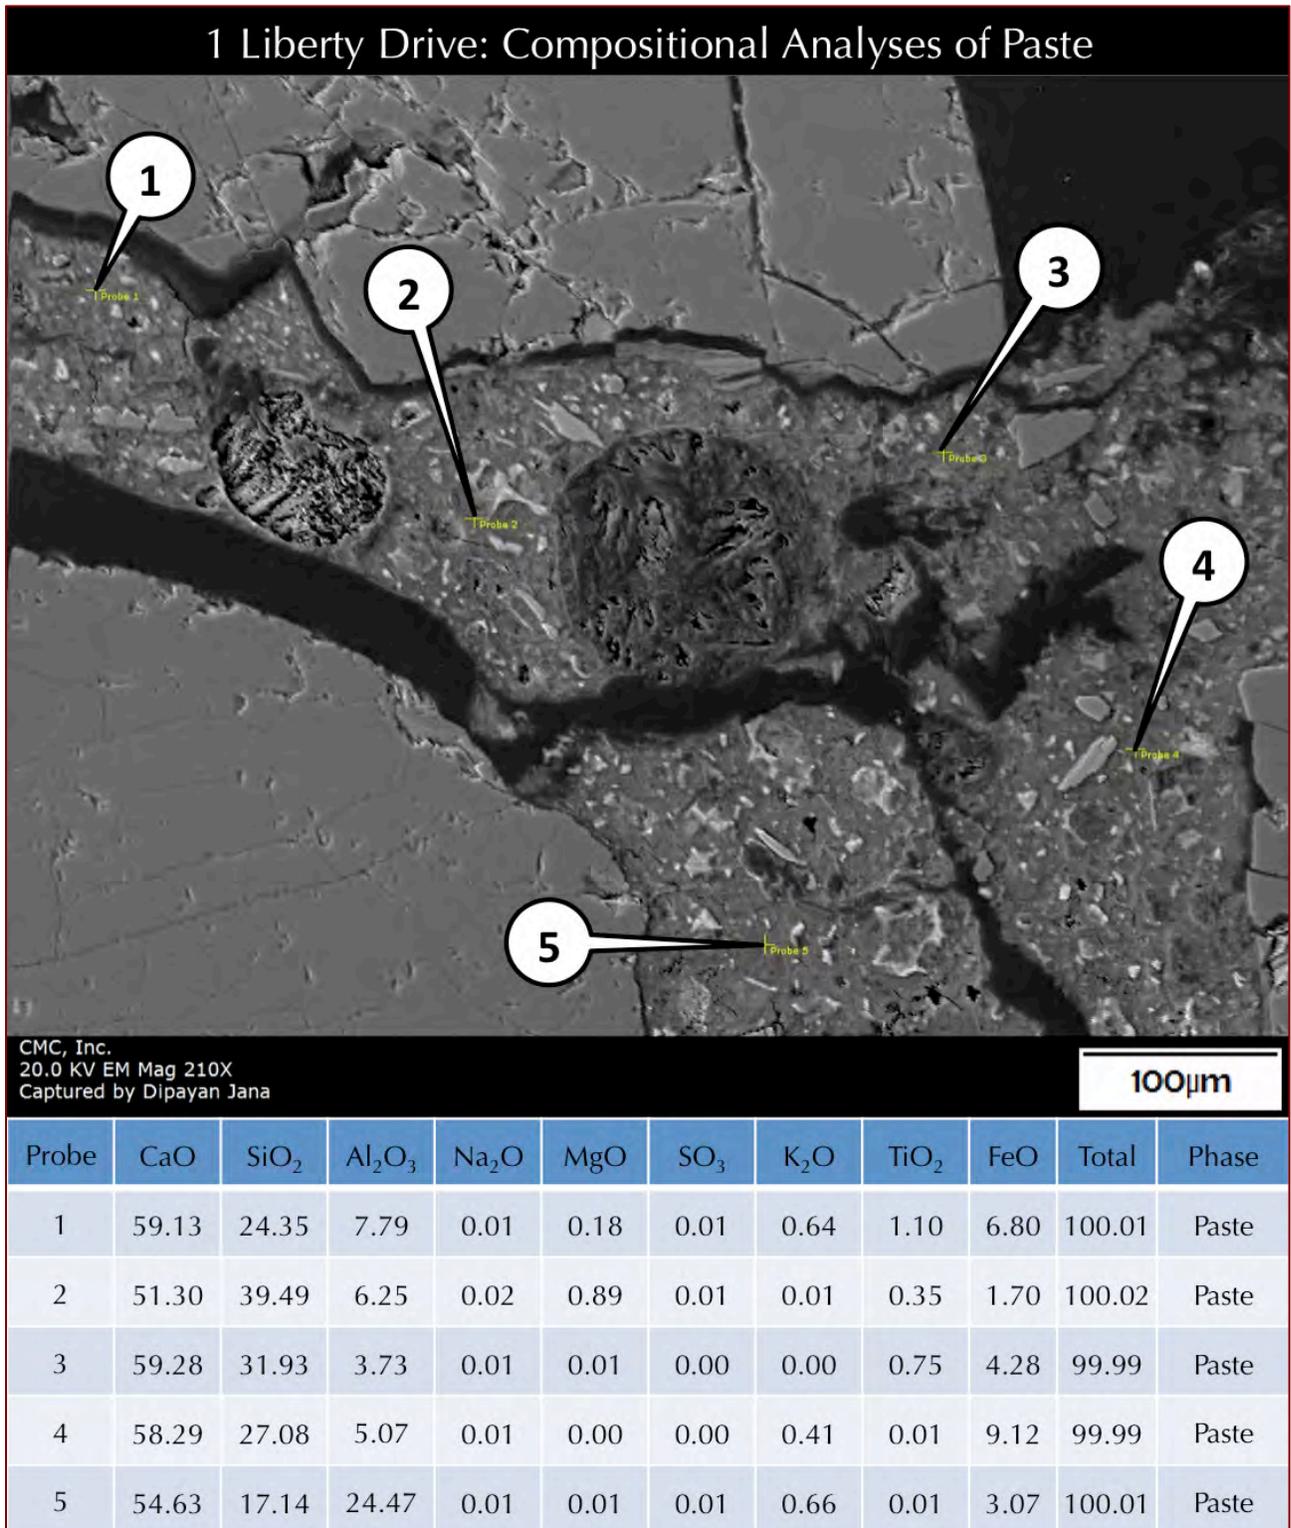
Figure 45: Backscatter electron image (top) and X-ray compositional analyses of concrete in the Core from 1 Liberty Drive showing compositions of various areas of paste at the tips of callouts that are provided in the Table below the image. Paste shows typical calcium silicate hydrate composition with negligible or no evidence of contamination by sulfates released from pyrrhotite oxidation, which is typically found in many other pyrrhotite-related distress in the area.

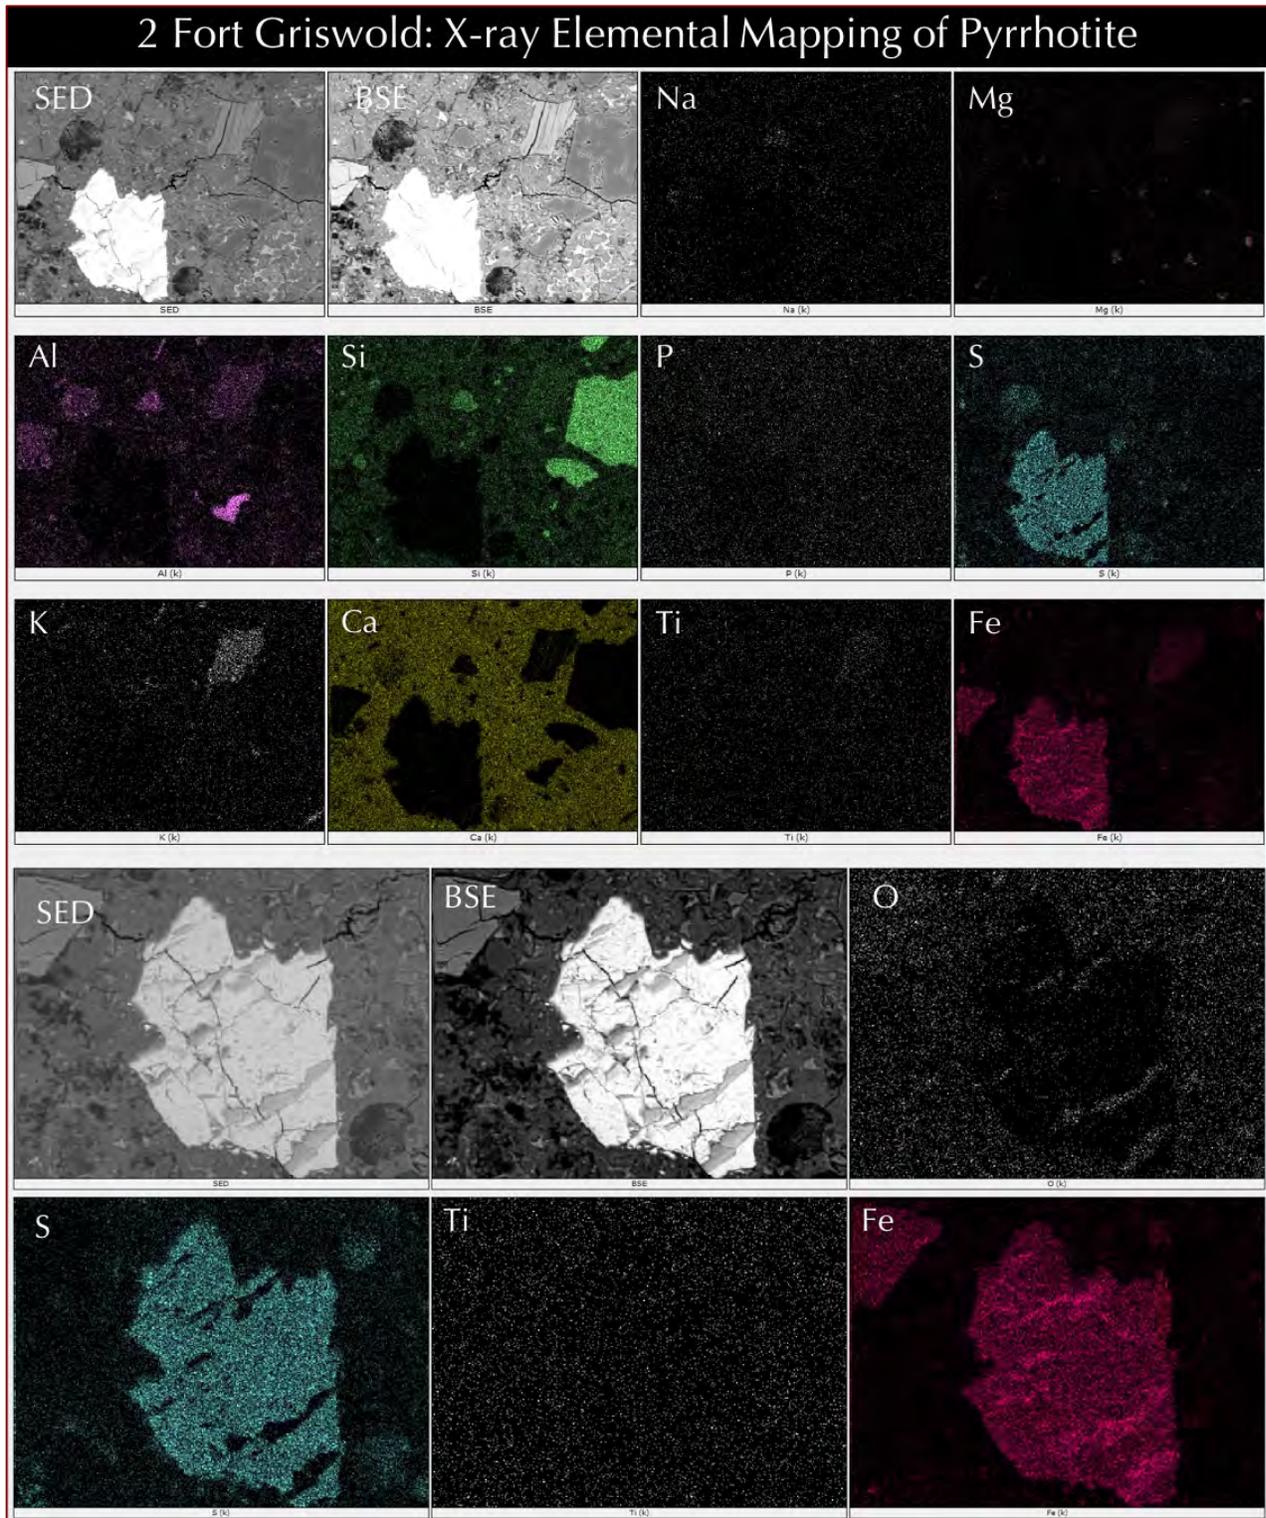
Figure 46: Secondary electron image (top left), corresponding backscatter electron image (2nd from top left) and corresponding X-ray elemental maps (rest) of Core from 2 Fort Griswold showing pyrrhotite grains highlighted in iron (Fe) and sulfur (S) maps, calcium silicate hydrate paste highlighted in calcium (Ca) and silicon (Si) maps, and feldspar grains in aggregate highlighted in aluminum (Al), silicon (Si), and potassium (K) maps. The bottom set shows another pyrrhotite grain highlighted in Fe and S maps that has veins of oxidized iron as highlighted in Fe and O maps and appeared as dark veins in S map.

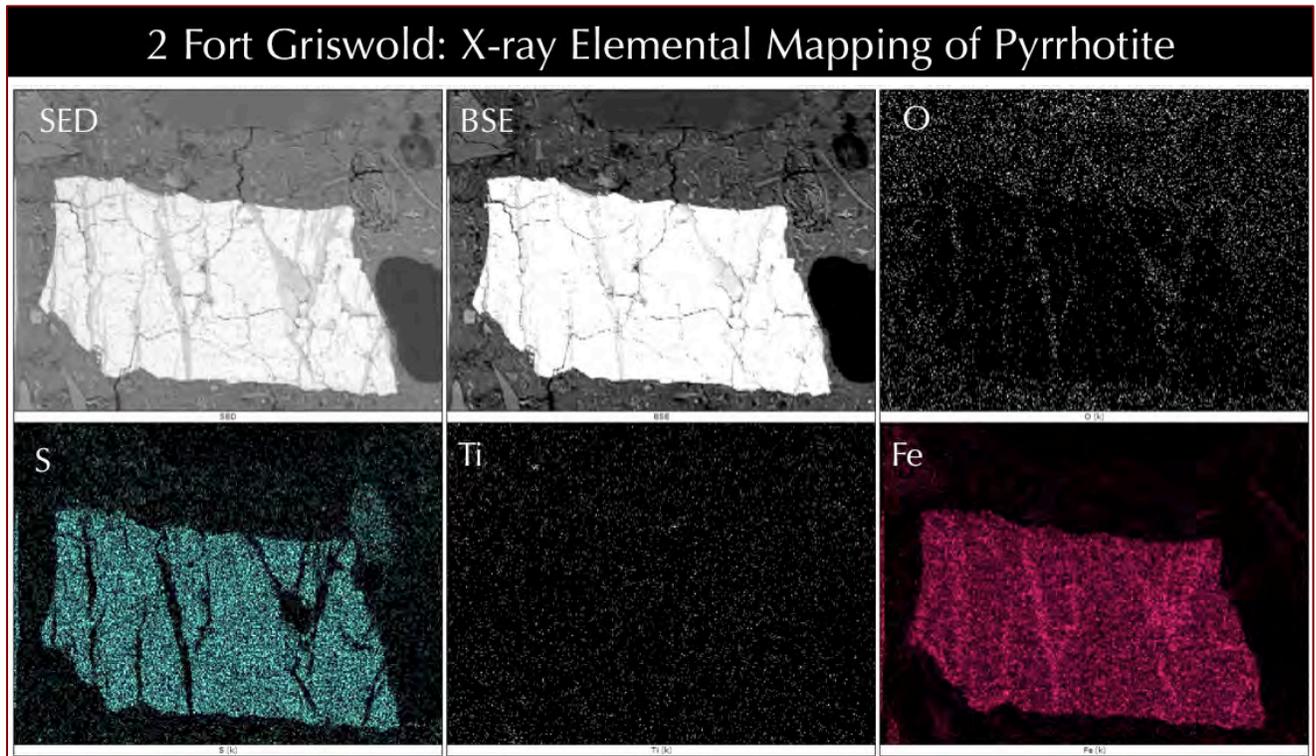
Figure 47: Secondary electron image (top left), corresponding backscatter electron image (2nd from top left) and corresponding X-ray elemental maps (rest) of Core from 2 Fort Griswold showing an oxidized pyrrhotite grain highlighted in Fe and S maps that has veins of oxidized iron as highlighted in Fe and O maps and appeared as dark veins in S map. Notice O map shows veins in pyrrhotite as well as the paste around pyrrhotite whereas it appears dark within the pyrrhotite grain.

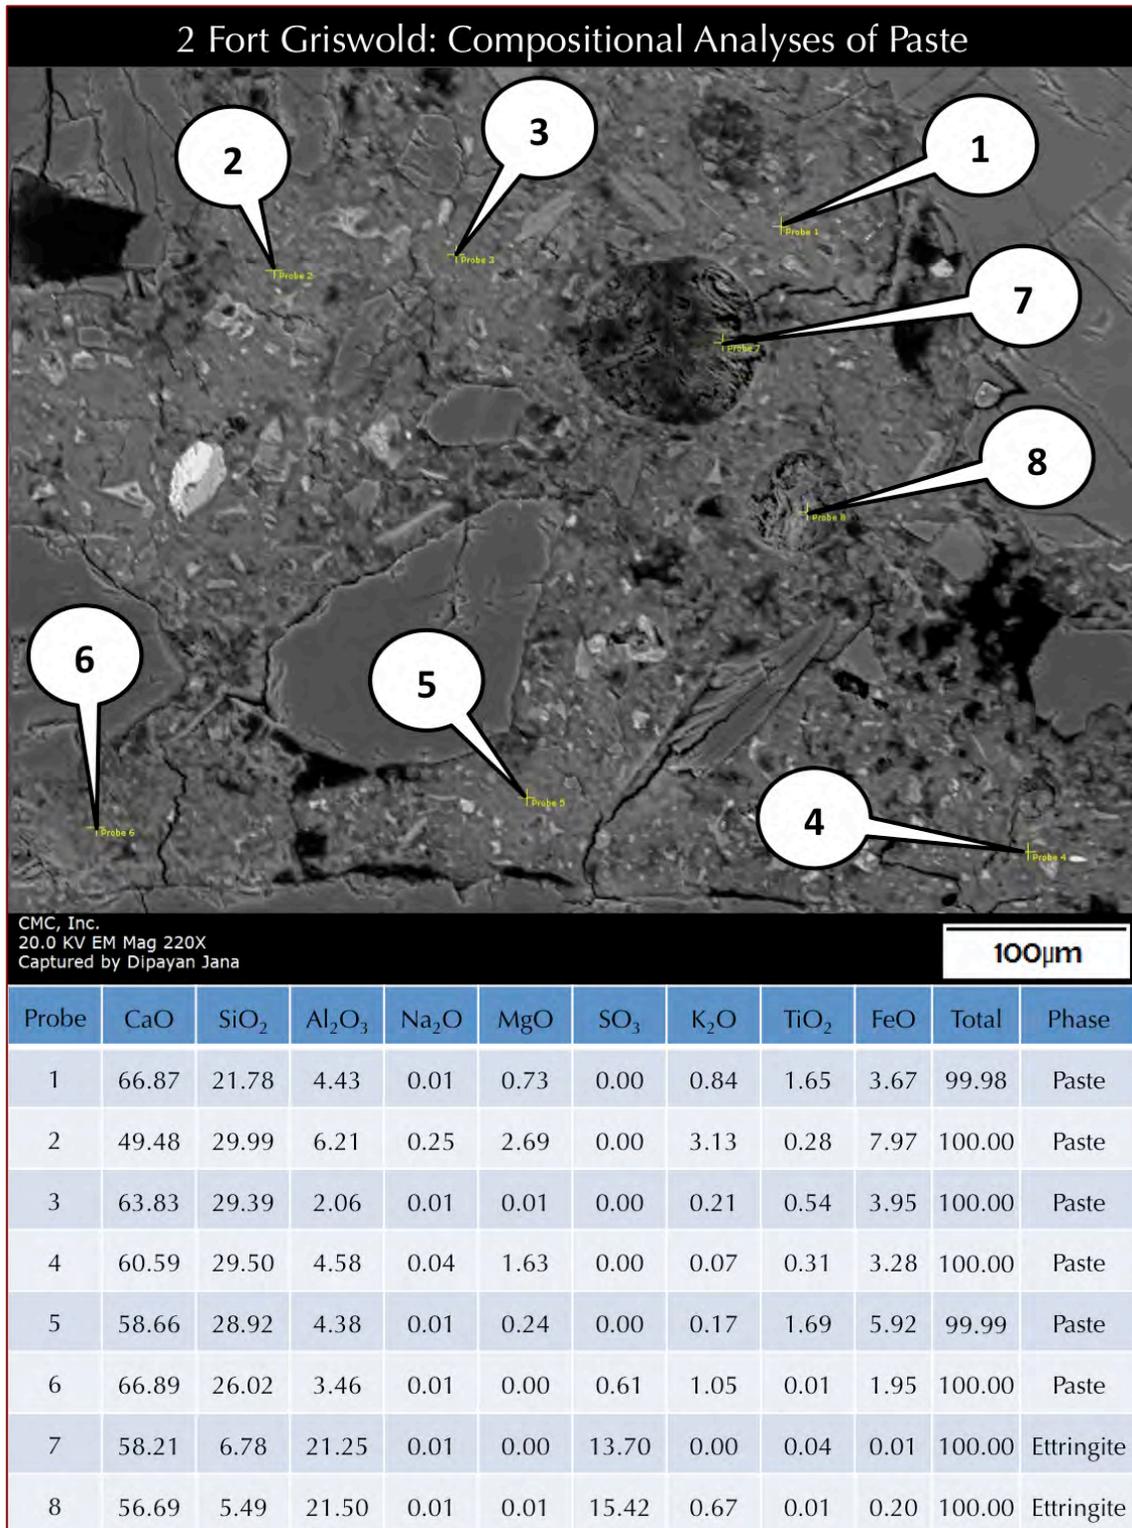
Figure 48: Backscatter electron image (top) and X-ray compositional analyses of concrete in the Core from 2 Fort Griswold showing compositions of secondary ettringite deposits in voids and various areas of paste at the tips of callouts that are provided in the Table below the image. Secondary ettringite shows high Ca, Al, and S whereas paste shows typical calcium silicate hydrate composition with negligible or no evidence of contamination by sulfates released from pyrrhotite oxidation, which is typically found in many other pyrrhotite-related distress in the area.

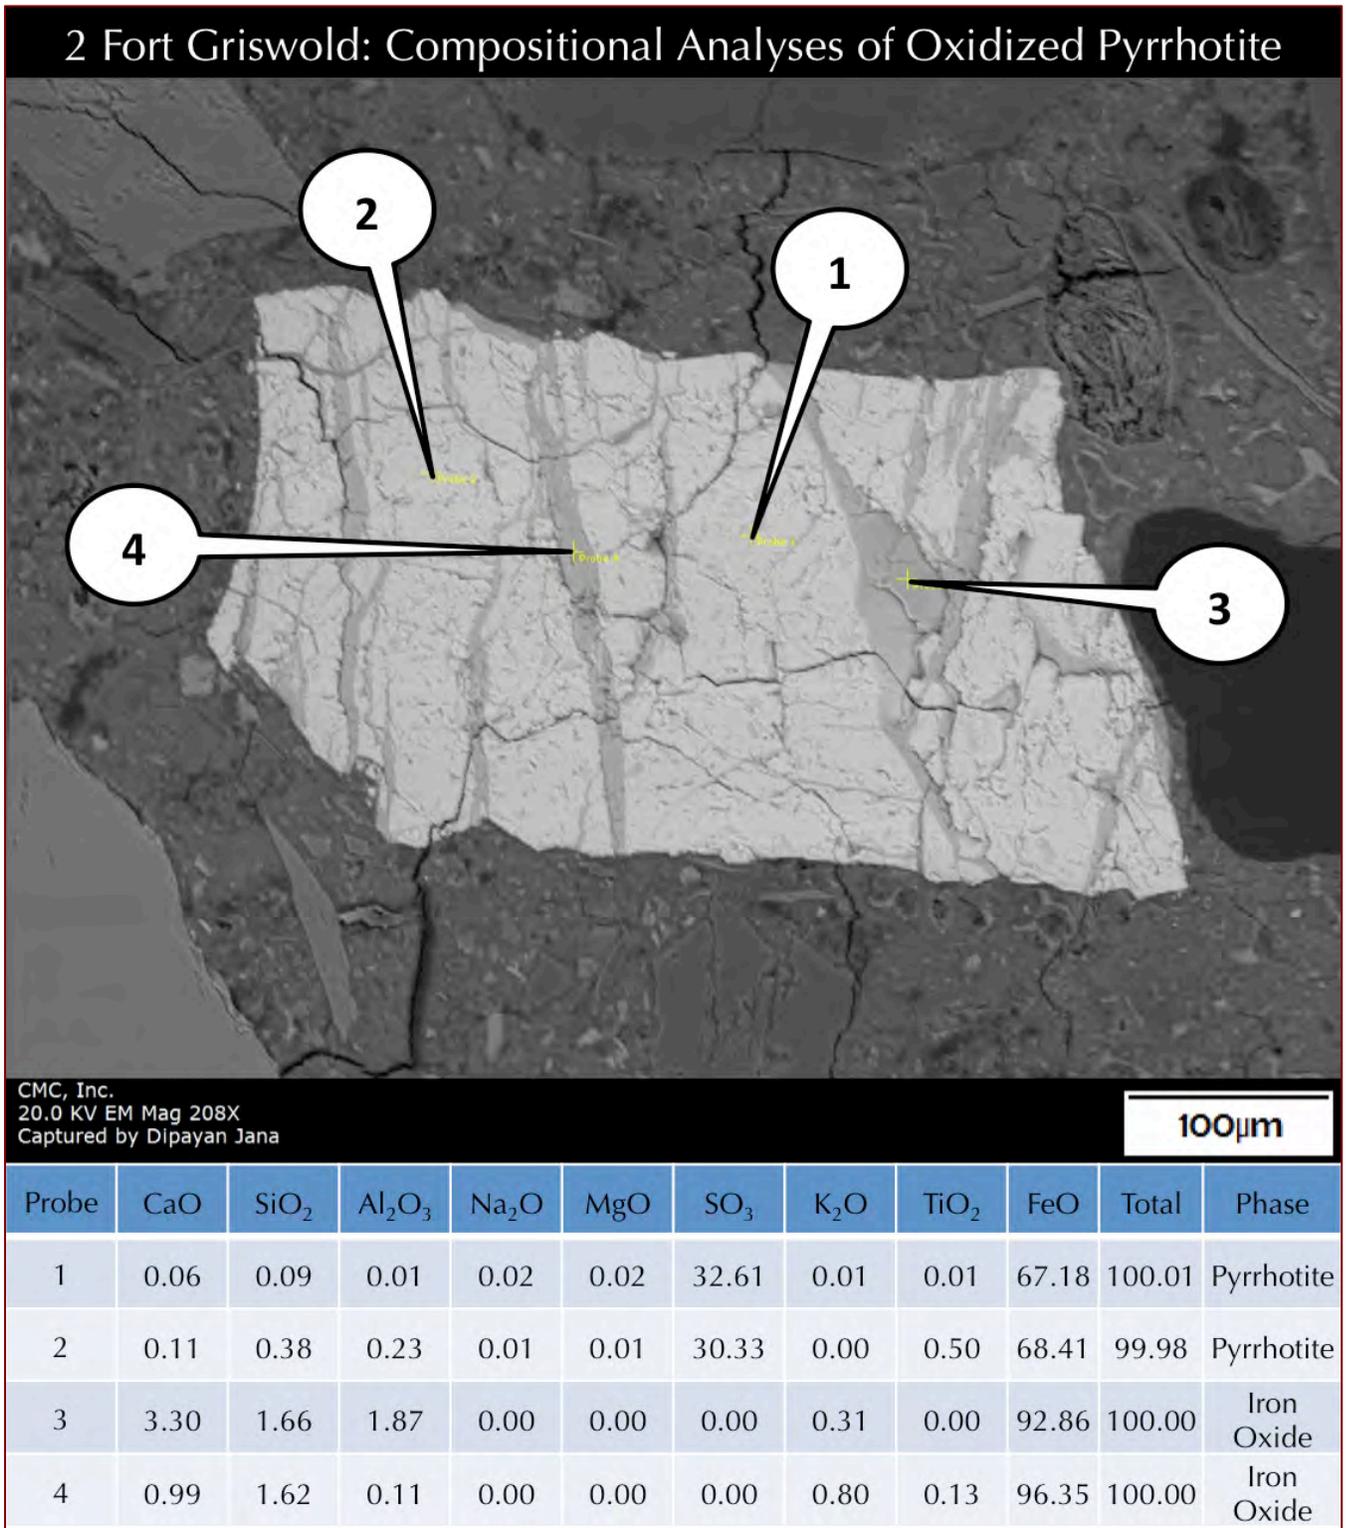
Figure 49: Backscatter electron image (top) and X-ray compositional analyses of concrete in the Core from 2 Fort Griswold showing compositions of oxidized iron veins within a pyrrhotite measured at the tips of callouts that are provided in the Table below the image. Pyrrhotite shows typical high FeO and SO₃ whereas oxidized iron veins within pyrrhotite show mostly FeO. Figure 47 shows elemental maps of this oxidized pyrrhotite grain.

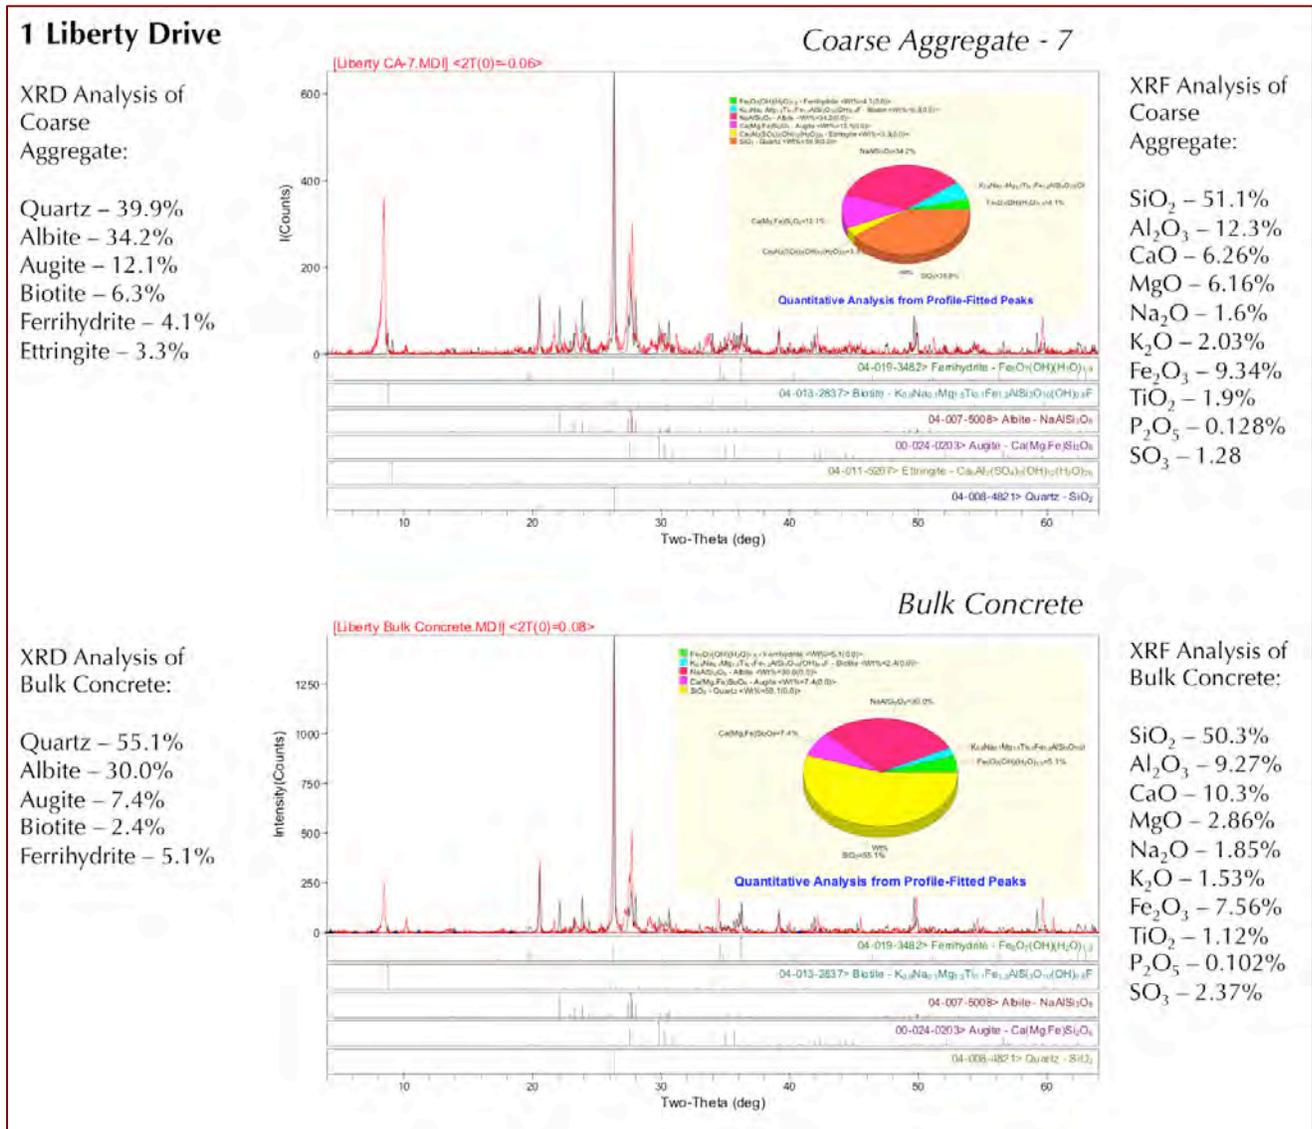
Figure 55: X-ray diffraction patterns (middle), quantitative proportions of minerals (middle pie-graph and tabulated in the left column), and corresponding X-ray fluorescence analyses of oxide compositions (in the right column) of a coarse aggregate particle extracted from the core at 1 Liberty Drive and the bulk concrete showing typical mineralogical and chemical compositions of coarse aggregate and concrete, detection of oxidized pyrrhotite as ferrihydrite, quartz, albite feldspar, augite, biotite, and pyrope garnet mineralogy of crushed gneiss, and secondary ettringite in aggregate, as well as the absence of pyrrhotite except its oxidation product ferrihydrite in aggregate and concrete. Notice high sulfate content of bulk concrete (2.37% SO₃), which is noticeably higher than the sulfate typically found in a typical Portland cement concrete (0.45% SO₃) assuming 3 percent sulfate (SO₃) in cement and 15 percent cement by mass in concrete.

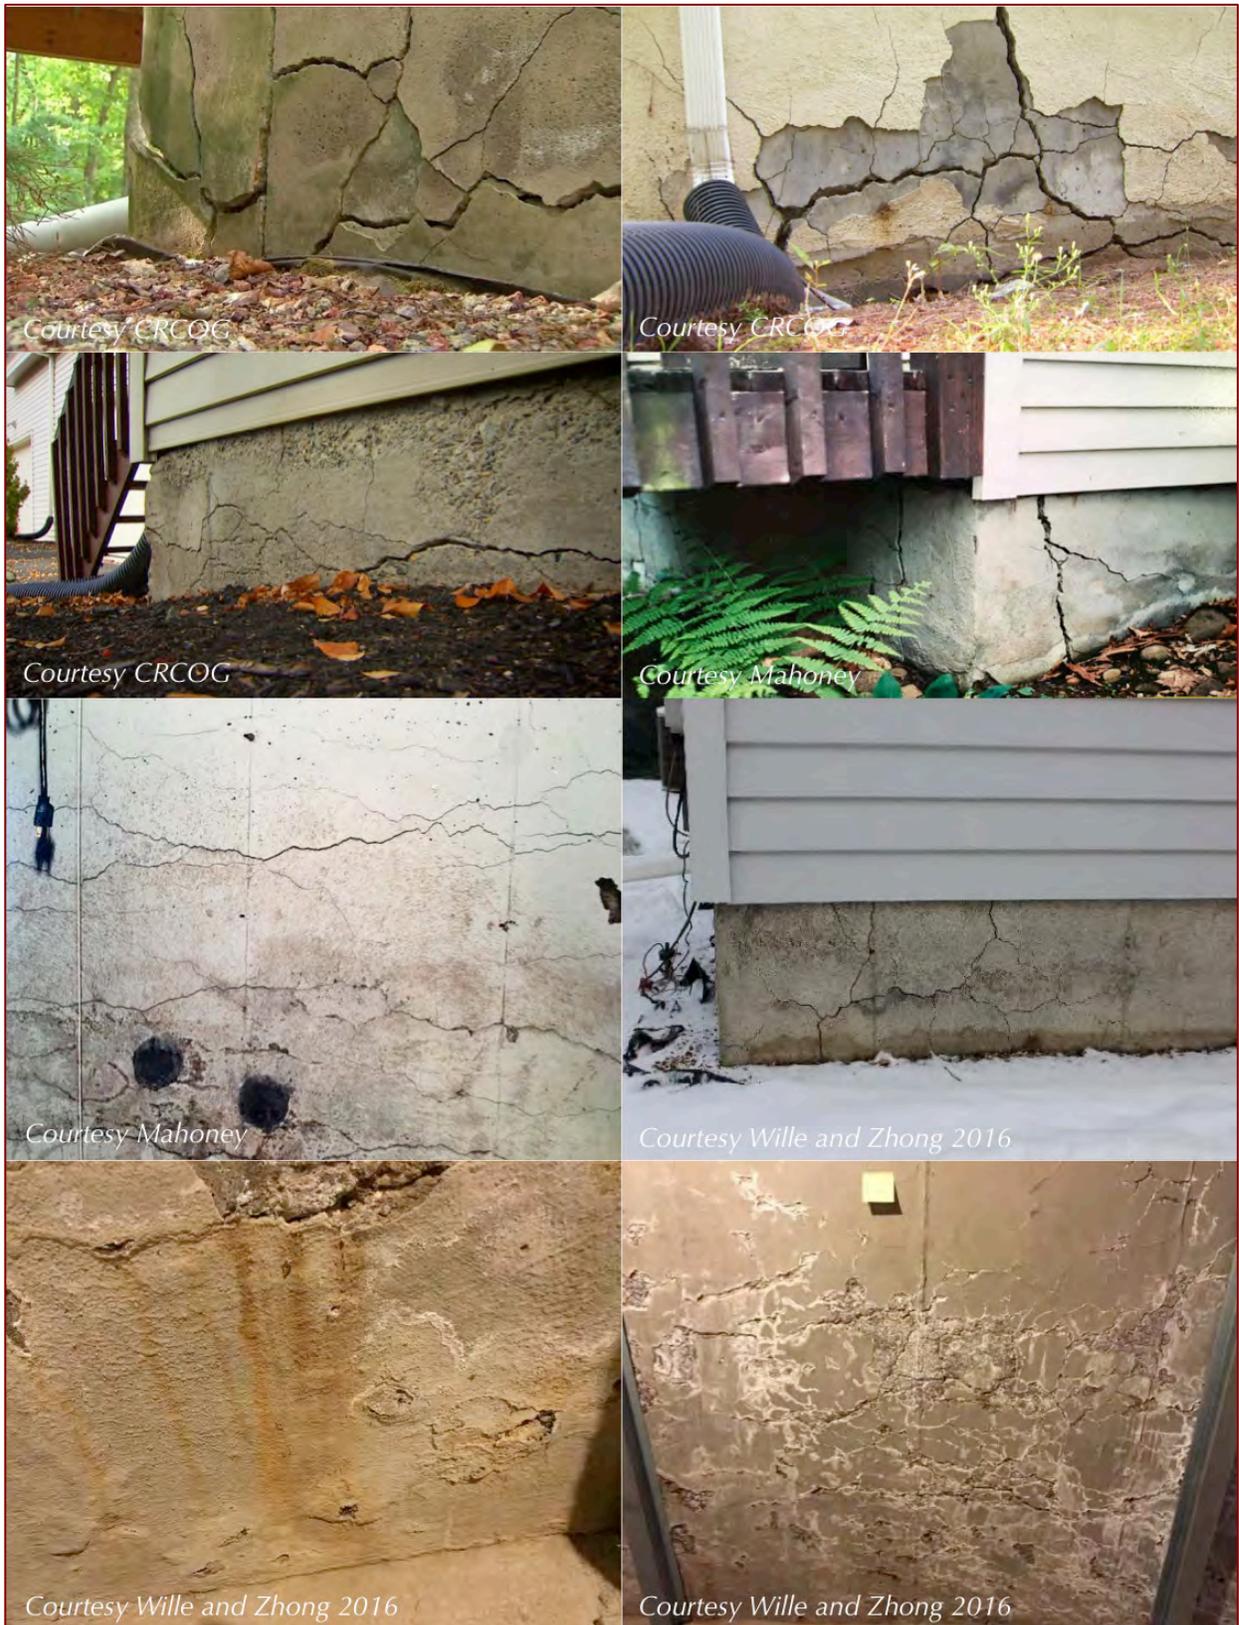
Figure 61: Cracking of concrete foundations in Connecticut due to oxidation of pyrrhotite bearing aggregates in concrete. Notice wide cracks in the top row as well as a network of numerous fine cracks in the wall in the bottom right row all from pyrrhotite oxidation and associated expansion of concrete.

Figure 60 shows regional spread of the latest reported incident of widespread outbreak of deterioration of concrete due to pyrrhotite oxidation in the aggregate along northeastern Connecticut with many hundreds of homes being affected. Figures 61 through 64 show various manifestations of distress in the affected homes from various sources. Typical visual deterioration was in the form of map cracking, some causing deformation of the wall, extensive longitudinal to random cracking of the wall, reddish-brown discoloration, and whitish formation in the vicinity of surface cracking most of which are shown in Figures 61 to 64. Currently, much of the information available on this problem is limited to newspaper articles but the cause of deterioration has initially been confirmed by an investigation conducted at the University of Connecticut (Wille and Zhong, 2016) and subsequently by Jana 2019 as oxidation of pyrrhotite present in the aggregate. In contrast to the problems encountered in Quebec, manifestation of the damage in Connecticut has taken as much as 10 to 20 years.
