Investigation of Pyrrhotite-Related Deterioration In Residential Concrete Foundations In Mansfield, Connecticut

Villages At Freedom Green Condominium Association, Inc.
1 Liberty Drive and 2 Fort Griswold
Mansfield, Connecticut

May 31, 2019
CMC 0419120

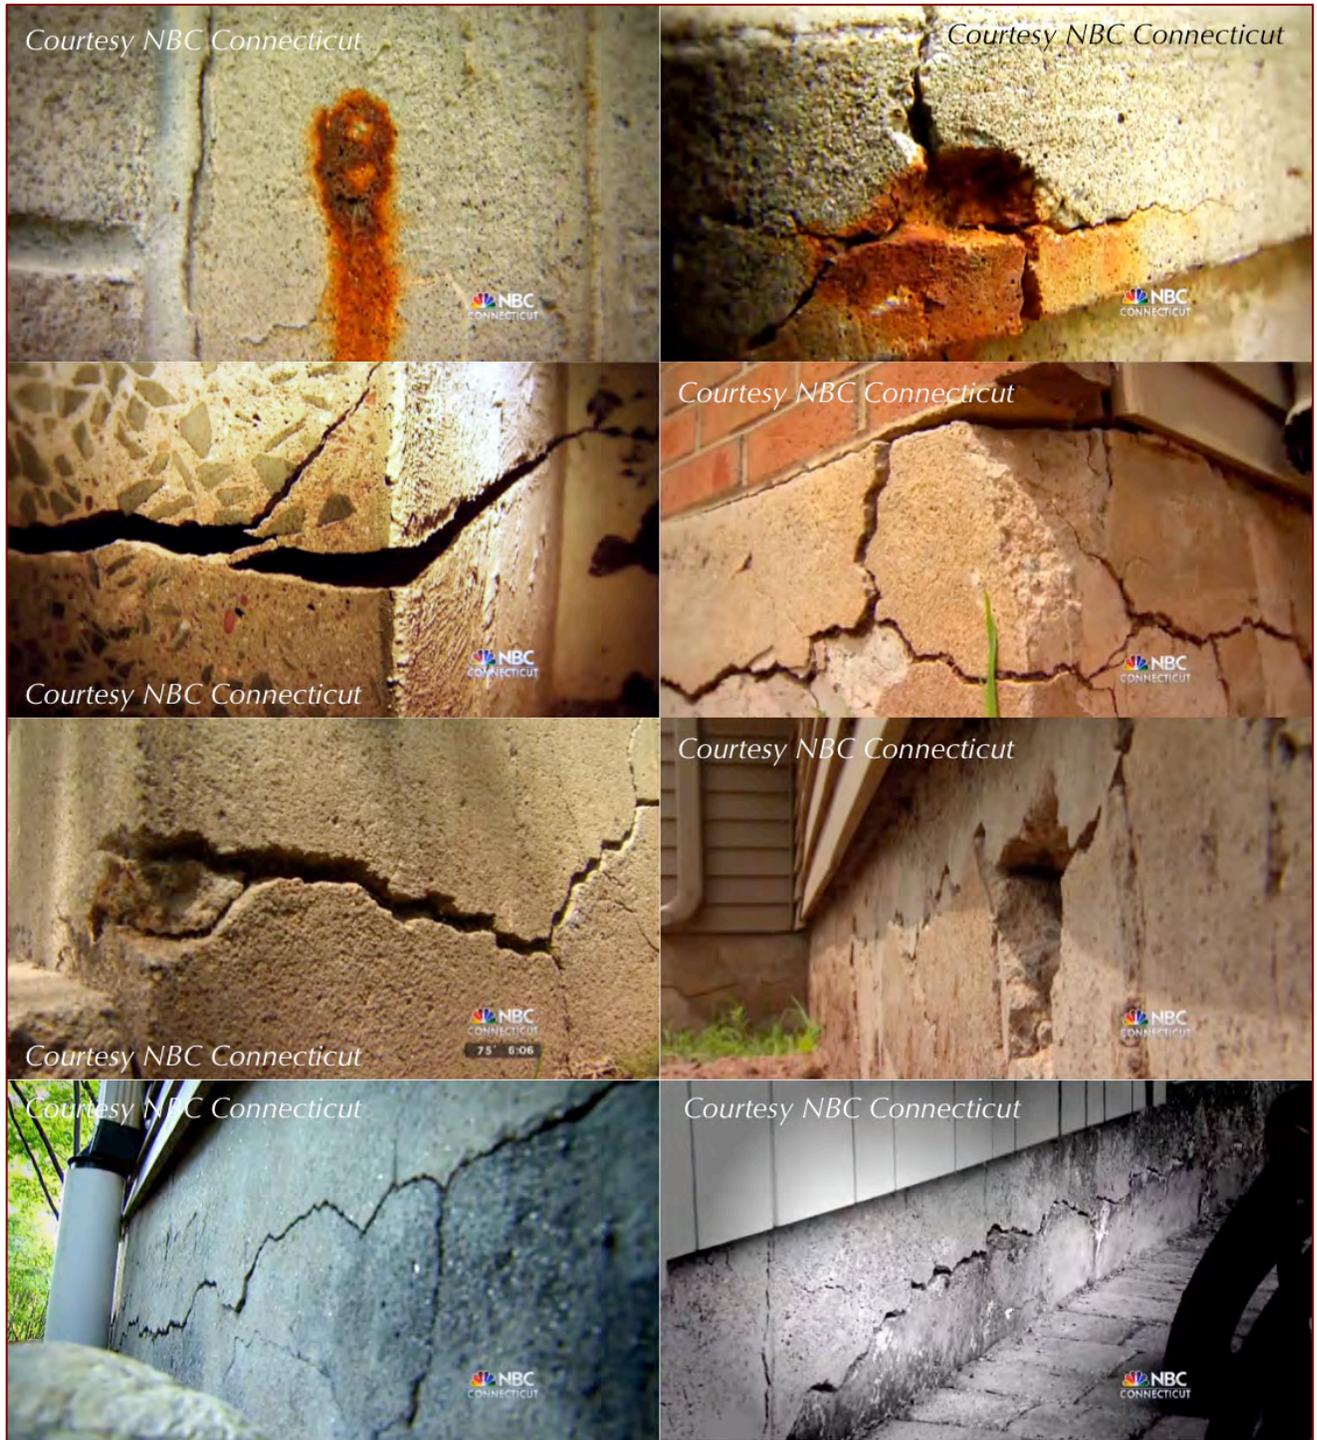
Figure 62: Cracking of concrete foundations in Connecticut due to oxidation of pyrrhotite bearing aggregates in concrete. Notice dark reddish-brown rust staining on the wall and associated cracking in the top row from pyrrhotite oxidation and formation of ferric oxy-hydroxide oxidation products (goethite, limonite, ferrihydrite rust minerals). Notice wide cracks in the 2nd through 4th rows from pyrrhotite oxidation and associated expansion of concrete.

Figure 60 shows regional spread of the latest reported incident of widespread outbreak of deterioration of concrete due to pyrrhotite oxidation in the aggregate along northeastern Connecticut with many hundreds of homes being affected. Figures 61 through 64 show various manifestations of distress in the affected homes from various sources. Typical visual deterioration was in the form of map cracking, some causing deformation of the wall, extensive longitudinal to random cracking of the wall, reddish-brown discoloration, and whitish formation in the vicinity of surface cracking most of which are shown in Figures 61 to 64. Currently, much of the information available on this problem is limited to newspaper articles but the cause of deterioration has initially been confirmed by an investigation conducted at the University of Connecticut (Wille and Zhong, 2016) and subsequently by Jana 2019 as oxidation of pyrrhotite present in the aggregate. In contrast to the problems encountered in Quebec, manifestation of the damage in Connecticut has taken as much as 10 to 20 years.

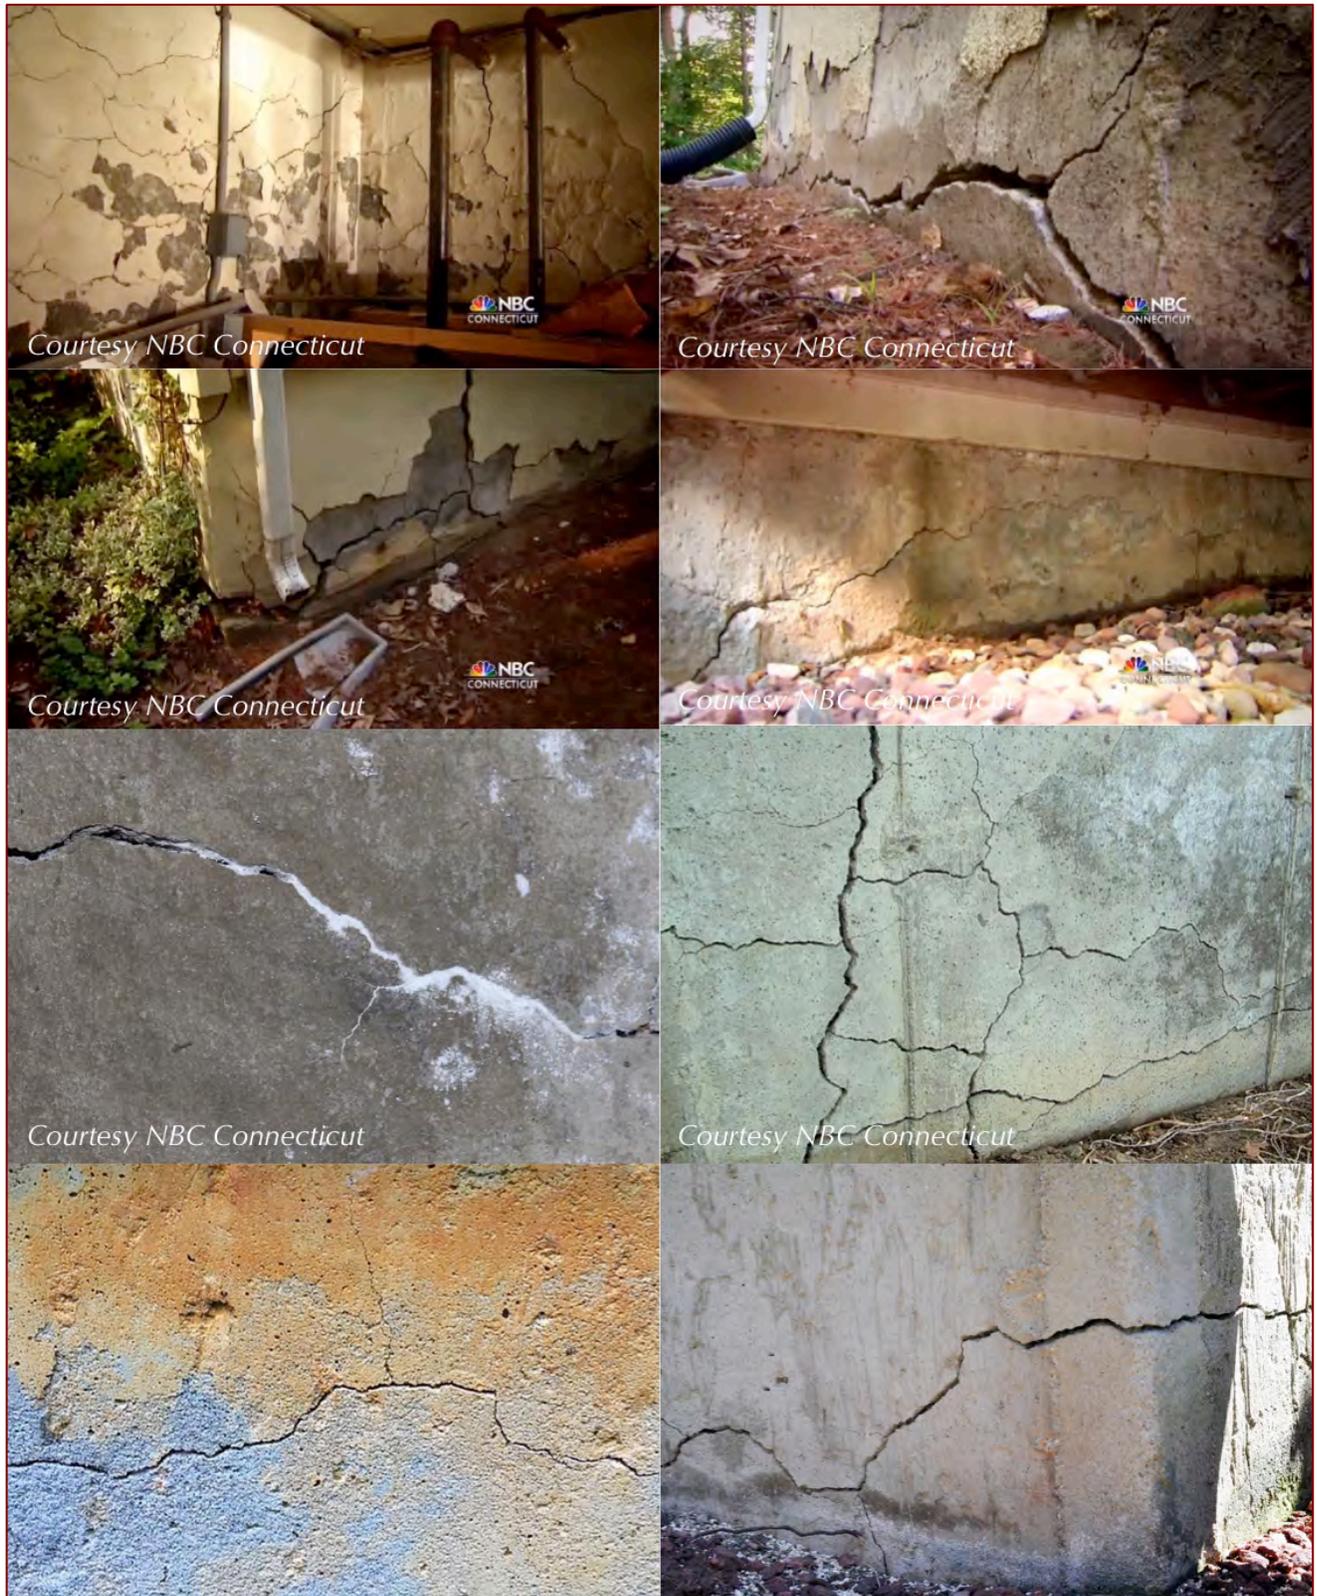
Figure 63: Cracking of concrete foundation in Connecticut due to oxidation of pyrrhotite bearing aggregates in concrete. Notice wide cracks in the foundation walls, extensive cracking of walls in the top left photo all reportedly from pyrrhotite oxidation and associated expansion of concrete.

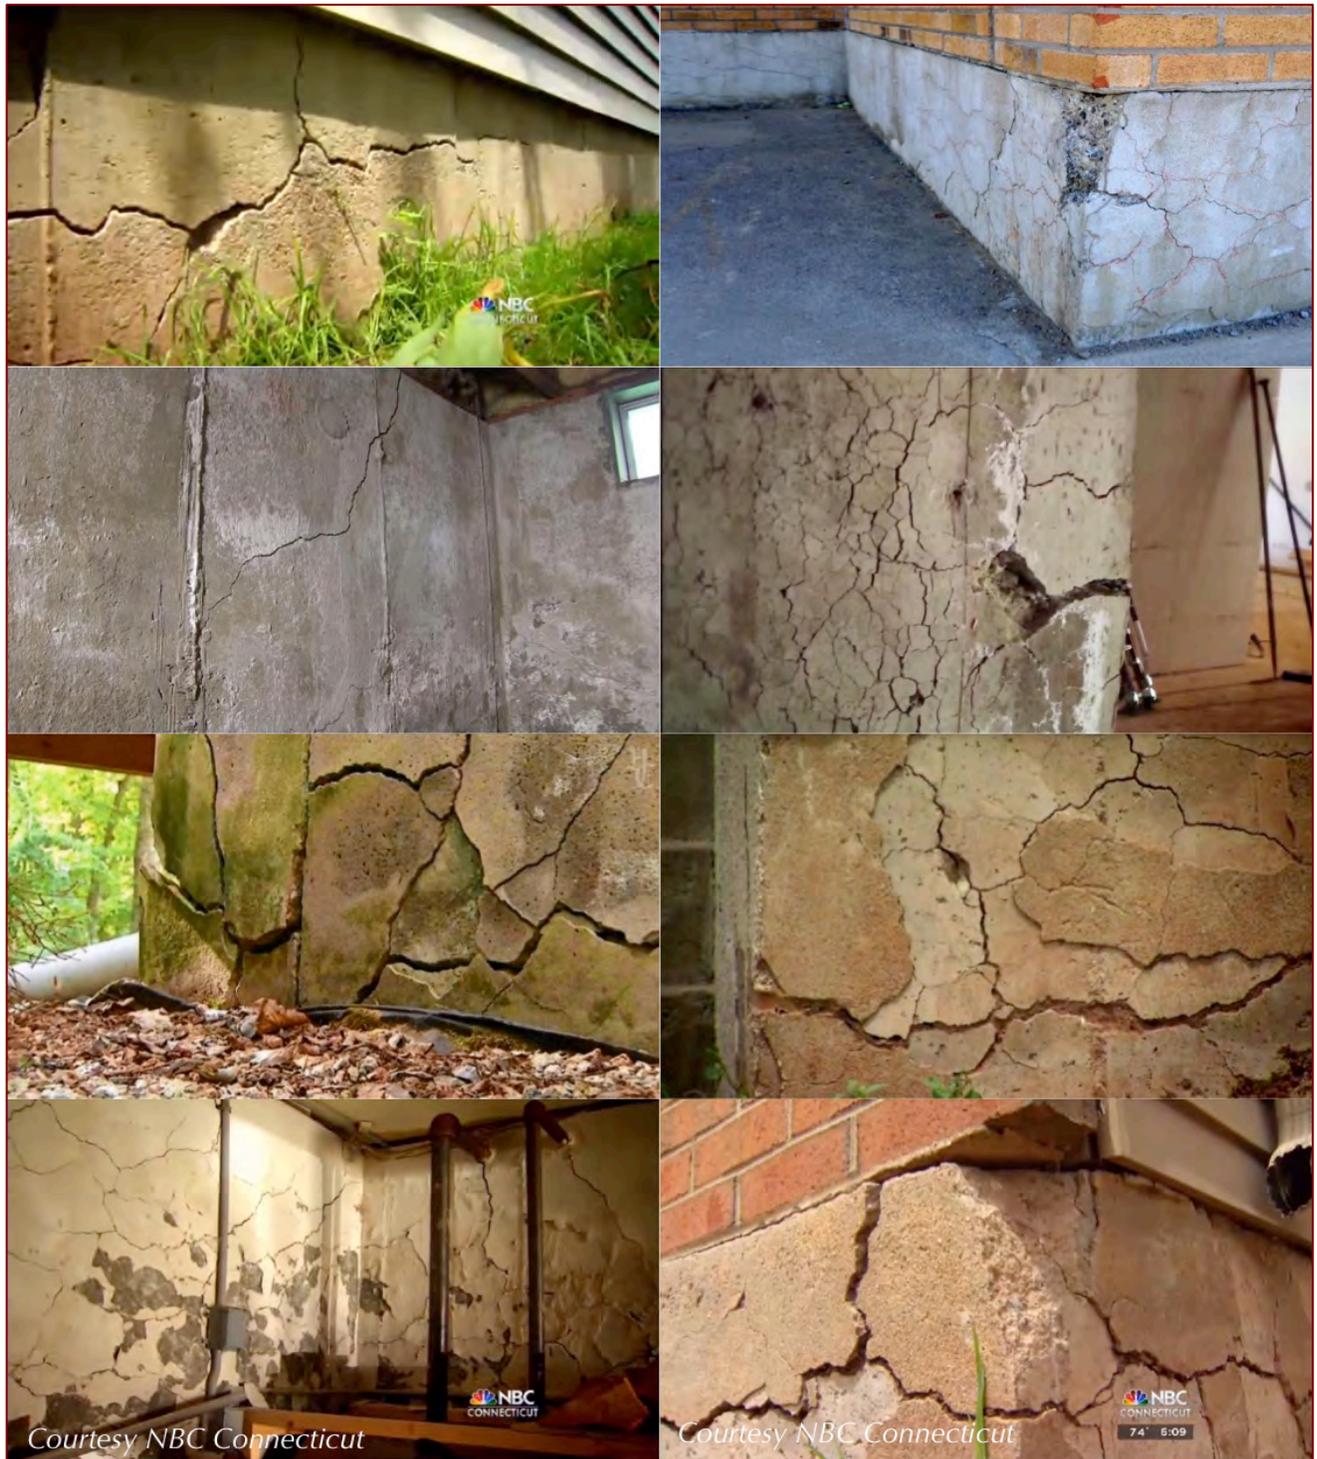
Figure 64: Cracking of concrete foundation in Connecticut due to oxidation of pyrrhotite bearing aggregates in concrete. Notice extensive cracking of foundation in all photos reportedly from pyrrhotite oxidation and associated expansion of concrete.
