Investigation of Concrete Blocks from
Michael McClelland's Residence
at 7 Carraig Bridge, Bridgend
County Donegal, Ireland

Prepared for:
Michael McClelland

July 17, 2024
CMC 0724158

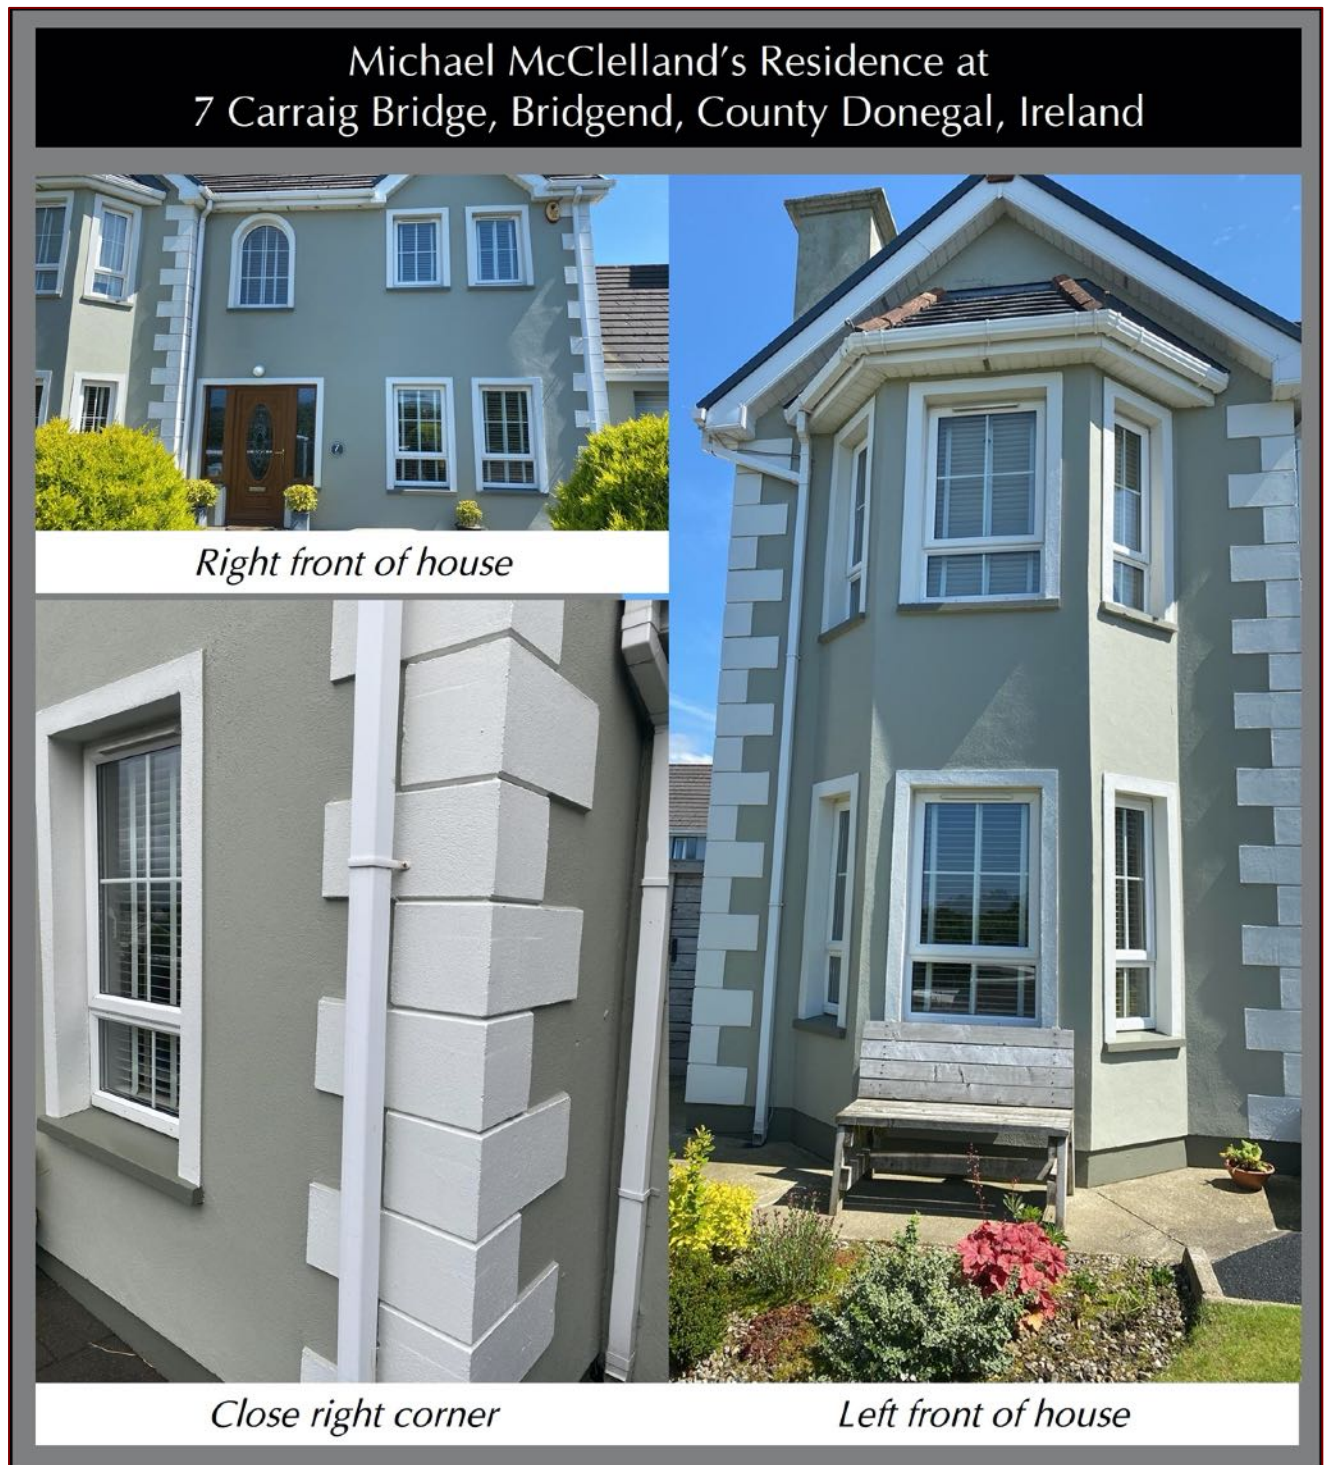
Figure 1: Field photos of the home from different sides showing the overall sound condition of walls and the absence of any visible cracking.

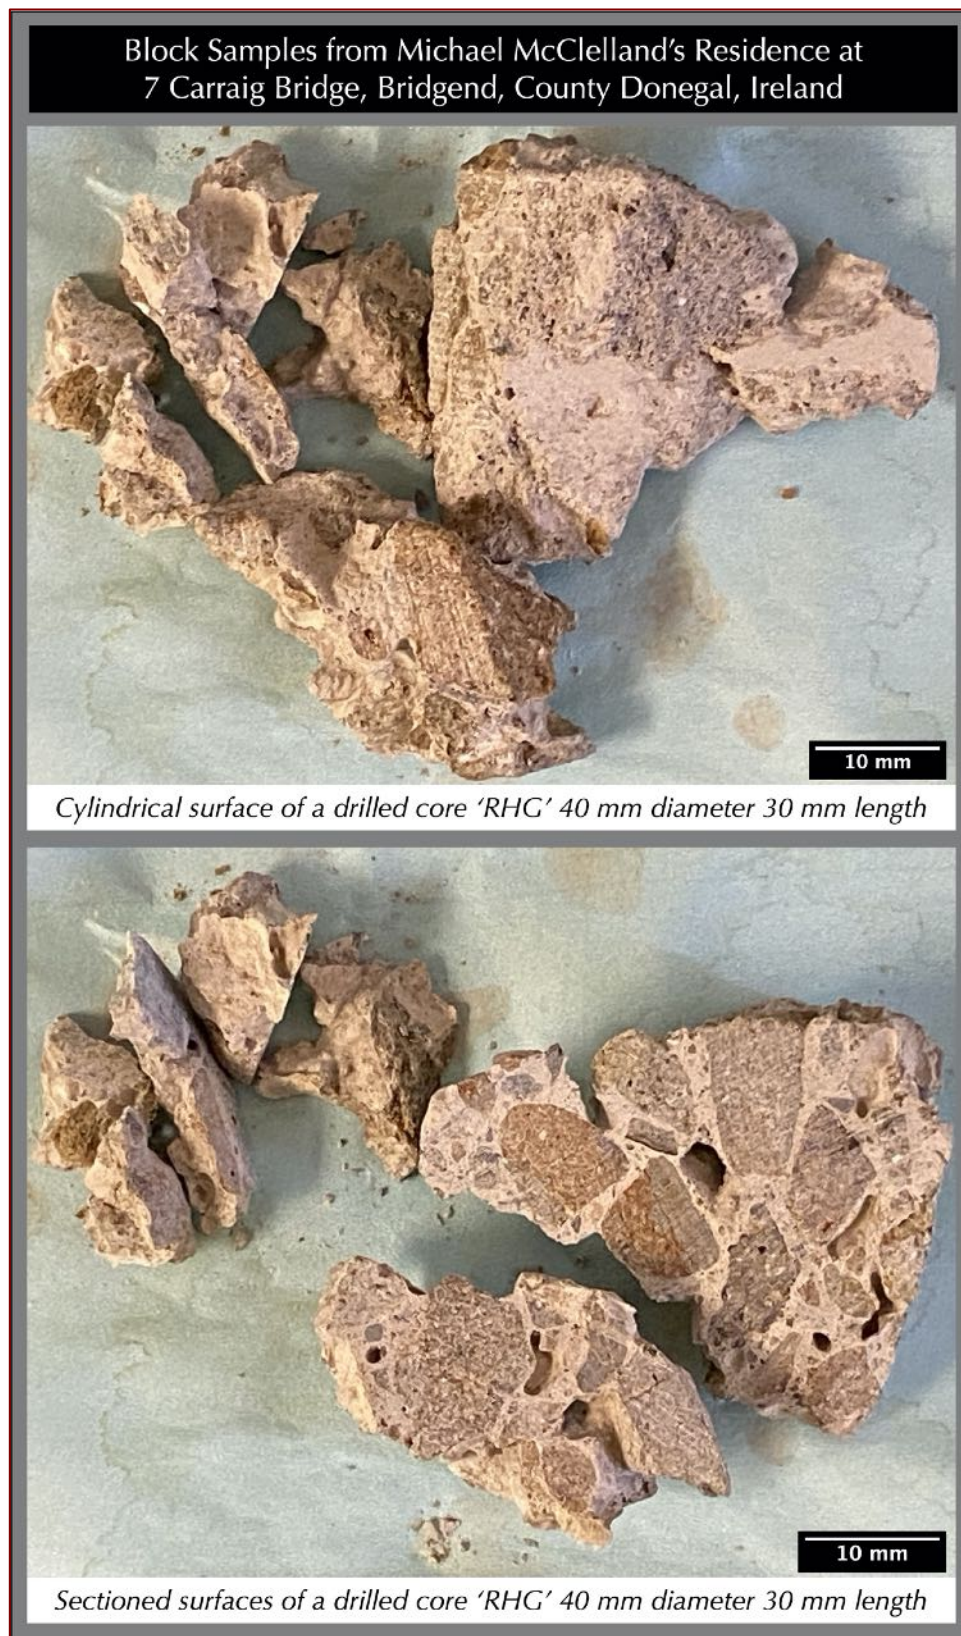
Figure 5: Cylindrical (top) and cross sectioned (bottom) surfaces of drilled core 'RHG' showing crushed micaceous quartzite aggregate, interstitial paste, and coarse voids.

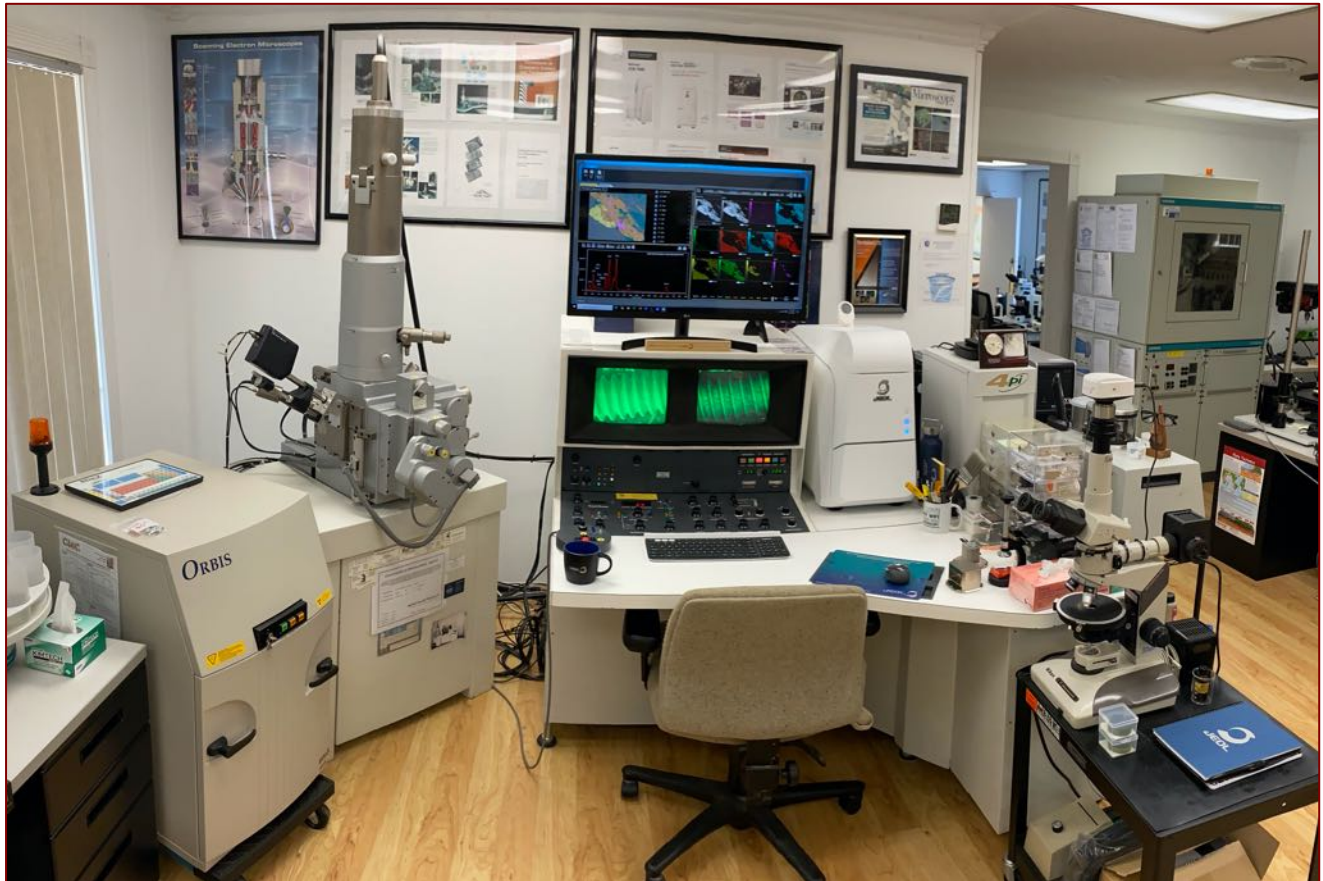
Figure 7: JEOL Neoscope JCM-7000 benchtop and CamScan Series 2 floor model scanning electron microscopes in CMC used to examine samples at noticeably higher magnifications than optical microscopes along with detailed microstructural and microchemical analyses.

In addition to optical microscopy, polished sections of blocks were further examined in JEOL Neoscope JCM-7000 and Camscan scanning electron microscopes (Figure 7) to determine their chemical compositions and microstructures. Both JEOL and Camscan SEMs are equipped with a high-resolution column 40Å tungsten, 15 to 40 kV electron optics zoom condenser 75° focusing lens (for Camscan) operating at 5kV to 20 kV, equipped with a variable geometry secondary electron detector, backscatter electron detectors, and Ametek EDAX EDS detectors for observations of microstructures at high-resolution, compositional analyses, and quantitative determinations of major element oxides from various areas of interest, respectively. Revolution 4Pi software in Camscan and Smileview software in JEOL Neoscope are used for digital storage of secondary electron and backscatter electron images, elemental mapping, and analysis along with point/raster mode, elemental map and cluster phase map analyses of an area of interest. Polished sections were coated with a gold-palladium alloy and used with a custom-made aluminum sample holder in the large multiported chamber with the eucentric 50 × 100 mm motorized stage in Camscan or 40 × 40 mm motorized stage in JEOL. SEM-EDS studies were done by using the methods of ASTM C 1723.

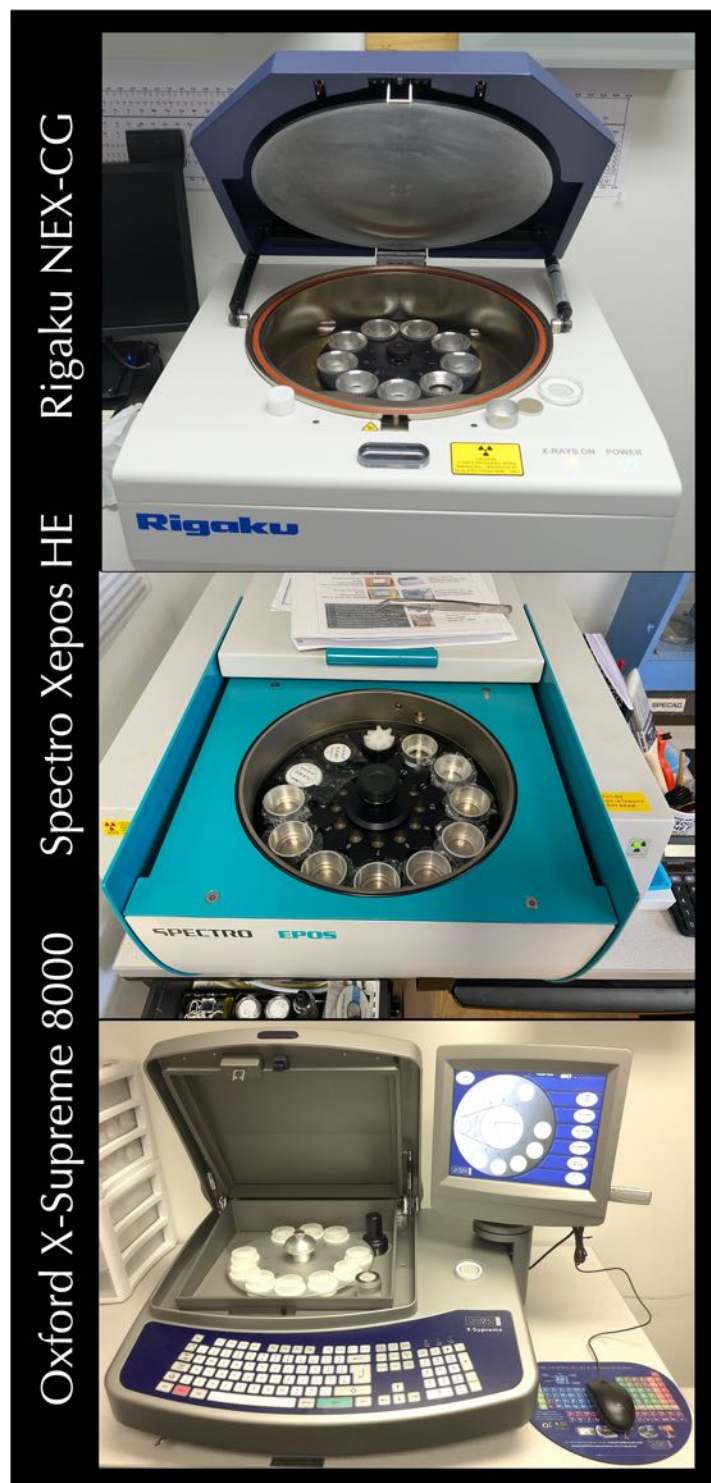
Figure 8: Rigaku NEX-CG (top), Spectro Xepos HE (middle), and Oxford X-Supreme 8000 (bottom) benchtop XRF units in CMC, all of which can perform analyses of multiple pressed pellets or fused beads of samples.

One of the three energy-dispersive bench-top X-ray fluorescence units in CMC shown in Figure 8 was used. All units deliver rapid qualitative and quantitative determination of major and minor atomic elements in a wide variety of sample types with minimal standards. The instruments were calibrated by using various certified (CCRL, NIST, GSA, and Brammer) reference standards of cements and rocks and major element oxidation composition of unknown sample was determined from empirical calibrations of well-documented standards.

Approximately 8 grams of representative sample was pulverized for 3 minutes with alcohol in a pulverizing mill (Spex floor model pulverizer) with three wax tablets for preparation of pressed pellets. A 25-ton Spex automated hydraulic press was used for preparation of pressed pellets.

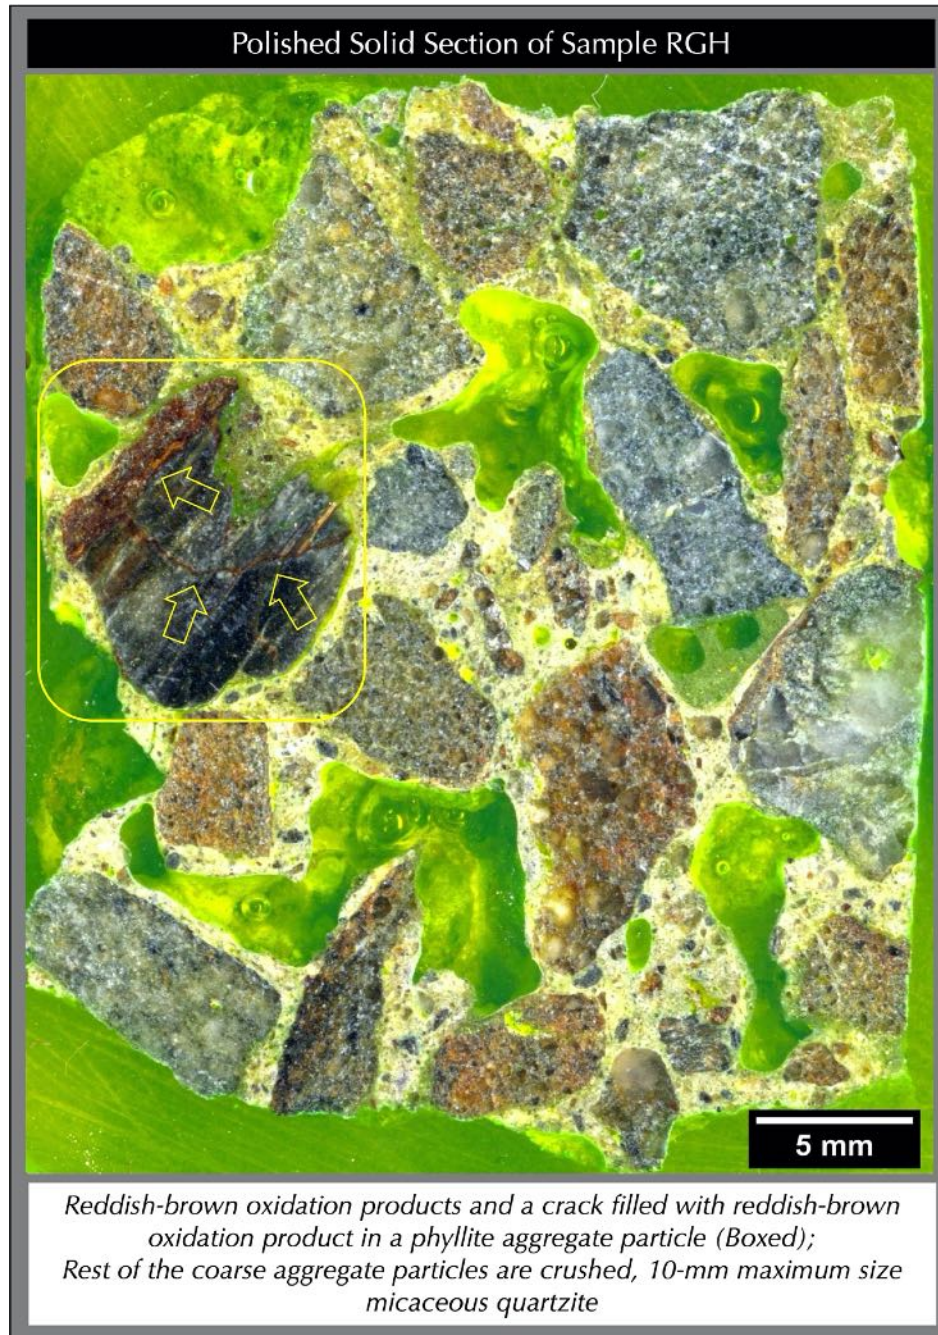
Figure 10: Polished section of sample RGH showing only one potentially deleterious phyllite coarse aggregate with reddish-brown oxidation products of iron and associated microcracks, which are also filled with the oxidation products (marked by arrows). Rest of the coarse aggregate particles are **crushed micaceous quartzite**, which are dense, hard, equigranular to elongated, massive quartzitic (granoblastic) textured mass of equigranular grains of major amount of quartz, subordinate feldspar (albite), and parallel bands of muscovite and chlorite, having a nominal maximum size of 10 mm. Interstitial paste in the mortar fraction shows beige color tone. Coarse irregular-shaped interstitial voids are calculated (from ImageJ) to be less than 10 percent.

Grading & Distribution	Well-graded and well-distributed (Figures 10-11)
Soundness	Sound for dominant micaceous quartzite grains but unsound (cracking in some phyllite grains, Figures 19-20, 23, 25)
Alkali-Aggregate Reactivity	Despite the presence of many strained quartz particles in the aggregate that are known to be potentially alkali-silica reactive, there is, however, no evidence of such a reaction found in the aggregates
Sulfide Minerals in Coarse Aggregates	Isolated finely disseminated blocky habit pyrite (<0.1 mm grain size) and associated minor chalcopyrite mostly in the mortar fraction and preferentially concentrated in the minor phyllite grain compared to quartzite (Figures 24, 25, 32)
Fine Aggregates	
Types	Natural siliceous sand mixed with abraded micaceous quartzite (Figures 21-22, 31-34)
Nominal maximum size (in.)	¼ in. (6.5 mm)
Rock Types	Major amount of siliceous component (quartz, quartzite, strained quartzite, feldspar, and chert) and subordinate amount of abraded component of coarse aggregate that has also contributed to 'free mica' in the mortar fraction (Figures 21-22, 31-34)
