Investigation of Concrete Sidewalk Scaling by Petrographic Examinations Of A Concrete Core

Traditions of America
1076 Constitution Drive
Lititz, Pennsylvania 17543

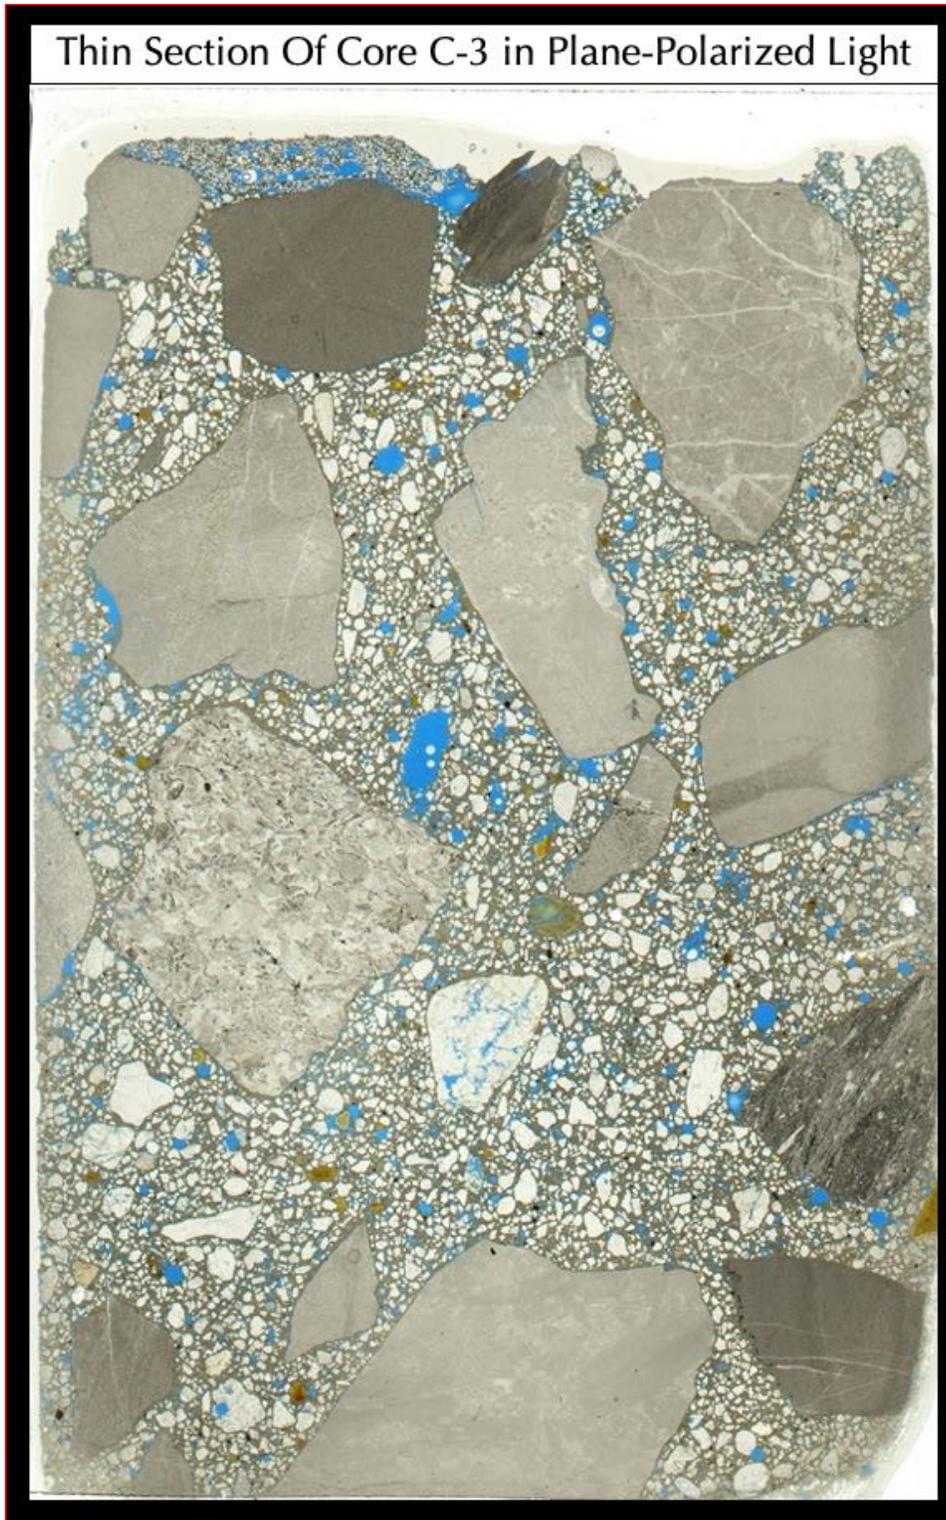
Concrete placed at the location of the examined core lacks air entrainment, which is contrary to common industry recommendations for an outdoor concrete exposed to cyclic freezing and thawing and deicing chemicals. Absence of entrained air is judged to have caused the surface scaling, which was potentially aggravated by exposure to chloride-containing deicing chemicals during service.

Figure 10: Blue dye-mixed epoxy-impregnated thin section of core showing crushed limestone coarse aggregate, natural siliceous sand fine aggregate, and interstitial paste marred with coarse spherical, near-spherical, and irregularly-shaped entrapped air voids. The image was taken on a flatbed film scanner with a polarizing filter.

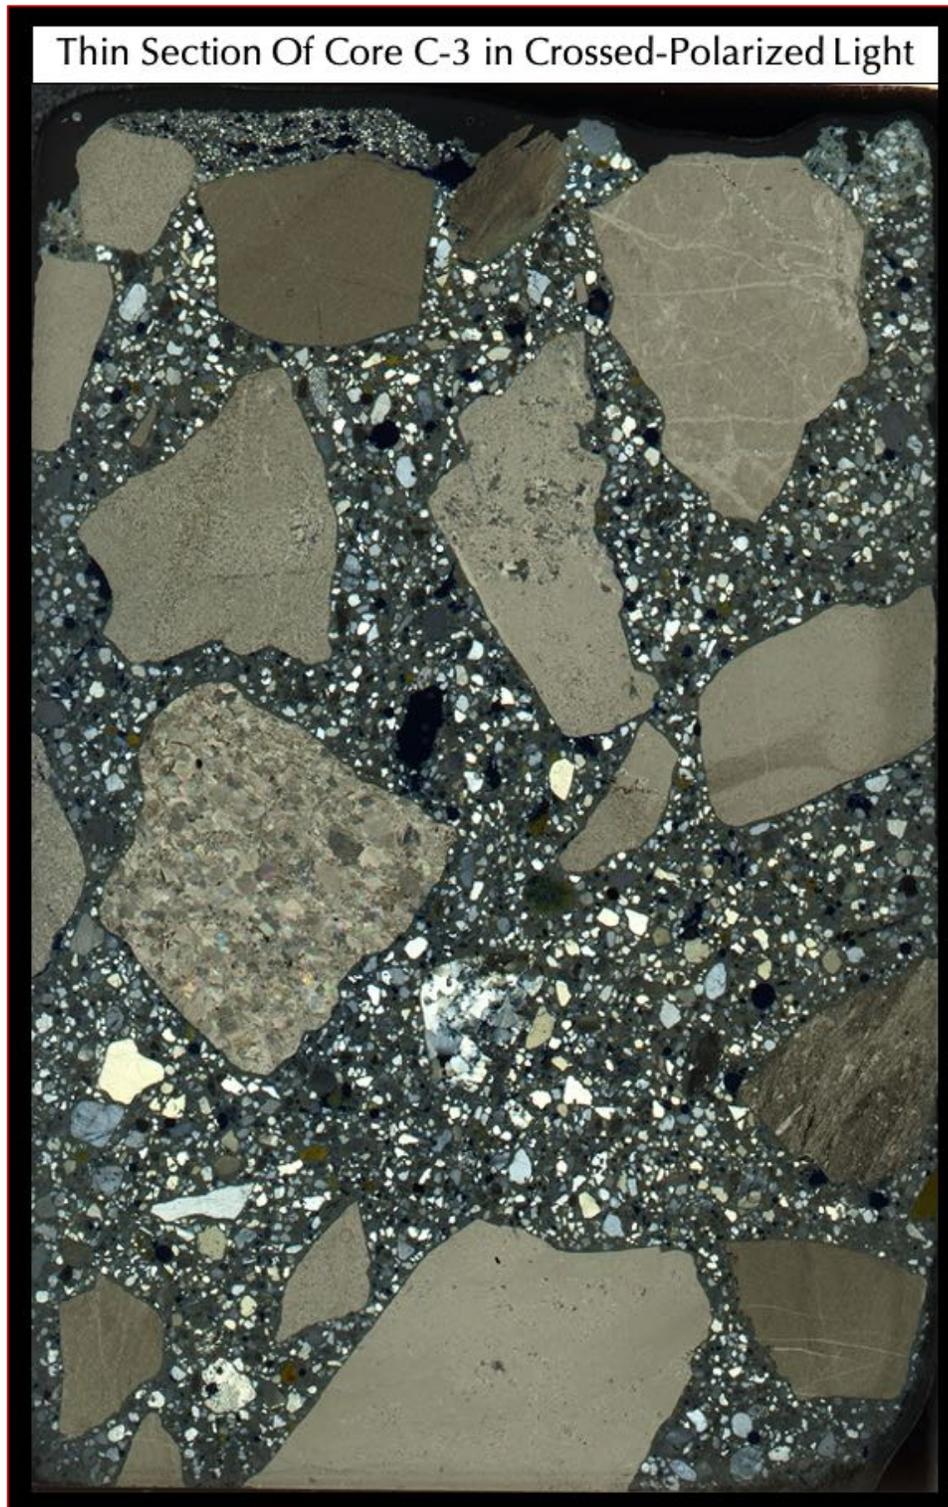
The crushed limestone coarse aggregate and siliceous sand fine aggregate particles are present in sound conditions and did not contribute to the observed surface distress. There is no evidence of any potentially deleterious alkali-aggregate reaction of coarse or fine aggregate found in the cores. A few crushed shale particles in coarse aggregate, however, has shown potential unsoundness as cracking from moisture absorption and potential freezing at critically saturated conditions, which are the conditions to cause popups of such aggregate particles situated immediately beneath the finished surface.

Figure 11: Blue dye-mixed epoxy-impregnated thin section of core showing crushed limestone coarse aggregate, and natural siliceous sand fine aggregate. The image was taken on a flatbed film scanner with two perpendicular polarizing filters to generate crossed polarized light effect to highlight the compositions of crushed stone coarse aggregate and sand fine aggregate.

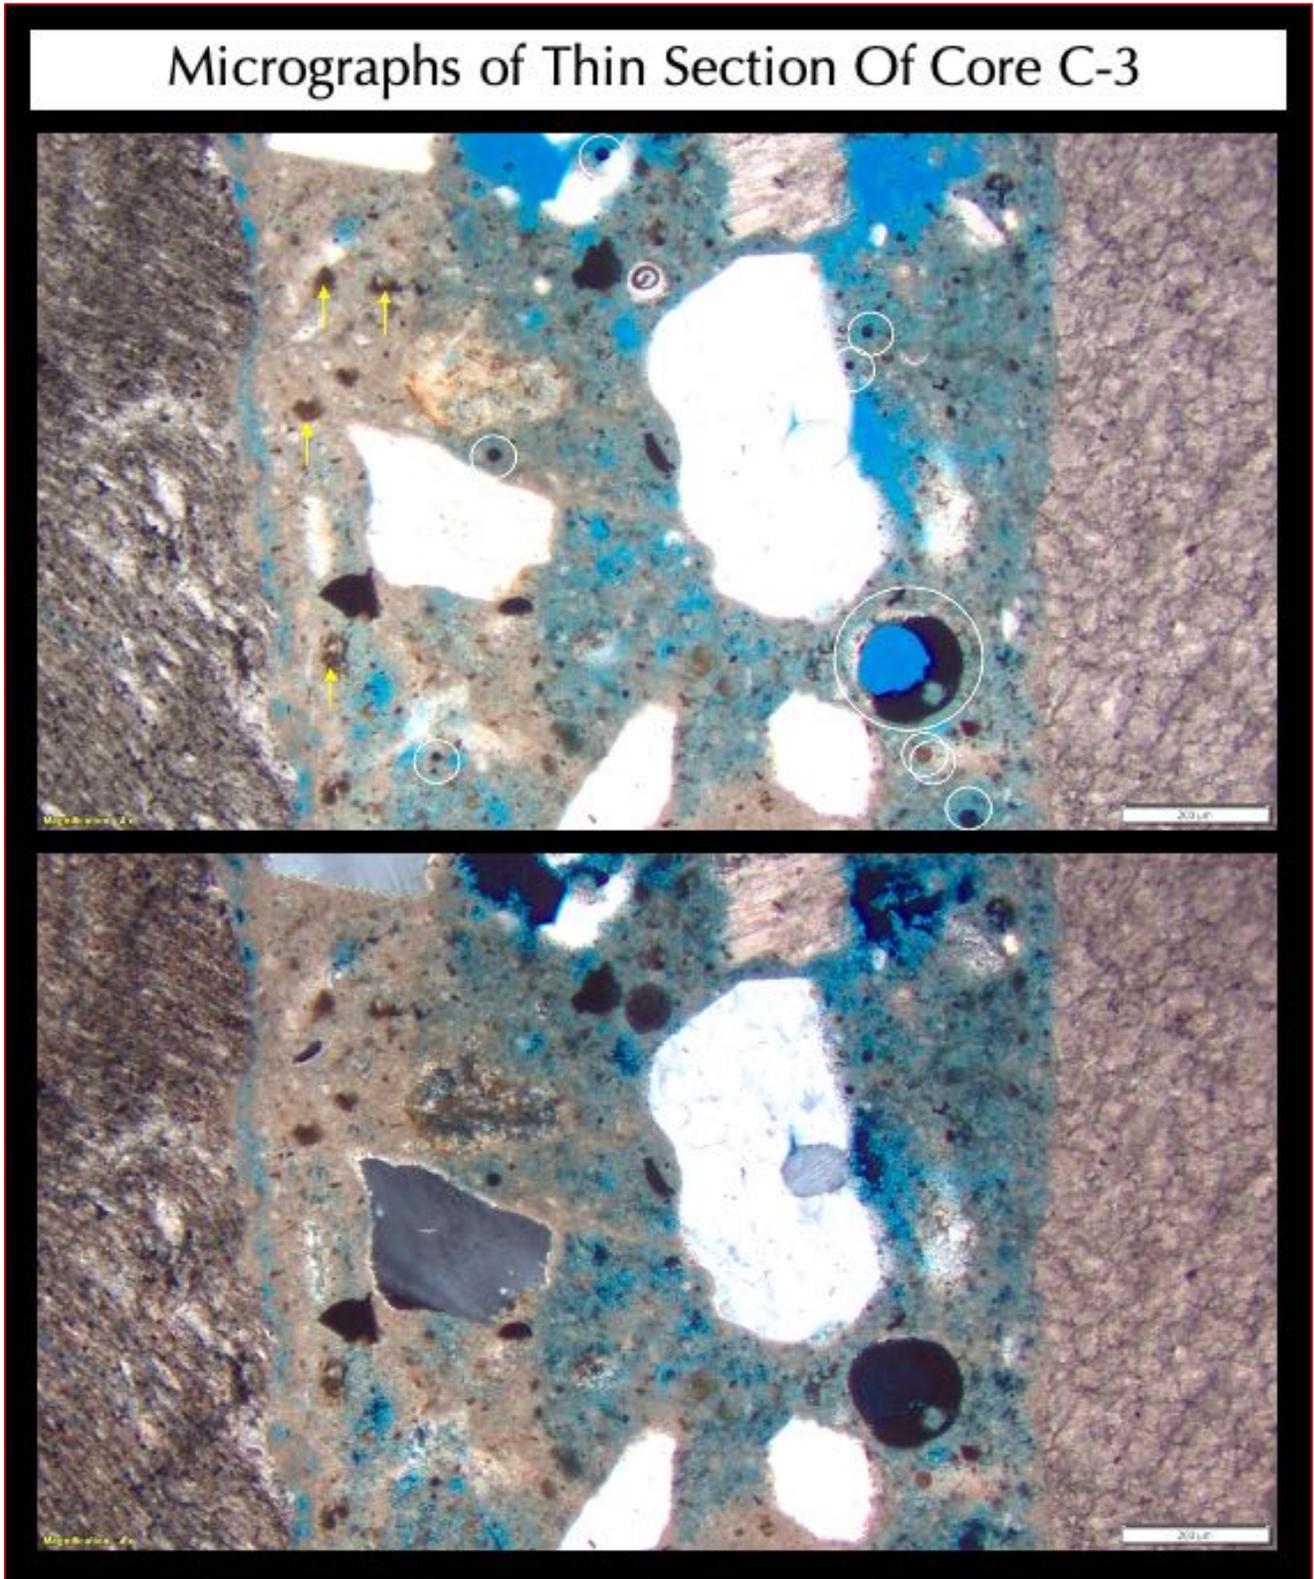
Figure 13: Micrographs of thin section of concrete at two ends showing crushed limestone coarse aggregate particles with interstitial mortar fraction containing silica sand and binary cement and fly ash paste where residual fly ash spheres are circled and a few residual Portland cement particles are marked with arrows. Paste is carbonated to form finely crystalline calcium carbonate deposits.

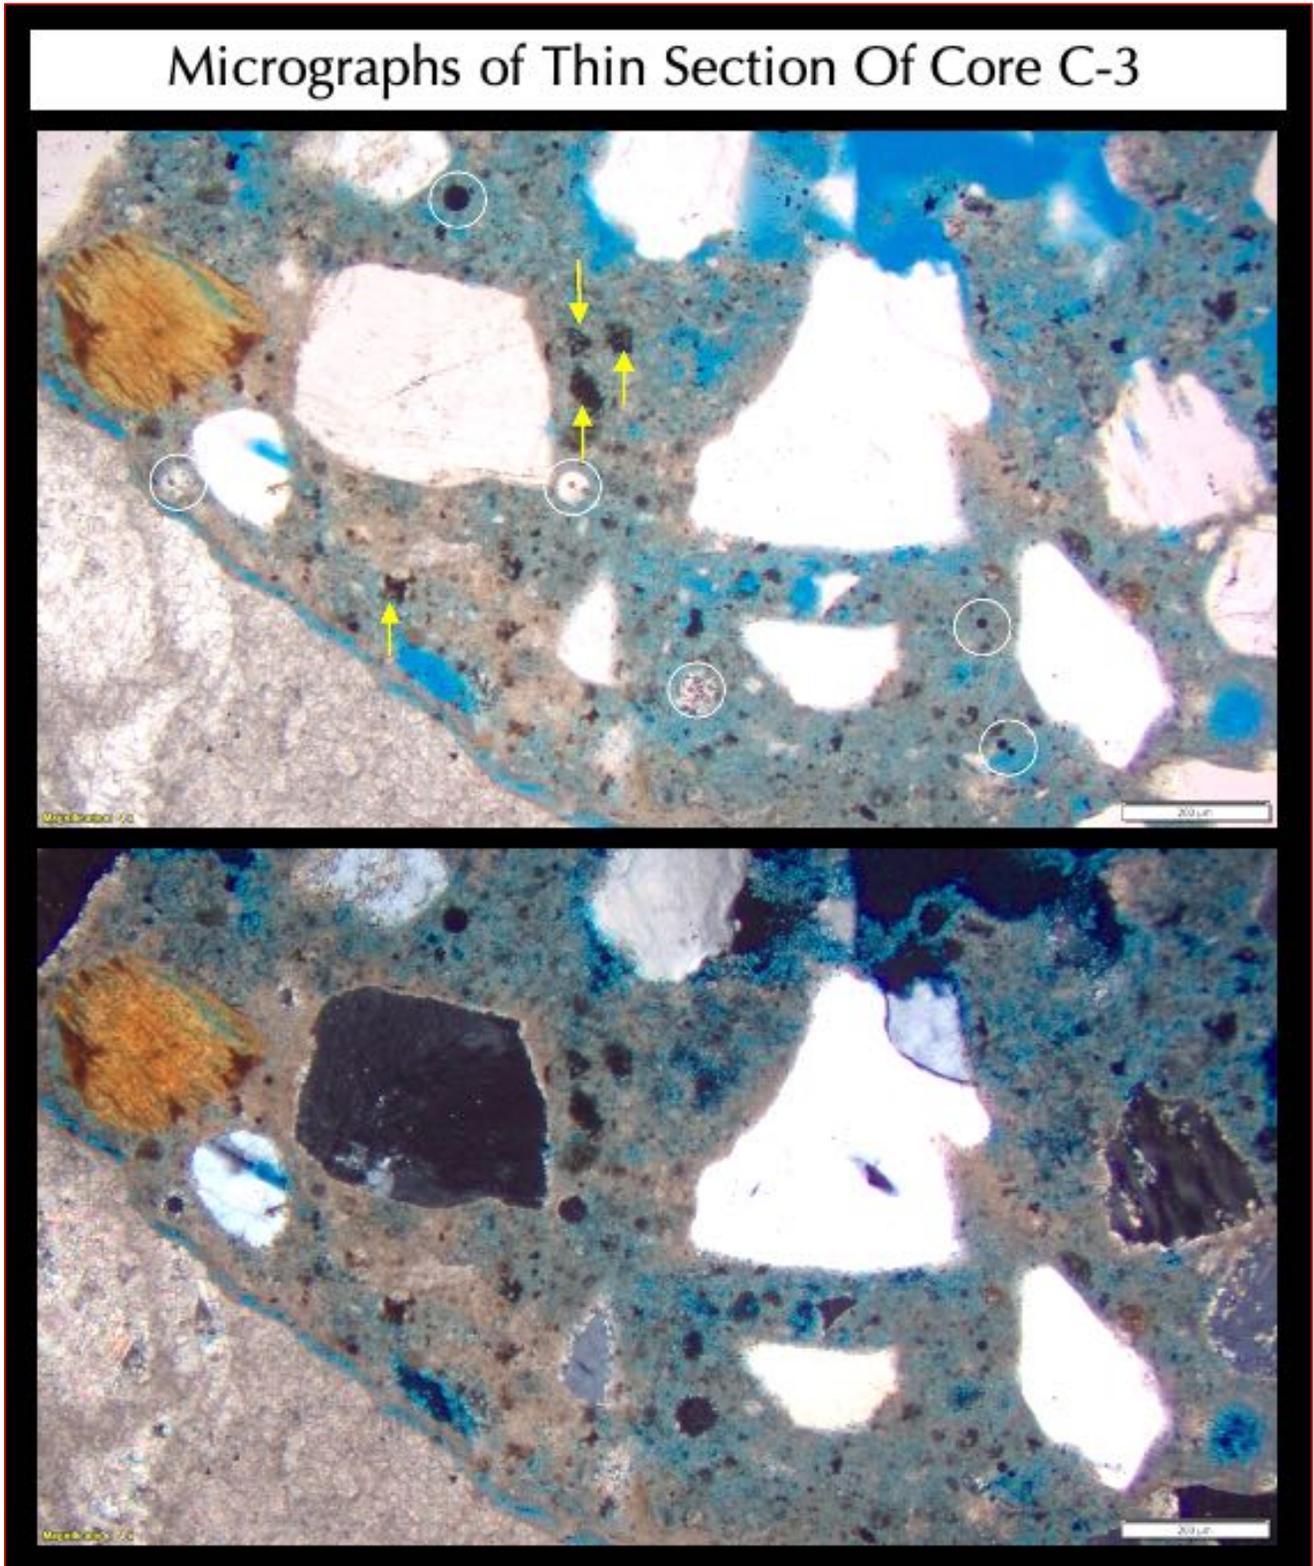
Figure 14: Micrographs of thin section of concrete at two ends showing crushed limestone coarse aggregate particles with interstitial mortar fraction containing silica sand and binary cement and fly ash paste where residual fly ash spheres are circled and a few residual Portland cement particles are marked with arrows. Paste is carbonated to form finely crystalline calcium carbonate deposits.

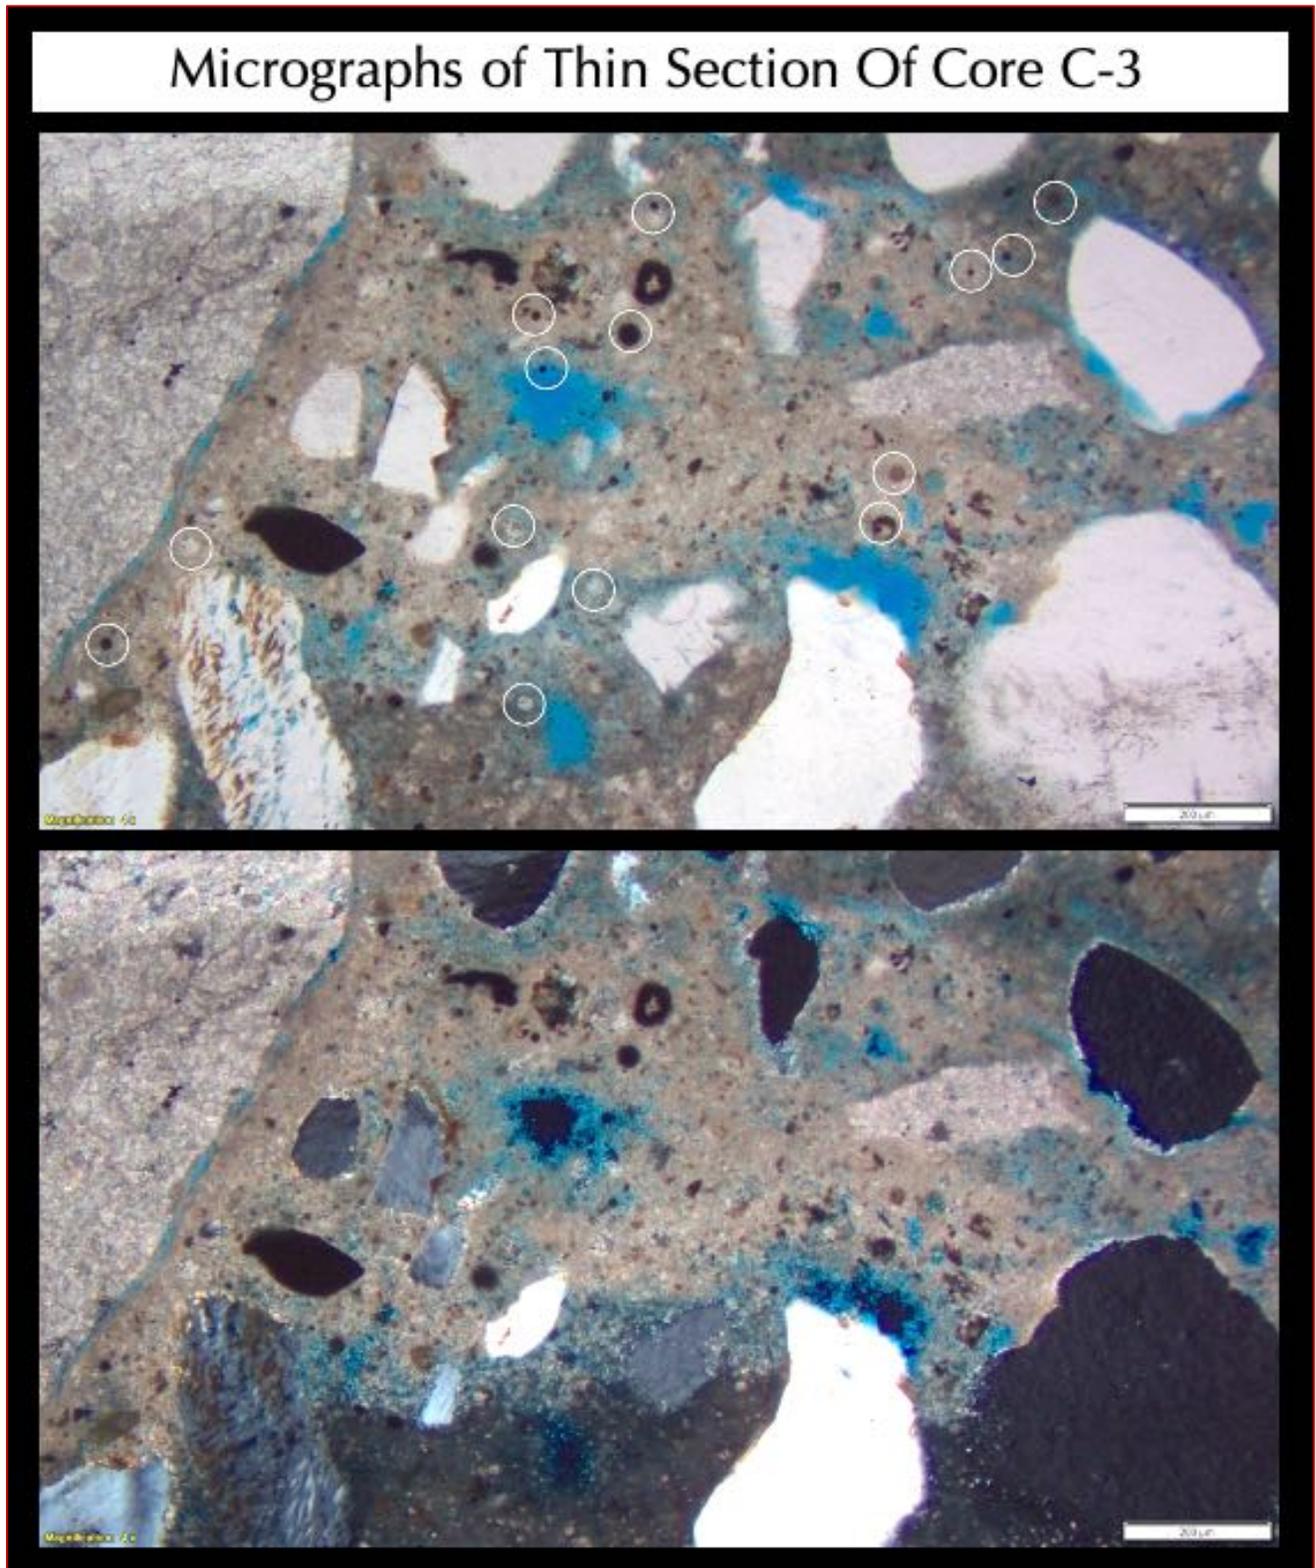
Figure 15: Micrographs of thin section of concrete at two ends showing crushed limestone coarse aggregate particles with interstitial mortar fraction containing silica sand and binary cement and fly ash paste where residual fly ash spheres are circled. Paste is carbonated at the top half to form finely crystalline calcium carbonate deposits whereas interior past at the bottom end of photos is non-carbonated.
