Laboratory Studies of a Mortar Coating Sample From a Prestressed Concrete Cylinder Pipe

Englewood 24-inch Transmission Main
Dean Street, Englewood, New Jersey

EXECUTIVE SUMMARY

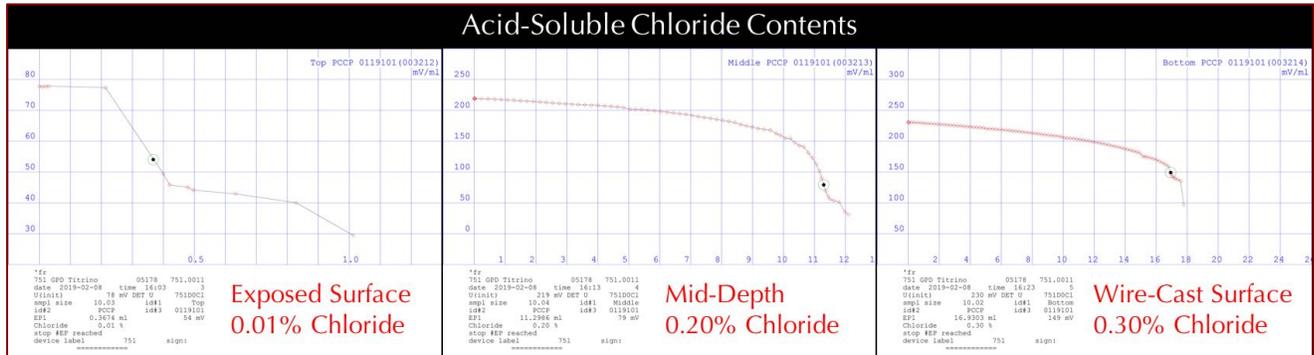
Results show negligible chloride content (0.04% by mass of cement) at the top exposed surface region due to leaching of chloride but high chloride content (1.32 to 1.99% by mass of cement) in the mid-depth and wire cast surface region respectively indicating penetration of chloride from the environment, which has caused corrosion of prestressing wires and resultant corrosion products seen in the failed portion of pipe in field photos.

Figure 16 shows plots of millivolts versus milliliters of silver nitrate solutions during potentiometric titration of acid-soluble chloride from coatings in Metrohm DMS Titrino 751 and the equivalence points of titration (circled on the

plots in the graphs) at the steepest slope that was used in calculations of chloride contents of coating [% chloride = (Equivalent point times 0.177) divided by sample weight in grams].

Figure 16: Plots of millivolts versus milliliters of silver nitrate solutions during titration in Metrohm DMS Titrino 751 and the equivalence points of titration (circled on the plots in the graphs) at the steepest slope that was used in calculations of chloride contents of coating [% chloride = (Equivalent point times 0.177) divided by sample weight in grams].
