CONSTRUCTION MATERIALS CONSULTANTS, INC.

Laboratory Investigation of Epoxy Terrazzo Failure From Concrete Slab-on-Grade

Knott Hall
Loyola Blakefield
Towson, Maryland

April 03, 2019
CMC 0219107

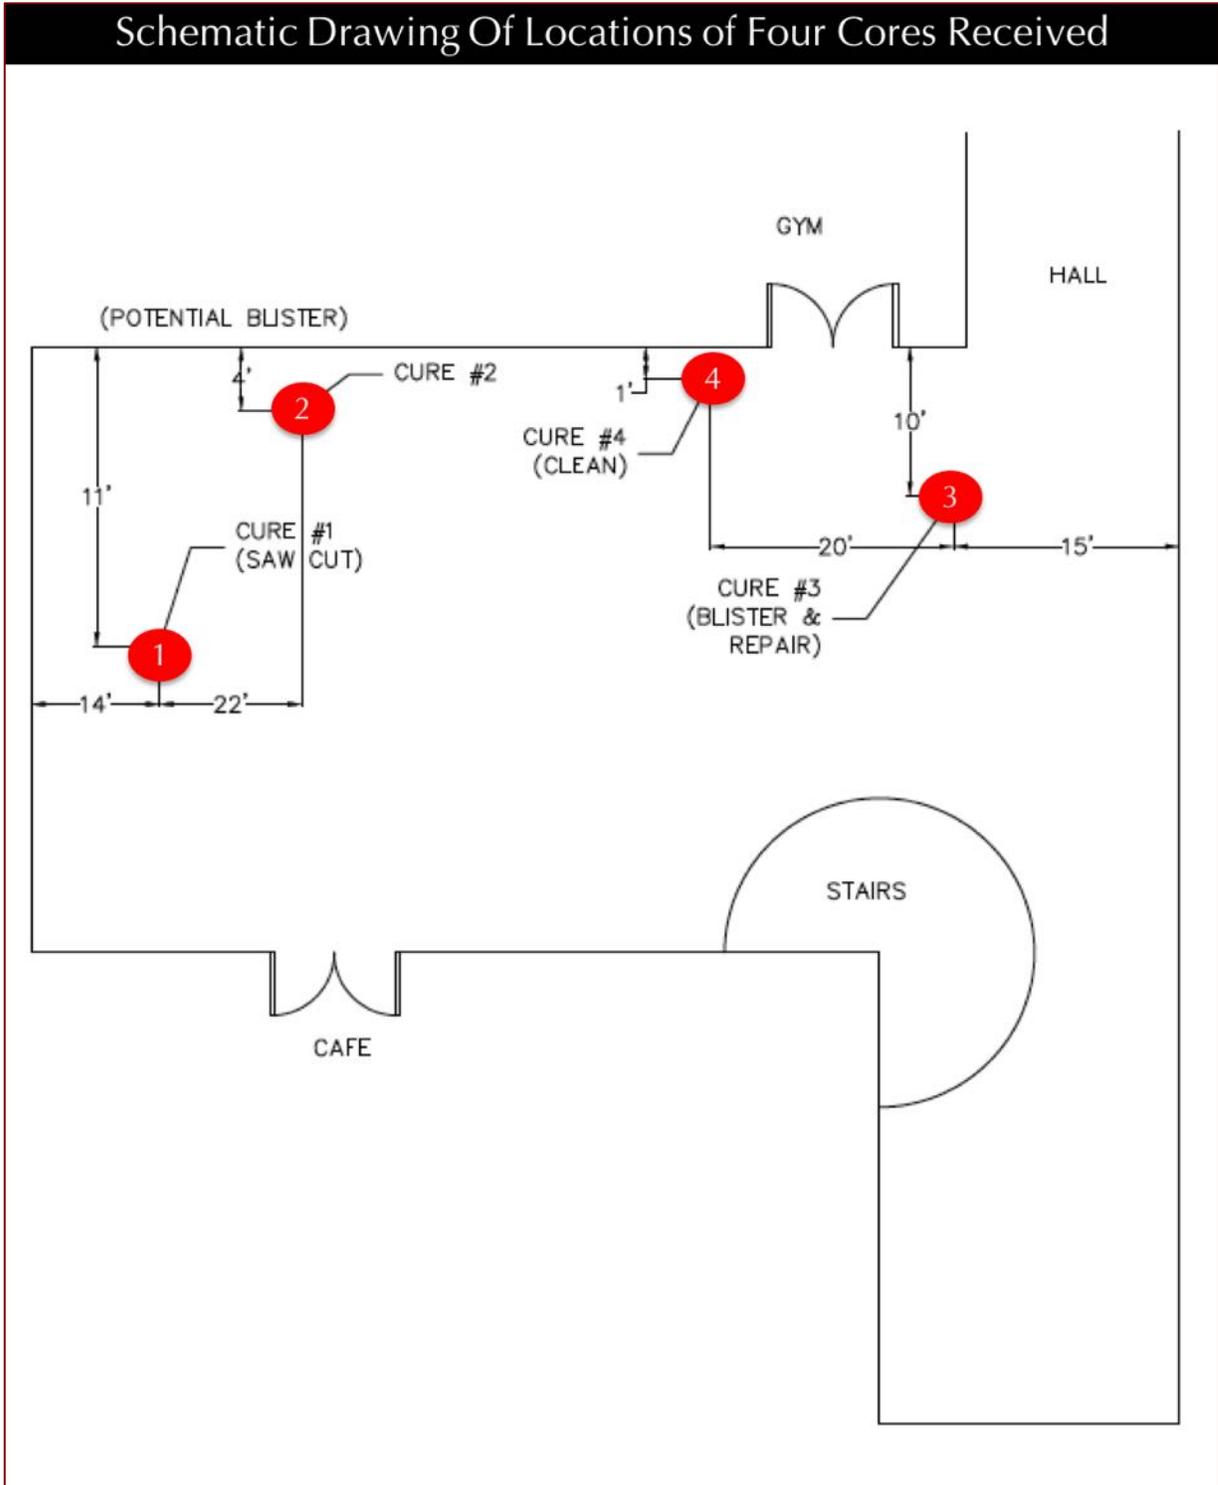
The following schematic drawing shows approximate locations of four cores received, proximity of Core 2 from a nearby blister on terrazzo, drilling of Core 1 from over control joints, and of Core 4 from a sound area.

Figure 2: Schematic hand drawing showing approximate locations of four cores received.

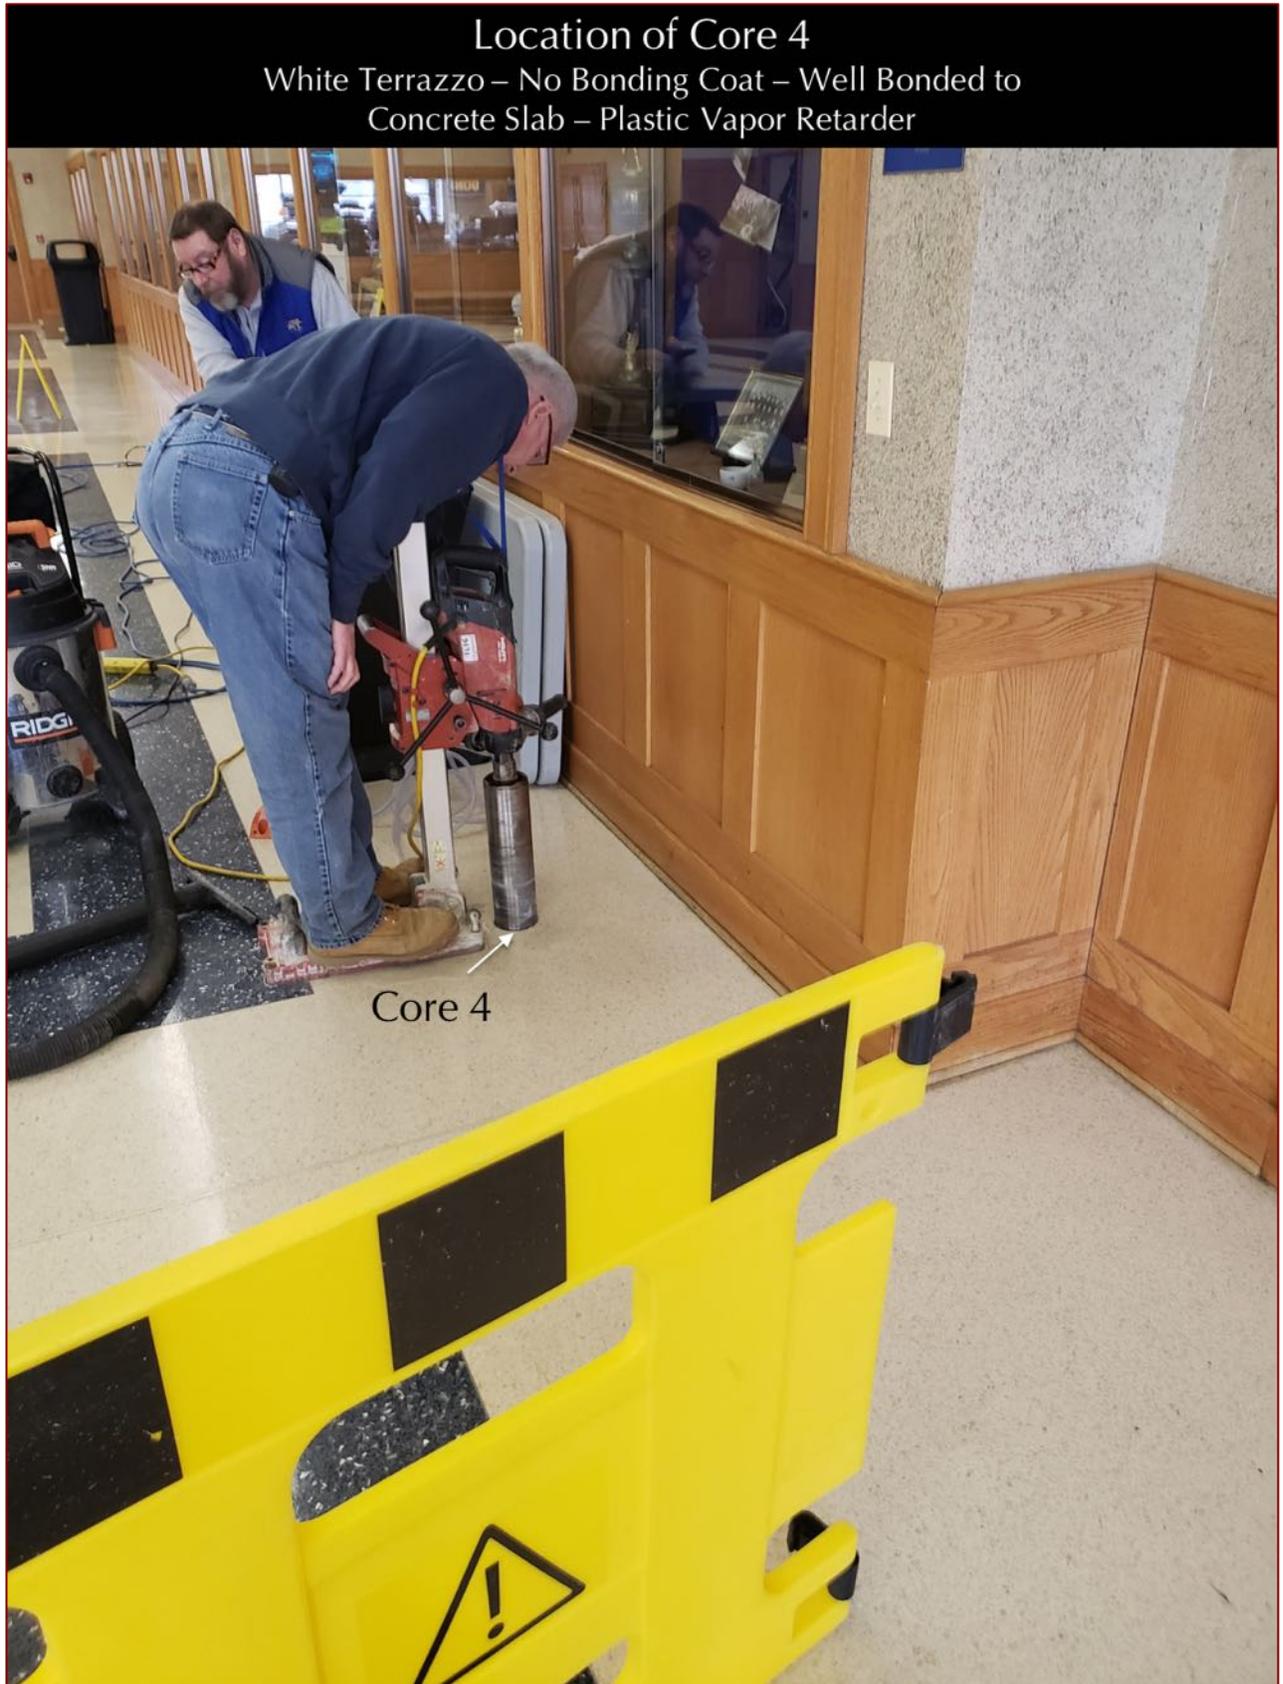
Figure 6: Location of Core 4 from a white terrazzo floor during drilling of the core.

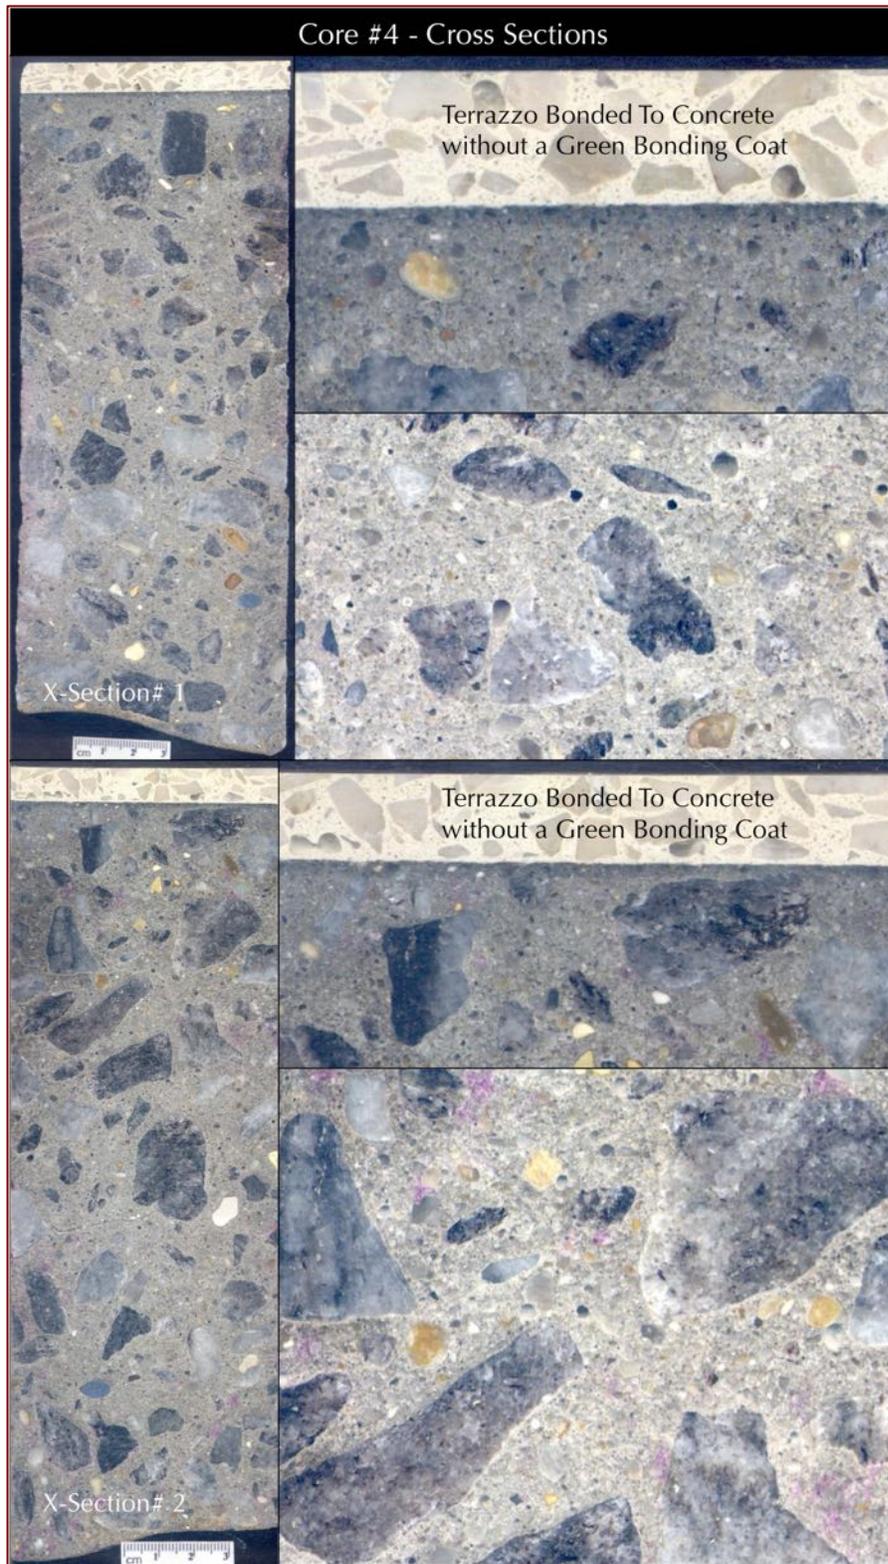
Figure 14: Lapped cross section of Core 4 showing: (a) white terrazzo flooring without any visible crack and smooth, wavy, formed bottom end of concrete with impression of placement of slab on a plastic vapor retarder; (c) good bond of terrazzo to concrete despite having no green bond coat between the two as found in other cores; (d) good grading and well-distribution of crushed stone coarse aggregate in concrete, and (e) dense terrazzo having crushed aggregate chips and white binder.

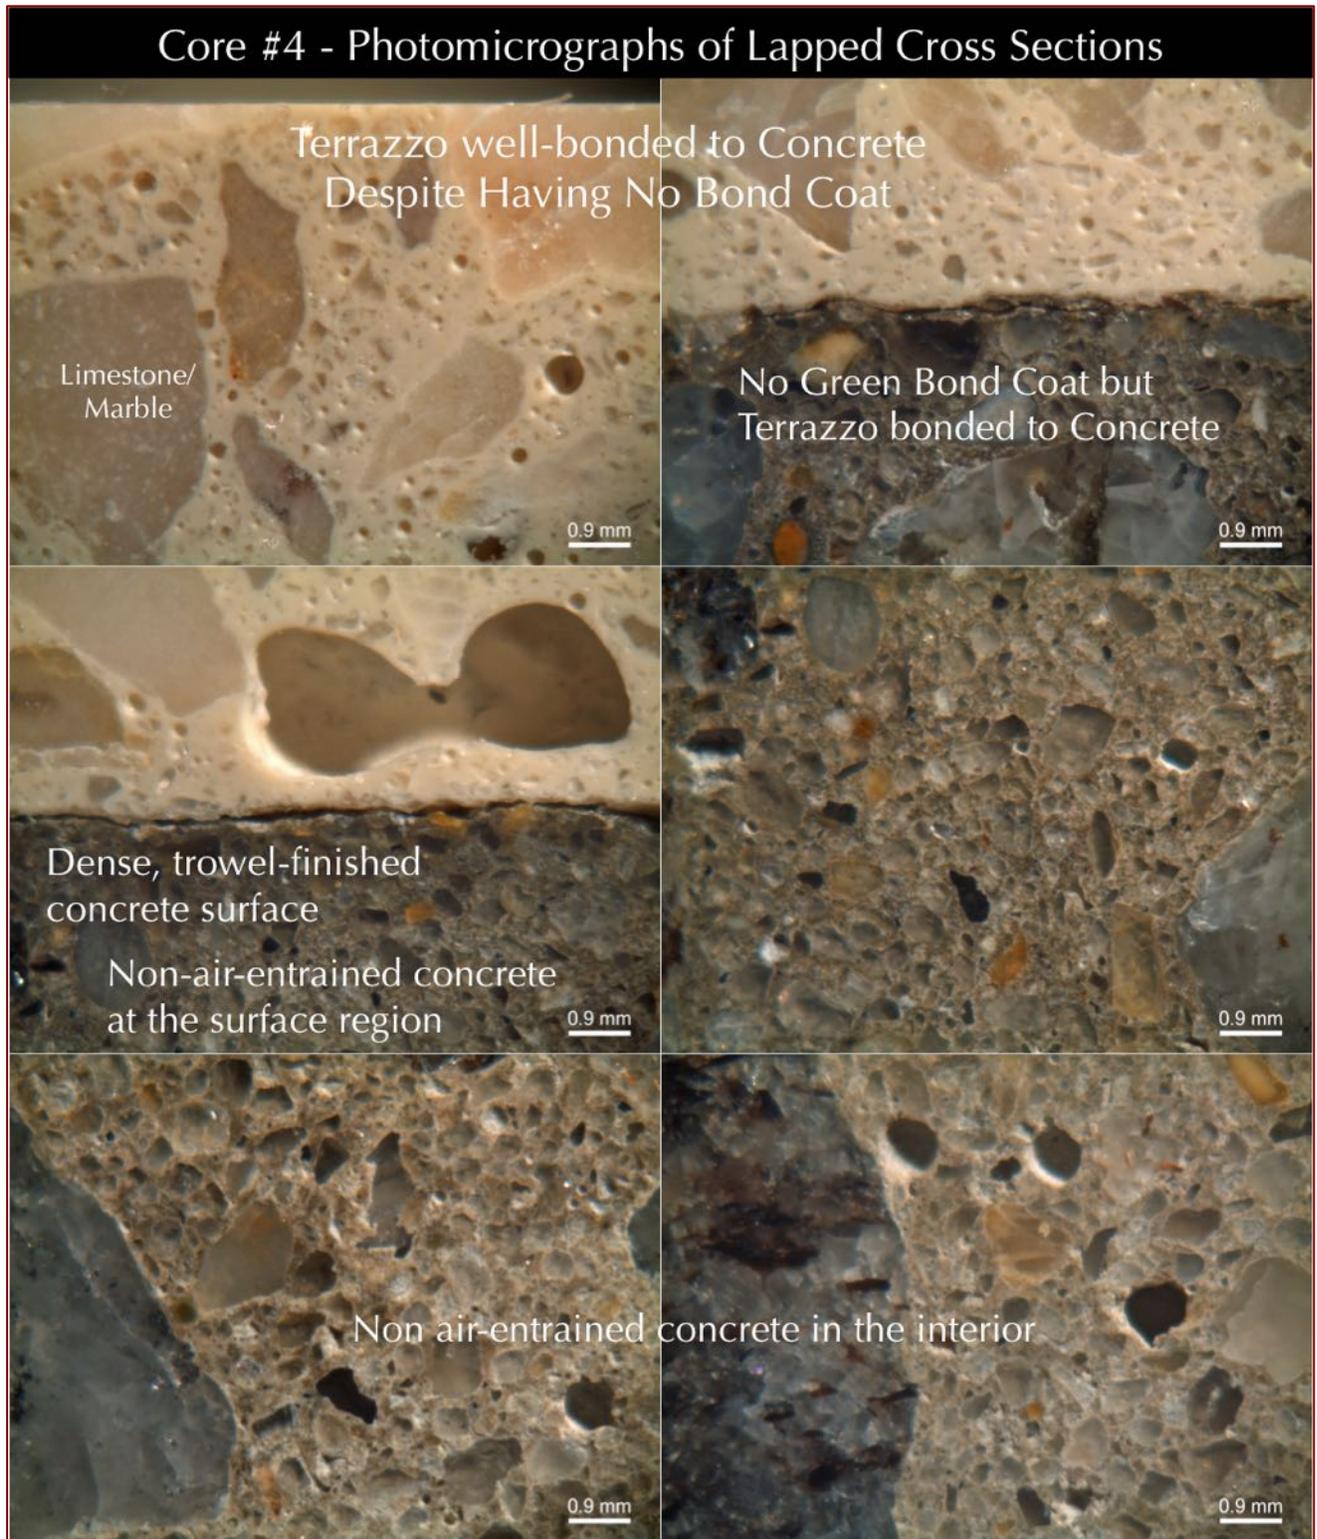
Figure 21: Photomicrographs of lapped cross section of Core 4 showing: (a) terrazzo flooring 10 mm in thickness, having crushed limestone/marble chips (3 mm nominal size) in white polymer binder, and dense, non-air-entrained nature of terrazzo; (b) no green bond coat at the base of terrazzo, yet terrazzo is well-bonded to concrete; (c) dense, dark gray, air-free trowel-finished surface region of concrete floor; and (d) non-air-entrained nature of concrete.

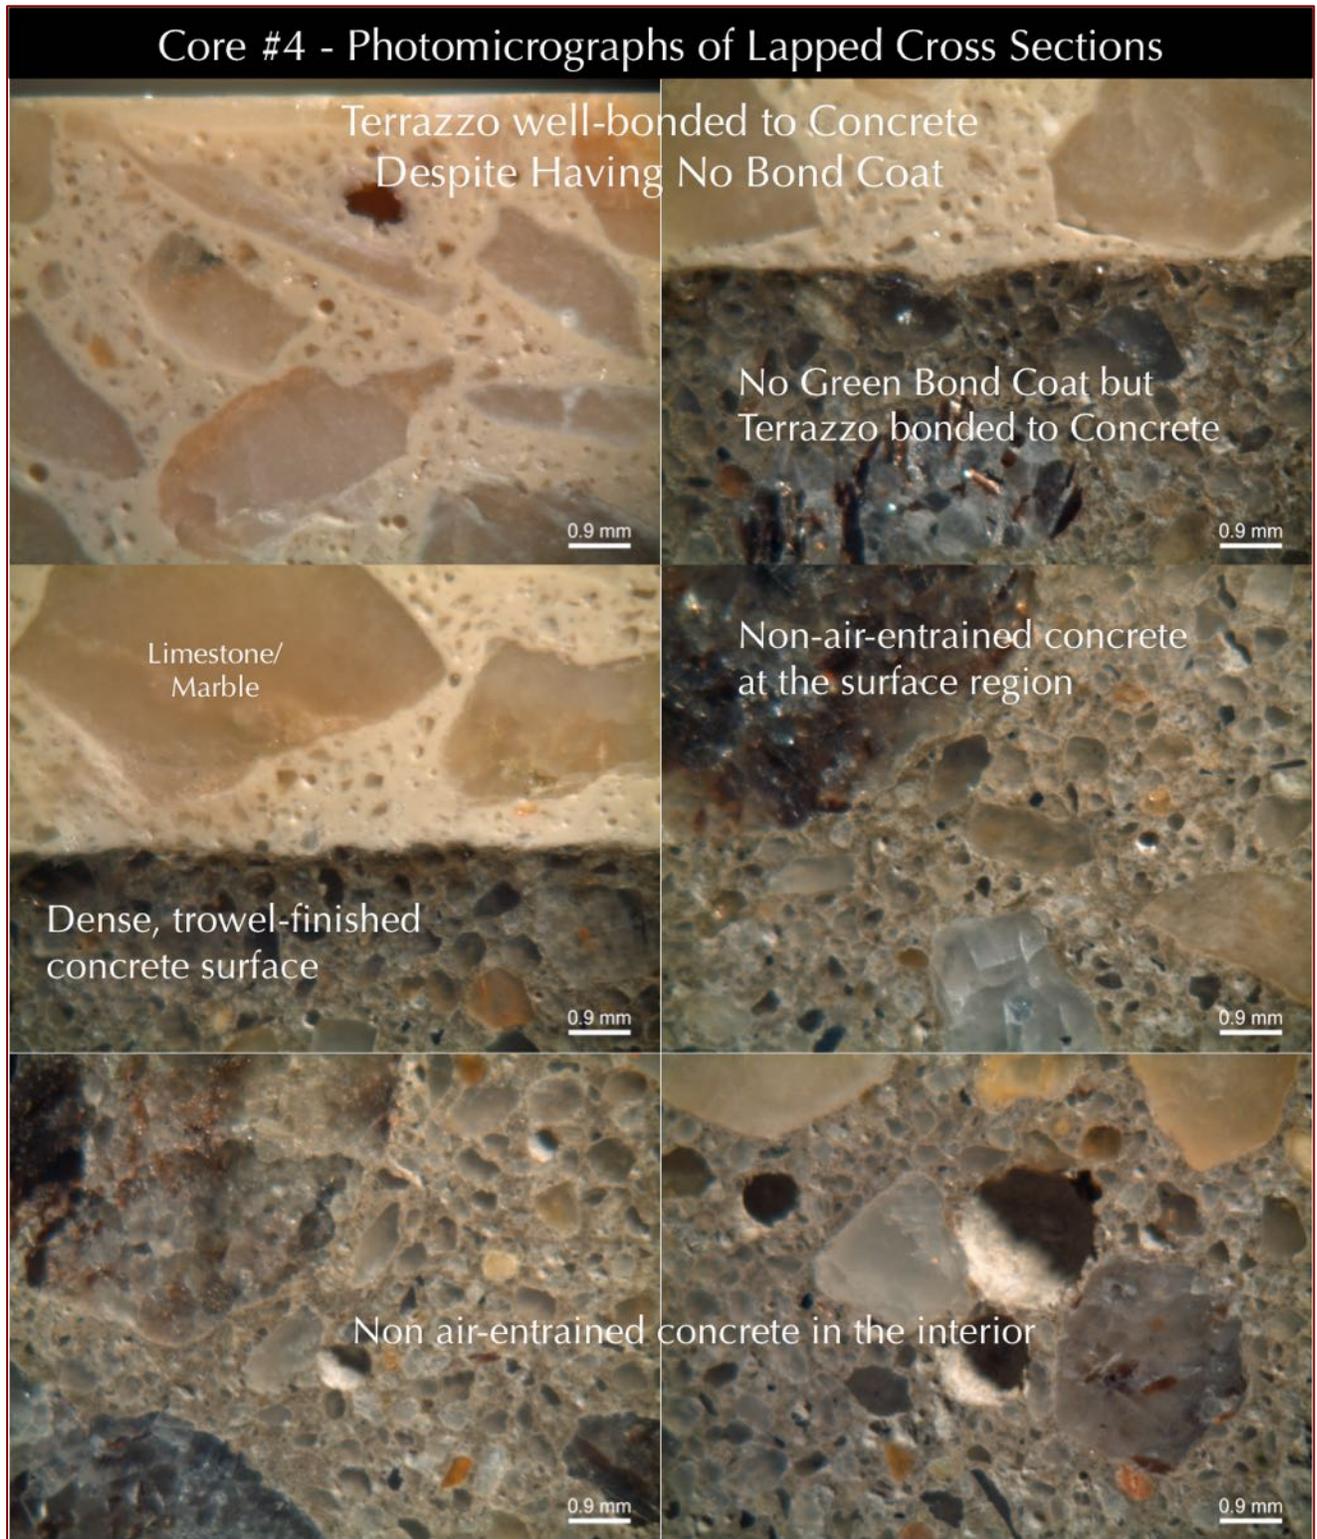
Figure 22: Photomicrographs of lapped cross section of Core 4 showing: (a) terrazzo flooring 10 mm in thickness, having crushed limestone/marble chips (3 mm nominal size) in white polymer binder, and dense, non-air-entrained nature of terrazzo; (b) no green bond coat at the base of terrazzo, yet terrazzo is well-bonded to concrete; (c) dense, dark gray, air-free trowel-finished surface region of concrete floor; and (d) non-air-entrained nature of concrete.

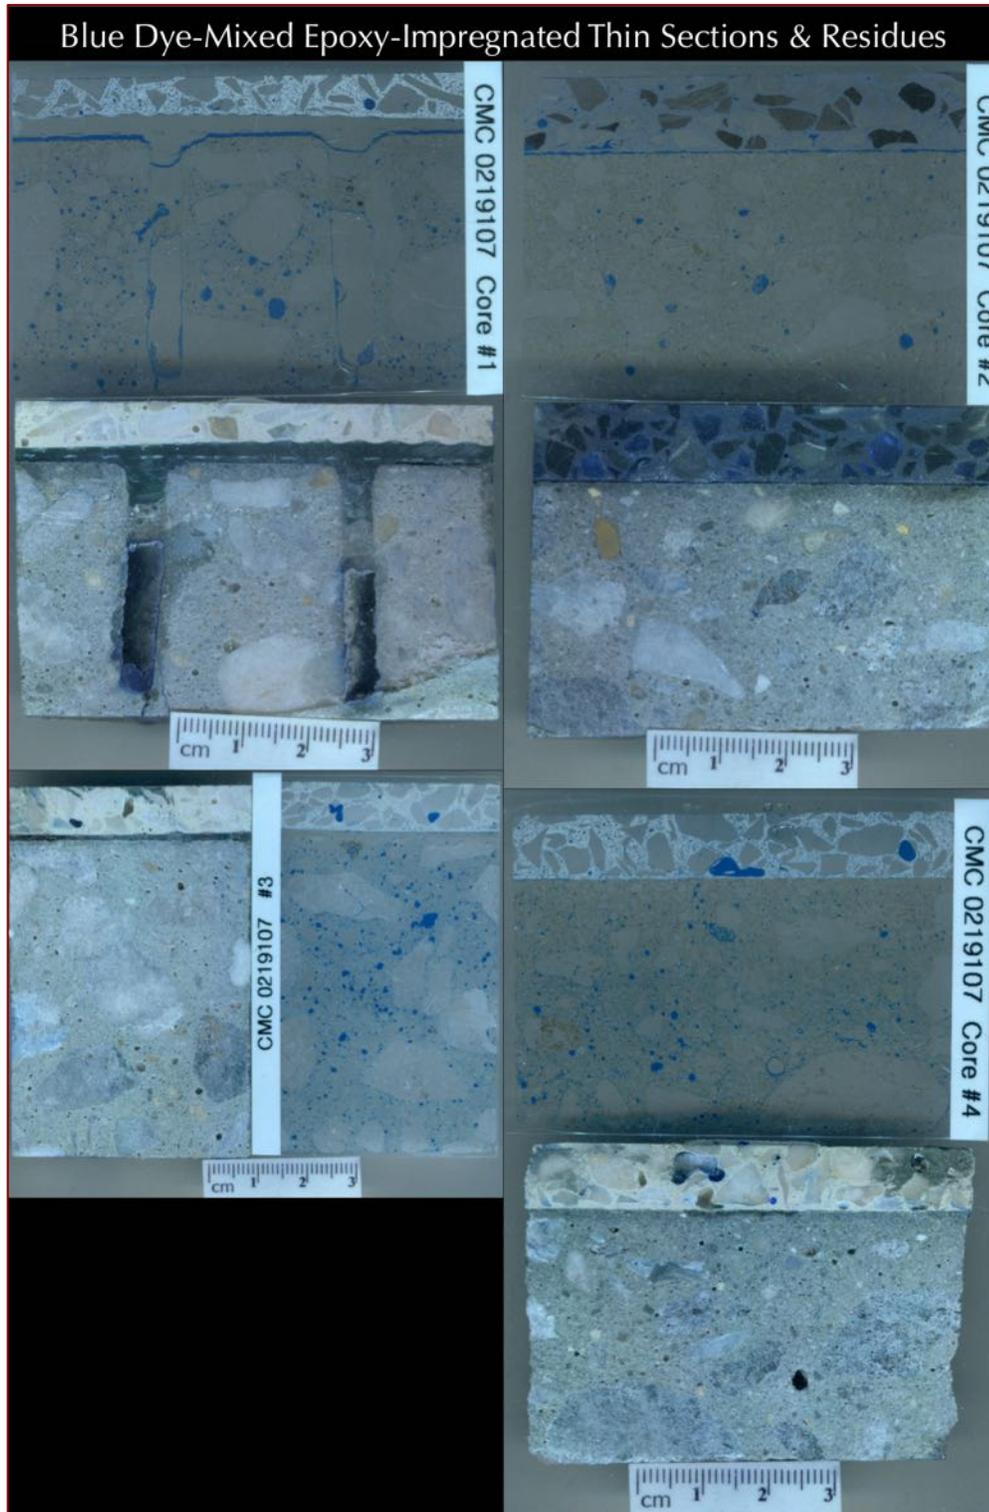
Figure 23: Photomicrographs of blue dye-mixed epoxy-impregnated thin sections of terrazzo and concrete composite cores showing size, shape, angularity, gradation, and distribution of marble/limestone chip particles in polymer binder in terrazzo, the underlying concrete where voids and cracks, if any are highlighted by blue epoxy. The top 2 inches from all four cores were sectioned and encapsulated with blue epoxy to prepare thin sections.

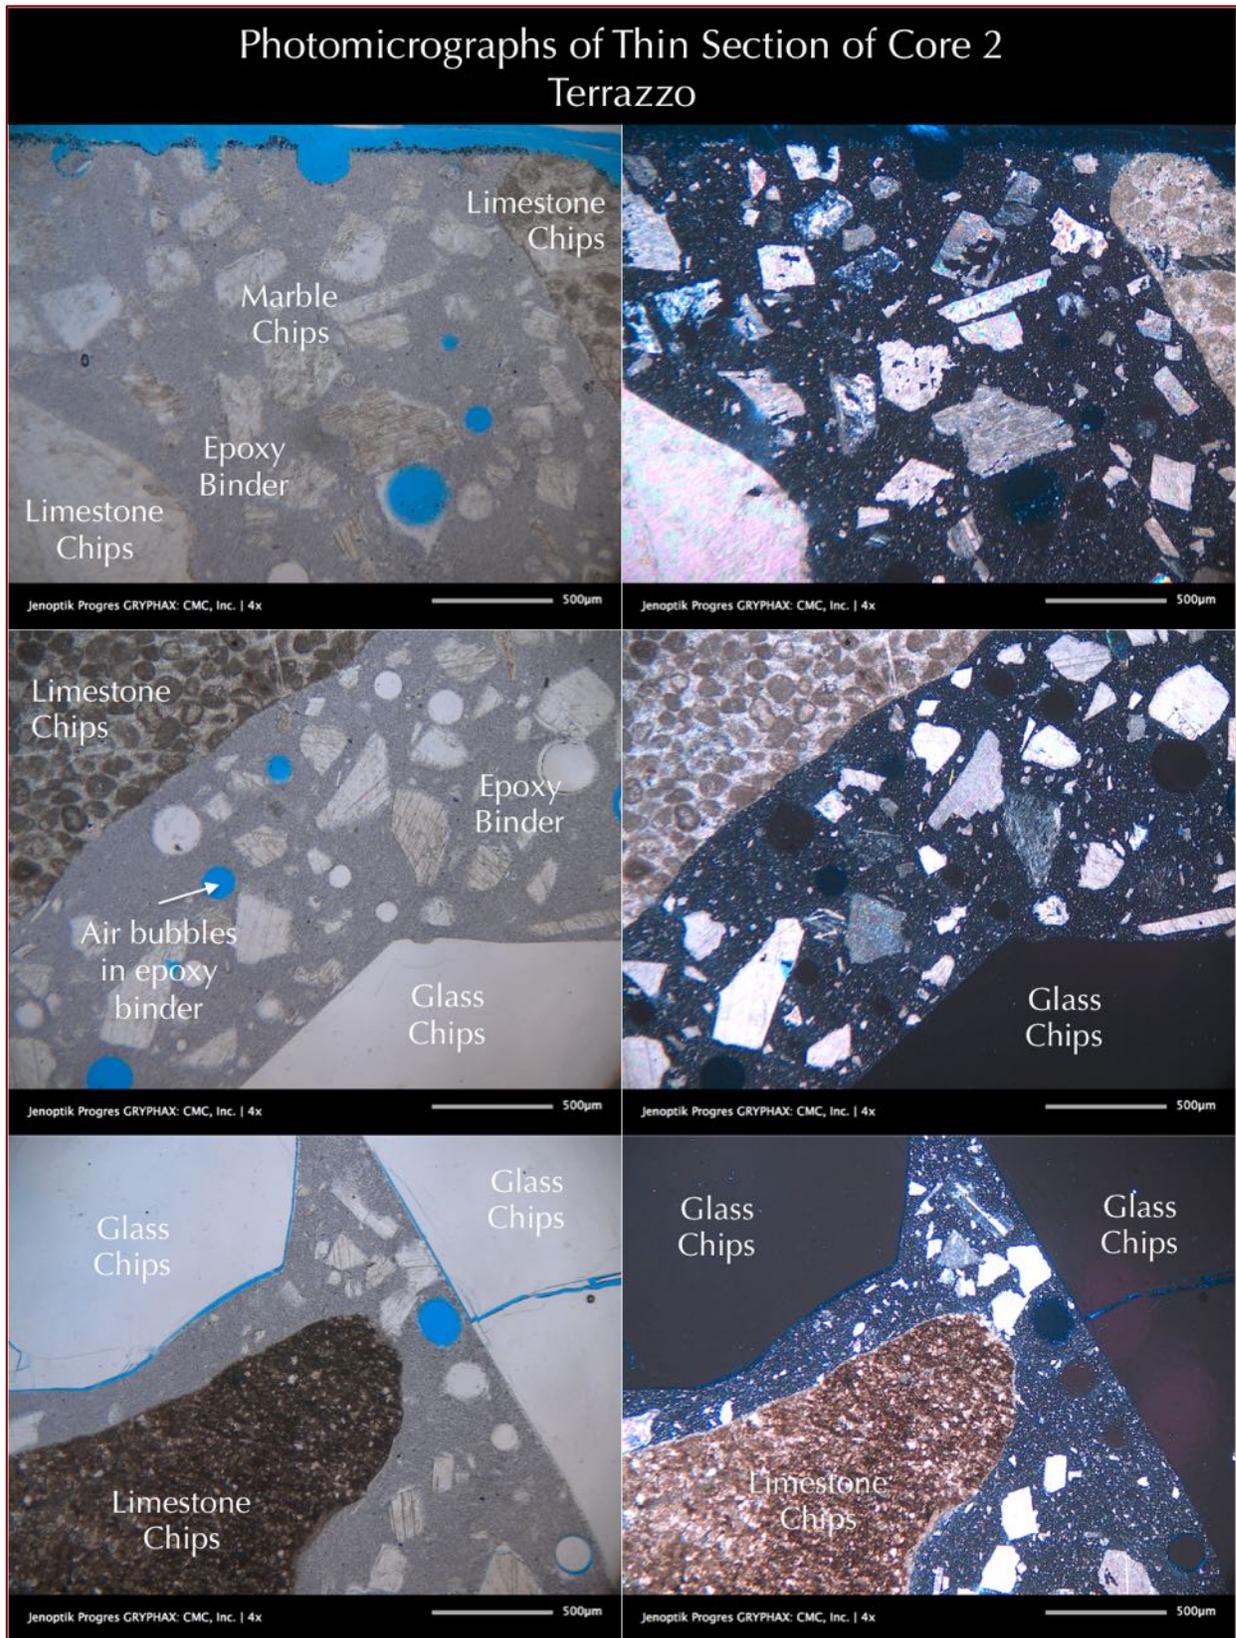
Figure 26: Photomicrographs of thin section of Core 2 showing: (a) crushed limestone, marble, and isotropic glass chips in dense polymer binder (appear much lighter toned than the binder in other three cores of white terrazzo flooring) with occasional spherical entrapped voids in terrazzo.

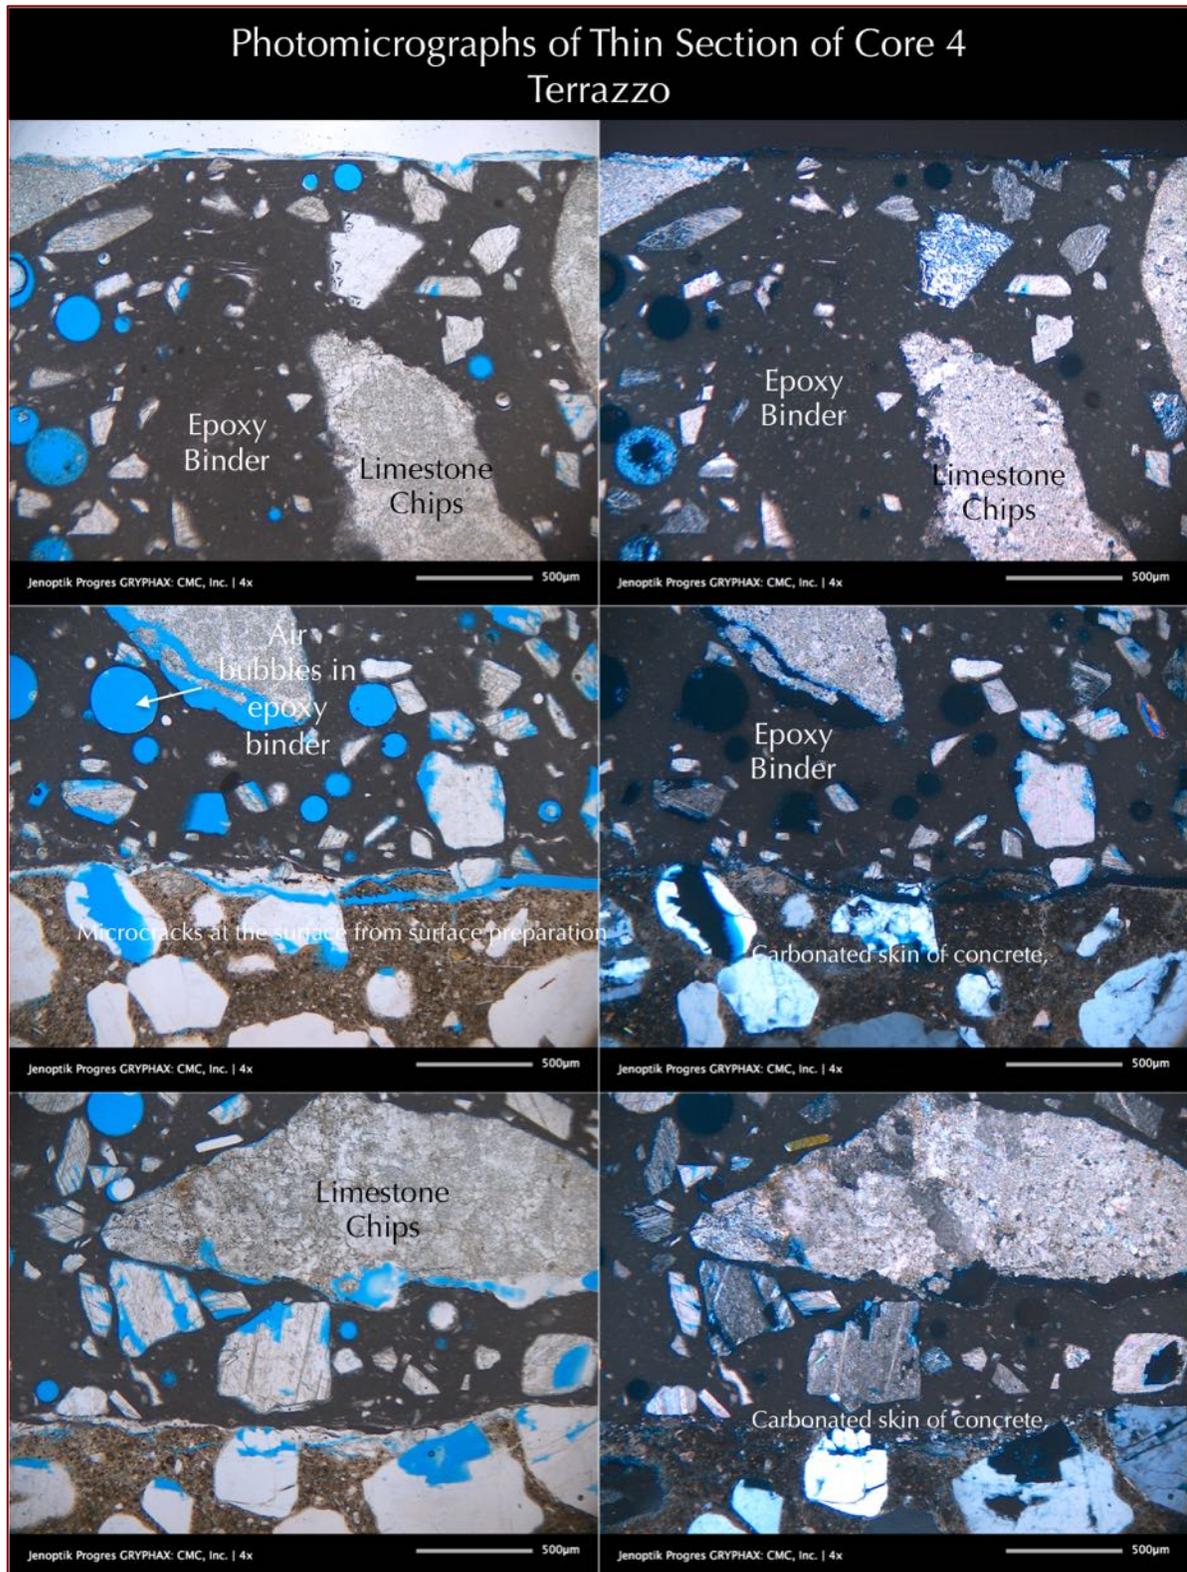
Figure 32: Photomicrographs of thin section of Core 4 showing: (a) crushed limestone and marble chips in dense polymer binder with occasional spherical entrapped voids in terrazzo; (b) occasional fine, hairline microcracks at terrazzo-concrete interface despite relatively good bond between the two; (c) dense trowel-finished concrete surface with a carbonated skin at the top on which terrazzo was placed, indicating inadequate removal of concrete surface prior to terrazzo installation, which, however, did not prevent good bond between terrazzo and concrete.

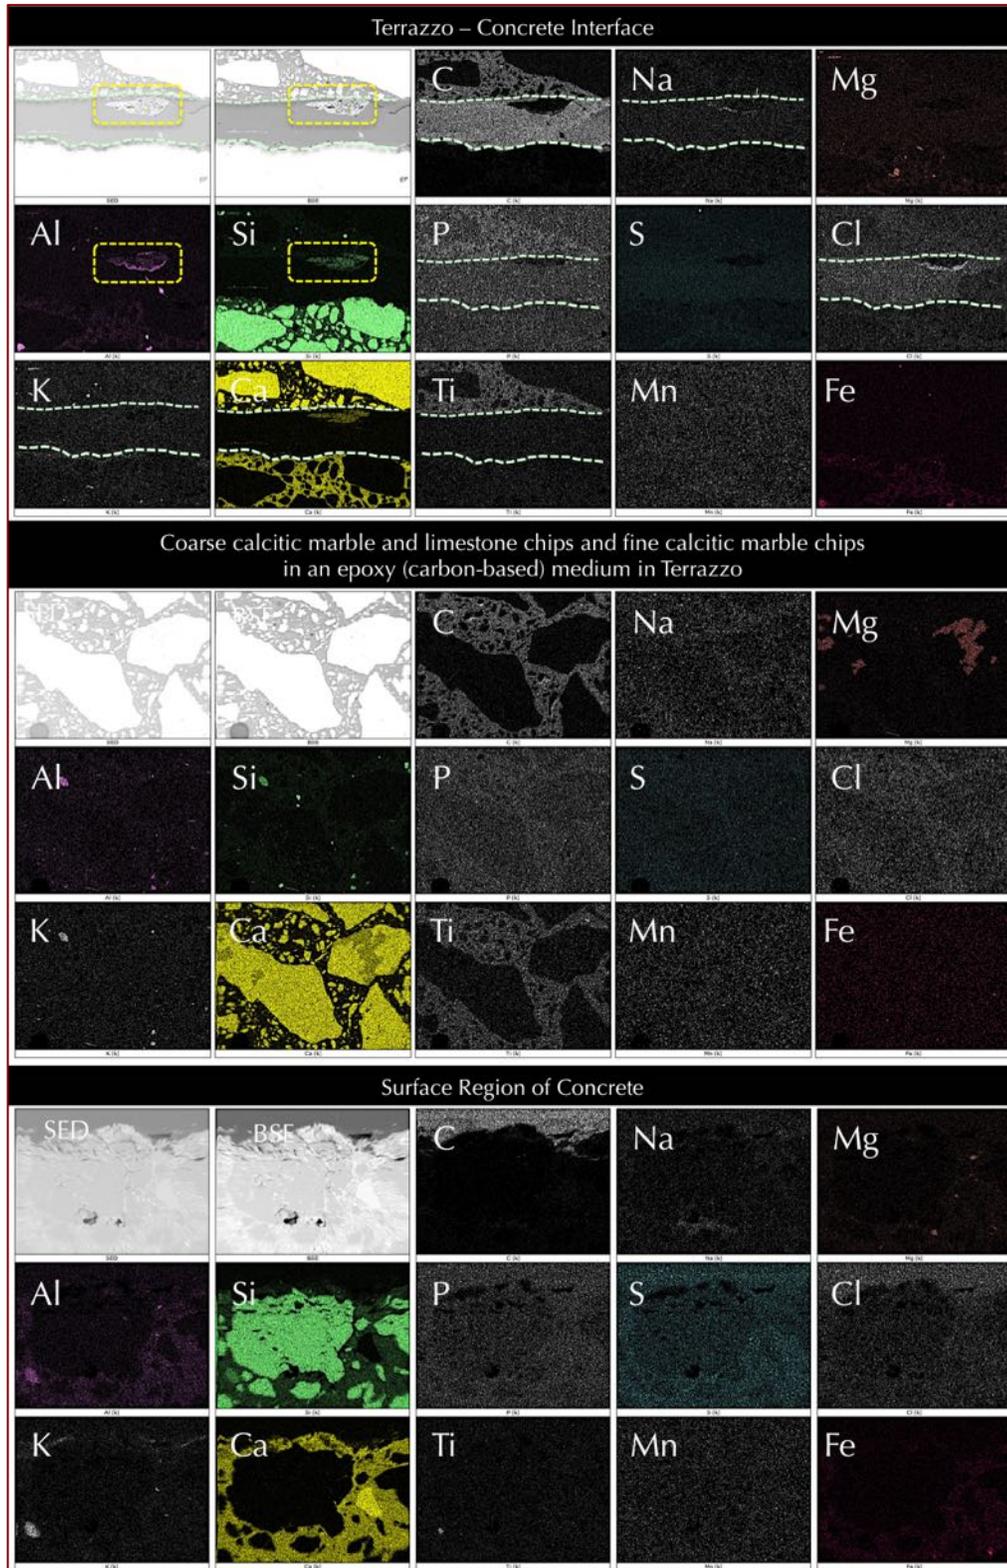
Figure 35: X-ray elemental maps of Terrazzo-concrete interface (top), interior of terrazzo (middle), and surface region of concrete (bottom) collected from energy-dispersive X-ray spectroscopy of scanning electron microscope.

X-ray elemental maps of terrazzo, concrete, and terrazzo-concrete interface in Core 3 from a scanning electron microscope shown in Figure 35 revealed a number of information that are listed below:

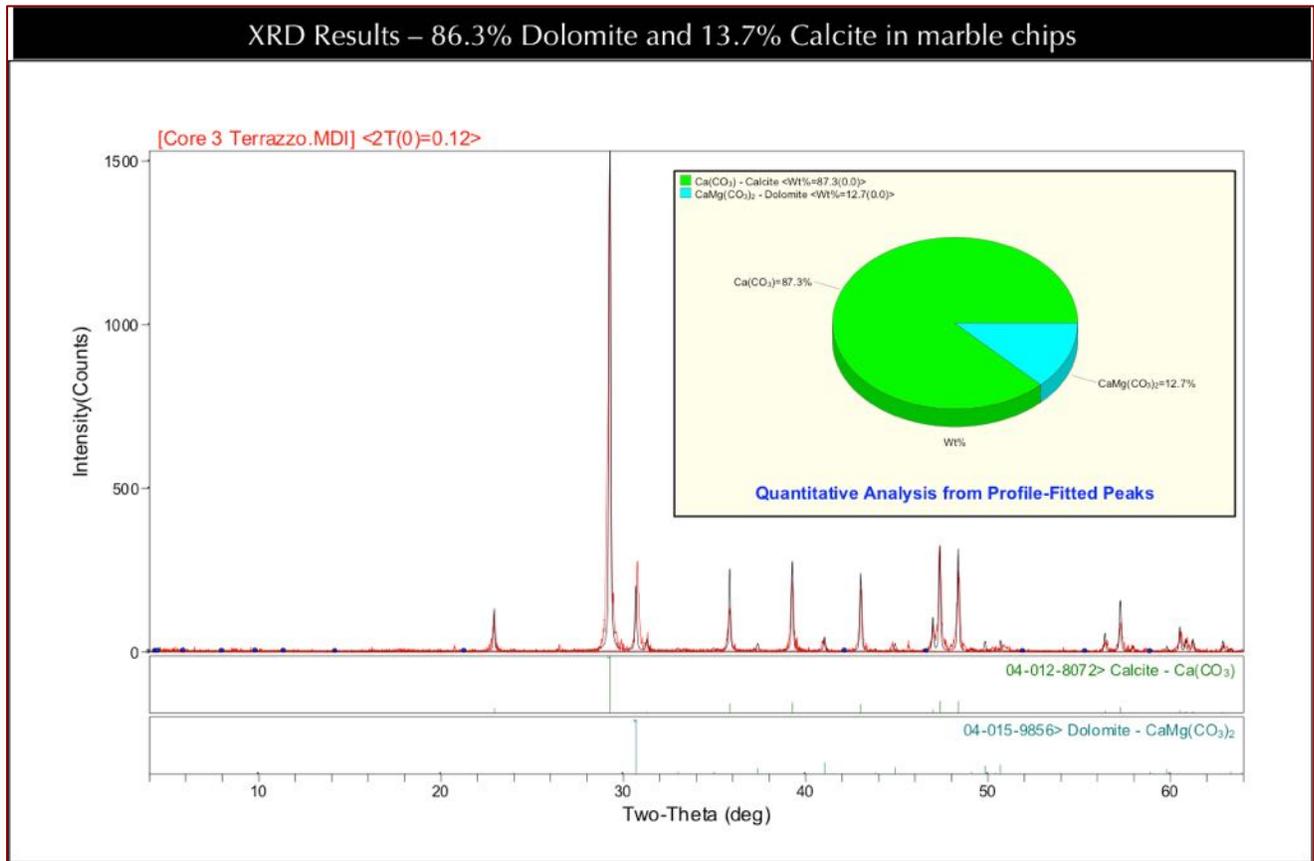
Figure 36 shows the X-ray diffraction pattern of the bulk terrazzo, which shows calcite as the main detectable phase from calcitic marble and limestone having with 87.3% calcite and 12.7% calcite, which is consistent with discovery of finer calcitic marble chips and coarser limestone fractions in optical microscopy (Figures 24 to 34) and X-ray elemental maps (Figure 35).

Figure 36: X-ray diffraction pattern of bulk terrazzo showing dolomite as the dominant mineral followed by calcite both from the marble chips.

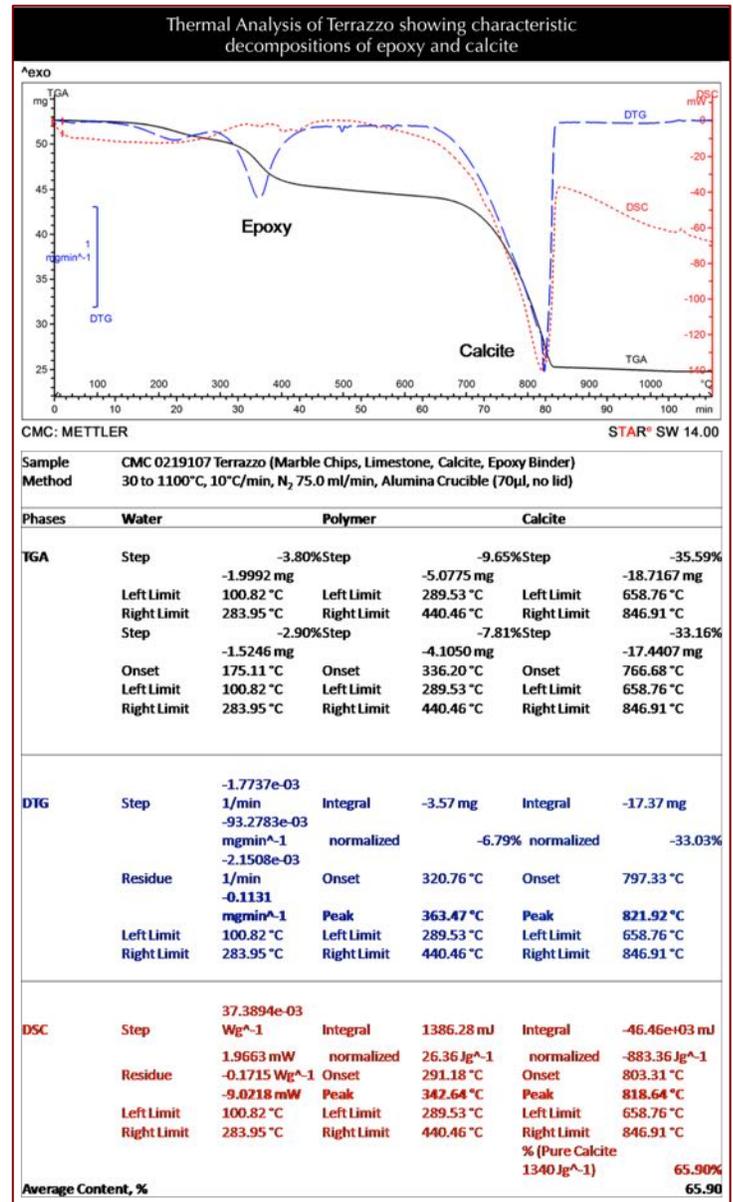
(a) decomposition of the epoxy binder (from an endothermic peak around 363.7°C in the DTG curve), and (b) decarbonation of calcite (from an endothermic peak around 821.9°C in the DTG curve). Thermal analysis detected about 8 percent weight loss from resin binder, and about 66 percent calcite in the filler chips.

Figure 37: TGA (bold black), DSC (dotted red), and DTG (dashed blue) curves of terrazzo showing losses in weight due to various decompositions (loss of water and carbon dioxide) during controlled heating in a Mettler-Toledo’s simultaneous TGA/DSC 1 unit from 30°C to 1000°C in a ceramic crucible (alumina 70µl, no lid) at a heating rate of 10°C/min in a nitrogen purge at a rate of 75 mL/min. The results show three major decompositions from: (a) the loss of combined water from polymer binder at the lower temperature (from a low temperature peak in DTG curve), (b) decomposition of the epoxy-resin itself at the intermediate temperature (from a peak in the DTG curve), and (c) decarbonation of calcite and dolomite at higher temperature (from the major peak in the DTG curve).

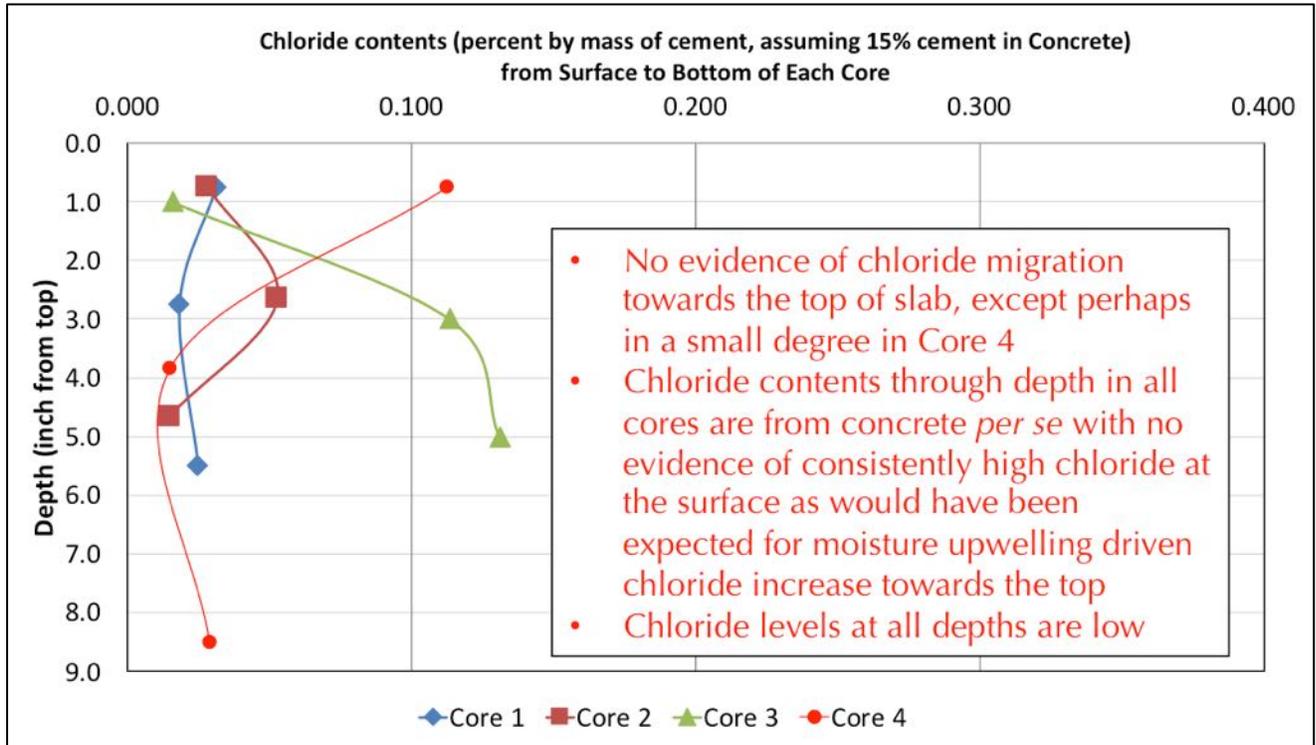
Figures 38 through 40 and Table 3 show results of water-soluble chloride contents at the top, mid-depth, and formed bottom ends of four cores determined from potentiometric titration *a la* ASTM C 1218. Chloride profiles of four cores show no systematic increase of chloride towards the surface (except perhaps in Core 4 to a small degree), as would have been anticipated for moisture upwelling and thus moisture-driven migration of water-soluble chloride towards the surface. Absolute chloride levels are all low at three depths for each core, indicating no preferential contamination of concrete by chloride at the surface.

Figure 38: Results of chloride analyses and chloride contents at the surface regions, mid-depth locations, and bottom ends of cores. Chloride contents are expressed as percentages by mass of cement assuming a cement content of 15 percent in normal-weight concretes.

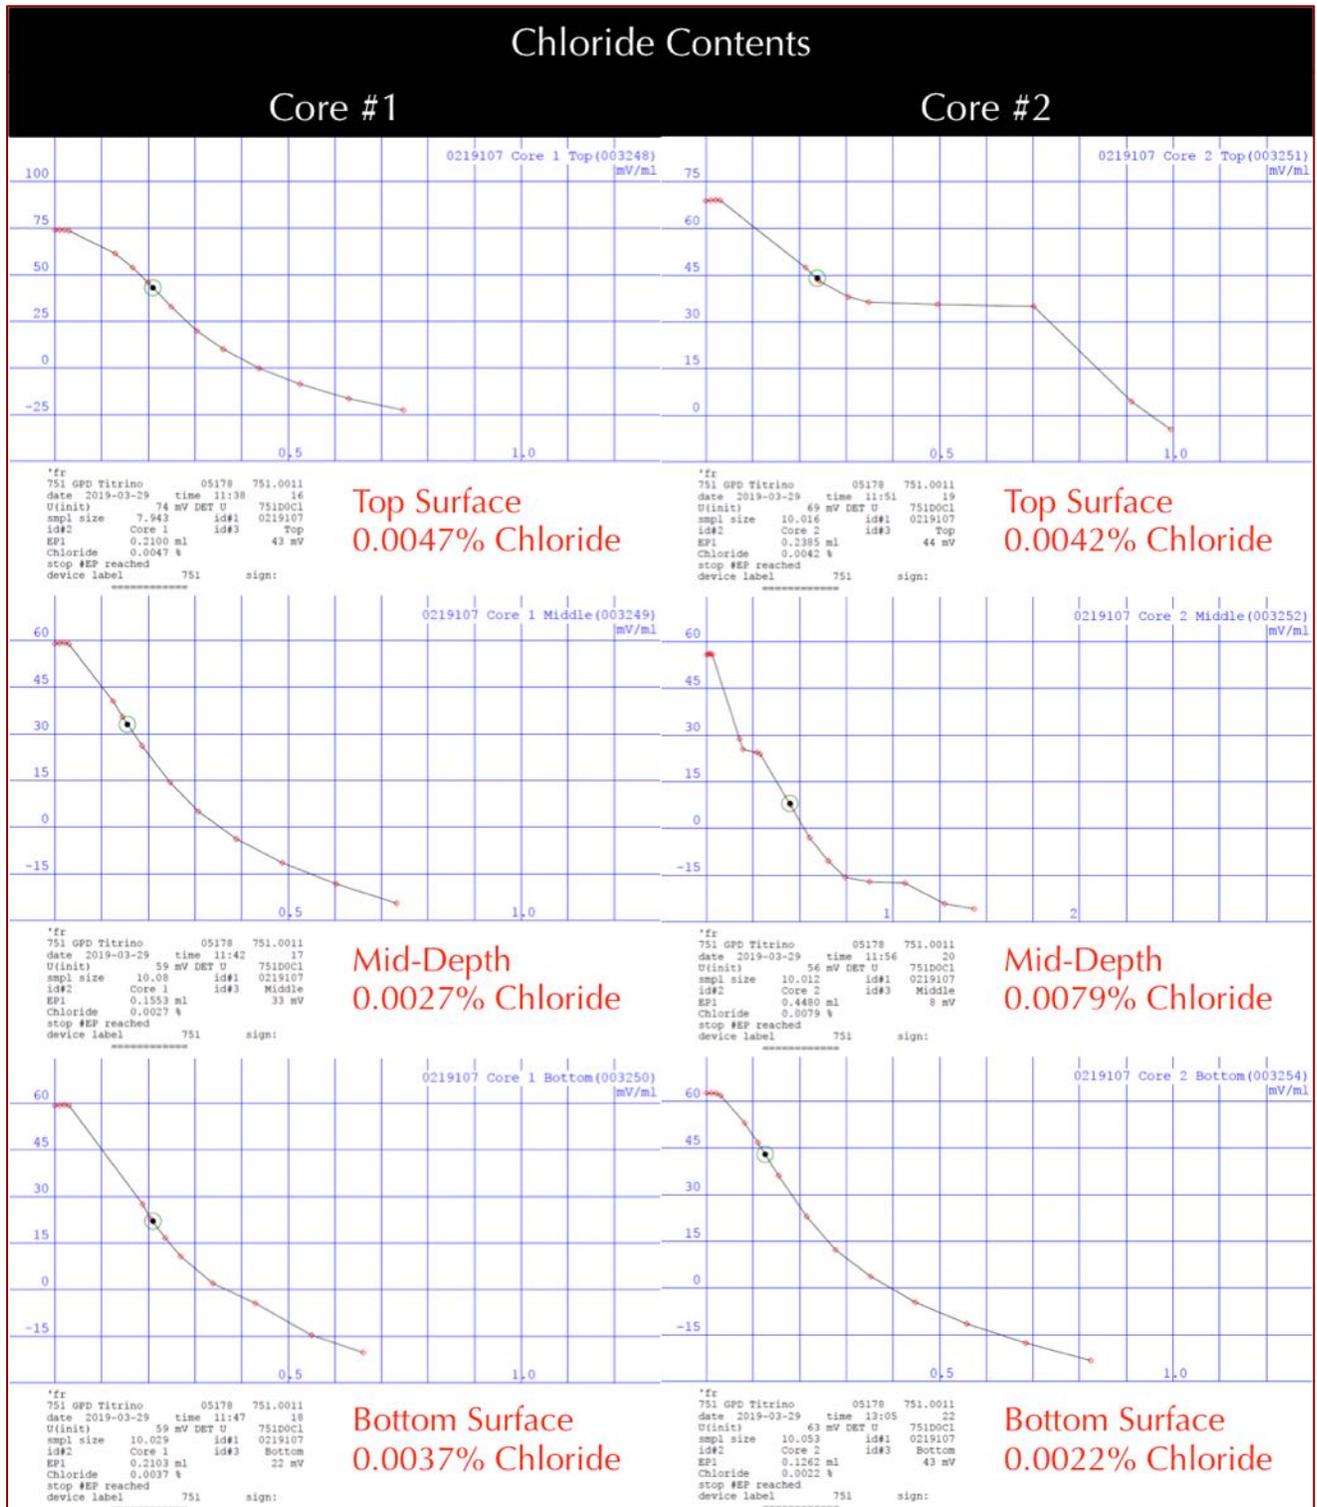
Figure 39: The potentiometric titration curves of chloride analyses from the top surface region (top plots), mid-depth locations (middle plots), and bottom ends (bottom plots) of Cores 1 and 2. In all titration curves, the equivalent points of titration are marked with a dot and circle on the mV-vs-mL AgNO₃ plots. Chloride contents are shown both in the data from the Metrohm Titrator as well as in red.
