CONSTRUCTION MATERIALS CONSULTANTS, INC.

Laboratory Investigation of Epoxy Terrazzo Failure From Concrete Slab-on-Grade

Knott Hall
Loyola Blakefield
Towson, Maryland

April 03, 2019
CMC 0219107

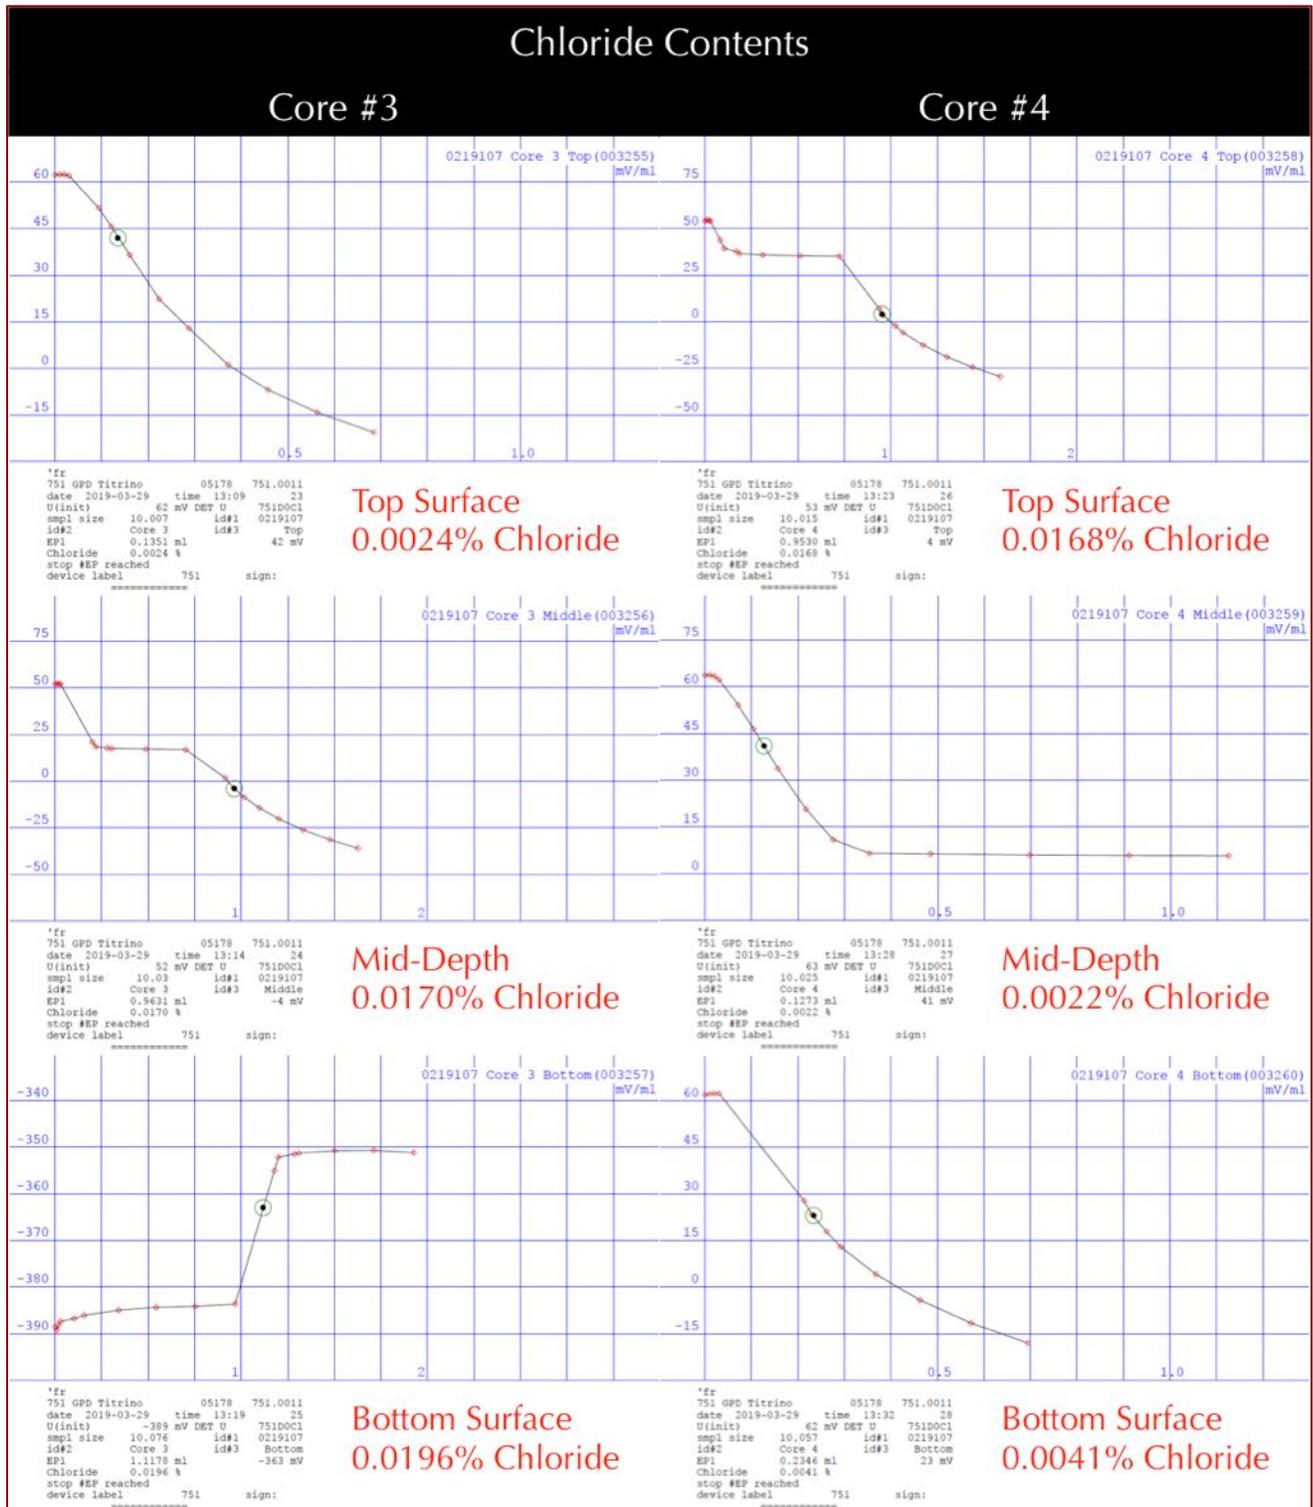
Figure 40: The potentiometric titration curves of chloride analyses from the top surface region (top plots), mid-depth locations (middle plots), and bottom ends (bottom plots) of Cores 3 and 4. In all titration curves, the equivalent points of titration are marked with a dot and circle on the mV-vs-mL AgNO₃ plots. Chloride contents are shown both in the data from the Metrohm Titrator as well as in red.

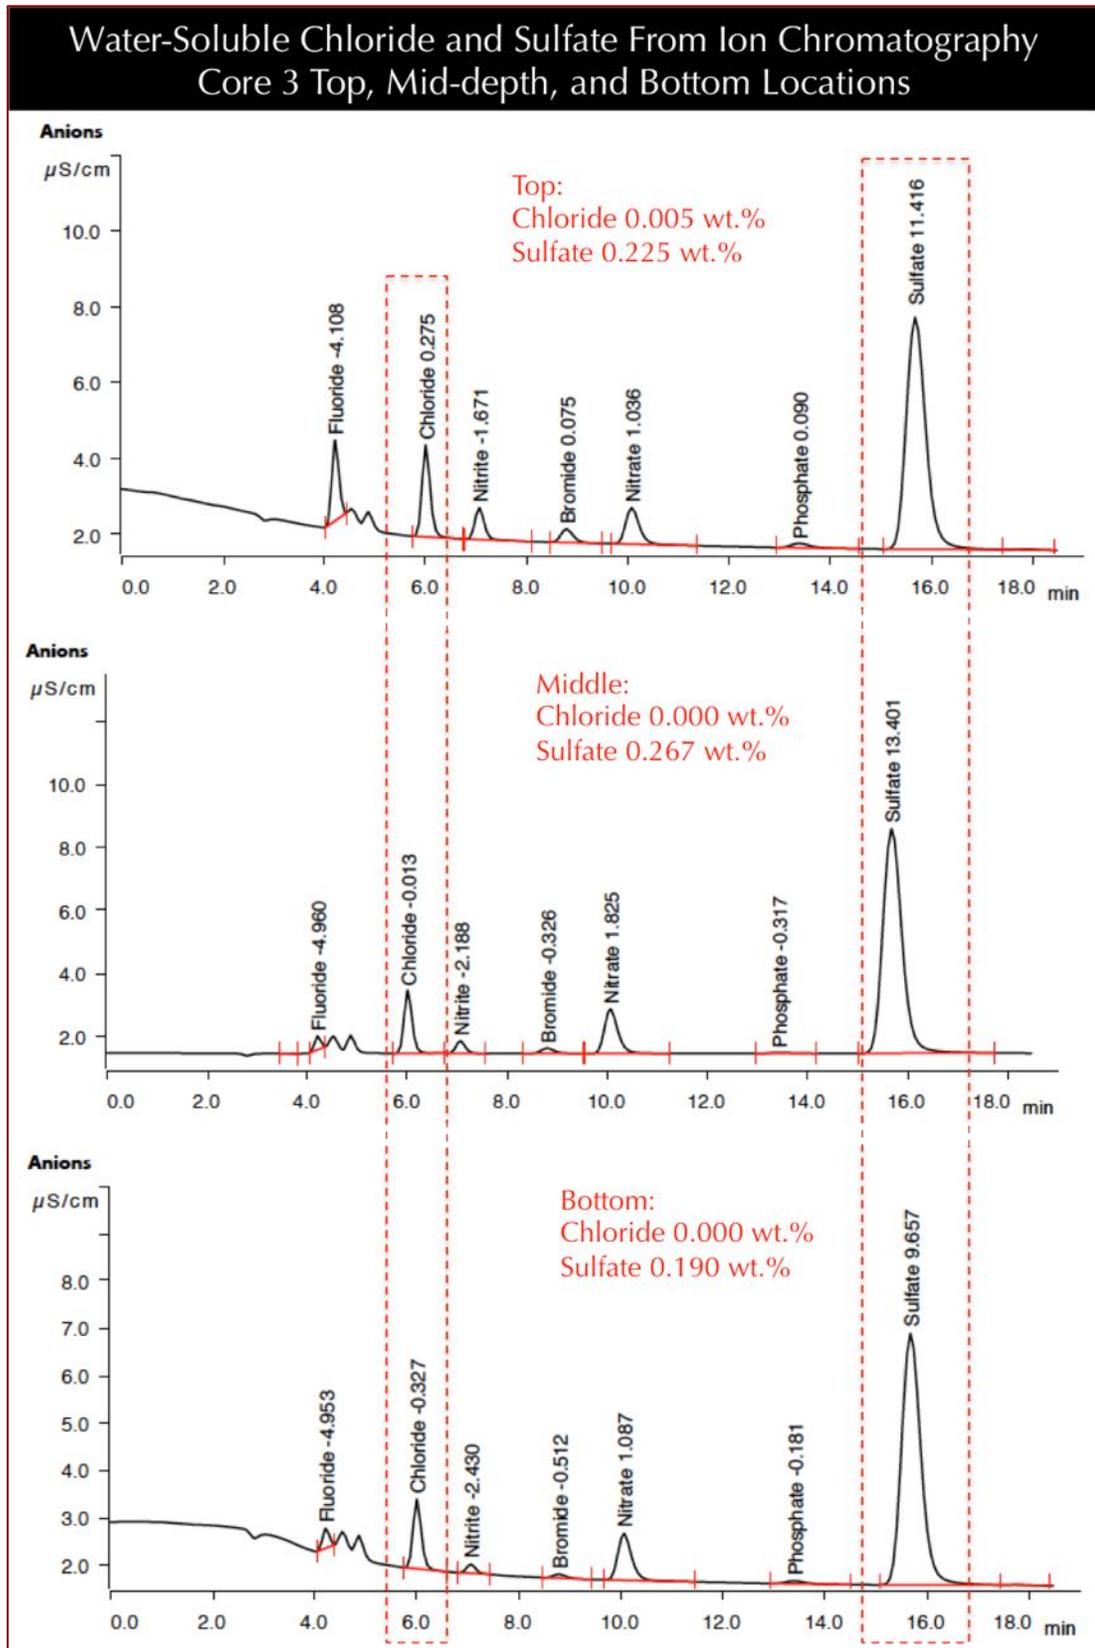
Figure 41 shows results of water-soluble chloride and sulfate contents from ion chromatography, where chloride results are all low, consistent with chloride results from titration. Similar to chloride, sulfate contents are also found to be very low.

Figure 41: Ion chromatograms of water-soluble chloride and sulfate ions from top, mid-depth, and bottom locations of Core 3 showing no systematic variations of chloride or sulfate contents from bottom to top.

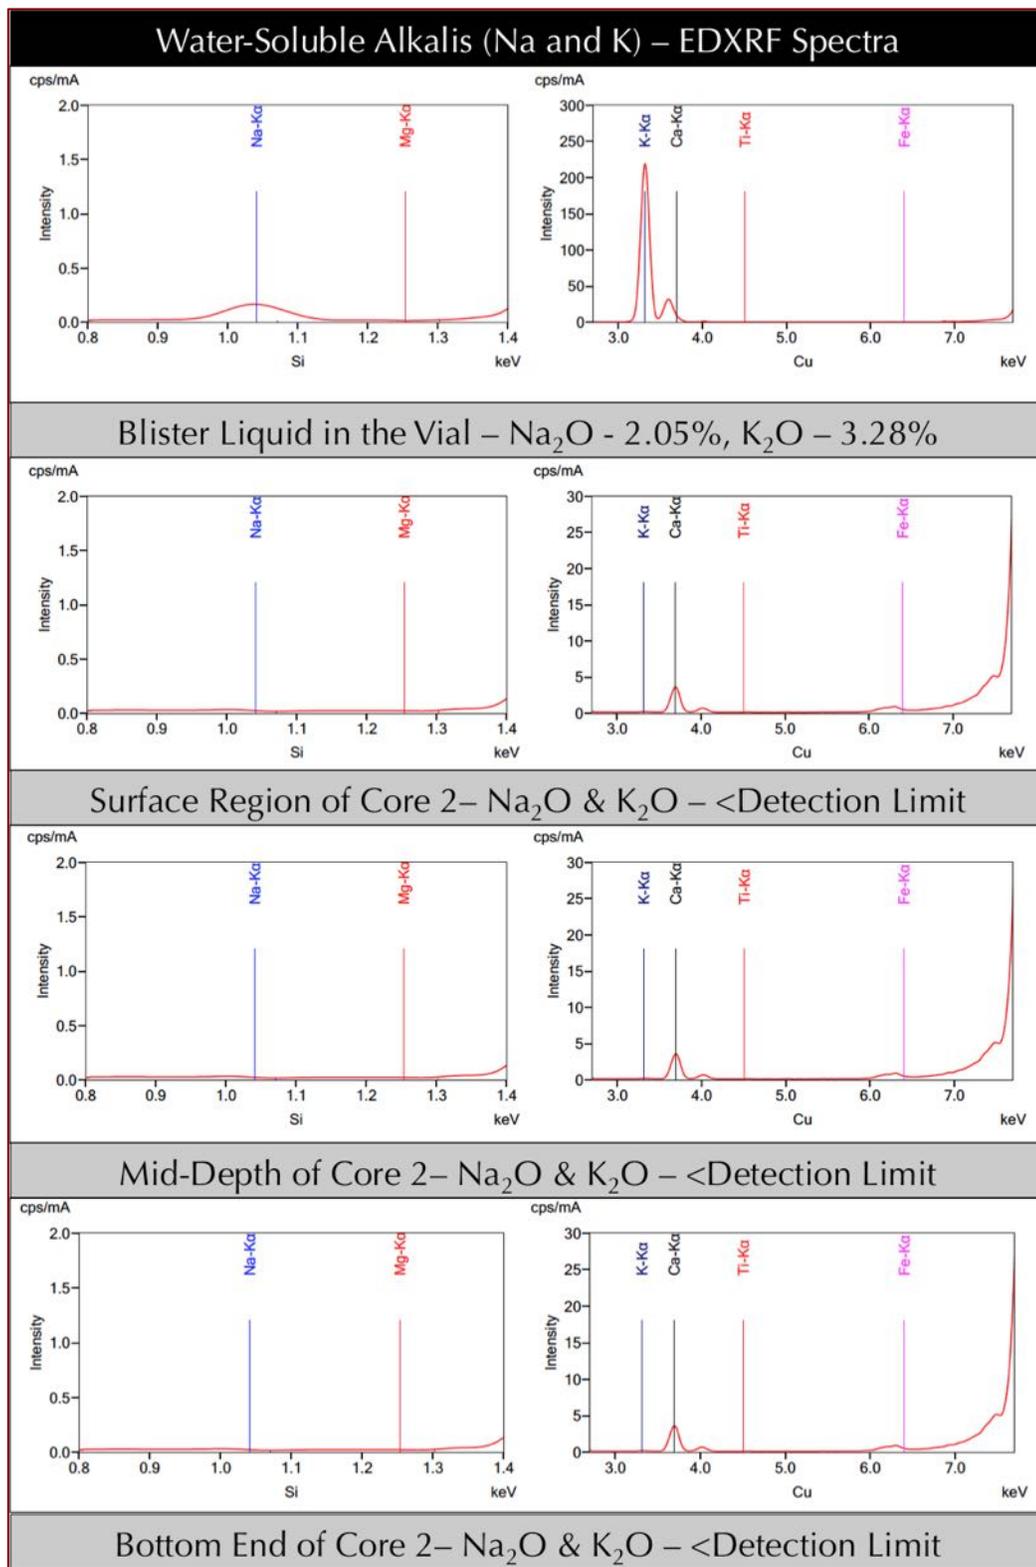
Figure 42 shows water-soluble alkali content measured from X-ray fluorescence spectroscopy, first in the light yellow liquid from a reported blister received in a vial and then through three depths in Core 2, which was reportedly retrieved from a blistered location. Liquid from blister showed oxides of 2.05 percent sodium and 3.28 percent potassium. By contrast, alkali levels in water digested concrete from three depths are all found to be below the detection limit of XRF. There was no evidence of increasing water-soluble alkali contents towards the top end of the core.

Figure 42: Results of water-soluble alkali contents from X-ray fluorescence spectroscopy: (a) the top spectrum is for the liquid from blister, and (b) three successive spectra are from three successive depths in Core 2, which was retrieved from a blistered location. Notice the presence of clear discernible peaks of sodium and potassium in the liquid from vial in the top spectrum, but no such peaks in the water-soluble filtrates of concrete in the bottom three spectra.

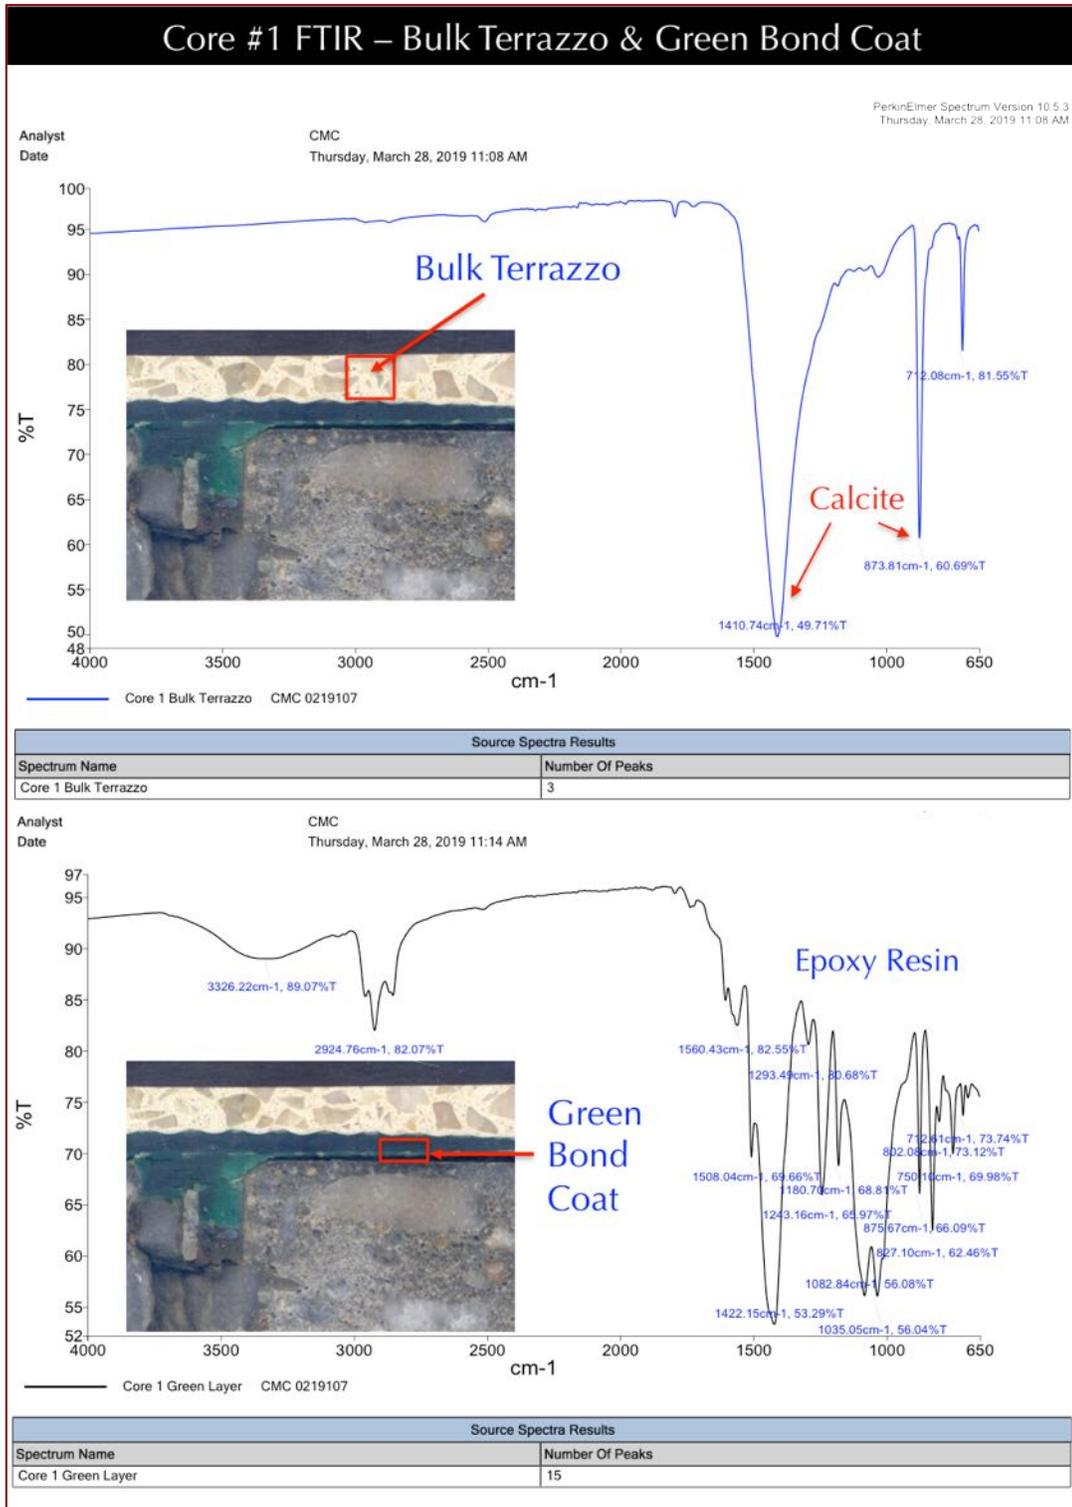
Figure 44: FTIR spectra of bulk terrazzo (top) and green bond coat adhered at the base of terrazzo (bottom) in Core 1. Terrazzo spectra shows dominant peaks for calcite from calcite/limestone/marble chips, whereas underlying green bond coat shows the presence of epoxy resin in the bond coat.

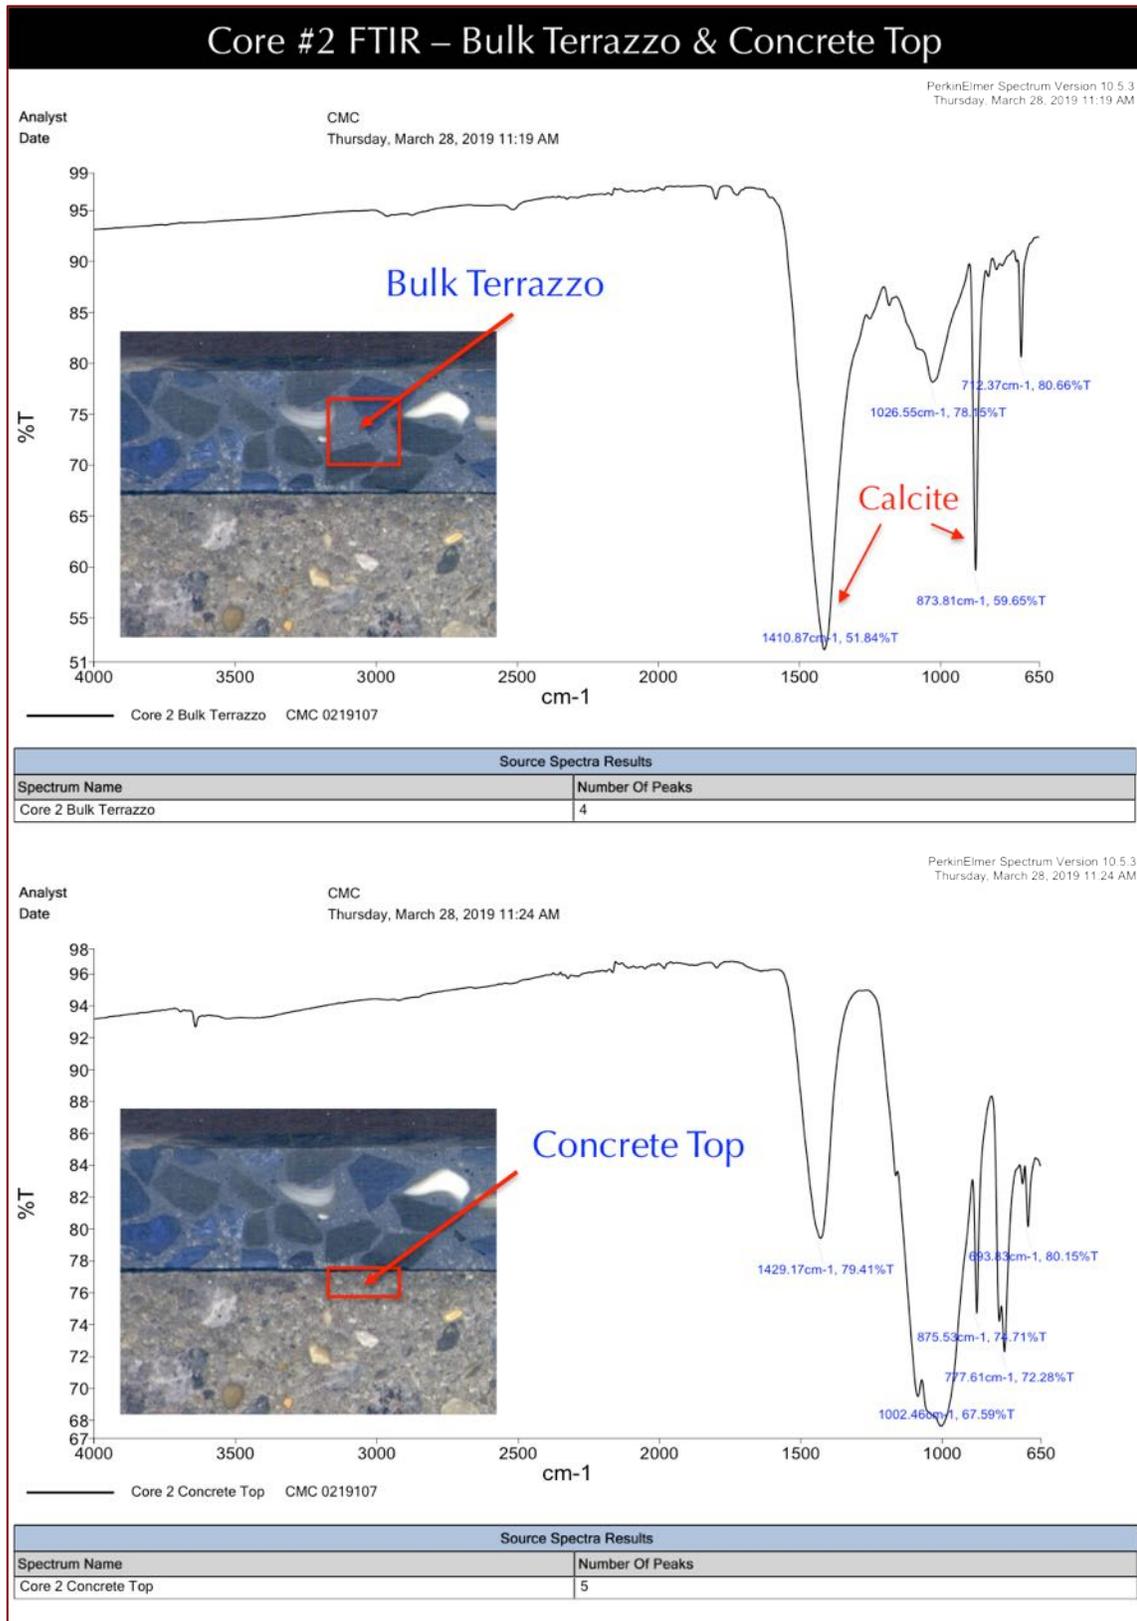
Figure 45: FTIR spectra of bulk terrazzo (top) and surface region of concrete (bottom) in Core 2. Terrazzo spectra shows dominant peaks for calcite from calcite/limestone/marble chips, whereas underlying concrete shows the presence of similar peaks for calcite from carbonated surface of concrete.

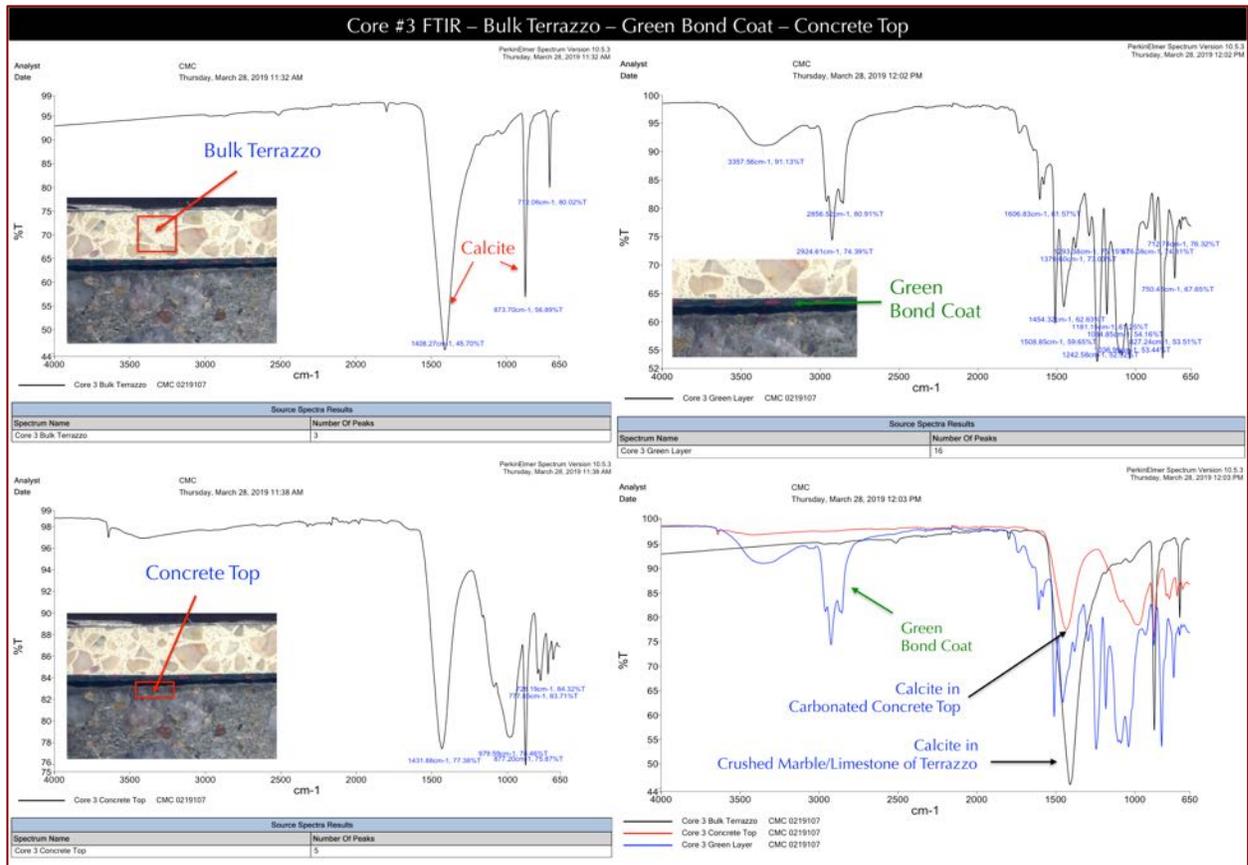
Figure 46: FTIR spectra of bulk terrazzo (top left), green bond coat beneath the terrazzo that is adhered to terrazzo but completely de-bonded from concrete (top right), and surface region of concrete (bottom left) in Core 3, as well as comparison of spectra from all three components in the bottom right photo. Terrazzo spectra shows dominant peaks for calcite from calcite/limestone/marble chips, green bond coat shows the polymeric composition, whereas underlying concrete shows the presence of similar peaks for calcite from carbonated surface of concrete.

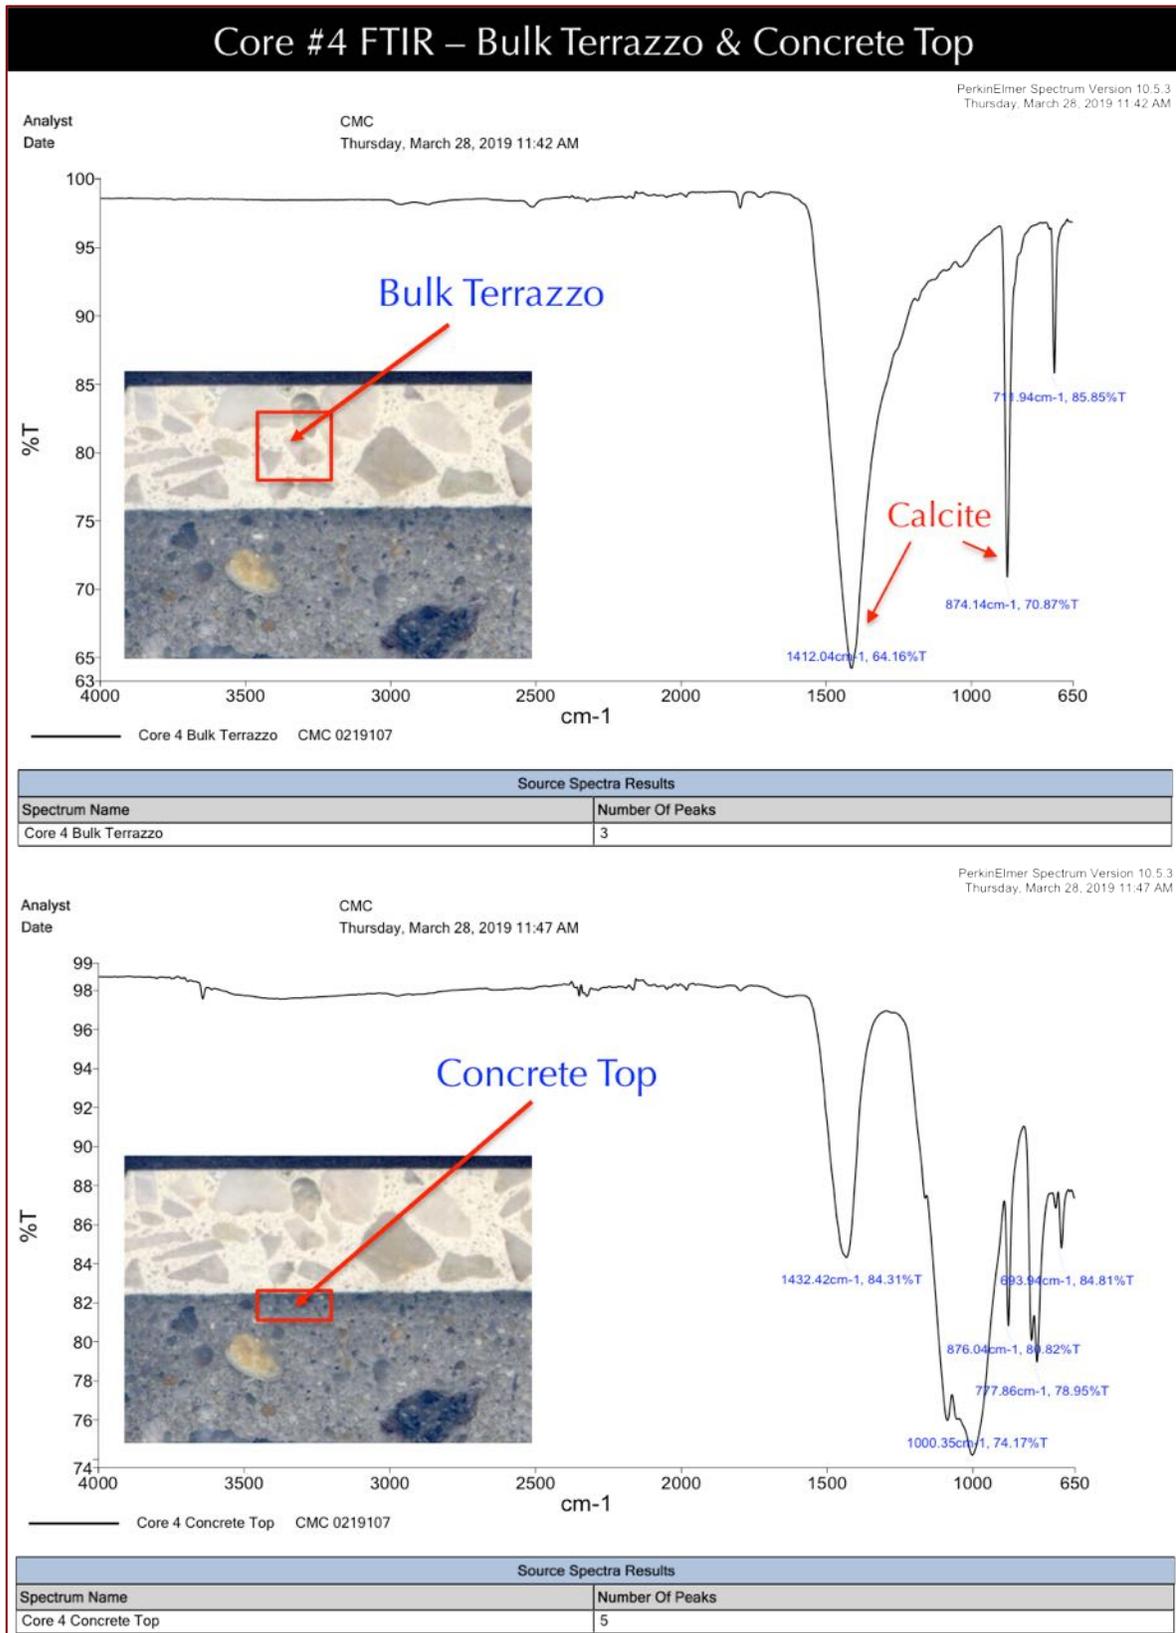
Figure 47: FTIR spectra of bulk terrazzo (top) and surface region of concrete (bottom) in Core 4. Terrazzo spectra shows dominant peaks for calcite from calcite/limestone/marble chips, whereas underlying concrete shows the presence of similar peaks for calcite from carbonated surface of concrete.

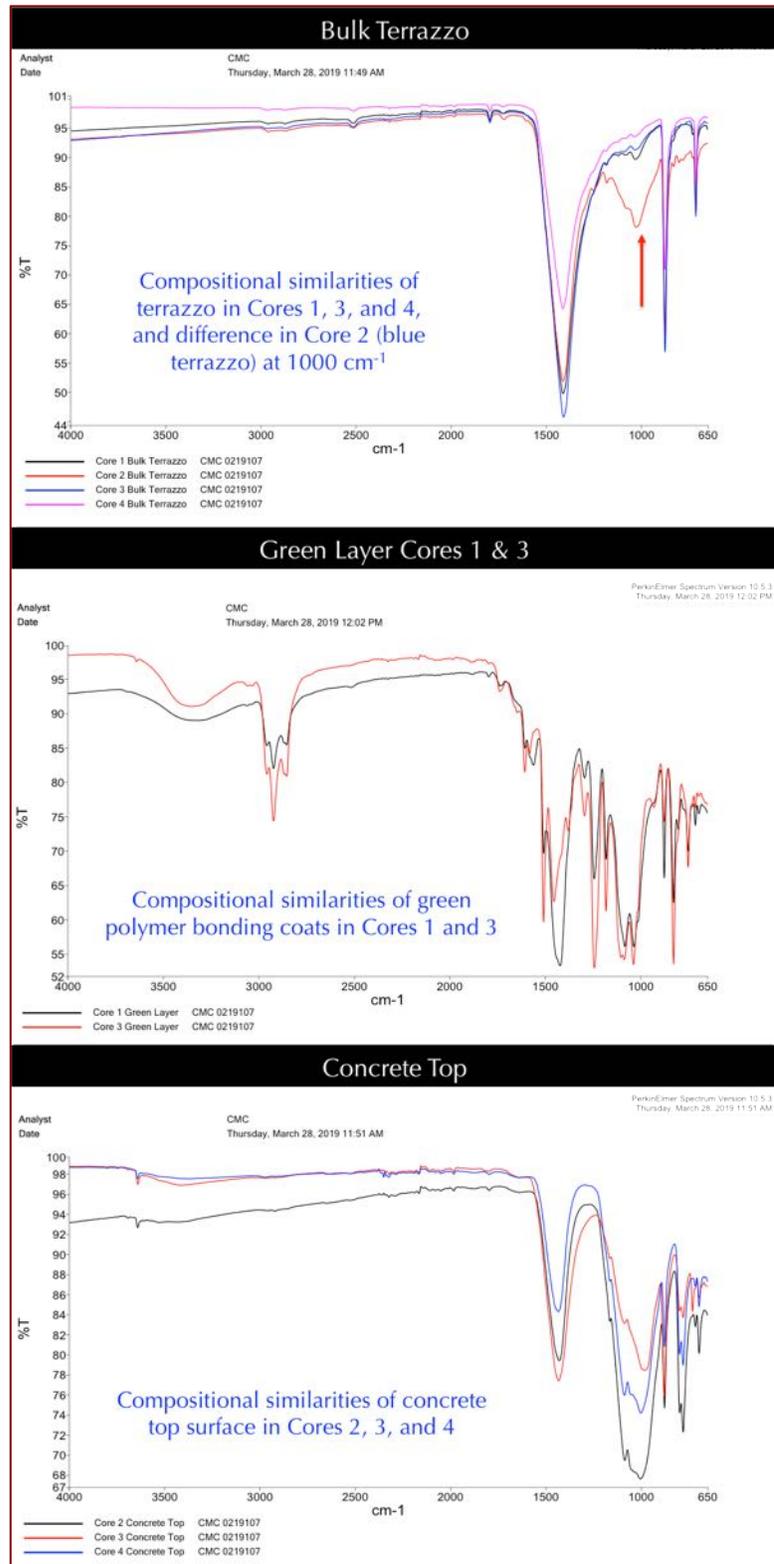
Fourier transform infrared spectroscopy of terrazzo flooring, underlying green bond coat, and top surface of concrete showed compositional similarity of white terrazzo consisting of calcite from marble and limestone chips and an epoxy resin binder in Cores 1, 3, and 4. By contrast the blue terrazzo in Core 2 shows a different epoxy resin binder, which is shown in Figure 48 where terrazzo from Cores 1, 3, and 4 are compared. The concrete surface shows compositional similarity in all cores (bottom graph in Figure 45) and calcite from carbonated surface, which is also found in the terrazzo spectra from limestone/marble chips. Spectra of concrete tops indicates application of an organic component found in many primers. The green bond coat found in Cores 1 and 3 are also compositionally similar (compared in the middle photo of Figure 48).

Figure 48: Compositional similarities of white terrazzo in Cores 1, 3, and 4, and difference from dark blue terrazzo in Core 2 with slight variations in absorbance peaks of terrazzo in the top photo. Middle spectra shows compositionally similar green bond coat in Cores 1 and 3 that are well-bonded to their respective terrazzo bases but mostly de-bonded from concrete. Bottom photo shows compositional similarities of carbonated concrete surfaces in Cores 2, 3, and 4.

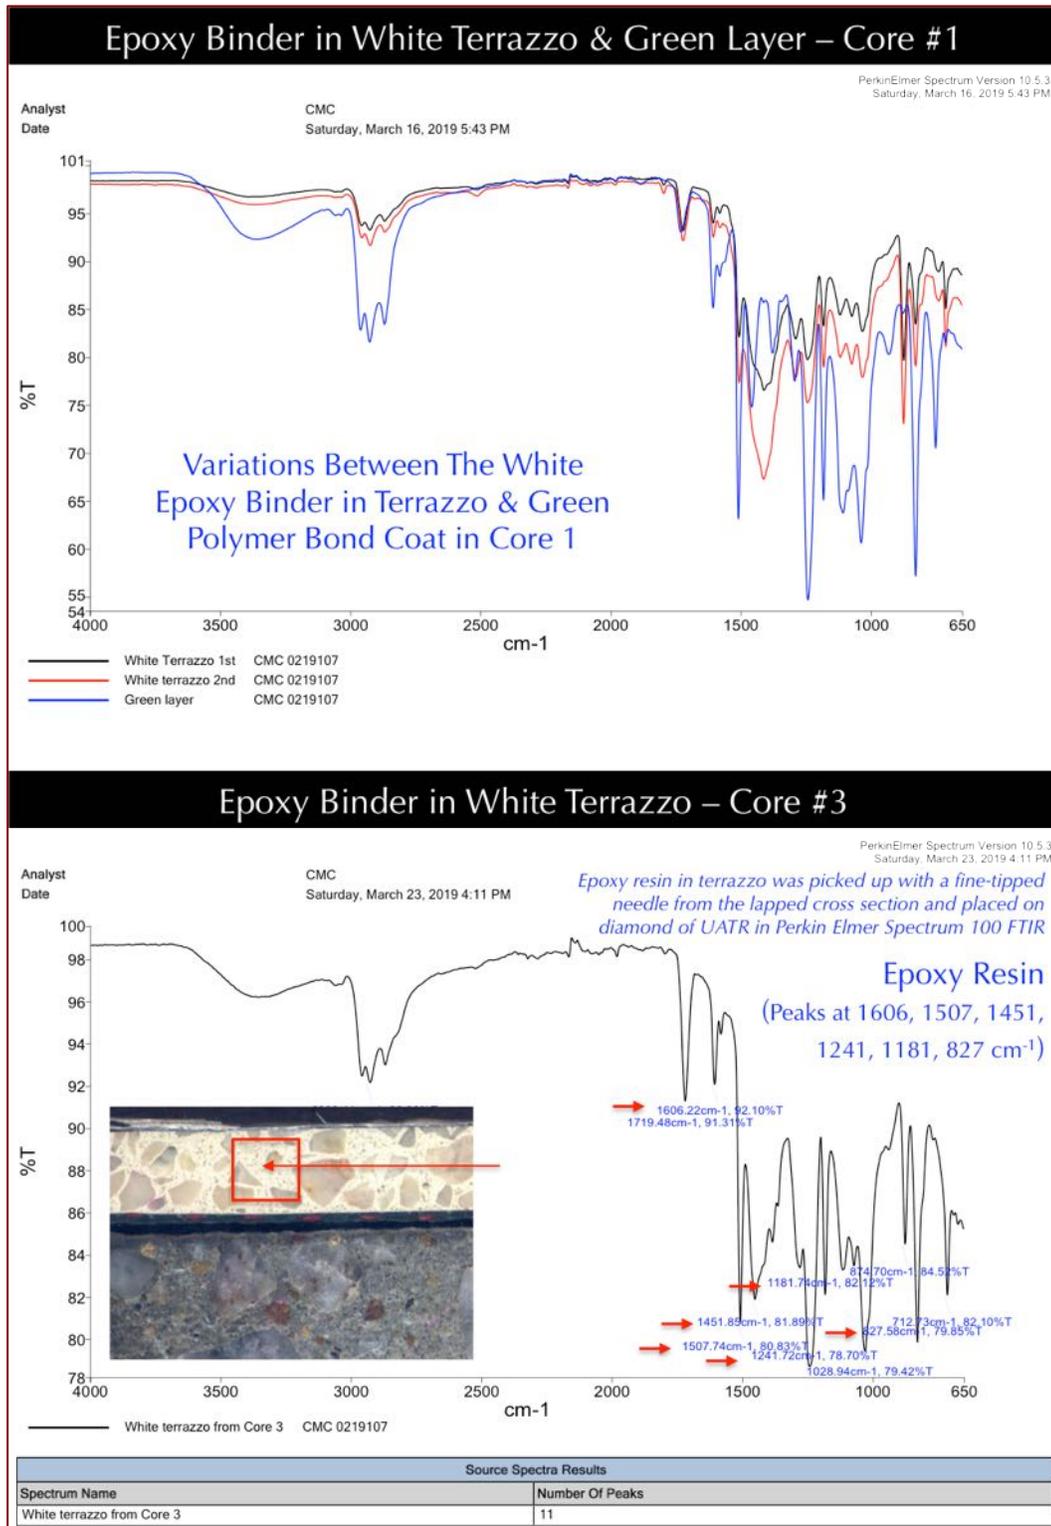
The binder in white terrazzo individually show typical absorbance spectra of epoxy resin having characteristic absorbance peaks at 1606, 1507, 1451, 12451, 1181, and 827 cm^{-1} (Figure 49).

Figure 49: FTIR spectra of the binder phase of white terrazzo (top) carefully removed from lapped cross section of Core 1, as well as the underlying green bond coat showing compositional differences between the white polymer binder of terrazzo and the underlying green bond coat. Bottom spectra shows another white polymer binder of terrazzo from Core 3, which shows compositional similarities to the polymer binder of terrazzo in Core 3, where epoxy resin binder is confirmed from characteristic absorbance peaks at 1606, 1507, 1451, 12451, 1181, and 827 cm⁻¹.
