### Swimming Pool Plaster Discoloration – A Case Study From Field & Laboratory-Cured Plasters

Primera Stone Sapphire Treasure & Blue Ocean

CONSTRUCTION MATERIALS CONSULTANTS, INC.

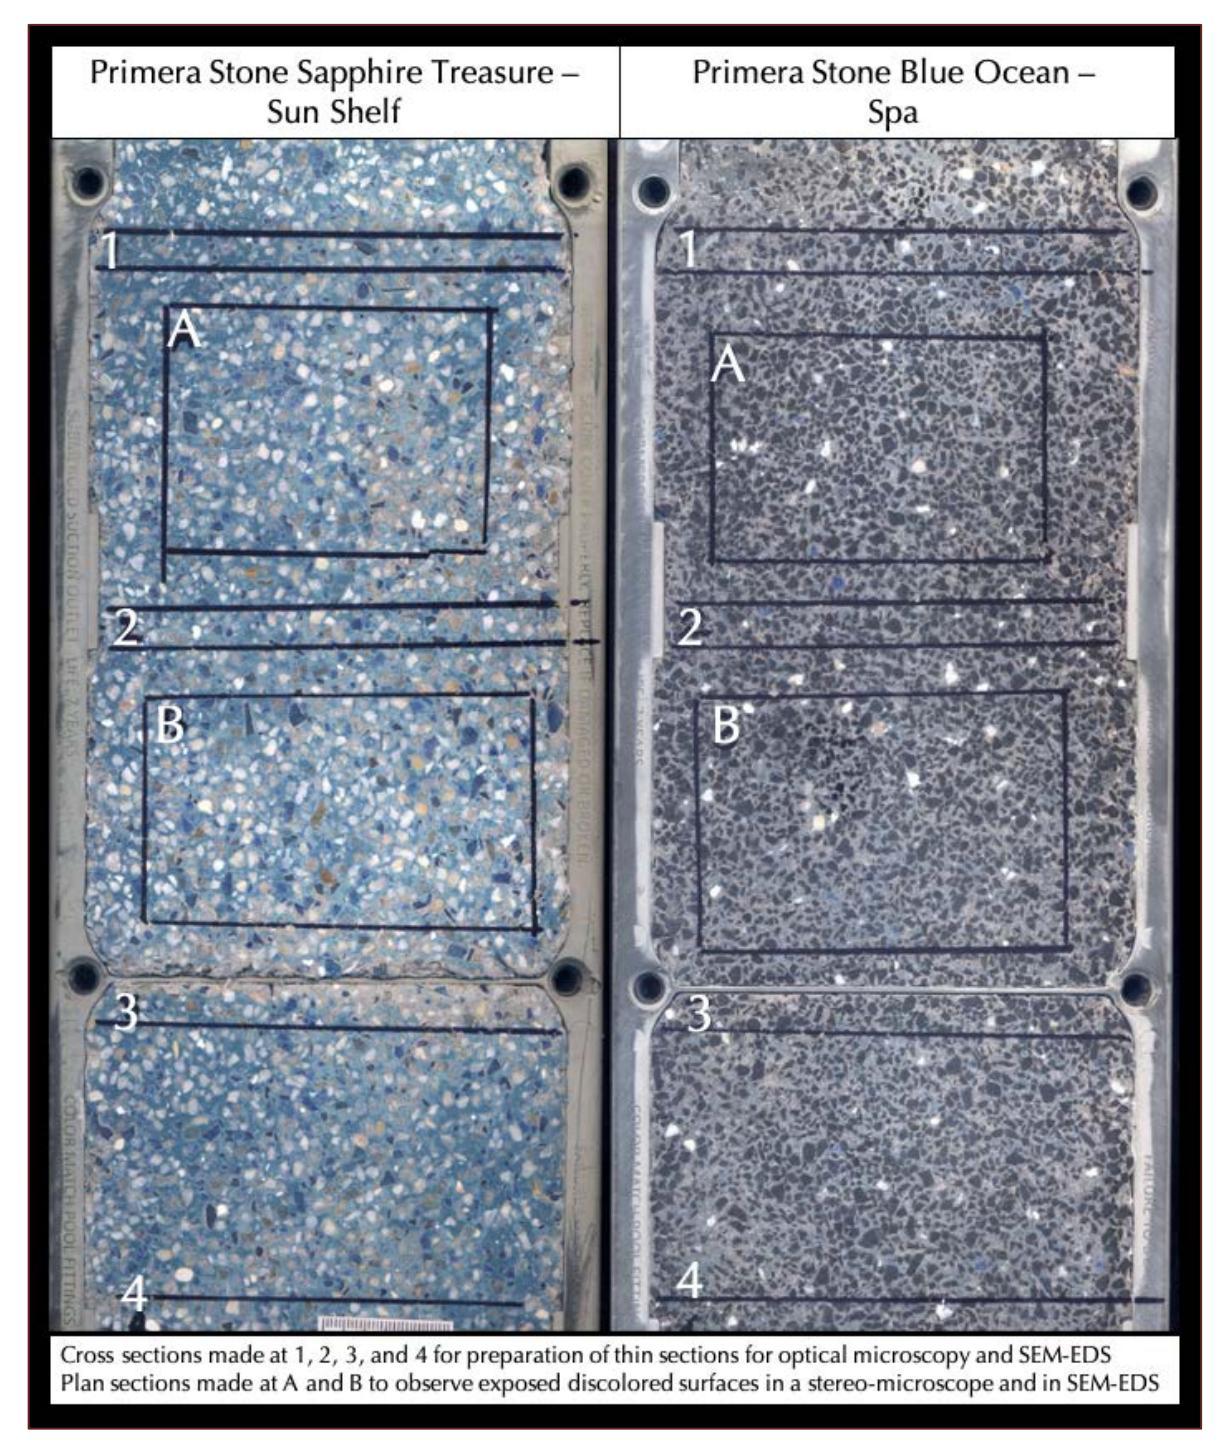
Figure 6: Shown are: (a) Primera Stone Sapphire Treasure plaster from Sun Shelf area at left with blotchy discoloration of exposed surface consisting of (i) fading of blue color from darker to lighter blue, and, (ii) beige gray discoloration of paste especially around the light gray, white, off-white, and blue crushed exposed aggregate particles, and, (b) Blue Ocean plaster from Spa area at right with blotchy discoloration of exposed surface consisting of (i) fading of color from darker to lighter blue along with (ii) beige gray discoloration of paste especially around the dark gray crushed exposed aggregate particles. Lines 1 through 4 in each plaster sample were sectioned vertically for through-depth variations in plaster compositions after interaction with pool water, and areas A and B were sectioned for observations of exposed discolored surfaces that were in contact with pool water by optical microscopy and SEM-EDS. See Appendix for more photos.

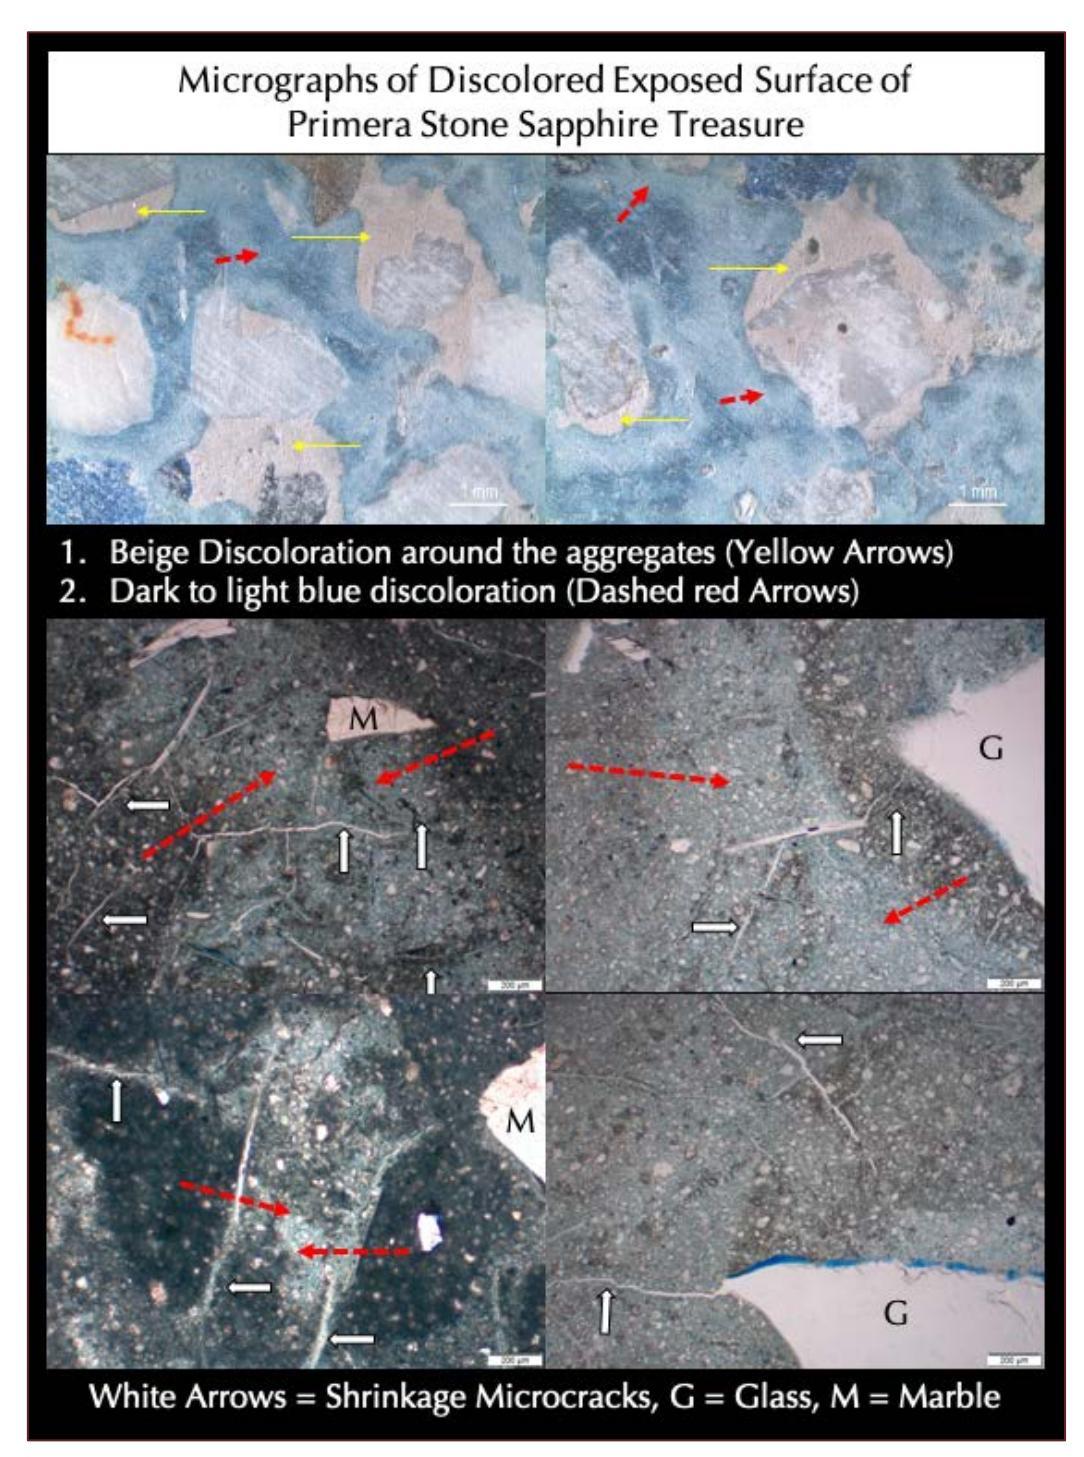
Figure 7: Stereomicrographs (top row), and thin section micrographs (middle and bottom rows) of the exposed discolored plaster surface of Primera Stone Sapphire Treasure showing blotchy discoloration of exposed surface consisting of (i) fading of blue color from darker to lighter blue (marked with dashed red arrows), and (ii) extreme fading to beige gray discoloration of paste mostly around light gray, white, off-white, and blue crushed exposed particles aggregate (marked with yellow arrows). Thin section show micrographs numerous fine hairline shrinkage microcracks (marked with white arrows, common in many plasters containing calcium chloride accelerator, many containing secondary calcite precipitates from pool water migration and evaporation through the microcracks), and darker to lighter blue paste from differences in paste porosities from differential leaching of paste by the pool water. See Appendix for more photos.

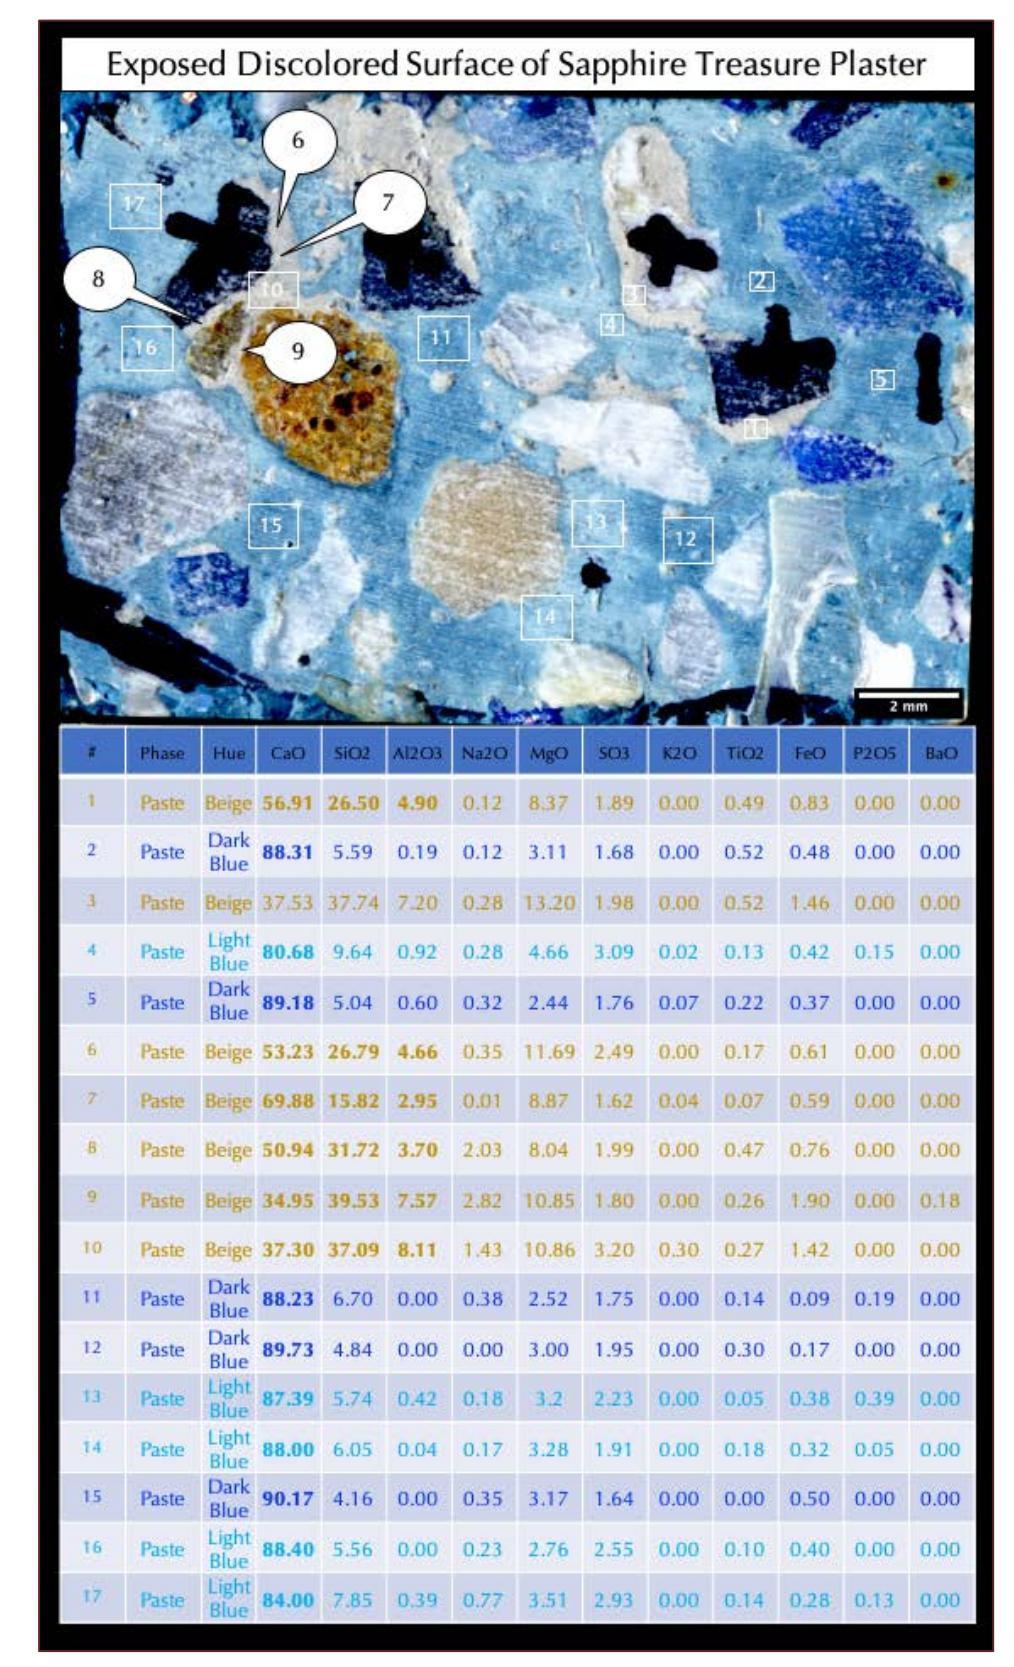
Figure 8: Exposed discolored surface of Sapphire Treasure plaster that was in contact with pool water and subsequently developed three color tones – a darker blue tone, which has faded into a lighter blue tone, and a beige tone of localized paste especially in contact with aggregate particles.

SEM-EDS analyses were done on all three paste color tones and correspondingly color coded by the oxide variations of discolored pastes measured at the tips of callouts and in boxed areas across the photo.

The beige paste at Probe# 1, 3, and 6 to 10, however, are very different than the dark or light blue pastes, which is shown in the subsequent compositional plots of oxide variation diagrams of all three paste color tones.

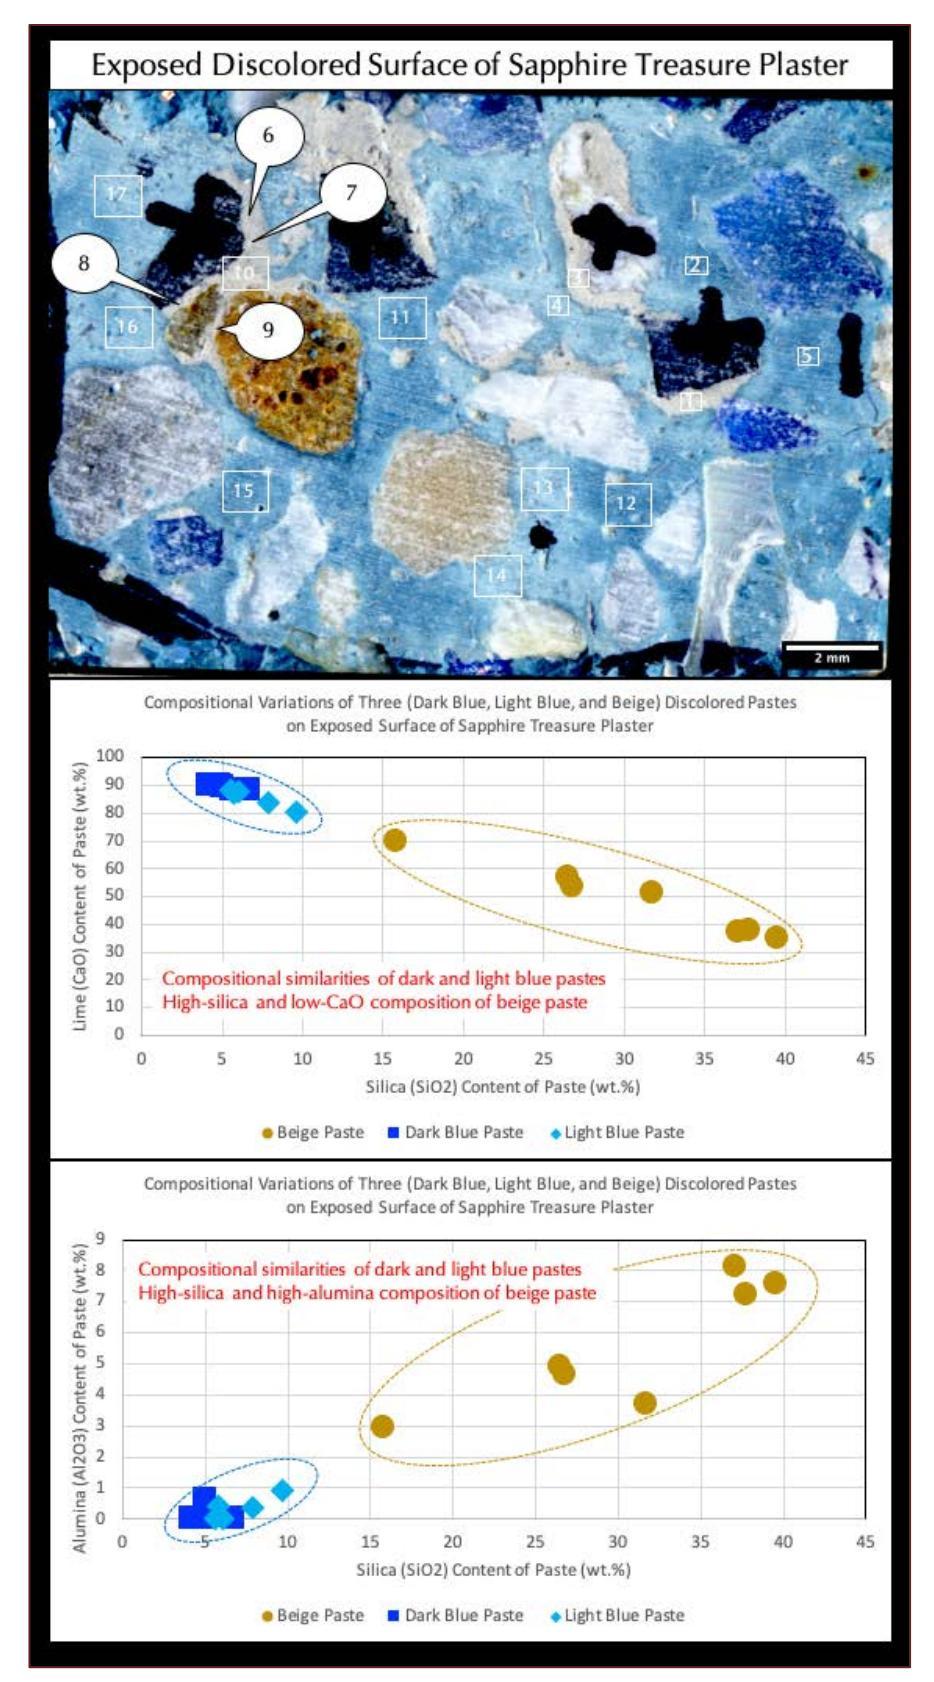
Figure 9: Exposed discolored surface of Sapphire Treasure plaster that was in contact with pool water and subsequently developed three color tones – a darker blue tone, which has faded into a lighter blue tone, and a beige tone of localized paste especially in contact with aggregate particles.

Oxide variation diagrams of darker and lighter blue pastes and localized beige toned pastes at aggregate surfaces show overall compositional similarities of darker to lighter faded blue pastes where darker paste at the locations of Probe# 2, 5, 11, 12, and 15 are more compositionally homogeneous than the lighter faded blue paste at the locations of Probe# 4, 13, 14, 16, and 17 (faded paste shows a slightly more spread) in the lime, alumina, and silica plots.

The beige paste at Probe# 1, 3, and 6 to 10, however, shows a distinctly different composition of lower lime and higher silica and alumina than the darker-to-lighter faded blue pastes, which could be due to excessive leaching of paste at the beige areas leading to loss of lime at the expense of silica and alumina compared to the ubiquitous darker-to-lighter faded blue paste.

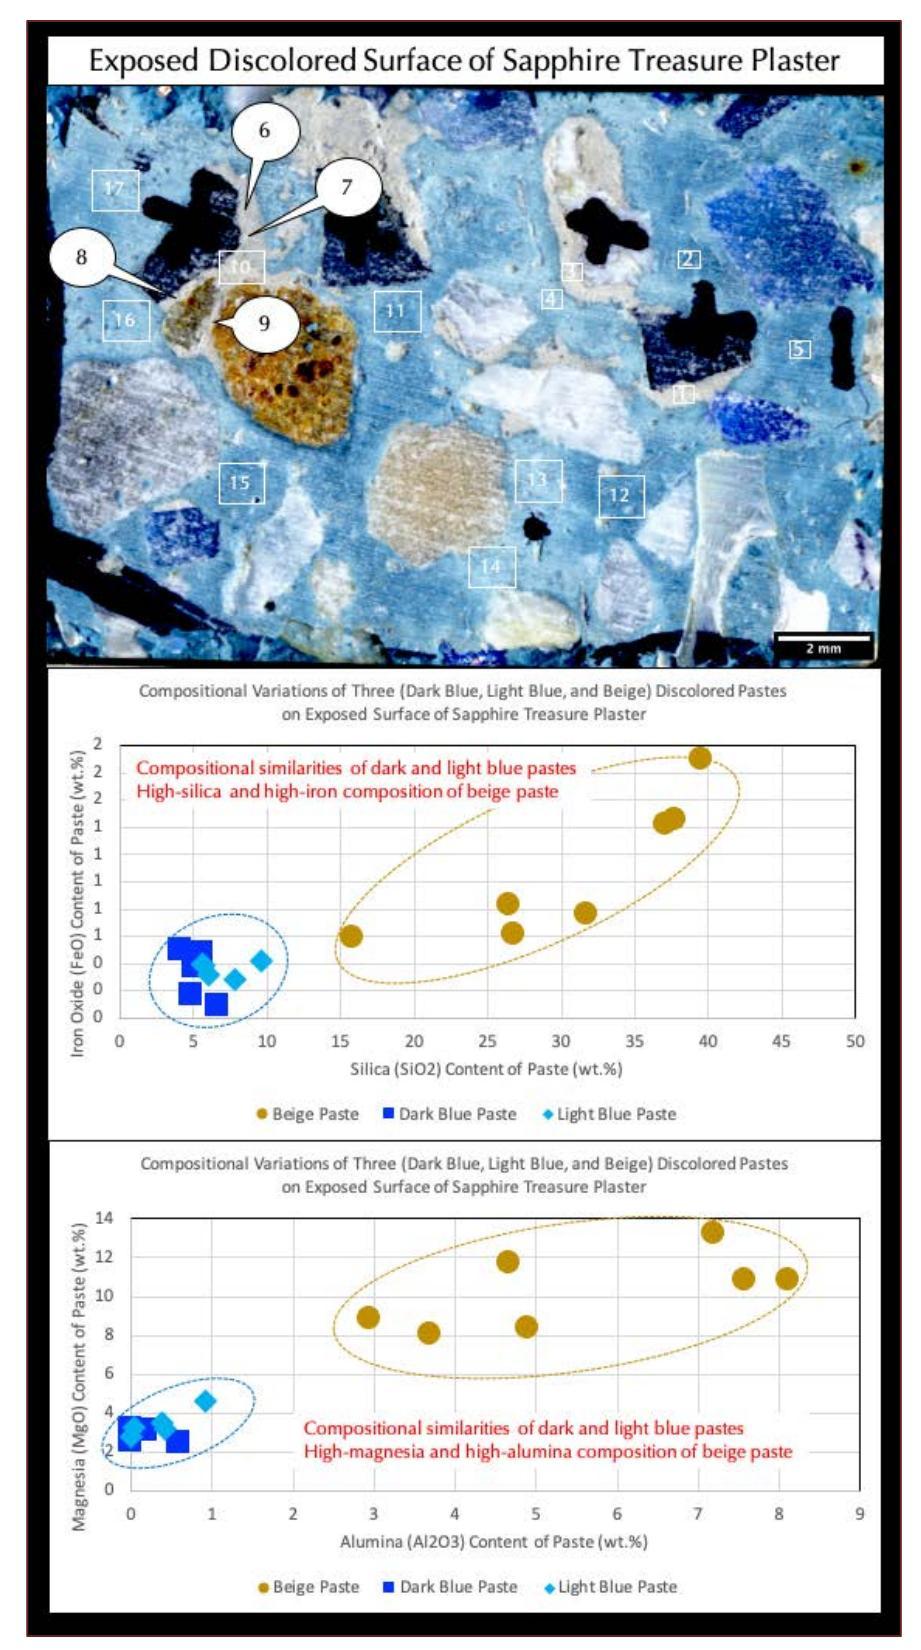
Figure 10: Exposed discolored surface of Sapphire Treasure plaster that was in contact with pool water and subsequently developed three color tones – a darker blue tone, which has faded into a lighter blue tone, and a beige tone of localized paste especially in contact with aggregate particles.

Oxide variation diagrams of darker and lighter blue pastes and localized beige toned pastes at aggregate surfaces show overall compositional similarities of darker to lighter faded blue pastes where darker paste at the locations of Probe# 2, 5, 11, 12, and 15 are more compositionally homogeneous than the lighter faded blue paste at the locations of Probe# 4, 13, 14, 16, and 17 (faded paste shows a slightly more spread) in the lime, alumina, and silica plots.

The beige paste at Probe# 1, 3, and 6 to 10, however, shows a distinctly different composition of higher iron, silica, magnesia, and alumina than the darkerto-lighter faded blue pastes, which could be due to excessive leaching of lime in the beige areas leading to enrichment of silica, alumina, and iron compared to the ubiquitous darker-to-lighter faded blue paste.

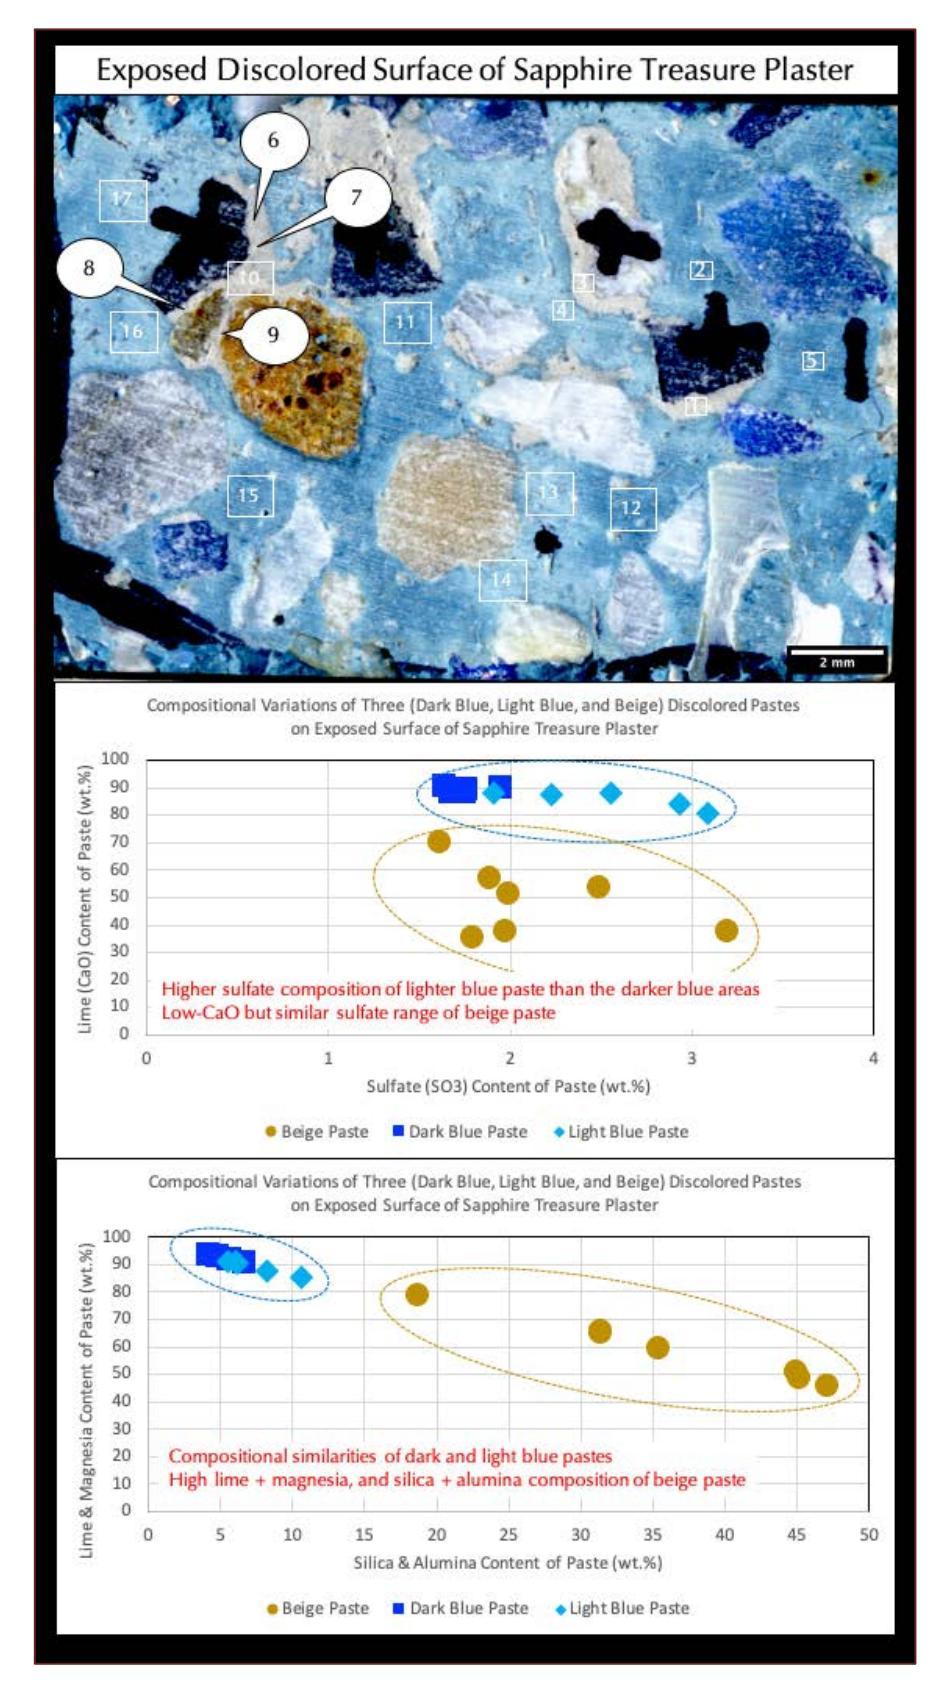
Figure 11: Exposed discolored surface of Sapphire Treasure plaster that was in contact with pool water and subsequently developed three color tones – a darker blue tone, which has faded into a lighter blue tone, and a beige tone of localized paste especially in contact with aggregate particles.

Oxide variation diagrams of darker and lighter blue pastes and localized beige toned pastes at aggregate surfaces show overall compositional similarities of darker to lighter faded blue pastes where darker paste at the locations of Probe# 2, 5, 11, 12, and 15 are more compositionally homogeneous than the lighter faded blue paste at the locations of Probe# 4, 13, 14, 16, and 17 (faded paste shows a slightly more spread) in the lime, alumina, and silica plots.

The beige paste at Probe# 1, 3, and 6 to 10, however, shows a distinctly different composition of lower lime due to lime leaching but similar sulfate contents as the darker-to-lighter blue paste but overall higher silica and alumina and lower lime and magnesia than the darker-to-lighter faded blue pastes, which are again due to excessive leaching of lime in the beige areas leading to enrichment of silica, alumina, and iron (without necessarily changing the sulfate contents) compared to the ubiquitous darker-to-lighter faded blue paste.

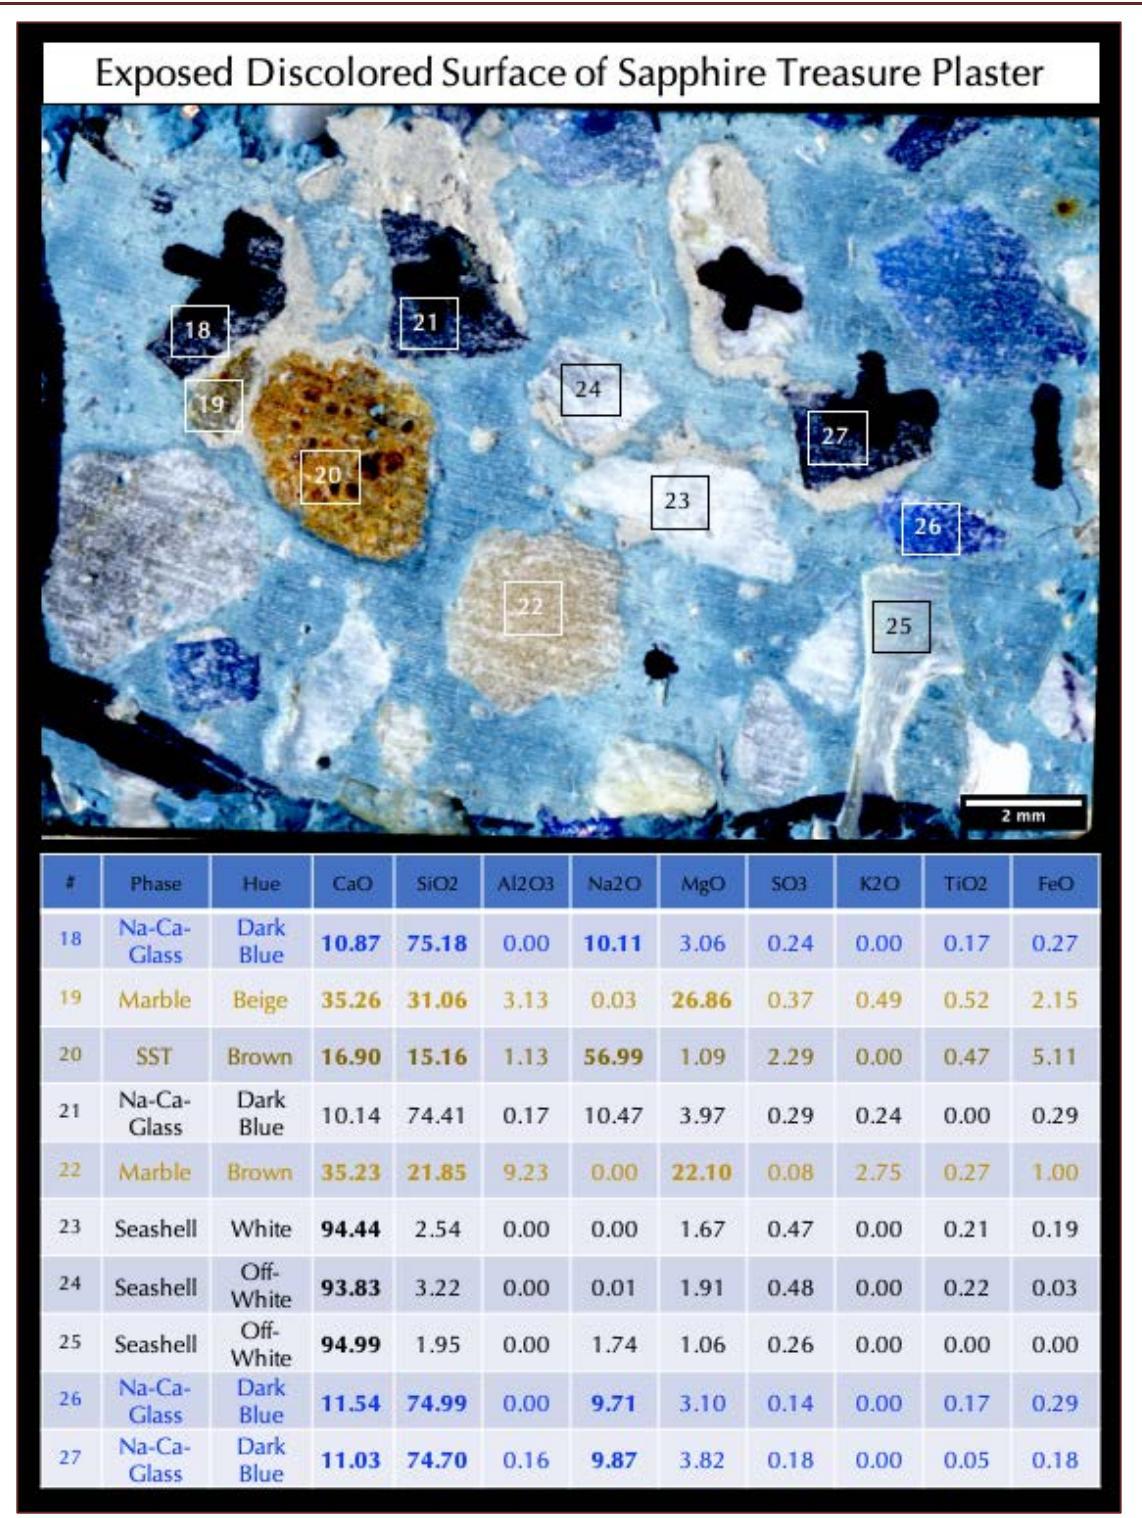
Figure 12: Exposed discolored surface of Sapphire Treasure plaster that was in contact with pool water and subsequently developed three color tones – a darker blue tone, which has faded into a lighter blue tone, and a beige tone of localized paste especially in contact with aggregate particles. In this Figure, chemical compositions of various aggregate particles are determined from SEM-EDS. Particles are lime-sodium-silicate glass, which is mostly dark blue in color, crushed dolomitic marble which are light to medium brown, and calcareous seashell particles, which are white to off-white. Contrary to these variations in aggregate compositions in the Sapphire Treasure sample, plaster in the Blue Ocean sample contains more uniform crushed basalt volcanic rocks. See Appendix for more photos.

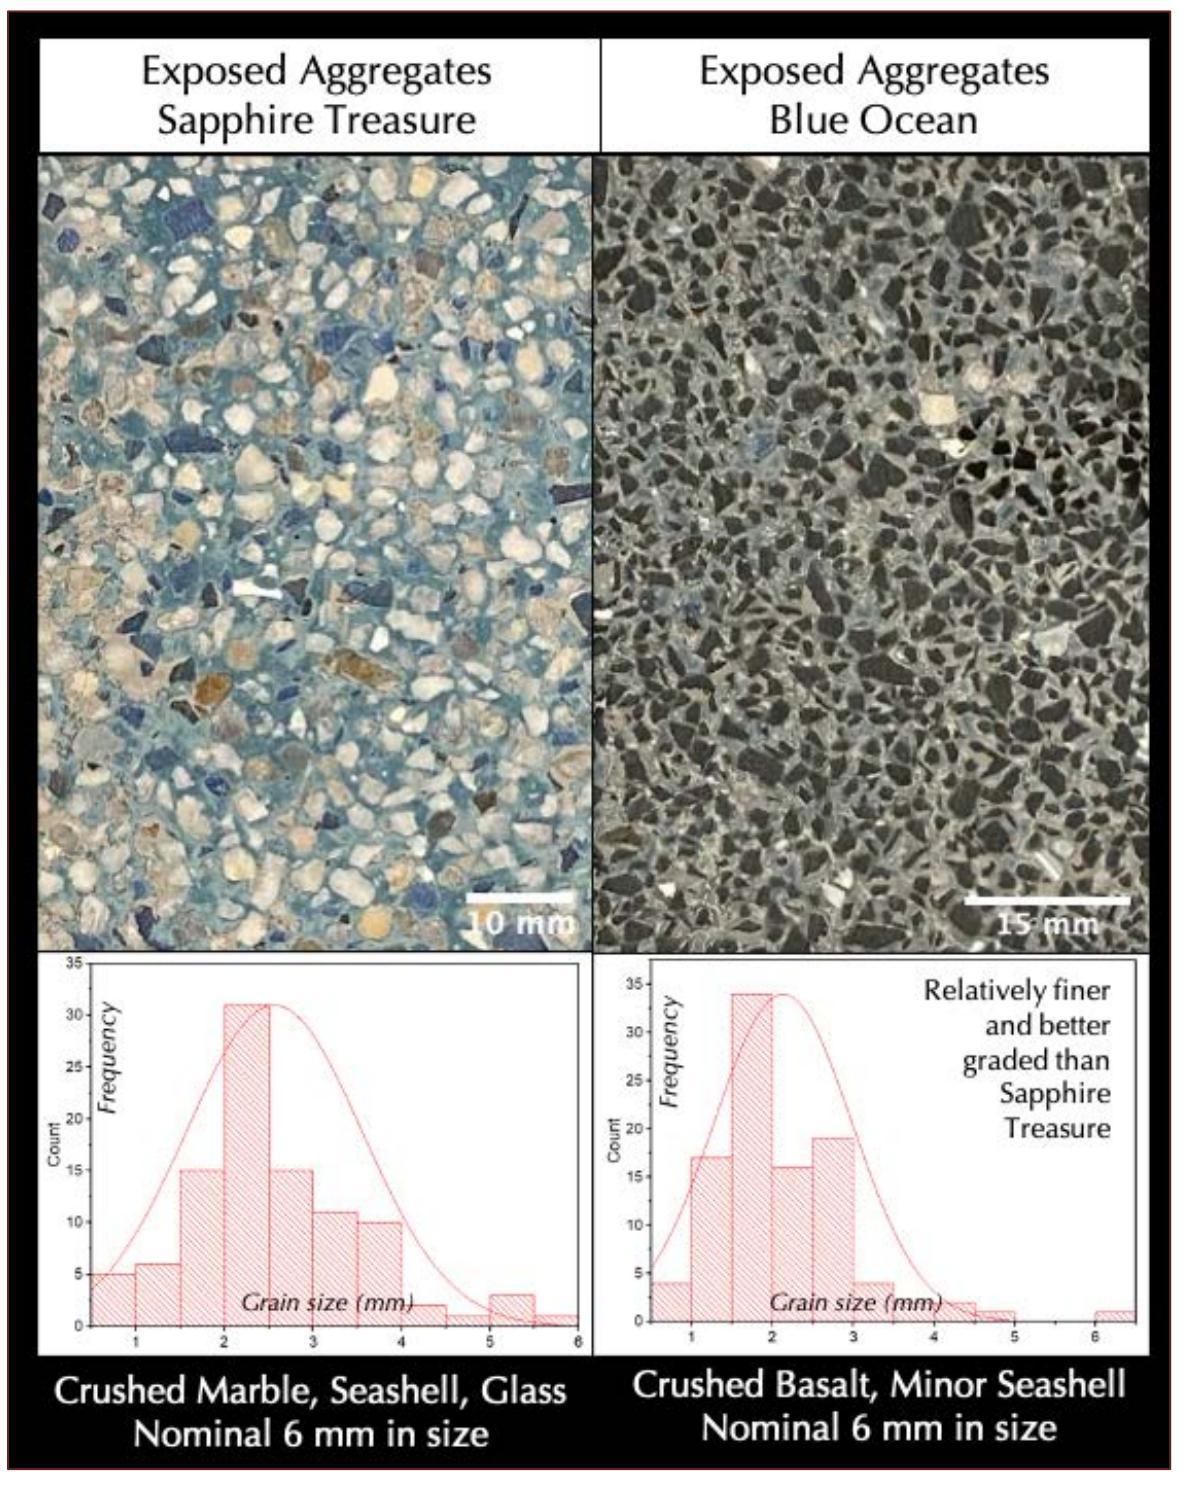
Figure 13: Grainsize distribution of exposed aggregate particles on the discolored surfaces of Sapphire Treasure (left) and Blue Ocean (right) plasters where aggregate particles in the former are lighter colored (white, off-white, brown, blue, light gray) crushed marble, seashell, quartz, quartzite, chert, and glass, whereas in the Blue Ocean plaster, aggregate particles are darker gray mostly basalt volcanic rocks and trace seashell particles. Grain size distribution plots of aggregates show relatively finer size and better grading of particles in the Blue Ocean plaster.

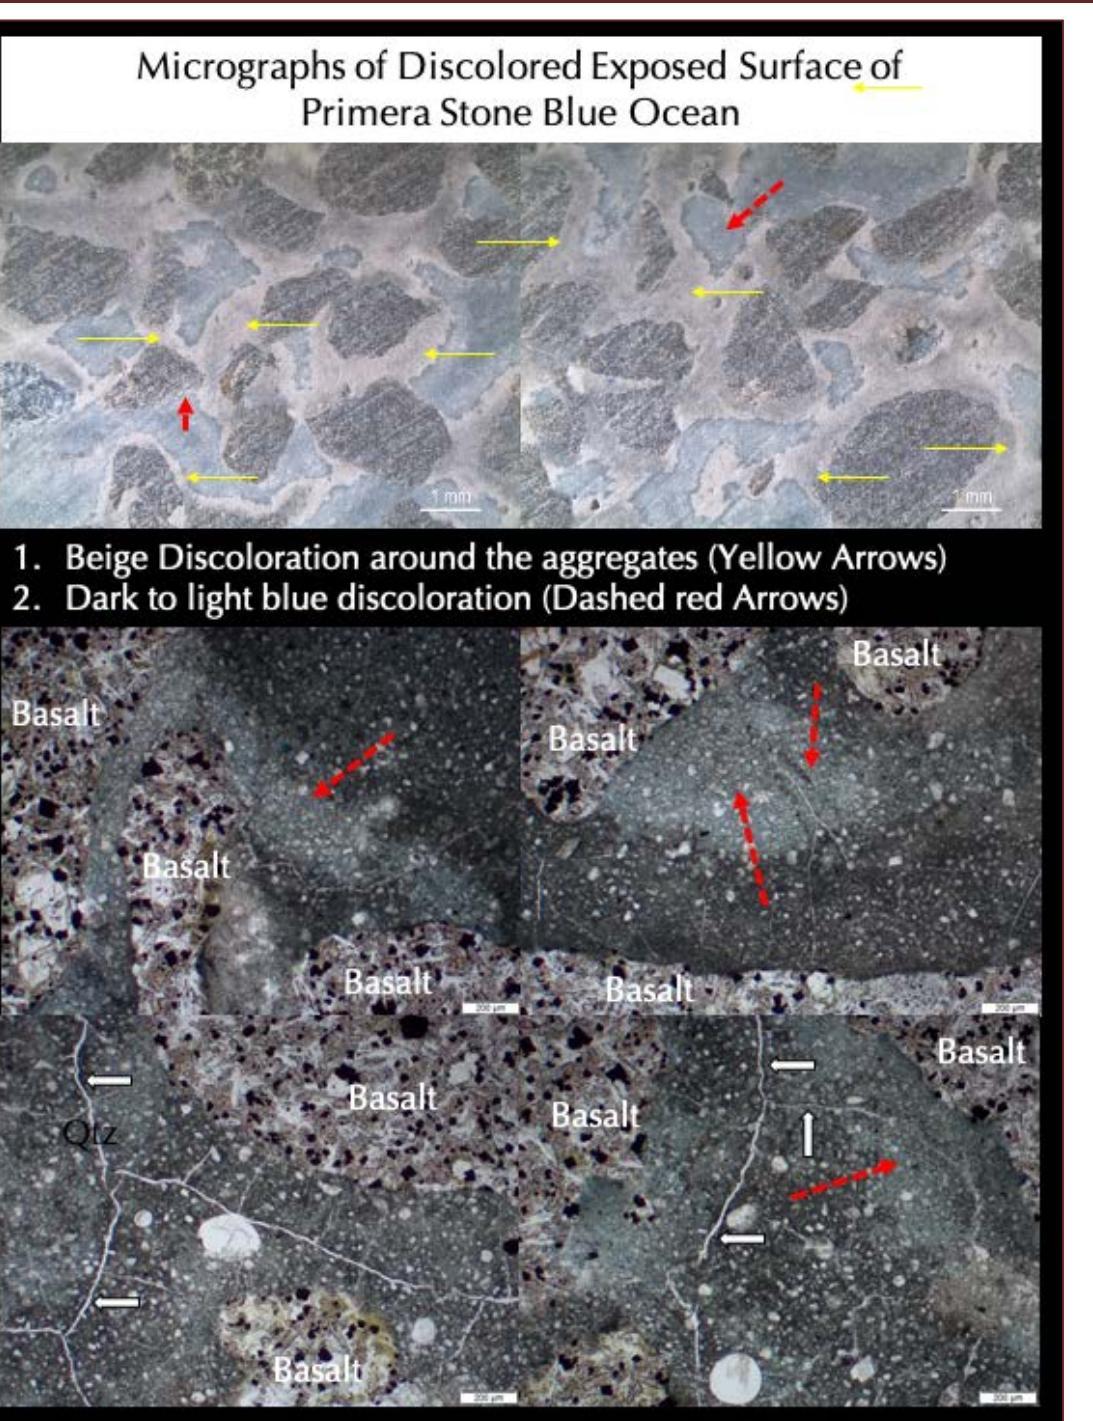
White Arrows = Shrinkage Microcracks, Crushed Basalt Aggregate

Figure 14: Stereo-micrographs (top row), and thin section micrographs (middle and bottom rows) of the exposed discolored plaster surface of Primera Stone Blue Ocean showing blotchy discoloration of exposed surface consisting of (i) fading of blue color from darker to lighter blue (marked in dashed red arrows), and (ii) extreme fading to beige gray discoloration of paste mostly around light gray, white, off-white, and blue crushed exposed aggregate particles (marked in yellow arrows). Thin section micrographs show numerous fine hairline shrinkage microcracks (marked in white arrows, common in many plasters containing calcium chloride accelerator, many containing secondary calcite precipitates from pool water migration and evaporation through the microcracks), and darker to lighter blue paste from differences in paste porosities resulted from differential leaching of paste by the pool water. See Appendix for more photos.

Figures 8 to 11 show evidence of leaching of lime in the beige discolored areas of exposed surface of Sapphire Treasure plaster in the oxide variation diagrams where depleted lime and enriched silica, alumina, and iron in the localized beige discolored areas compared to the overwhelming darker to lighter blue areas of paste are clear. Similar trends are present in the beige discolored areas on the exposed surface of Blue Ocean plaster (Figure 14).

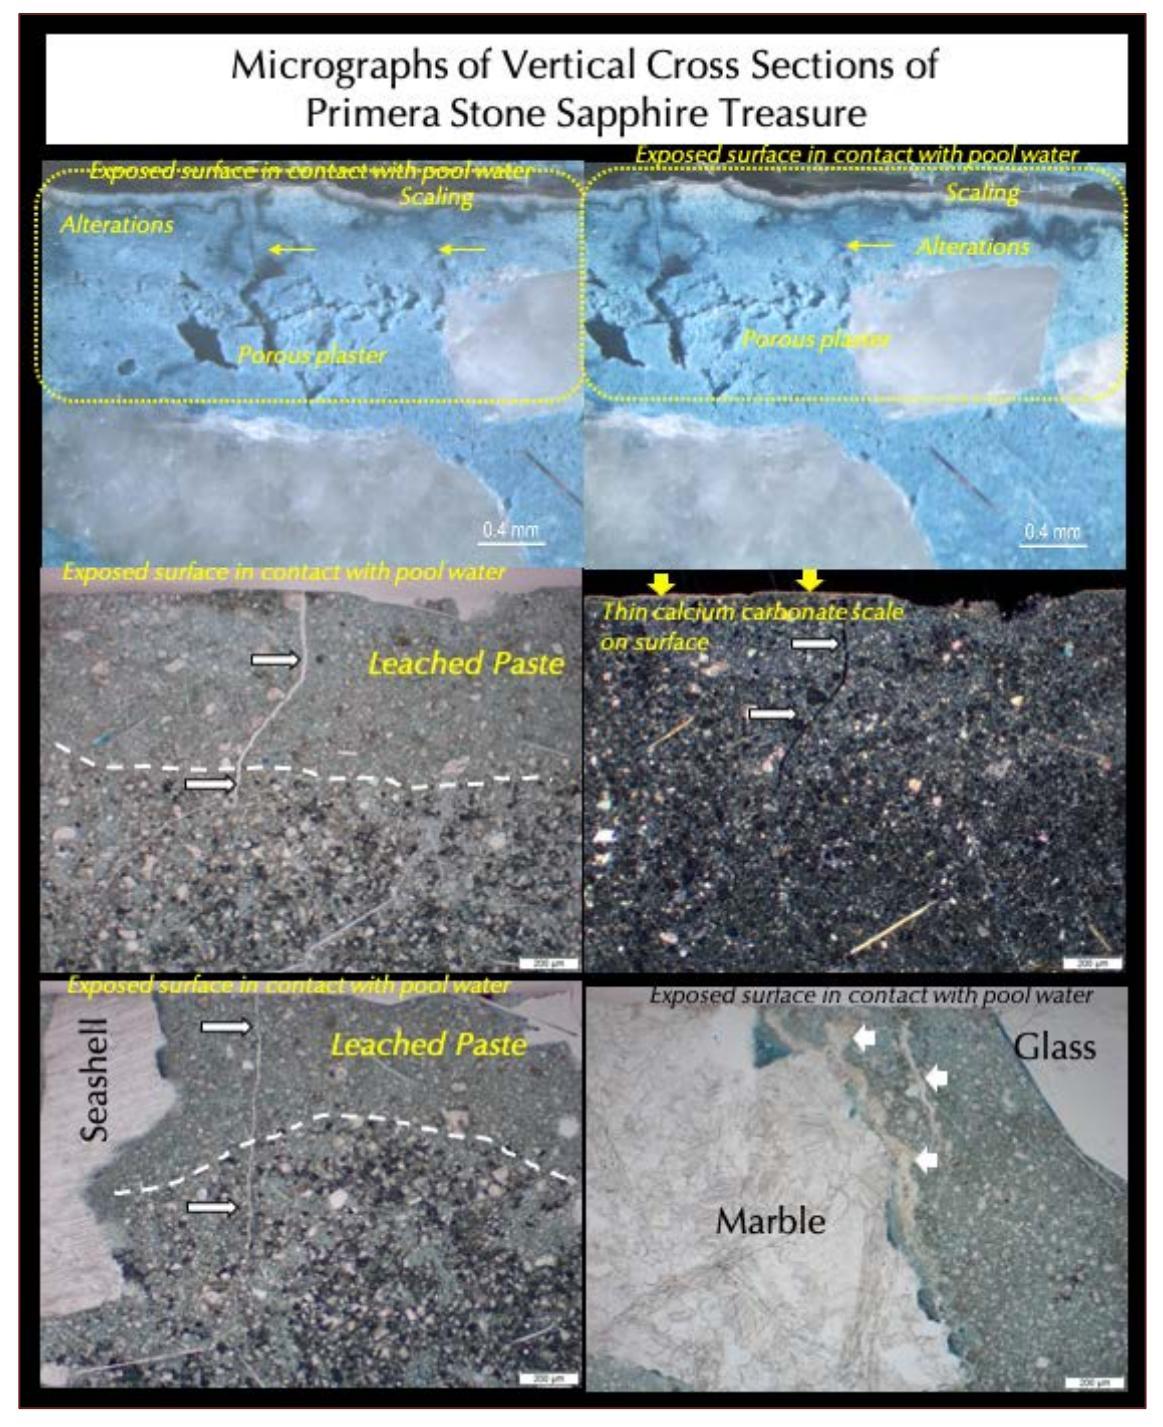
Figure 15: Stereo-micrographs (top row), and thin section micrographs (middle and bottom rows) of vertical cross section of Primera Stone Sapphire Treasure showing soft, crumbly, and noticeably porous paste at the top 2 to 3 mm (within the boxed area in the top row) due to leaching of calcium hydroxide component of Portland cement hydration and calcium chloride accelerator added in the plaster. Corresponding thin section micrographs in the middle and bottom rows show noticeably porous paste at the surface region (above the white dashed lines) compared to variably dense paste in the interior, and some fine, hairline vertical shrinkage microcracks marked with yellow or white arrows (common in many plasters containing calcium chloride accelerator), and darker to lighter blue paste from differences in paste porosities resulted from differential leaching of paste by the pool water. See Appendix for more photos.

Figures 15 and 16 show stereo-micrographs and thin section micrographs of vertical cross sections of Sapphire Treasure and Blue Ocean plasters, respectively where the surface regions of both field plaster show clear evidence of (a) increased porosity due to loss of materials by the pool water, and (b) a lighter fading of the plaster color tone at the leached zone from the interior plaster. Appendix Figures A 31 to A 33 (stereo-micrographs), and A 35 (thin section micrograph) show vertical cross sections of Sapphire Treasure where leaching of paste at the surface and increased paste porosity are shown. Appendix Figures A 59 to A 61 (stereo-micrographs) and A 63 to A 66 (thin section micrographs) show similar microstructures of increased porosity of paste on cross sections of Blue Ocean plaster with zoned alterations of near-surface paste from carbonated to leached to interior carbonated zones.

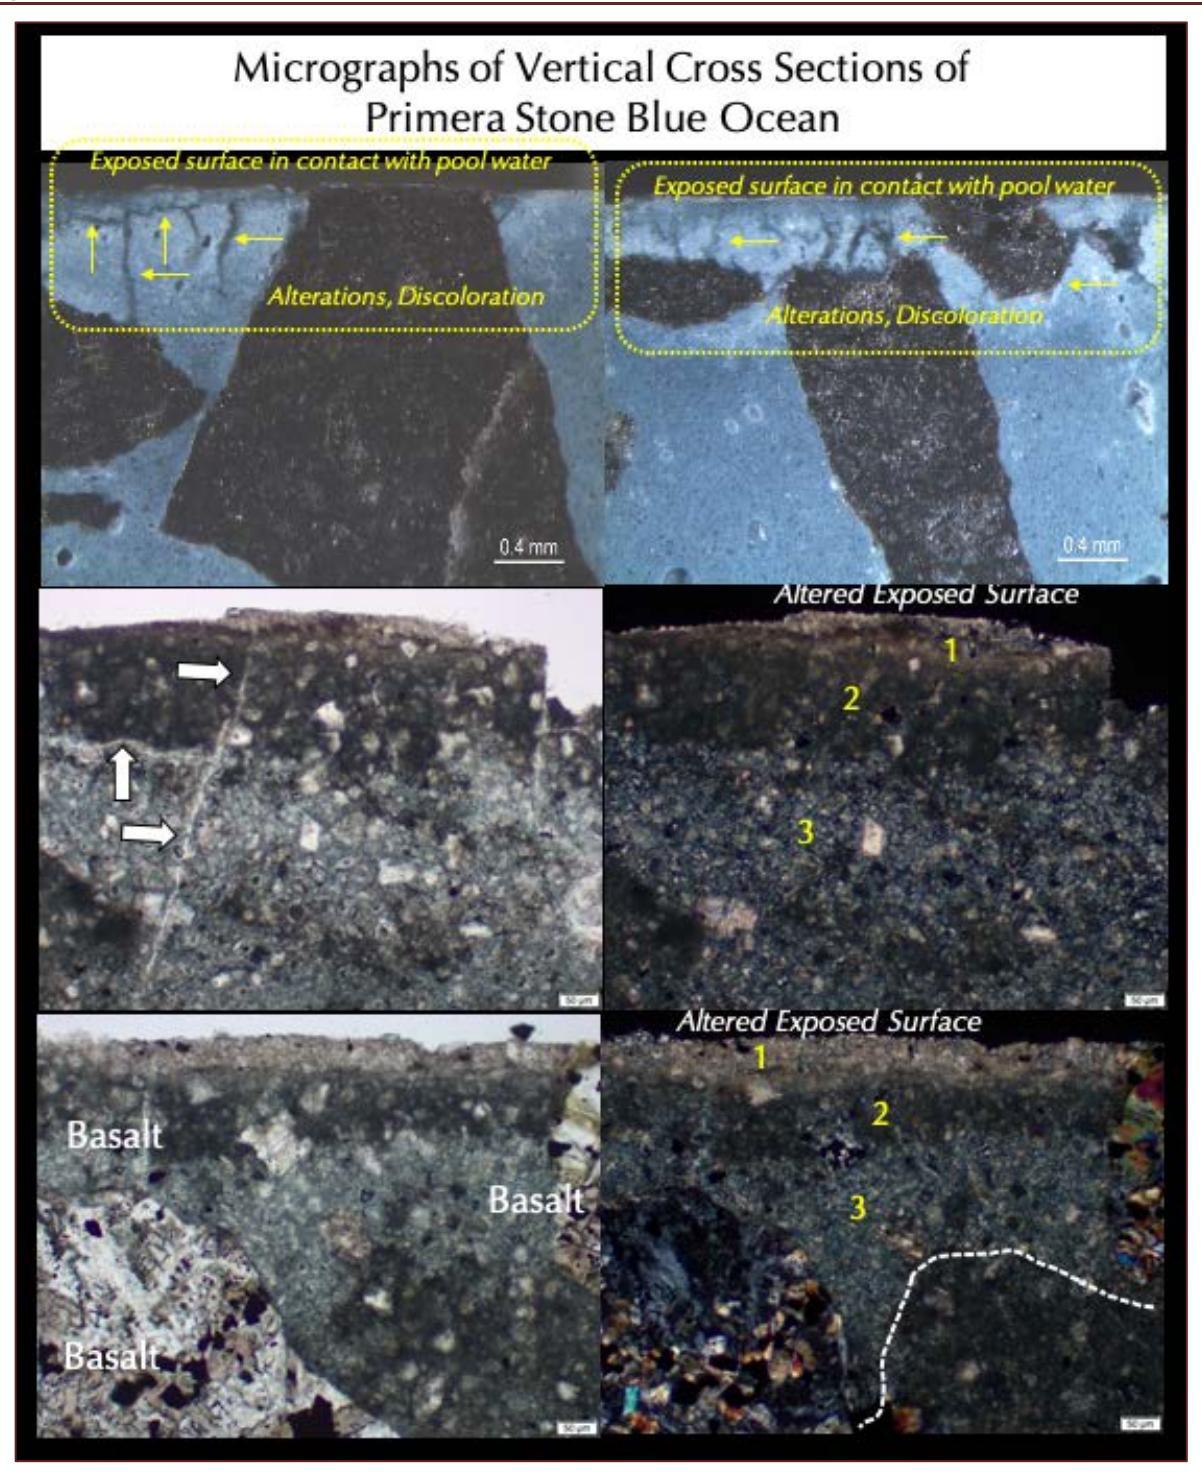
Figure 16: Stereo-micrographs (top row), and thin section micrographs (middle and bottom rows) of vertical cross section of Primera Stone Blue Ocean showing soft, crumbly, and noticeably porous paste at the top 1 to 2 mm (within the boxed area in the top row) due to leaching of calcium hydroxide component of Portland cement hydration and calcium chloride accelerator added in the plaster. Corresponding thin section micrographs in the middle and bottom rows show noticeably altered paste at the surface region (marked as carbonated zone at '1' and underlying leached zone at '2' then carbonated and porous paste at '3' above white dashed line separating surface altered and porous paste from interior), and some fine, hairline vertical shrinkage microcracks marked with yellow or white arrows (common in many plasters containing calcium chloride accelerator), and darker to lighter blue paste from differences in paste porosities resulted from differential leaching of paste by the pool water. See Appendix for more photos.
