### Swimming Pool Plaster Discoloration – A Case Study From Field & Laboratory-Cured Plasters

Primera Stone Sapphire Treasure & Blue Ocean

CONSTRUCTION MATERIALS CONSULTANTS, INC.

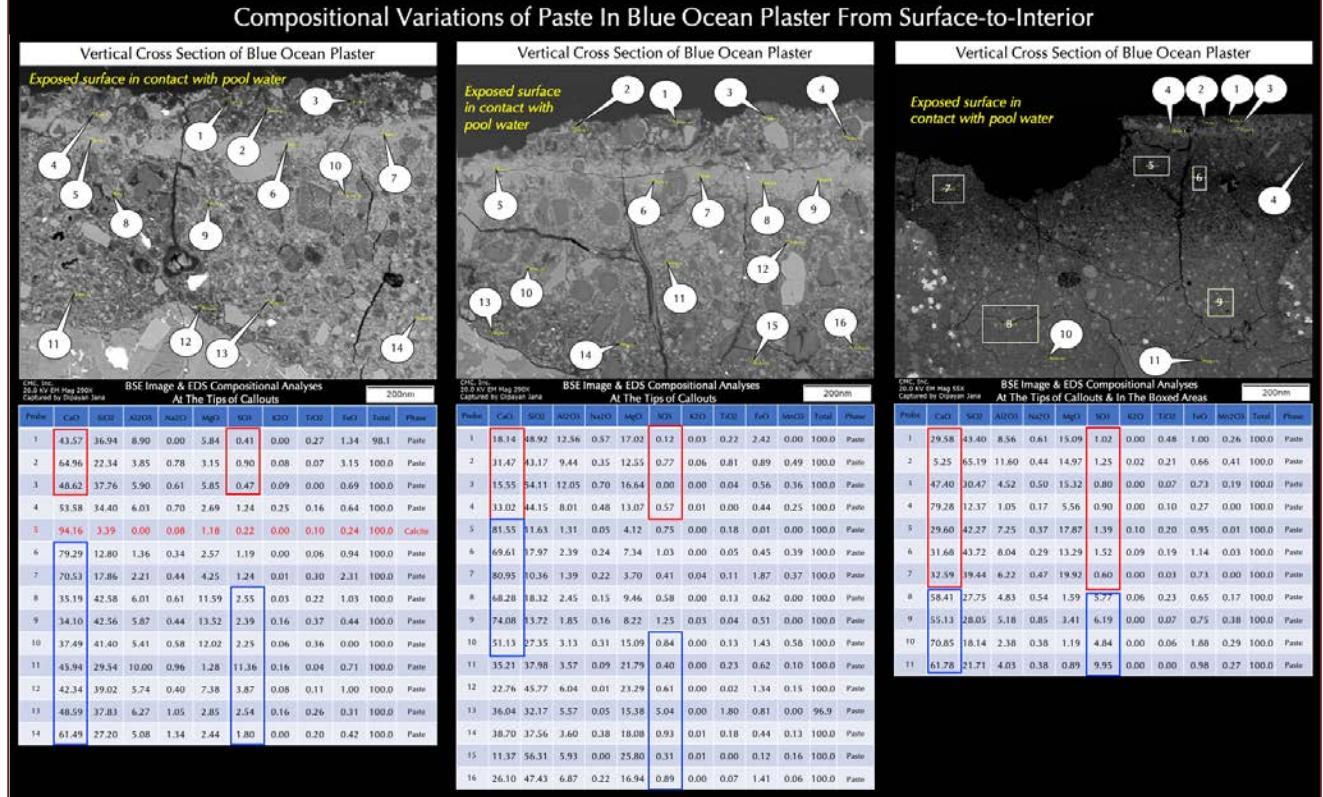
Figure 17: Backscatter electron (BSE) images and X-ray microanalyses of paste at the vertical cross sections of Primera Stone Blue Ocean plaster from the discolored exposed surface at the top ends of the images through depth to the interior to determine the compositional variations of plaster pastes from interactions with the pool water. Compositions of pastes are analyzed at the tips of callouts and in boxed areas, and, results are provided as major element oxide variations in the Tables beneath the images. In the BSE images, variations in paste porosities and compositions are portrayed by corresponding variations in gray scales of images. Notice the darker paste appearance at the very top exposed surface ends due to leaching of calcium hydroxide and calcium chloride from the paste by the pool water that has increased the paste porosities as we have seen in the optical micrographs. A layer of secondary calcite precipitate formed either on the exposed surface at the very top as a thin (< 1 mm thick) scale (not seen in these images, but shown in many other images in the Appendix), or, immediately beneath the leached surface as a thin carbonate layer shown in the left and middle BSE images. Right BSE image shows a leached paste at the top surface region where it appeared dark gray compared to denser brighter gray paste in the interior. Compositional variations show loss of CaO with an increase of  $SiO_2$  due to leaching, along with a loss of sulfate (as  $SO_3$ ) from the leached zone and magnesia, where the last two components were derived more from the pigments used than from cement hydration products. Therefore, leaching of not only paste to increase paste porosity but also of pigment components is seen at the leached surface zones of plaster. Similar features are seen in the Sapphire Treasure plaster at the exposed surface ends. The next Table and compositional plots show variations in plaster paste compositions due to interaction with the pool water. As opposed to a homogeneous composition of the paste without any pool water interactions, paste from the exposed leached surface region to interior show linear or other compositional variations of oxide compositions due to pool water interactions.

Backscatter electron images and microanalyses of paste in vertical cross sections of plasters in Figure 17 show various surface alterations of plaster paste compositions compared to the interior, e.g., from leaching of lime to precipitation of lime beneath the leached zone as a narrow band of secondary calcite precipitate or on the exposed surface as a thin film (scale). Appendix Figure A 39 shows leaching at the surface region whereas A 40 to A 42 show precipitation of thin secondary calcite layer (scale) on the exposed surface of Sapphire Treasure. Figures A 67 to A 72 show leaching and precipitation of secondary calcite beneath the leached surface region on vertical cross section of Blue Ocean plaster.

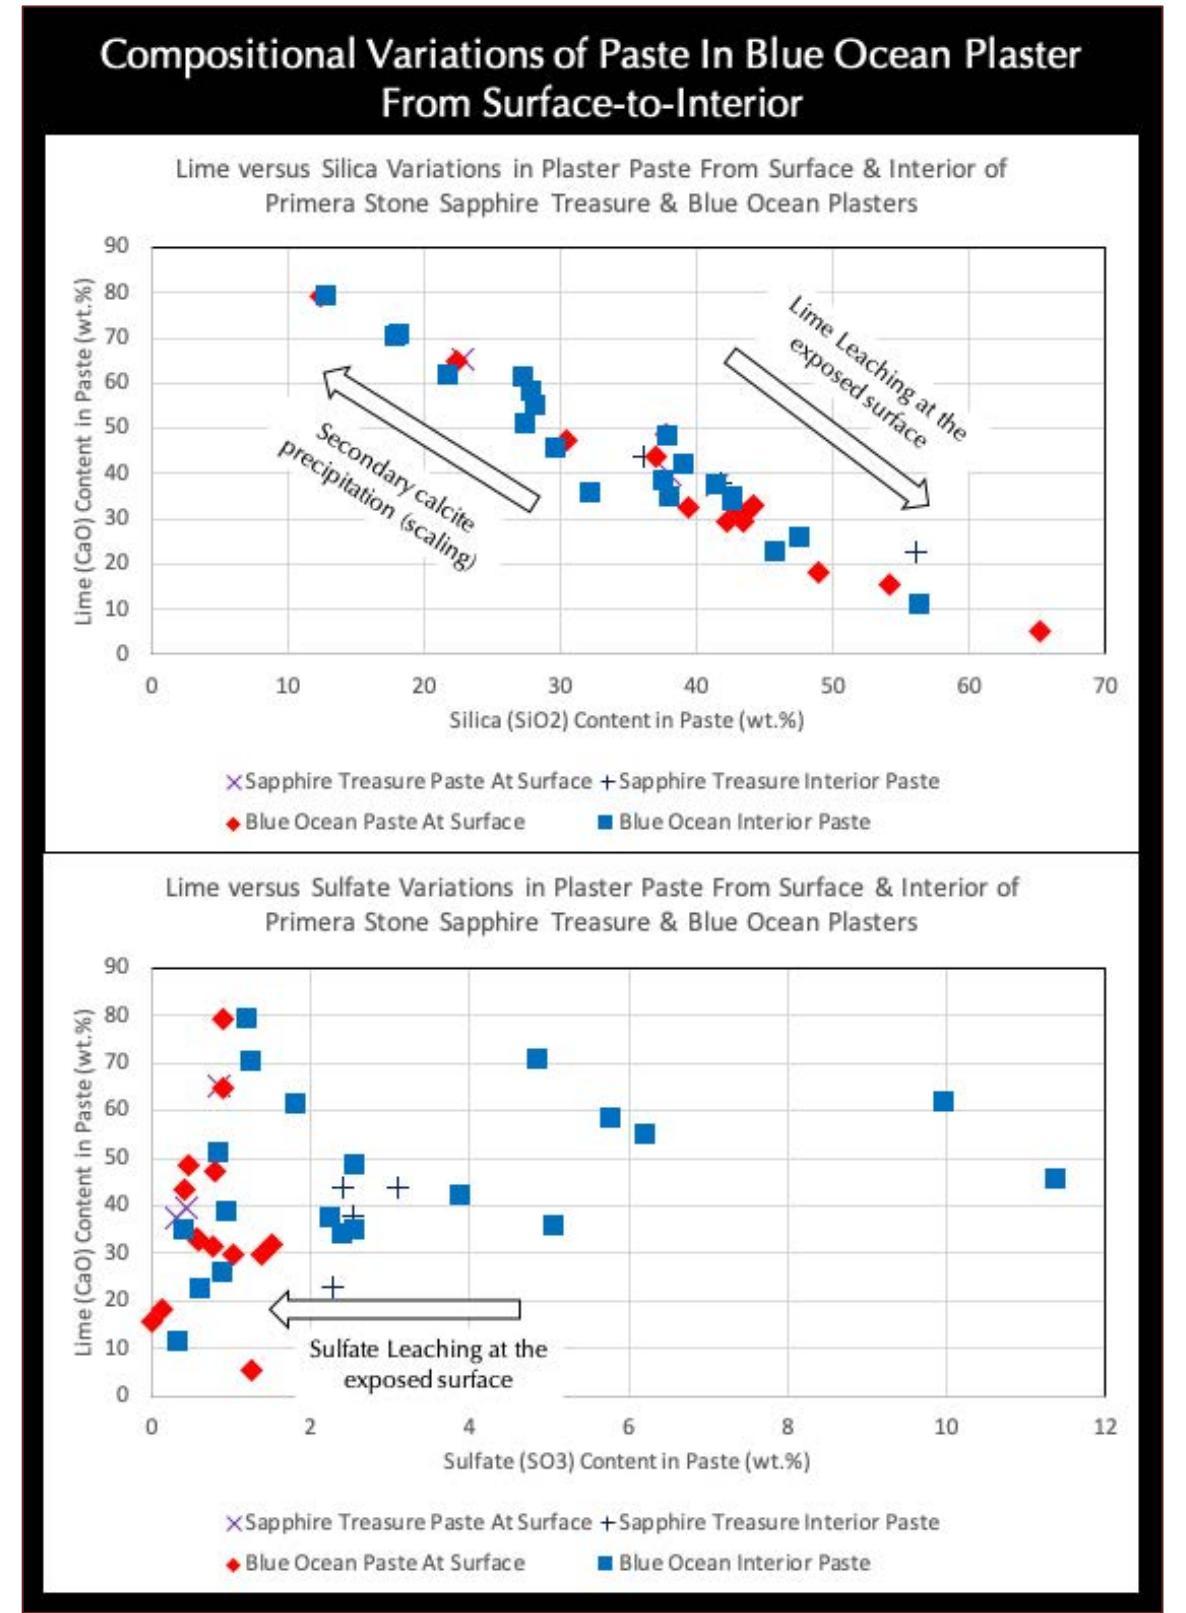
Figure 19: Oxide compositional variations of plaster paste at the surface regions to the interior of Sapphire Treasure and Blue Ocean plasters due to interaction with pool water. The linear trend at the top and large spread at the bottom plots are indicative of strong interactions of pool water with plaster, without which paste compositions would have been homogenous i.e., without any trend or spread.

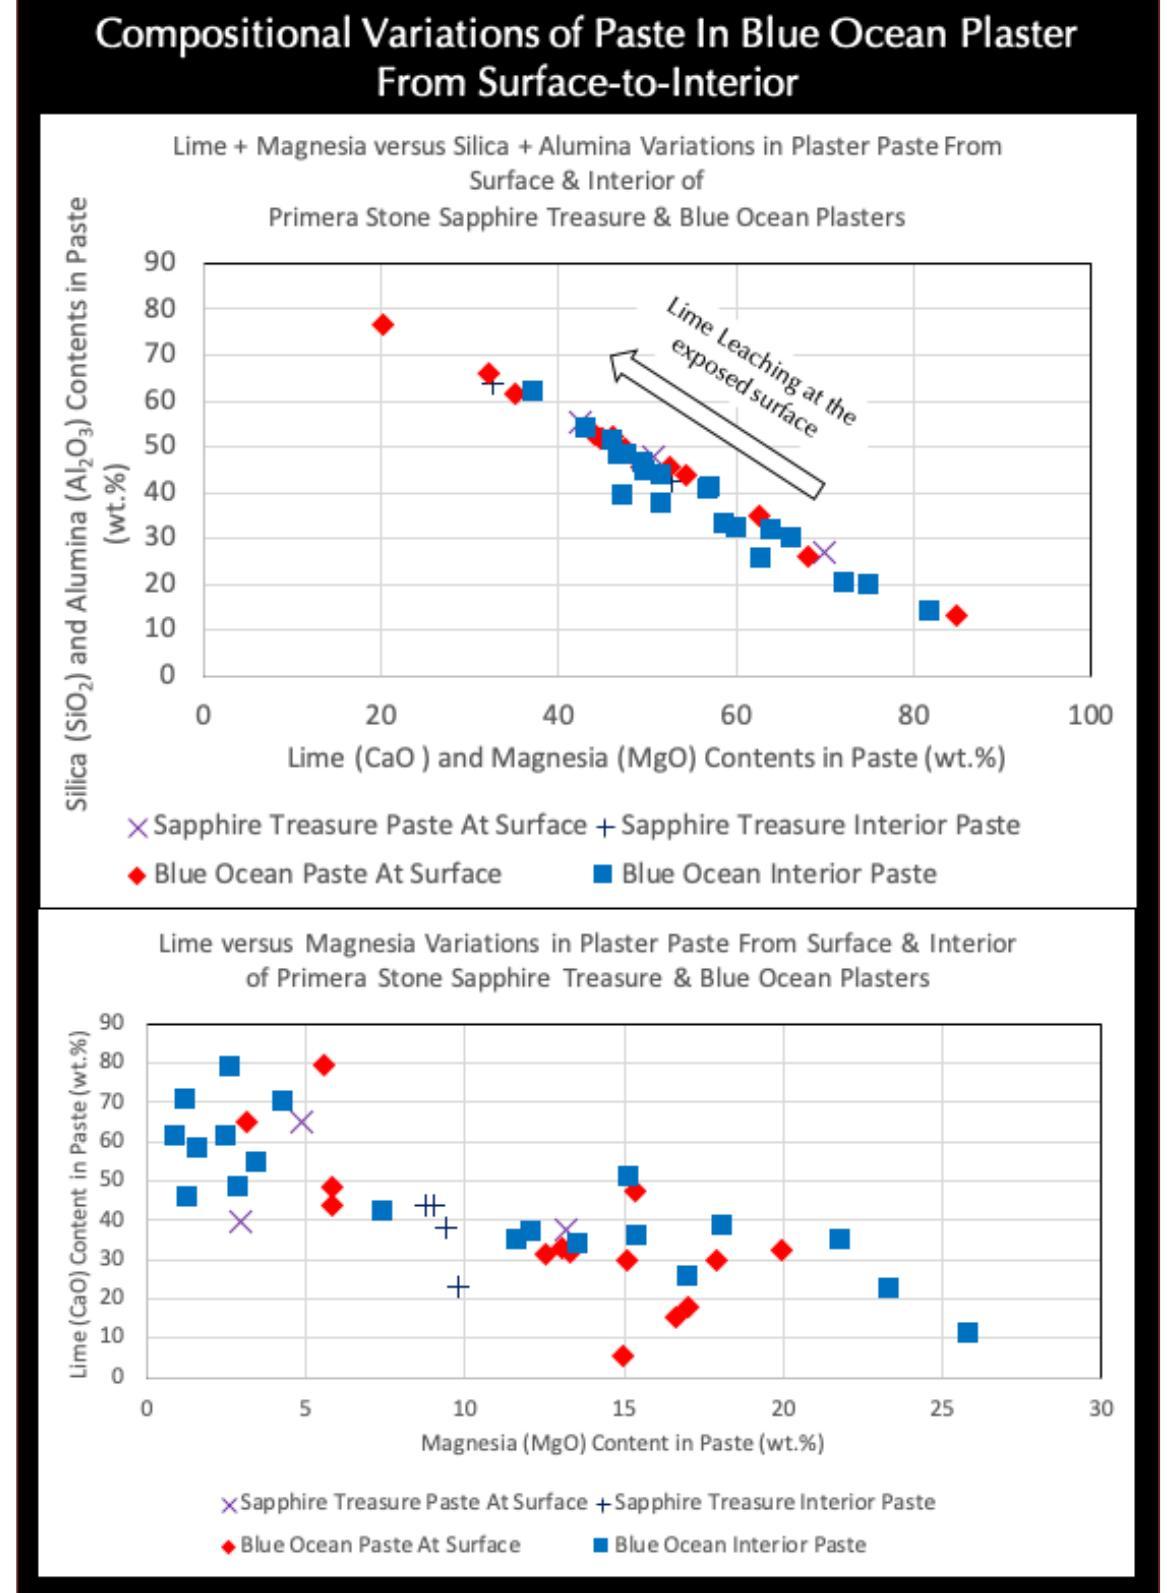
Figure 20: Oxide compositional variations of plaster paste at the surface regions to the interior of Sapphire Treasure and Blue Ocean plasters due to interaction with pool water. The linear trend at the top and large spread at the bottom plots are indicative of strong interactions of pool water with plaster, without which paste compositions would have been homogenous i.e., without any trend or spread.

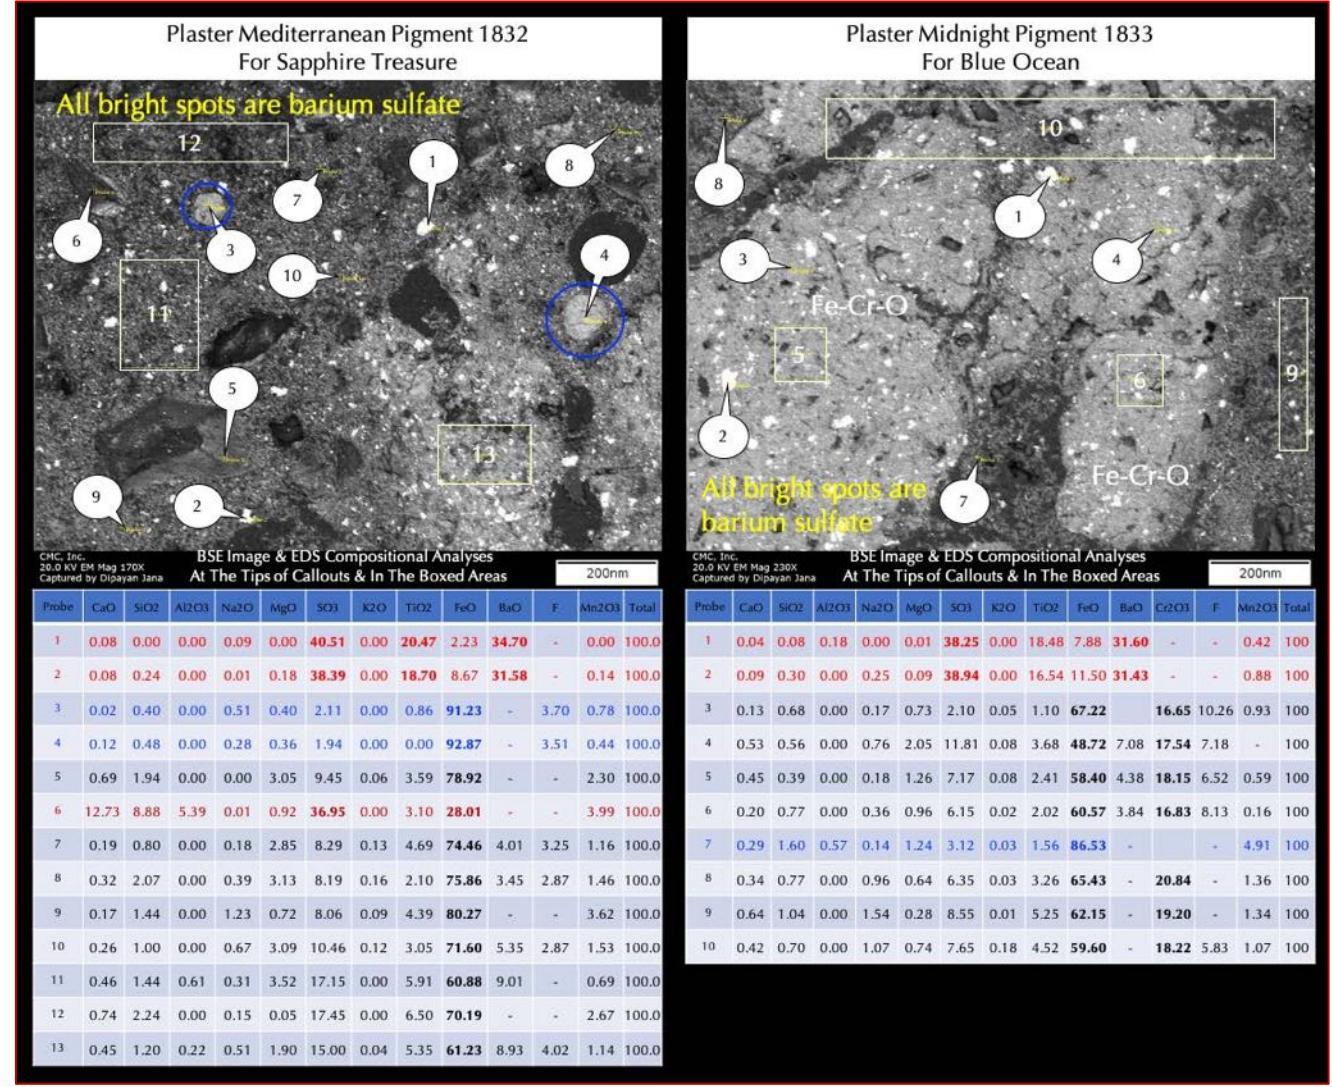
Figure 25: Backscatter electron micrographs (top) of the Mediterranean Pigment (left) and Midnight Pigment (right) showing the presence of barium sulfate as a major component and source of sulfate, along with iron oxide-based composition of Mediterranean Pigment in 1832 as opposed to iron-chromium oxide-based composition of Midnight Pigment in 1833.

Since barium sulfate is found to be present as a stabilizer in both pigment samples (#1832 and #1833) provided (Figure 25), the high sulfate contents in the pastes found in both field plaster samples i.e., higher than the sulfate contributed from white Portland cement is determined to be from the pigments where the large spread in the sulfate contents of paste in Figure 19 compositional plot of pastes on vertical cross sections of both plasters from the leached surface regions to the interiors are testaments of leaching of pigments along with paste. Addition of calcium chloride accelerator is commonly known to enhance leaching of pigments, which is noted in both plasters from large spread of sulfate variations across the vertical cross sections as well as relatively lower sulfate results at the leached zones of plasters than the interiors.

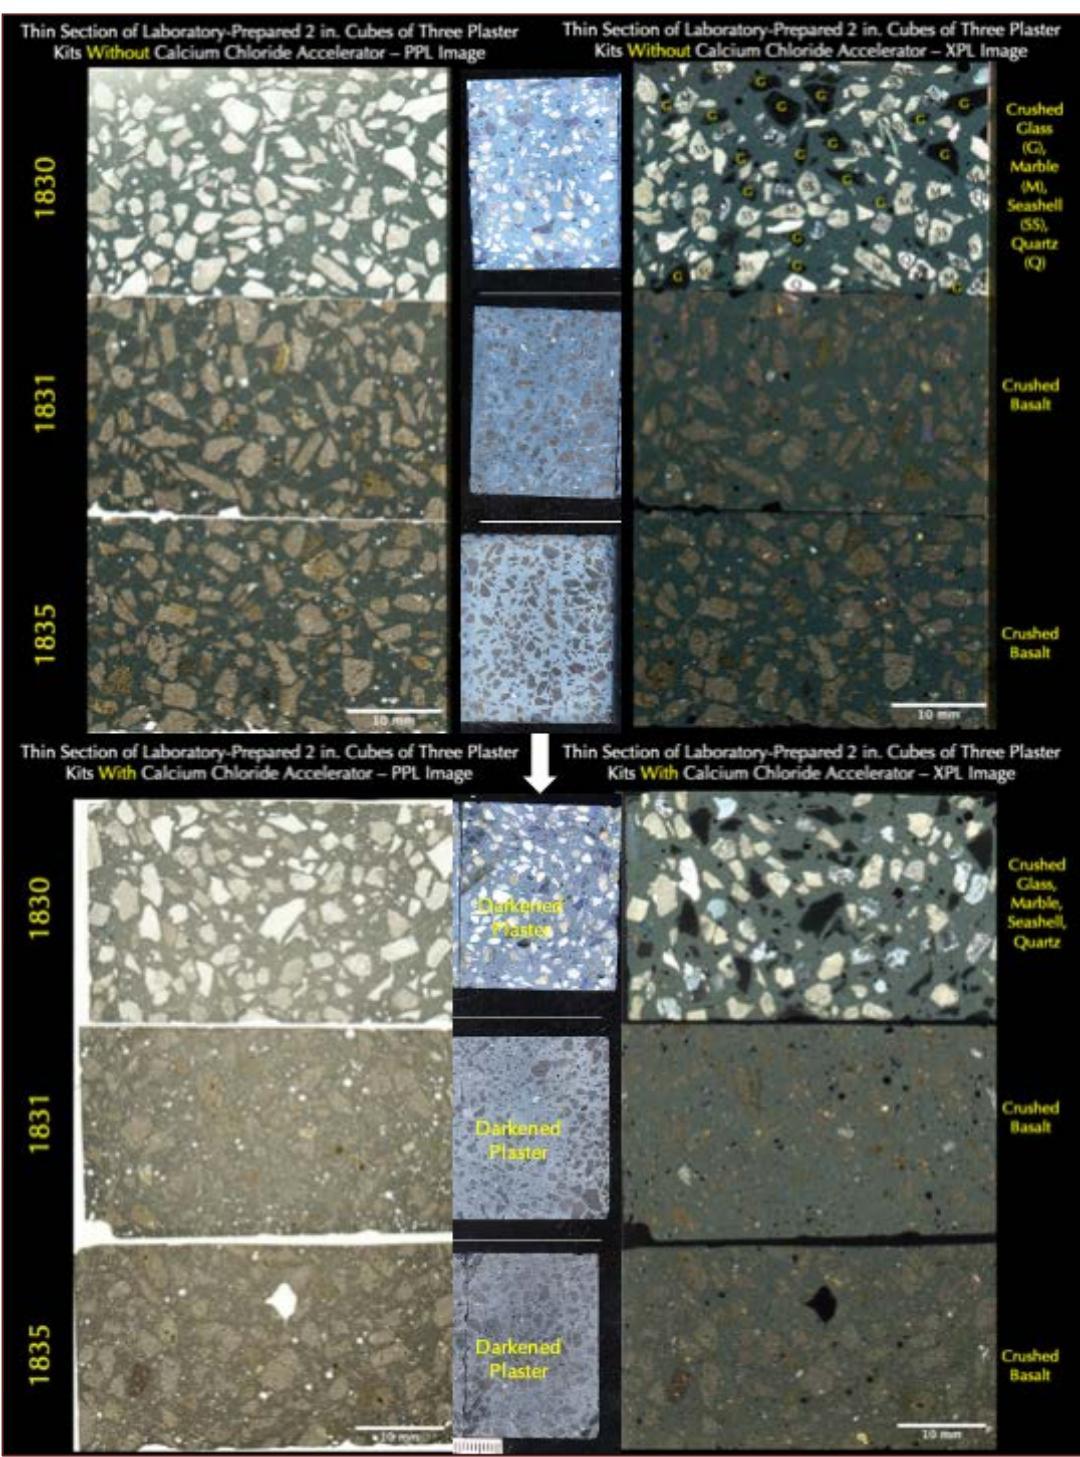
Figure 26: Laboratory-cured hardened plaster kits 1831, 1831, and 1835 prepared with and without calcium chloride set accelerator addition to the mix water, which were subsequently immersed in aggressive (tap) water and balanced (calcium hypochlorite) waters for 7 days. Shown are the solid sections in the middle and thin sections in PPL and XPL modes at left and right, respectively.

- a. Three hardened plaster kits# 1830, 1831, and 1835 without CaCl<sub>2</sub> addition (top row) showed typical mineralogies of residual calcium silicates (alite and belite) from white Portland cement, and limestone fine microfillers (mostly for kit# 1830 and 1831) as seen in their dry microstructures except having an overwhelming matrix of calcium silicate hydrate hydration products of cement on which the residual cement grains are scattered, fine-grained short prismatic or lath-shaped grains of water-soluble calcium hydroxide component of cement hydration, sometimes appearing as coarsely crystalline laths in air voids.

- a. Addition of CaCl<sub>2</sub> accelerator in the mix water during preparation of hardened plasters from kit# 1830, 1831, and 1835 showed no major difference in microstructure compared to the companion CaCl<sub>2</sub>-free ones. There is no evidence of any increase in the frequency of fine hairline drying shrinkage microcracks that are present in all hardened plasters irrespective of CaCl<sub>2</sub> addition. All three hardened plaster kits showed typical mineralogies of residual calcium silicates (alite and belite) from white Portland cement, and limestone fine microfillers (mostly for kit# 1830 and 1831) as seen in their dry microstructures except having an overwhelming matrix of calcium silicate hydrate hydration products of cement on which the residual cement grains are scattered, fine-grained short prismatic or lath-shaped grains of water-soluble calcium hydroxide component of cement hydration.

- c. Similar microstructures of localized dissolution but no surface scaling is found when the CaCl<sub>2</sub> doped kit were immersed in calcium hypochlorite disinfectant solution. Abundant coarse lath-shaped secondary calcium hydroxide deposits in air voids in all three kits indicates high solubility of this component of white Portland cement hydration.

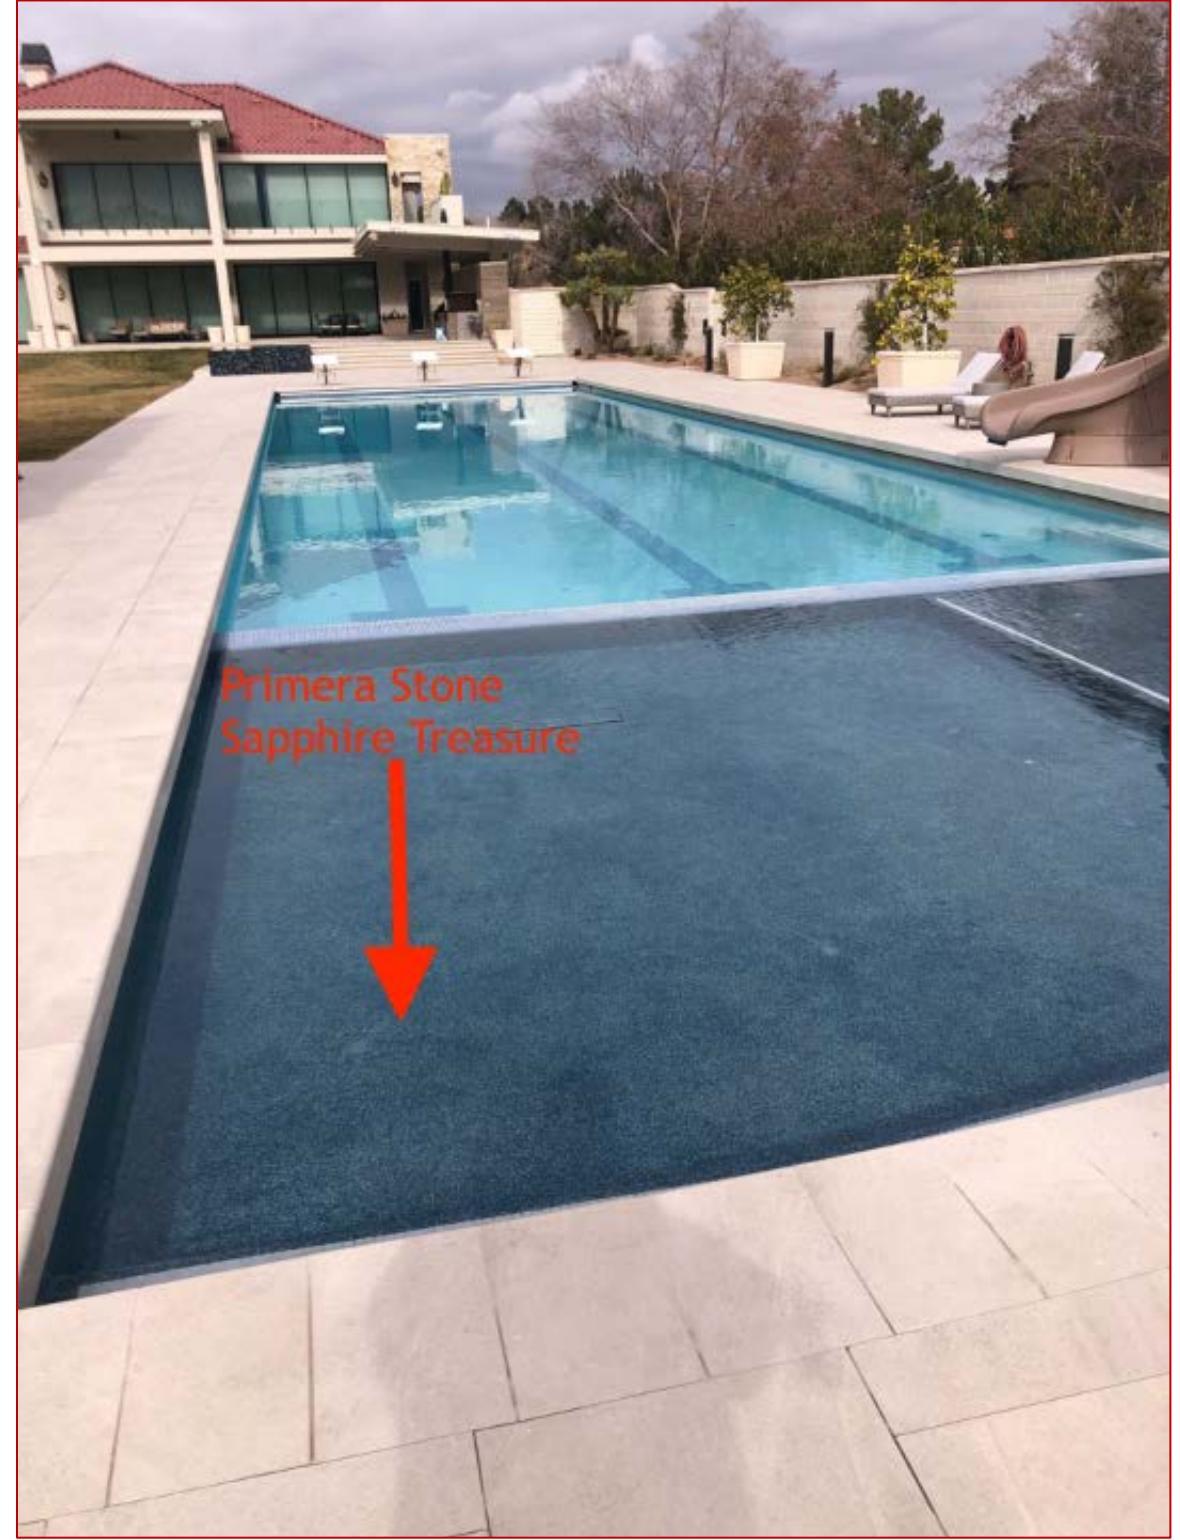
Fig. A 4: Field photo of swimming pool portion where Primera Stone Sapphire Treasure plaster was installed.

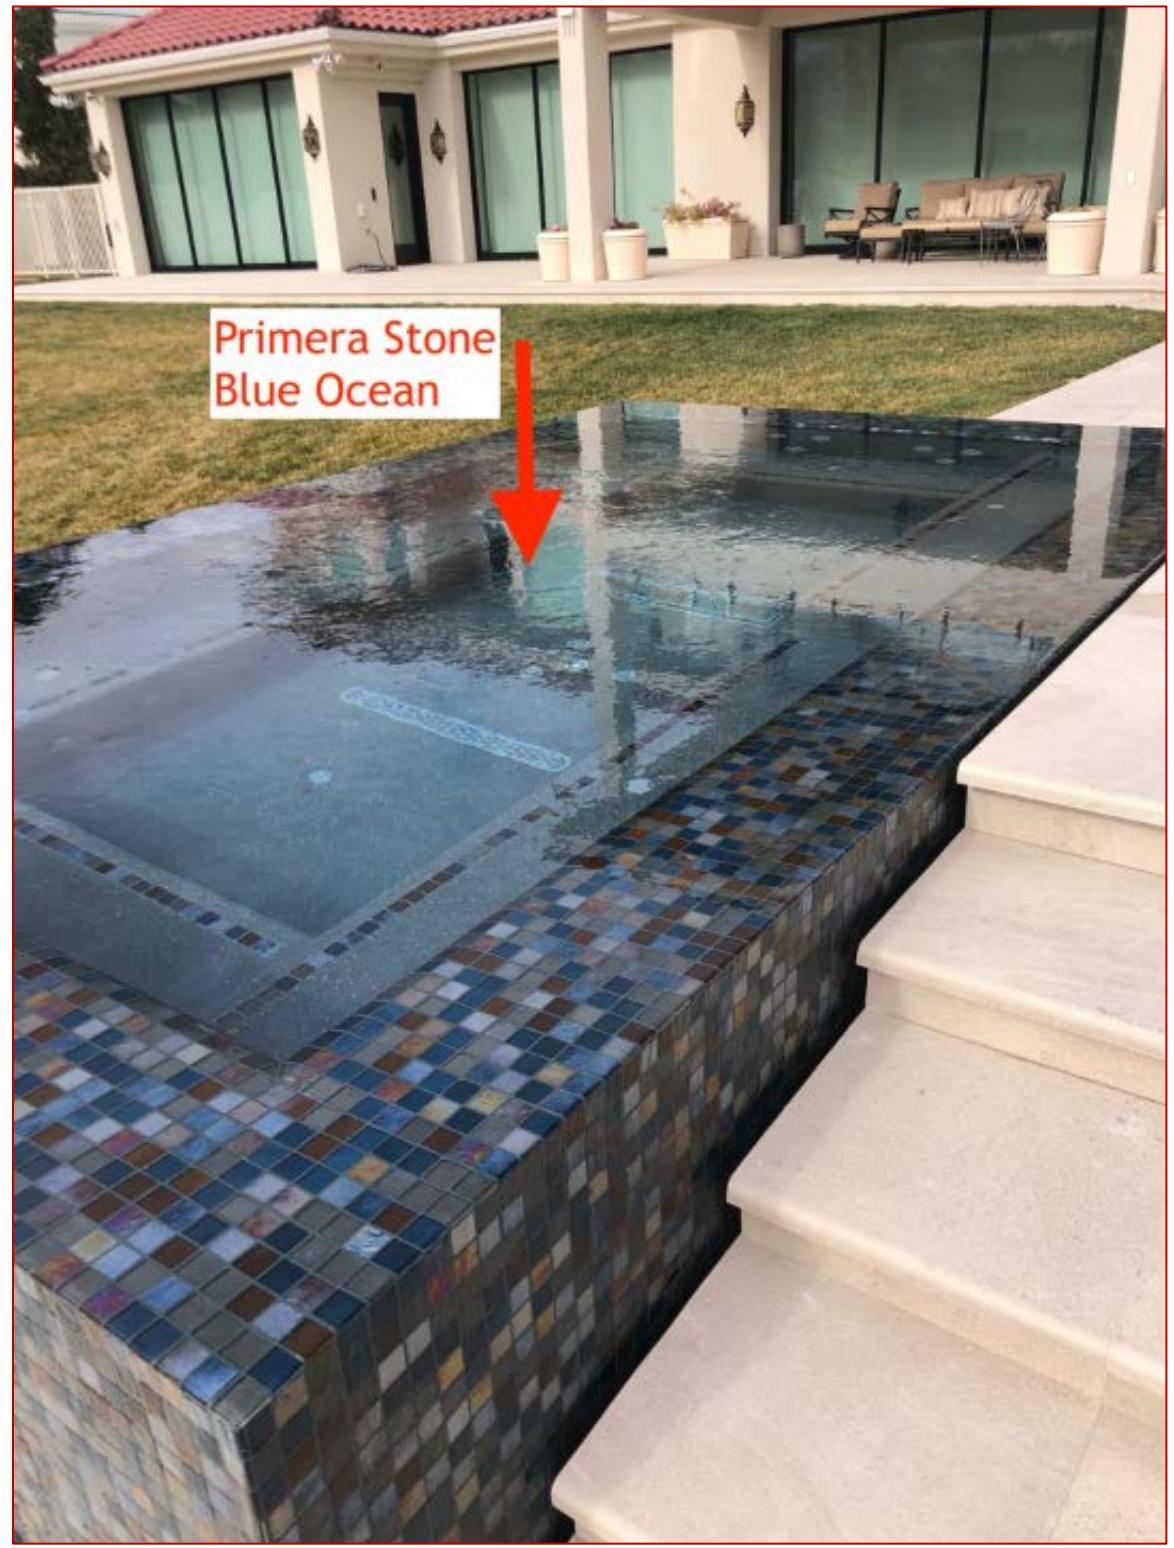
Fig. A 5: Field photo of swimming pool portion where Primera Stone Blue Ocean plaster was installed.

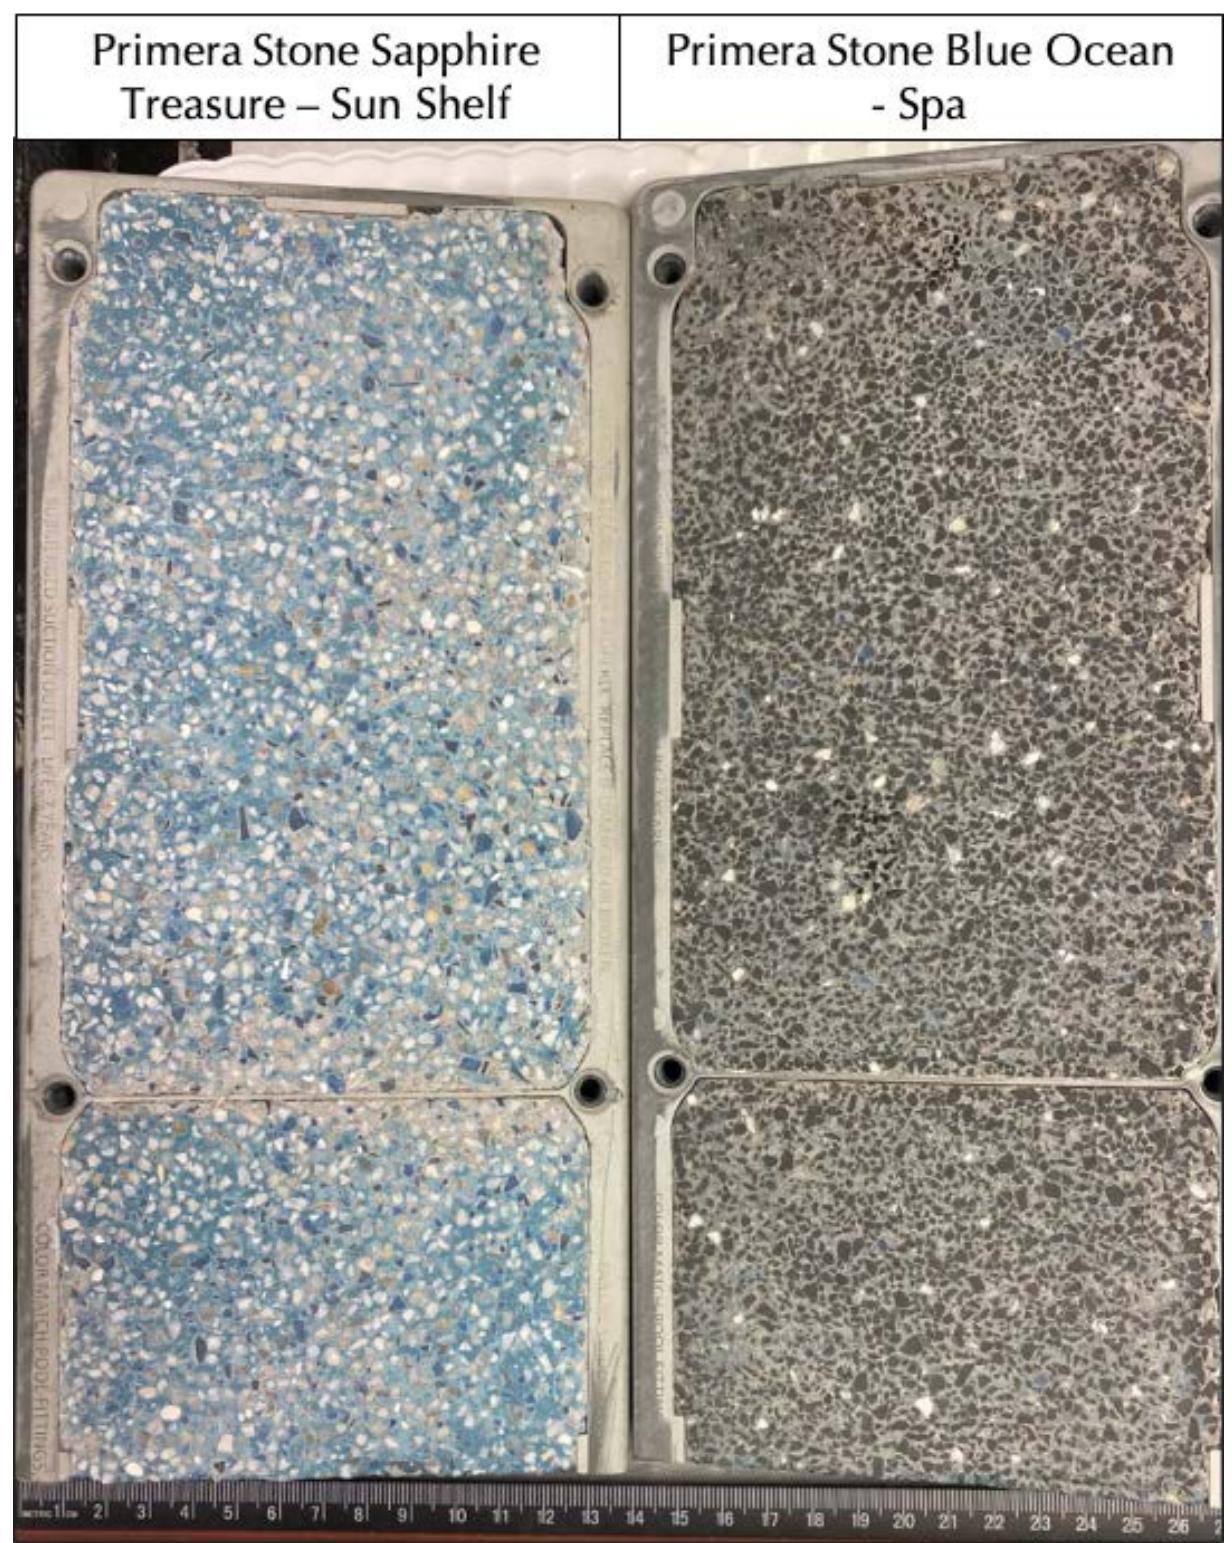
Fig. A 6: Two field plaster samples provided from Primera Stone Sapphire Treasure from Sun Shelf (left) and Primera Stone Blue Ocean from Spa (right).

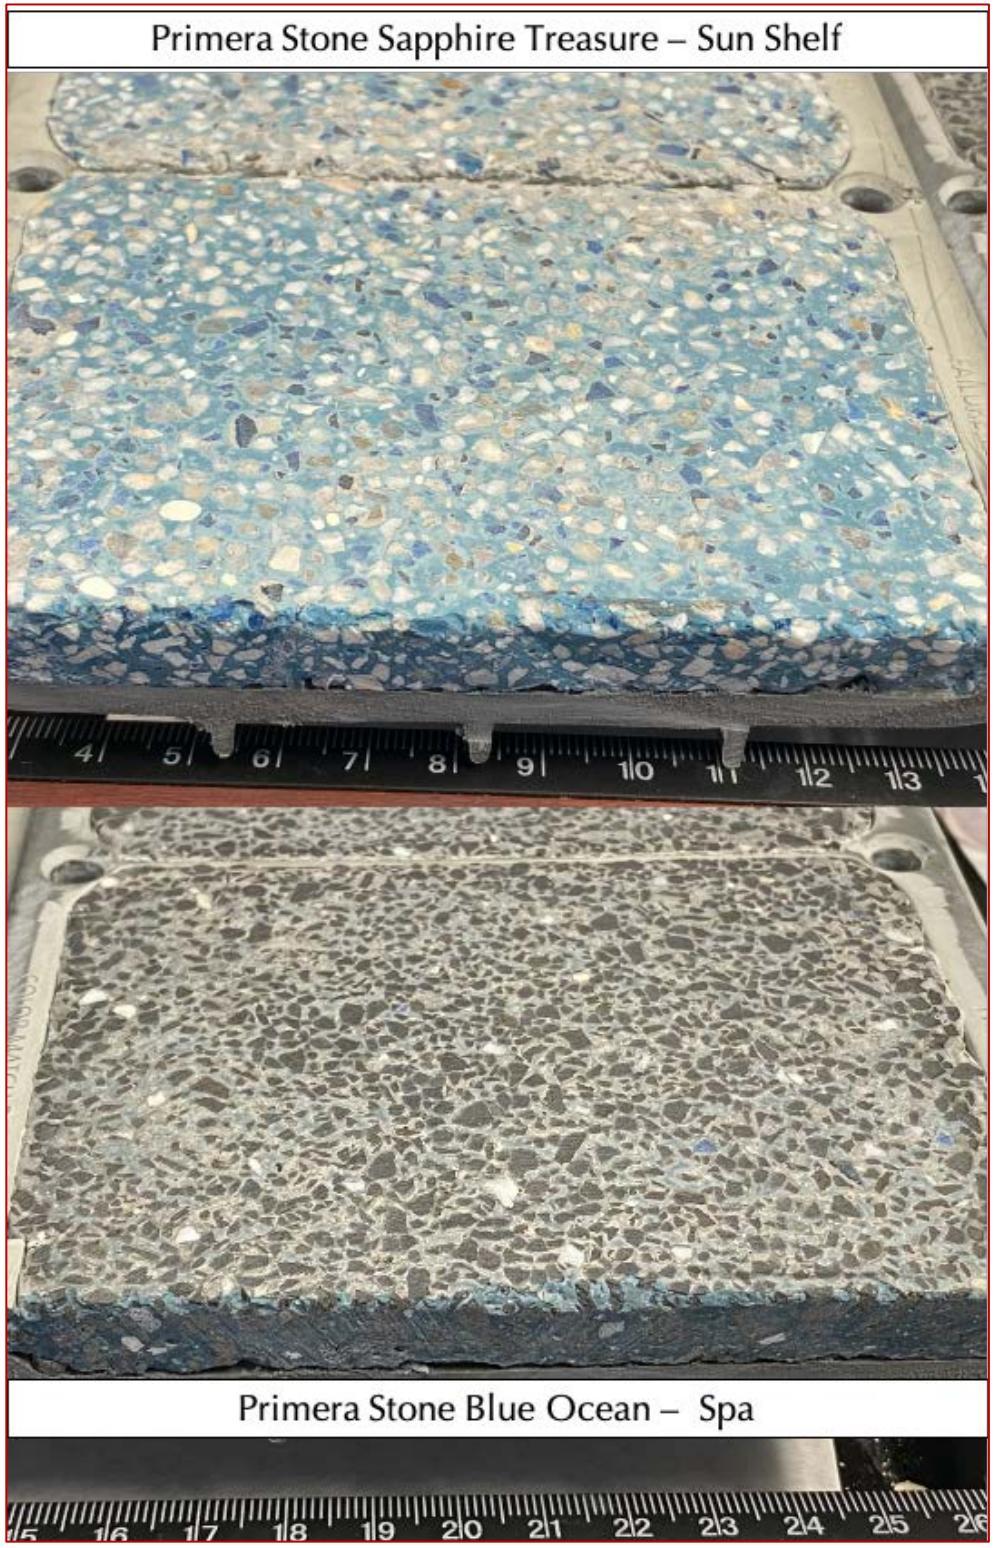
Fig. A 7: Blotchy discoloration (mottling) of exposed surfaces of Primera Stone Sapphire Treasure (top) and Primera Stone Blue Ocean (bottom) plasters from the field.

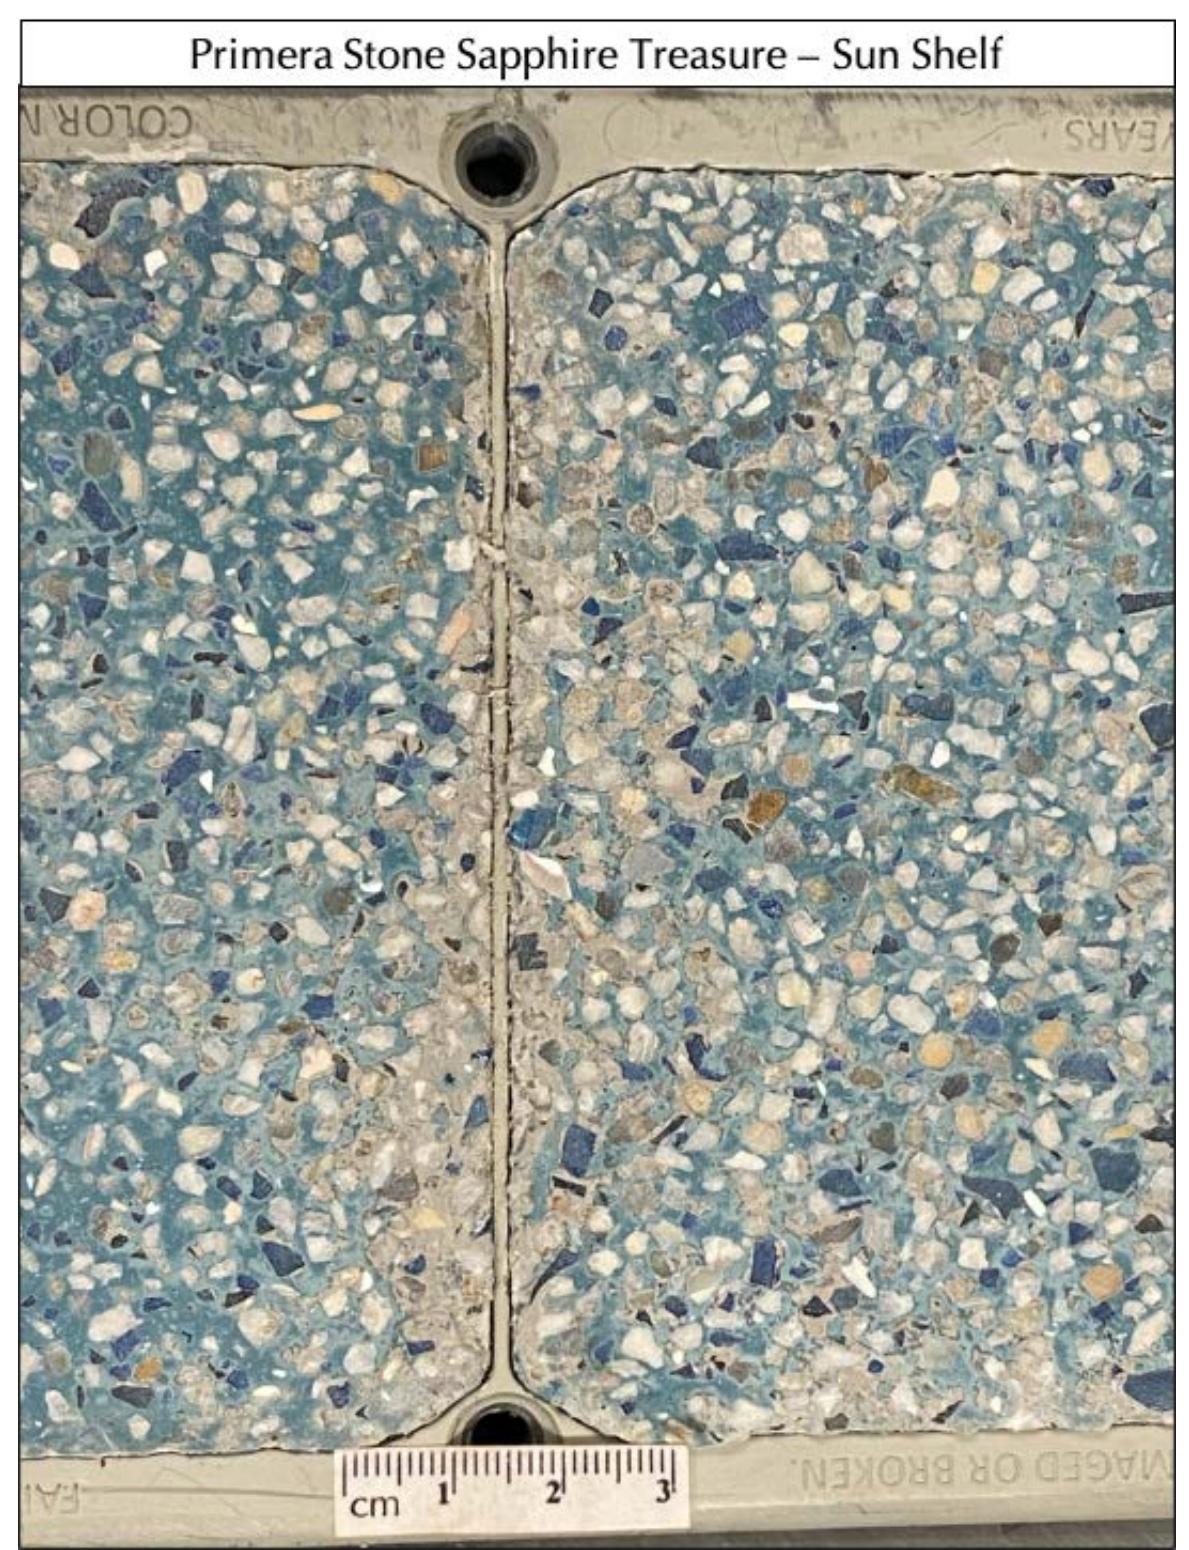
Fig. A 8: Blotchy discoloration (mottling) of exposed surface of Primera Stone Sapphire Treasure plaster.

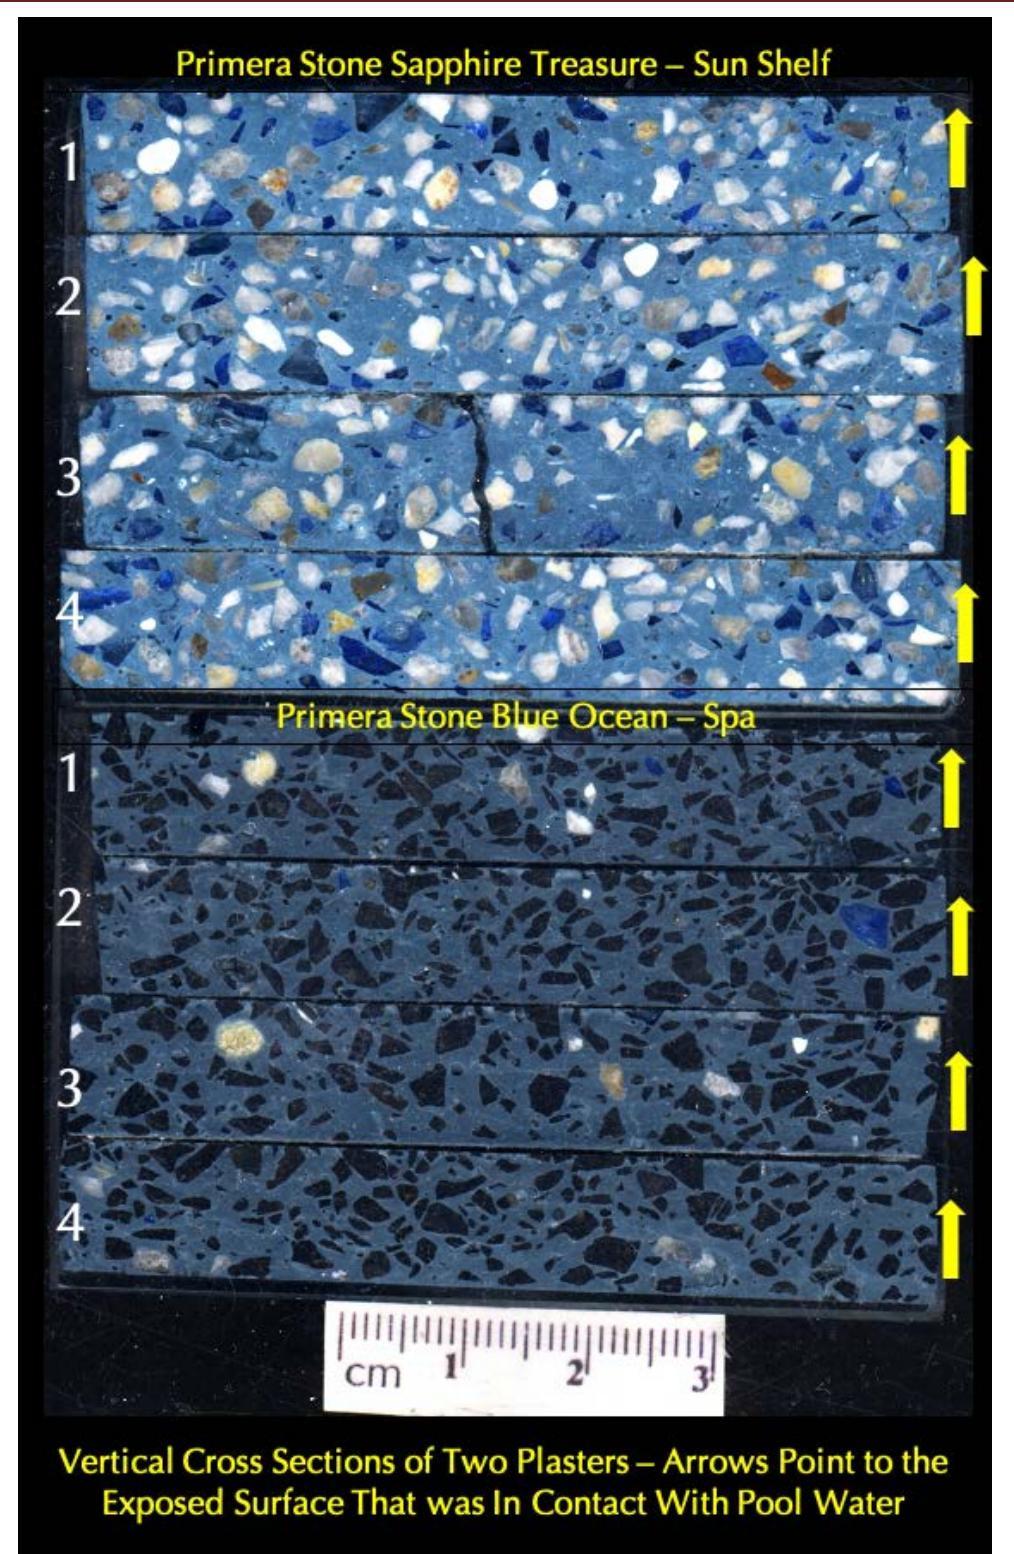
Fig. A 11: Vertical cross sections of Primera Stone Sapphire Treasure and Blue Ocean showing size, shape, angularity, distribution of aggregates, color tones of paste, color variations or uniformity through depths, and overall consolidated natures of plaster in both samples. Locations of Sections 1 through 4 in each sample is shown in the previous Figure.

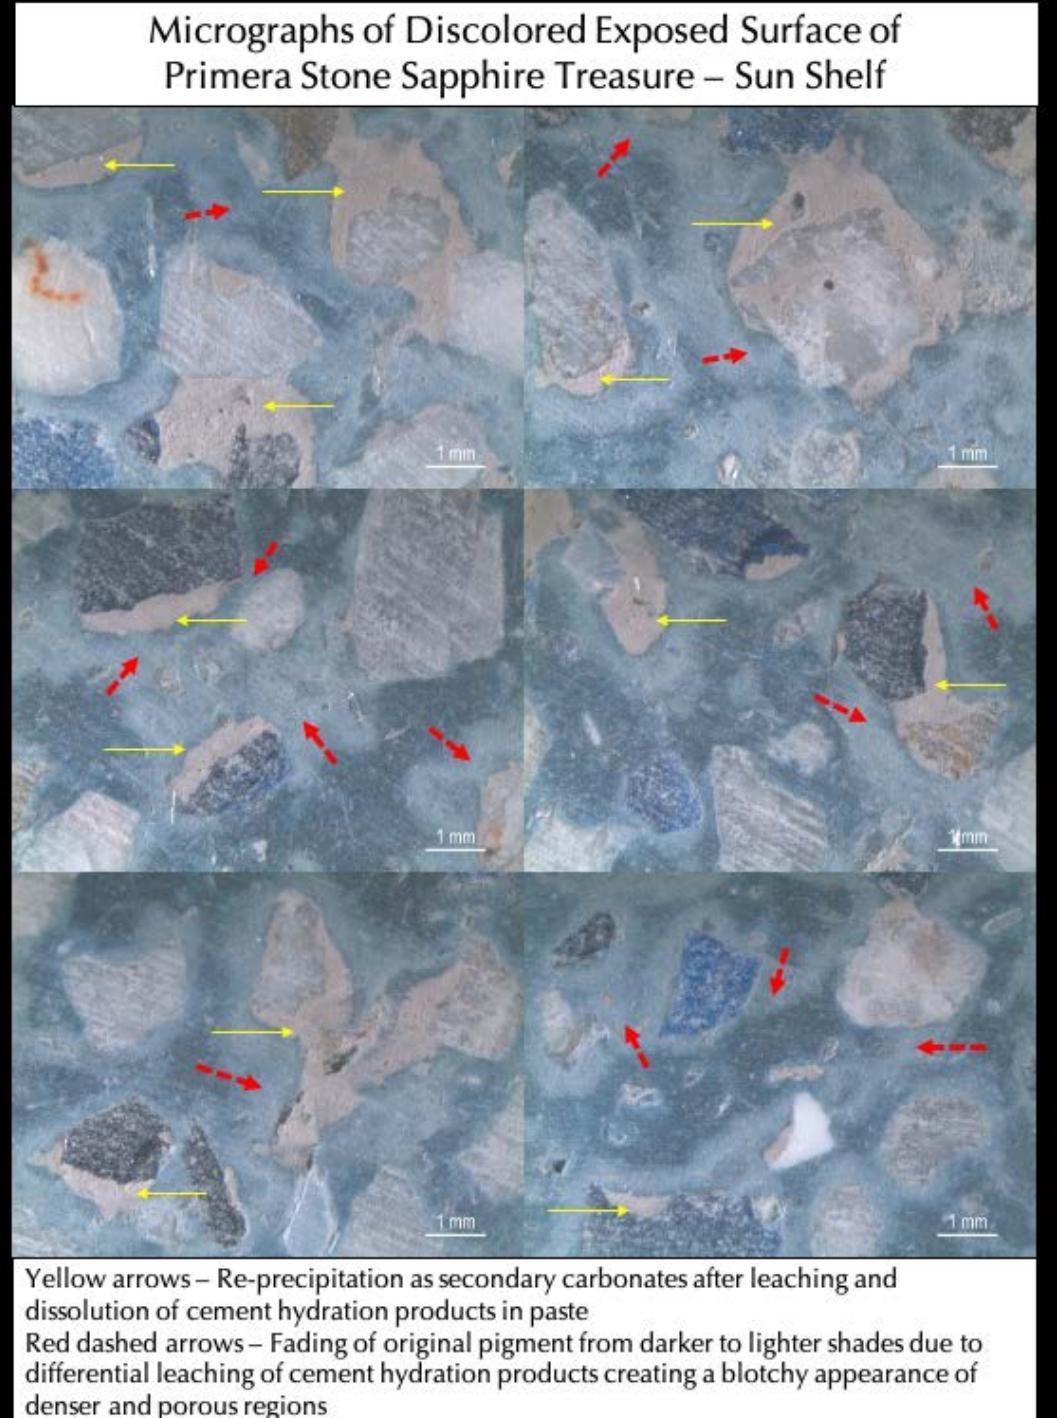
Multi-colored crushed aggregate – Blue glass, White quartz, quartzite, chert, Off-white marble, seashell, Gray marble, etc.

Fig. A 12: Micrographs of exposed discolored surface of Primera Stone Sapphire Treasure pool plaster that was in contact with the pool water from the Sun Shelf area showing blotchy appearance of plaster consisting of: (a) beige gray discolored plaster patches marked with yellow arrows and (b) fading of darker to lighter blue colors of plaster marked by the dashed red arrows. Both the beige and lighter blue fading of color are the result of interaction of plaster and pool water. The micrographs were taken with a stereo-microscope.
