### Swimming Pool Plaster Discoloration – A Case Study From Field & Laboratory-Cured Plasters

Primera Stone Sapphire Treasure & Blue Ocean

CONSTRUCTION MATERIALS CONSULTANTS, INC.

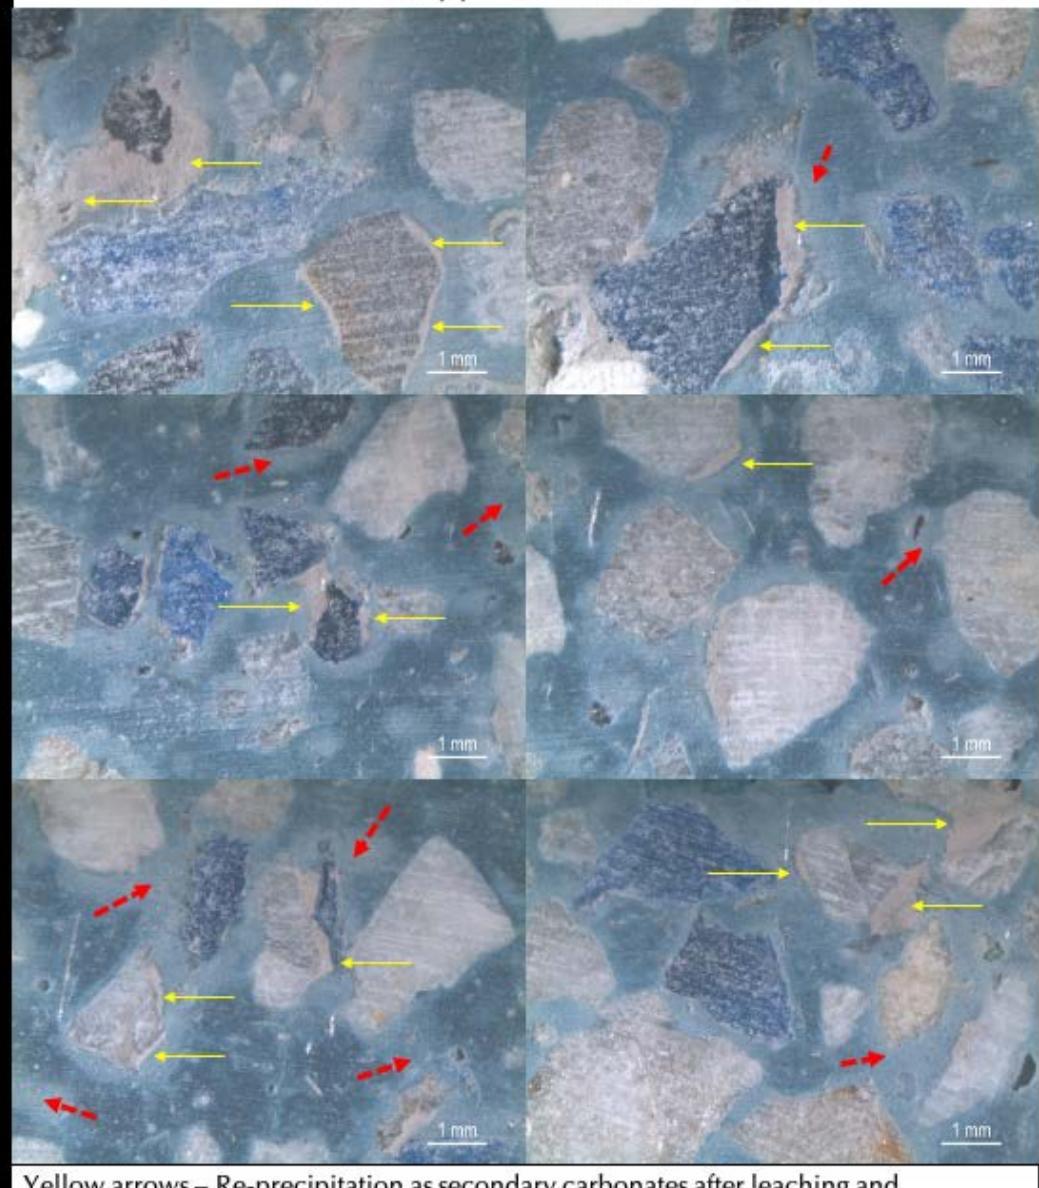
Yellow arrows – Re-precipitation as secondary carbonates after leaching and dissolution of cement hydration products in paste Red dashed arrows – Fading of original pigment from darker to lighter shades due to differential leaching of cement hydration products creating a blotchy appearance of denser and porous regions Multi-colored crushed aggregate – Blue glass, White quartz, quartzite, chert, Off-white marble, seashell, Gray marble, etc.

Fig. A 13: More micrographs of exposed discolored surface of Primera Stone Sapphire Treasure pool plaster that was in contact with the pool water from the Sun Shelf area showing blotchy appearance of plaster consisting of: (a) beige gray discolored plaster patches marked with yellow arrows and (b) fading of darker to lighter blue colors of plaster marked by the dashed red arrows. Both the beige and lighter blue fading of color are the result of interaction of plaster and pool water. The micrographs were taken with a stereo-microscope.

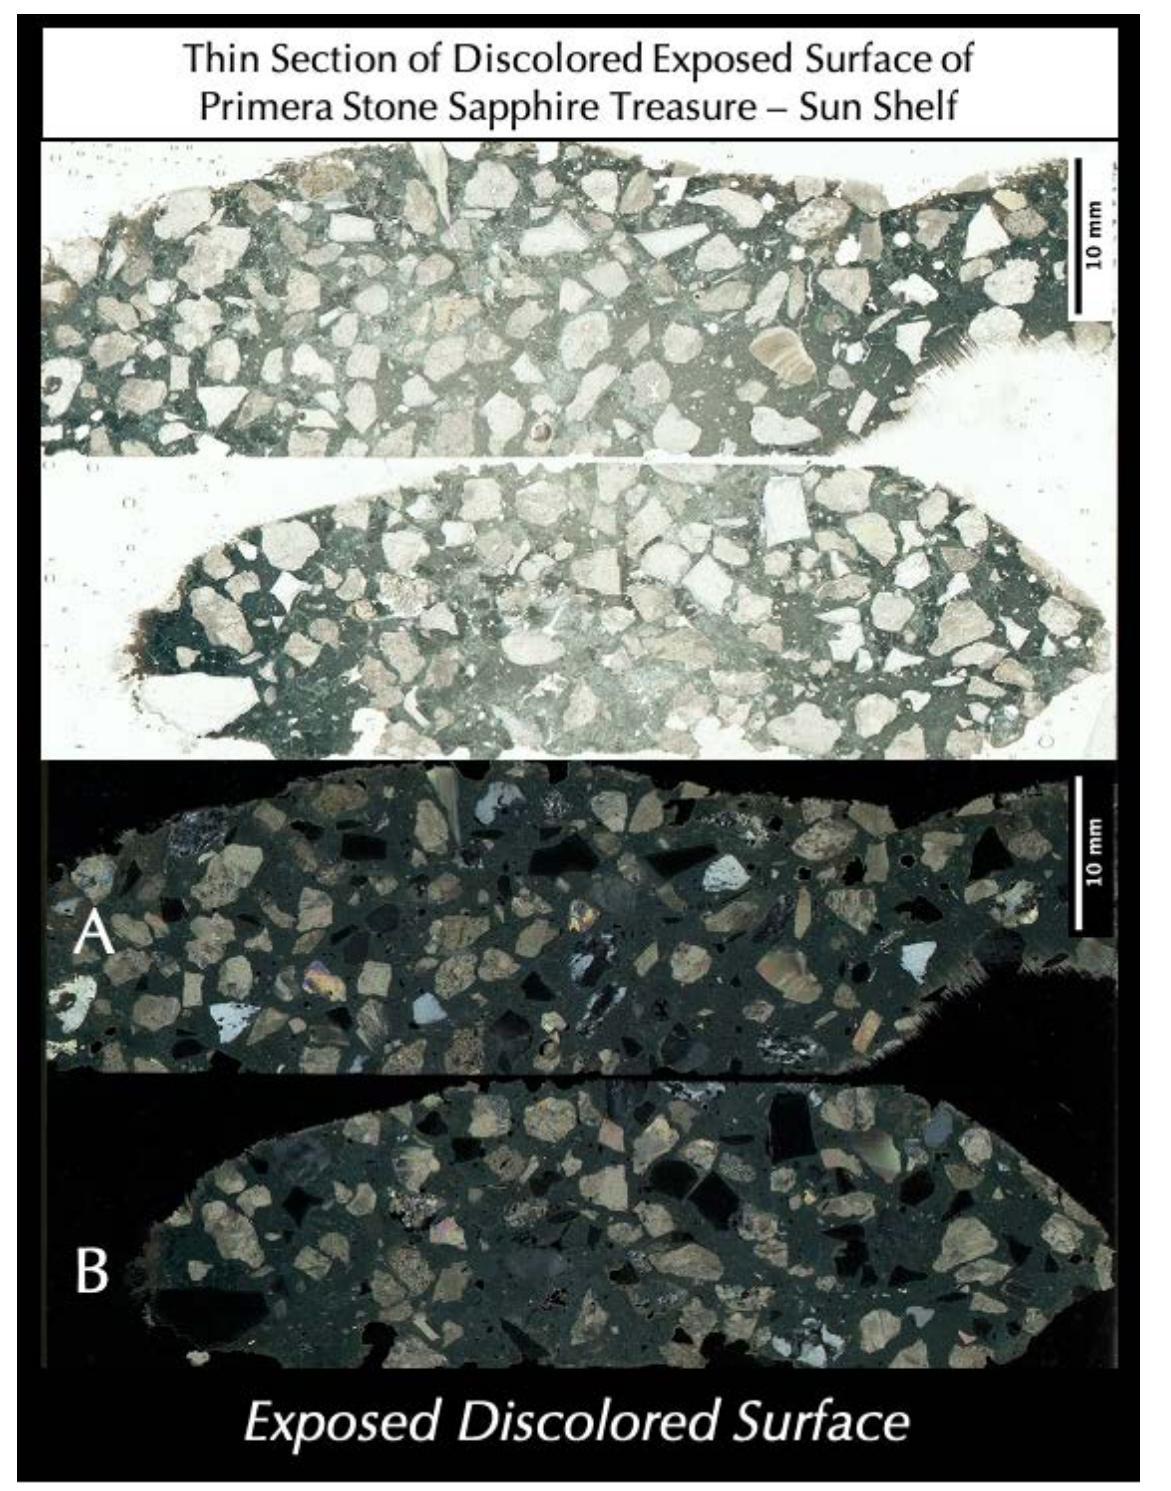
Fig. A 14: Blue dye-mixed epoxy-impregnated thin section (30 micron thickness) of exposed discolored surface of Primera Stone Sapphire Treasure pool plaster that was in contact with the pool water from the Sun Shelf area. The thin section was scanned on a flatbed film scanner with a polarizing filter to create plane polarized light (PPL) view at the top image, and then sandwiched between two polarizing filters at perpendicular positions to create crossed polarized light (XPL) view at the bottom. The PPL image shows difference in porosities of paste from variations in the degree of absorption of blue epoxy used for preparation of thin section, where porous areas absorbed more blue dye to appear brighter blue whereas denser areas absorb less blue epoxy to appear darker. The XPL image shows the different aggregate types used, which showed major amounts of crushed marble and seashell carbonate particles and minor amounts of siliceous (quartz, quartzite sand) components.

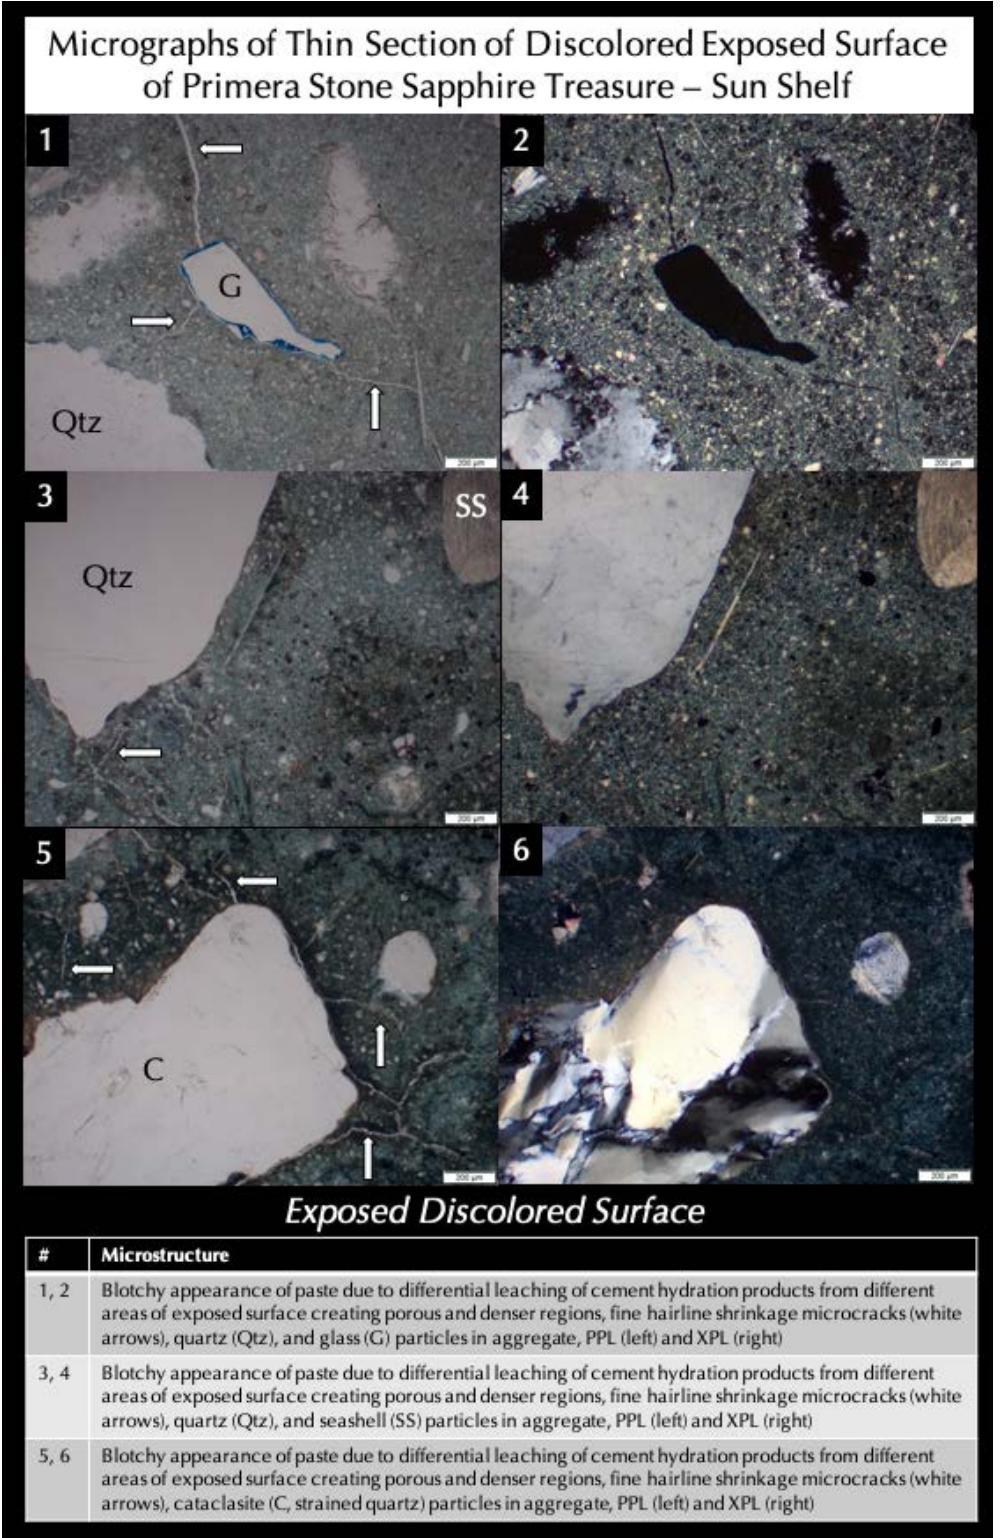
Fig. A 15: Micrographs of thin section of exposed discolored surface of Primera Stone Sapphire Treasure plaster showing: (a) crushed marble (C), quartz (Qtz), alkali-silicate glass (G), strained quartzite, and seashell particles in aggregate; (b) dense interstitial paste consisting of white Portland cement; (c) blotchy or patchy discoloration of plaster from darker to lighter shades due to variations in paste porosities;; and (d) fine, hairline shrinkage microcracks in paste (arrows).

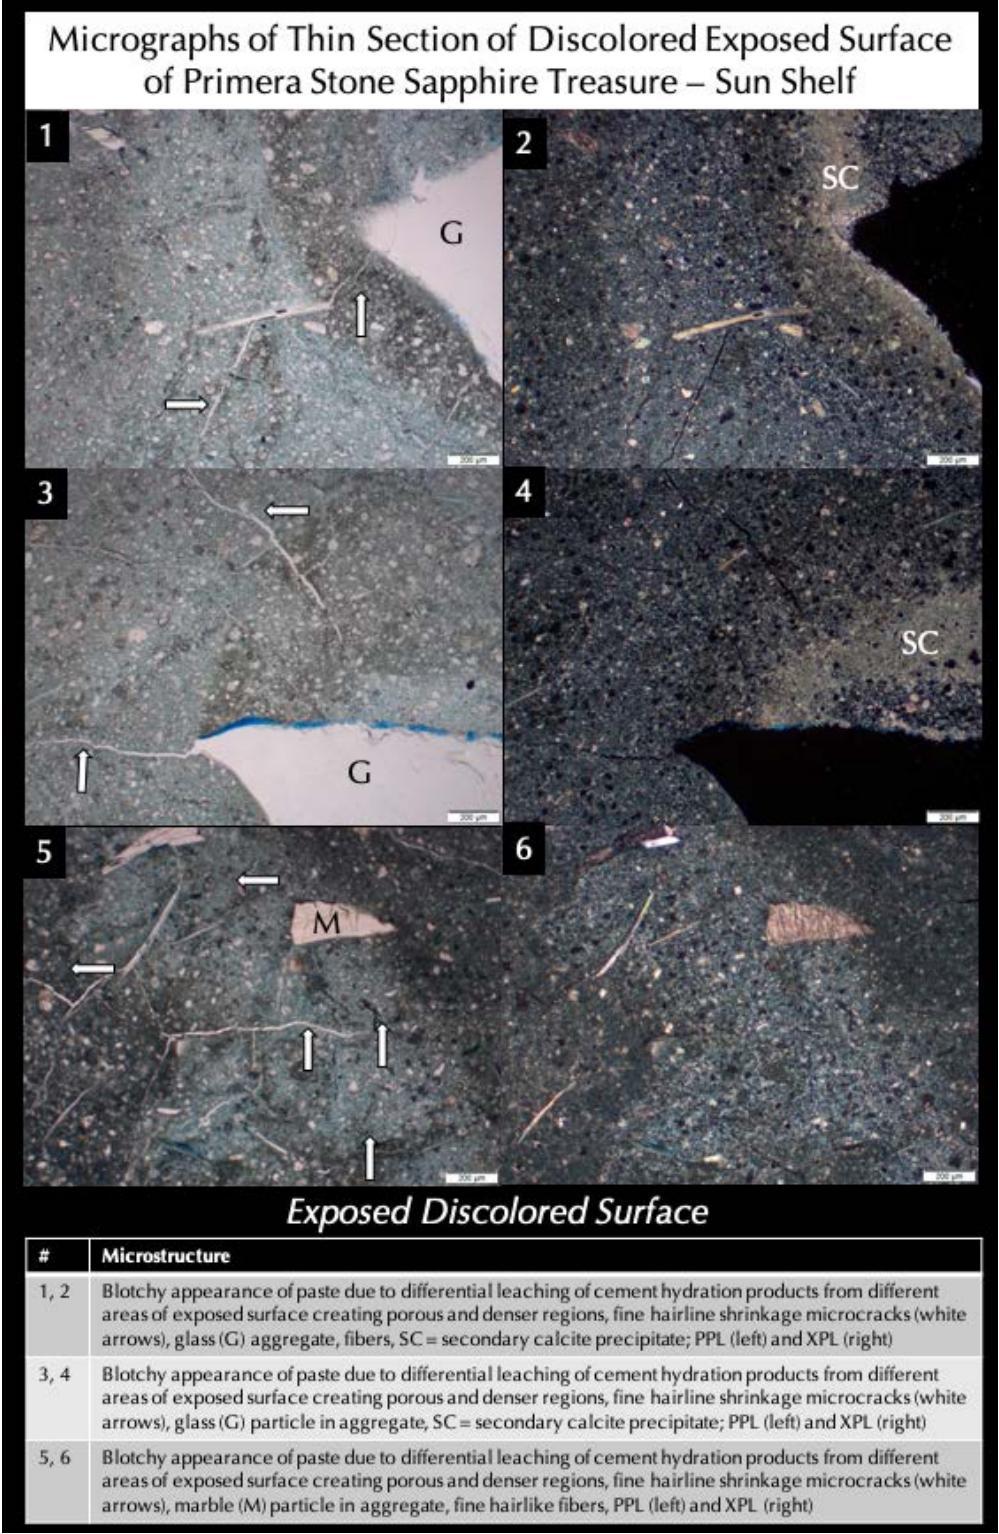
Fig. A 16: Micrographs of thin section of exposed discolored surface of Primera Stone Sapphire Treasure plaster showing: (a) crushed marble (M), alkali-silicate glass (G), and seashell particles in aggregate; (b) dense interstitial paste consisting of white Portland cement; (c) blotchy or patchy discoloration of plaster from darker to lighter shades due to variations in paste porosities; (d) secondary calcite (SC) precipitates from dissolution and re-precipitation of dissolved constituents from plaster by the pool water; and (e) fine, hairline shrinkage microcracks in paste (arrows).

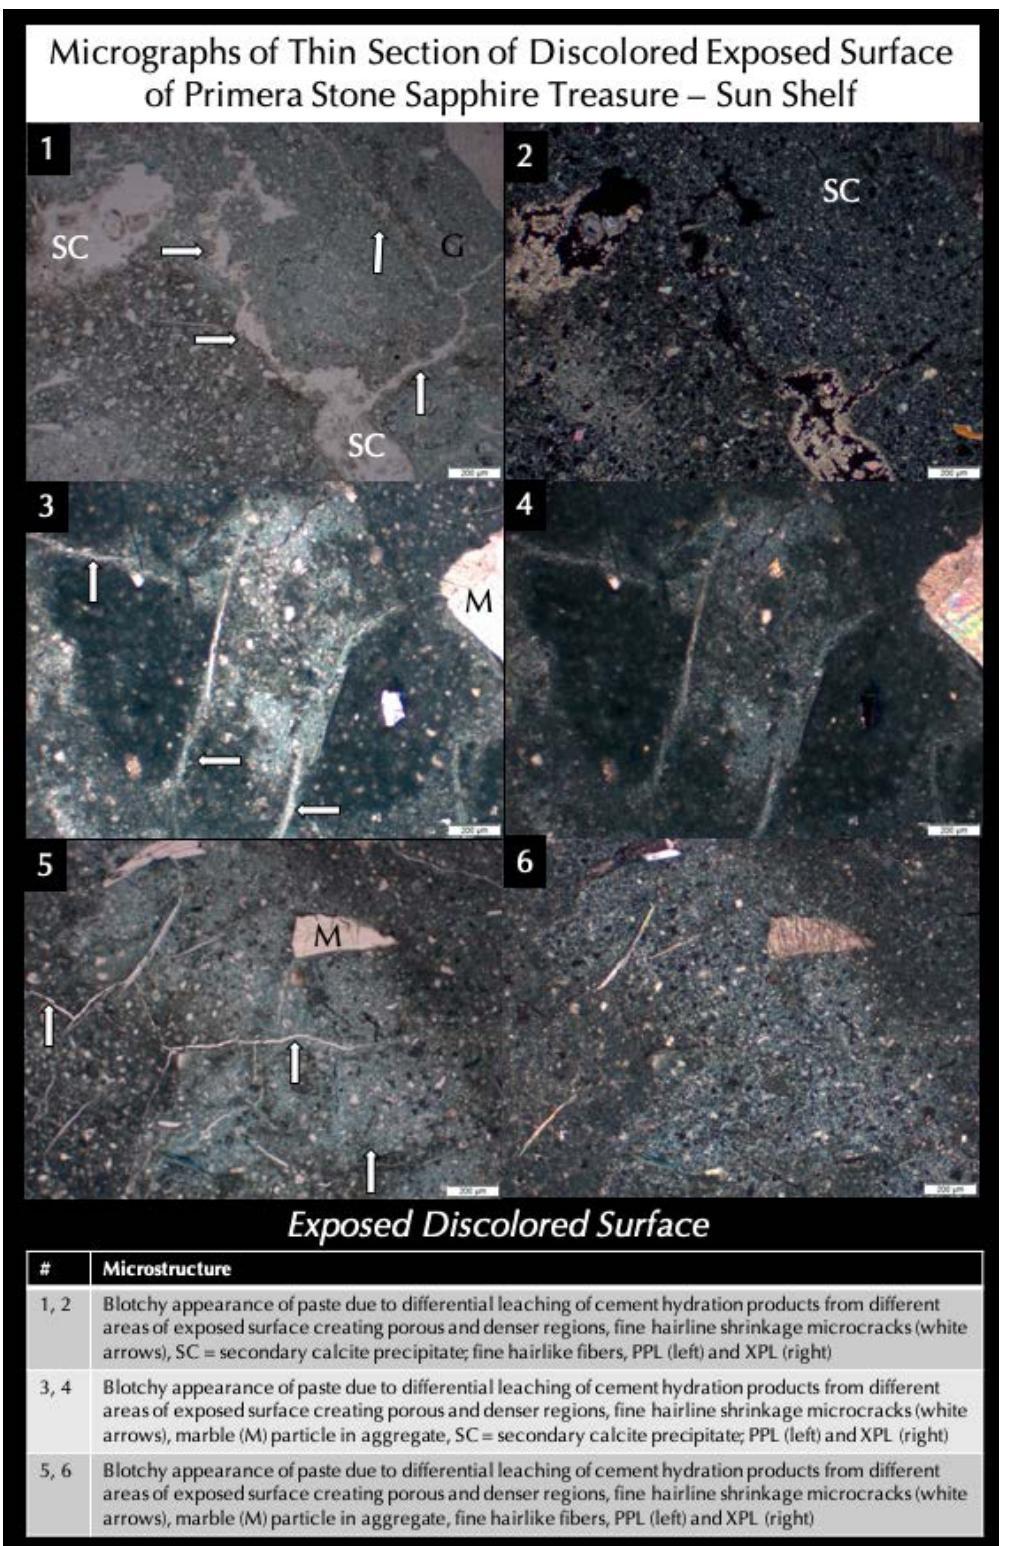
Fig. A 17: Micrographs of thin section of exposed discolored surface of Primera Stone Sapphire Treasure plaster showing: (a) crushed marble (M), and seashell particles in aggregate; (b) dense interstitial paste consisting of white Portland cement; (c) blotchy or patchy discoloration of plaster from darker to lighter shades due to variations in paste porosities; (d) secondary calcite (SC) precipitates from dissolution and re-precipitation of dissolved constituents from plaster by the pool water; and (e) fine, hairline shrinkage microcracks in paste (arrows).

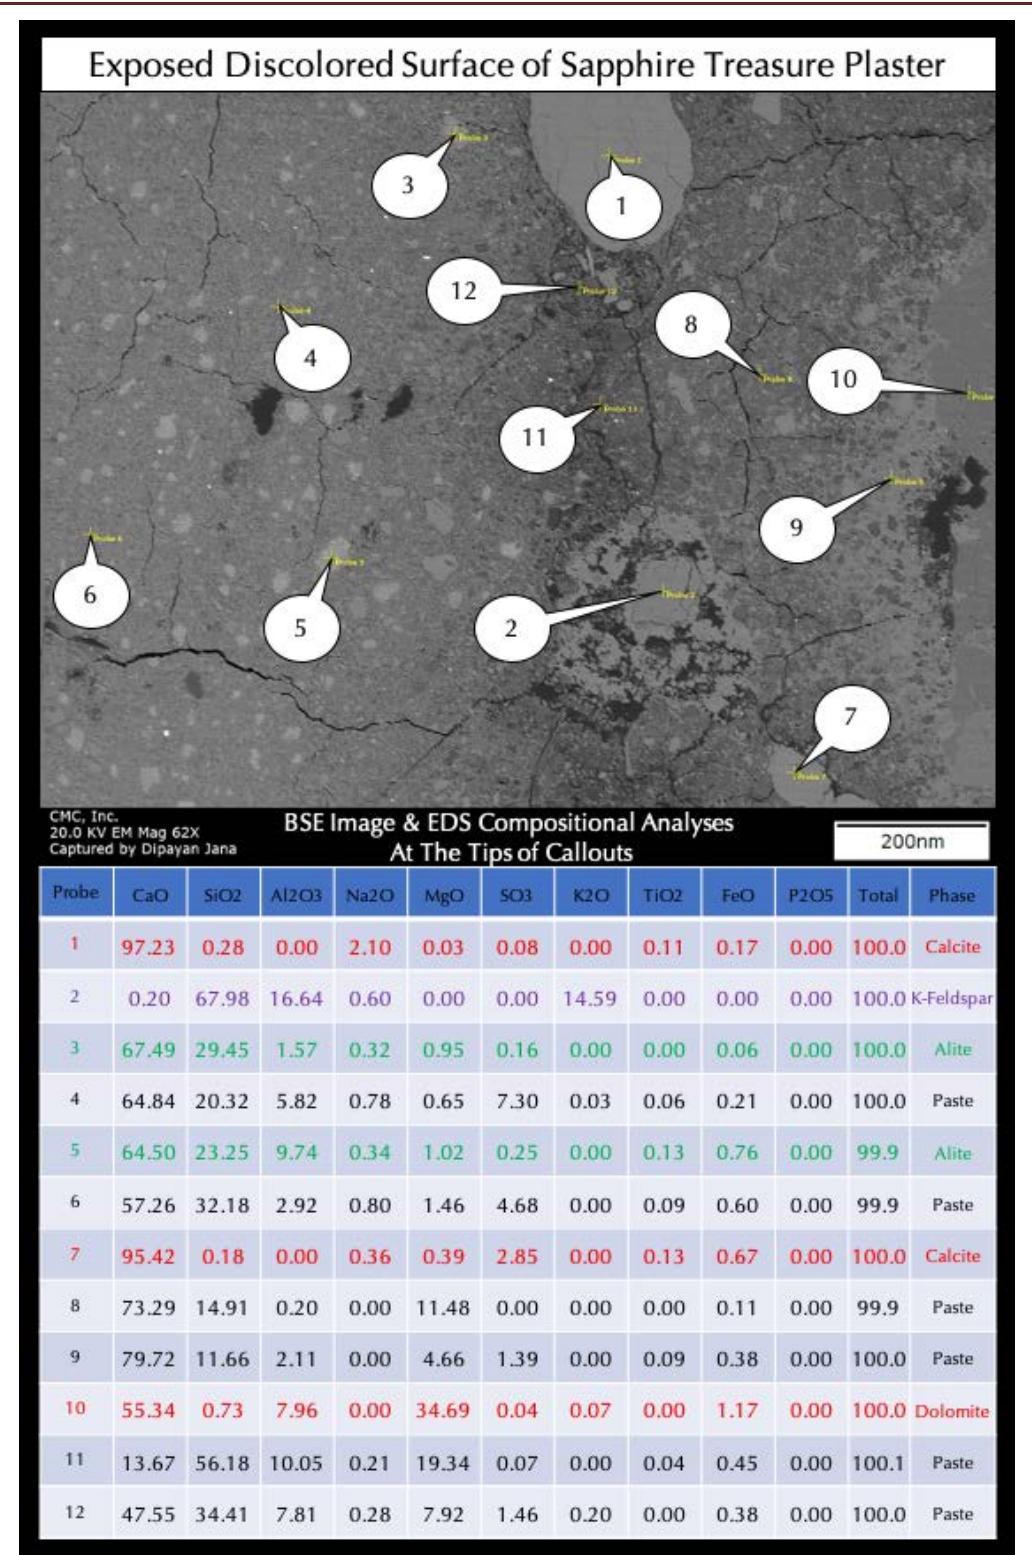
Fig. A 18: Backscatter electron (BSE) image (top) and X-ray microanalyses at the tips of callouts on the exposed discolored surface of Primera Stone Sapphire Treasure plaster showing: (a) calcite and dolomite grains from crushed marble and carbonate deposits (probed at Nos. 1, 7, and 10); (b) residual alite grains from white Portland cement (which appear in lighter shades of small grains Probed at Nos. 3 and 5); and (c) interstitial calcium silicate hydrate and calcium hydroxide components of white Portland cement paste (Probed at Nos. 4, 8, 9, 11, and 12). Each component is showing its characteristic chemical composition. Sulfate contents in the paste in Probe# 4, 6, 8, 9, 11, and 12 are highly variable due to differential leaching and dissolution by the pool water.

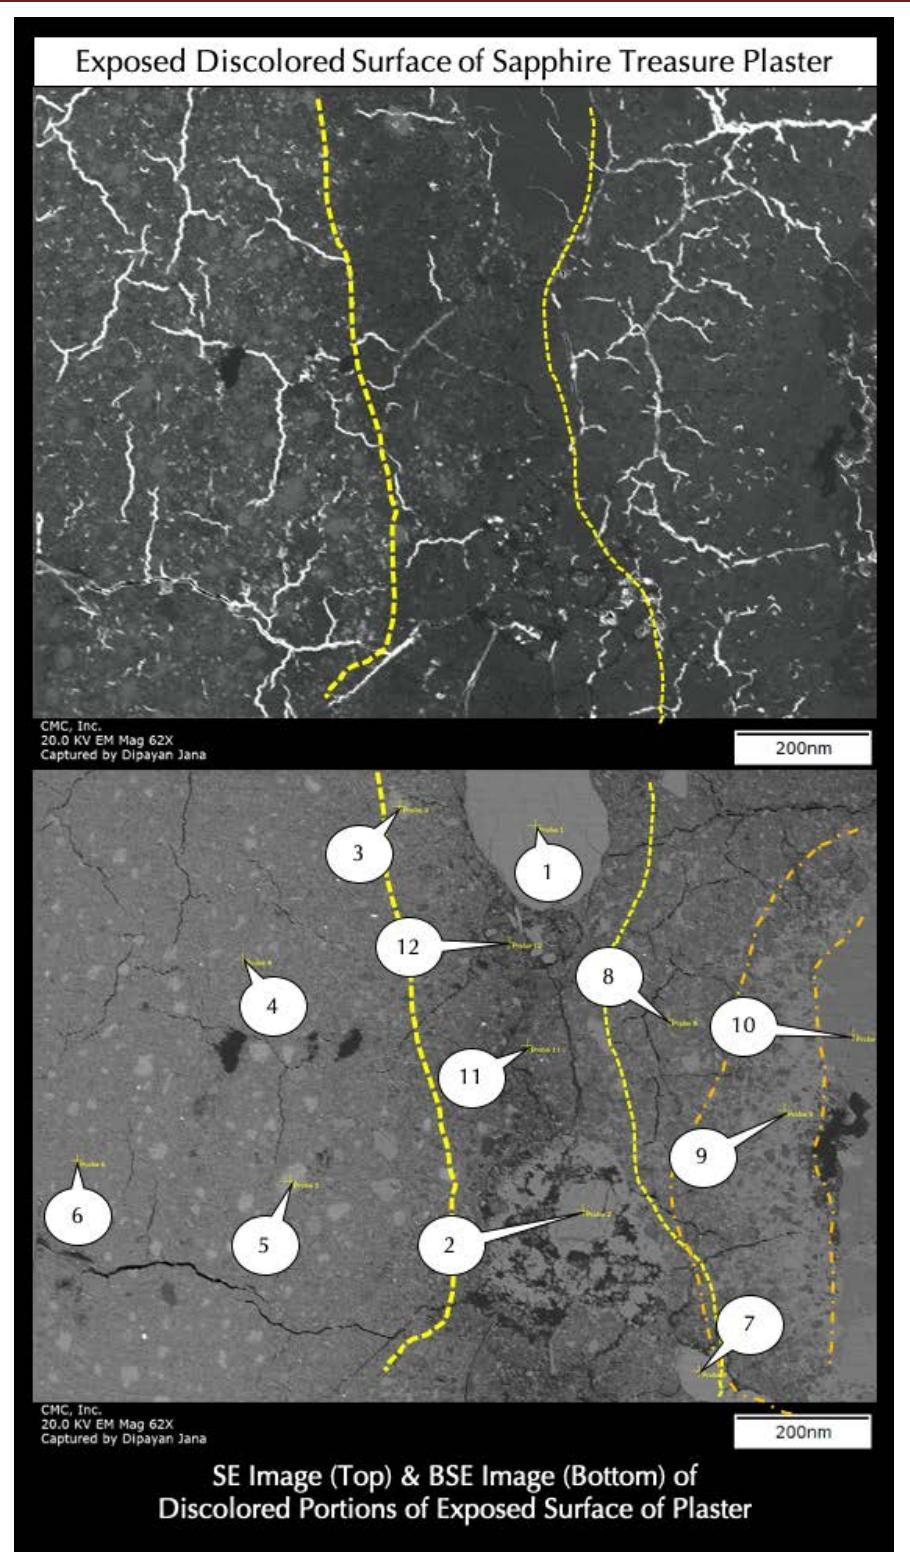
Fig. A 19: Secondary electron (SE) image (top) and corresponding backscatter electron (BSE) image (bottom) of the exposed discolored surface of Primera Stone Sapphire Treasure plaster showing: (a) extensive fine, hairline shrinkage microcracks in the plaster, which are distinct in the SE image at the top; and (b) different shades of lighter and darker gray areas of paste due to leaching and dissolution of cement hydration products and calcium chloride accelerator from the plaster by the pool water that are separated by yellow dashed lines.

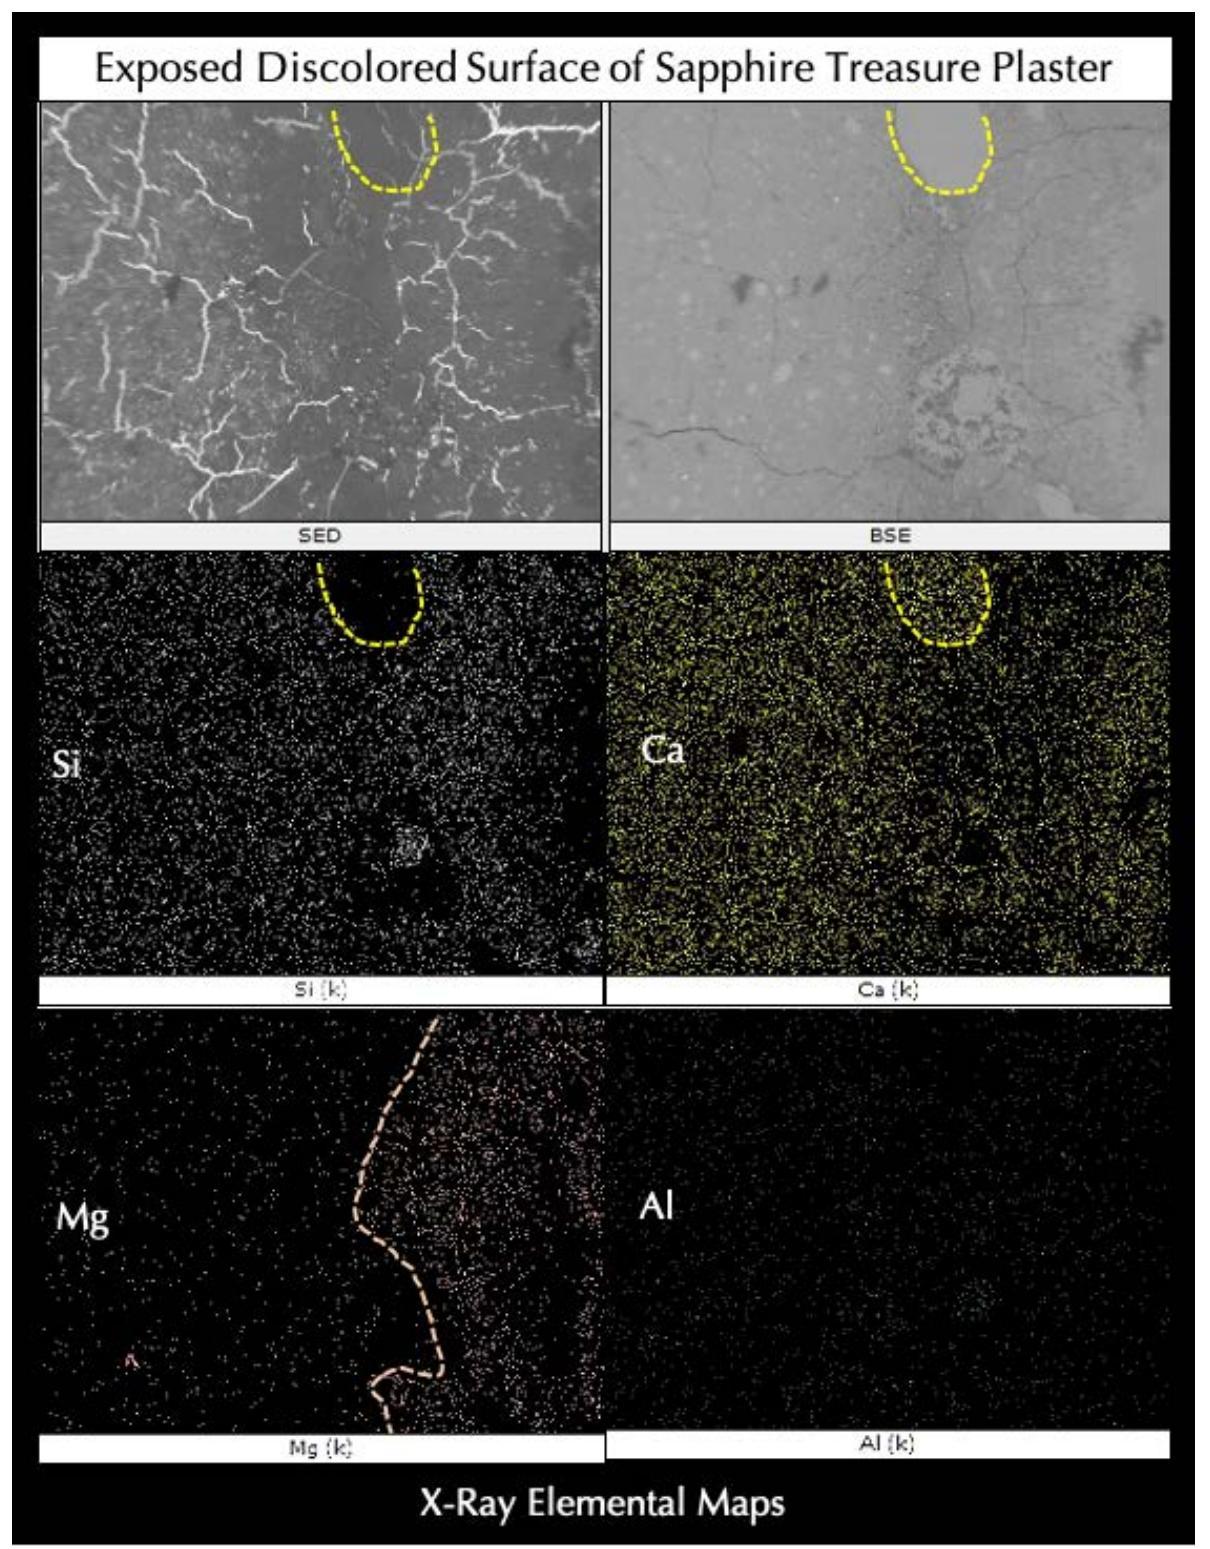
Fig. A 20: X-ray elemental maps of different elements showing compositional variations of the exposed discolored surface of Primera Stone Sapphire Treasure plaster, where paste is showing overall calcium enrichment from white Portland cement paste, with patches enriched in magnesium as shown in the Mg map indicating a potential source of magnesium besides the Portland cement, which could come from the reported addition of the pigment dyes.

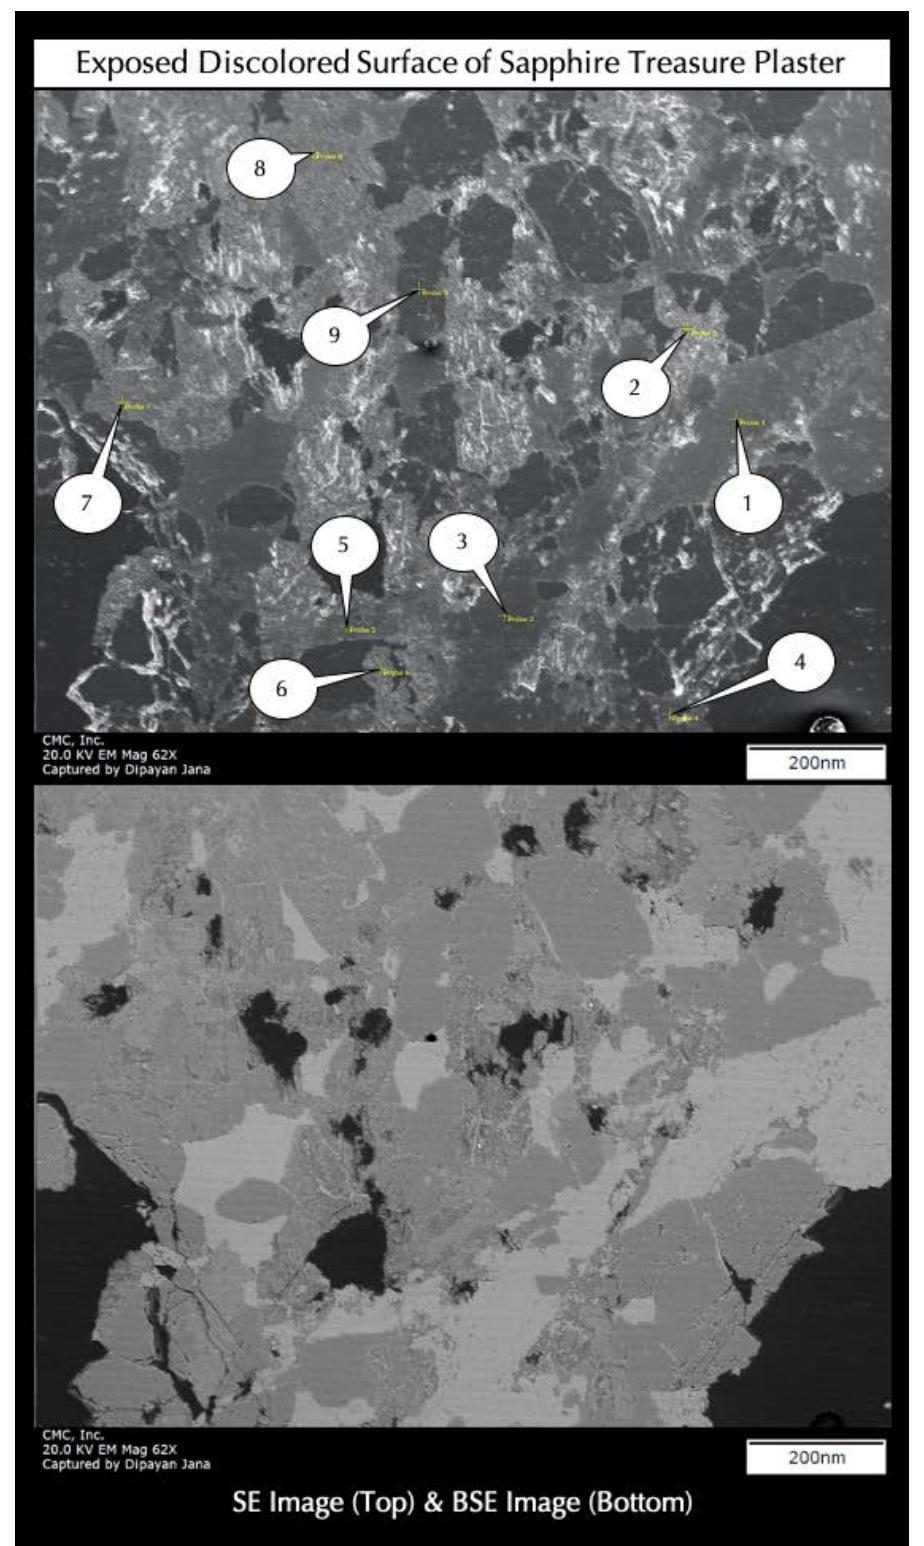
Fig. A 21: Secondary electron (SE) image (top) and corresponding backscatter electron (BSE) image (bottom) of the exposed discolored surface of Primera Stone Sapphire Treasure plaster showing different shades of lighter and darker gray areas of paste due to leaching and dissolution of cement hydration products and calcium chloride accelerator from the plaster by the pool water that are distinct in both images. In the BSE image, variations in different shades of gray indicates a variation in chemical compositions and/or porosities of paste.

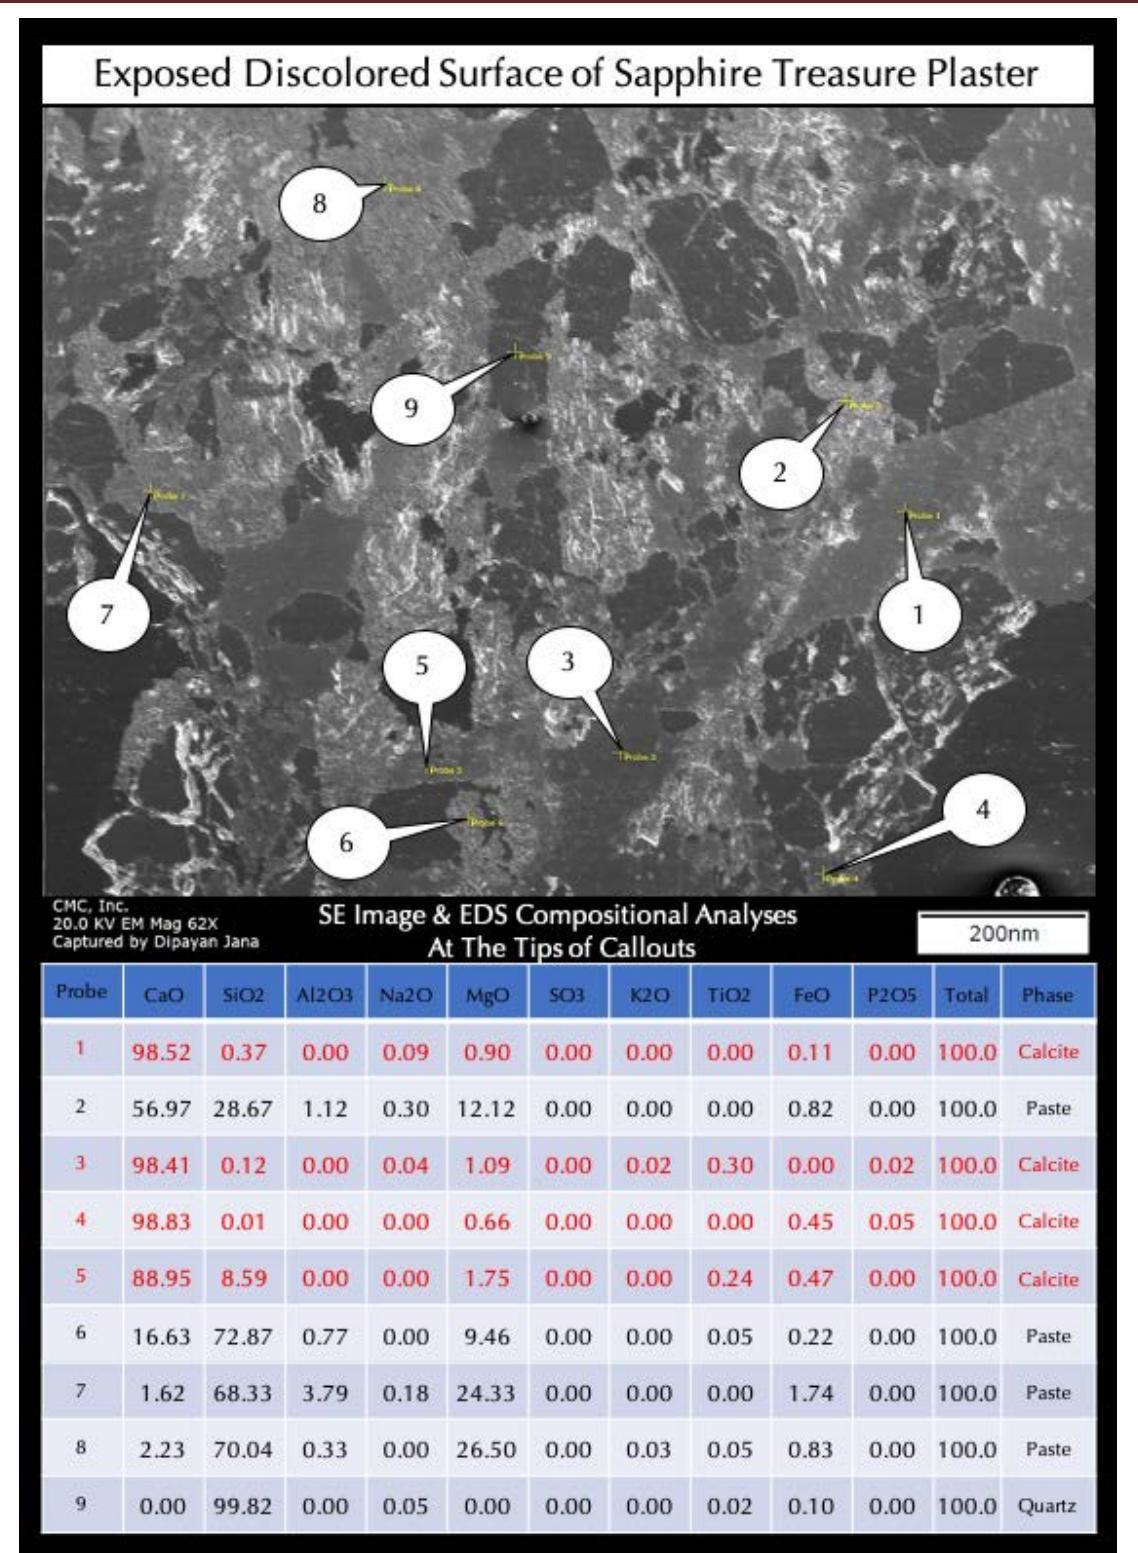
Fig. A 22: Secondary electron (SE) image (top) and X-ray microanalyses at the tips of callouts on the exposed discolored surface of Primera Stone Sapphire Treasure plaster showing: (a) calcite grains from crushed marble and carbonate deposits (probed at Nos. 1, 3, 4, and 5); (b) a quartz sand particle Probed at No. 9; and (c) interstitial calcium silicate hydrate and calcium hydroxide components of white Portland cement paste (Probed at Nos. 2, 6, 7, and 8). Each component is showing its characteristic chemical composition. Sulfate contents in the paste in Probe# 2, and 6 to 8 are negligible to none due to leaching and dissolution by the pool water.

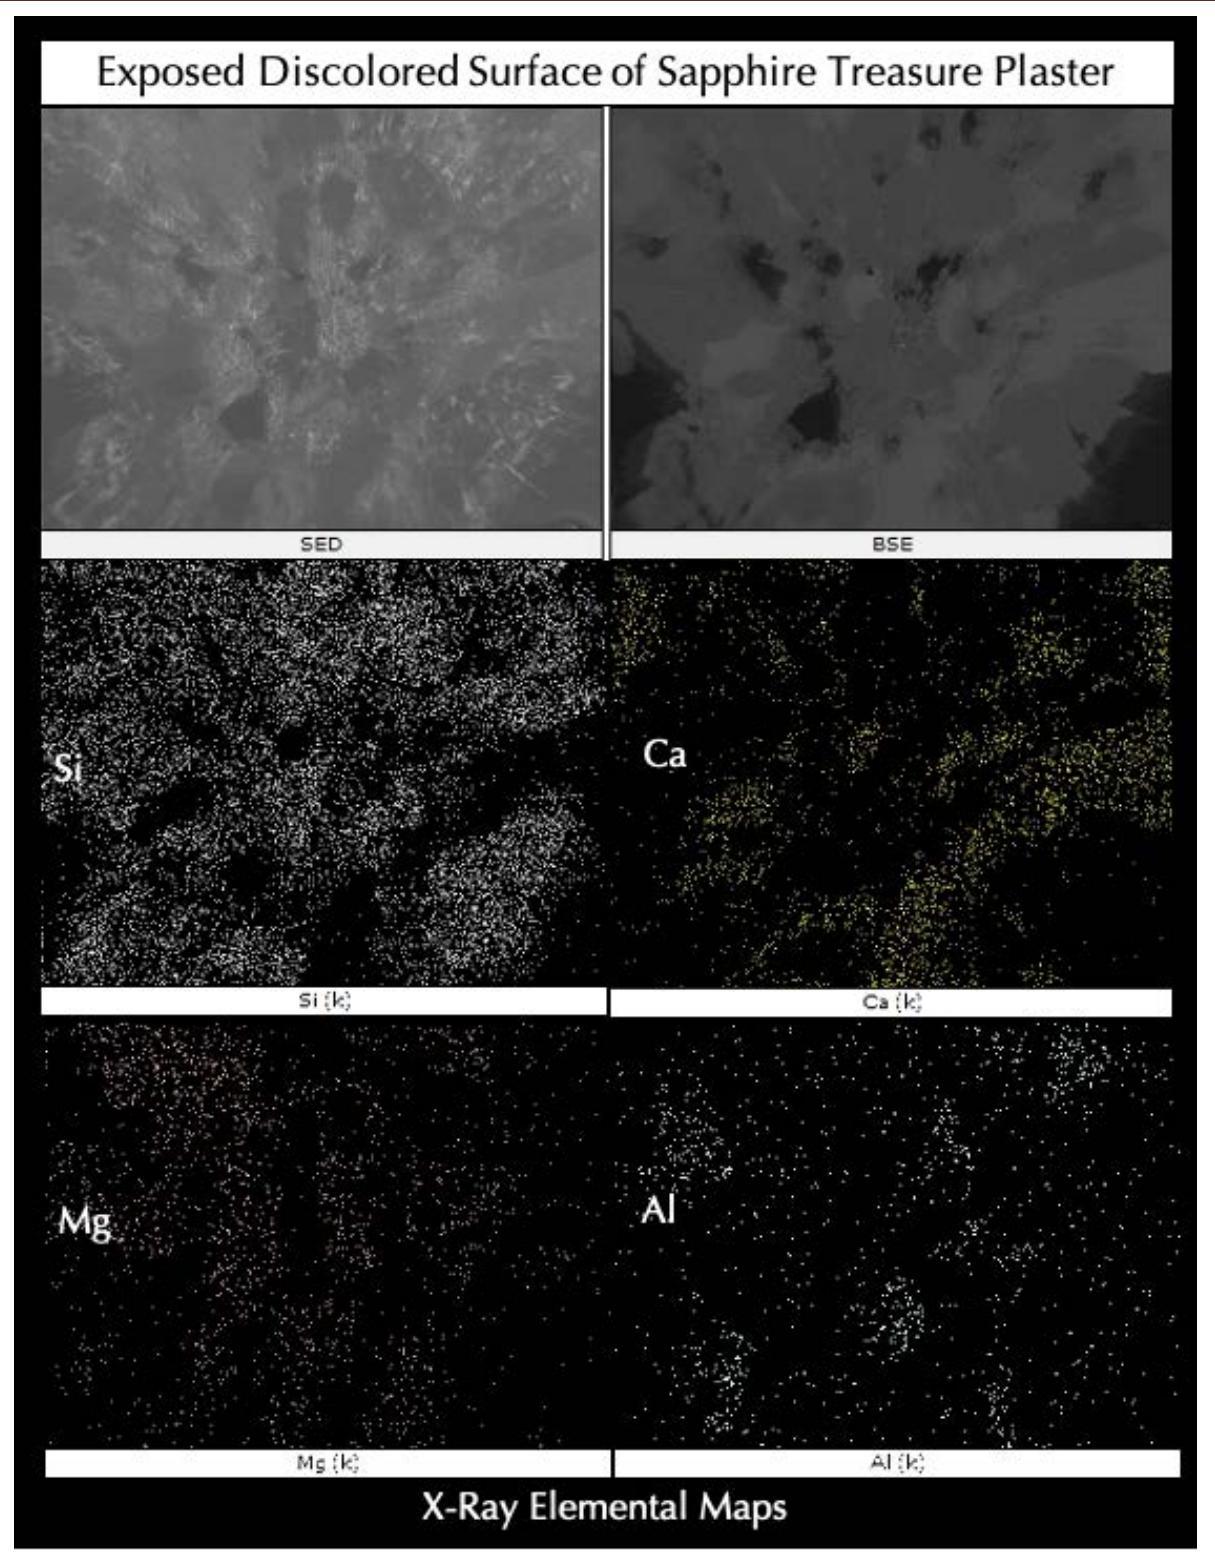
Fig. A 23: X-ray elemental maps of different elements showing compositional variations of the exposed discolored surface of Primera Stone Sapphire Treasure plaster, where paste is showing patchy areas of calcium enrichment in Ca-map from differential dissolution of white Portland cement paste, with patches enriched in magnesium in the Mg map indicating a potential source of magnesium besides the Portland cement, which could come from the reported addition of the pigment dyes. Overall silica enrichment is from calcium silicate hydrate component of paste where silicon was left behind whereas calcium was leached out at various patches.

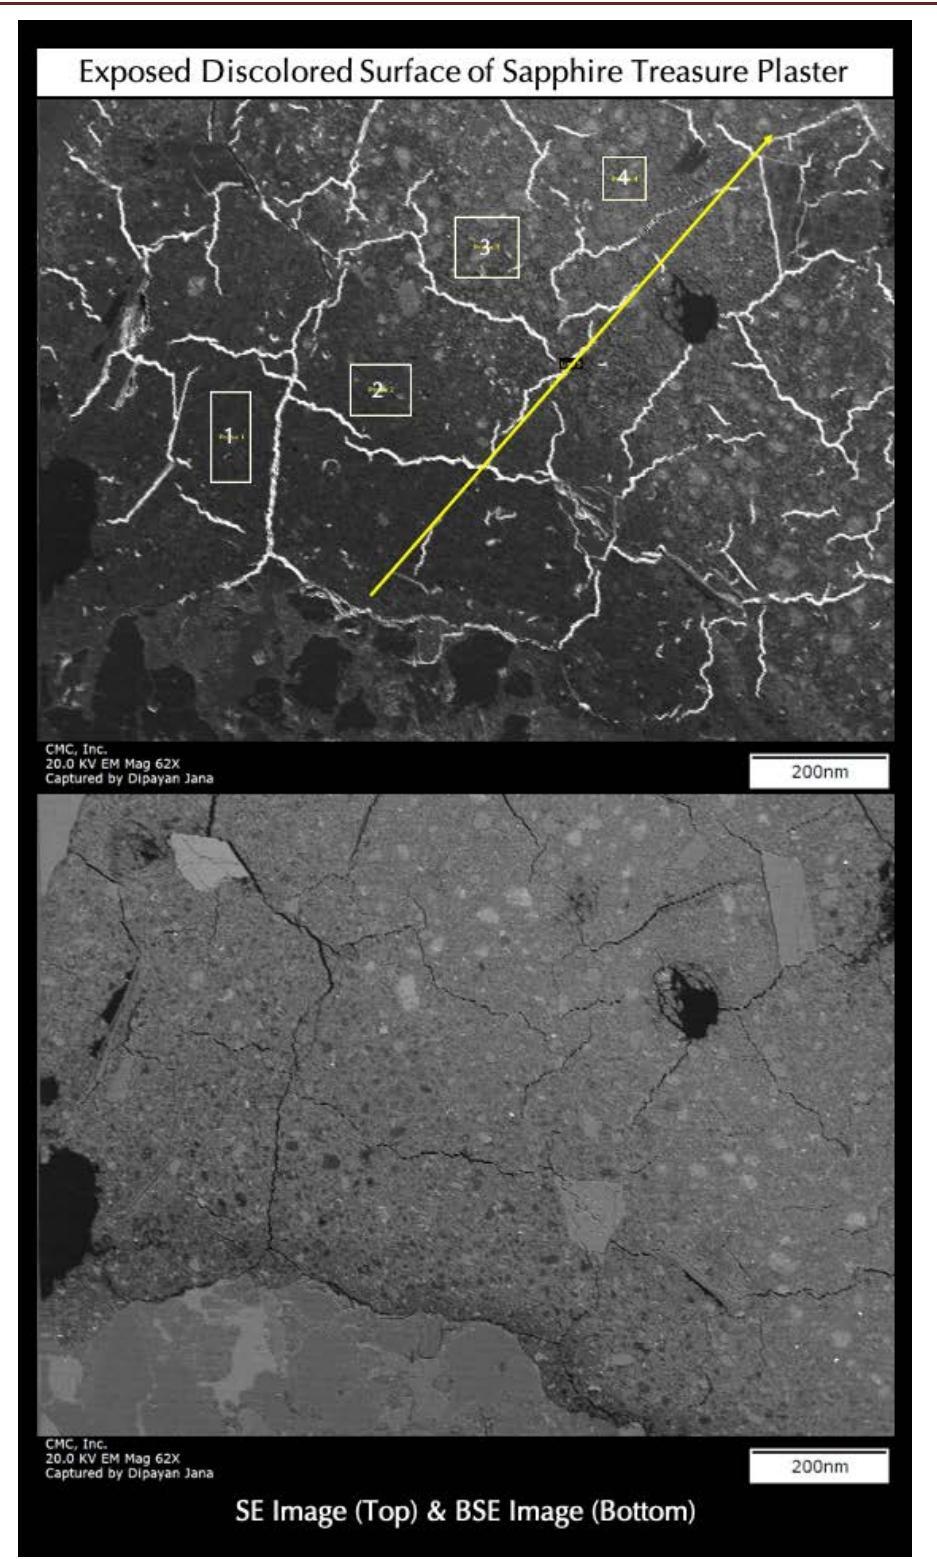
Fig. A 24: Secondary electron (SE) image (top) and corresponding backscatter electron (BSE) image (bottom) of the exposed discolored surface of Primera Stone Sapphire Treasure plaster showing different shades of lighter and darker gray areas of paste due to leaching and dissolution of cement hydration products and calcium chloride accelerator from the plaster by the pool water that are distinct in both images. Also shown are fine hairline shrinkage microcracks in paste which are more distinct in the SE image. Notice a marble aggregate at the bottom and a darker gray paste immediately around the aggregate.
