### Swimming Pool Plaster Discoloration – A Case Study From Field & Laboratory-Cured Plasters

Primera Stone Sapphire Treasure & Blue Ocean

CONSTRUCTION MATERIALS CONSULTANTS, INC.

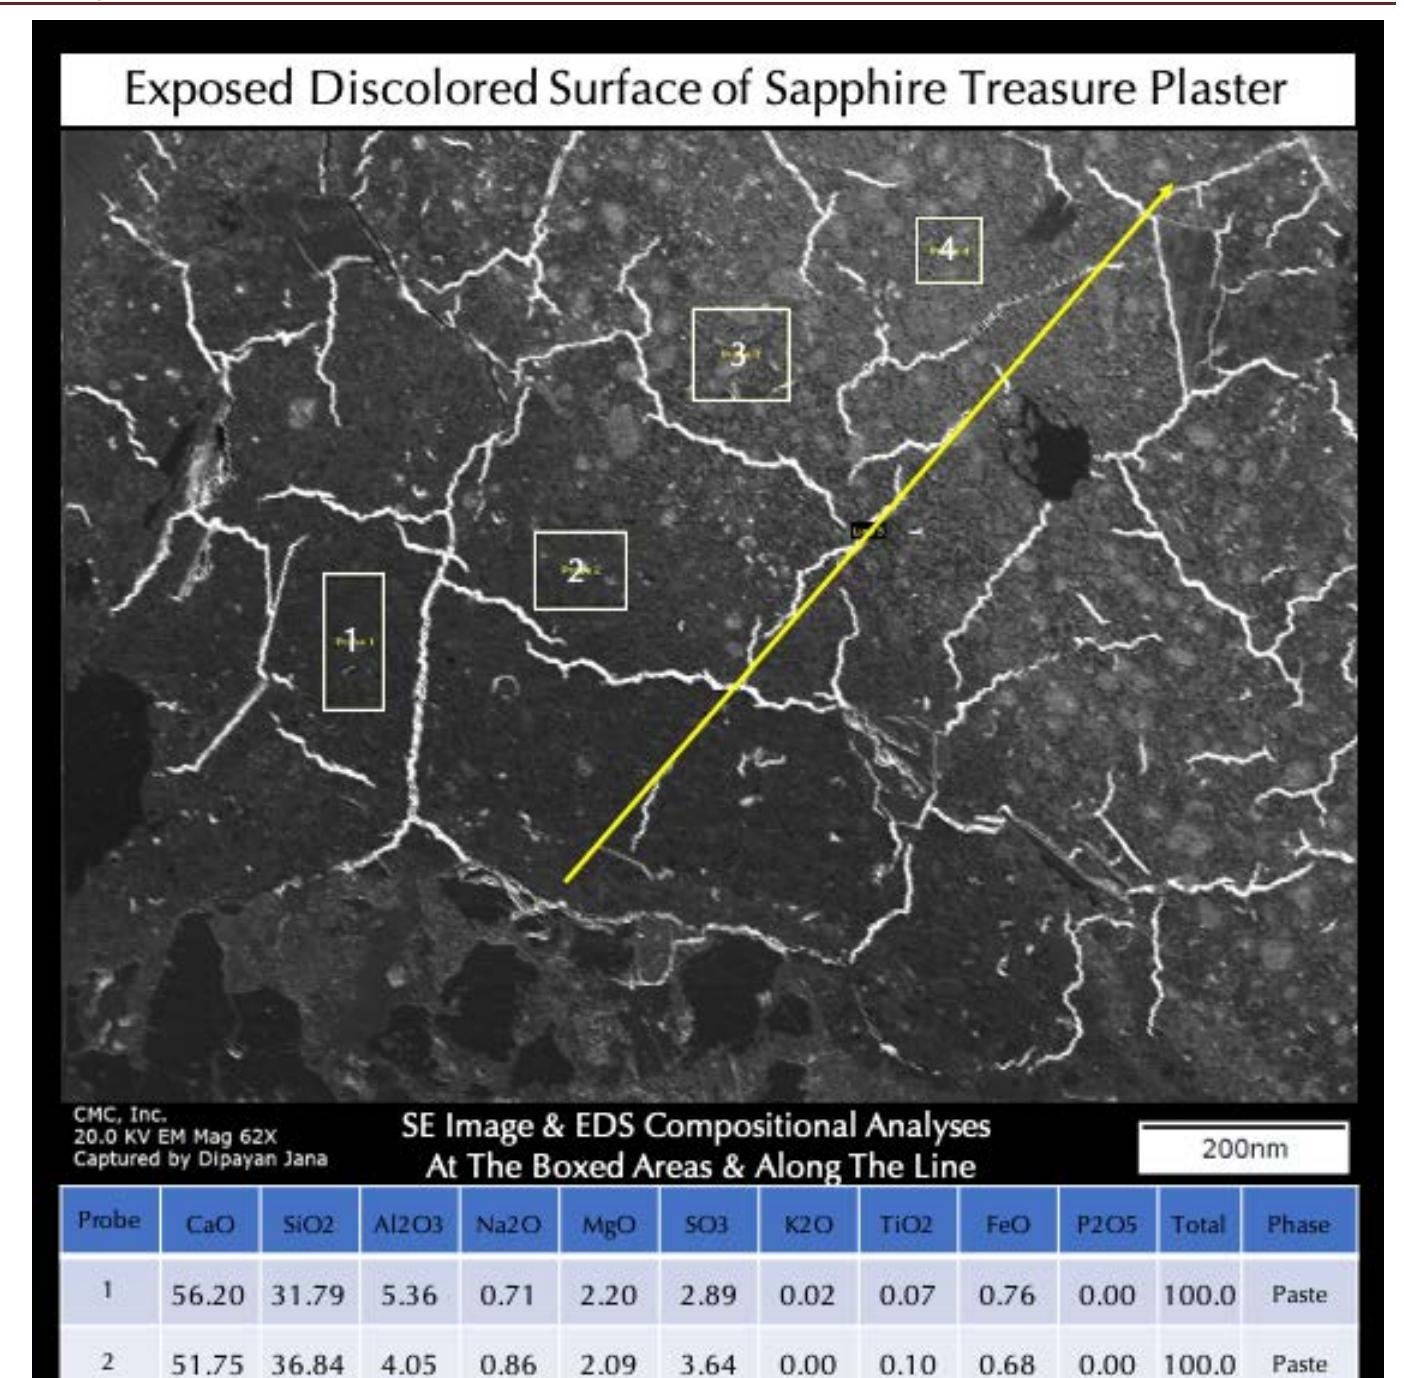
Fig. A 25: Secondary electron (SE) image (top) and X-ray microanalyses at the boxed areas on the exposed discolored
surface of Primera Stone Sapphire Treasure plaster showing the typical characteristic calcium silicate hydrate and
calcium hydroxide components of white Portland cement paste. The next Figure shows a line scan along the arrow
to show chemical variations from darker to lighter gray area of paste.

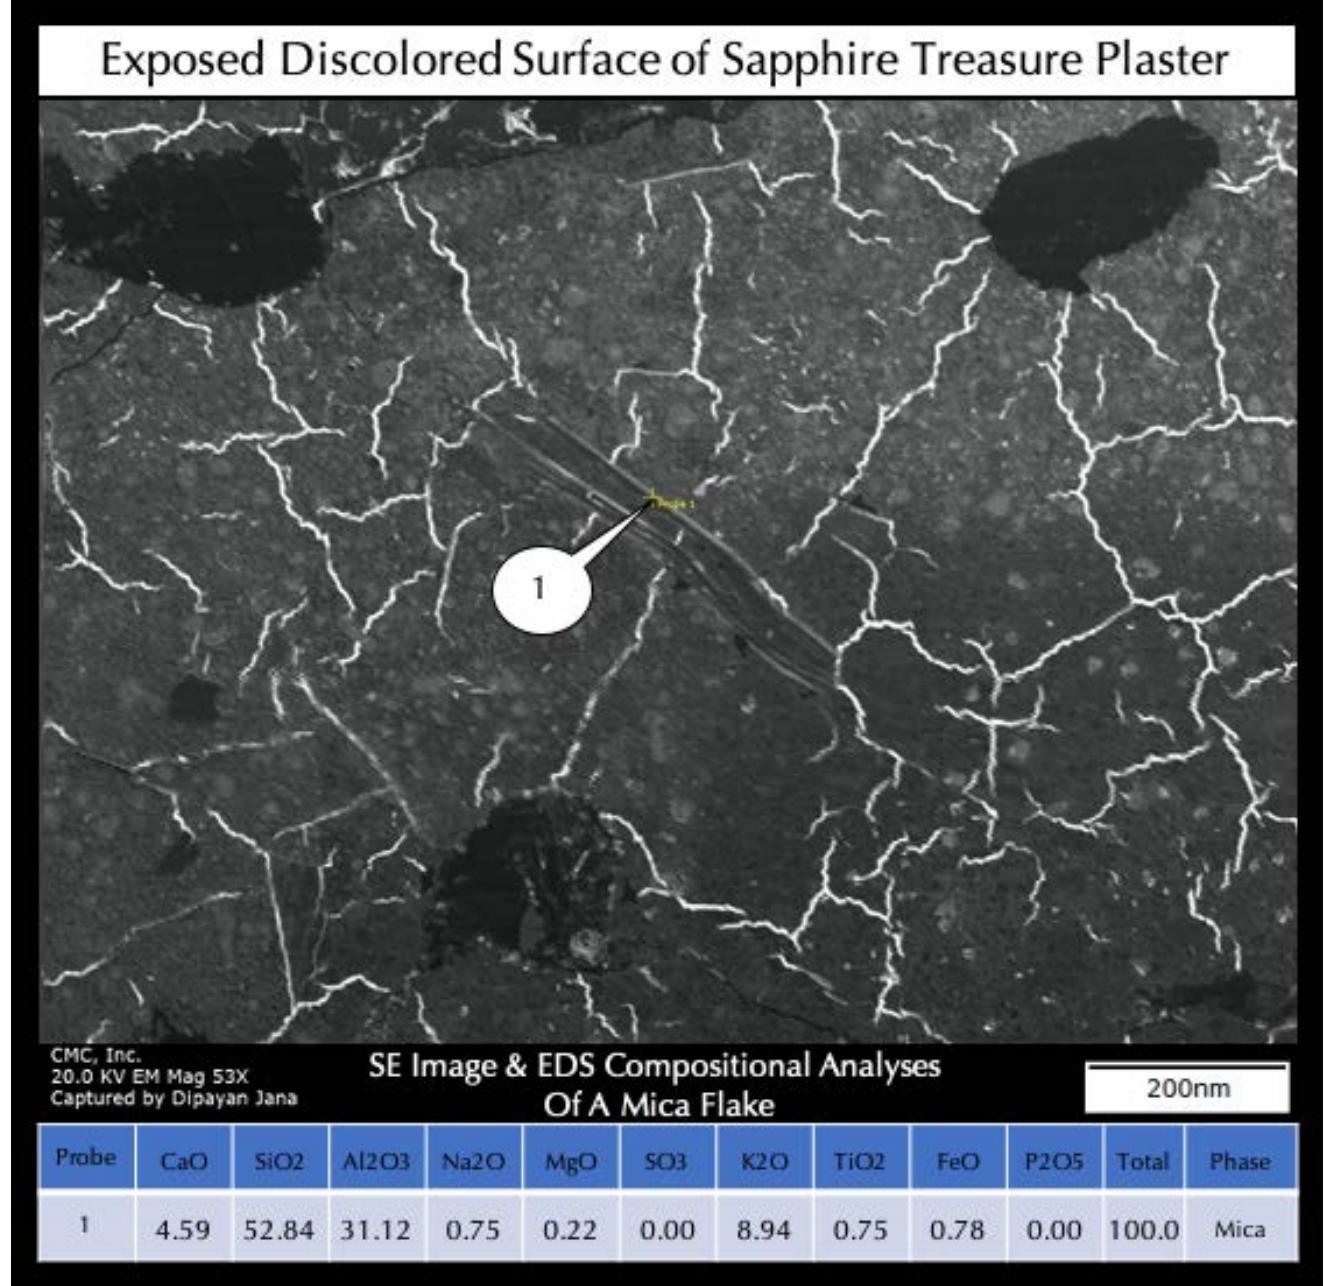
Fig. A 30: Secondary electron image of the exposed discolored surface of Primera Stone Sapphire Treasure plaster where paste is showing a network of numerous fine, hairline shrinkage microcracks. Also shown at the center is a fiber, which is analyzed by EDS to determine the potassium aluminum silicate composition indicating a possible mica flake in the paste.

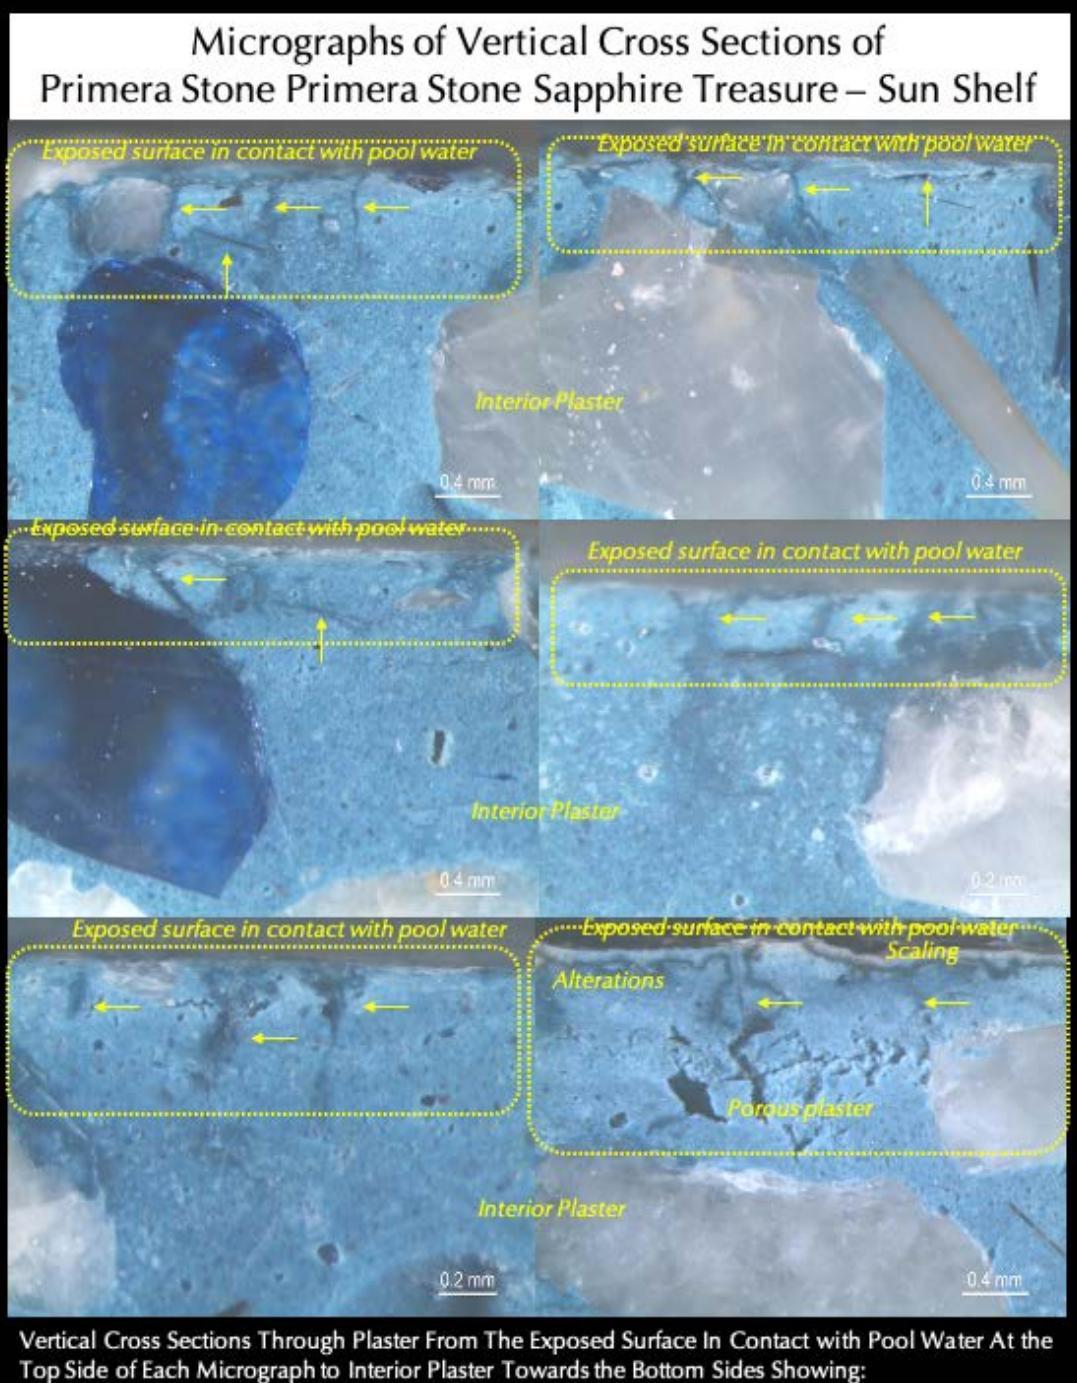
- 1. Chemical Alterations and associated discoloration of paste
- 2. Thin Scale on Exposed Surface
- 3. Dissolution and Increased Porosity of Plaster Immediately Beneath the Exposed Surface
- 4. Vertical and Horizontal Near-Surface Shallow depth Fine Shrinkage Microcracking

Fig. A 31: Micrographs of vertical cross section of Primera Stone Sapphire Treasure pool plaster where the top edge in each photo was in contact with the pool water showing evidence of leaching and dissolution of paste with increased paste porosity due to dissolution within the boxed areas at the surface regions in all photos. Arrows show vertical, shallow-depth shrinkage microcracks. Fading of darker interior to lighter blue colors of plaster at the surface region is seen from the interior to the boxed areas at the surface. The micrographs were taken with a stereomicroscope.

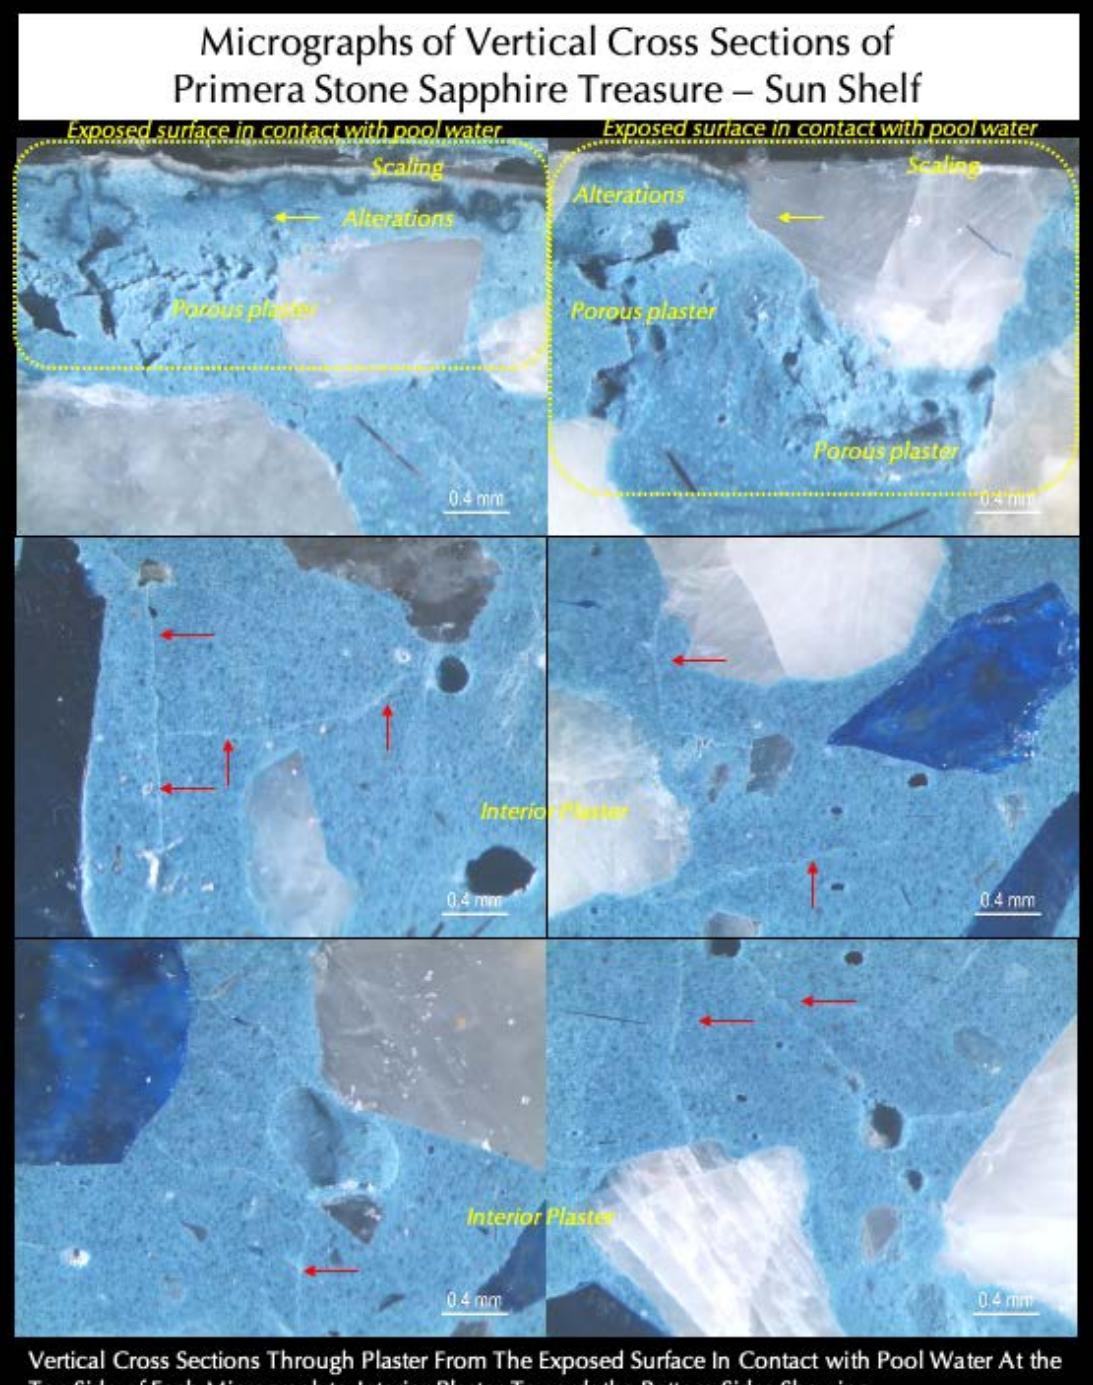
- Top Side of Each Micrograph to Interior Plaster Towards the Bottom Sides Showing: 1. Chemical Alterations and associated discoloration of paste
- 2. Thin Scale on Exposed Surface
- 3. Dissolution and Increased Porosity of Plaster Immediately Beneath the Exposed Surface
- 4. Vertical and Horizontal Near-Surface Shallow depth Fine Shrinkage Microcracking

Fig. A 32: Micrographs of vertical cross section of Primera Stone Sapphire Treasure pool plaster where the top edges in the top row photos were in contact with the pool water showing evidence of leaching and dissolution of paste with increased paste porosity due to dissolution within the boxed areas at the surface regions. Yellow arrows in the top row show vertical, shallow-depth shrinkage microcracks. Red arrows in the middle and bottom row photos of interior plaster mark fine hairline shrinkage microcracks in paste. The micrographs were taken with a stereomicroscope.

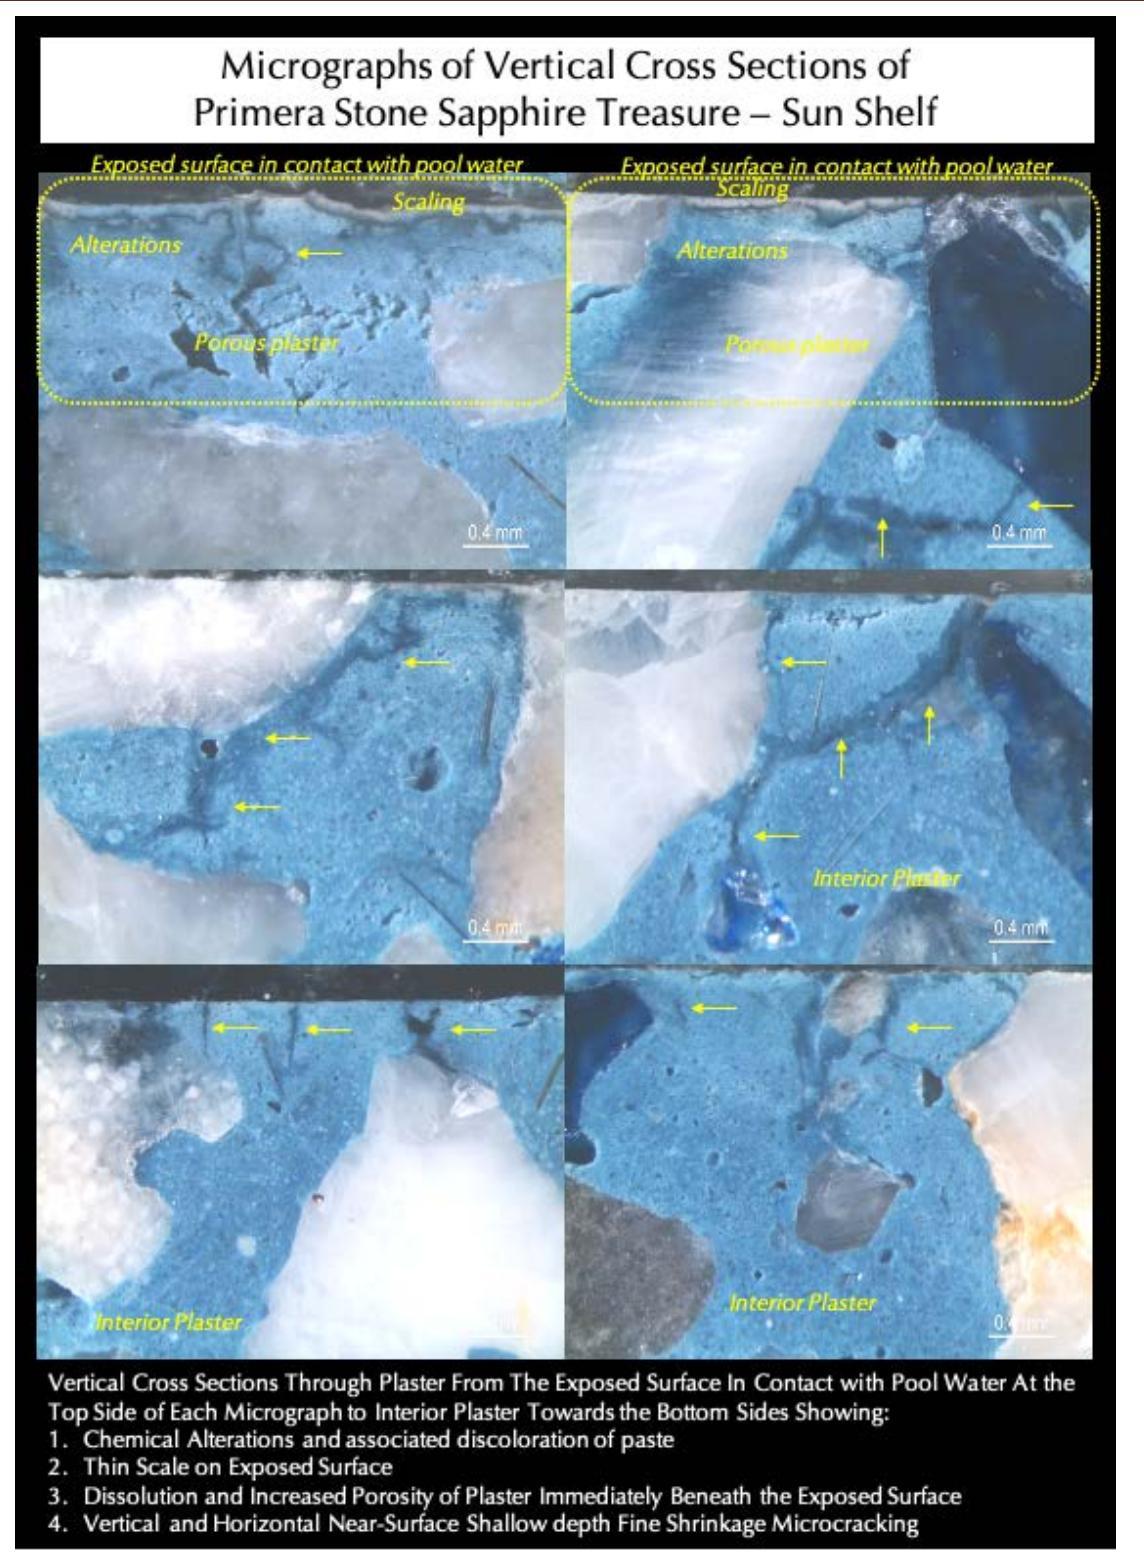
Fig. A 33: Micrographs of vertical cross section of Primera Stone Sapphire Treasure pool plaster where the top edges in the top row photos were in contact with the pool water showing evidence of leaching and dissolution of paste with increased paste porosity due to dissolution within the boxed areas at the surface regions. Yellow arrows show vertical, shallow-depth shrinkage microcracks. The micrographs were taken with a stereo-microscope.

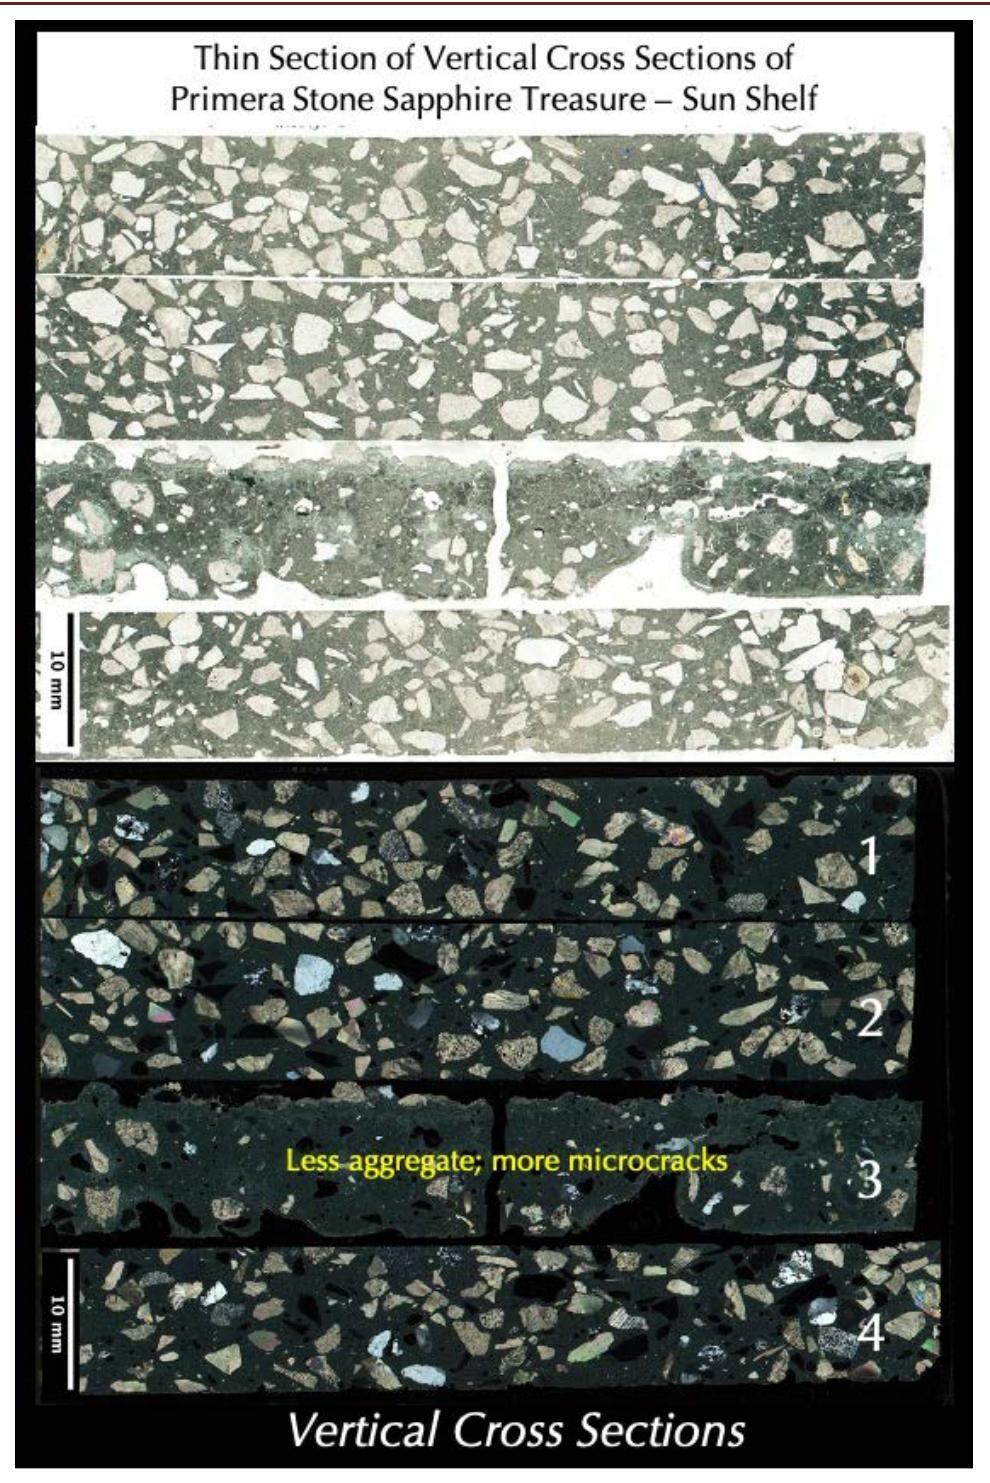
Fig. A 34: Blue dye-mixed epoxy-impregnated thin section (30 micron thickness) of vertical cross sections of Primera Stone Sapphire Treasure pool plaster from the Sun Shelf area. The thin section was scanned on a flatbed film scanner with a polarizing filter to create plane polarized light (PPL) view at the top image, and then sandwiched between two polarizing filters at perpendicular positions to create crossed polarized light (XPL) view at the bottom. The PPL image shows difference in porosities of paste from variations in the degree of absorption of blue epoxy used for preparation of thin section where porous areas absorbed more blue dye to appear brighter blue whereas denser areas absorb less blue epoxy to appear darker. The XPL image shows the different aggregate types used, which showed major amounts of crushed marble and seashell carbonate particles and minor amounts of siliceous (quartz sand) components.

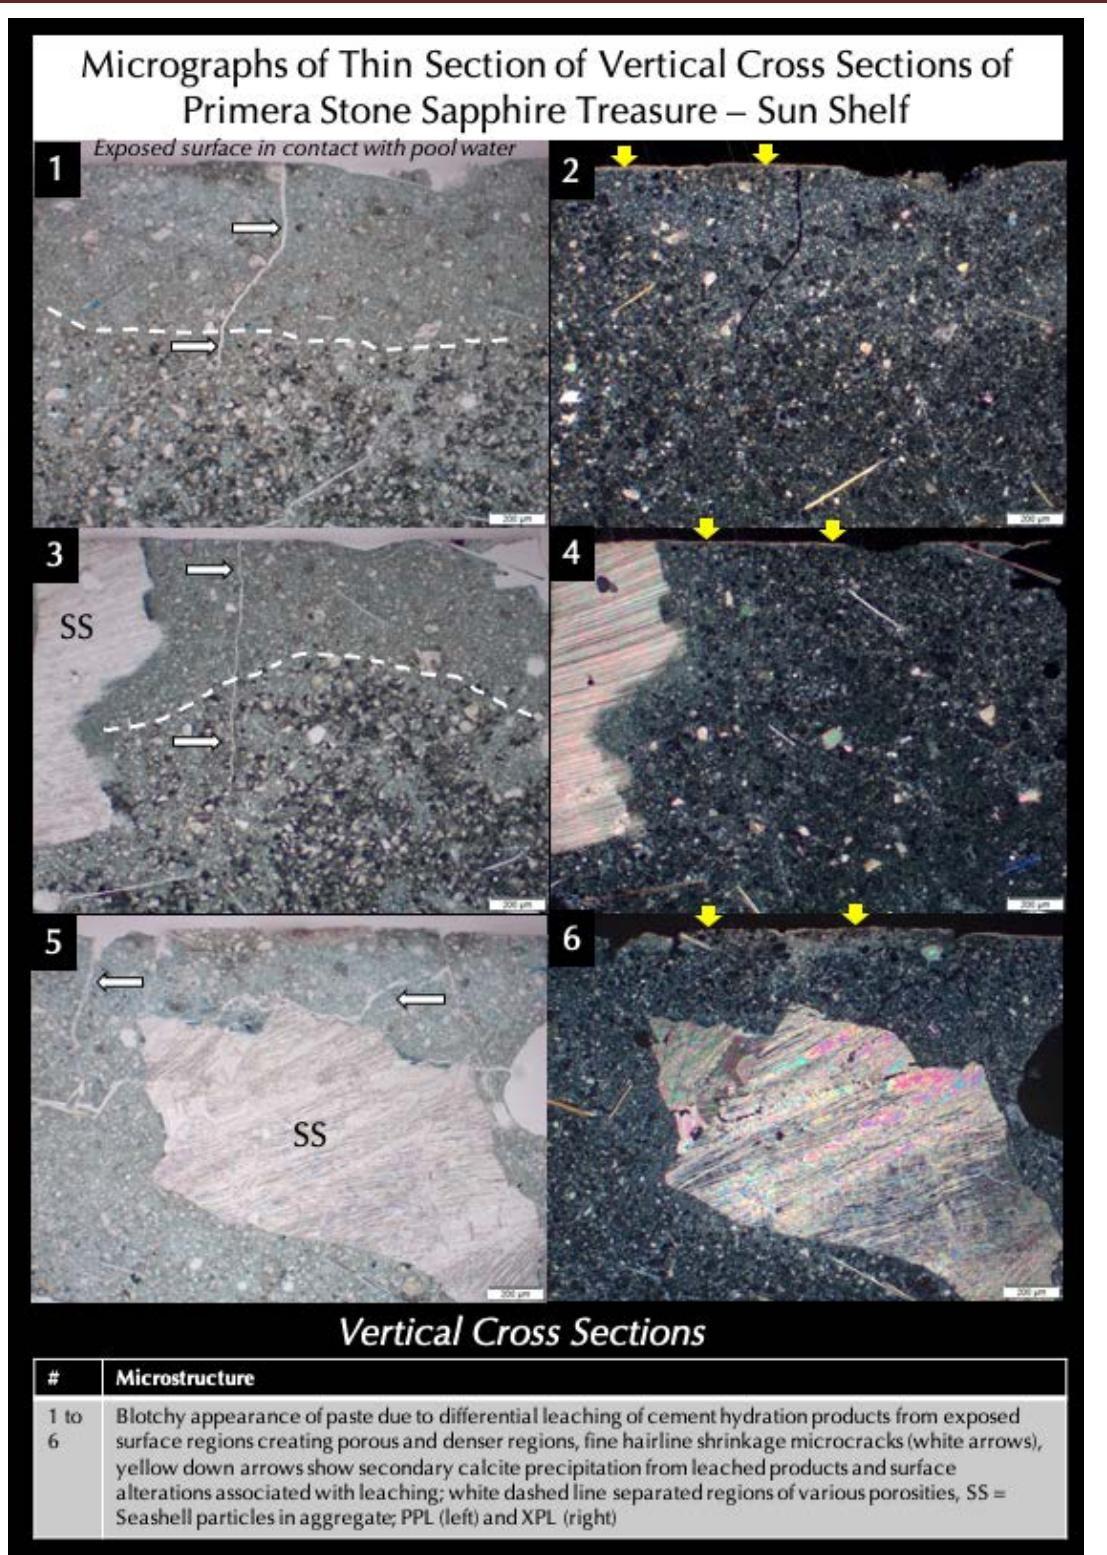
Fig. A 35: Micrographs of thin section of vertical cross section of Primera Stone Sapphire Treasure plaster showing: (a) crushed seashell (SS) particles in aggregate; (b) dense interstitial paste consisting of white Portland cement; (c) blotchy or patchy discoloration of plaster from lighter (more porous) shade at the surface region and darker (denser) shade in the interior separated by white dashed lines; and (d) fine, hairline shrinkage microcracks in paste (arrows). The top and middle left photos show increased paste porosity above the dashed lines due to dissolution of cement hydration products by the pool water. Down arrows in the right column show thin films of secondary calcium carbonate precipitation on the exposed surface of plaster.

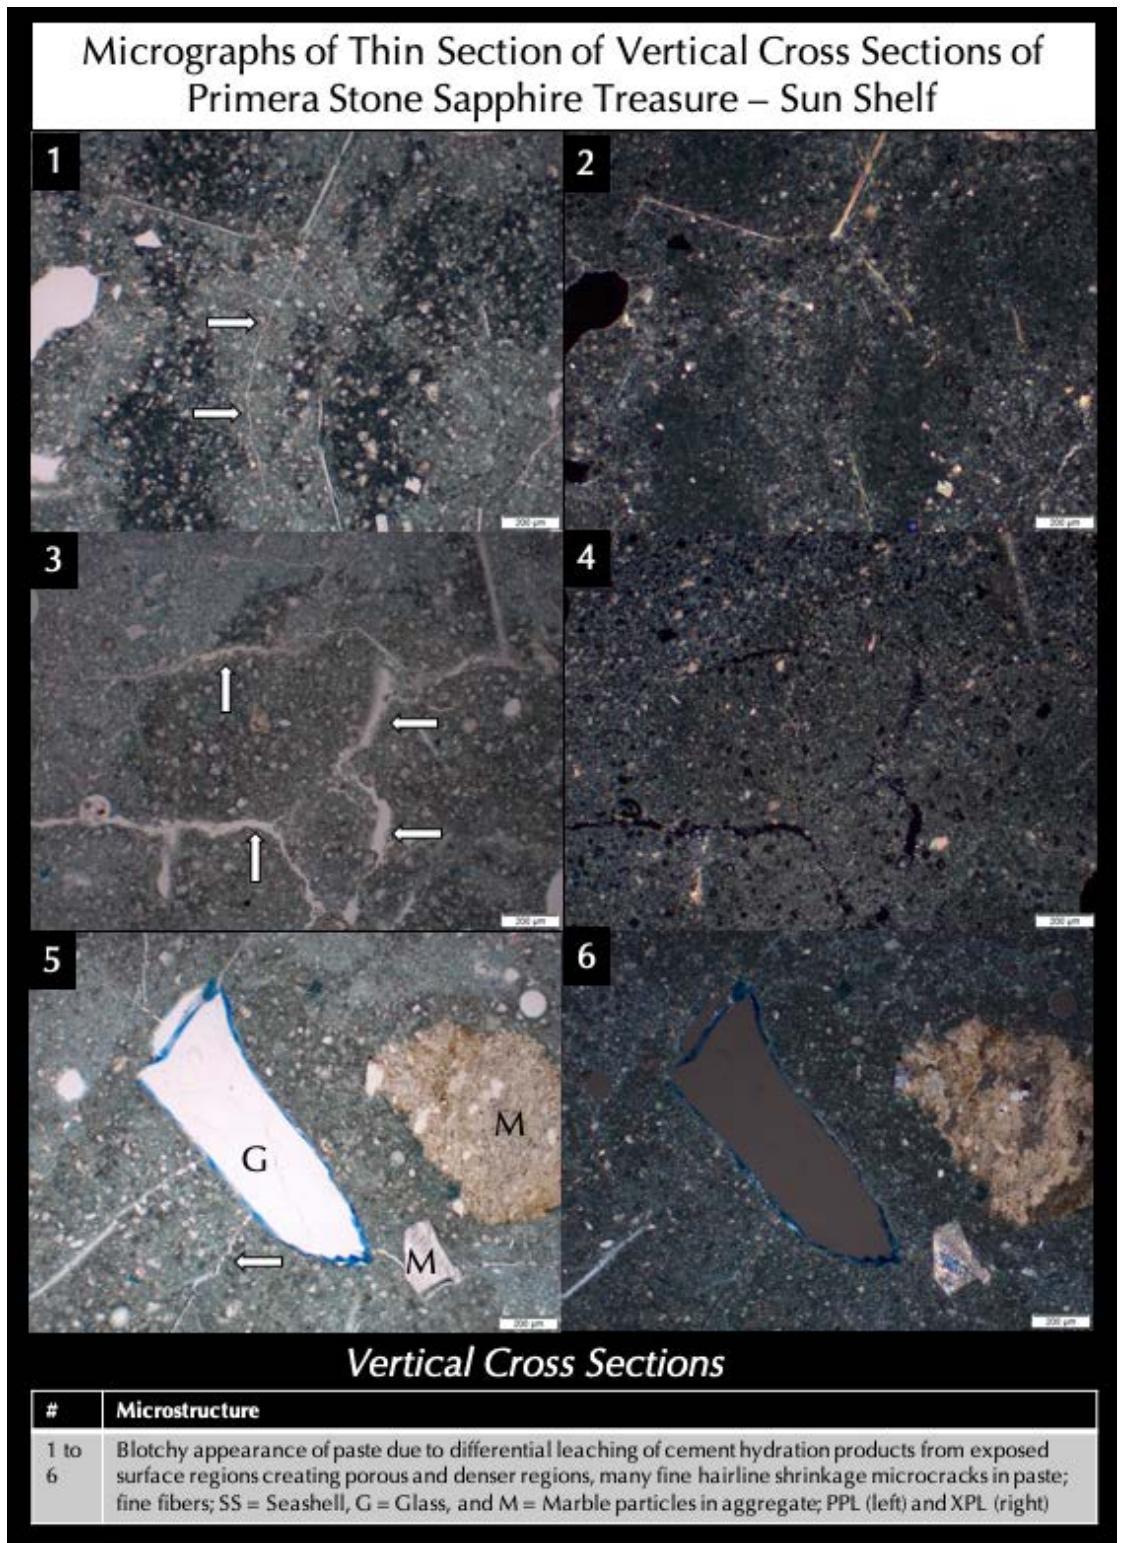
Fig. A 36: Micrographs of thin section of vertical cross section of Primera Stone Sapphire Treasure plaster showing: (a) crushed marble (M), glass (G), and seashell (SS) particles in aggregate; (b) dense interstitial paste consisting of white Portland cement; (c) blotchy or patchy discoloration of plaster from lighter (more porous) shade at the surface region and darker (denser) shade in the interior; and (d) shrinkage microcracks in paste that are filled with secondary calcium carbonate and sulfate deposits (arrows). Down arrows in the top right photo show a thin film of secondary calcium carbonate precipitation on the exposed surface of plaster.

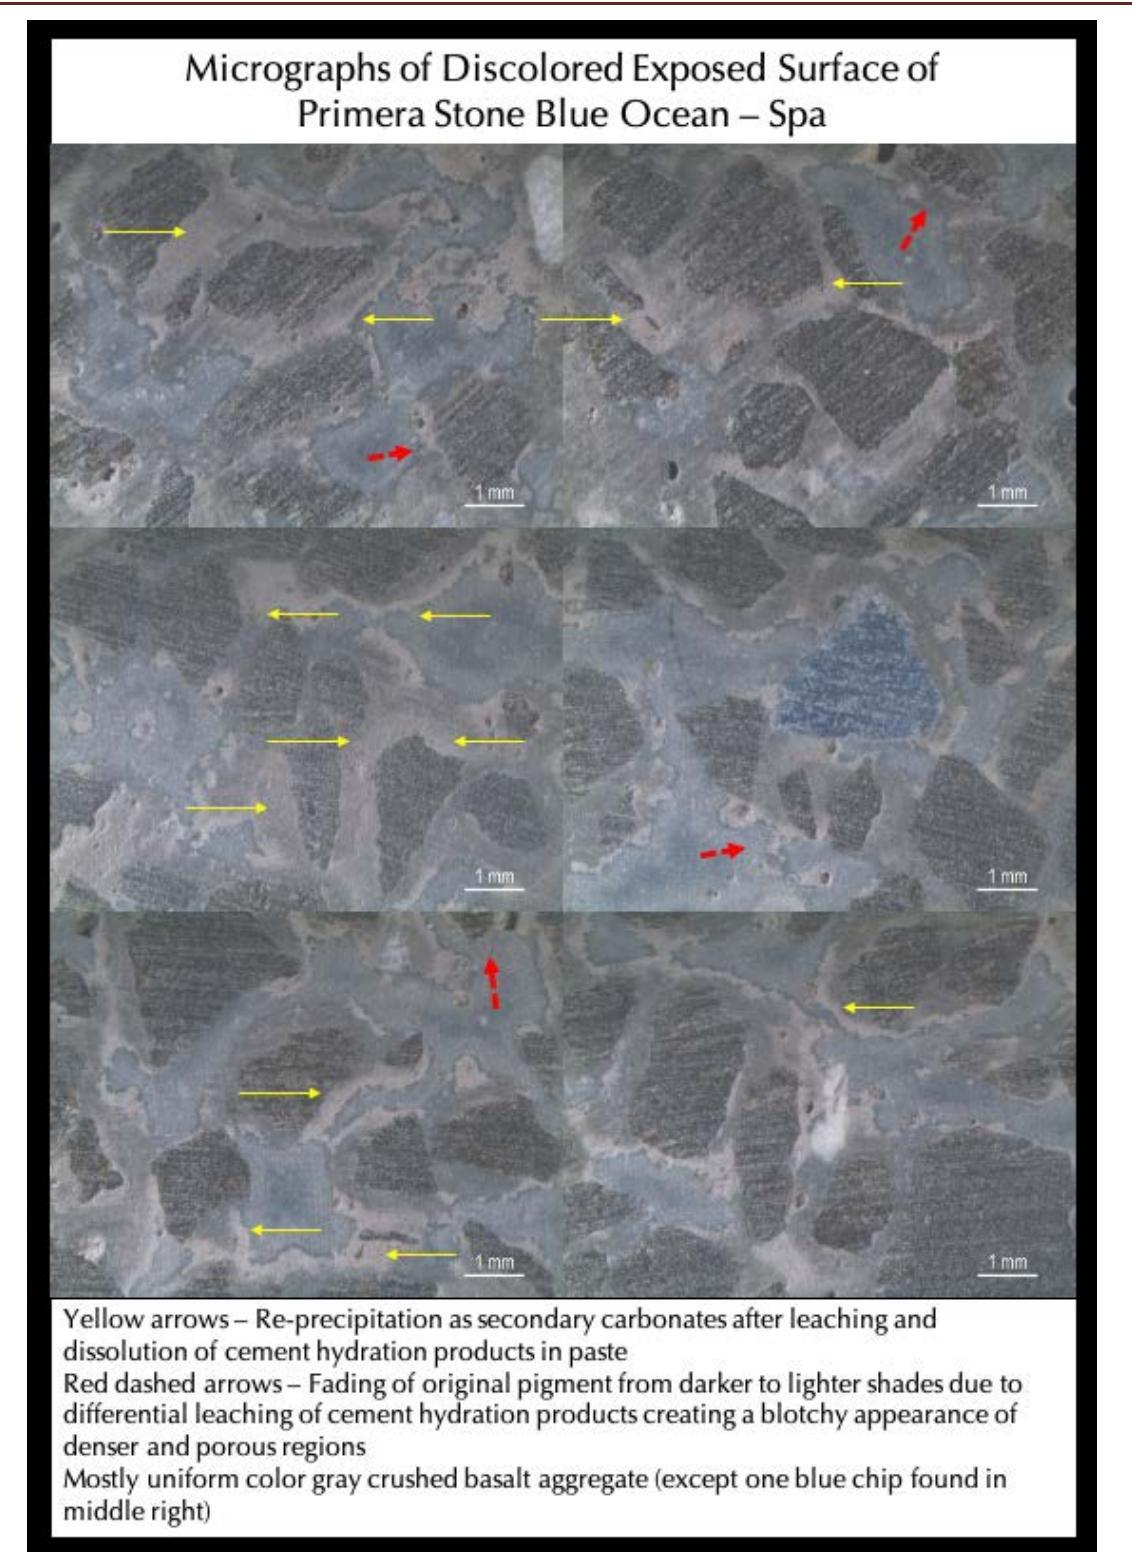
Fig. A 45: Micrographs of exposed discolored surface of Primera Stone Blue Ocean pool plaster that was in contact with the pool water from the Spa area showing blotchy appearance of plaster consisting of: (a) beige gray discolored plaster patches marked with yellow arrows and (b) fading of darker to lighter blue colors of plaster marked by the dashed red arrows. Both the beige and lighter blue fading of color are the result of interaction of plaster and pool water. The micrographs were taken with a stereo-microscope.

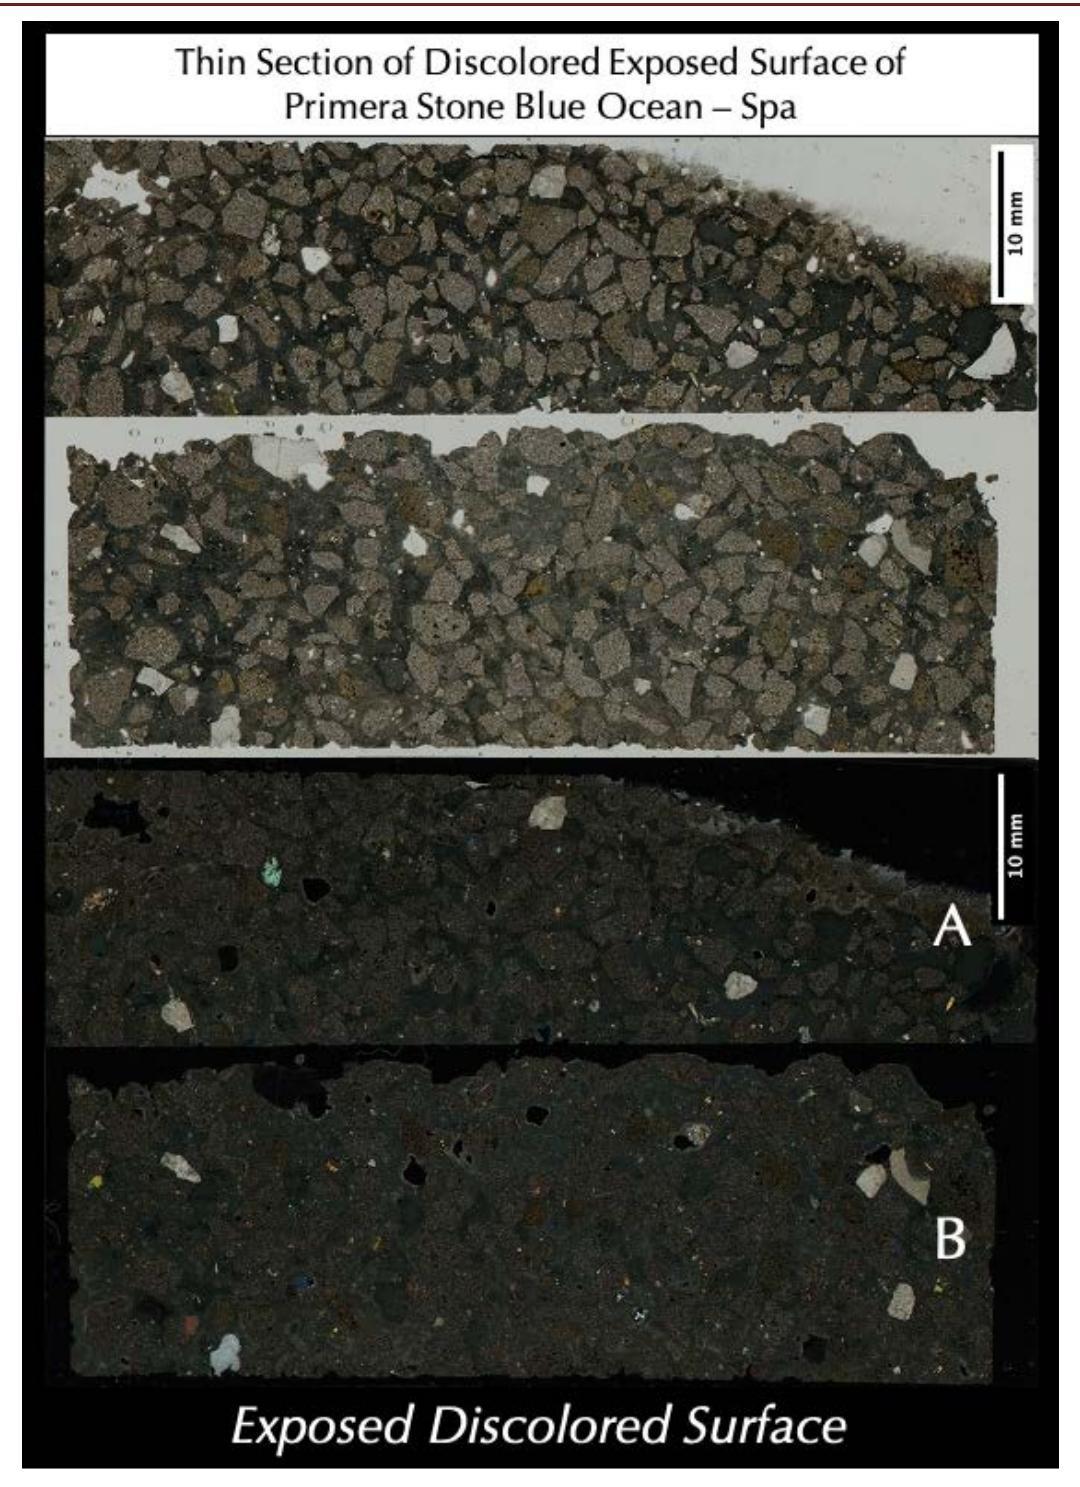
Fig. A 46: Micrographs of exposed discolored surface of Primera Stone Blue Ocean pool plaster that was in contact with the pool water from the Spa area showing blotchy appearance of plaster consisting of: (a) beige gray discolored plaster patches marked with yellow arrows and (b) fading of darker to lighter blue colors of plaster marked by the dashed red arrows. Both the beige and lighter blue fading of color are the result of interaction of plaster and pool water. The micrographs were taken with a stereo-microscope.

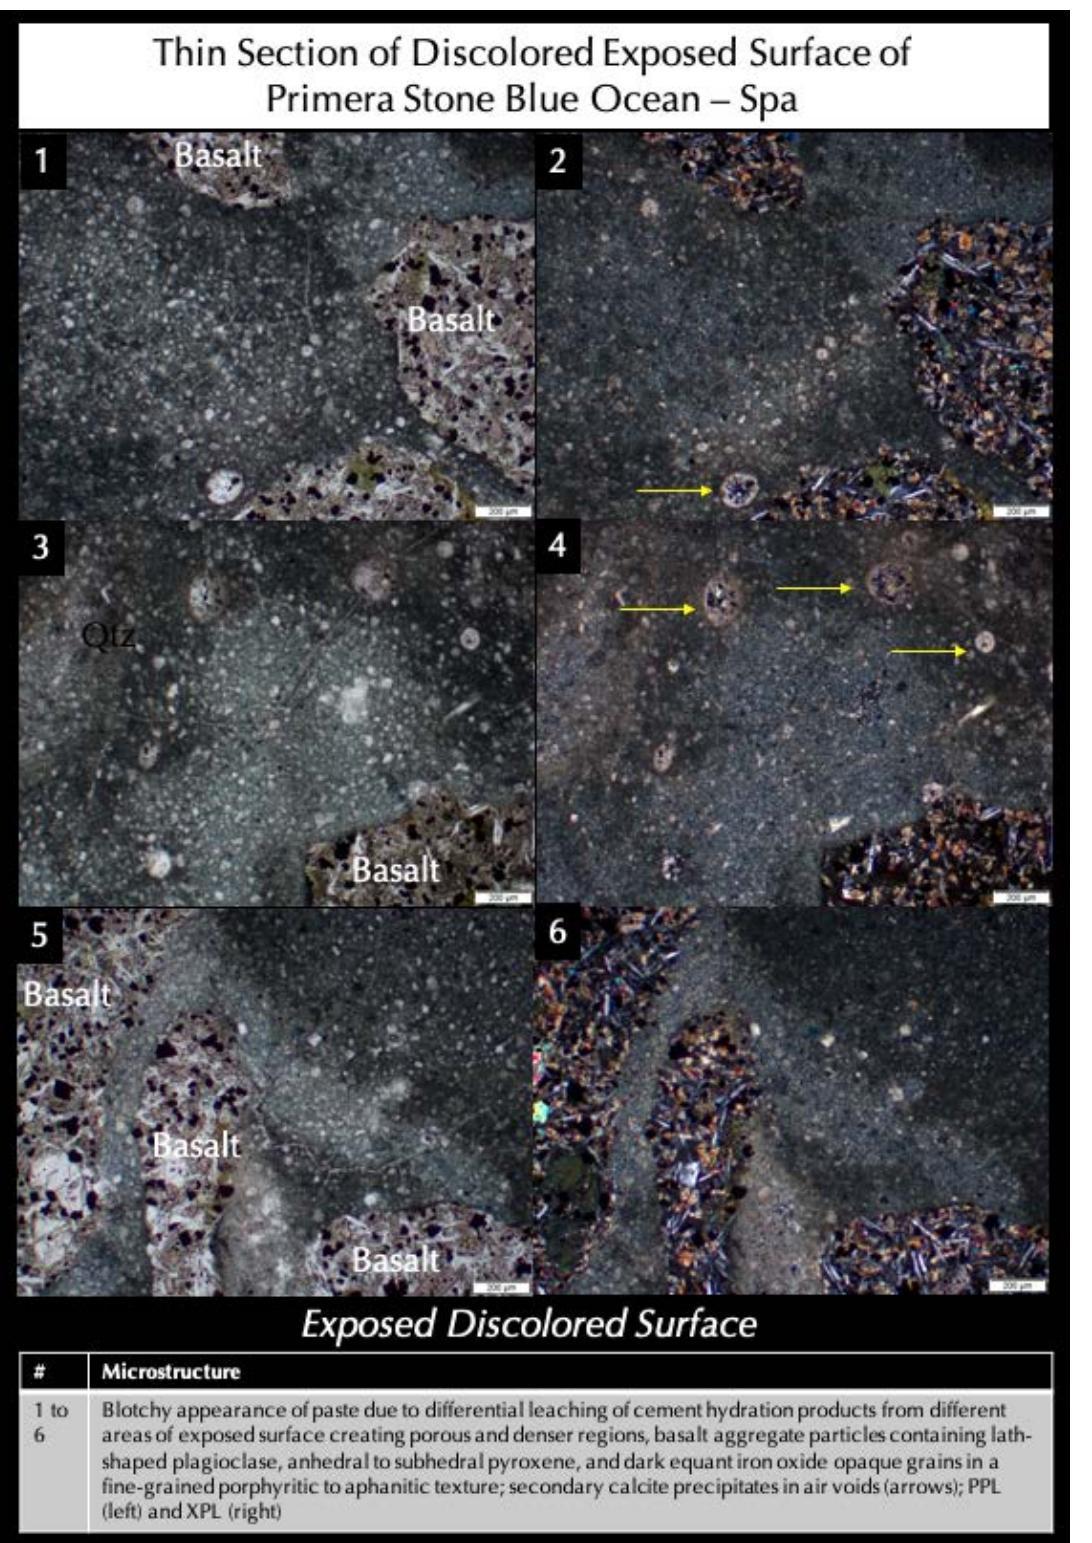
Fig. A 47: Blue dye-mixed epoxy-impregnated thin section (30 micron thickness) of exposed discolored surface of Primera Stone Blue Ocean pool plaster that was in contact with the pool water from the Spa area. The thin section was scanned on a flatbed film scanner with a polarizing filter to create plane polarized light (PPL) view at the top image, and then sandwiched between two polarizing filters at perpendicular positions to create crossed polarized light (XPL) view at the bottom. The PPL image shows difference in porosities of paste from variations in the degree of absorption of blue epoxy used for preparation of thin section where porous areas absorbed more blue dye to appear brighter blue whereas denser areas absorb less blue epoxy to appear darker. The XPL image shows the different aggregate types used, which showed major amounts of crushed basalt particles and trace amounts of siliceous (quartz sand) and calcareous (seashell) components.

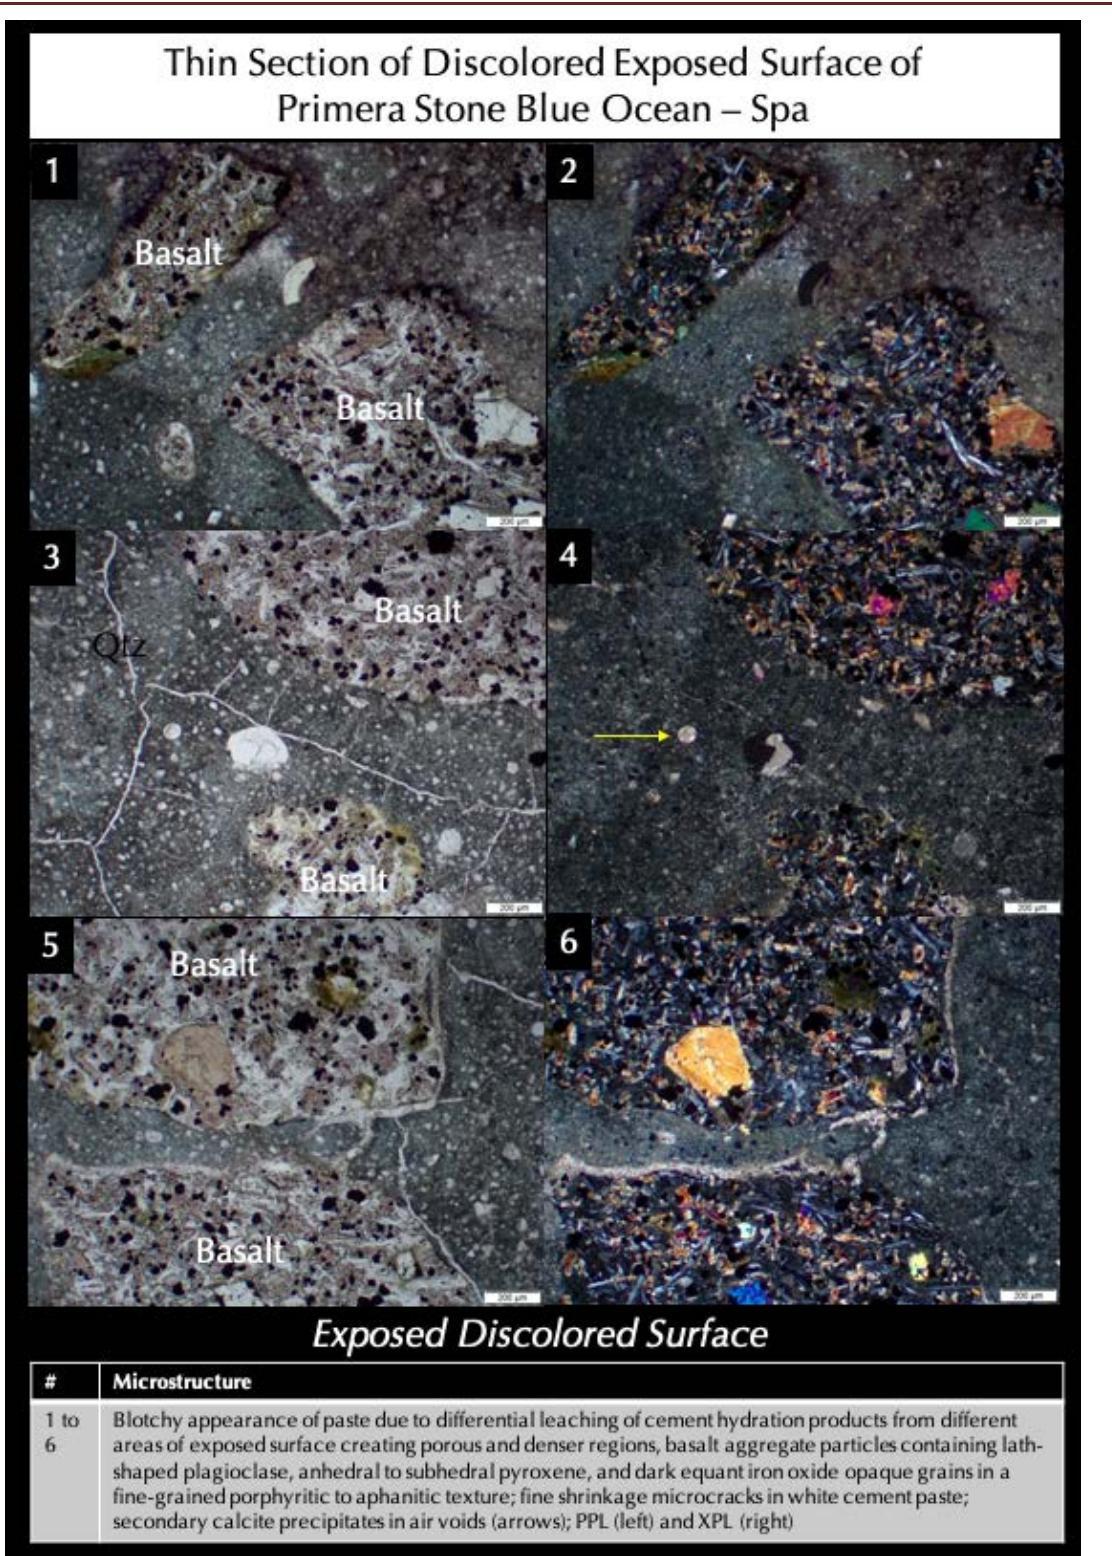
Fig. A 48: Micrographs of thin section of exposed discolored surface of Primera Stone Blue Ocean plaster showing: (a) crushed basalt particles in aggregate consisting of anhedral to subhedral pyroxene, subhedral plagioclase laths, and dark opaque grains arranged in a porphyritic texture; (b) dense interstitial paste consisting of white Portland cement; (c) blotchy or patchy discoloration of plaster from darker to lighter shades; and (d) secondary calcite precipitates in some voids due to dissolution and re-precipitation of paste by the pool water (arrows).
