### Swimming Pool Plaster Discoloration – A Case Study From Field & Laboratory-Cured Plasters

Primera Stone Sapphire Treasure & Blue Ocean

CONSTRUCTION MATERIALS CONSULTANTS, INC.

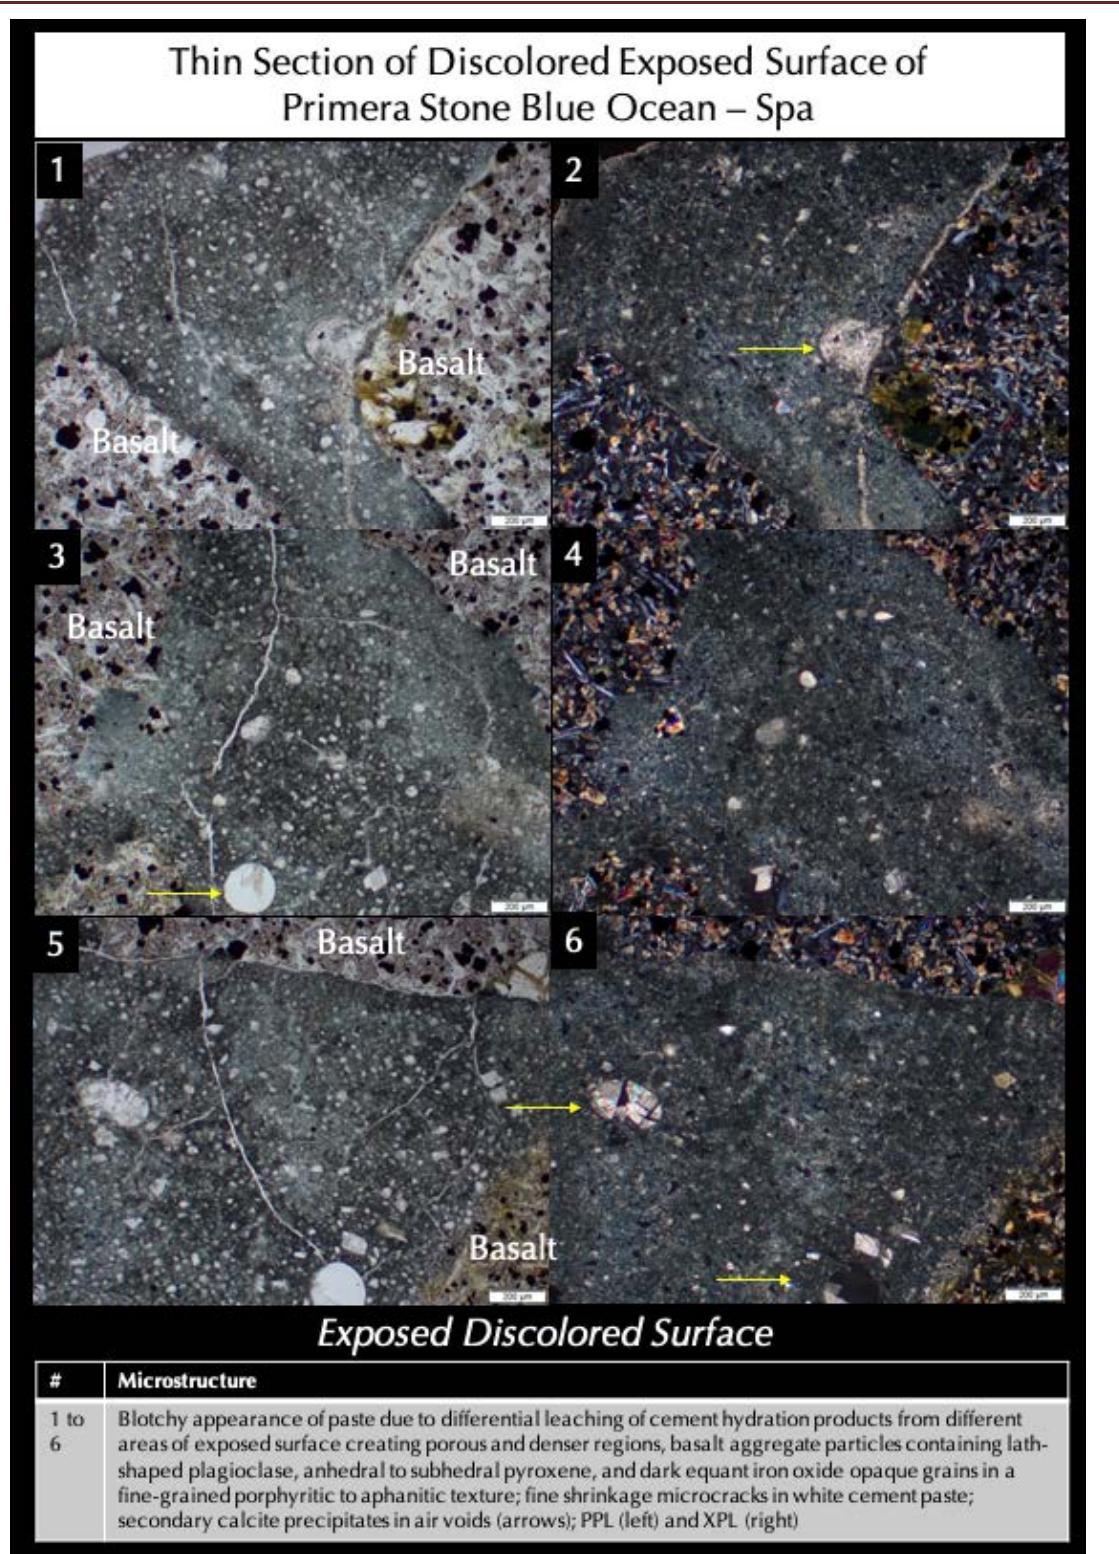
Fig. A 49: Micrographs of thin section of exposed discolored surface of Primera Stone Blue Ocean plaster showing: (a) crushed basalt particles in aggregate consisting of anhedral to subhedral pyroxene, subhedral plagioclase laths, and dark opaque grains arranged in a porphyritic texture; (b) dense interstitial paste consisting of white Portland cement; (c) blotchy or patchy discoloration of plaster from darker to lighter shades; (d) fine, hairline shrinkage microcracks in paste; and (e) secondary calcite precipitates in some voids due to dissolution and re-precipitation of paste by the pool water (arrow in middle right photo).

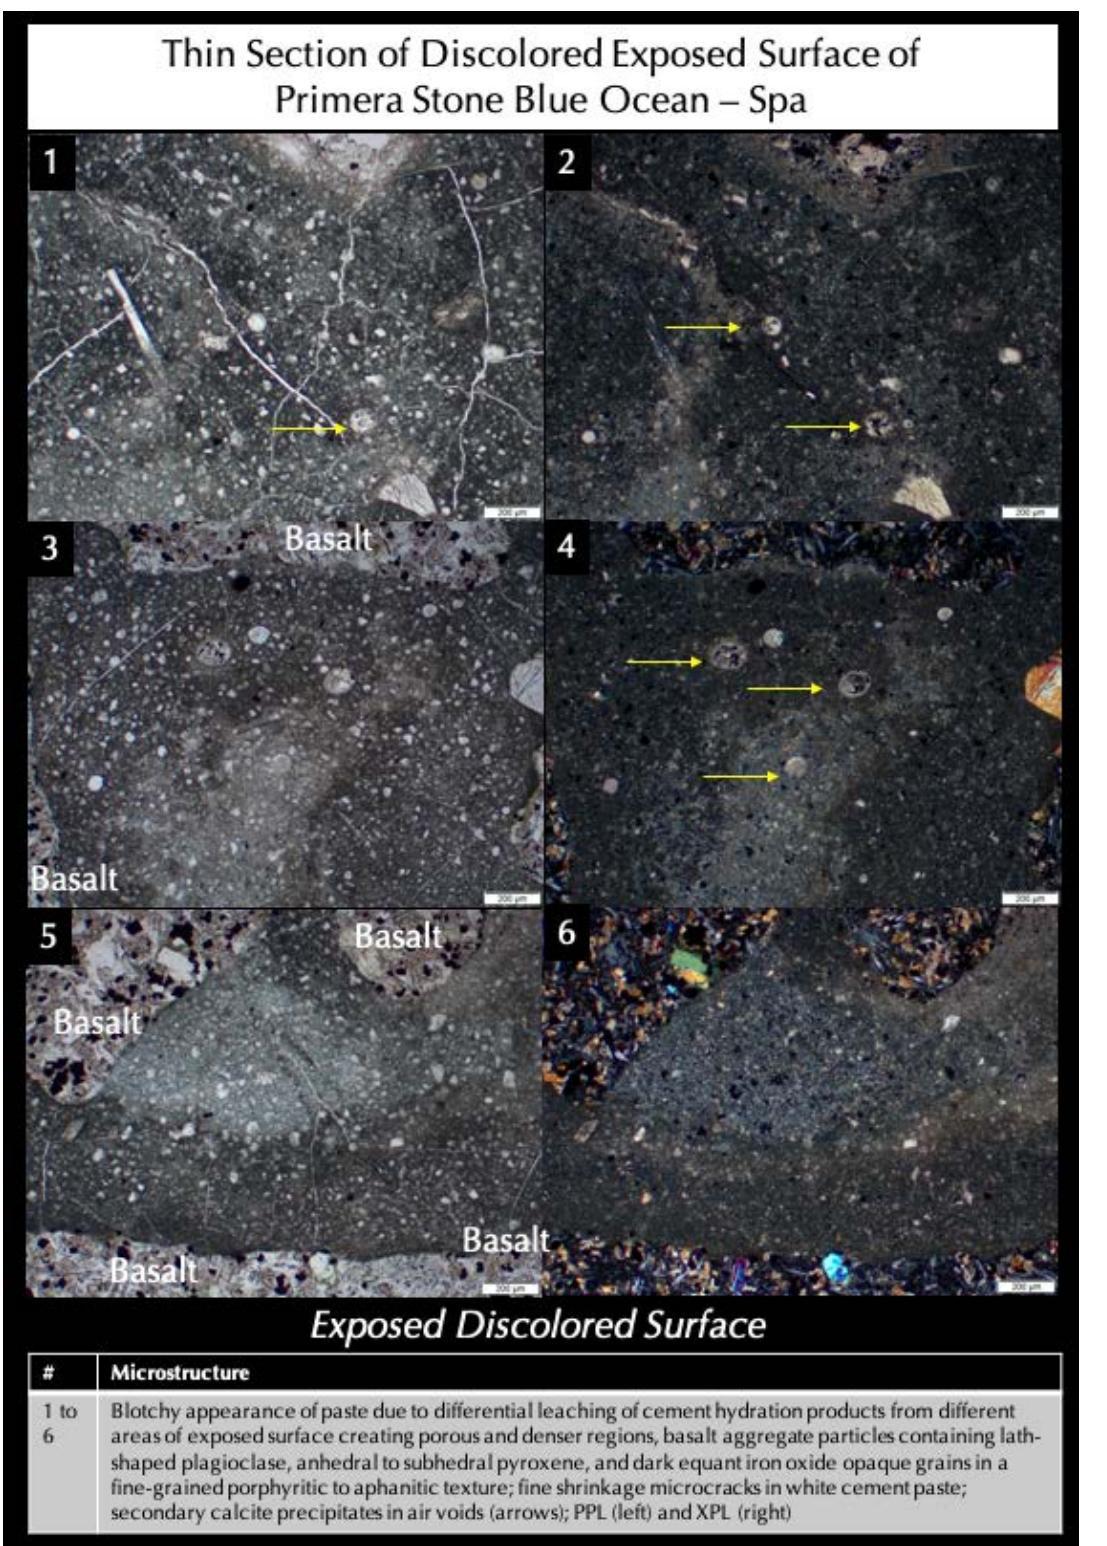
Fig. A 50: Micrographs of thin section of exposed discolored surface of Primera Stone Blue Ocean plaster showing: (a) crushed basalt particles in aggregate consisting of anhedral to subhedral pyroxene, subhedral plagioclase laths, and dark opaque grains arranged in a porphyritic texture; (b) dense interstitial paste consisting of white Portland cement; (c) blotchy or patchy discoloration of plaster from darker to lighter shades; (d) fine, hairline shrinkage microcracks in paste; and (e) secondary calcite precipitates in some voids due to dissolution and re-precipitation of paste by the pool water (arrows).

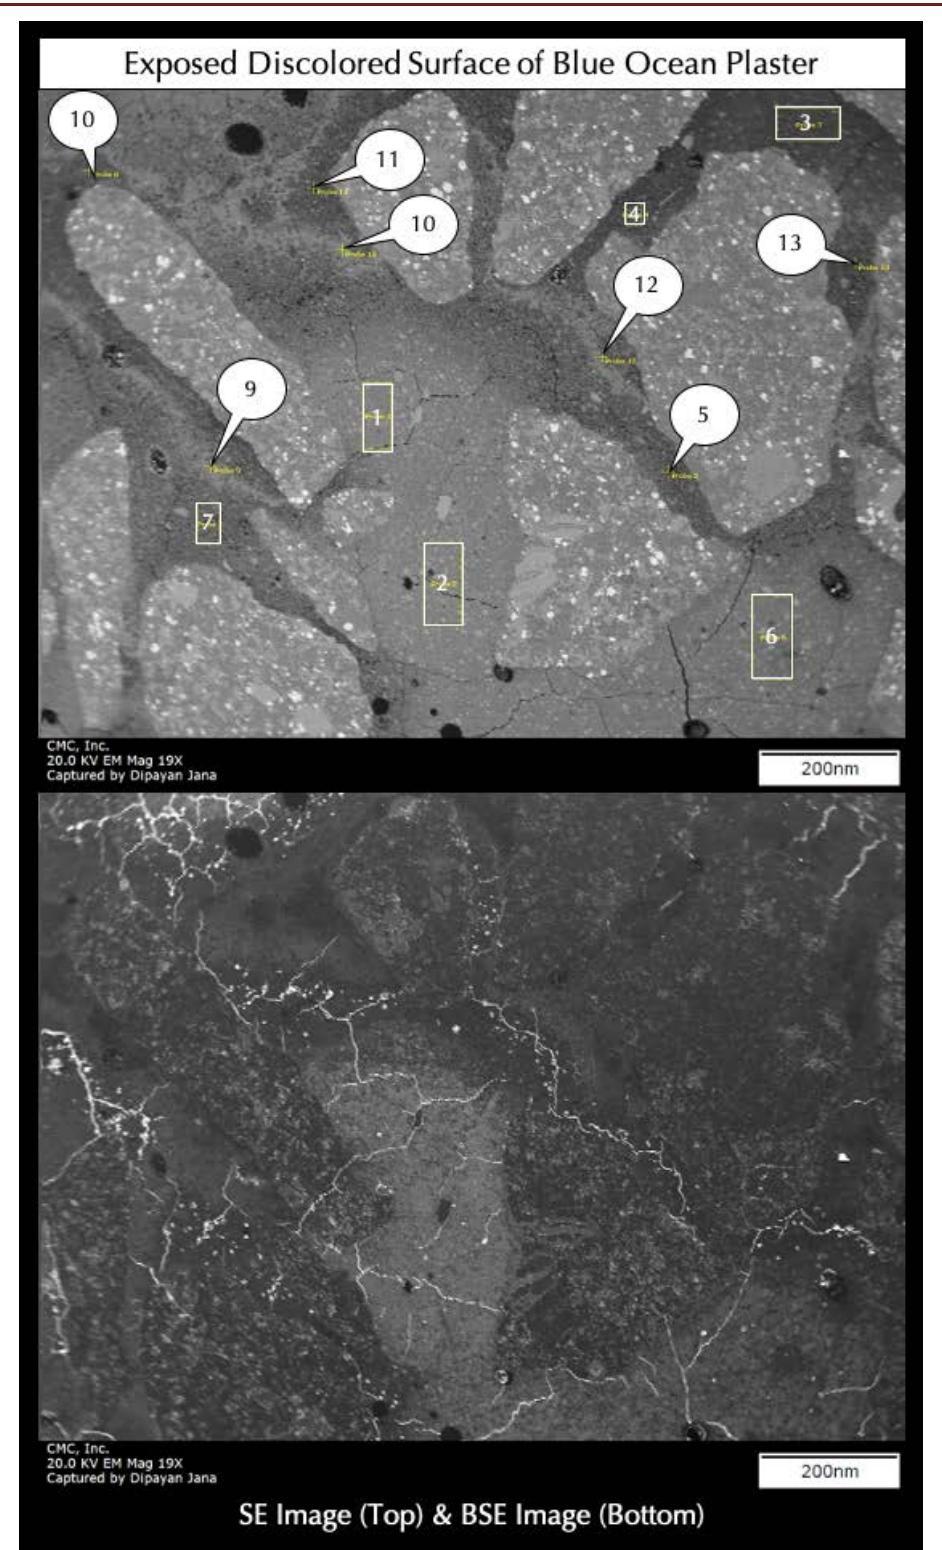
Fig. A 57: Backscatter electron (BSE) image (top) and X-ray microanalyses at the tips of callouts and in boxed areas on the exposed discolored surface of Primera Stone Blue Ocean plaster showing crushed basalt aggregate particles (where bright spots within the particles are from iron-titanium oxide opaque grains in basalt) and interstitial paste. Paste was analyzed at various locations from Probe# 1 to 13. Paste shows typical compositions of calcium silicate hydrate and calcium hydroxide components of cement hydration products except higher sulfate than that contributed from Portland cement, which is found to be from the barium sulfate extender present in the pigment dyes used in the plaster. Sulfate content is variable due to dissolution of plaster by pool water.

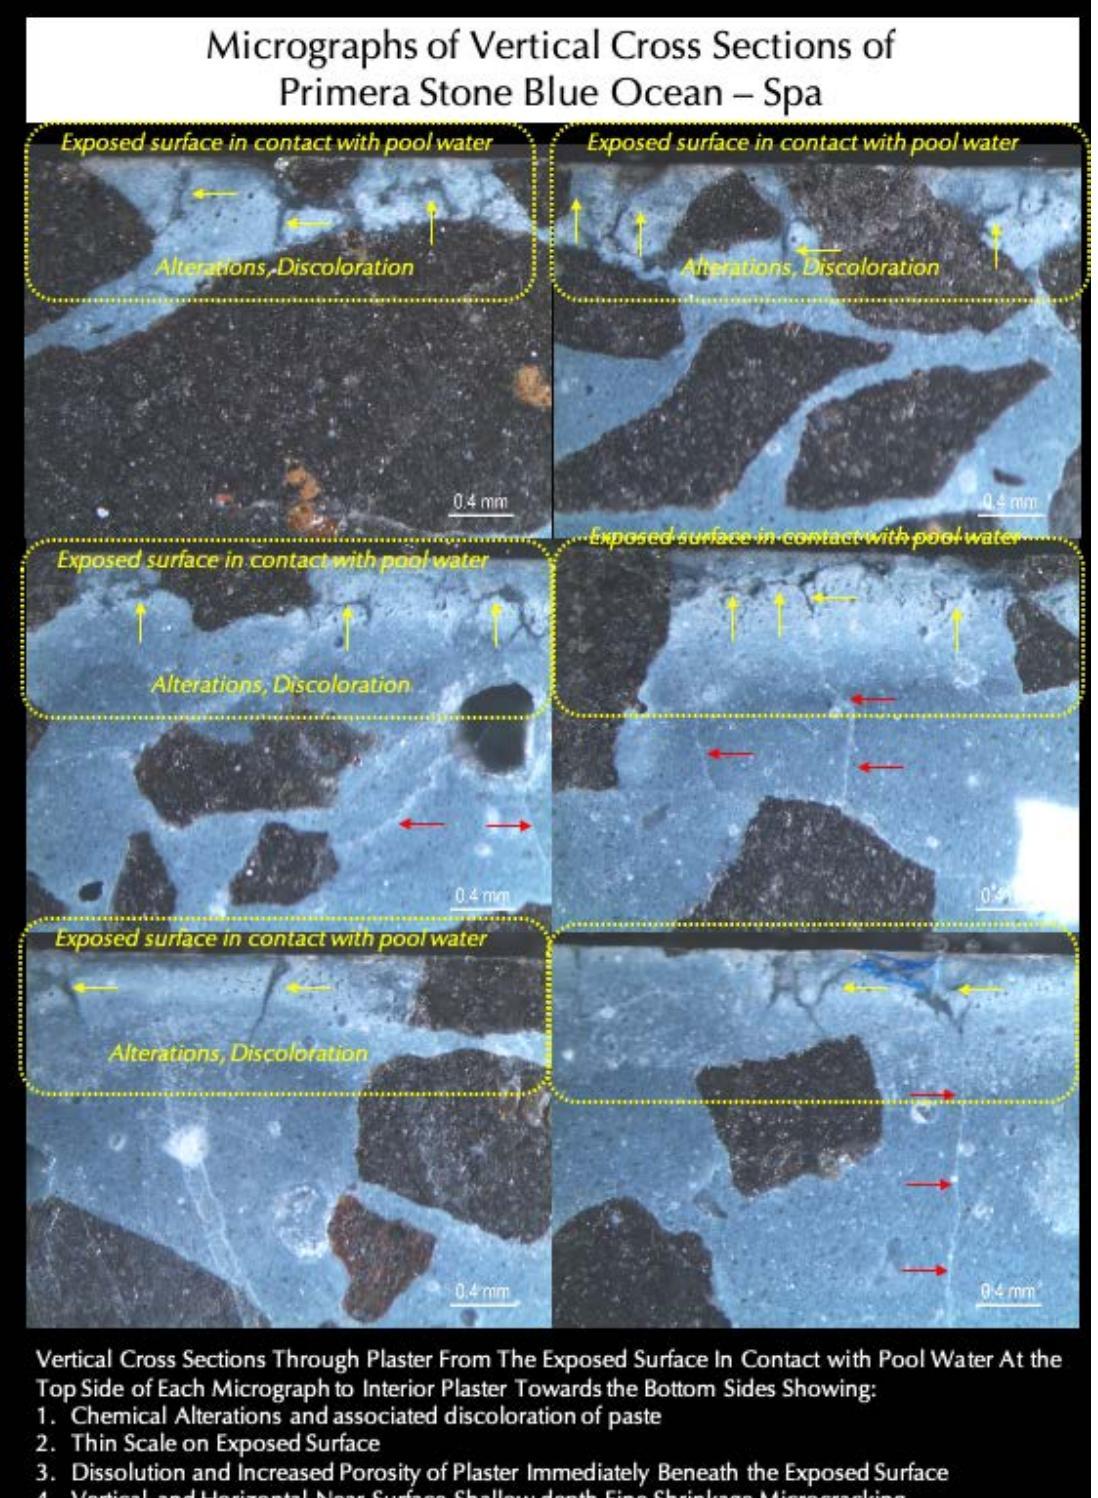
Vertical Cross Sections Through Plaster From The Exposed Surface In Contact with Pool Water At the Top Side of Each Micrograph to Interior Plaster Towards the Bottom Sides Showing: 1. Chemical Alterations and associated discoloration of paste

- 2. Thin Scale on Exposed Surface
- 3. Dissolution and Increased Porosity of Plaster Immediately Beneath the Exposed Surface
- 4. Vertical and Horizontal Near-Surface Shallow depth Fine Shrinkage Microcracking

Fig. A 59: Micrographs of vertical cross section of Primera Stone Blue Ocean pool plaster where the top edge in each photo was in contact with the pool water showing evidence of leaching and dissolution of paste with increased paste porosity due to dissolution within the boxed areas at the surface regions in all photos. Arrows show vertical, shallow-depth shrinkage microcracks. Fading of darker interior to lighter blue colors of plaster at the surface region is seen from the interior to the boxed areas at the surface. The micrographs were taken with a stereo-microscope.

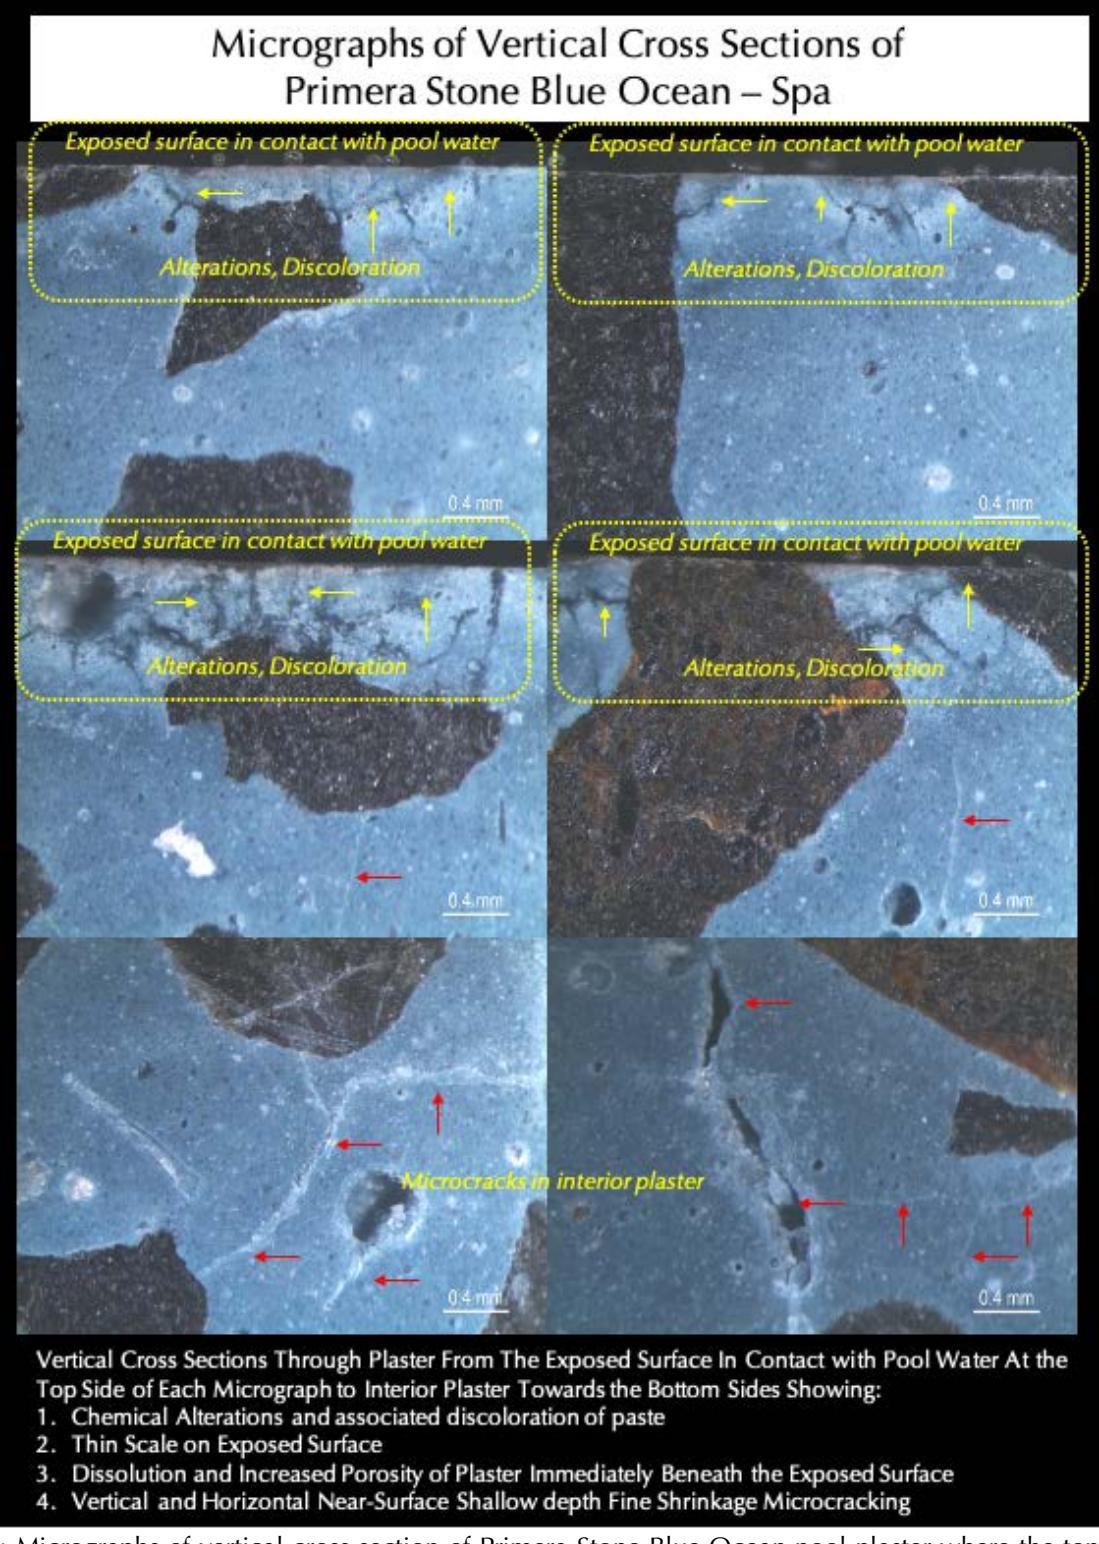
Fig. A 60: Micrographs of vertical cross section of Primera Stone Blue Ocean pool plaster where the top edge in each photo was in contact with the pool water showing evidence of leaching and dissolution of paste with increased paste porosity due to dissolution within the boxed areas at the surface regions in all photos. Arrows show vertical, shallow-depth shrinkage microcracks. Fading of darker interior to lighter blue colors of plaster at the surface region is seen from the interior to the boxed areas at the surface. The micrographs were taken with a stereo-microscope.

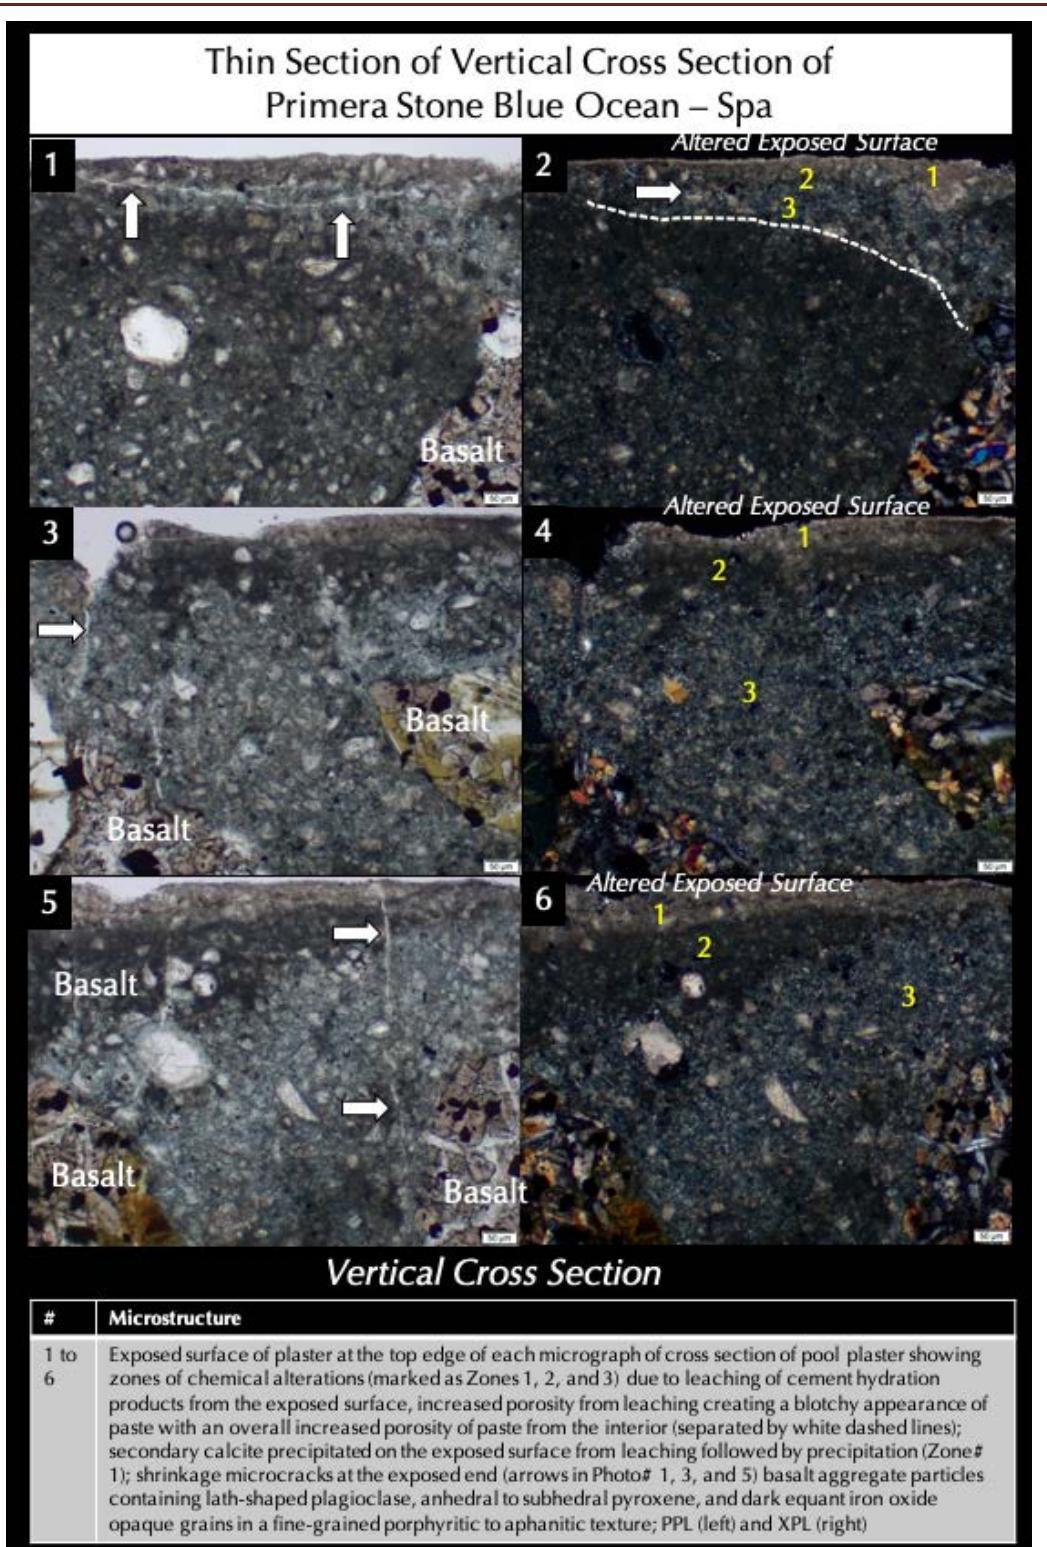
Fig. A 63: Micrographs of thin section of vertical cross sections of Primera Stone Blue Ocean plaster showing: (a) crushed basalt particles in aggregate consisting of anhedral to subhedral pyroxene, subhedral plagioclase laths, and dark opaque grains arranged in a porphyritic texture; (b) dense interstitial paste consisting of white Portland cement; (c) blotchy or patchy discoloration of plaster from darker to lighter shades; (d) fine, hairline shrinkage microcracks in paste (arrows in the top row); and (e) zones of chemical alterations of exposed surface region due to pool water interactions that are marked in Photo 6 as carbonated zone at the very top surface (#1), a darker intermediate zone beneath (#2), and interior paste (#3).

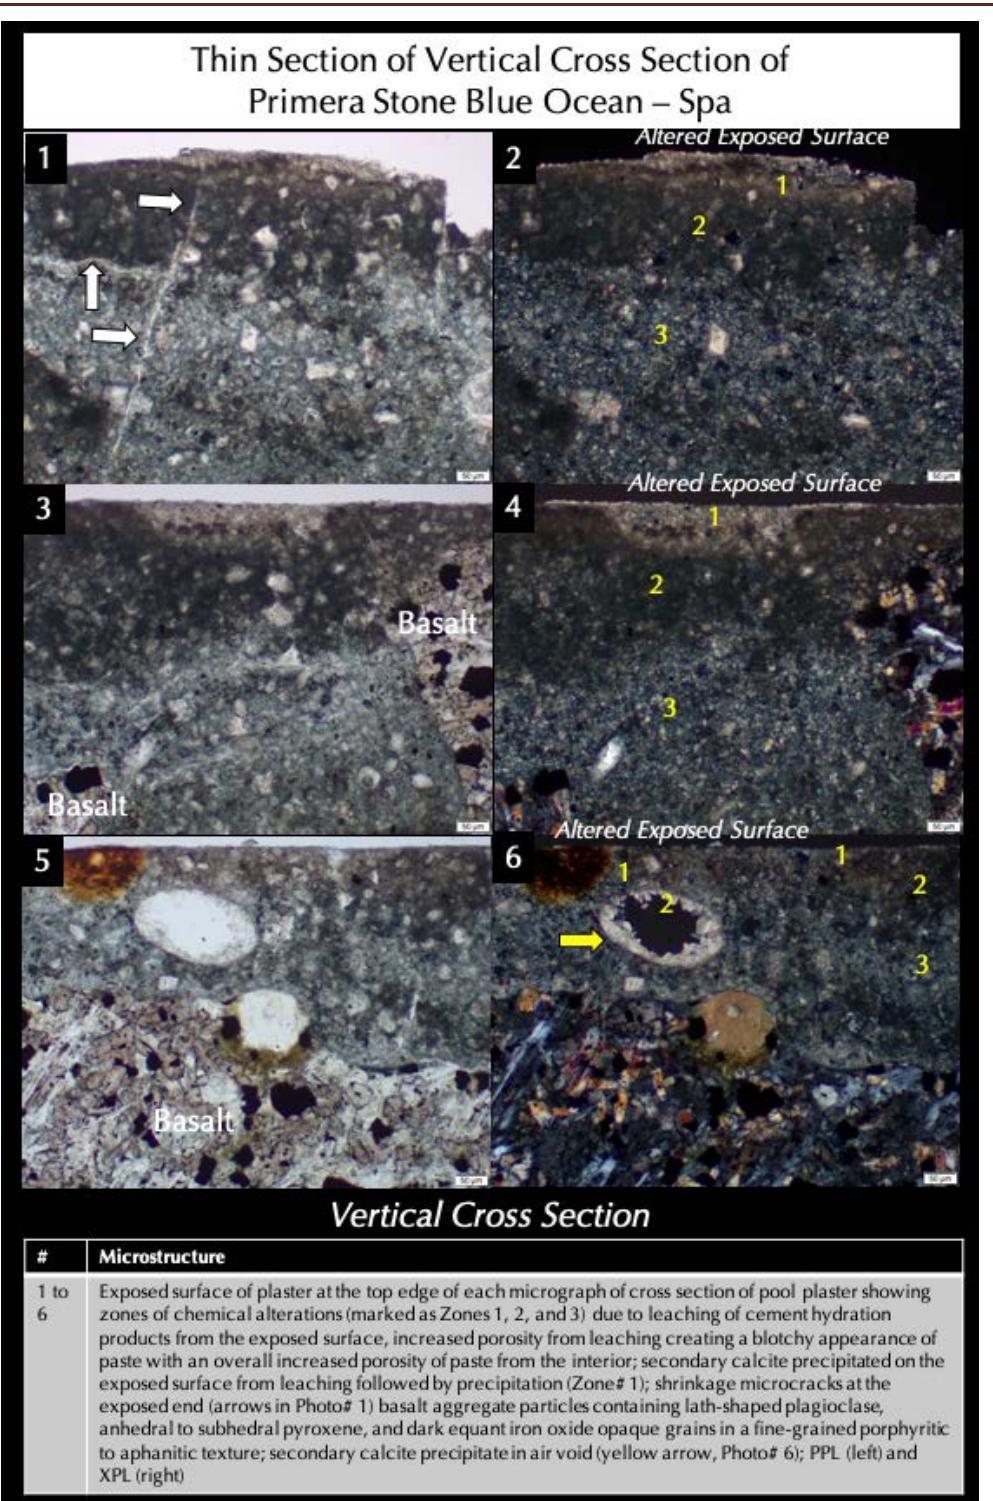
Fig. A 64: Micrographs of thin section of vertical cross sections of Primera Stone Blue Ocean plaster showing: (a) crushed basalt particles in aggregate consisting of anhedral to subhedral pyroxene, subhedral plagioclase laths, and dark opaque grains arranged in a porphyritic texture; (b) dense interstitial paste consisting of white Portland cement; (c) blotchy or patchy discoloration of plaster from darker to lighter shades; (d) fine, vertical, hairline shrinkage microcracks in paste (arrows in the left column photos); and (e) zones of chemical alterations of exposed surface region due to pool water interactions that are marked in Photos 2, 4, and 6 as carbonated zone at the very top surface (#1), a darker intermediate zone beneath (#2), and interior paste (#3).

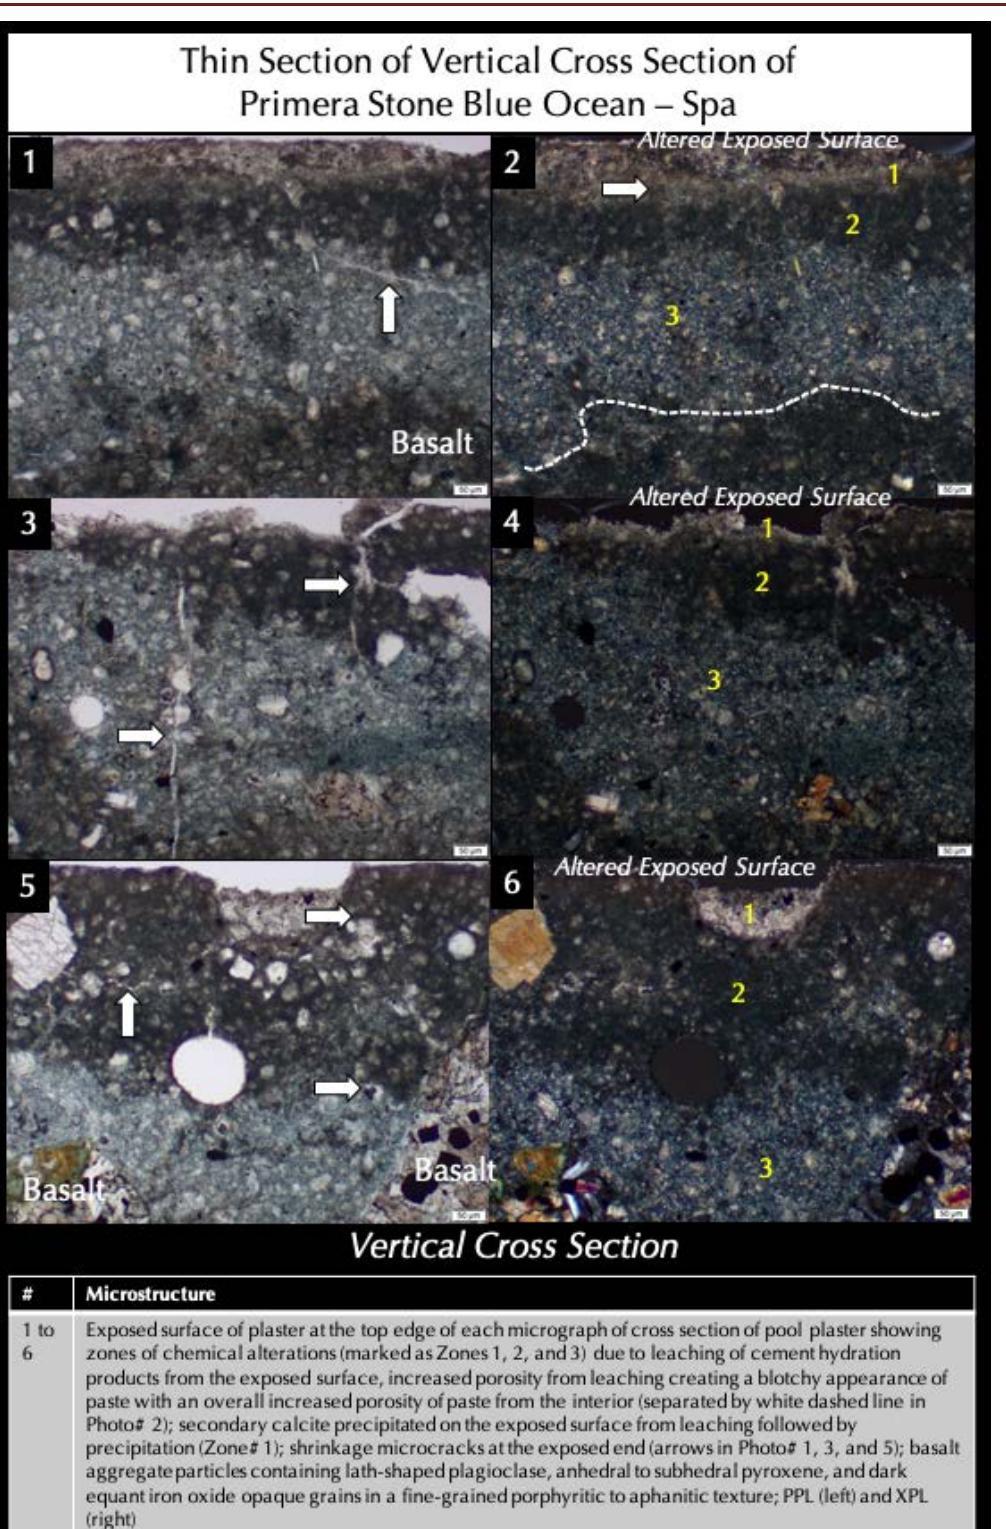
Fig. A 65: Micrographs of thin section of vertical cross sections of Primera Stone Blue Ocean plaster showing: (a) crushed basalt particles in aggregate consisting of anhedral to subhedral pyroxene, subhedral plagioclase laths, and dark opaque grains arranged in a porphyritic texture; (b) dense interstitial paste consisting of white Portland cement; (c) blotchy or patchy discoloration of plaster from darker to lighter shades; (d) fine, vertical, hairline shrinkage microcracks in paste (arrows in the top left photo); and (e) zones of chemical alterations of exposed surface region due to pool water interactions that are marked in Photos 2, 4, and 6 as carbonated zone at the very top surface (#1), a darker intermediate zone beneath (#2), and interior paste (#3). Yellow arrow in Photo 6 marks a secondary calcite precipitate in an air void immediately beneath the surface.

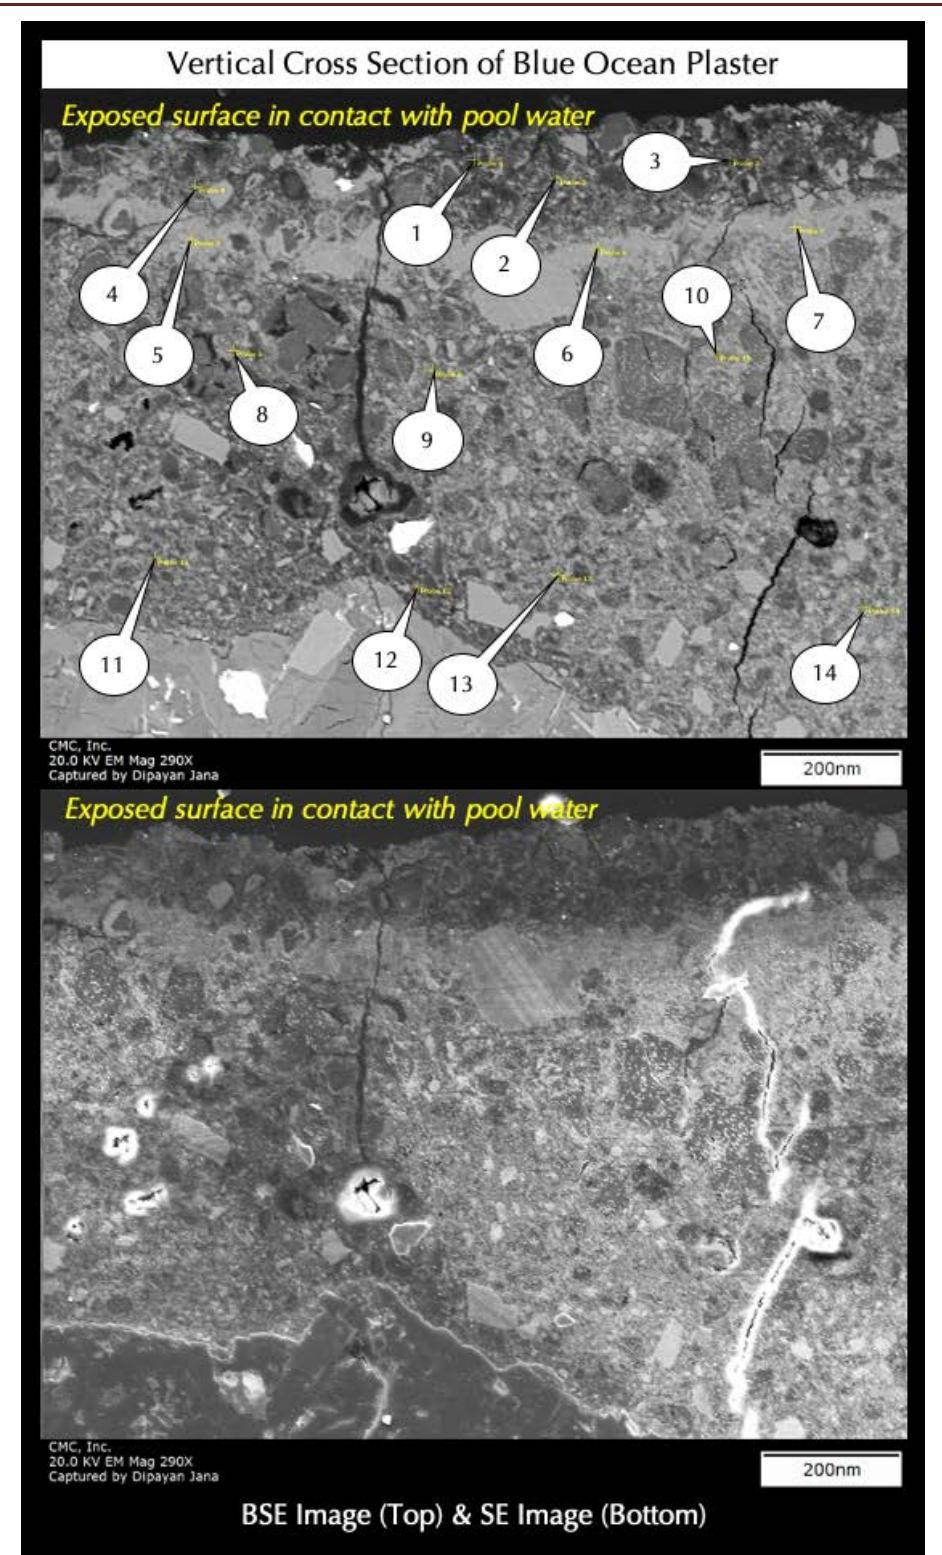
Fig. A 67: Backscatter electron (BSE) image (top) and X-ray microanalyses at the tips of callouts on the vertical cross section of Primera Stone Blue Ocean plaster showing: (a) secondary calcium precipitate in the near-surface region of paste (e.g., Probe# 5) having noticeably higher calcium oxide than silica compared to paste at the surface region (Probe# 1, 2, 3, 4) or in the interior (Probe# 6 to 14). Paste in the interior (Probe# 6 to 14) shows typical compositions of calcium silicate hydrate and calcium hydroxide components of cement hydration products except higher sulfate than that contributed from Portland cement, which is found to be from the barium sulfate extender present in the pigment dyes used in the plaster. Sulfate at the surface region of paste at Probe# 1 to 3 are noticeably lower than the interior due to dissolution of sulfate at the surface by pool water.

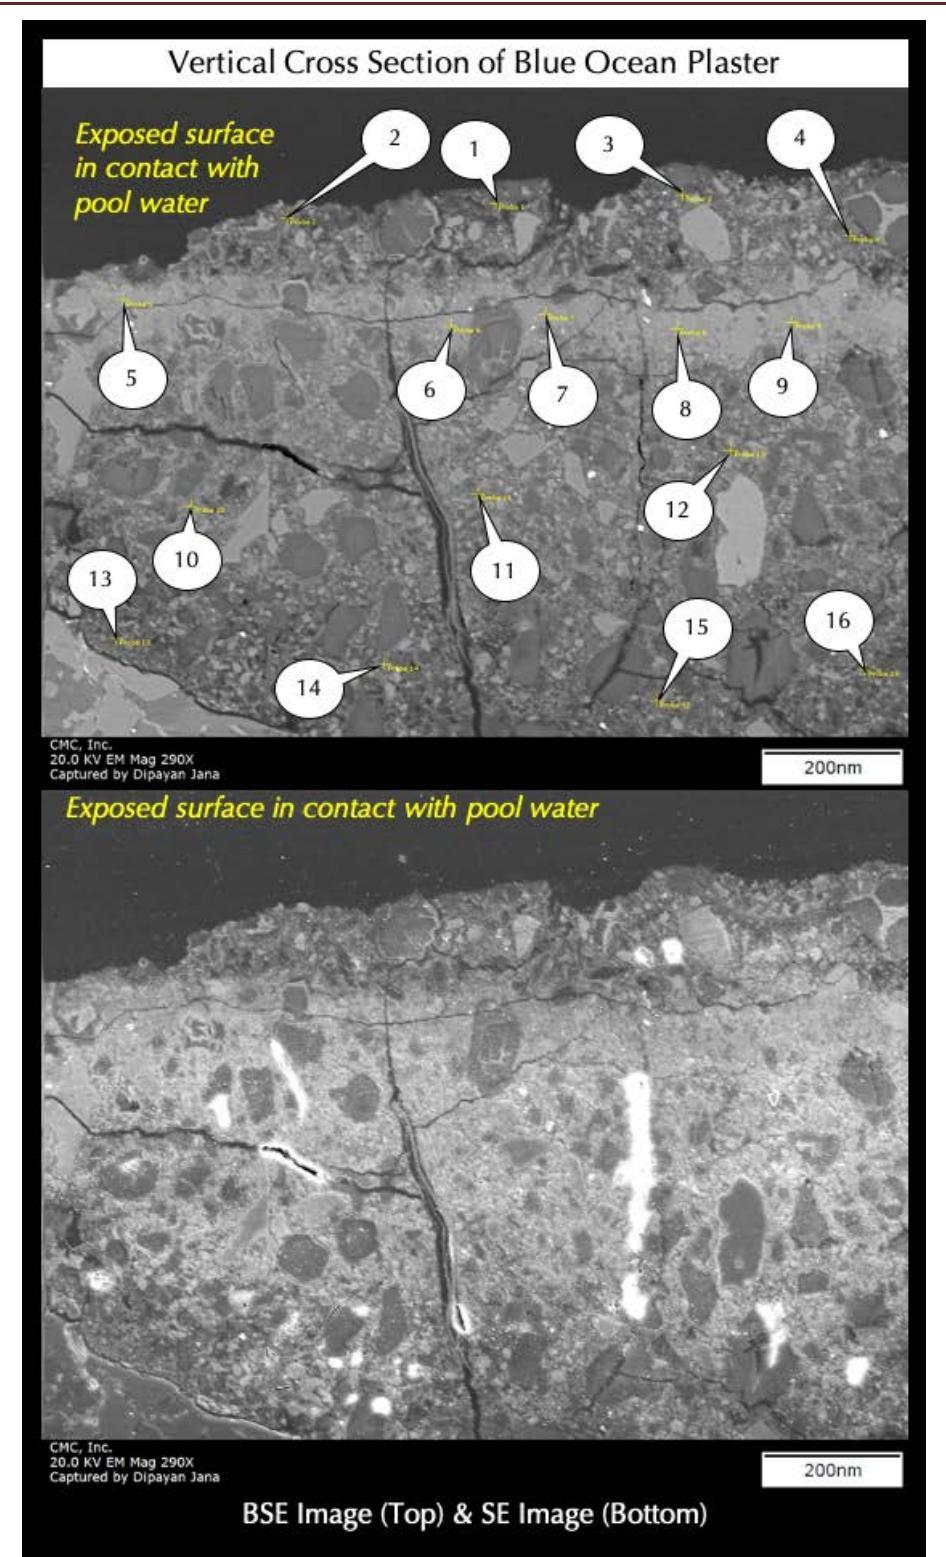
Fig. A 69: Backscatter electron (BSE) image (top) and X-ray microanalyses at the tips of callouts on the vertical cross section of Primera Stone Blue Ocean plaster showing: (a) secondary calcium precipitate in the near-surface region of paste (e.g., Probe# 5 to 9) having noticeably higher calcium oxide than silica compared to paste at the surface region (Probe# 1, 2, 3, 4) or in the interior (Probe# 11 to 16). Paste in the interior (Probe# 11 to 16) shows typical compositions of calcium silicate hydrate and calcium hydroxide components of cement hydration products except higher sulfate than that contributed from Portland cement, which is found to be from the barium sulfate extender present in the pigment dyes used in the plaster. Sulfate at the surface region of paste at Probe# 1 to 4 are lower than the interior due to dissolution of sulfate at the surface by pool water.

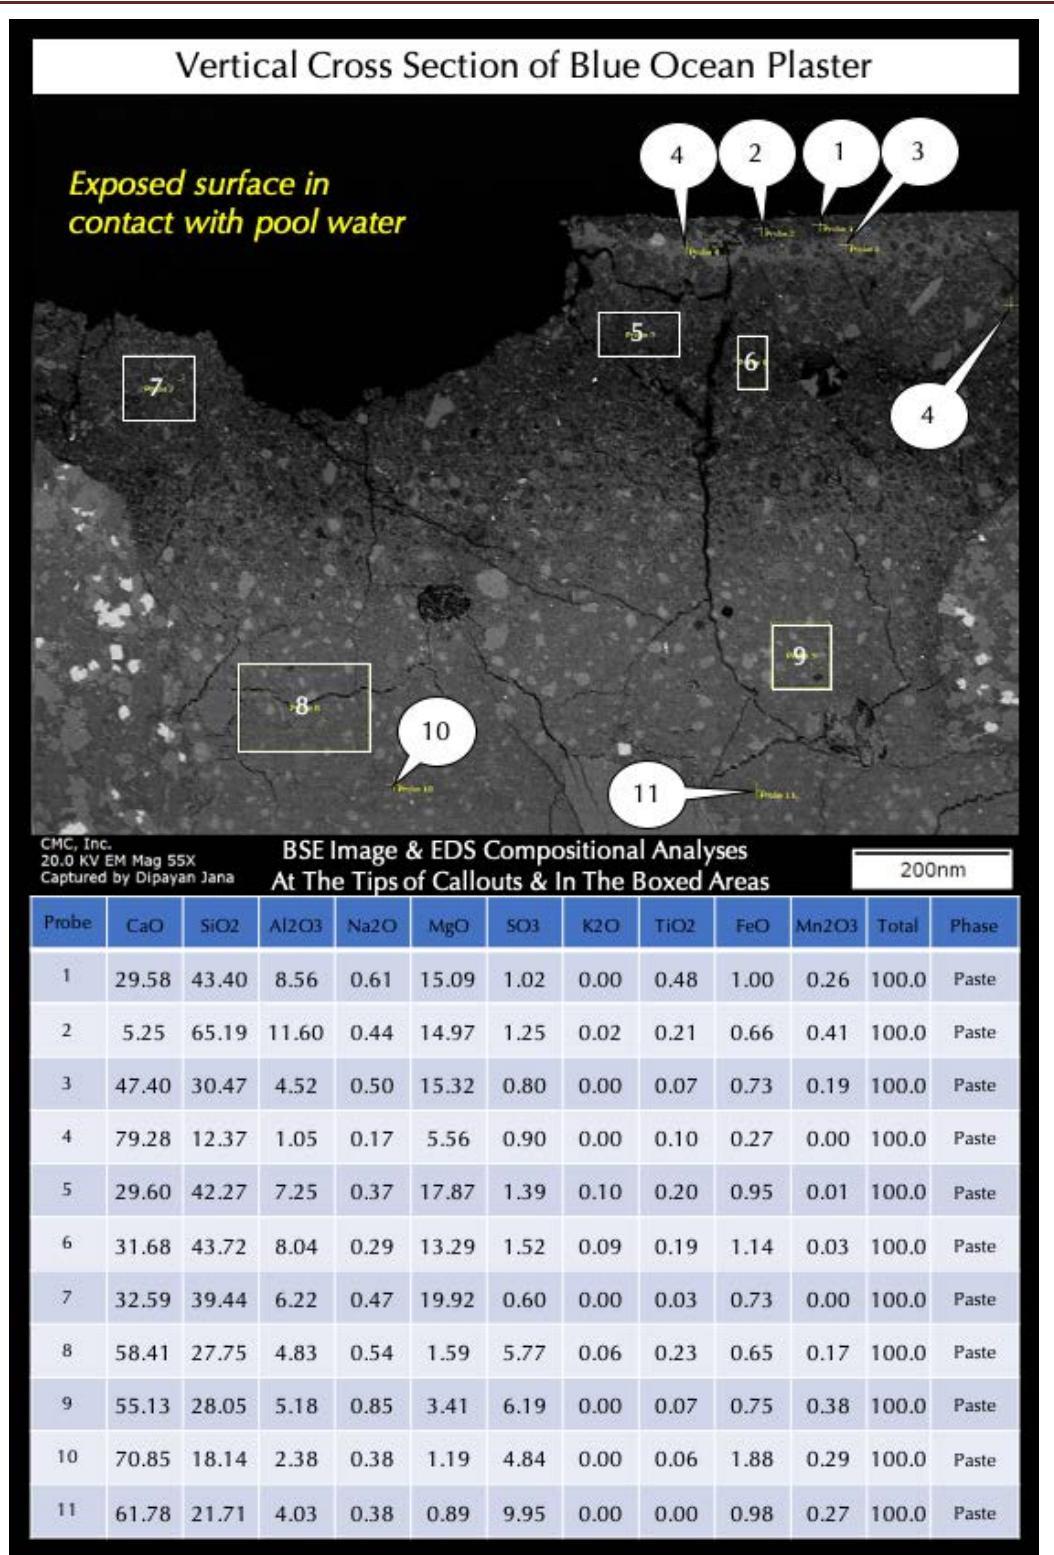
Fig. A 70: Backscatter electron (BSE) image (top) and corresponding secondary electron (SE) image (bottom) of the vertical cross section of Primera Stone Blue Ocean plaster showing different shades of lighter and darker gray areas of paste due to variations in chemical compositions of aggregates and interstitial paste where the latter shows numerous fine vertical hairline shrinkage microcracks. The tips of callouts in the BSE image were analyzed in the previous Figure.

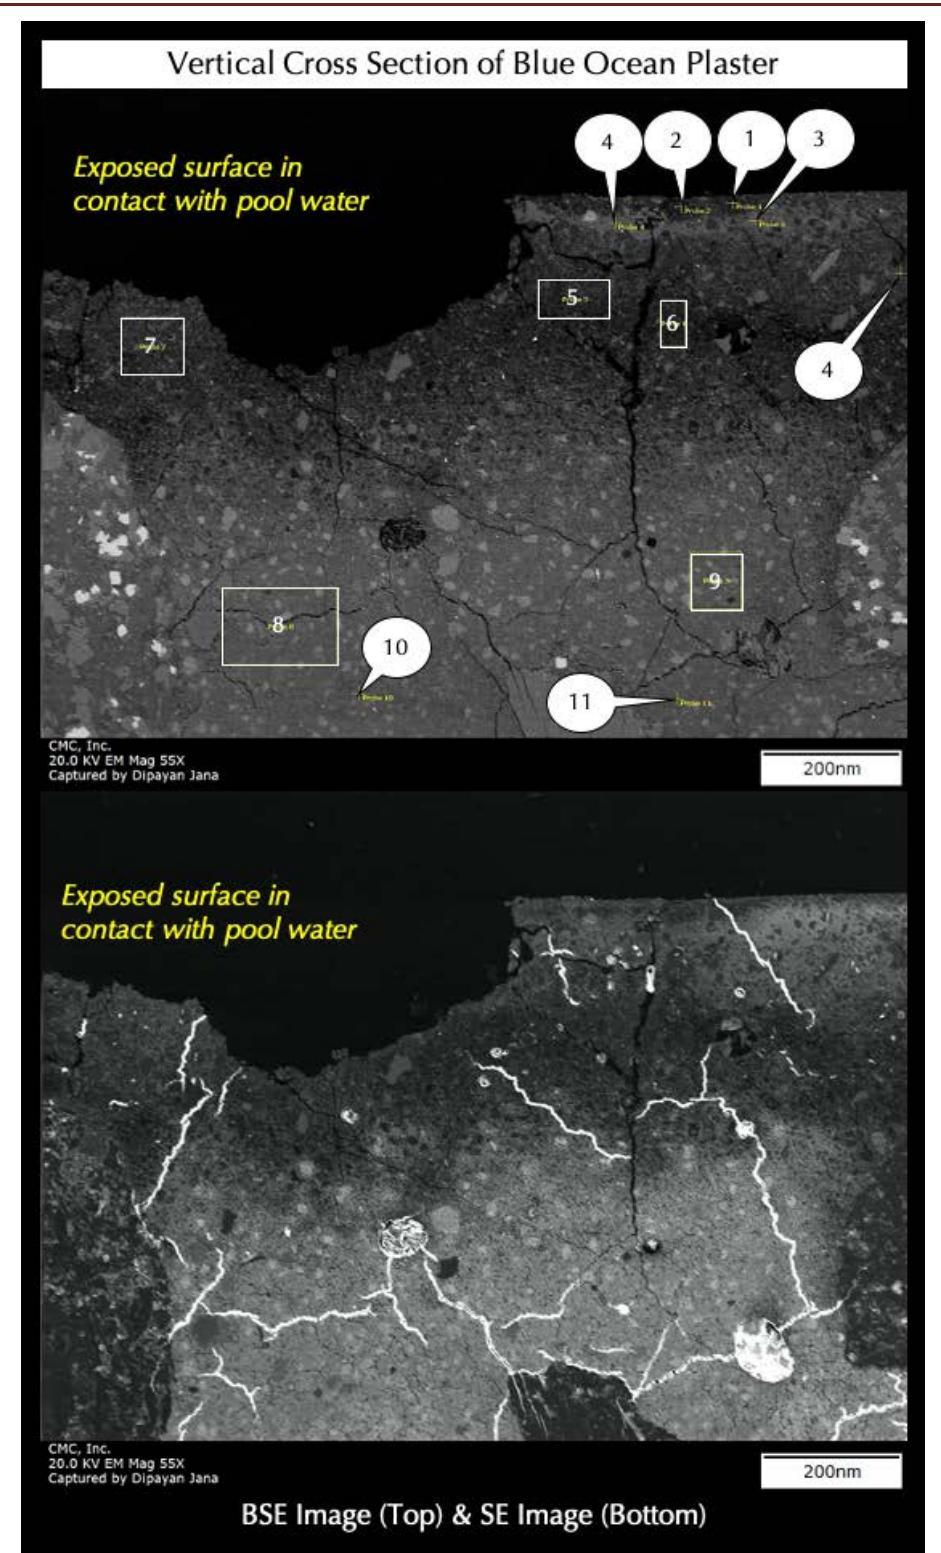
Fig. A 71: Backscatter electron (BSE) image (top) and X-ray microanalyses at the tips of callouts and in boxed areas on the vertical cross section of Primera Stone Blue Ocean plaster showing compositional variations of paste from the exposed surface region (Probe# 1 to 4) to interior (Probe# 8 to 11) due to interaction of plaster with pool water. Dissolution of paste by pool water is seen from variations in sulfate contents from the low sulfate in the dissolved paste at the top (Probe# 1 to 4) compared to higher sulfate in the interior paste in Probe# 8 to 11. The fine light gray particles in paste are residual alite. Two basalt particles in aggregate are seen at left and right edges. Paste shows network of fine shrinkage microcracks.

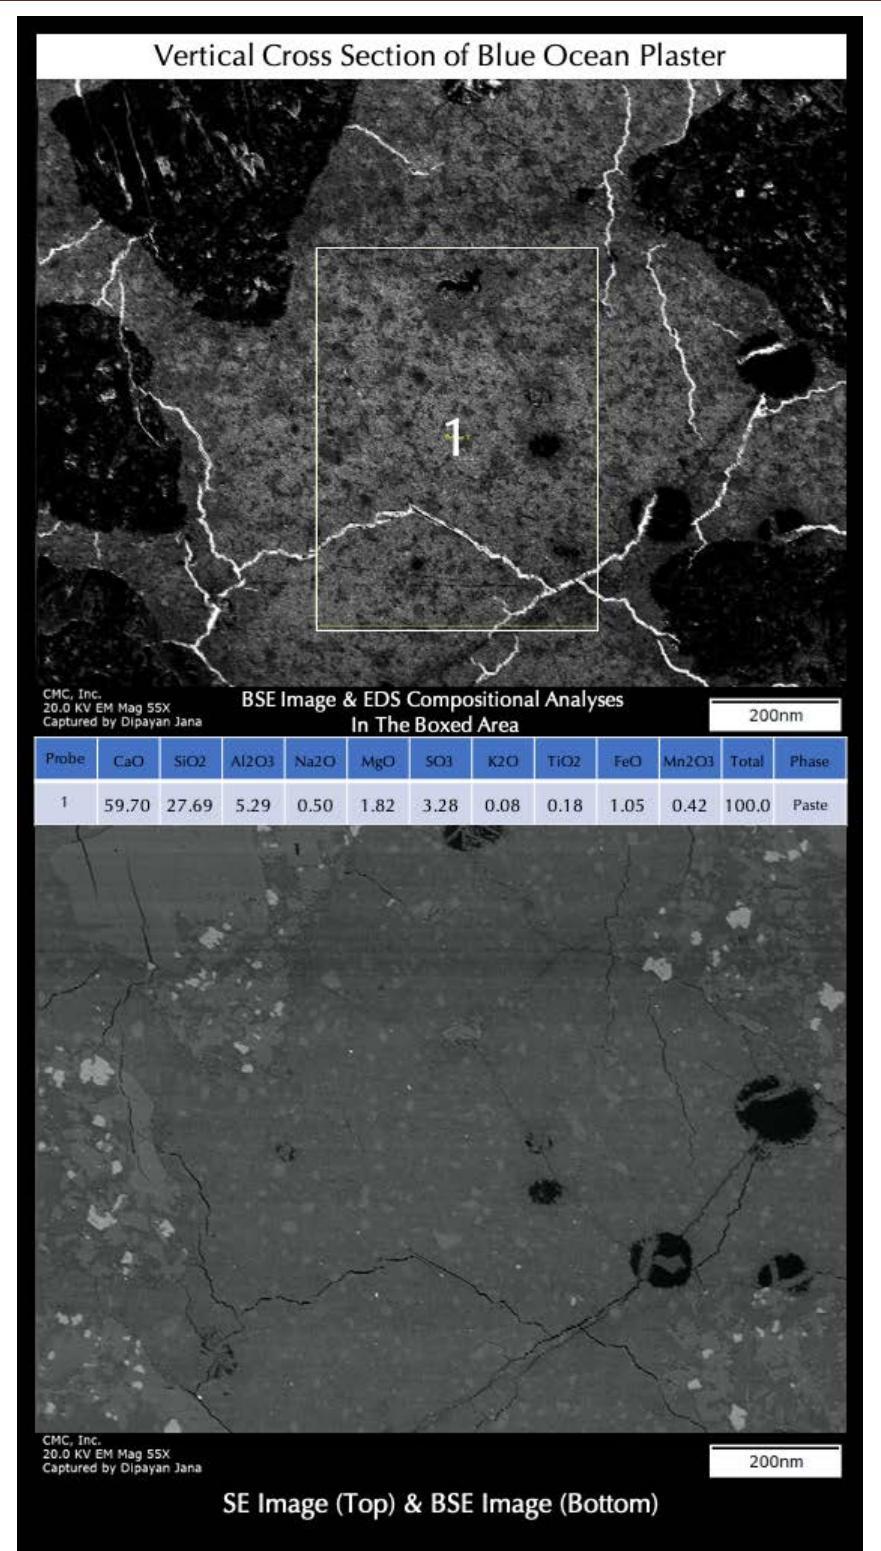
Fig. A 72: Backscatter electron (BSE) image (top) and corresponding secondary electron (SE) image (bottom) of the vertical cross section of Primera Stone Blue Ocean plaster showing different shades of lighter and darker gray areas of paste due to variations in chemical compositions of aggregates and interstitial paste where the latter shows numerous fine vertical hairline shrinkage microcracks. The tips of callouts and boxed areas in the BSE image are analyzed in the previous Figure. Notice the paste color variations in SE image due to dissolution of paste by pool water that has created a darker gray paste at the surface region in both images.
