### Swimming Pool Plaster Discoloration – A Case Study From Field & Laboratory-Cured Plasters

Primera Stone Sapphire Treasure & Blue Ocean

CONSTRUCTION MATERIALS CONSULTANTS, INC.

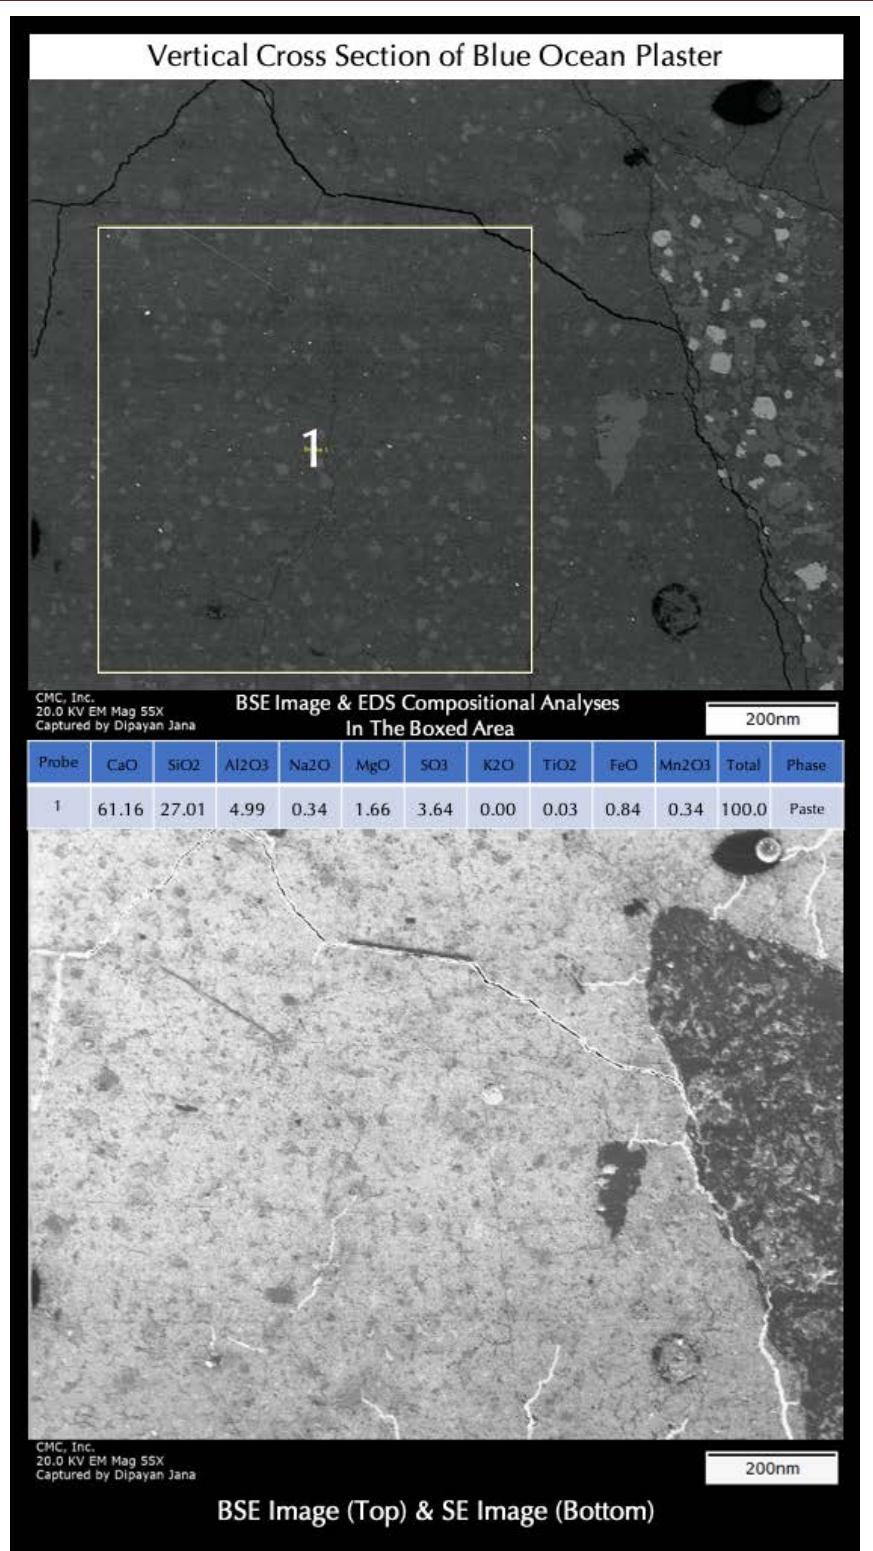
Fig. A 74: Secondary electron (SE) image (top) and corresponding backscatter electron (BSE) image (bottom) of the vertical cross section of Primera Stone Blue Ocean plaster from the interior region of plaster showing a central region of paste having numerous fine shrinkage microcracks and a basalt aggregate at the right side. The boxed area in the paste in SE image is analyzed below which showed typical calcium silicate hydrate and calcium hydroxide compositions of cement hydration products except higher sulfate than that contributed from Portland cement due to dissolution of some sulfate from barium sulfate extender present in the pigment dyes.

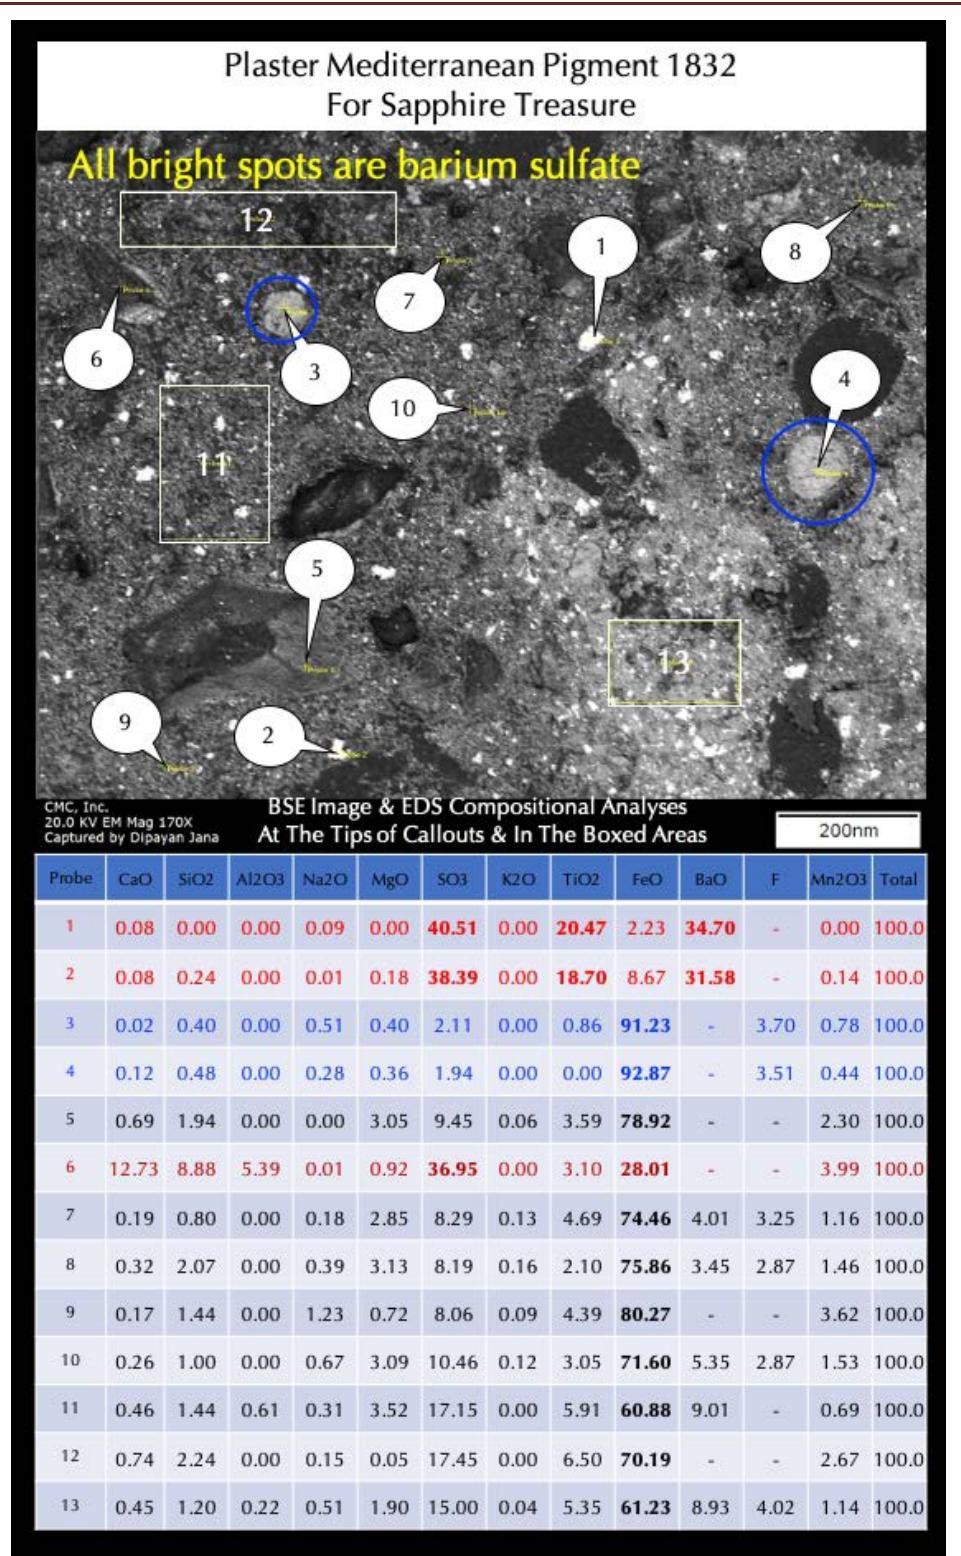
Fig. A 89: Backscatter electron image (BSE) and corresponding X-ray microanalyses of 1832 Mediterranean pigment dye used for Primera Stone Sapphire Treasure plaster. The dye showed the presence of a barium sulfate extender (Probe# 1 and 2), which appeared as bright spots in this image all over the dye, which is responsible for the higher sulfate content of paste in the field plaster samples compared to the sulfate contributed from hydration of Portland cement. The dye showed iron oxide as the main component along with variable other components present in minor amounts.

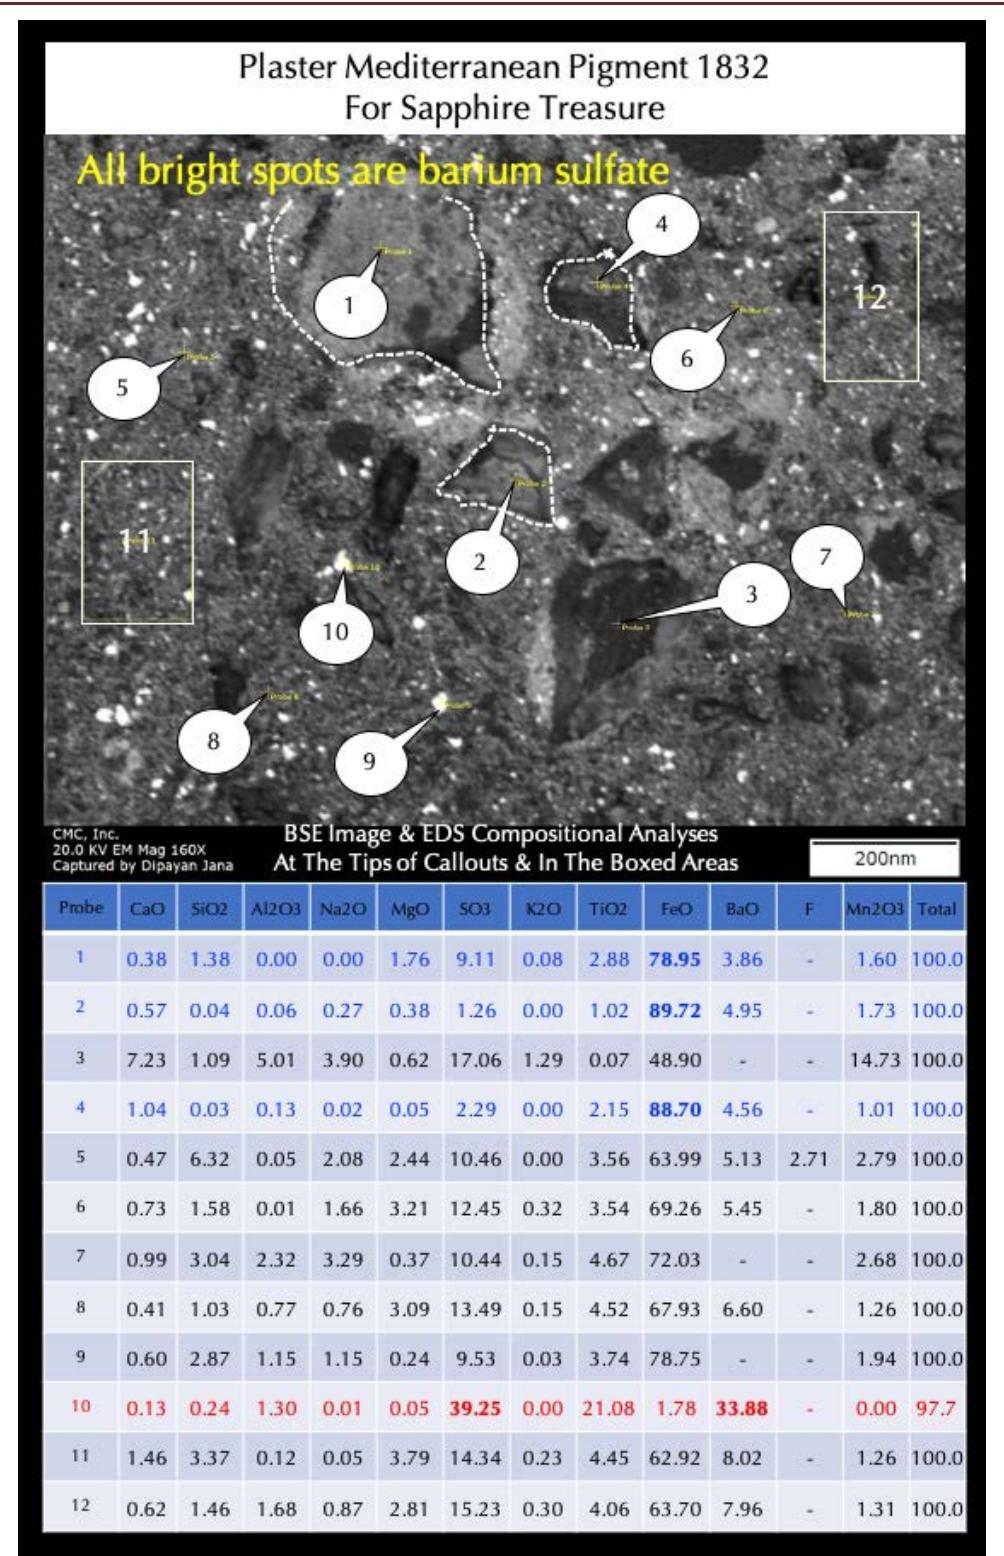
Fig. A 90: Backscatter electron image (BSE) and corresponding X-ray microanalyses of 1832 Mediterranean pigment dye used for Primera Stone Sapphire Treasure plaster. The dye showed the presence of a barium sulfate extender (Probe# 10), which appeared as bright spots in this image all over the dye, which is responsible for the higher sulfate content of paste in the field plaster samples compared to the sulfate contributed from hydration of Portland cement. The dye showed iron oxide as the main component along with variable other components present in minor amounts.

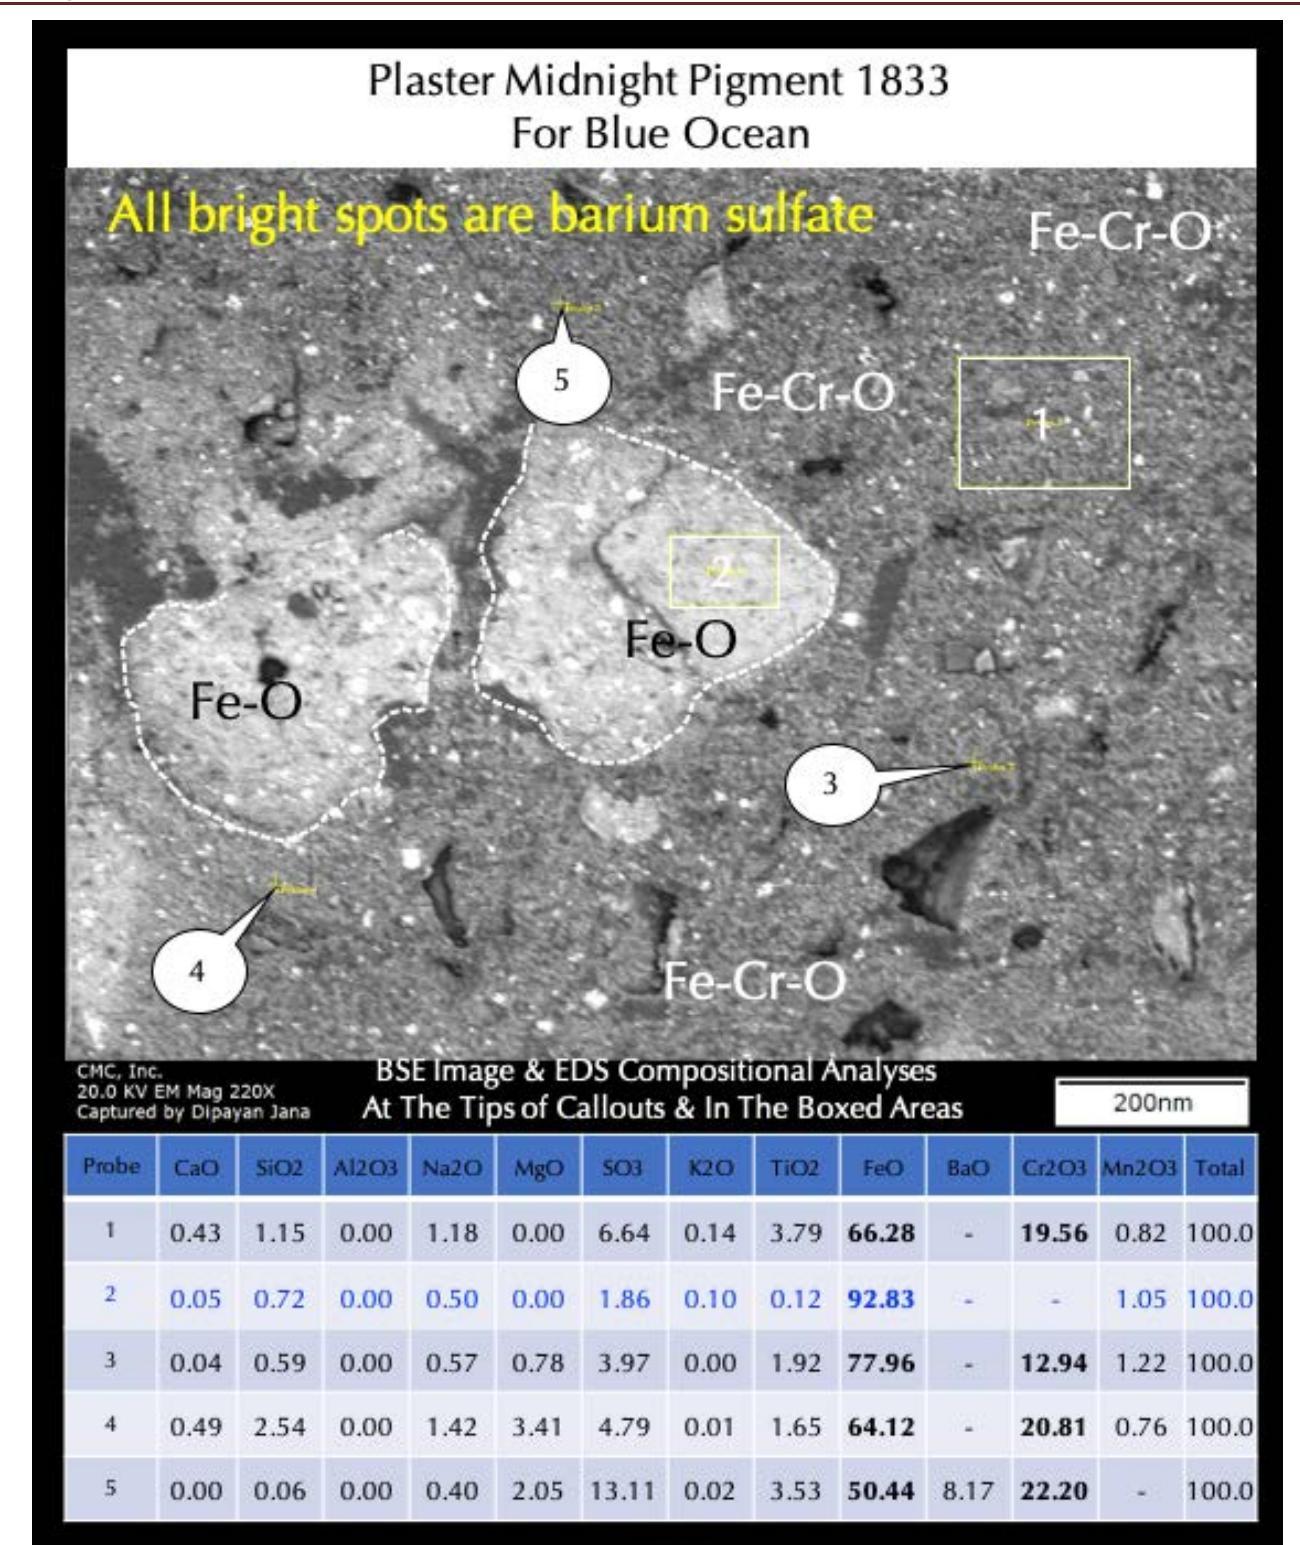
Fig. A 92: Backscatter electron image (BSE) and corresponding X-ray microanalyses of 1833 Midnight pigment dye used for Primera Stone Blue Ocean plaster. The dye showed the presence of a barium sulfate extender, which appeared as bright spots in this image all over the dye, which is responsible for the higher sulfate content of paste in the field plaster samples compared to the sulfate contributed from hydration of Portland cement. The dye showed iron-chromium oxide as the main component along with variable other components present in minor amounts.

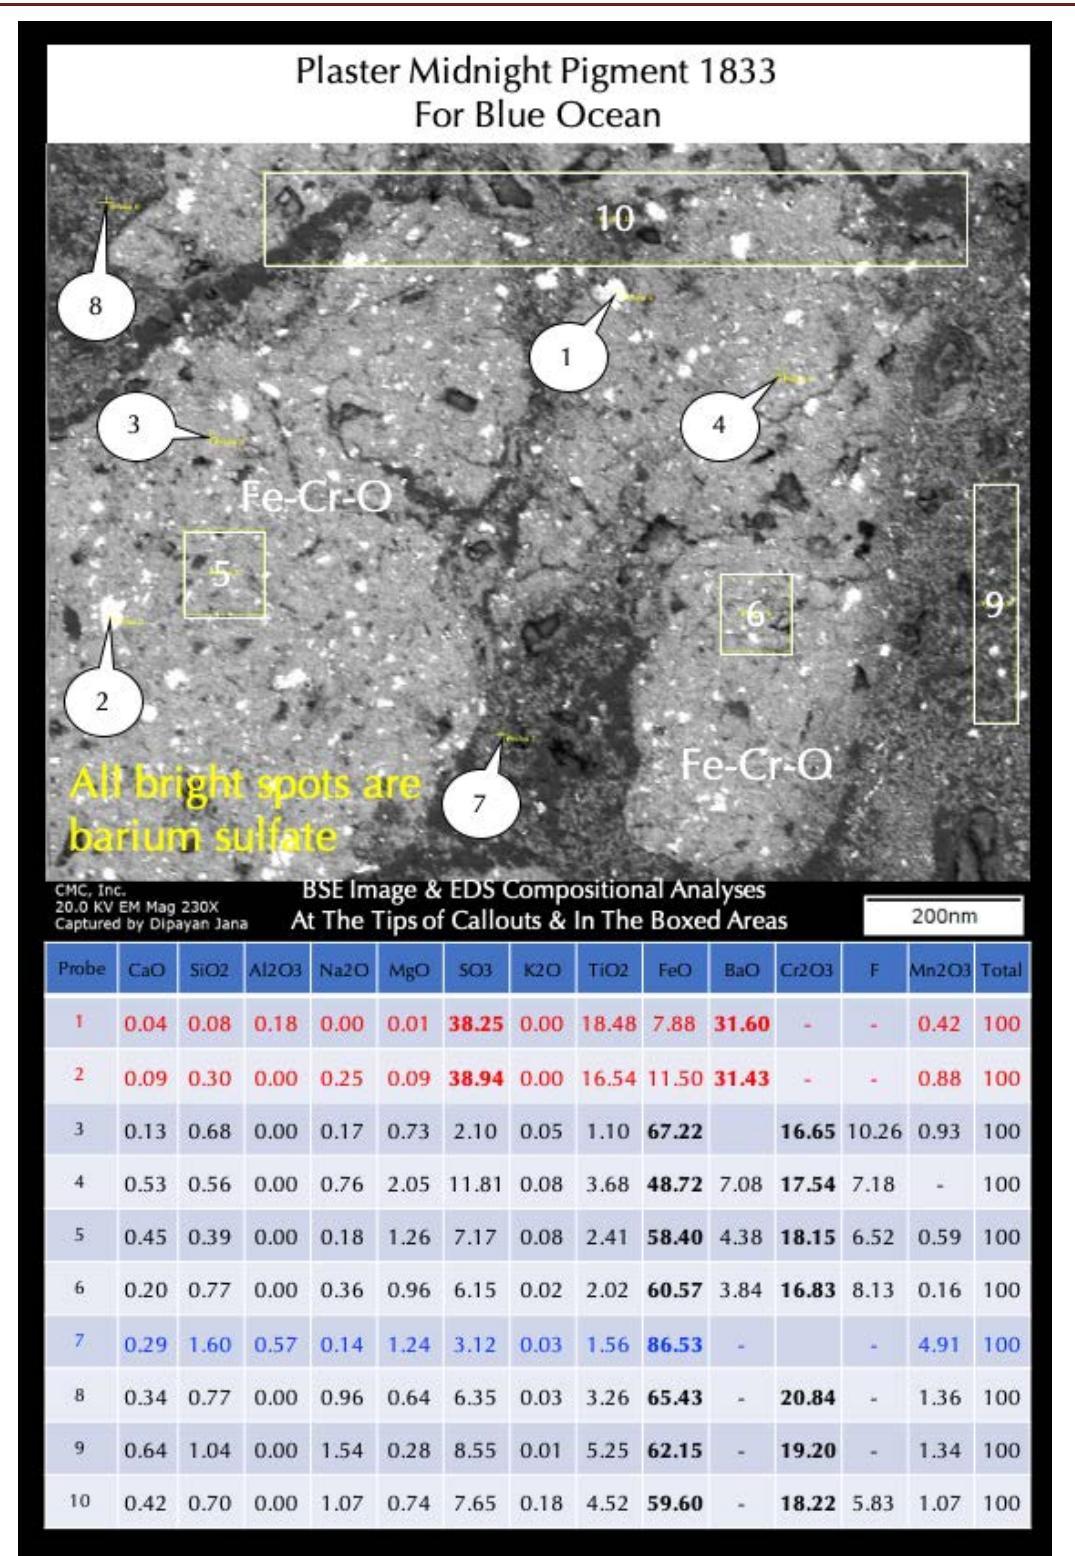
Fig. A 93: Backscatter electron image (BSE) and corresponding X-ray microanalyses of 1833 Midnight pigment dye used for Primera Stone Blue Ocean plaster. The dye showed the presence of a barium sulfate extender (Probe# 1 and 2), which appeared as bright spots in this image all over the dye, which is responsible for the higher sulfate content of paste in the field plaster samples compared to the sulfate contributed from hydration of Portland cement. The dye showed iron-chromium oxide as the main component along with variable other components present in minor amounts.

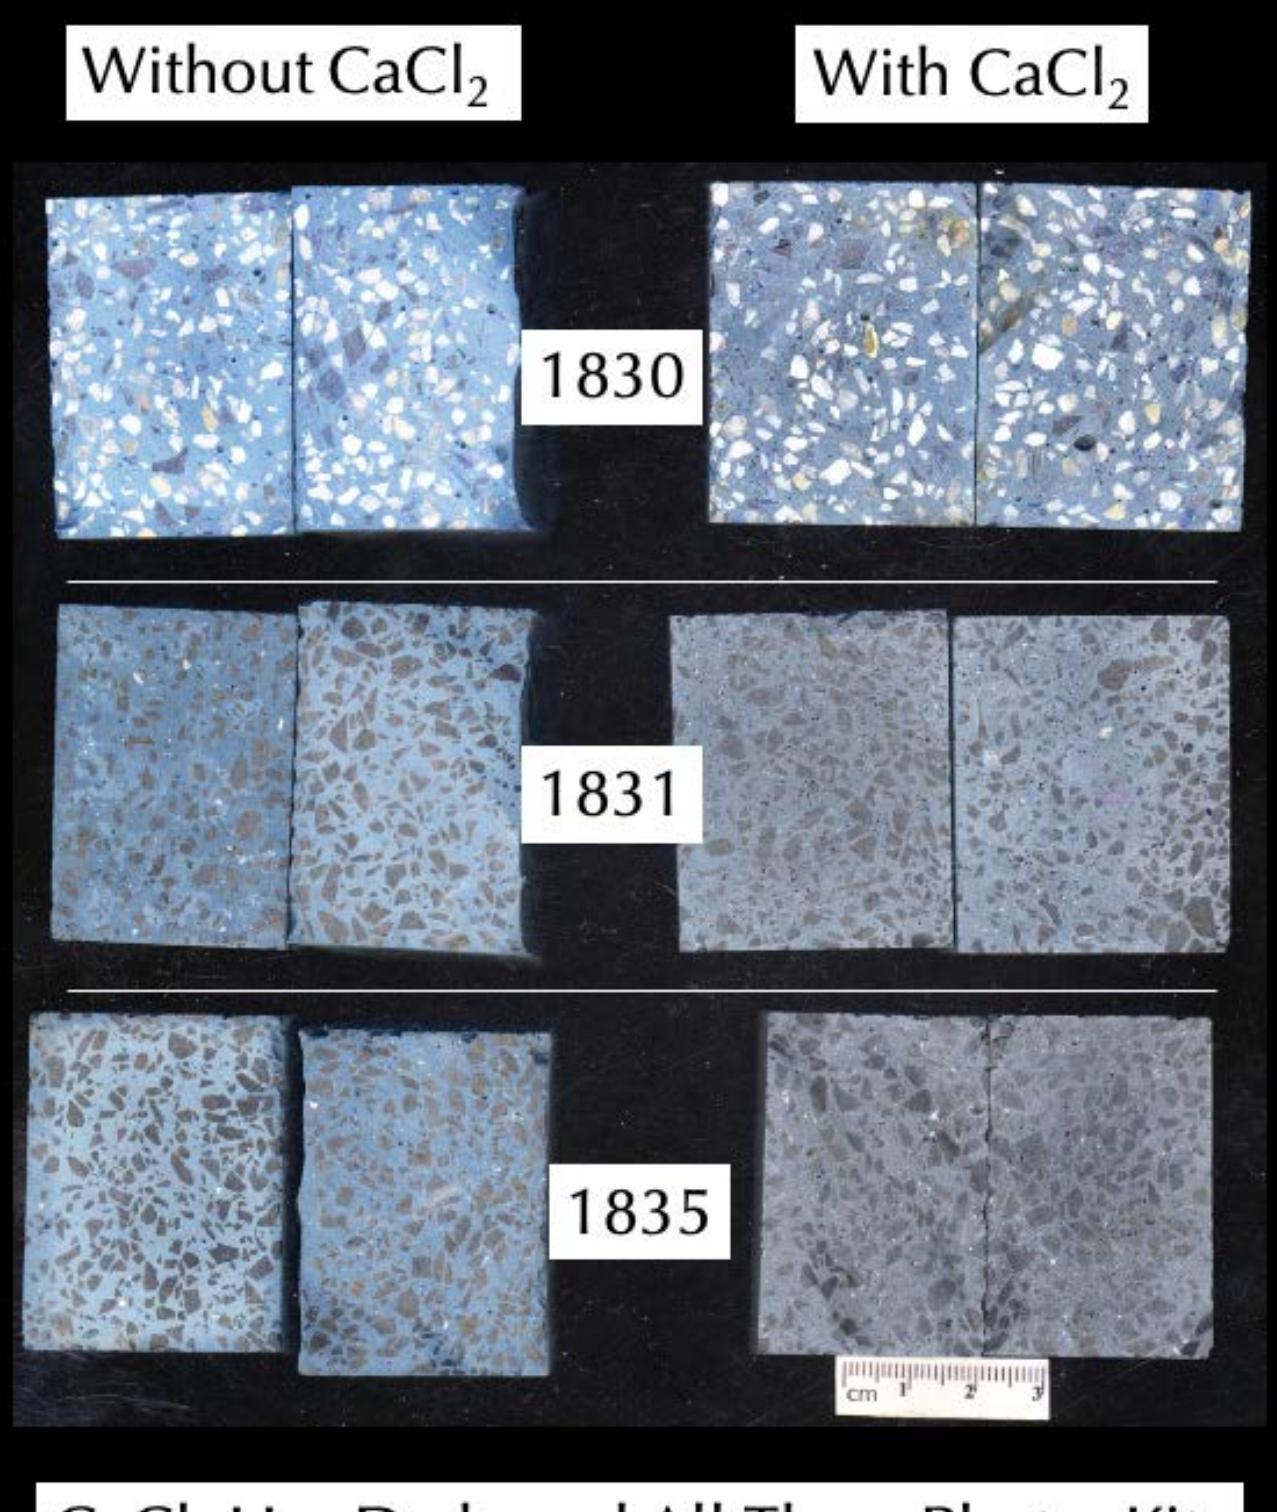
### CaCl<sub>2</sub> Has Darkened All Three Plaster Kits

Fig. A 106: Darkening of all three lab-cured hardened plaster kits due to addition of flake calcium chloride accelerating admixture in the mix water. The photos were taken prior to the immersion of samples in tap water or hypochlorite solution.

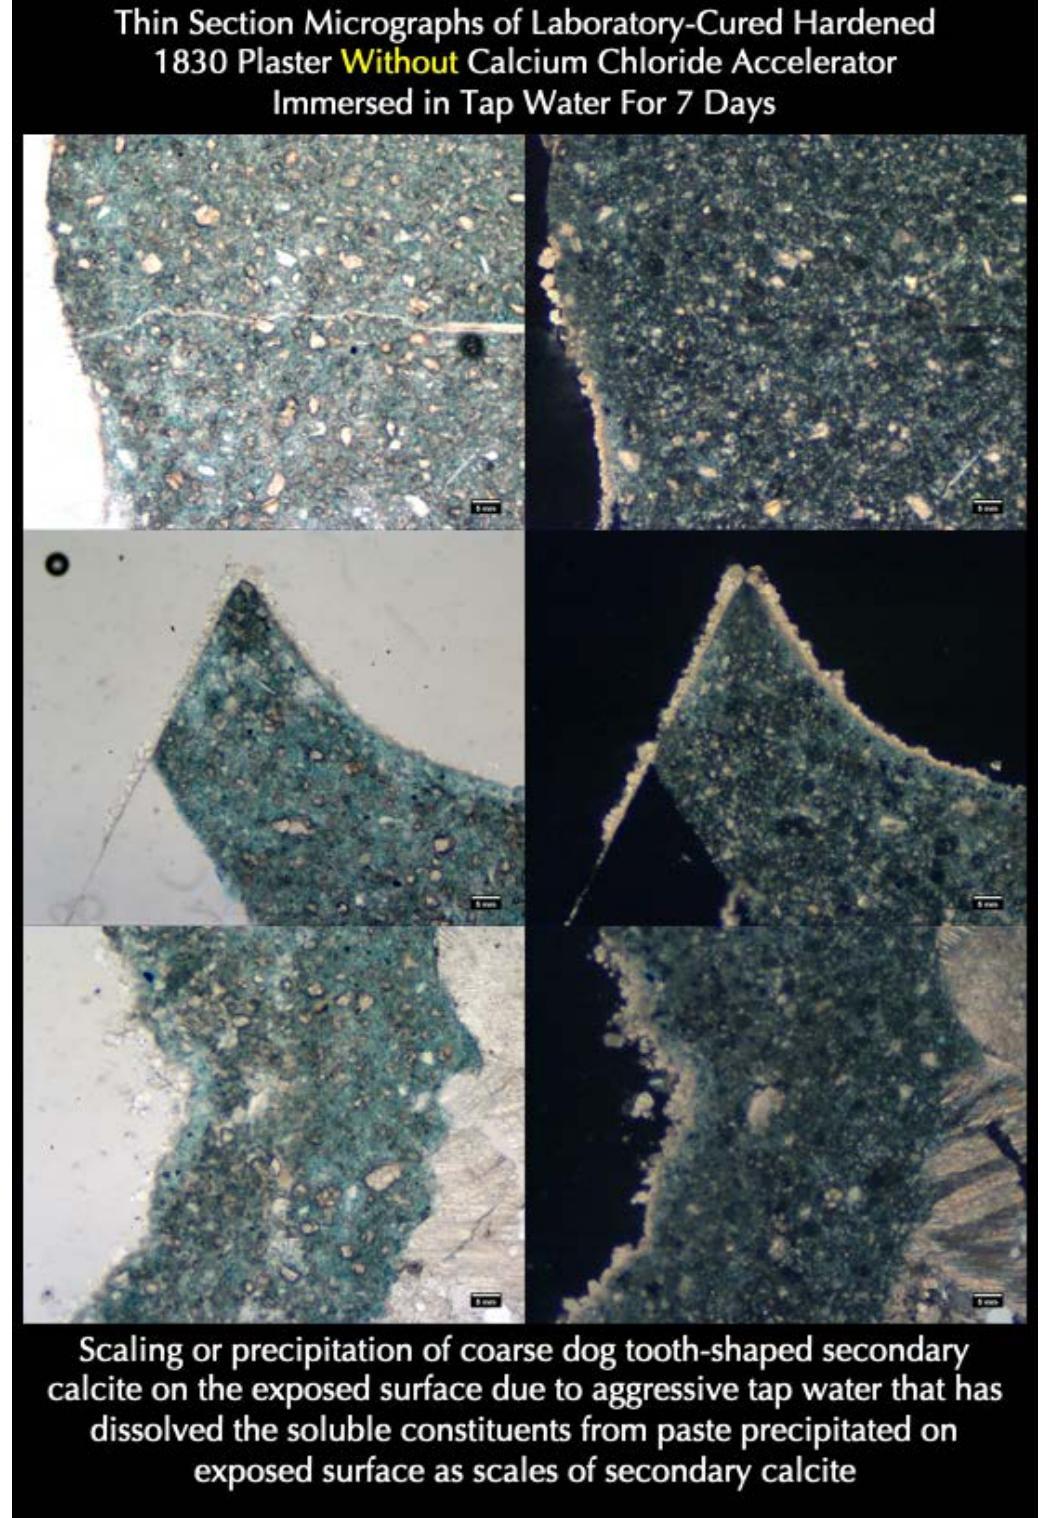
Fig. A 116: Micrographs of thin section of laboratory-cured hardened plaster kit# 1830 without calcium chloride accelerator after 7 days of immersion in tap water showing aggressive action of tap water by dissolution of soluble components of paste and precipitation as dog tooth-shaped secondary calcite precipitates on exposed surfaces.

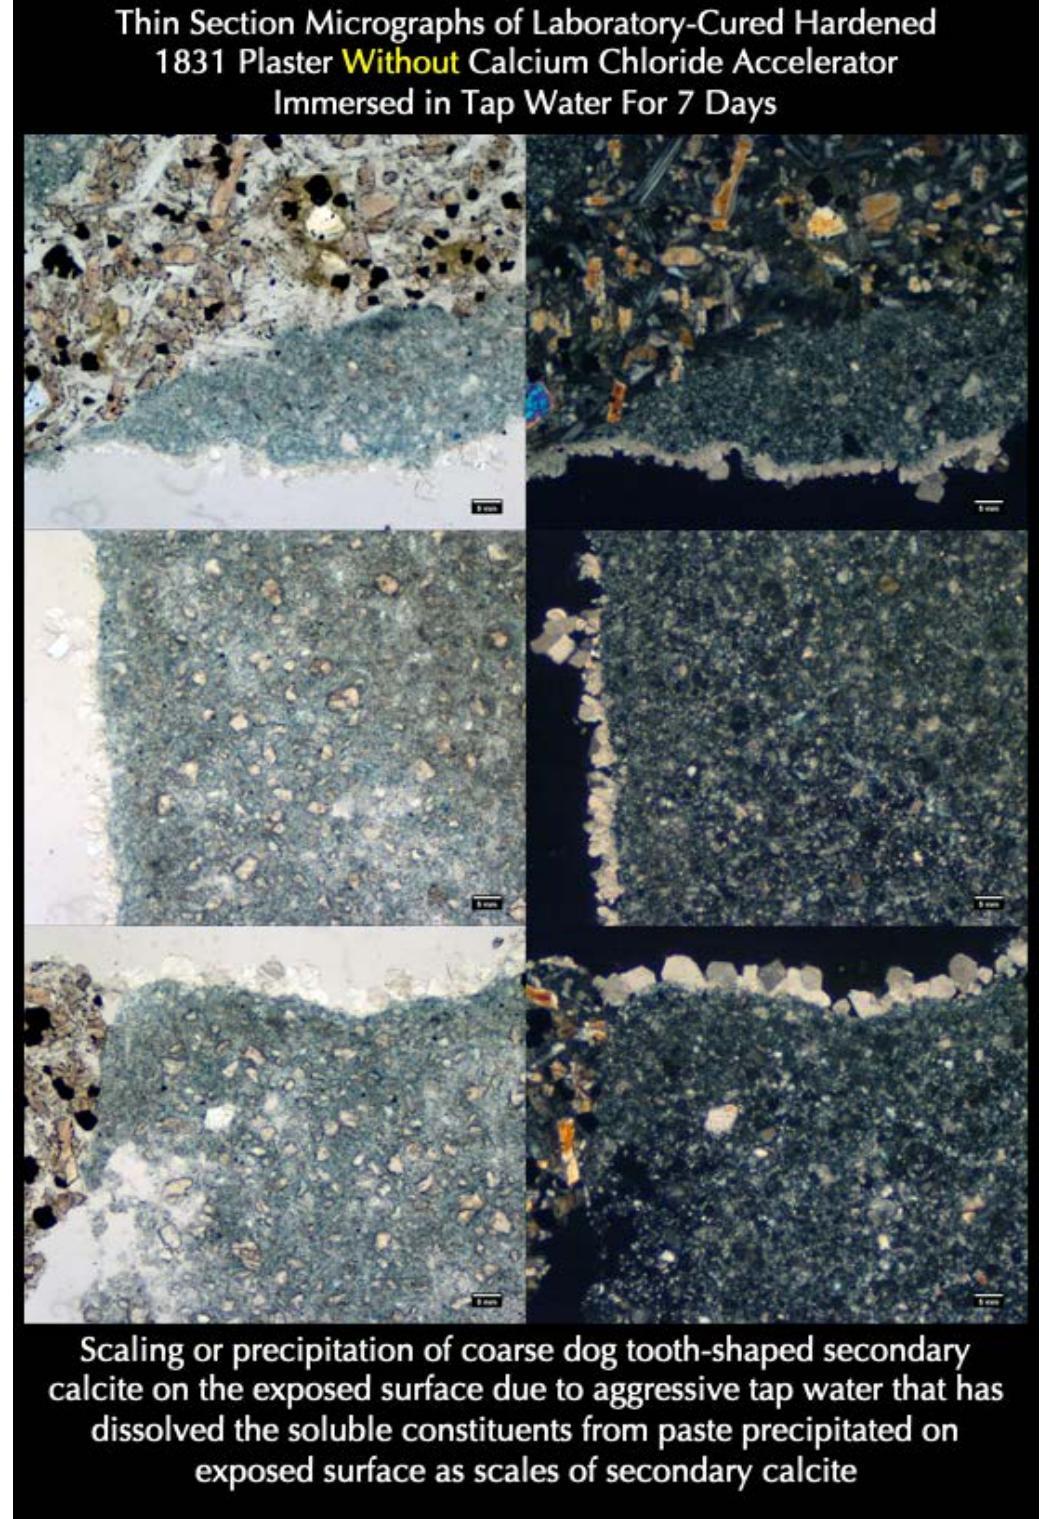
Fig. A 117: Micrographs of thin section of laboratory-cured hardened plaster kit# 1831 without calcium chloride accelerator after 7 days of immersion in tap water showing aggressive action of tap water by dissolution of soluble components of paste and precipitation as dog tooth-shaped secondary calcite precipitates on exposed surfaces.

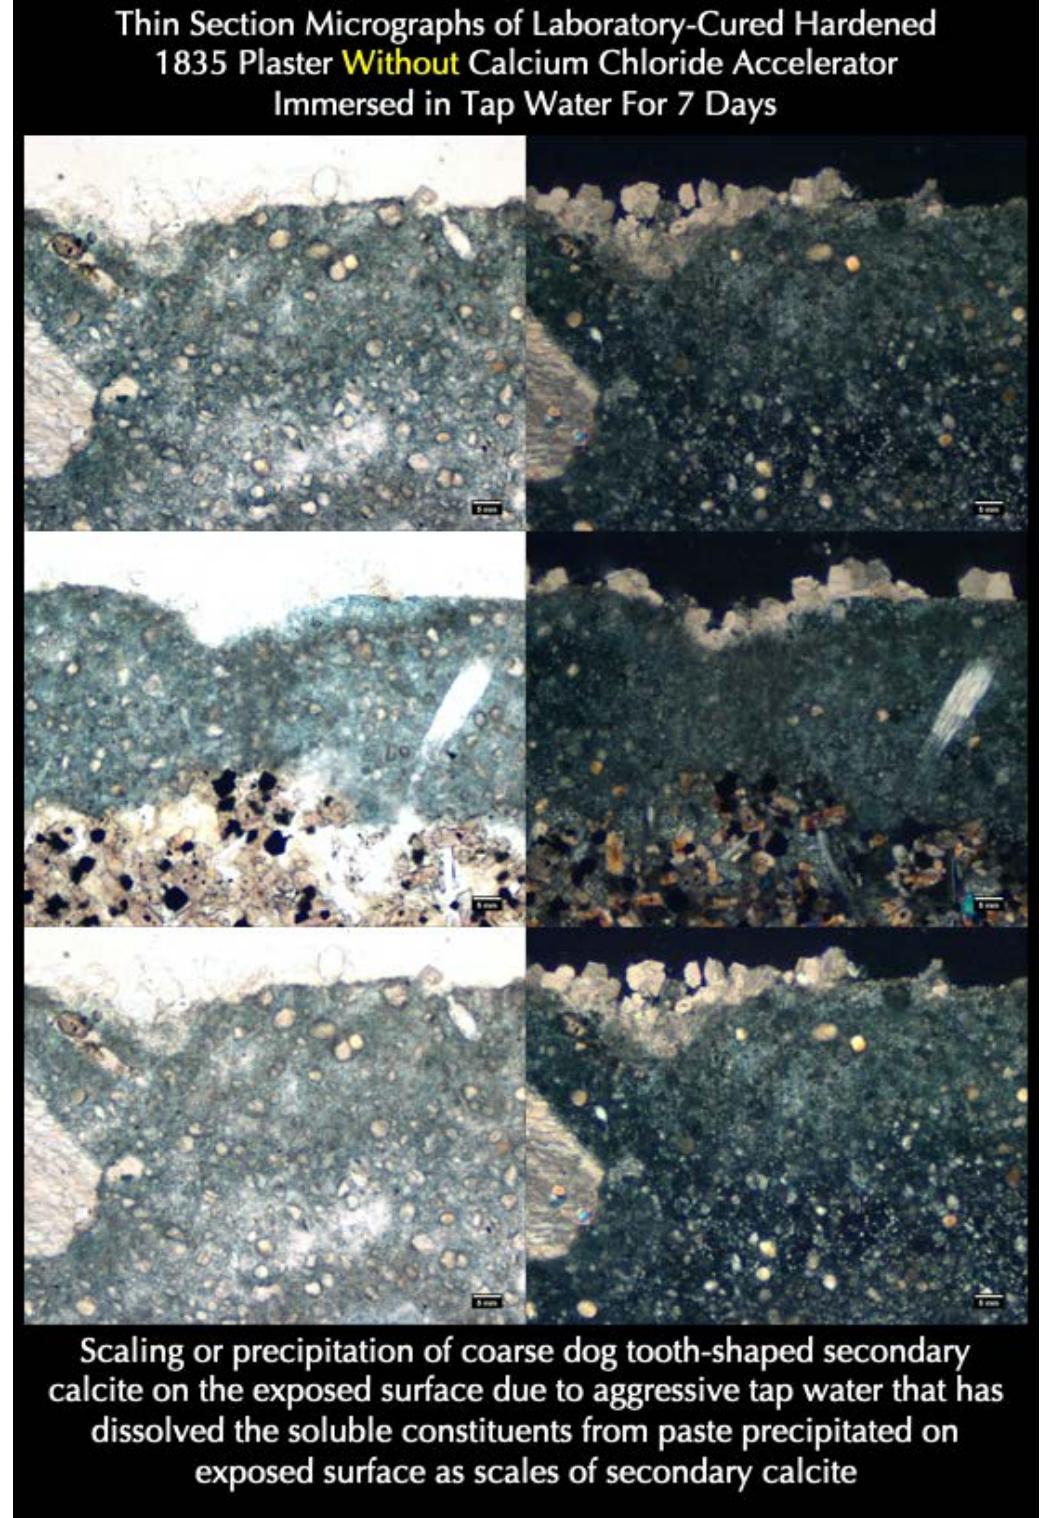
Fig. A 118: Micrographs of thin section of laboratory-cured hardened plaster kit# 1835 without calcium chloride accelerator after 7 days of immersion in tap water showing aggressive action of tap water by dissolution of soluble components of paste and precipitation as dog tooth-shaped secondary calcite precipitates on exposed surfaces.

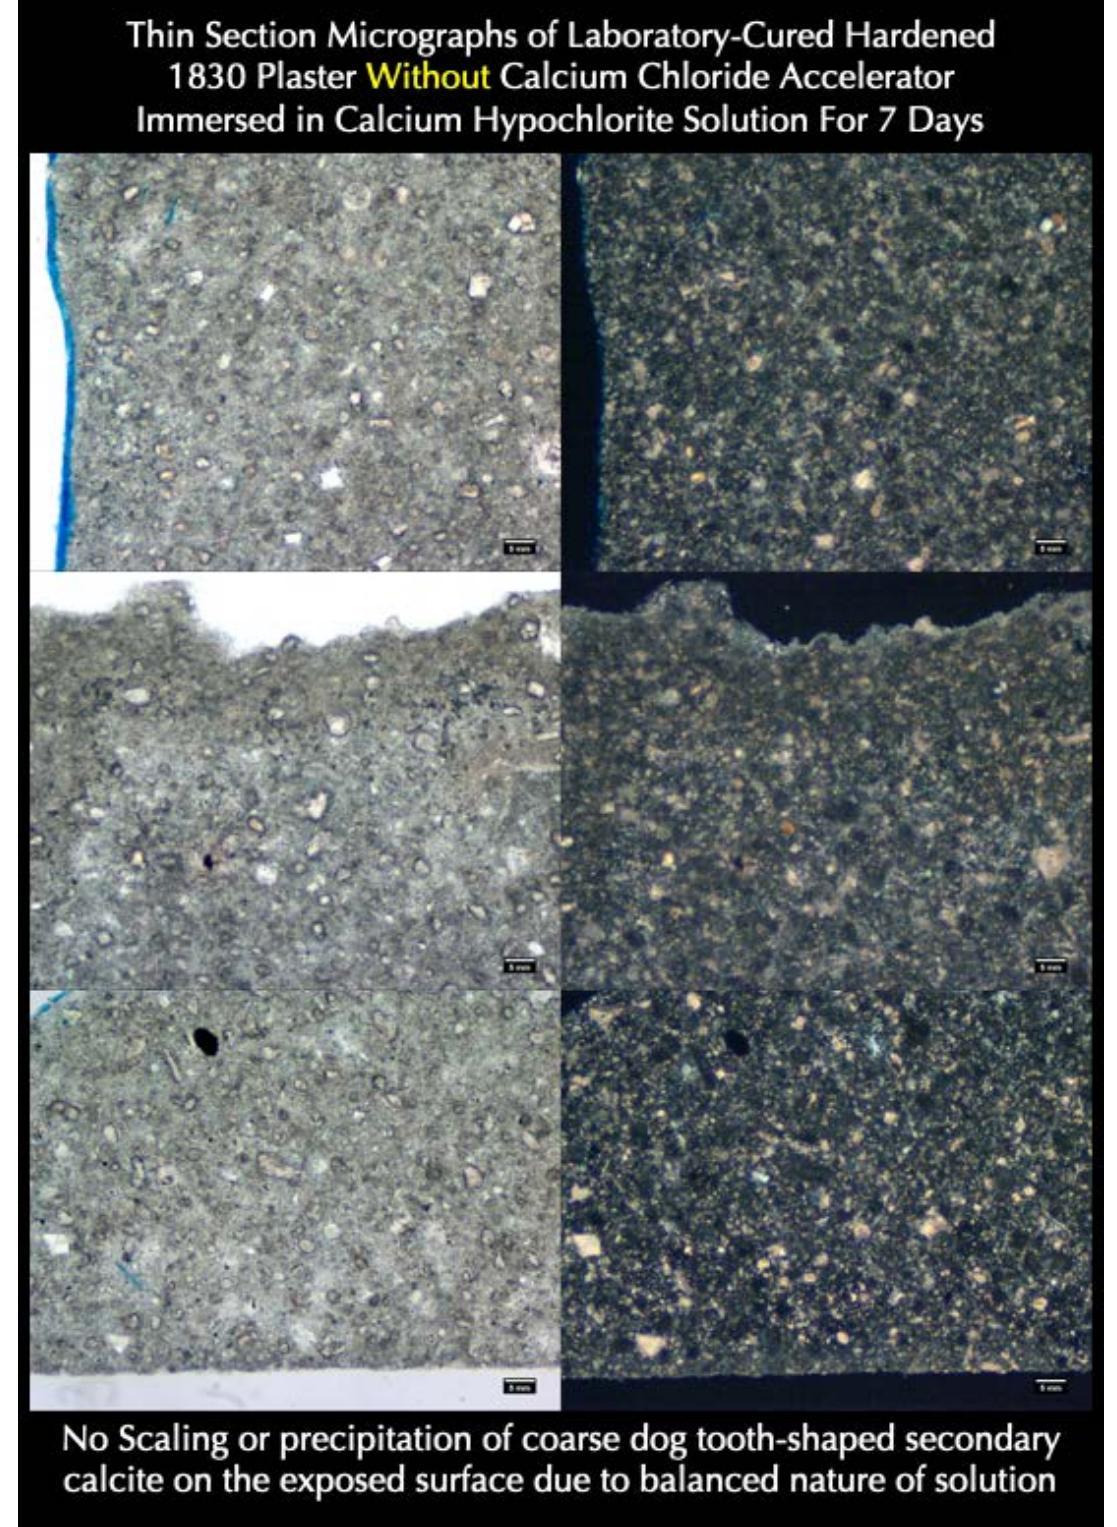
Fig. A 121: Micrographs of thin section of laboratory-cured hardened plaster kit# 1830 without calcium chloride accelerator after 7 days of immersion in calcium hypochlorite solution showing balanced nature of solution due to lack of scaling or secondary calcite precipitate on exposed surface which was seen in tap water immersion.

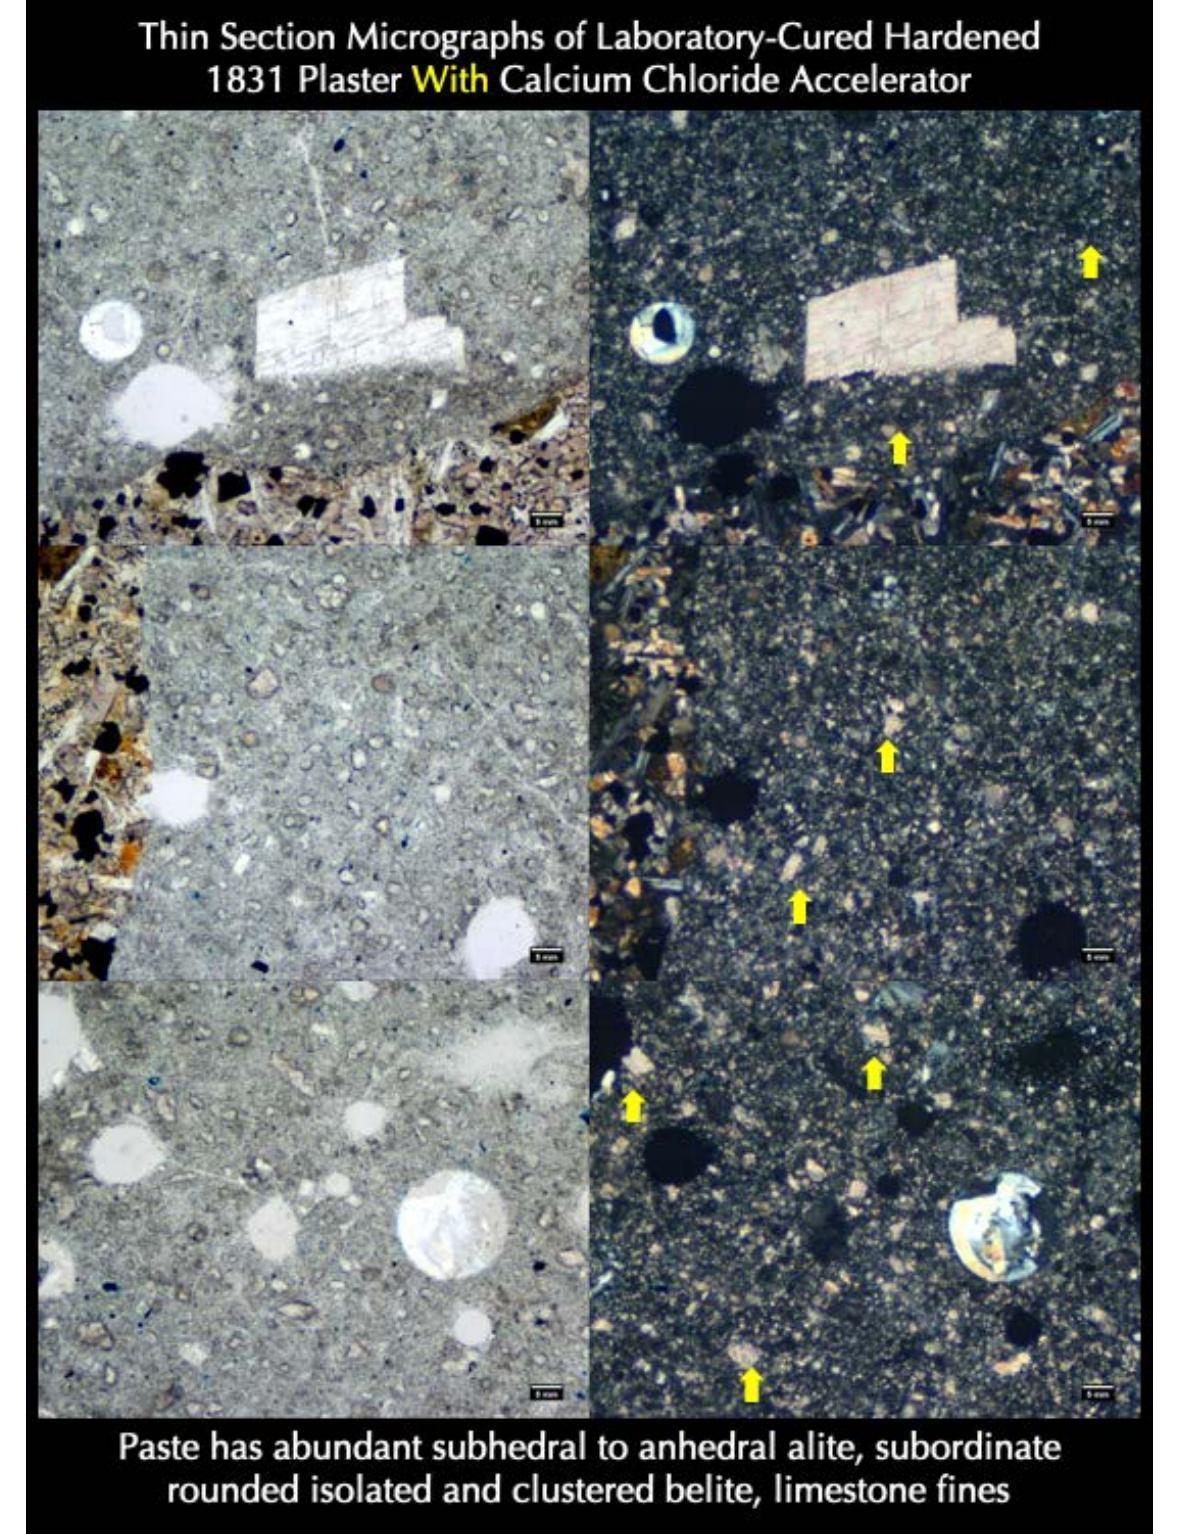
Fig. A 127: Micrographs of thin section of laboratory-cured hardened plaster kit# 1831 with calcium chloride accelerator showing abundant subhedral to anhedral alite, subordinate rounded belite, and limestone fines (a few are marked with arrows) in paste. Notice some coarsely crystalline secondary calcium hydroxide crystals in an air void in the bottom row indicating high solubility of finely crystalline calcium hydroxide component of cement hydration.

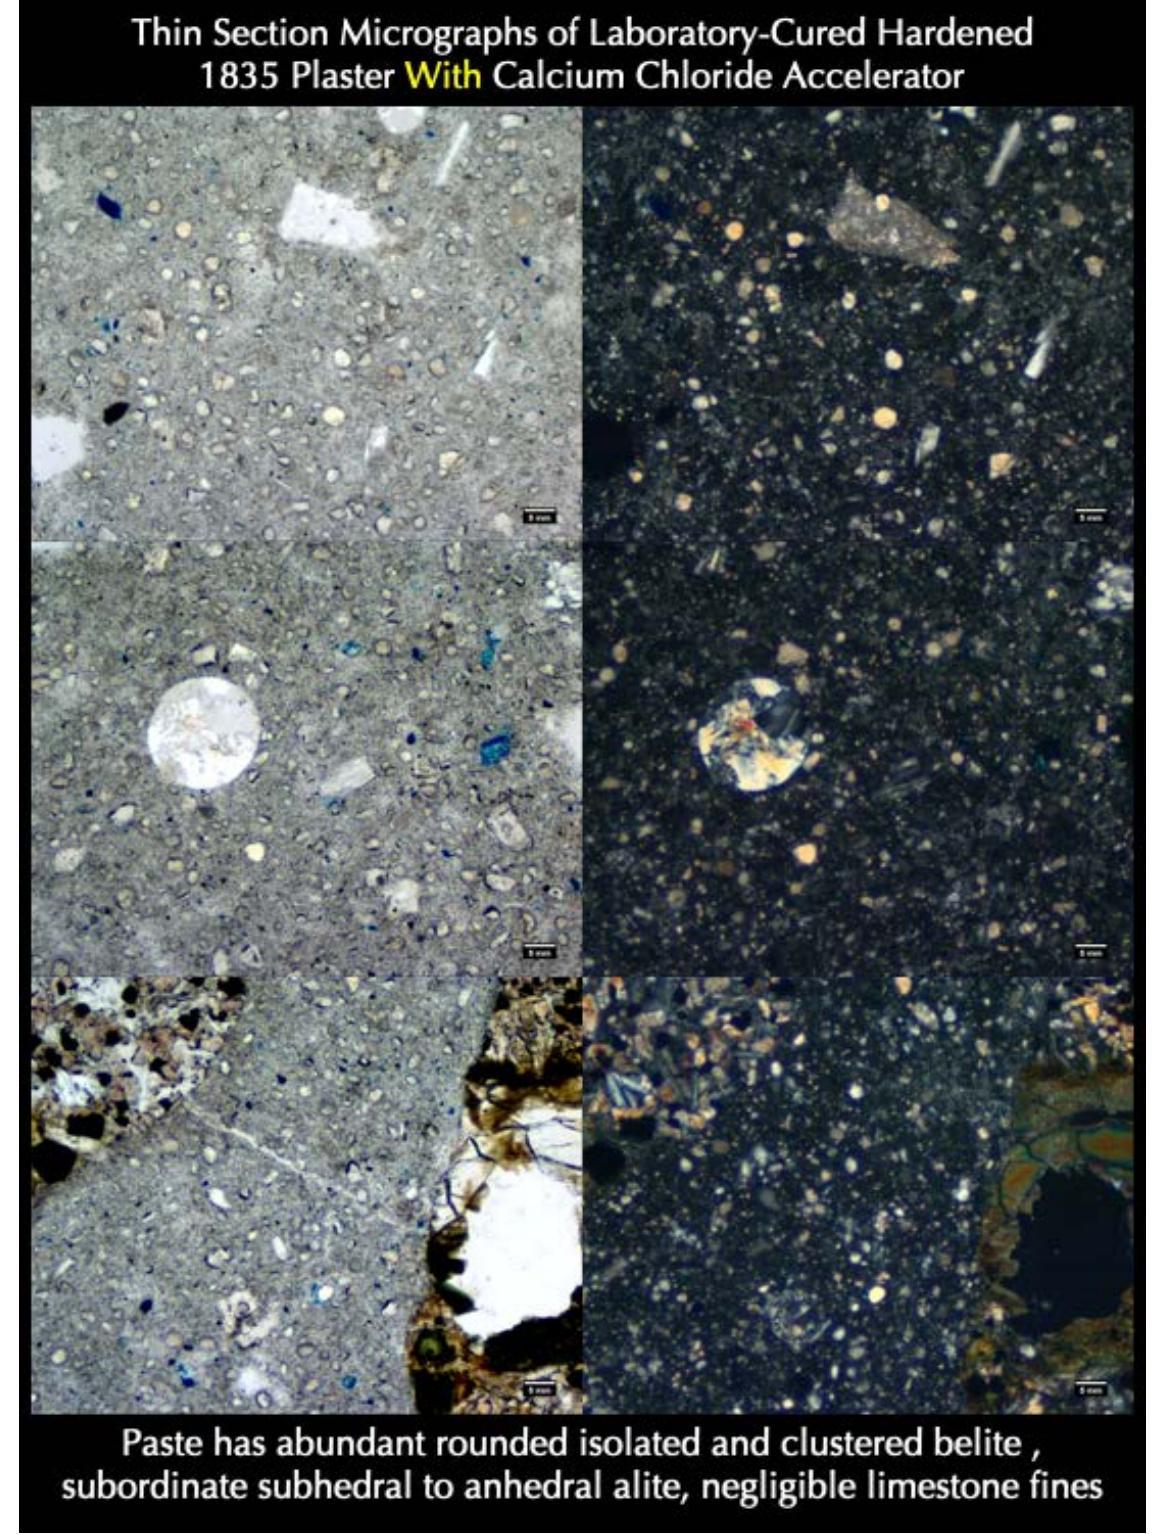
Fig. A 128: Micrographs of thin section of laboratory-cured hardened plaster kit# 1835 with calcium chloride accelerator showing abundant rounded belite, subordinate subhedral to anhedral alite, and minor limestone fines in paste. Notice some coarsely crystalline secondary calcium hydroxide crystals in an air void in the middle row indicating high solubility of finely crystalline calcium hydroxide component of cement hydration.
