### Swimming Pool Plaster Discoloration – A Case Study From Field & Laboratory-Cured Plasters

Primera Stone Sapphire Treasure & Blue Ocean

CONSTRUCTION MATERIALS CONSULTANTS, INC.

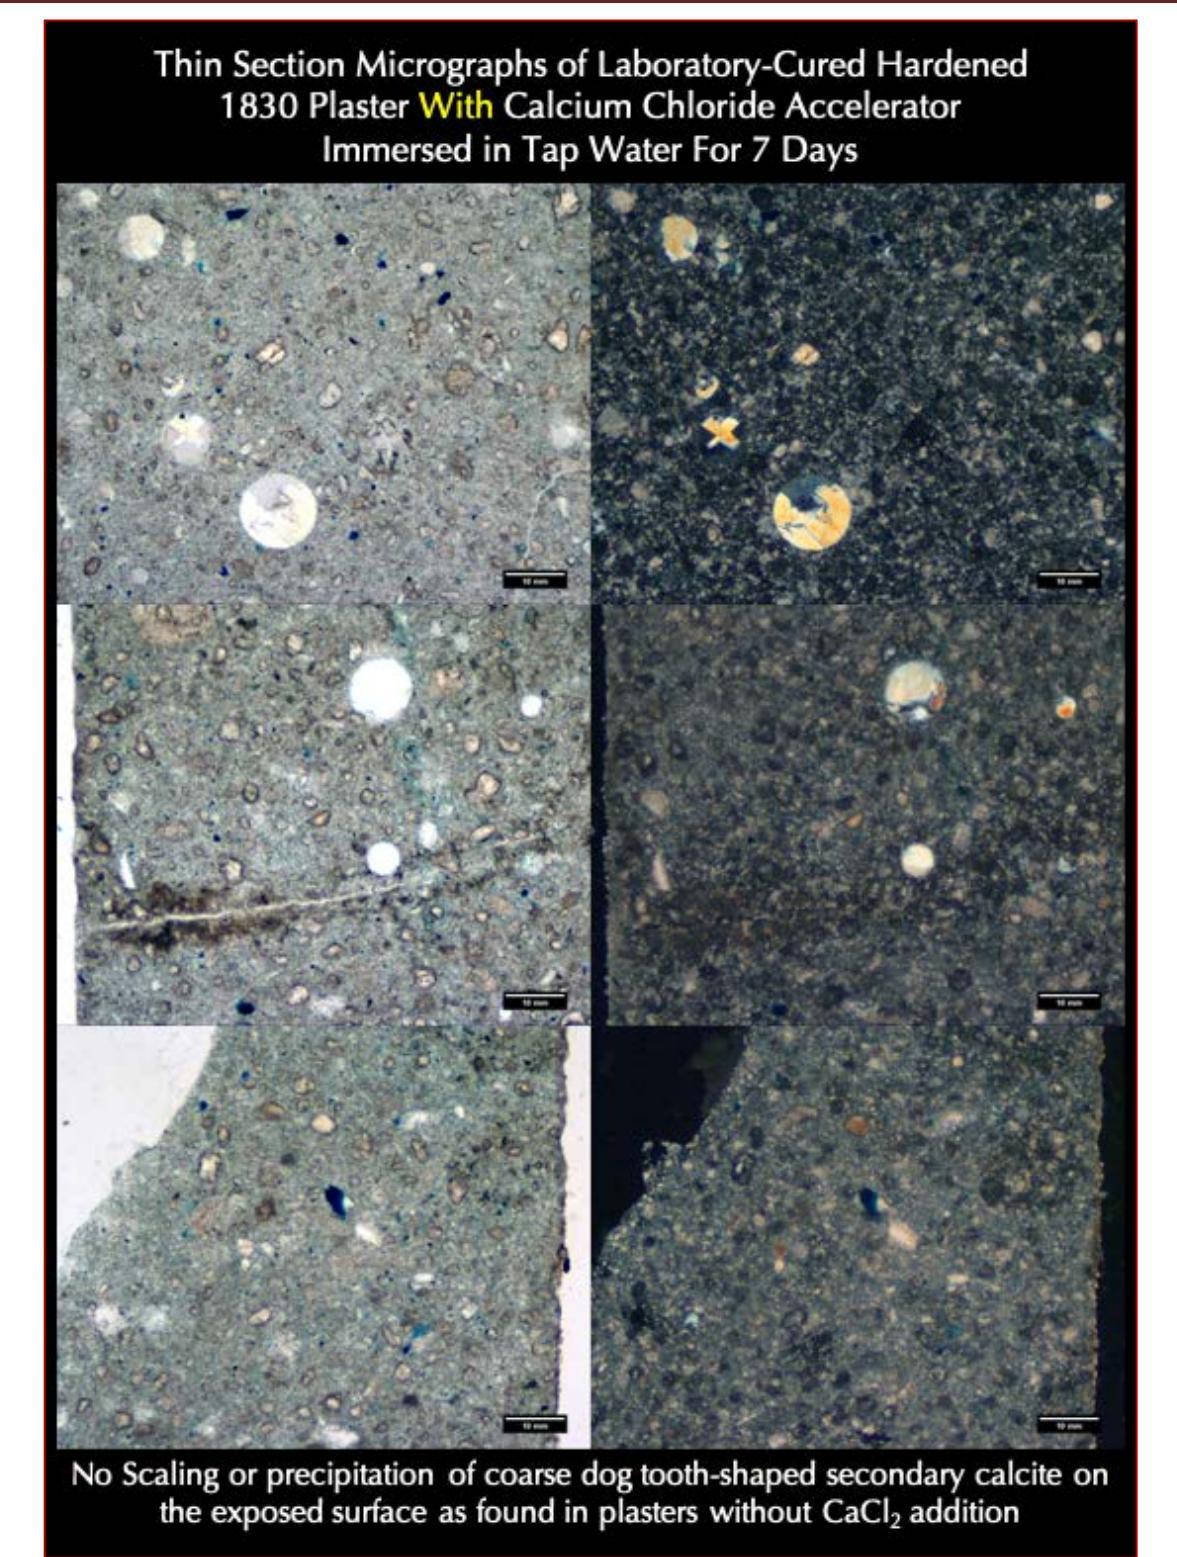
Fig. A 129: Micrographs of thin section of laboratory-cured hardened plaster kit# 1830 with calcium chloride accelerator immersed in tap water for 7 days, showing abundant residual alite grains, and subordinate limestone fines in paste. Notice some coarsely crystalline lath-shaped secondary calcium hydroxide crystals in air voids indicating high solubility of finely crystalline calcium hydroxide component of cement hydration in water. Notice the lack of surface scaling of secondary calcite.

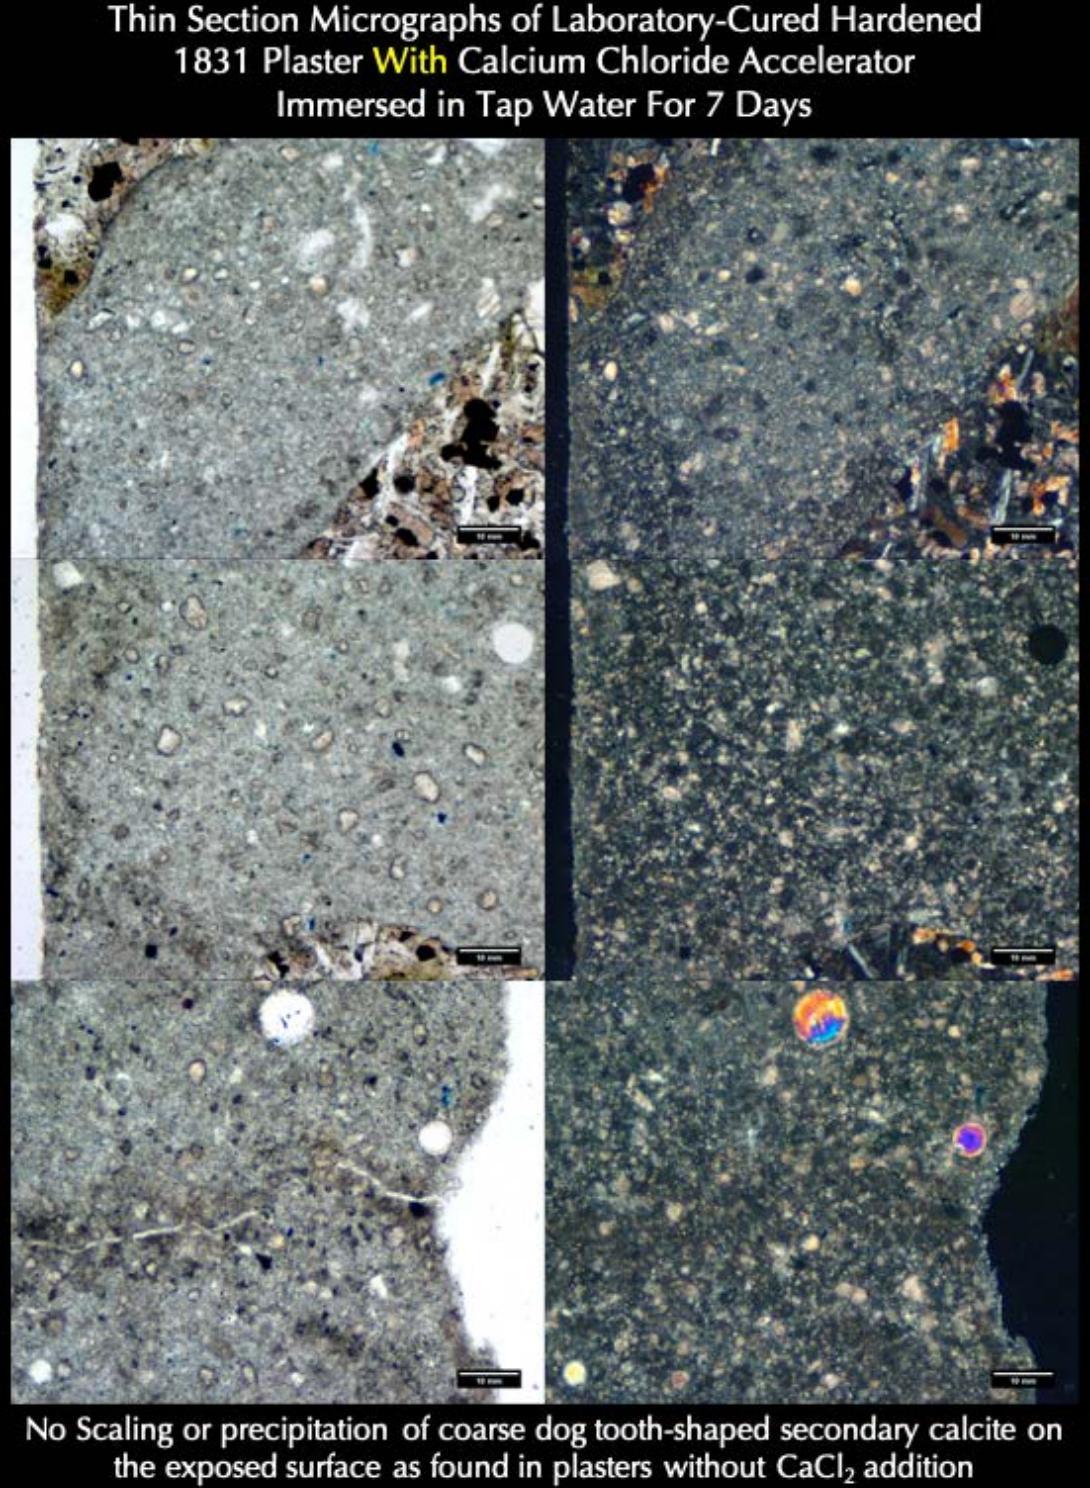
Fig. A 130: Micrographs of thin section of laboratory-cured hardened plaster kit# 1831 with calcium chloride accelerator immersed in tap water for 7 days, showing abundant residual alite grains, and subordinate limestone fines in paste. Notice some coarsely crystalline lath-shaped secondary calcium hydroxide crystals in air voids indicating high solubility of finely crystalline calcium hydroxide component of cement hydration in water. Notice the lack of surface scaling of secondary calcite.

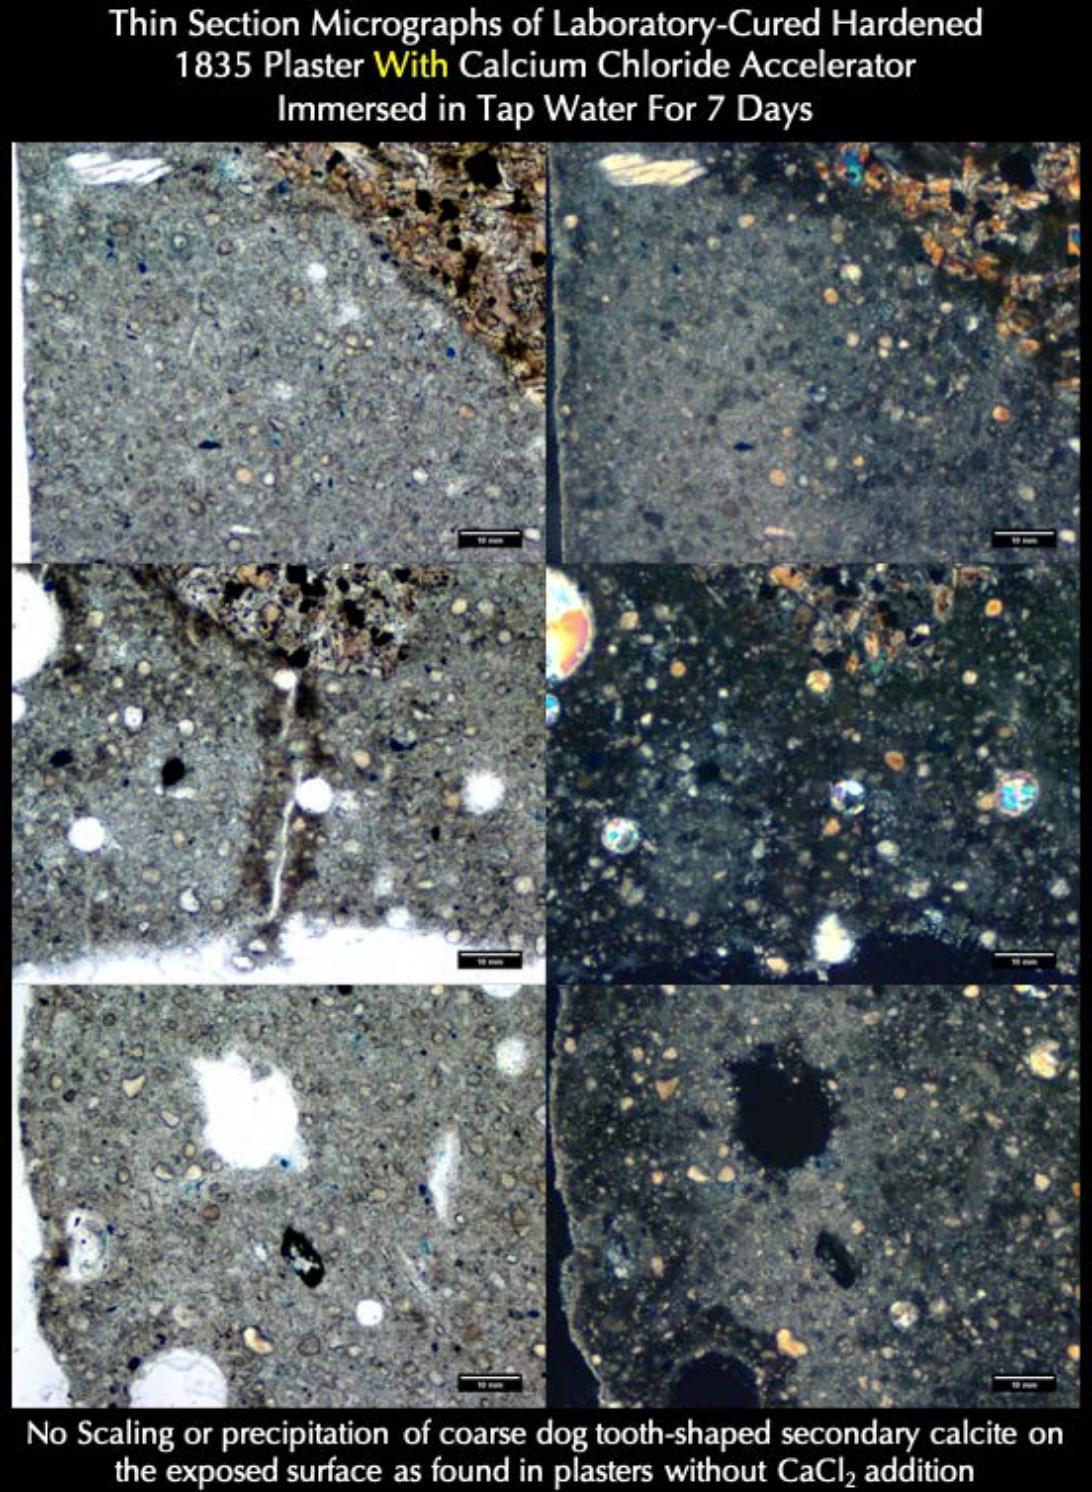
Fig. A 131: Micrographs of thin section of laboratory-cured hardened plaster kit# 1835 with calcium chloride accelerator immersed in tap water for 7 days, showing abundant residual belite grains, subordinate alite, and negligible limestone fines in paste. Notice some coarsely crystalline lath-shaped secondary calcium hydroxide crystals in air voids indicating high solubility of finely crystalline calcium hydroxide component of cement hydration in water. Notice the lack of surface scaling of secondary calcite.

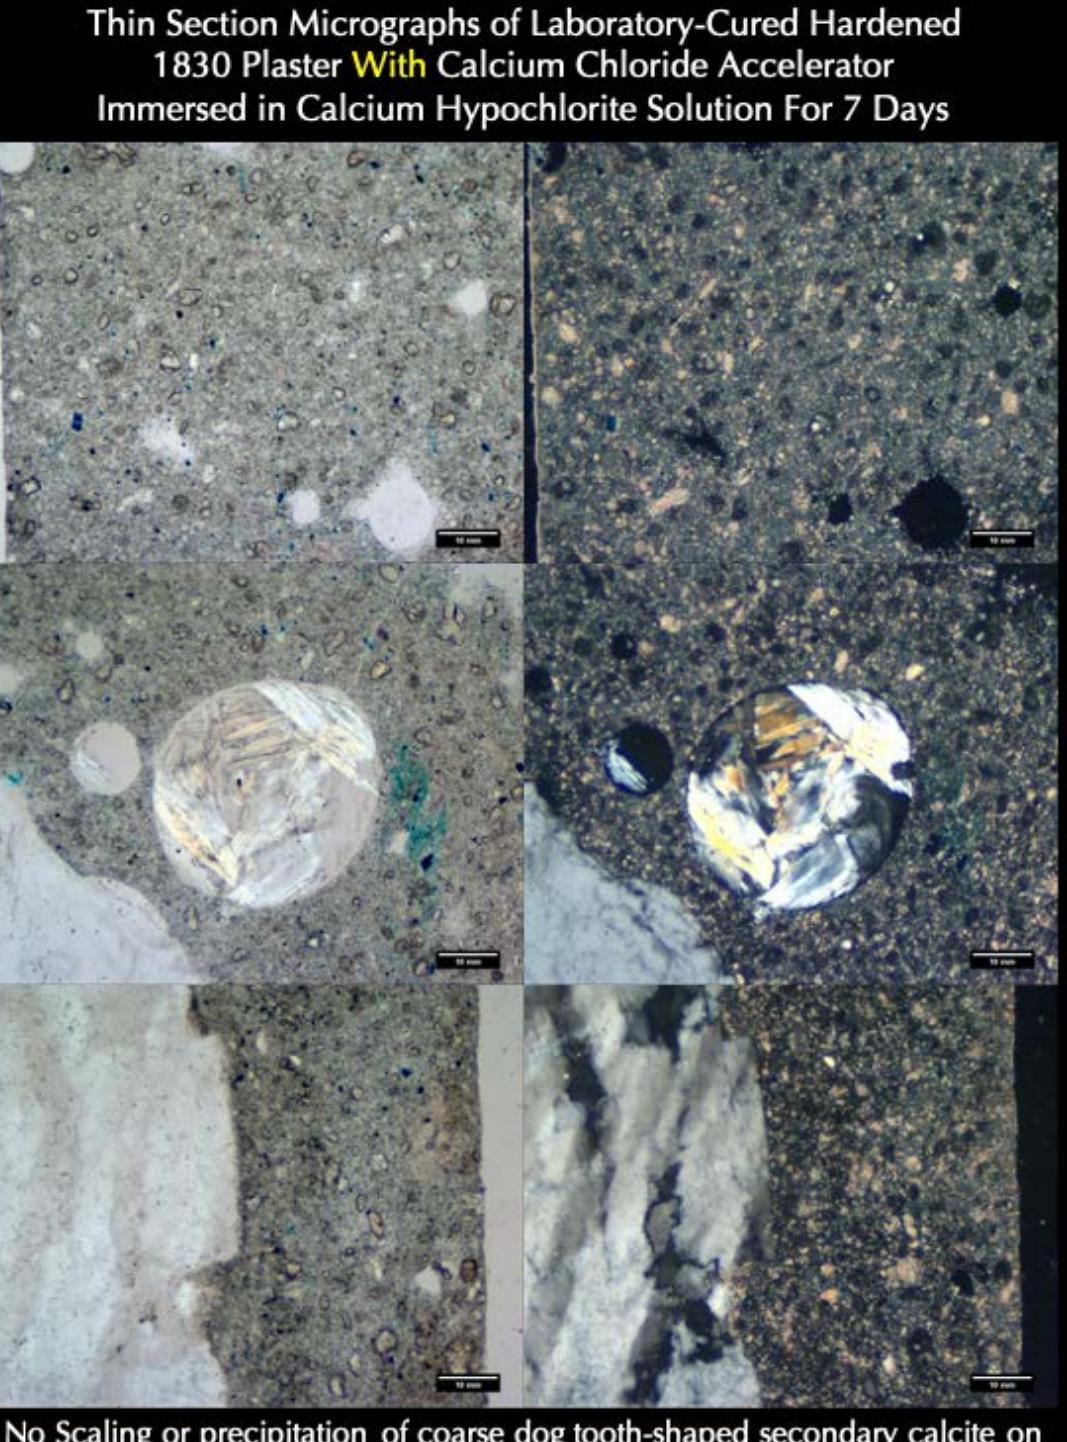
No Scaling or precipitation of coarse dog tooth-shaped secondary calcite on the exposed surface as found in plasters without CaCl<sub>2</sub> addition

Fig. A 132: Micrographs of thin section of laboratory-cured hardened plaster kit# 1830 with calcium chloride accelerator immersed in calcium hypochlorite disinfectant solution for 7 days, showing abundant residual alite grains, and subordinate limestone fines in paste. Notice some coarsely crystalline lath-shaped secondary calcium hydroxide crystals in air voids indicating high solubility of finely crystalline calcium hydroxide component of cement hydration in water. Notice the lack of surface scaling of secondary calcite.

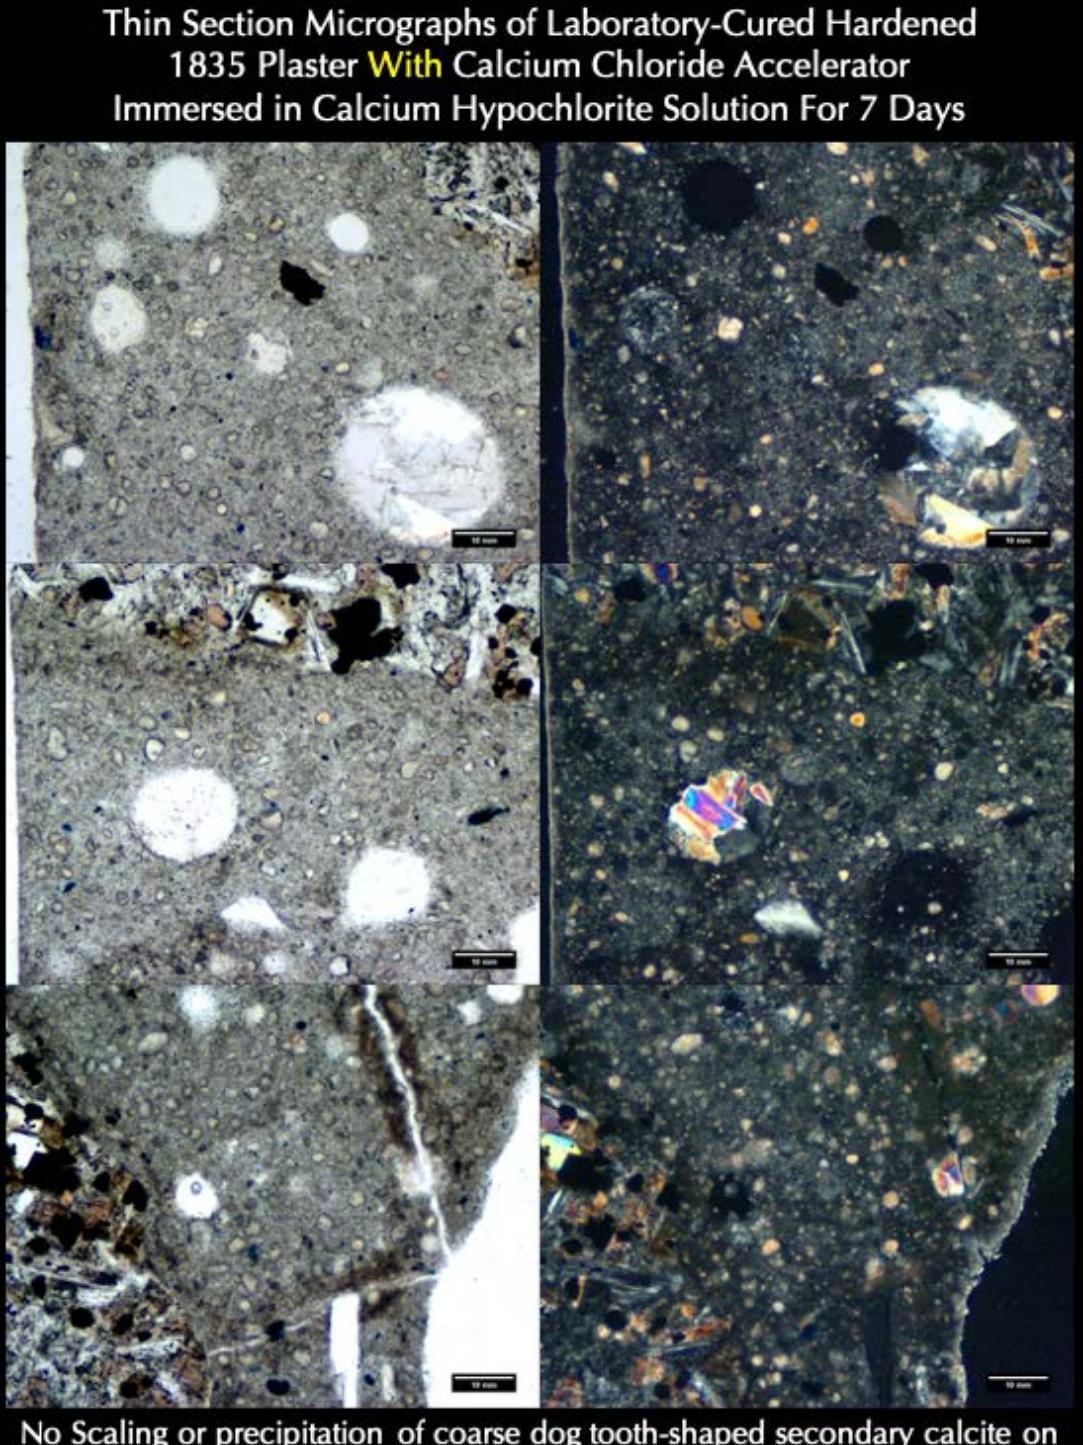
No Scaling or precipitation of coarse dog tooth-shaped secondary calcite on the exposed surface as found in plasters without CaCl<sub>2</sub> addition

Fig. A 134: Micrographs of thin section of laboratory-cured hardened plaster kit# 1835 with calcium chloride accelerator immersed in calcium hypochlorite disinfectant solution for 7 days, showing abundant residual belite grains, subordinate alite, and negligible limestone fines in paste. Notice some coarsely crystalline lath-shaped secondary calcium hydroxide crystals in air voids indicating high solubility of finely crystalline calcium hydroxide component of cement hydration in water. Notice the lack of surface scaling of secondary calcite.

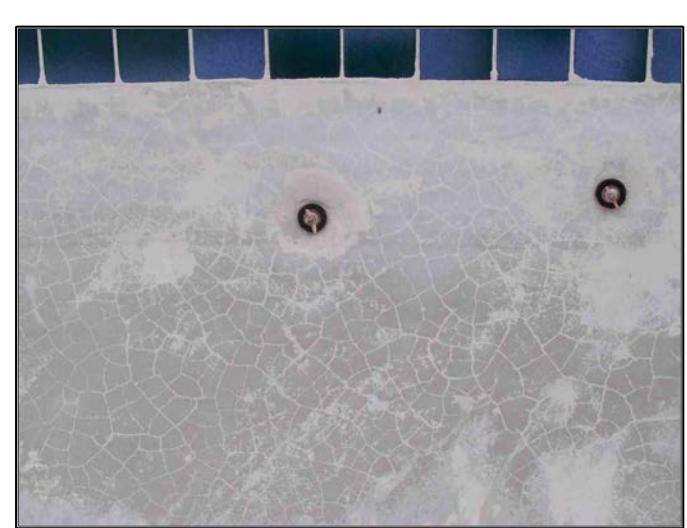
Figure 3 – A pool plaster surface showing closed polygonal-shaped check cracks.

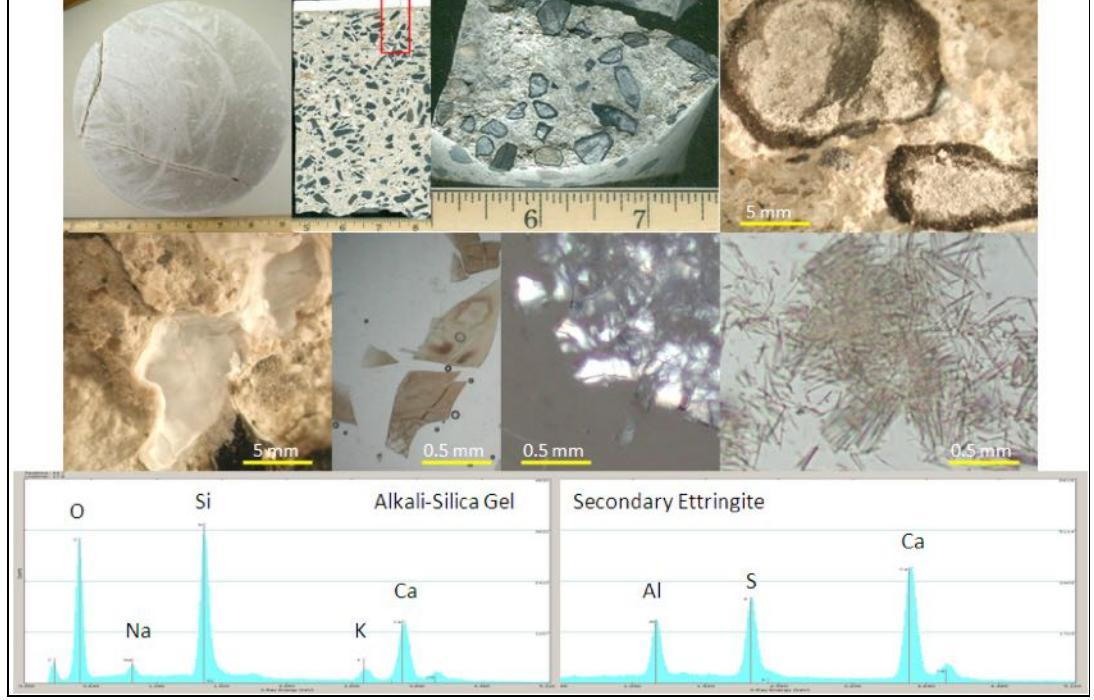
Concrete alkali-silica reaction (ASR) is evidenced by (see Figure 5):

All forms of gel contained sodium, potassium, calcium, and silica (see Figure 5), where calcium in gel came from paste by cation-exchange with alkali; white gel deposits on the fresh fractured surfaces of dark-rimmed coarse aggregate particles, however, do not show calcium enrichment due to the absence of such cation exchange. Associated with ASR gel in many places are secondary ettringite deposits indicating prolonged presence of moisture in the concrete, a condition necessary for sustaining ASR.

Figure 5 – Top Row from Left = Top surface of a core showing plaster cracks; lapped cross section of the core showing the plaster intimately bonded to the concrete substrate, within the boxed area is a vertical crack that has extended through the entire plaster and a portion of the concrete substrate; fresh fractured surface of core showing white deposits of alkali-silica gel on the fractured aggregate surfaces in concrete that are surrounded by dark reaction rims; photomicrograph of fractured aggregate surfaces showing dark reaction rims and white powdery alkali-silica gel deposits on aggregate surface within the rims. Middle Row = Air voids in concrete lined with white alkali-silica gel; oil immersion mounts of white deposits in voids showing layered and birefringent gel deposits; the right photo shows immersion mount of acicular secondary ettringite deposits that are associated with ASR gel in many voids. Bottom Row = X-ray microanalyses of gel and secondary ettringite deposits in voids.

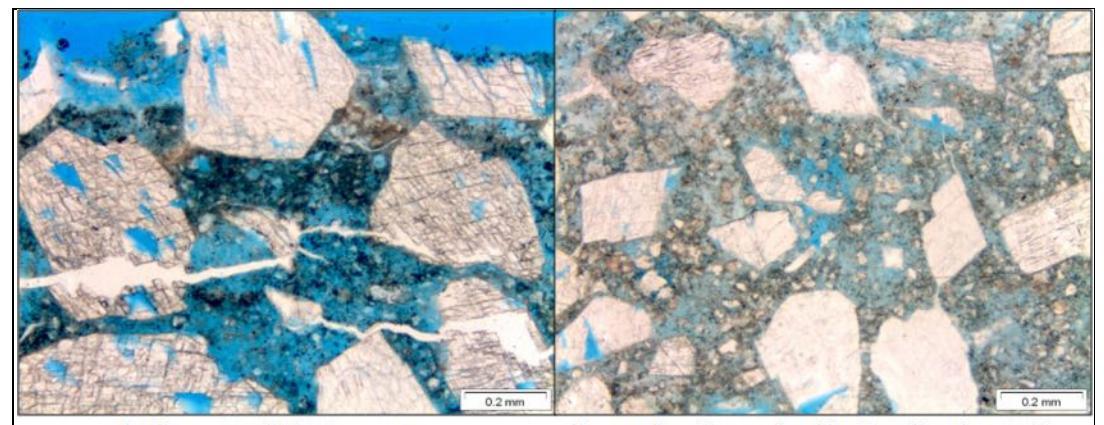
Surface parallel microcracks

Excess abundance of residual portland cement particles and high capillary porosity of paste

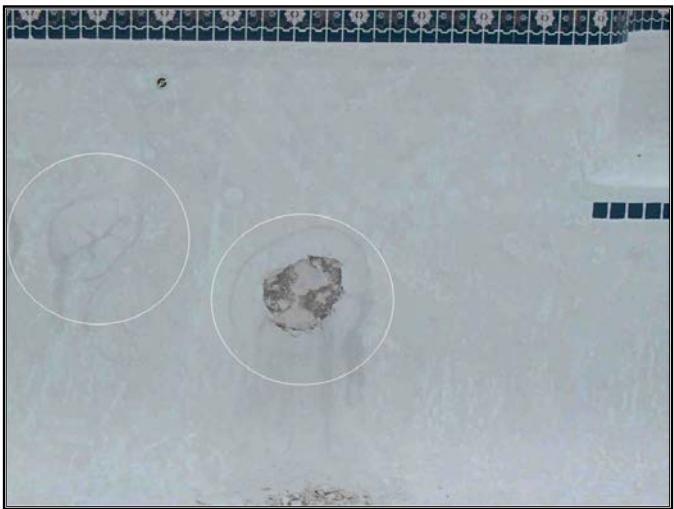
The delaminated new plaster was too thin, only <sup>1</sup>/<sub>8</sub> in. in nominal thickness, which showed evidence of rapid drying and restricted hydration of portland cement particles. The plaster was made using marble chips and white portland cement. Acid-soluble chloride analysis showed 0.126 percent chloride, by mass of plaster, which is indicative of less than one percent calcium chloride addition by mass of cement, well within the normal range, or of no addition, where chloride came from interactions with pool water. Thin section photomicrographs of plaster show surface-parallel microcracking from shrinkage and abundant residual portland cement particles and high capillary porosity in the paste in the body of the thin plaster (Figure 11), indicating premature drying prior to the immersion of plaster underwater. Debonding was judged to be due to premature stiffening and rapid drying of a thin plaster coat, which was probably overly wet and exposed to a dry or windy weather condition.

Figure 11 – Thin section photomicrographs showing microstructure of loose, debonded plaster samples. The left photo shows surface-parallel microcracks and porous paste in plaster. The right photo shows excess abundances of residual portland cement particles and capillary pores in the paste. Both features indicate premature stiffening and rapid curing of plaster.

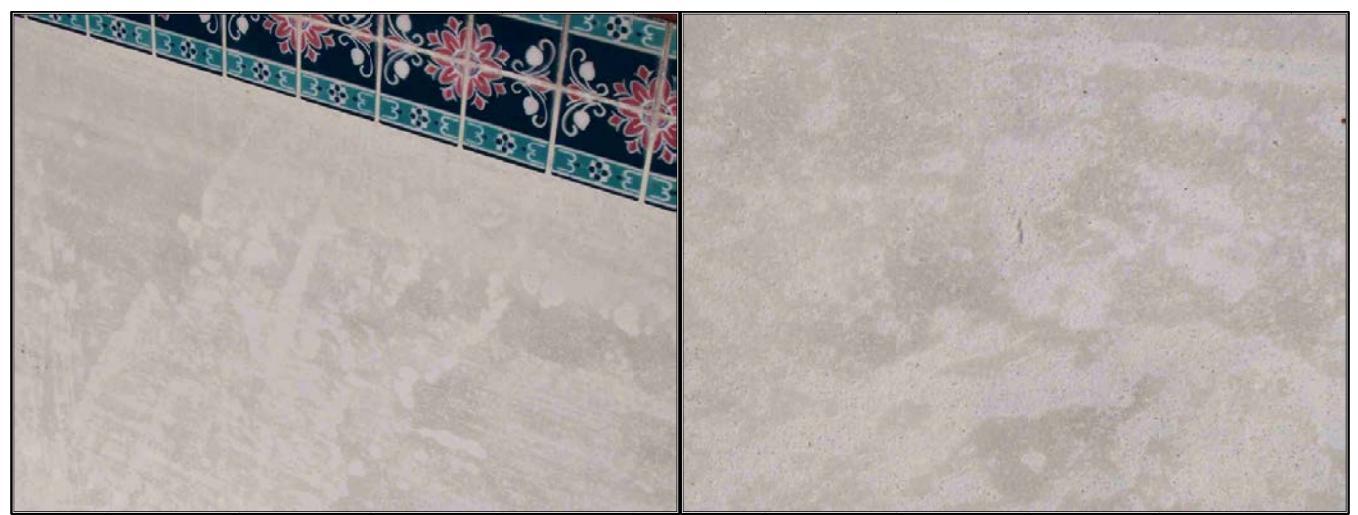
Due to the alkaline nature of the plaster, aggrassive pool water causes etching of plaster paste and carbonate aggregates. The depth and severity of etching depends on the aggressiveness of the water, the duration that the water remained aggrassive, and the quality of the plaster. The following case study shows an example, where plaster surface developed broad areas of etching (see Figure 13).

Figure 13 - Photographs of a swimming pool showing etching of plaster surface.

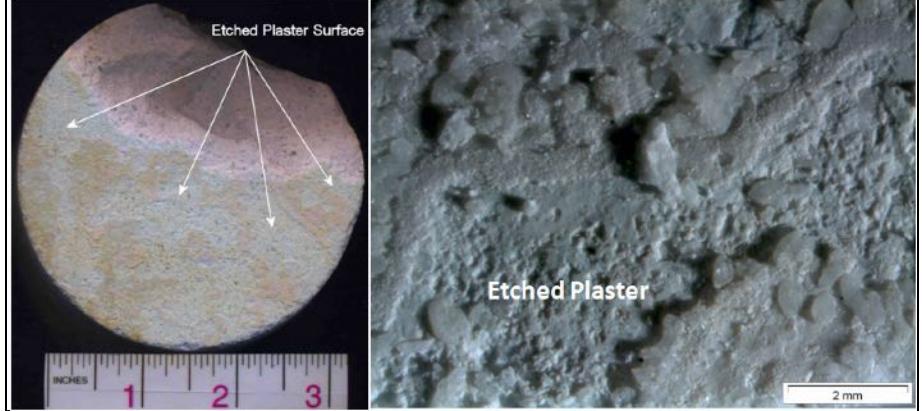
Core samples of plaster plus concrete substrate show evidence of plaster surface etching as darker patchy areas rich in carbonate aggregates (where the intervening paste in between the aggregate particles has been lost), and relatively lighter areas rich in leached and etched porous paste (see Figure 14). Plaster contained marble chip aggregate and white portland cement, acid-soluble chloride analysis indicated 2.6 percent calcium chloride addition.

Figure 14 – Photograph of the top etched plaster surface in the core (left photo) taken from the pool shown in Figure 13, which, at a higher magnification (right photo) shows the loss of paste from around the aggregate particles, and loss of marble aggregate particles at the surface as well. The brown patchy areas are rich in aggregates and lighter gray areas are etched paste.

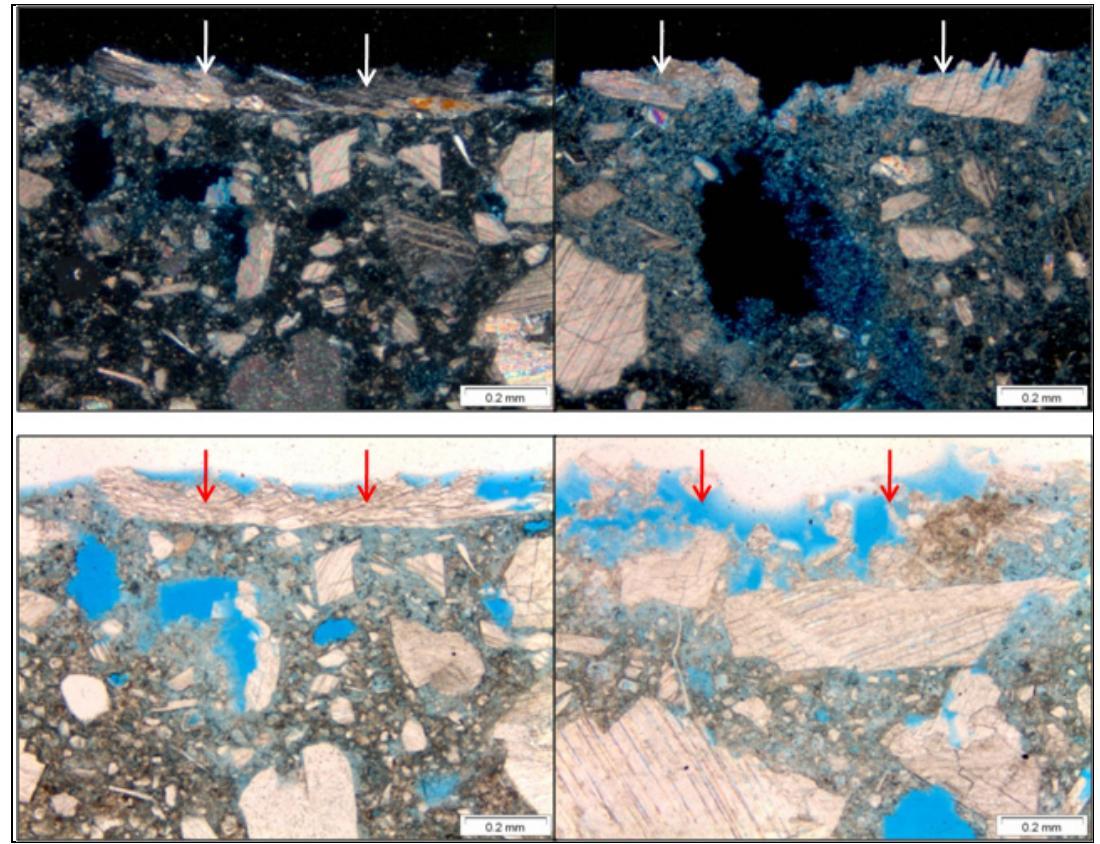
Thin section photomicrographs of the plaster show clear evidence of loss of the paste and carbonate aggregates at the plaster surface, to a depth of 0.2 to 0.5 mm (Figure 15), and an overall porous nature of the plaster paste at the surface and down to a uniform depth of 3 to 4 mm. The total plaster thickness is 10 to 12 mm, where a denser region is present beneath the top porous region. The porous nature at the surface is clearly distinct in blue dye-mixed epoxy-impregnated thin section by a greater degree of blue dye absorption at the top 3 to 4 mm than the interior denser plaster body. Such a porous surface may indicate application of a finish coat having a higher water-cementitious materials ratio than the body, or, finishing in the presence of excess water at the surface, either of which has decreased the resistance of plaster to surface etching by the aggrassive water.

Figure 15 – Photomicrographs of blue dye-mixed epoxy-impregnated thin section of plaster showing etching of marble aggregates and paste on the plaster surface, loss of paste, and highly porous zone of paste at the top 0.2 to 0.5 mm. The porous nature of the paste at the surface region, beneath the etched plaster surface can be readily highlighted by the blue dye-mixed epoxy used for impregnating the sample prior to thin sectioning.

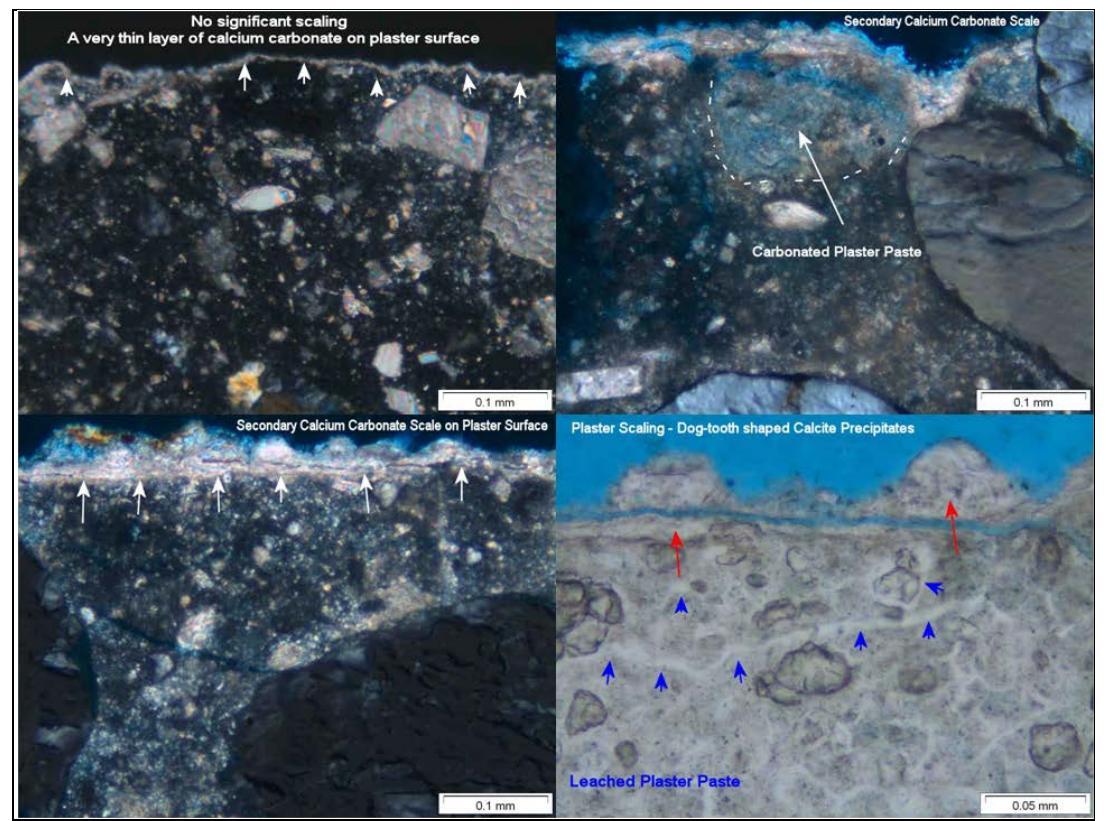
As the opposite extreme of etching, the following case study shows surface scaling, as secondary calcium carbonate precipitates on the plaster surface, due to the exposure of plaster to a pool water having a high pH, high alkalinity, high calcium hardness, and the presence of excess dissolved solids. The plaster surface showed dog-tooth shaped secondary calcite precipitates, 50 to 70 micron in thickness, some overlain by a relatively leached and porous paste.

Figure 16 – Photomicrographs of thin sections of plasters showing no scaling in the top left photo versus scaling and dog-tooth shaped secondary calcite precipitates on the plaster surface in the other photos. The bottom right photo shows leaching of paste beneath the calcite scales indicating effects of a fluctuating pool water chemistry from a low pH (caused leaching) to a high pH environment (caused scaling).

The top photomicrographs are thin sections of plaster cross sections showing appearance of a scaled plaster surface. Excessive development of secondary calcium carbonate scales on the surface requires acid washing or sanding – the extent of scaling or its removal after washing can be best diagnosed by examination of thin section of plaster in a petrographic microscope.

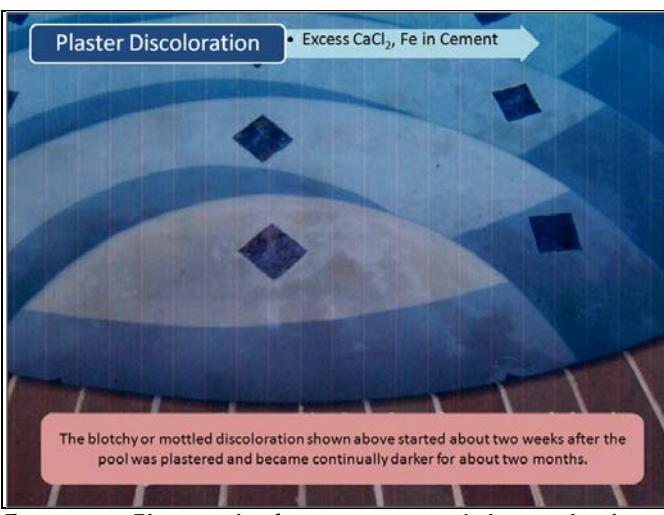
Figure 17 – Photograph of a swimming pool showing botchy or mottled grey-hued discoloration of pool plaster over a broad area.

In order to investigate the dark gray hued mottled or blotchy nature of discoloration of the abovepictured pool, a core sample was examined that contained a  $^{1}/_{2}$  in. thick plaster intimately bonded to a  $^{6}/_{2}$  in. thick shotcrete substrate. Acid-soluble chloride content of the plaster was 1.03 percent by mass of bulk plaster, which corresponds to a 5.3 percent addition of calcium chloride by mass of cement, well in excess of the standard limit of 2 percent. Calcium chloride admixture is known to impart a grayish hued discoloration on pool plaster, which was determined to have caused blotchy discoloration in the above pool as well. In addition, the white portland cement paste in the plaster showed an unusually high amount of ferrite phase, which also imparts a darker hue from delayed hydration of ferrite phase in the presence of excess calcium chloride (which explains the reported progressive darkening of the pool plaster with time). Discoloration reportedly occurred in a number of other pools as well, which were constructed with the present one by the same plasterer, after a change of the cement source. The evidence is consistent with the observed high iron content in the residual portland cement particles detected in the present sample being a possible reason for plaster discoloration. No evidence of leaching or etching of plaster paste was found, rather a thin layer of calcium carbonate deposit was noticed, as scale from alkaline pool water.

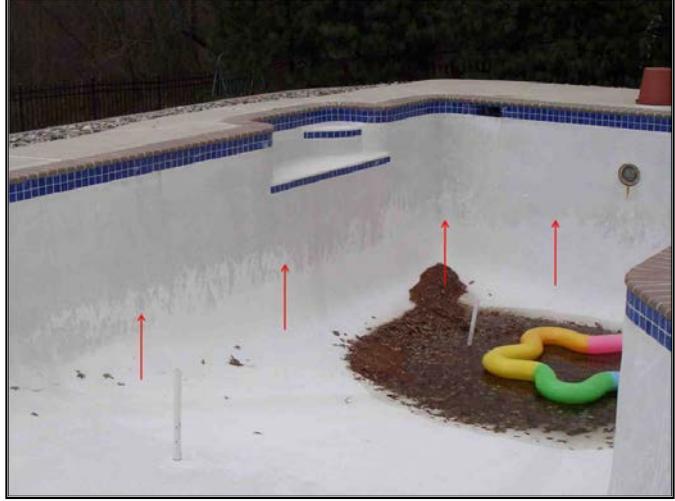
The following type of plaster discoloration (see Figure 18), from a uniform grey-hued top portion to a cloudy white bottom is very common in many pools, which is due to prolonged settling of pool water at a low level after a partial drainage (which was during the entire winter season in this case), where portions remained underwater appeared lighter in color than the aerated portion of the pool. The aerated portion, being drier than the underwater portion appeared as a darker shade.

Figure 18 - Darker versus lighter gray discoloration of aerated and underwater portions of a pool.

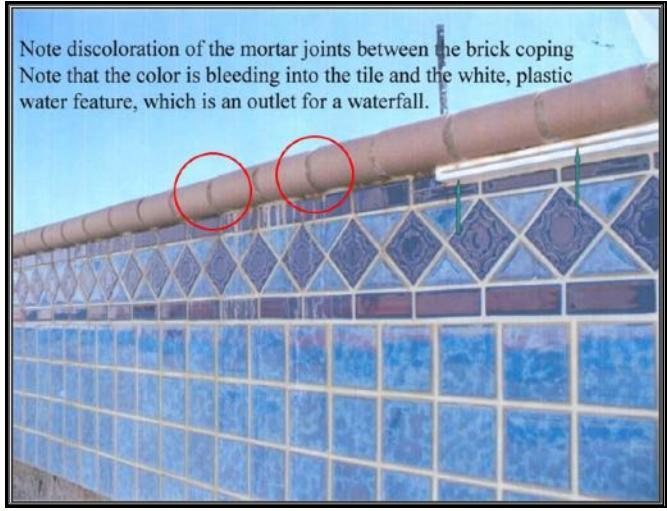
The brick-masonry coping of a swimming pool showed dark gray to brown discoloration of jointing mortars, causing drip stains on plaster surface from the mortar joints. Brick units were brown, solid, clay-fired masonry, containing dark brown glassy aluminosilicate matrix, fine (< 1 mm size), angular quartz and feldspar grains, and dark brown to black grog of ferruginous materials. Jointing mortars are non-air-entrained and made using portland cement, sand, and a polymer binder. Elemental analyses of jointing mortars from stained areas show a marked enrichment of manganese in the stained mortars, having maximum concentration at darkest stained areas adjacent to bricks, an element, also detected in the adjacent bricks. Migration of manganese from bricks to the adjacent jointing mortar by splashing of the pool water has caused the stain. Manganese is common in many clay fired bricks that can cause similar staining in masonry coping or pool plaster.

Figure 20 – Dark brown stain on mortar joints (circled) from migration of manganese in bricks.

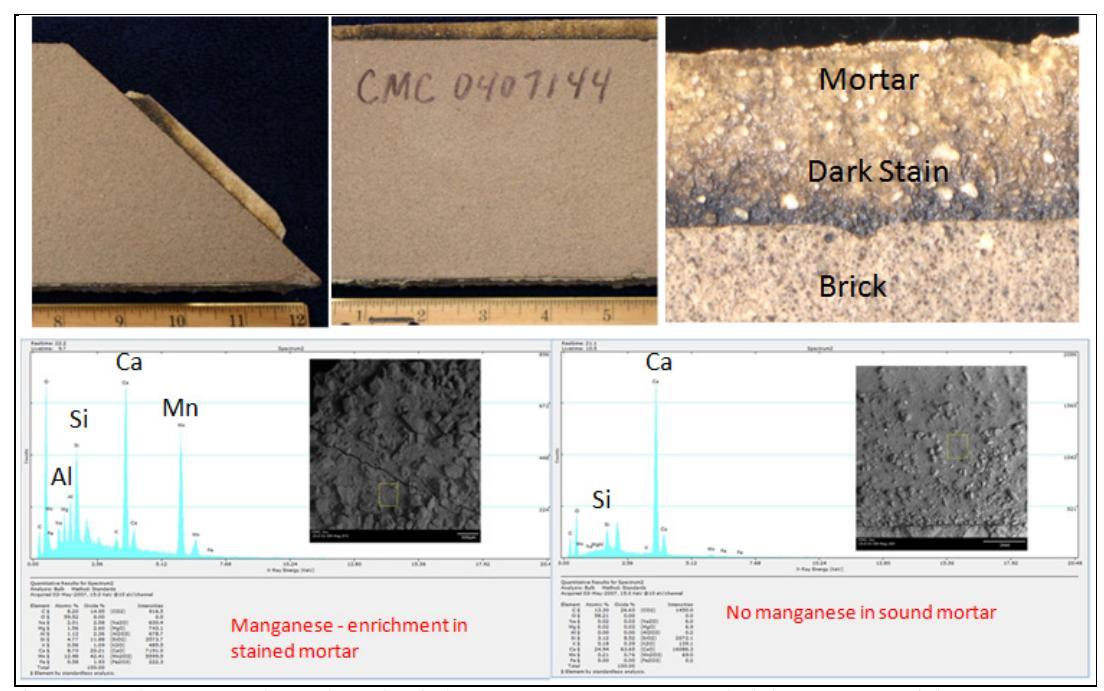
Figure 21 – The top row photos show the dark stain on jointing mortars, which have prompted the investigation. The bottom rows show manganese (Mn) enrichment in the stained mortar and its absence in the sound mortar, where Mn was derived from the adjacent bricks.

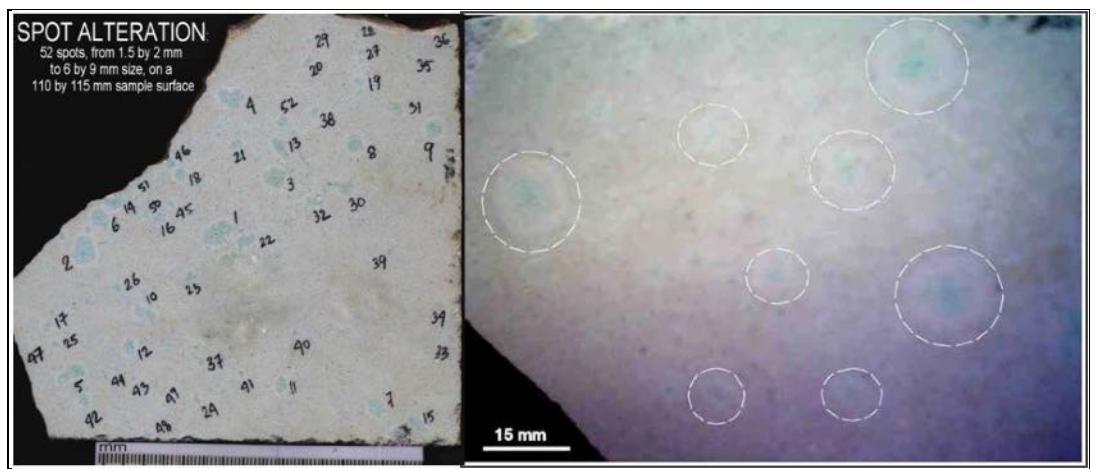
Figure 23 – Photographs of a plaster sample showing spot alteration. The left photo shows 52 spots of different sizes (from  $1.5 \times 2$  mm to  $6 \times 9$  mm) over an area of  $110 \times 115$  mm. The right photo is an enlarged view showing spots having green stained cores and white rims.

In the example shown here, 52 spots of shapes from circular to elliptical to irregular, and sizes from 1.5 × 2 mm to 6 × 9 mm are found on a 110 × 115 mm surface (Figure 23). Centers of the spots are stained green with copper and phosphorus enrichment, which are surrounded by white rims due to the porous nature of paste, and then normal dense, sound, smooth plaster (having no Cu or P signature) away from the spots. The green stains are from preferential absorption of copper and phosphate salts in pool water by the soft porous paste, where copper was introduced from copper algaecides. X-ray elemental analyses of spots, as shown in Figures 25 and 29, also indicated an enrichment of chlorine at many spots, which are not found in areas away from the spots (similar chlorine enrichment in spots was also mentioned by Rothstein et al., 11].

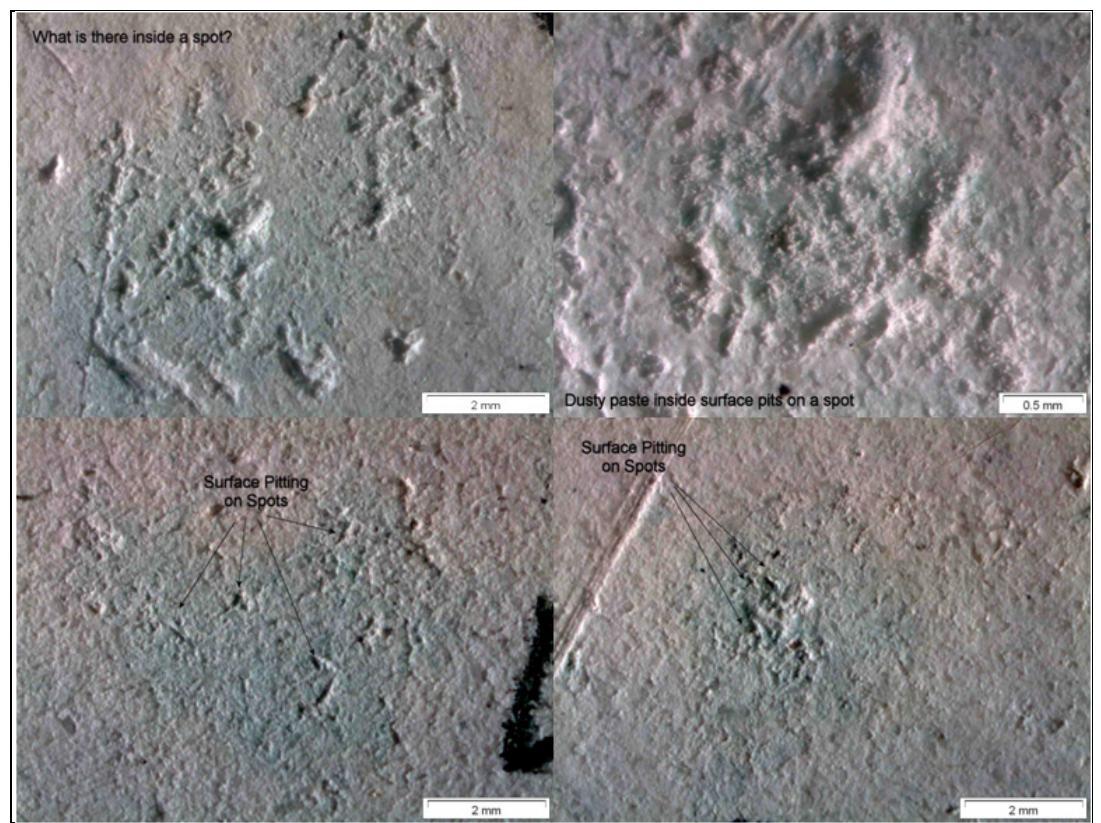
- (b) Common small pitting of the plaster surface preferentially inside the spots (Figure 24);
- (c) Dusty appearance of paste in between the aggregate particles on the spot (Figure 24);

Figure 24 – Photomicrographs of plaster surface on and around the spots (taken by using a stereo microscope at a magnification of 10X) showing small surface pitting and leaching of paste on the spots, dusty appearance of paste around the aggregate particles on the spots, and greenish stains due to preferential enrichment of copper at the spots. Note the surface pitting at the spots are characteristic, occurred in almost all the spots and are not so evident in areas away from the spots.

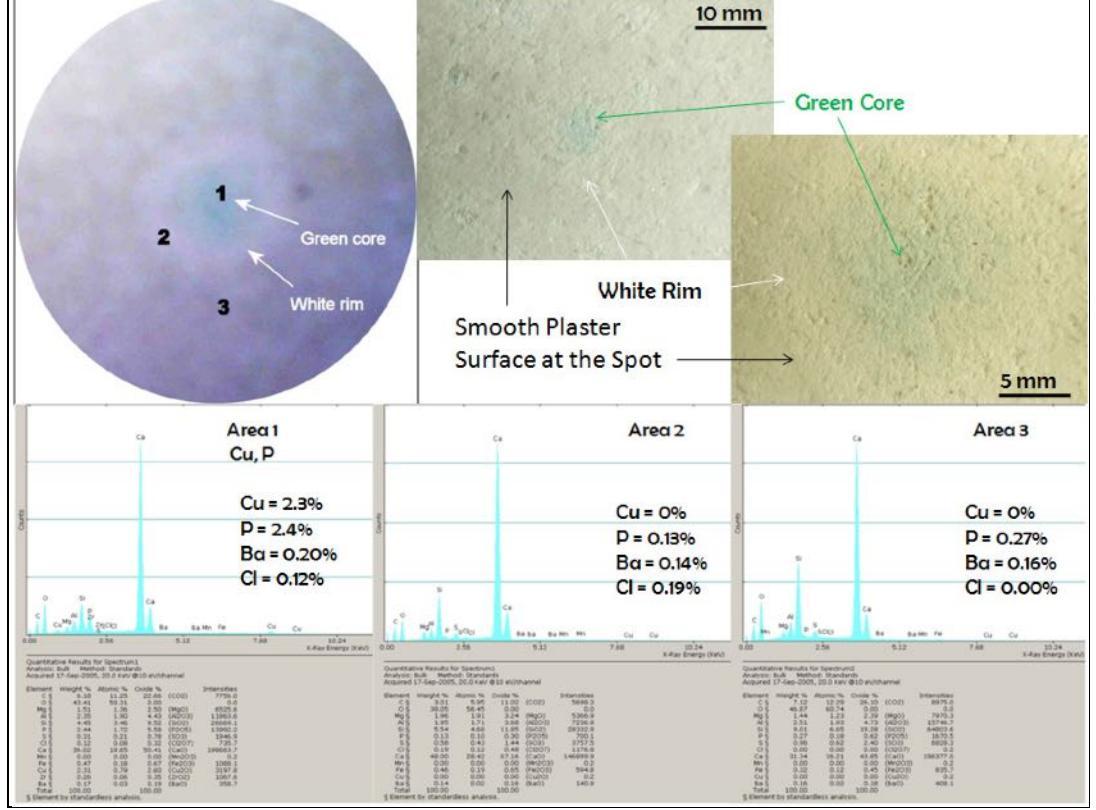
- (f) Staining on spots for preferential heavy metal precipitation on porous paste (Figure 25);
- (g) Occurrences of spot etching on plasters containing normal dosages of calcium chloride admixtures; and,

Figure 25 – The top left photo shows scanned image of a spot, where the green core, surrounded by a white rim are noticed. The two photomicrographs on the right show the spot at higher magnifications, where the green stain at the core is distinct. The lower three spectra are x-ray elemental analyses of the green core (marked as '1'), white rim (marked as '2'), and area away from the spot (marked as '3'), showing enrichment of copper, chlorine, and phosphorus at the spot. Copper stain at the spot is from copper algaecides used in this pool, where the porous paste beneath the spot absorbed copper from the pool water.
