### Swimming Pool Plaster Discoloration – A Case Study From Field & Laboratory-Cured Plasters

Primera Stone Sapphire Treasure & Blue Ocean

CONSTRUCTION MATERIALS CONSULTANTS, INC.

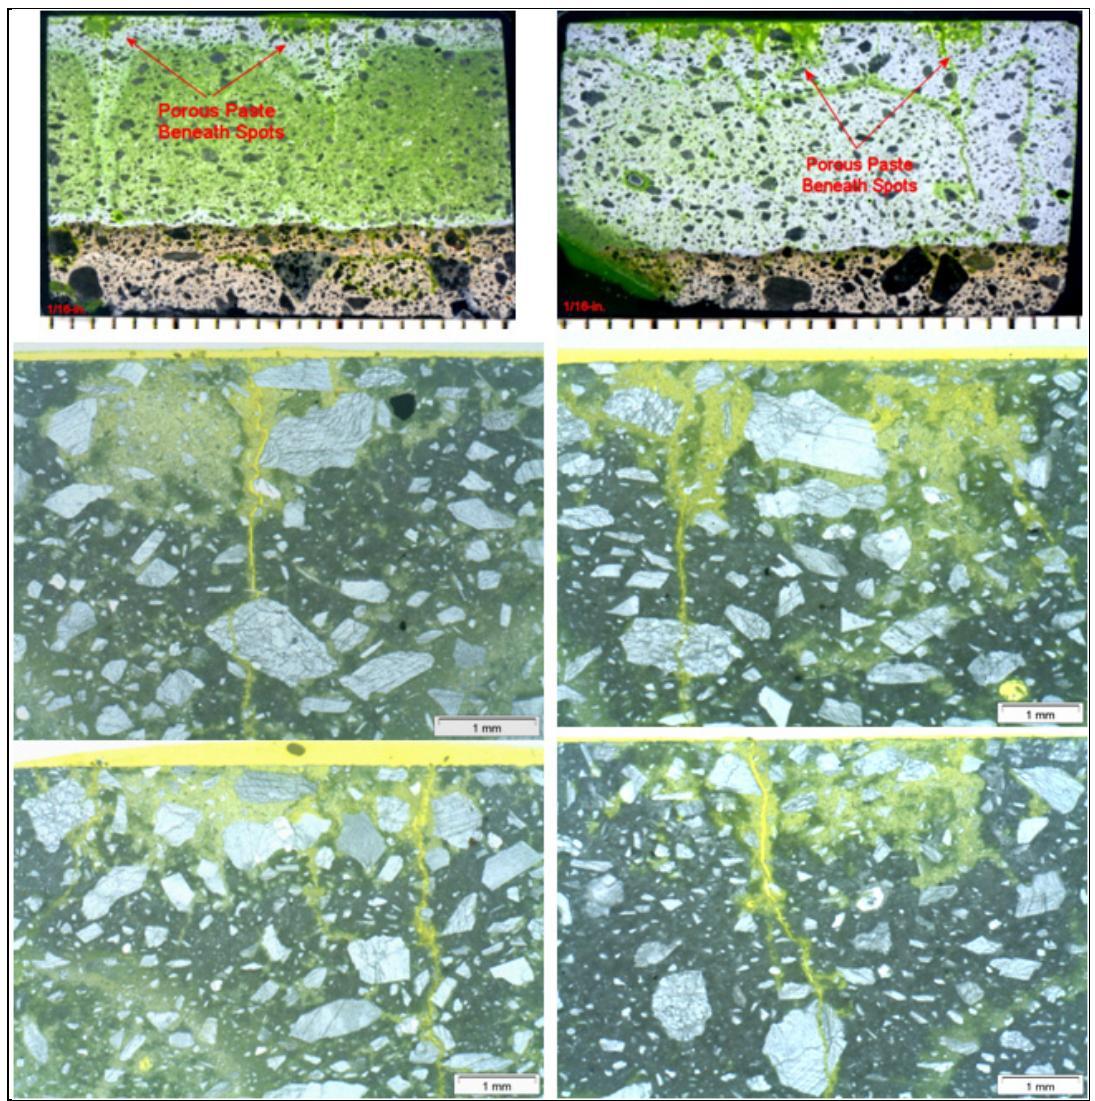
Figure 26 – Photomicrographs of polished fluorescent dye-mixed epoxy-impregnated thick sections (~100 microns thick) of plaster and concrete in the core, cross-sectioned through the spots, showing: (a) carbonation of plaster at the surface region, down to a depth of <sup>1</sup>/s to <sup>3</sup>/16 in., where the carbonated paste at the surface being denser than the paste in the body showed a lower absorption of dyed epoxy than that in the body, a greater depth of carbonation along the vertical shrinkage microcracks than the areas in between the microcracks (creating V-shaped carbonation fronts along the paths of the microcracks), and (b) small zones of leached and porous paste at the surface, immediately beneath the spots, within the carbonated paste, which are highlighted by the fluorescent dye-mixed epoxy (marked with arrows).

The middle and bottom row photos are reflected-light photomicrographs of sections (by using an Olympus SZX12 stereo zoom microscope), where porous areas of paste around the microcracks and situated beneath the spots are readily highlighted by the yellow fluorescent dye-mixed epoxy.

Sequence of events depicted by these photomicrographs in Figures 26 and 27 is – microcracking in plaster, followed by deep carbonation along the microcracks, which was followed by local leaching of carbonated paste beneath the spots in areas significantly smaller than the carbonated zone of paste.

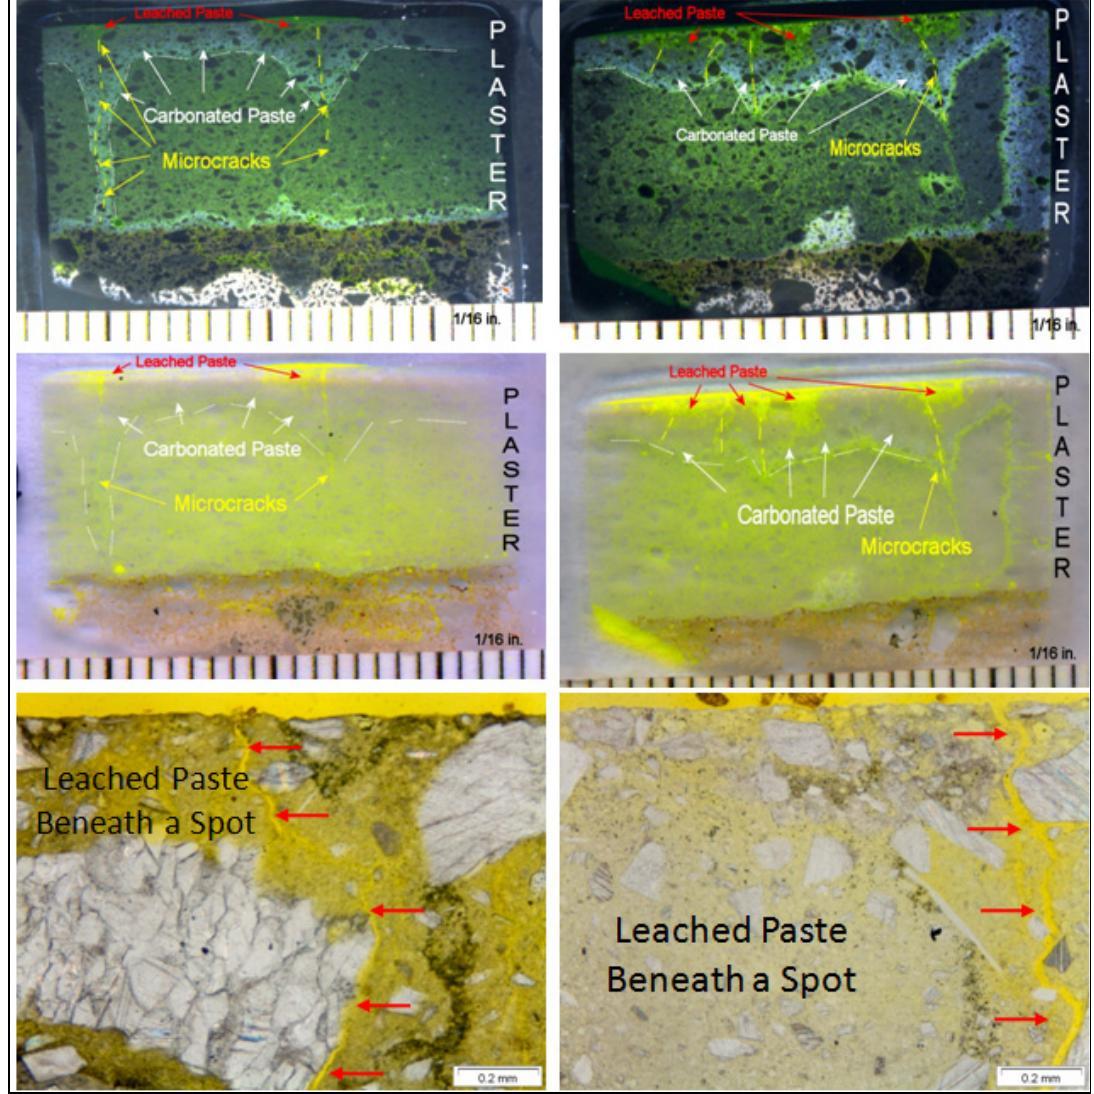
Figure 27 – Photomicrographs of fluorescent dye-mixed epoxy-impregnated thin sections (~ 30 microns thick) of plaster and concrete in the core, cross-sectioned through the spots (of the same samples shown in Figure 25 but after further grinding the sample thickness from ~ 100 to ~ 30 microns), showing: (a) carbonation of plaster at the surface region, down to a depth of  $^{1}$ /s to  $^{3}$ /16 in., greater depth of carbonation along shrinkage microcracks (creating V-shaped carbonation front along the paths of the microcracks, and (b) small zones of leached paste immediately beneath the surface spots, where carbonated paste has been leached out relative to aggregates.

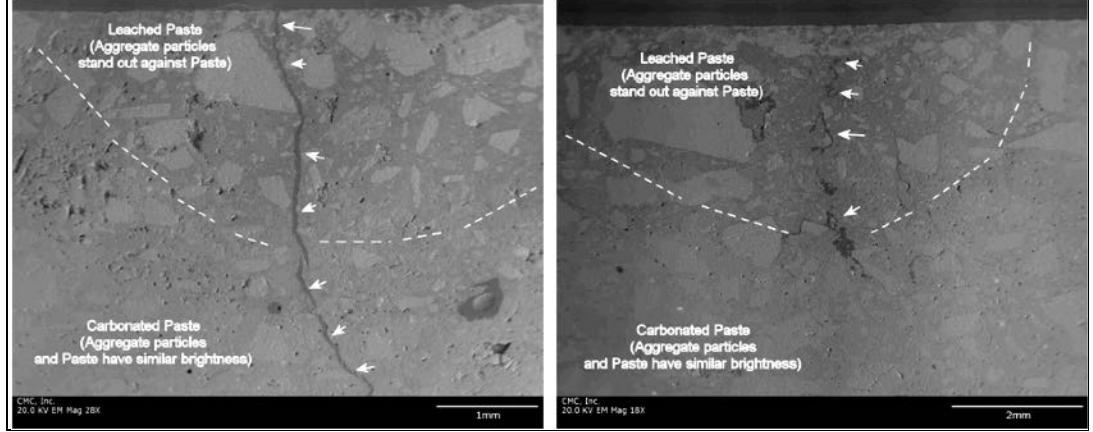
Figure 28 – Backscatter electron images of polished cross section of plaster (taken by using a CamScan Series II SEM) showing preferential leaching of paste relative to aggregates (areas within the dashed lines) beneath the surface spots causing proud exposure of aggregate against the paste, and, more or less non-differentiated aggregate and paste (carbonated) in areas away from the leached zones. Arrows mark shrinkage microcracks.

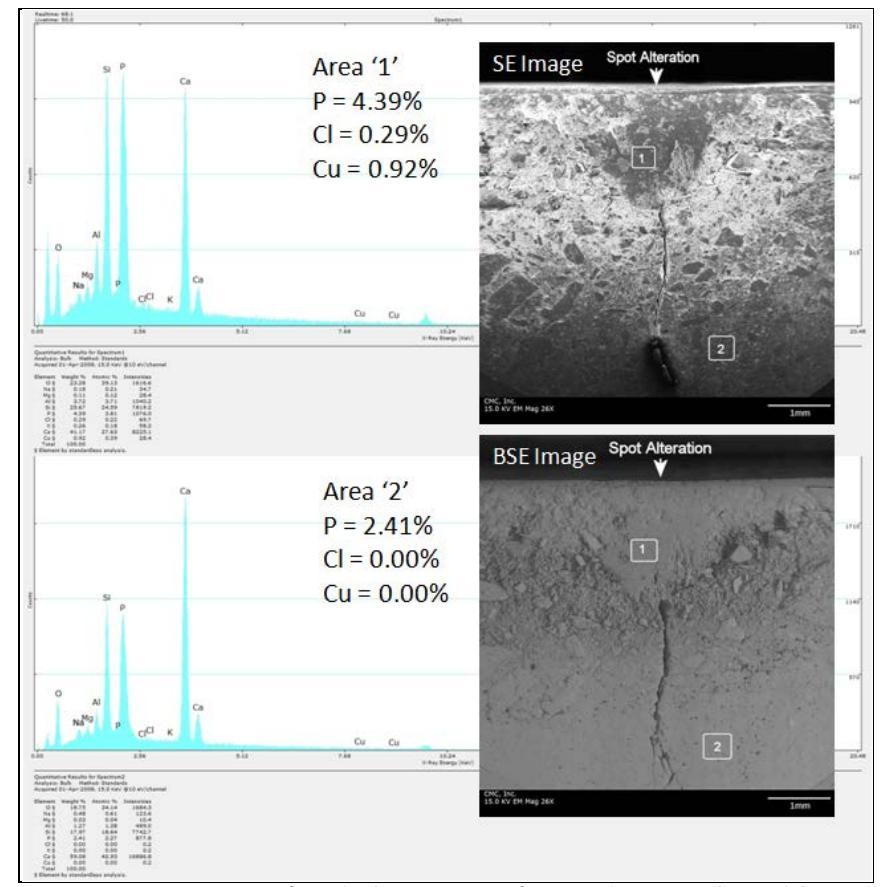
Figure 29 – X-ray elemental analyses of polished cross section of plaster showing P, Cu, and Cl enrichment in an area beneath the surface spot (marked as '1') and their depletion in an area away from the spot (marked as '2').

Based on the present case study of occurrence of spot alteration at the locations of preexisting microcracks, as local leaching of paste beneath the spots, with no evidence of excess calcium chloride or improper finishing, and slightly elevated chloride levels in paste at the spots than elsewhere (Figure 29, similar to the findings of Rothstein et al. [11]), the author proposed a model (see Figure 30) where entry of water and chemicals having a high chloride/low pH chemistry (e.g., stabilizers) caused spot alteration at the loci of precipitation of chemicals on plaster surface at and around the microcracks. The presence of a preexisting microcrack, however, is not essential, since a local high chloride/low pH environment at the point of precipitation of such chemicals on the plaster surface can cause spot-like leaching of paste.

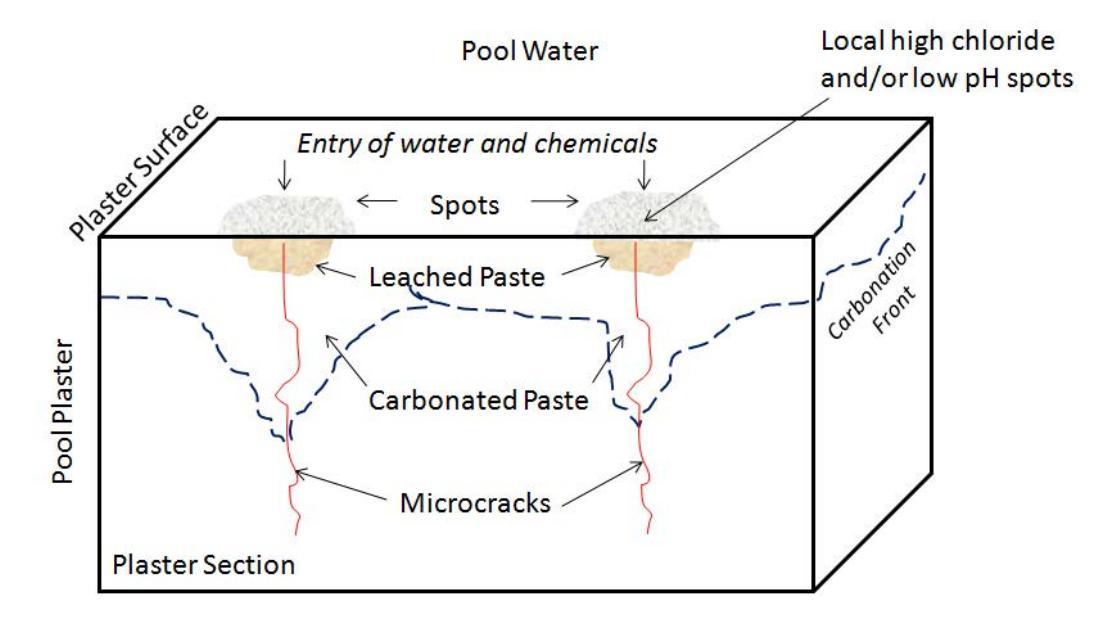
Figure 30 – A model of spot alteration based on the present case study, and recent researches of Rothstein et al. [11] and Arch Chemicals [12]. Preexisting microcracks on the plaster provided pathways for entry of pool water and chemicals. Certain chemicals (probably of high chloride and/or low pH chemistry) precipitated on the plaster surface, entered through the microcracks, and created a local high chloride and/or low pH environment at the surface have caused preferential leaching of cement hydration products, increased porosity of paste beneath the point of entry and, as a result, spot like discoloration of plaster at the sites of precipitation. The presence of microcracks helps entry of chemicals but is not necessary for spot alteration from excess chemicals in water.
