CORROSION OF ALUMINUM METAL IN CONCRETE – A CASE STUDY

Abstract

Background

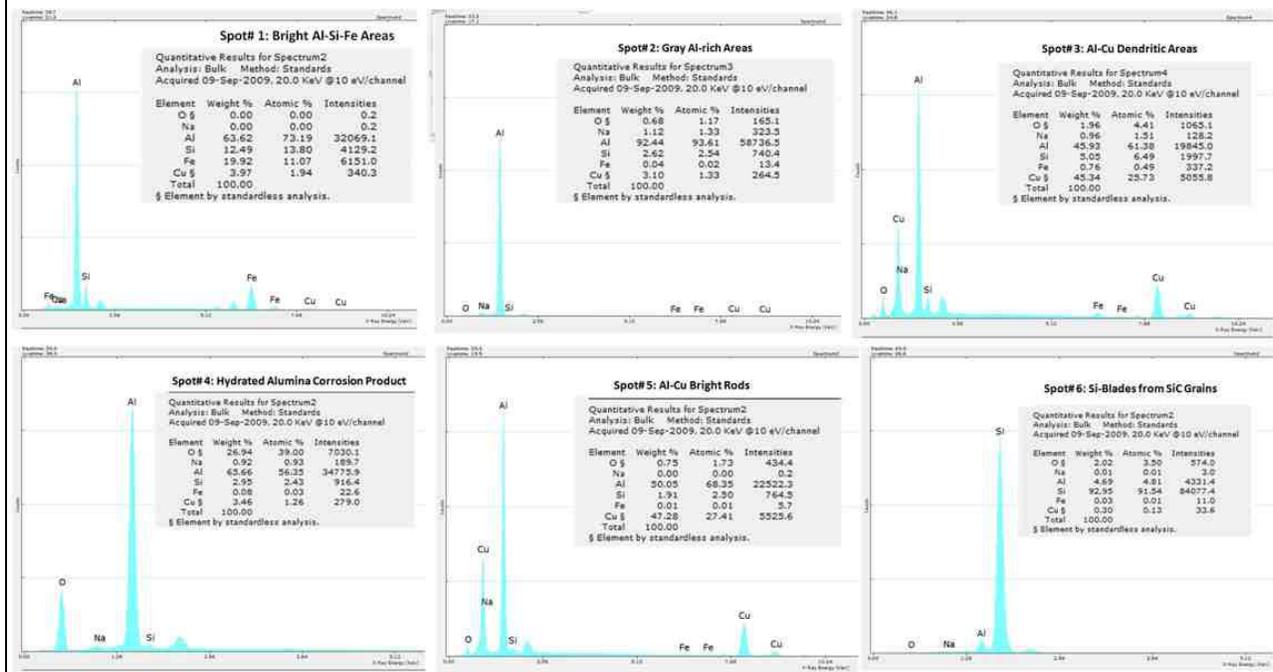
SEM-EDS Spectra & Chemical Compositions (in Atomic Weight Percent) of Different Areas Near the Base of Aluminum Nosing in the Corroded Region

Elements	Spot# 1 (Bright Area)	Spot# 2 (Gray Area)	Spot# 3 (Dendritic Area)	Spot# 4 (Dark Area)	Spot# 5 (Bright Rods)	Spot# 6 (Si-Blades)	Spot# 6a (Si-Blades)	Spot# 7 (Dark Area)
Al	73.2	93.6	61.4	56.3	68.3	11.3	4.8	63.6
Si	13.8	2.5	6.5	2.4	2.5	86.8	91.5	3.8
Fe	11.1	0.0	0.5	0.0	0.0	0.0	0.1	0.0
Cu	1.9	1.3	25.7	1.3	27.4	0.3	0.1	0.3
O	0.0	1.1	4.4	39.0	1.7	1.4	3.5	32.2
Comments on Possible Phases	<i>Al-Si-Fe Metal Area (Fe-infiltration in Al-Si Nosing)</i>	<i>Al-rich Area of Metal</i>	<i>Al-Cu Alloy in the Metal</i>	<i>Hydrated Alumina Corrosion Product of Metal</i>	<i>Al-Cu Alloy in the Metal</i>	<i>Si-Rich Blades in Metal from SiC Grains</i>	<i>Si-Rich Blades in Metal from SiC Grains</i>	<i>Hydrated Alumina Corrosion Product of Metal</i>

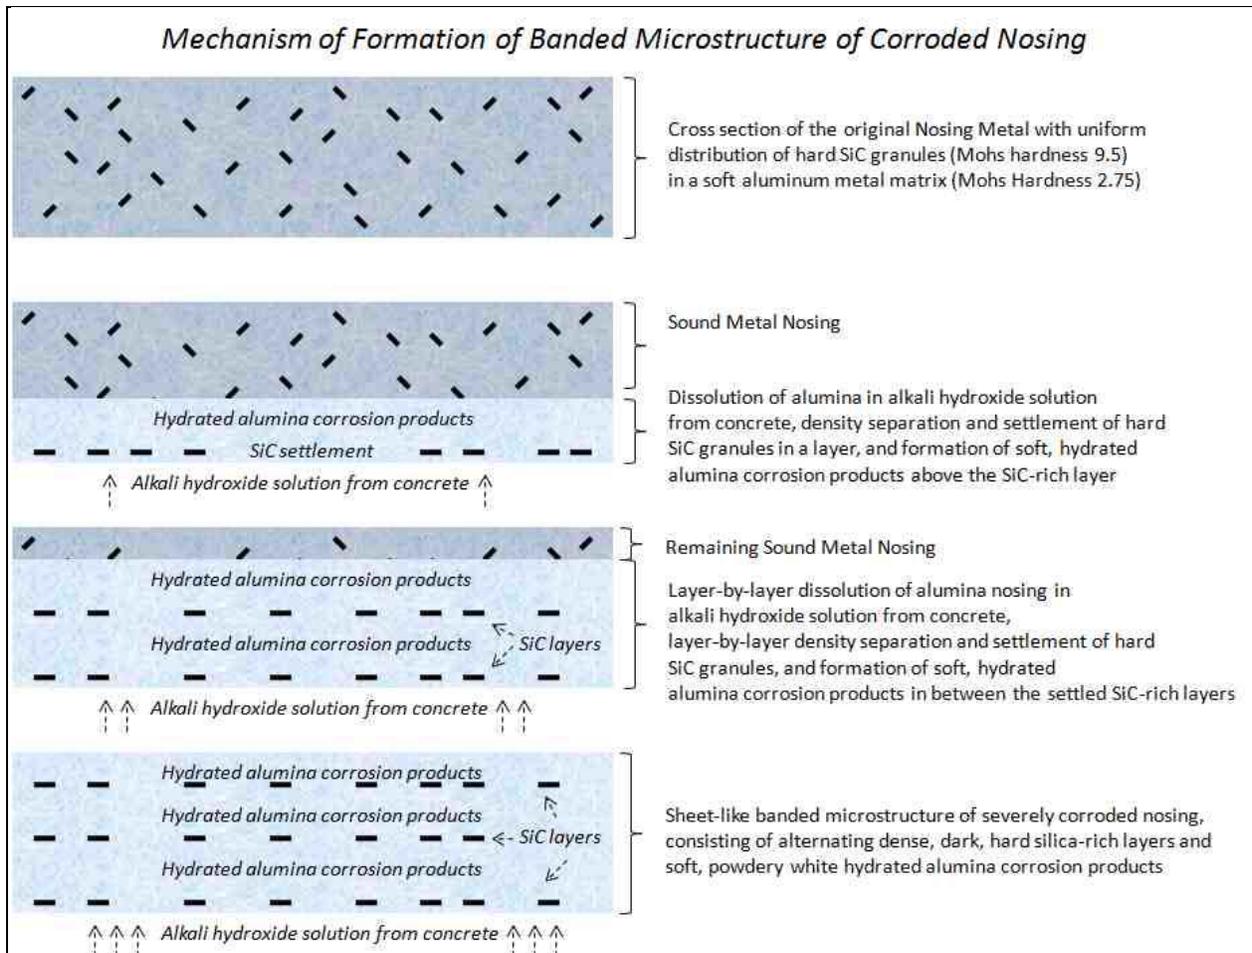
Figure 21: Schematic diagram of formation of banded microstructure and sheet-like corrosion product of nosing.

The following schematic diagram in Figure 21 illustrates a possible mechanism of formation of a sheet-like banded microstructure of severely corroded nosing by layer-by-layer dissolution of the original aluminum nosing by alkali hydroxide solution from the concrete, followed by layer-by-layer density settlement of hard silicon-rich phases (from original embedded SiC granules) and soft hydrated aluminum corrosion products on top of silicon-rich phases:

Such a banded microstructure is the result of embedding a very hard material (silicon carbide granules having Mohs hardness of 9.5) in a very soft aluminum metal matrix (Mohs hardness of 2.75), and is indicative of formation of corrosion products by dissolution of the original metal in alkali hydroxide solution, followed by density settlement of hard silicon-rich phases in the solution to form a silicon-rich layer beneath the relatively less dense layer of hydrated

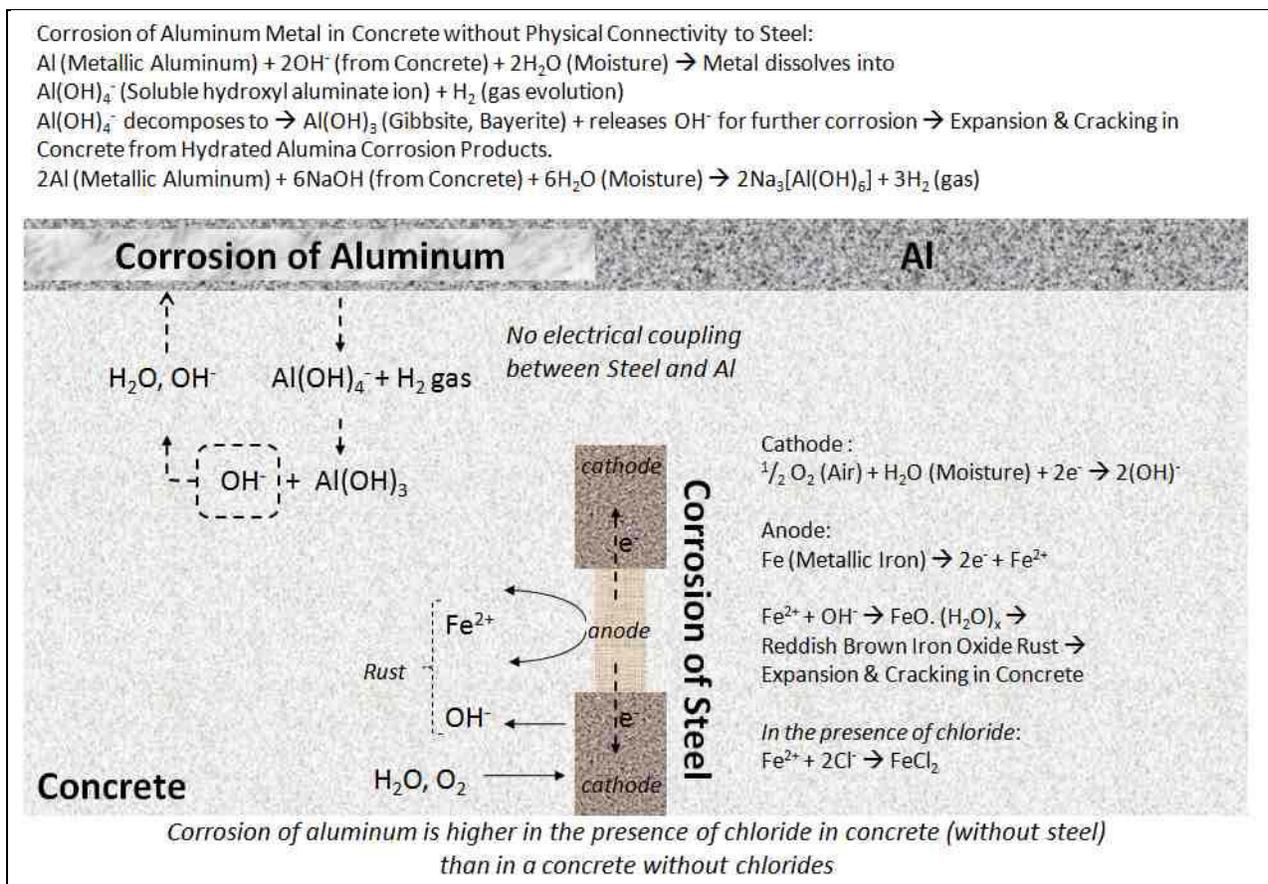
Figure 22: Mechanism of corrosion of aluminum metal in concrete without electrical connectivity to steel.

The following two schematic diagrams (Figures 22 and 23) illustrate the mechanism of corrosion of aluminum in a portland cement concrete in a case where the metal is not electrically connected (coupled) to steel (Figure 22), and in a case similar to the present one where aluminum is coupled to steel and exposed to moisture and chloride for galvanic corrosion (Figure 23):

Steel embedded in concrete does not typically corrode due to the formation of a passive layer over the steel surface in high pH environments. When the passive layer is destroyed, for instances, from a lowering of the pH from carbonation or the presence of sufficient quantities of chlorides, corrosion of steel may occur, with the rate being dependent on several factors.

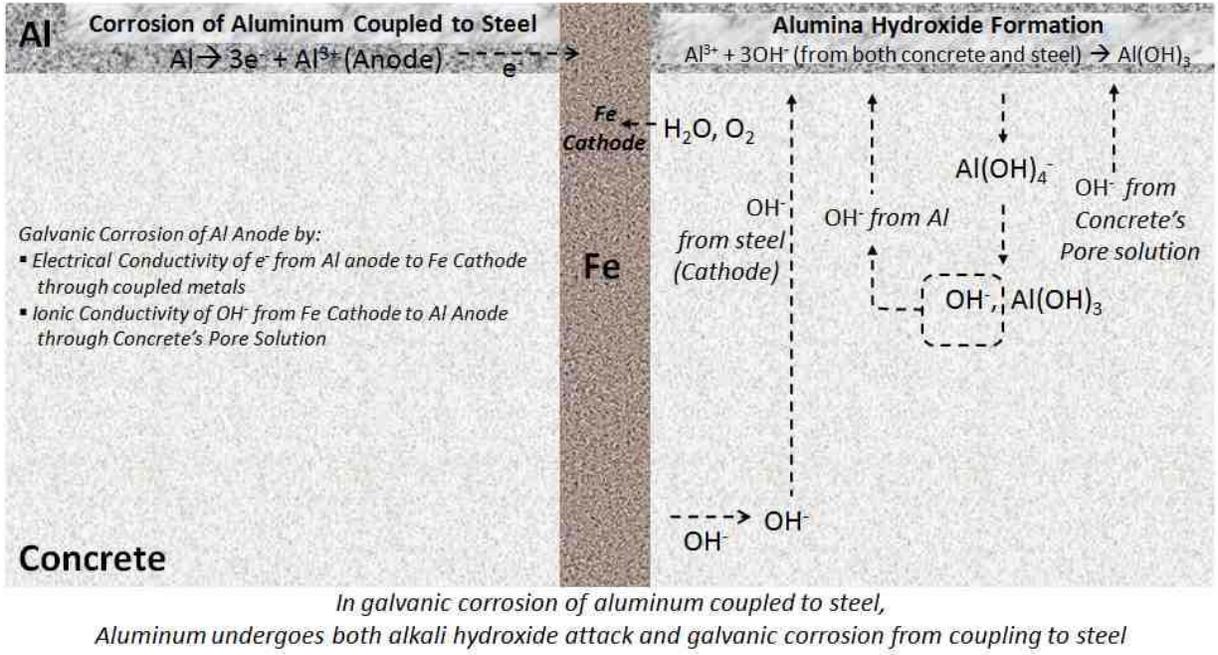
Figure 23: Mechanism of galvanic corrosion of aluminum metal in concrete coupled to steel.

Steel Cathode: $\frac{1}{2} \text{O}_2$ (Air) + H_2O (Moisture in Concrete) + 2e^- (from Aluminum Anode) $\rightarrow 2(\text{OH})^-$

Alumina Hydroxide Formation: $\text{Al}^{3+} + 3\text{OH}^-$ (from both concrete and steel) $\rightarrow \text{Al}(\text{OH})_3$
