CONSTRUCTION MATERIALS CONSULTANTS, INC.

Laboratory Investigation Of A Precast Roof Assessment
At The Biofilter Structure
In Arauco Wood Manufacturing Plant
In Moncure, North Carolina

Biofilter Roof Assessment At Arauco Wood Manufacturing Plant
Moncure, North Carolina

April 28, 2021
CMC 0321111

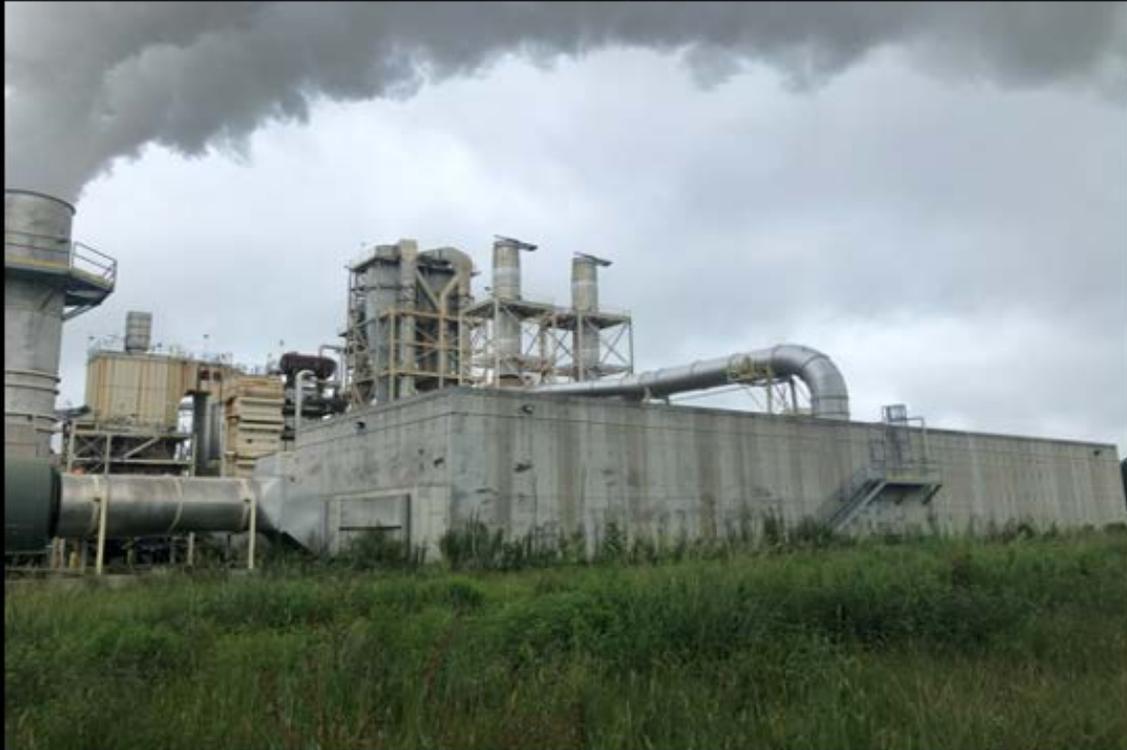
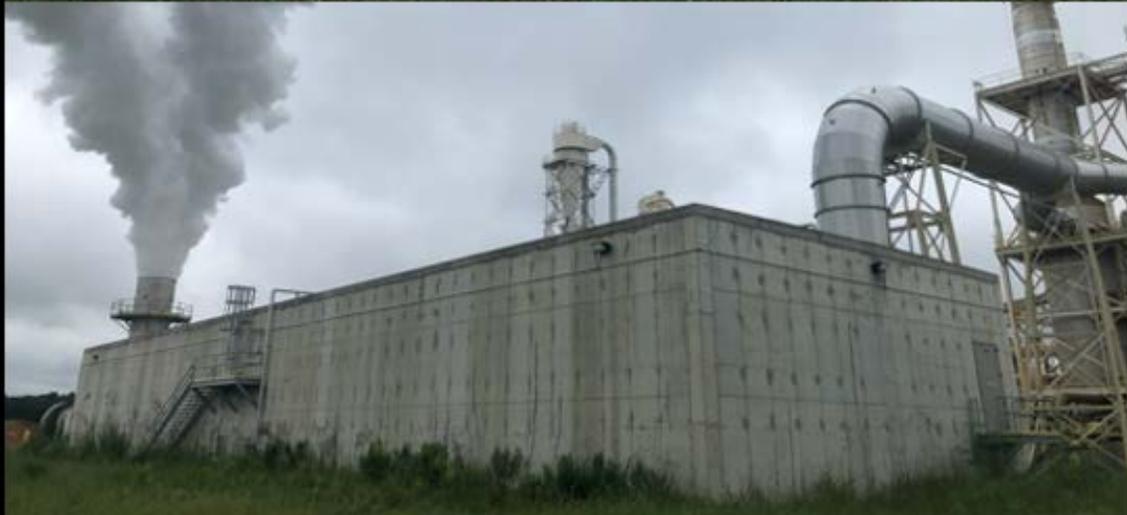
The two-year old structure is 45' by 165' in plan area and includes 25' tall cast-in-place reinforced concrete exterior walls and precast hollow core roof panels (HCPs) topped with a reinforced concrete slab. The function of the structure is to filter formaldehyde and exhaust from wood processing and manufacturing operations for pollution control. The HCPs are the subject of this evaluation.

Figure 1: The biofilter at Arauco Wood Manufacturing Plant containing a 25 ft. tall cast-in-place reinforced concrete exterior walls and precast hollow core roof panels (HCPs) topped with a reinforced concrete slab (RCS).

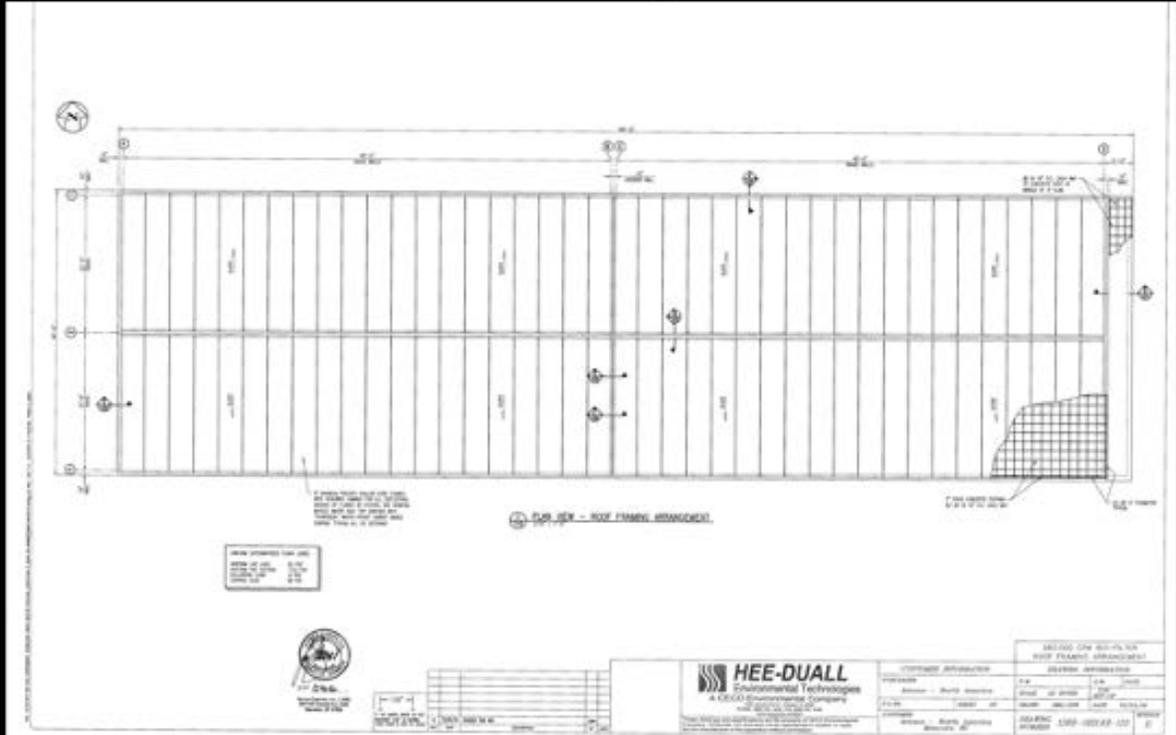
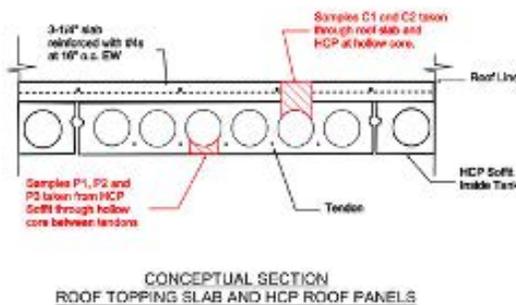
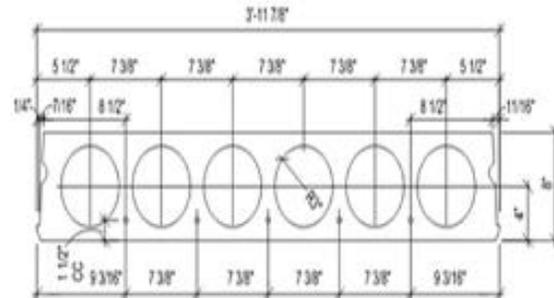
Eighty (80) HCPs form the roof structure in two (2) rows of forty (40). Each row spans about 21-feet between exterior walls and an interior wall. Panels are approximately 4-feet wide and 8-inches deep with six (6) evenly spaced 6-inch diameter cores and five (5) prestress tendons near the bottom of panels surfaces between cores. Hollow core panels are topped with a reinforced concrete slab exposed at the roof surface without a waterproofing membrane.

Figure 3: Relevant drawings of structure consisting of eighty HCPs forming the roof structure in two rows of forty panels. HCPs are topped with a reinforced concrete slab exposed at the roof surface without a waterproofing membrane.

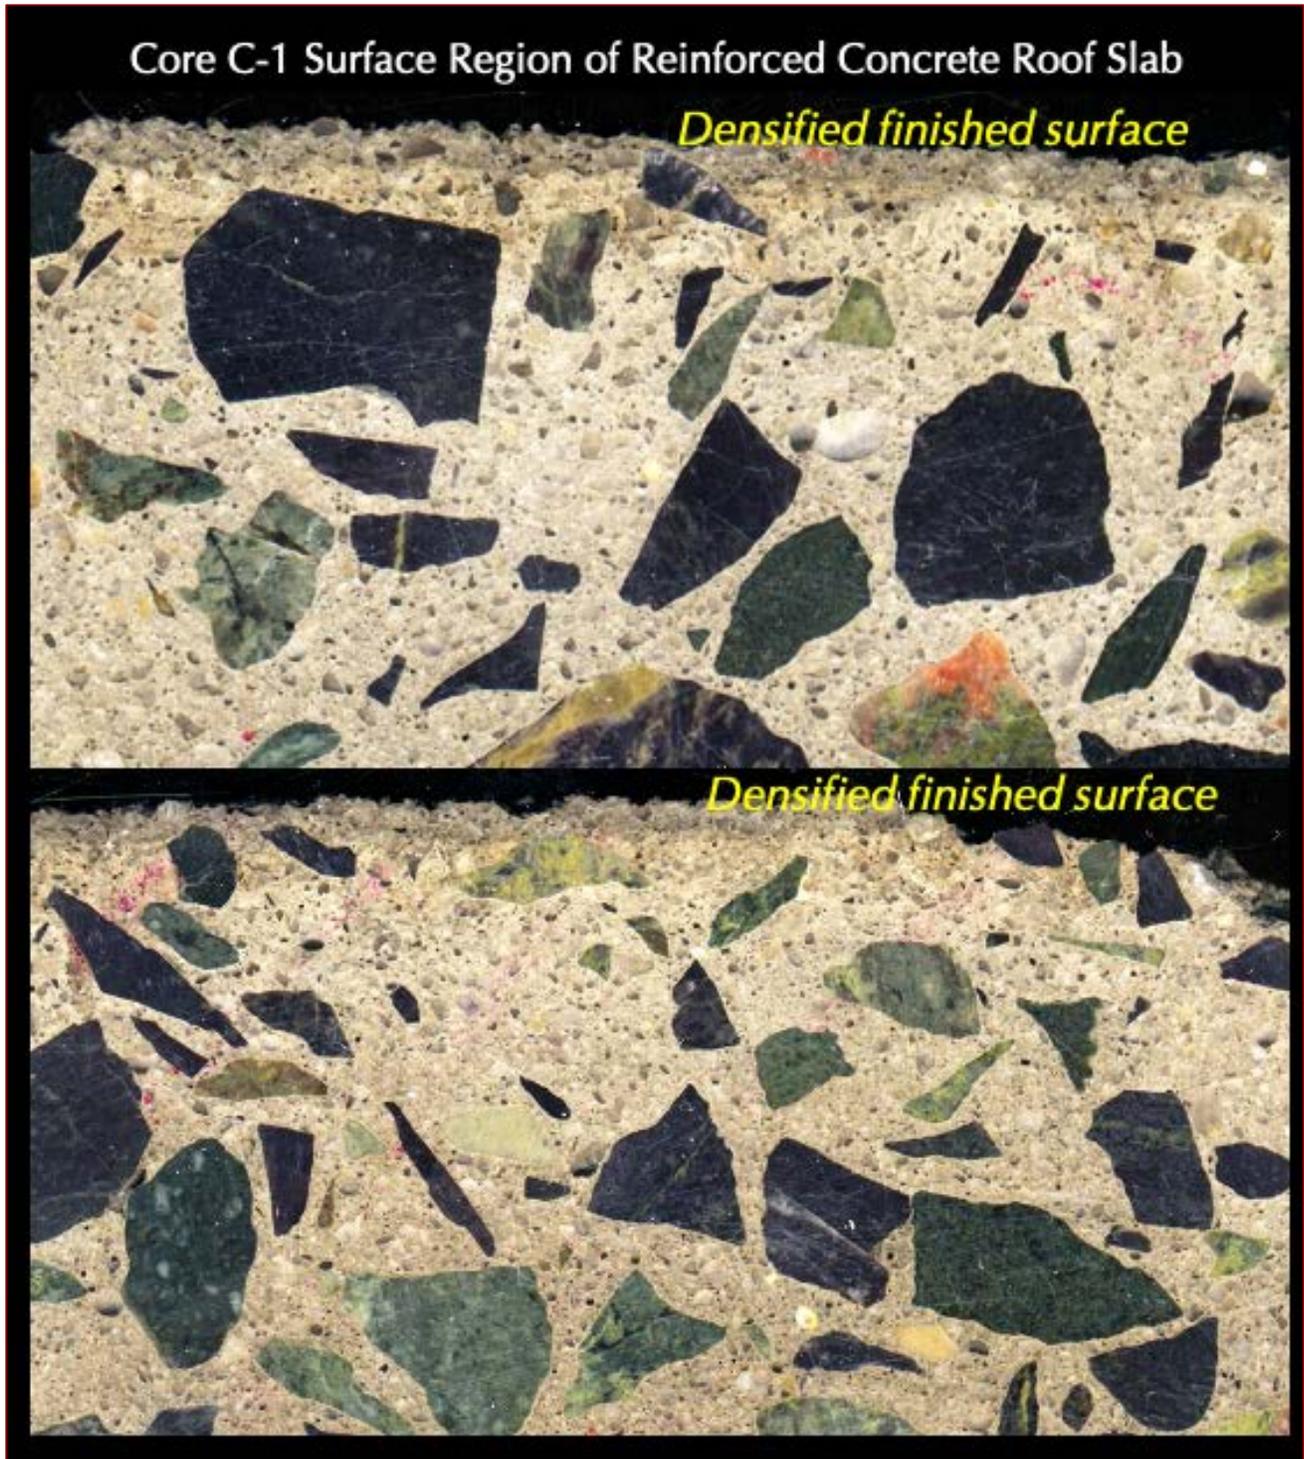
Figure 13: Lapped cross section of reinforced concrete roof top slab (RCS) portion of Core C-1 showing crushed volcanic stone coarse aggregate of 1 in. (25 mm) nominal size which are dense, hard, medium greenish-gray to black, angular, equidimensional to elongated, sound, well-graded, and well-distributed. Notice the darker gray densified finished surface at the top $\frac{1}{8}$ in. due to finishing-induced densification of the surface.

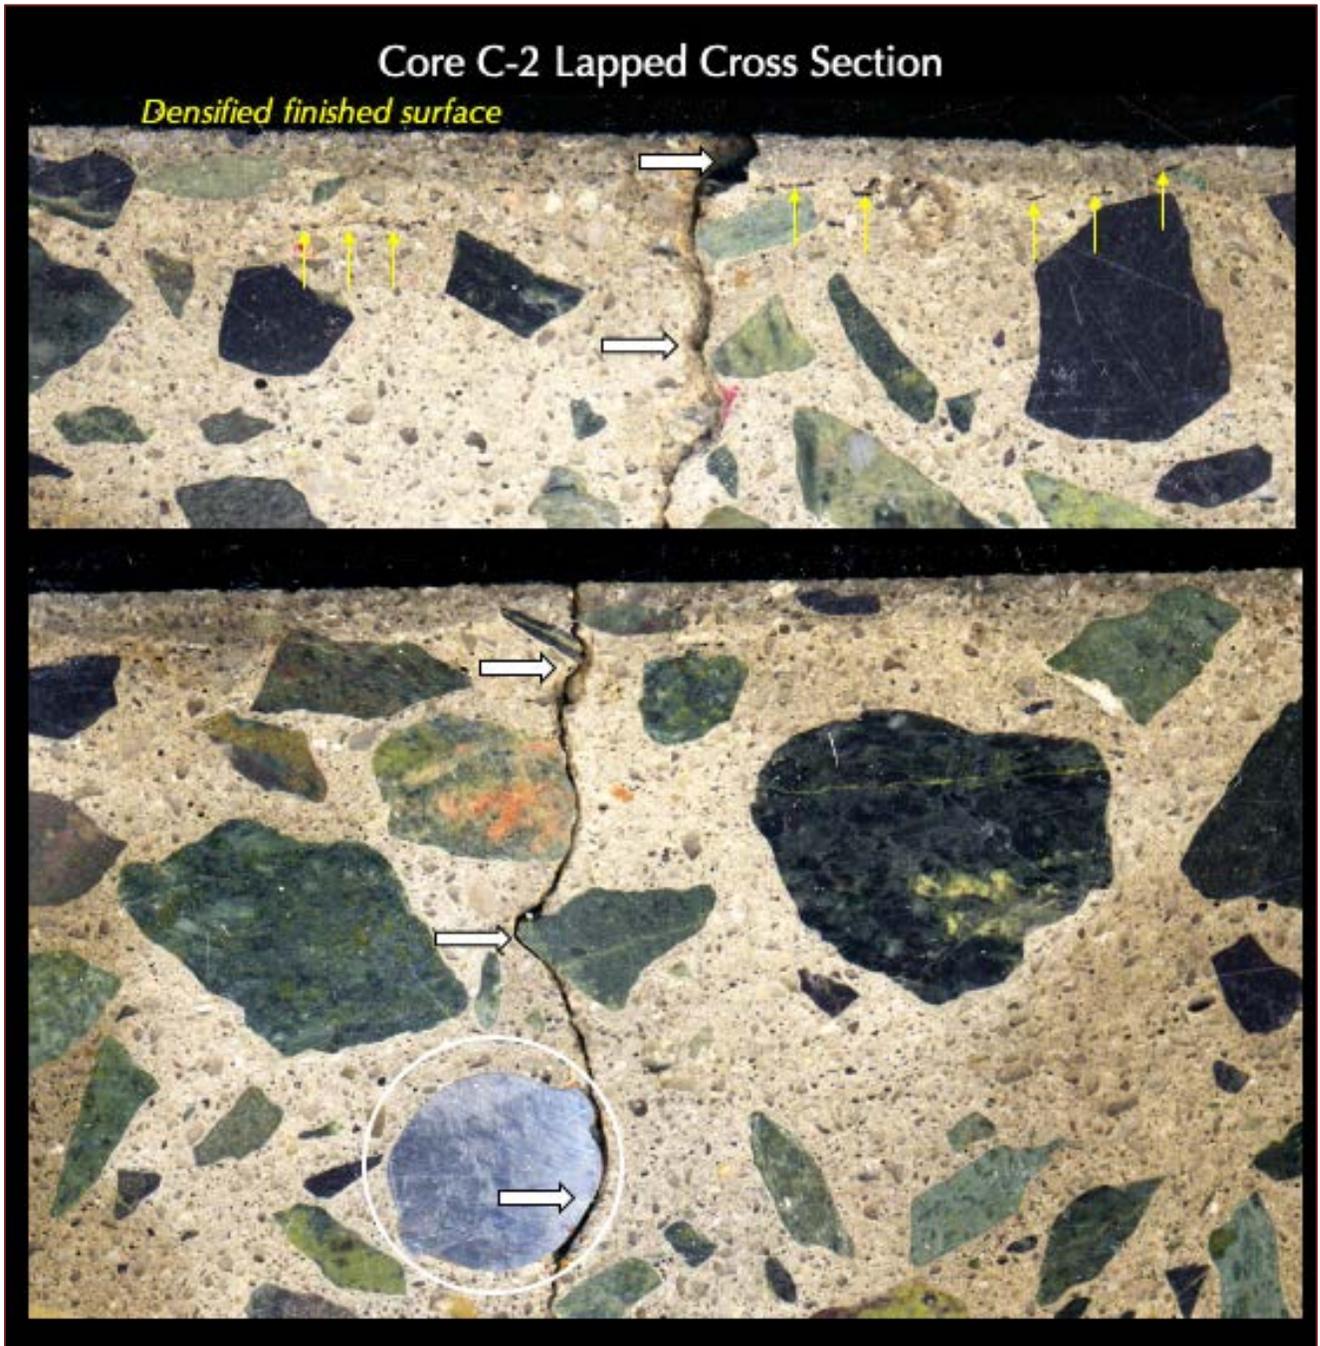
Figure 17: Lapped cross section of reinforced concrete roof top slab (RCS) portion of Core C-2 showing crushed volcanic stone coarse aggregate of 1 in. (25 mm) nominal size which are dense, hard, medium greenish-gray to black, angular, equidimensional to elongated, sound, well-graded, and well-distributed. Notice the darker gray densified finished surface at the top $\frac{1}{8}$ in. due to finishing-induced densification of the surface.

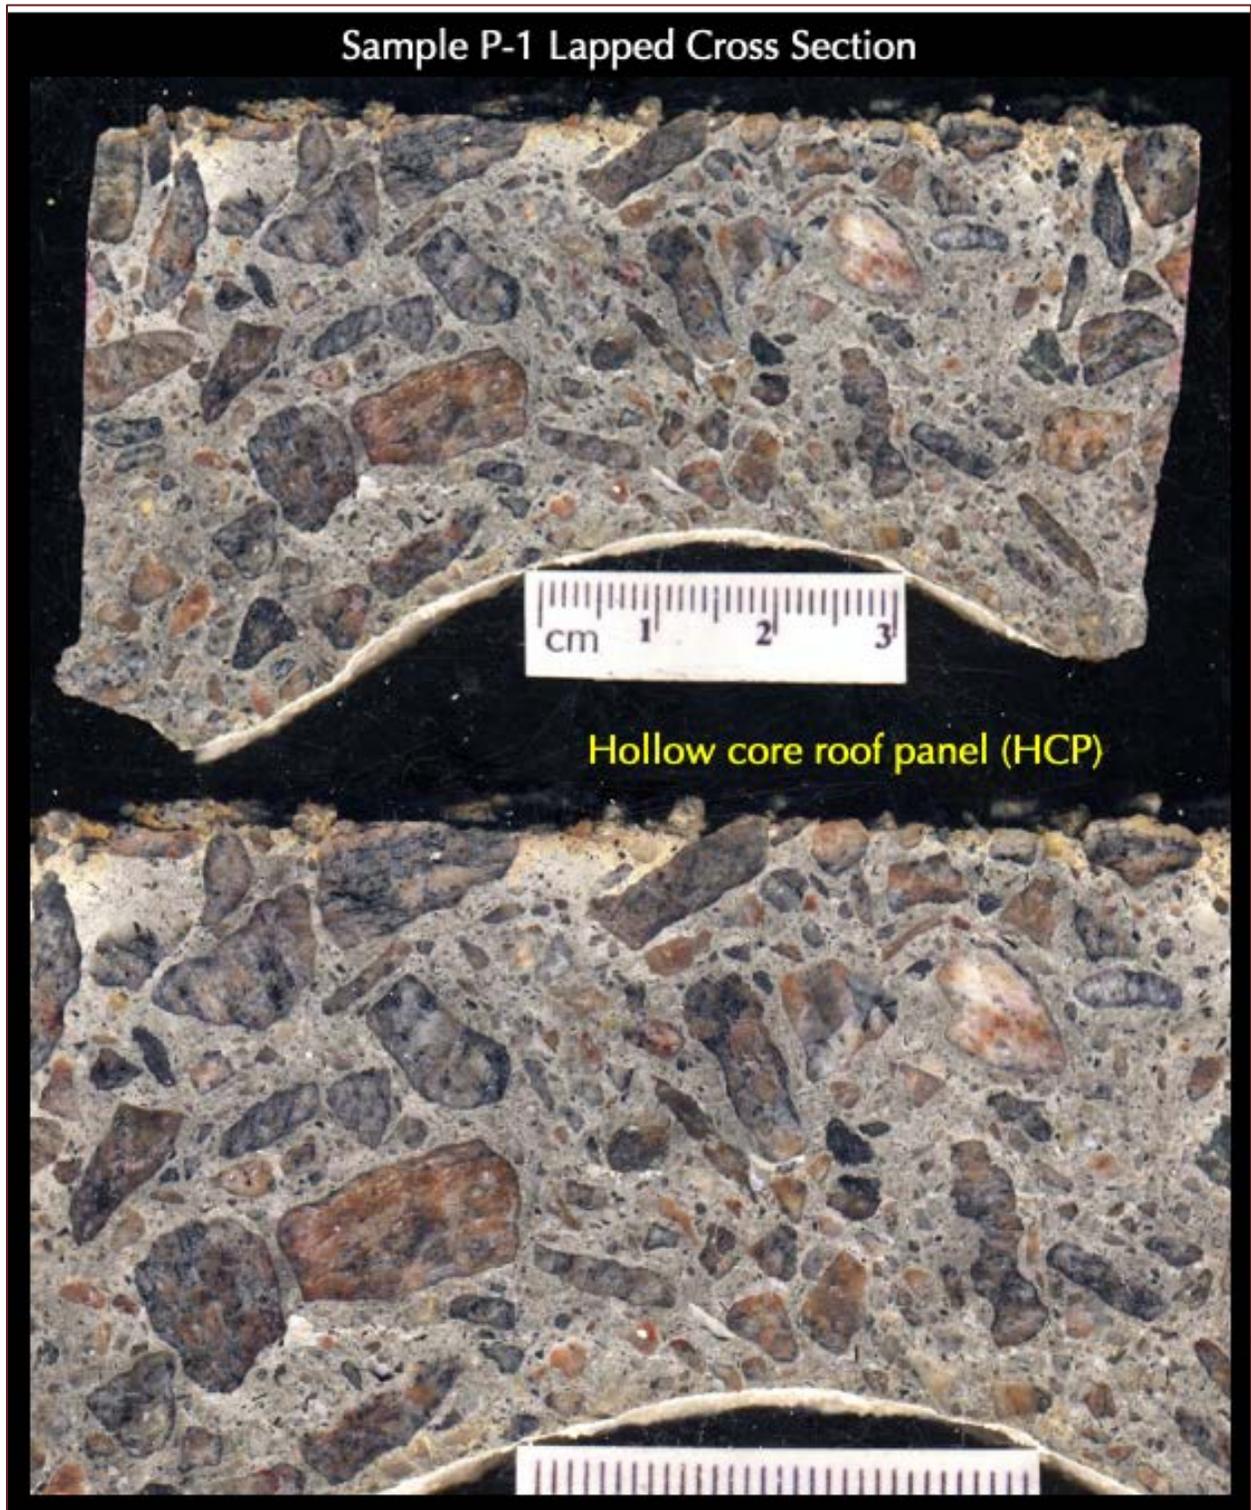
The undersides of HCP in P-1, P-2, and P-3 showed weathered brown altered, carbonated and leached paste exposing the aggregate particles relative to paste due to interactions with exhaust materials, which has affected the 5 to 10 mm zone of the underside. Coarsely crystalline secondary calcite precipitates are found at the underside surfaces of HCP, which are precipitated on leached and carbonated and porous pastes extended to depths of 2 to 3 mm beyond which paste is denser, but still shows carbonation for a few millimeters before sound non-carbonated interior paste. Beyond the altered zone, the majority of the interior portions of HCP are present in dense, well-consolidated, and sound conditions without any physical or chemical deterioration.

Figure 18: Lapped cross section of hollow core panel (HCP) in P-1 showing: (a) crushed granite coarse aggregate of 1/2 in. (12.5 mm) nominal size; (c) dark gray paste in HCP; (d) light beige discolored altered surface at the weathered leached, carbonated end of HCP at the top edge of photos where aggregate particles are exposed relative to paste; (c) relatively sound condition of panel towards the opposite, i.e., concave end; (d) lack of air entrainment, non-air-entrained nature of HCP; and (e) relatively sound visually crack-free condition of the interior of HCP.

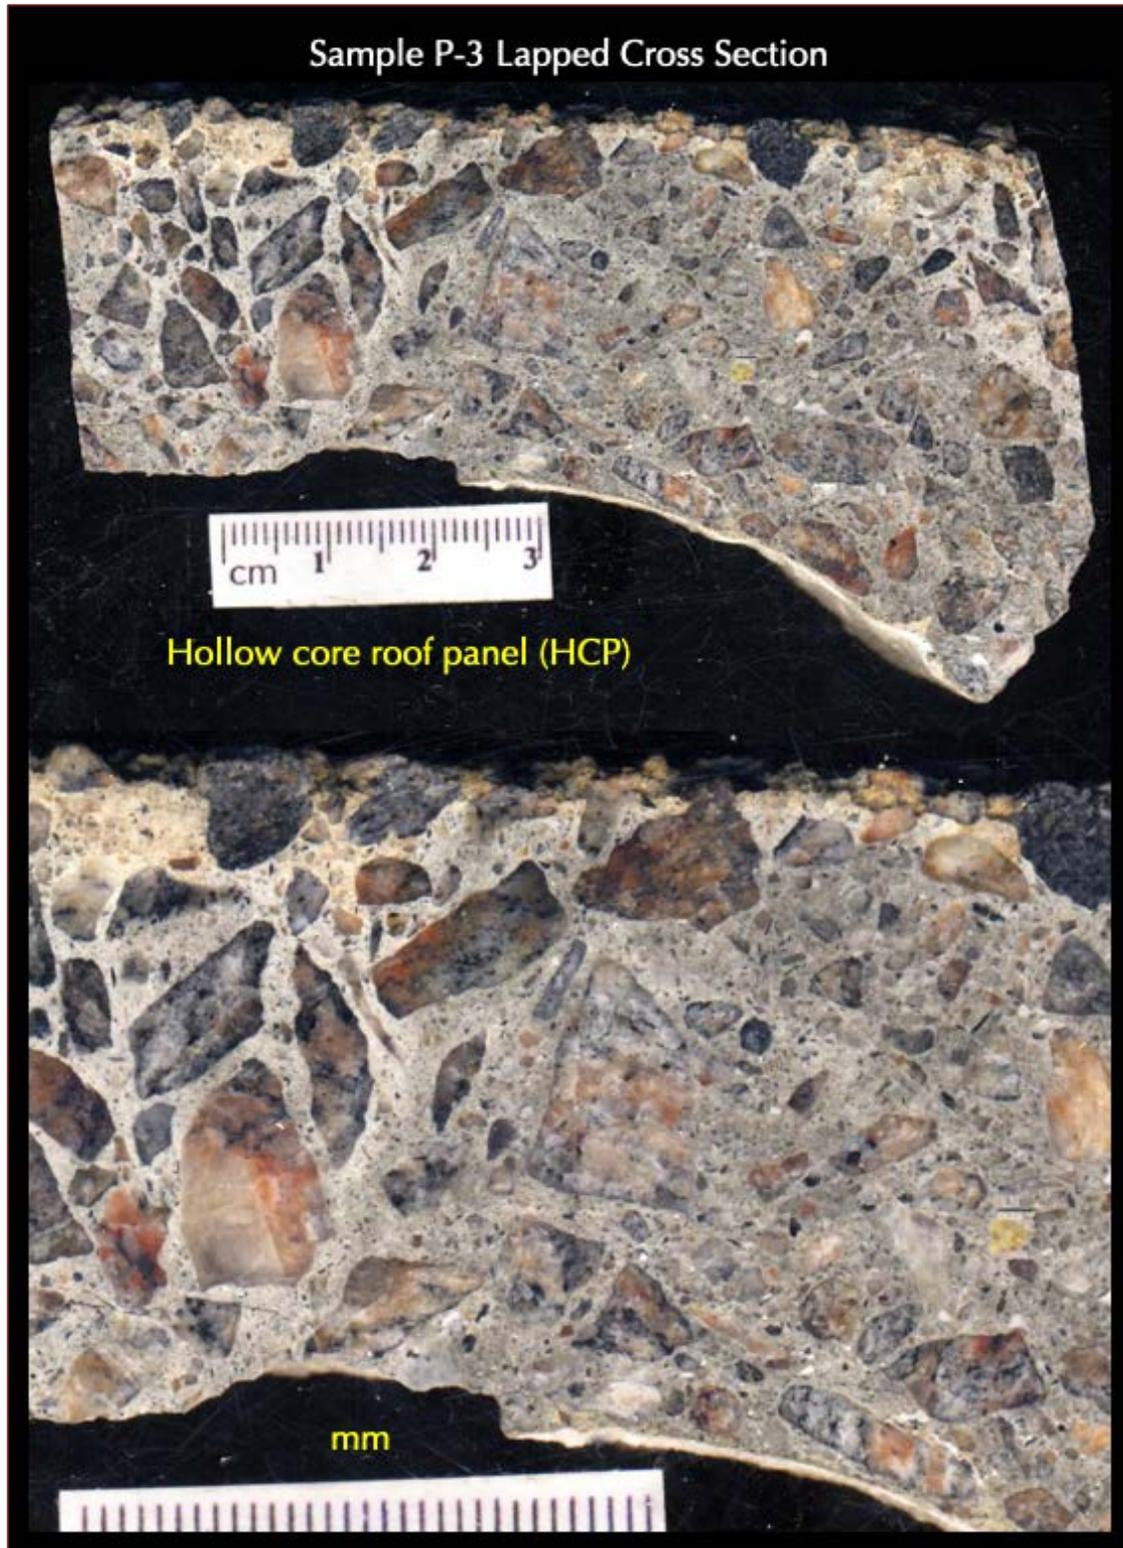
Figure 19: Lapped cross section of hollow core panel (HCP) in P-3 showing: (a) crushed granite coarse aggregate of 1/2 in. (12.5 mm) nominal size; (c) dark gray paste in HCP; (d) light beige discolored altered surface at the weathered leached, carbonated end of HCP at the top edge of photos where aggregate particles are exposed relative to paste; (c) relatively sound condition of panel towards the opposite, i.e., concave end; (d) lack of air entrainment, non-air-entrained nature of HCP; and (e) relatively sound visually crack-free condition of the interior of HCP.

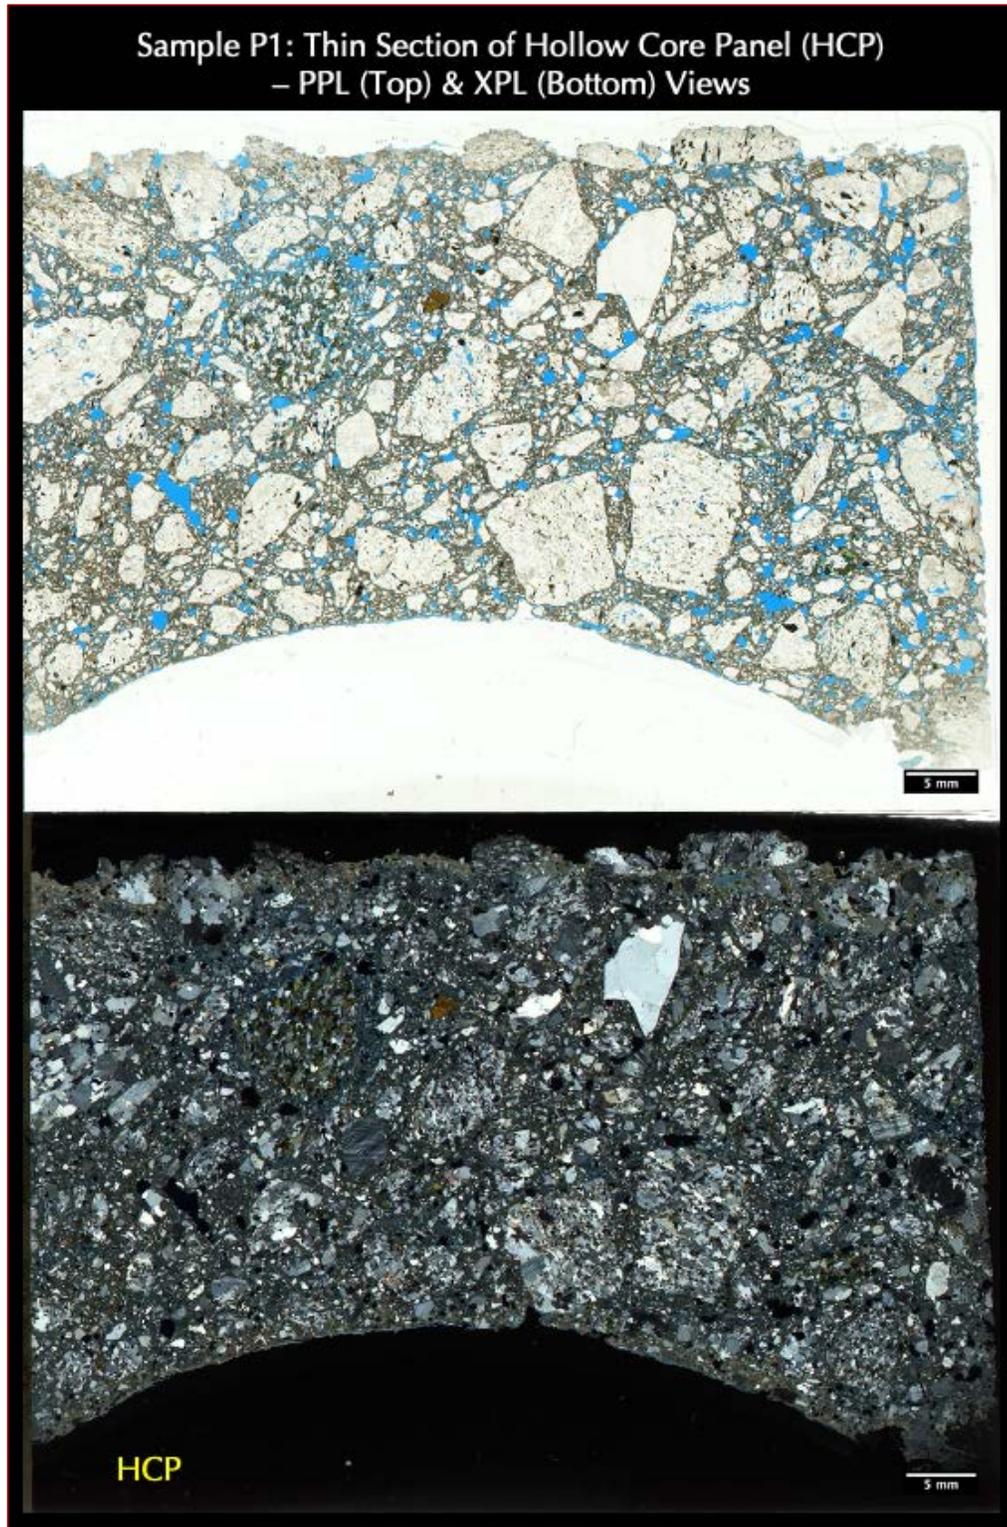
Figure 28: Blue dye-mixed epoxy-impregnated thin section of P-1 in plane polarized light (PPL) at the top and corresponding crossed-polarized light (XPL) mode at the bottom showing: (a) the crushed granite coarse aggregate in HCP; (b) crushed silica sand fine aggregate in both RCS and HCP; (c) excessively air-entrained RCS as opposed to non-air-entrained HCP, where air voids are highlighted in blue epoxy in PPL, and (c) overall dense, non-carbonated interiors of both RCS and HCP, which are evident in both PPL and XPL images. Surface alterations of paste at the weathered brown surface end is not distinct in the entire image in XPL mode except some paste carbonation.

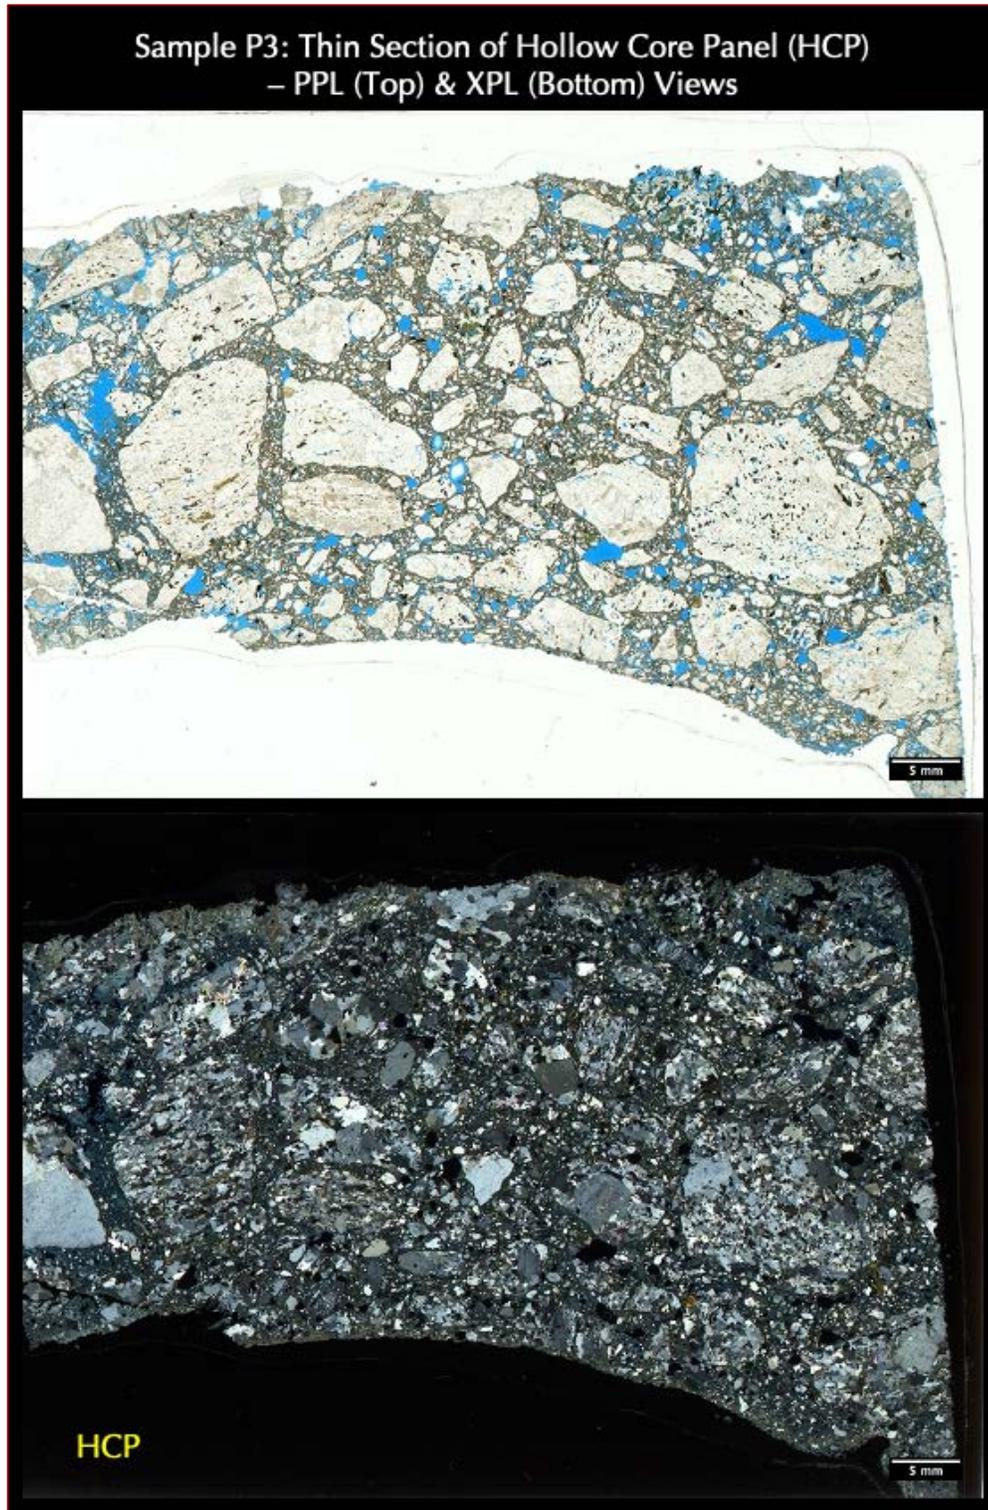
Figure 29: Blue dye-mixed epoxy-impregnated thin section of P-3 in plane polarized light (PPL) at the top and corresponding crossed-polarized light (XPL) mode at the bottom showing: (a) the crushed granite coarse aggregate in HCP; (b) crushed silica sand fine aggregate in both RCS and HCP; (c) excessively air-entrained RCS as opposed to non-air-entrained HCP, where air voids are highlighted in blue epoxy in PPL, and (c) overall dense, non-carbonated interiors of both RCS and HCP, which are evident in both PPL and XPL images. Surface alterations of paste at the weathered brown surface end is not distinct in the entire image in XPL mode except some paste carbonation.

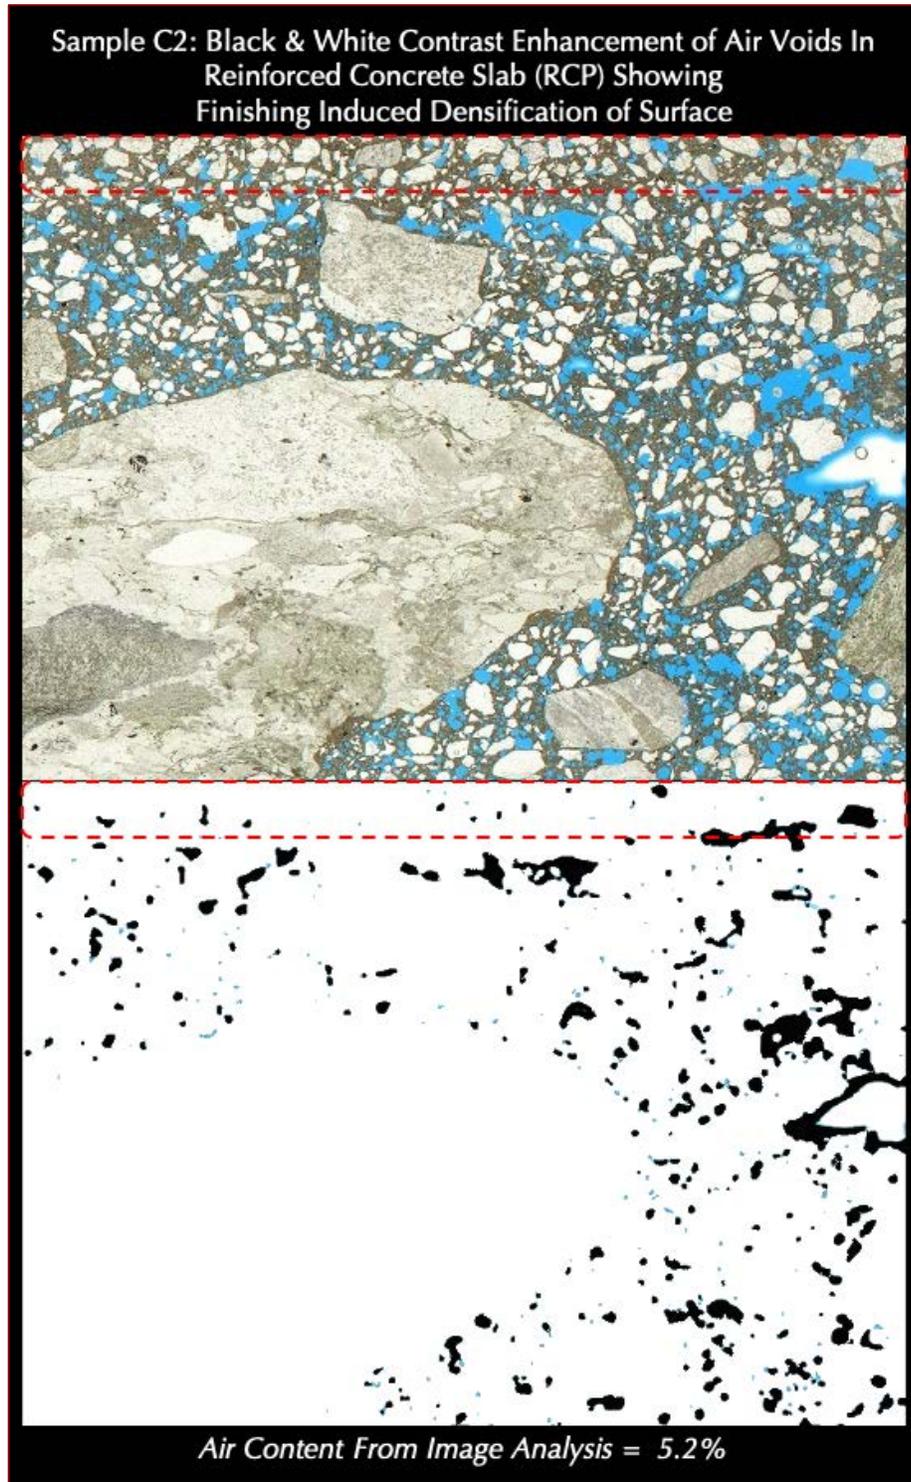
Figure 30: Black and white contrast enhancement of PPL image of RCS in Core C-2 where air voids are highlighted in blue epoxy in the top and corresponding black areas in the bottom binary image where air voids are highlighted in black against everything else in white to calculate air content of RCS as 5.2 percent by volume. The air content is lower than actually observed in the range of 10 to 12 percent (e.g., see Figures 22 and 23) due to the presence of a coarse aggregate particle covering almost 40 percent area of the image.

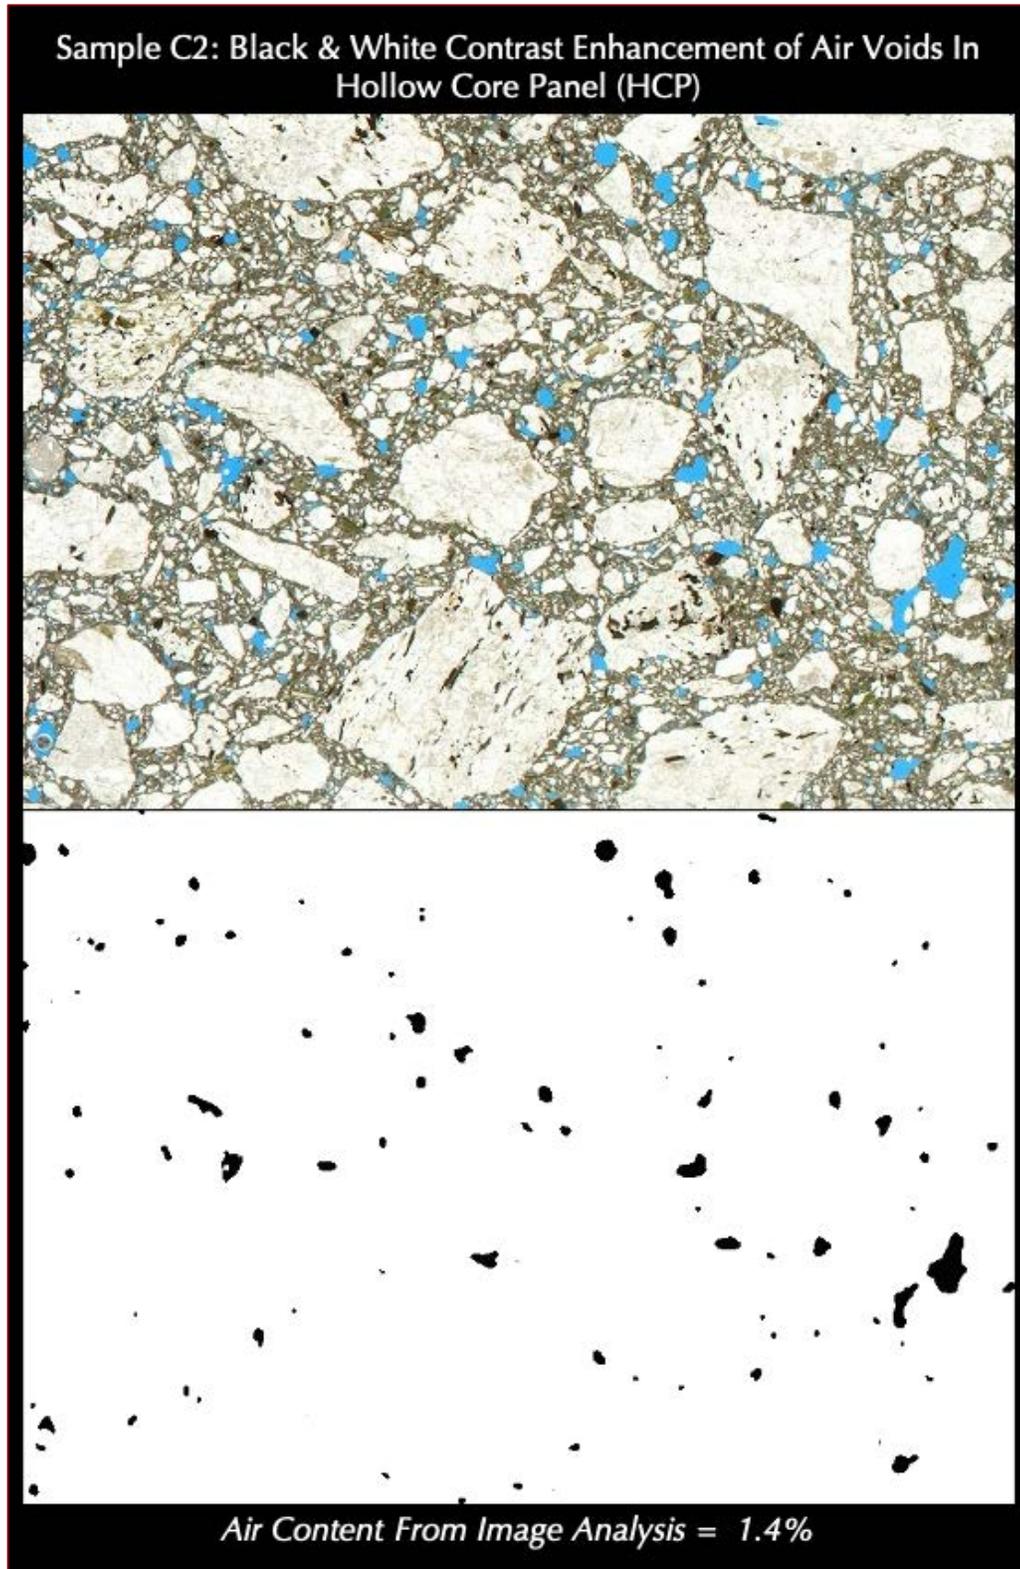
Figure 31: Black and white contrast enhancement of PPL image of HCP in Core C-2 where air voids are highlighted in blue epoxy in the top and corresponding black areas in the bottom binary image where air voids are highlighted in black against everything else in white to calculate air content of HCP as 1.4 percent by volume.

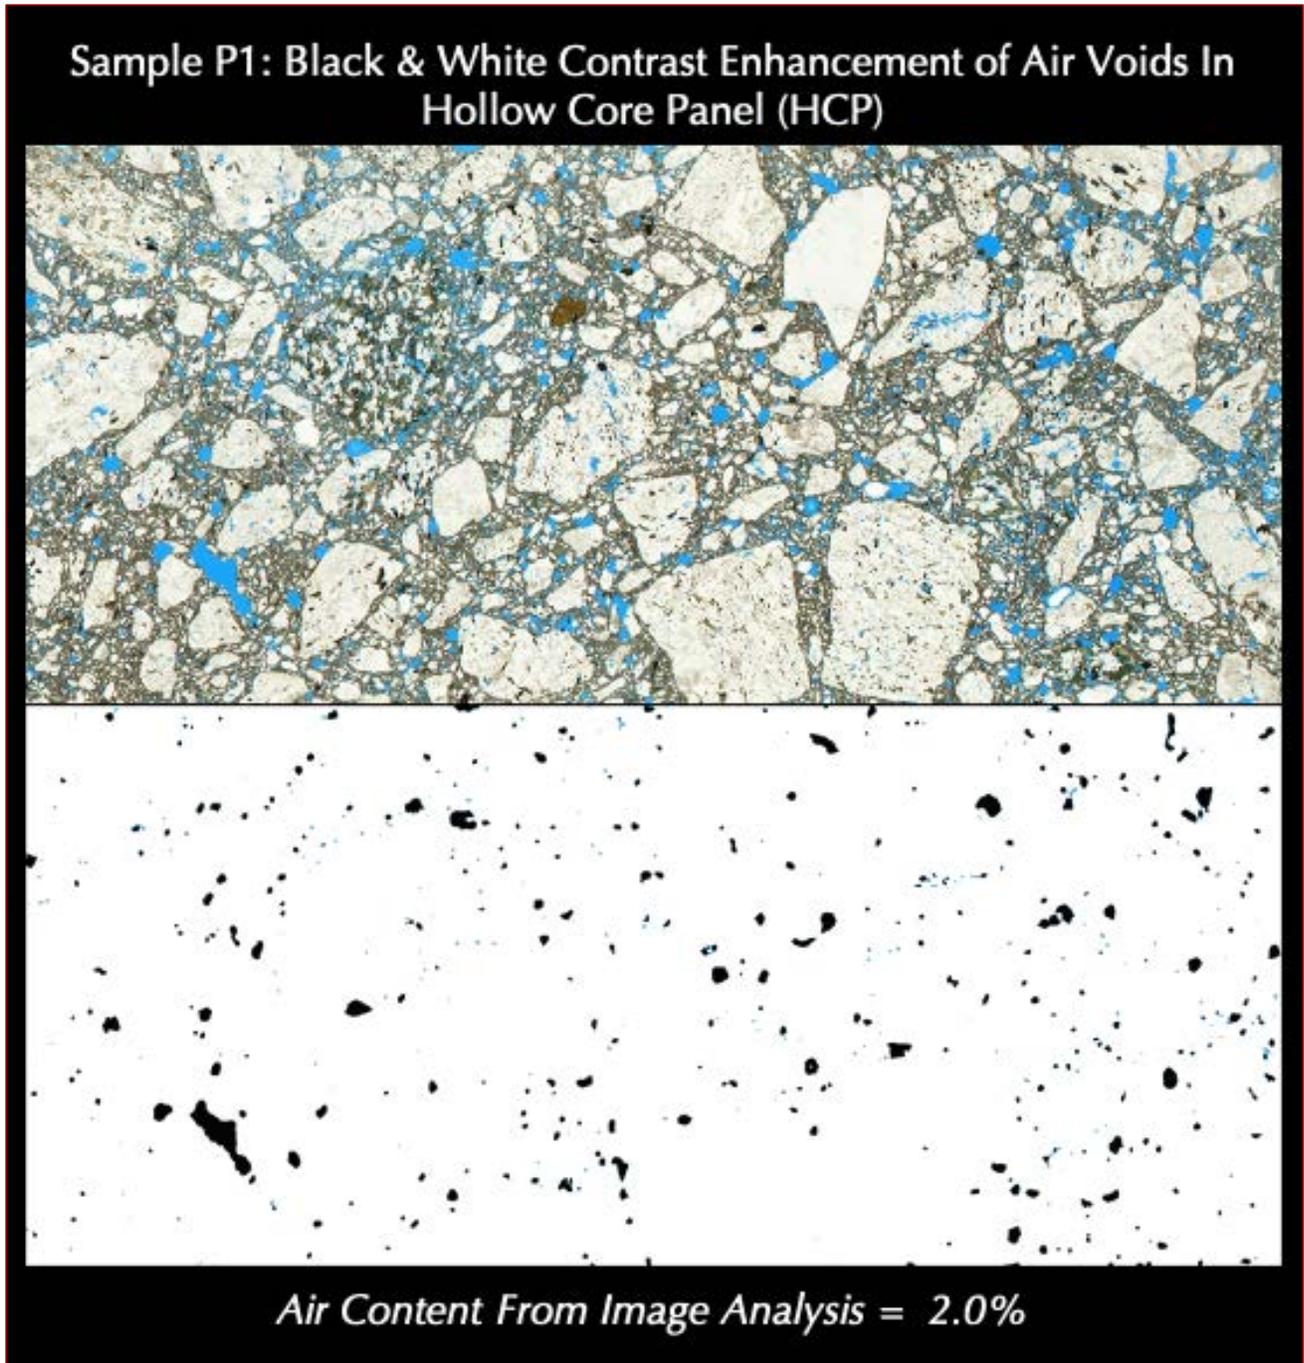
Figure 32: Black and white contrast enhancement of PPL image of HCP in P-1 where air voids are highlighted in blue epoxy in the top and corresponding black areas in the bottom binary image where air voids are highlighted in black against everything else in white to calculate air content of HCP as 2.0 percent by volume.

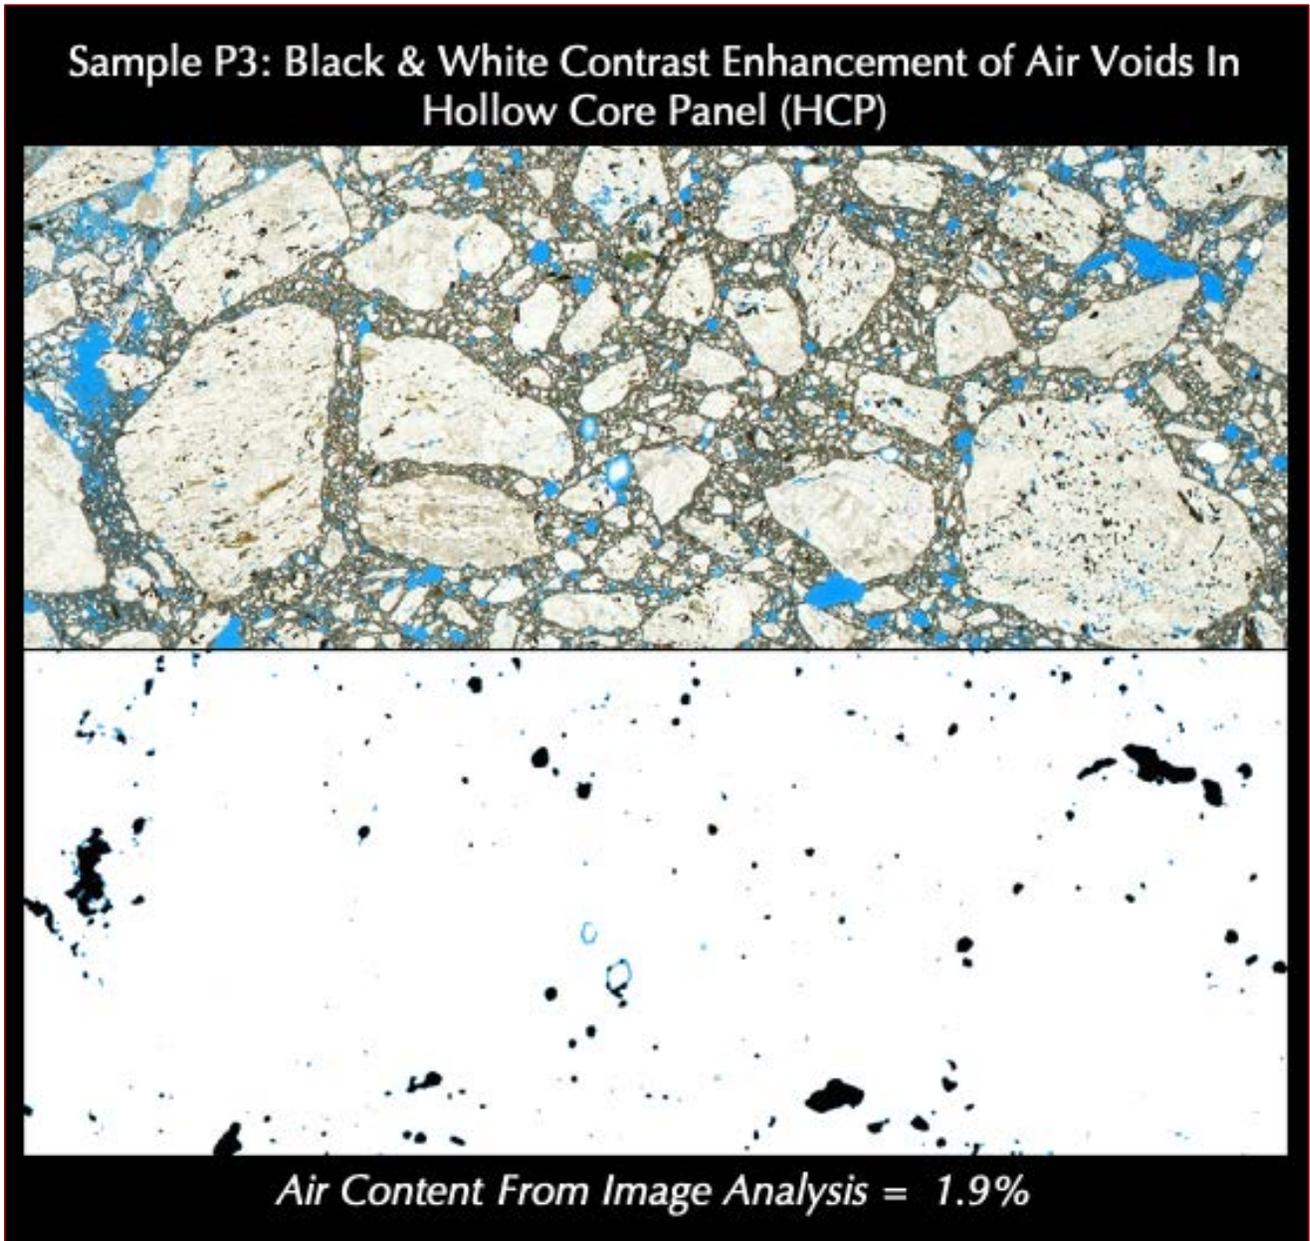
Figure 33: Black and white contrast enhancement of PPL image of HCP in P-3 where air voids are highlighted in blue epoxy in the top and corresponding black areas in the bottom binary image where air voids are highlighted in black against everything else in white to calculate air content of HCP as 1.9 percent by volume. Air contents in three HCPs in Core C-2 and in Samples P1 and P3 are calculated as 1.4%, 2.0%, and 1.9%, respectively, which are noticeably lower than the minimal air content in RCS calculated from image analysis to be 5.2% in Figure 29.
