CONSTRUCTION MATERIALS CONSULTANTS, INC.

Laboratory Investigation Of A Precast Roof Assessment
At The Biofilter Structure
In Arauco Wood Manufacturing Plant
In Moncure, North Carolina

Biofilter Roof Assessment At Arauco Wood Manufacturing Plant
Moncure, North Carolina

April 28, 2021
CMC 0321111

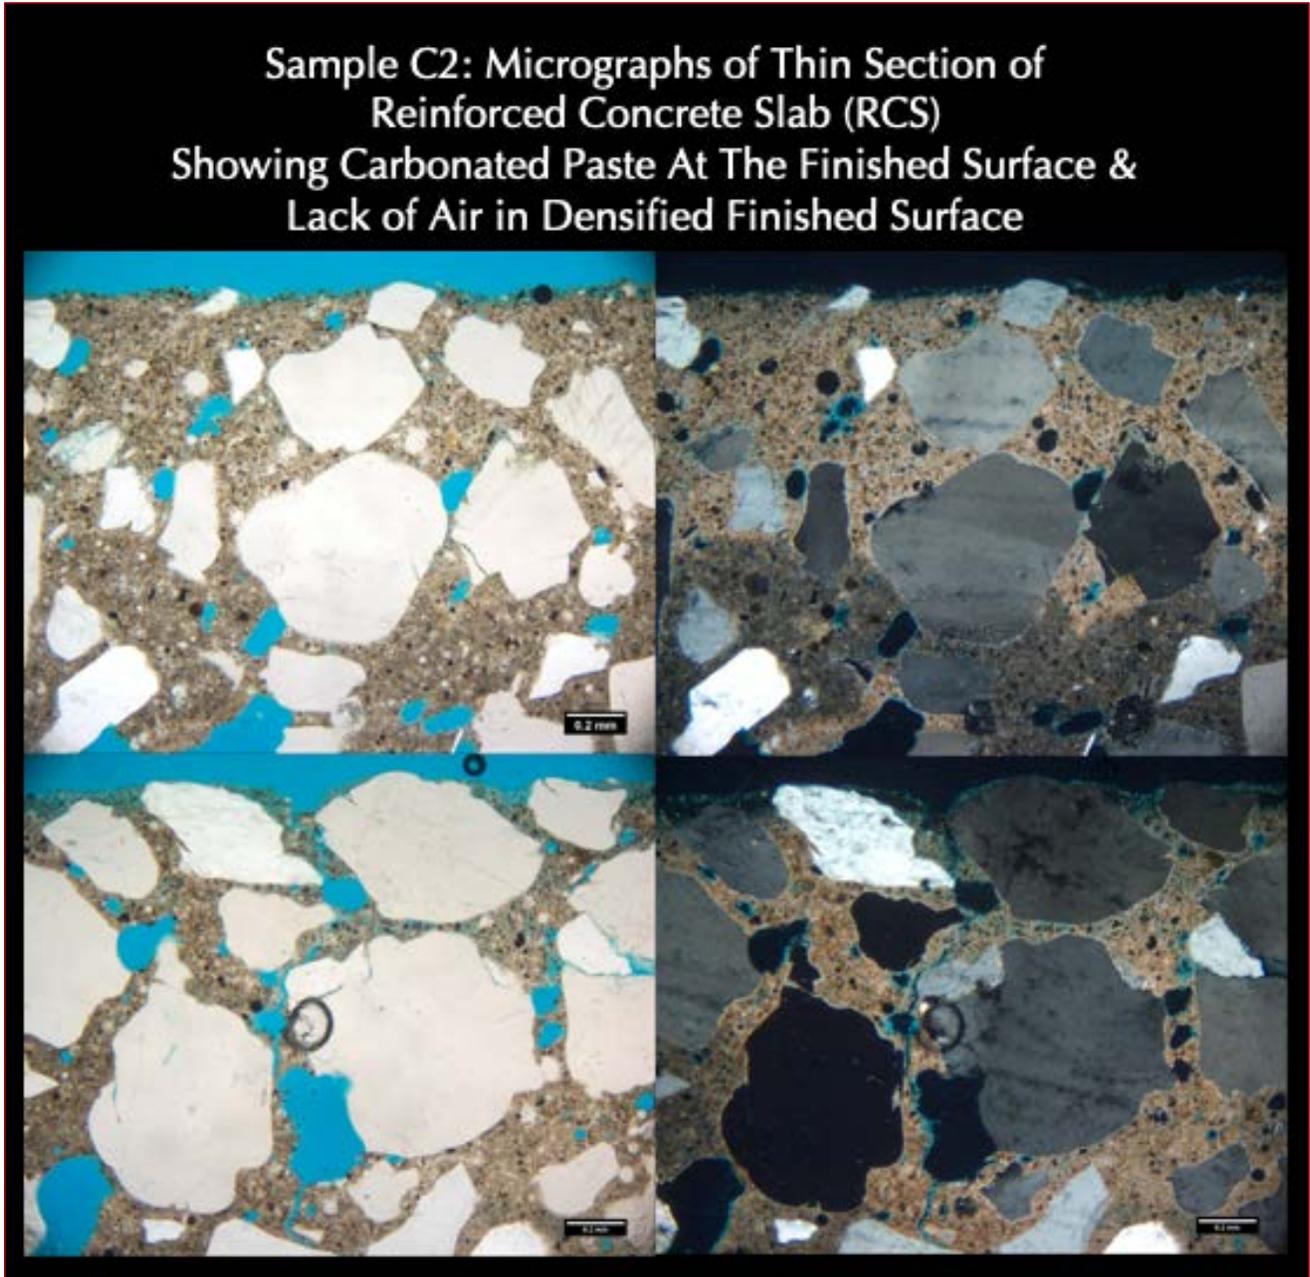
Figure 34: Micrographs of thin section of RCS in Core C-2 showing the golden yellow interference color of carbonated paste at the finished surface region in the right column photos taken in XPL mode of the corresponding PPL images in left column where finishing-induced densification of paste is also noted due to the lack of overall entrained air voids that are excessively present in the interior body. Also notice the presence of a few, fine, spherical black fly ash particles in the paste in the PPL images indicating a binary cementitious mix of major amount of Portland cement and subordinate amount of fly ash. Scale bars are 0.1 mm in length.

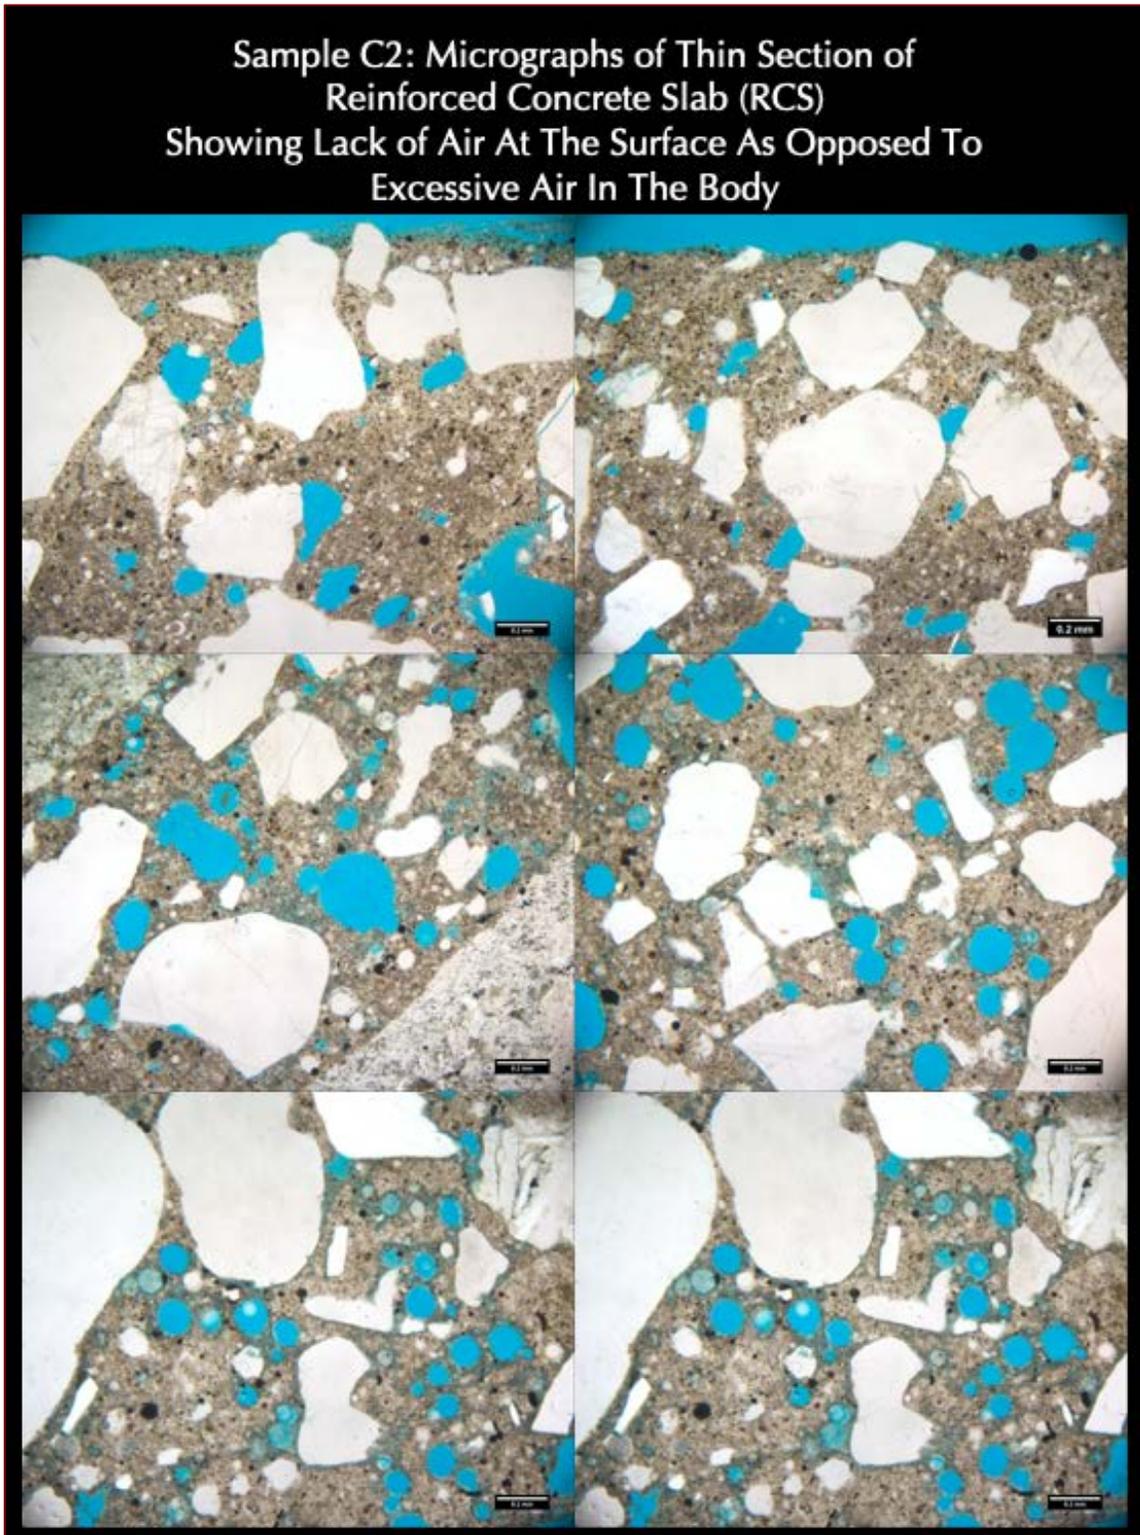
Figure 37: Micrographs of thin section of RCS in Core C-2 showing the finishing-induced loss of air voids at the top finished surface regions in the top row photos where only a few irregular-shaped air voids are highlighted in blue epoxy as opposed to excessively air-entrained fine, discrete spherical and near-spherical entrained air voids in the interior in middle and bottom row photos where spherical entrained air voids are highlighted in blue epoxy. Scale bars are 0.2 mm in length.

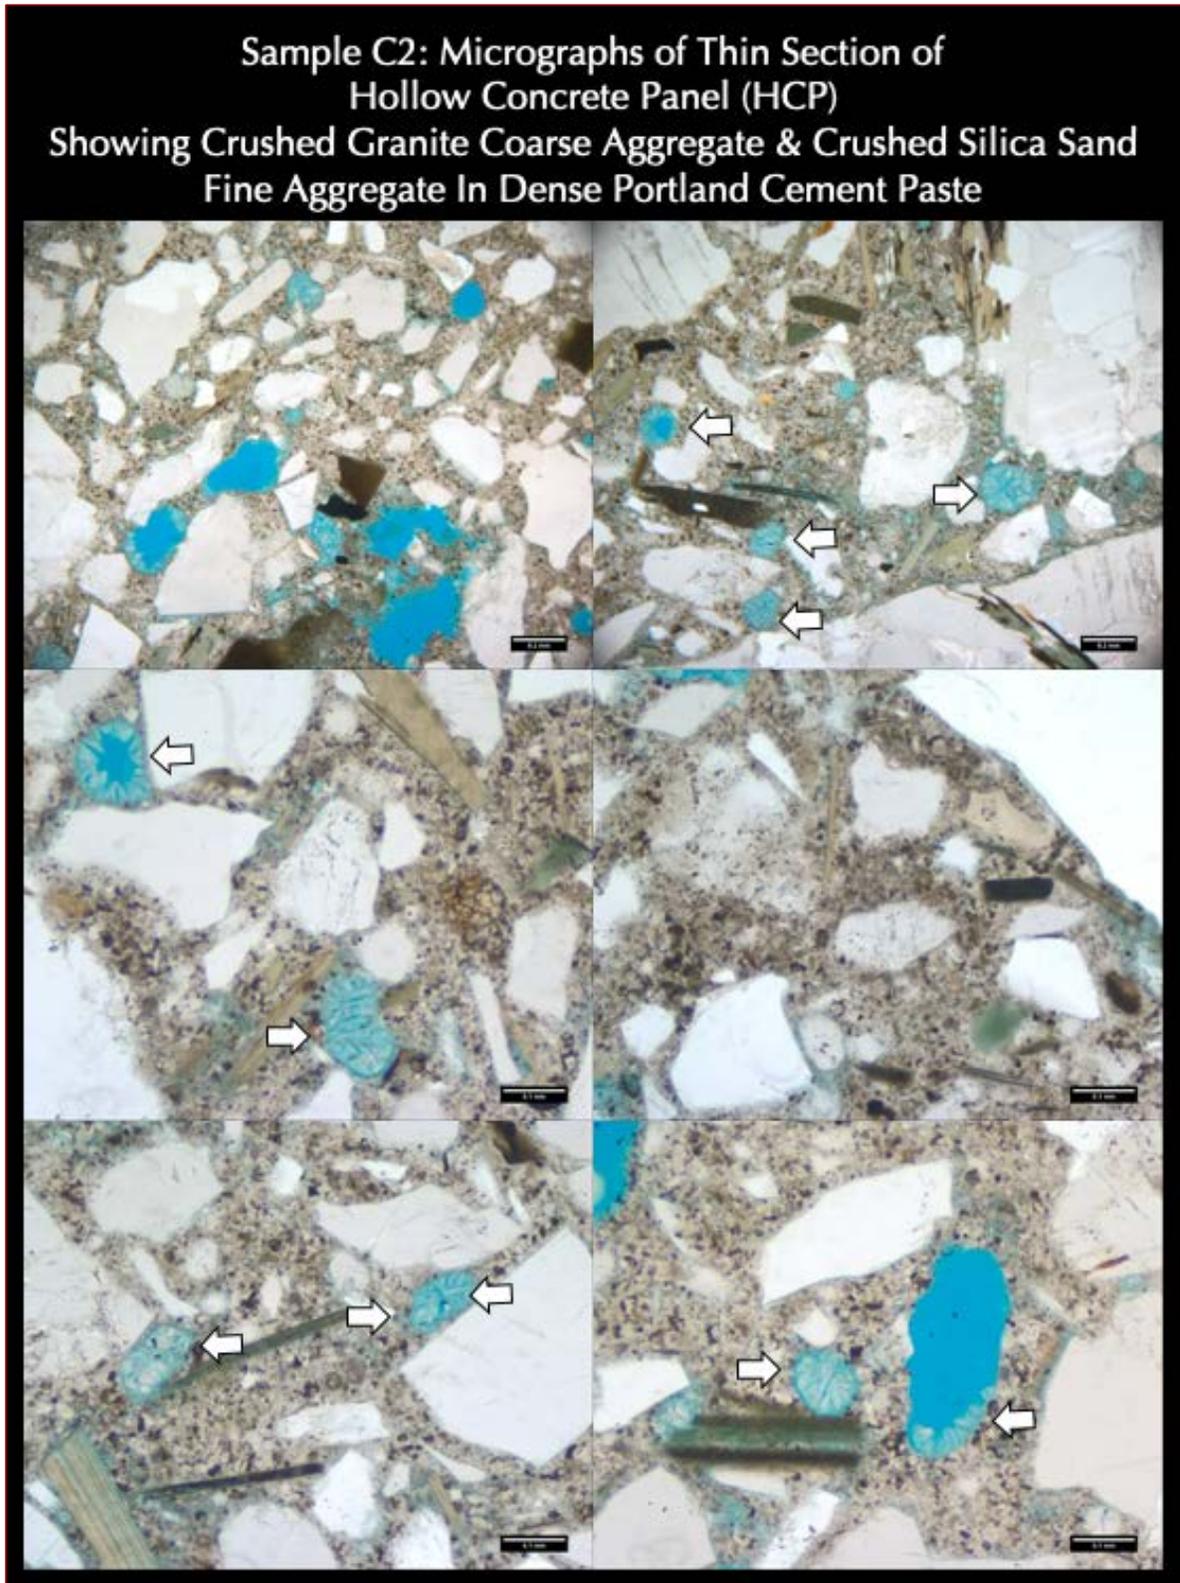
Figure 39: Micrographs of thin section of hollow core panel (HCP) component in Core C-2 showing the dense Portland cement paste between the crushed granite coarse aggregate, crushed silica sand fine aggregate, and sporadic irregular-shaped entrapped air voids many lined with fibrous secondary ettringite deposits indicating prolonged presence of moisture in HCP during service. Scale bars are 0.1 mm in length.

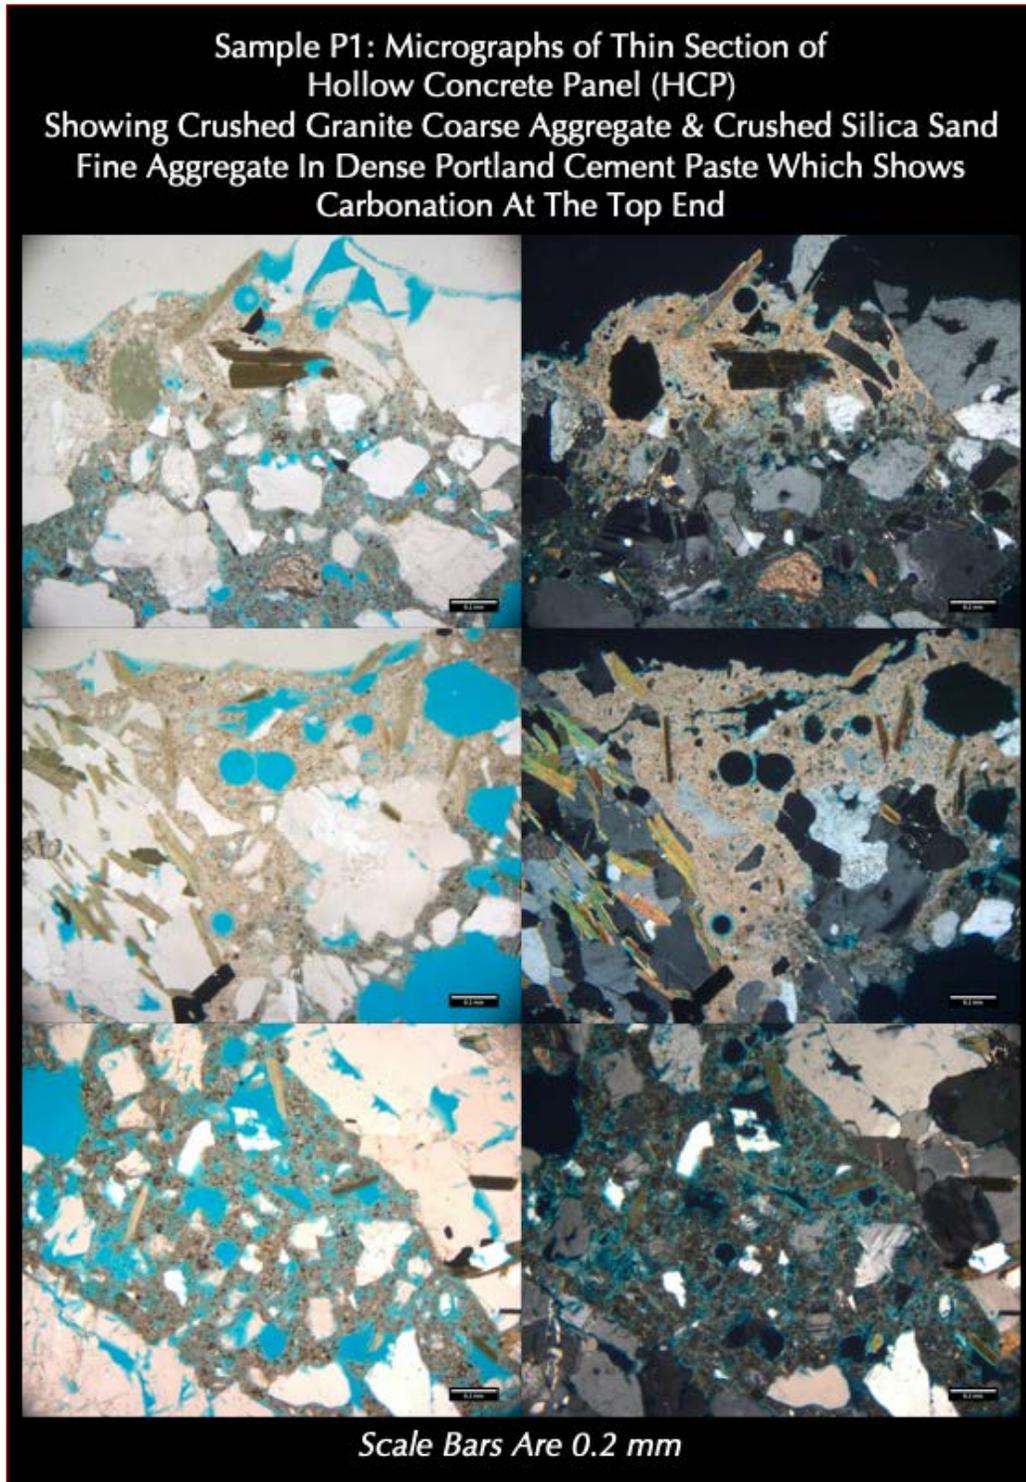
Figure 40: Micrographs of thin section of hollow core panel (HCP) in P-1 showing the crushed granite coarse aggregate particles having quartz, alkali feldspar (microcline, and orthoclase), and plagioclase (albite) mineralogies of granite with minor muscovite and biotite flakes, showing typical coarse-grained intergranular crystalline texture of granite, and crushed silica sand fine aggregate particles having major amounts of quartz and subordinate amounts of quartzite, granite, feldspar particles and dense interstitial Portland cement paste without any spherical particles of residual fly ash found in the RCS component. Notice golden yellow interference color of carbonated paste at the altered weathered brown surface of HCP that are highlighted in top and middle right XPL images.

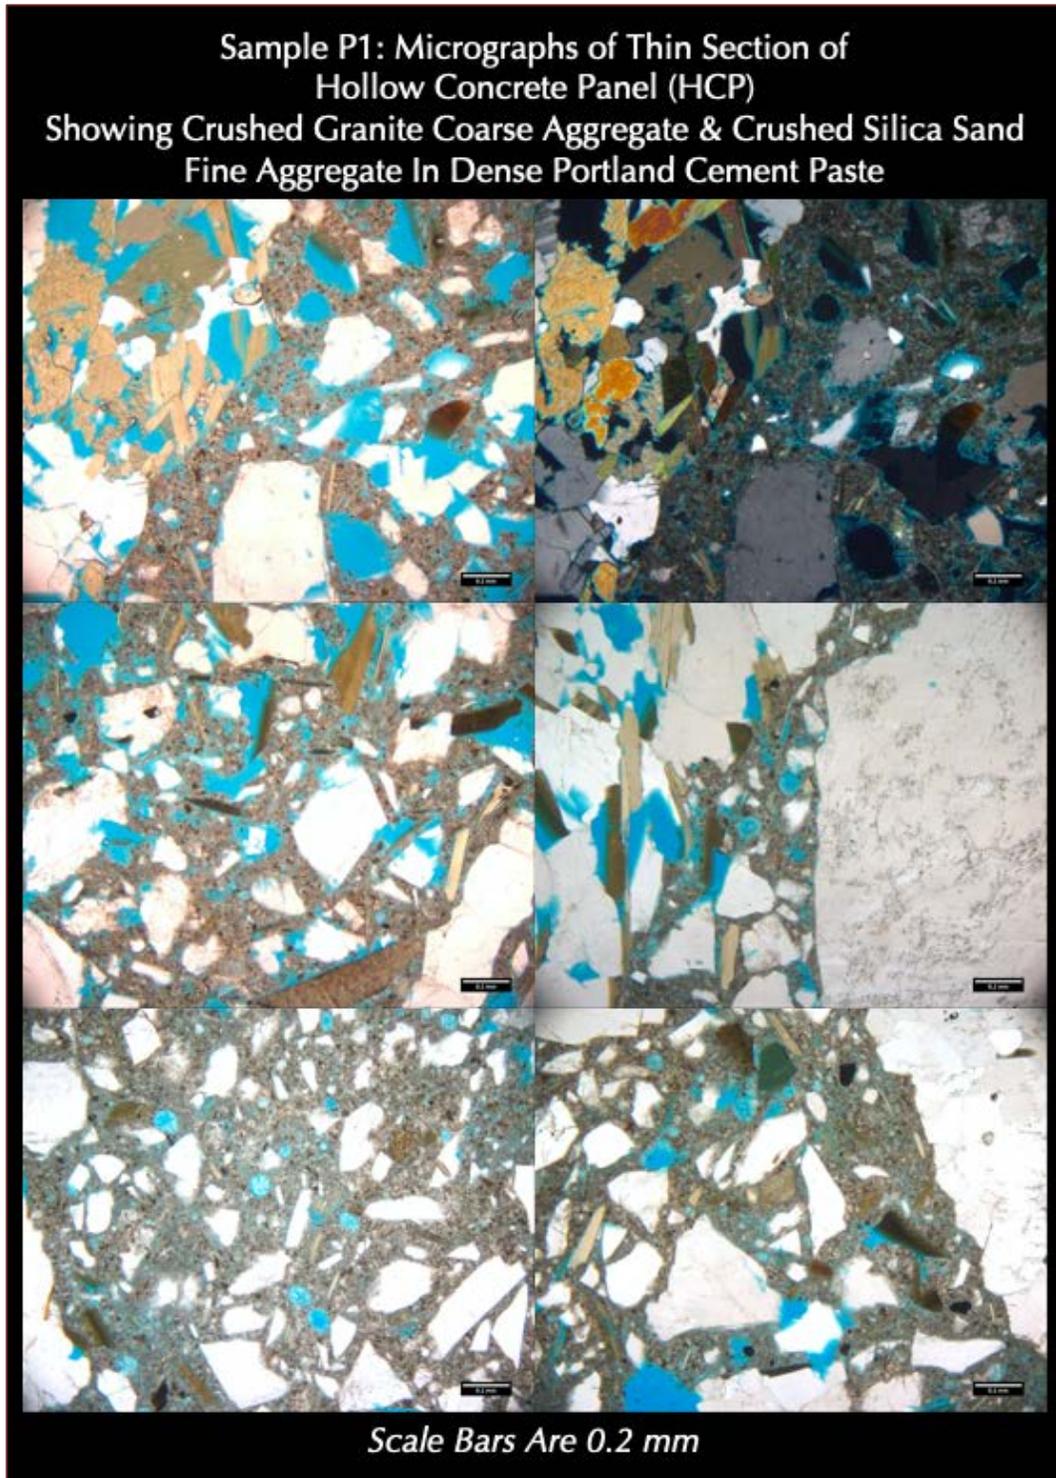
Figure 41: Micrographs of thin section of hollow core panel (HCP) in P-1 showing the crushed granite coarse aggregate particles having quartz, alkali feldspar (microcline, and orthoclase), and plagioclase (albite) mineralogies of granite with minor muscovite and biotite flakes, showing typical coarse-grained intergranular crystalline texture of granite, and crushed silica sand fine aggregate particles having major amounts of quartz and subordinate amounts of quartzite, granite, feldspar particles and dense interstitial Portland cement paste without any spherical particles of residual fly ash found in the RCS component. Notice many entrapped air voids highlighted by blue epoxy are lined or filled with fibrous secondary ettringite deposits in the bottom left photo indicating the presence of moisture in HCP during service.

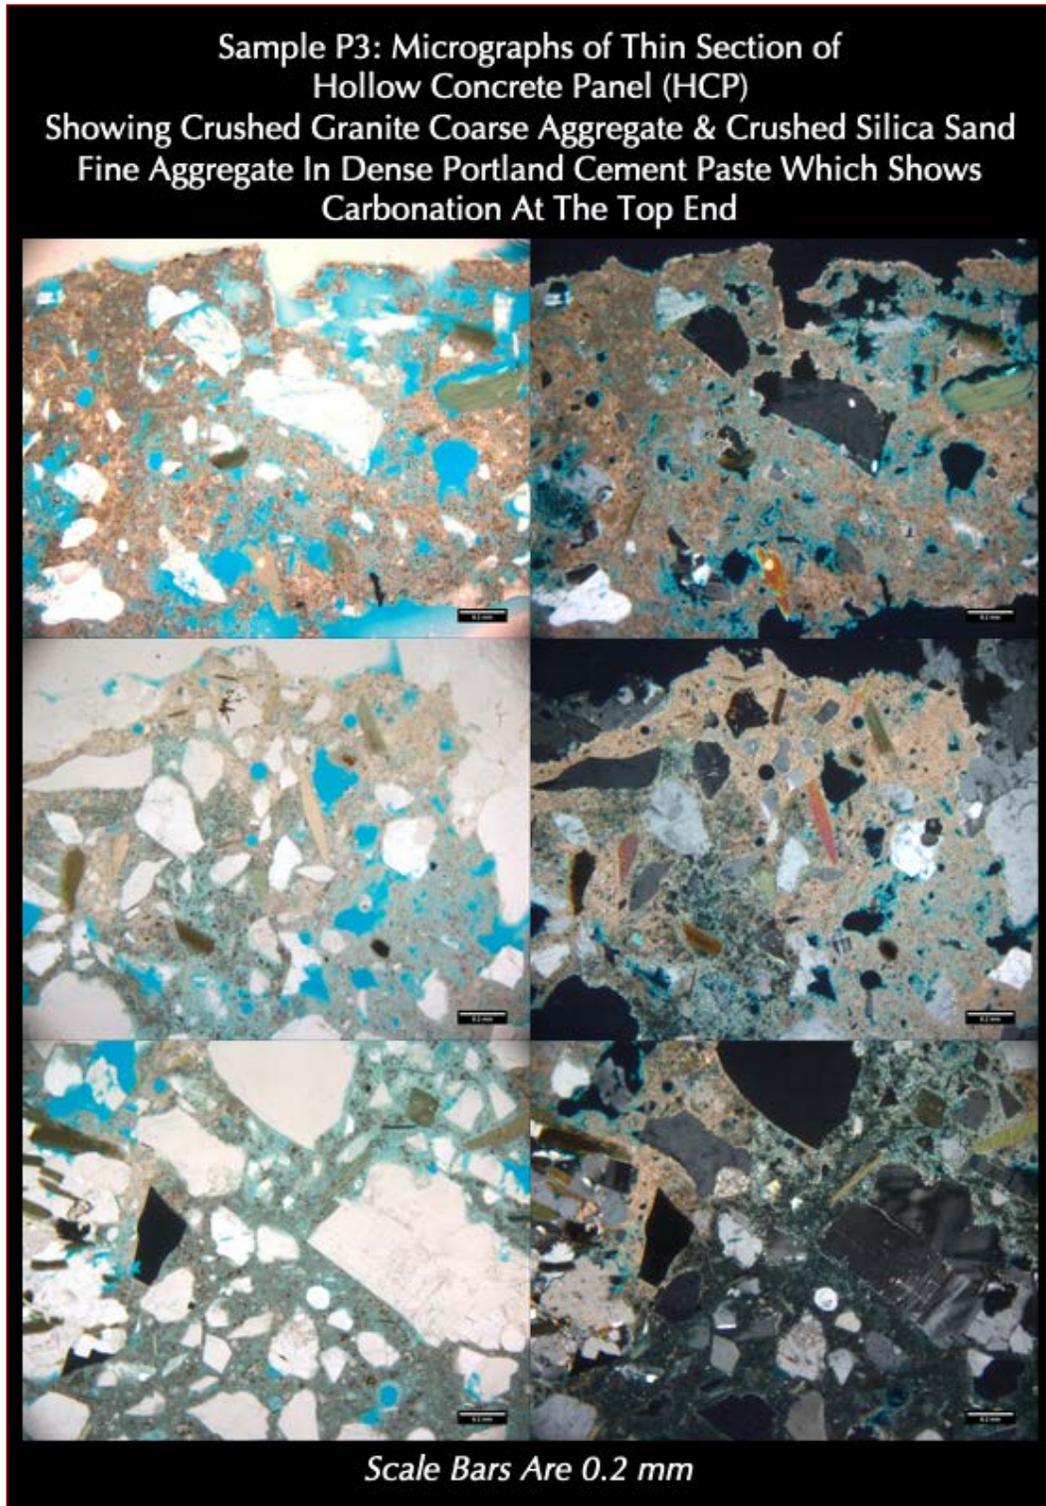
Figure 44: Micrographs of thin section of hollow core panel (HCP) in P-3 showing the crushed granite coarse aggregate particles having quartz, alkali feldspar (microcline, and orthoclase), and plagioclase (albite) mineralogies of granite with minor muscovite and biotite flakes, showing typical coarse-grained intergranular crystalline texture of granite, and crushed silica sand fine aggregate particles having major amounts of quartz and subordinate amounts of quartzite, granite, feldspar particles and dense interstitial Portland cement paste without any spherical particles of residual fly ash found in the RCS component. Notice golden yellow interference color of carbonated paste at the altered weathered brown surface of HCP that are highlighted in the right column XPL images.

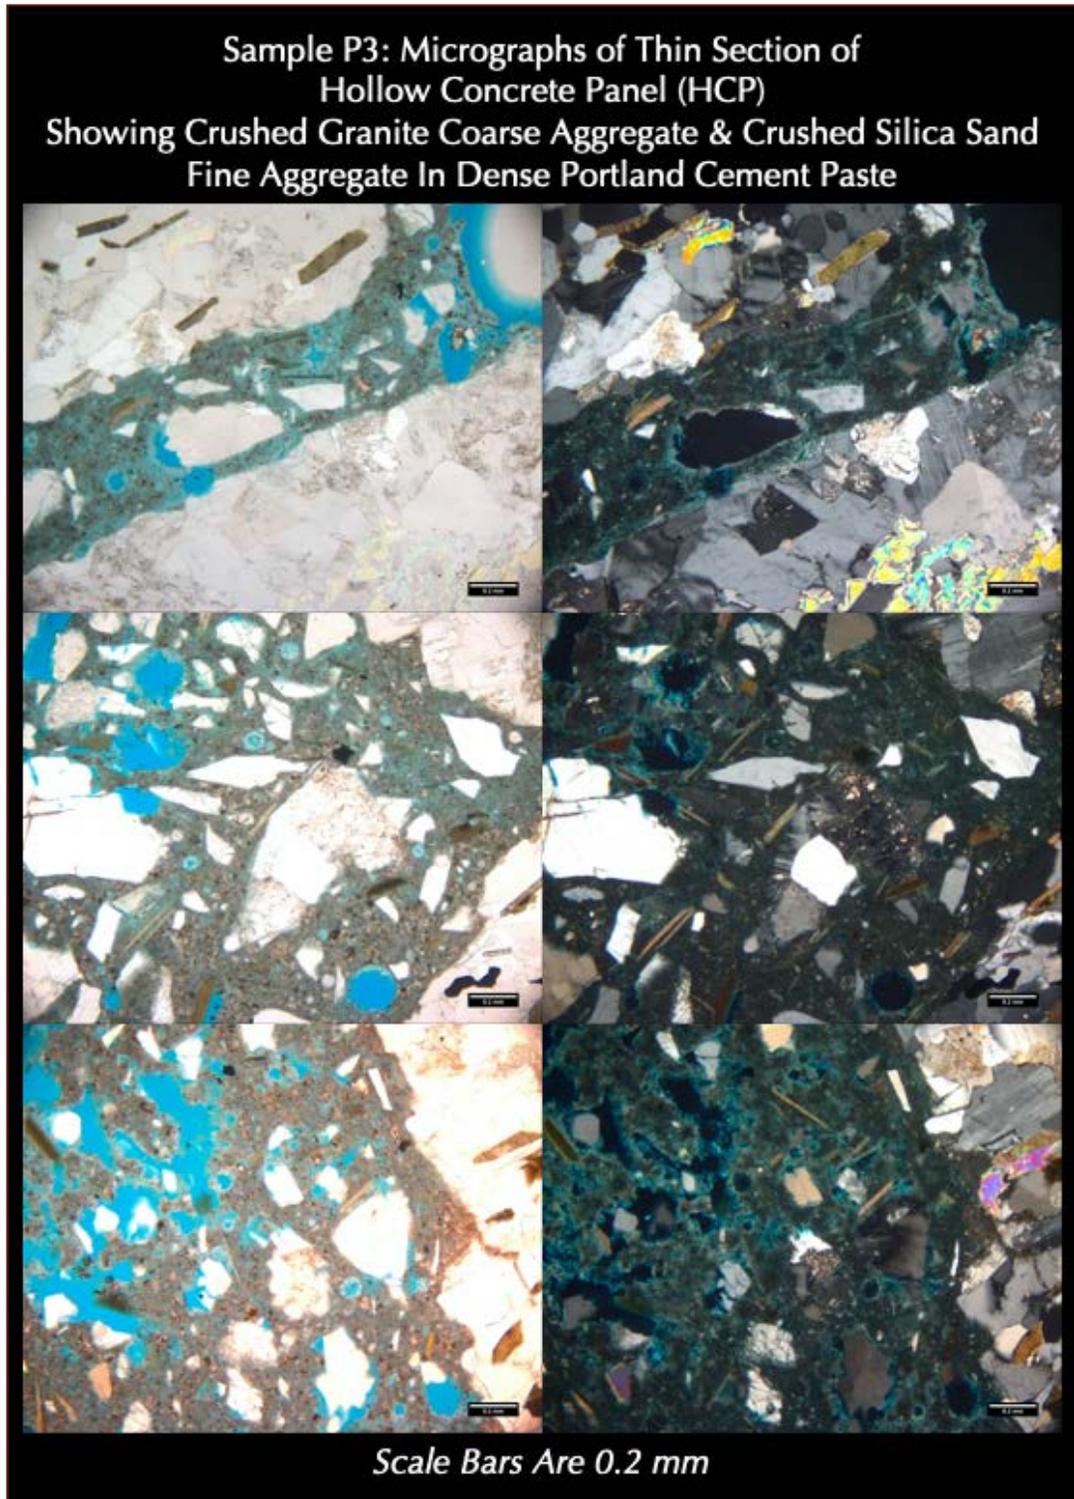
Figure 45: Micrographs of thin section of hollow core panel (HCP) in P-3 showing the crushed granite coarse aggregate particles having quartz, alkali feldspar (microcline, and orthoclase), and plagioclase (albite) mineralogies of granite with minor muscovite and biotite flakes, showing typical coarse-grained intergranular crystalline texture of granite, and crushed silica sand fine aggregate particles having major amounts of quartz and subordinate amounts of quartzite, granite, feldspar particles and dense interstitial Portland cement paste without any spherical particles of residual fly ash found in the RCS component.

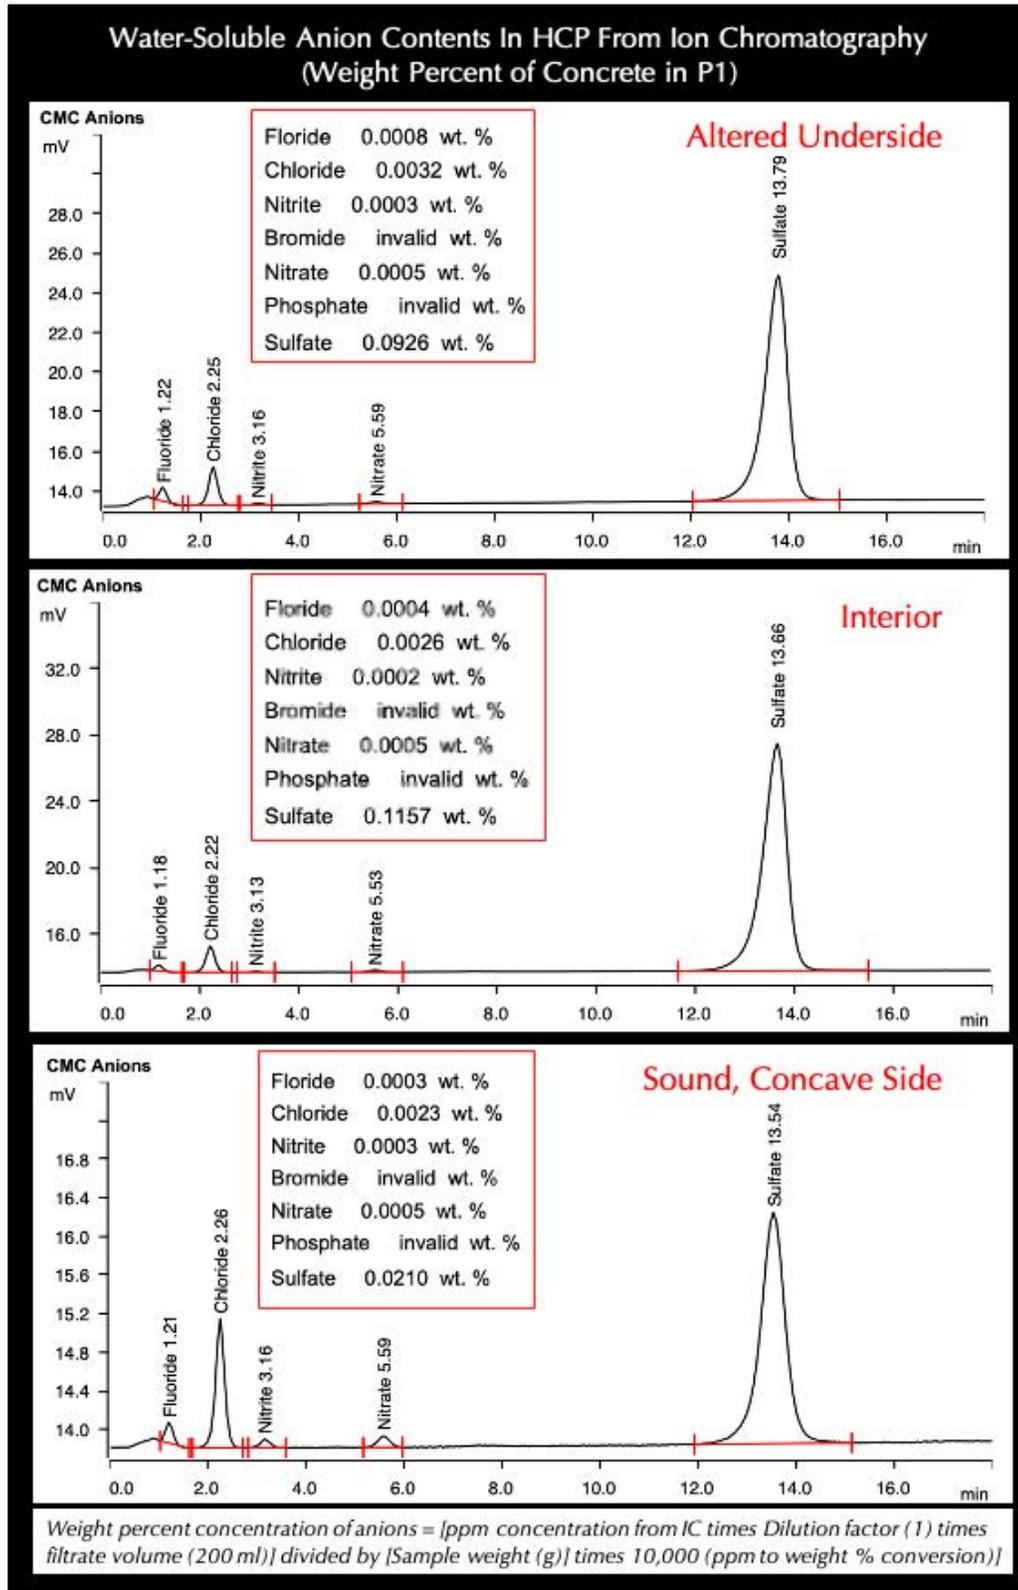
HCP	Depth (mm)	Chloride Content from Ion Chromatography (% Chloride by mass of concrete)	Sulfate Content from Ion Chromatography (% Sulfate by mass of concrete)
P-1	Altered Underside	0.0032	0.0926
	Mid-Depth	0.0026	0.1157
	Concave Side	0.0023	0.0210
P-3	Altered Underside	0.0032	0.1506
	Mid-Depth	0.0028	0.1624
	Concave Side	0.0027	0.0154

Figure 47: Ion chromatograms of water-soluble anions of filtrates of HCP in Sample P-1 from altered underside (top), mid-depth (middle), and concave end (bottom).

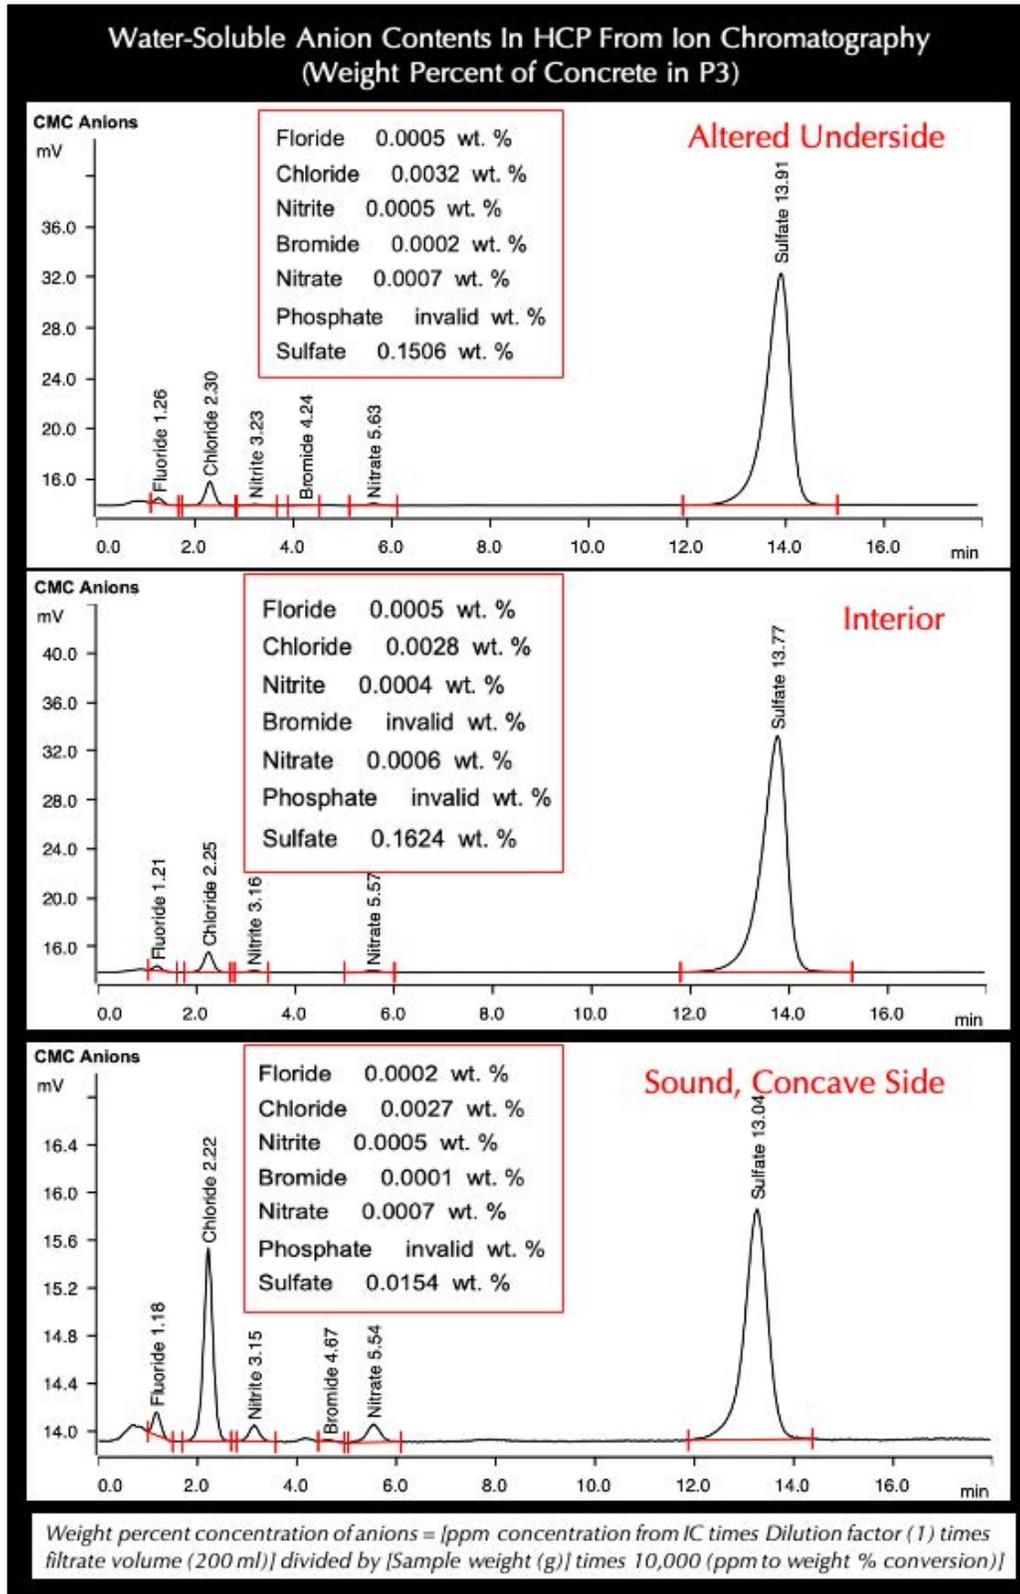
Figure 48: Ion chromatograms of water-soluble anions of filtrates of HCP in Sample P-3 from altered underside (top), mid-depth (middle), and concave end (bottom).
