SWIMMING POOL PLASTER DETERIORATION – OVERVIEW & CASE STUDIES

Dipayan Jana

Applied Petrographic Services, Inc., and Construction Materials Consultants, Inc. Greensburg, PA, USA

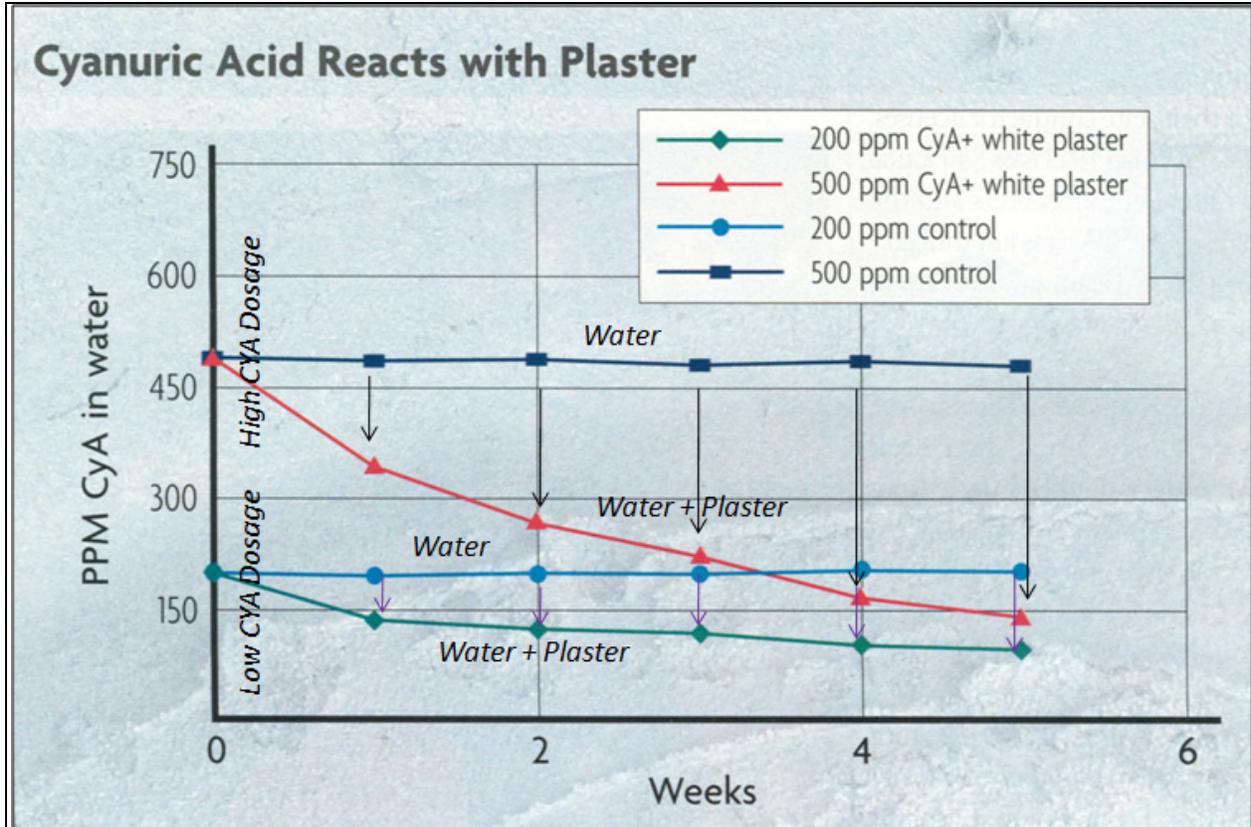
Research by Arch Chemical's Water Products division [12, see Figure 22] showed that high levels of cyanuric acid stabilizer can cause over-stabilization of pool water and shorten the life of plaster finishes, even in a balanced water pool⁹, and can generate spot deterioration. Their research shed new lights on spot alteration of pool plaster by specific localized high concentration of stabilizers in the pool water, their precipitation on plaster surface as local spots, and progressive development of spot leaching by localized high chlorine and acidic environments on the plaster surface, which increases rate of leaching of plaster on small spots.

Figure 22 – Arch Chemical's research [12] showing reaction of cyanuric acid with pool plaster, which increases with time in weeks, and dosage.

Both studies by Rothstein et al. [11] and Arch Chemical [12] show the influence of pool stabilizers (i.e., trichlor, CYA, which have high chloride and low pH characteristics) on spot alteration. Based on these studies, spot alteration may indicate an early stage of more advanced etching of pool plaster, if the pool water remains over-stabilized by excessive dosage of chemicals.

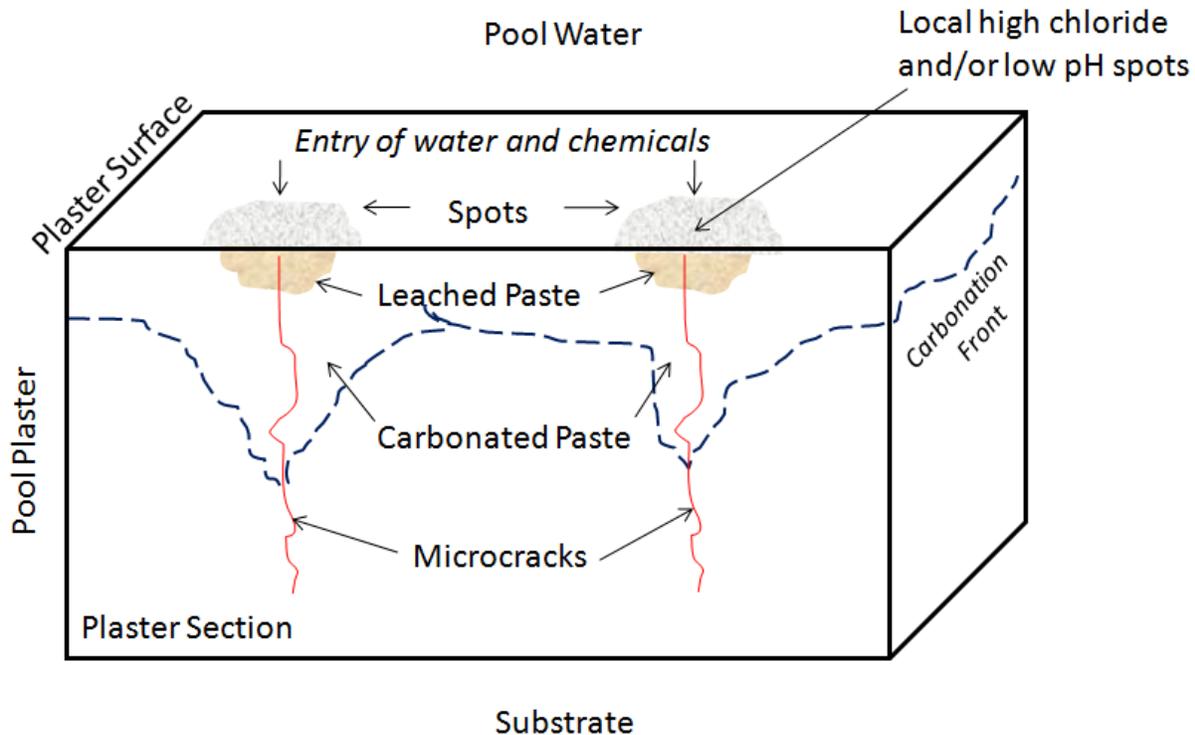
Figure 30 – A model of spot alteration based on the present case study, and recent researches of Rothstein et al. [11] and Arch Chemicals [12]. Preexisting microcracks on the plaster provided pathways for entry of pool water and chemicals. Certain chemicals (probably of high chloride and/or low pH chemistry) precipitated on the plaster surface, entered through the microcracks, and created a local high chloride and/or low pH environment at the surface have caused preferential leaching of cement hydration products, increased porosity of paste beneath the point of entry and, as a result, spot like discoloration of plaster at the sites of precipitation. The presence of microcracks helps entry of chemicals but is not necessary for spot alteration from excess chemicals in water.

Based on the present case study of occurrence of spot alteration at the locations of preexisting microcracks, as local leaching of paste beneath the spots, with no evidence of excess calcium chloride or improper finishing, and slightly elevated chloride levels in paste at the spots than elsewhere (Figure 29, similar to the findings of Rothstein et al. [11]), the author proposed a model (see Figure 30) where entry of water and chemicals having a high chloride/low pH chemistry (e.g., stabilizers) caused spot alteration at the loci of precipitation of chemicals on plaster surface at and around the microcracks. The presence of a preexisting microcrack, however, is not essential, since a local high chloride/low pH environment at the point of precipitation of such chemicals on the plaster surface can cause spot-like leaching of paste.

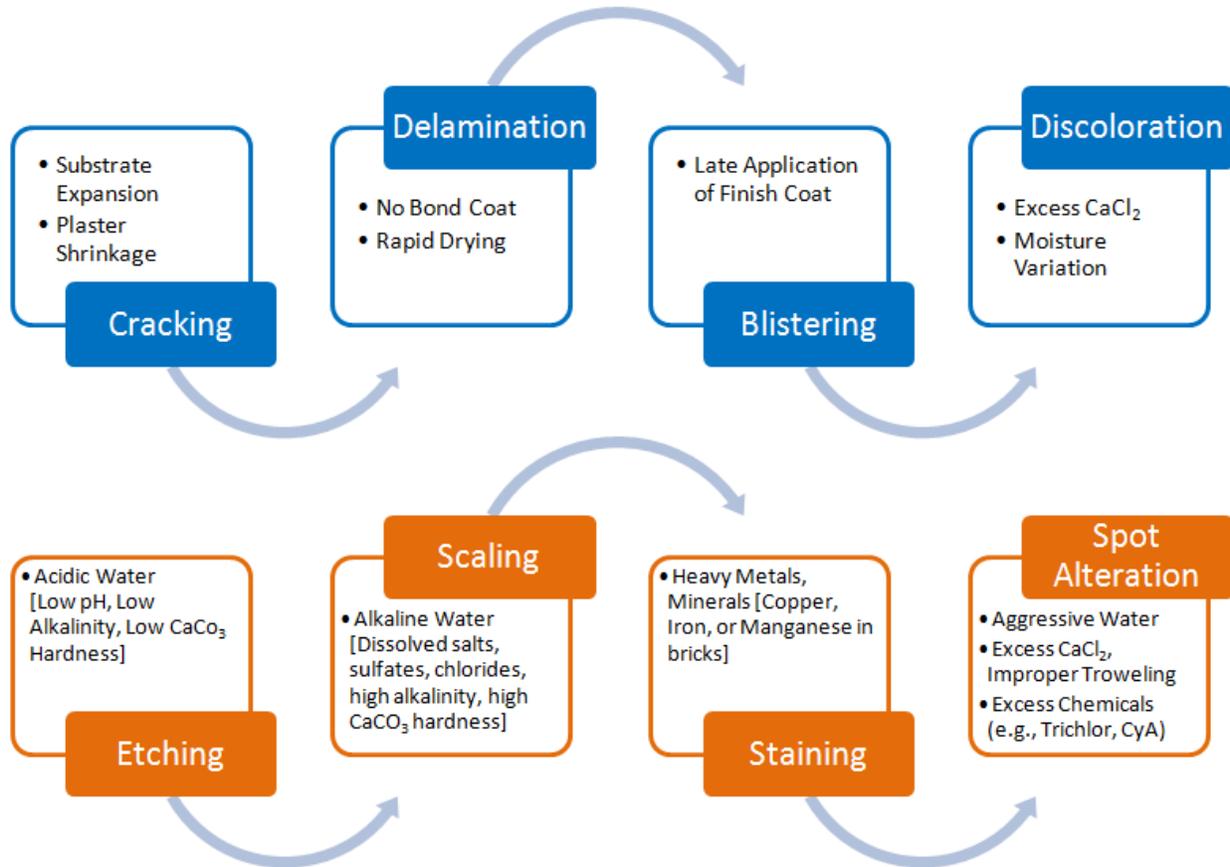
The paper presented fifteen different case studies of various such problems, summarized in Figure 31, diagnosed their causes, summarized as well in the Figure, and emphasized the importance of detailed laboratory investigation in determining reasons for these problems. Importance was given on the author's most frequently observed problems on plaster cracking, etching/scaling, delamination, discoloration, and spot alteration. Finally, a mechanism of spot alteration is proposed based on the observed chemical and microstructural properties of plaster in an interesting case study.

Figure 31 – A summary of case studies of plaster problems presented here and their causes (note the causes mentioned here are related to the present cases only, and may not be applicable to other cases of similar problems). Arched arrows do not indicate that one problem leads to the other.

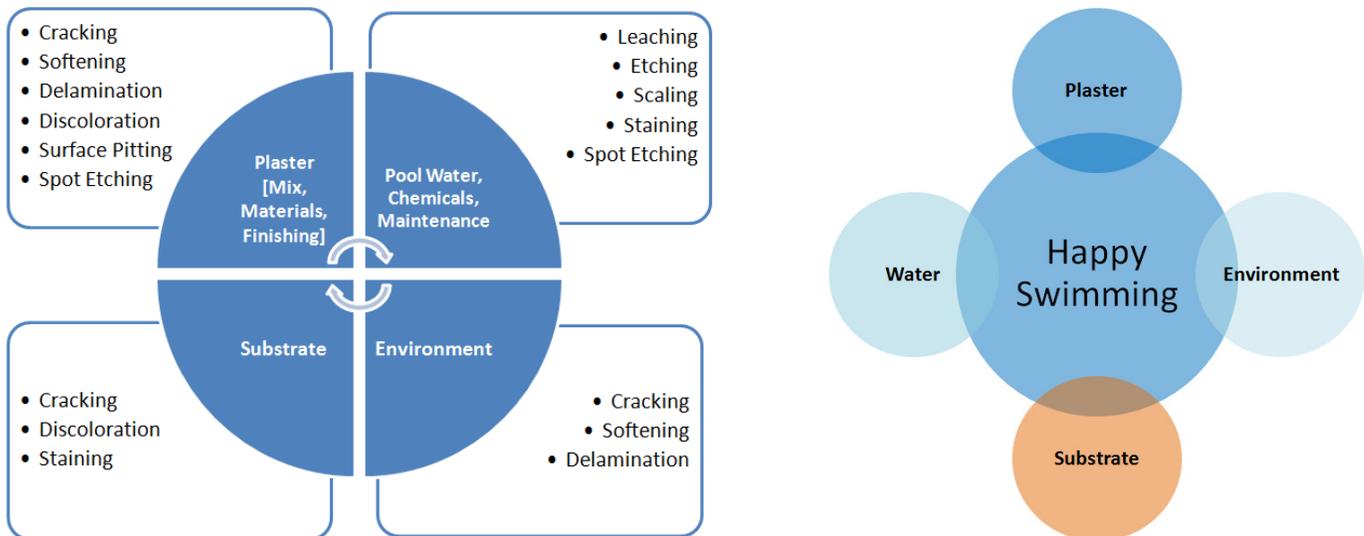
As seen in all cases, the basic issues of plaster problems are related to the quality and composition of plaster, the soundness and stability of substrate, the characteristics of pool water and its chemicals, pool maintenance, and the environment in which the plaster was placed and is in service (Figure 32). Improper plaster quality and/or mix proportions (e.g., excess sand, fines in sand, unsound or reactive sand, excess water, calcium chloride admixture, lime addition, etc.), and improper finishing practices (over-troweling, finishing with excess water, etc.) can lead to plaster cracking, softening, delamination, surface pitting, discoloration, and other problems. Imbalanced pool water can cause plaster scaling and etching. Heavy metals, minerals, contaminants in water can cause staining. An unstable substrate (e.g., expanding or settling) can induce plaster cracking. Plaster placement in a subfreezing temperature, or in a hot, dry, windy weather condition can cause cracking, softening, and delamination issues. Improper pool maintenance, e.g., excessive dosage of water treatment chemicals, or, inadequate brushing of leached lime from plaster and water at the early stage, etc. can cause plaster spotting or scaling. A good understating of all these systems, and their influences on plaster properties are, therefore, essential for prolonged durability and serviceability of swimming pool plaster.

Figure 32 – Four major components responsible for most of the plaster problems (see the left photo). A basic understating of these four systems is, therefore, essential for prolonged durability and serviceability of plaster.
