## Laboratory Investigation Of Coating Failure From Stucco Façades Of An 18<sup>th</sup> Century Courthouse In Charleston, South Carolina

Charleston County Courthouse Exterior Façade  
Charleston, South Carolina

September 29, 2020  
CMC 0820145

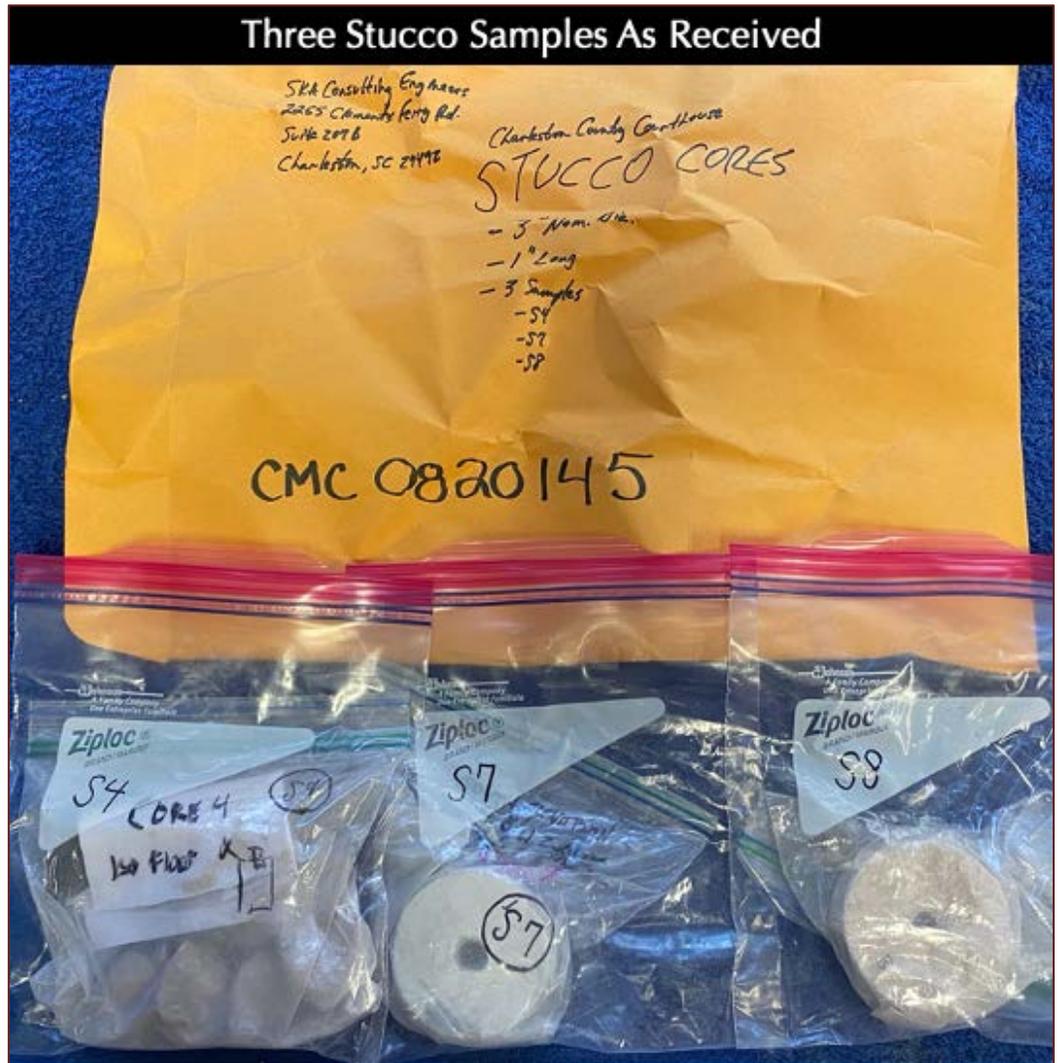
Sample S4 was received in multiple fragmented pieces even though the sample was reportedly collected from a location away from the location of coating failure in the north elevation (see Figures 2 and 4). By contrast, Samples S7 and S8 from south and east elevations, respectively were received in relatively intact conditions without any fragmentations.

Figure 17: Shown are the drilled 3-in. diameter and approximately 1 in. thick stucco cores from north, south, and east elevations of courthouse that are marked as S4, S7, and S8, respectively.

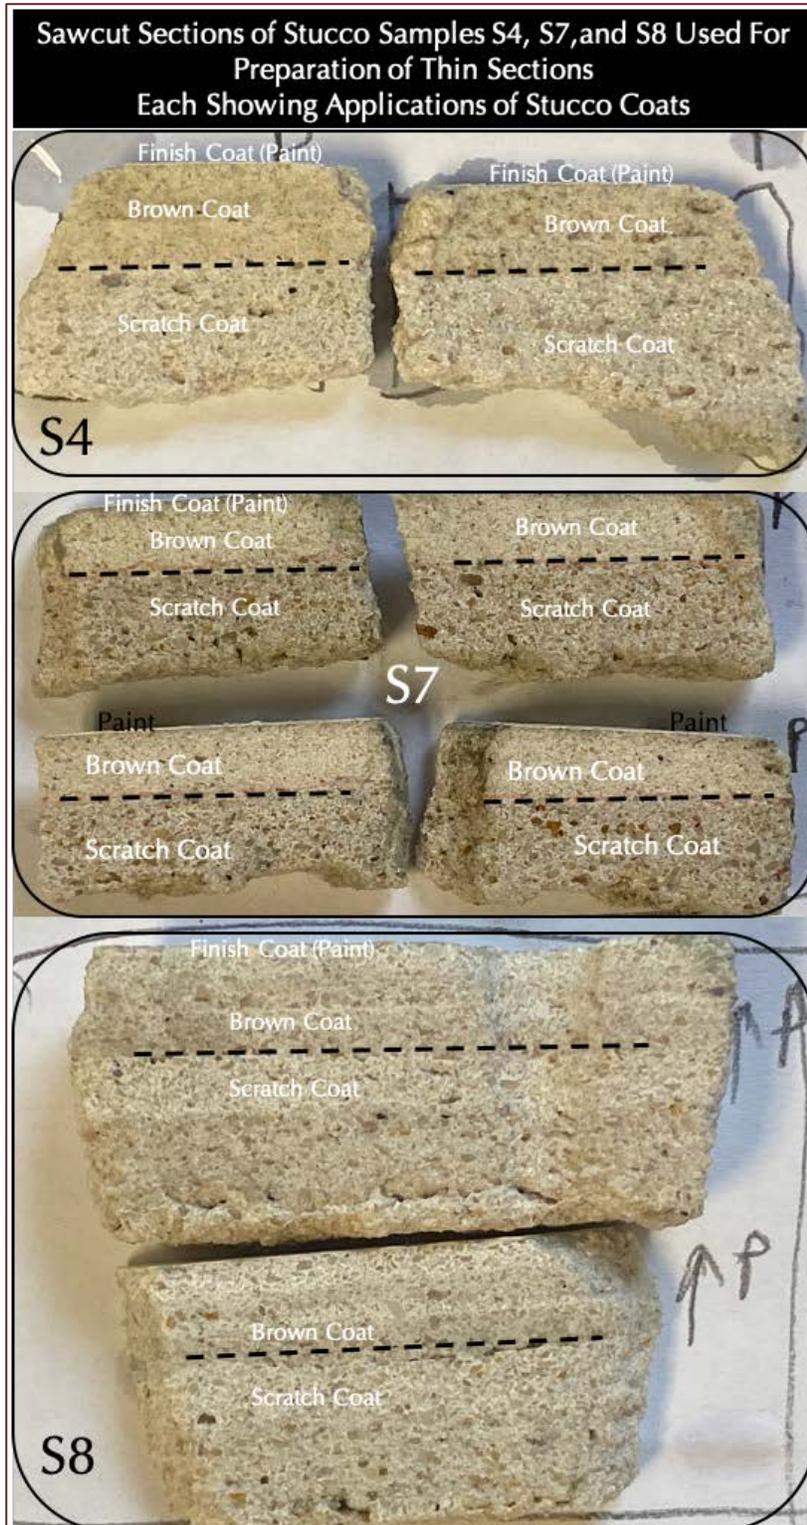
Figure 21: Saw-cut cross sections of the three stucco samples showing:

- (a) At least two discernable coats in each stucco sample beneath the paint coat (finish coat) – a brown coat which is approximately 8 mm in S4, 7 mm in S7, and 8 mm in S8, and, a scratch coat, which is approximately 10 mm in S4, 7 mm in S7, and 14 mm in S8;
- (b) Overall nominal thickness of stucco range from 18 mm in S4, to 16 mm in S7, to 22 mm in S8;
- (c) Overall good bond between two coats of stucco in each sample, the interface between brown and scratch coats are marked with dashed lines;
- (d) A very thin (less than 1 mm thickness) light colored paint coat on all three stucco samples;
- (e) Well adherence of paint to the stucco base in all three samples; and,
- (f) The fragments shown here are impregnated with a fluorescent dye-mixed epoxy for preparation of thin sections.

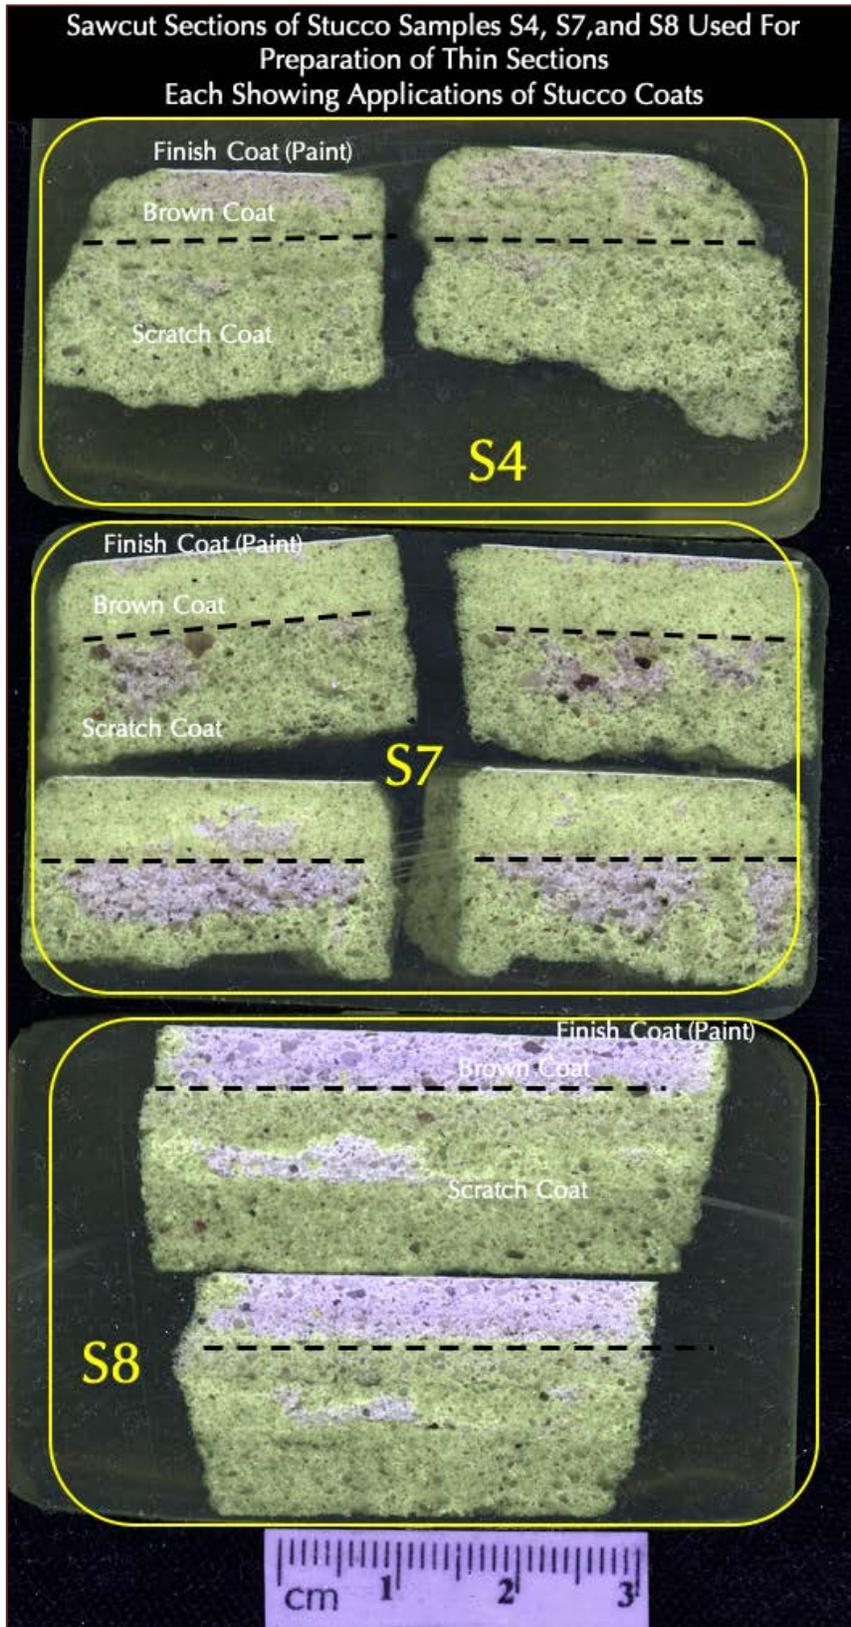
Figure 22: Fluorescent dye-mixed epoxy-impregnated residues of thin sections of stucco samples showing:

- (a) At least two discernable coats in each stucco sample beneath the paint (finish) coat – a brown coat which is approximately 8 mm in S4, 7 mm in S7, and 8 mm in S8, and, a scratch coat, which is approximately 10 mm in S4, 7 mm in S7, and 14 mm in S8;
- (b) Overall nominal thickness of stucco range from 18 mm in S4, to 16 mm in S7, to 22 mm in S8;
- (c) Overall good bond between two coats of stucco in each sample, the interface between brown and scratch coats are marked with dashed lines;
- (d) A very thin (less than 1 mm thickness) light colored paint coat on all three stucco samples;
- (e) Well adherence of paint to the stucco base in all three samples; and,
- (f) Variable porosities of paste in brown and scratch coats of stucco that are revealed from various degrees of absorption of fluorescent dye-mixed epoxy in the stucco.

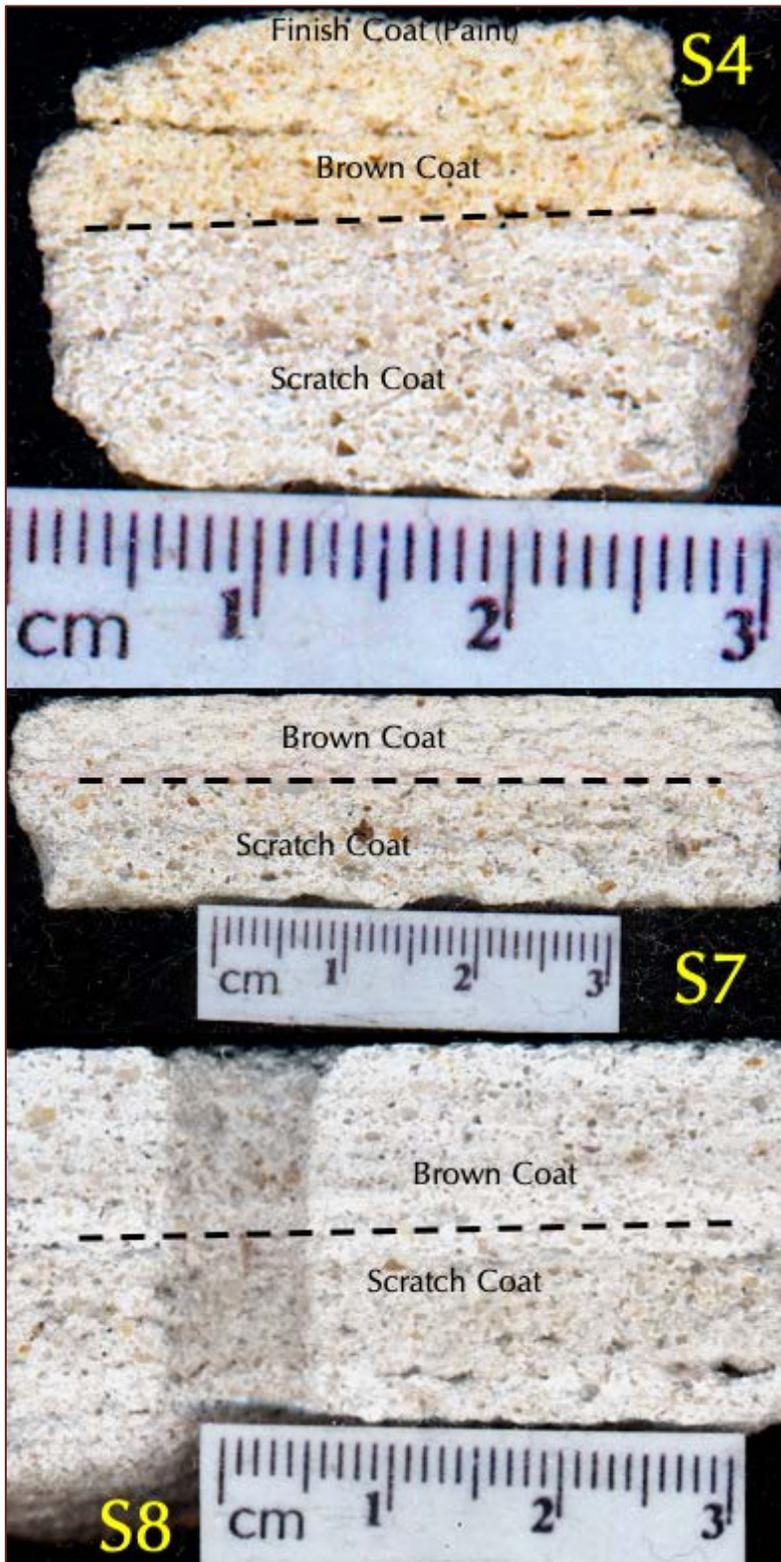
Figure 23: Lapped cross sections of stucco samples showing:

- (a) At least two discernable coats in each stucco sample beneath the paint (finish) coat – a brown coat which is approximately 8 mm in S4, 7 mm in S7, and 8 mm in S8, and, a scratch coat, which is approximately 10 mm in S4, 7 mm in S7, and 14 mm in S8;
- (b) Overall nominal thickness of stucco range from 18 mm in S4, to 16 mm in S7, to 22 mm in S8;
- (c) Overall good bond between two coats of stucco in each sample, the interface between brown and scratch coats are marked with dashed lines; and,
- (d) Variable color tones and densities of brown and scratch coats of stucco indicating variations in mix proportions of individual coats across three sample locations.

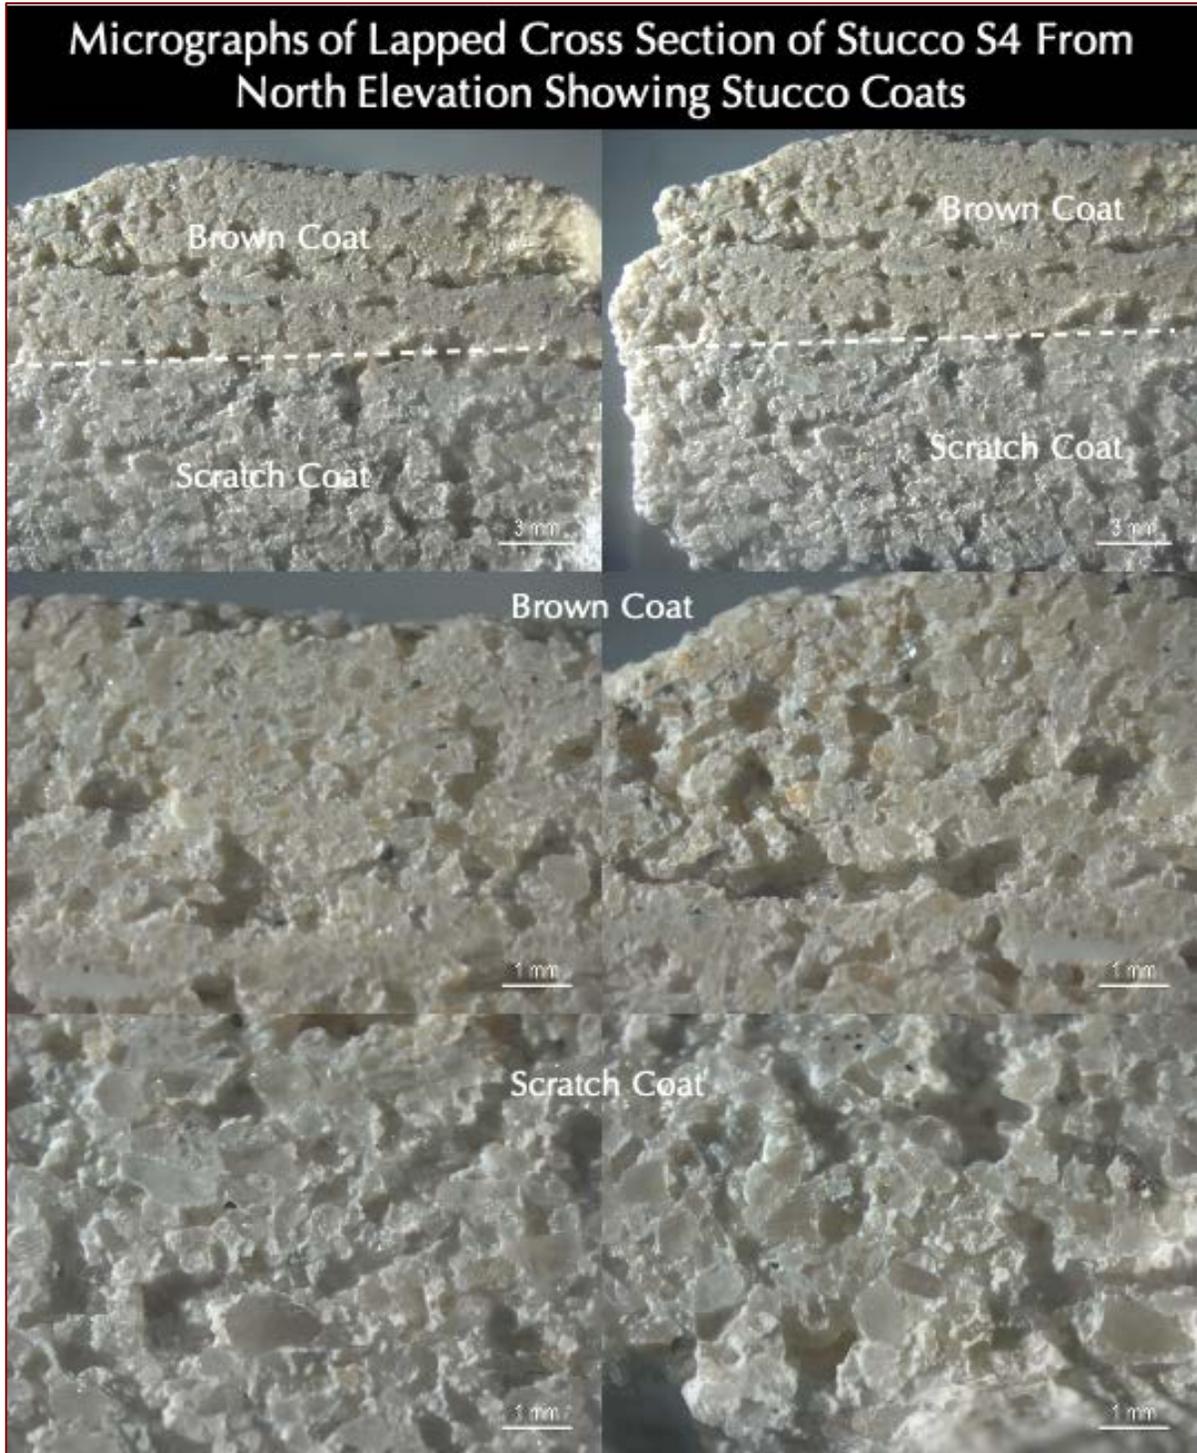
Figure 24: Micrographs of lapped cross section of stucco Sample S4 from north elevation showing: (a) the brown and scratch coats of stucco in the top row where relatively denser nature of the brown coat and porous popcorn-type texture of scratch coat are seen; dashed line separates the two coats; (b) higher magnification view of the brown coat showing distribution of fine crushed sand particles in a light gray toned paste and overall dense nature of brown coat; and (c) the porous popcorn-type texture of scratch coat where sand particles are relatively coarser in size than sand in the brown coat. Scale bars are 3 mm in the top row and 1 mm in the middle and bottom rows.

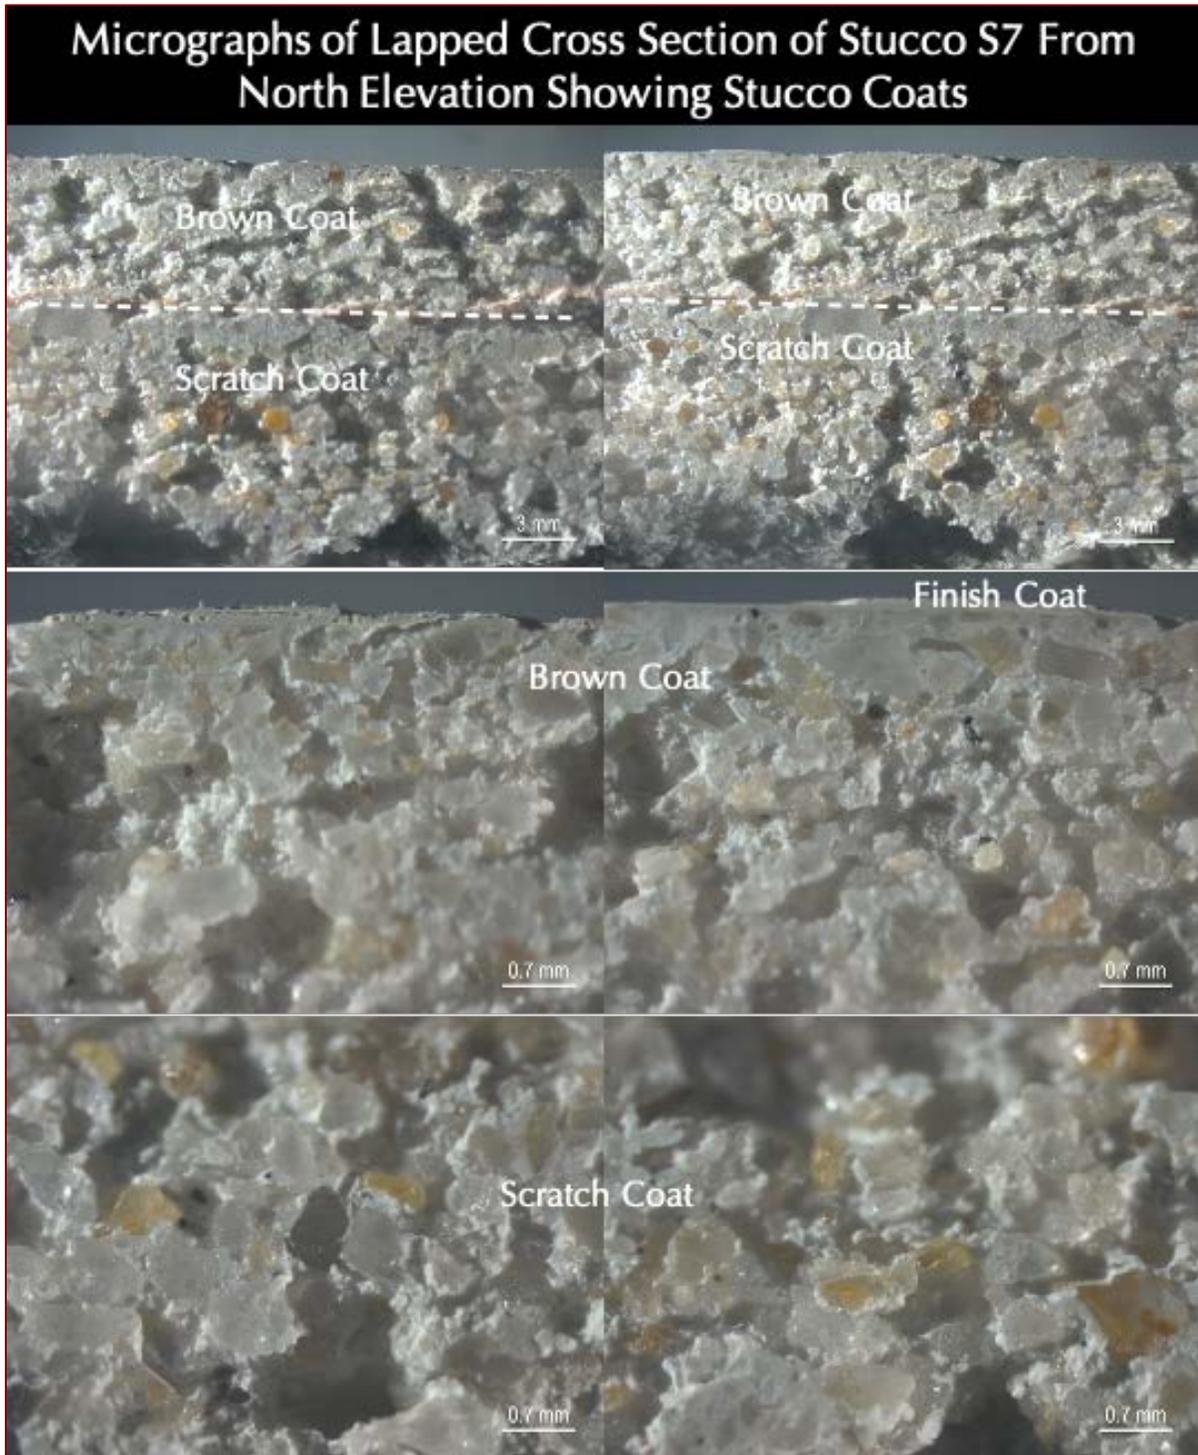
Figure 25: Micrographs of lapped cross section of stucco Sample S7 from south elevation showing: (a) the brown and scratch coats of stucco in the top row where relatively denser nature of the brown coat and porous popcorn-type texture of scratch coat are seen; dashed line separates the two coats; (b) higher magnification view of the brown coat showing distribution of fine crushed sand particles in a light gray toned paste and overall dense nature of brown coat; and (c) the porous popcorn-type texture of scratch coat where sand particles are relatively coarser in size than sand in the brown coat. Scale bars are 3 mm in the top row and 1 mm in the middle and bottom rows.

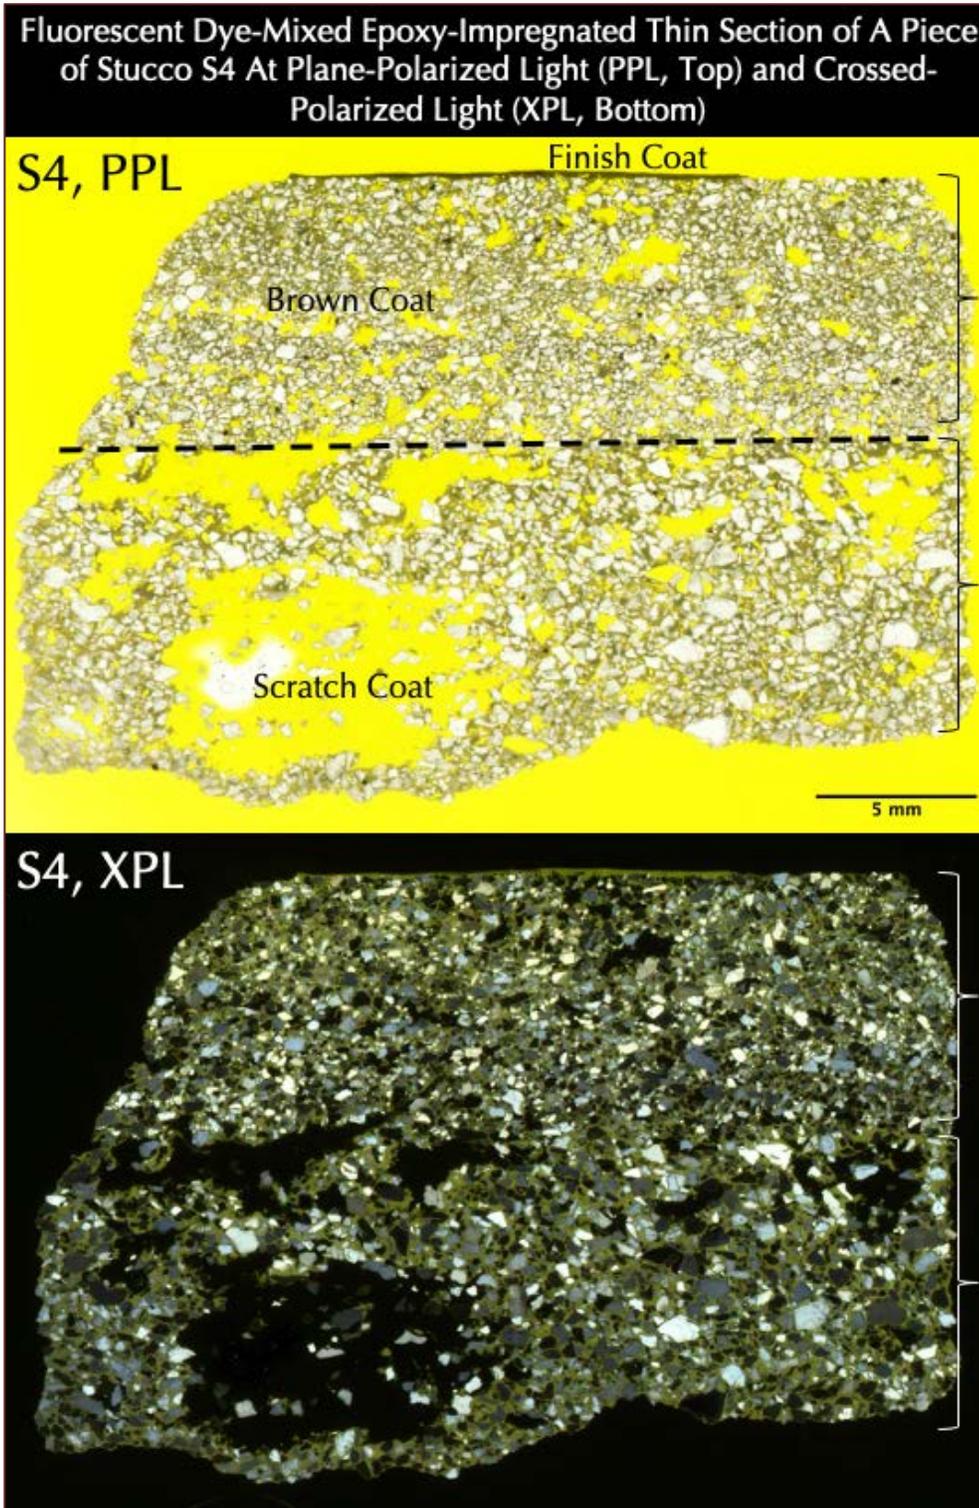
Figure 27: Fluorescent dye-mixed epoxy-impregnated 50 mm x 75 mm size thin section of stucco in Sample S4 scanned on a film scanner in plane (PPL) and crossed (XPL) polarized-light modes with one or two perpendicular polarizing filters, respectively showing:

- (a) Size, shape, angularity, gradation, and distribution of sand particles in brown and scratch coats in PPL and XPL images;
- (b) A thin paint (finish) coat adhered to the brown coat and seen as a dark brown layer at the top in PPL image;
- (c) Relatively finer overall grain-size of sand in the brown coat than sand found in the scratch coat, which is seen in both PPL and XPL images; sand in both coats are angular in nature indicating use of crushed sand;
- (d) Siliceous composition of crushed sand revealed in XPL image,
- (e) Overall carbonated nature of paste in XPL image,
- (f) Overall porous nature of scratch coat relative to the brown coat in PPL image, and,
- (g) Overall good bond between the two coats and between the paint and

topcoat in PPL image.

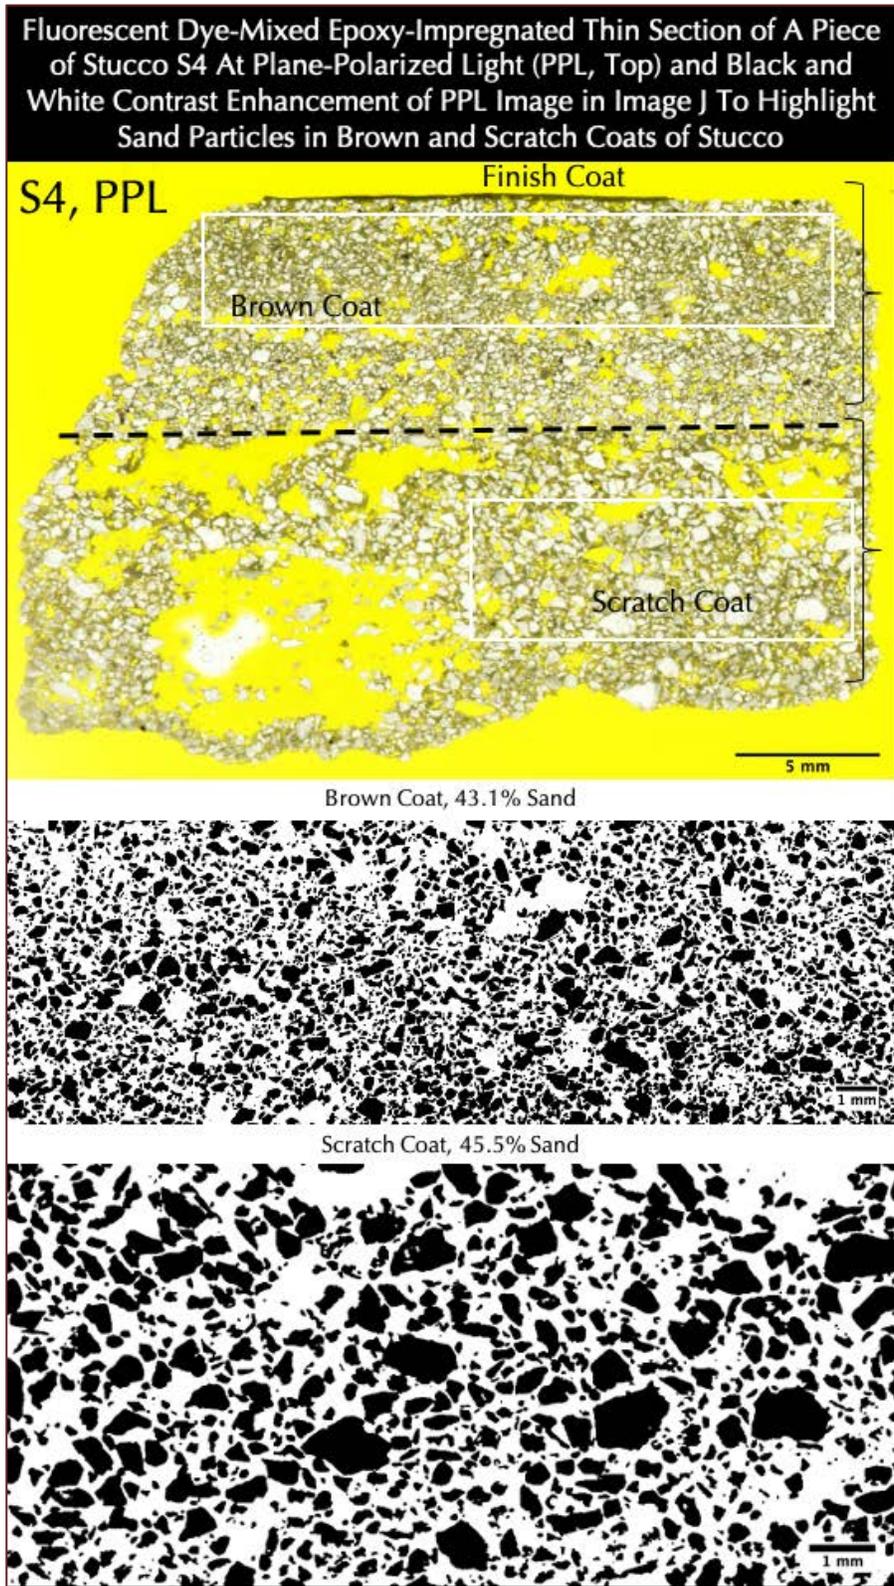
Figure 28: Fluorescent dye-mixed epoxy-impregnated 50 mm x 75 mm size thin section of stucco in Sample S4 scanned on a film scanner in plane (PPL) and crossed (XPL) polarized-light modes with one or two perpendicular polarizing filters, respectively showing:

- (a) Size, shape, angularity, gradation, and distribution of sand particles in brown and scratch coats in PPL and XPL images;
- (b) A thin paint (finish) coat adhered to the brown coat seen as a dark brown layer at the top in PPL image;

- (g) Overall good bond between the two coats and between the paint and brown coat in PPL image; and,
- (h) Boxed areas in brown and scratch coats were selected for image analysis in Image J to determine sand contents (by volume) in each coat, after converting the images to binary black and white contrasts to highlight sand particles in each coat in black, which showed 43.1% sand in brown coat and 45.5% sand in scratch coat and overall coarser sand in the scratch

coat as seen in black and white images.

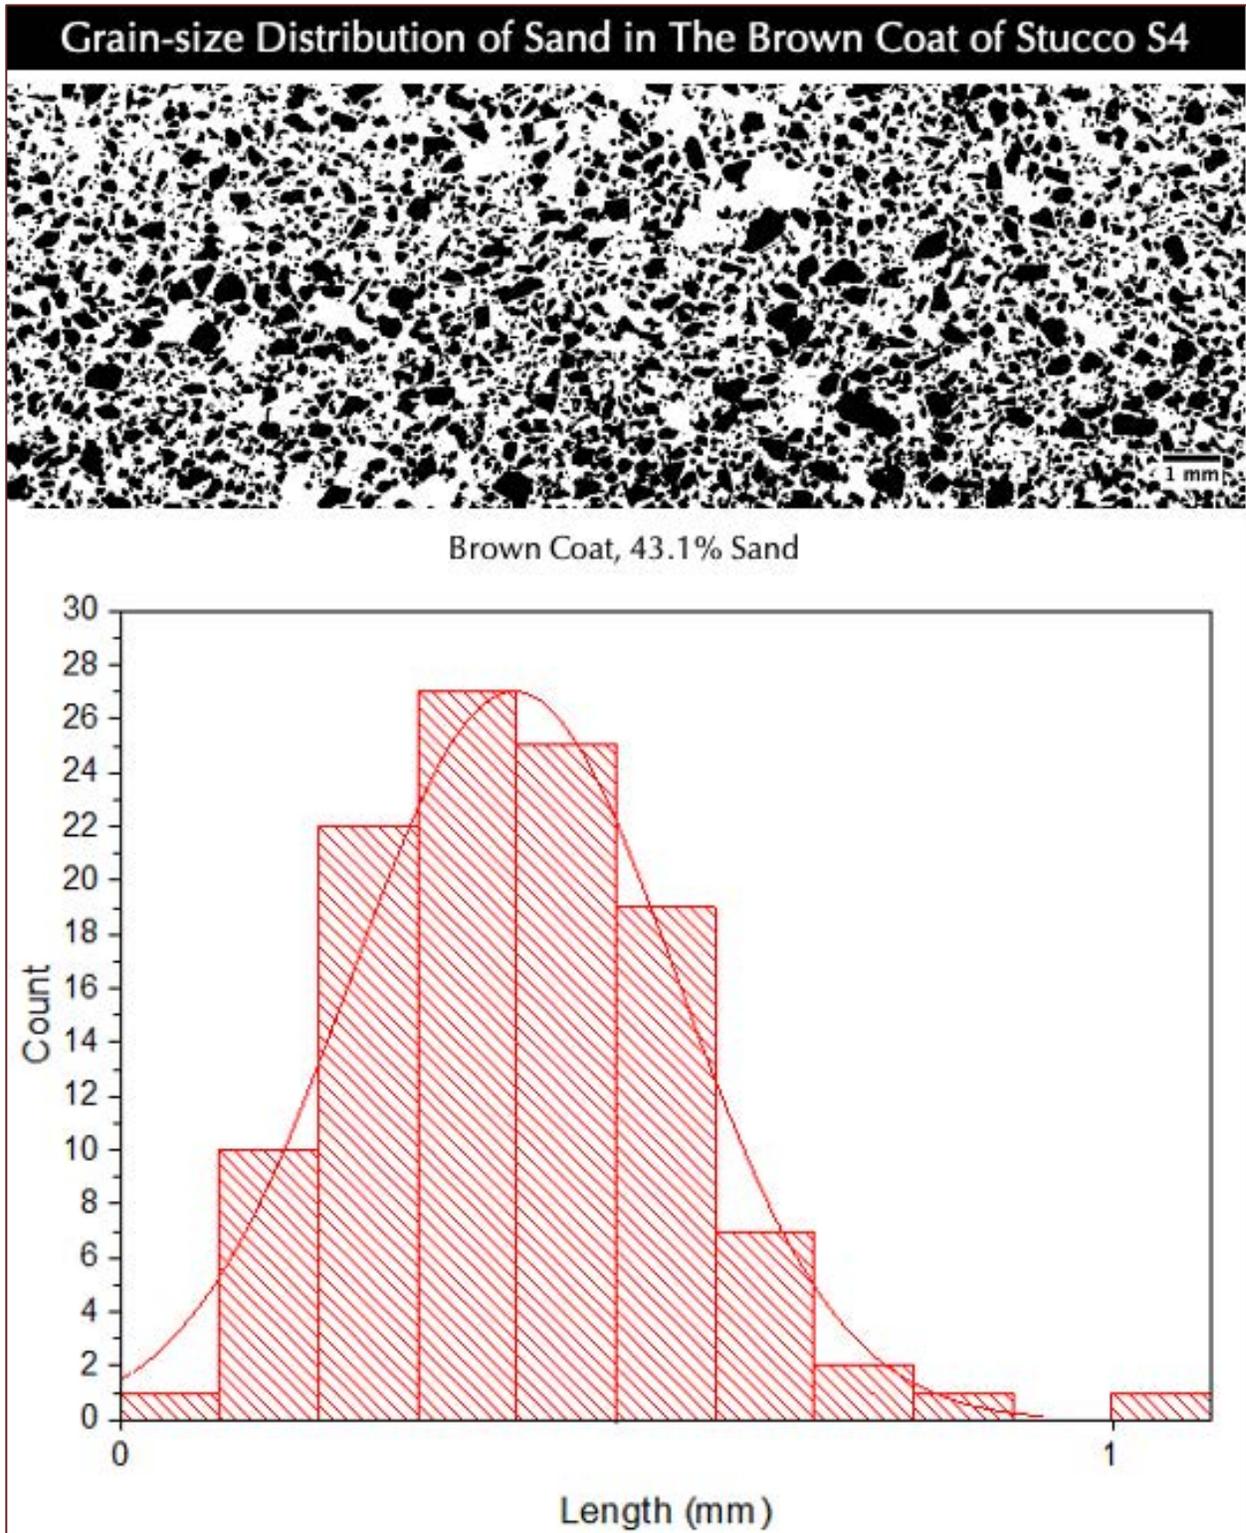
Figure 29: Grain-size distribution of sand in the brown coat from black and white contrast enhancement of boxed area of PPL image of thin section of S4 stucco in Figure 28 showing a normal distribution of sand sizes with a median sand size of around 0.5 mm with almost all of the particles less than a millimeter in grain size. Image analysis of sand sizes were done in Image J.

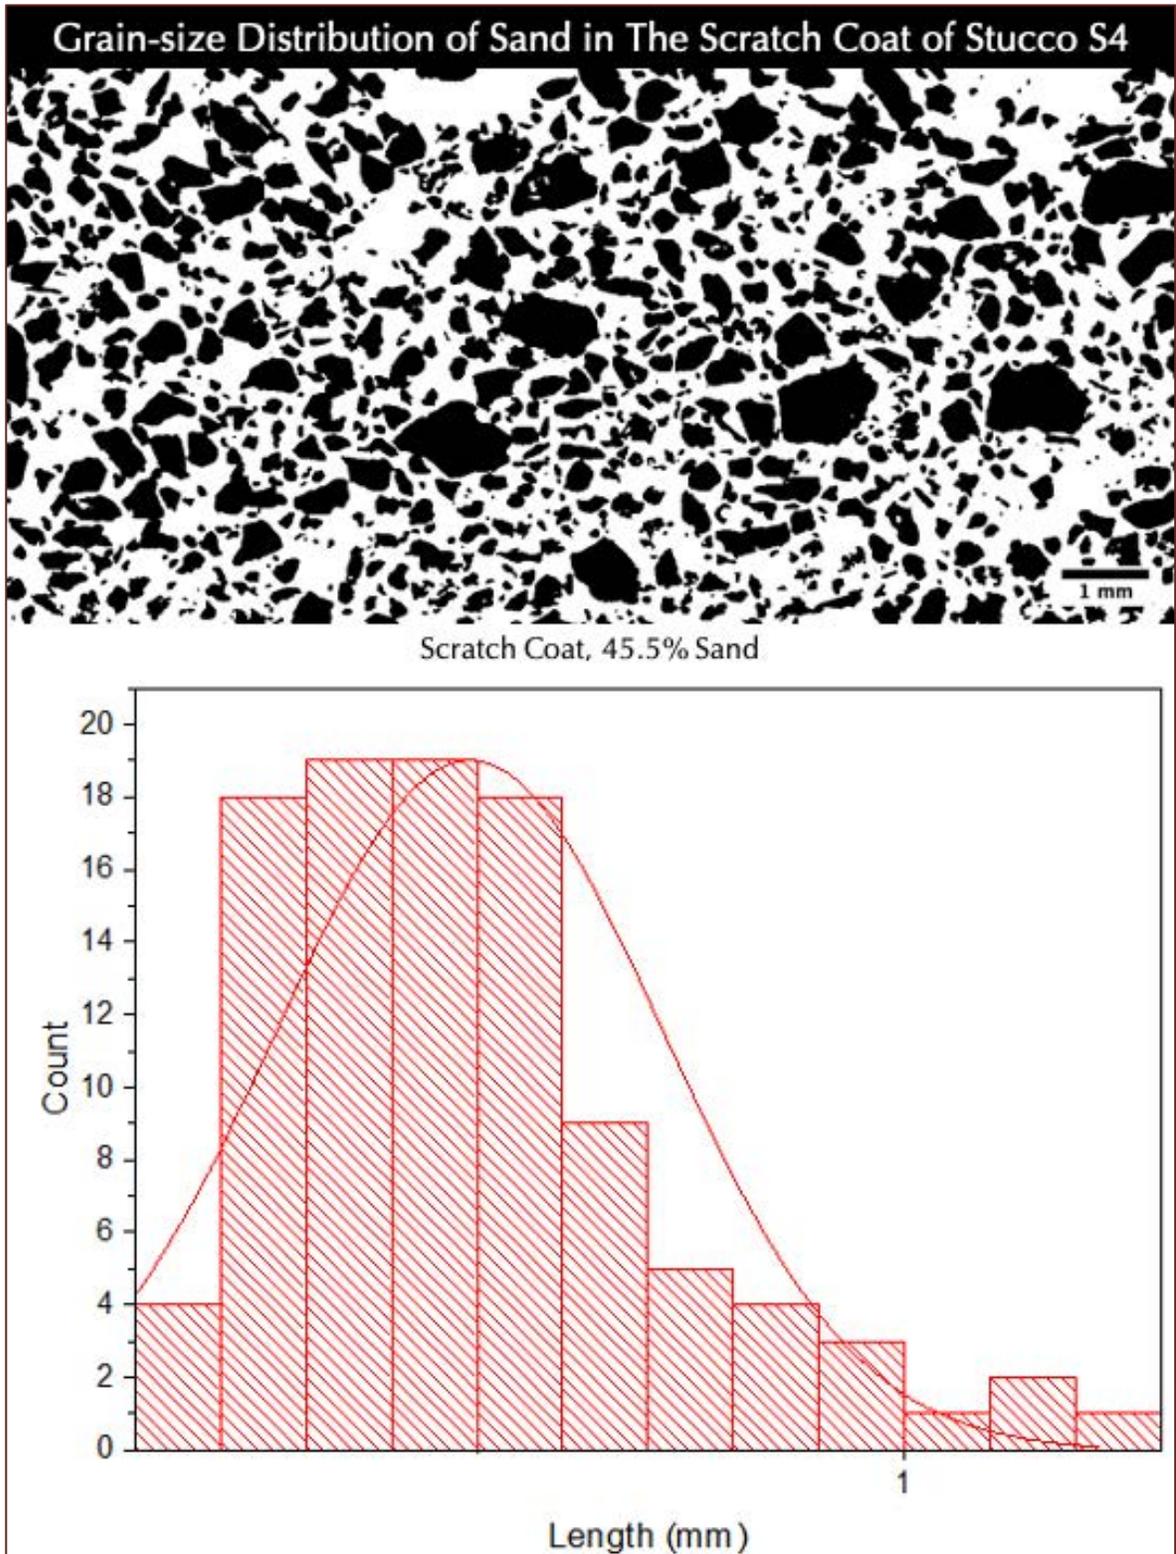
Figure 30: Grain-size distribution of sand in the scratch coat from black and white contrast enhancement of boxed area of PPL image of thin section of S4 stucco in Figure 28 showing a normal distribution of sand sizes with a median sand size of around 0.5 mm with almost all of the particles less than a millimeter in grain size and a fewer particles over 1 mm size which are rare in the brown coat but more in the scratch coat hence giving an overall coarser grain size of sand in the scratch coat. Image analysis of sand sizes were done in Image J.

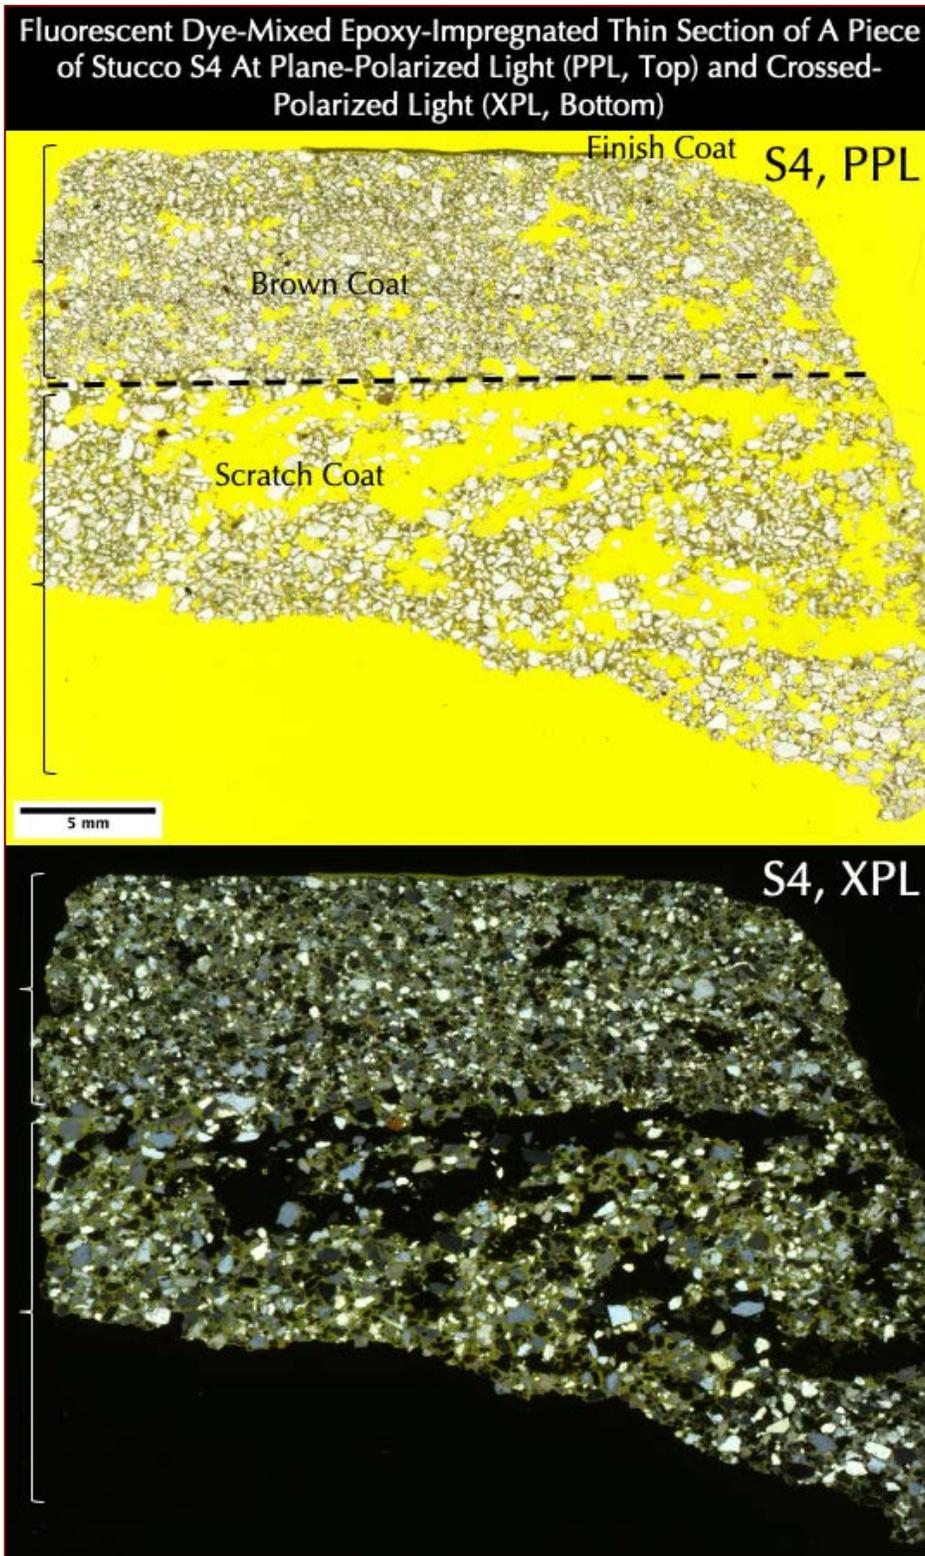
Figure 31: Fluorescent dye-mixed epoxy-impregnated 50 mm x 75 mm size thin section of stucco in Sample S4 scanned on a film scanner in plane (PPL) and crossed (XPL) polarized-light modes with one or two perpendicular polarizing filters, respectively showing:

- (a) Size, shape, angularity, gradation, and distribution of sand particles in brown and scratch coats in PPL and XPL images;
- (b) A thin paint (finish) coat adhered to the brown coat seen as a dark brown layer at the top in PPL image;
- (c) Relatively finer overall grain-size of sand in the brown coat than sand found in the scratch coat, which is seen in both PPL and XPL images; sand in both coats are angular in nature indicating use of crushed sand;
- (d) Siliceous composition of crushed sand revealed in XPL image,
- (e) Overall carbonated nature of paste in XPL image,
- (f) Overall porous nature of scratch coat relative to the brown coat in PPL image, and,
- (g) Overall good bond between the two coats and between the paint and topcoat in PPL image.

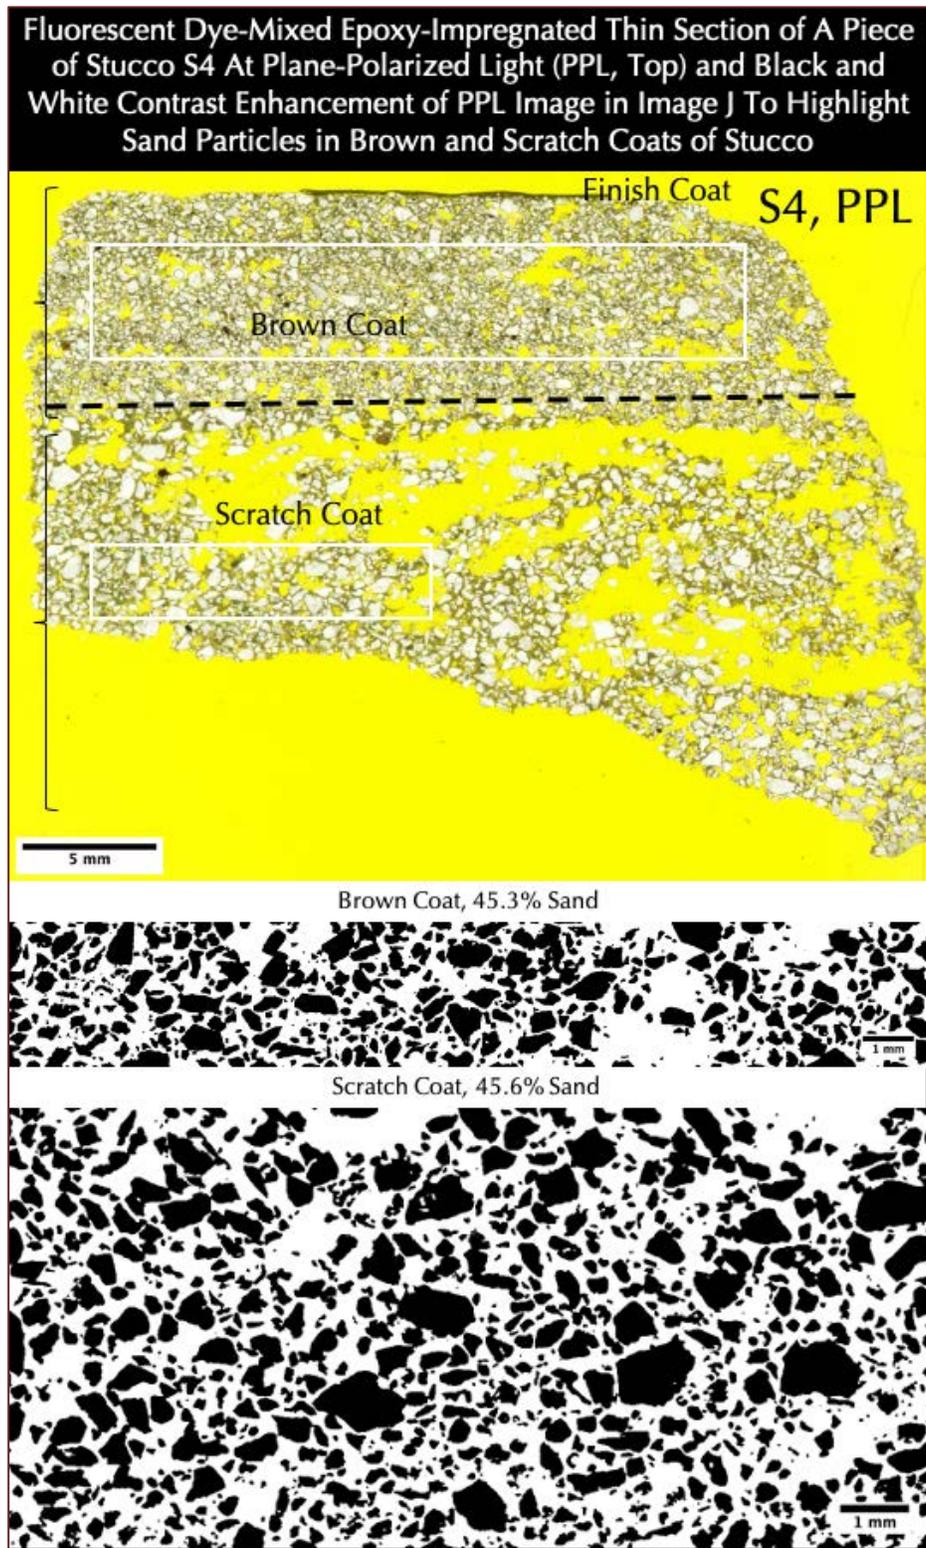
Figure 32: Fluorescent dye-mixed epoxy-impregnated 50 mm x 75 mm size thin section of stucco in Sample S4 scanned on a film scanner in plane (PPL) polarized-light mode with one polarizing filter showing:

- (a) Size, shape, angularity, gradation, and distribution of sand particles in brown and scratch coats;
- (b) A thin paint (finish) coat adhered to the brown coat seen as a dark brown layer at the top;

- (c) Relatively finer overall grain-size of sand in the brown coat than sand found in the scratch coat; sand in both coats are angular in nature indicating use of crushed sand;

- (d) Overall porous nature of scratch relative to the brown coat;
- (e) Overall good bond between the two coats and between the paint and topcoat; and,

- (f) Boxed areas in brown and scratch coats were selected for image analysis in Image J to determine sand contents (by volume) in each coat, after converting the images to binary black and white contrasts to highlight sand particles in each coat, which showed 45.3% sand in brown coat and 45.6% sand in scratch coat, and overall coarser sand in the scratch coat as seen in black and white images.

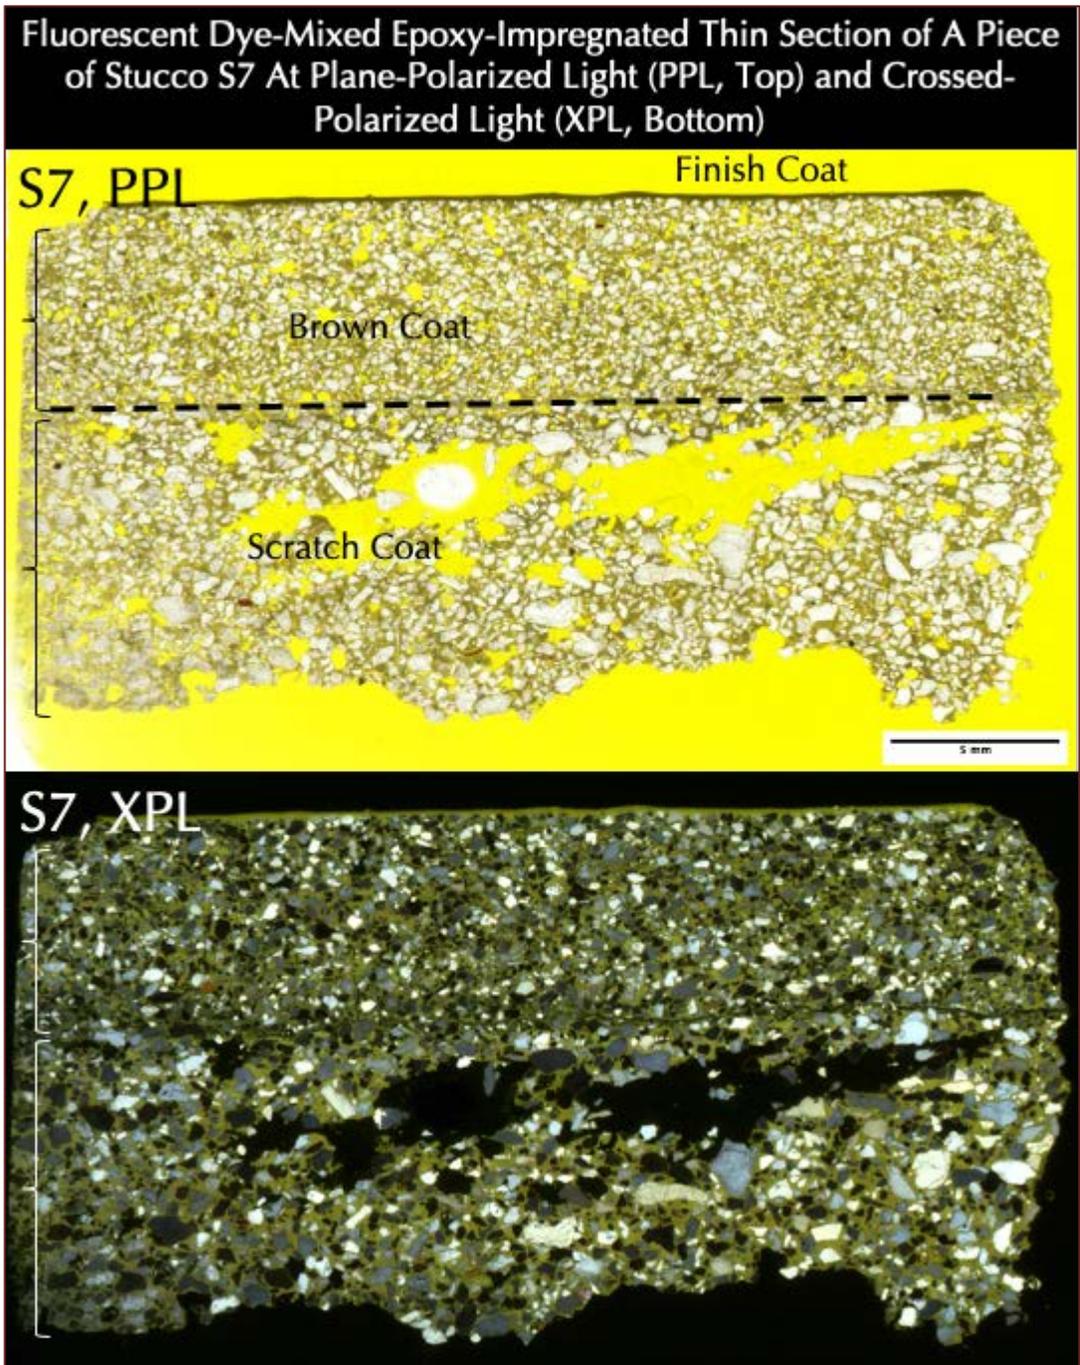
Figure 33: Fluorescent dye-mixed epoxy-impregnated 50 mm x 75 mm size thin section of stucco in Sample S7 scanned on a film scanner in plane (PPL) and crossed (XPL) polarized-light modes with one or two perpendicular polarizing filters, respectively showing:

(a) Size, shape, angularity, gradation, and distribution of sand particles in brown and scratch coats in PPL and XPL images;

(c) Relatively finer overall grain-size of sand in the brown coat than sand found in the scratch coat, which is seen in both PPL and XPL images; sand in both coats are angular in nature indicating use of crushed sand;

(f) Overall porous nature of scratch coat relative to the brown coat in PPL image, and,

(g) Overall good bond between the two coats and between the paint and topcoat in PPL image.
