## Laboratory Investigation Of Coating Failure From Stucco Façades Of An 18<sup>th</sup> Century Courthouse In Charleston, South Carolina

Charleston County Courthouse Exterior Façade  
Charleston, South Carolina

September 29, 2020  
CMC 0820145

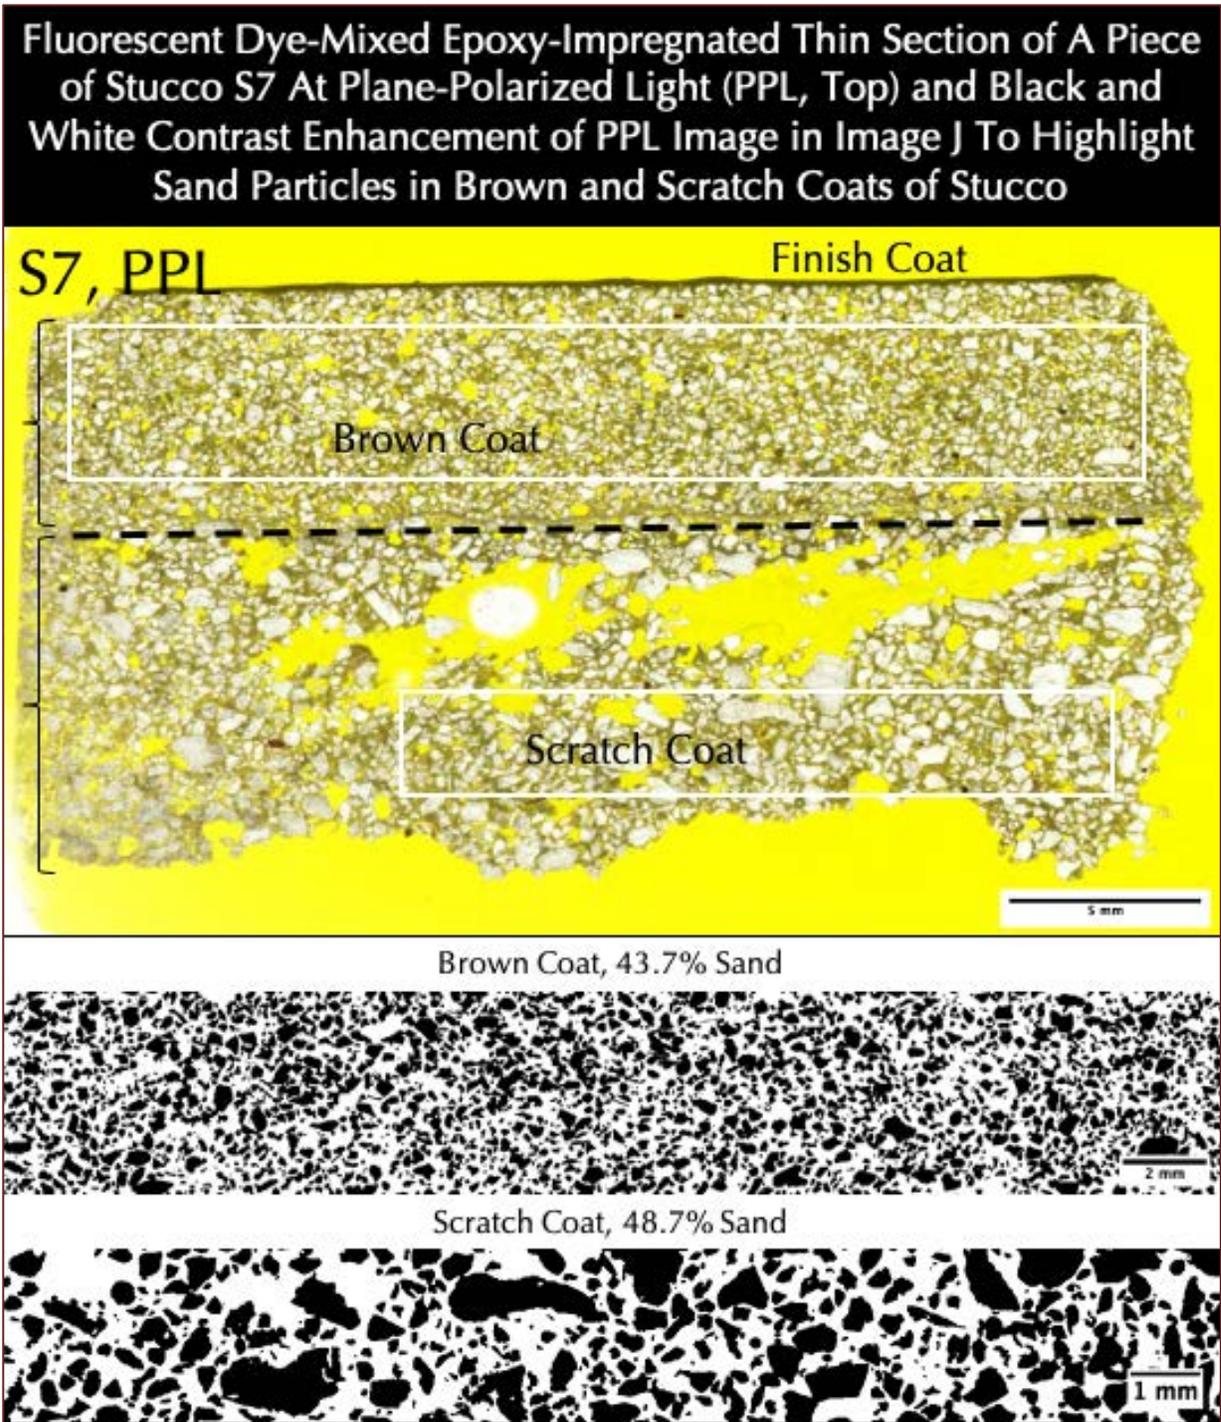
Figure 34: Fluorescent dye-mixed epoxy-impregnated 50 mm x 75 mm size thin section of stucco in Sample S7 scanned on a film scanner in plane (PPL) polarized-light mode showing: (a) size, shape, angularity, gradation, and distribution of sand particles in brown and scratch coats; (b) a thin paint (finish) coat adhered to the brown coat seen as a dark brown layer at the top; (c) relatively finer overall grain-size of sand in the brown coat than sand found in the scratch coat; and sand in both coats are angular in nature indicating use of crushed sand; (d) overall porous nature of scratch coat relative to the brown coat, (e) overall good bond between the two coats and between the paint and brown coat; and, (f) boxed areas in brown and scratch coats were selected for image analysis in Image J to determine sand contents (by volume) in each coat, after converting the images to binary black and white contrasts to highlight sand particles in each coat in black, which showed 43.7% sand in brown coat and 48.7% sand in scratch coat, and overall coarser sand in the scratch coat as seen in black and white images.

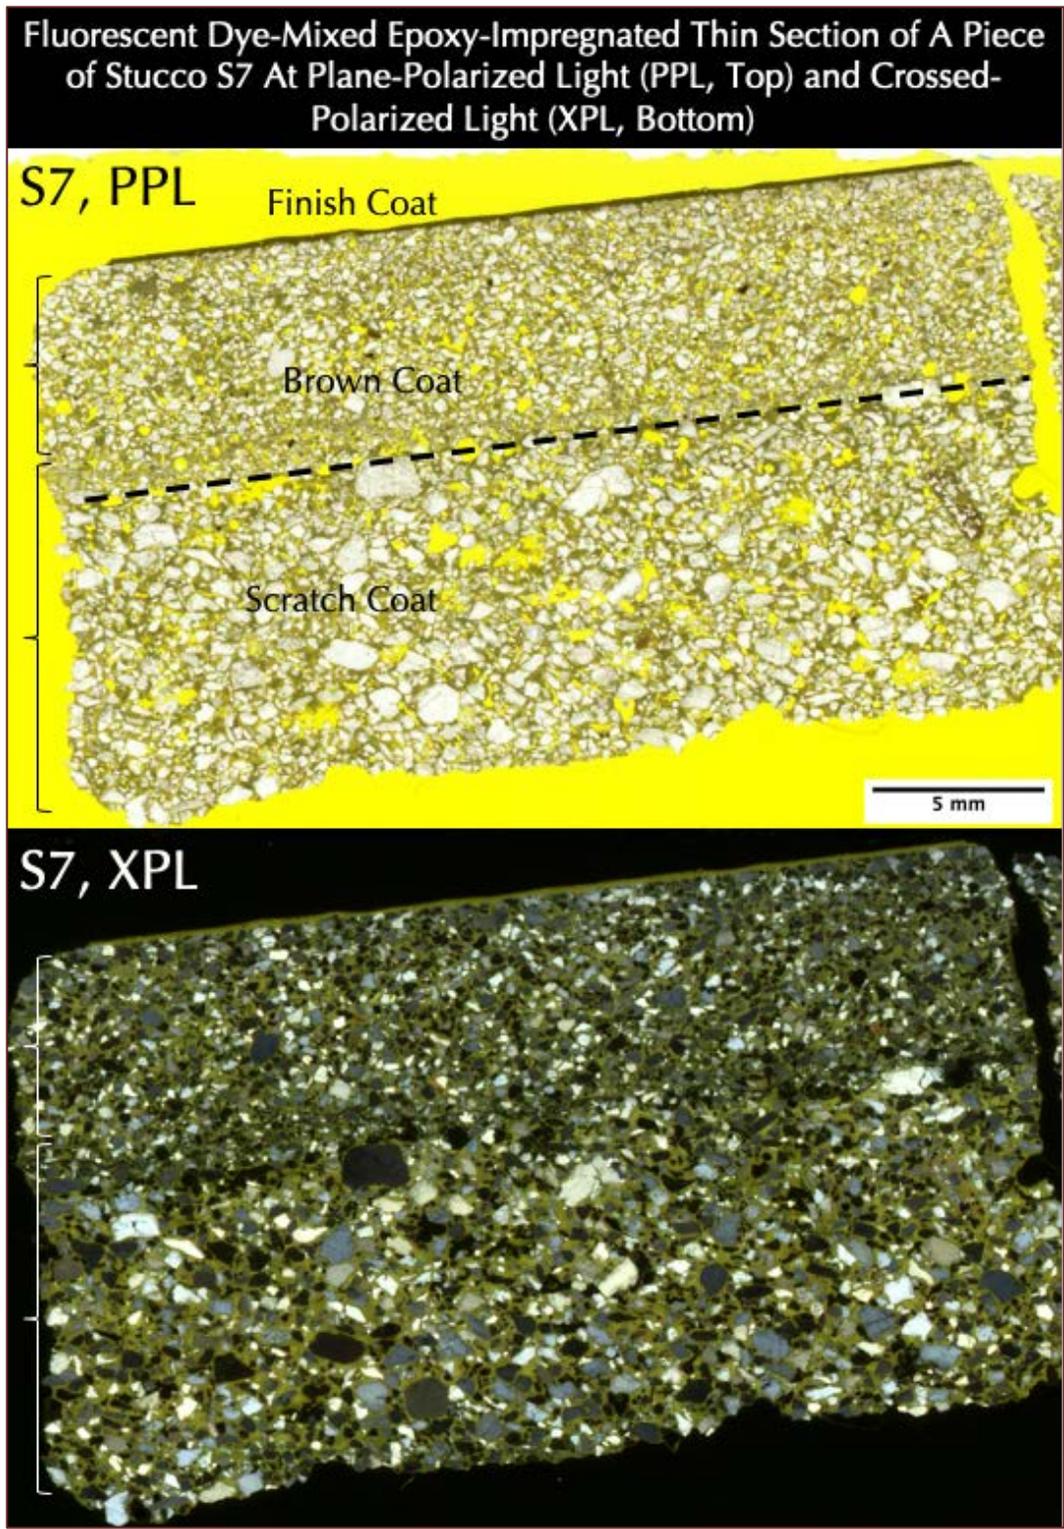
Figure 35: Fluorescent dye-mixed epoxy-impregnated 50 mm x 75 mm size thin section of stucco in Sample S7 scanned on a film scanner in plane (PPL) and crossed (XPL) polarized-light modes with one or two perpendicular polarizing filters, respectively showing:

(a) Size, shape, angularity, gradation, and distribution of sand particles in brown and scratch coats in PPL and XPL images;

(c) Relatively finer overall grain-size of sand in the brown coat than sand found in the scratch coat, which is seen in both PPL and XPL images; sand in both coats are angular in nature indicating use of crushed sand;

coat in PPL image, and,

(g) Overall good bond between the two coats and between the paint and topcoat in PPL image.

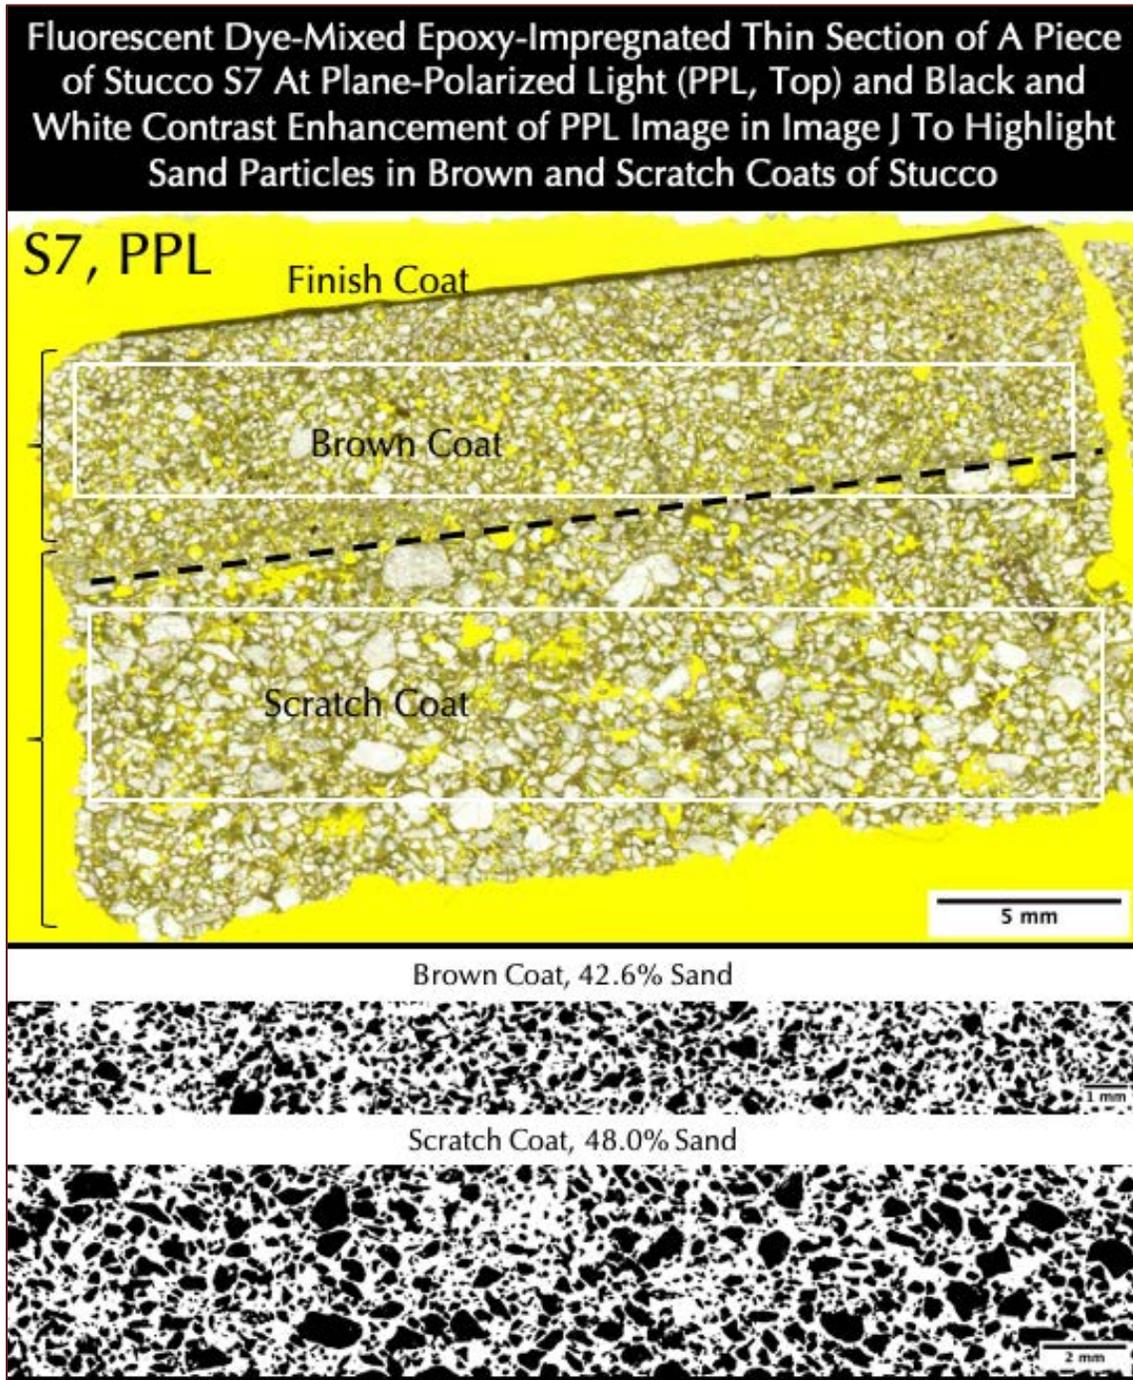
Figure 36: Fluorescent dye-mixed epoxy-impregnated 50 mm x 75 mm size thin section of stucco in Sample S7 scanned on a film scanner in plane (PPL) polarized-light mode showing: (a) size, shape, angularity, gradation, and distribution of sand particles in brown and scratch coats; (b) a thin paint (finish) coat adhered to the brown coat seen as a dark brown layer at the top; (c) relatively finer overall grain-size of sand in the brown coat than sand found in the scratch coat; sand in both coats are angular in nature indicating use of crushed sand; (d) overall porous nature of scratch coat relative to the brown coat, (e) overall good bond between the two coats and between the paint and brown coat; and, (f) boxed areas in brown and scratch coats were selected for image analysis in Image J to determine sand contents (by volume) in each coat, after converting the images to binary black and white contrasts to highlight sand particles in each coat in black, which showed 42.6% sand in brown coat and 48.0% sand in scratch coat, and overall coarser sand in the scratch coat as seen in black and white images.

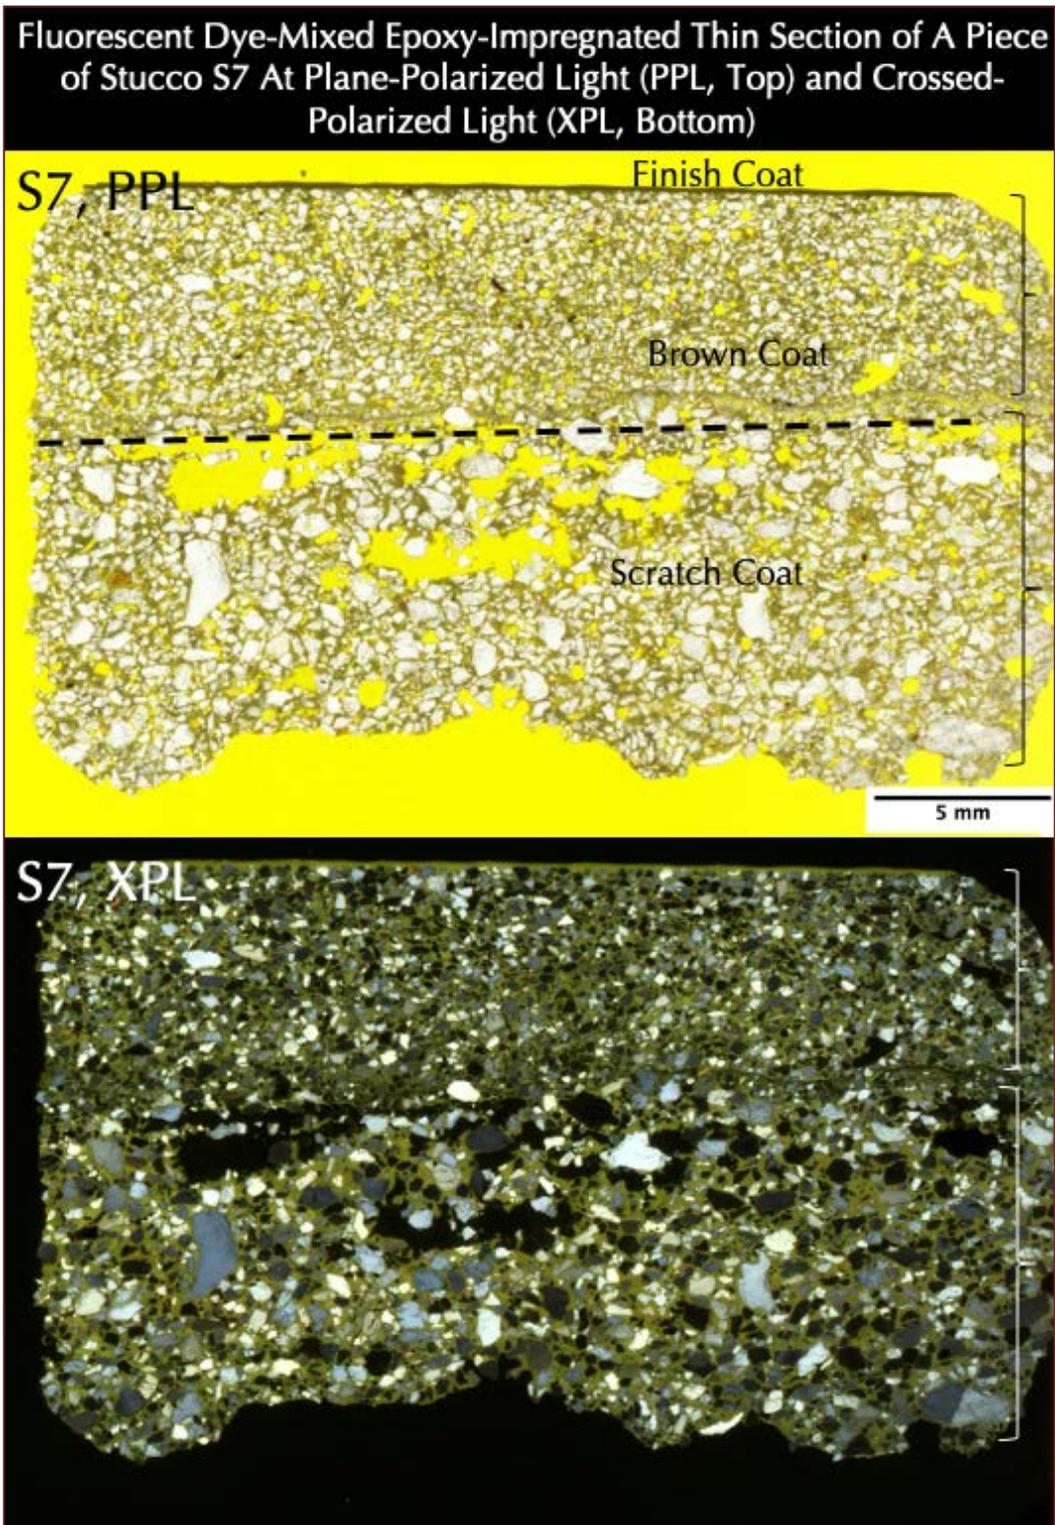
Figure 37: Fluorescent dye-mixed epoxy-impregnated 50 mm x 75 mm size thin section of stucco in Sample S7 scanned on a film scanner in plane (PPL) and crossed (XPL) polarized-light modes with one or two perpendicular polarizing filters, respectively showing:

- (a) Size, shape, angularity, gradation, and distribution of sand particles in brown and scratch coats in PPL and XPL images;
- (b) A thin paint (finish) coat adhered to the topcoat seen as a dark brown layer at the top in PPL image;
- (c) Relatively finer overall grain-size of sand in the brown coat than sand found in the scratch coat, which is seen in both PPL and XPL images; sand in both coats are angular in nature indicating use of crushed sand;
- (d) Siliceous composition of crushed sand revealed in XPL image,
- (e) Overall carbonated nature of paste in XPL image,
- (f) Overall porous nature of scratch coat

relative to the brown coat in PPL image, and,

(g) Overall good bond between the two coats and between the paint and topcoat in PPL image.

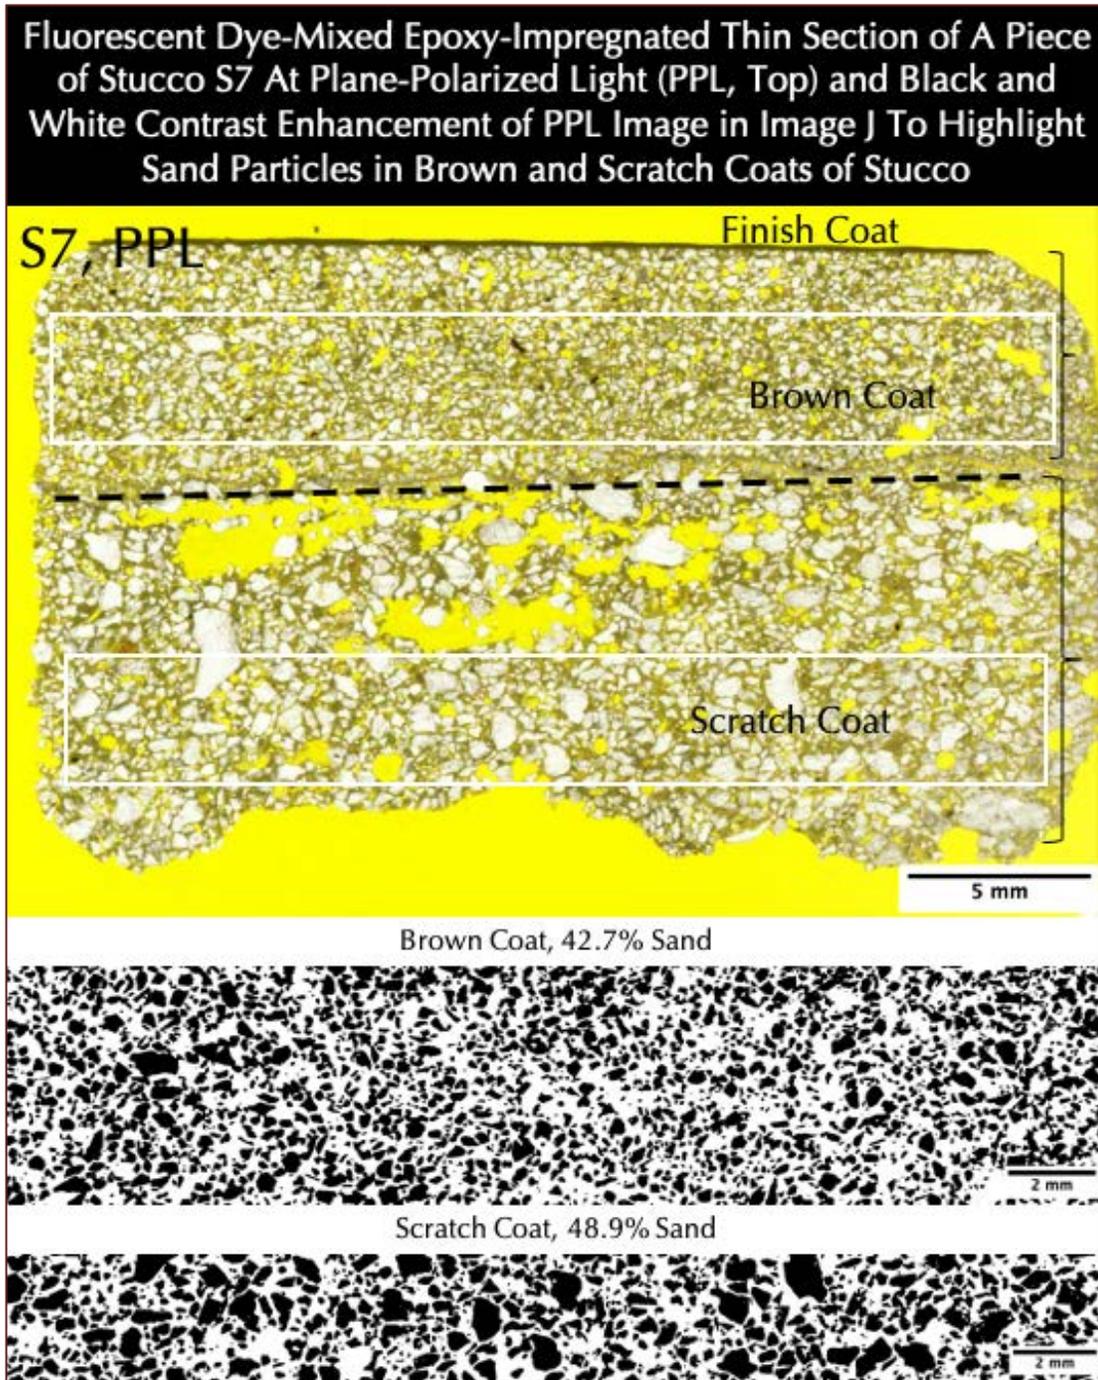
Figure 38: Fluorescent dye-mixed epoxy-impregnated 50 mm x 75 mm size thin section of stucco in Sample S7 scanned on a film scanner in plane (PPL) polarized-light mode showing: (a) size, shape, angularity, gradation, and distribution of sand particles in brown and scratch coats; (b) a thin paint coat adhered to the brown coat seen as a dark brown layer at the top; (c) relatively finer overall grain-size of sand in the brown coat than sand found in the scratch coat; sand in both coats are angular in nature indicating use of crushed sand; (d) overall porous nature of scratch coat relative to the brown coat, (e) overall good bond between the two coats and between the paint and brown coat; and, (f) boxed areas in brown and scratch coats were selected for image analysis in Image J to determine sand contents (by volume) in each coat, after converting the images to binary black and white contrasts to highlight sand particles in each coat in black, which showed 42.7% sand in brown coat and 48.9% sand in scratch coat, and overall coarser sand in the scratch as seen in black and white images.

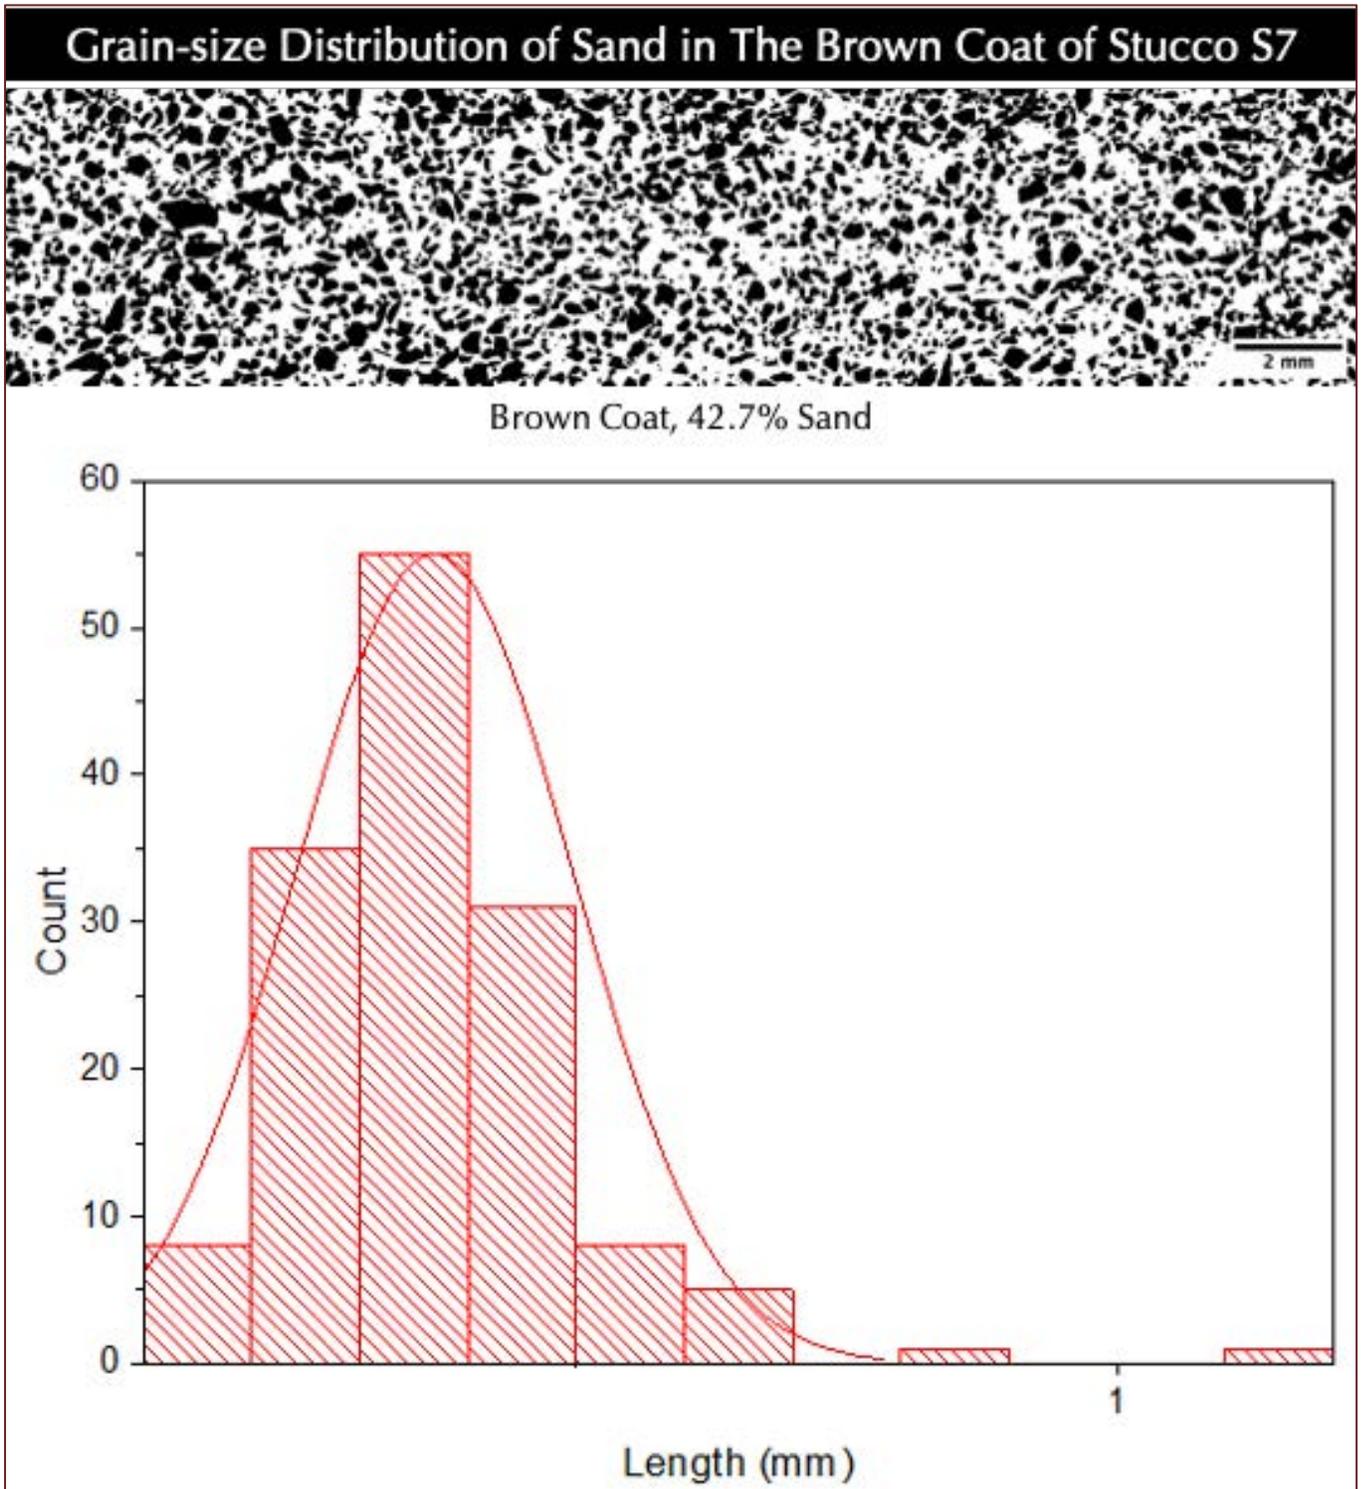
Figure 39: Grain-size distribution of sand in the brown coat from black and white contrast enhancement of boxed area of PPL image of thin section of S7 stucco in Figure 38 showing a normal distribution of sand sizes with a median sand size of around 0.5 mm with almost all of the particles less than a millimeter in grain size. Image analysis of sand sizes were done in Image J.

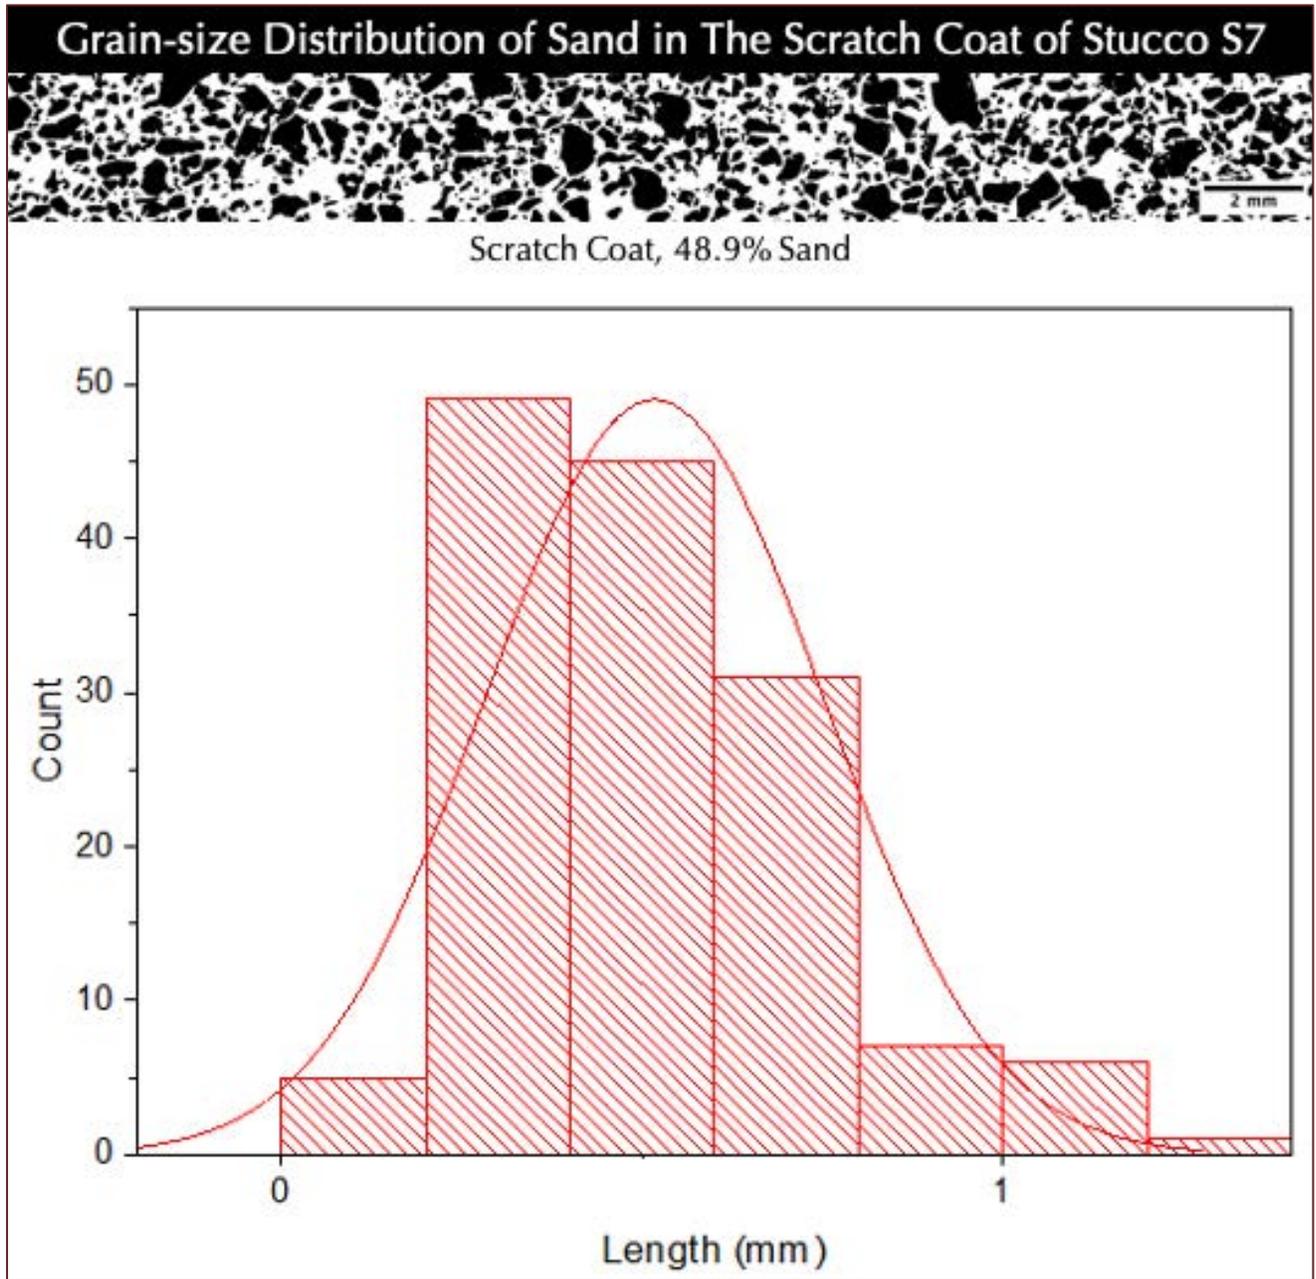
Figure 40: Grain-size distribution of sand in the scratch coat from black and white contrast enhancement of boxed area of PPL image of thin section of S7 stucco in Figure 38 showing a normal distribution of sand sizes with a median sand size of around 0.5 mm with almost all of the particles less than a millimeter in grain size and a few particles over 1 mm size which are rare in the brown coat but more in the scratch coat hence giving an overall coarser grain size of sand in the scratch coat. Image analysis of sand sizes were done in Image J.

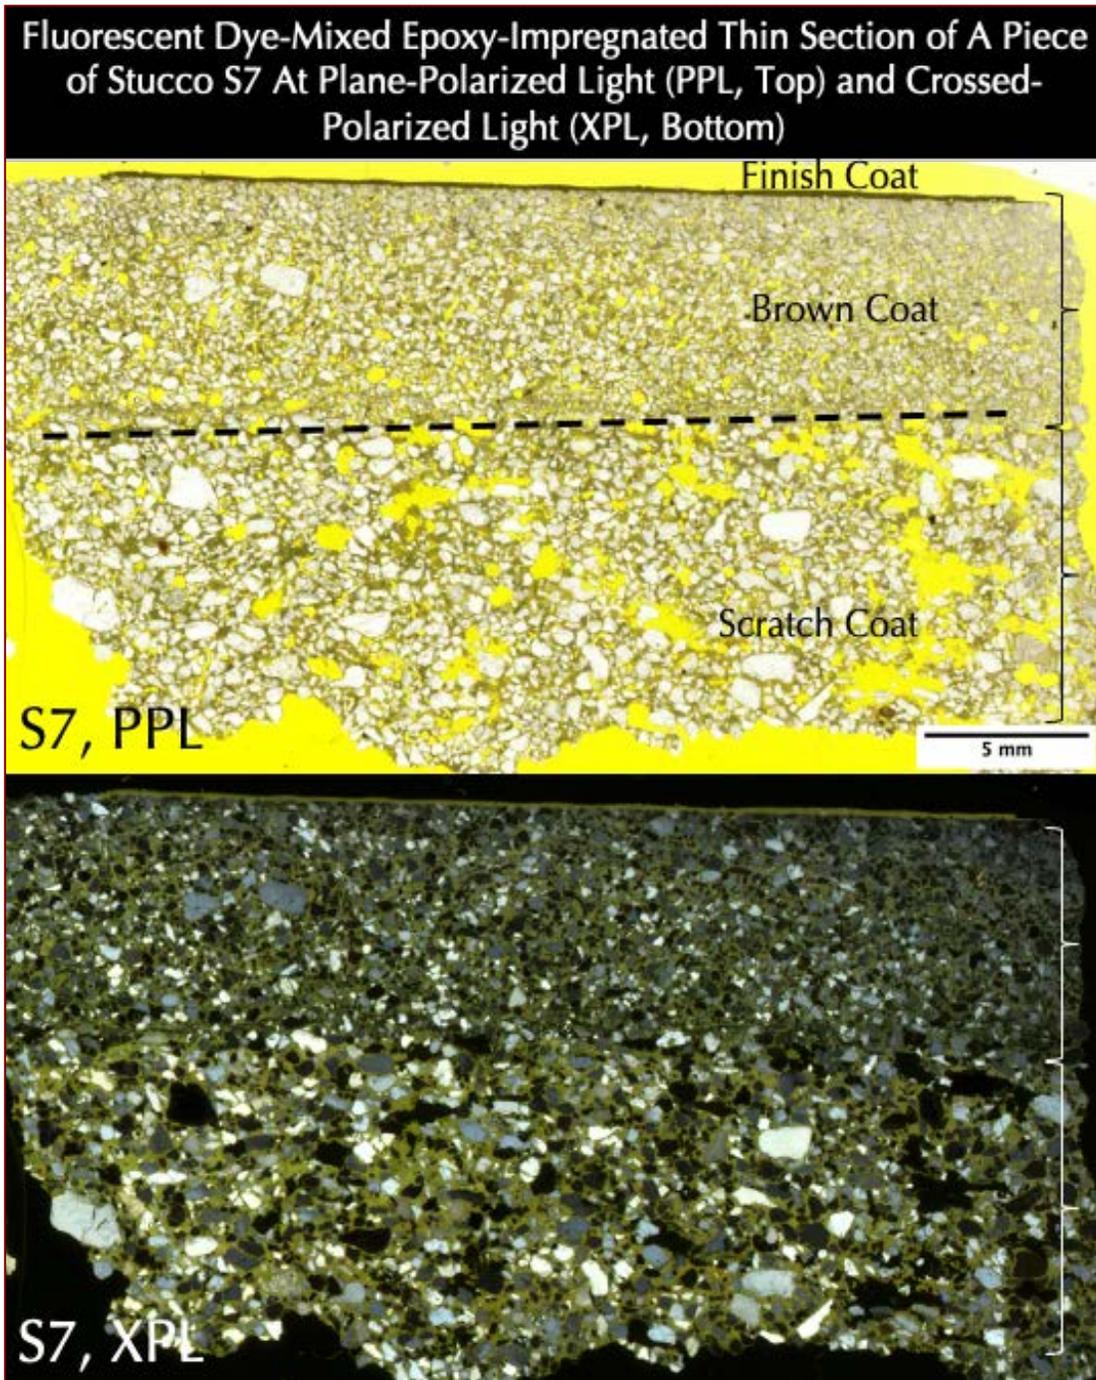
Figure 41: Fluorescent dye-mixed epoxy-impregnated 50 mm x 75 mm size thin section of stucco in Sample S7 scanned on a film scanner in plane (PPL) and crossed (XPL) polarized-light modes with one or two perpendicular polarizing filters, respectively showing:

- (a) Size, shape, angularity, gradation, and distribution of sand particles in brown and scratch coats in PPL and XPL images;
- (b) A thin paint (finish) coat adhered to the brown coat seen as a dark brown layer at the top in PPL image;
- (c) Relatively finer overall grain-size of sand in the brown coat than sand found in the scratch coat, which is seen in both PPL and XPL images; sand in

- both coats are angular in nature indicating use of crushed sand;
- (d) Siliceous composition of crushed sand revealed in XPL image;
- (e) Overall carbonated nature of paste in XPL image;
- (f) Overall porous nature of scratch coat relative to the brown coat in PPL image; and,
- (g) Overall good bond between the two coats and between the paint and topcoat in PPL image.

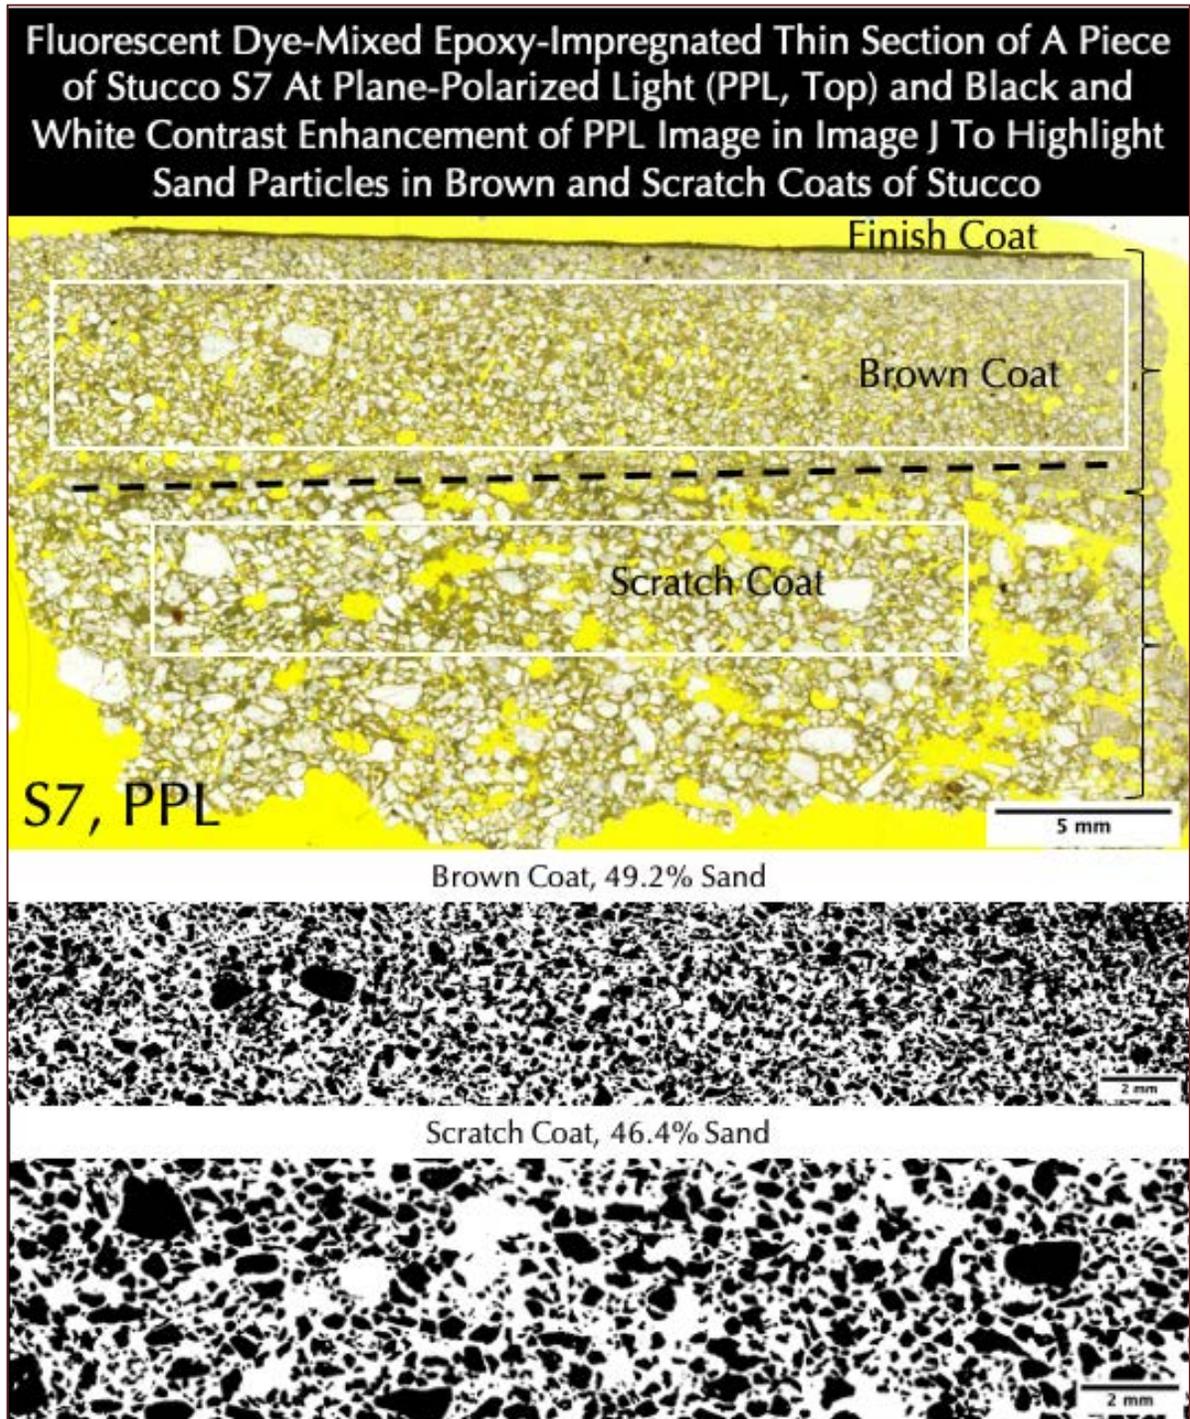
Figure 42: Fluorescent dye-mixed epoxy-impregnated 50 mm x 75 mm size thin section of stucco in Sample S7 scanned on a film scanner in plane (PPL) polarized-light mode showing: (a) size, shape, angularity, gradation, and distribution of sand particles in brown and scratch coats; (b) a thin paint (finish) coat adhered to the brown coat seen as a dark brown layer at the top; (c) relatively finer overall grain-size of sand in the brown coat than sand found in the scratch coat; sand in both coats are angular in nature indicating use of crushed sand; (d) overall porous nature of scratch coat relative to the brown coat, (e) overall good bond between the two coats and between the paint and brown coat; and, (f) boxed areas in brown and scratch coats were selected for image analysis in Image J to determine sand contents (by volume) in each coat, after converting the images to binary black and white contrasts to highlight sand particles in each coat in black, which showed 49.2% sand in brown coat and 46.4% sand in scratch coat, and overall coarser sand in the scratch coat as seen in black and white images.

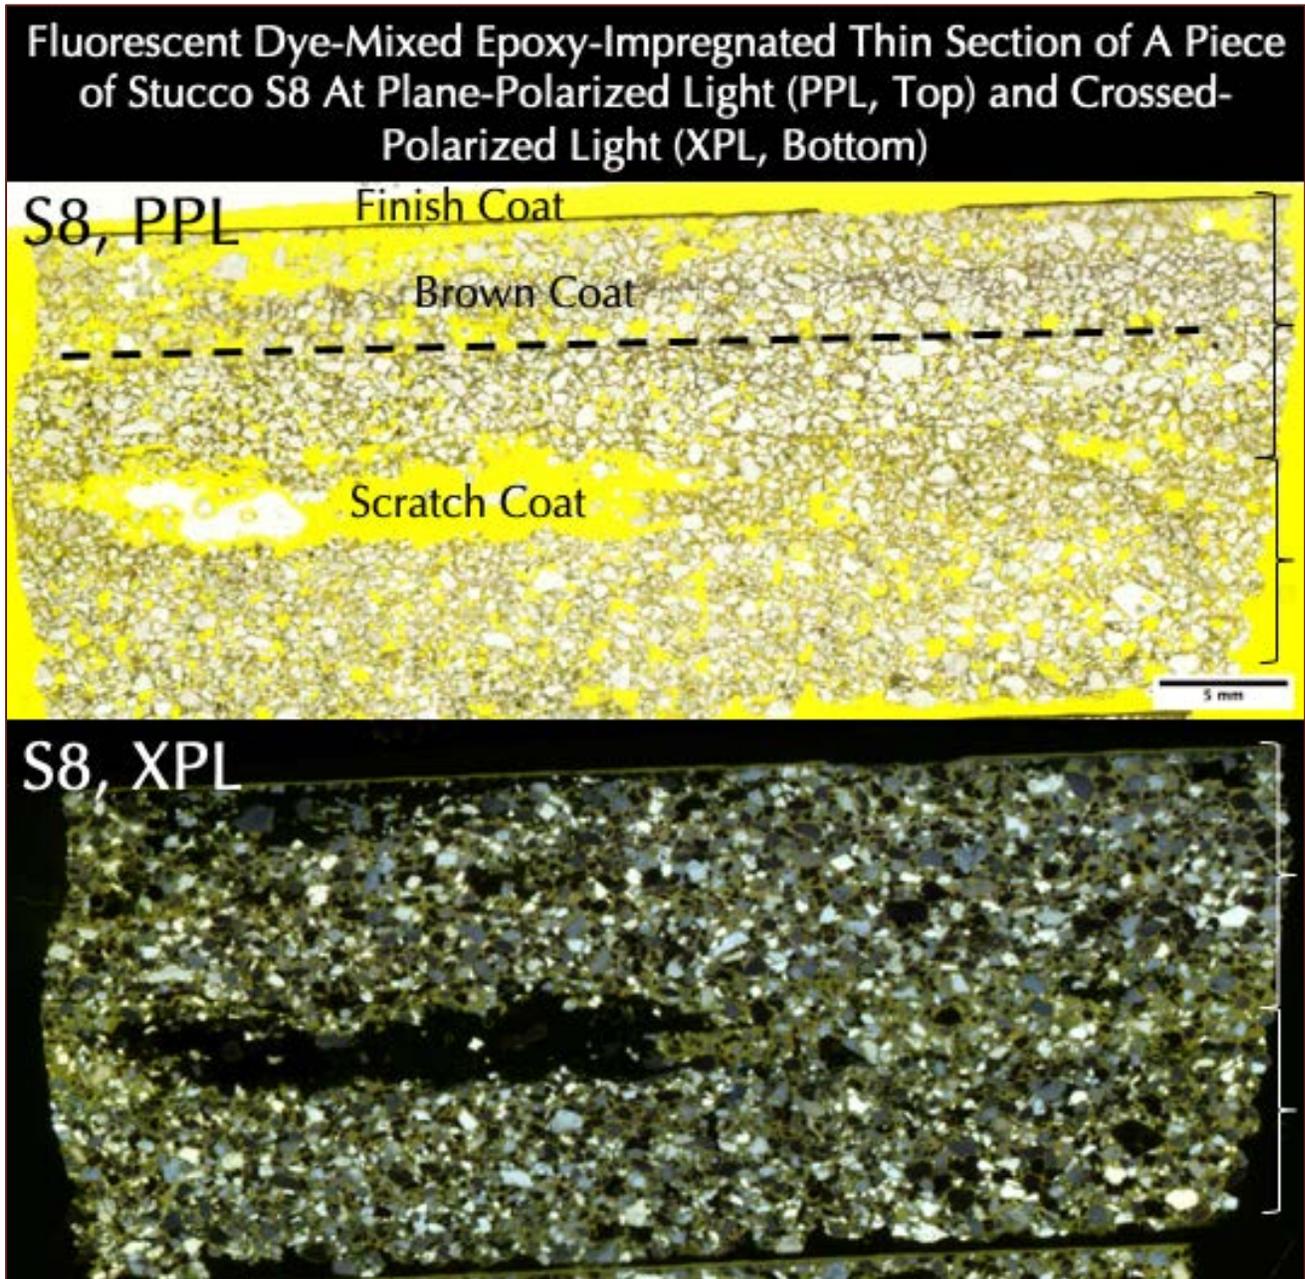
Figure 43: Fluorescent dye-mixed epoxy-impregnated 50 mm x 75 mm size thin section of stucco in Sample S8 scanned on a film scanner in plane (PPL) and crossed (XPL) polarized-light modes with one or two perpendicular polarizing filters, respectively showing: (a) size, shape, angularity, gradation, and distribution of sand particles in brown and scratch coats in PPL and XPL images; (b) a thin paint (finish) coat adhered to the brown coat seen as a dark brown layer at the top in PPL image; (c) relatively finer overall grain-size of sand in the brown coat than sand found in the scratch coat, which is seen in both PPL and XPL images; sand in both coats are angular in nature indicating use of crushed sand; (d) siliceous composition of crushed sand revealed in XPL image, (e) overall carbonated nature of paste in XPL image, (f) overall porous nature of scratch coat relative to the brown coat in PPL image, and, (g) overall good bond between the two coats and between the paint and topcoat in PPL image.

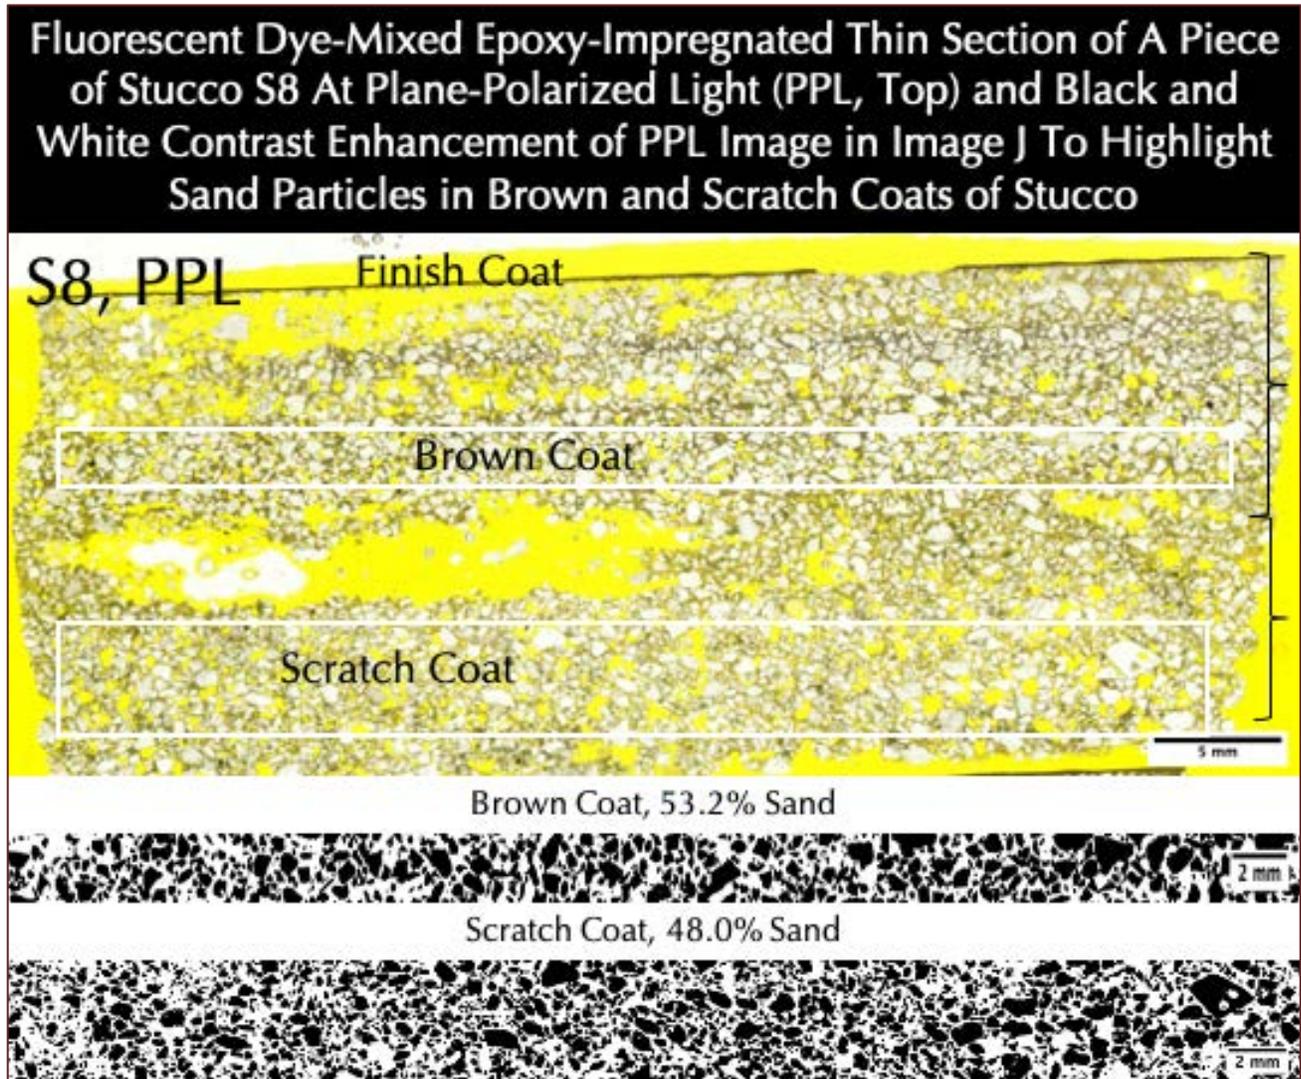
Figure 44: Fluorescent dye-mixed epoxy-impregnated 50 mm x 75 mm size thin section of stucco in Sample S8 scanned on a film scanner in plane (PPL) polarized-light mode showing: (a) size, shape, angularity, gradation, and distribution of sand particles in brown and scratch coats; (b) a thin paint (finish) coat adhered to the brown coat seen as a dark brown layer at the top; (c) relatively finer overall grain-size of sand in the brown coat than sand found in the scratch coat; sand in both coats are angular in nature indicating use of crushed sand; (d) overall porous nature of scratch coat relative to the brown coat, (e) overall good bond between the two coats and between the paint and brown coat; and, (f) boxed areas in brown and scratch coats were selected for image analysis in Image J to determine sand contents (by volume) in each coat, after converting the images to binary black and white contrasts to highlight sand particles in each coat in black, which showed 53.2% sand in brown coat and 48.0% sand in scratch coat, and overall coarser sand in the scratch coat as seen in black and white image.

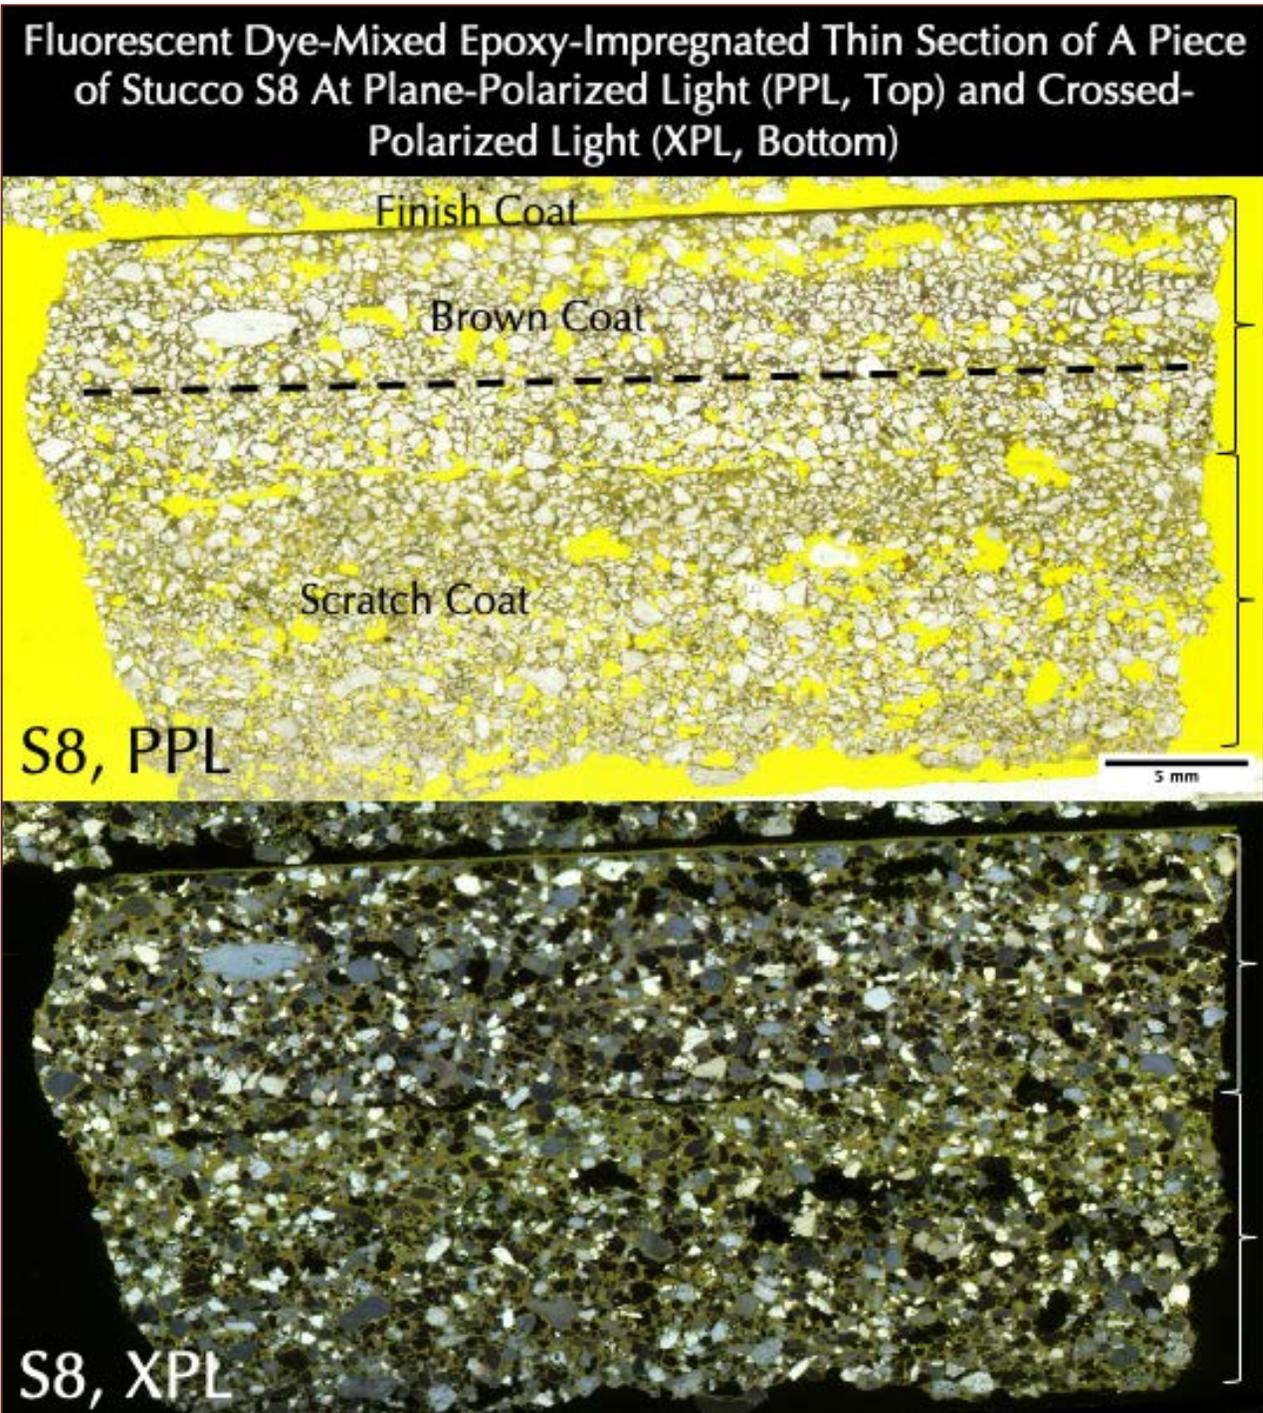
Figure 45: Fluorescent dye-mixed epoxy-impregnated 50 mm x 75 mm size thin section of stucco in Sample S8 scanned on a film scanner in plane (PPL) and crossed (XPL) polarized-light modes with one or two perpendicular polarizing filters, respectively showing: (a) size, shape, angularity, gradation, and distribution of sand particles in brown and scratch coats in PPL and XPL images; (b) a thin paint (finish) coat adhered to the brown coat seen as a dark brown layer at the top in PPL image; (c) relatively finer overall grain-size of sand in the brown coat than sand found in the scratch coat, which is seen in both PPL and XPL images; sand in both coats are angular in nature indicating use of crushed sand; (d) siliceous composition of crushed sand revealed in XPL image, (e) overall carbonated nature of paste in XPL image, (f) overall porous nature of scratch coat relative to the brown coat in PPL image, and, (g) overall good bond between the two coats and between the paint and topcoat in PPL image.
