## Laboratory Investigation Of Coating Failure From Stucco Façades Of An 18<sup>th</sup> Century Courthouse In Charleston, South Carolina

Charleston County Courthouse Exterior Façade  
Charleston, South Carolina

September 29, 2020  
CMC 0820145

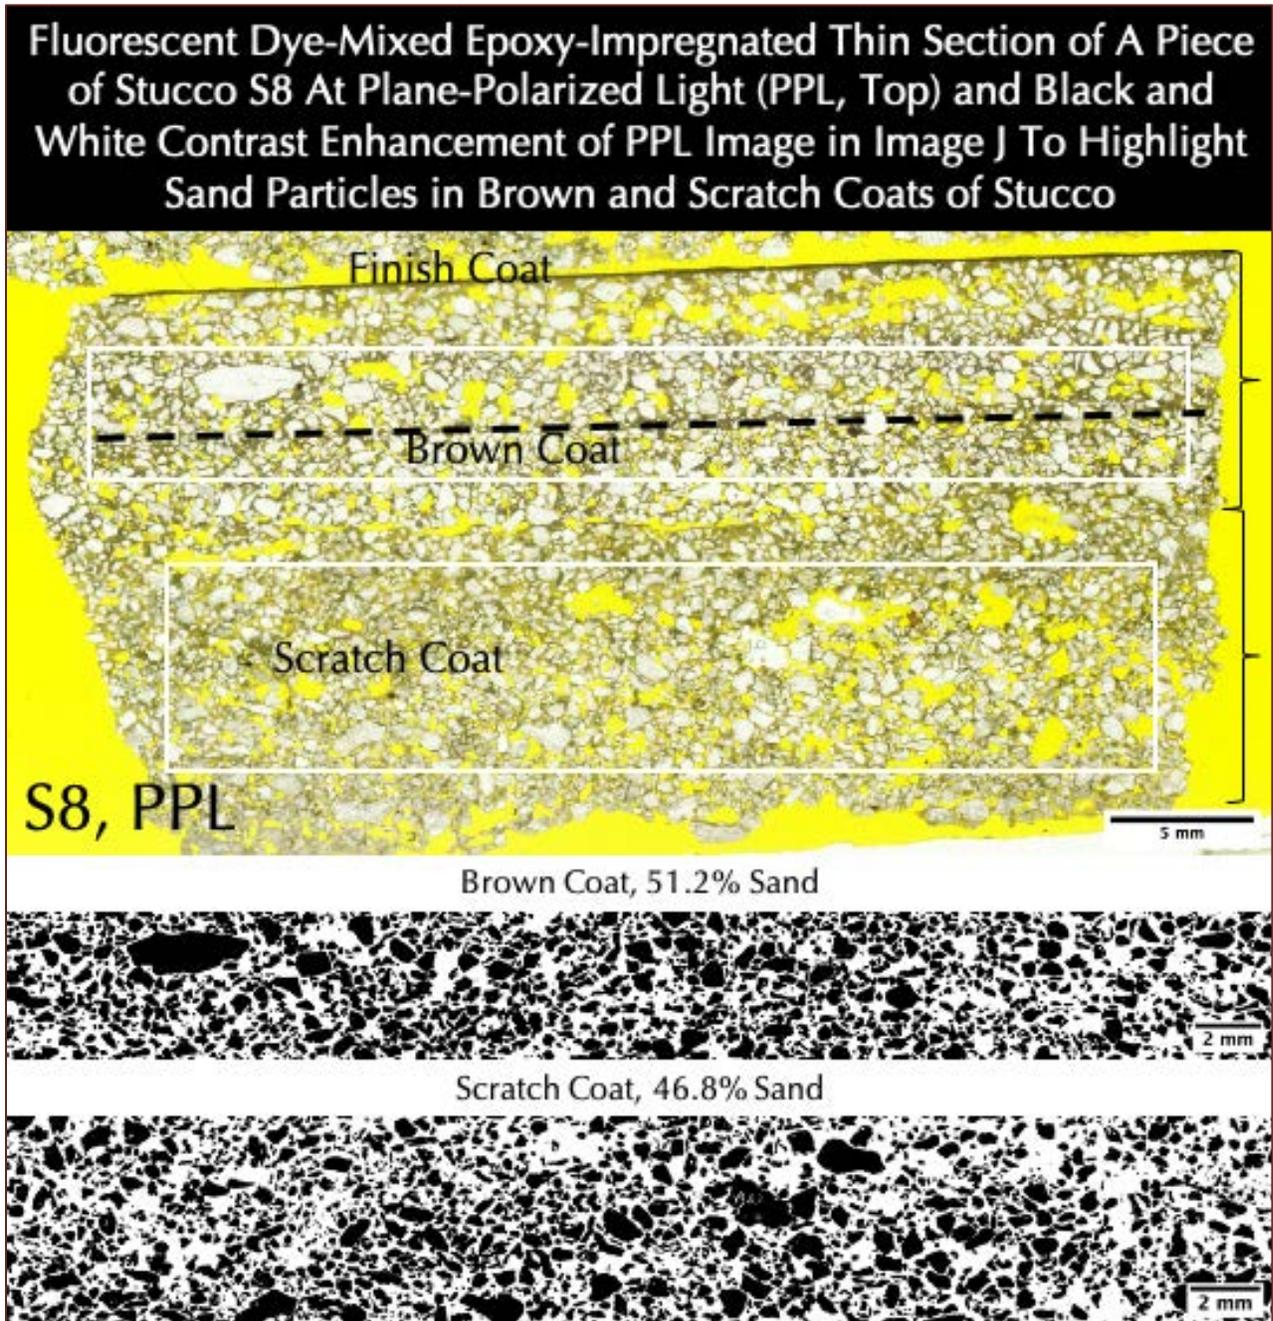
Figure 46: Fluorescent dye-mixed epoxy-impregnated 50 mm x 75 mm size thin section of stucco in Sample S8 scanned on a film scanner in plane (PPL) polarized-light mode showing: (a) size, shape, angularity, gradation, and distribution of sand particles in brown and scratch coats; (b) a thin paint (finish) coat adhered to the brown coat seen as a dark brown layer at the top; (c) relatively finer overall grain-size of sand in the brown coat than sand found in the scratch coat; sand in both coats are angular in nature indicating use of crushed sand; (d) overall porous nature of scratch coat relative to the brown coat, (e) overall good bond between the two coats and between the paint and brown coat; and, (f) boxed areas in brown and scratch coats were selected for image analysis in Image J to determine sand contents (by volume) in each coat, after converting the images to binary black and white contrasts to highlight sand particles in each coat in black, which showed 51.2% sand in brown coat and 46.8% sand in scratch coat, and overall coarser sand in the scratch coat as seen in black and white image.

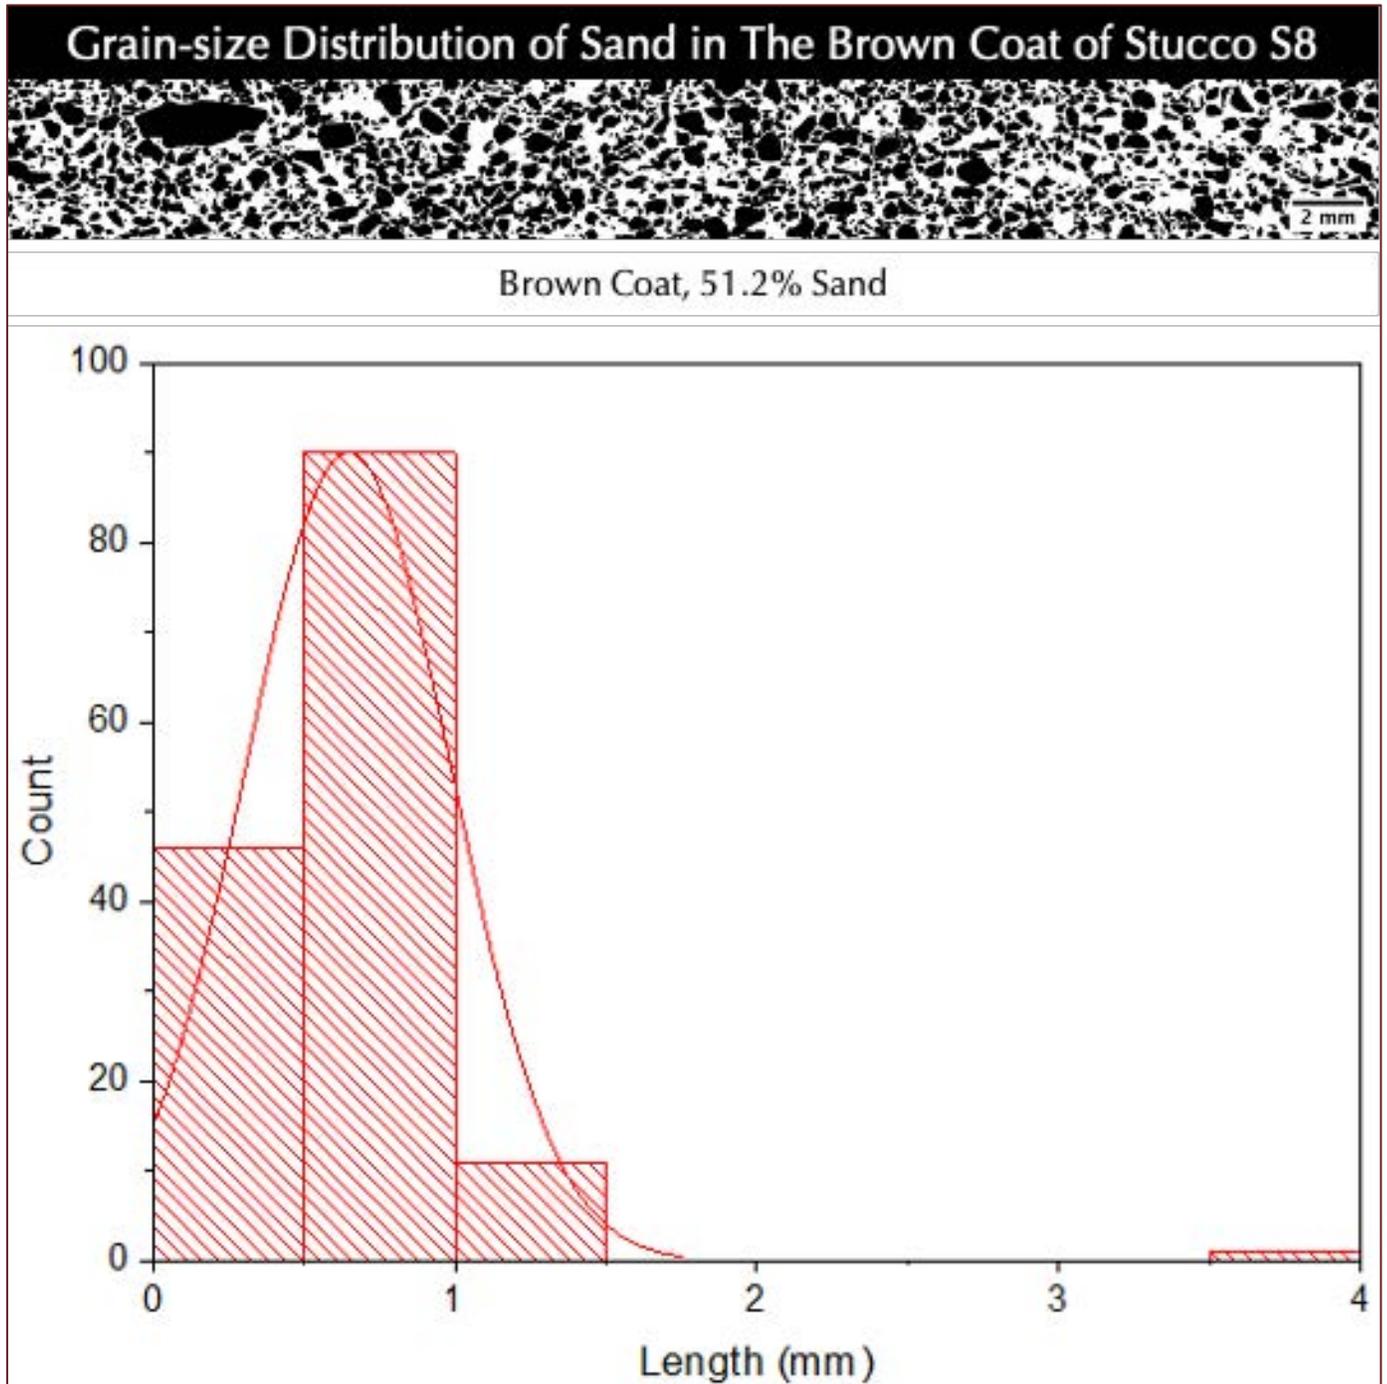
Figure 47: Grain-size distribution of sand in the brown coat from black and white contrast enhancement of boxed area of PPL image of thin section of S8 stucco in Figure 46 showing a normal distribution of sand sizes with a median sand size of around 0.5 mm with almost all of the particles less than a millimeter in grain size. Image analysis of sand sizes were done in Image J.

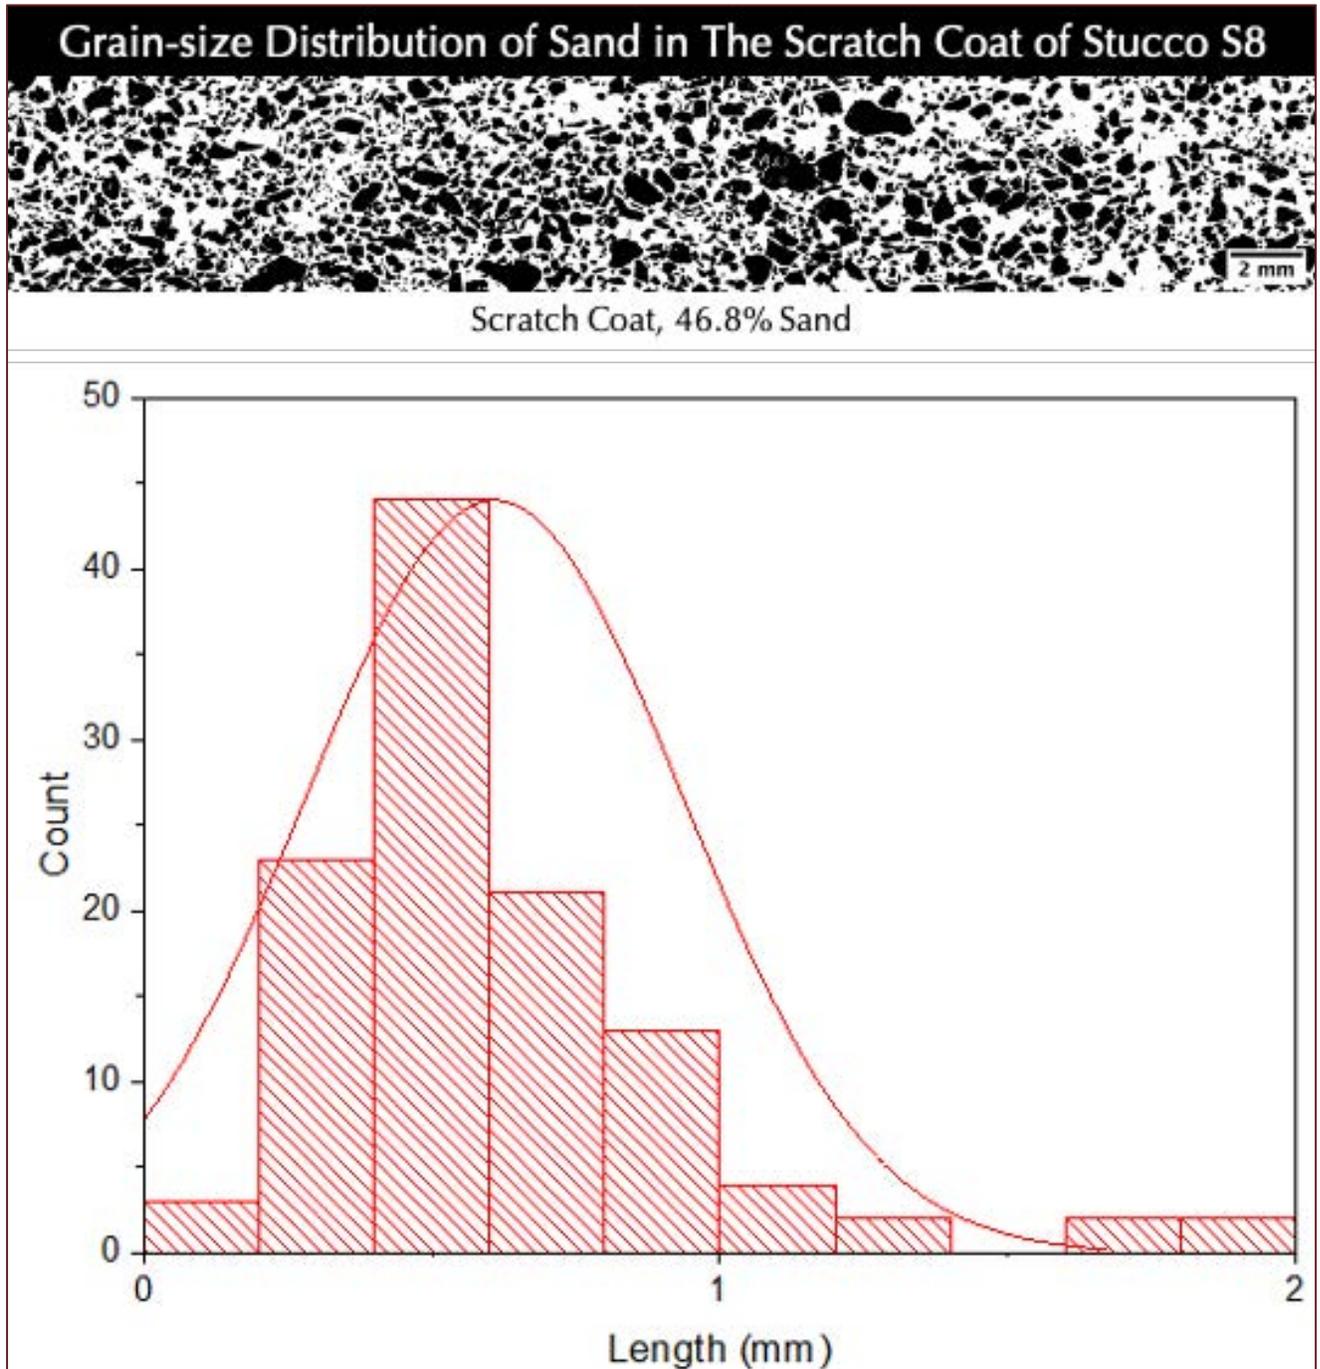
Figure 48: Grain-size distribution of sand in the scratch coat from black and white contrast enhancement of boxed area of PPL image of thin section of S8 stucco in Figure 46 showing a normal distribution of sand sizes with a median sand size of around 0.5 mm with almost all of the particles less than a millimeter in grain size and a fewer particles over 1 mm size which are rare in the brown coat, but more in the scratch coat hence giving an overall coarser grain size of sand in the scratch coat. Image analysis of sand sizes were done in Image J.

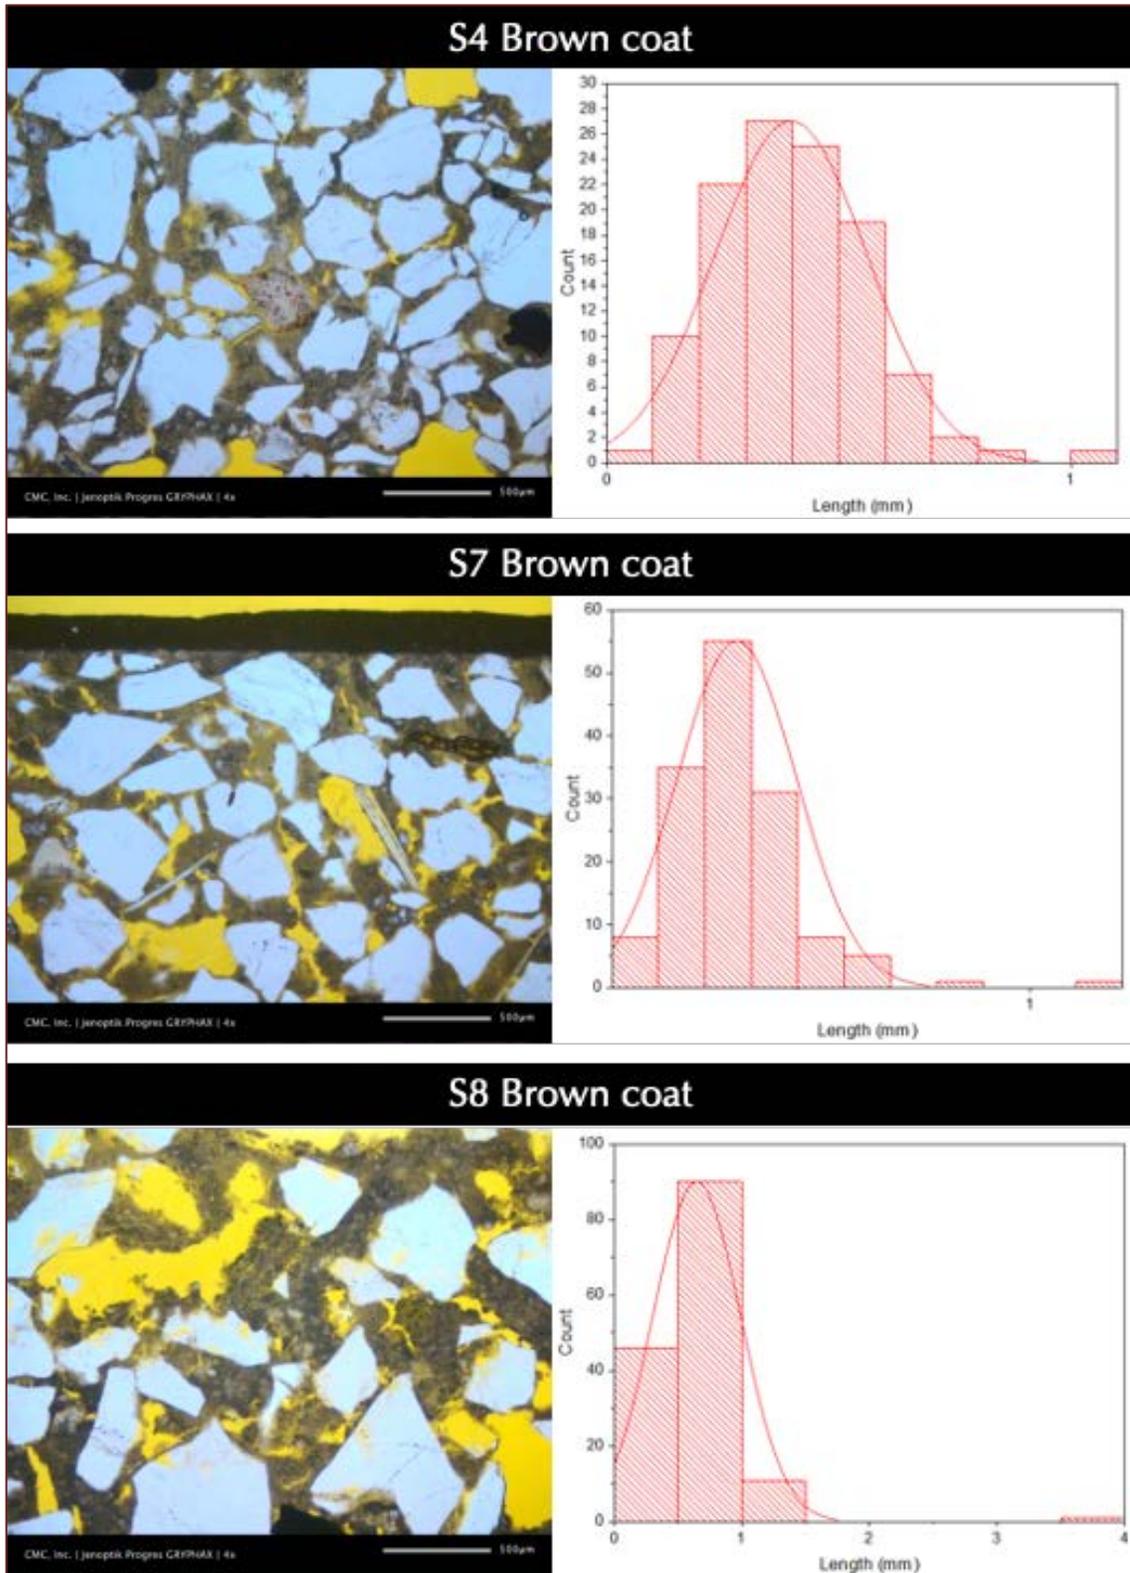
Figure 49: Grain-size distribution of sand in the brown coats from three stucco samples showing a normal distribution of sand sizes with a median sand size of around 0.5 mm with almost all of the particles less than a millimeter in grain size.

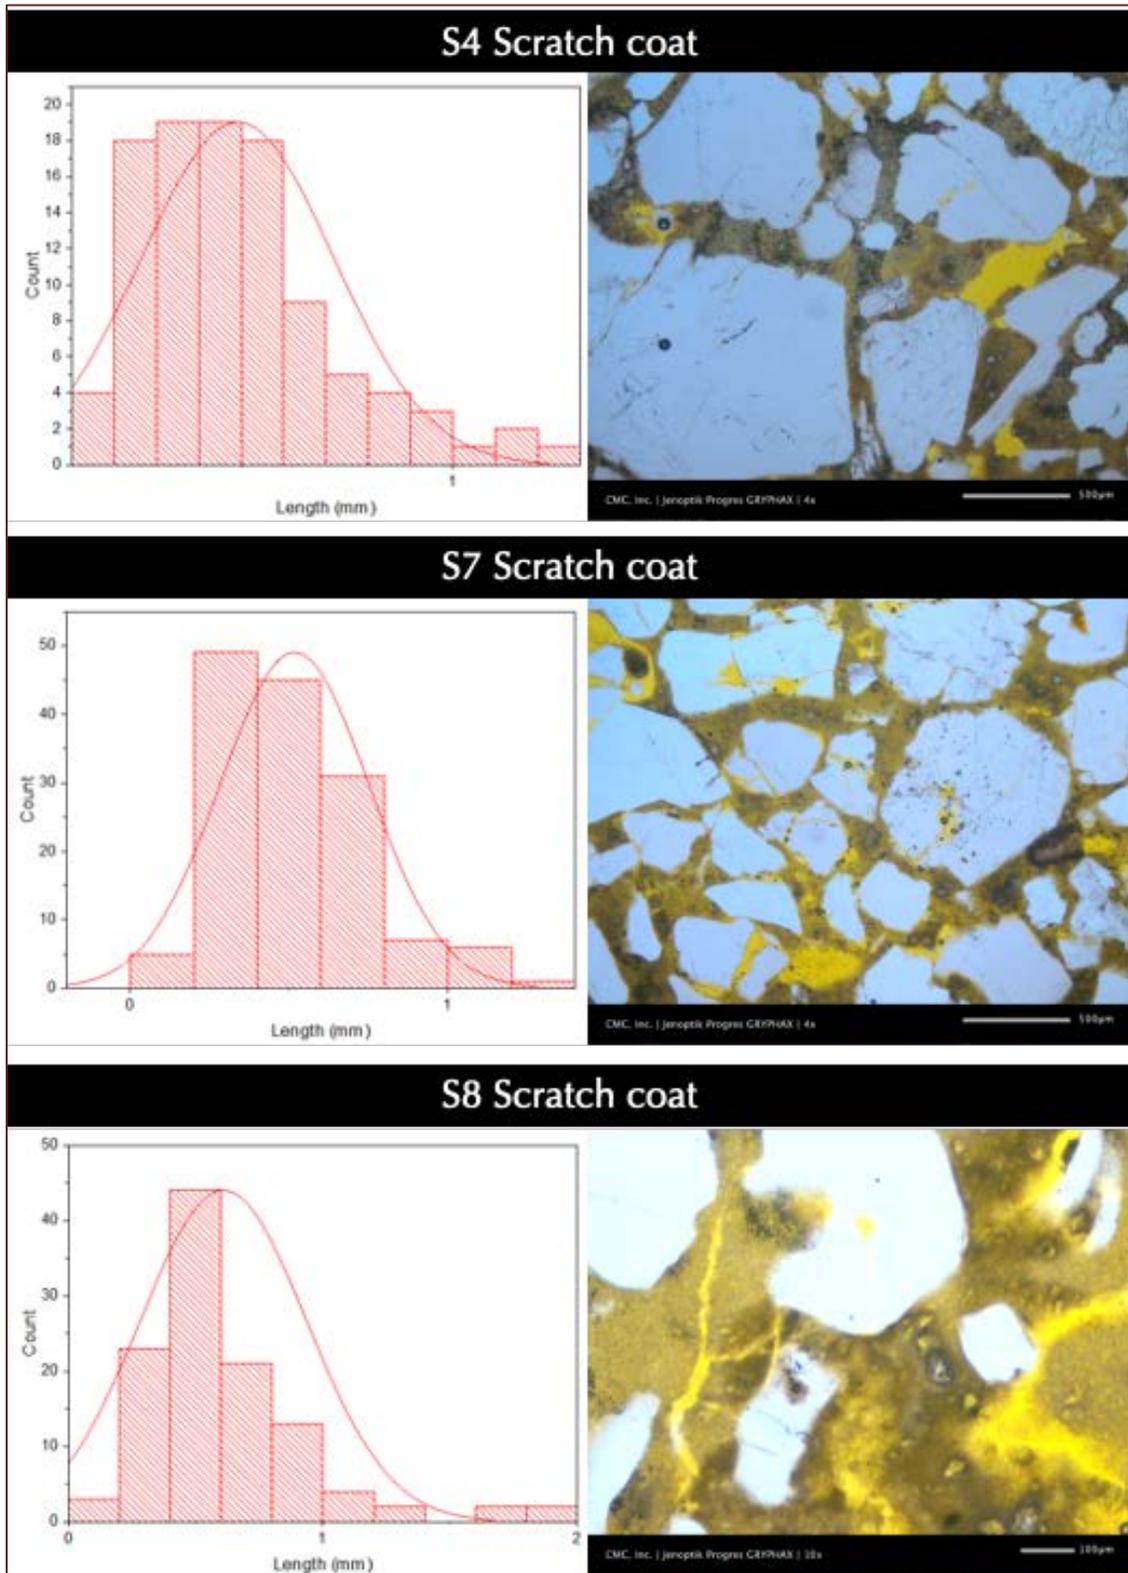
Figure 50: Grain-size distribution of sand in the scratch coats from three stucco samples showing a normal distribution of sand sizes with a median sand size of around 0.5 mm with few sand particles coarser than a millimeter in grain size which are rare in the brown coat, but more in the scratch coat hence giving an overall coarser grain size of sand in the scratch coat.

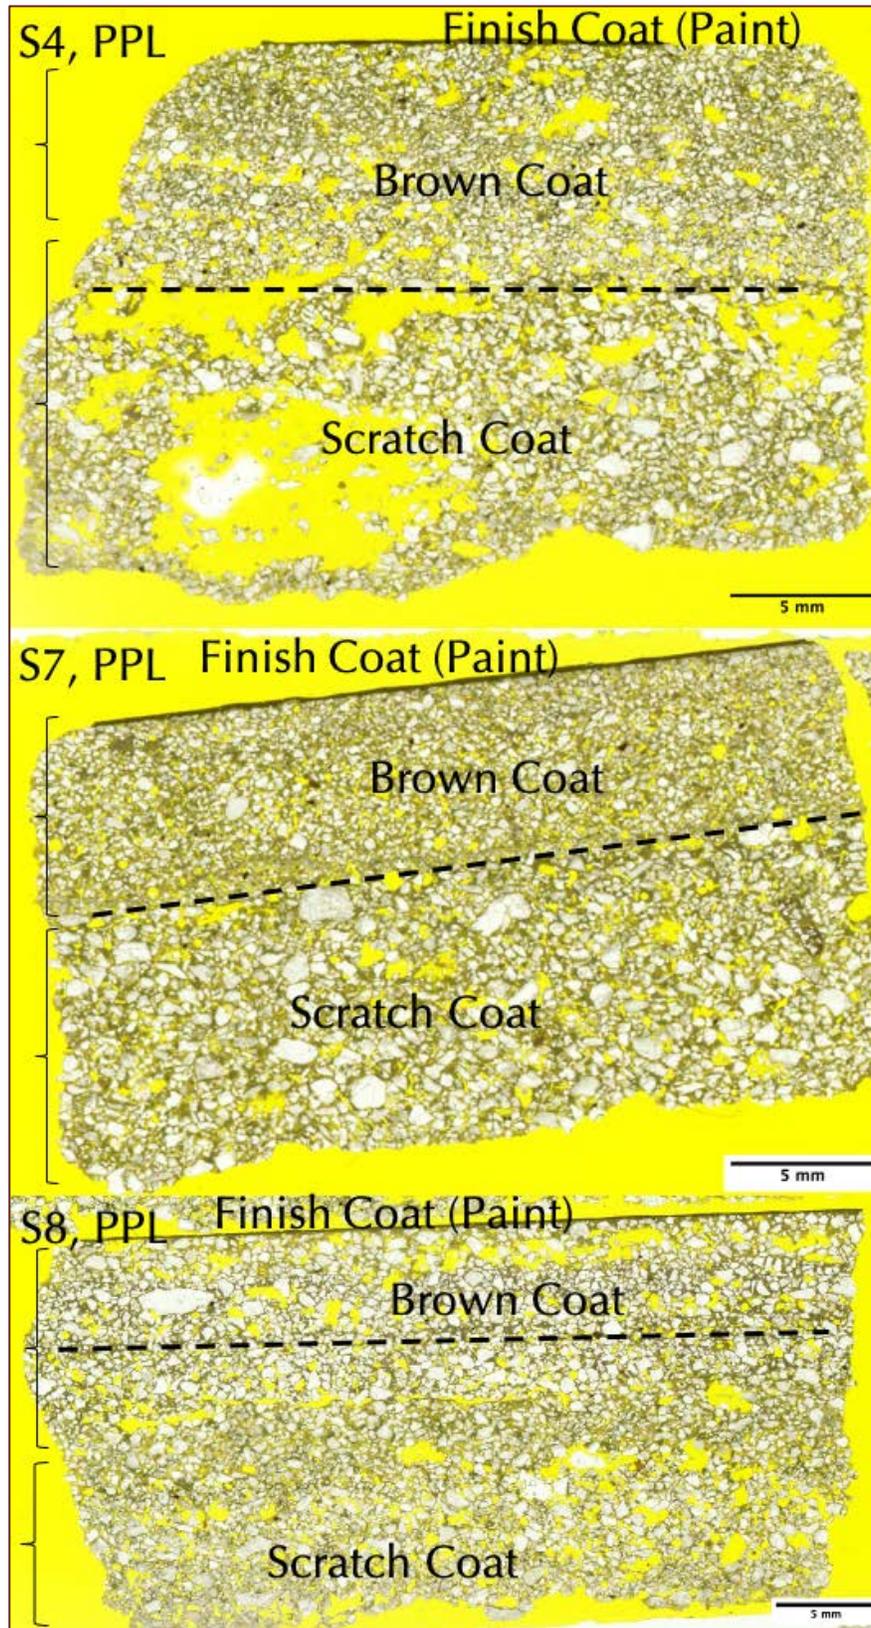
Figure 51: Fluorescent dye-mixed epoxy-impregnated 50 mm x 75 mm size thin sections of three stucco samples scanned on a film scanner in plane (PPL) polarized-light mode showing:

- (a) Size, shape, angularity, gradation, and distribution of sand particles in brown and scratch coats;
- (b) A thin paint (finish) coat adhered to the brown coat seen as a dark brown layer;
- (c) Relatively finer overall grain-size of sands in the brown coats than sand found in the scratch coats;
- (d) Sand in both coats are angular in nature indicating use of crushed sand;
- (e) Overall porous natures of scratch coats relative to the brown coats, and,
- (f) Overall good bonds between the two coats and between the paint and brown coats.

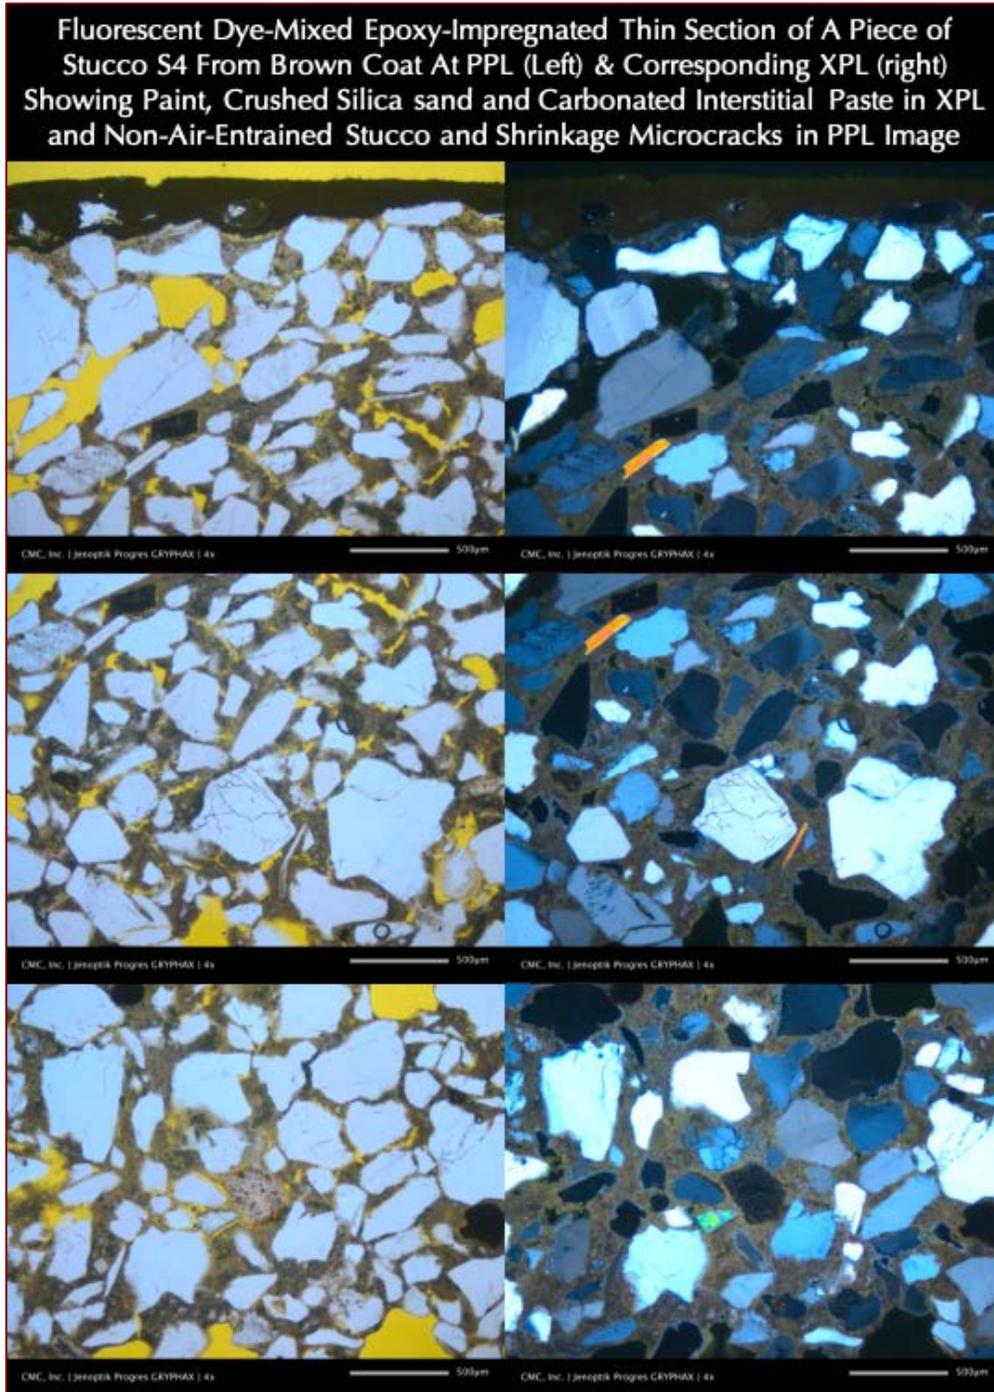
Figure 52: Micrographs of thin section of stucco S4 from north elevation in PPL (left) and corresponding XPL images, showing:

- (a) The thin (< 0.25 mm) paint (finish) coat on top of brown coat in top row;
- (b) Crushed silica sand particles in brown coat;
- (c) Fine-grained, porous, carbonated lime paste of brown coat;
- (c) Fine, hair-line, discontinuous elongated shrinkage microcracks in lime paste in brown coat; and,
- (d) Dominance of quartz sand in the brown coat's sand.

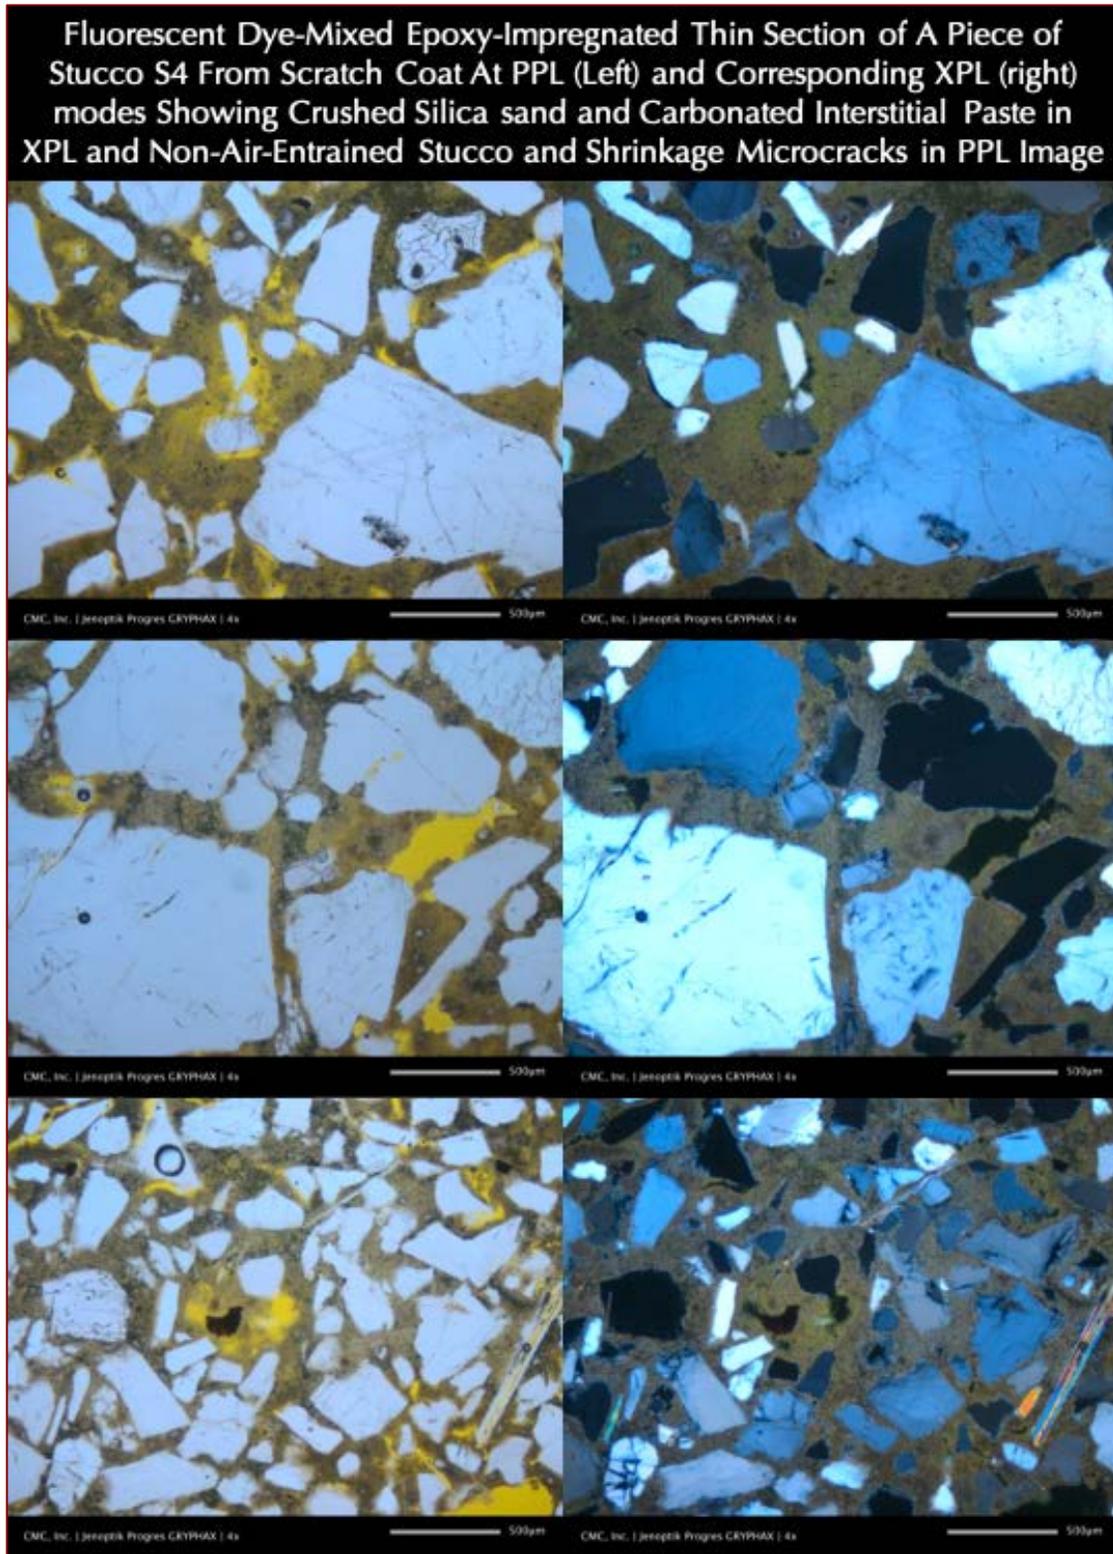
Figure 53: Micrographs of thin section of stucco S4 from north elevation in PPL (left) and corresponding XPL images, showing: (a) crushed silica sand particles in scratch coat in top and middle rows and finer crushed sand in the brown coat in the bottom row; (b) fine-grained, porous, carbonated lime paste of brown and scratch coats having fine, hair-line, discontinuous elongated shrinkage microcracks in lime paste; and (c) dominance of quartz sand in the sand in both brown and scratch coats. Notice the absence of any Portland cement particles in the paste.

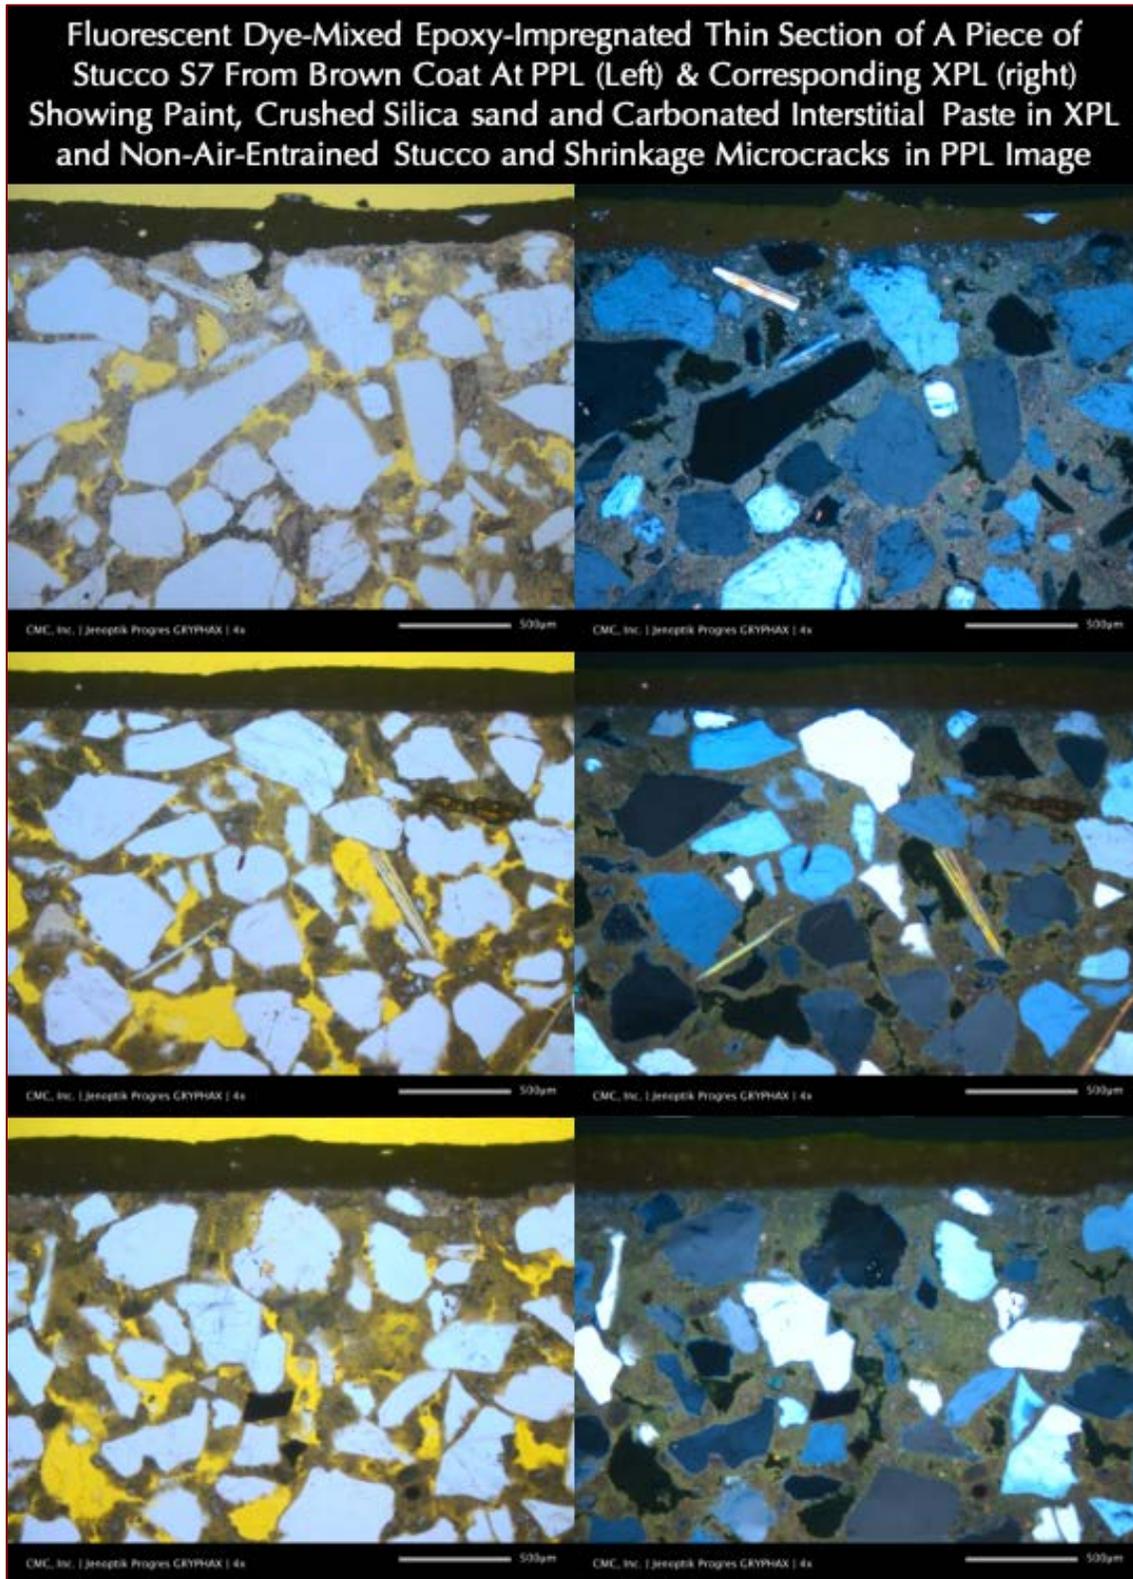
Figure 55: Micrographs of thin section of stucco S7 from south elevation in PPL (left) and corresponding XPL images, showing: (a) the thin (< 0.25 mm) paint (finish) coat on top of brown coat; (b) crushed silica sand particles in brown coat; (c) fine-grained, porous, carbonated lime paste of brown coat; (d) fine, hair-line, discontinuous elongated shrinkage microcracks in lime paste in brown coat; and (e) dominance of quartz sand in the brown coat's sand.

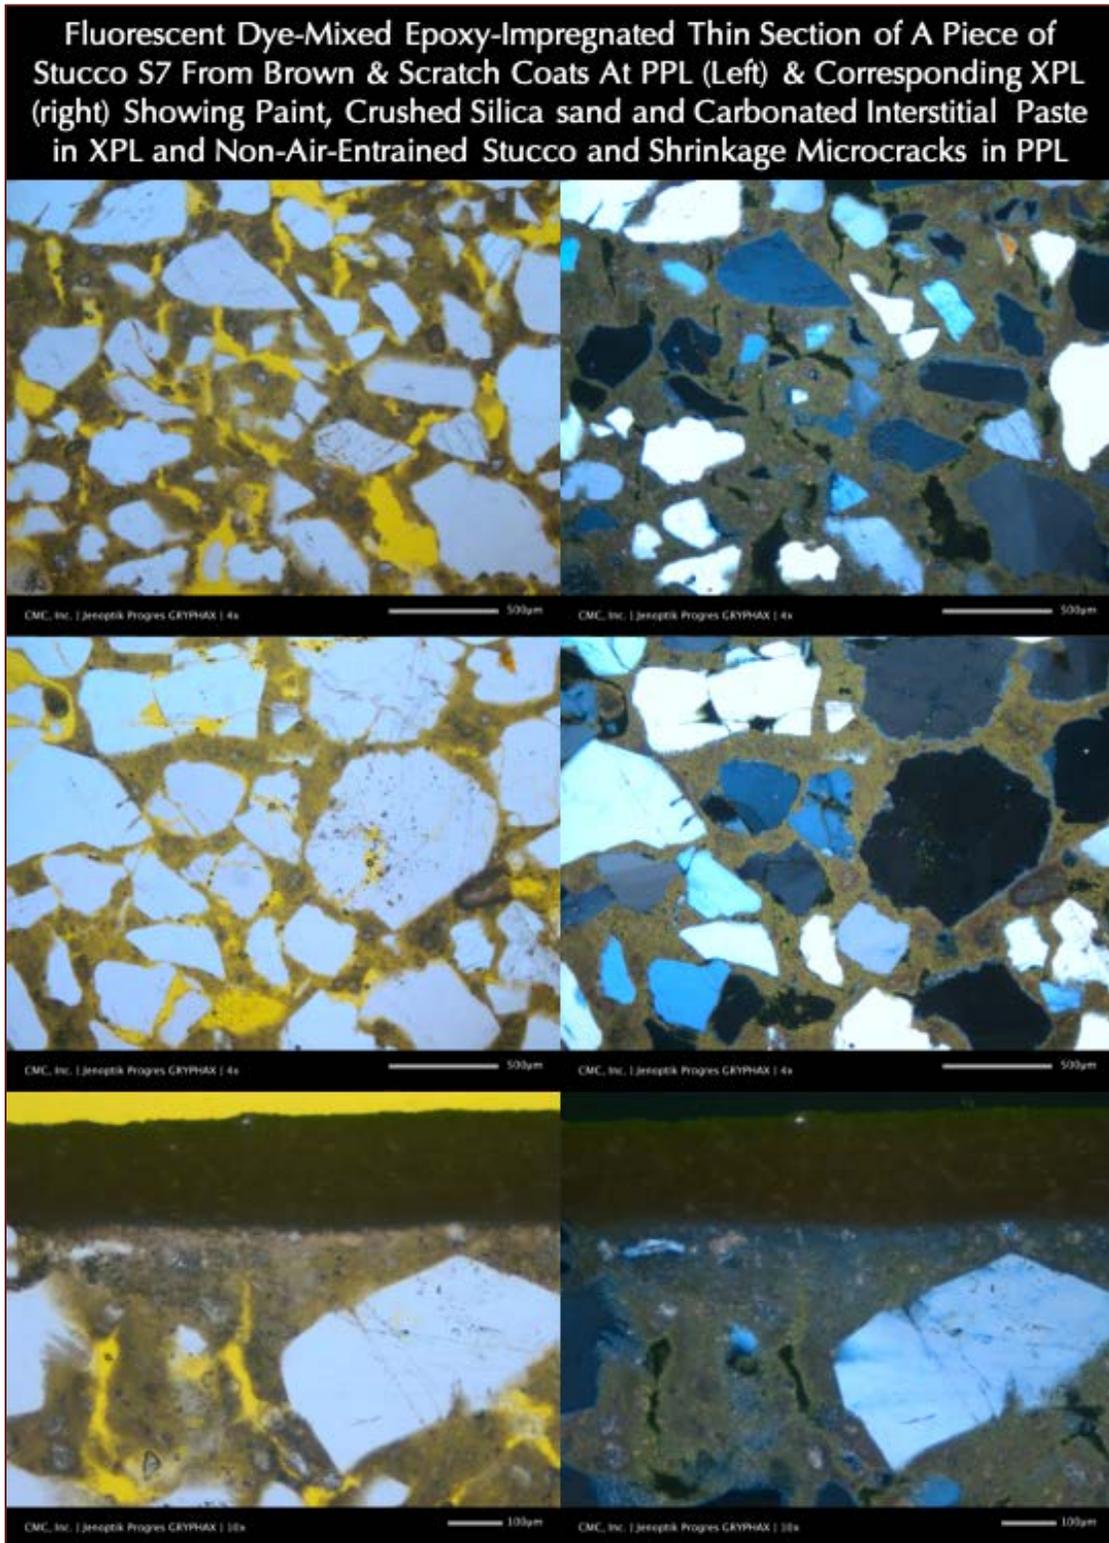
Figure 56: Micrographs of thin section of stucco S7 from south elevation in PPL (left) and corresponding XPL images, showing: (a) finer crushed silica sand particles in brown coat in top and middle rows and coarser crushed sand in the scratch coat in the bottom row; (b) fine-grained, porous, carbonated lime paste of brown and scratch coats having fine, hair-line, discontinuous elongated shrinkage microcracks in lime paste; and (c) dominance of quartz sand in the sand in both brown and scratch coats. Notice the absence of any Portland cement particles in the paste.

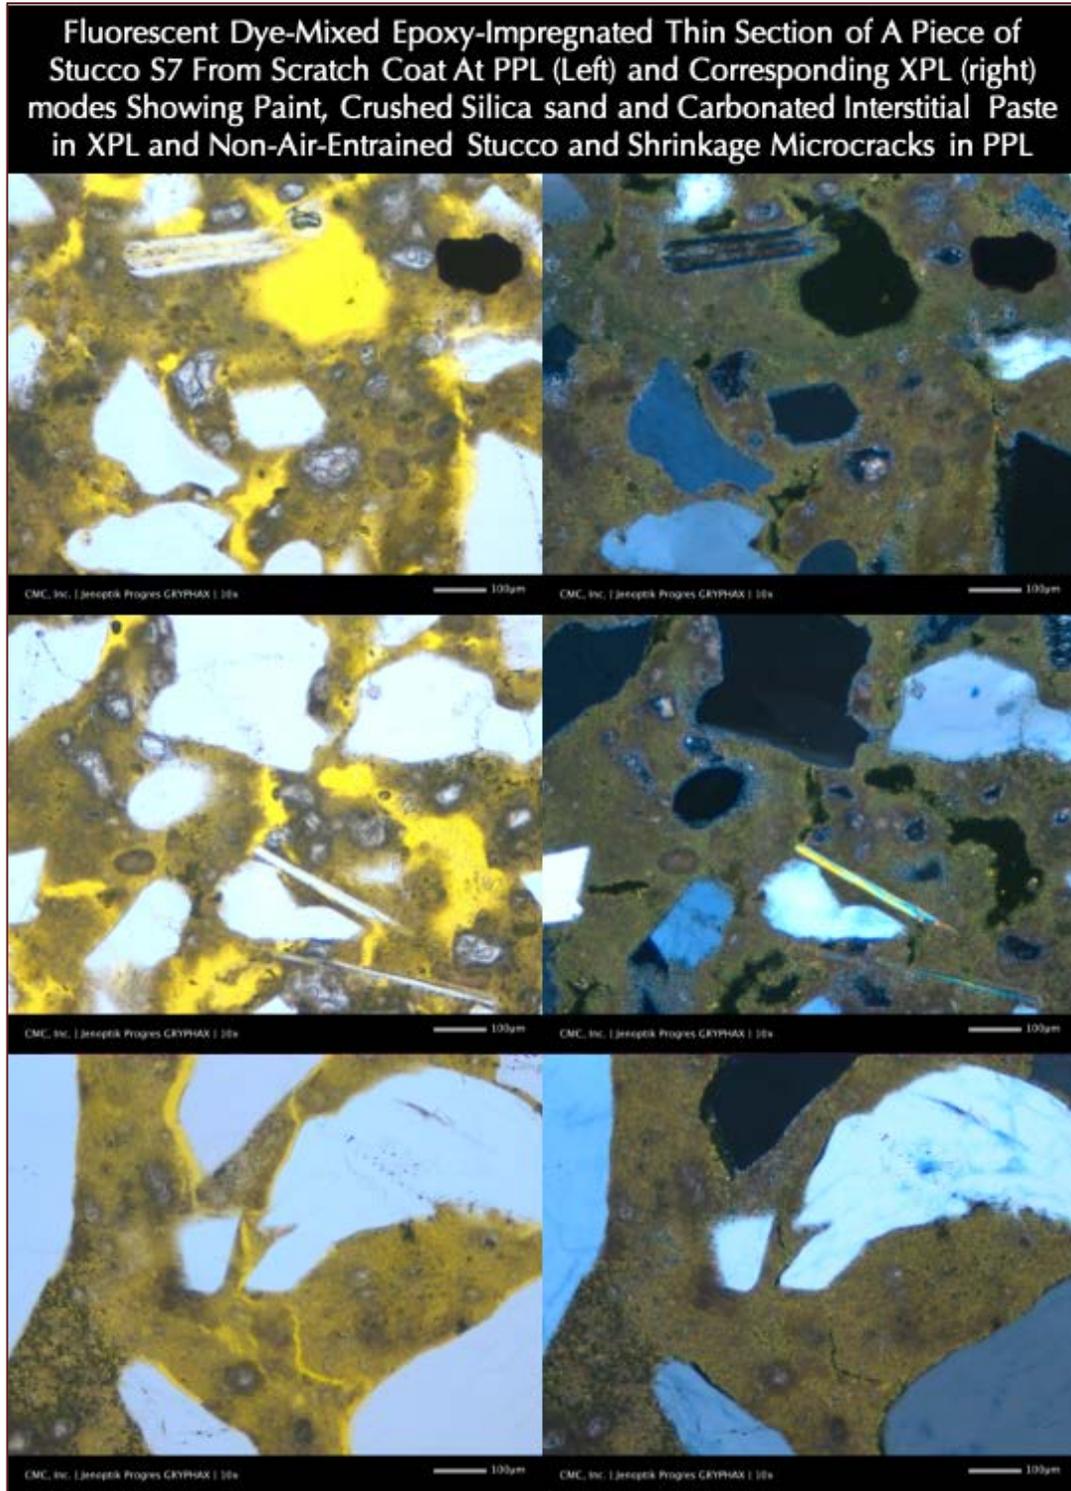
Figure 57: Micrographs of thin section of stucco S7 from south elevation in PPL (left) and corresponding XPL images, showing: (a) crushed sand in the scratch coat; (b) fine-grained, porous, carbonated lime paste of scratch coat having fine, hair-line, discontinuous elongated shrinkage microcracks in lime paste; and (c) dominance of quartz sand in the sand in scratch coat. Notice the absence of any Portland cement particles in the paste.

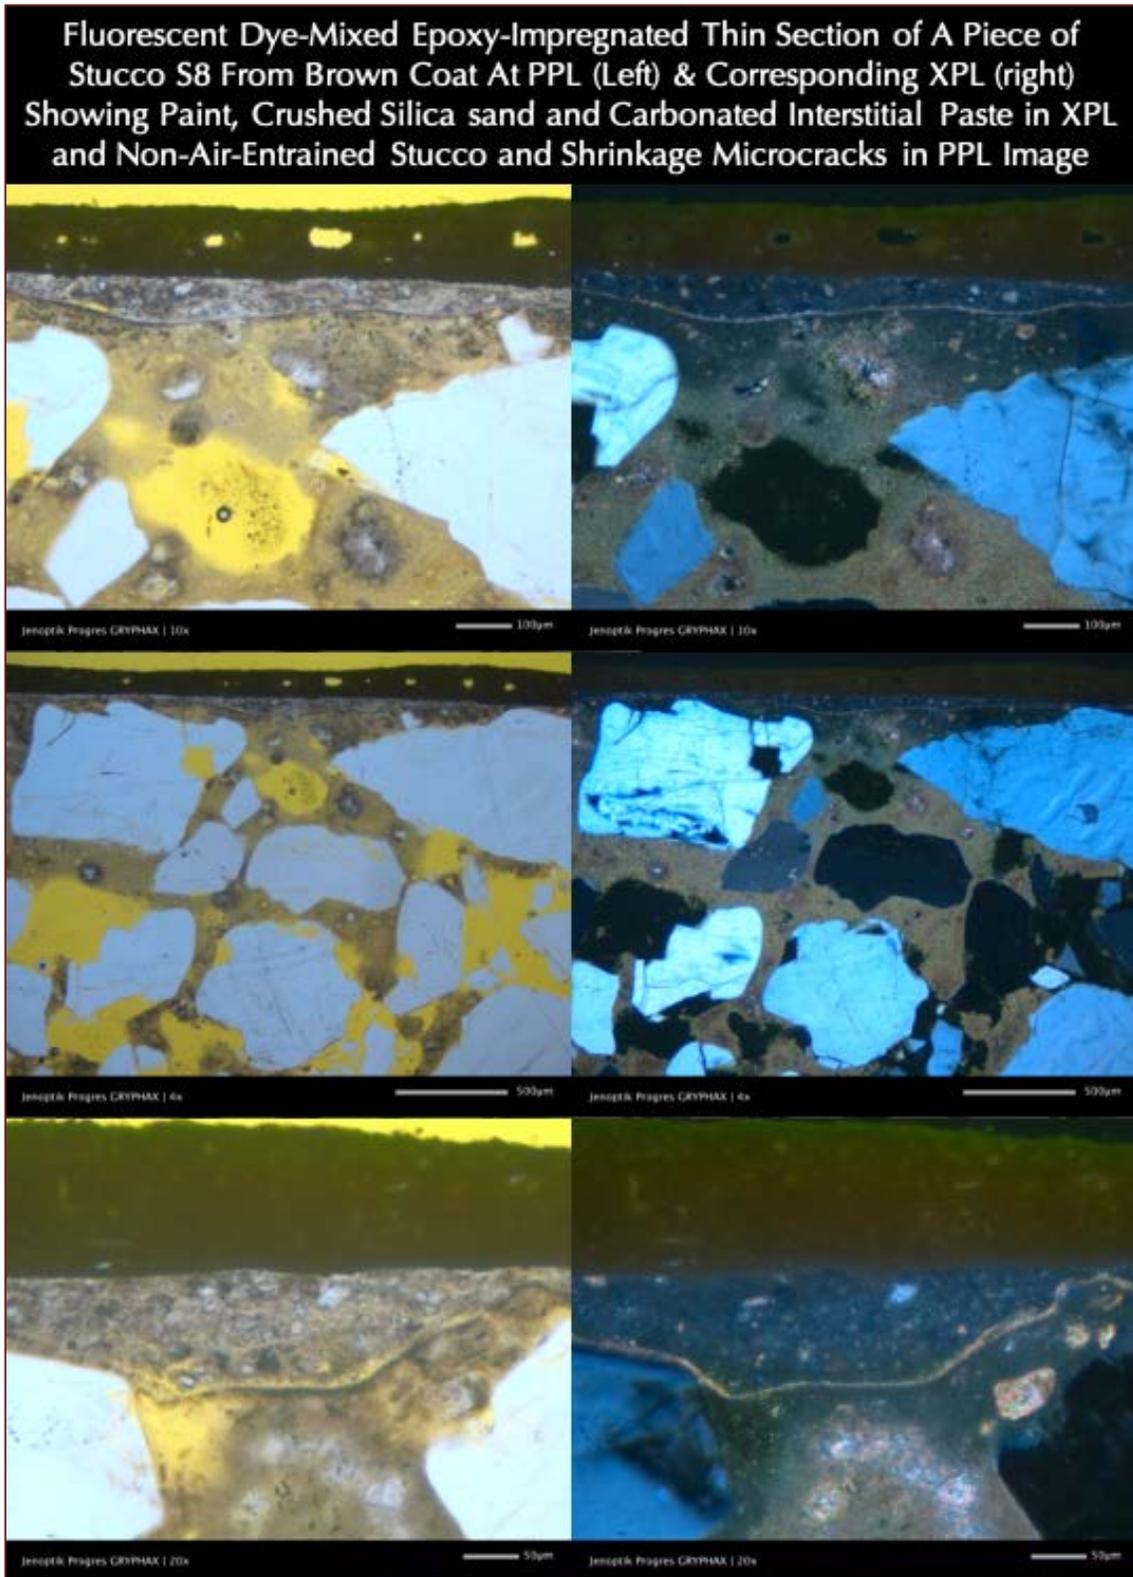
Figure 58: Micrographs of thin section of stucco S8 from east elevation in PPL (left) and corresponding XPL images, showing: (a) the thin (< 0.25 mm) paint (finish) coat and a distinct bonding agent coat on top of brown coat; (b) crushed silica sand particles in brown coat; (c) fine-grained, porous, carbonated lime paste of brown coat; (d) fine, hair-line, discontinuous elongated shrinkage microcracks in lime paste in brown coat; and (e) dominance of quartz sand in the brown coat's sand.
