## Laboratory Investigation Of Coating Failure From Stucco Façades Of An 18<sup>th</sup> Century Courthouse In Charleston, South Carolina

Charleston County Courthouse Exterior Façade  
Charleston, South Carolina

September 29, 2020  
CMC 0820145

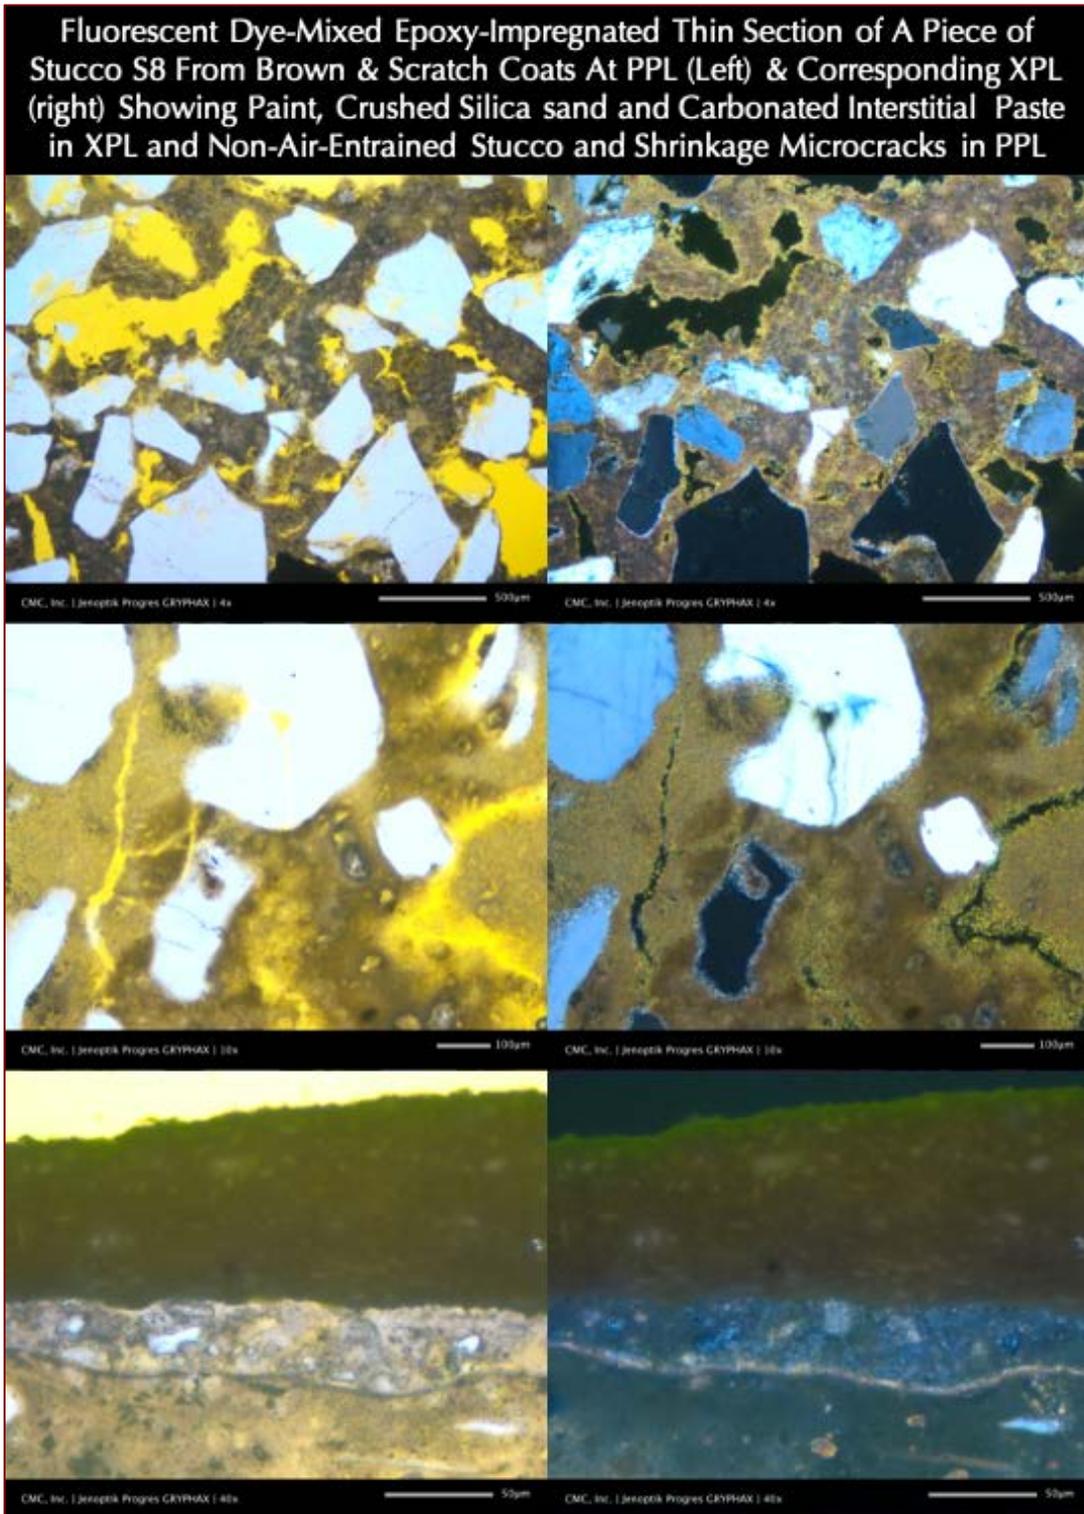
Figure 59: Micrographs of thin section of stucco S8 from east elevation in PPL (left) and corresponding XPL images, showing: (a) the thin (< 0.25 mm) paint (finish) coat and a distinct bonding agent coat on top of brown coat in the bottom row; (b) crushed silica sand particles in brown coat in the top row and relatively coarser crushed sand in the scratch coat in middle row; (c) fine-grained, porous, carbonated lime paste of brown coat; (d) fine, hair-line, discontinuous elongated shrinkage microcracks in lime paste in brown coat; and (e) dominance of quartz sand in the brown coat's sand.

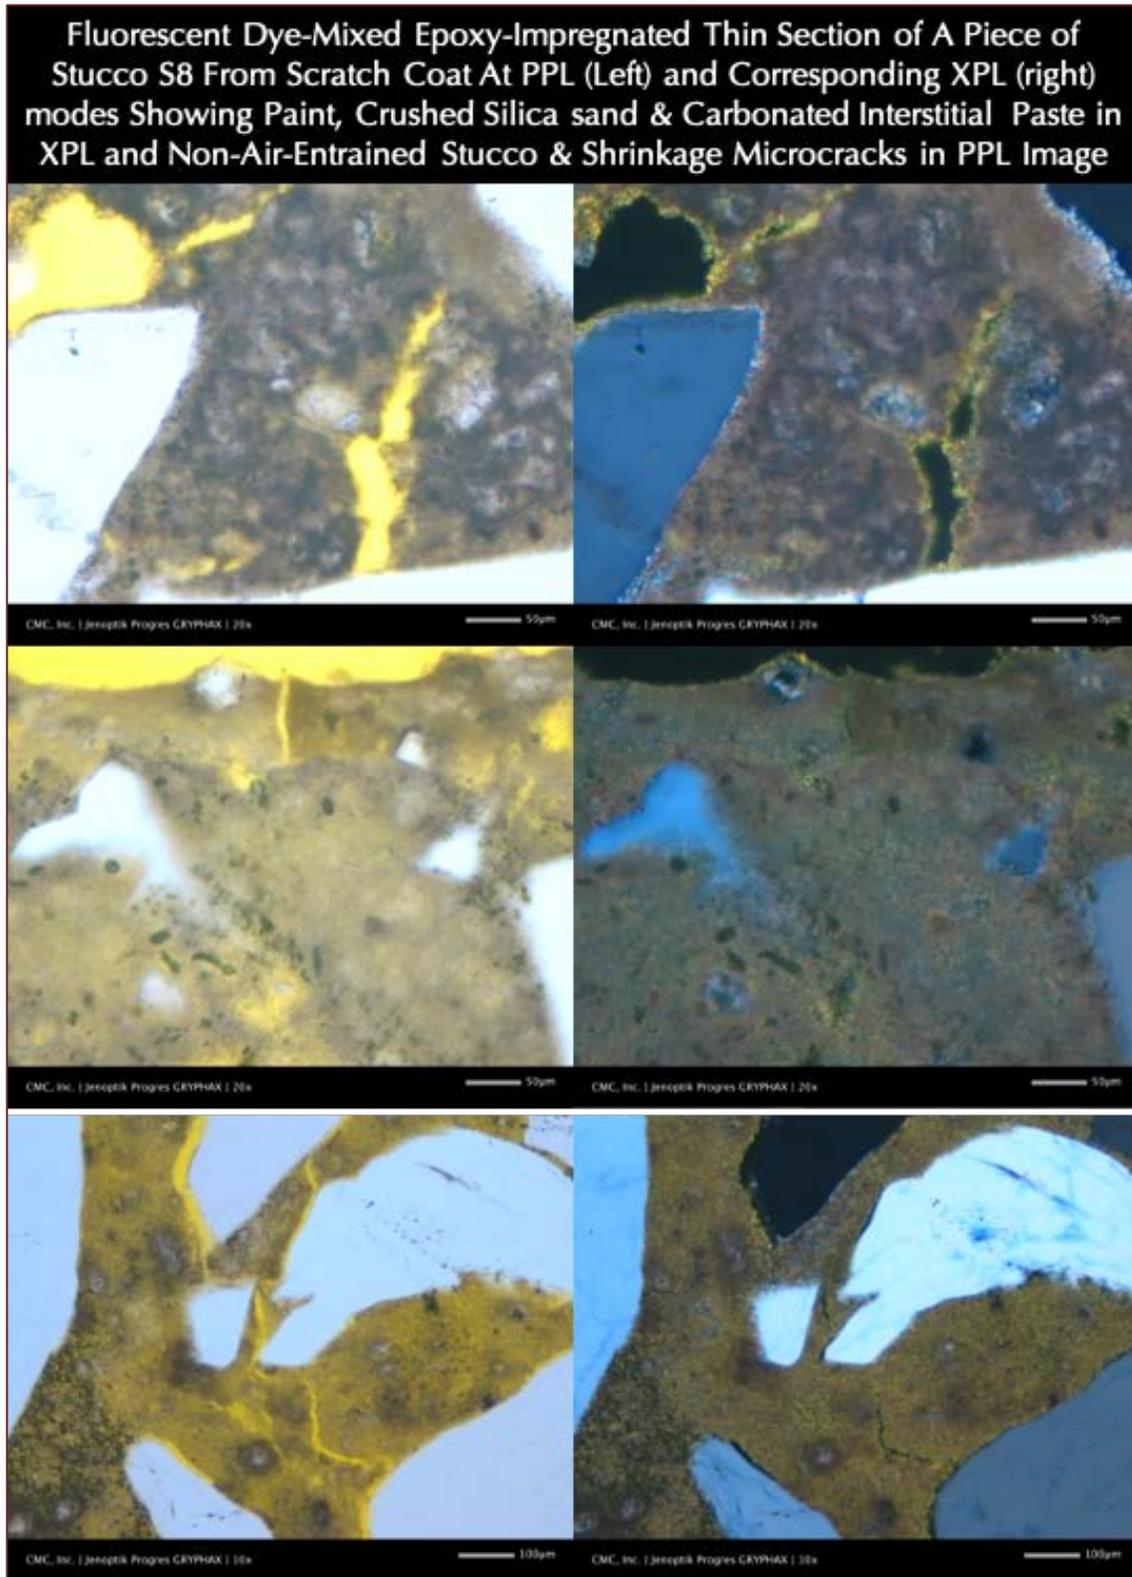
Figure 60: Micrographs of thin section of stucco S8 from east elevation in PPL (left) and corresponding XPL images, showing: (a) crushed sand in the scratch coat; (b) fine-grained, porous, carbonated lime paste of scratch coat having fine, hair-line, discontinuous elongated shrinkage microcracks in lime paste; and (c) dominance of quartz sand in the sand in scratch coat. Notice the absence of any Portland cement particles in the paste.

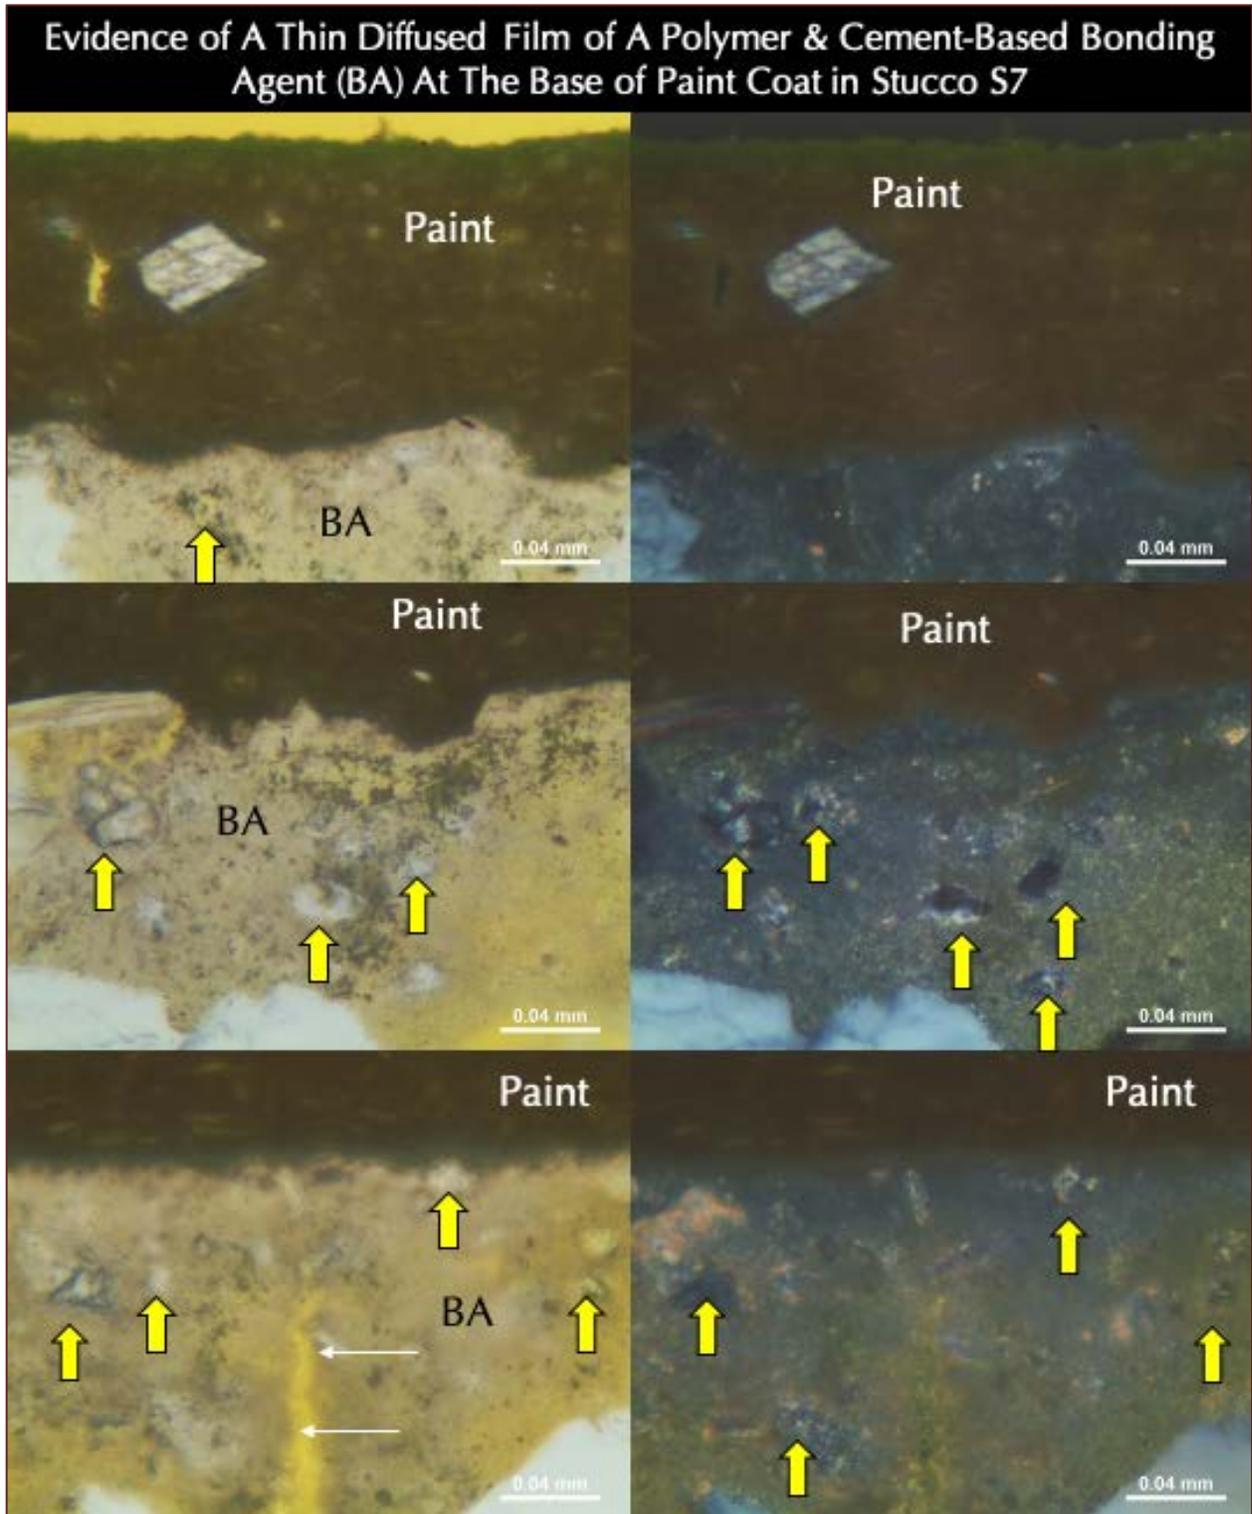
Figure 63: Micrographs of fluorescent dye-mixed epoxy-impregnated thin section of stucco S7 from south elevation showing details of paint coat, which has very fine talc filler (some are shown by fine vertical arrows) and titanium oxide pigment both of which are better detected from SEM-EDS and FTIR studies, an alkyd-based binder detected from FTIR studies, a thin porous diffused bonding agent beneath the paint containing fine residual cement particles (some are marked with thick vertical arrows) in a polymer binder which shows dark gray semi-isotropic appearance in XPL image with some fine carbonate fillers, somehow diffused into the stucco mass. Notice a vertical shrinkage microcrack in stucco that is truncated against the paint coat indicating its formation before application of paint.

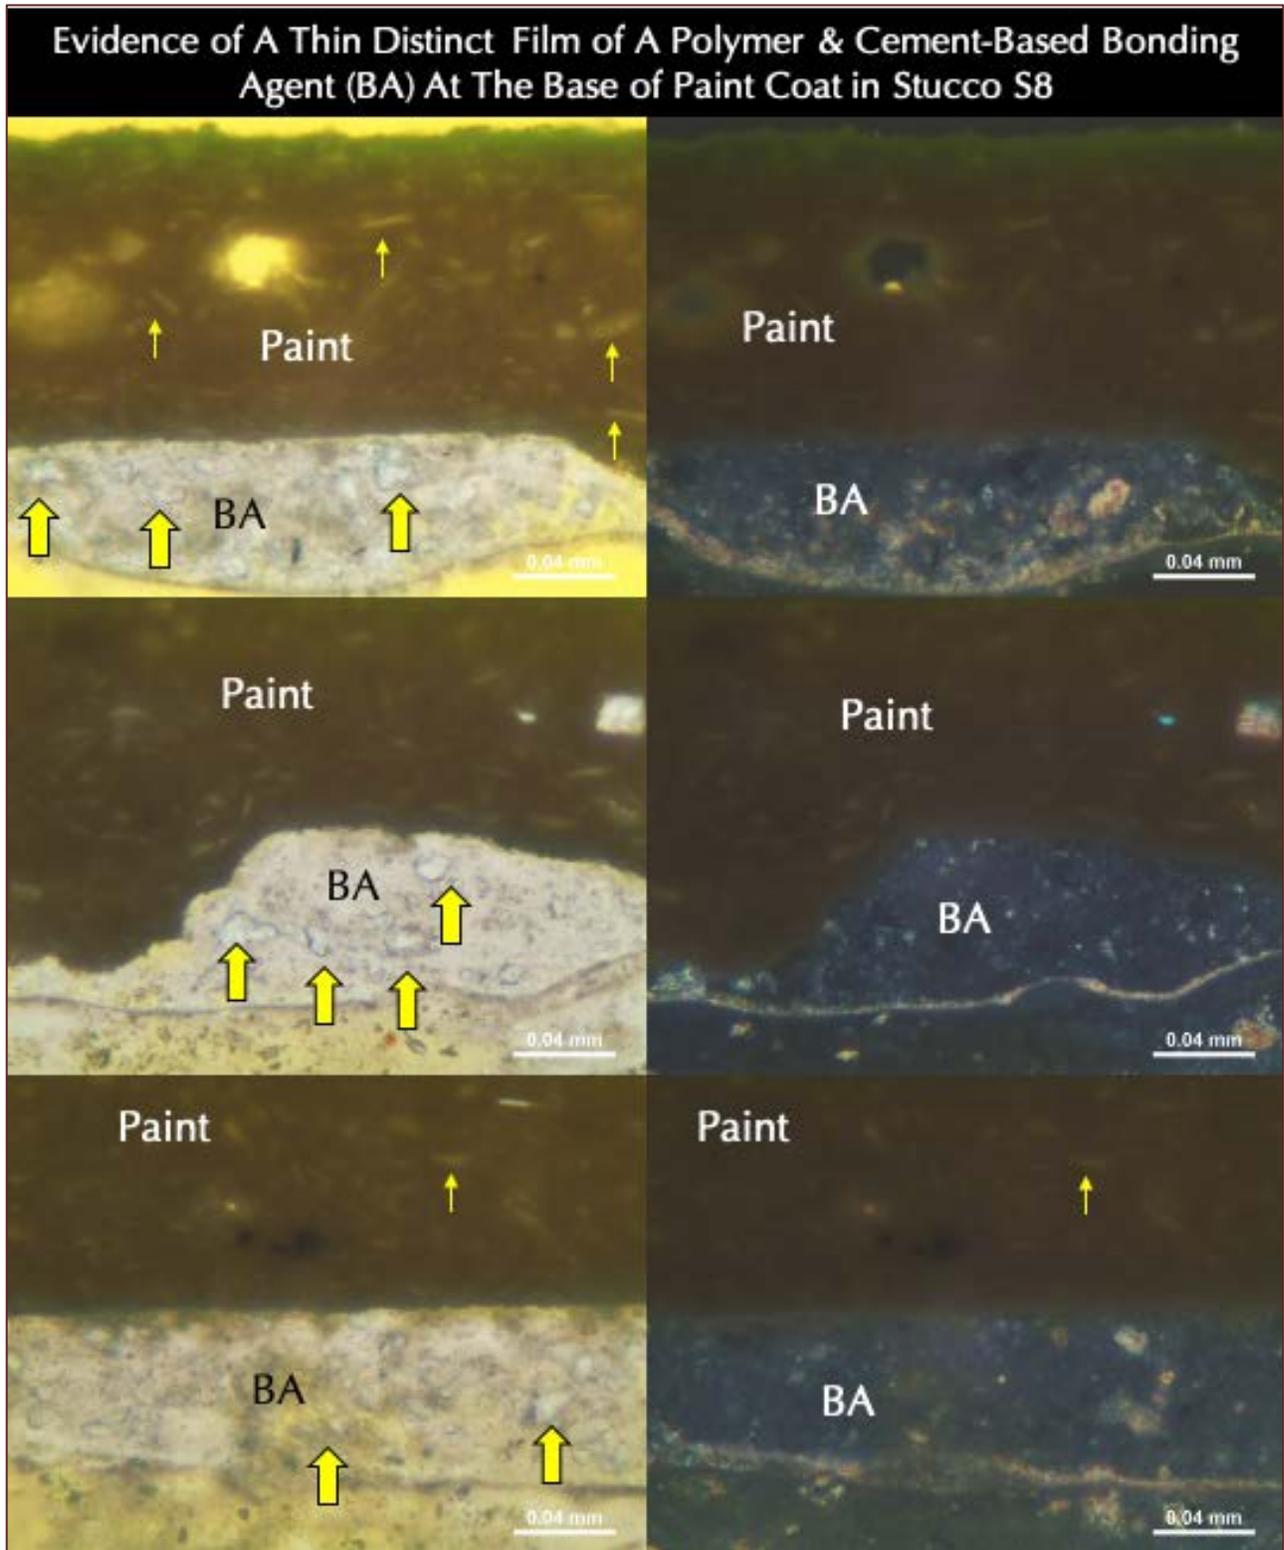
Figure 64: Micrographs of fluorescent dye-mixed epoxy-impregnated thin section of stucco S8 from east elevation showing details of paint coat, which has very fine talc filler (some are shown by fine vertical arrows) and titanium oxide pigment both of which are better detected from SEM-EDS and FTIR studies, an alkyd-based binder detected from FTIR studies, a thin distinct bonding agent beneath the paint containing fine residual cement particles (some are marked with thick vertical arrows) in a polymer binder which shows dark gray semi-isotropic appearance in XPL image with some fine carbonate fillers, which is not diffused into the stucco mass as in other two stuccos.

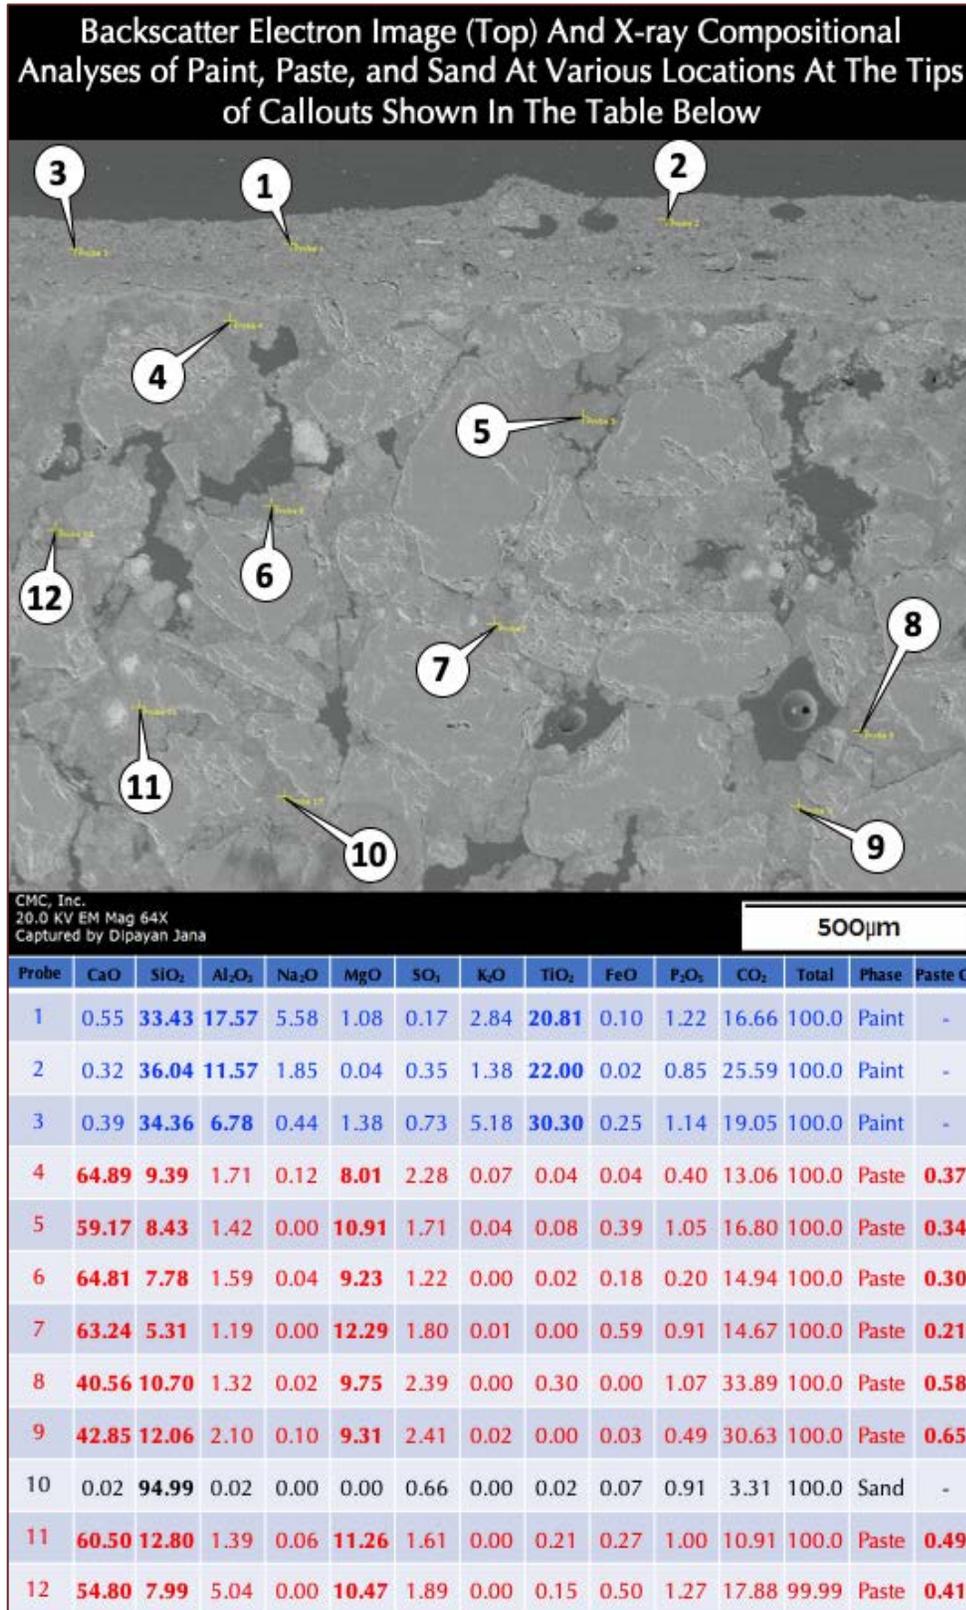
Figure 65: Backscatter electron image (top) and X-ray elemental (oxide compositional) analyses of paste, sand, and paint coat of stucco in S4 showing:

- (a) Distinct compositions of paint coat, sand, and interstitial paste in the stucco that are represented by oxide compositional variations in the Table from measurements at the tips of callouts in the backscatter image;

- (d) Absence of any Portland cement particles in the paste, which is consistent with its absence in the optical micrographs, hence all silica in the paste came from the hydraulic lime binder;

- (e) Measurable magnesium content of paste indicating use of a dolomitic lime binder; and,
- (f) Cementitious indices (CI after Eckel, 1922) of paste are all less than 1 which are consistent with hydraulic lime composition of the binder without any cement.

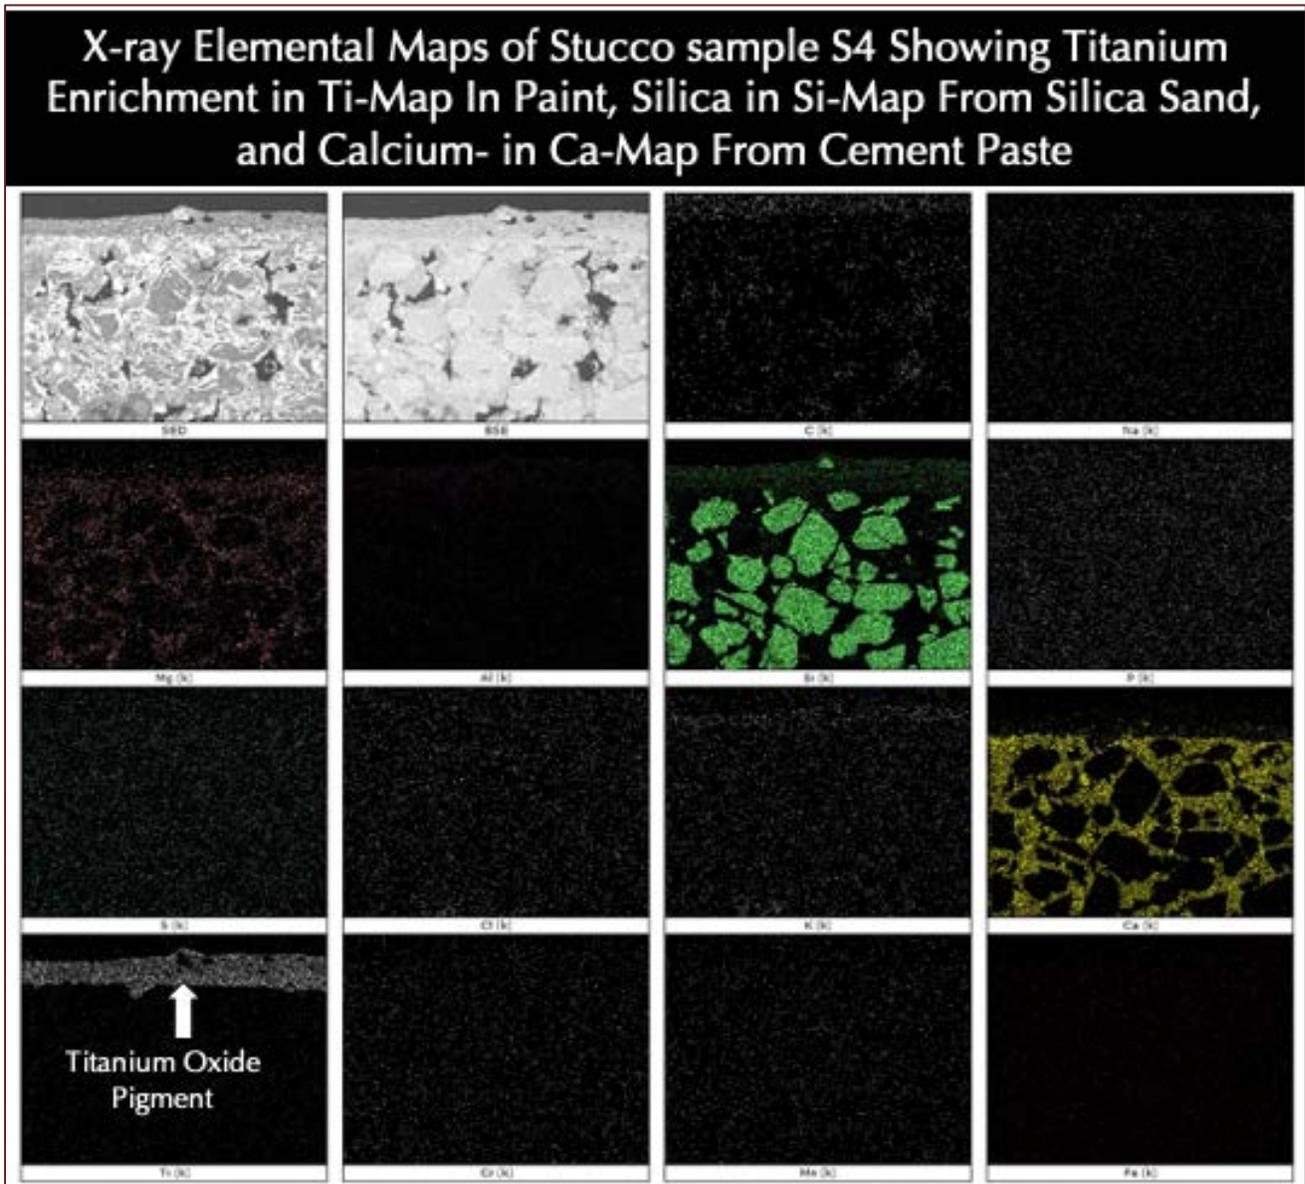
Figure 66: X-ray elemental maps of stucco S4 in SEM-EDS studies showing: (a) titanium enrichment in the paint coat from use of titanium oxide pigment in the paint, (b) characteristic lime-based composition of lime paste in the Ca map, along with (c) some magnesium in the paste detected in the Mg-map indicating use of dolomitic lime binder in stucco; (d) silica sand composition indicated by detection of sand in Si map; and (e) the absence of any other elements to be detected in EDS studies.

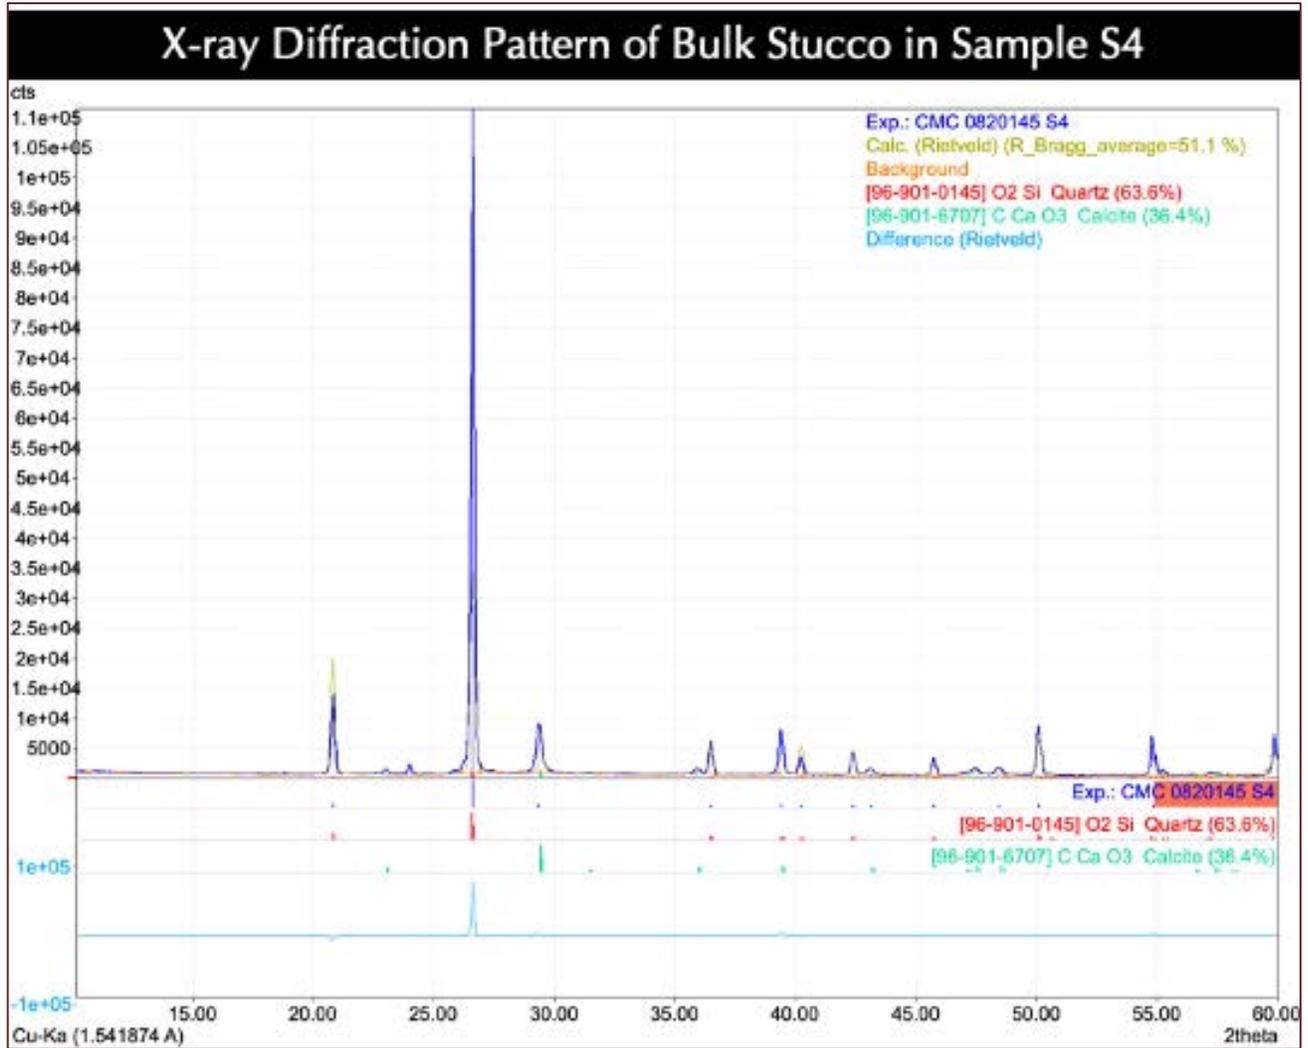
Figure 67: X-ray diffraction pattern of the entire stucco in S4 including both scratch and brown coats showing the dominance of crushed silica sand seen in optical micrographs of both coats as the dominant quartz peak followed by subordinate calcite from the overwhelming carbonated lime paste of lime binder.

XRD studies showed 63.6 percent quartz from quartz sand and 36.4 percent calcite from fine-grained carbonated lime paste.

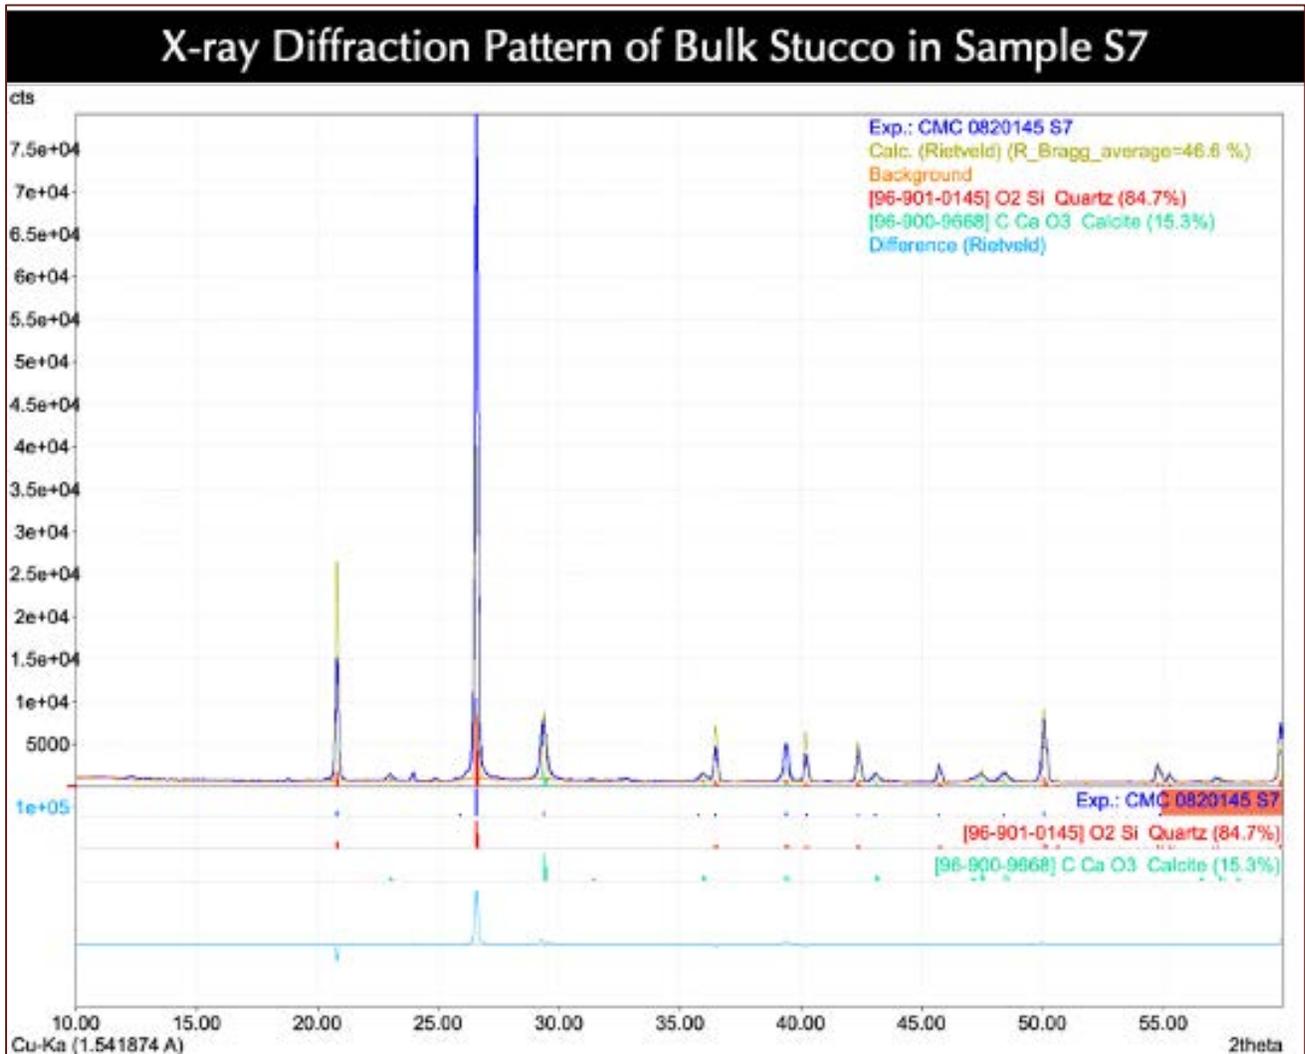
Figure 68: X-ray diffraction pattern of the entire stucco in S7 including both scratch and brown coats showing the dominance of crushed silica sand seen in optical micrographs of both coats as the dominant quartz peak followed by subordinate calcite from the overwhelming carbonated lime paste of lime binder.

XRD studies showed 84.7 percent quartz from quartz sand and 15.3 percent calcite from fine-grained carbonated lime paste.

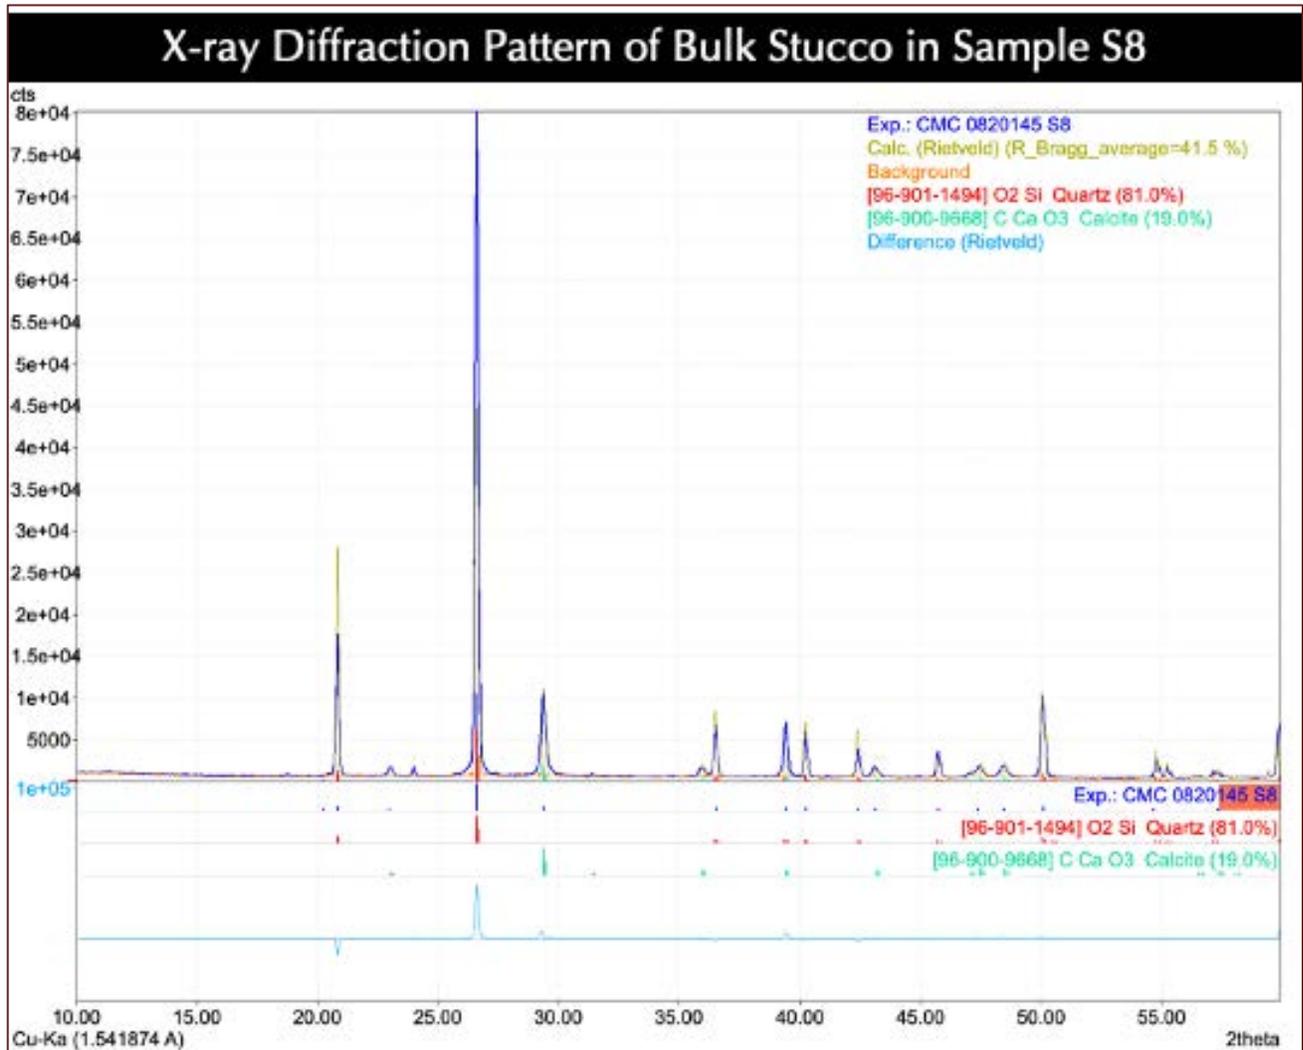
Figure 69: X-ray diffraction pattern of the entire stucco in S8 including both scratch and brown coats showing the dominance of crushed silica sand seen in optical micrographs of both coats as the dominant quartz peak followed by subordinate calcite from the overwhelming carbonated lime paste of lime binder.

XRD studies showed 81.0 percent quartz from quartz sand and 19.0 percent calcite from fine-grained carbonated lime paste.

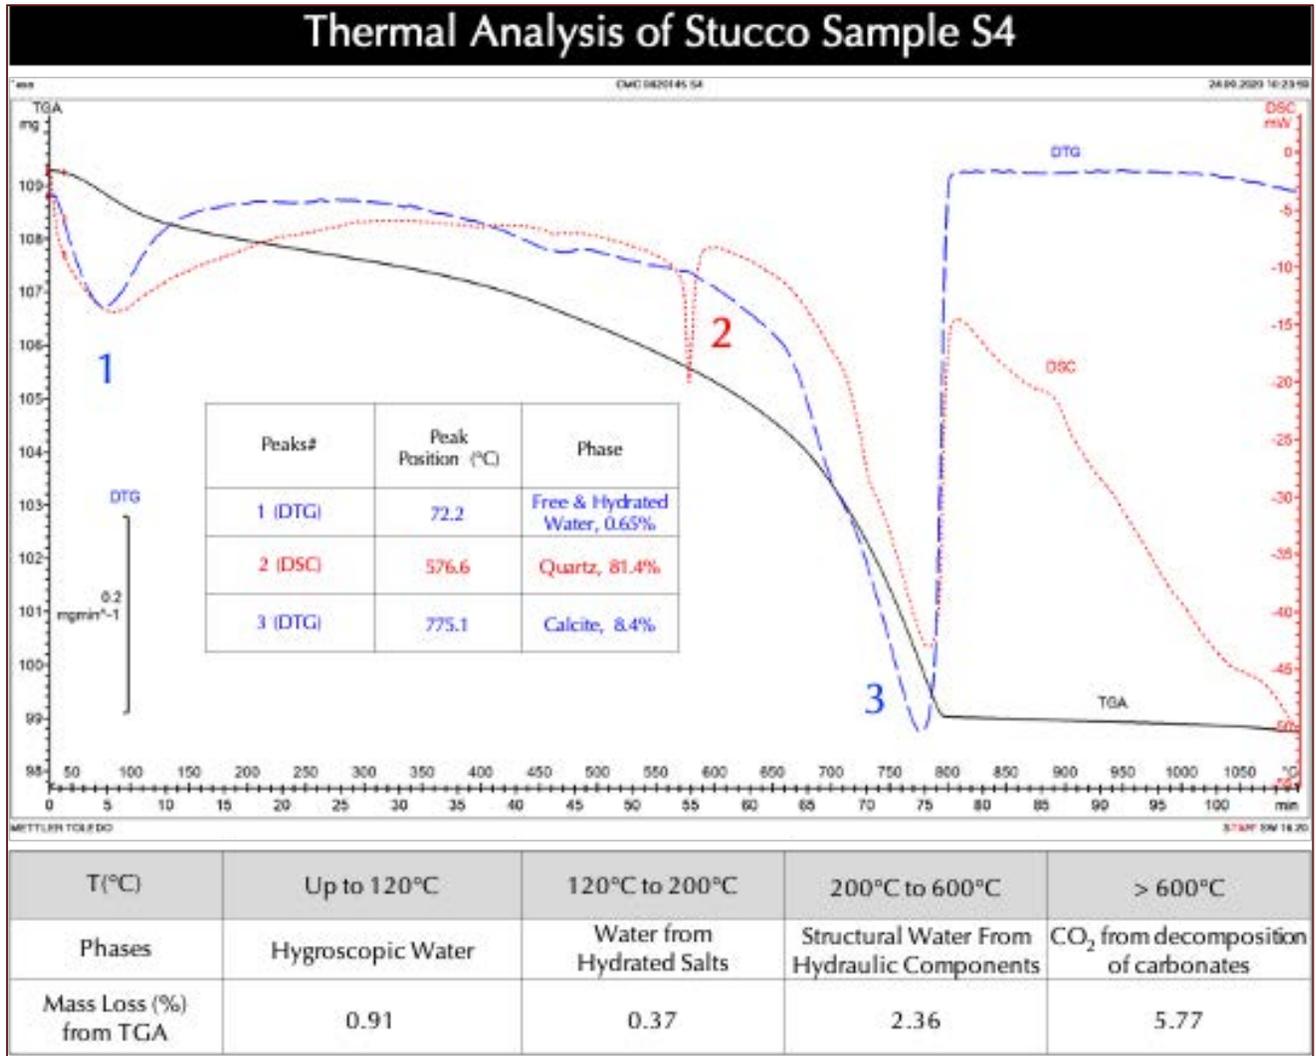
Figure 71: TGA (bold black), DSC (dotted red), and DTG (dashed blue) curves of stucco S4 showing losses in weight due to various decompositions (loss of water and carbon dioxide) during controlled heating in a Mettler-Toledo’s simultaneous TGA/DSC 1 unit from 30°C to 1000°C in a ceramic crucible (alumina 70µl, no lid) at a heating rate of 10°C/min in a nitrogen purge at a rate of 75 mL/min.

Result shows about 1 percent loss in mass from loss of free water and hydrate water at up to 120°C followed by a lesser loss of 0.37 percent from 120°C to 200°C, then a loss of 2.36 percent from 200°C to 600°C due to loss of hydrate water from hydration products of hydraulic lime paste. Degree of carbonation is 5.77% due to decomposition of carbonate lime paste in stucco. Quartz content is around 80 percent determined from polymorphic transition of quartz around 575°C.

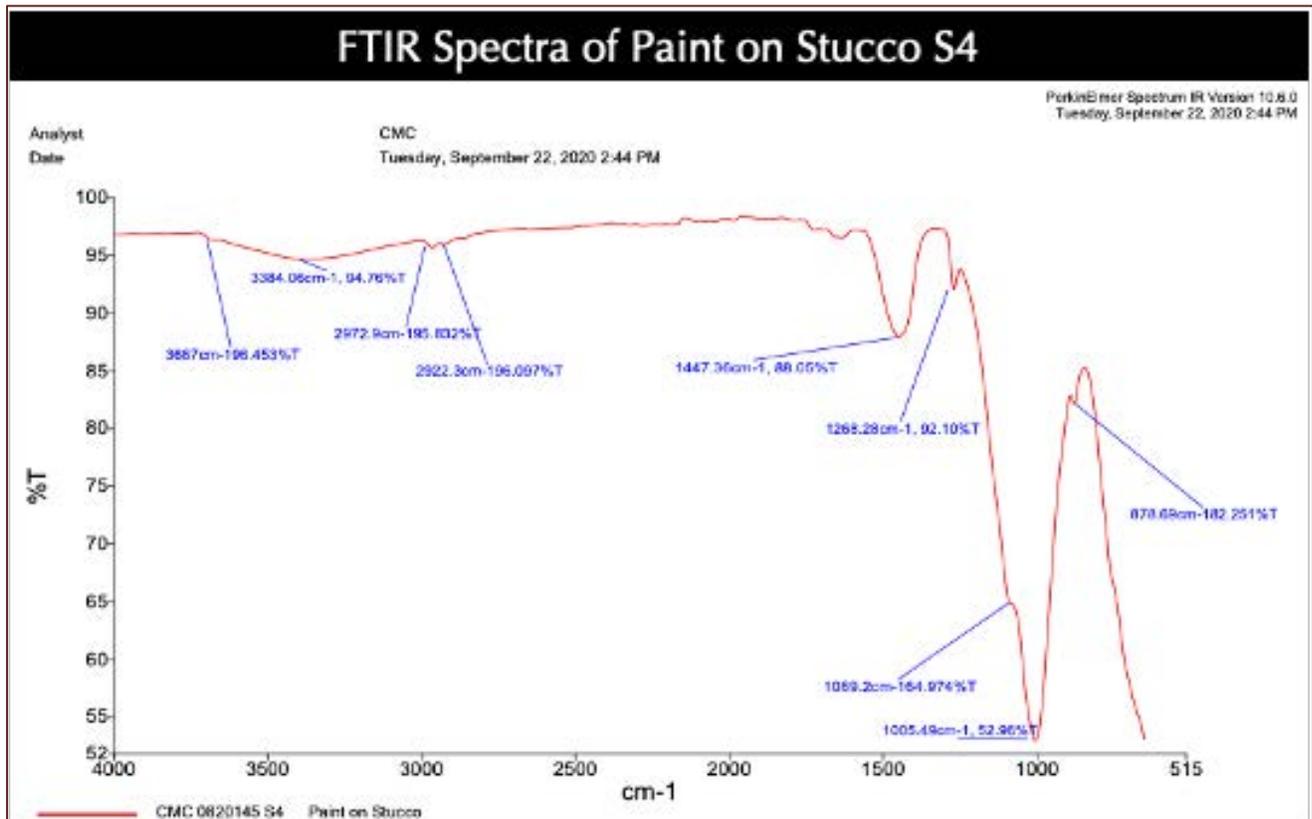
- The bands near 1005 and 3687 are from talc filler in paint
- The bands at 878 and 1447 are from calcite
- The band at 1268 is a resin band consistent with an alkyd or oil-based material, which is odd in a stucco since this resin is sensitive to alkalinity, so acrylic resins are more often used on stucco.

Figure 72: FTIR spectra of paint coat scrapped from the exterior face of Sample S4 showing: (a) bands near 1005 cm<sup>-1</sup> and 3687 cm<sup>-1</sup> corresponding to talc filler in paint; (b) bands at 878 cm<sup>-1</sup> and 1147 cm<sup>-1</sup> corresponding to

calcite partly from calcite filler in the bonding agent of paint and partly from contaminant carbonated lime binder of stucco; and (c) a band at  $1268\text{ cm}^{-1}$  corresponding to an alkyd resin or oil-based binder, which is not resistant to the alkaline medium of stucco especially at the newly installed stage before the stucco surface that was painted has had a pH around 9 or lower from atmospheric carbonation to prevent alkali-induced deterioration of alkyd based paint. An acrylic paint would have produced a band near  $1170\text{ cm}^{-1}$  sometimes with a smaller band near  $1240\text{ cm}^{-1}$ .

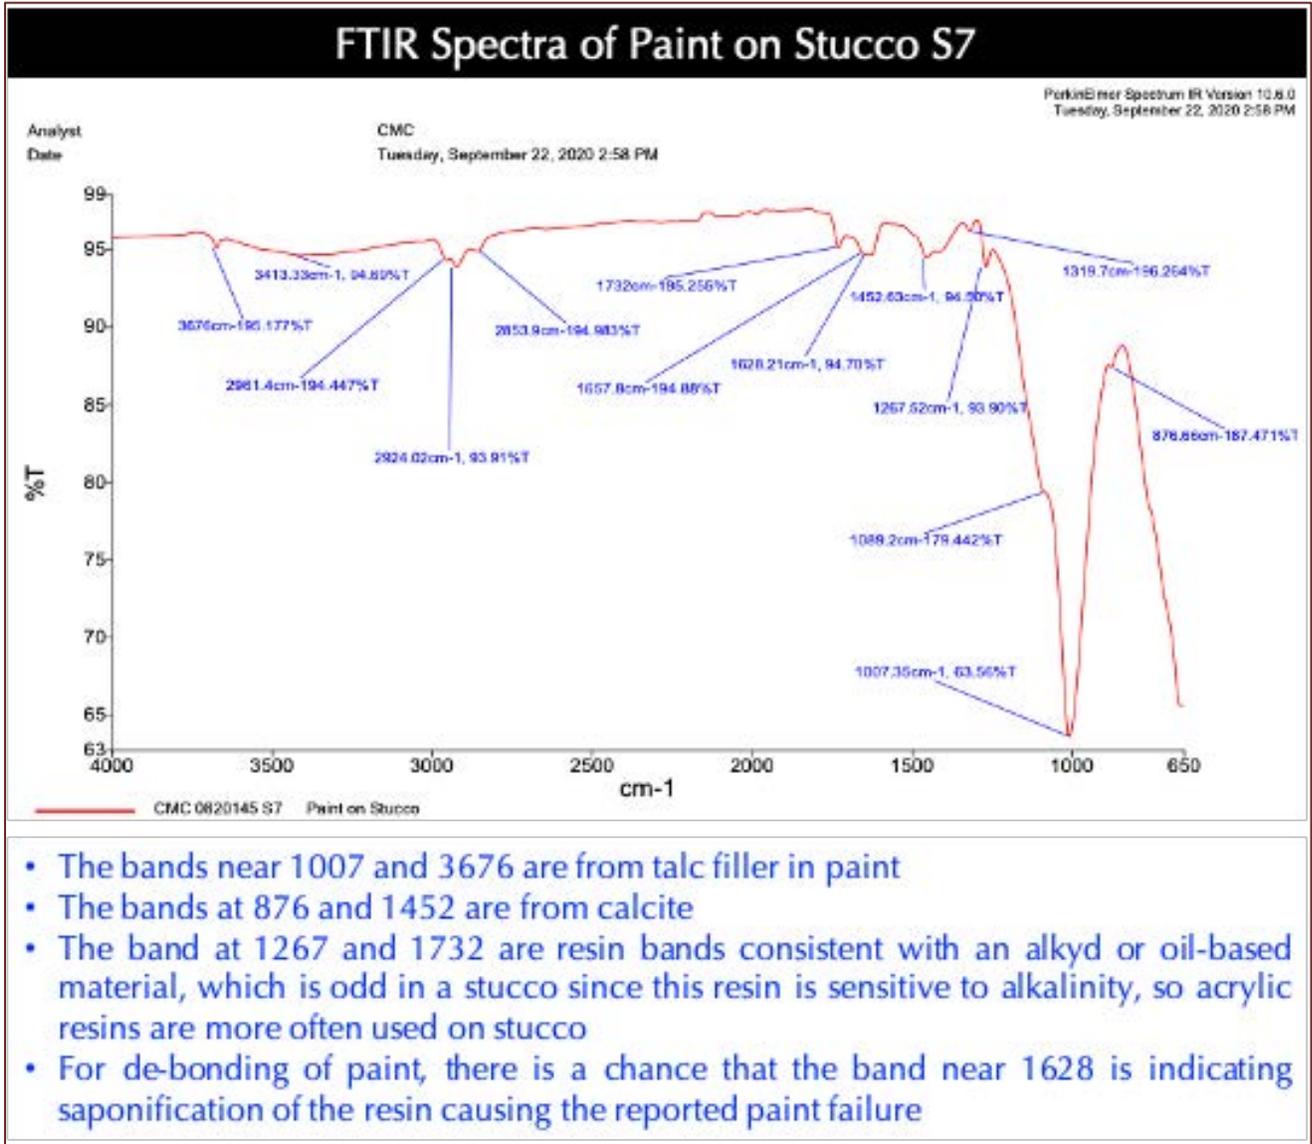
Figure 73: FTIR spectra of paint coat scrapped from the exterior face of Sample S7 showing: (a) bands near  $1007\text{ cm}^{-1}$  and  $3676\text{ cm}^{-1}$  corresponding to talc filler in paint; (b) bands at  $876\text{ cm}^{-1}$  and  $1452\text{ cm}^{-1}$  corresponding to calcite partly from calcite filler in the bonding agent of paint and partly from contaminant carbonated lime binder of stucco; and (c) bands at  $1267\text{ cm}^{-1}$  and  $1732\text{ cm}^{-1}$  corresponding to an alkyd resin or oil-based binder, which is not resistant to the alkaline medium of stucco especially at the newly installed stage before the stucco surface that was painted has had a pH around 9 or lower from atmospheric carbonation to prevent alkali-induced deterioration of alkyd based paint. For the reported peeling of paint, there is a possibility that the band near  $1628\text{ cm}^{-1}$  is indicating saponification of the resin to cause the paint failure from alkaline degradation of alkyd-based paint. An acrylic paint would have produced a band near  $1170\text{ cm}^{-1}$  sometimes with a smaller band near  $1240\text{ cm}^{-1}$ .

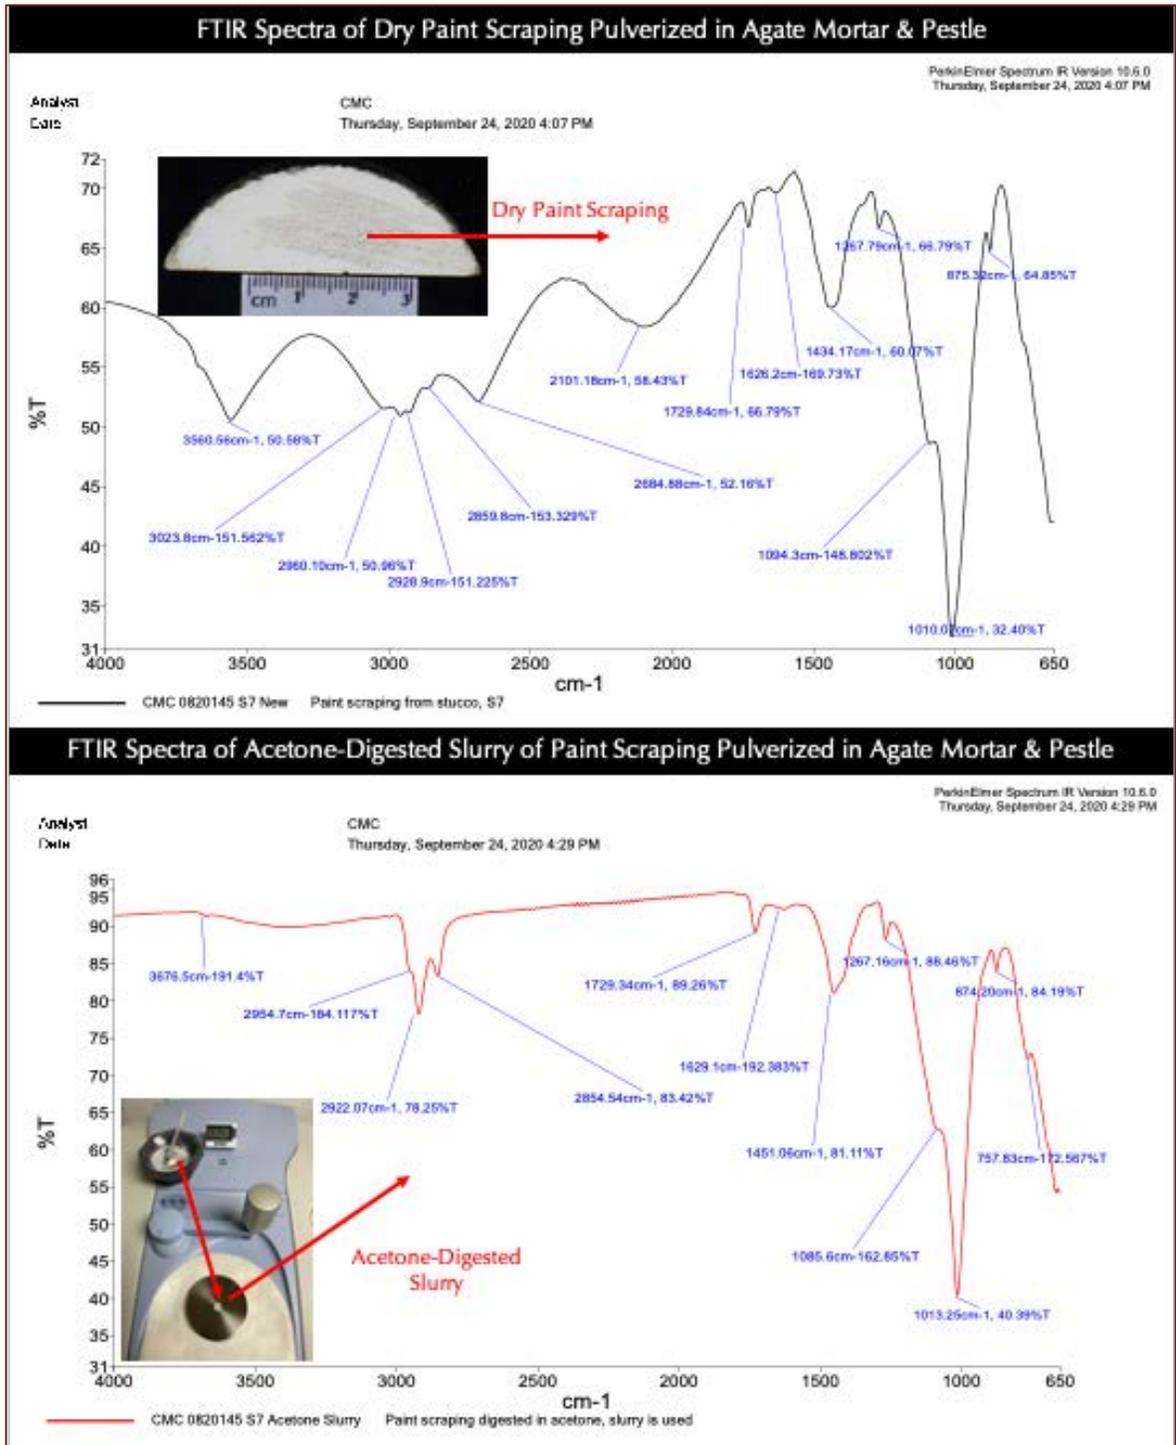
Figure 74: FTIR spectra of pulverized dry powder of paint coat scrapped from the exterior face of Sample S7 at the top, and the slurry after digesting the paint in acetone at the bottom showing: (a) bands near 1010  $\text{cm}^{-1}$  and 3676  $\text{cm}^{-1}$  corresponding to the talc filler in paint; (b) bands at 874  $\text{cm}^{-1}$  and 1451  $\text{cm}^{-1}$  corresponding to calcite partly from calcite filler in the bonding agent of paint and partly from contaminant carbonated lime binder of stucco; and (c) bands at 1267  $\text{cm}^{-1}$  and 1729  $\text{cm}^{-1}$  corresponding to an alkyd resin or oil-based binder, which is not resistant to the alkaline medium of stucco especially at the newly installed stage before the stucco surface that was painted has had a pH around 9 or lower from atmospheric carbonation to prevent alkali-induced deterioration of alkyd based paint. For the reported peeling of paint, there is a possibility that the band near 1628  $\text{cm}^{-1}$  is indicating saponification

of the resin to cause the paint failure from alkaline degradation of alkyd-based paint. An acrylic paint would have produced a band near  $1170\text{ cm}^{-1}$  sometimes with a smaller band near  $1240\text{ cm}^{-1}$ .
